# Luscar Mine Tailings Storage Facility 2021 Annual Inspection

*Cardinal River Mine*

**Teck Coal Limited**

**Golder Associates Ltd.**

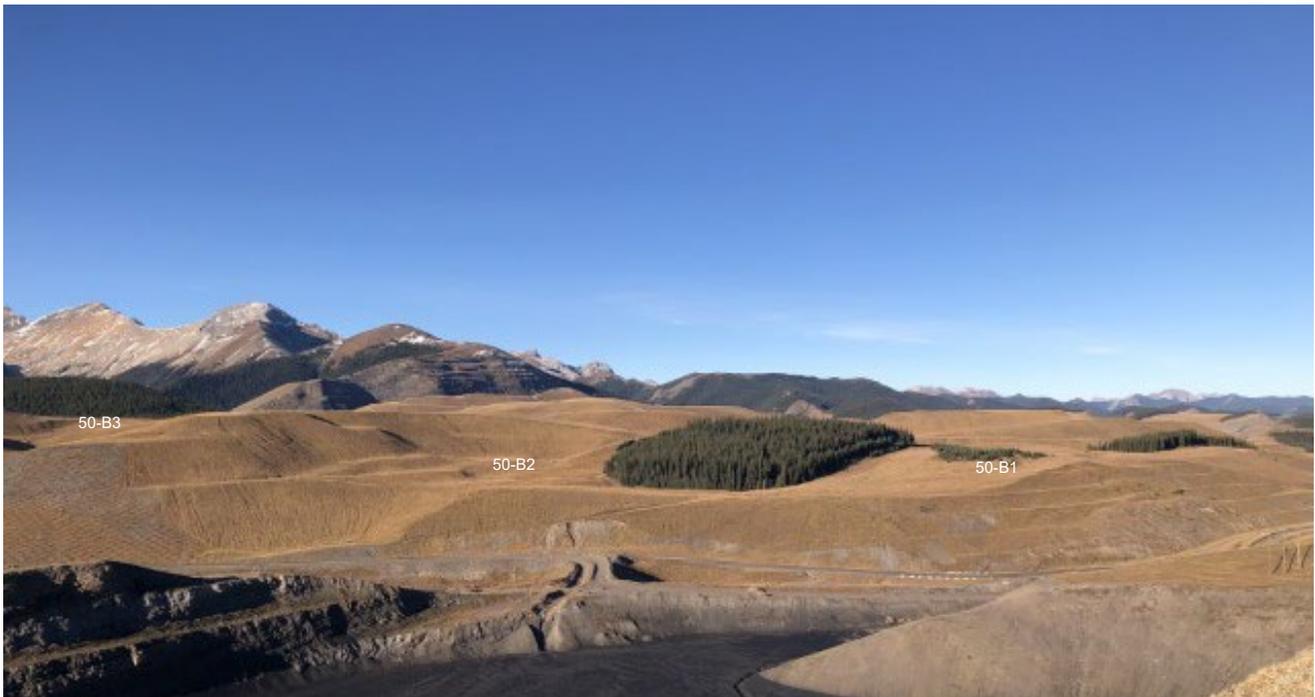
- The overall condition of three TSFs is shown in Photo A-1 through Photo A-6. The three TSFs appeared to be in satisfactory physical condition. The backfilled and recontoured slopes appeared to be stable with no visual signs of distress, apparent settlement, or ground movement that would suggest potential instability or poor performance.

**Photo A-1: Panoramic view looking north west near WP03 at the reclaimed 50-B1, 50-B2, and 50-B3 areas (WP03, IMG\_6945)**

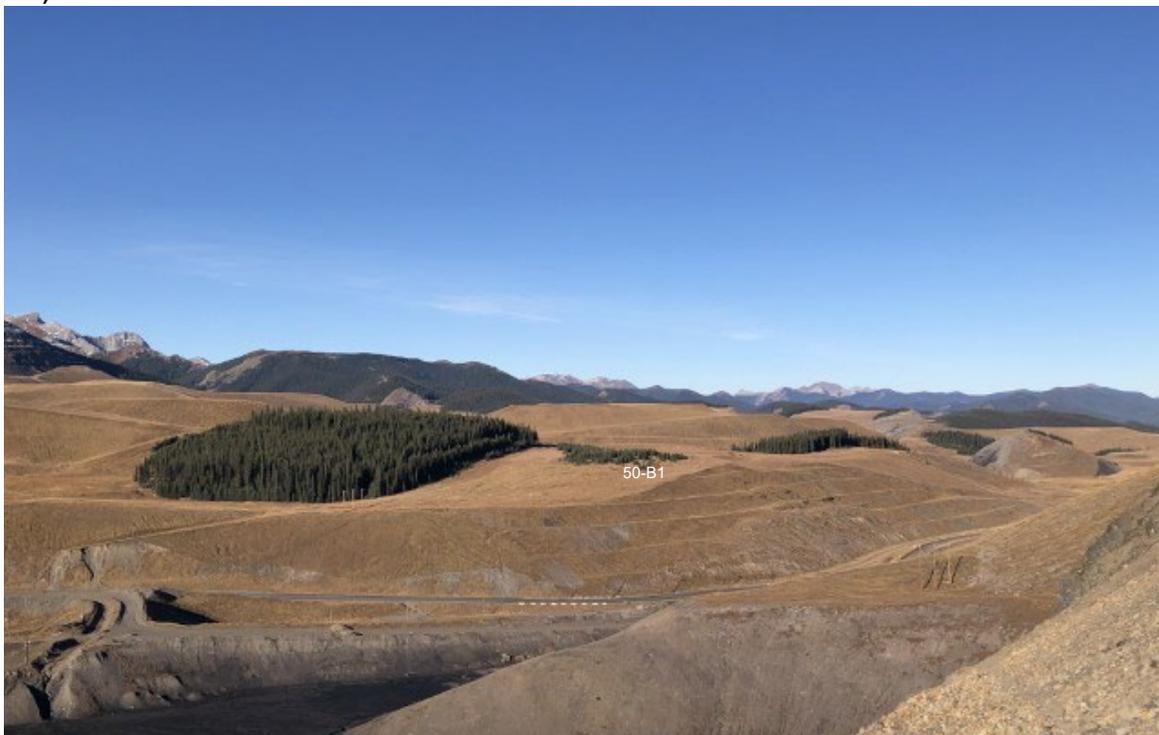
- No exposed pit slopes were observed.
- The reclamation appears to be well established across the majority of the filled areas. There are areas of underdeveloped vegetation in the slopes of 50-B1 (Photo A-2), and 50-B2/50-B3 (Photo A-6), but the slopes appeared to remain stable.

**Photo A-2: Looking north west near WP03 at the reclaimed 50-B1 surface and slopes (WP03, IMG\_6944)**

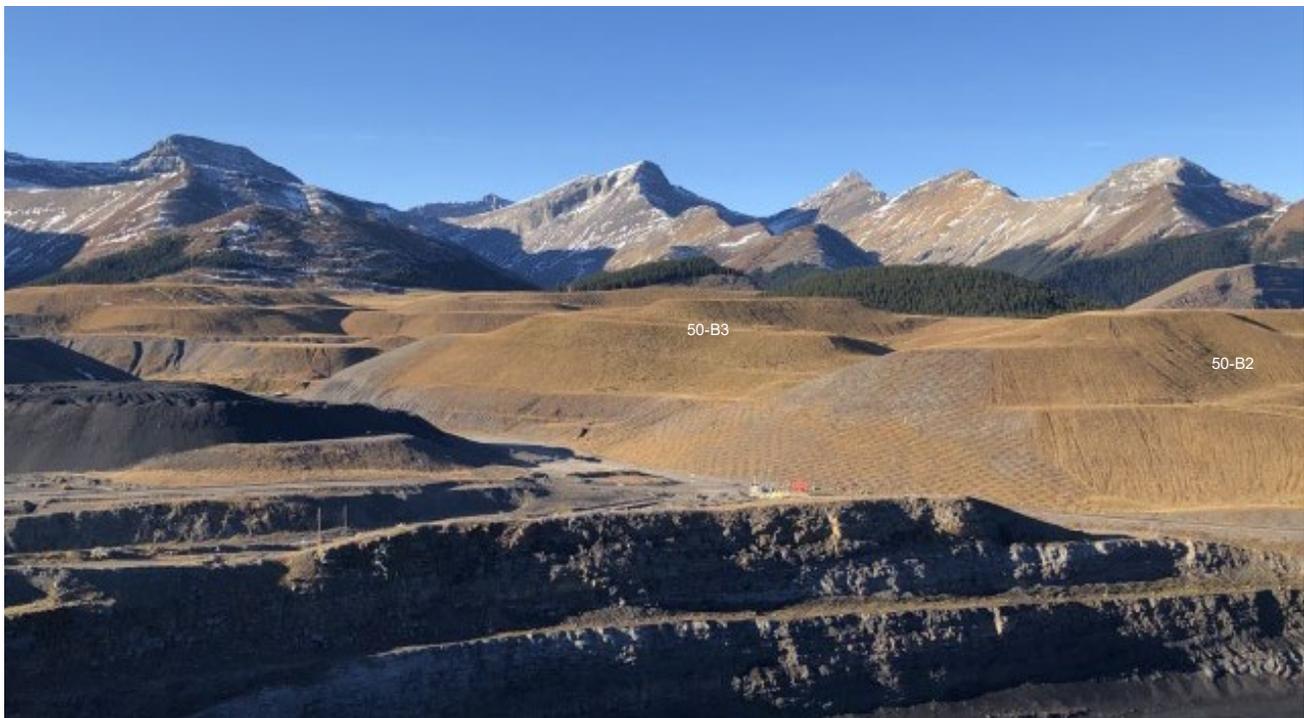
- The backfilled and contoured areas appeared to be well drained and no areas of ponded water were observed. It is not clear from the inspection whether water will pond in contoured depressions above 50-B3 (Photo A-6).

Photo A-6: Looking west from WP03 at the reclaimed surface and slopes of 50-B3 (IMG\_6942)

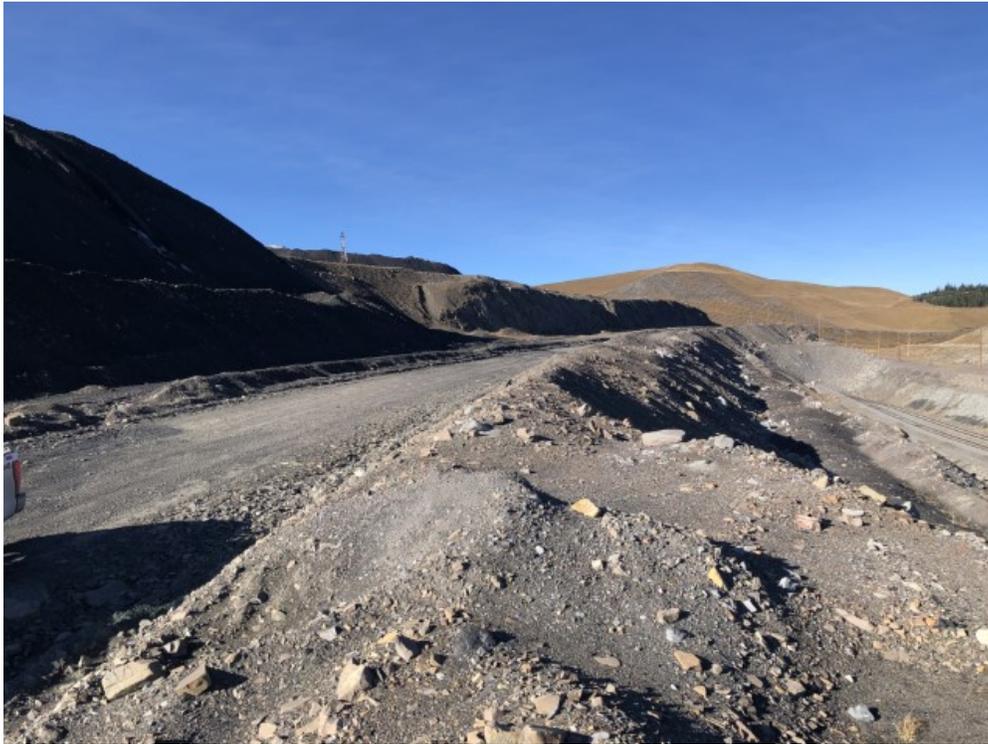
- The surface of the CCR remains exposed and has not been reclaimed.
- No exposed tailings were observed.
- Some infrastructure extends along the north perimeter of 50-B4 including a railway, hwy 40, and a power line (Photo A-7 and Photo A-8).

**Photo A-7: Looking north near WP11 at the exposed CCR surfaces above 50-B4 (WP11, IMG\_6997)**

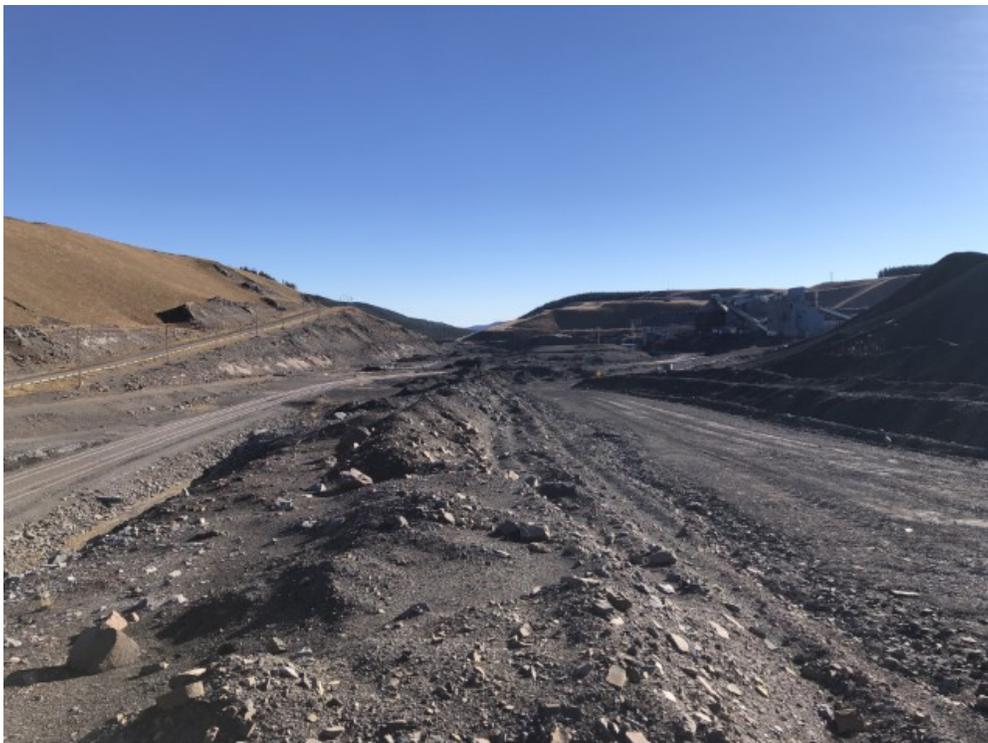
**Photo A-8: Looking south near WP11 at the exposed CCR surface and east pit wall associated with 50-B4 (WP11, IMG\_6995)**

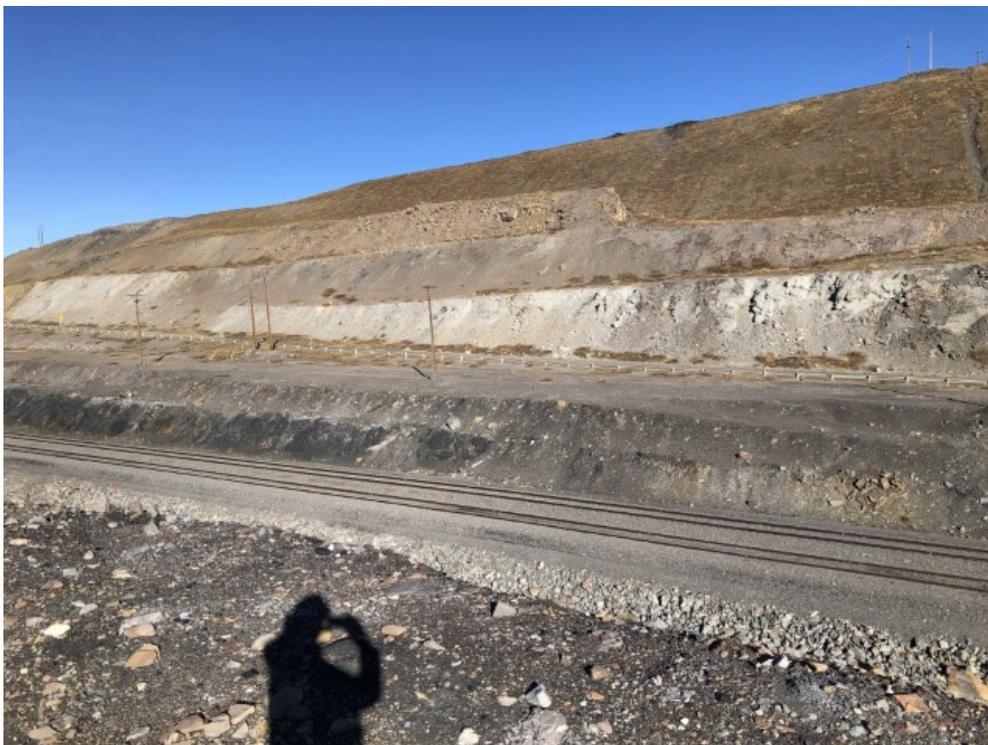
- The pit slopes along the north perimeter are exposed over limited heights and generally appeared to be stable (Photo A-10, Photo A-11, Photo A-14, and Photo A-15). A pit wall stability analysis was completed by Teck in 2021 and submitted to the regulator in 2021 (Teck, 2021a).

**Photo A-10: Looking north west near WP11 at the east pit wall boundary of 50-B4 (WP11, IMG\_7001)**

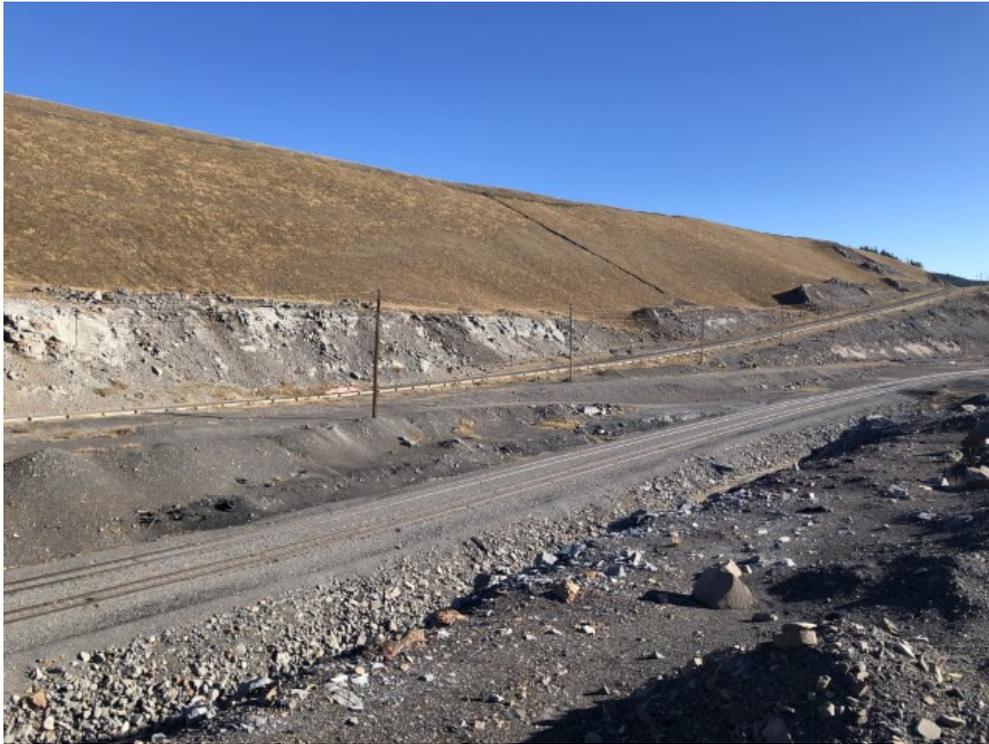
**Photo A-11: Looking south west near WP11 at the east pit wall boundary of 50-B4 (WP11, IMG\_7002)**

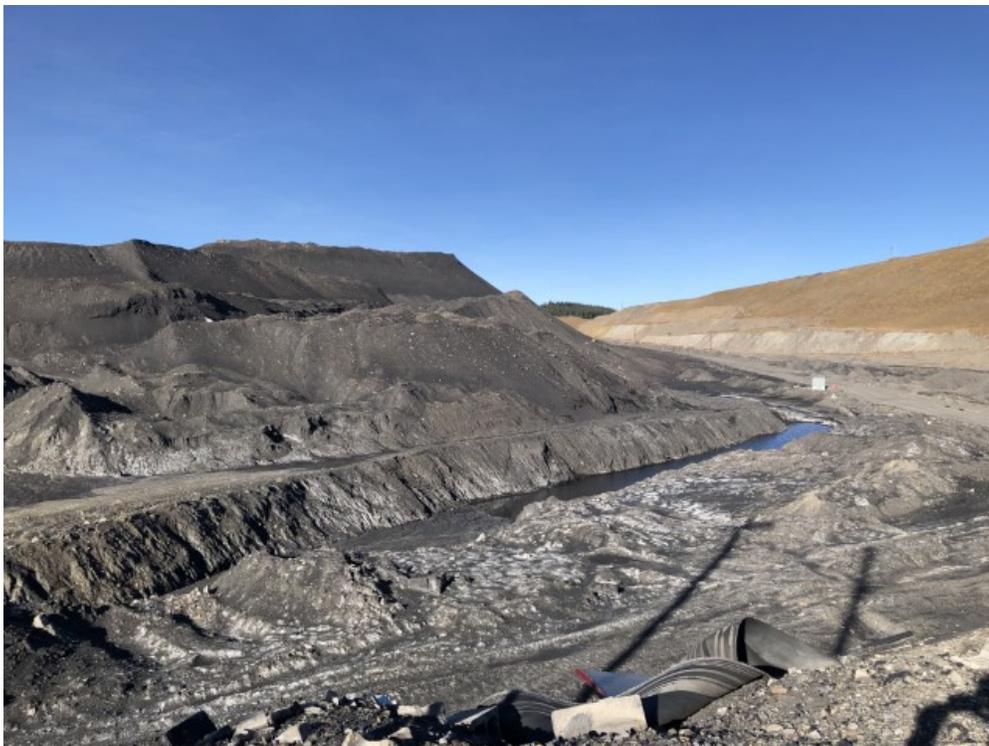
- The CCR material appeared to be well drained and is likely to have a low internal phreatic surface (not confirmed). Some areas of ponded water were observed in low lying areas near the toe of some slopes (Photo A-12) and some surface runoff was observed that was likely due to melting of the recent snow cover (Photo A-13).

**Photo A-12: Looking north west near WP12 at the CCR stack above 50-B4 (WP12, IMG\_7004)**

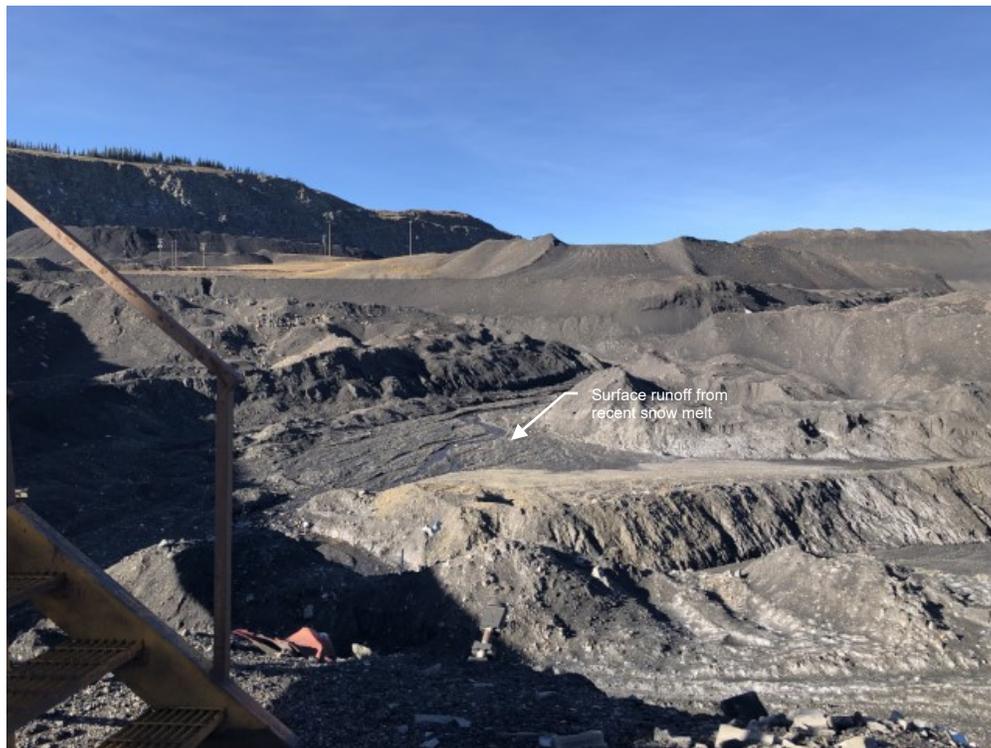
**Photo A-13: Looking north near WP12 at the CCR stack above 50-B4 (WP12, IMG\_7003)**

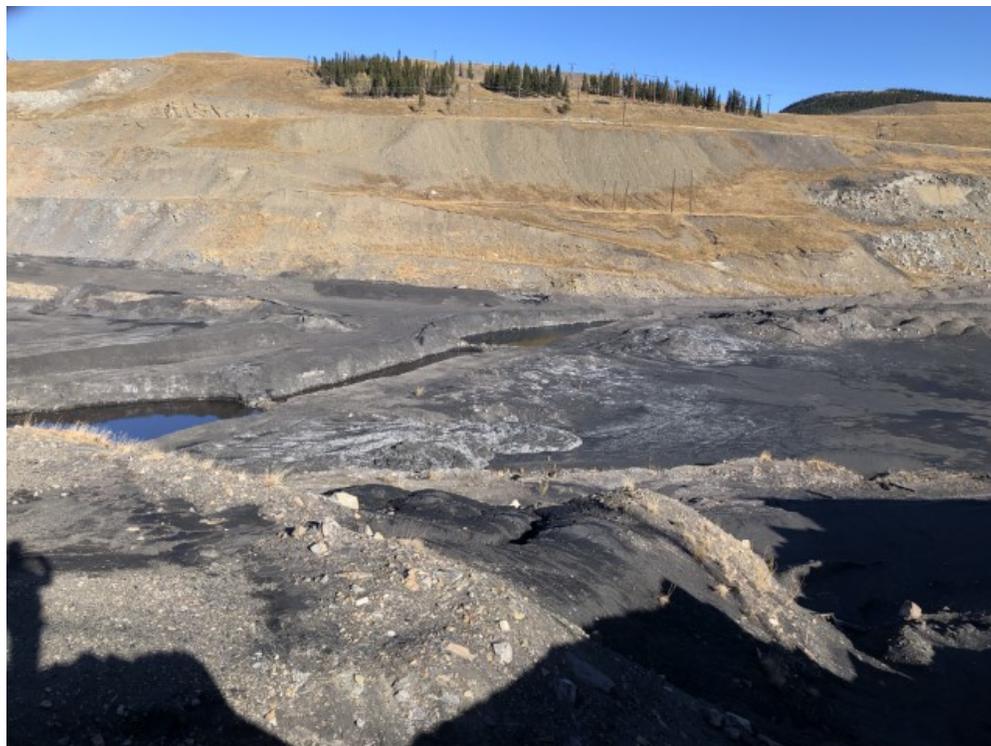
**Photo A-14: Looking west near WP13 at the west pit wall and exposed CCR above 50-B4 (WP13, IMG\_7012)**

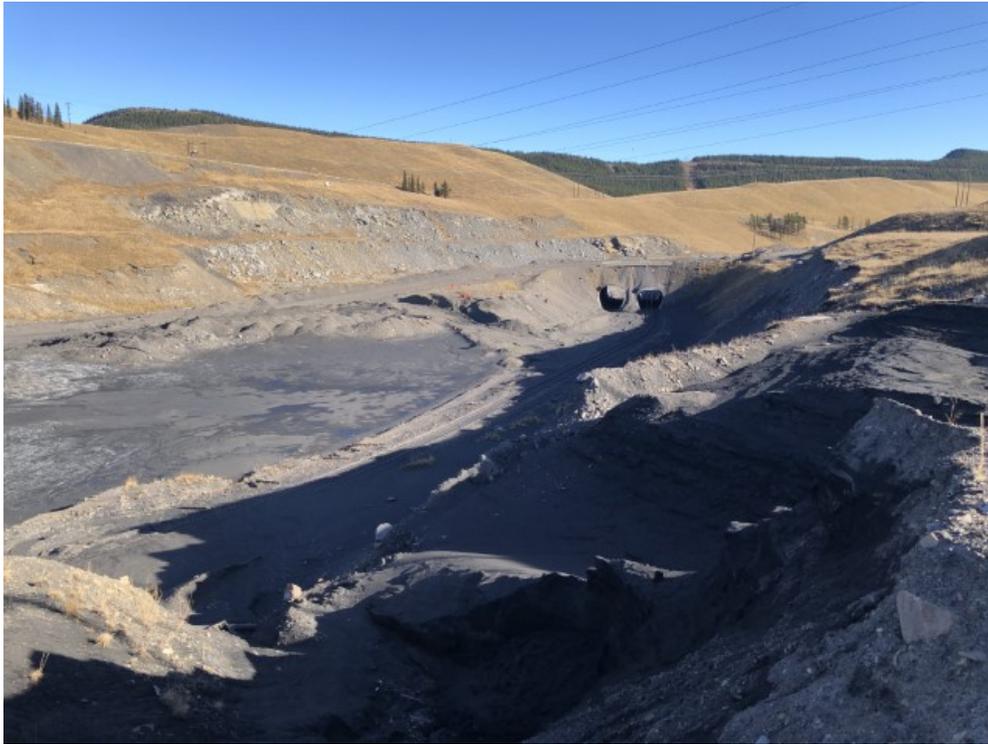
**Photo A-15: Looking south near WP13 at the west pit wall and exposed CCR above 50-B4 (WP13, IMG\_7013)**

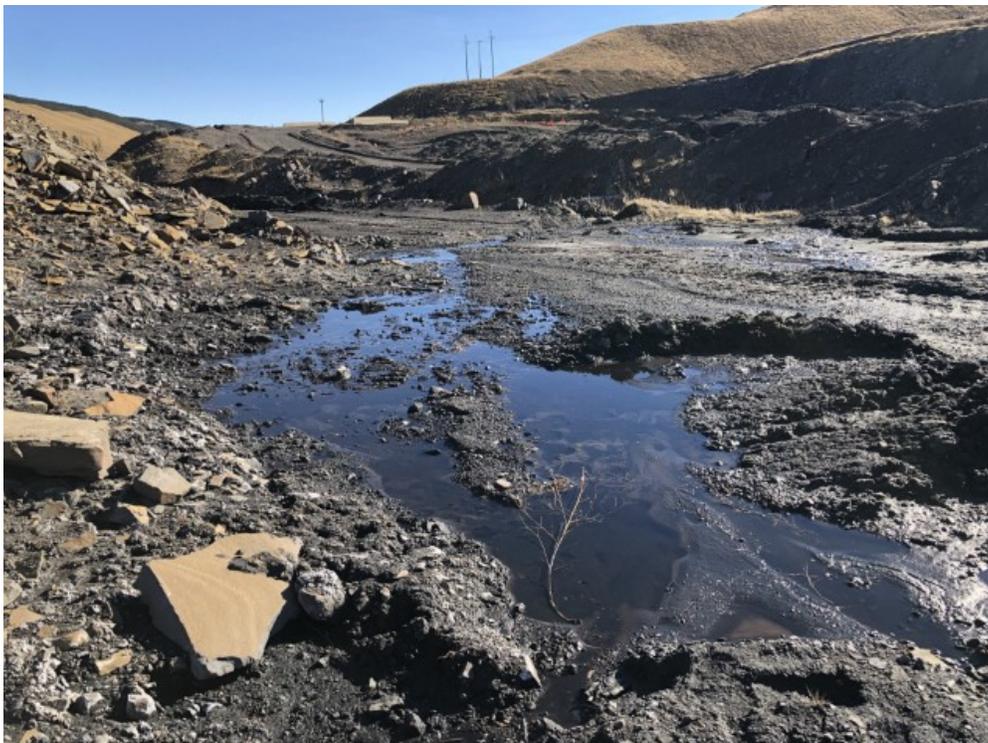
- An area of seepage was observed to be reporting from the pit slope CCR contact near the west end of 50-B4 (Photo A-16 and Photo A-17). The source of the seepage is not confirmed but is thought by Teck to originate from 51-B4 to the north. The possibility that the seepage is sourced from 51-B2X has also been considered due to the orientation of faults mapped within the 51-B2X pit.

**Photo A-16: Looking south near WP15 at an area of seepage near the west pit wall of 50-B4 (WP15, IMG\_7029)**

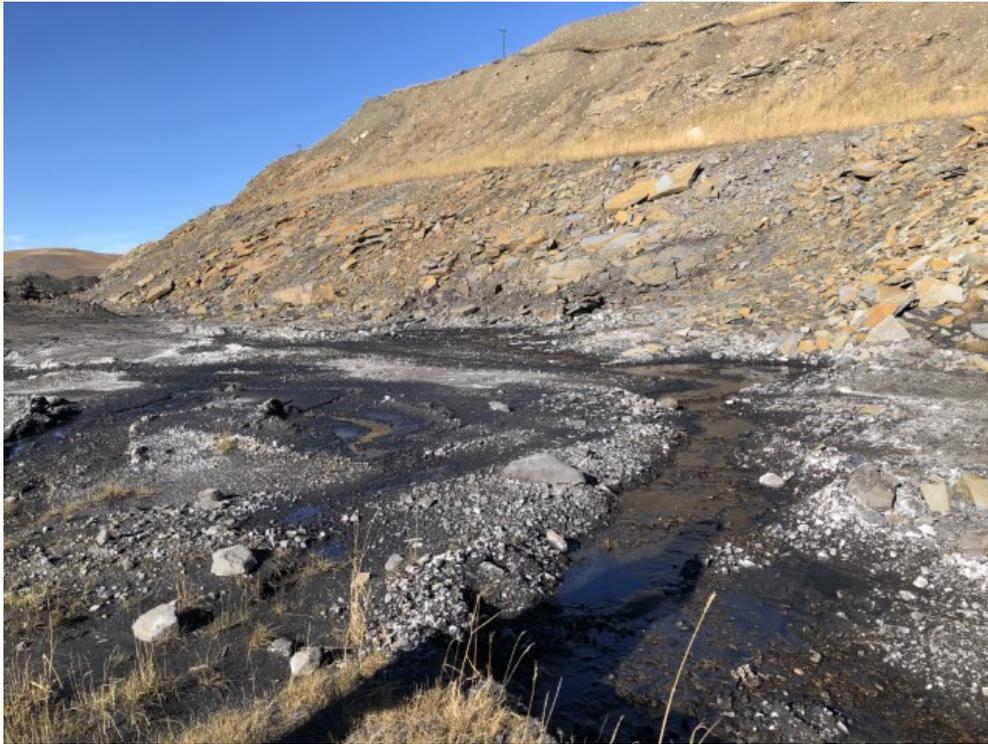
**Photo A-17: Looking north east near WP15 at an area of seepage near the west pit wall of 50-B4 (WP15, IMG\_7031)**

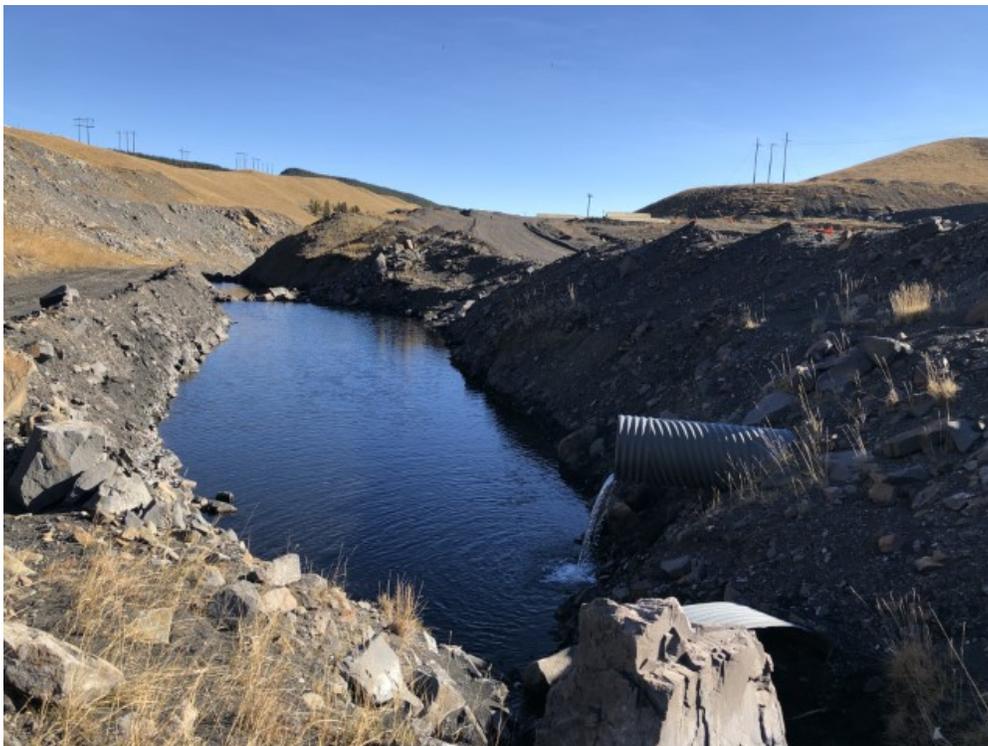
**Photo A-18: Looking south near WP15 at surface runoff water discharge into conveyance ditch at the south end of 50-B4 (WP15, IMG\_7030)**

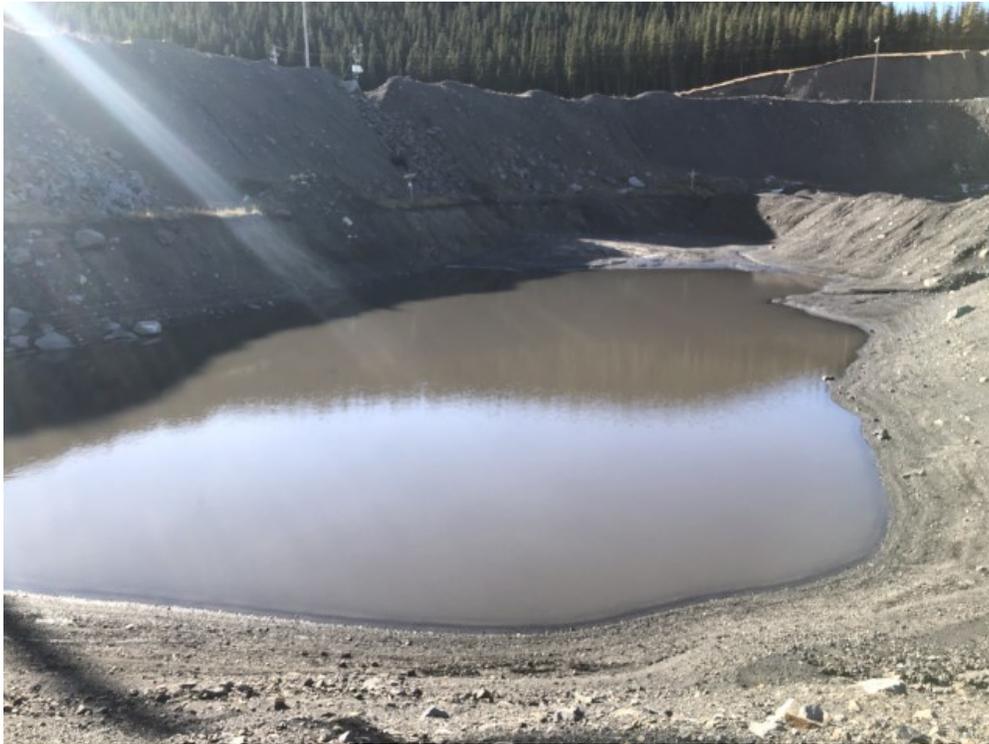
- A small pond of water is located in the south end of the TSF and was noted by Teck to be above an area with exposed tailings. The pond is maintained to control the flow of surface water that sheds from surrounding areas to avoid water flooding the refuse road and refuse loadout areas.

Photo A-21: Pond above an isolated area of exposed tailings in 50-B9 (WP14, IMG\_7015)

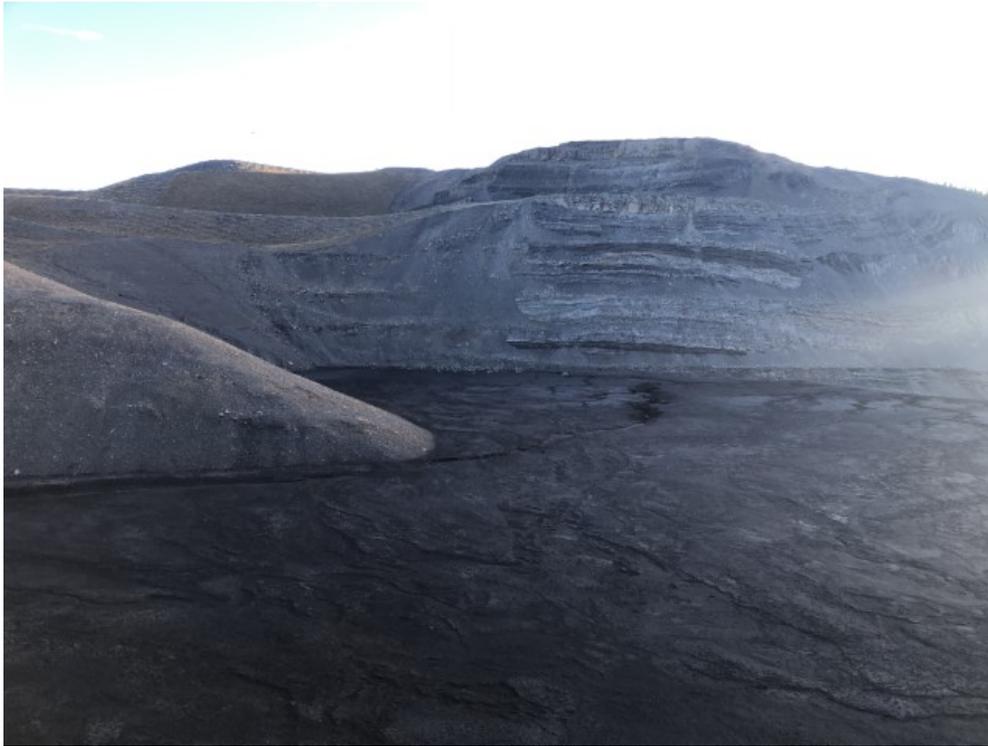
- Three of the TSFs were observed to include exposed pit walls (Table 1). The exposed pit walls appeared to be generally stable. The pit slope at one location in 50-B8 was observed experiencing some ravelling with some debris accumulated near the toe of the slope (Photo A-32). Some minor amounts of debris have accumulated at the base of the pit wall (east side) of 51-B2X (Photo A-56 or Photo A-57).

**Photo A-56: Looking east near WP01 at the pit wall slopes and tailings surface of 51-B2X (WP01, IMG\_6920)**

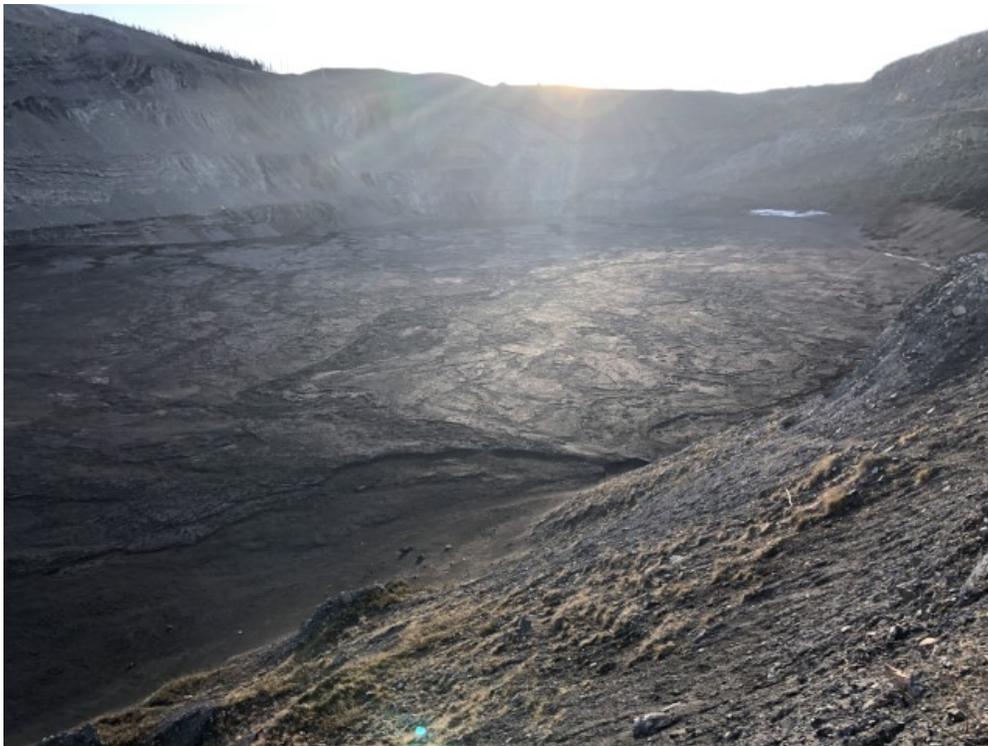
**Photo A-57: Looking south east near WP01 at the pit wall slopes and tailings surface of 51-B2X (WP01, IMG\_6926)**

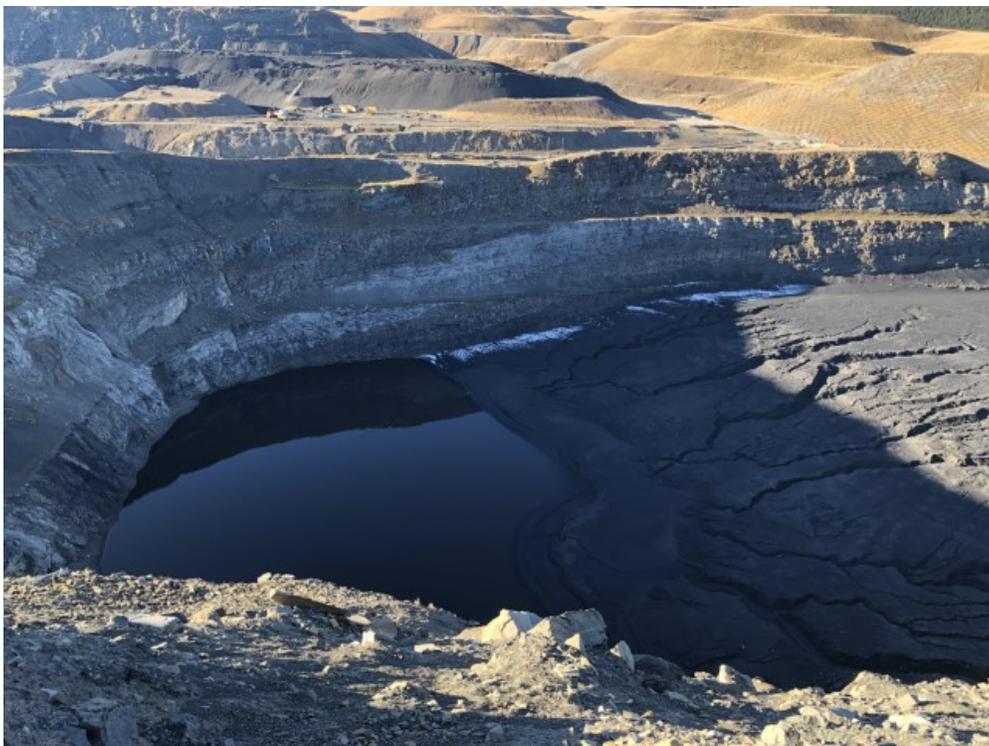
Photo A-61: Looking west near WP03 along the pit wall, area with ponded water, and eroded tailings surface (WP03, 51-B2X (WP03, IMG\_6935))

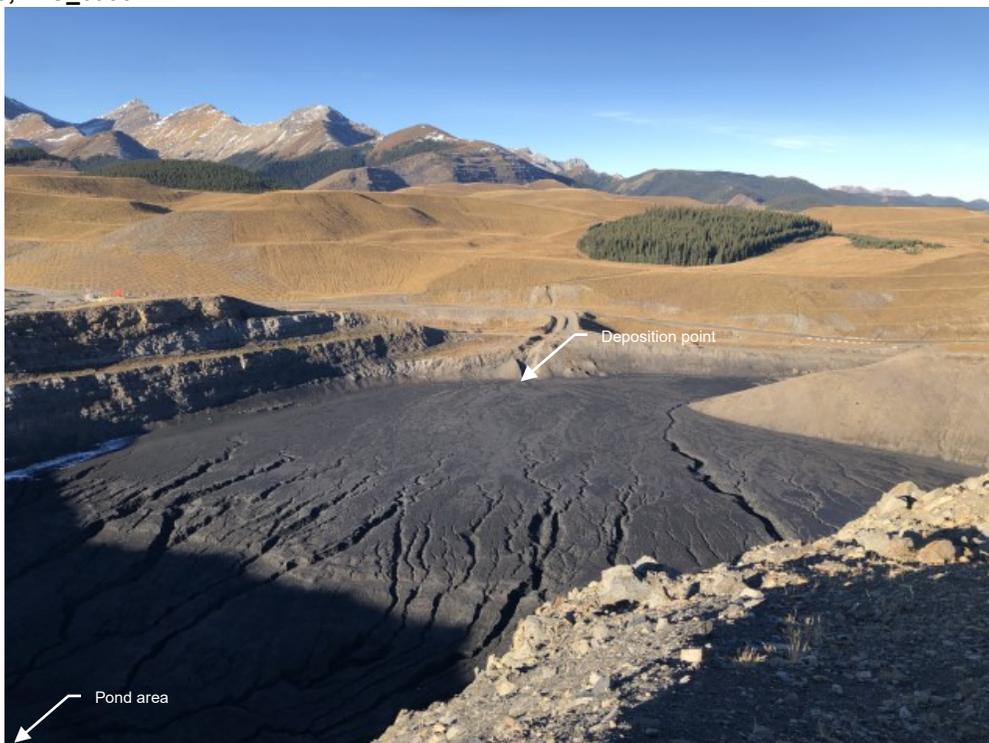
Photo A-63: Looking north west near WP03 along the pit wall, area with ponded water, and eroded tailings surface of 51-B2X (WP03, IMG\_6937)
