# **Teck Highland Valley Copper Partnership**

## **2021 Annual Facility Performance Report**

*Highmont Tailings Storage Facility*

March 2022

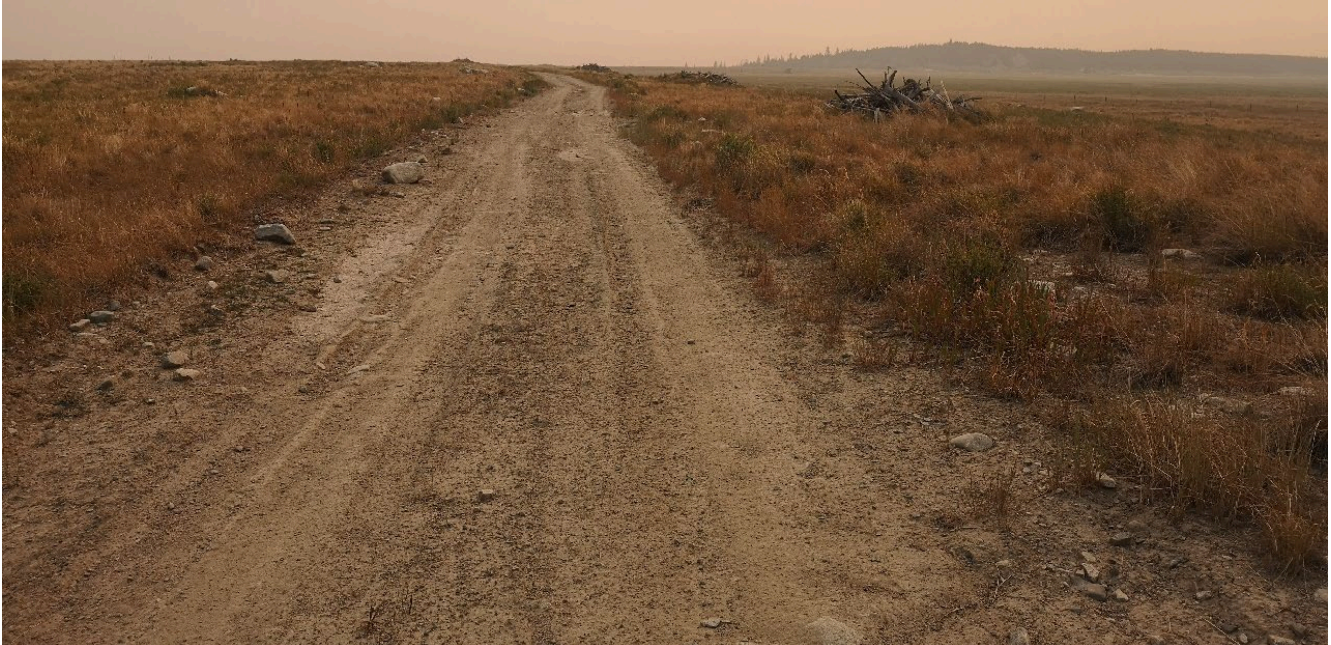
**Photo I-A-4 North Dam crest is in good condition. No signs of distress, settlement or depression; minor rutting observed is managed by HVC, as needed (HGH-2021-01)**

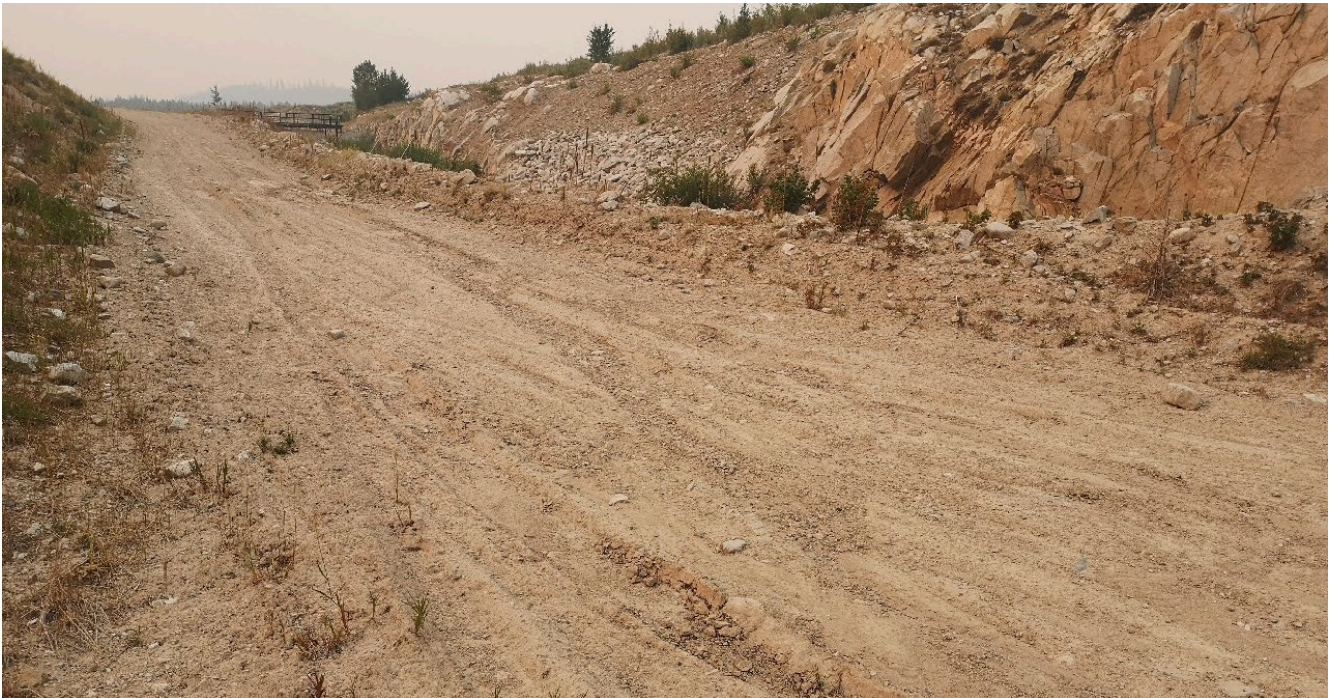
**Photo I-A-5 North Dam crest access road to S1 Diversion. Minor rutting observed is managed by HVC as needed (HGH-2021-04)**

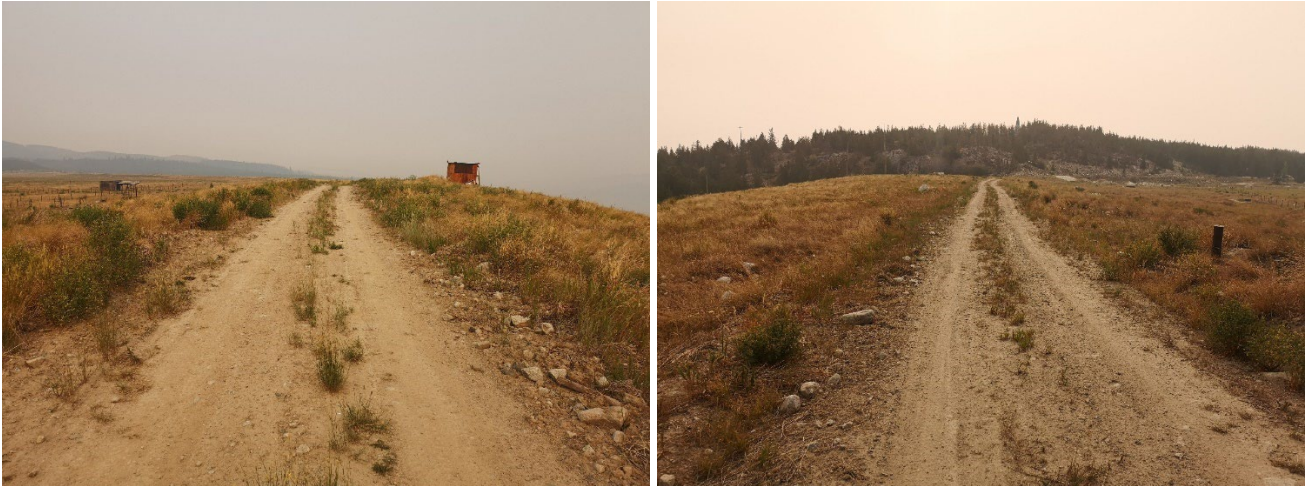
**Photo I-A-6 North Dam crest near right abutment. Crest is in good condition (HGH-2021-05)**

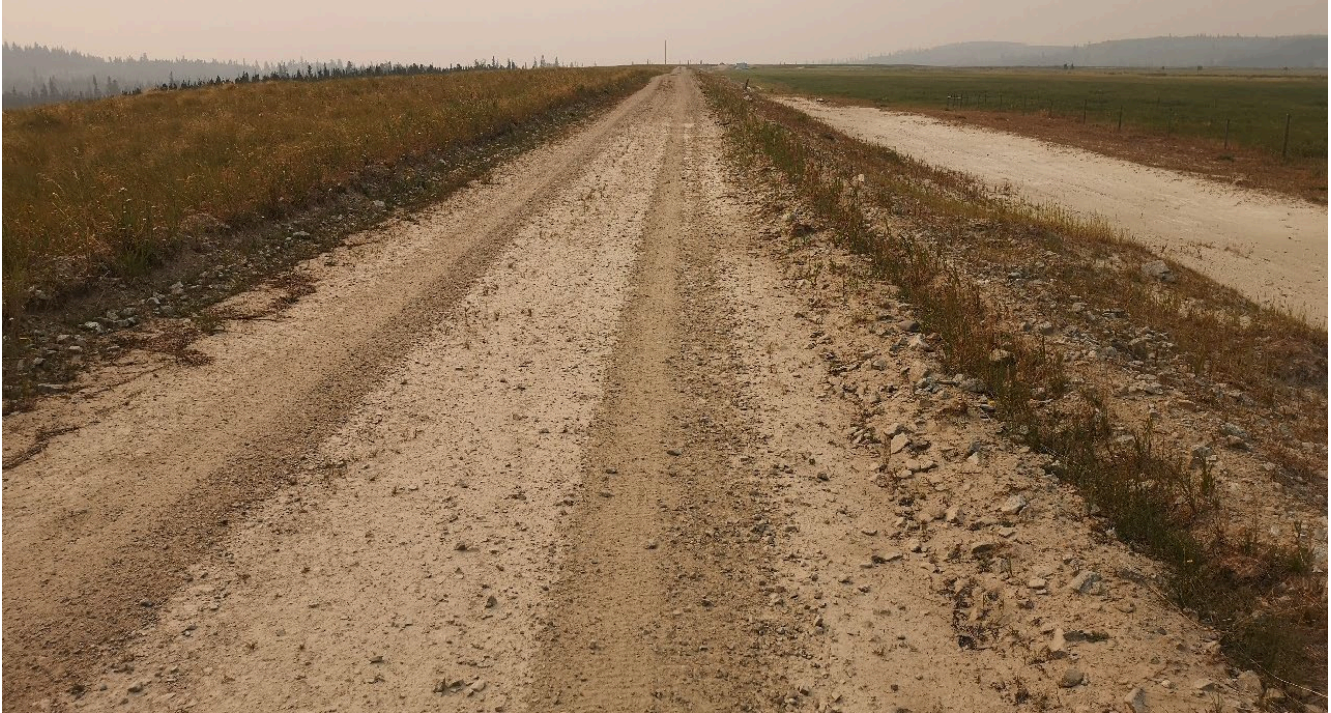
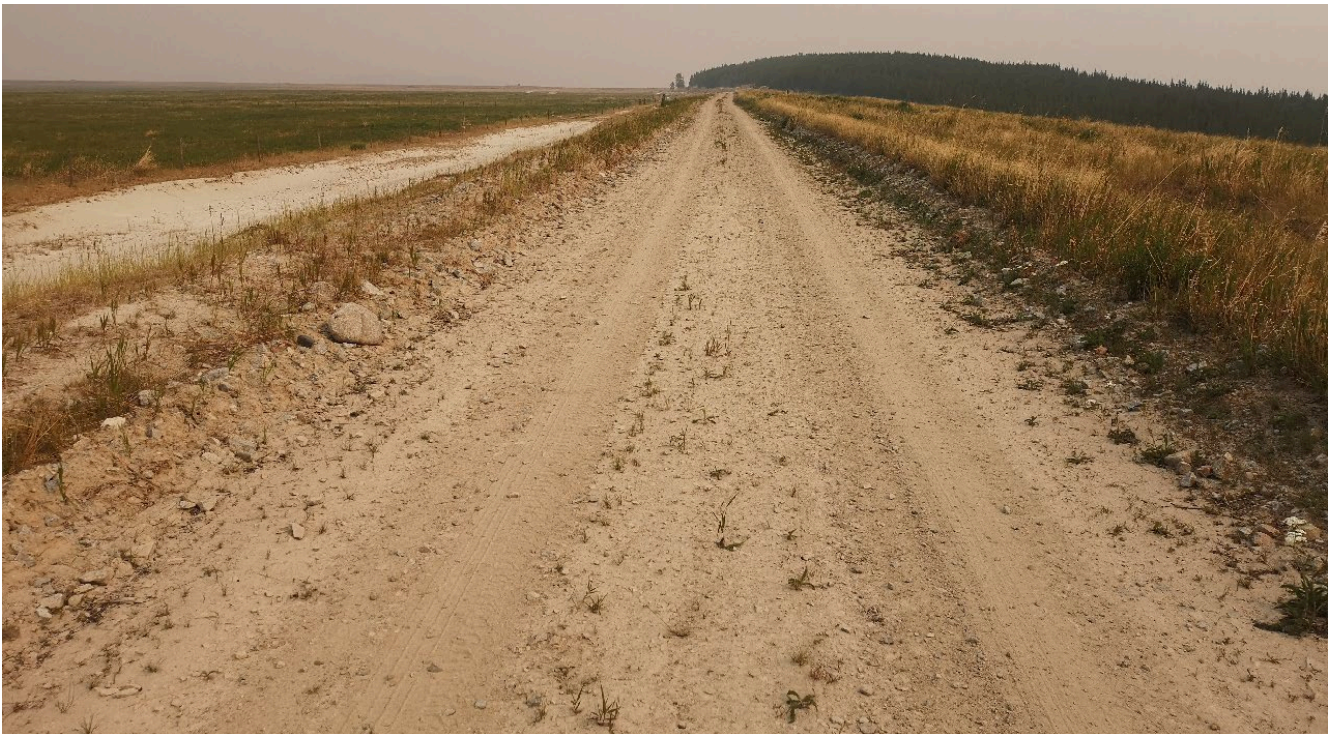
**Photo I-A-7 East Dam crest. Crest is in good condition. No signs of deformation or distress were observed (HGH-2021-02)**

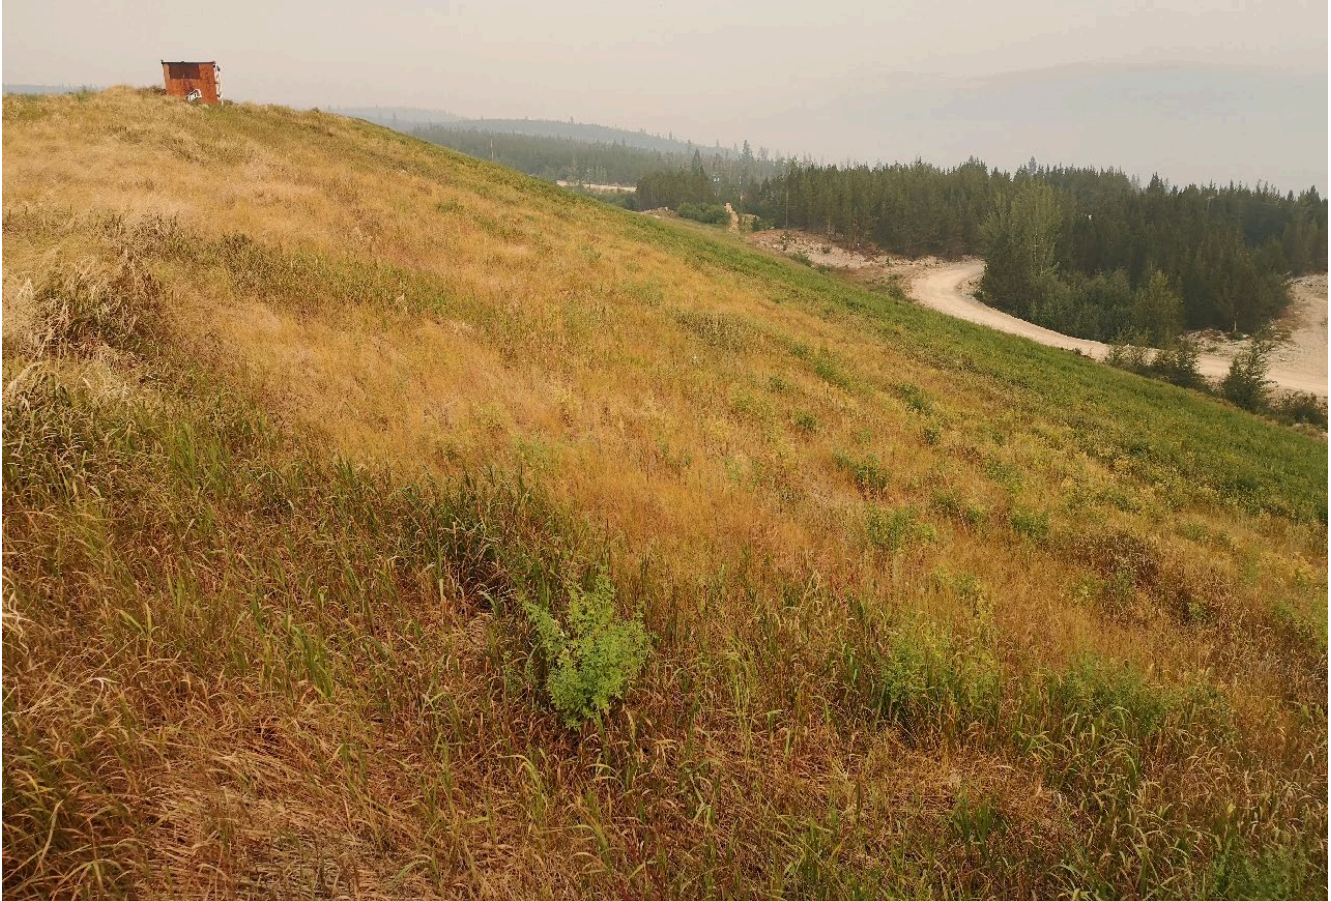
**Photo I-A-8 View of North Dam downstream slope looking northwest. Vegetation was about 0.5 m tall. No signs of distress or deformation were observed (HGH-2021-06)**

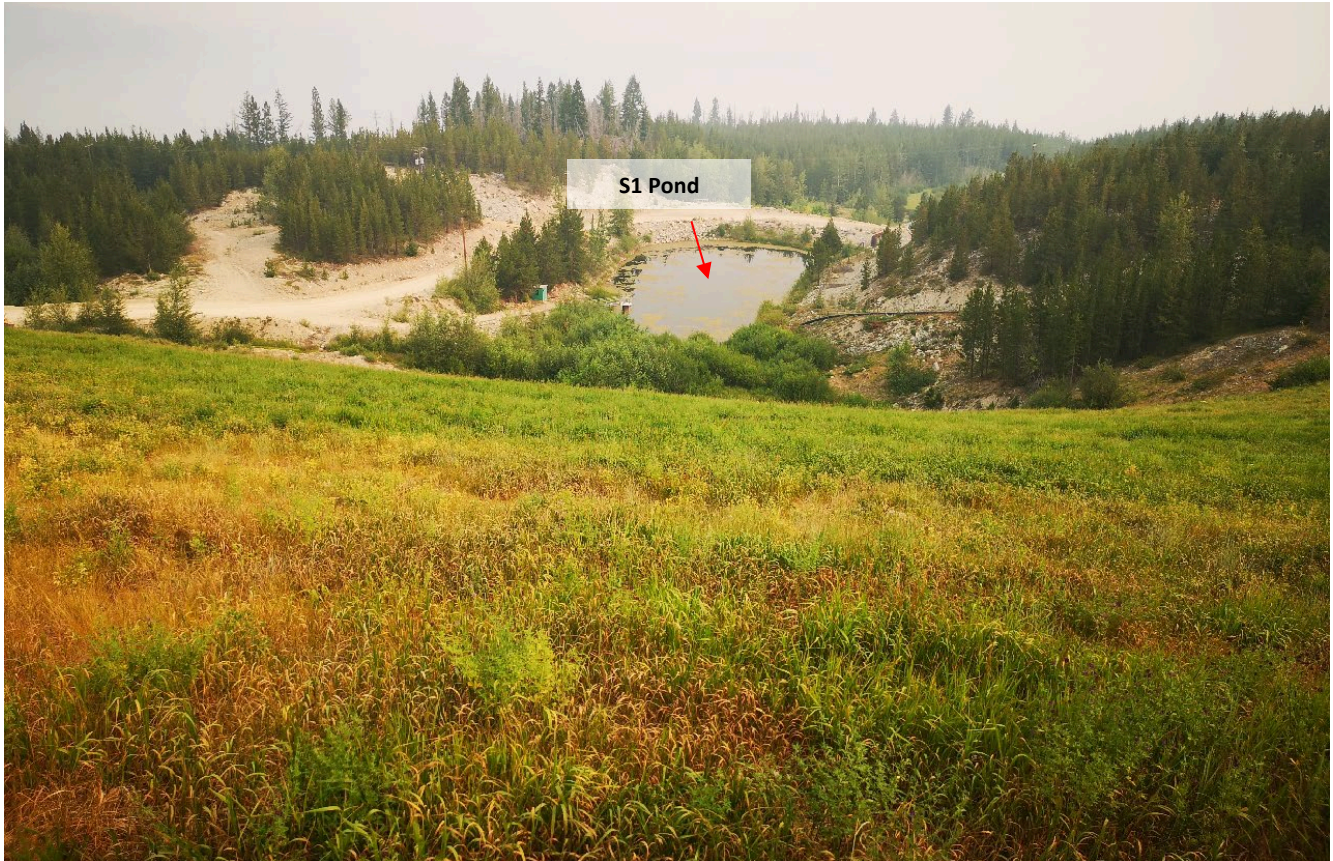
**Photo I-A-9 View of North Dam downstream toe and S1 Pond. No signs of distress or deformation were observed (HGH-2021-06)**

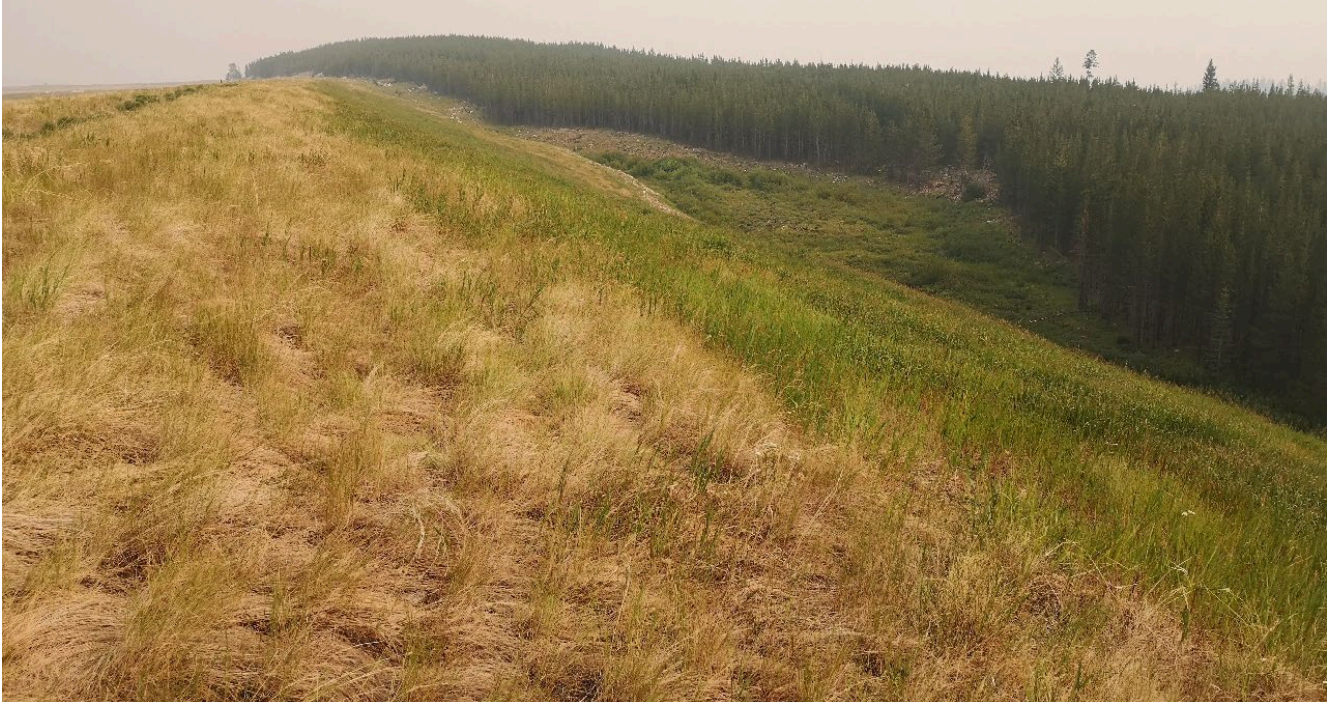
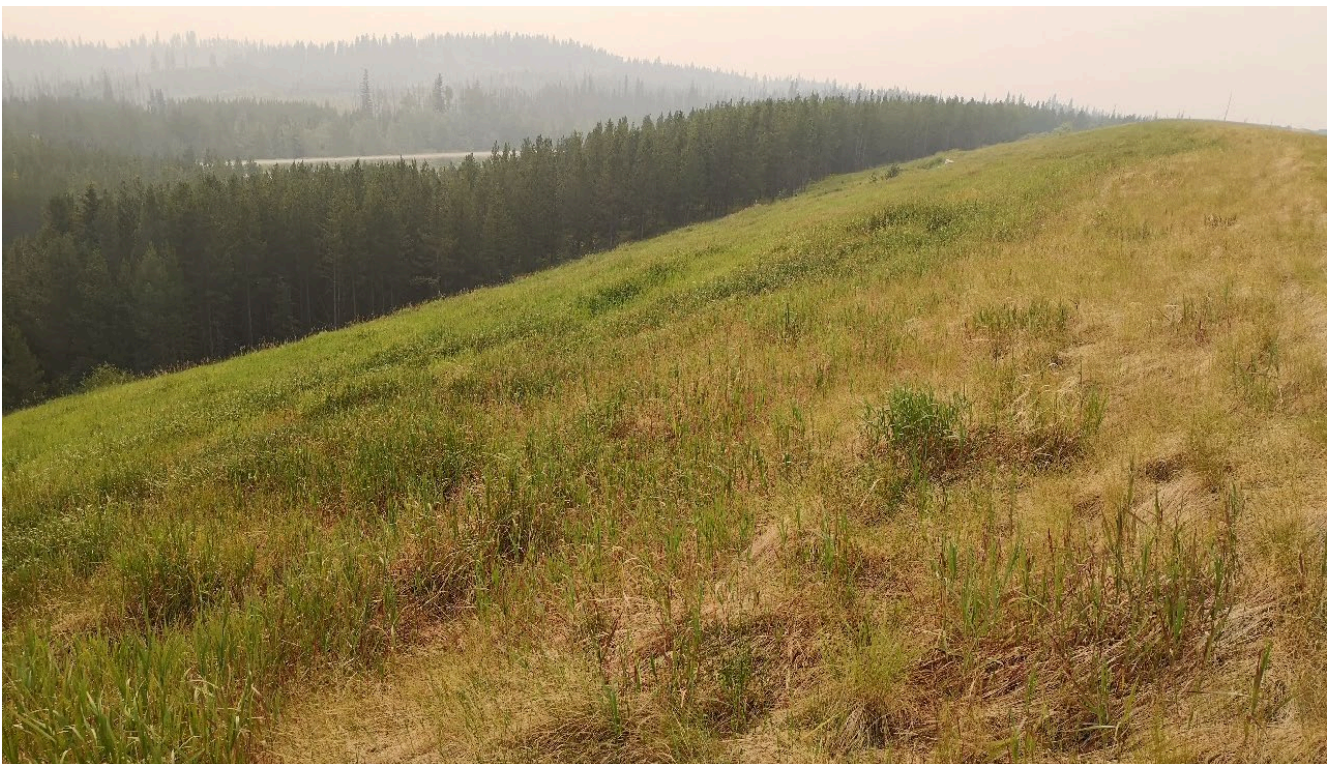
**Photo I-A-11 East Dam downstream slope. Slope is vegetated and in good condition (HGH-2021-07)**

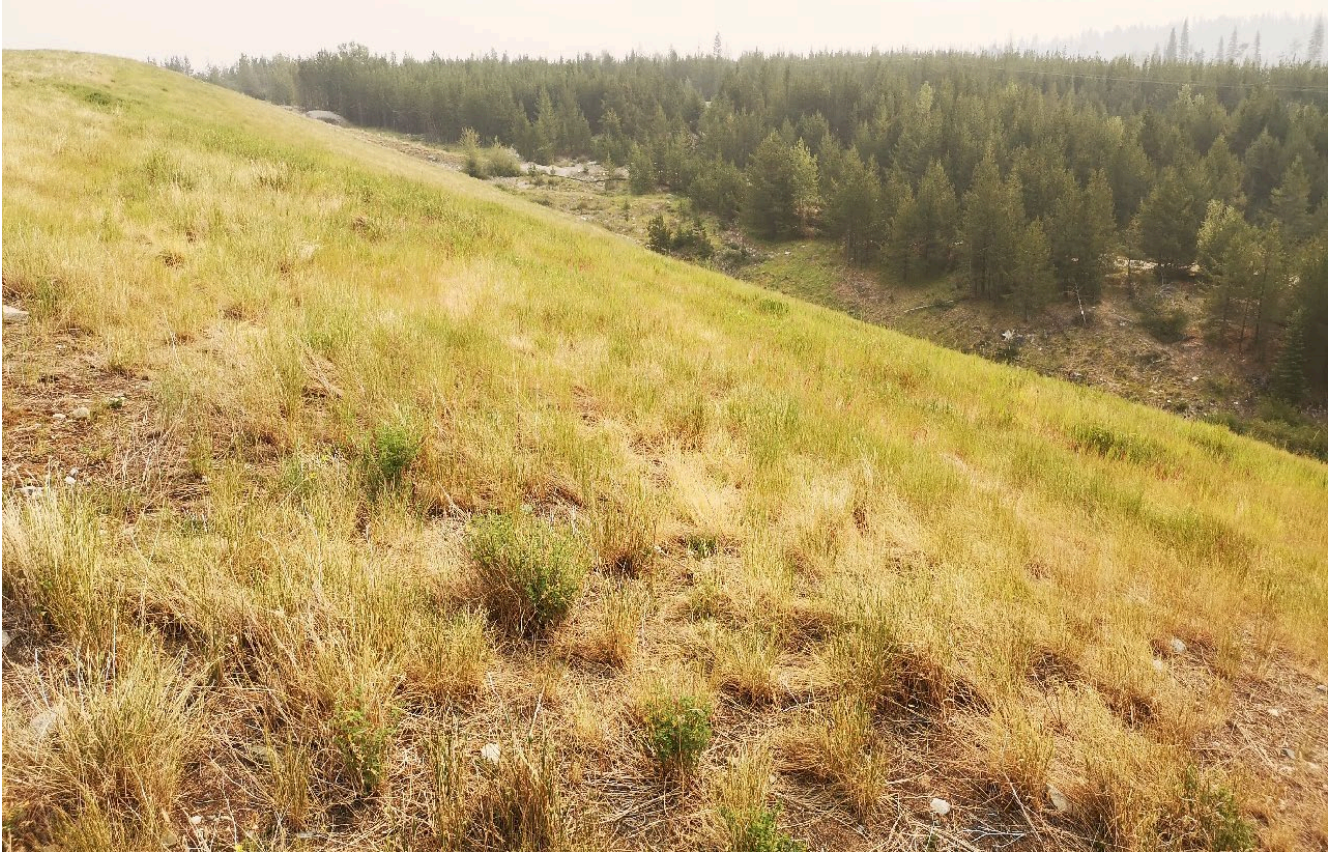
**Photo I-A-12 View of South Dam downstream slope looking northeast. Slope is vegetated and in good condition (HGH-2021-08)**

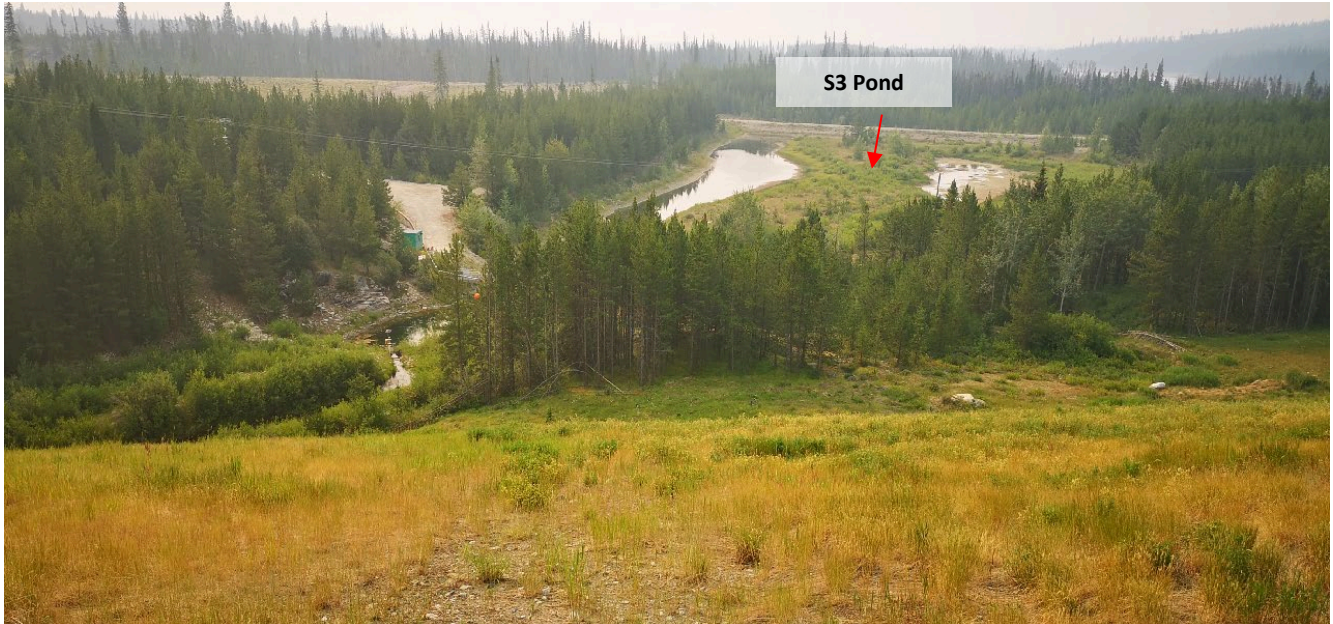
**Photo I-A-13 South Dam downstream slope and view of S3 Pond with two pools of water (pond El. ~1456.5 m). South Dam slope is vegetated and in good condition (HGH-2021-08)**

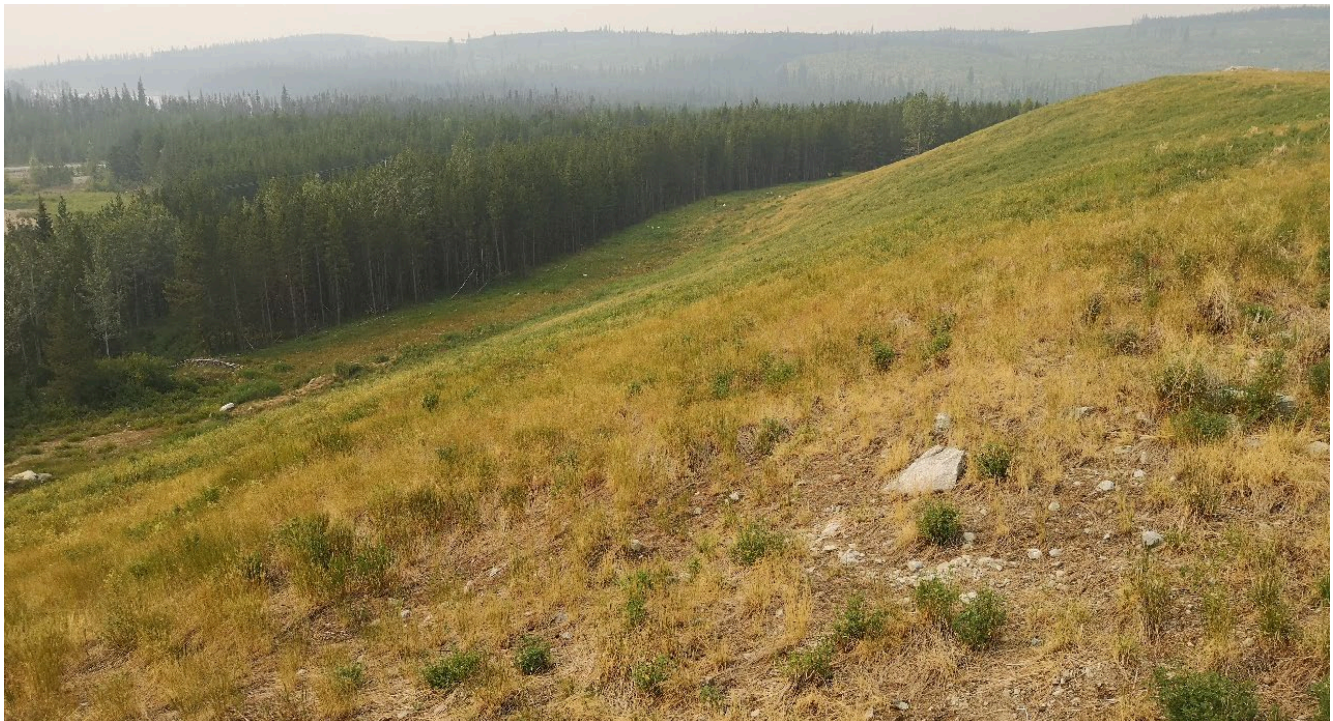
**Photo I-A-14 View of South Dam downstream slope looking southwest. Slope is vegetated and in good condition (HGH-2021-08)**

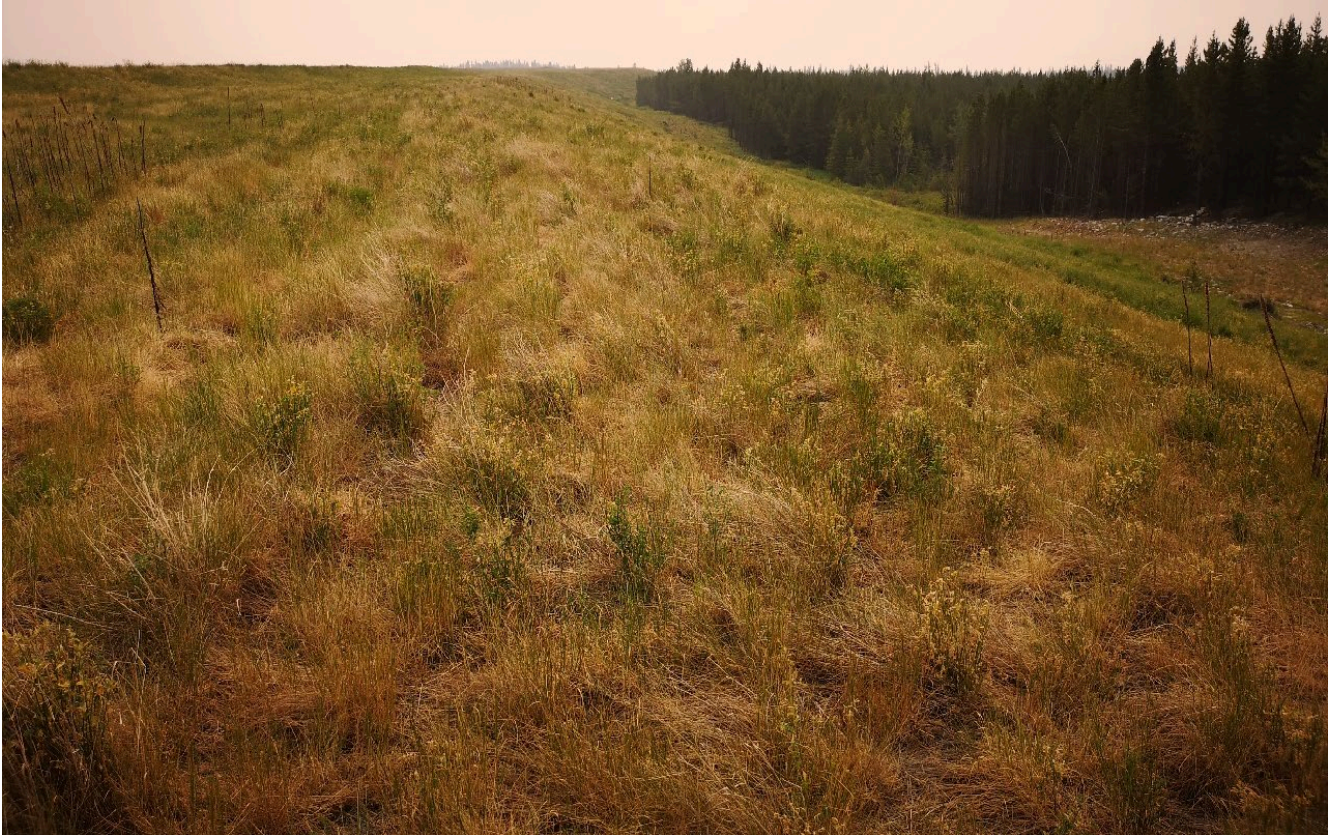
**Photo I-A-15 View of South Dam downstream slope at right abutment looking east. Slope is vegetated and in good condition (HGH-2021-09)**

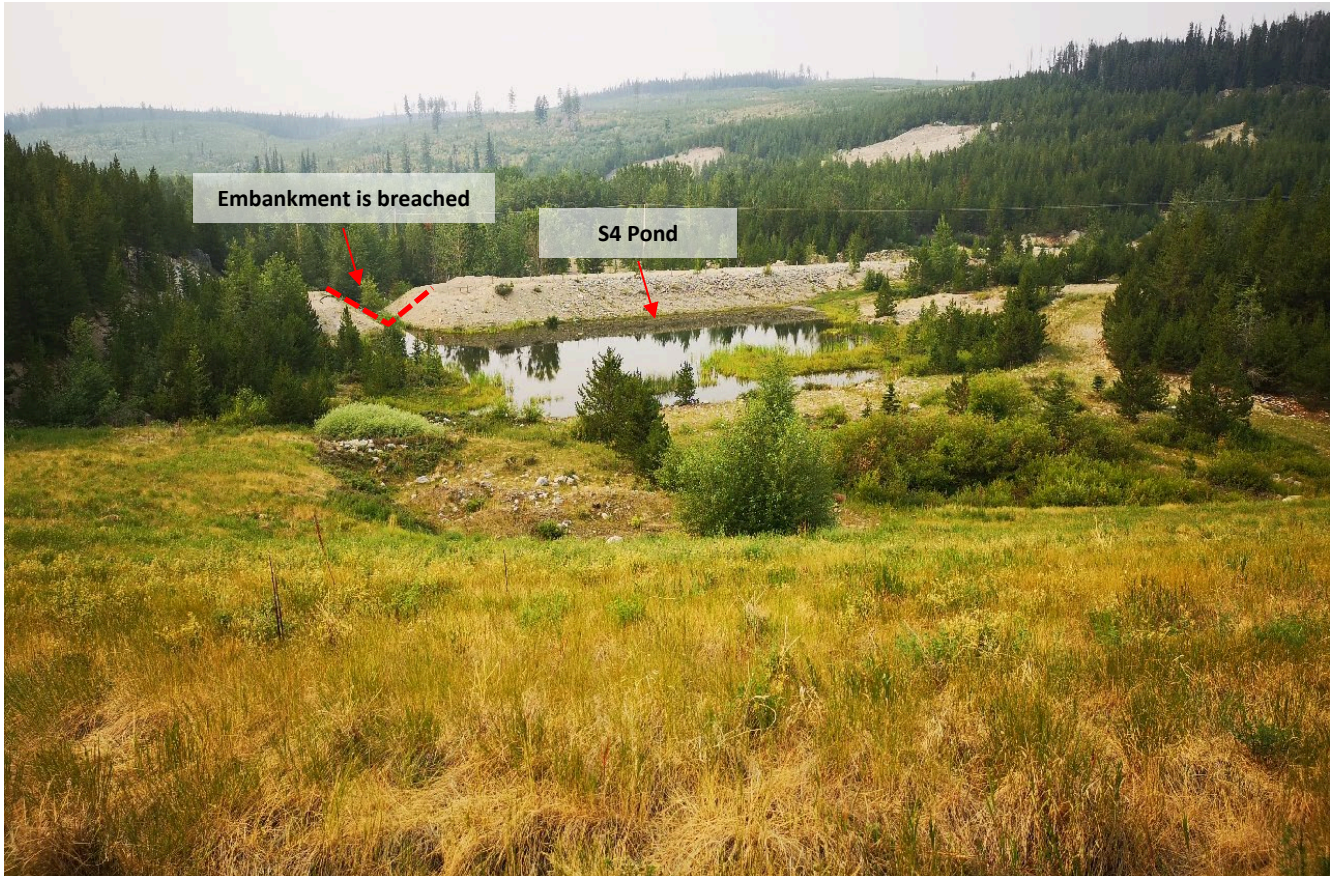
**Photo I-A-16 South Dam downstream slope and view of S4 Pond from South Dam. S4 embankment is breached (HGH-2021-09)**

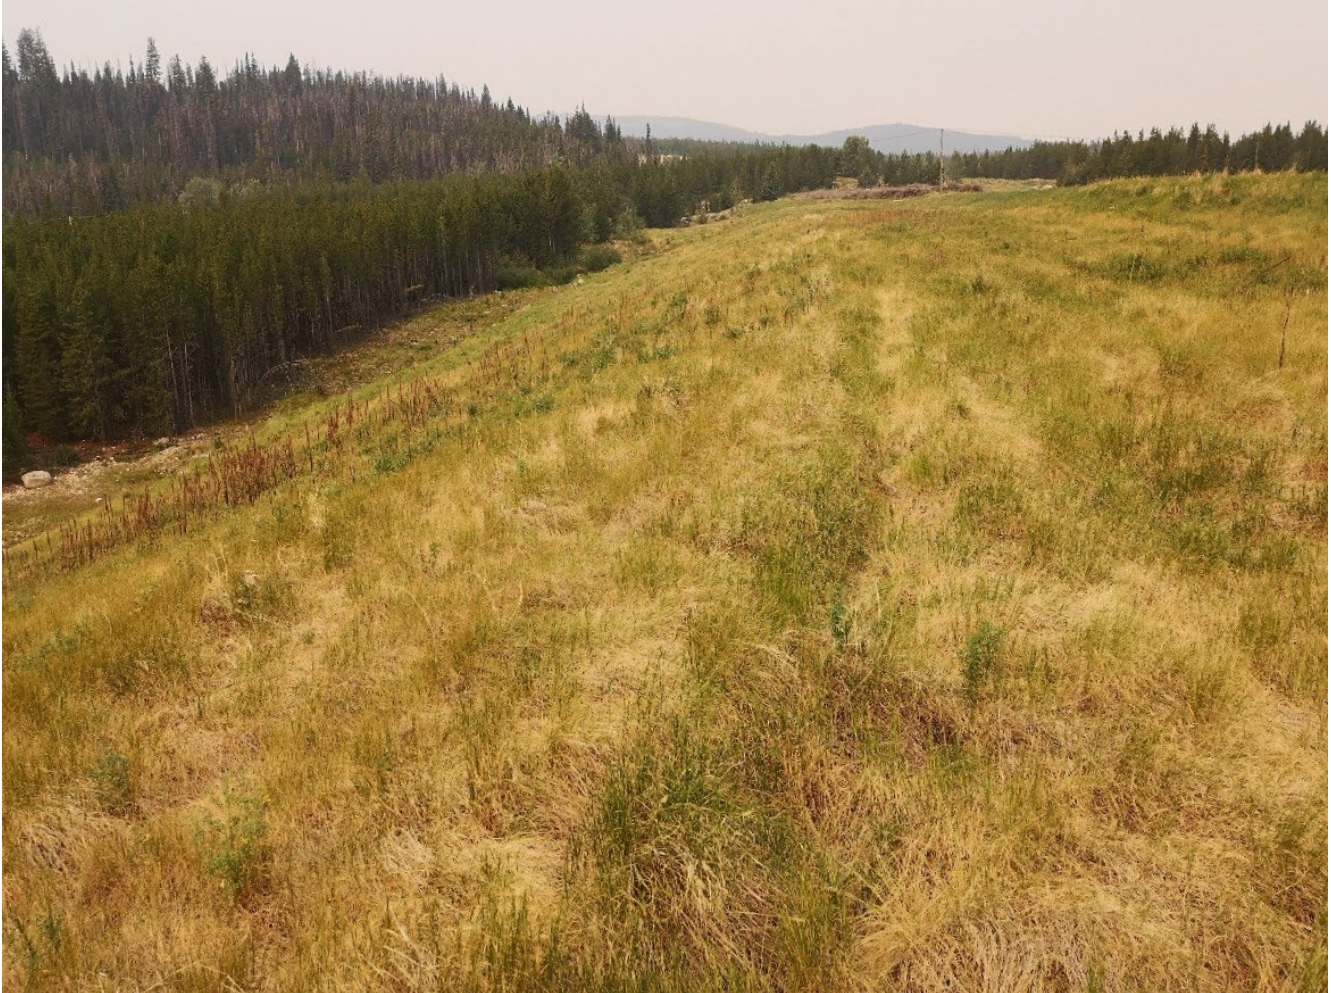
**Photo I-A-17 View of South Dam downstream slope at right abutment looking northwest. Slope is vegetated and in good condition (HGH-2021-09)**

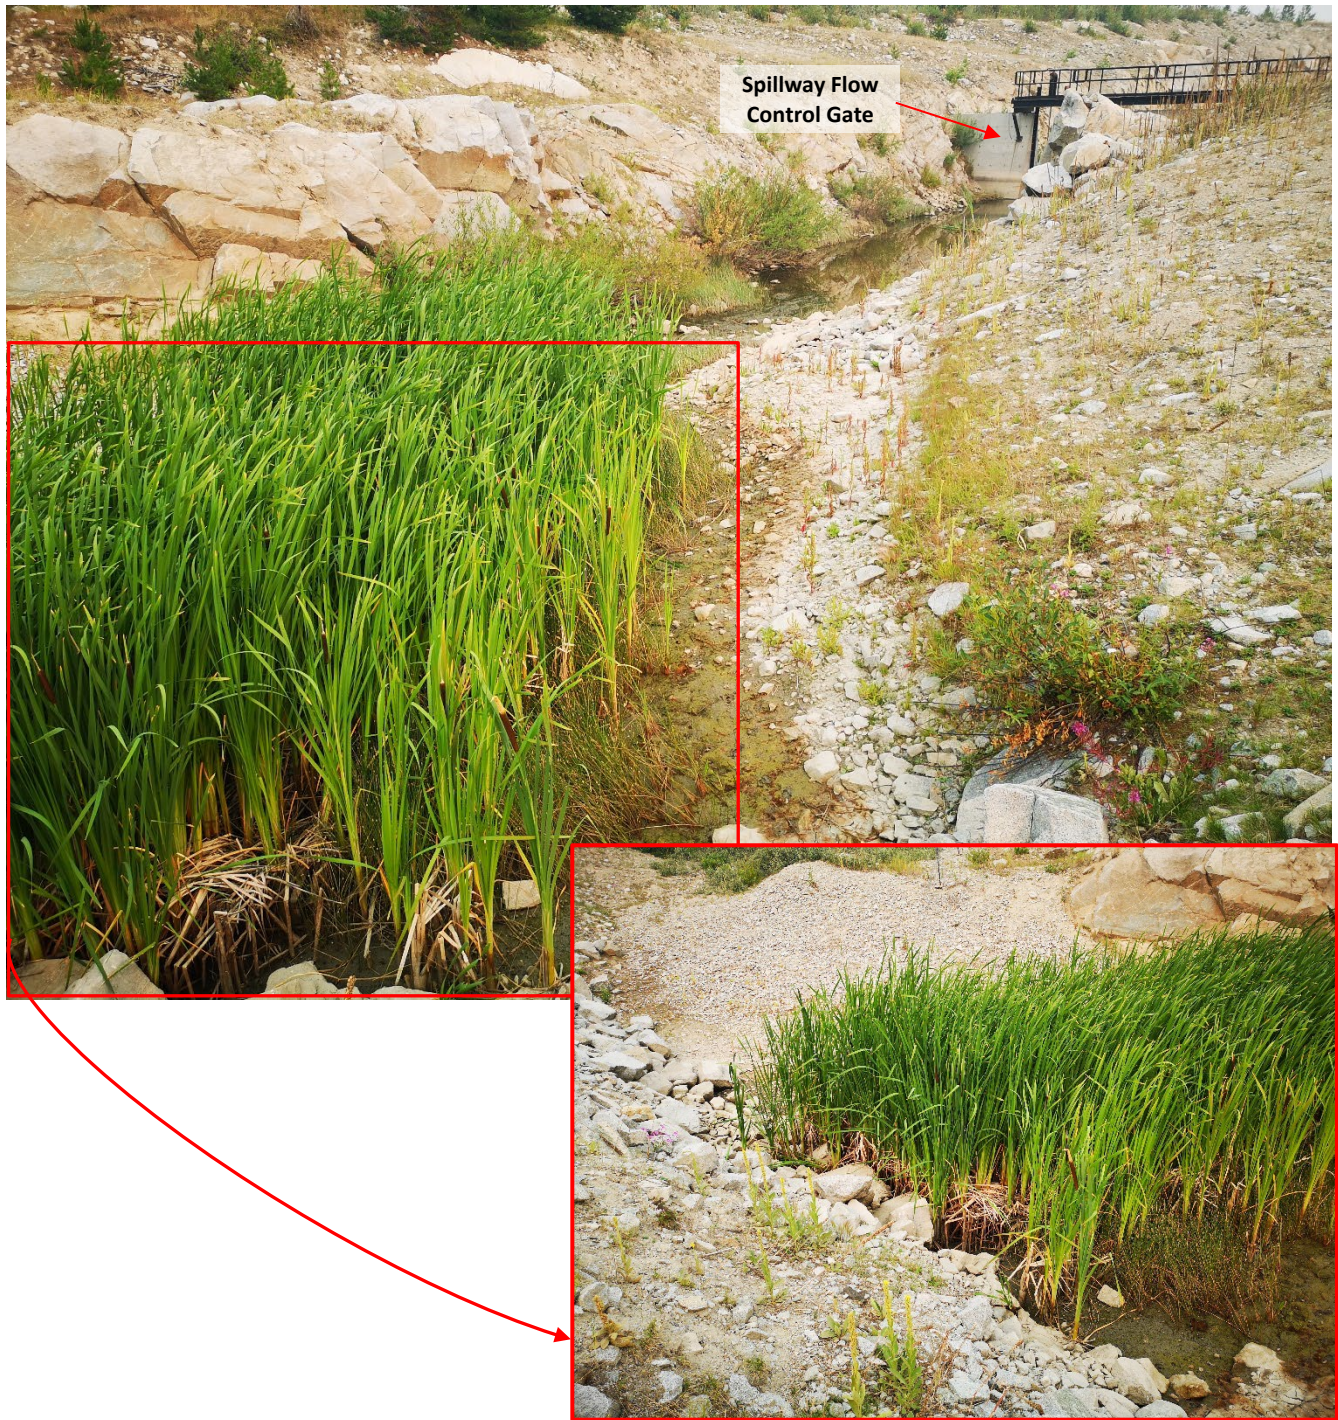
**Photo I-A-20 Area downstream of approach channel culverts and upstream of flow control gate – Culverts and channel were partially obstructed during the site visit, but vegetation was cleared by HVC in Q3/Q4 2021 as part of routine maintenance (HGH-2021-11)**

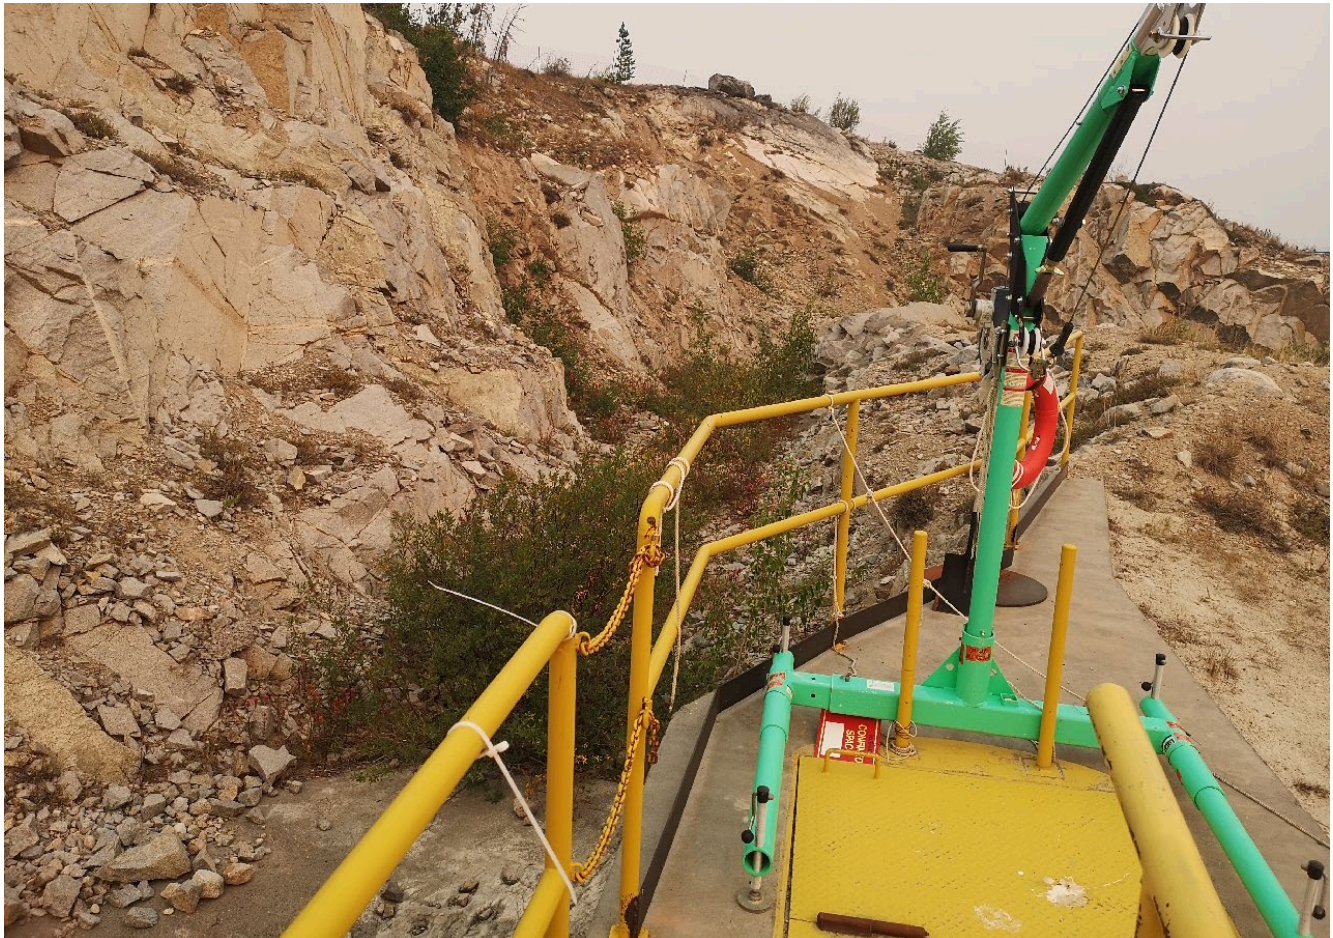
**Photo I-A-25 Highmont Spillway channel, downstream of S1 Pond diversion and control. No flow downstream of S1 diversion. Minor vegetation was observed in the channel (HGH-2021-14)**

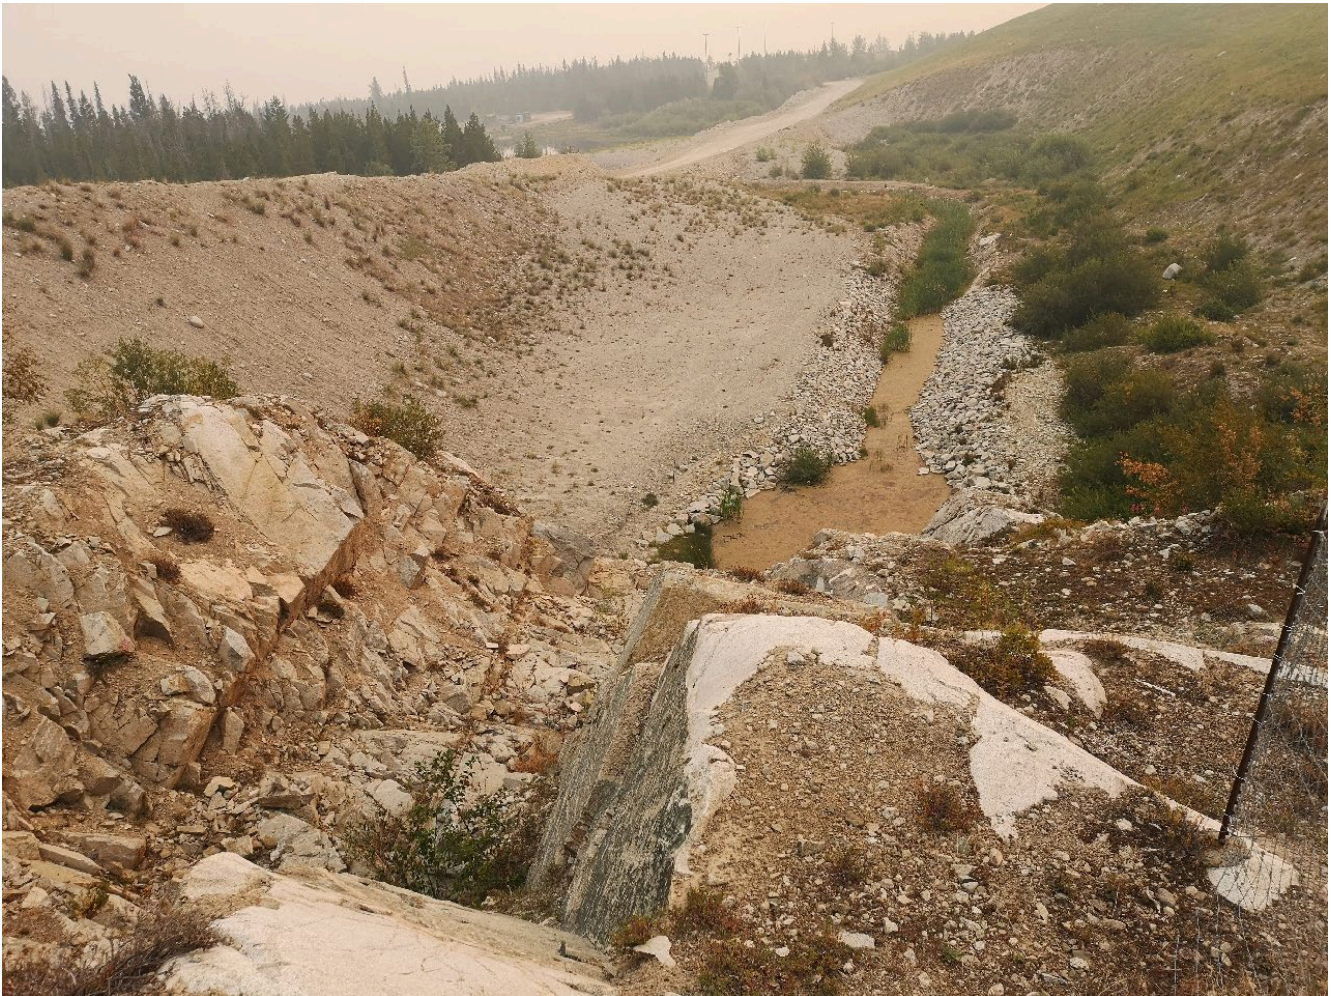
**Photo I-A-27 Highmont Spillway channel downstream of spillway drop. Channel is in good condition. North Dam downstream toe is visible. No signs of distress or deformation (HGH-2021-15)**

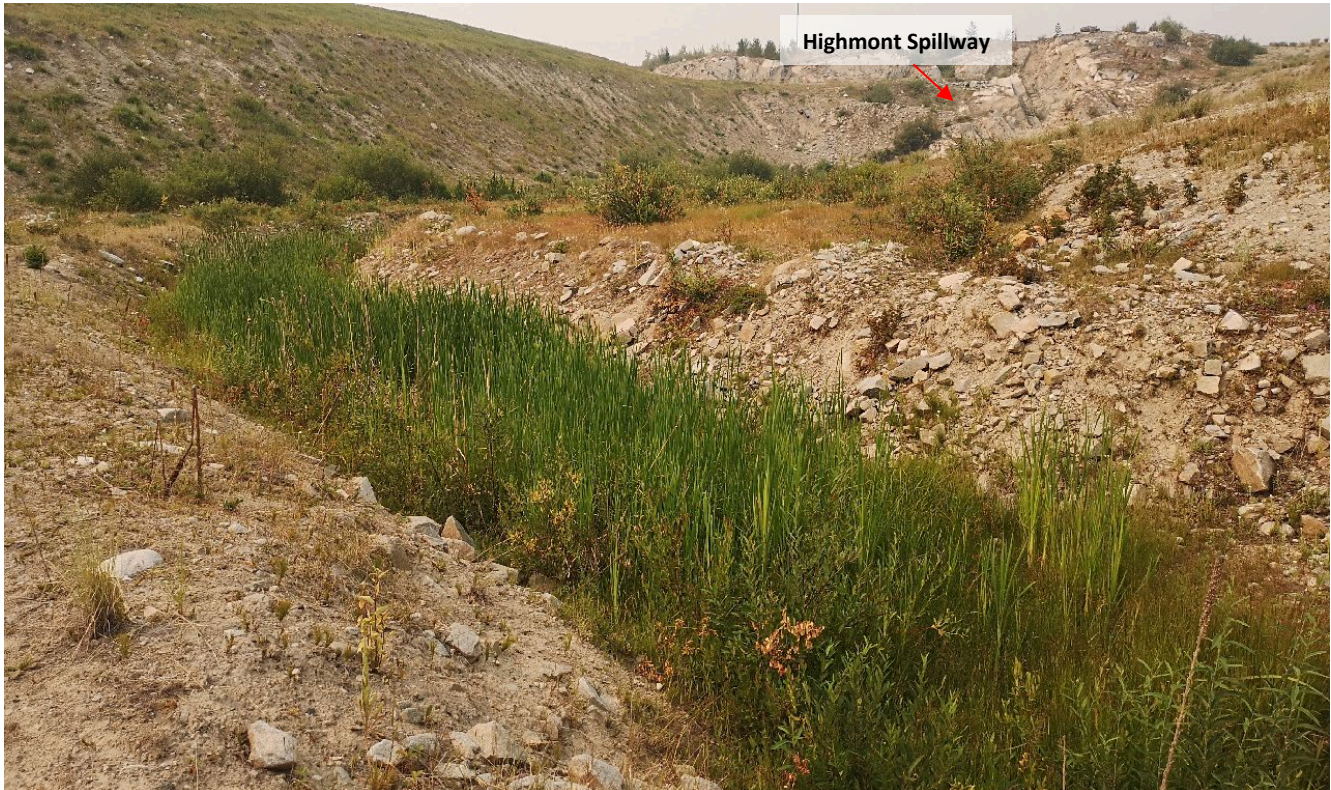
**Photo I-A-28 North Dam downstream slope and toe, downstream of Highmont Spillway. North dam toe is in good condition. Spillway stilling basin is heavily vegetated. (HGH-2021-16)**
