# **Teck Highland Valley Copper Partnership**

## **2021 Annual Facility Performance Report**

*Highmont Tailings Storage Facility*

March 2022

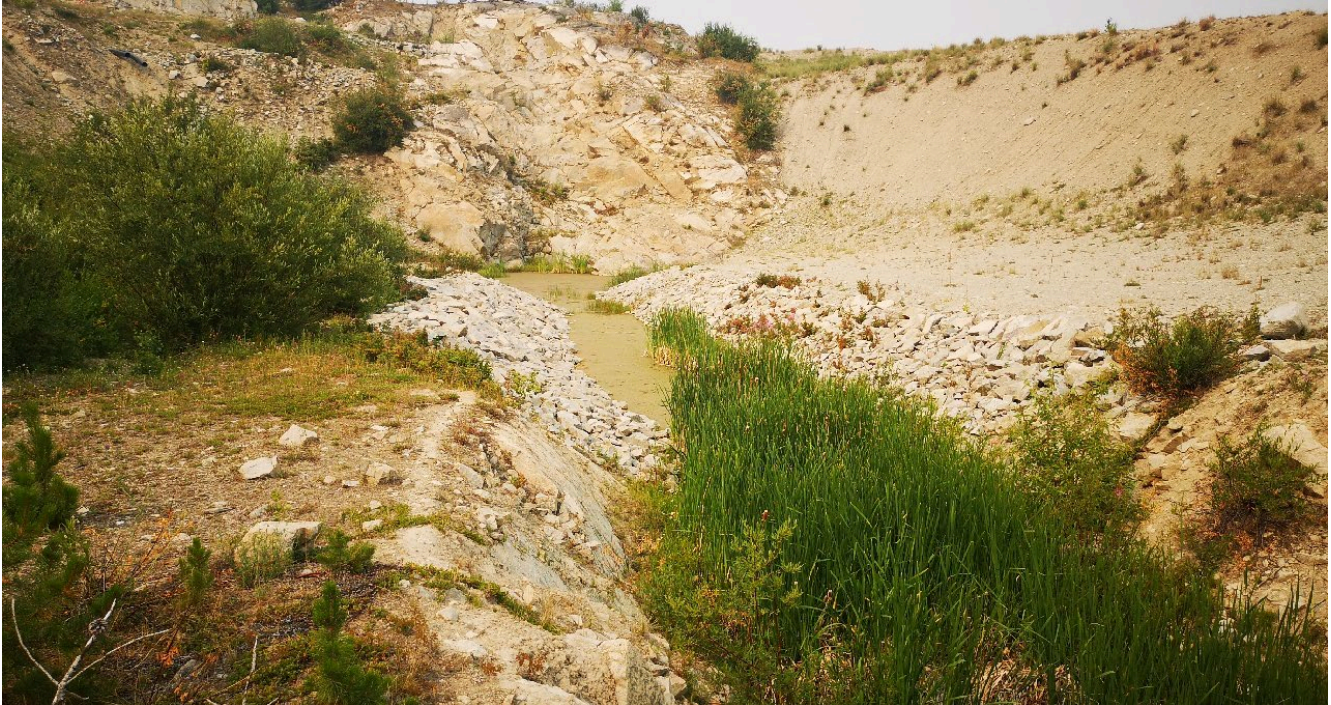
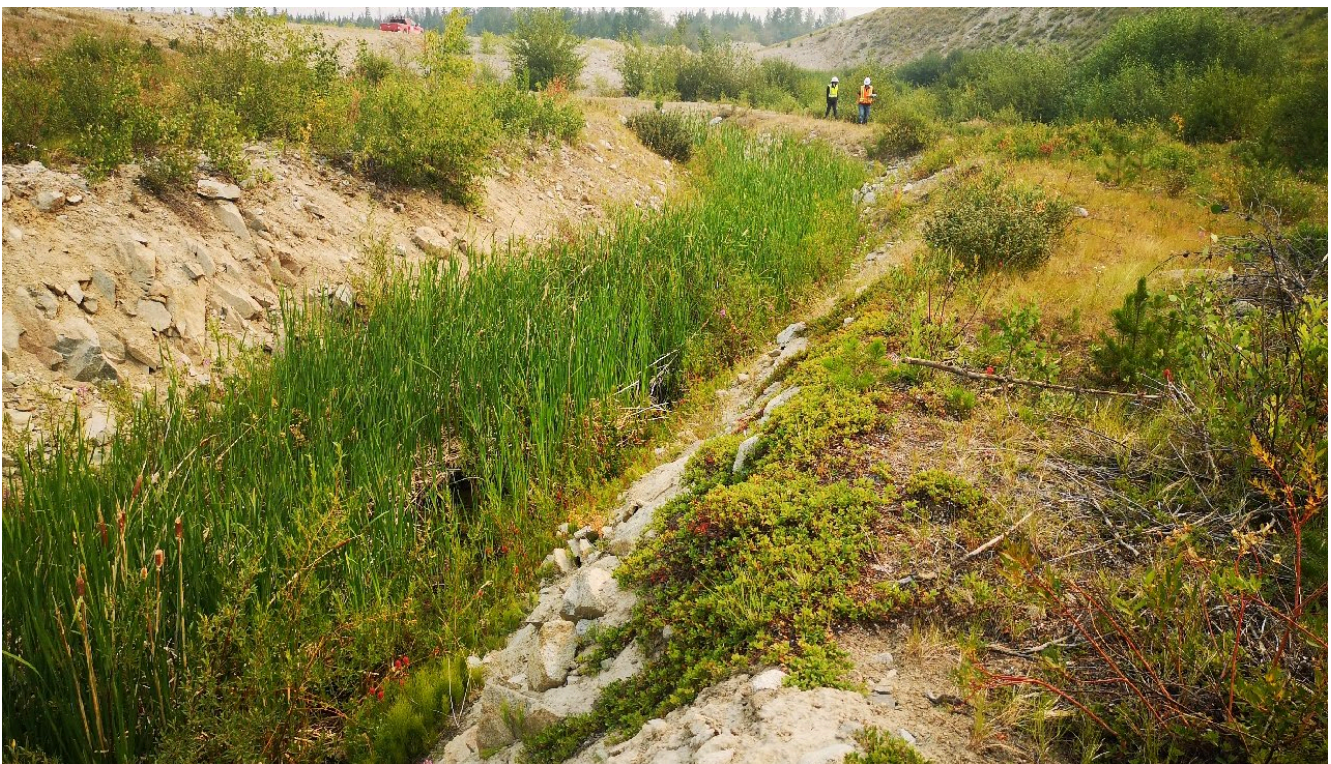
**Photo I-A-29 Water is ponded downstream of spillway drop. Vegetation obstructing spillway channel (HGH-2021-17)**

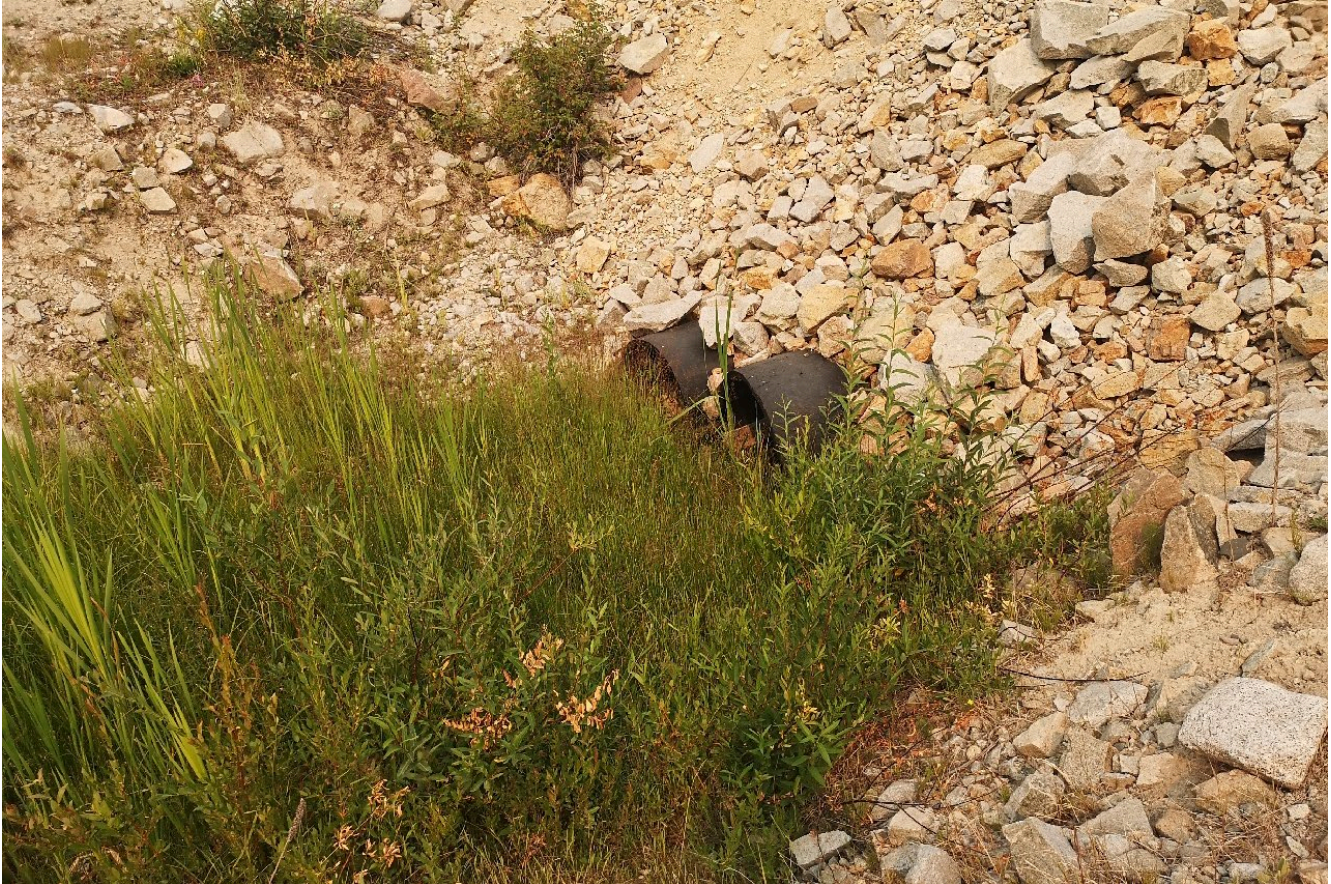
**Photo I-A-30 North Dam toe access road crossing culverts. Culverts are misshapen; see AFPR recommendation HD-2017-01 (HGH-2021-16)**

ID No.	Performance Area	Recommended Action	Priority <sup>(1)</sup>	Recommended Deadline
HD-2017-01	Flood Management	HVC should modify the spillway channel to pass the peak spillway design outflow beneath the access road or regrade the road surface so that water that flows over the road will report to the downstream spillway channel.	3	Q4 2020 (Open – HVC Revised Target Date Q2 2022)
HD-2018-02	Flood Management	<i>Update flood routing assessment for Highmont TSF and associated seepage ponds based on the most recent site wide hydrology information for consistency and to confirm compliance.</i>	3	Q3 2019 (CLOSED)
S2-2019-01	Flood Management	S2 Pond spillway channel profile has been changed due to the temporary access over the channel. Original channel profile/capacity should be restored.	3	Q1 2020 (Open – HVC Revised Target Date Q4 2022)
S5-2018-02	Flood Management	To accommodate the temporary blocking of the S5 Pond spillway during freshet, raise the dam crest so that the IDF (100-year 72-hour duration) can be stored within the reservoir, assuming no pumping is required. (Take into consideration, HD-2018-02)	2	Q3 2021 (Open – HVC Revised Target Date Q2 2022, following results from HD-2018-02) Status Update: HVC is planning to level dam crest low point to El. 1452.2 m to increase flood attenuation capacity in the facility. Additional pumping capacity required to manage IDF has been included in OMS Manual. Although, this system still relies upon pumping, IDF requirements will be met so recommendation can be closed after crest is levelled-up.

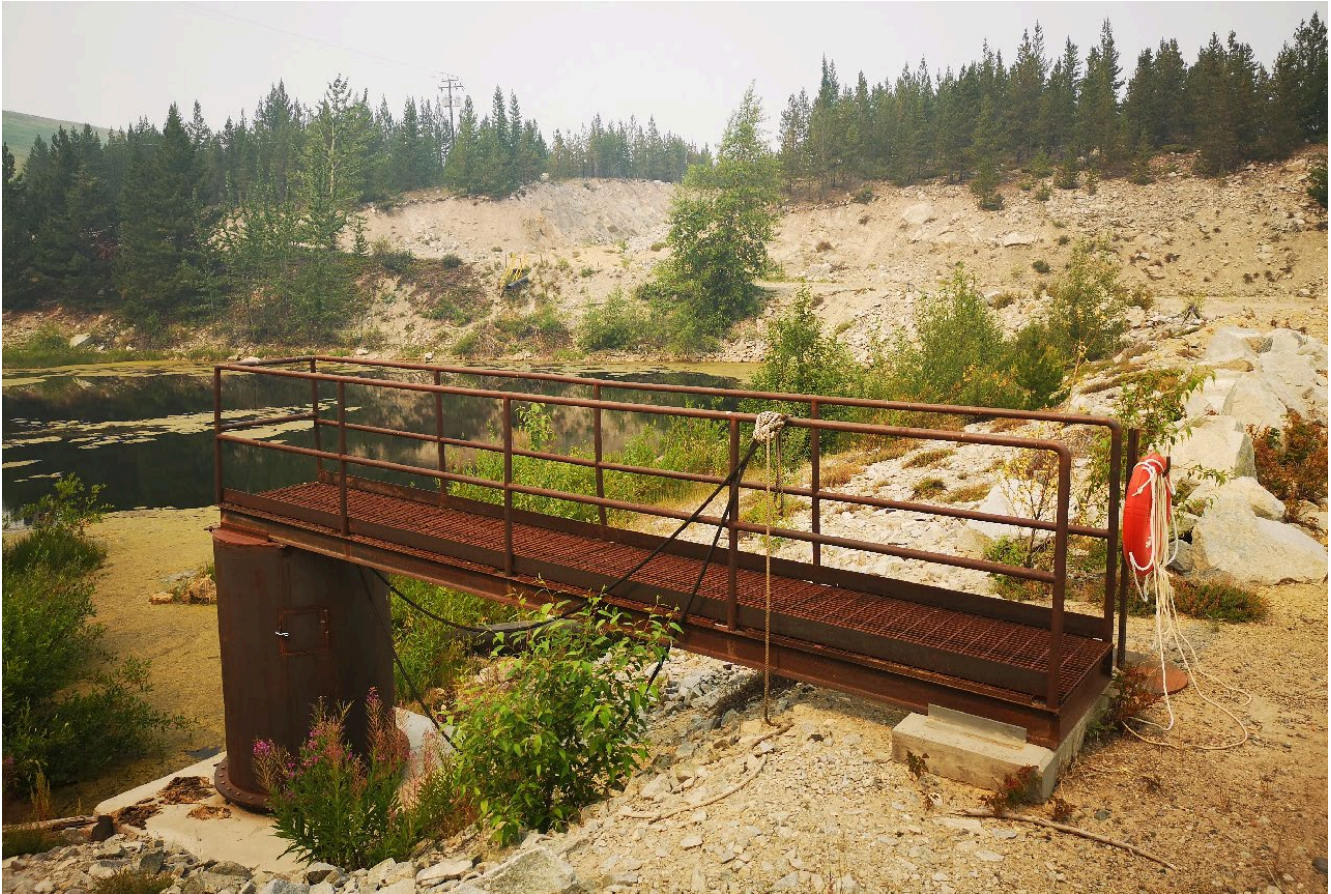
**Photo I-B-4 S1 Pond: LLO to the left of spillway intake. Pond level was about 1.5 m below inlet. Vegetation partially obstructing intake; needs to be cleared during routine maintenance (HGH-2021-18).**

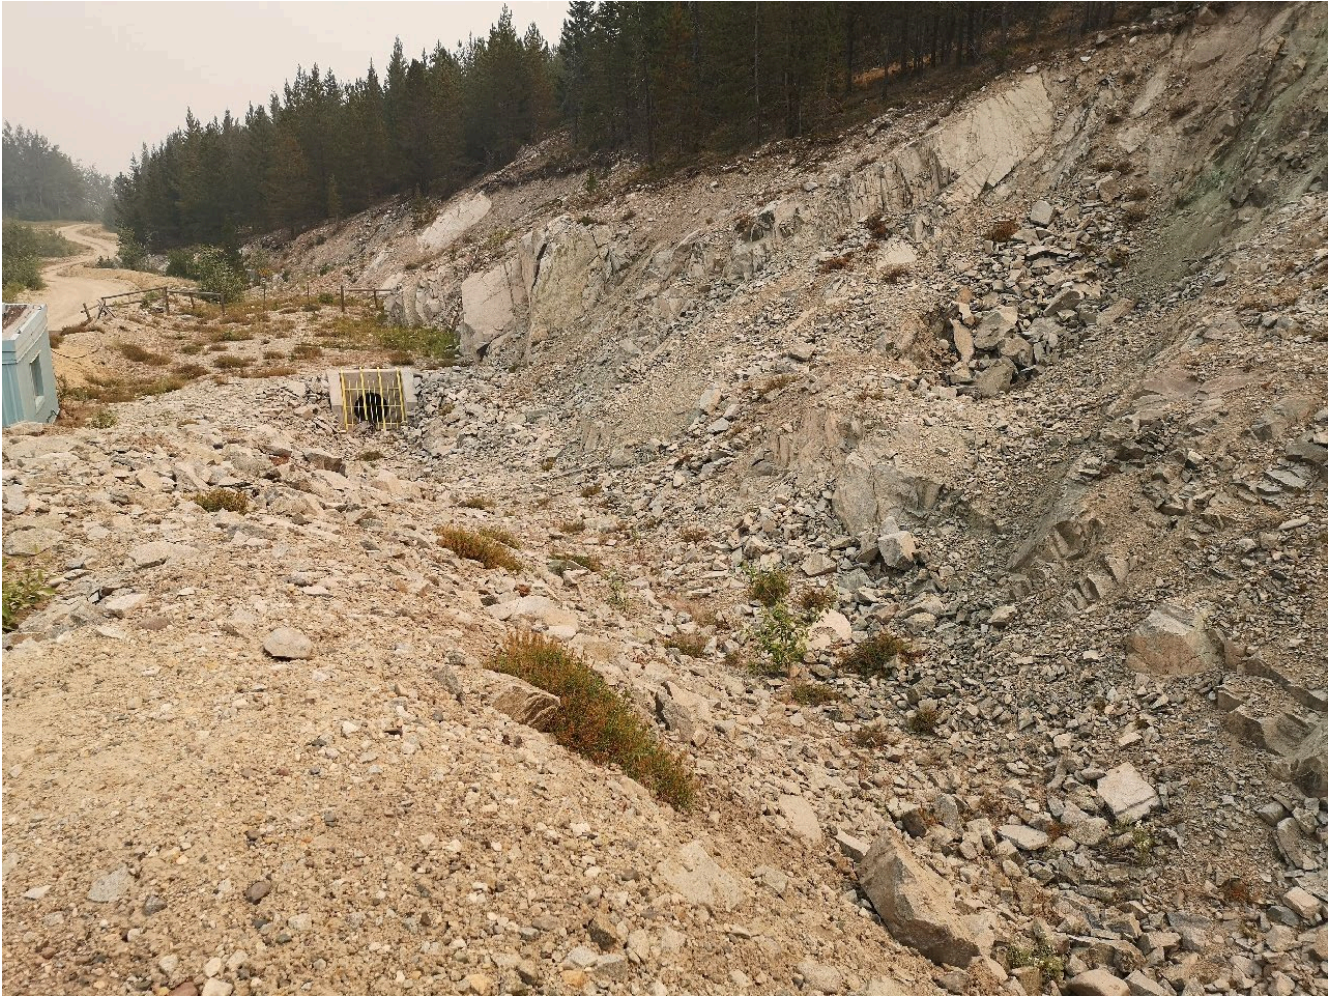
**Photo I-B-5 S1 Pond: Spillway channel and pipe intake looking downstream. Channel is clear of vegetation and no sign of obstruction was observed at the pipe intake (HGH-2021-18).**

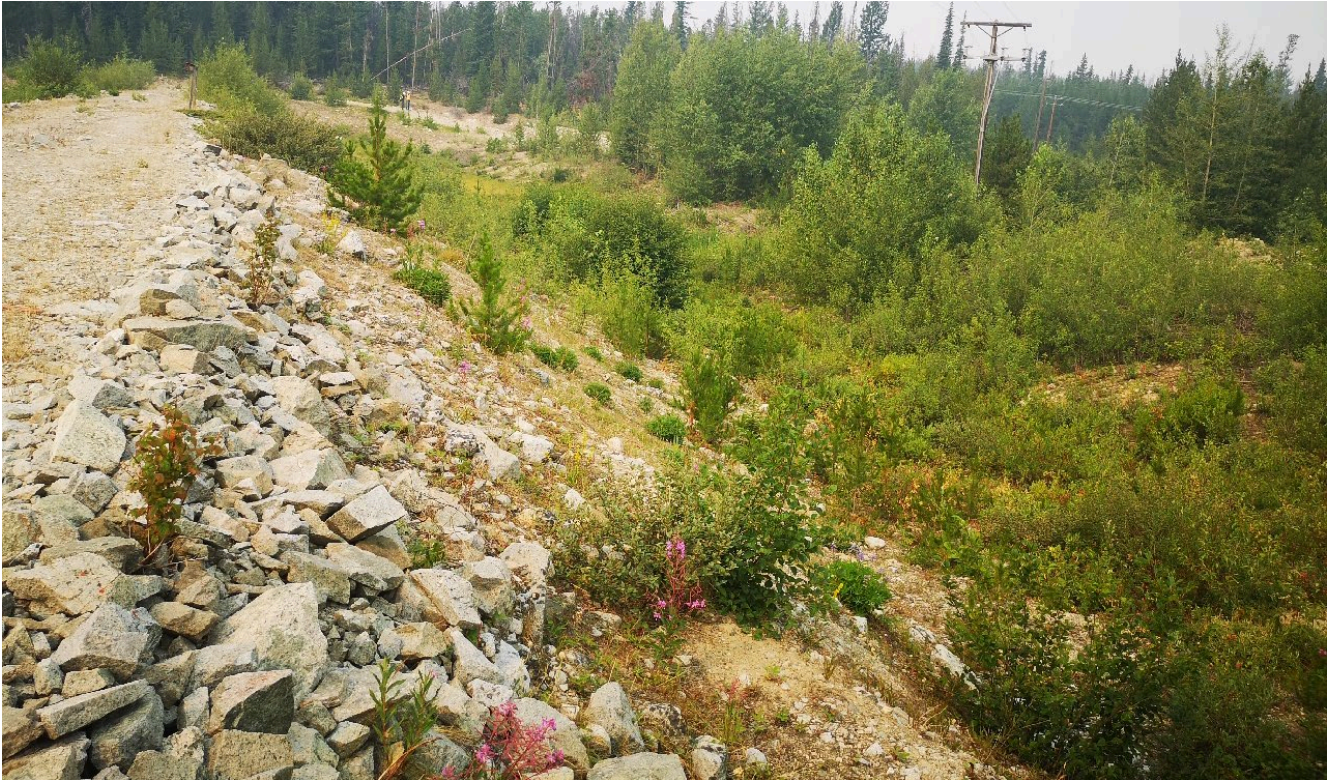
**Photo I-B-9 S2 Pond: View of downstream slope. Slope is in good condition (HGH-2021-21).**

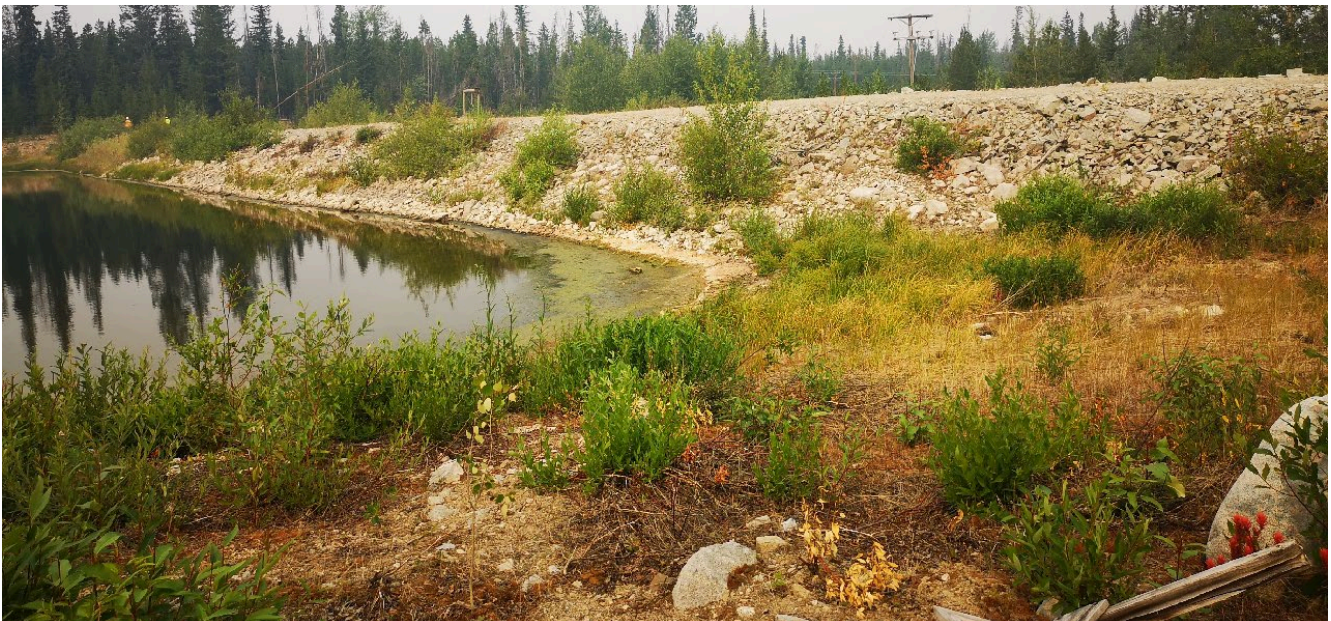
**Photo I-B-10 S2 Pond: Overview of upstream slope riprap. Slope is in good condition (HGH-2021-23).**

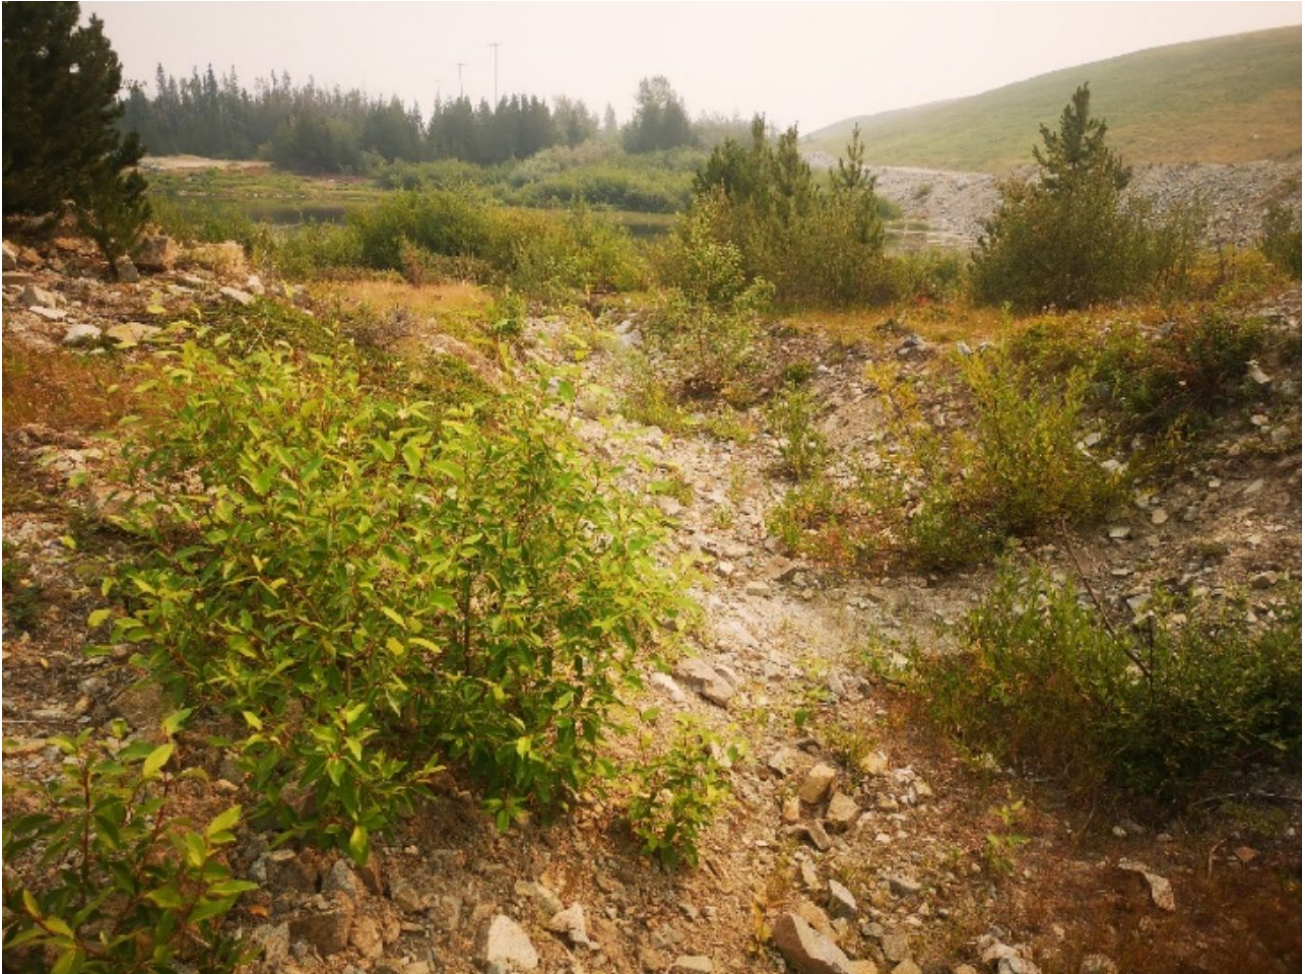
**Photo I-B-14 S2 Pond: S2 Pond inlet and channel from Highmont Spillway Diversion. Channel and the inlet are vegetated; needs to be cleared as part of routine maintenance. (HGH-2021-24).**

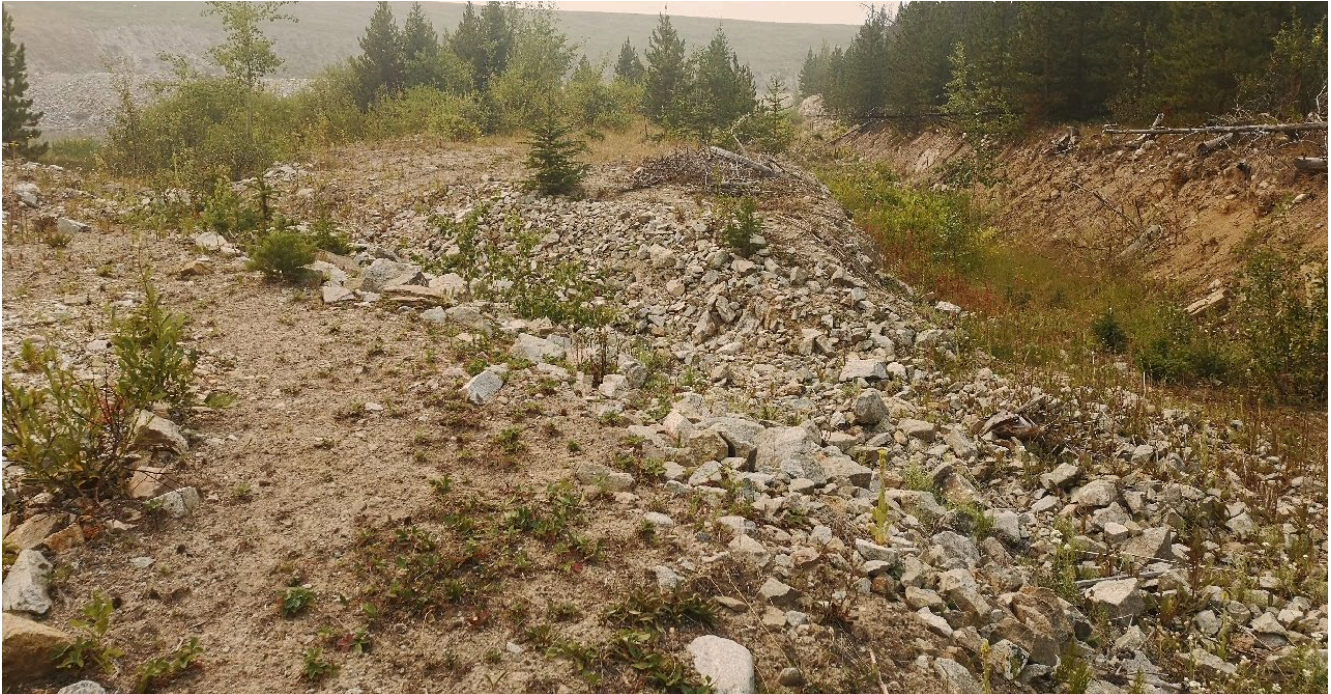
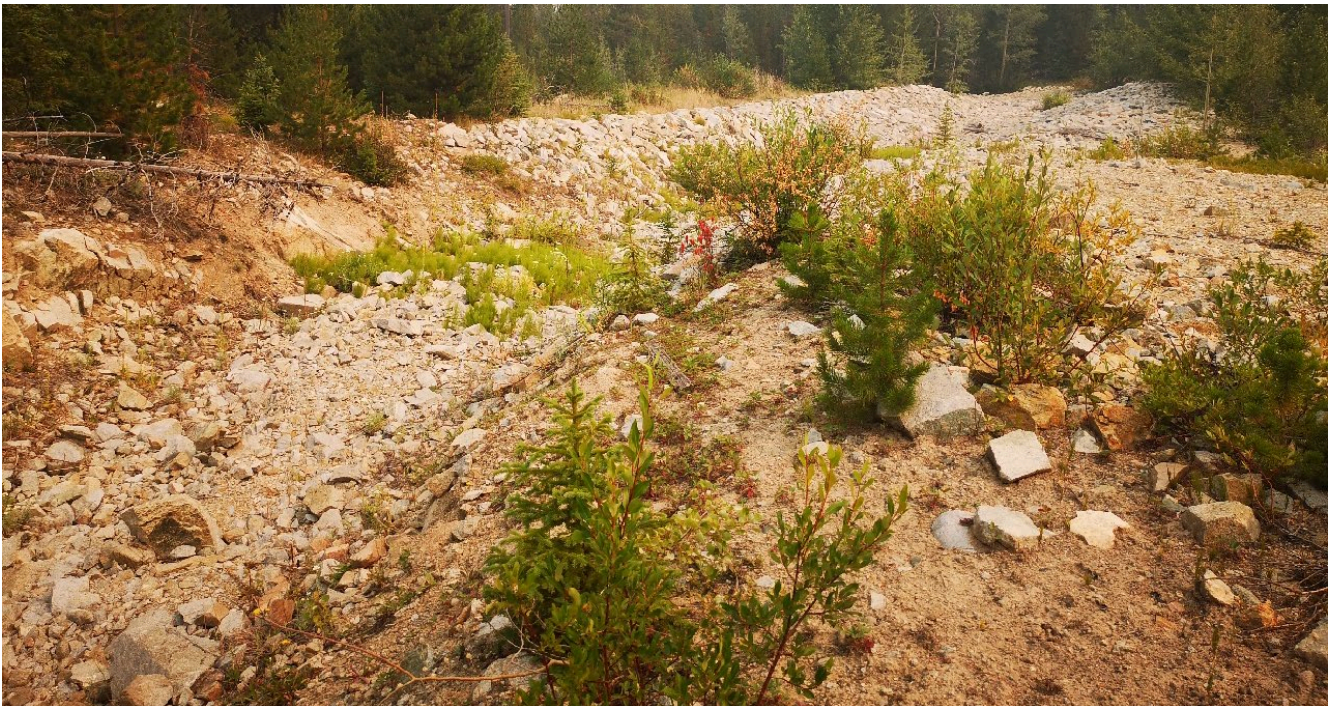
**Photo I-B-15 S2 Pond: View of Highmont Spillway channel. Channel is in good condition. Excess vegetation needs to be removed by HVC as part of routine maintenance (HGH-2021-25).**

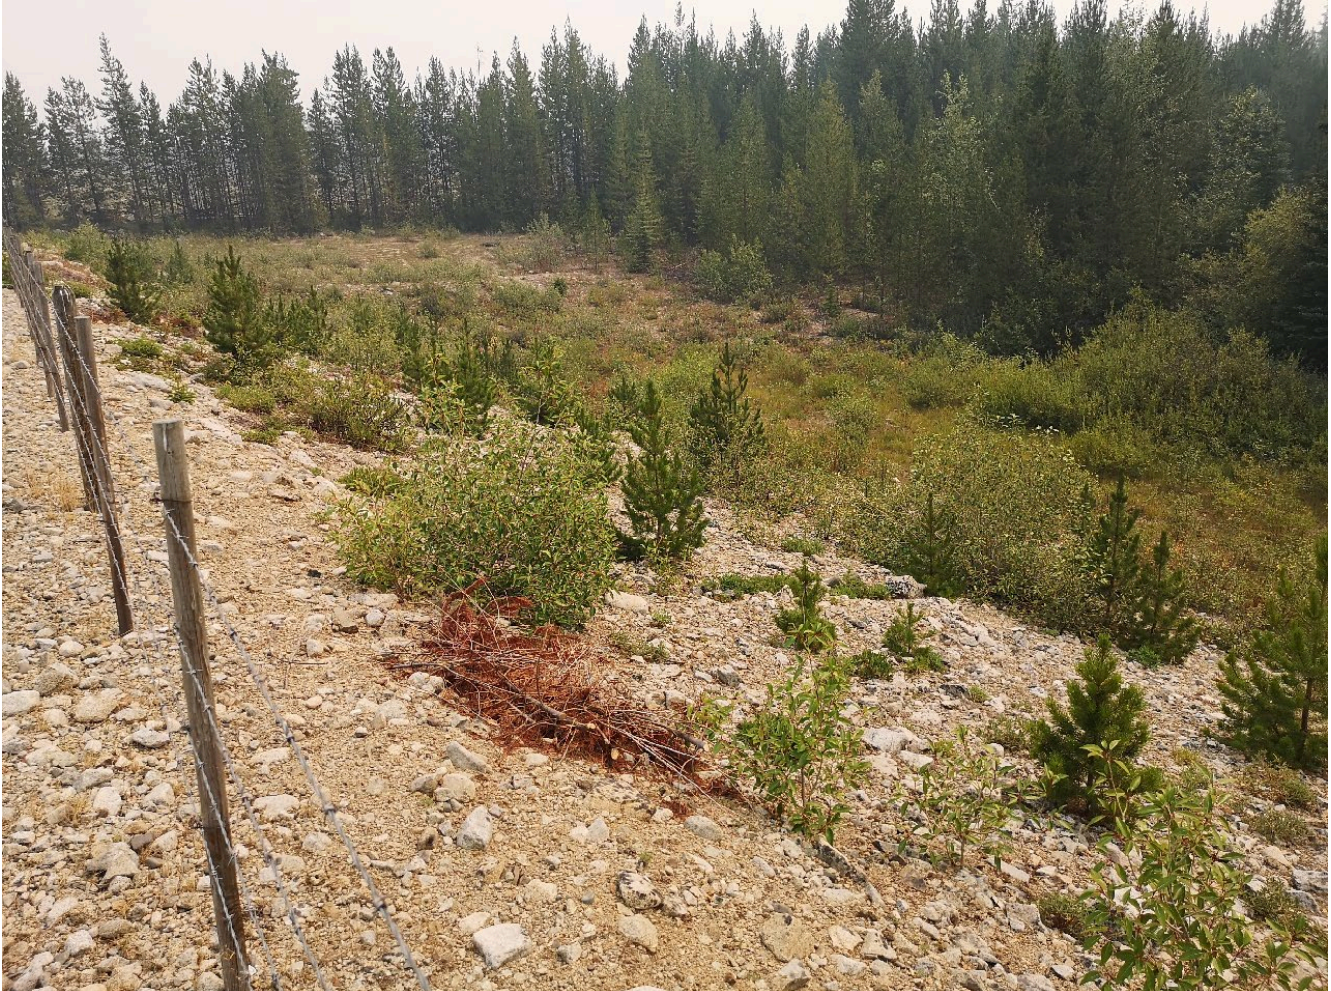
**Photo I-B-21 S3 Pond: Overview of downstream slope with small trees from mid dam (HGH-2021-28).**

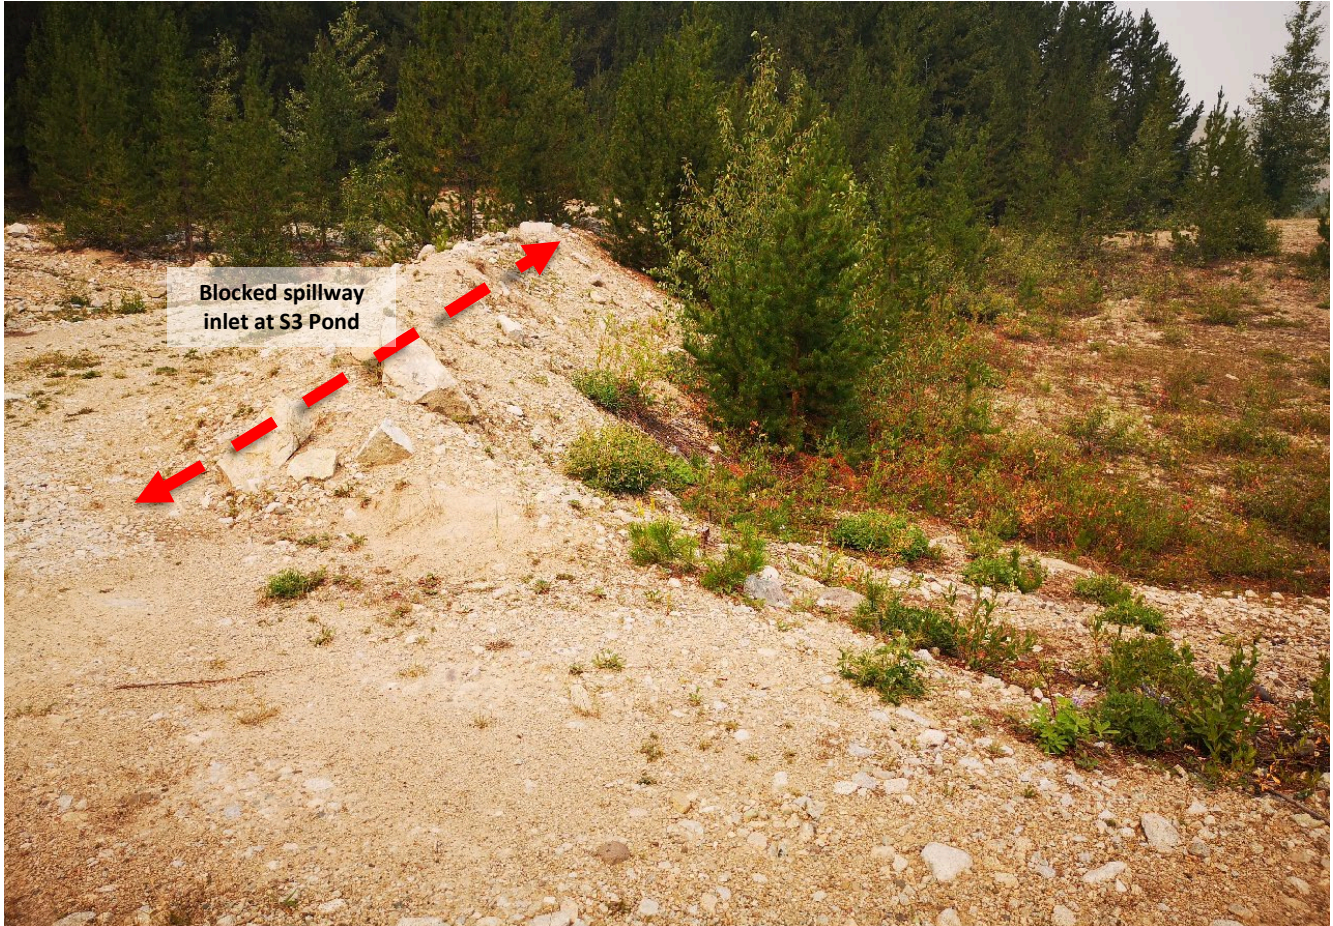
**Photo I-B-25 S3 Pond: View of blocked spillway inlet at right abutment (HGH-2021-30).**

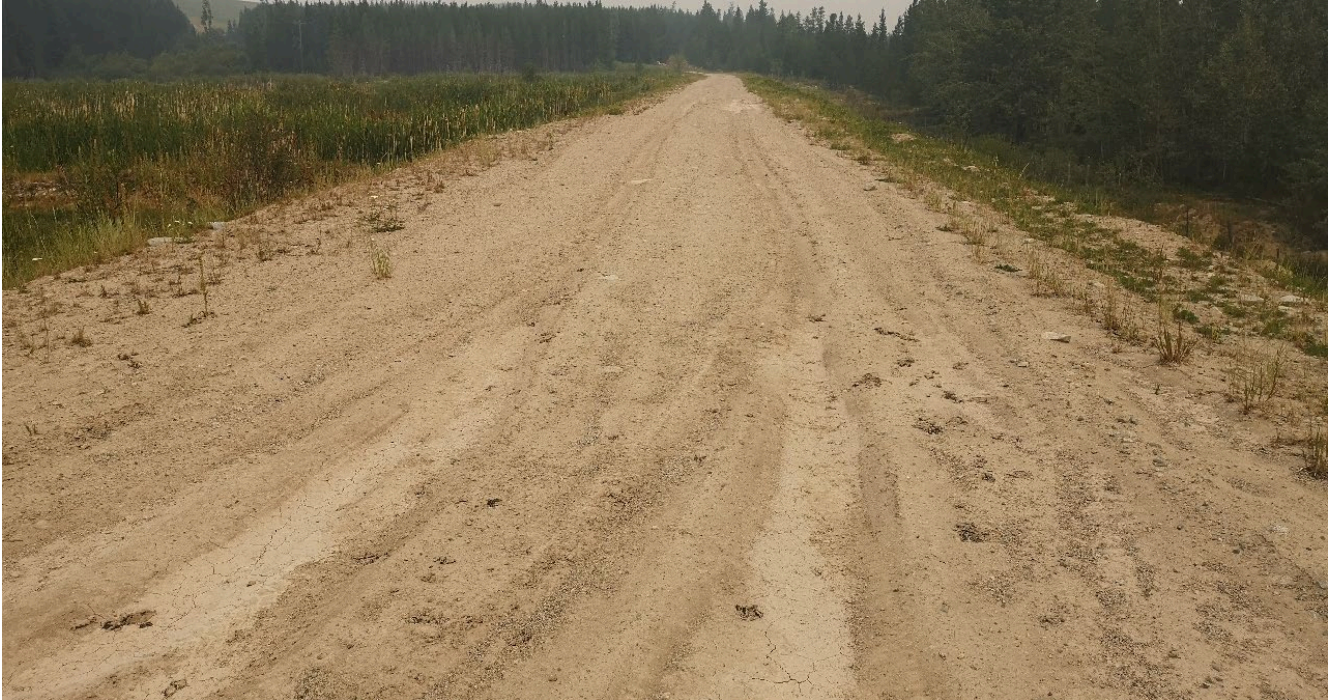
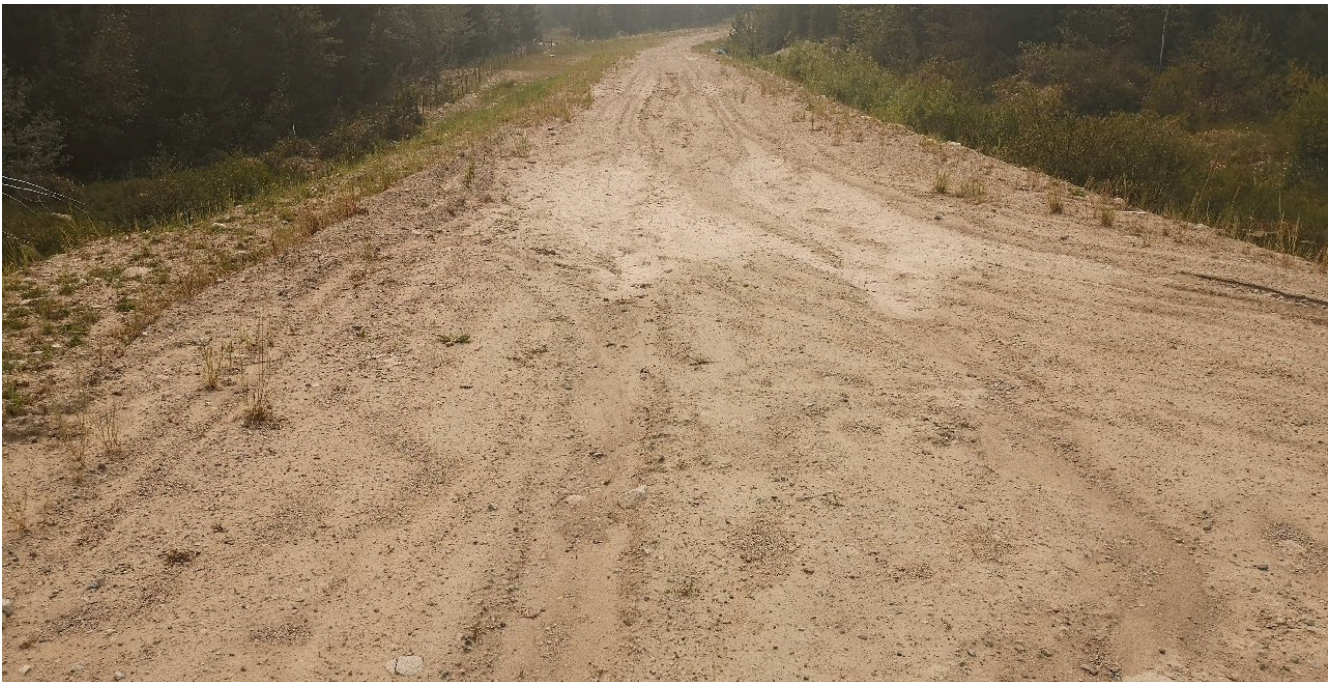
**Photo I-B-26 S5 Pond: Overview of crest. Minor rutting observed on crest and access road is managed by HVC, as needed (HGH-2021-31).**

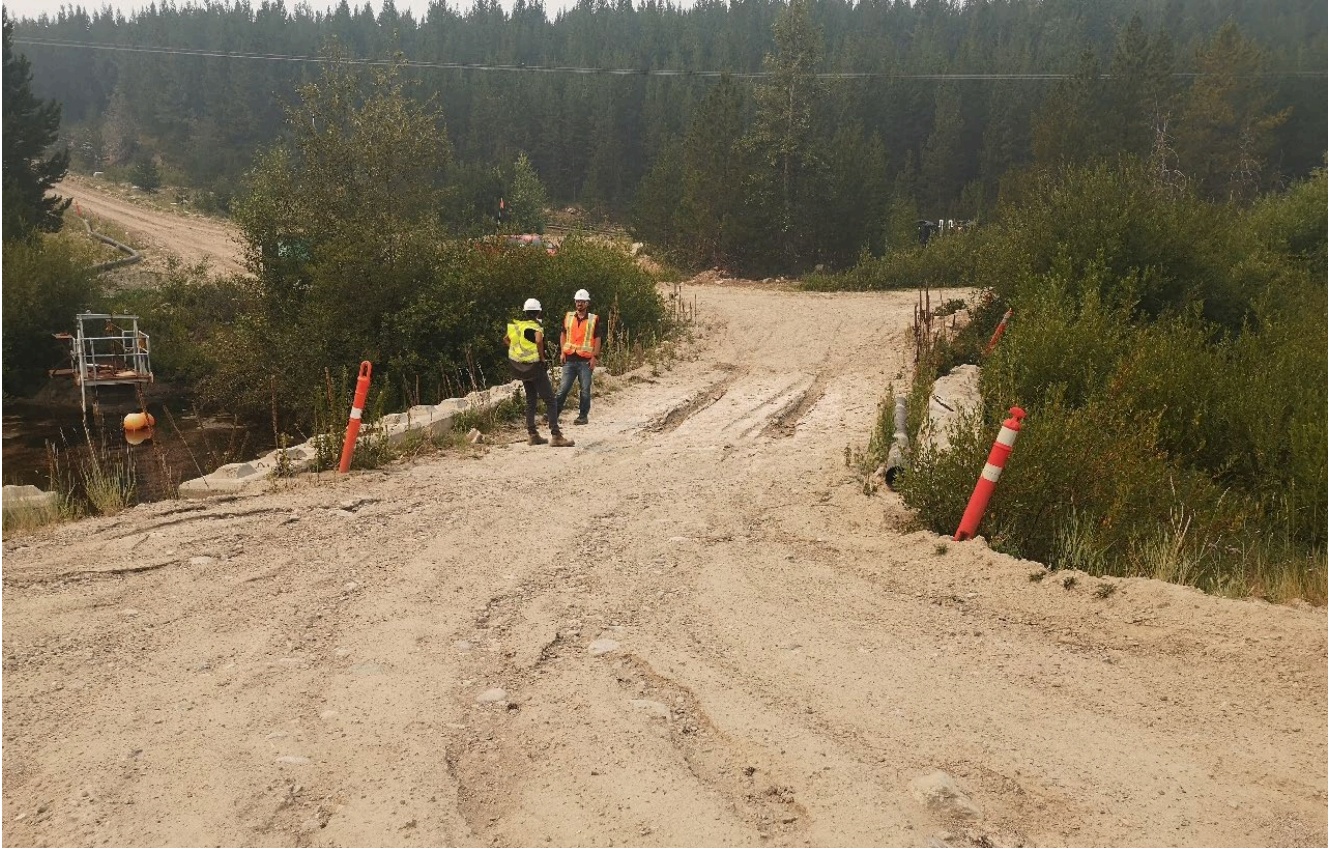
**Photo I-B-27 S5 Pond: View of access road on the divider dyke. Minor rutting observed on crest of divider dyke is managed under routine maintenance (HGH-2021-31).**

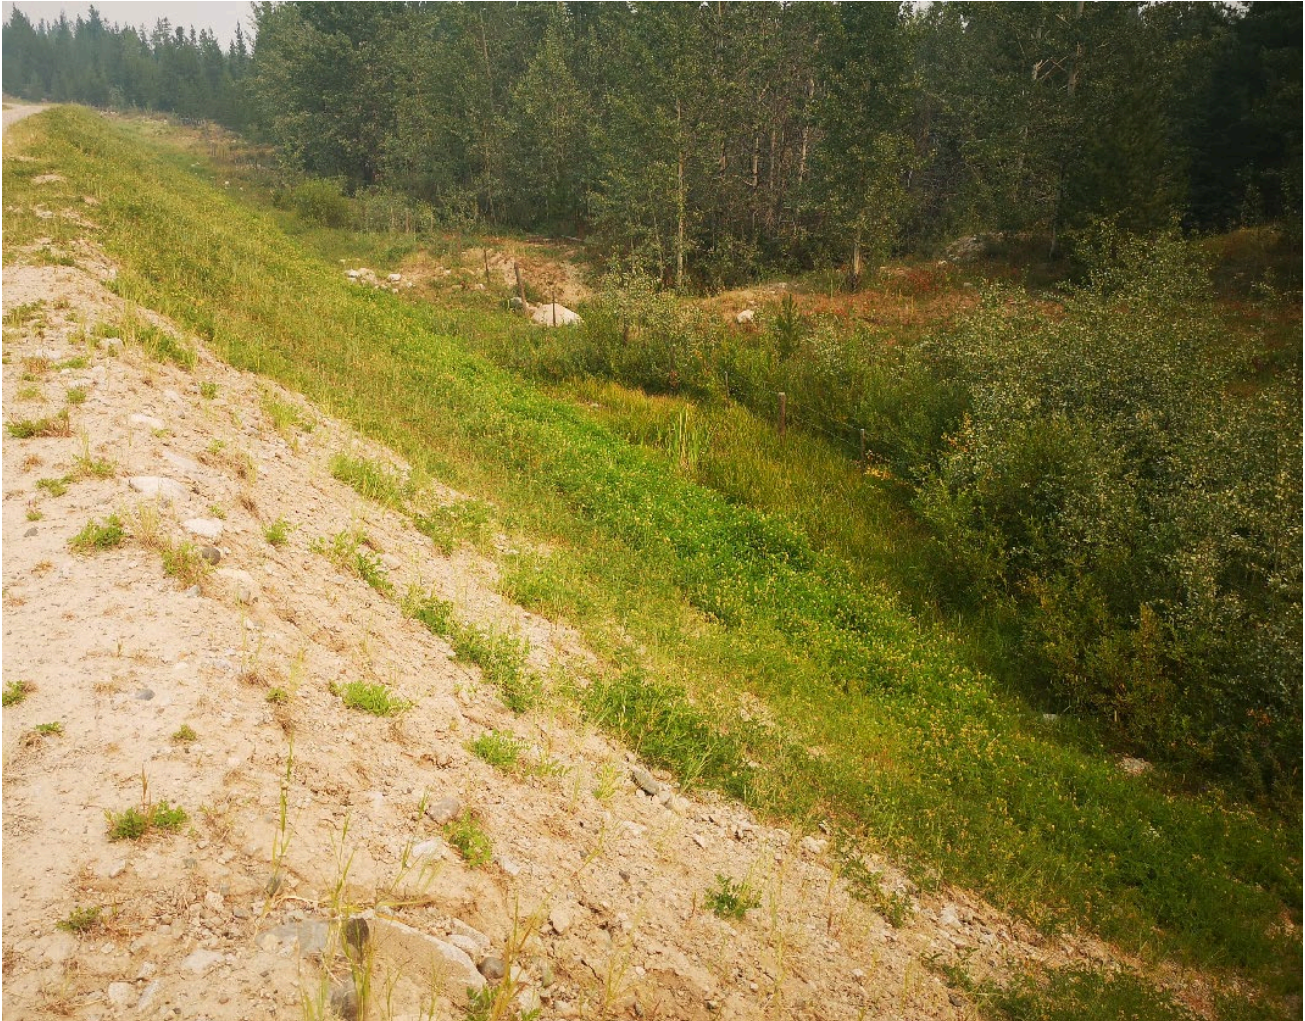
**Photo I-B-37 S5 Pond: Downstream toe of perimeter crest. Change of vegetation suggests there has been temporary ponding at the toe likely due to the run-off; no signs of seepage (HGH-2021-31).**

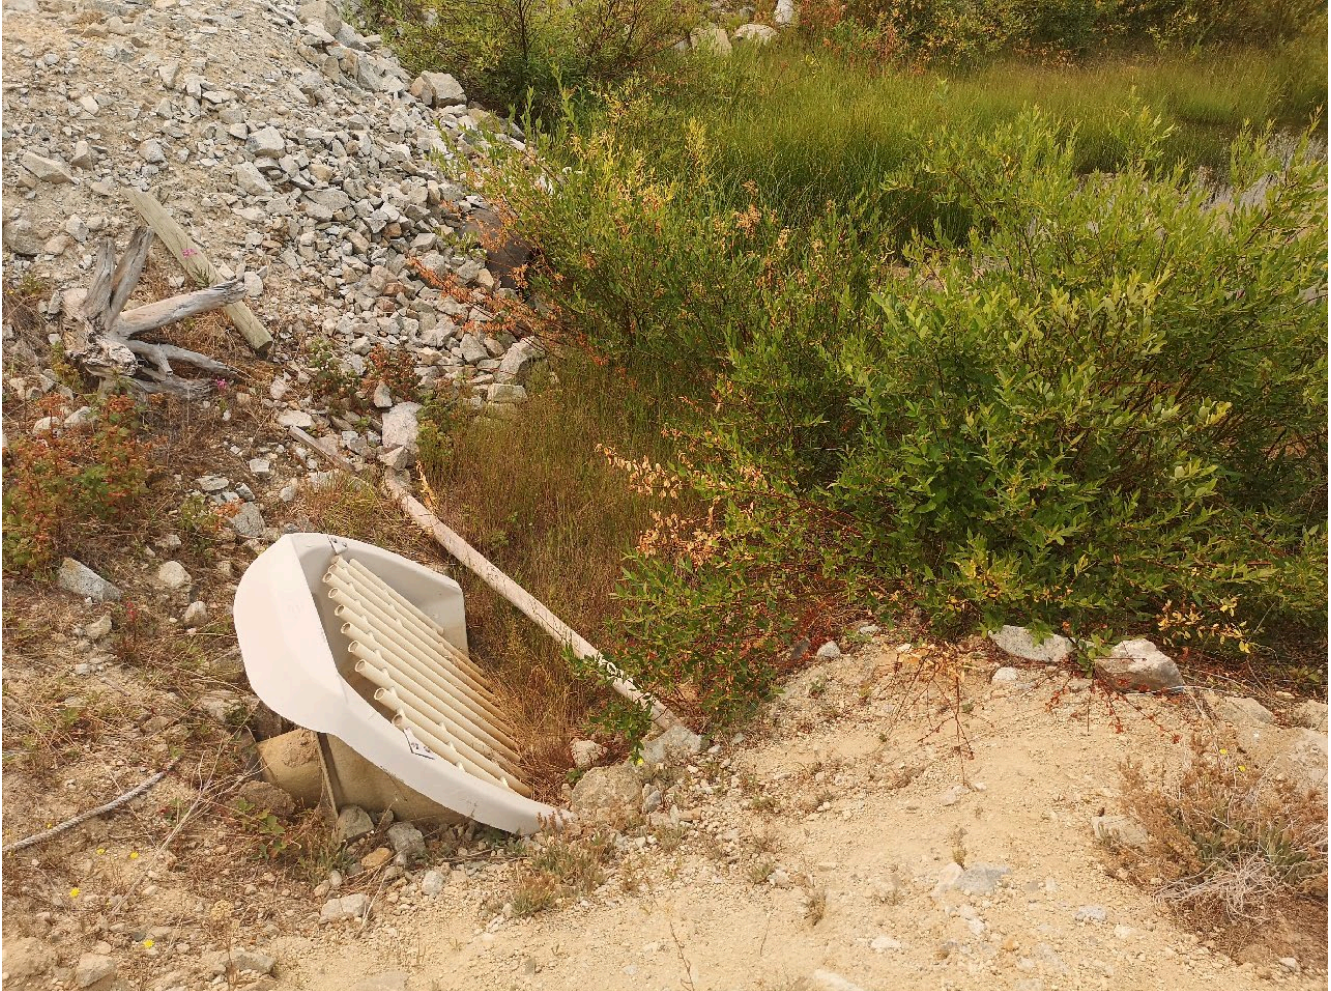
**Photo I-B-42 S8 Pond: Overview of overflow pipe trash rack. Rack is clear of debris. Current water level is below the invert (HGH-2021-40).**
