Klohn Crippen Berger

Bullmoose Mine

Bullmoose Tailings Storage Facility 2022

Annual Facility Performance Report

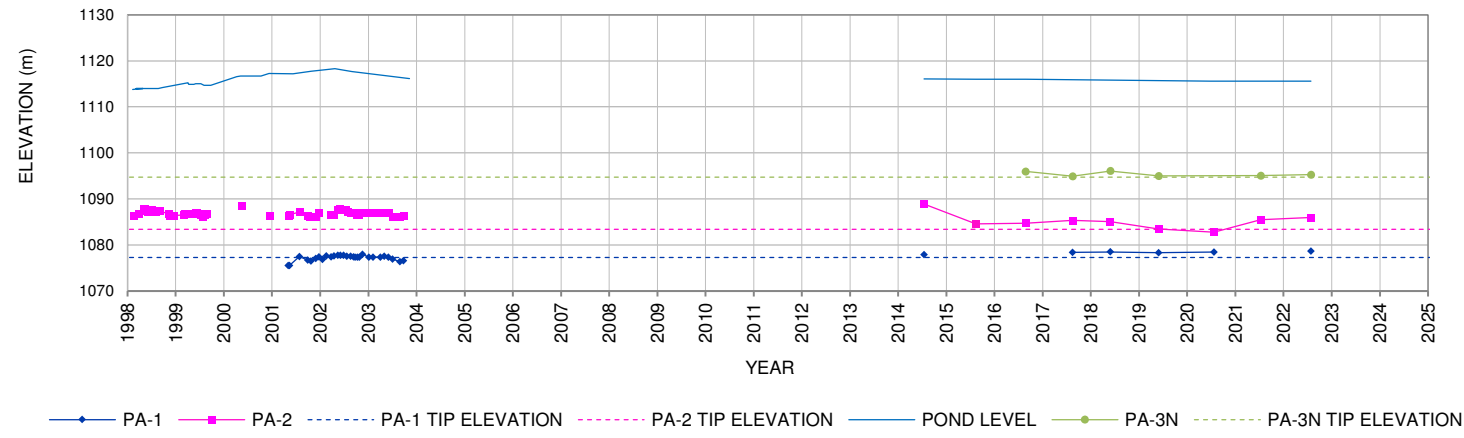
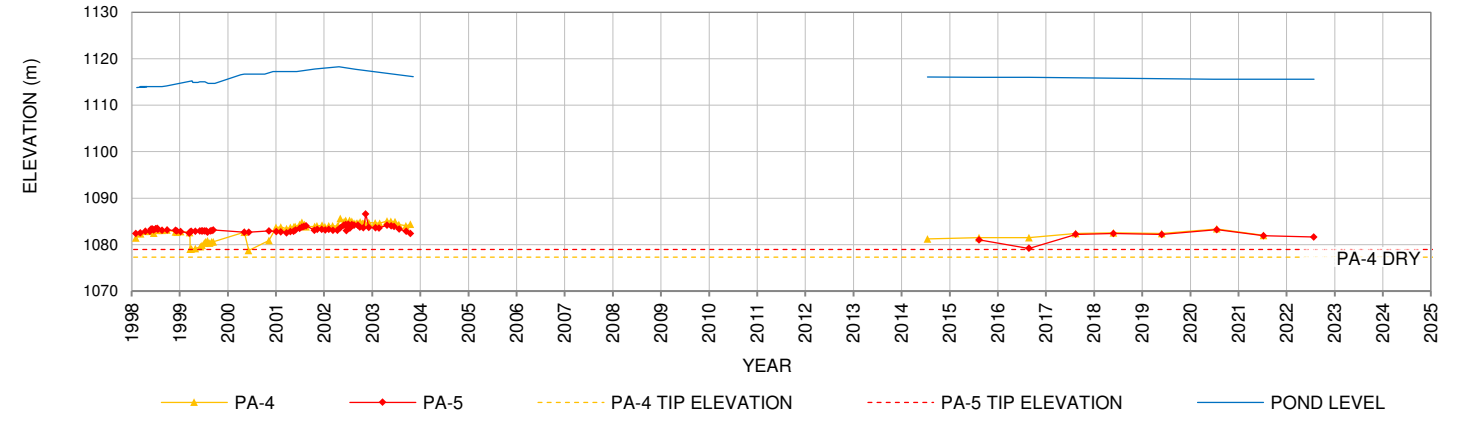
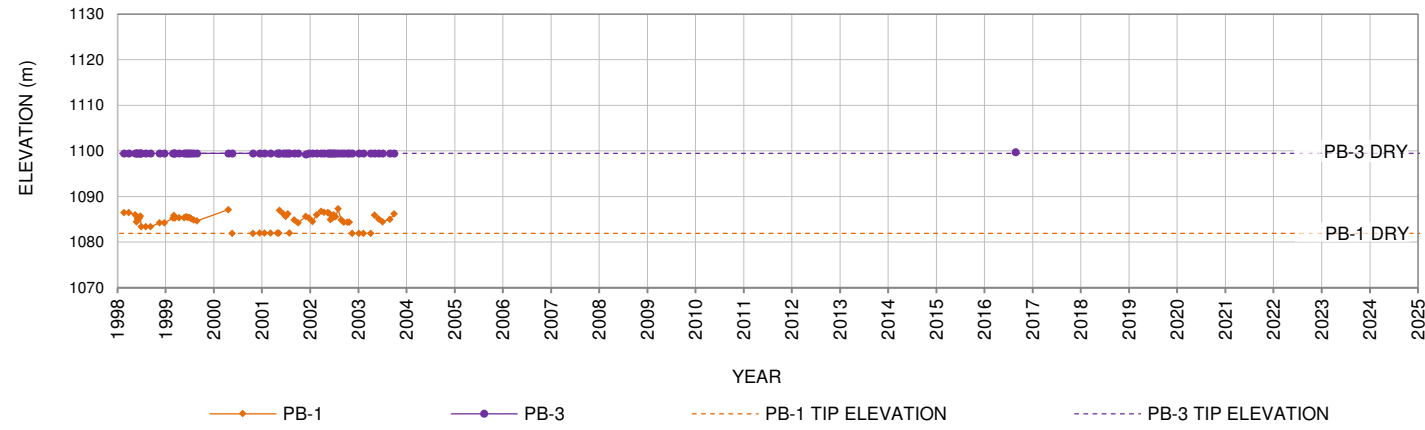
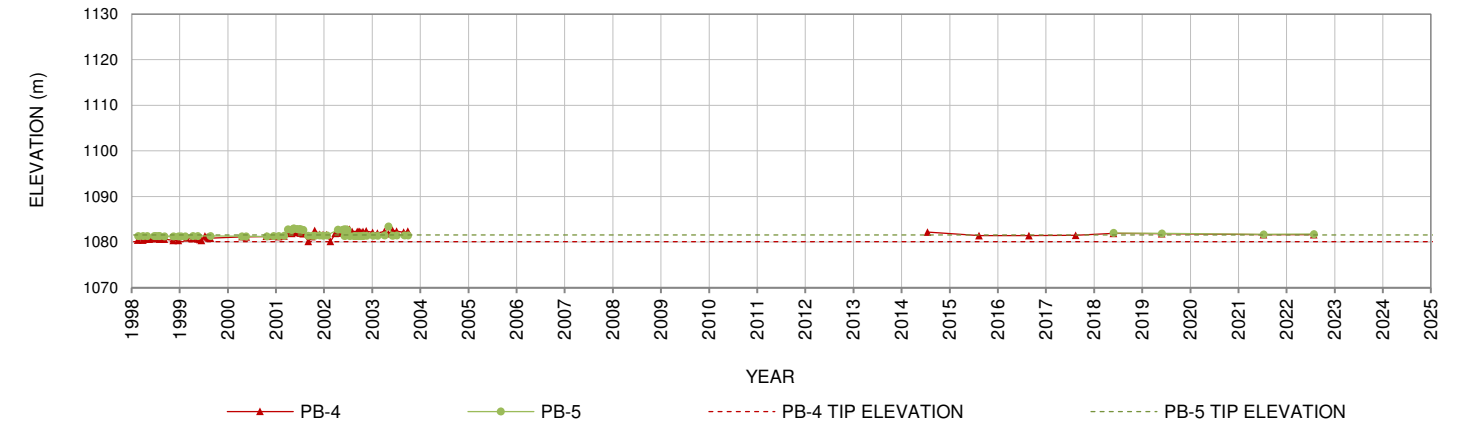
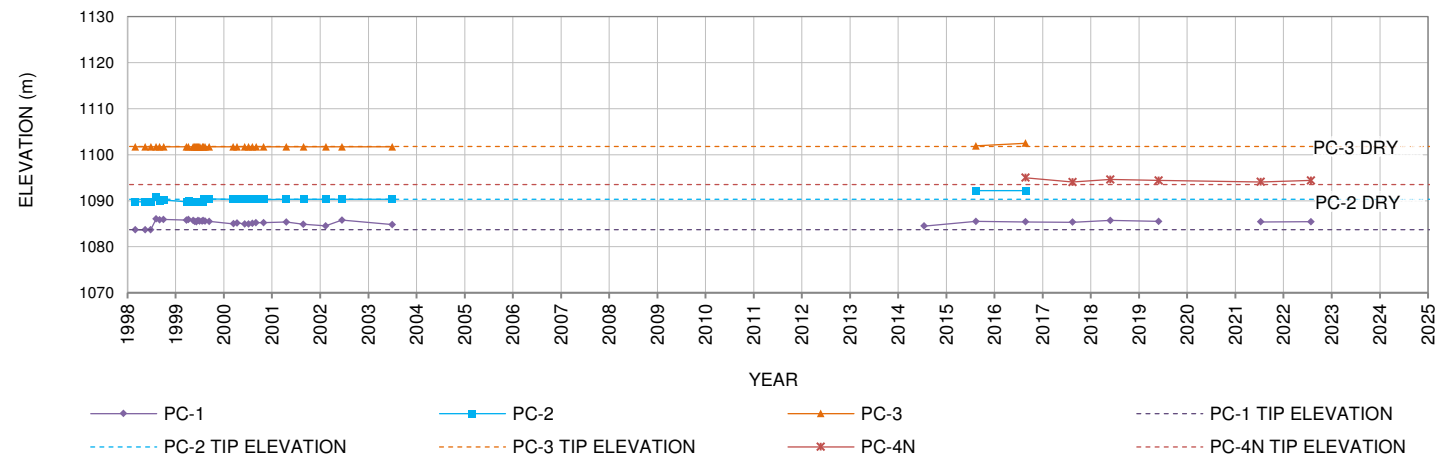
PROJECT	BULLMOOSE MINE 2022 ANNUAL FACILITY PERFORMANCE REPORT	
TITLE	BULLMOOSE TAILINGS STORAGE FACILITY HISTORICAL PIEZOMETER READINGS	
PROJECT No.	M09893A13	FIG. No. 4

A summary of the historical piezometer readings can be found in Figure 4, and selected cross-sections of the facility displaying the latest readings can be found in Figure 5. None of the measured piezometers exceed Threshold Level 1, and none of the piezometers indicate a trend of increasing pore pressures within the embankment or foundation. The piezometer data collected to date continues to show that the dam shell is well drained with a low gradient of approximately 0.04 to 0.05 (KCB 2018b).

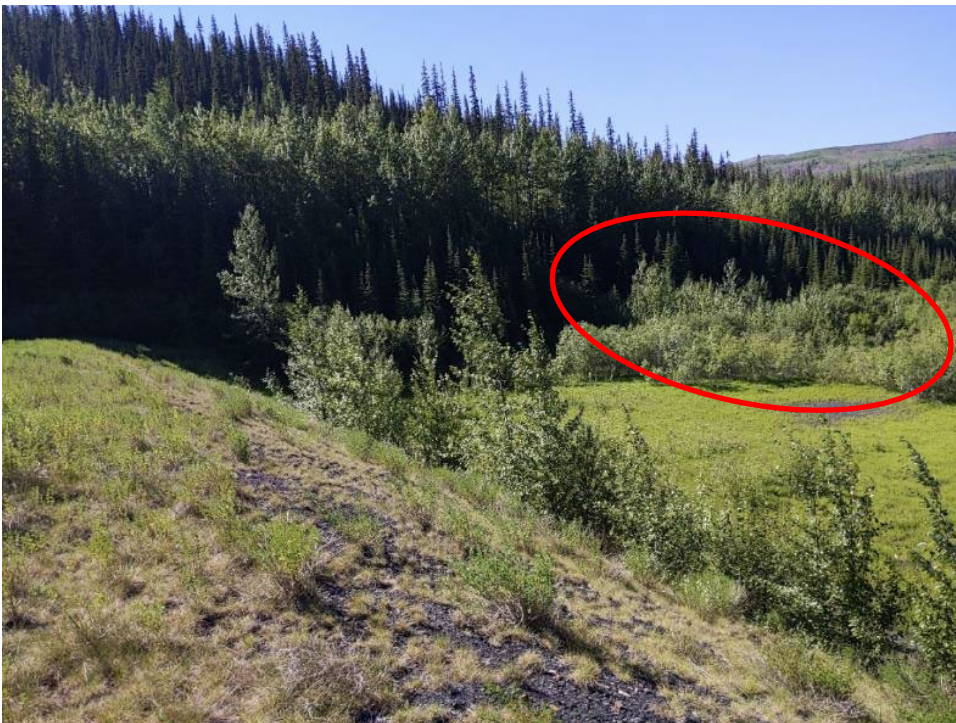
- Historical Slope Failure on Natural Slope South of Impoundment:** A historical slope failure is present in the natural slope on the south side of the impoundment (Photo II-9). The area impacted is about 20 m by 60 m. The failure is also visible in photographs from previous annual reports (Teck 2013a, KCB 2011, KCB 2014a, and KCB 2020a) indicating this has been present since at least 2010. The slide mass is overgrown with vegetation including small trees. Comparison of photographs between 2010 and 2022 does not indicate any visually identifiable changes, and the feature is not a risk to the facility.

Photo II-9 BTSF impoundment and historic slope failure looking southwest (BTSF-2022-05)

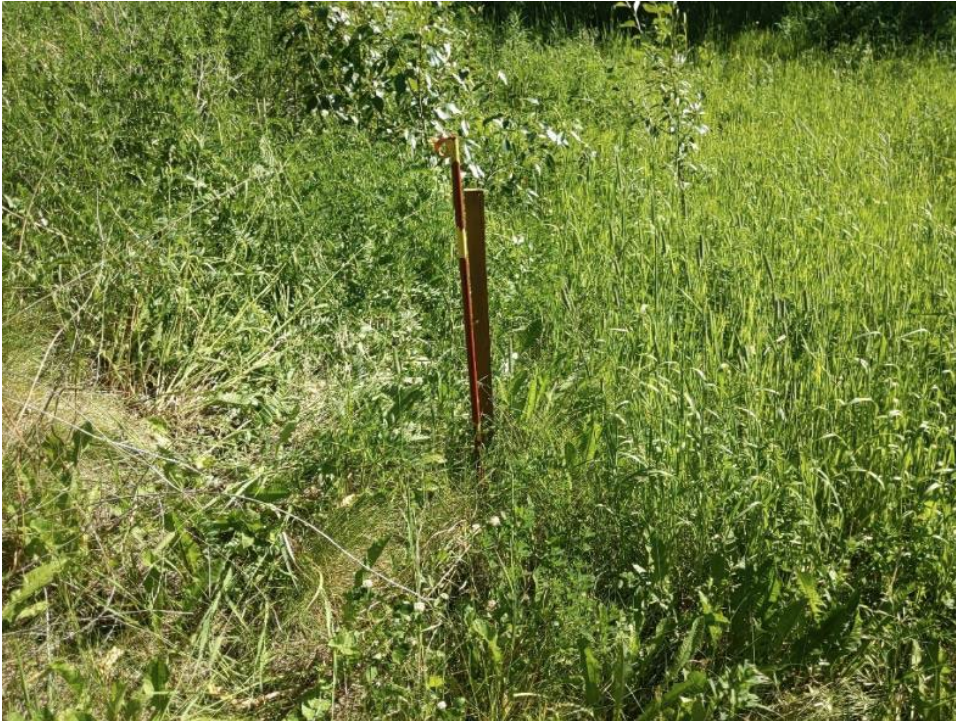
Photo II-10 Freeboard monitoring stake was dry at the time of the site visit (BTSF-2022-06)

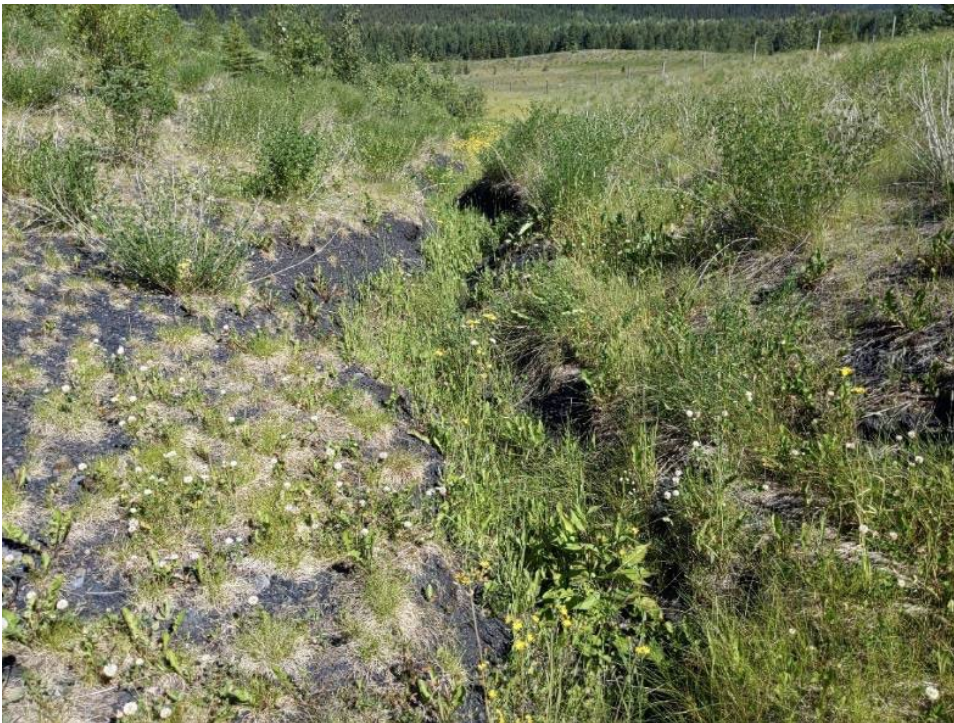
- ◆ No change to the small erosion gully observed at the toe near the right abutment (Photo II-13). The gully was first observed in 2017 and has not shown signs of change since that time. The gully was presumably formed during a period of concentrated local flow during spring freshet. This feature continues to be monitored during annual site visits for signs of change.

Photo II-13 Erosion gully near the toe of BTSF. No visible change from previous site visits. (BTSF-2022-08)

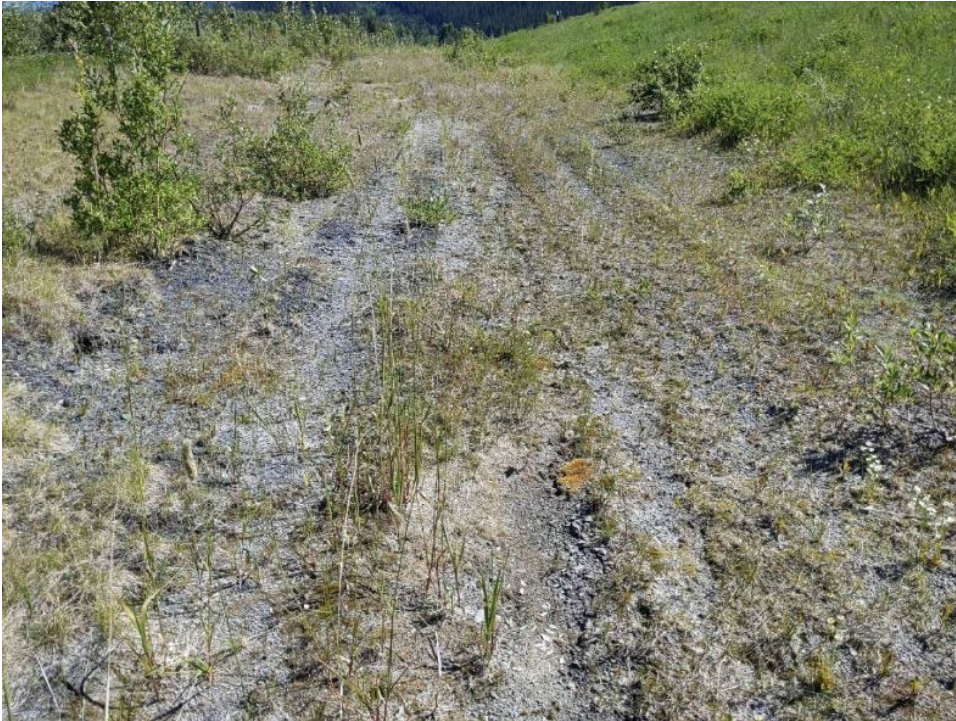
- ◆ There is typically a small wet area near the toe of the north arm of the BTSF (Photo II-18) which was first noted in 2019. There were no signs of seepage emerging from the downstream slope, and the wet area is believed to be due to ponding from snowmelt from the slopes. This area was dry during the site visit.

Photo II-18 Known wet area near the toe of BTSF, dry at the time of visit (BTSF-2022-11)
