# 2022 Annual Facility Performance Report—Coal Reject Spoils

*Teck Coal Limited, Fording River Operations*

Reference No. 22516328-2022-123-R-Rev0-1800

29 March 2023

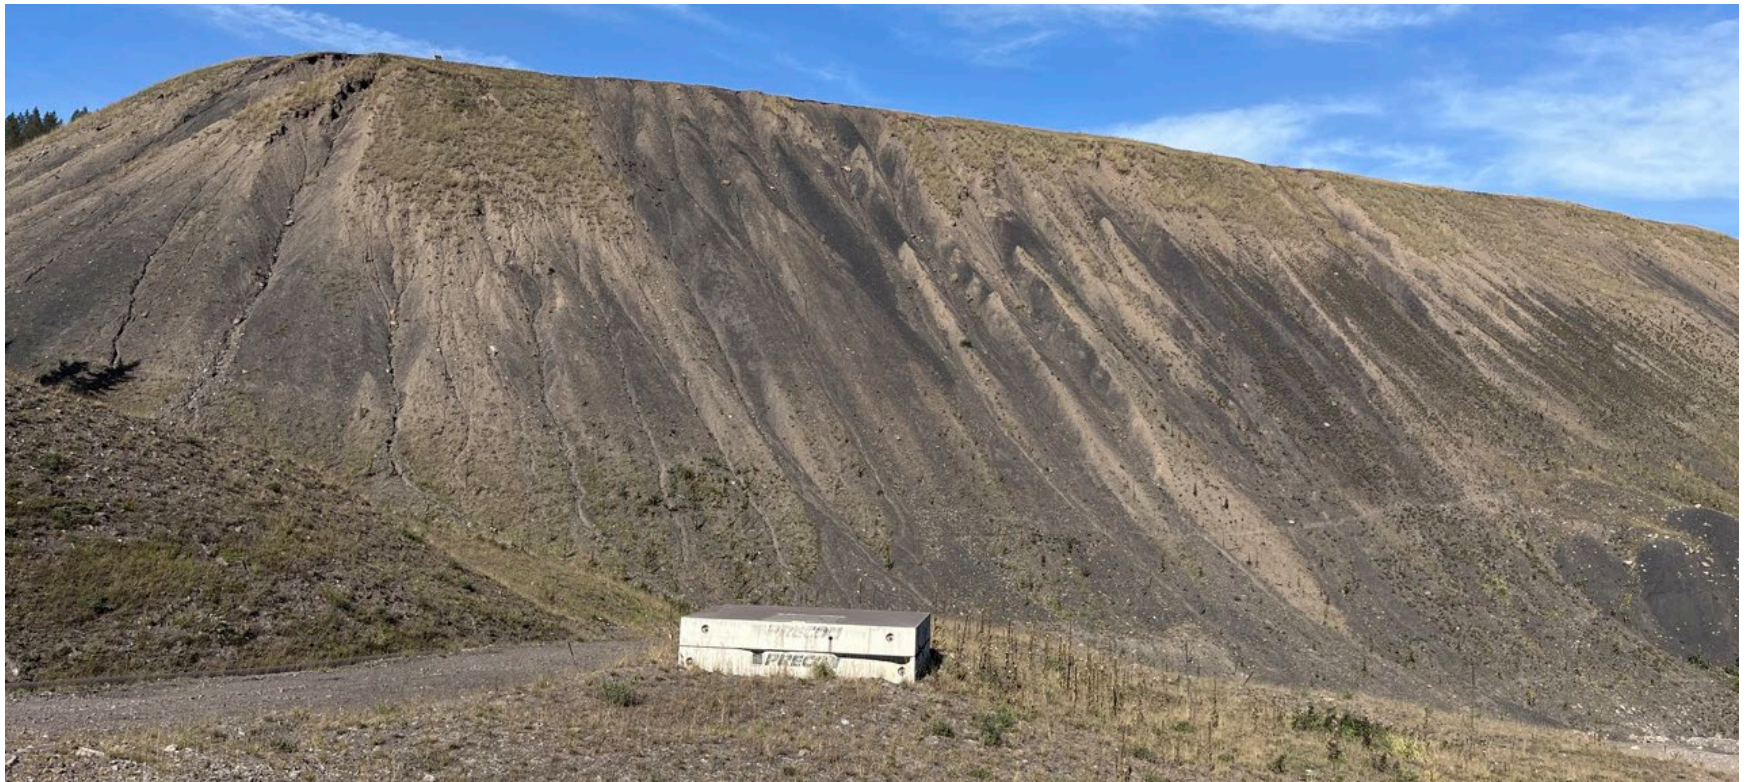
A-Spoil: South side of the slope above Liverpool Settling ponds, looking north.

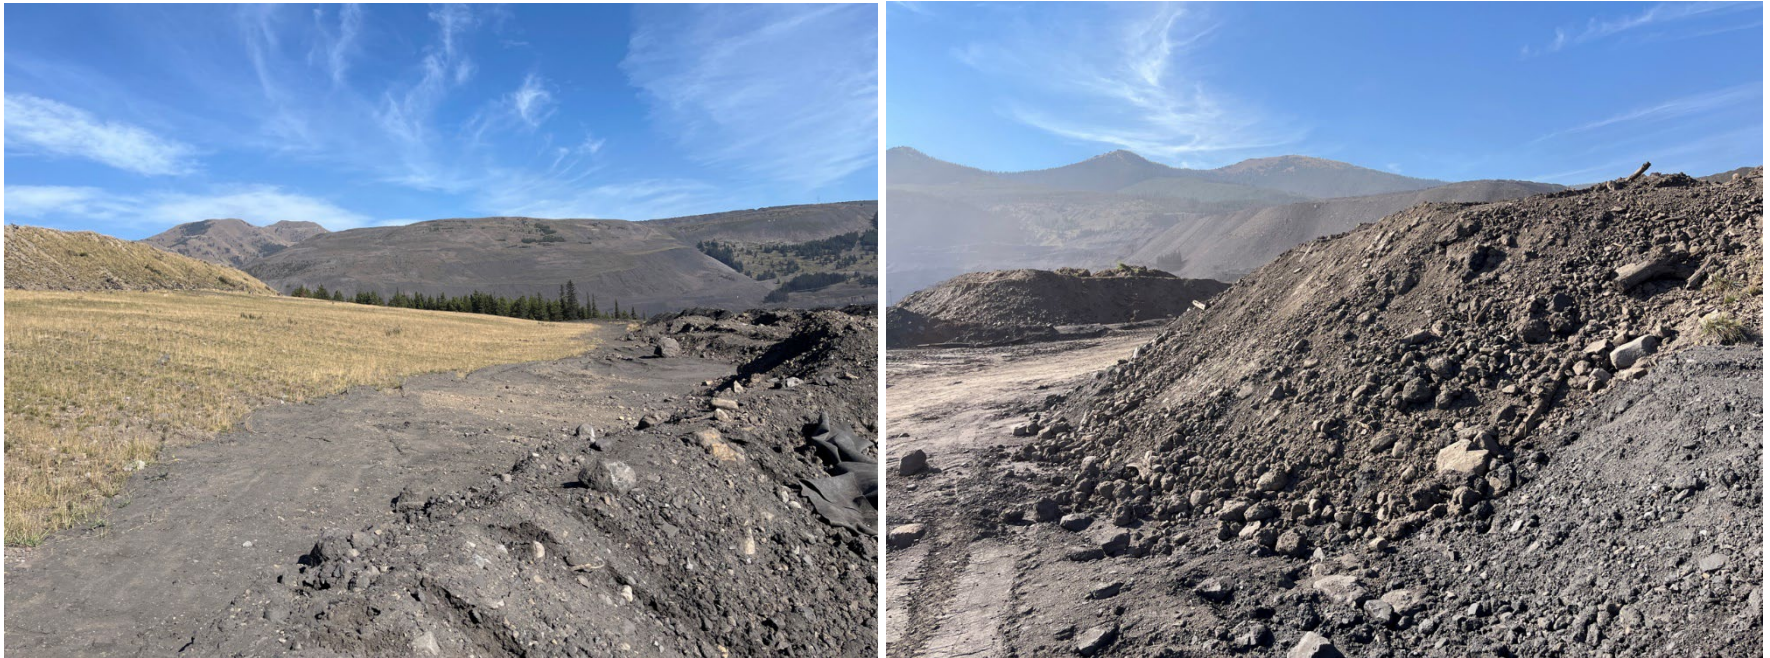
A-Spoil: topsoil stockpiling was observed on the south crest, looking west (Photograph 2) and east (Photograph 3).

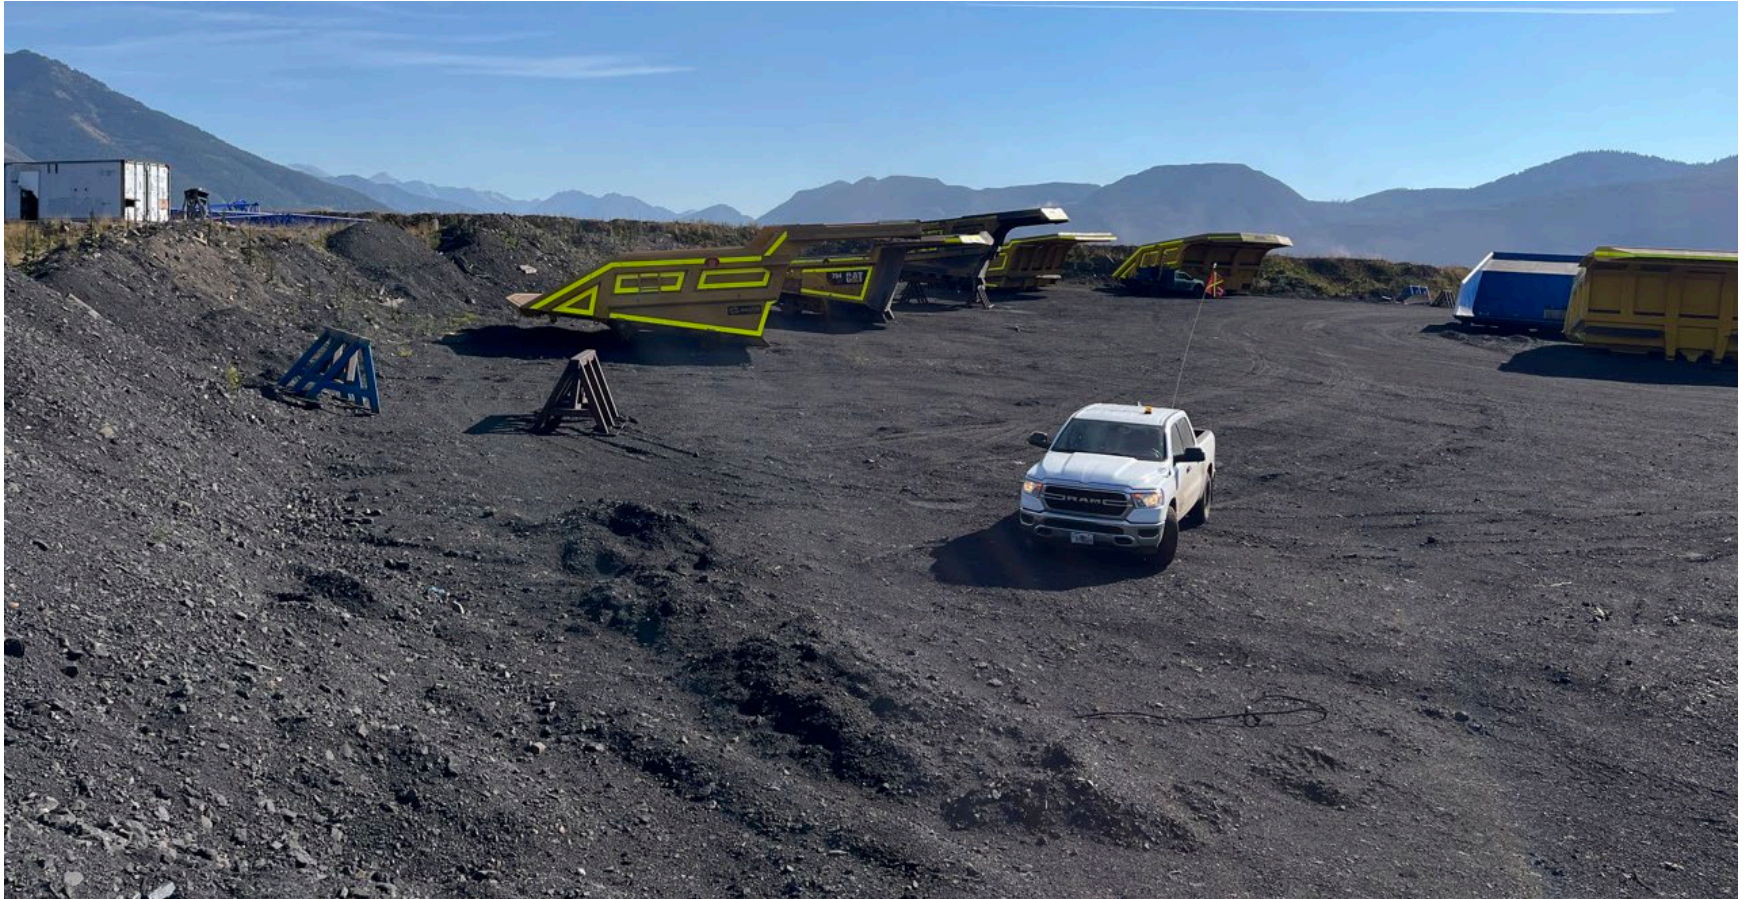
A-Spoil: overview of the crest, including equipment storage, looking north.

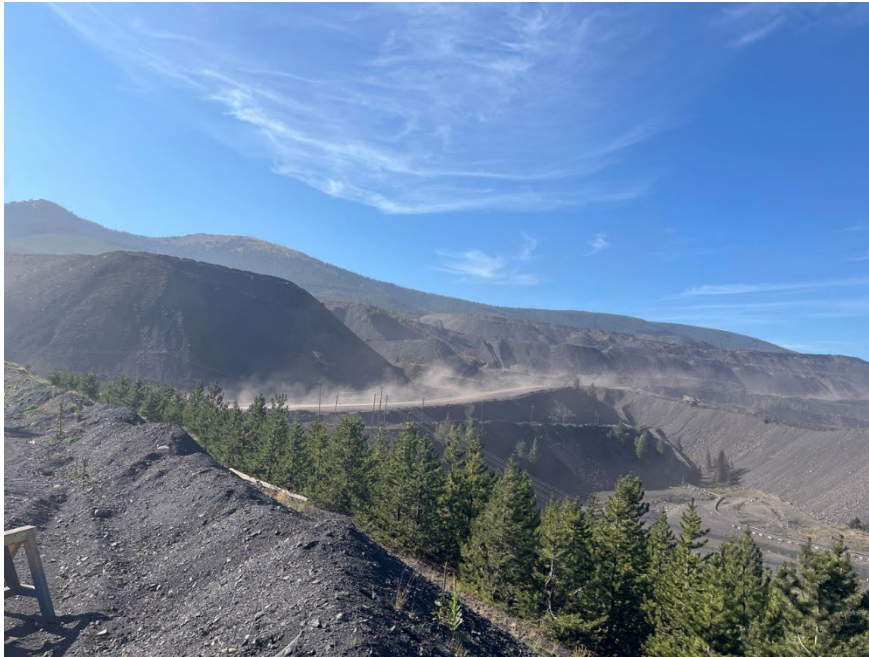
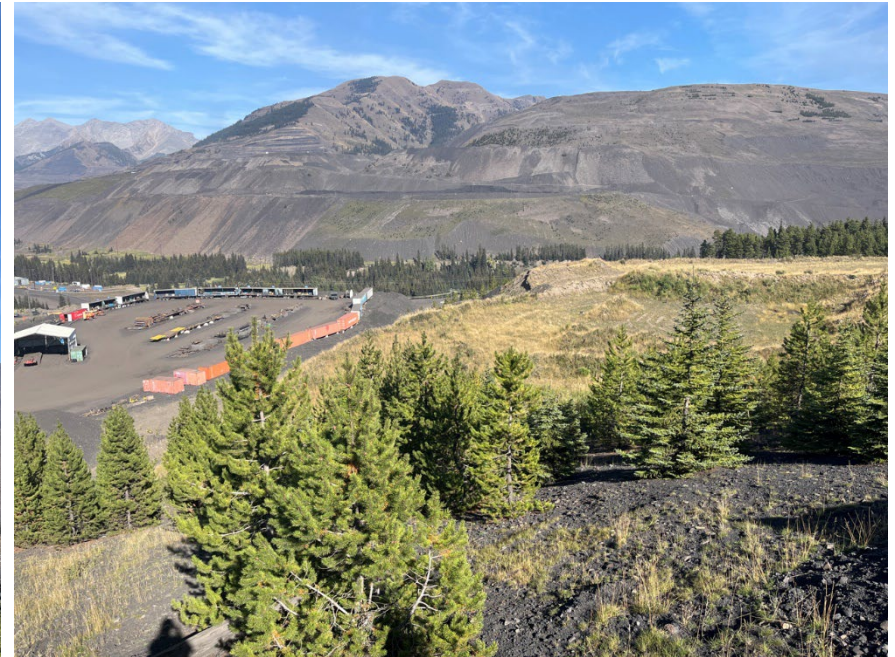
A-Spoil: view of the north side of Spoil showing revegetation, looking northwest (Photograph 5) and north (Photograph 6).

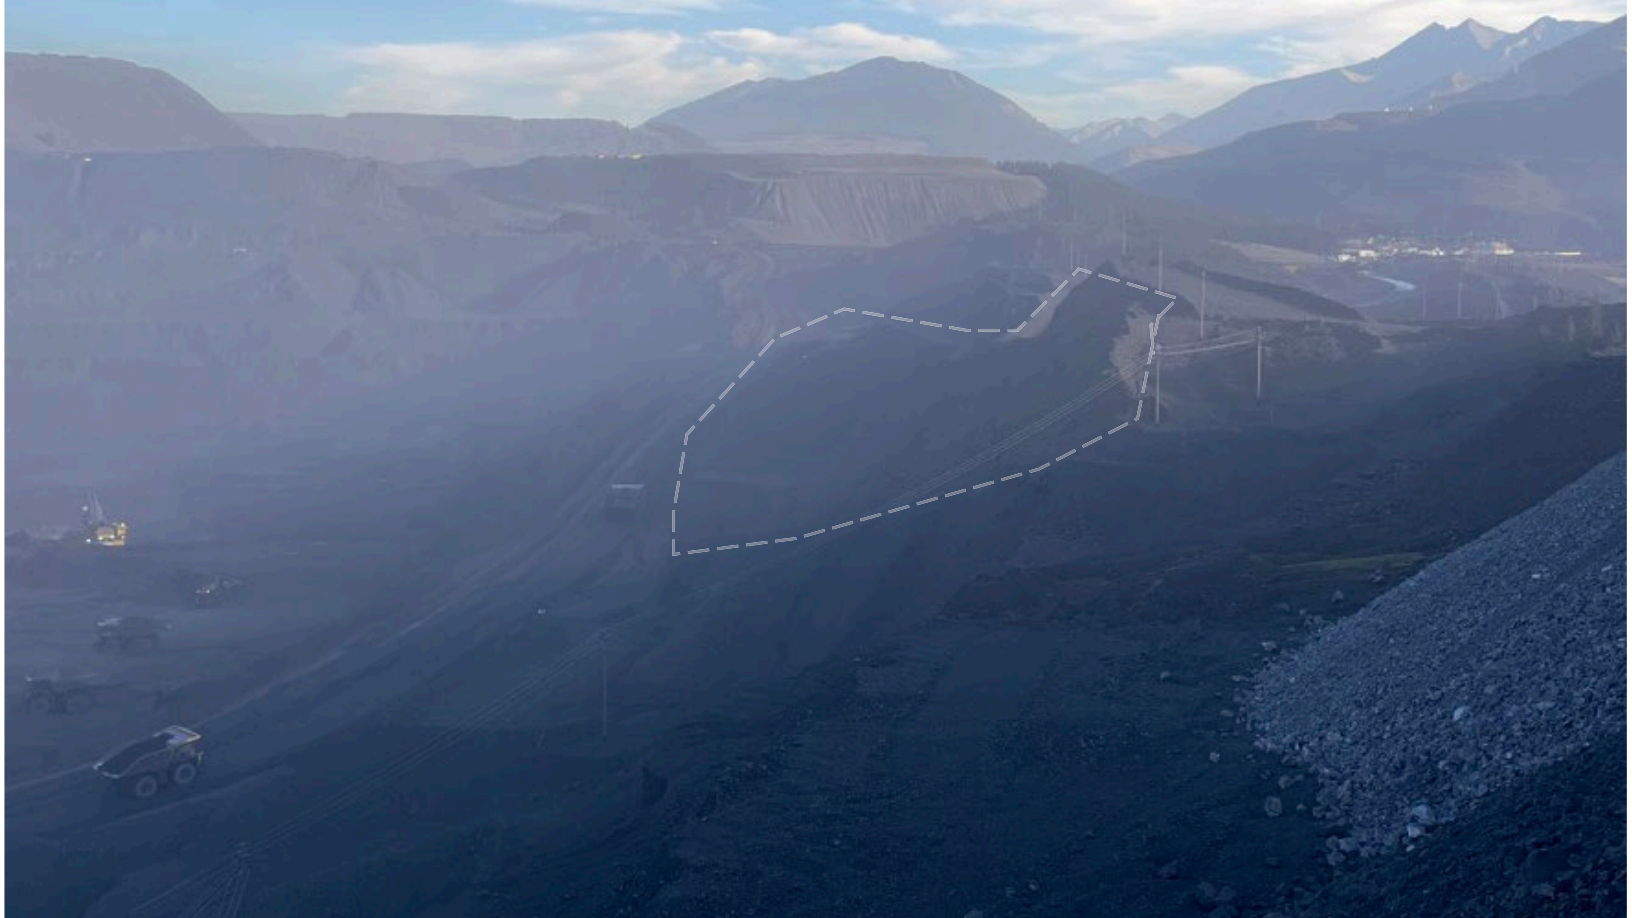
The remainder of the Box Yard spoil is within the pit wall of the Swift Pit. Sections of the facility are oversteepened from excavation efforts (approximately 0.75H:1V; recommended action 2021-11), with overall slope angles generally 37°.

Box Yard spoil: view of excavated spoil remnant (white dash), looking north.

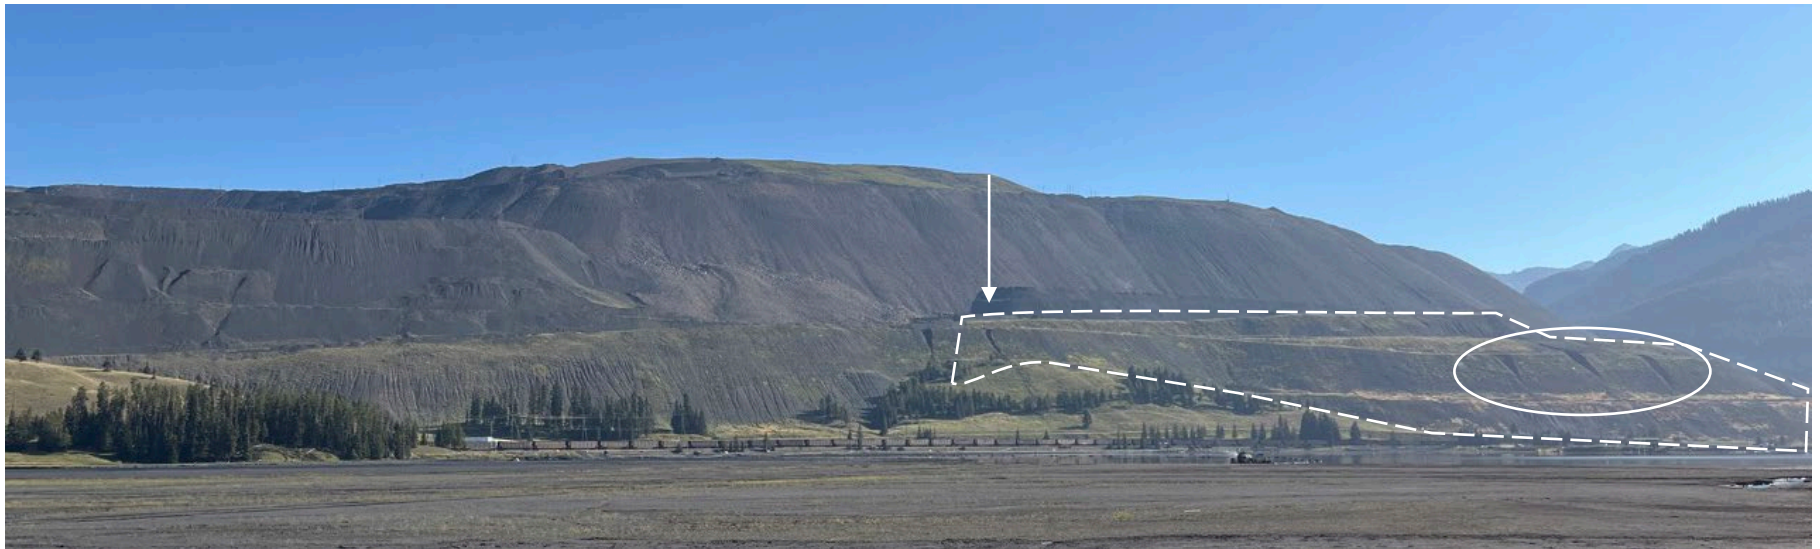
Kilmarnock / Toe Berm spoil: overview of the Kilmarnock / Toe Berm spoil (white dash) including erosion gully from 2022 precipitation event (white arrow) and the 2013 flood (white circle), looking northeast from the South Tailings Pond.

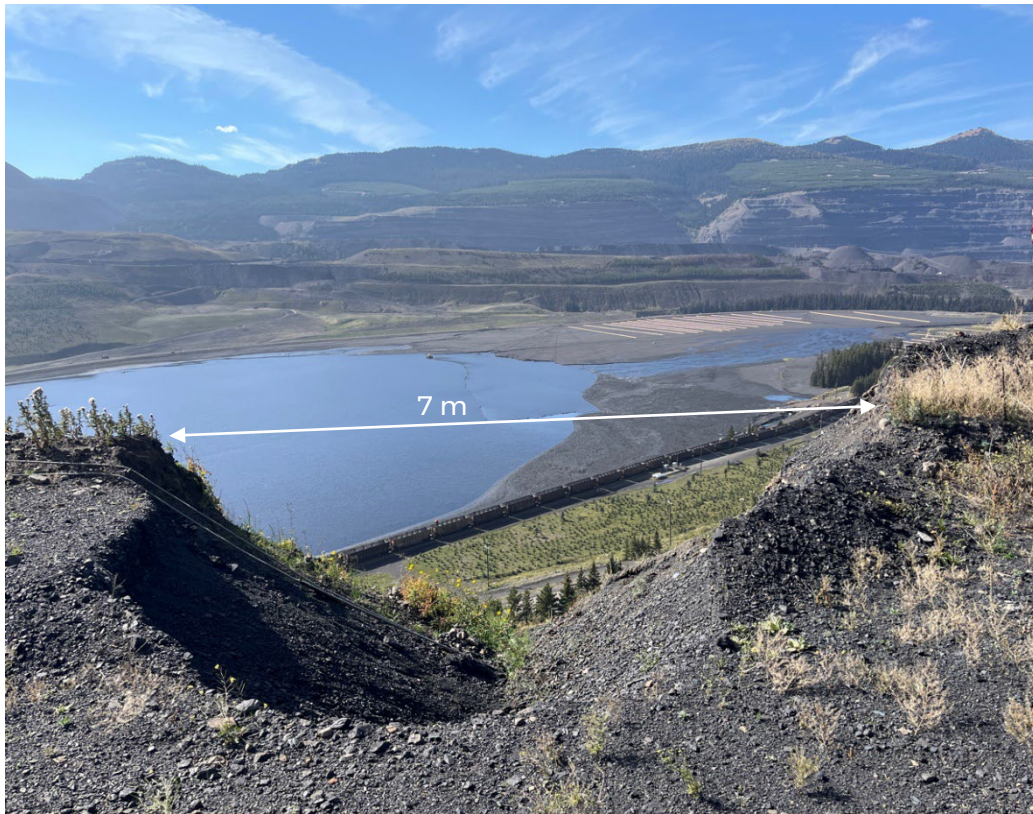
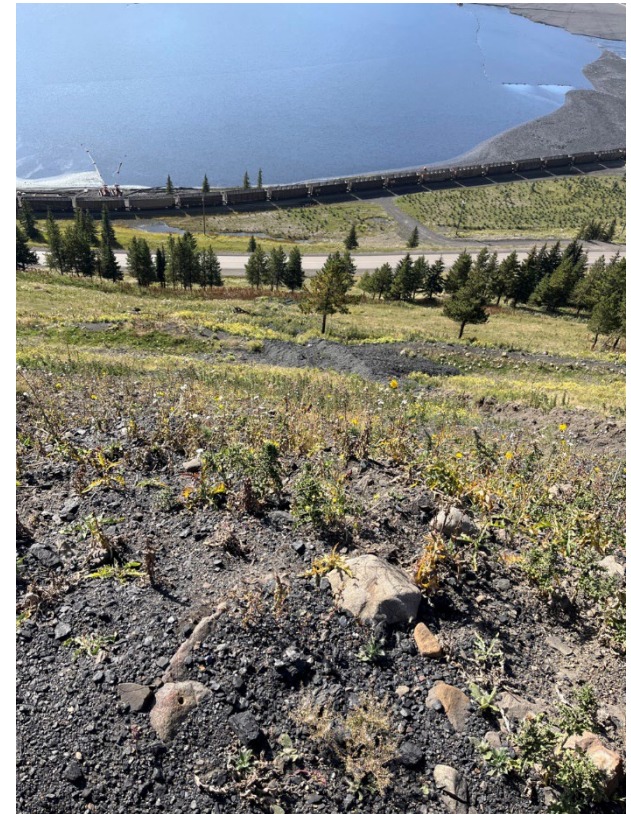
Kilmarnock / Toe Berm spoil: view of the erosion gully and runout that formed following the 2022 precipitation event.

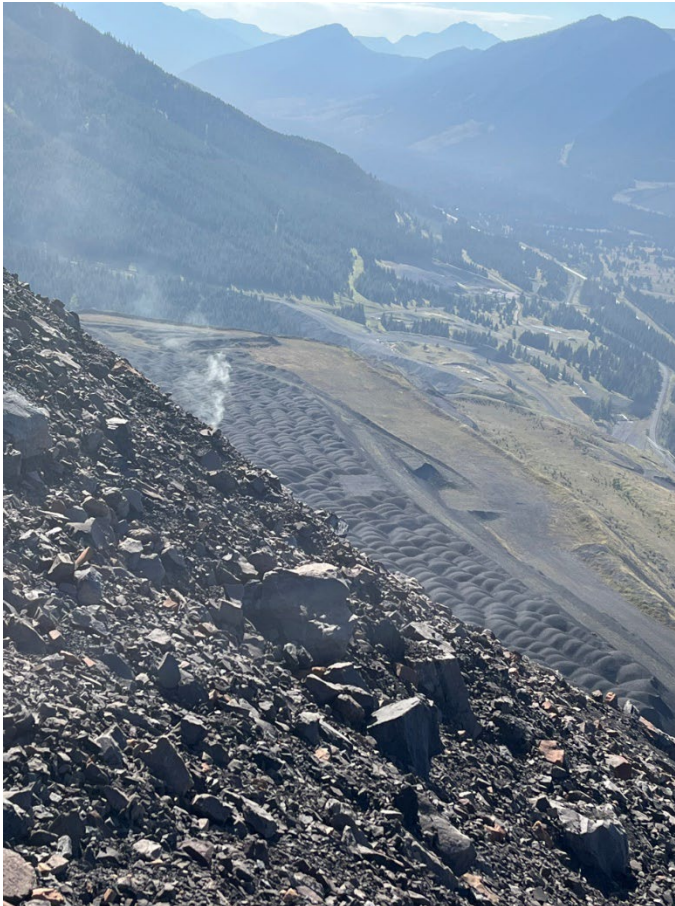
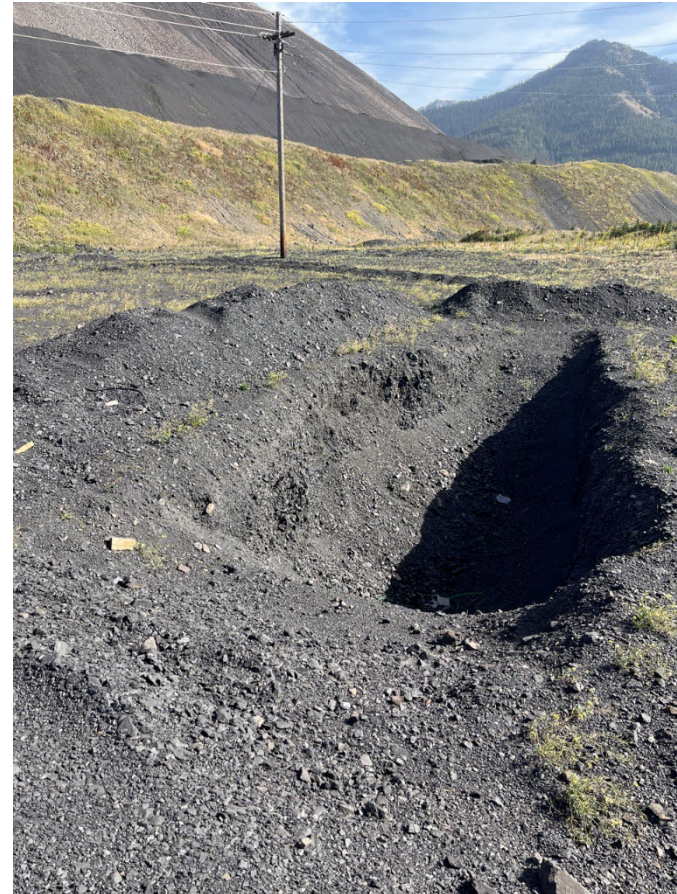
Kilmarnock / Toe Berm spoil: view of burning material plume, looking south (Photograph 10) and of an excavation on the Kilmarnock / Toe Berm spoil platform, looking southeast (Photograph 11).

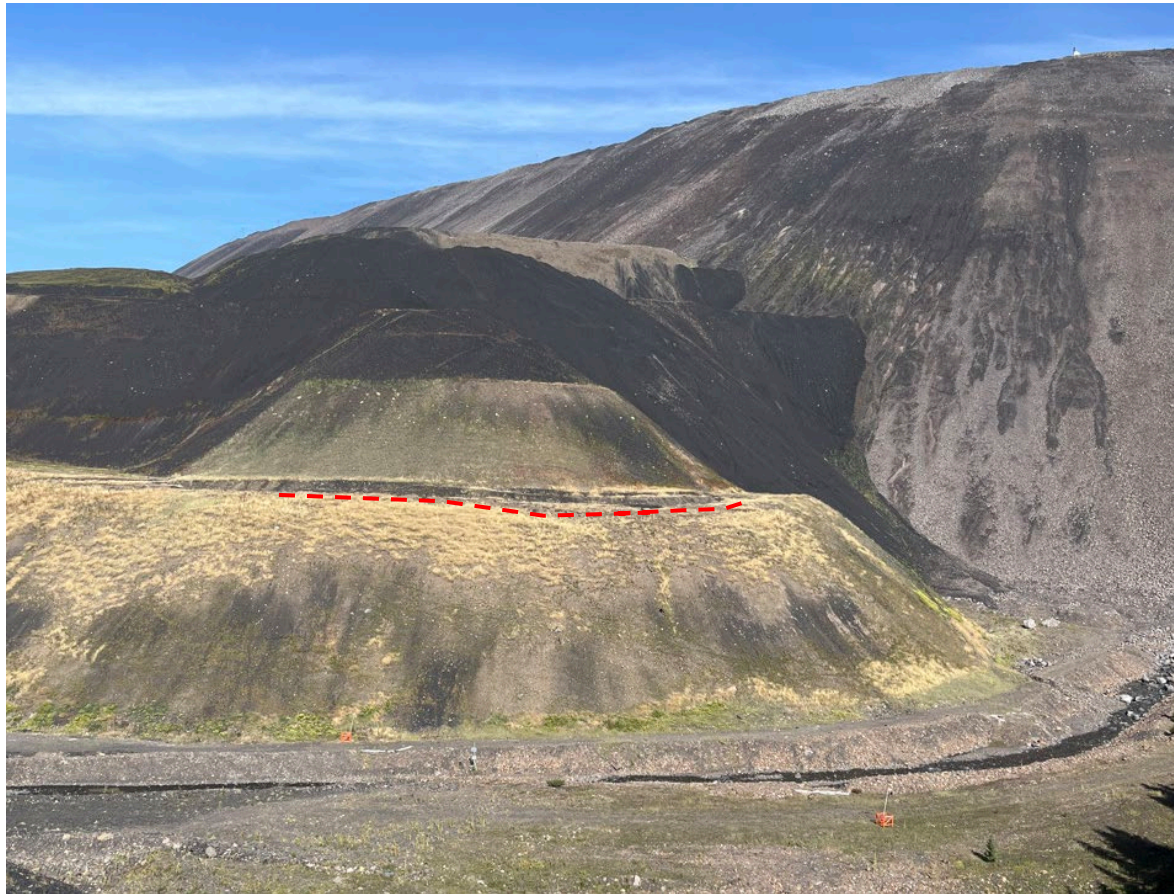
Kilmarnock / Toe Berm spoil: overview of facility at the south, showing crest settlement (noted in red), looking north.

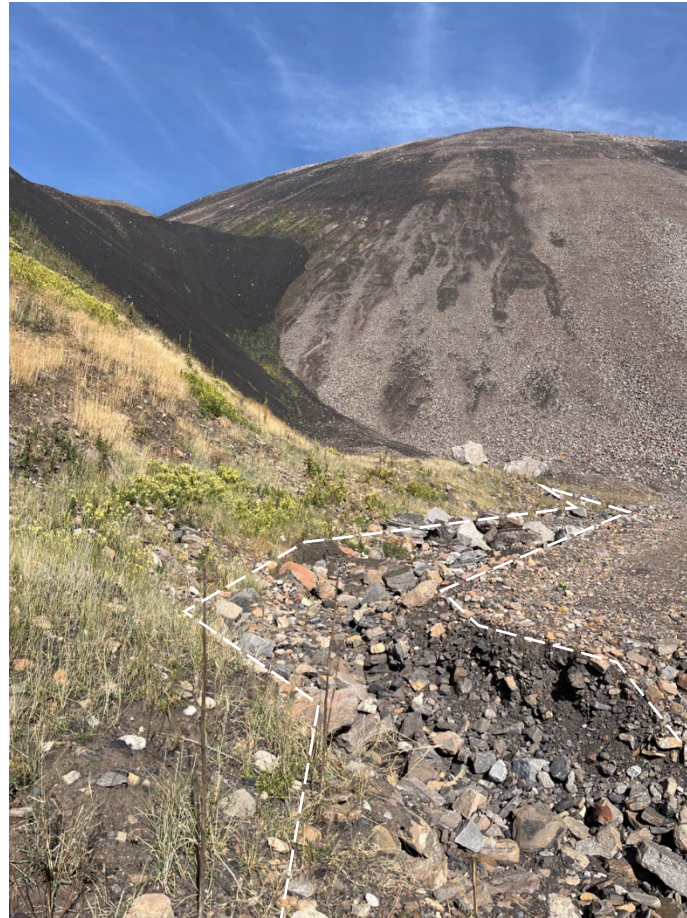
Kilmarnock / Toe Berm spoil: erosion feature (shown in white), due to water seepage from the Old South spoil, no flow at time of inspection, erosion increased since 2021 inspection, looking north.

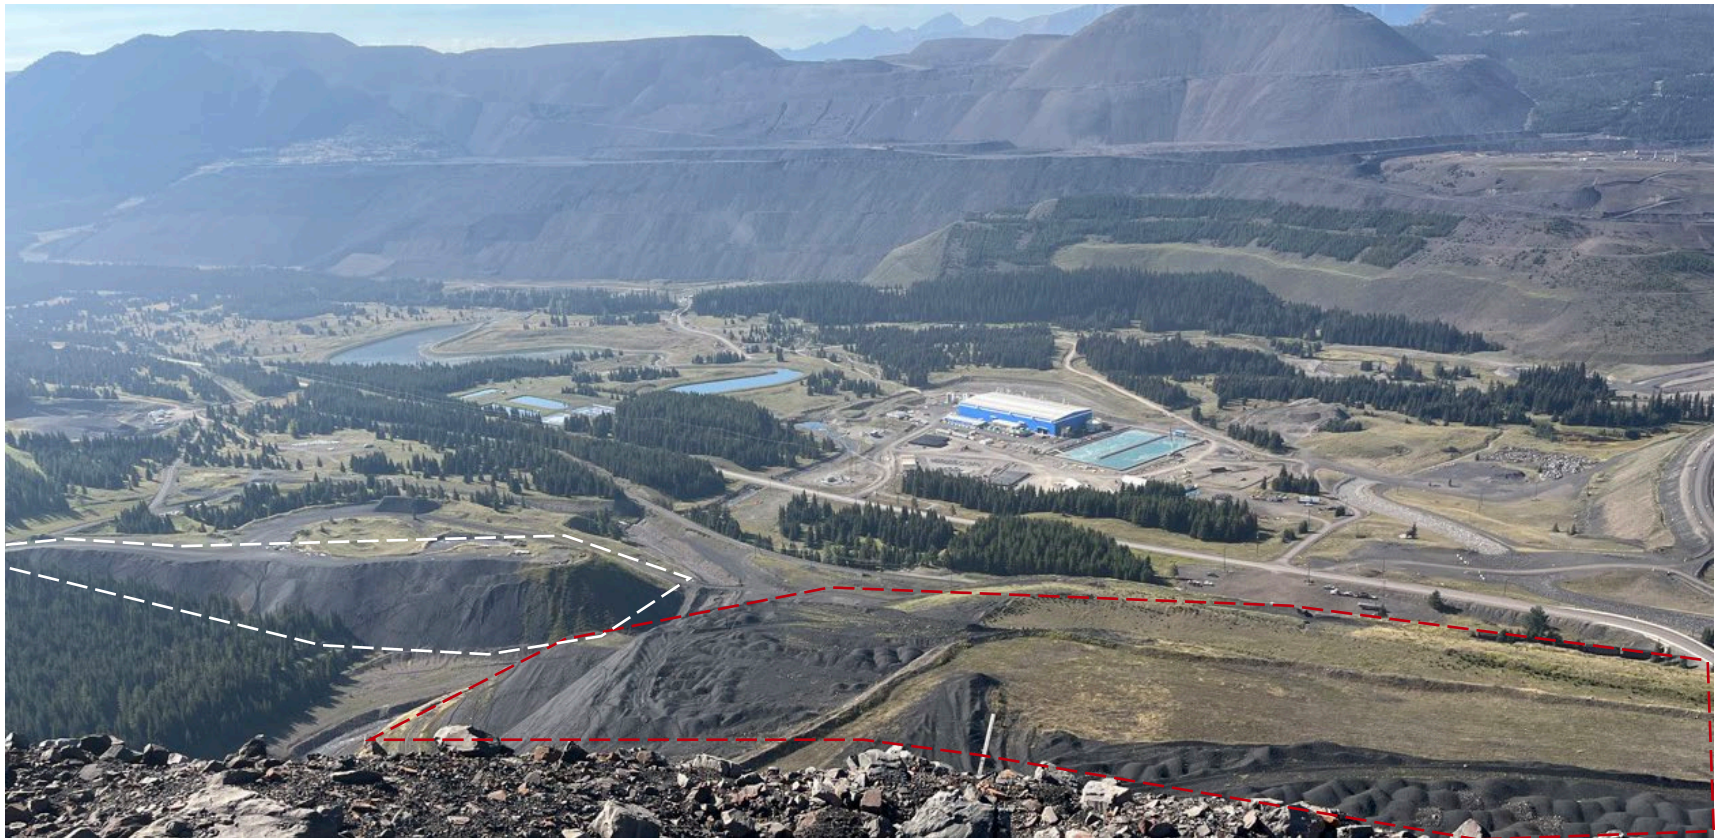
Kilmarnock / Toe Berm spoil (red dash) and Impact Berm spoil (white dash), looking southwest from the Old South spoil.

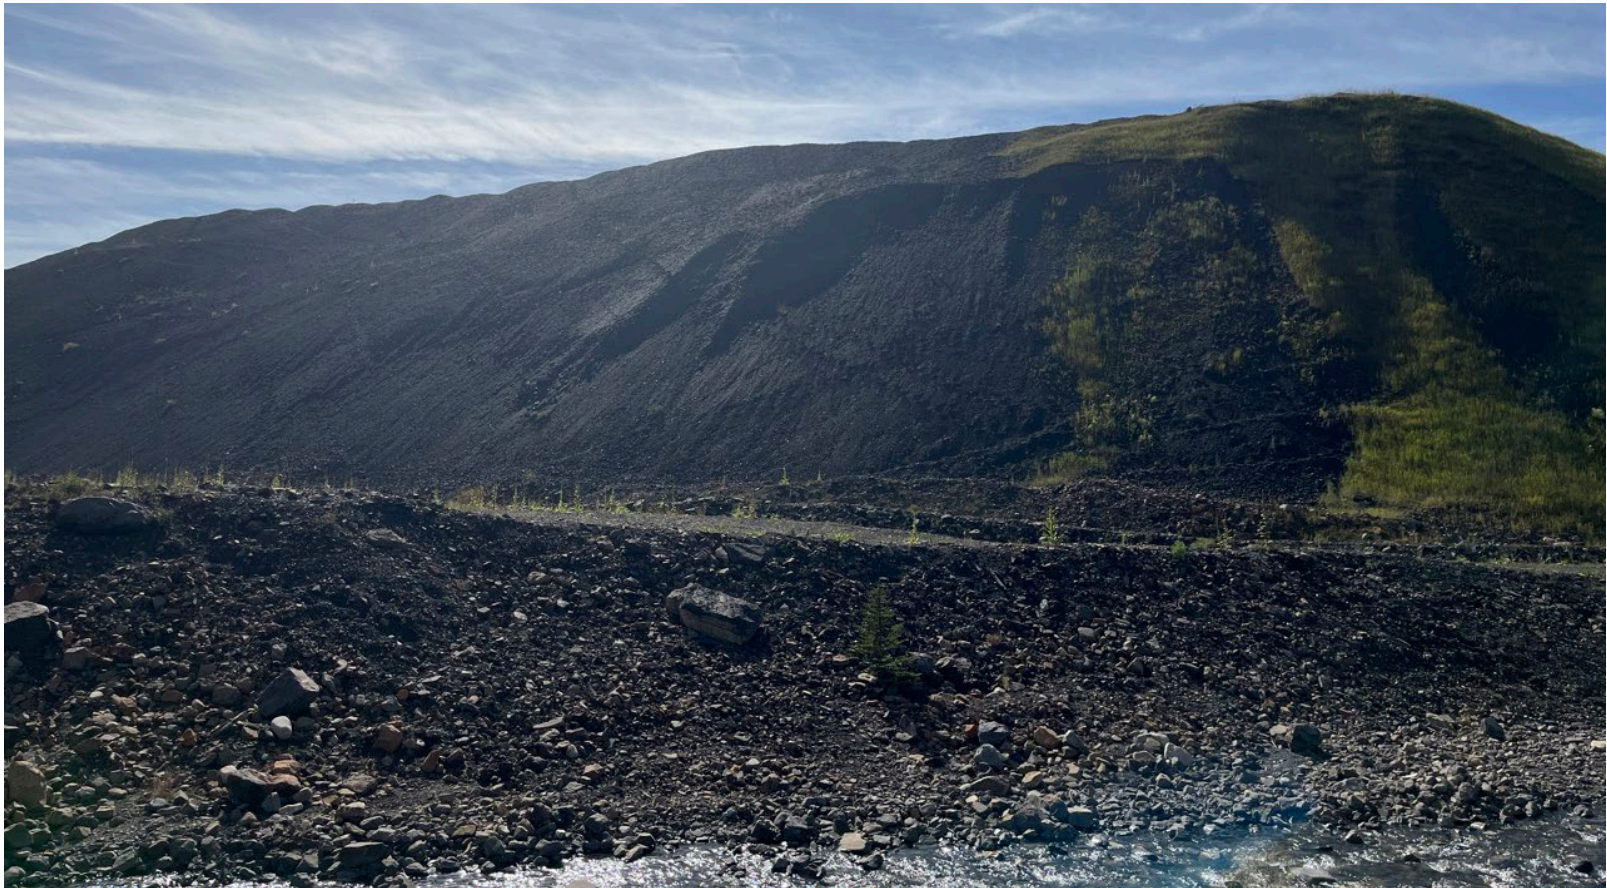
Impact Berm spoil: eastern slope and toe, looking southwest from Kilmarnock Creek.

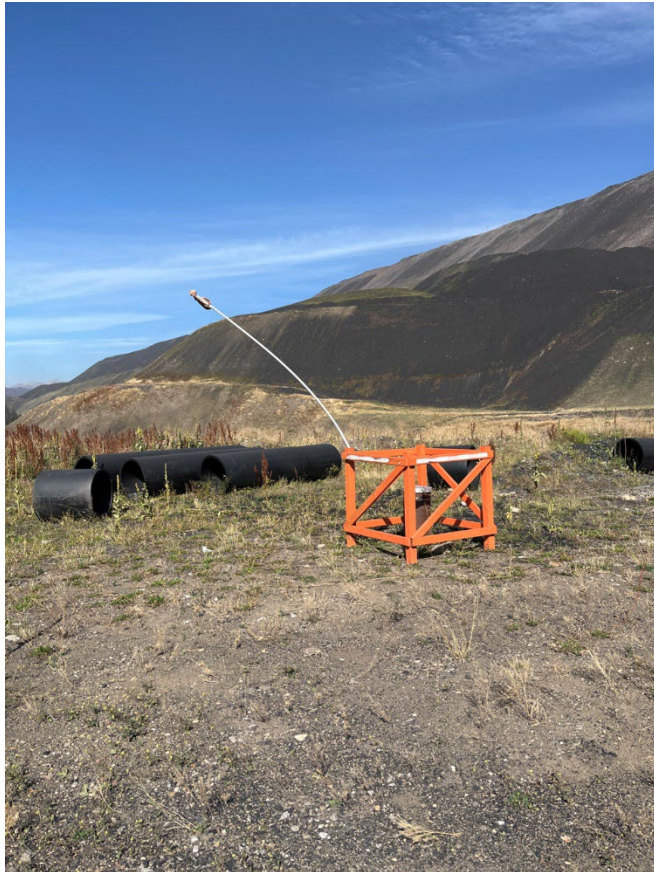
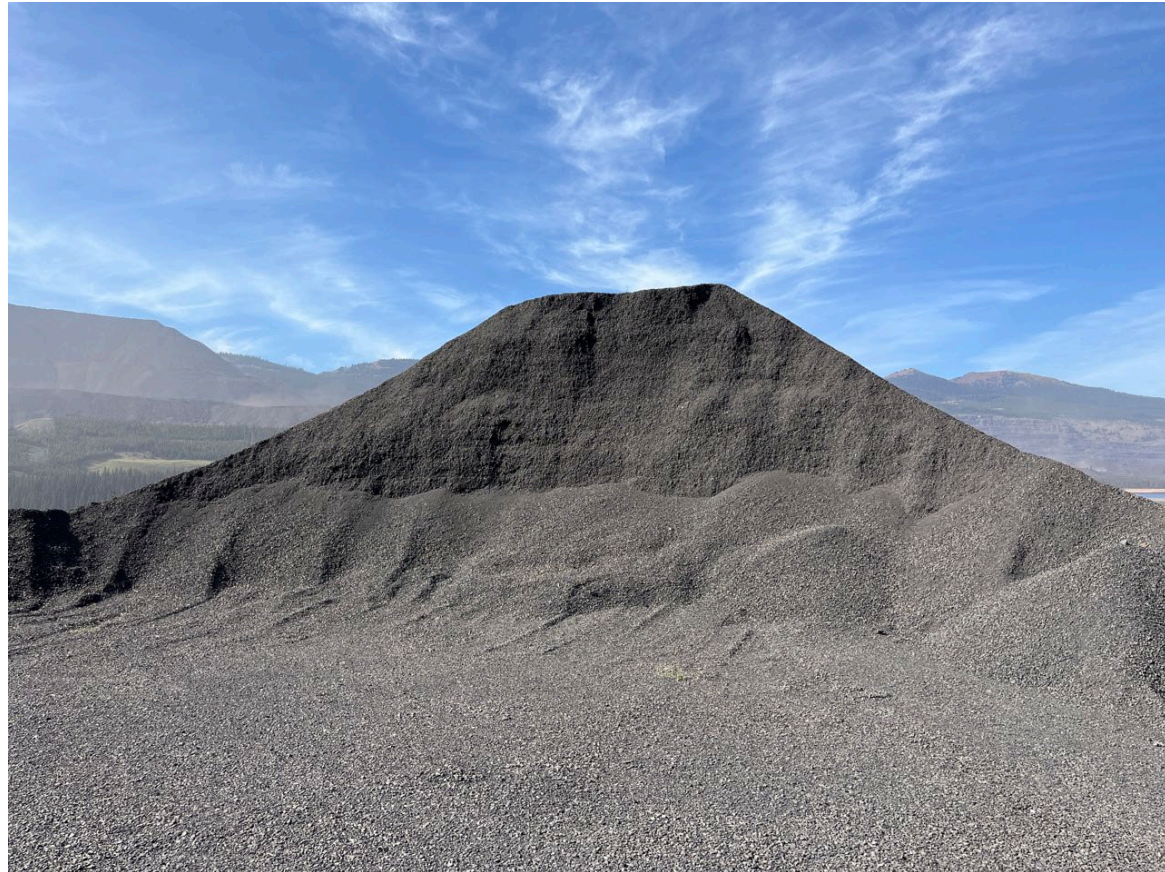
Impact Berm spoil: monitoring well, looking north (16), and oversteepened stockpile, looking west (17).

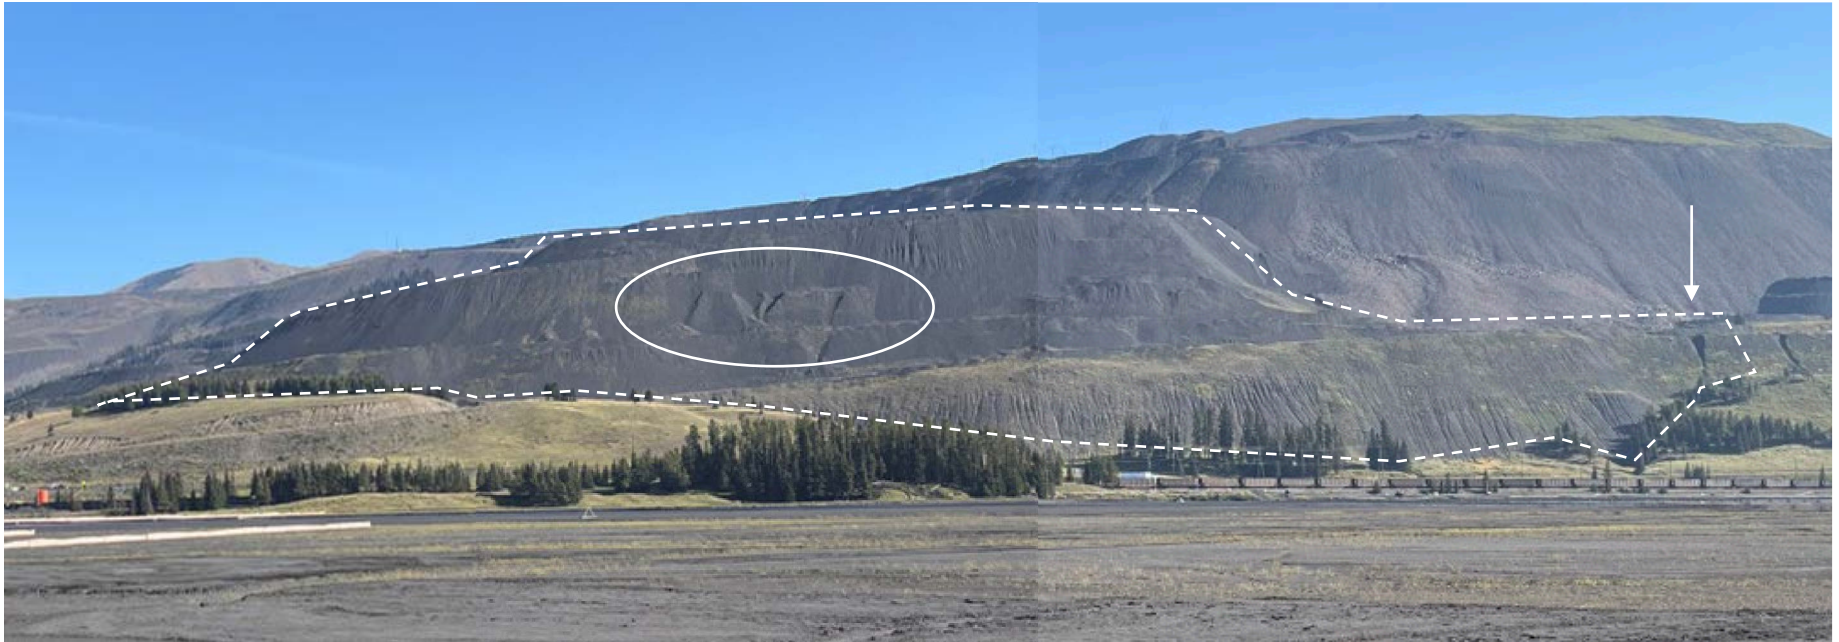
Blake spoil (white dash): large erosion features (old, white circle; 2021, white arrow) along western slope, looking northeast from the South Tailings Pond.

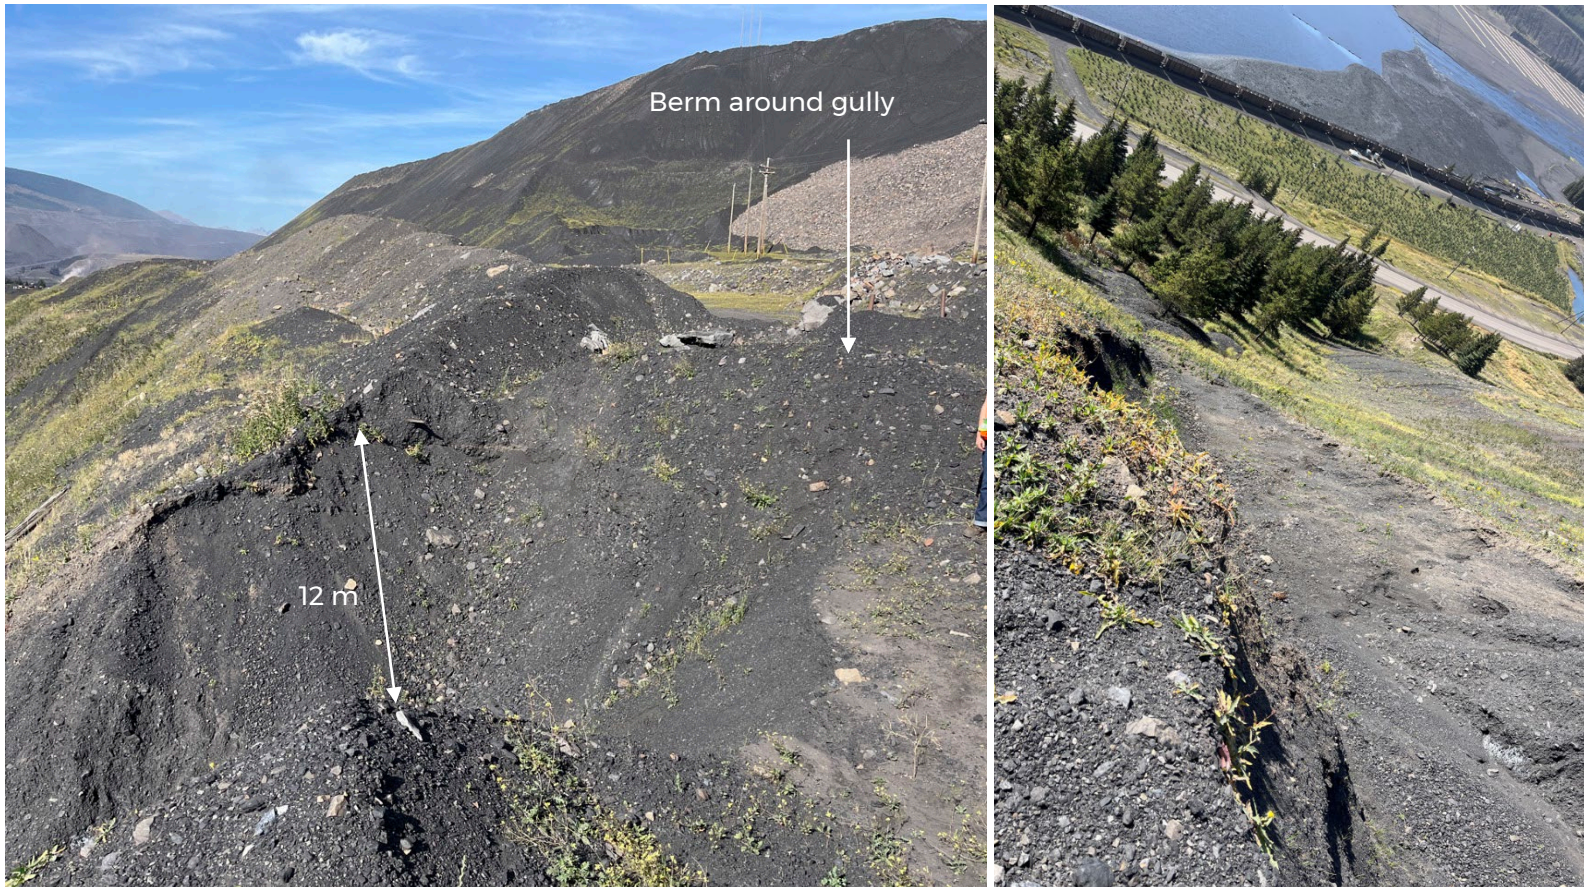
Blake spoil: view of erosion gully and runout that formed following the 2021 precipitation event.

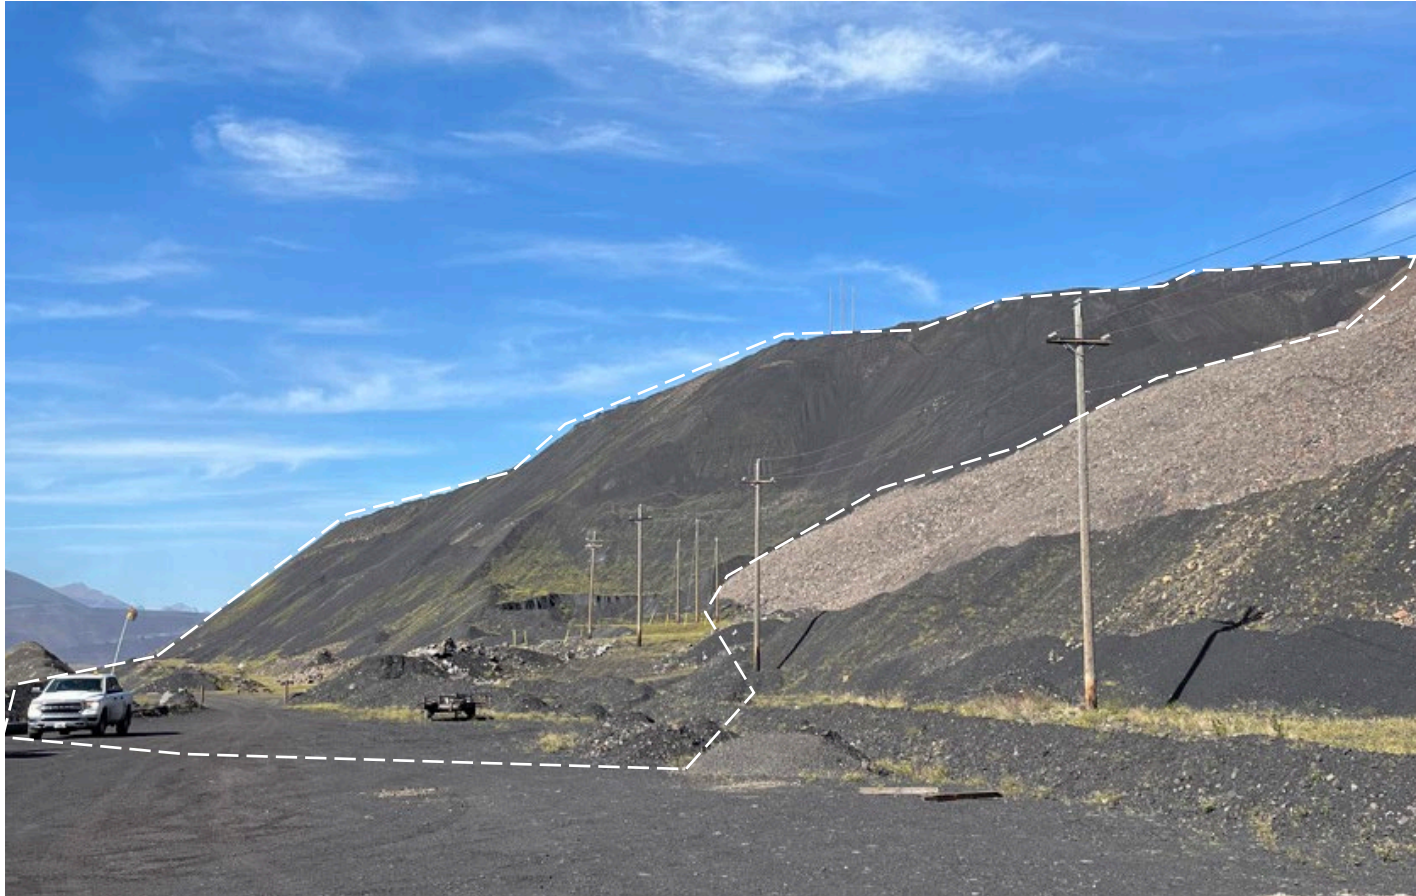
Blake spoil (white dash): overview from north end of Kilmarnock / Toe Berm spoil, looking northwest.

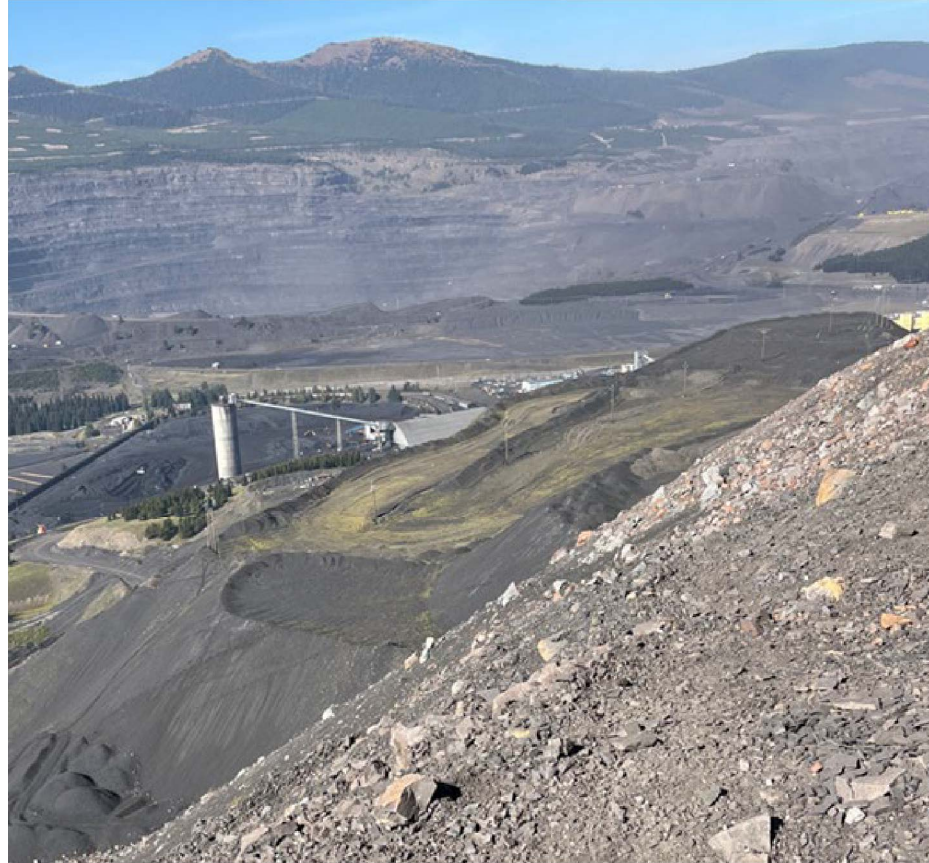
Blake and Kilmarnock / Toe Berm spoils: overview from Old South spoil, bermed around erosion gully from 2021; overview of Blake spoil, looking northwest.

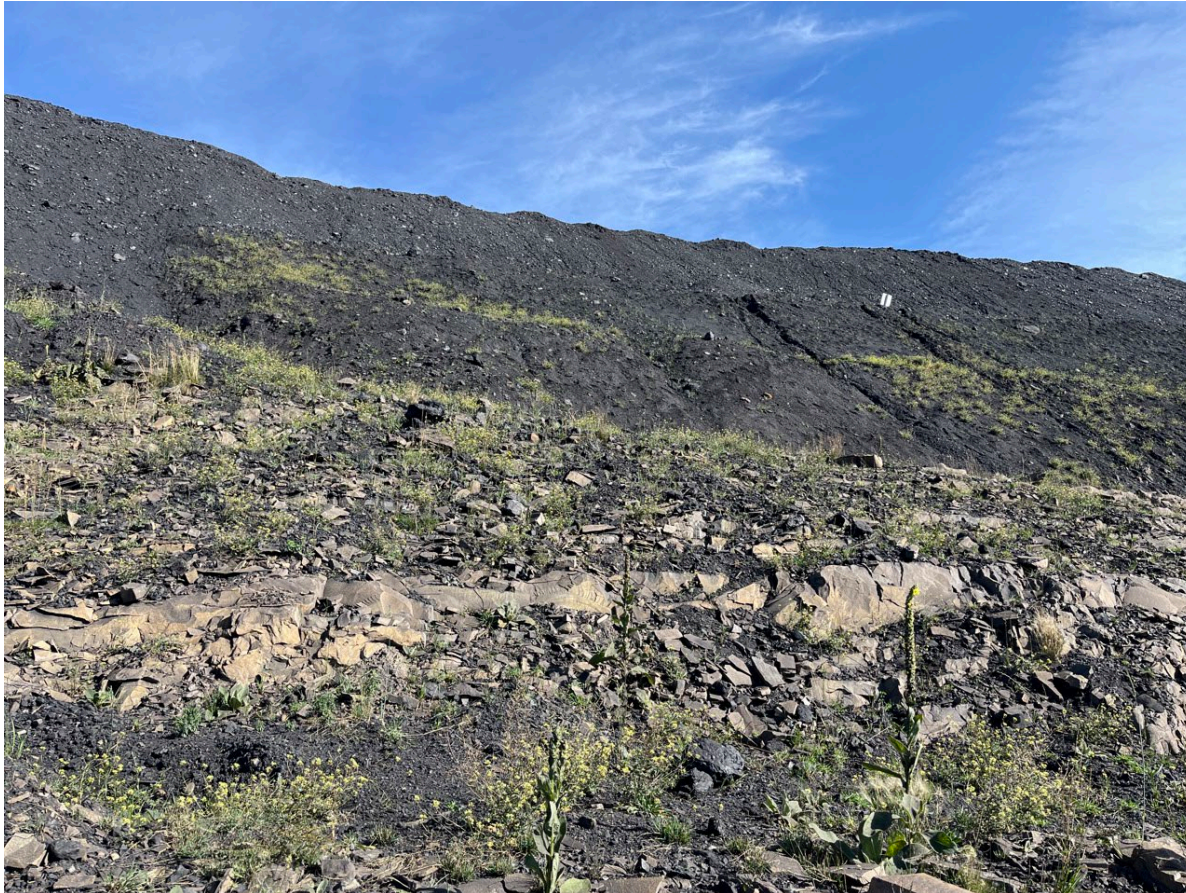
Blake spoil: west slope with minor vegetation, minor erosion rilling, and bedrock outcrop, looking east.
