# 2022 Annual Facility Performance Report—Coal Reject Spoils

*Teck Coal Limited, Fording River Operations*

Reference No. 22516328-2022-123-R-Rev0-1800

29 March 2023

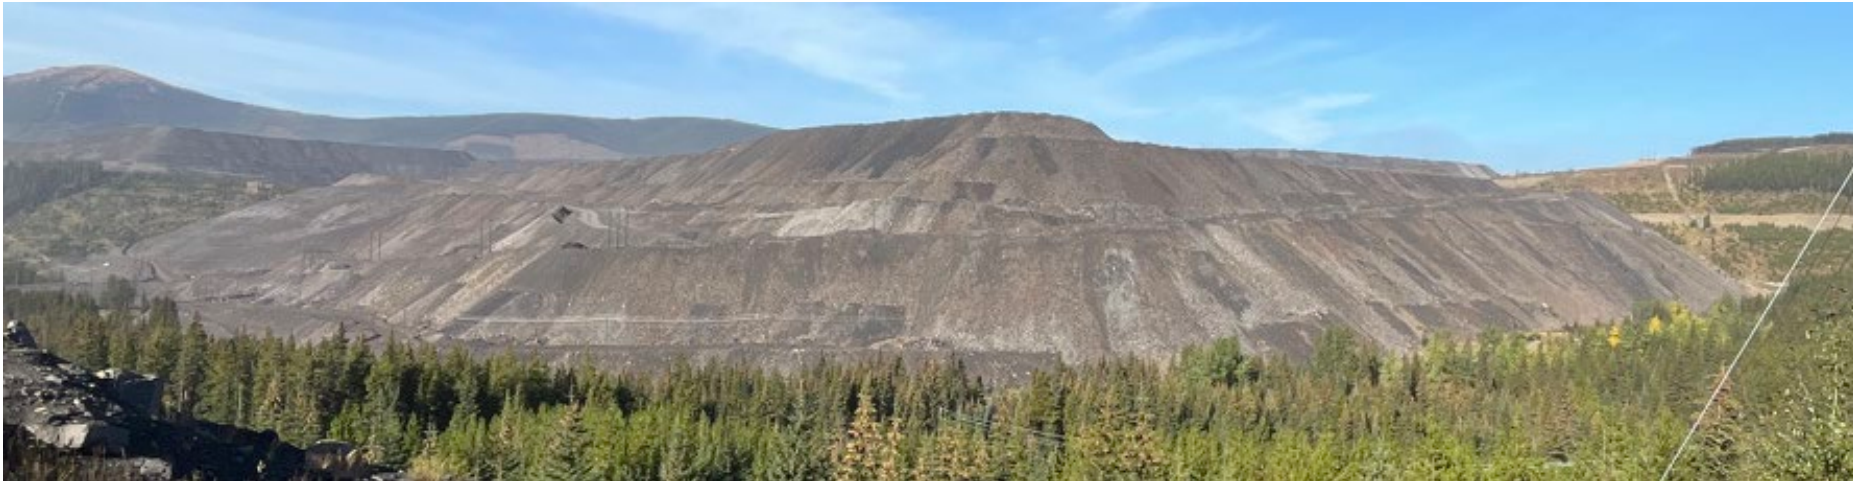
Turnbull West spoil: looking west at downstream slopes.

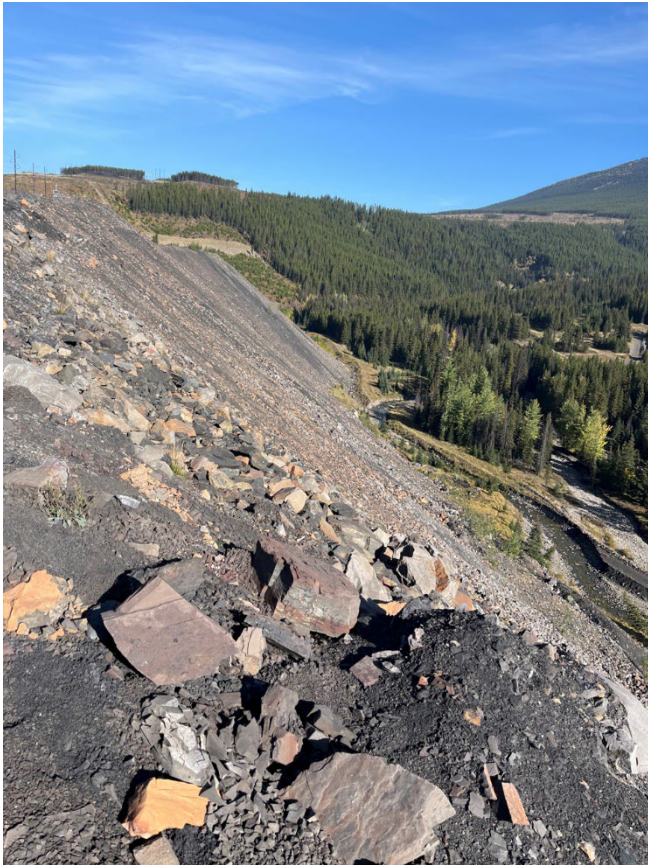
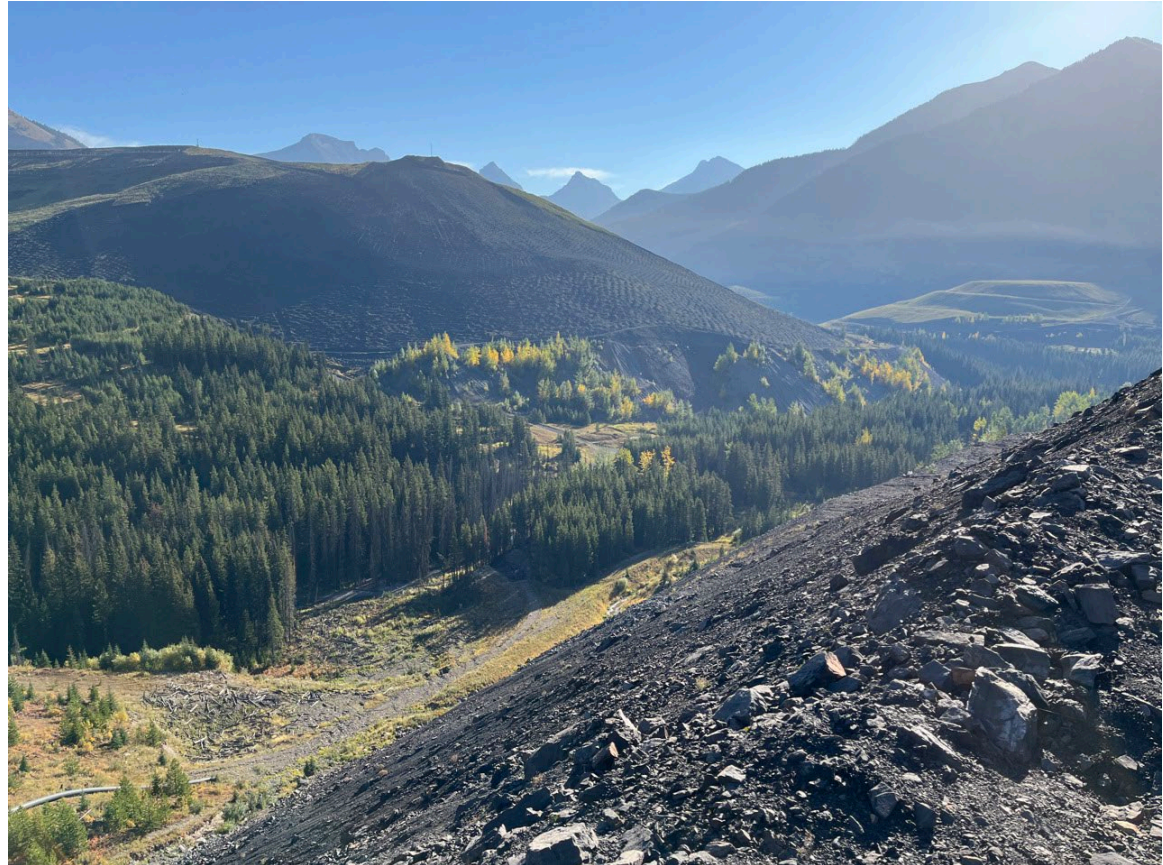
Turnbull West spoil: downstream slopes of north side, looking northwest (24) and northeast towards Fording River at the toe (25).

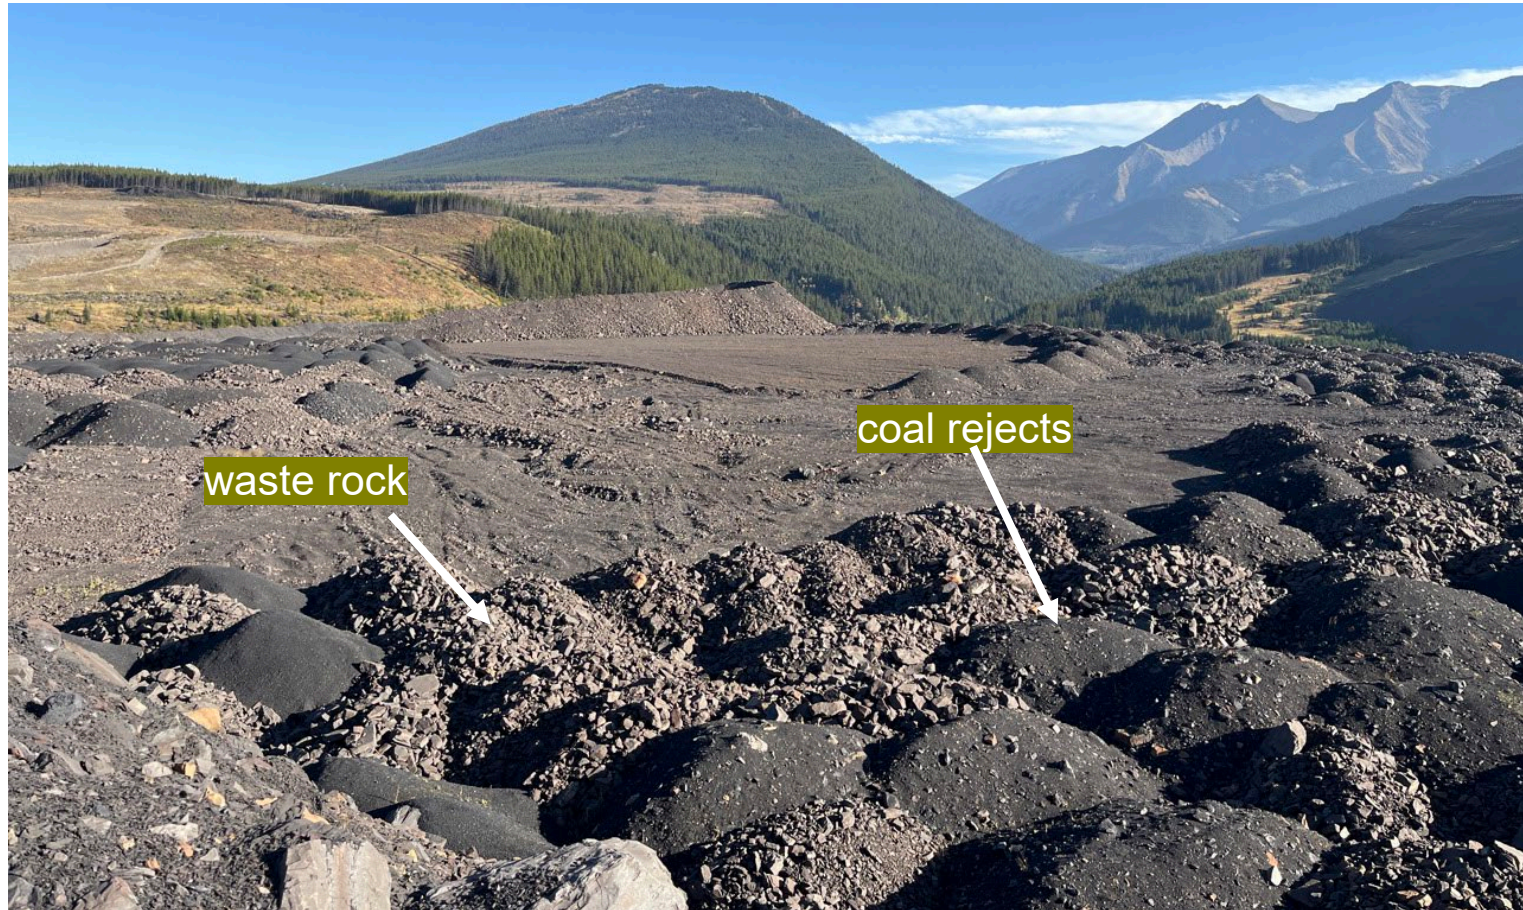
Turnbull West spoil: platform, looking north.

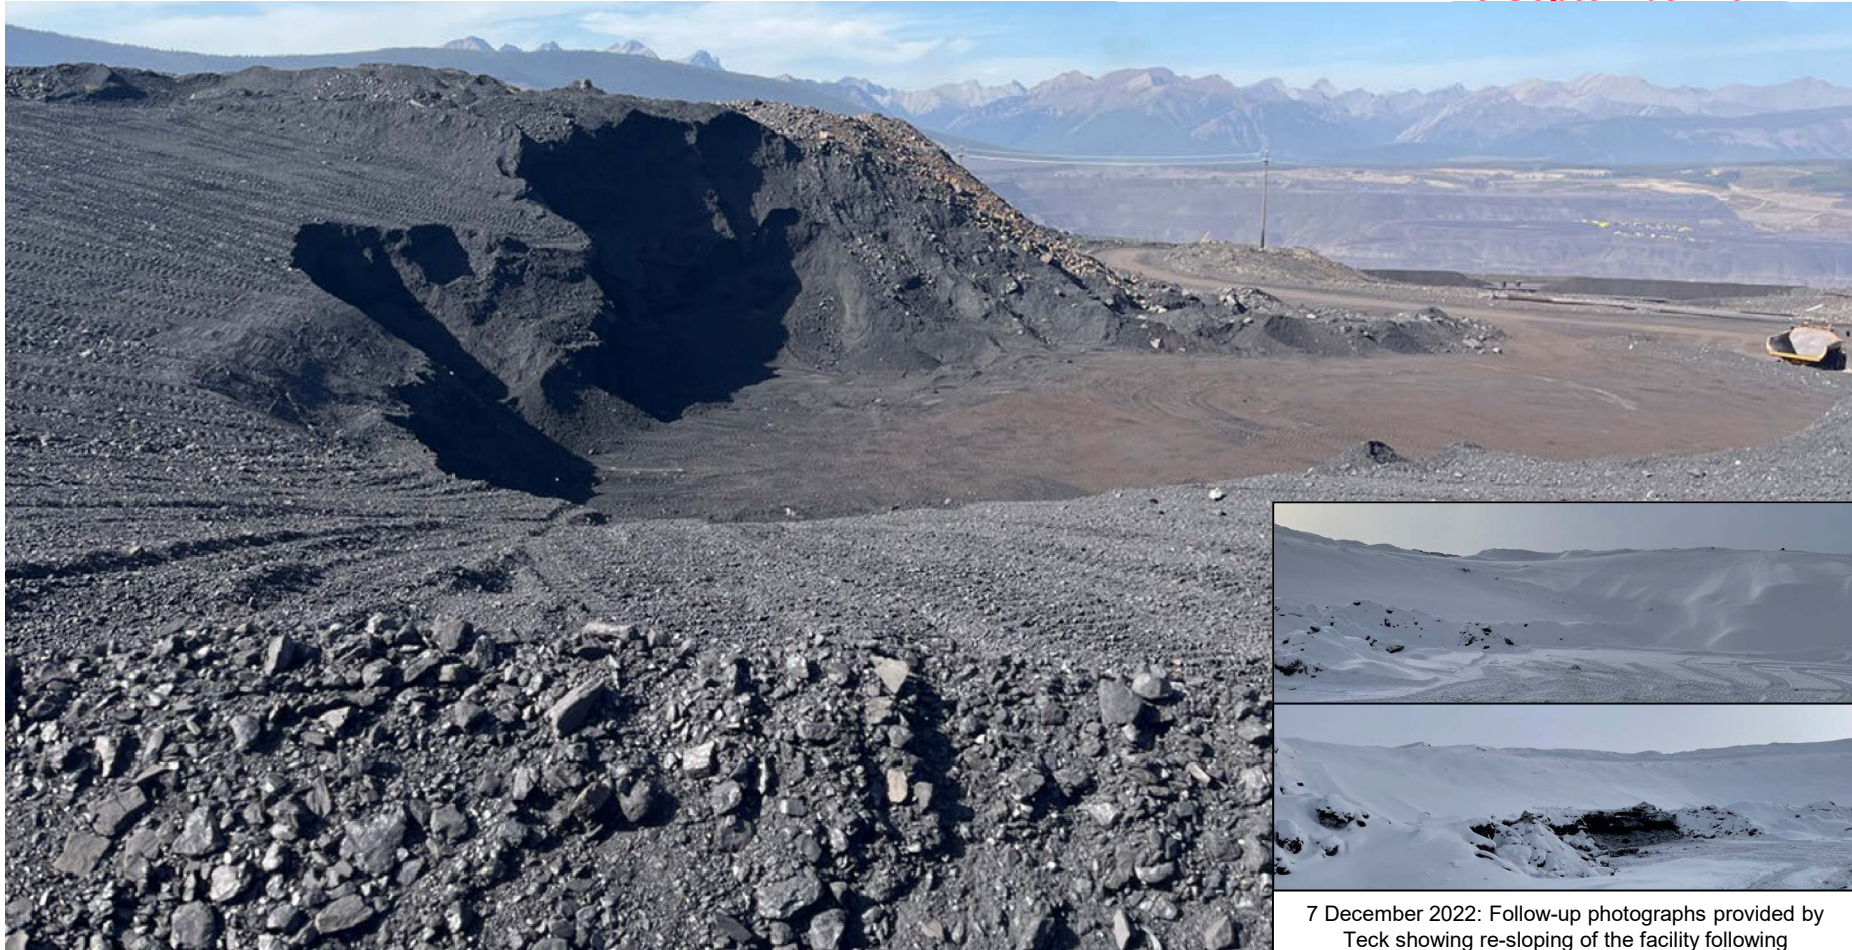
7 December 2022: Follow-up photographs provided by Teck showing re-sloping of the facility following notification, view from north end, looking south.

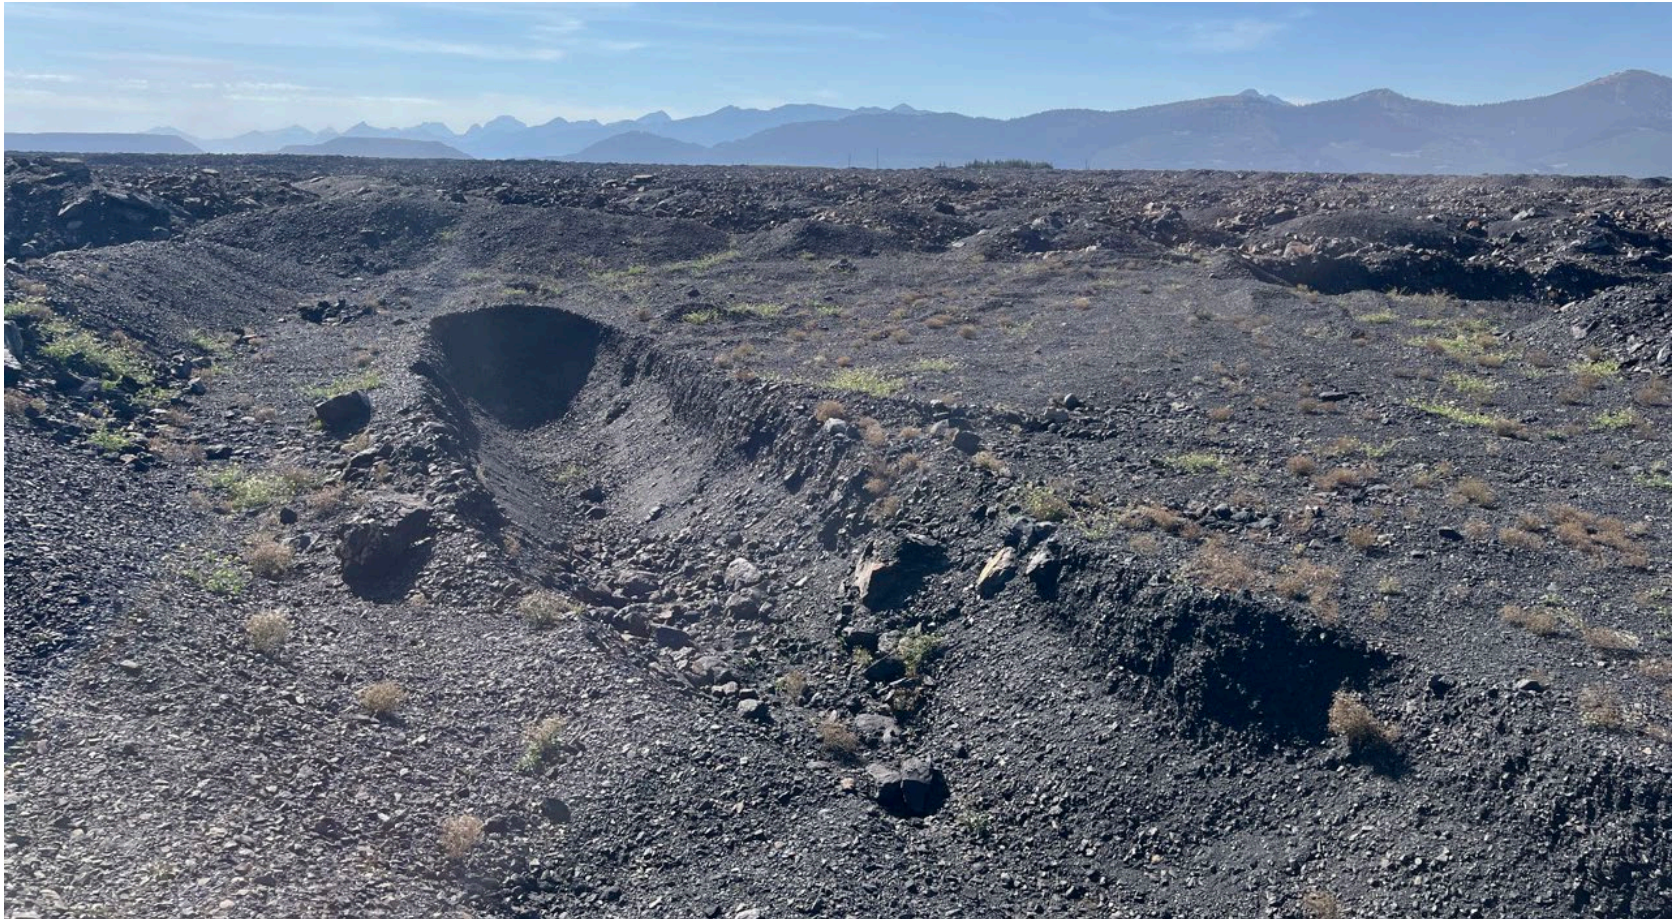
Taylor spoil: platform, looking southwest.

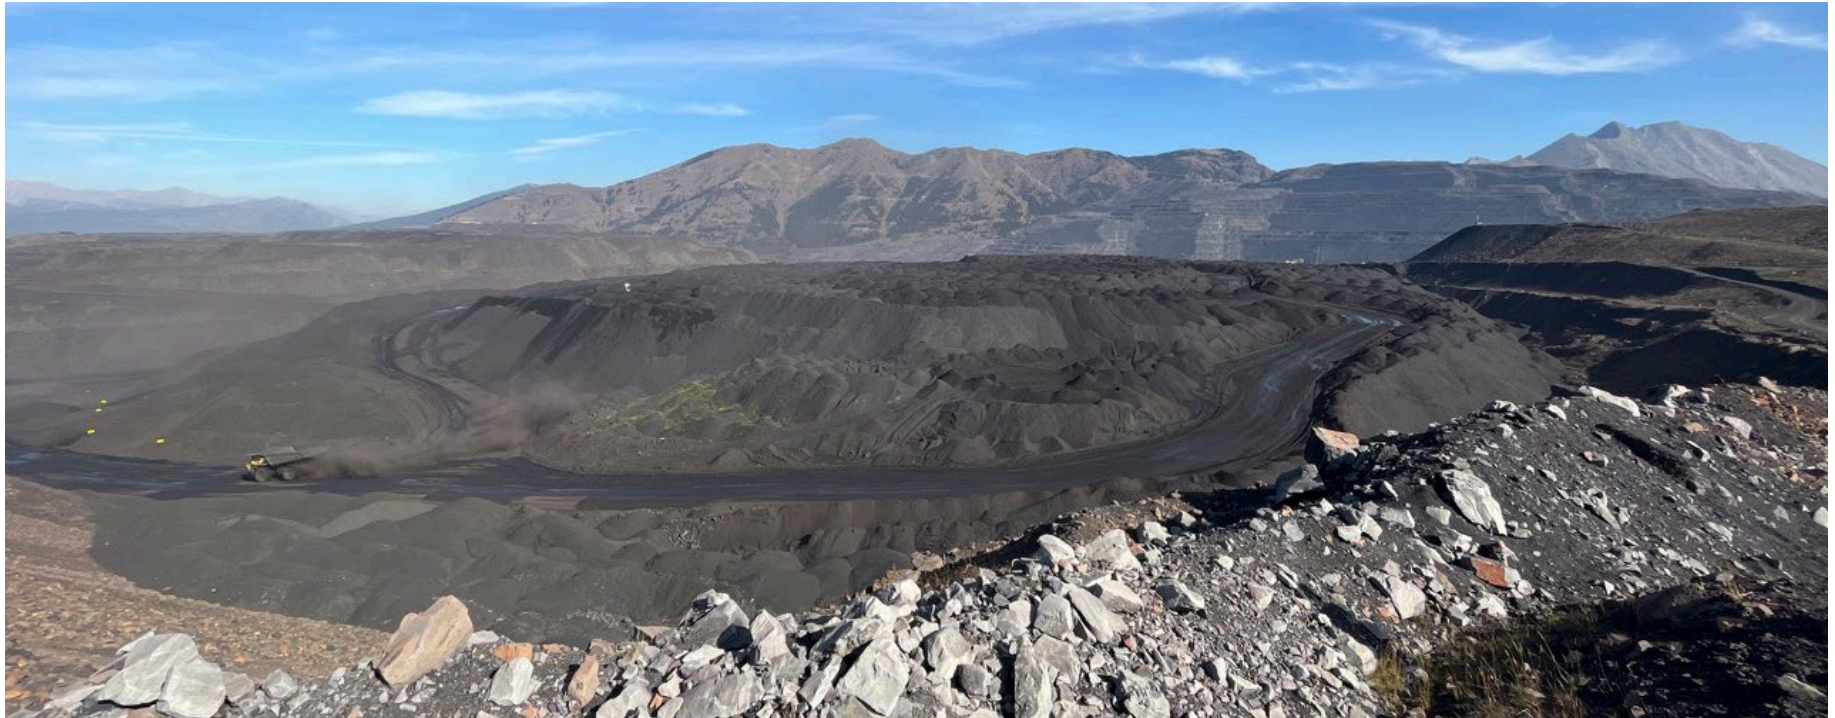
Eagle 4 South Backfill spoil: overview, looking north.

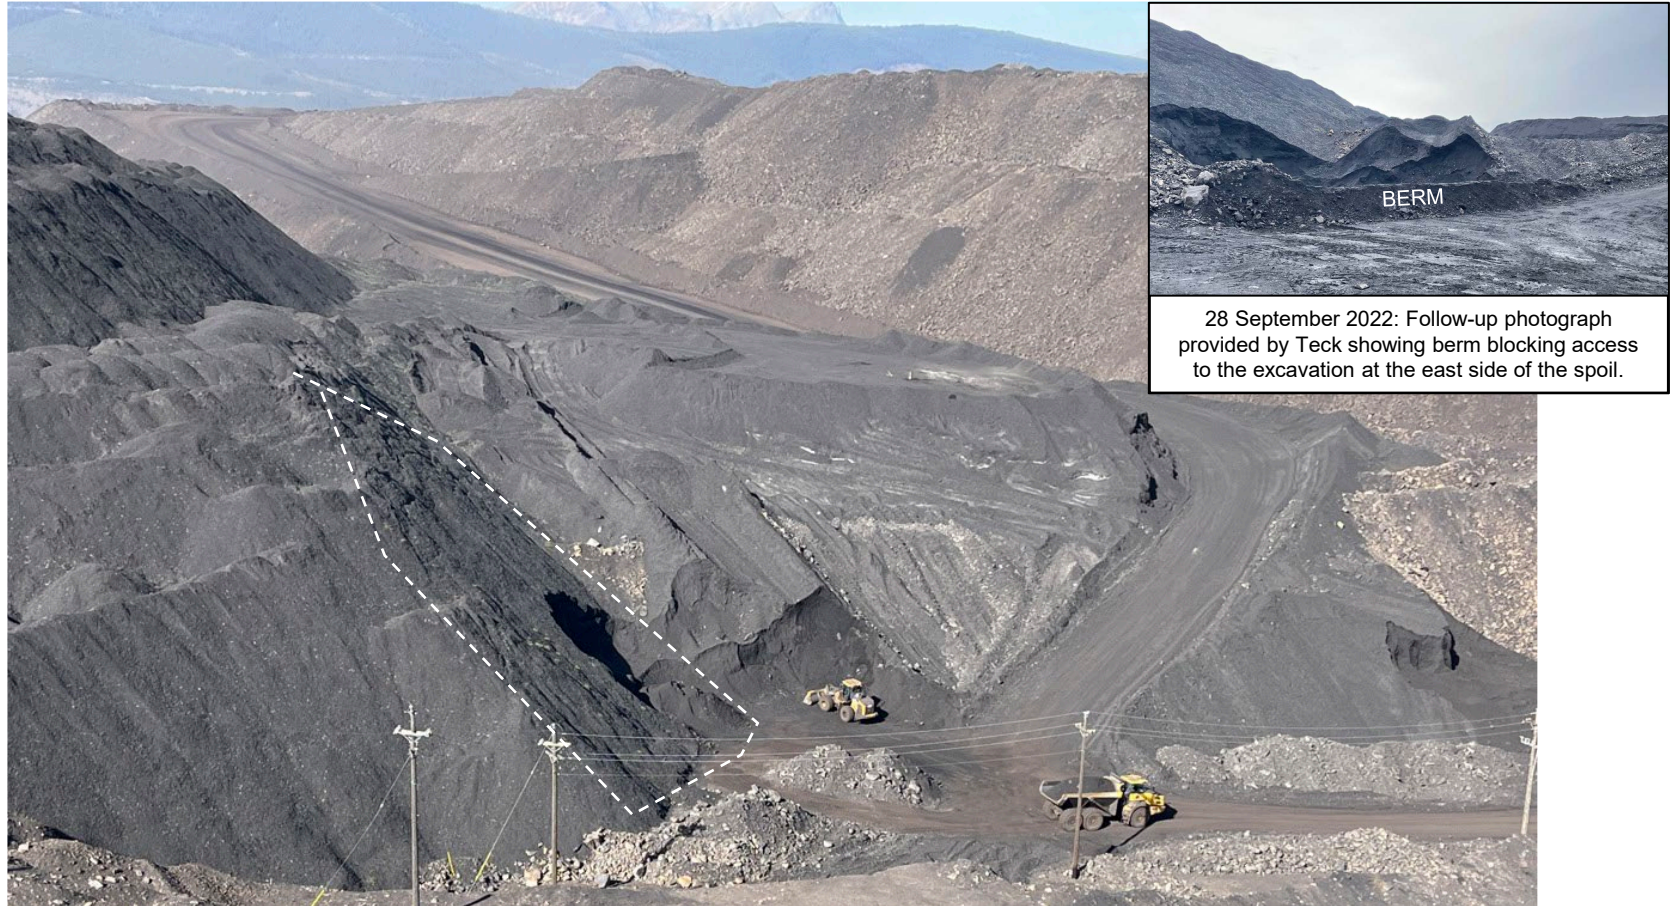
- Eagle 4 South Backfill—Excavation at the east toe was observed at the time of the site with the excavated slope (up to approximately 10 m high) left in an oversteepened state. This presented an immediate danger to equipment and personnel working in the area (HSRC Section 6.20.2(2)). Following identification, work was halted, and an initial berm placed to block access to the excavation. Teck also identified an alternate source of borrow material and placed an additional berm adjacent to the access road to block access as well as added signage to restrict access. Corrective action to re-slope the excavated toe area is required prior to resumption of operations in this area.

Eagle 4 South Backfill spoil: east side spoil at the toe, looking west at unauthorized operations at the toe and deformation above and adjacent to the excavated slope (white dashed area).

2022-04	Eagle 4 South Backfill	Unauthorized excavation at toe	Unsupported toe could result in local failure, risk to personnel working in the area	Remediation of slope is required prior to the removal of the exclusion zone and commencement of operations in the area.	2	Q2 2023	<b>New Recommendation</b>

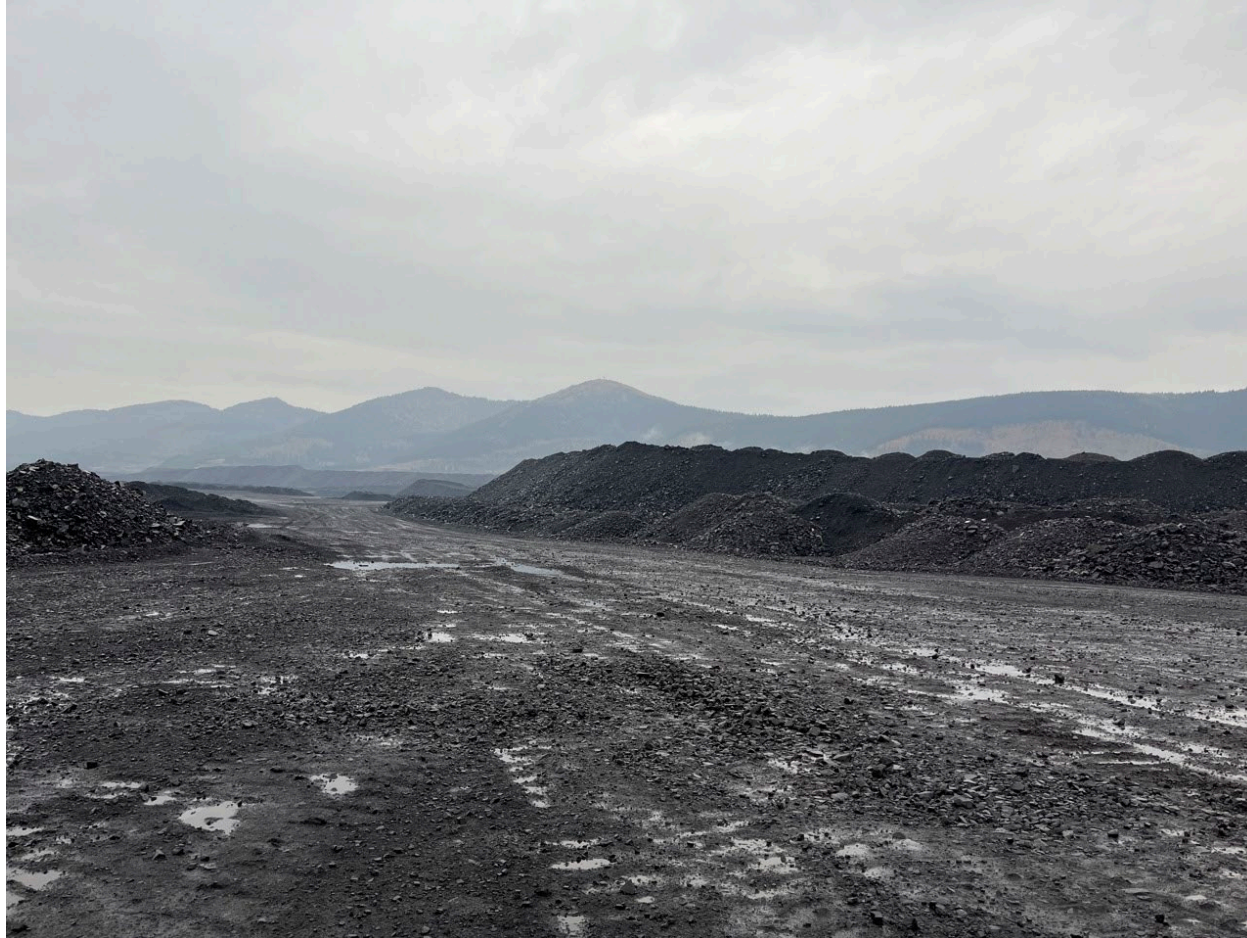
Rehandled Box Yard spoil: approximate location of the excavated Box Yard spoil material placed in the potentially acid-generating zone in the Swift North spoil, looking southwest.
