2022 Annual Facility Performance Report for 2 Pit and 3 Pit Tailings Storage Area

Teck Coal Limited, Fording River Operations

WSP Canada Inc.

Reference No. 22516328-2022-120-R-Rev0-1000

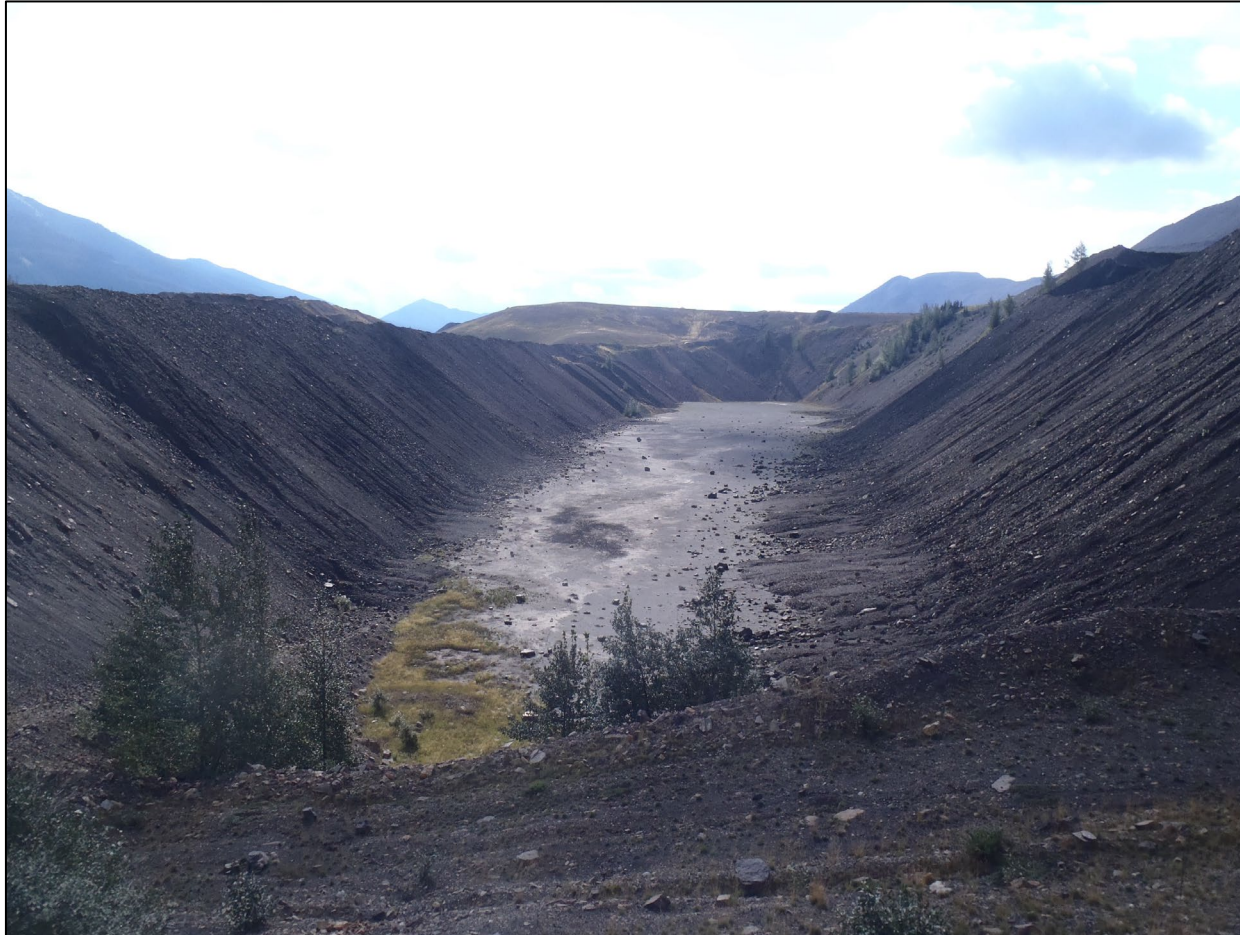
PHOTOGRAPH 1

2 Pit overview, looking southeast.

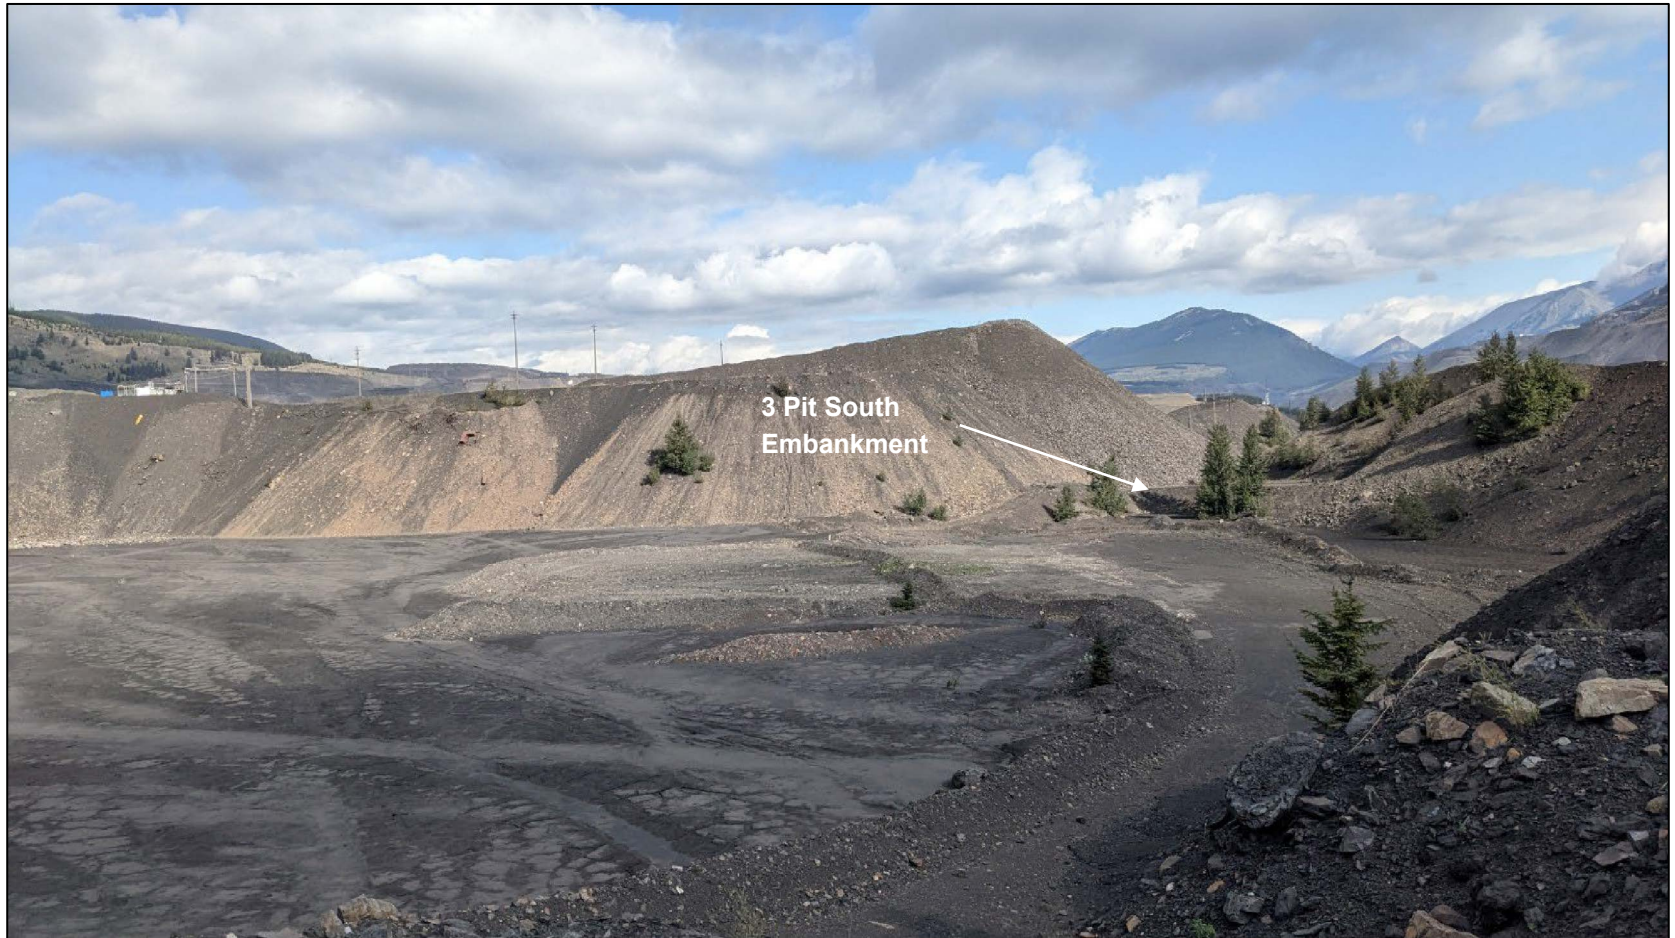
PHOTOGRAPH 2

3 Pit South overview, looking north.

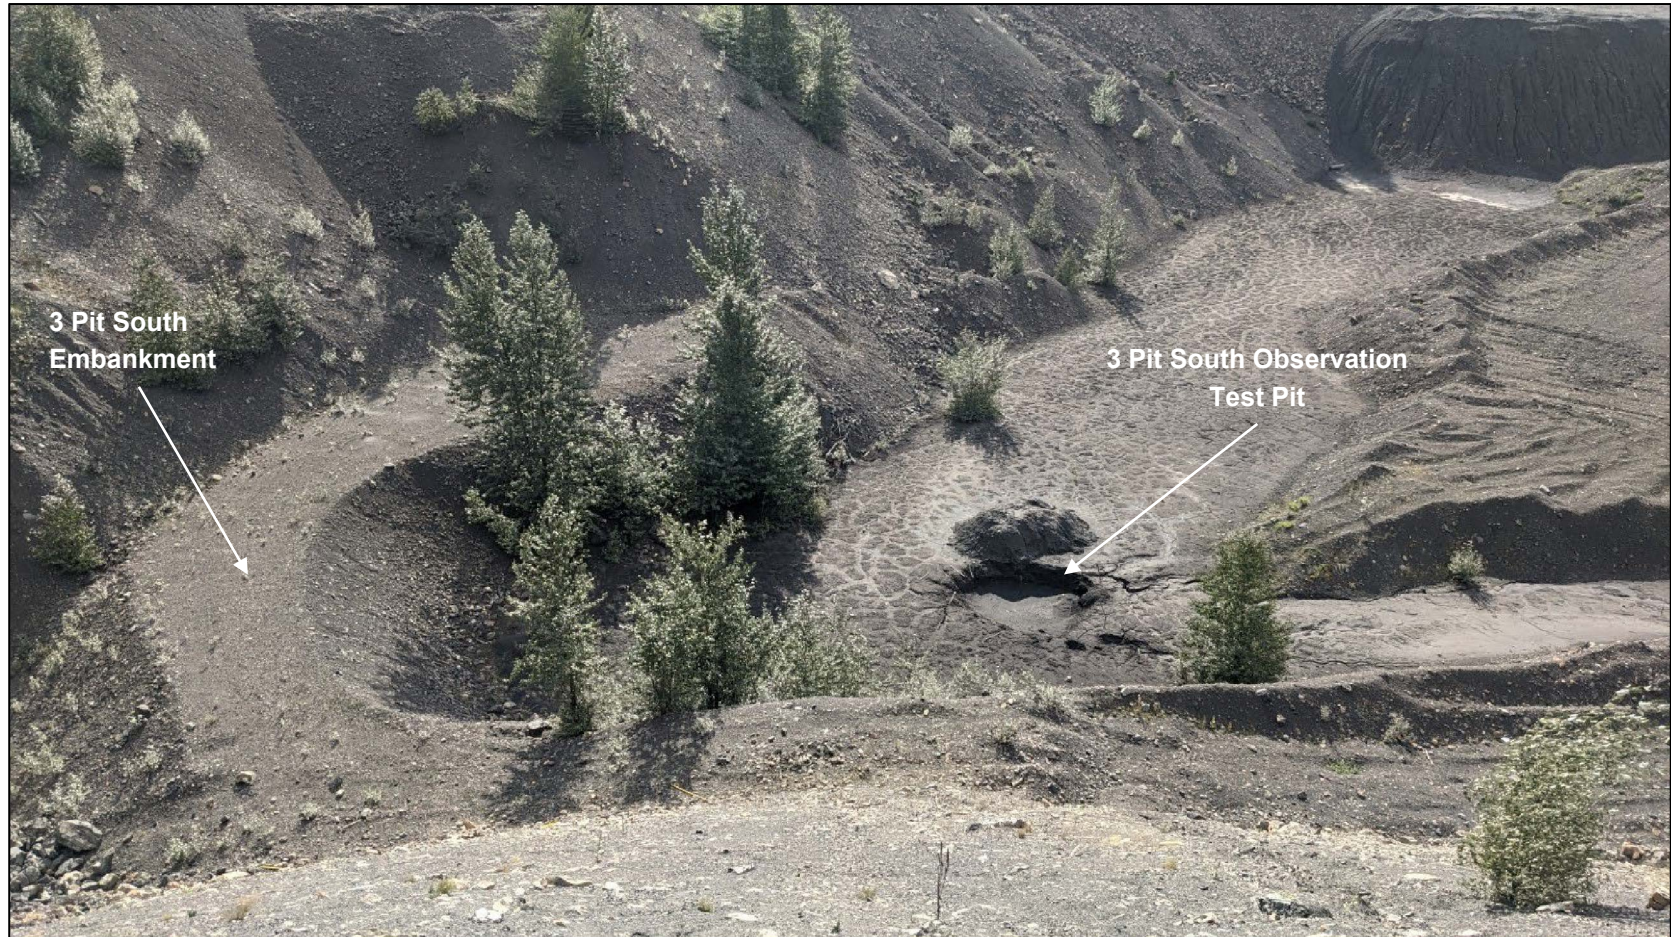
PHOTOGRAPH 3

During the 8 September 2022 inspection, dry tailings were noted (Photograph 3 in Appendix A) in the 3PS observation pit, which was dug in 2016. The 3PS water elevation was noted as having no water or being dry on the FRO monthly inspection sheets throughout the reporting period.

3 Pit South desiccated tailings surface and dry conditions observed in test pit upstream of the 3 Pit South Embankment, 3 Pit South Embankment crest, and upstream slope, looking southeast.

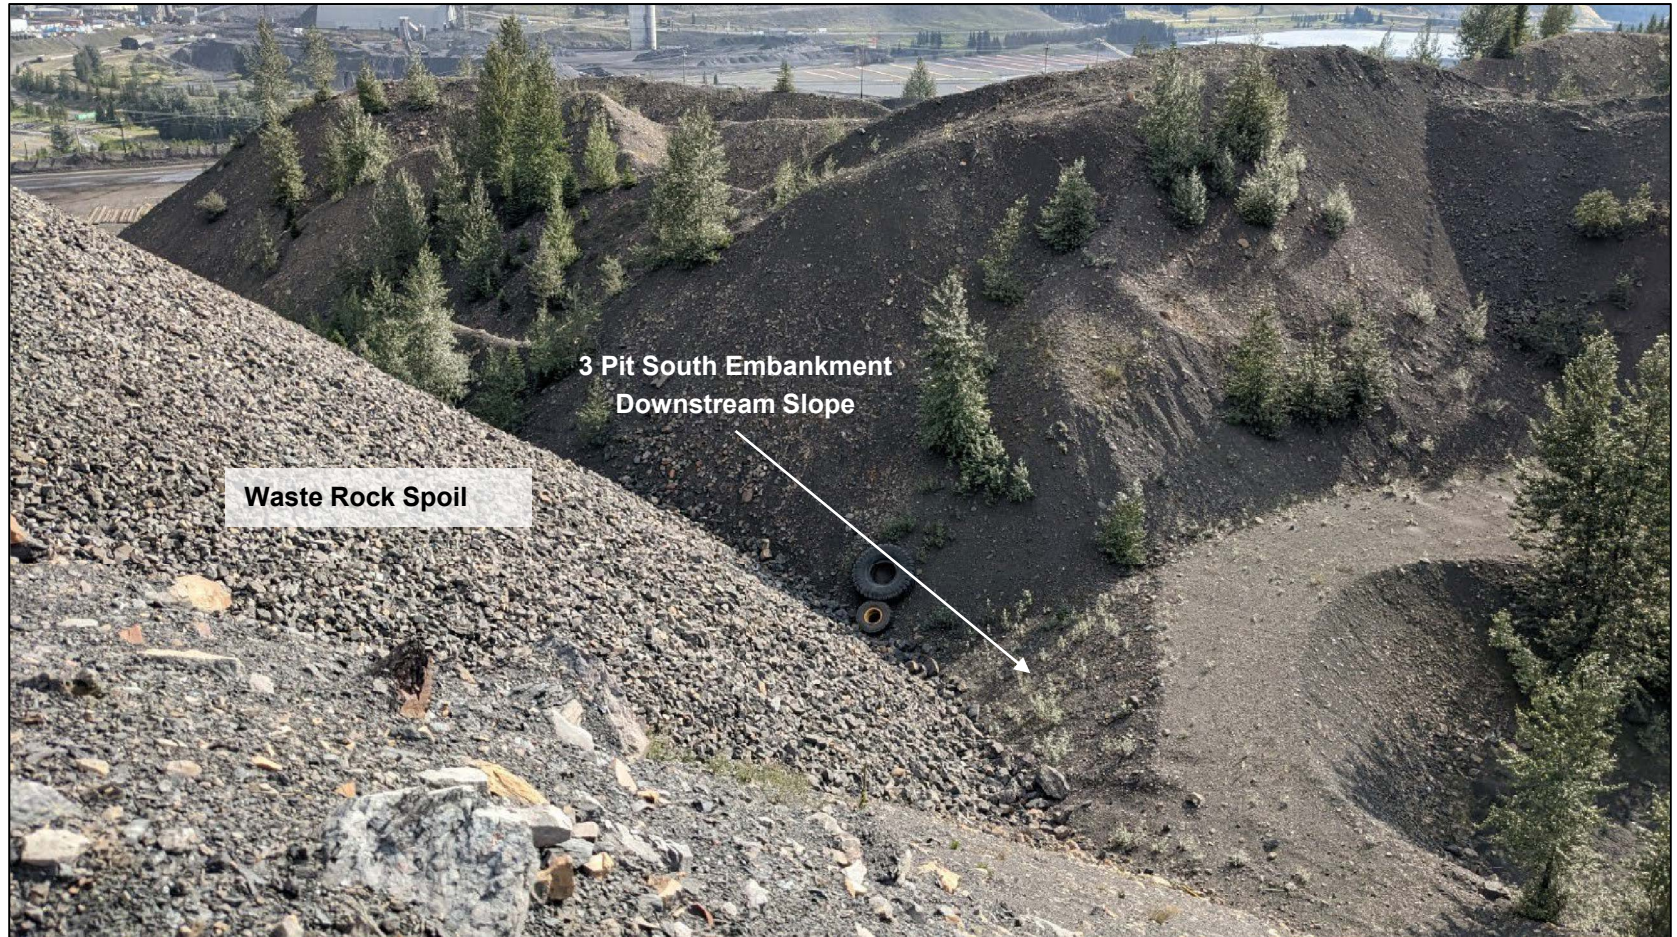
PHOTOGRAPH 4

3 Pit South downstream slope, partially filled with adjacent spoil expansion, looking east.

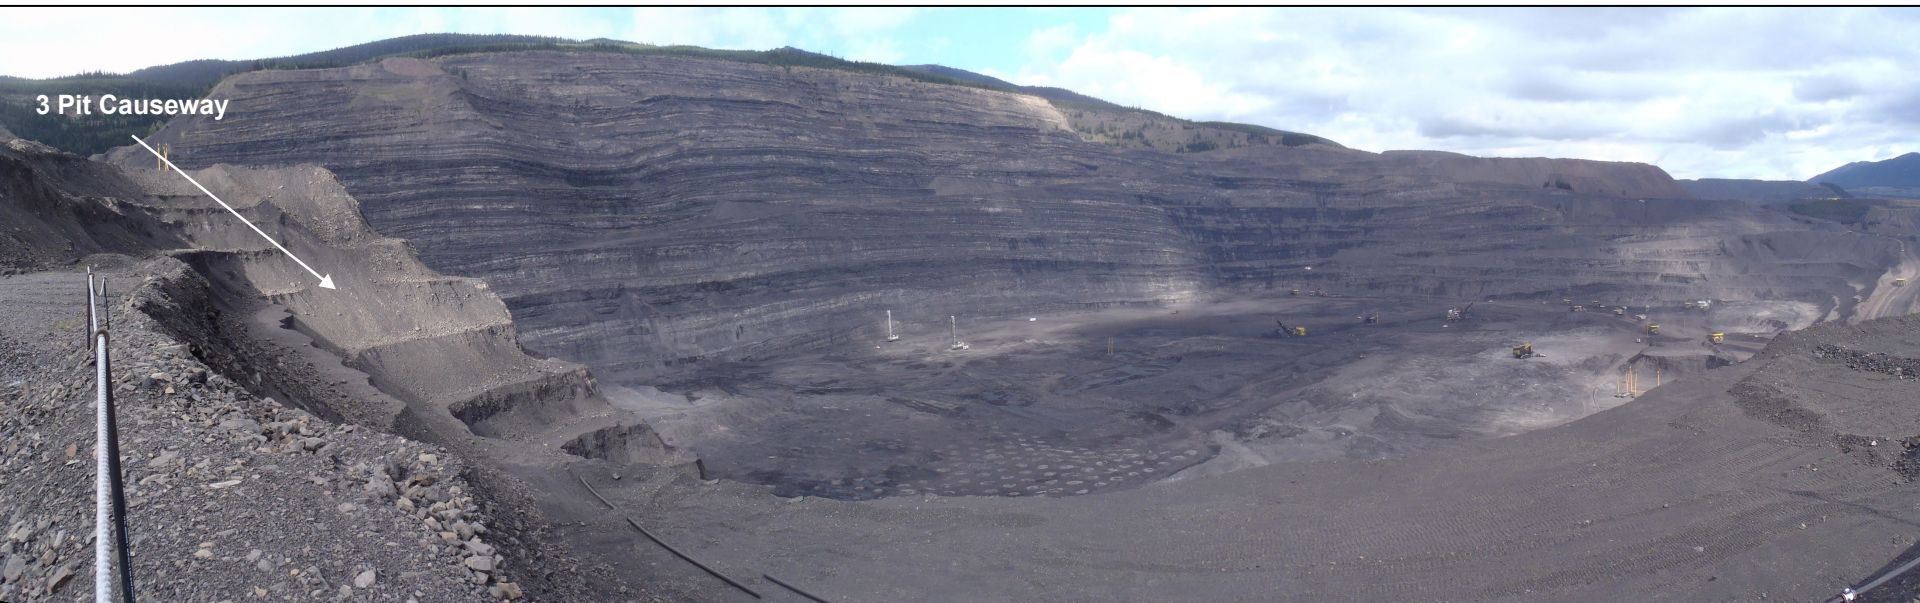
PHOTOGRAPH 5

Overview of mining activities in Swift Pit below the 3 Pit Causeway, looking northwest.
