**2022 Annual Facility Performance Report for
South Tailings Pond and North Tailings Pond**
Teck Coal Limited, Fording River Operations

WSP Canada Inc.

Reference No. 22516328-2022-118-R-Rev0-1300

23 March 2023

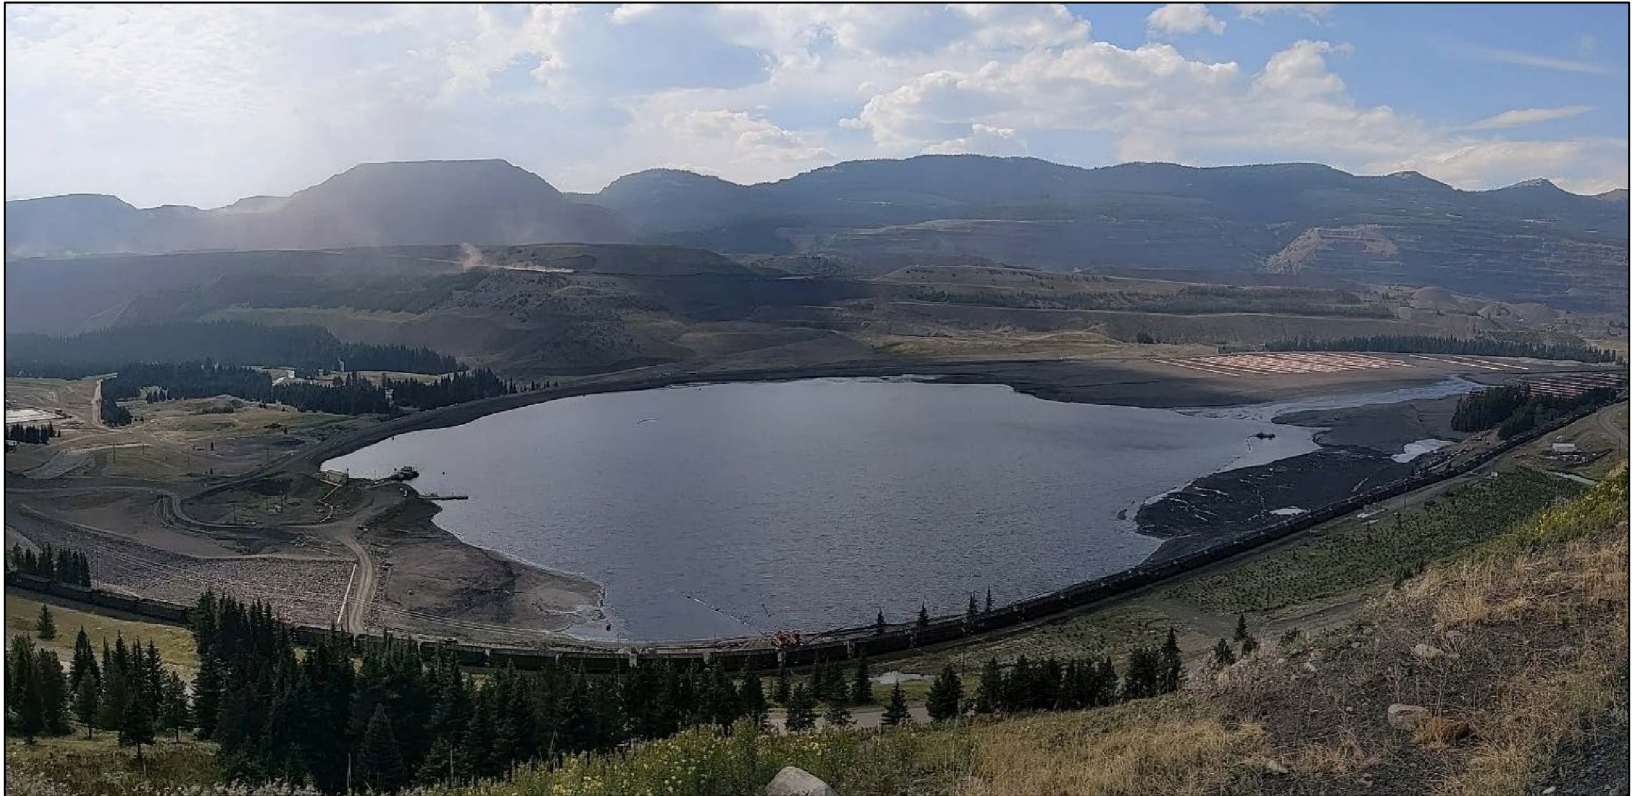
South Tailings Pond (STP) overview, looking west.

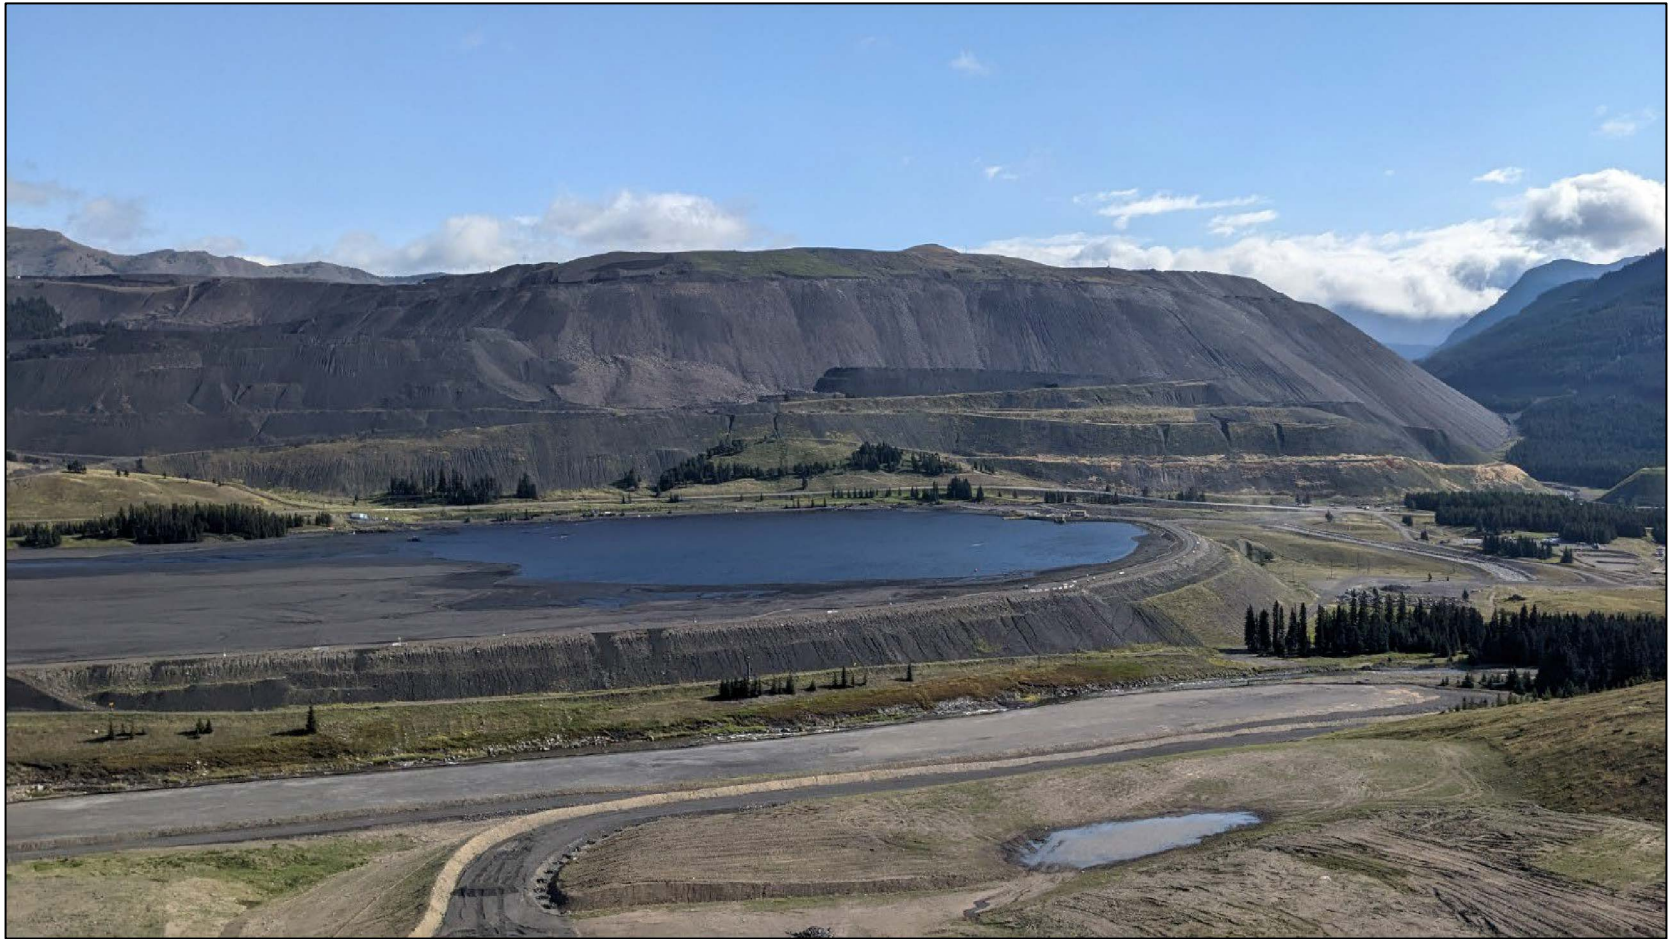
South Tailings Pond (STP) overview, looking east.

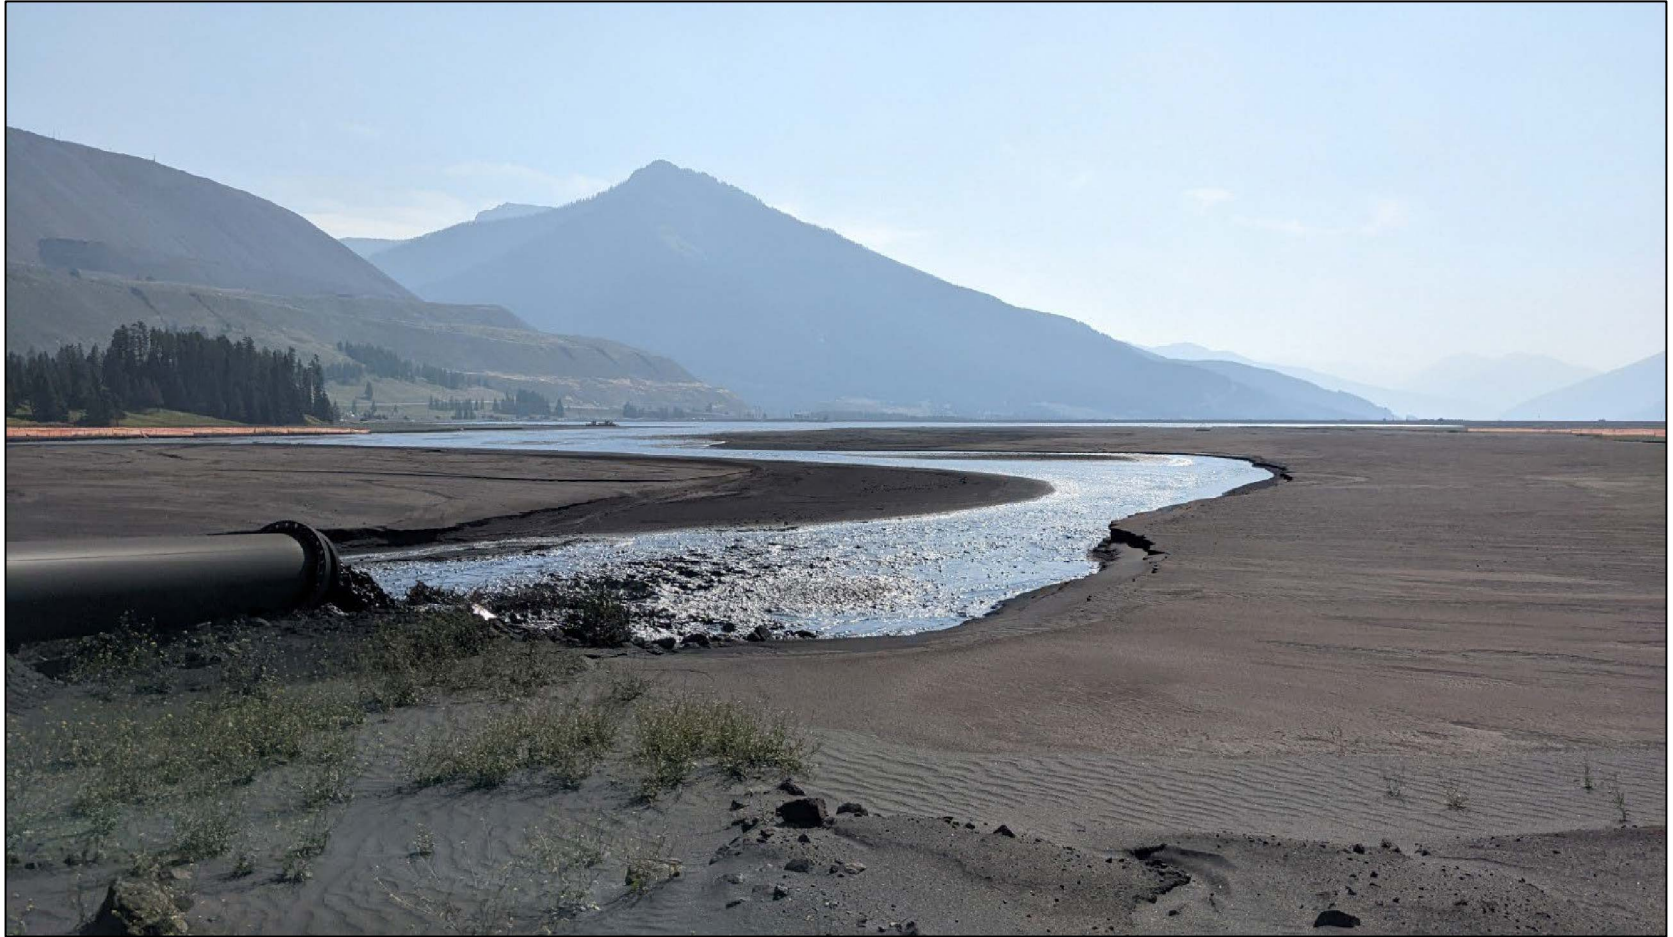
STP tailings pipeline at north single point discharge, north beach area, looking southeast.

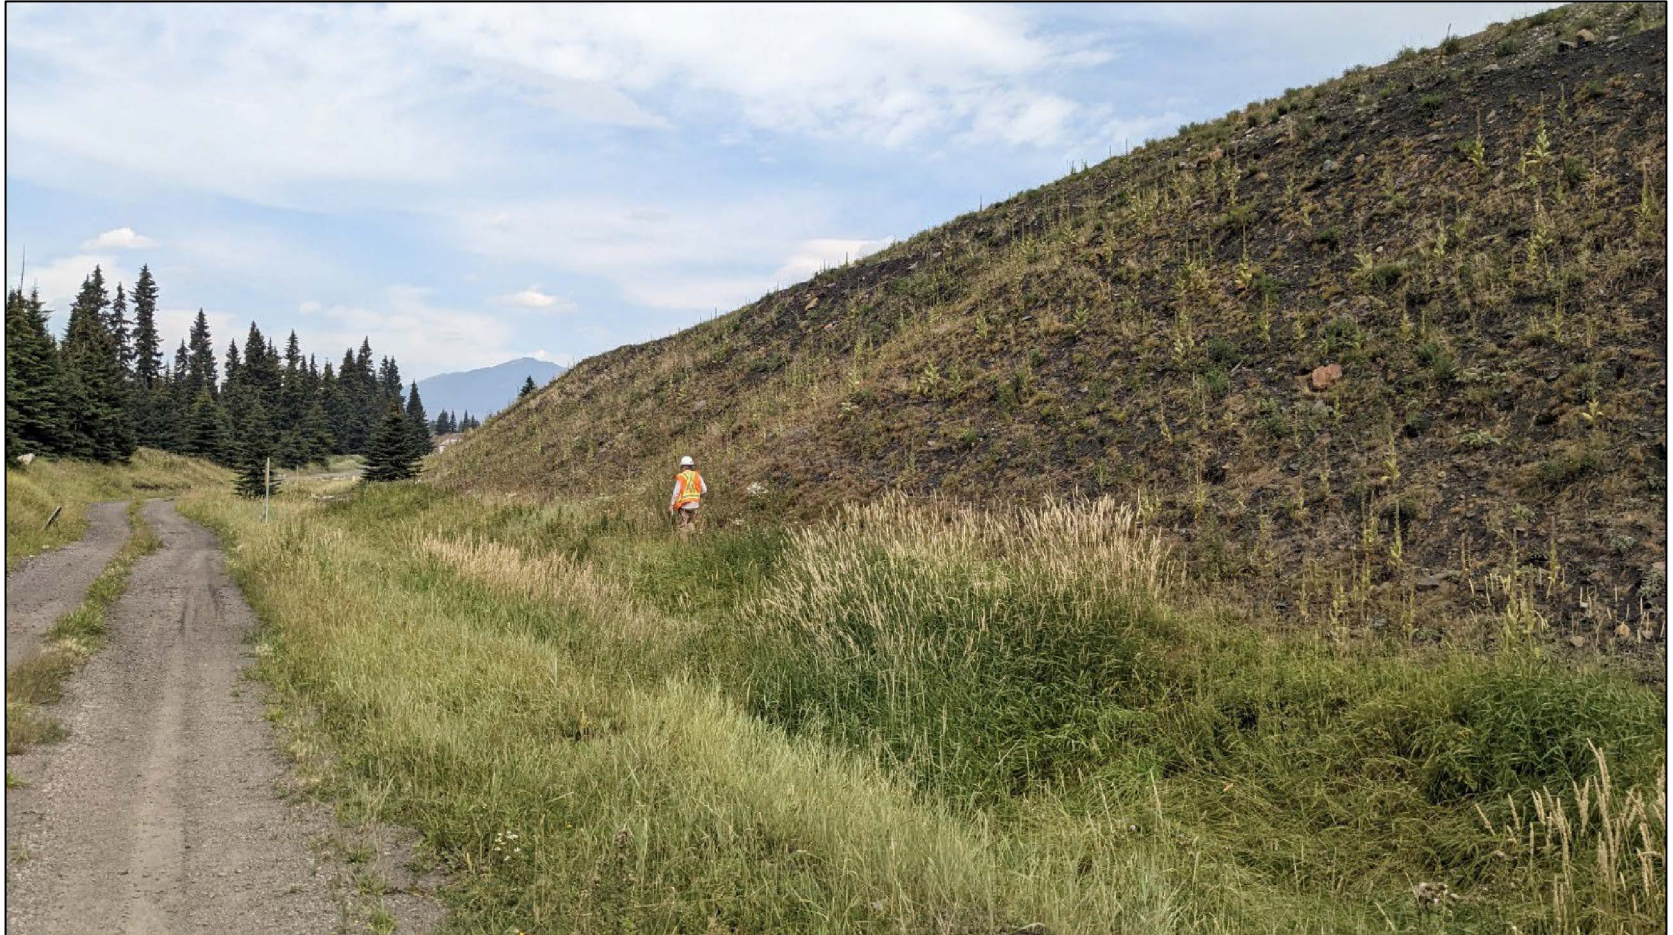
STP West Dam downstream slope, looking northeast from approximately Sta. 0+050.

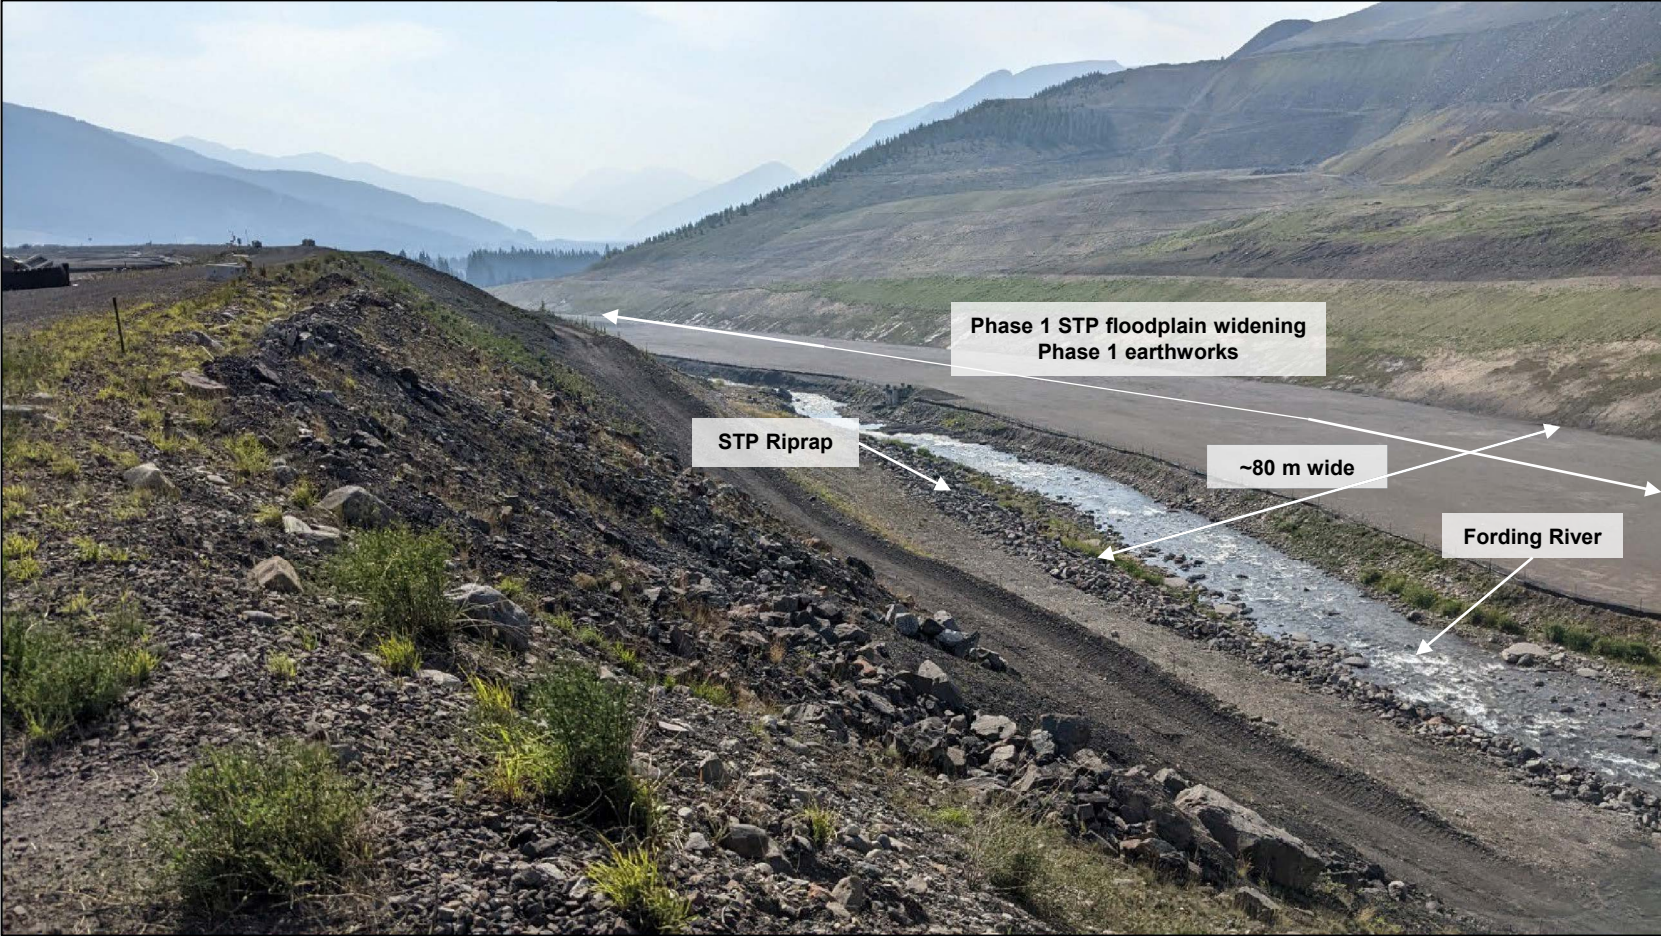
STP West Dam downstream slope, along Fording River, and widened floodplain, looking southwest from approximately Sta. 0+550.

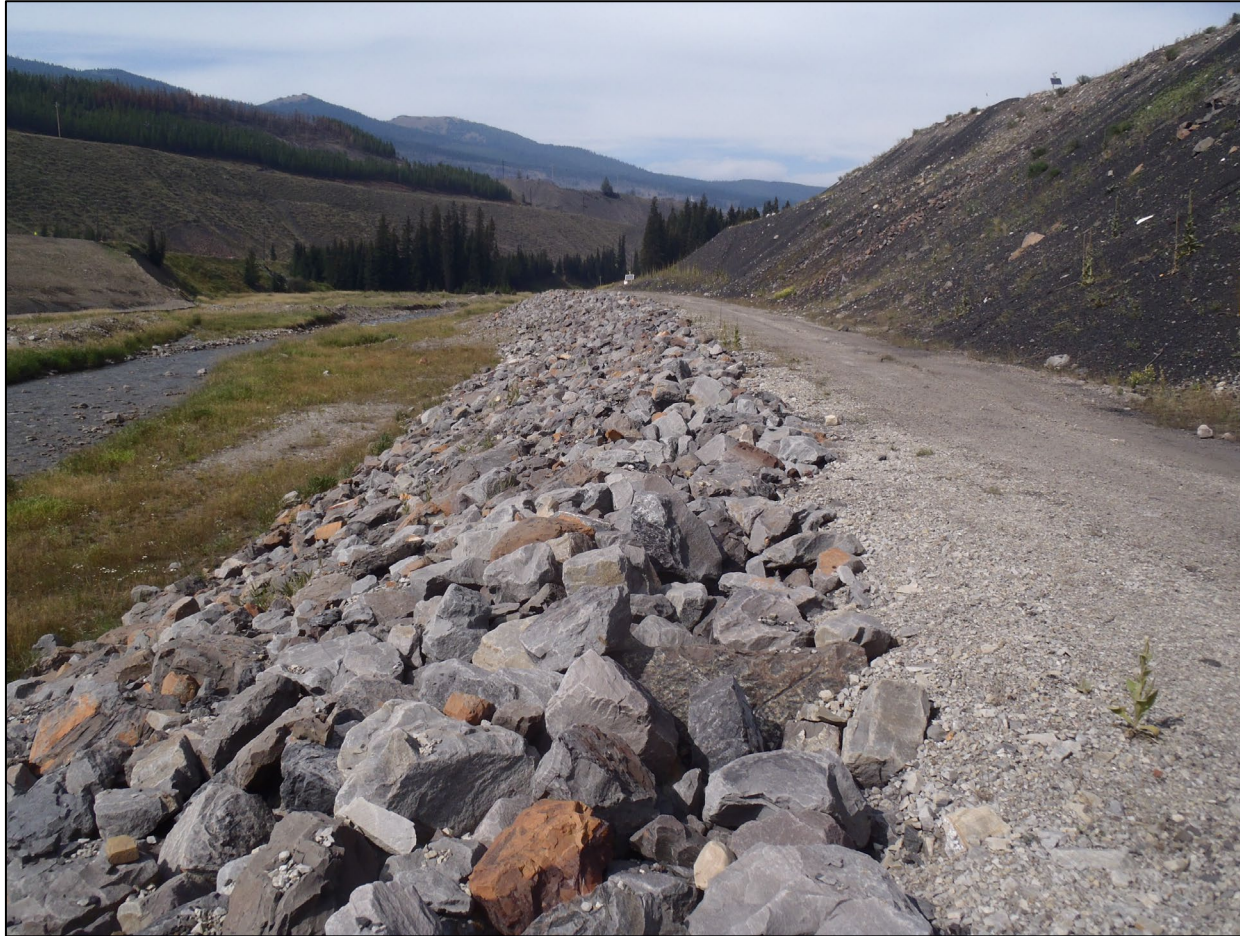
STP West Dam downstream slope and riprap along Fording River, looking northwest from approximately Sta. 0+450.

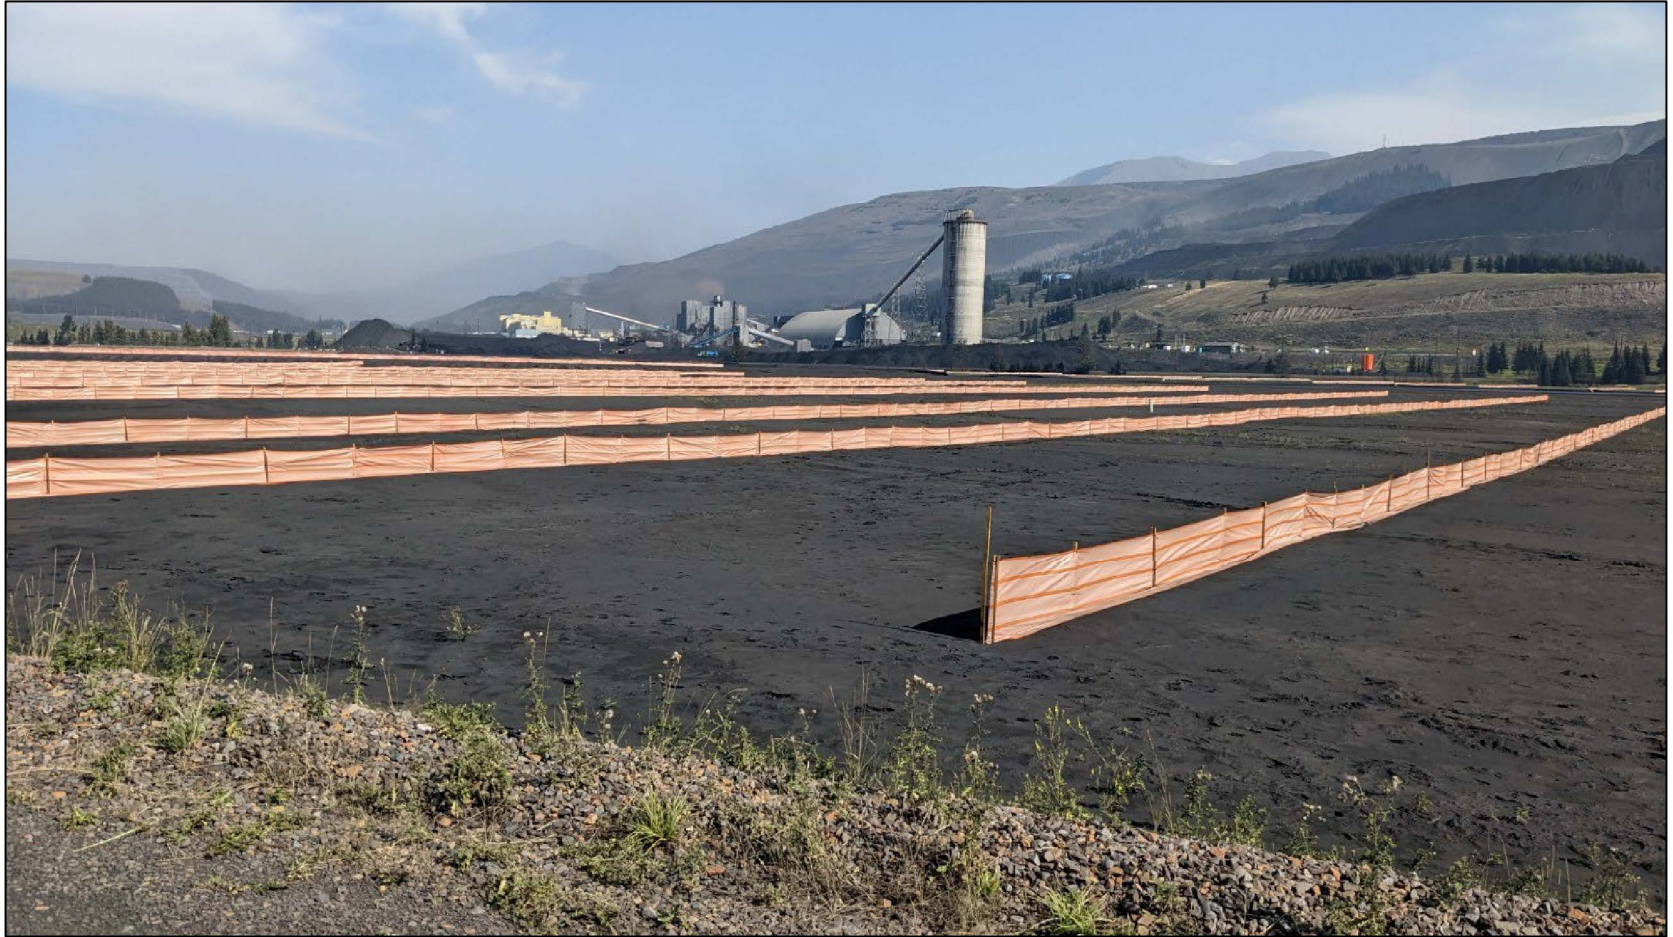
Silt fences installed at northern end of STP beach, looking northeast from approximately Sta. 0+375.

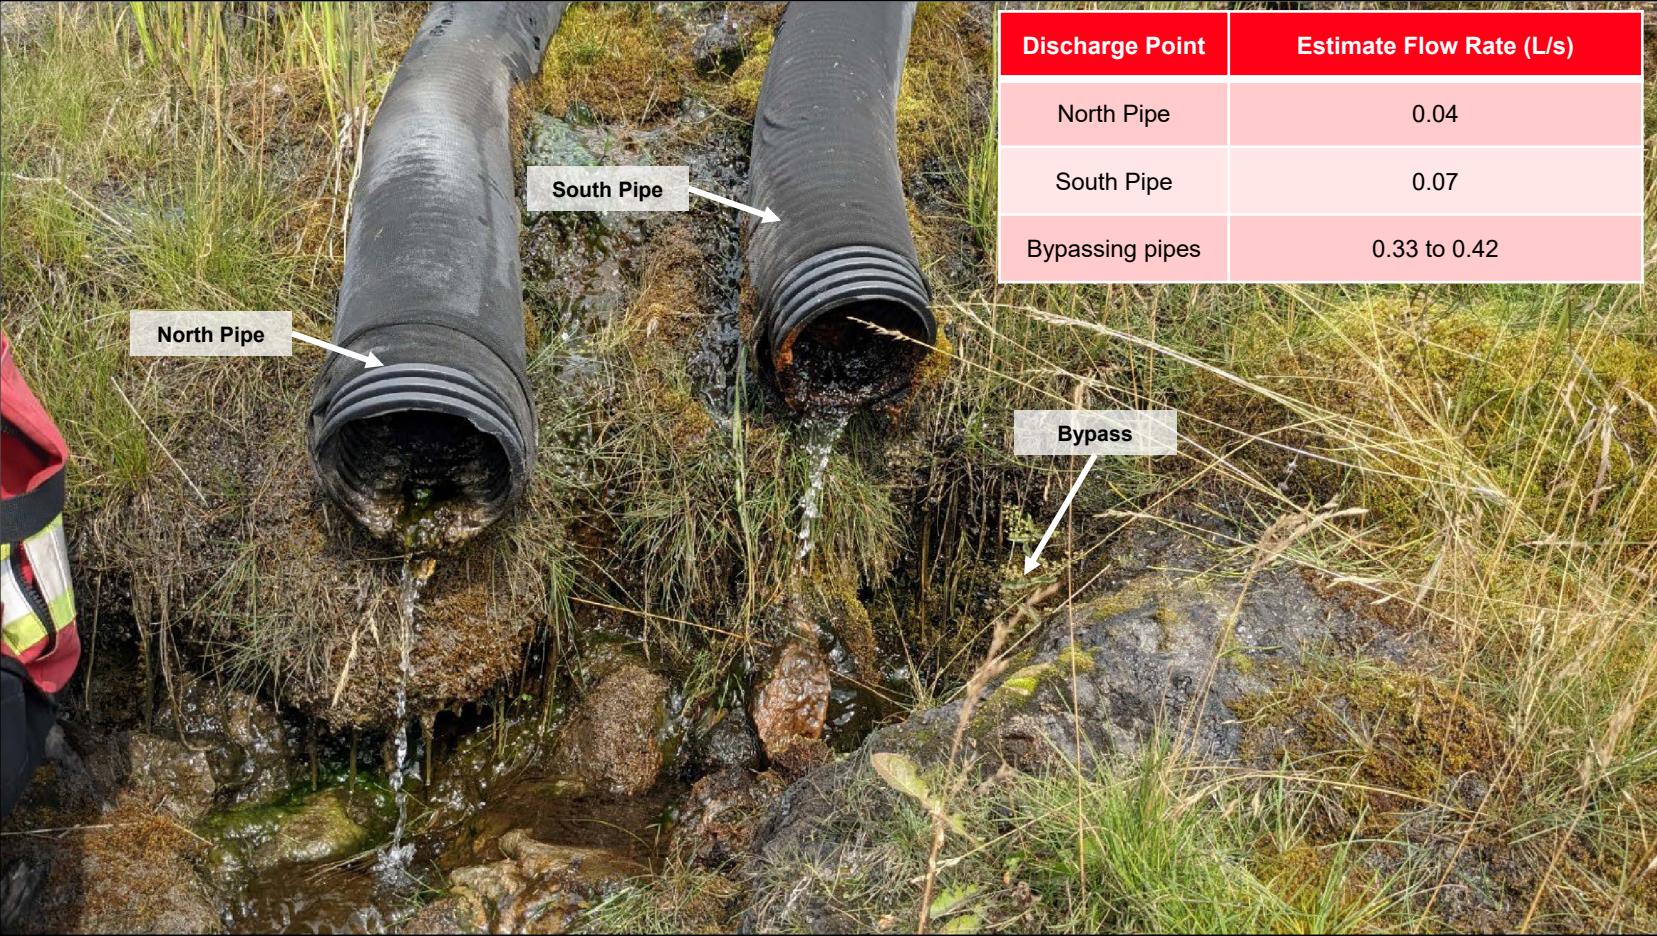
Seepage collection pipes in till slope below West Dam, looking northeast from approximately Sta. 1+000.

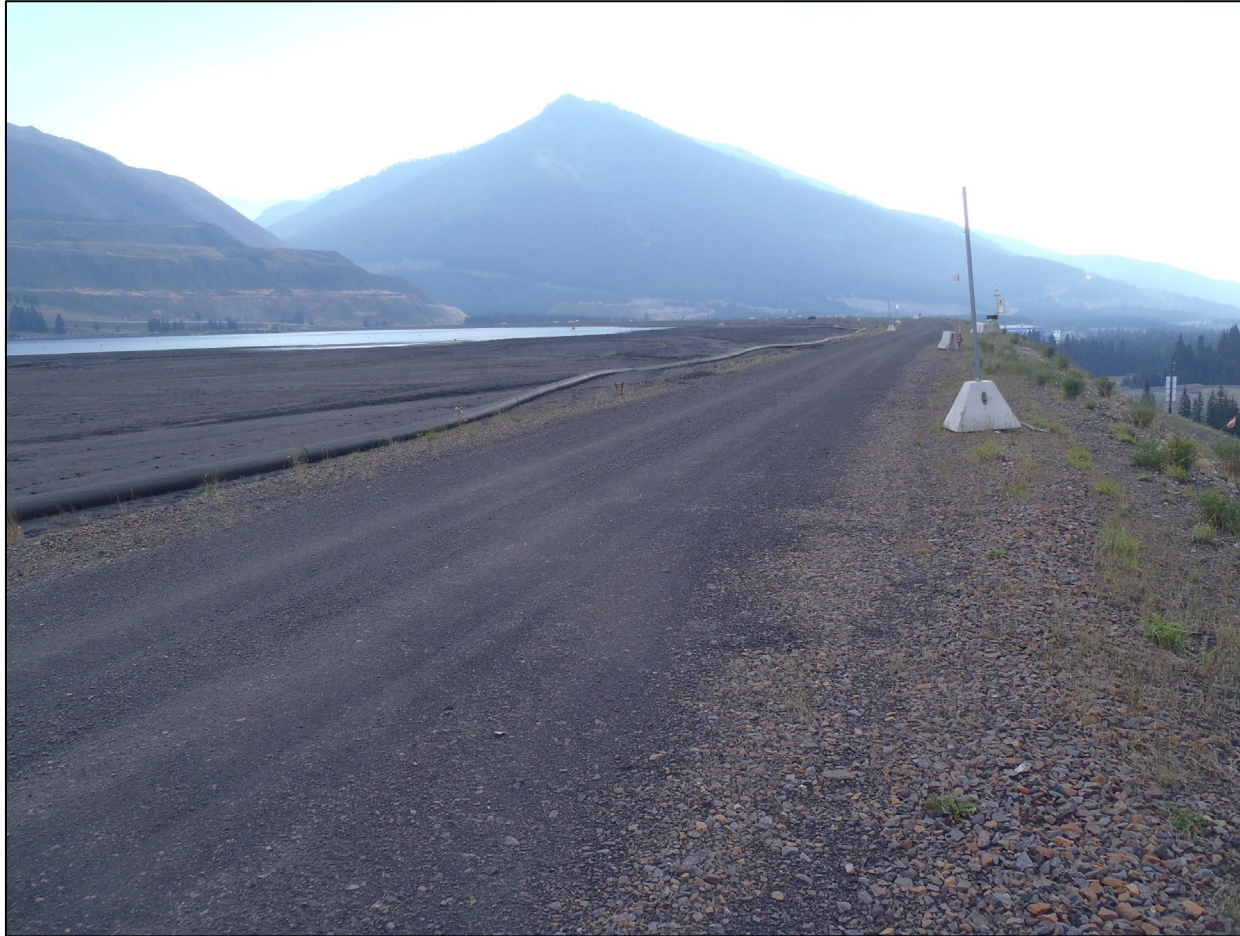
STP West Dam crest, looking southeast from approximately Sta. 0+950.

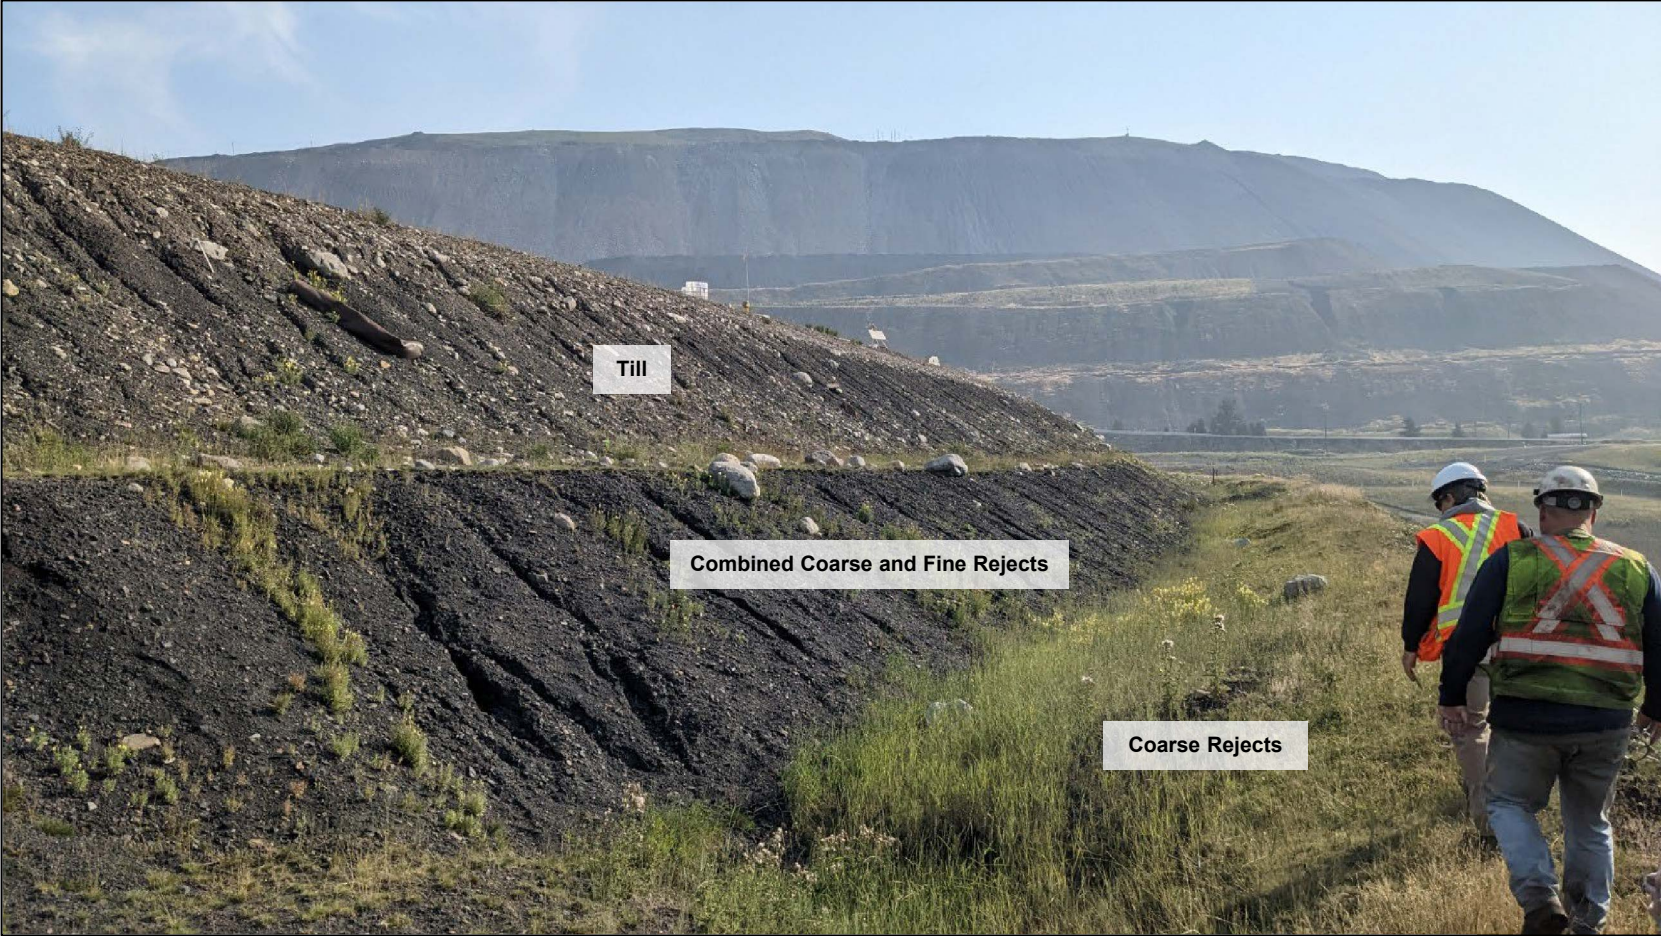
STP Main Dam downstream slope showing till, CCFR, and CR slopes, looking east from approximately Sta. 1+350.

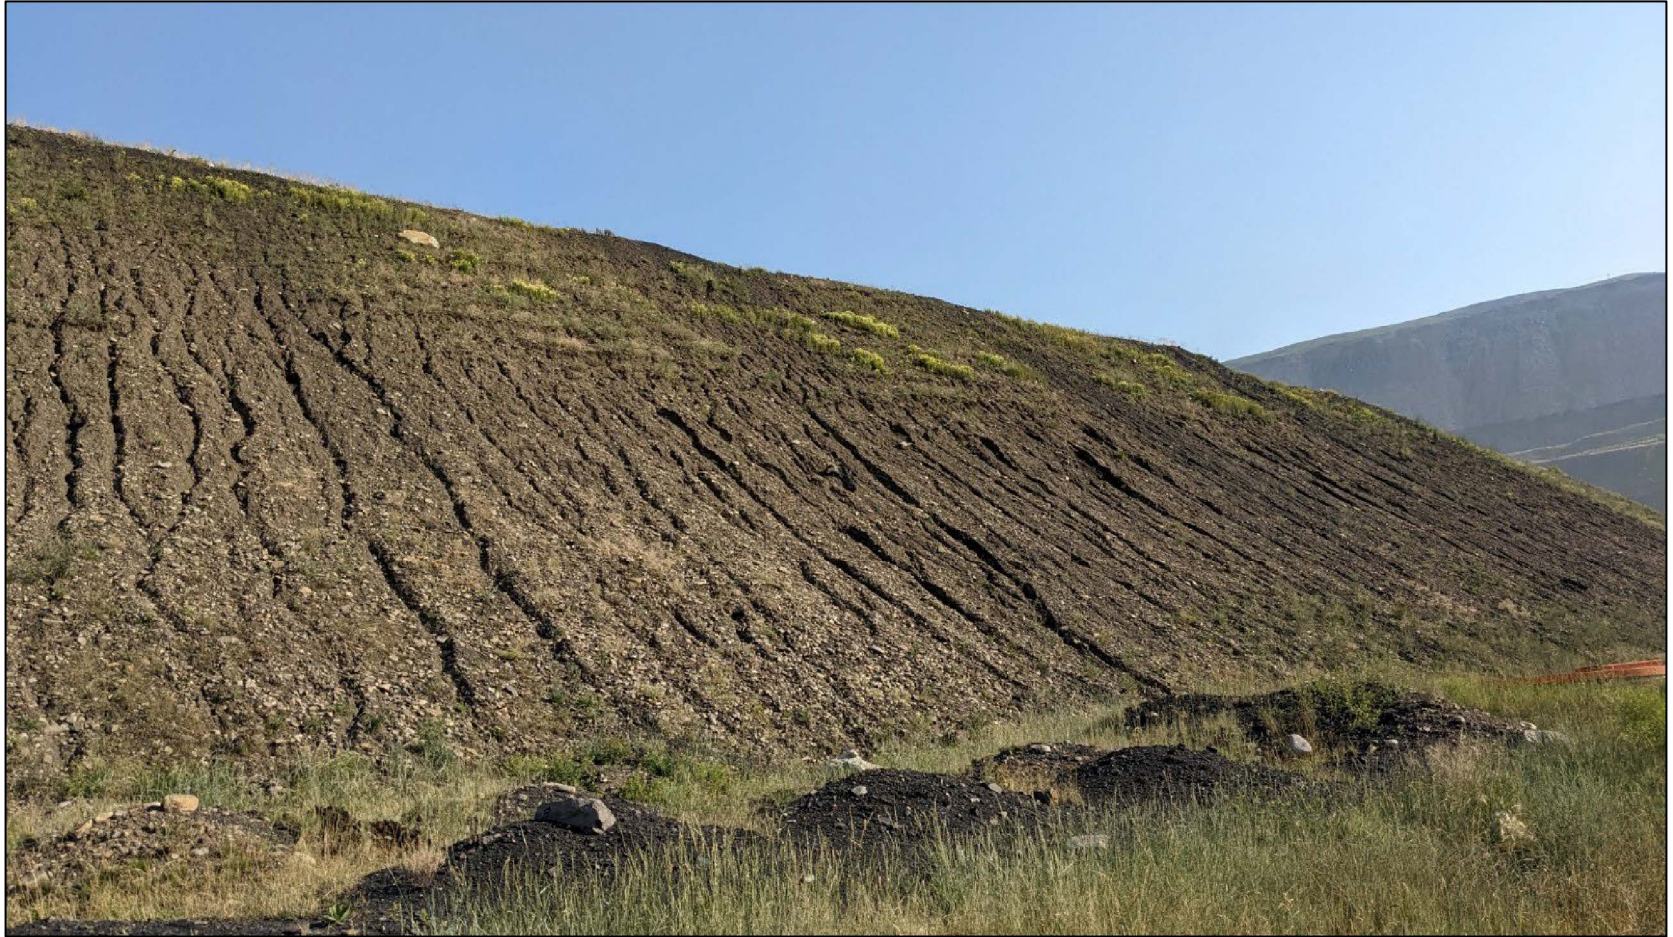
STP Main Dam downstream slope showing surficial erosion, looking northeast from approximately Sta. 1+375.

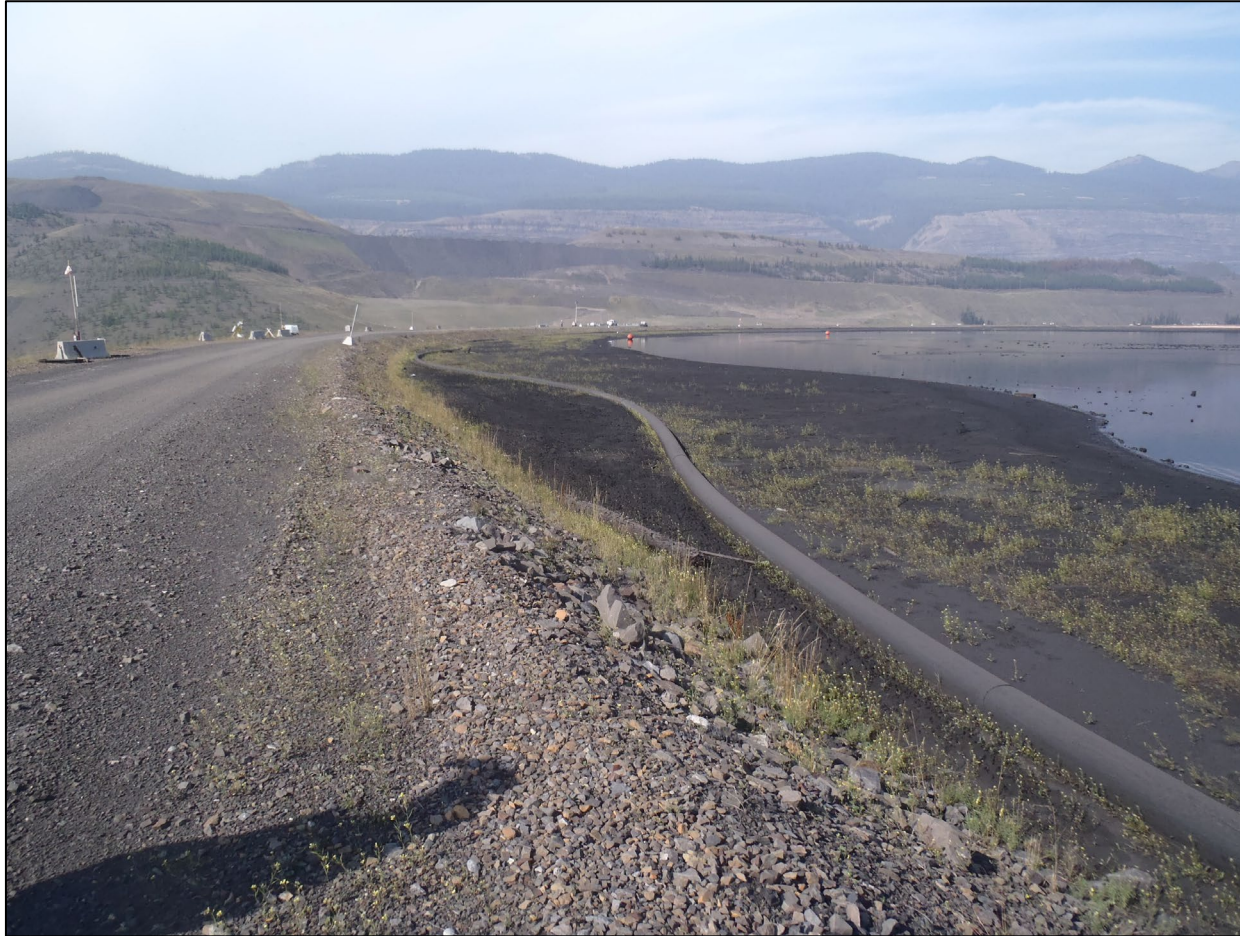
STP Main Dam crest and upstream beach, looking southwest from approximately Sta. 1+450.

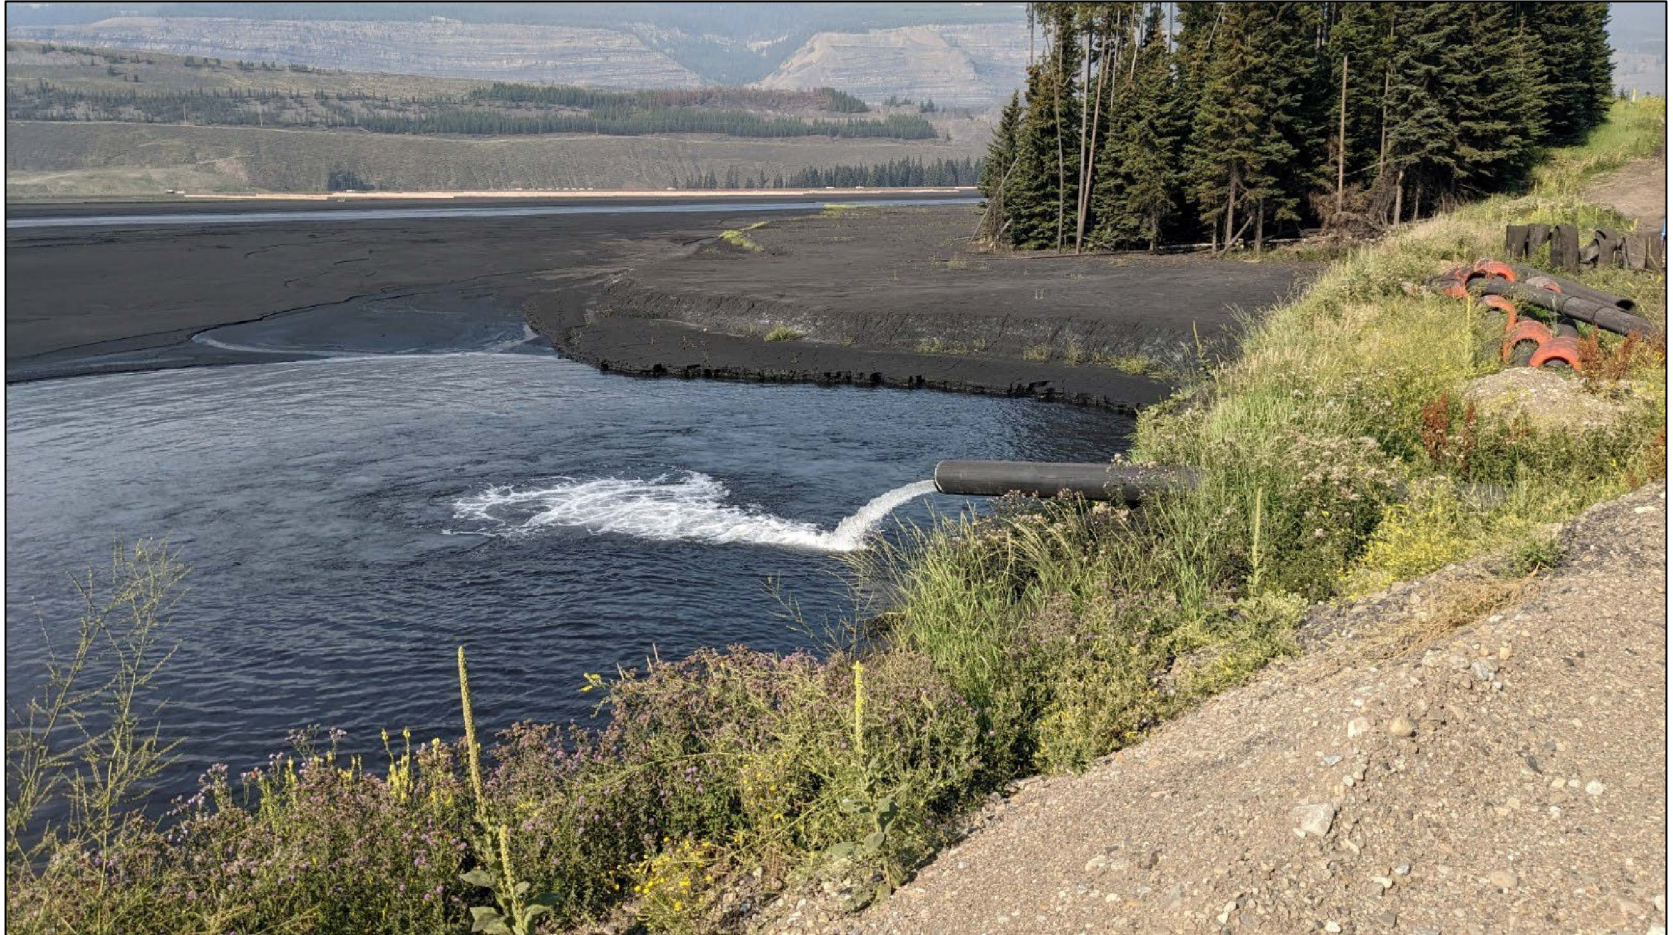
STP reclaim water pipeline from Turnbull TSF, looking northwest.

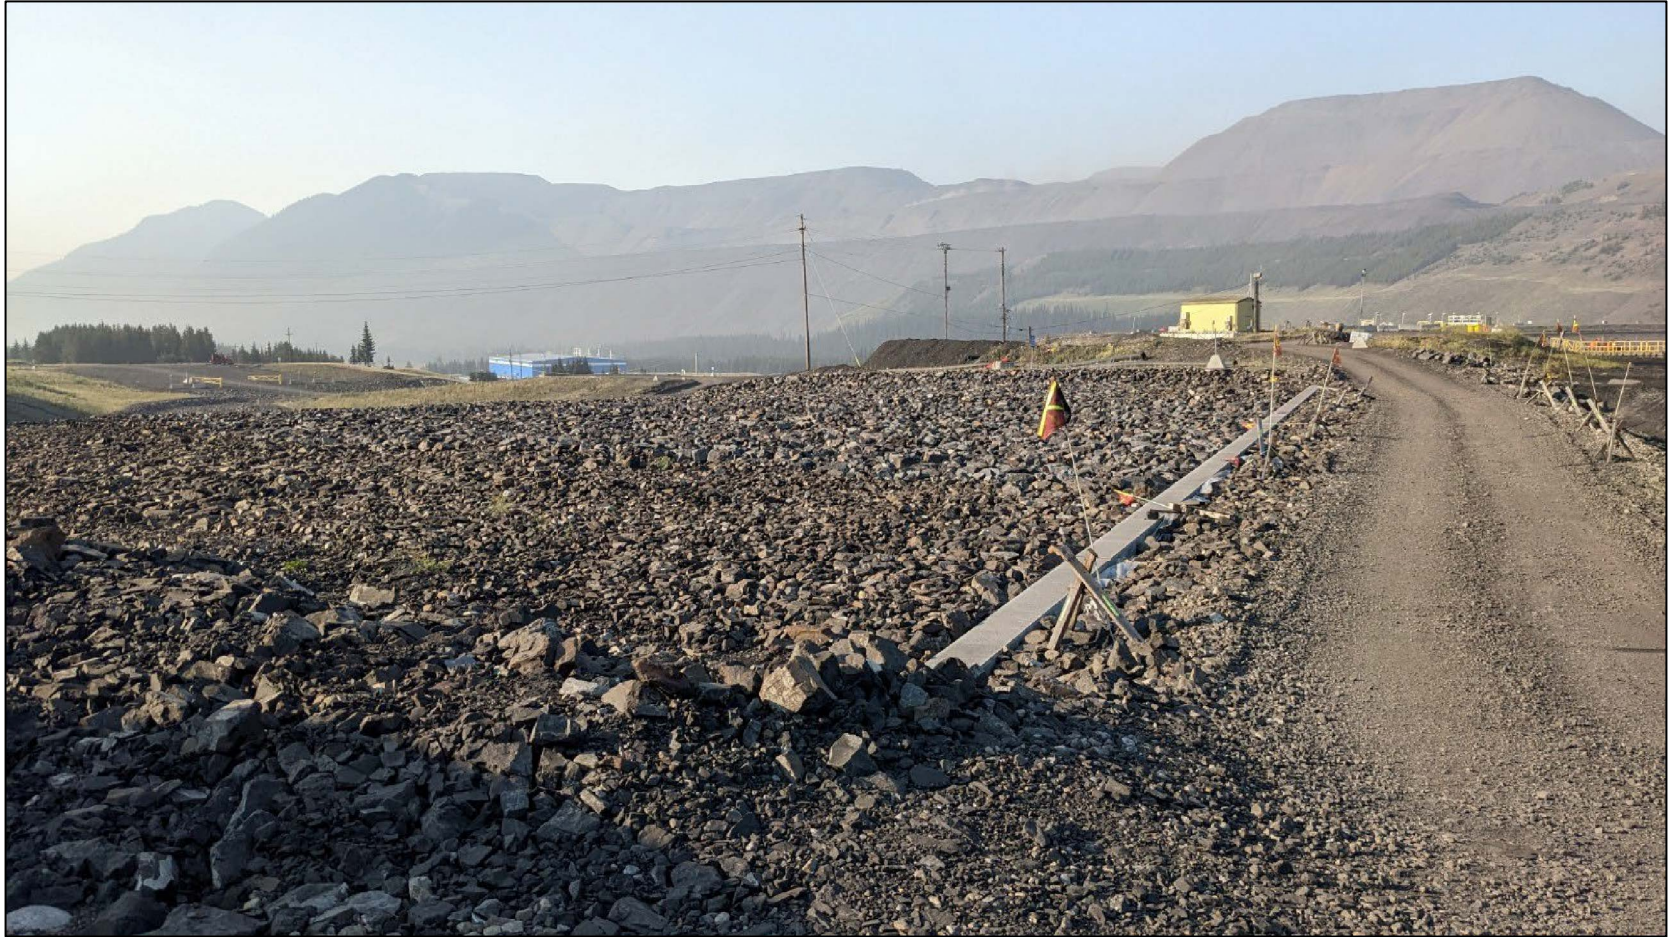
STP spillway channel and concrete sill at invert, looking southwest from STP south abutment.

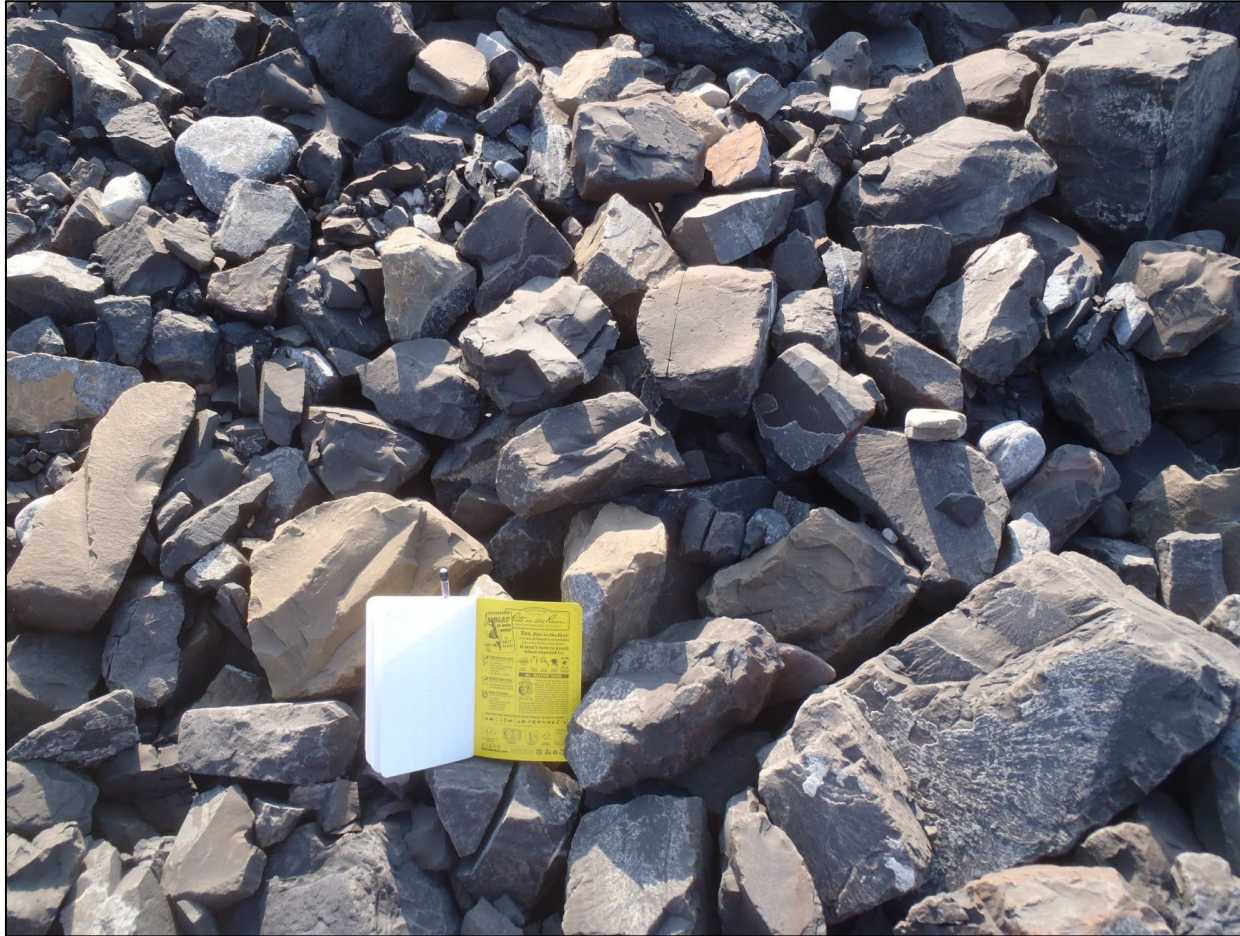
STP spillway channel Class 10 kg riprap at approximately spillway Sta. 0+025.

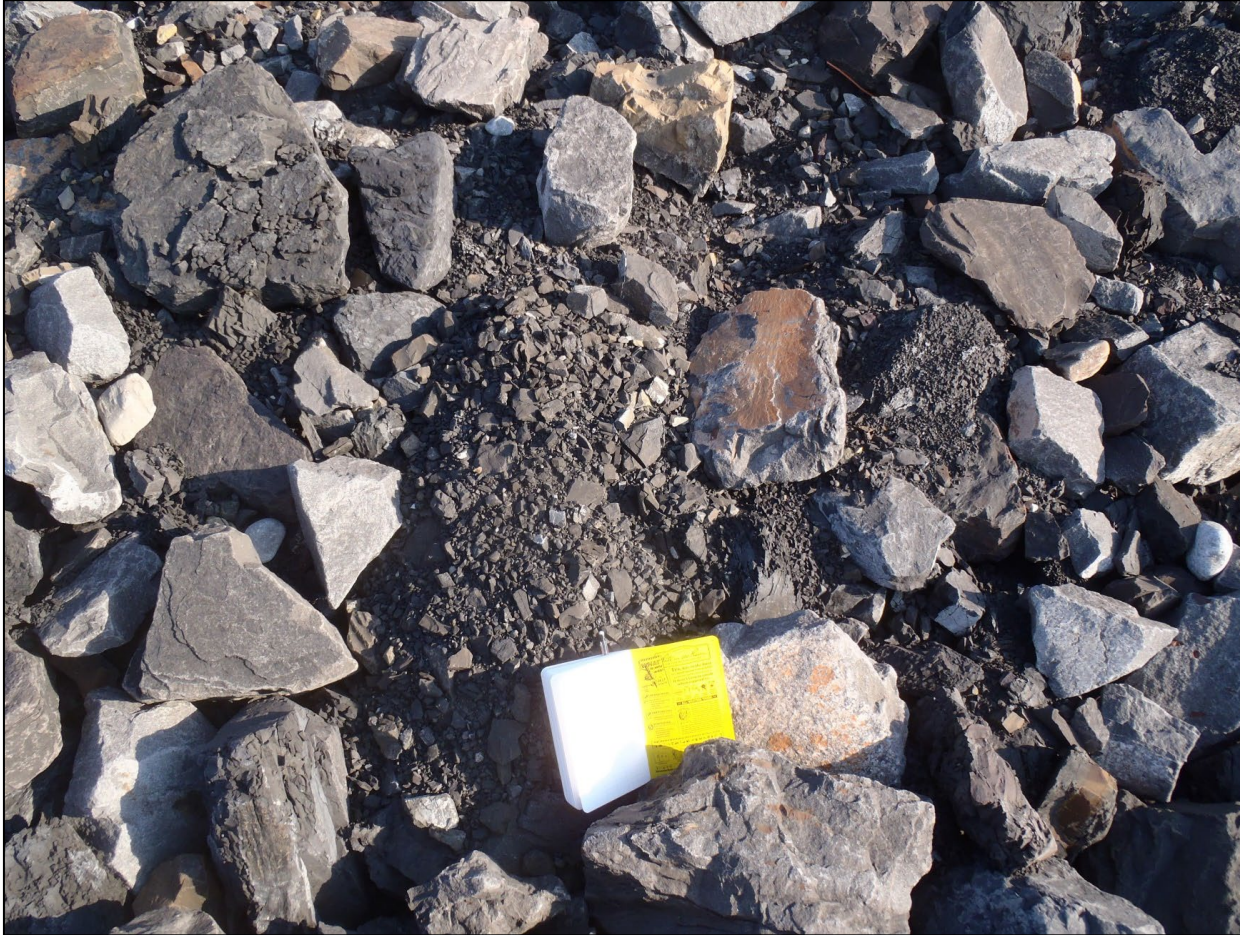
STP spillway channel Class 50 kg riprap at approximately spillway Sta. 0+090.
