**2022 Annual Facility Performance Report for
South Tailings Pond and North Tailings Pond**
Teck Coal Limited, Fording River Operations

WSP Canada Inc.

Reference No. 22516328-2022-118-R-Rev0-1300

23 March 2023

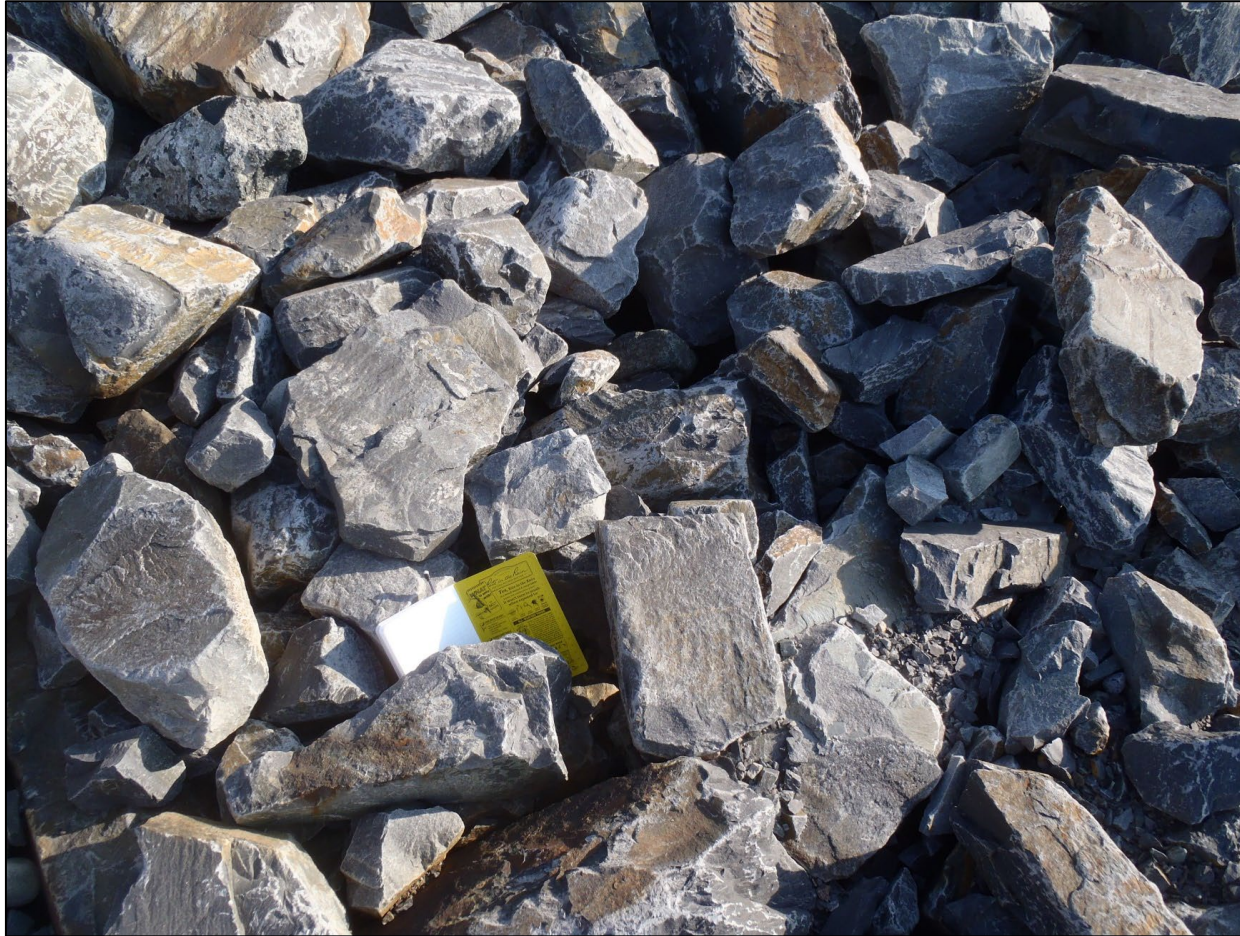
STP spillway channel Class 250 kg riprap at approximately spillway Sta. 0+350.

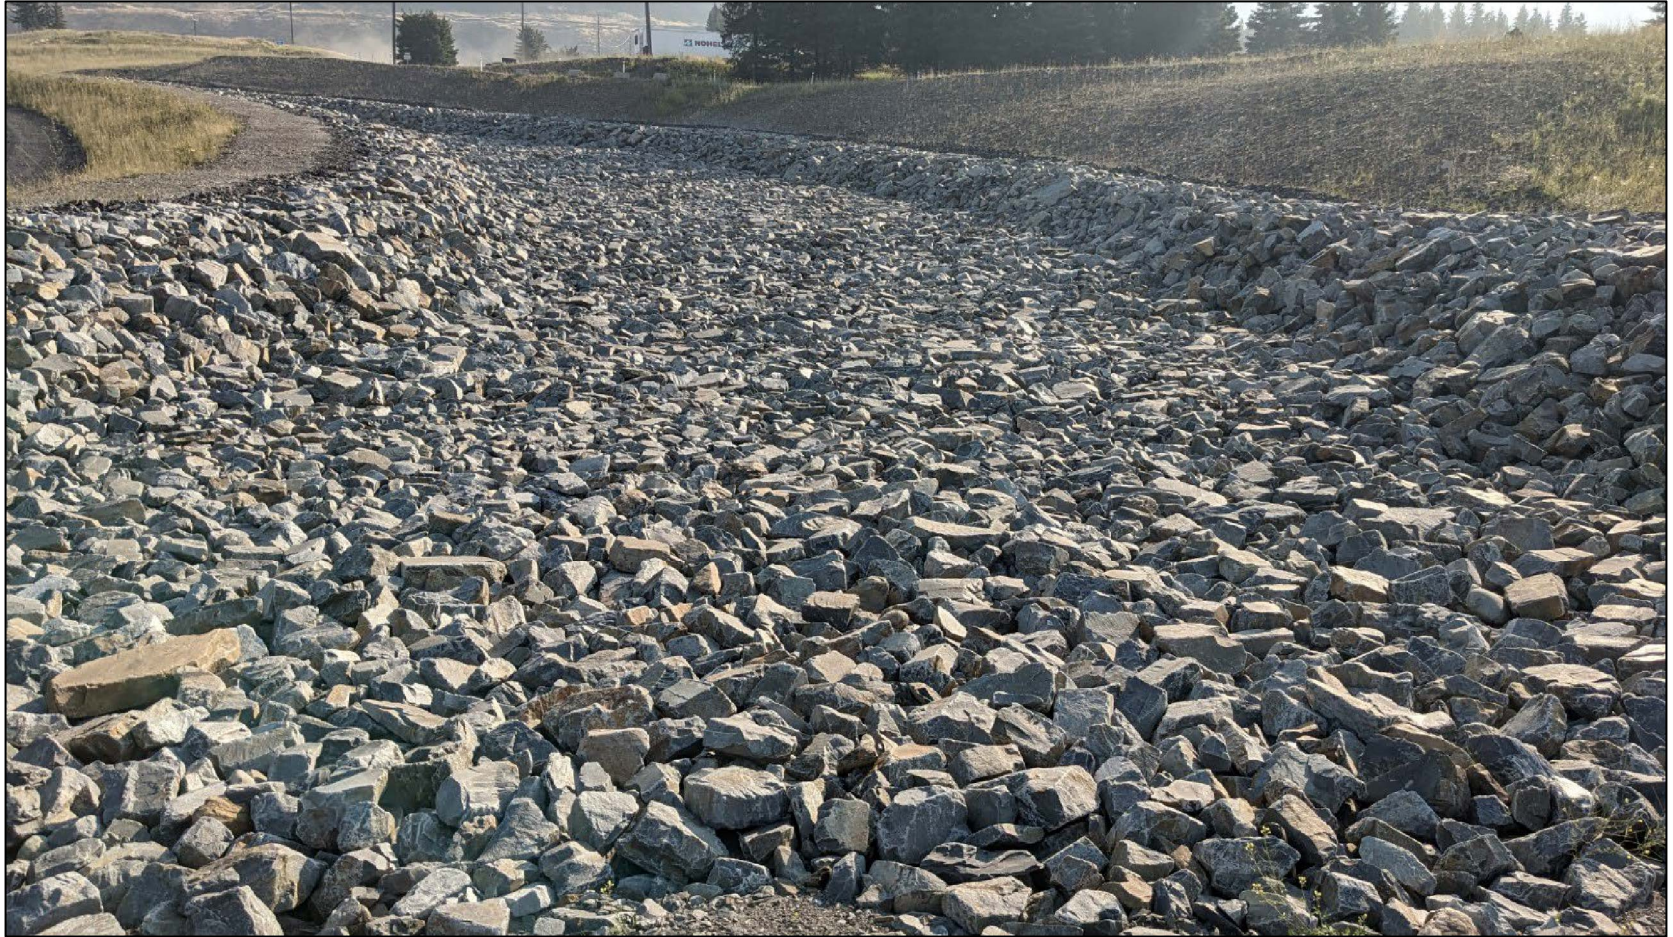
STP spillway channel outlet, looking northeast.

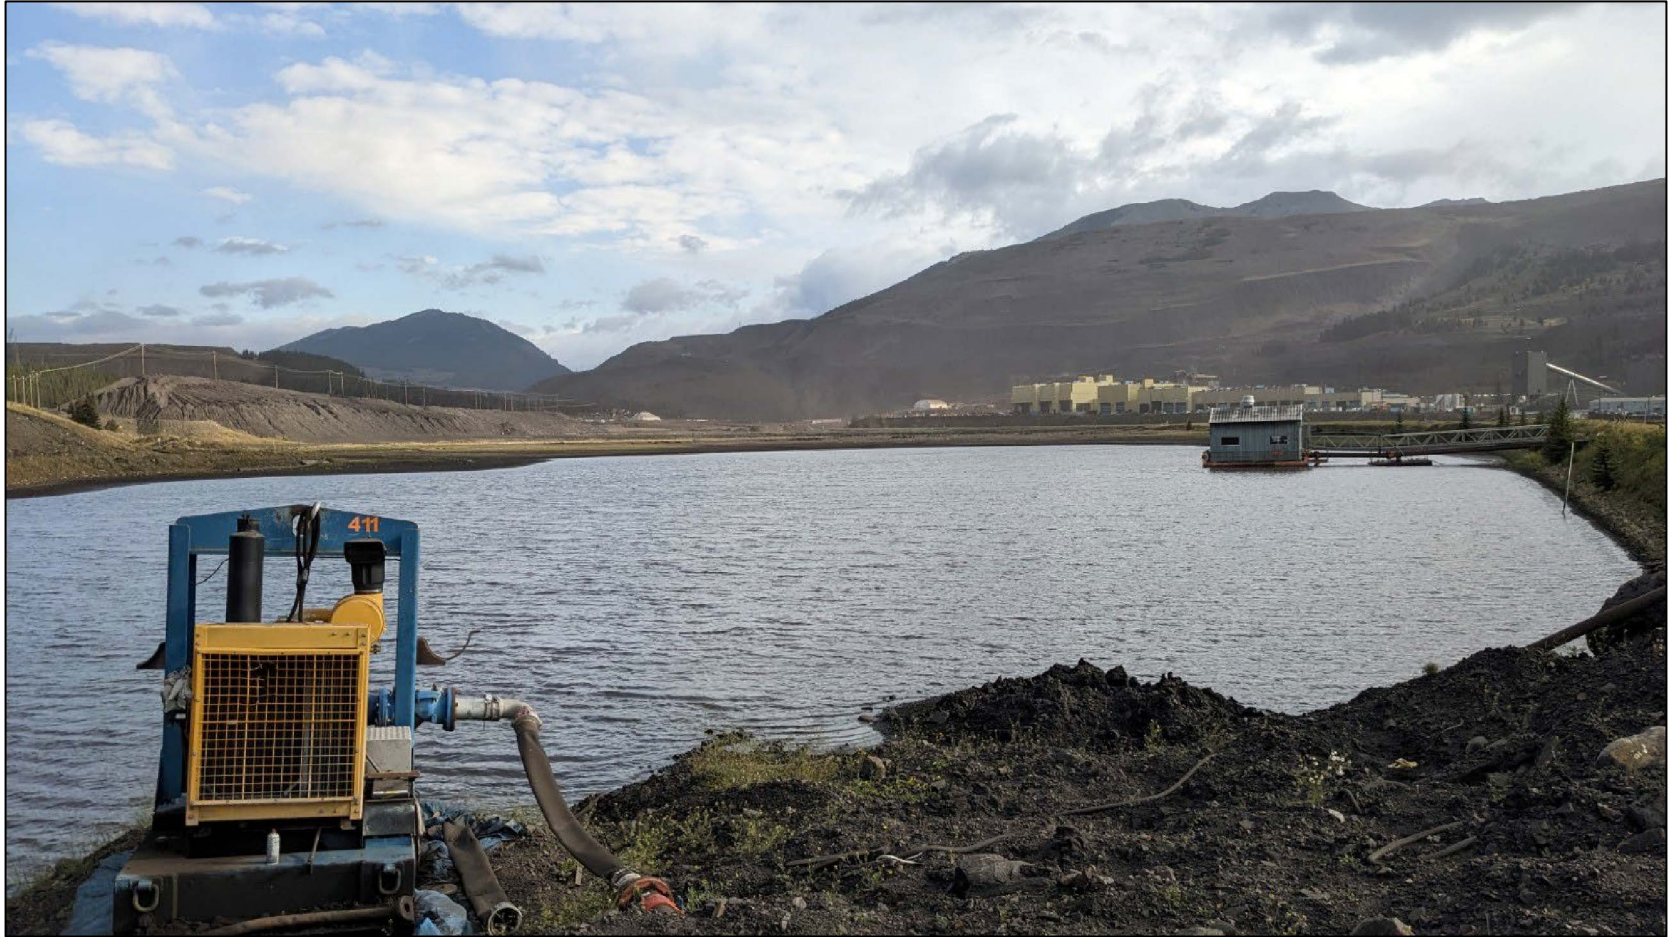
North Tailings Pond (NTP) overview of pond and upstream slope at south end, looking north from approximately Sta. 1+400.

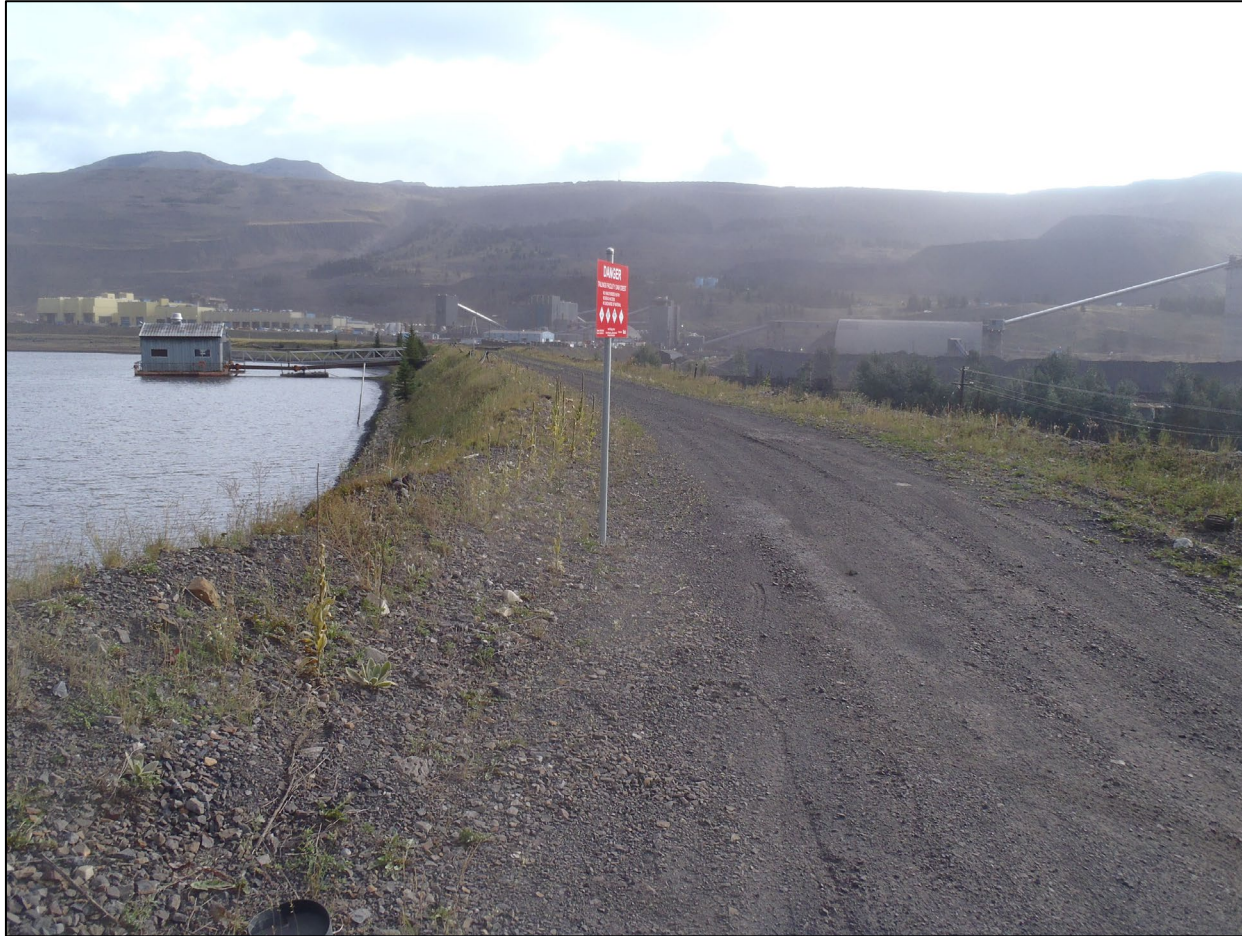
NTP Dam upstream slope and crest at south end, looking northeast from approximately Sta. 1+350.

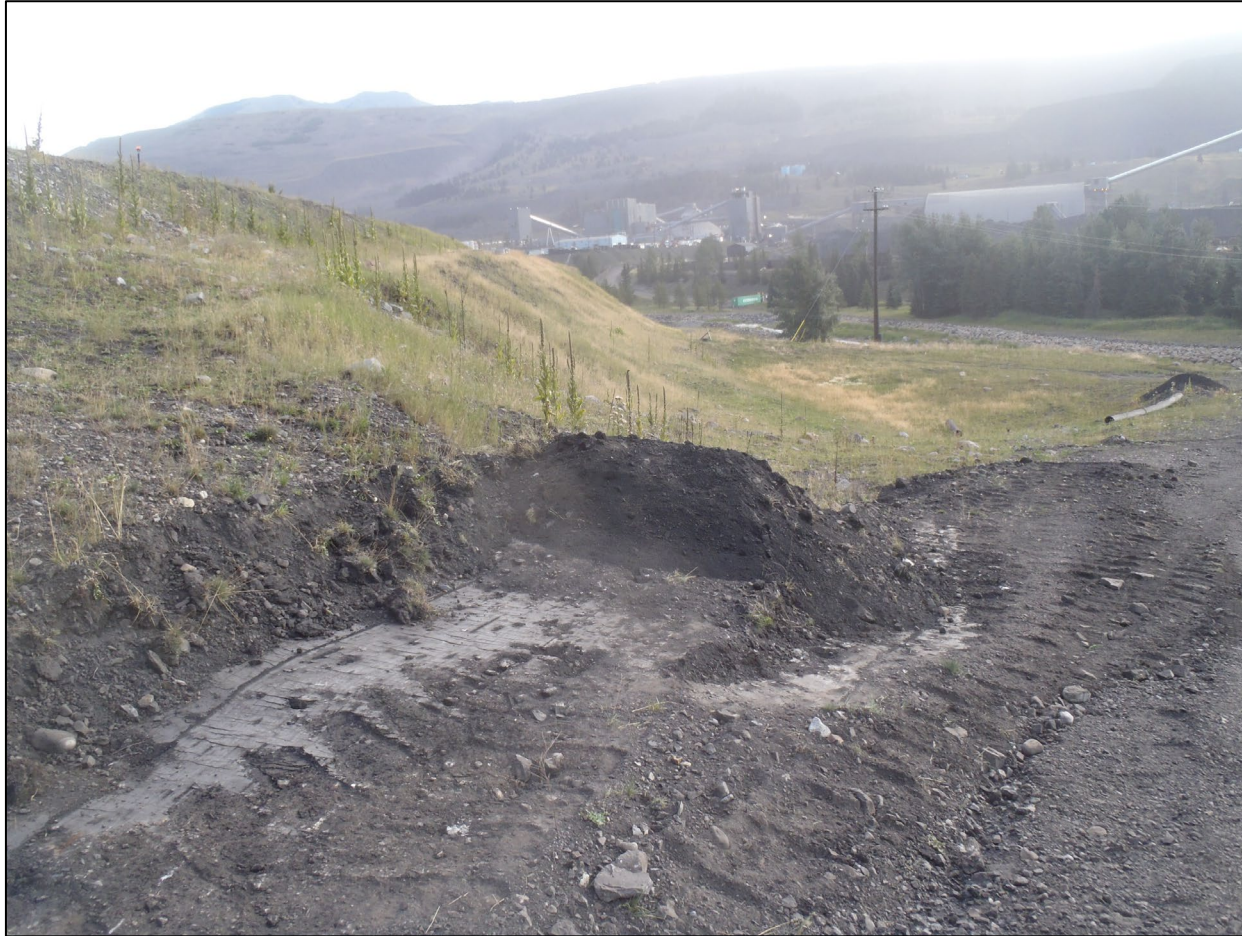
A new area along the downstream toe of the NTP dam near the south abutment approximately 3 m wide and 0.5 m deep was found to have been disturbed by heavy equipment and should be repaired by FRO maintenance. The area of the downstream toe of the NTP dam that was excavated for a monitoring well installation program in 2019 had not been repaired. These excavated areas are to be backfilled and graded.

NTP Dam downstream slope and toe, damage from heavy equipment, looking northeast from approximately Sta. 1+375.

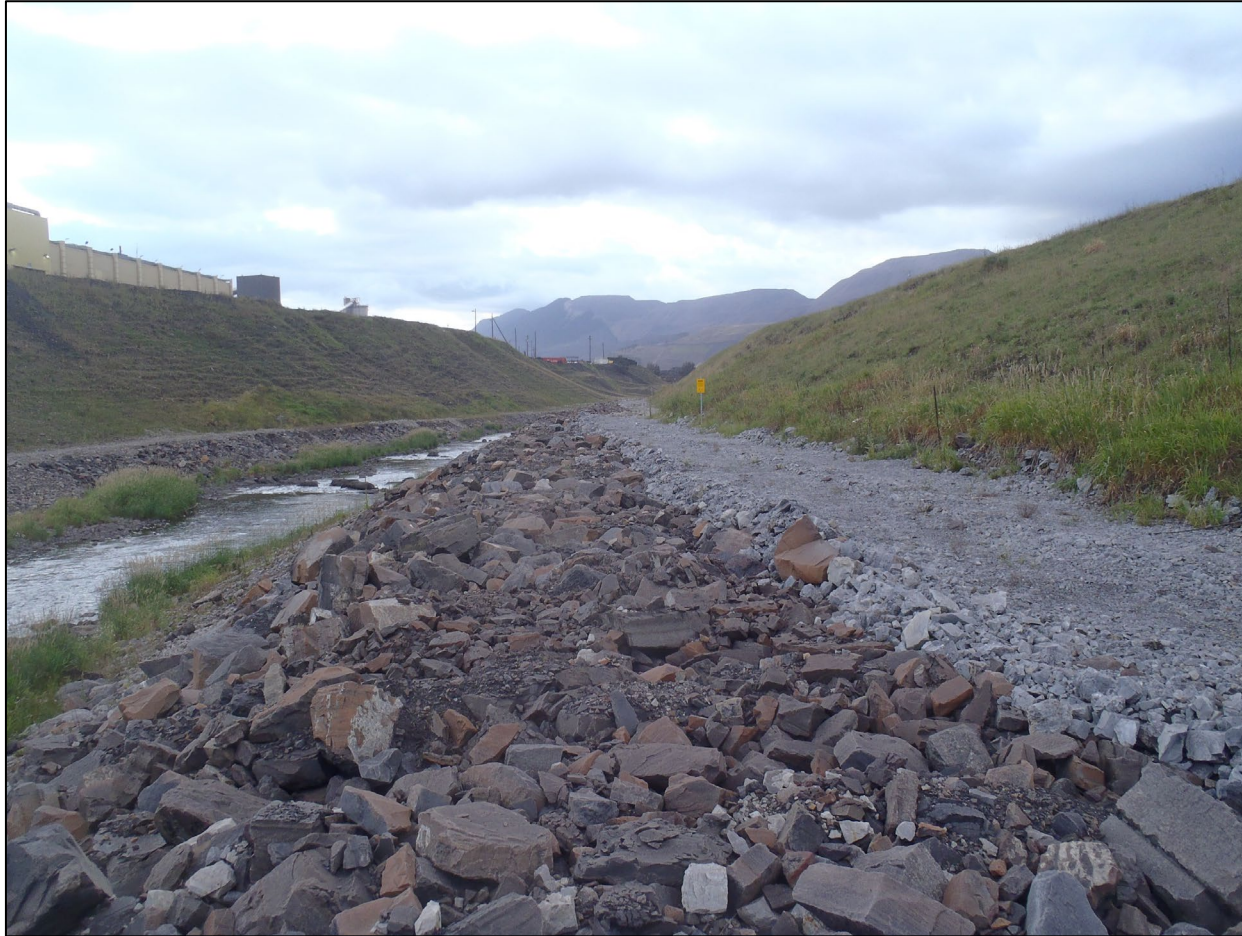
NTP Dam downstream slope and riprap along Fording River, looking southwest from approximately Sta. 0+475.

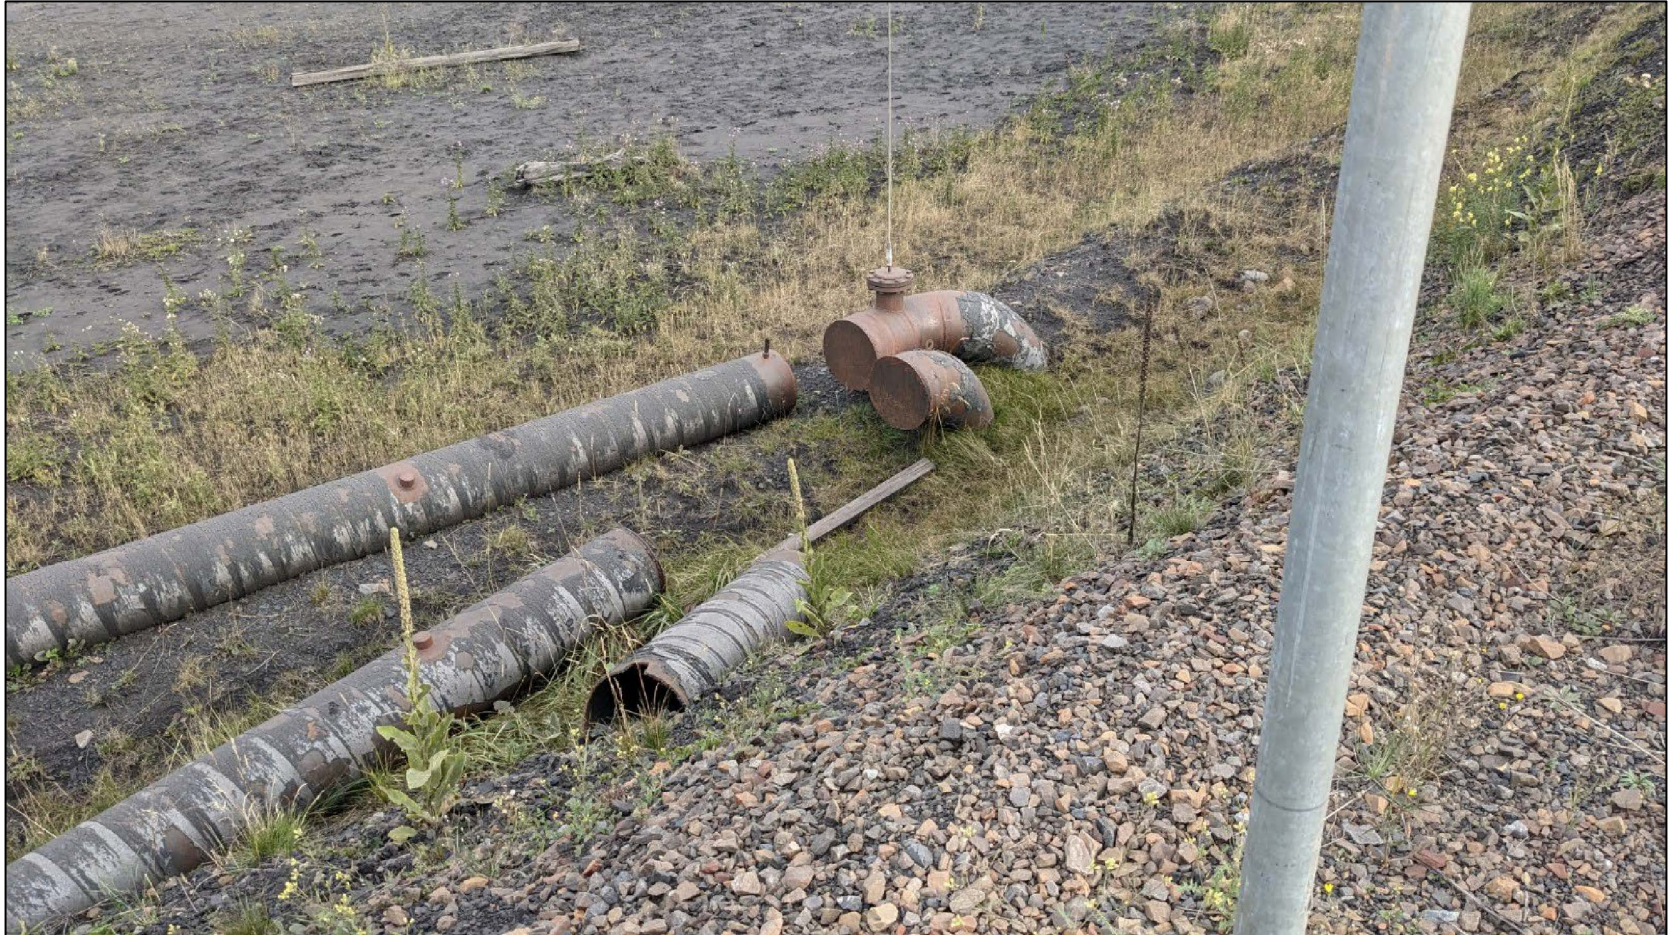
NTP capped and unused dual reclaim pipes on upstream slope and crossing under crest, looking northwest from approximately Sta. 0+850.

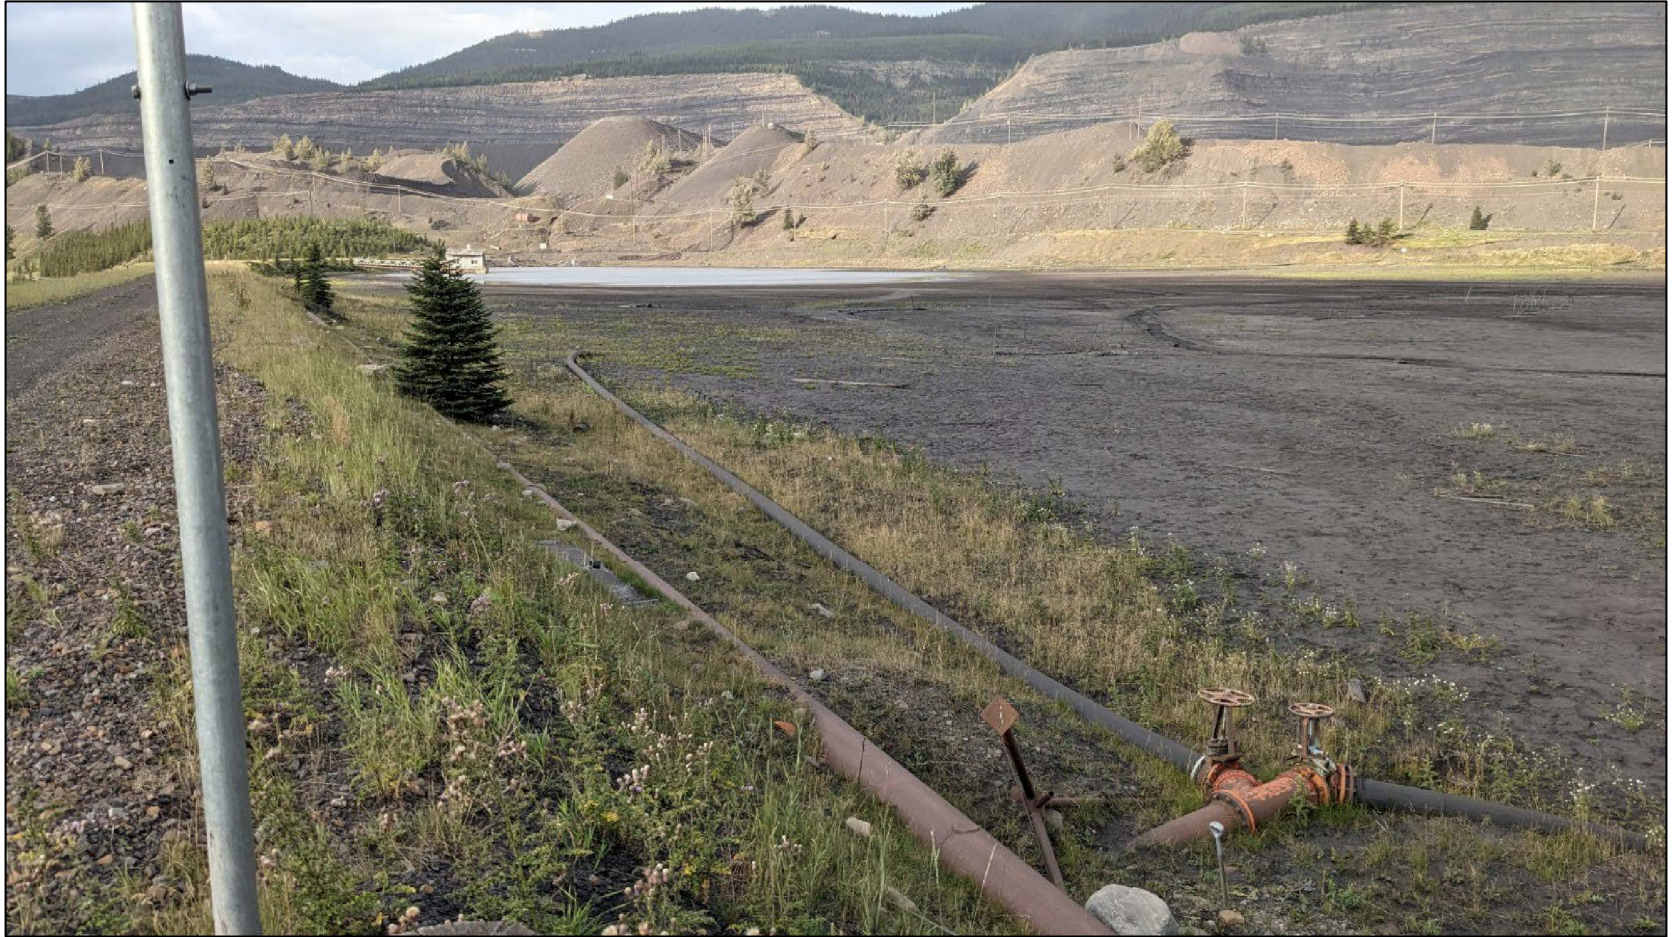
NTP Dam crest, upstream slope, and tailings surface, steel pipe runs under dam crest valves observed to be closed, looking southwest from approximately Sta. 0+950.

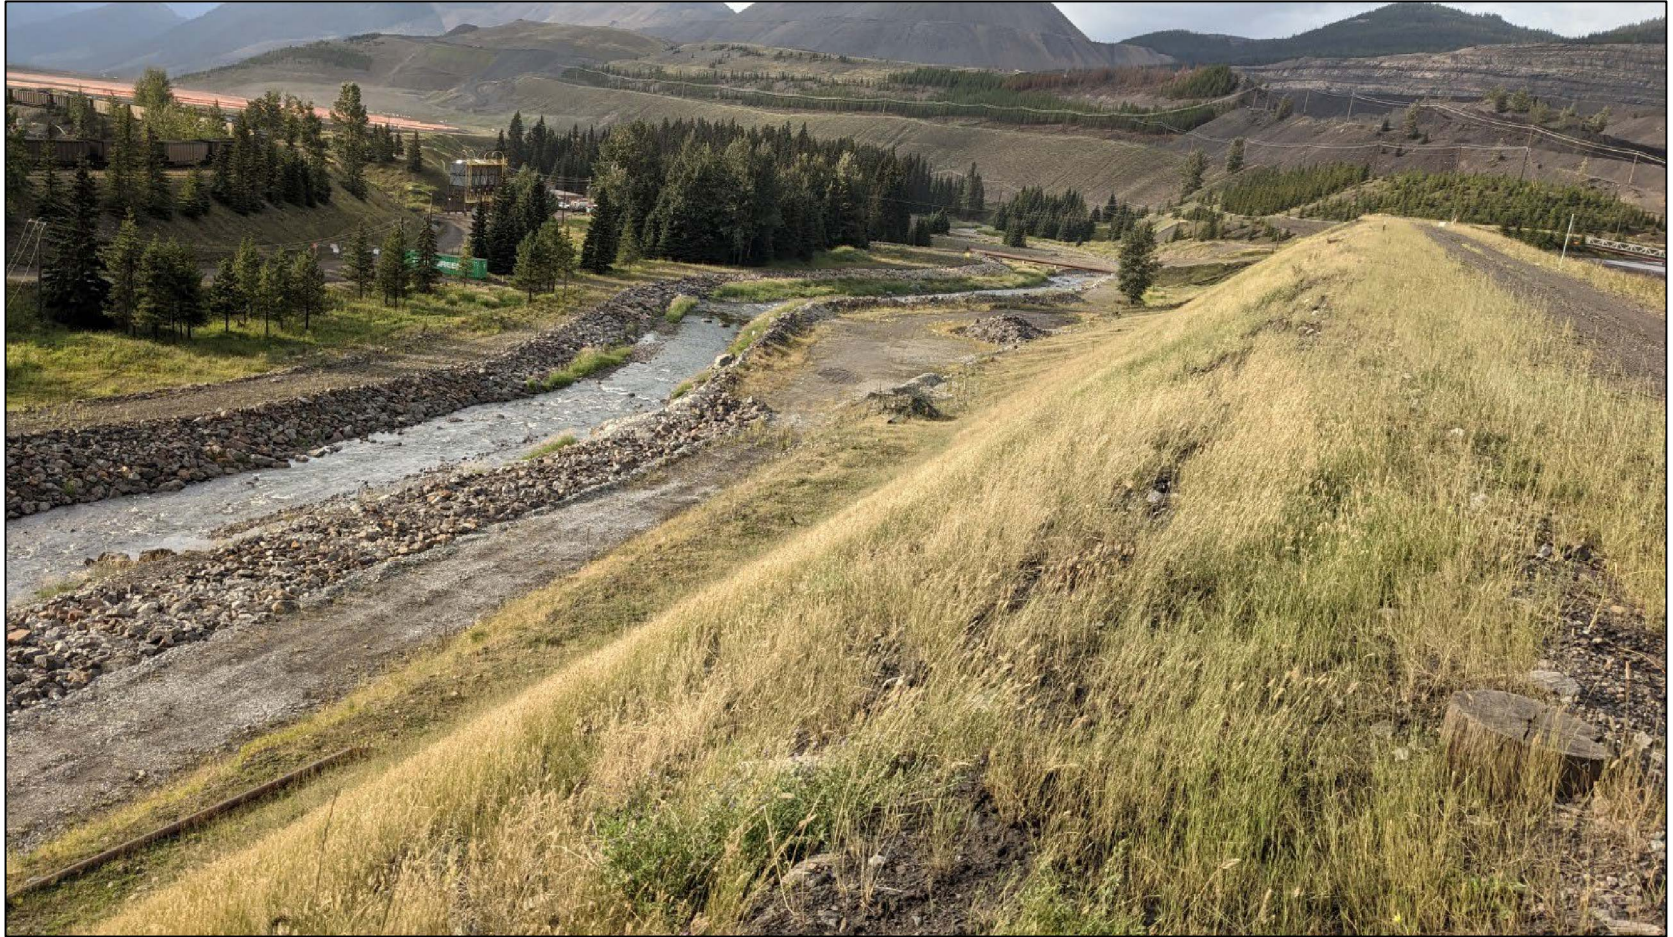
NTP Dam crest, downstream slope, and riprap along Fording River, looking southwest from approximately Sta. 1+050.

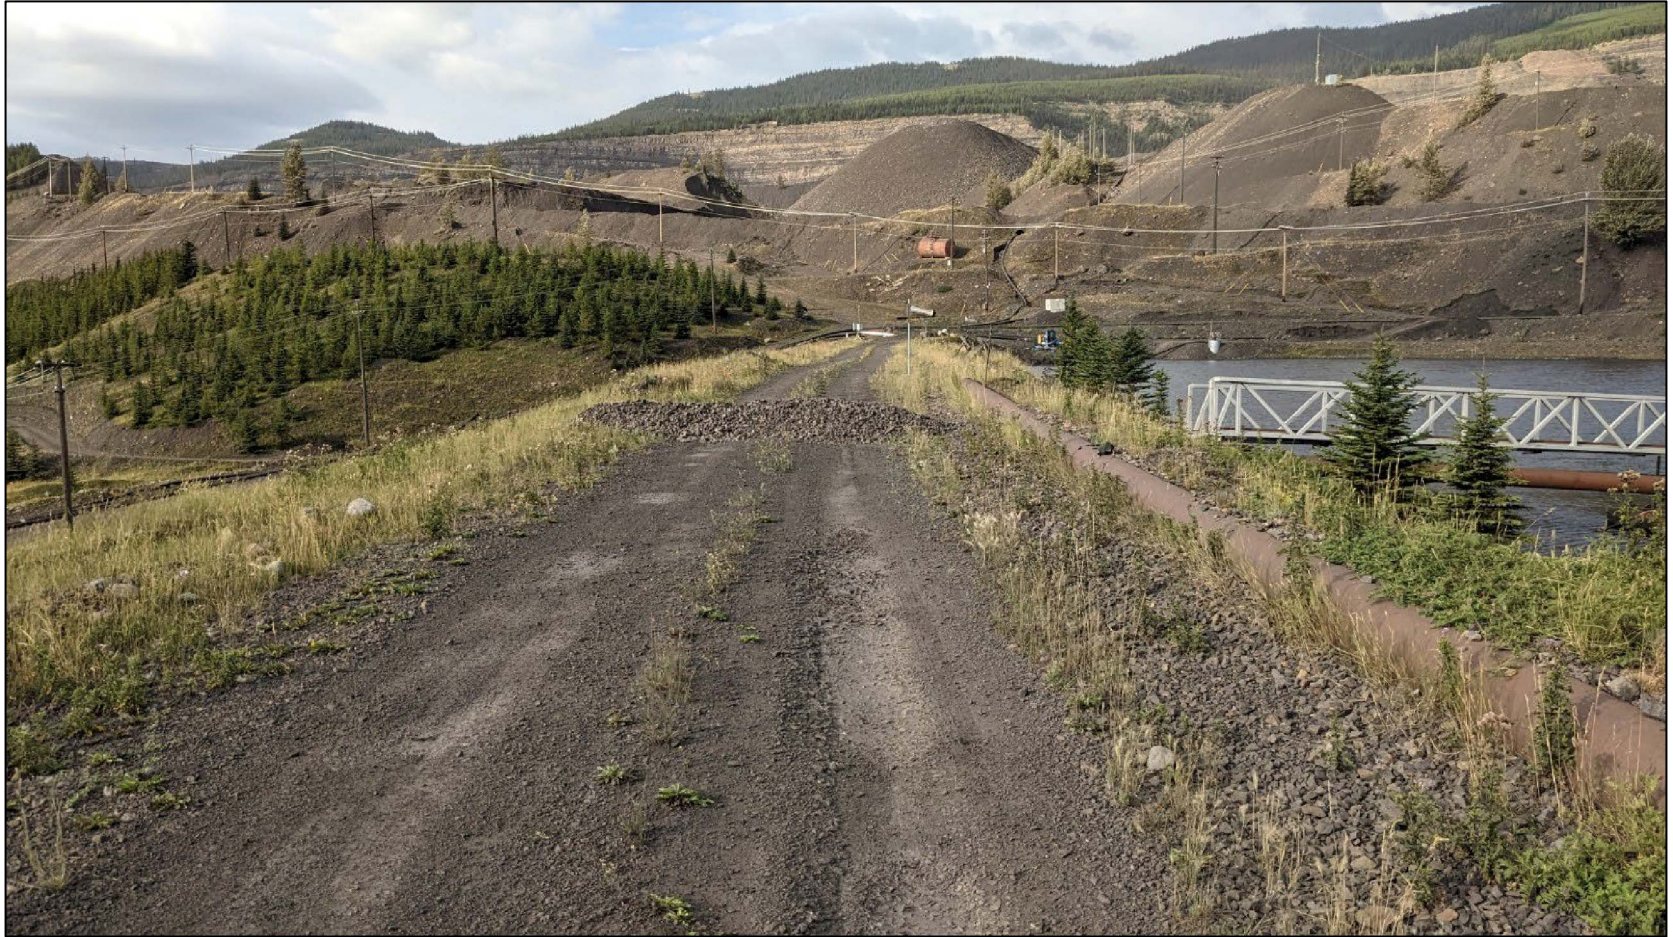
NTP Dam crest with temporary berm placed on crest, looking southwest from approximately Sta. 1+225.

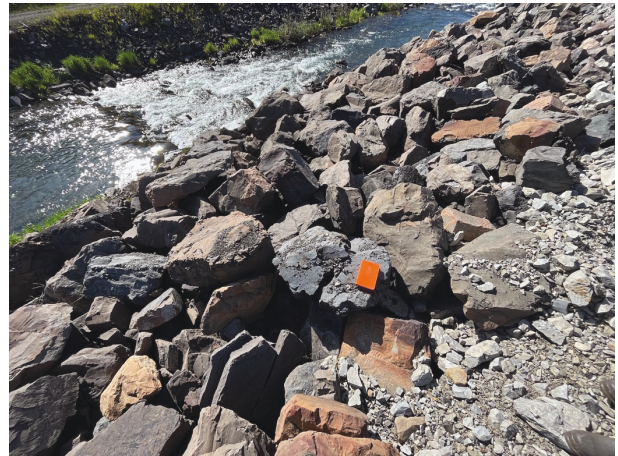
Photo 4: Riprap degradation due to weathering on several pieces of riprap (approx. Sta. 0+550)

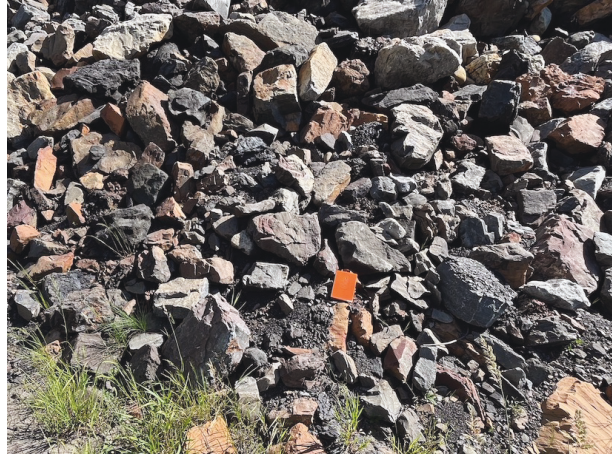
Photo 10: Riprap degradation due to weathering on several pieces of riprap (approx. Sta. 0+275)

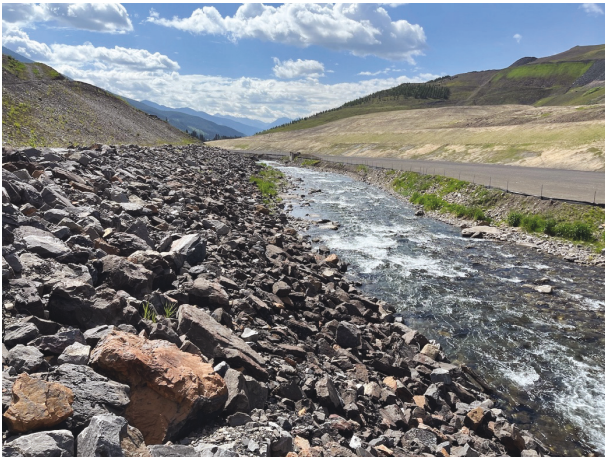
Photo 11: Looking downstream at STP riprap (from approx. Sta. 0+600). The right bank has been excavated/widened and the pipe bridge removed

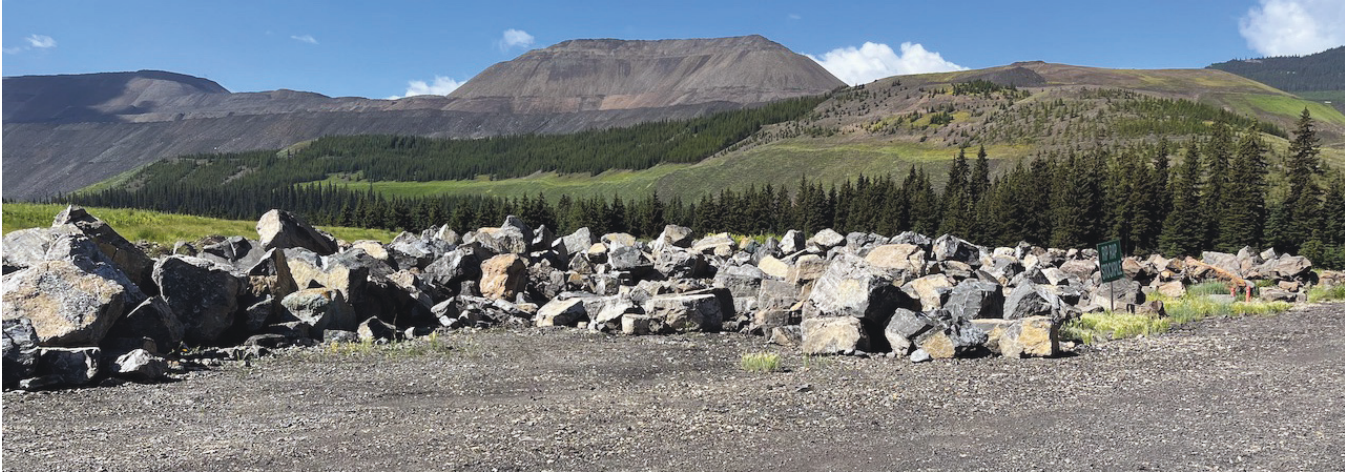
Photo 13: Emergency riprap stockpile south of STP
