Teck Metals Ltd.

Pinchi Mine Lake Tailings Storage Facility

2022 Annual Facility Performance Review

October 2022

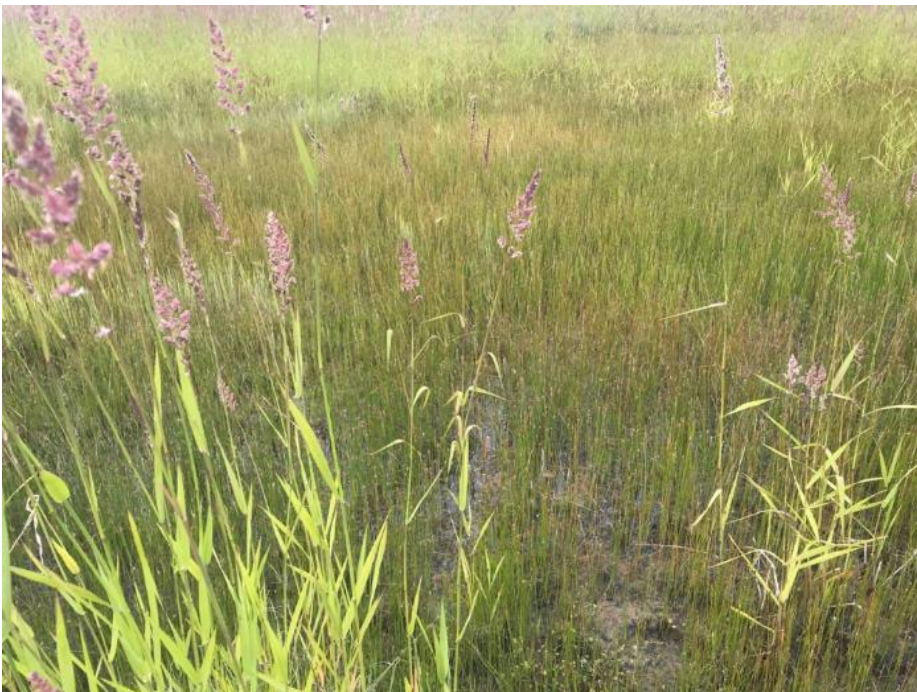
Photo II-2 Tailings Impoundment – Shallow local ponding on soil cover

- The Tailings Impoundment was observed from the embankment crest, and by walking a path across the soil cover between the east side and the south side of the TSF.
- There was minimal standing water in the Tailings Impoundment at the time of inspection. No water was observed at the entrance to the Closure Spillway (see Photo II-19 in Appendix II). Small, local ponds about 5 cm deep were encountered on the cover (see Photo II-2). There is a drainage channel on the cover that directs flow from east to west towards the Closure Spillway, and there was standing water in the channel in some locations, but no flow was observed (see Photo II-3).
- The soil cover on the tailings is covered in grass (Photos II-1 to II-3, II-8, and II-10). No signs of erosion, large ponds, or deformation of the cover were observed.

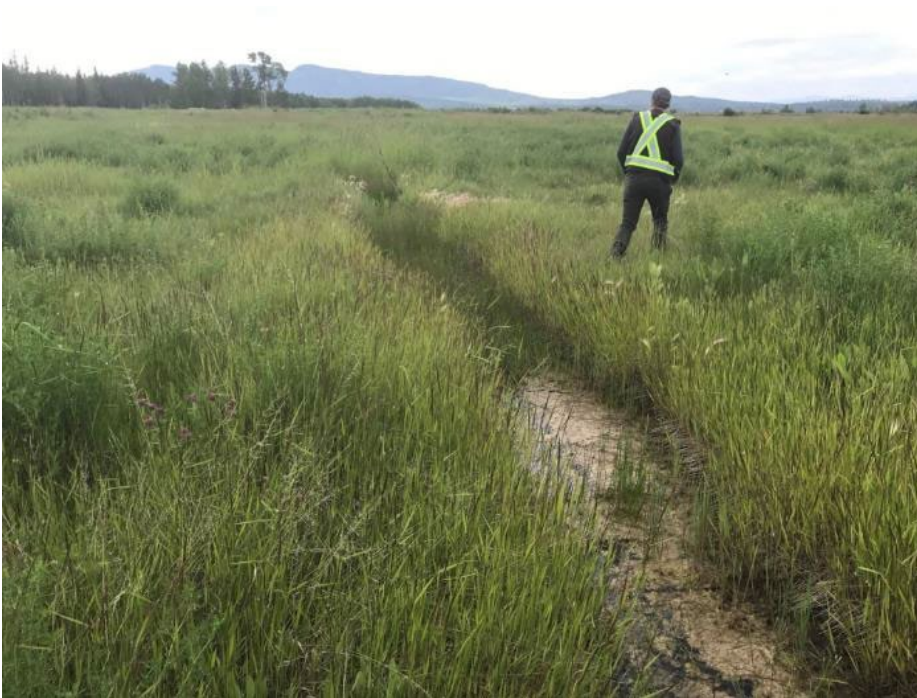
Photo II-3 Tailings Impoundment – Looking south along drainage channel in cover, ~70 m west of TSF Embankment East Leg. Note standing water

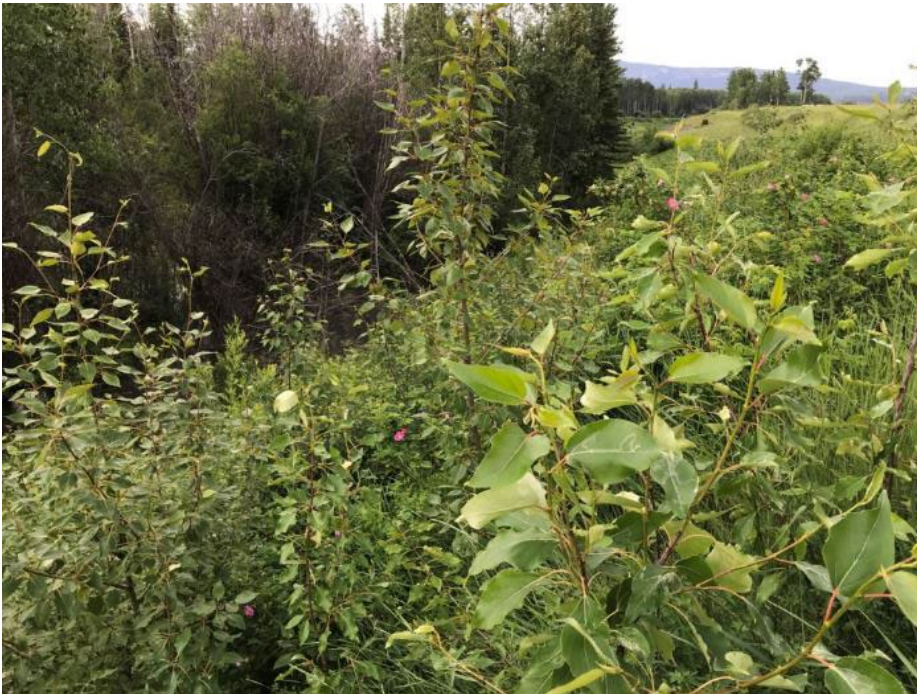
Photo II-4 TSF Embankment – East leg, looking south. Note vegetation

- The embankment slopes were covered with grasses and small shrubs. The most significant vegetation was observed on the downstream slope of the east leg, near the northeast corner of the TSF, where many bushes are higher than 2 m (see Photo II-4). The southwest and east legs have a few plants higher than 1.5 m but most of the vegetation is much shorter than that (see Photos II-13 to II-17). This does not present an immediate concern for embankment safety but note that the vegetation management plan recommends clearing vegetation higher than 1.5 m from the embankment slopes (Spectrum 2017).

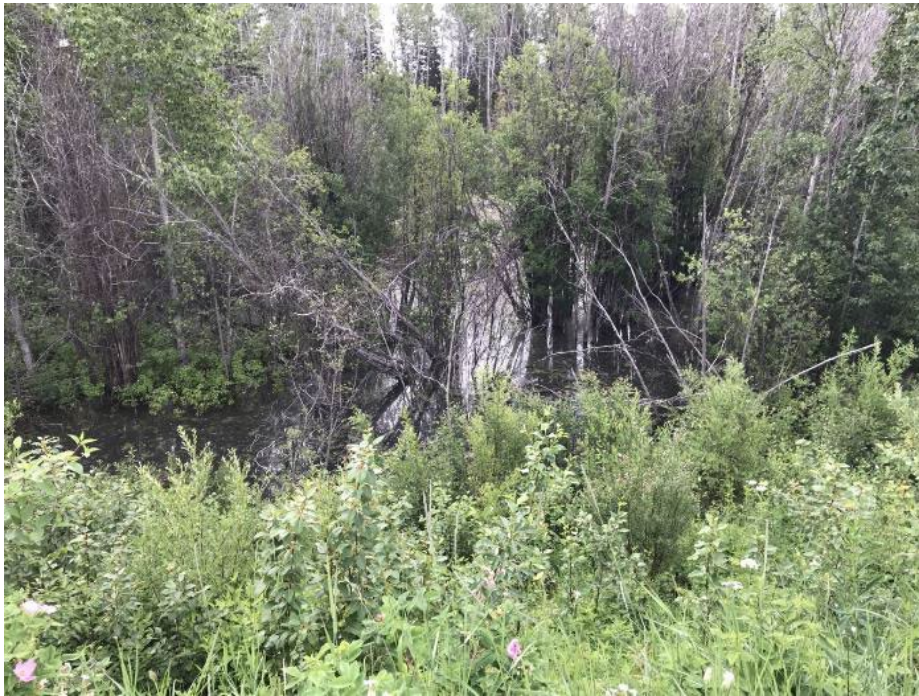
Photo II-5 TSF Embankment – Pond near toe of east leg

- A pond was observed in the trees near the toe of the east leg of the TSF Embankment (see Figure 1.2 for location; Photo II-5) as in previous inspections. This pond is located near a drainage channel that was shown on historical drawings of the TSF (see Appendix IV) and labelled “runoff channel.” The channel ran parallel to the main Ed Creek channel, and apparently once joined up with Ed Creek just inside the TSF. The pond appears to collect local runoff, and it drains through a channel to the south and through a culvert into Ed Creek Diversion Channel. The pond level was slightly higher than was observed during inspections prior to 2021 due to the beaver dam noted below.

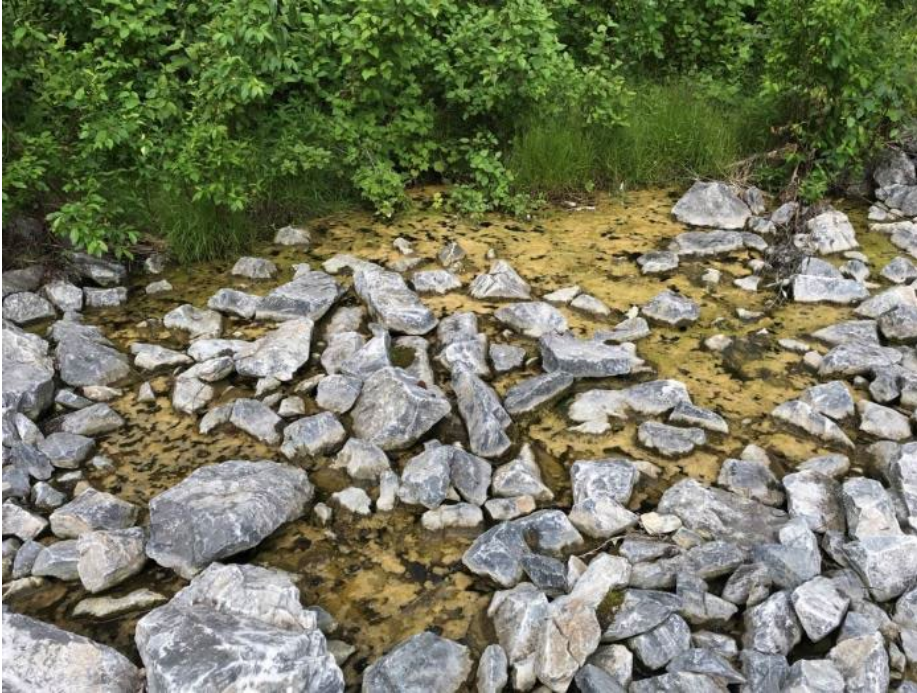
Photo II-23 Closure spillway – Pond at downstream end of riprap

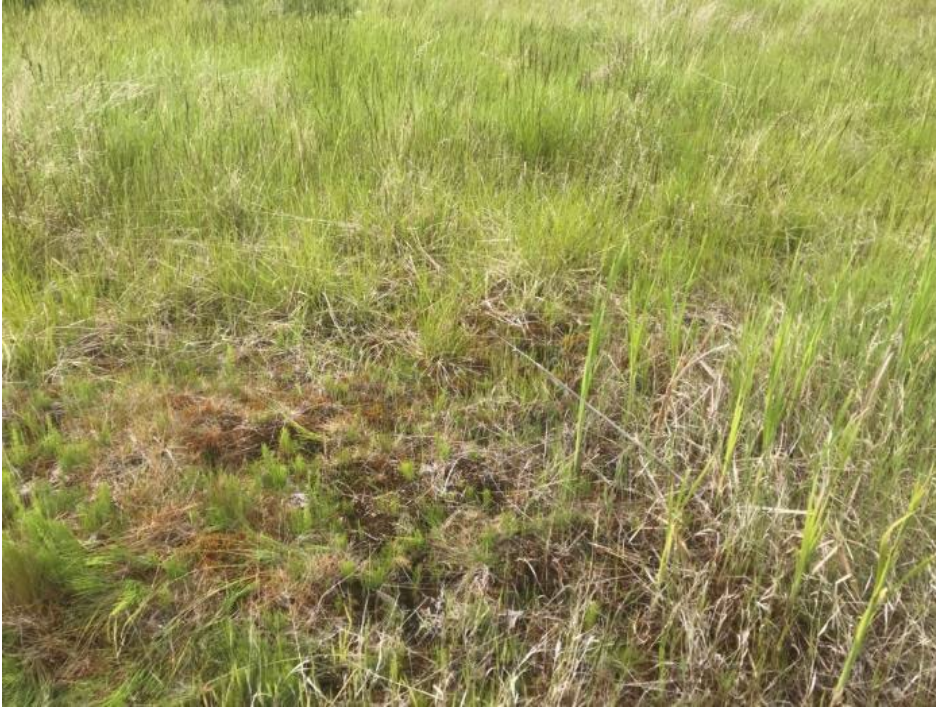
Photo II-29 Borrow Area A – Wet ground in northeast corner

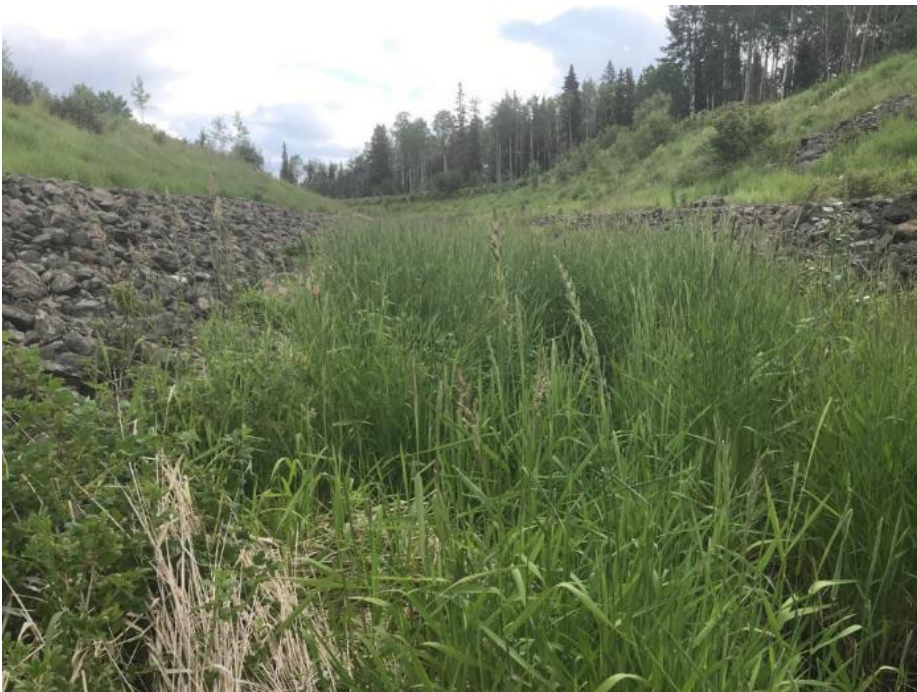
Photo II-34 Ed Creek Diversion Channel – Vegetation in channel, looking upstream from between second and third bends

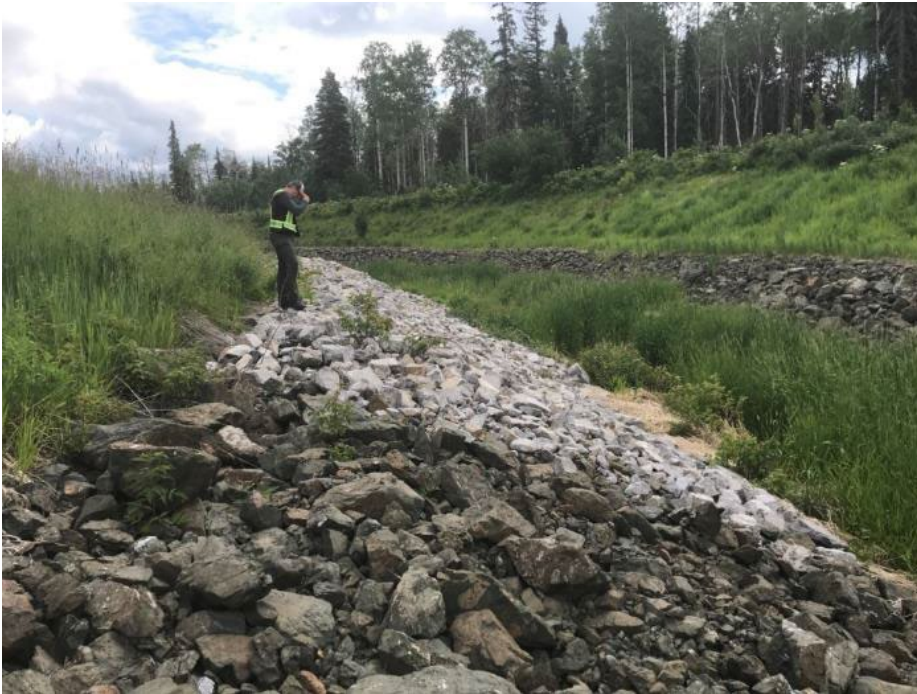
Photo II-35 Ed Creek Diversion Channel – looking upstream from near second bend. Light coloured area of riprap was replaced in 2014 and is in good condition

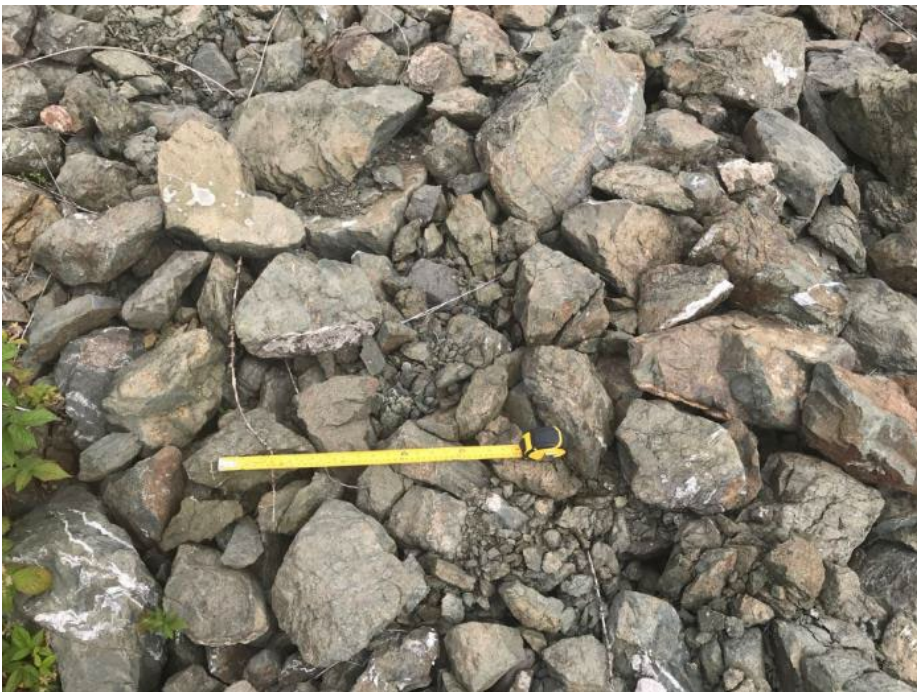
Photo II-36 Ed Creek Diversion Channel – Riprap on right bank, showing weathering and breakage

- The potential for toe erosion to affect embankment stability has been considered, and there are controls in place to address this. Ed Creek Diversion Channel was designed to convey the 1000-year flood event without erosion damage, but gradual weathering and breakage of the riprap has reduced its capacity. A 100 m section of the channel is approximately 10 m from the TSF Embankment, and damage to the riprap during an extreme flood event could initiate gradual erosion of the channel towards the embankment. This is addressed through surveillance and maintenance, and erosion would not be allowed to progress to the point where it could undermine the toe of the embankment. Options for remediating the channel are also being investigated, including replacing the riprap and possibly realigning the channel away from the TSF.

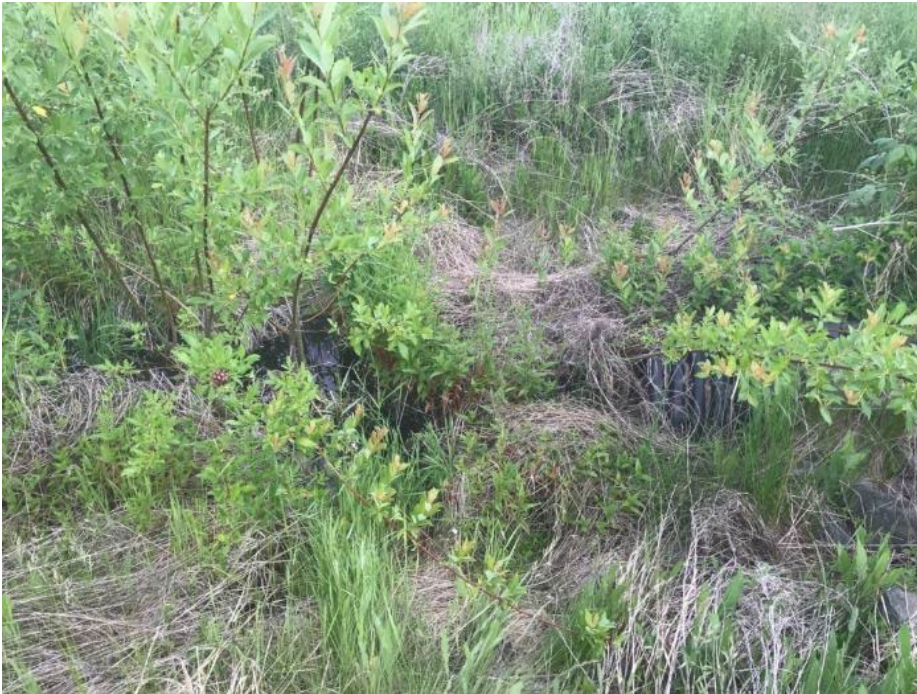
Photo II-41 Inlet of 460 mm culvert on north bank of Ed Creek Diversion Channel. Note vegetation near the inlet

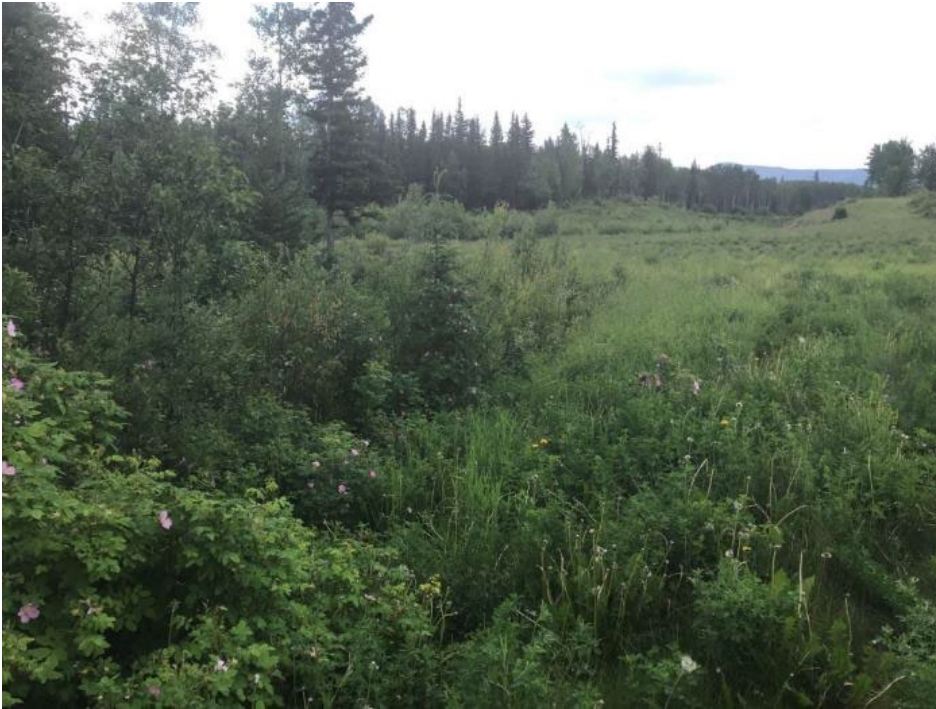
Photo II-43 Ditch north of Ed Creek Diversion Channel, looking south. Ditch is filled with vegetation

- A small beaver dam (0.8 m high) was observed in the channel south of the pond described above (see Location 5 in Figure 4.1, Photo II-44). Although this beaver dam is not currently an embankment safety issue, removal is recommended to discourage beaver activity in the area, and there is an open recommendation (2021-01) to remove it. The spring routine inspection (EcoFor 2022) notes the presence of a second smaller beaver dam about 20 m downstream in the same channel, but the vegetation in the channel at the time of the AFPR site visit was too dense to observe the second beaver dam. Based on the coordinates provided in the spring inspection, the second beaver dam should be located within the vegetation shown in Photo II-43.
