2022 Annual Facility Performance Review

Sä Dena Hes Mine, Yukon Territory
Teck Resources Limited

SRK Consulting (Canada) Inc. ■ CAPR001928 ■ November 2022

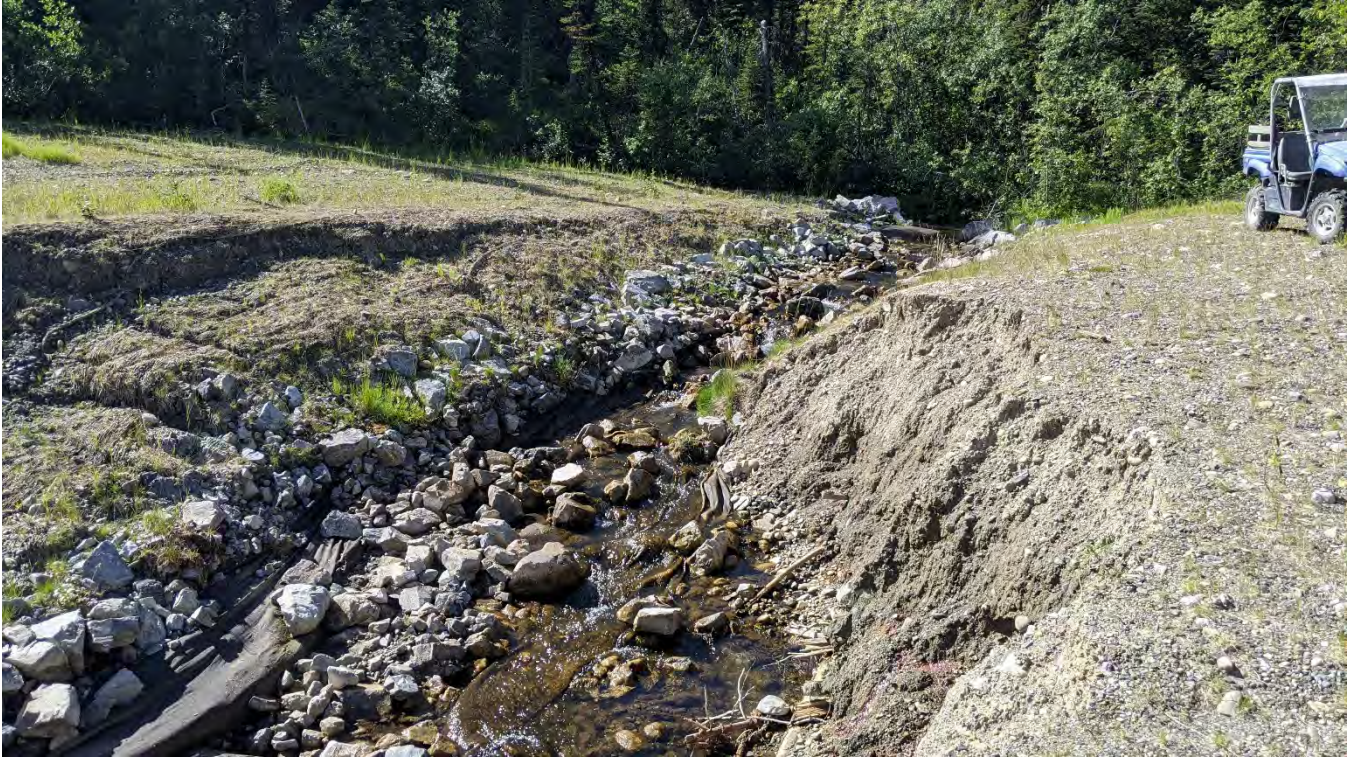
Photo NC-01: Channel Erosion at North Creek across the decommissioned access road to Burnick Zone.

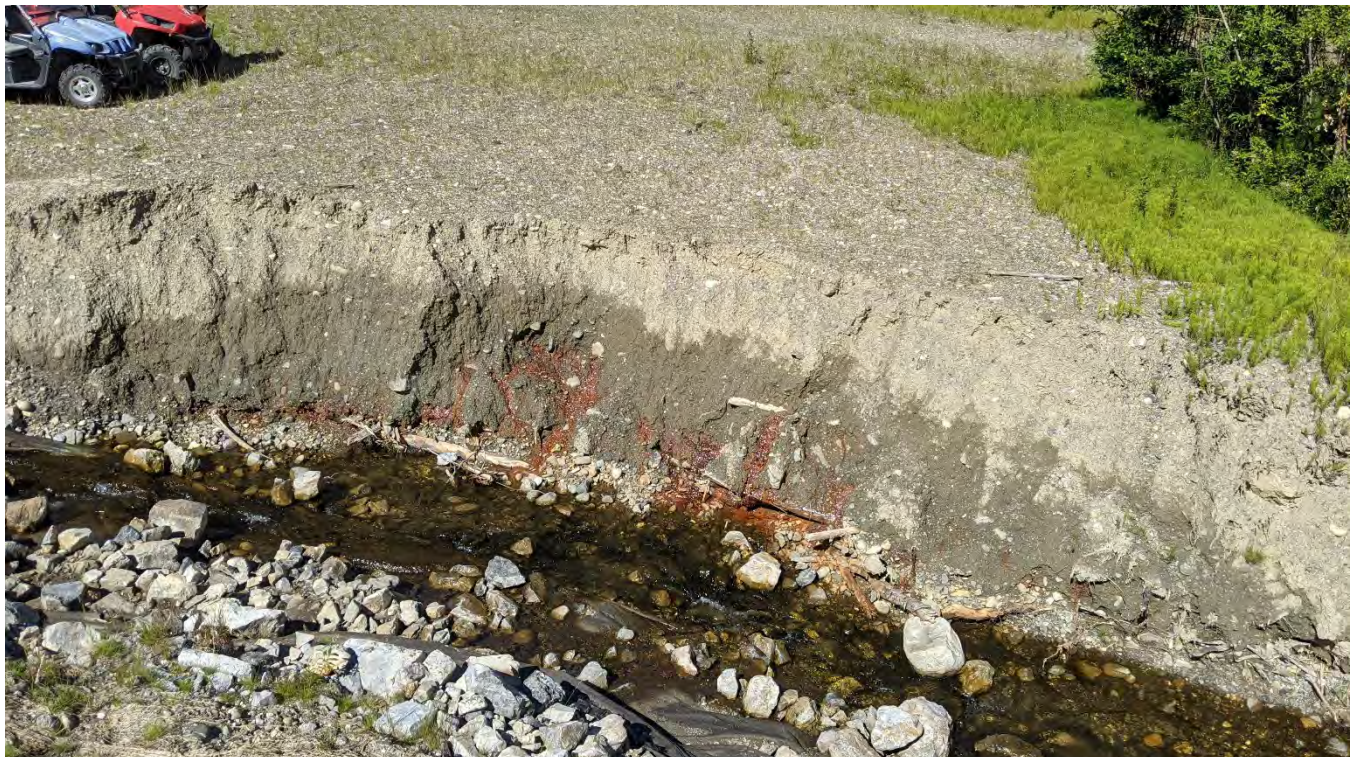
Photo NC-02: Channel Erosion at North Creek across the decommissioned access road to Burnick Zone. Seepage observed entering channel leaving a rusty-reddish coloured stain on the soils.

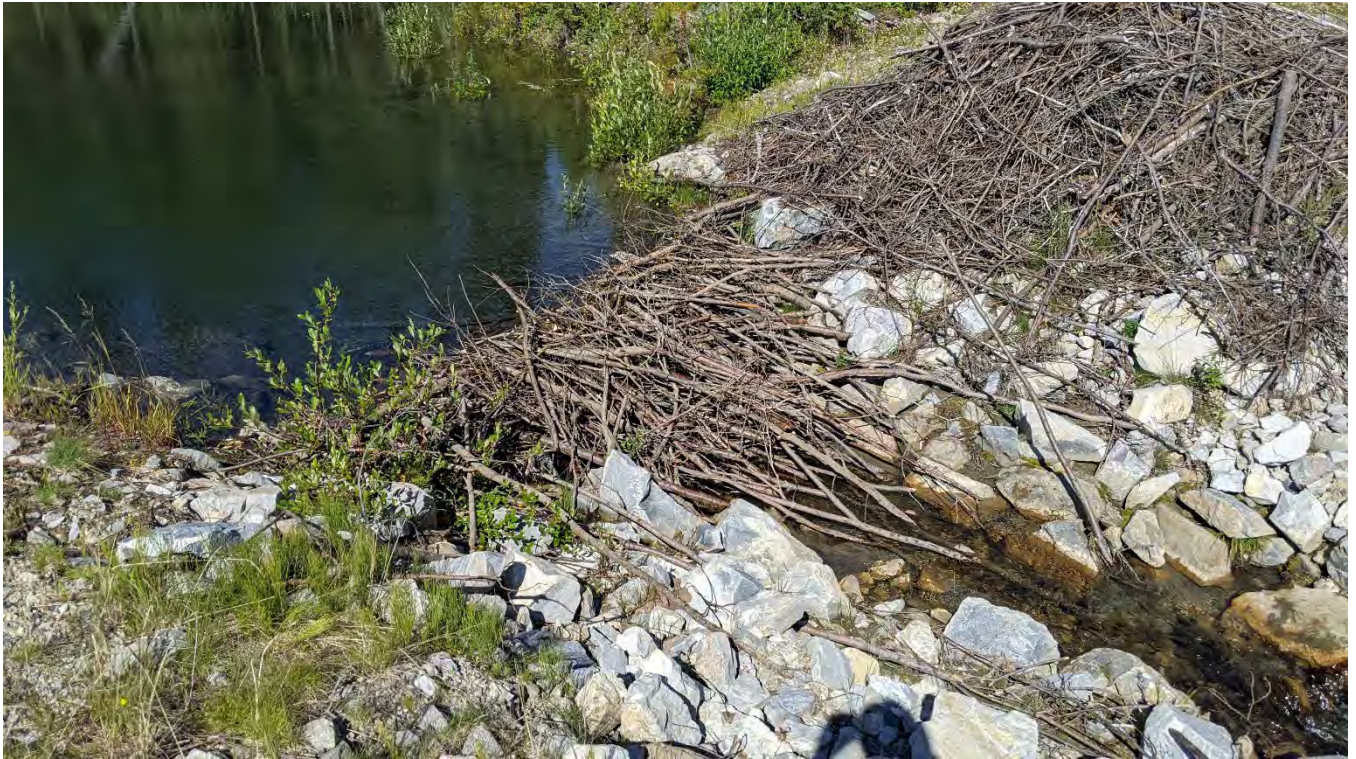
Photo NC-03: Beaver dam at the upstream end of the decommissioned North Creek Dike structure.

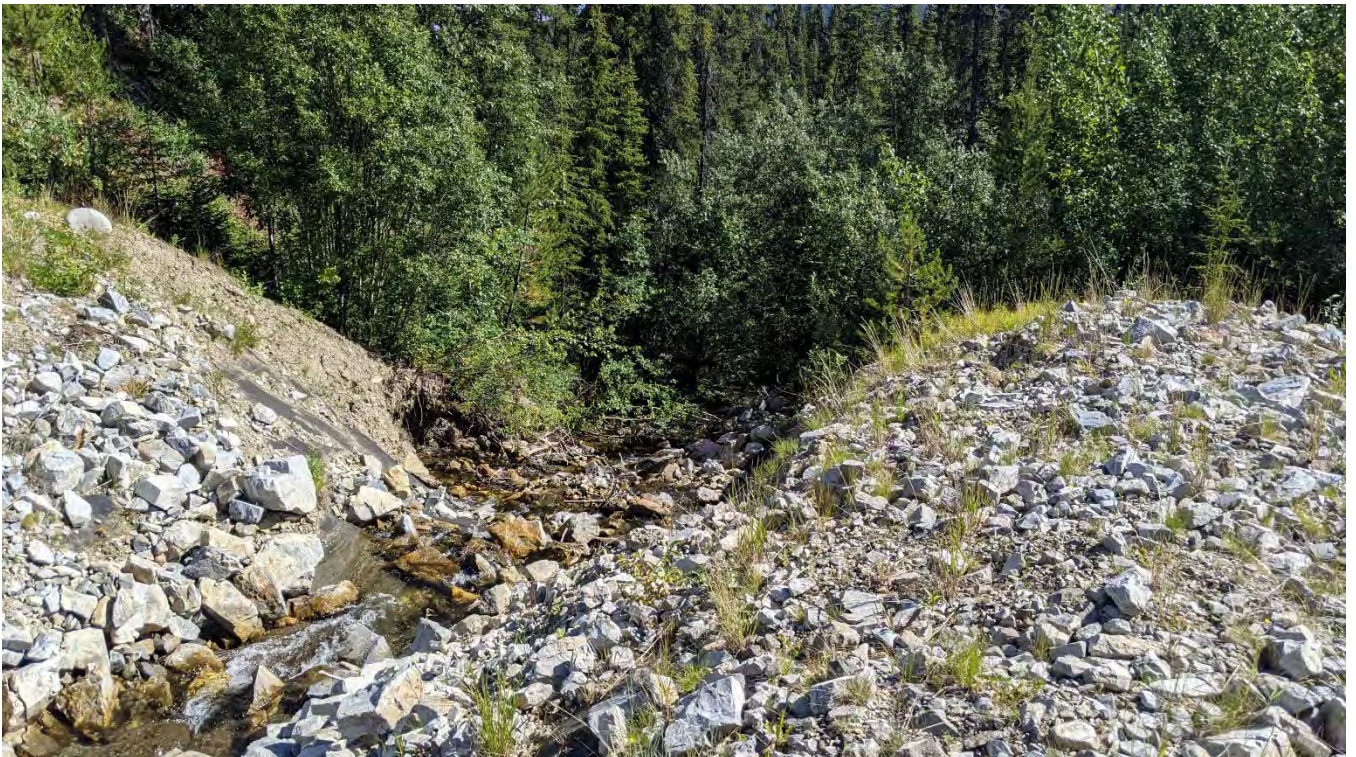
Photo NC-04: Channel erosion at the downstream end of the decommissioned North Creek Dike structure with exposed geotextile. The condition appears unchanged compared to 2021 inspection photos.

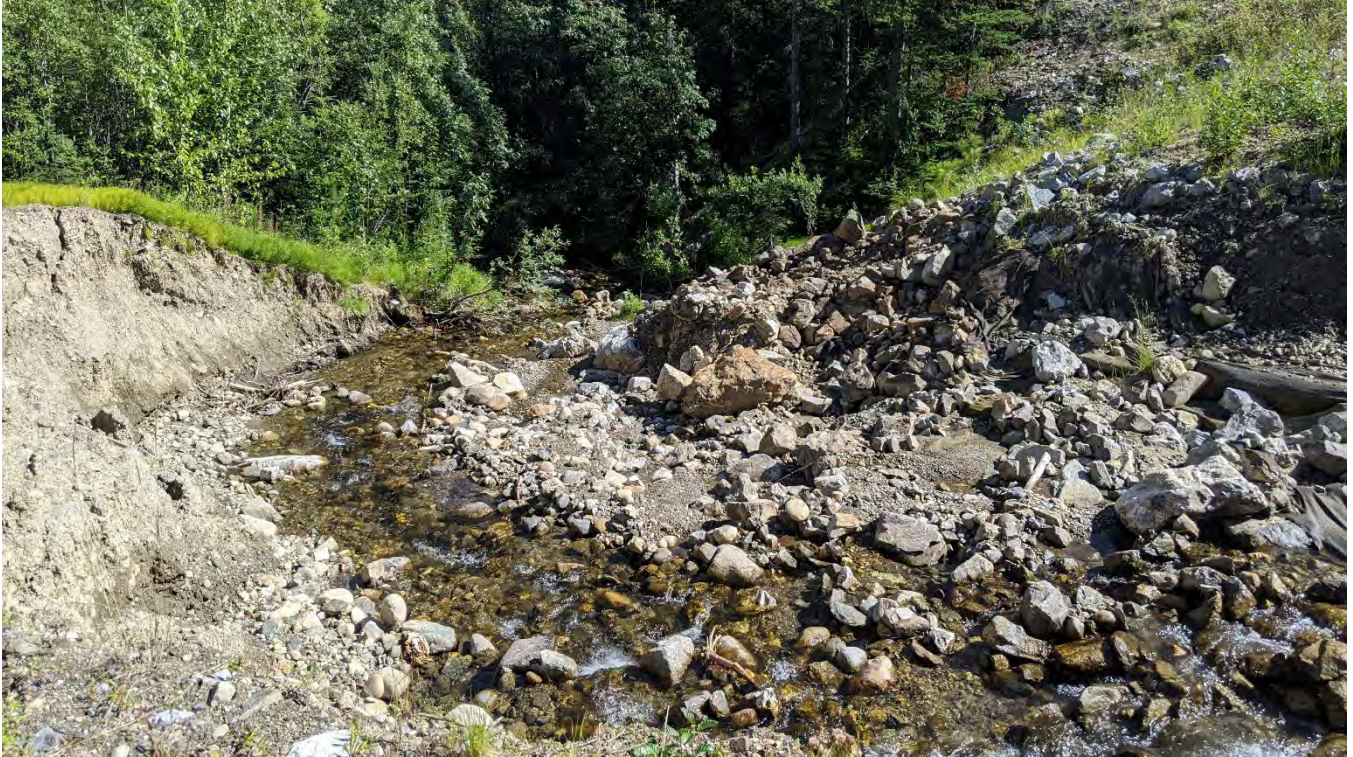
Photo NC-05: On-going channel and bank erosion at the downstream end of the lower decommissioned access road crossing of North Creek to the landfill area.

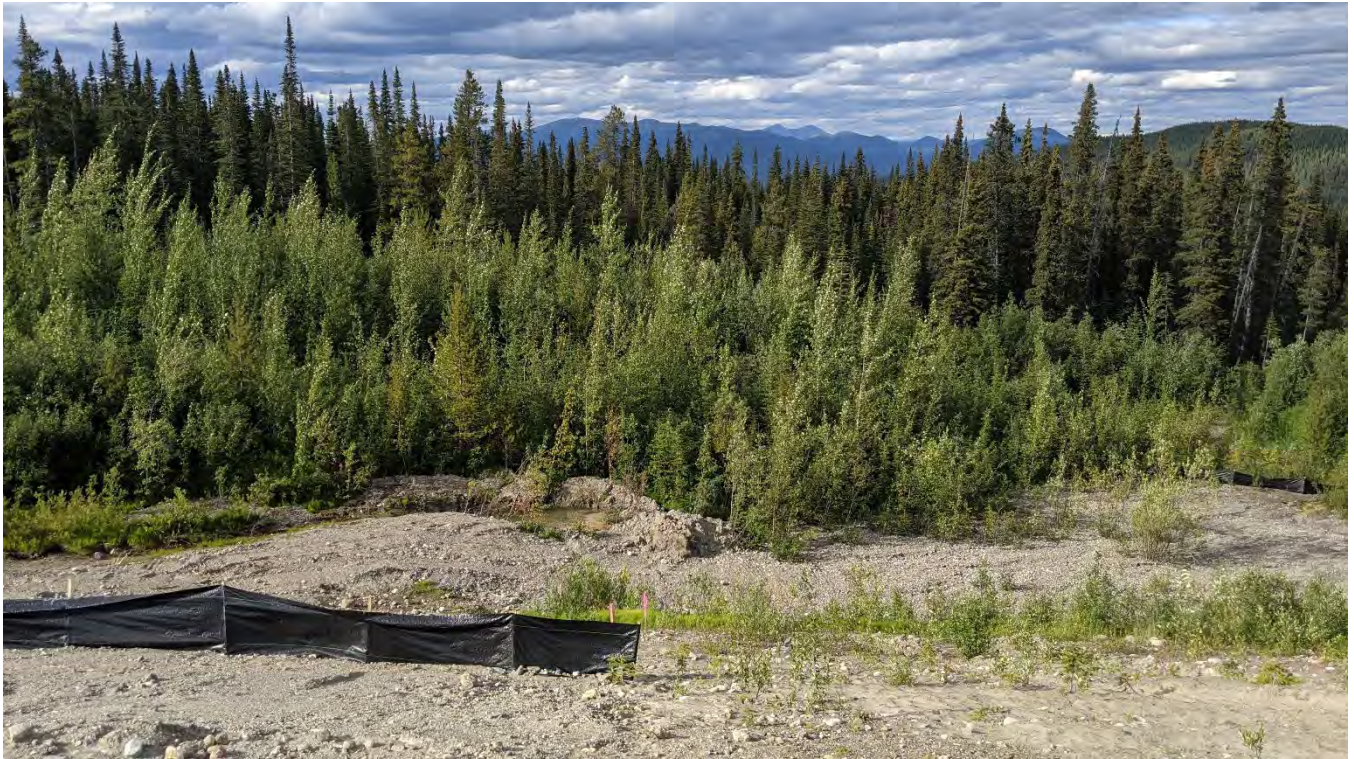
Photo ND-03: Erosion debris downstream of the dam. The silt fence is placed across the erosion gully repair area approximately midway down the slope. Historical wind-blown tailings visible to the right of the silt fence, further upslope.

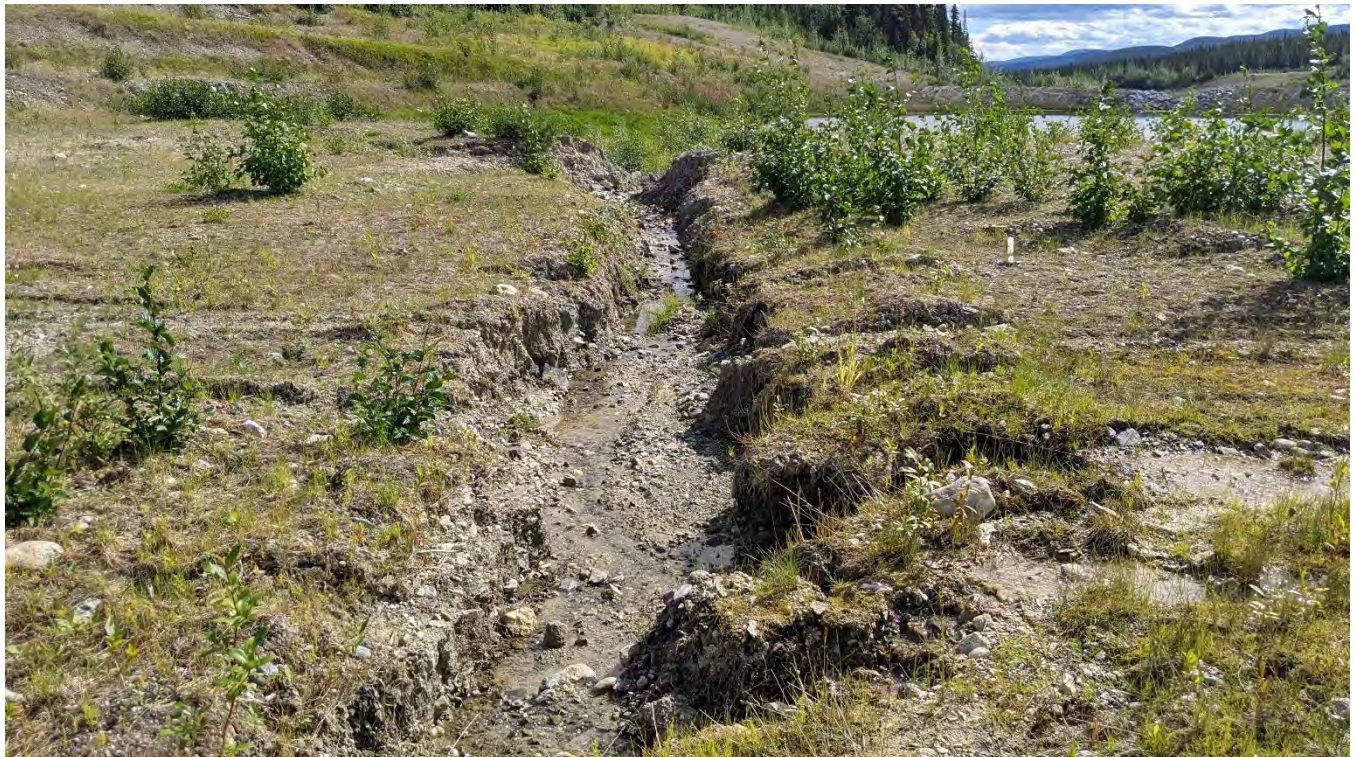
Photo TC-06: Erosion gully in tailings cover immediately to the south of the SRS Pond. Areas of exposed geotextile observed. No visible tailings observed.

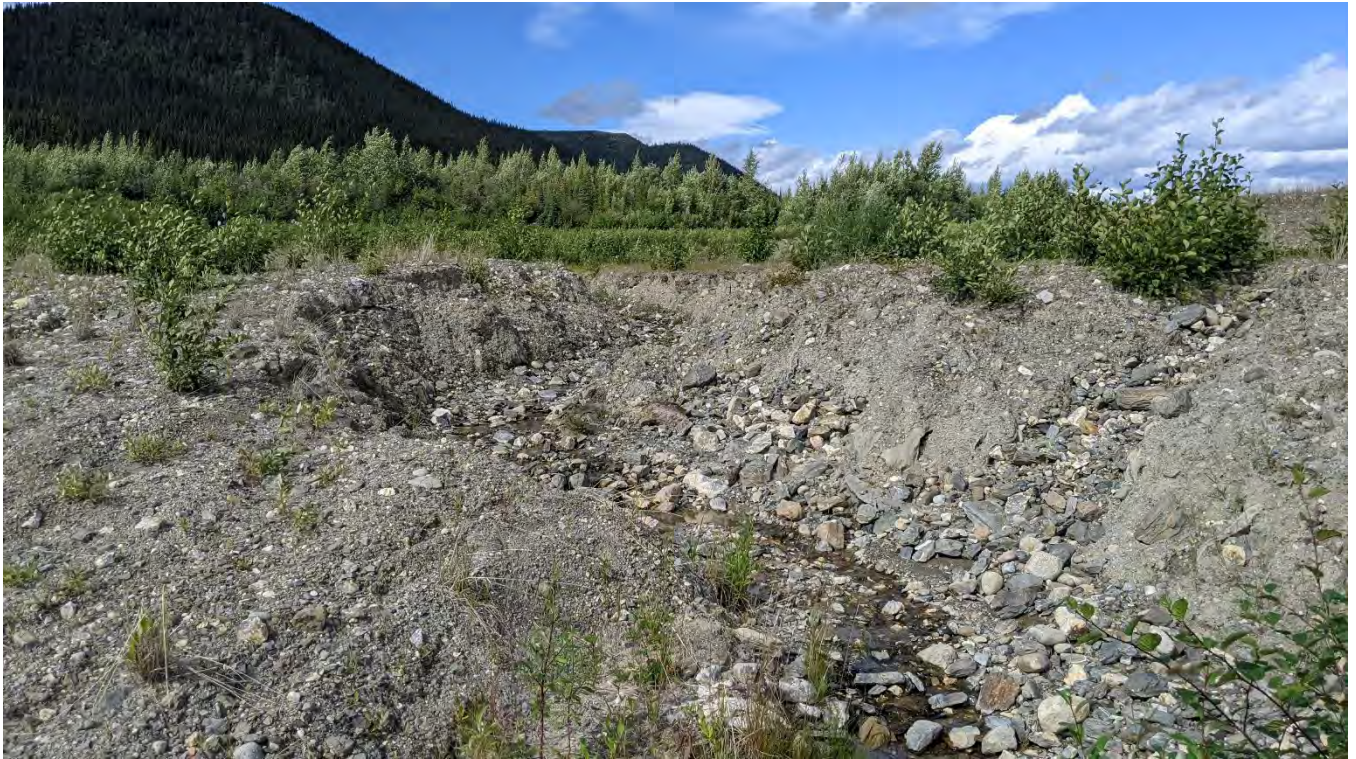
Photo TC-07: Upstream end of the erosion gully in the tailings cover south of the SRS Pond.

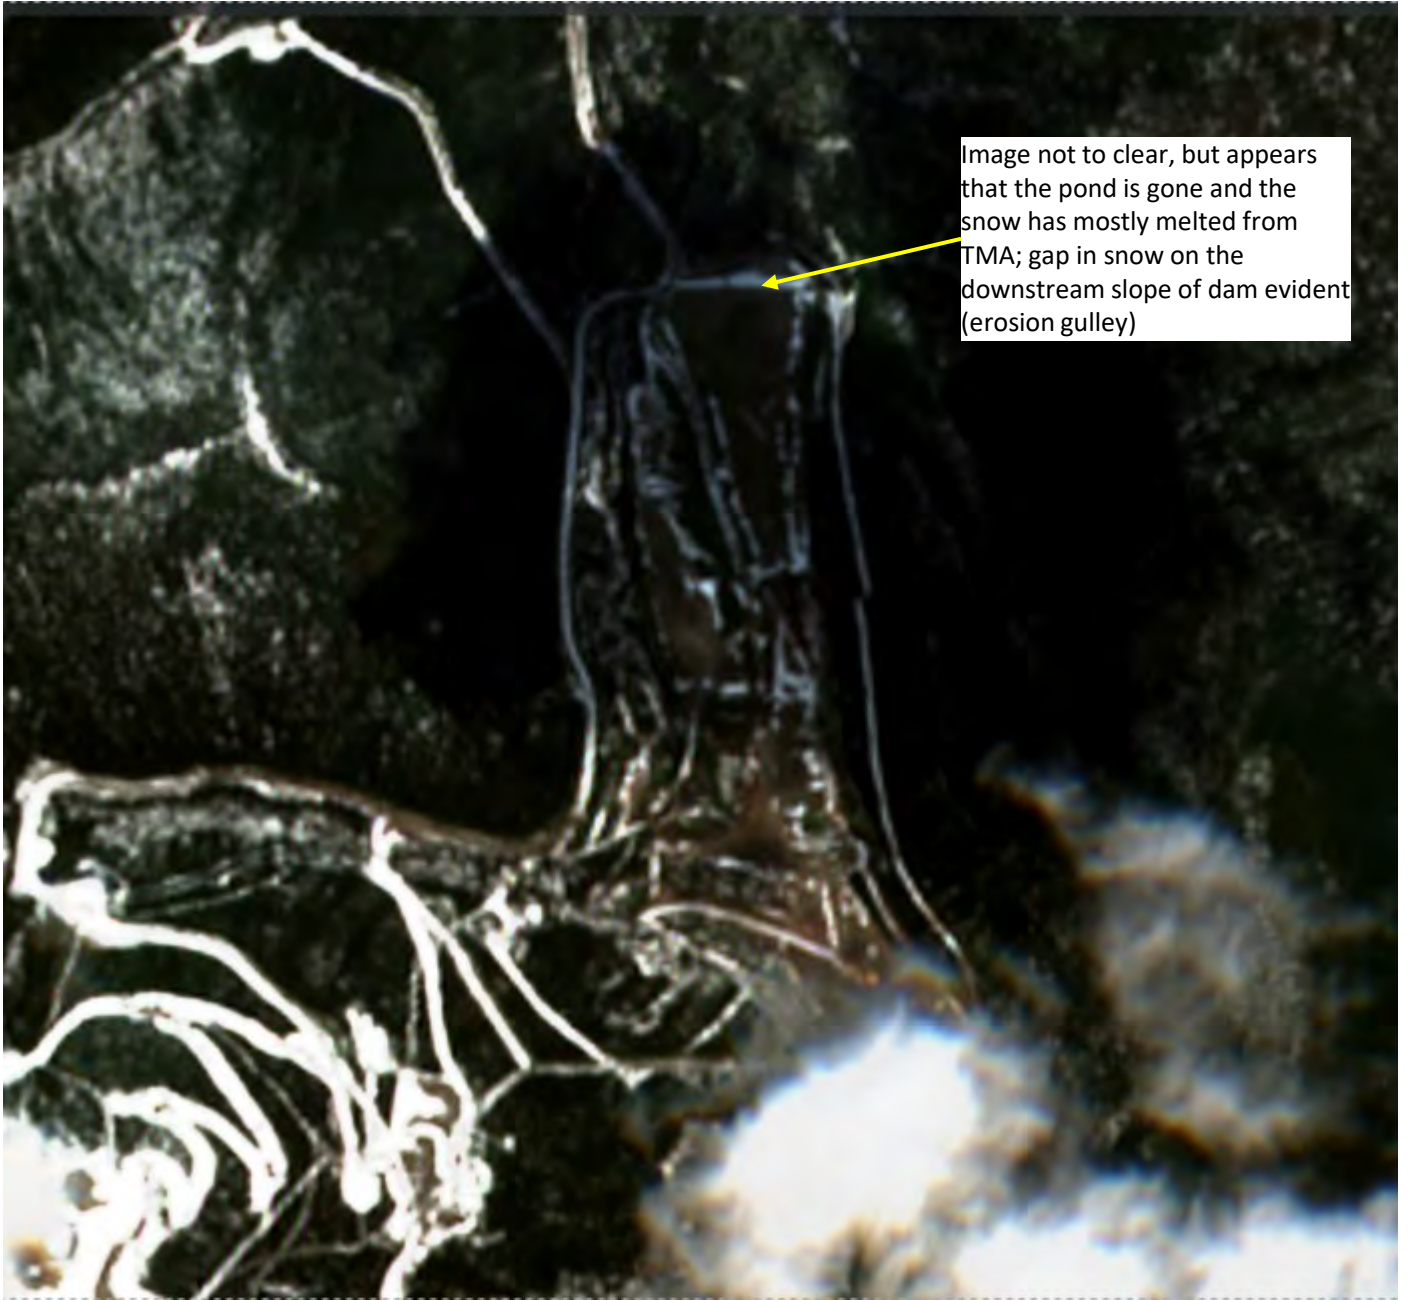
Image not to clear, but appears that the pond is gone and the snow has mostly melted from TMA; gap in snow on the downstream slope of dam evident (erosion gully)

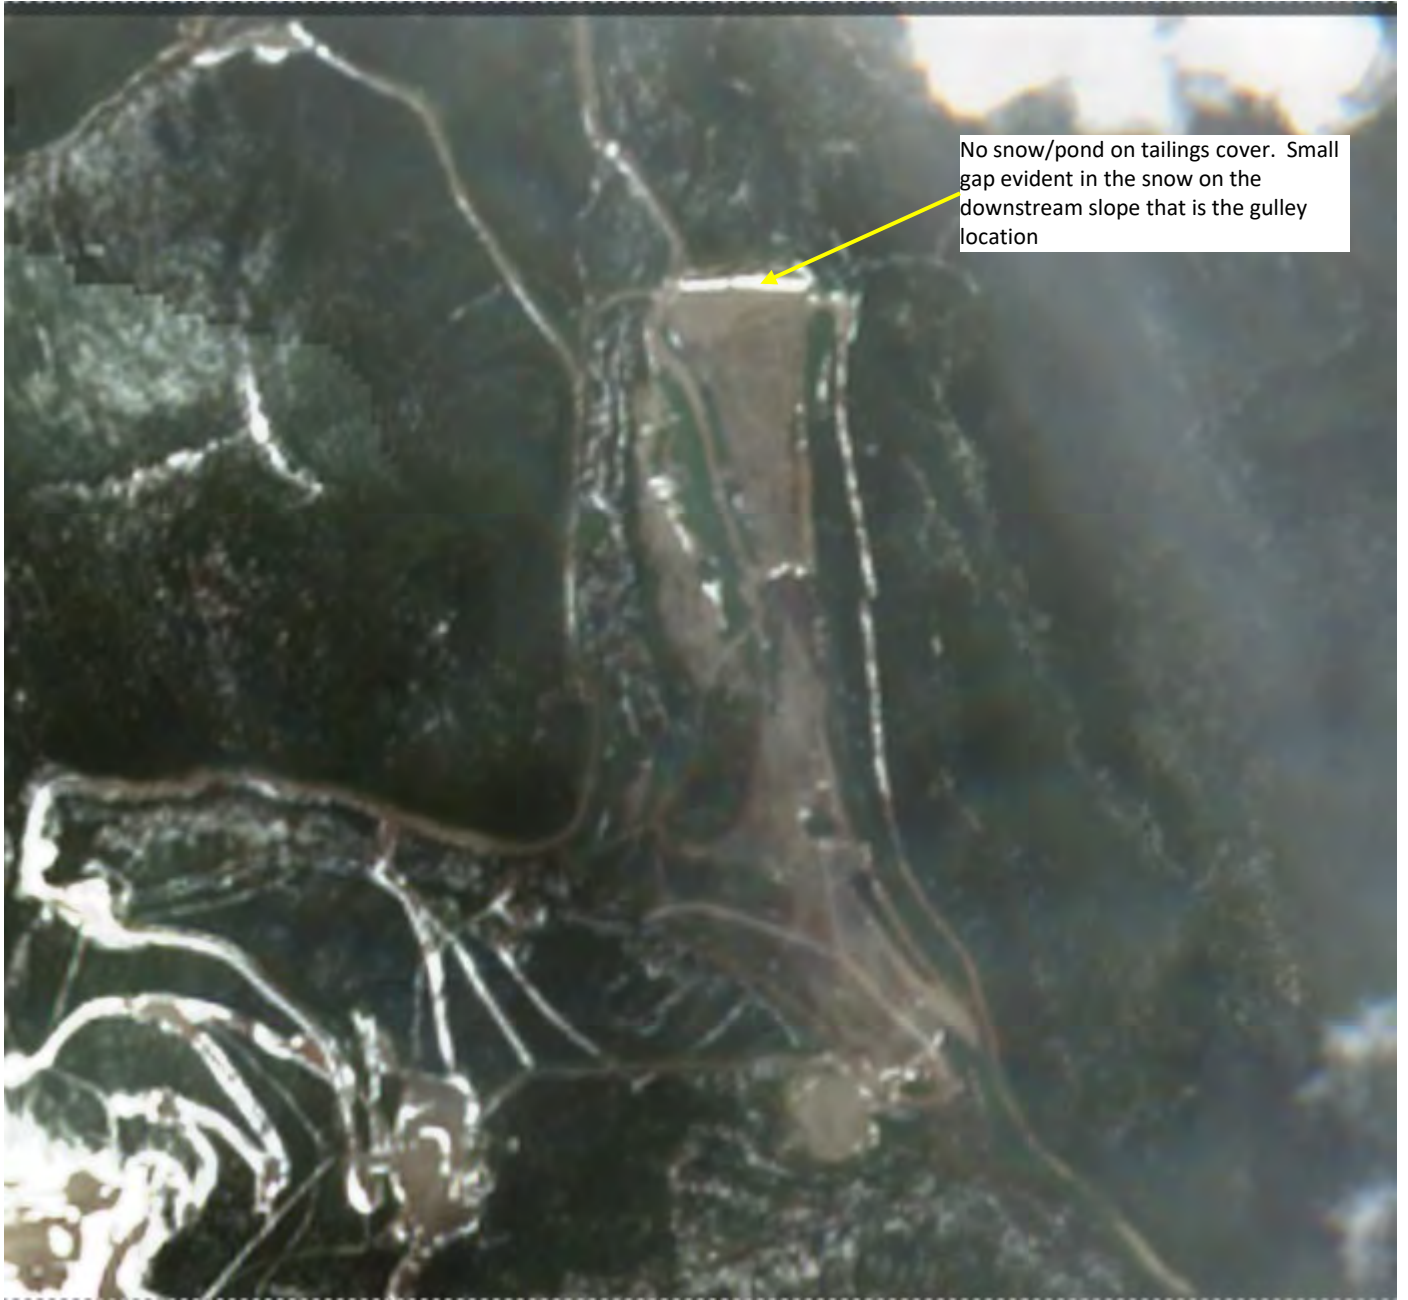
No snow/pond on tailings cover. Small gap evident in the snow on the downstream slope that is the gulley location

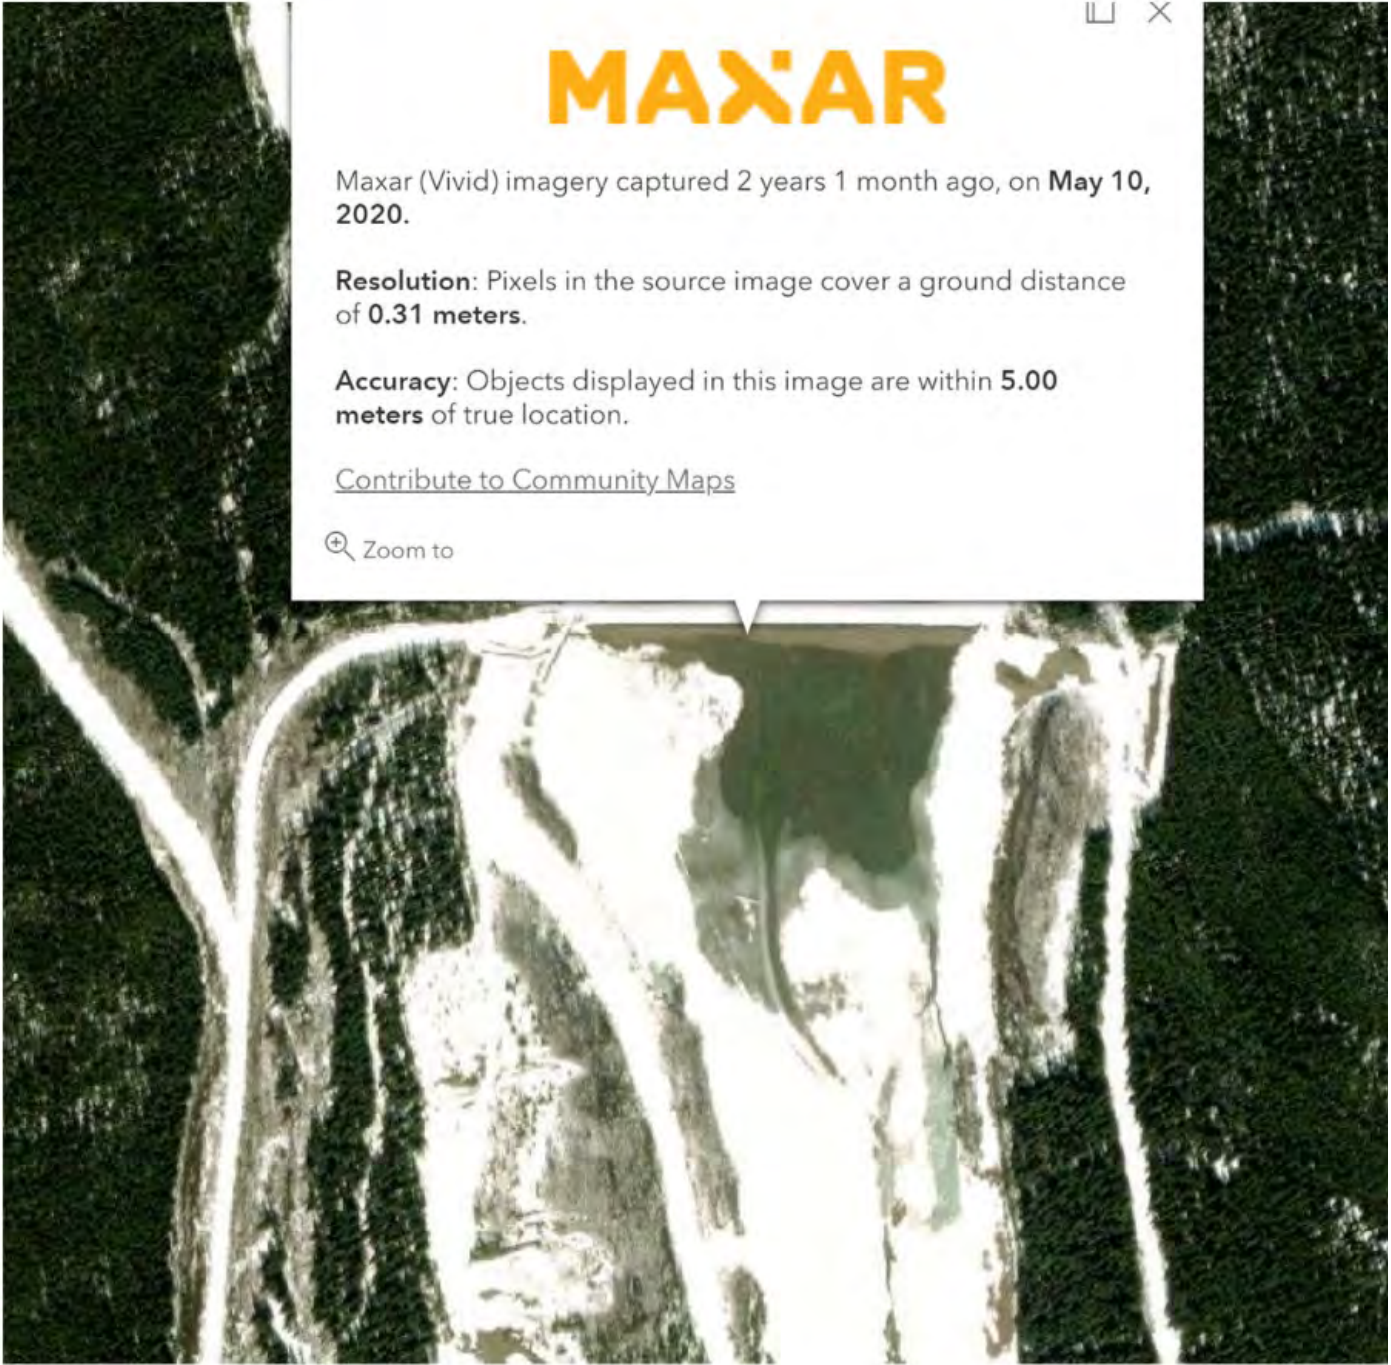
May 10, 2020, satellite imagery showing a large pond on the cover surface..

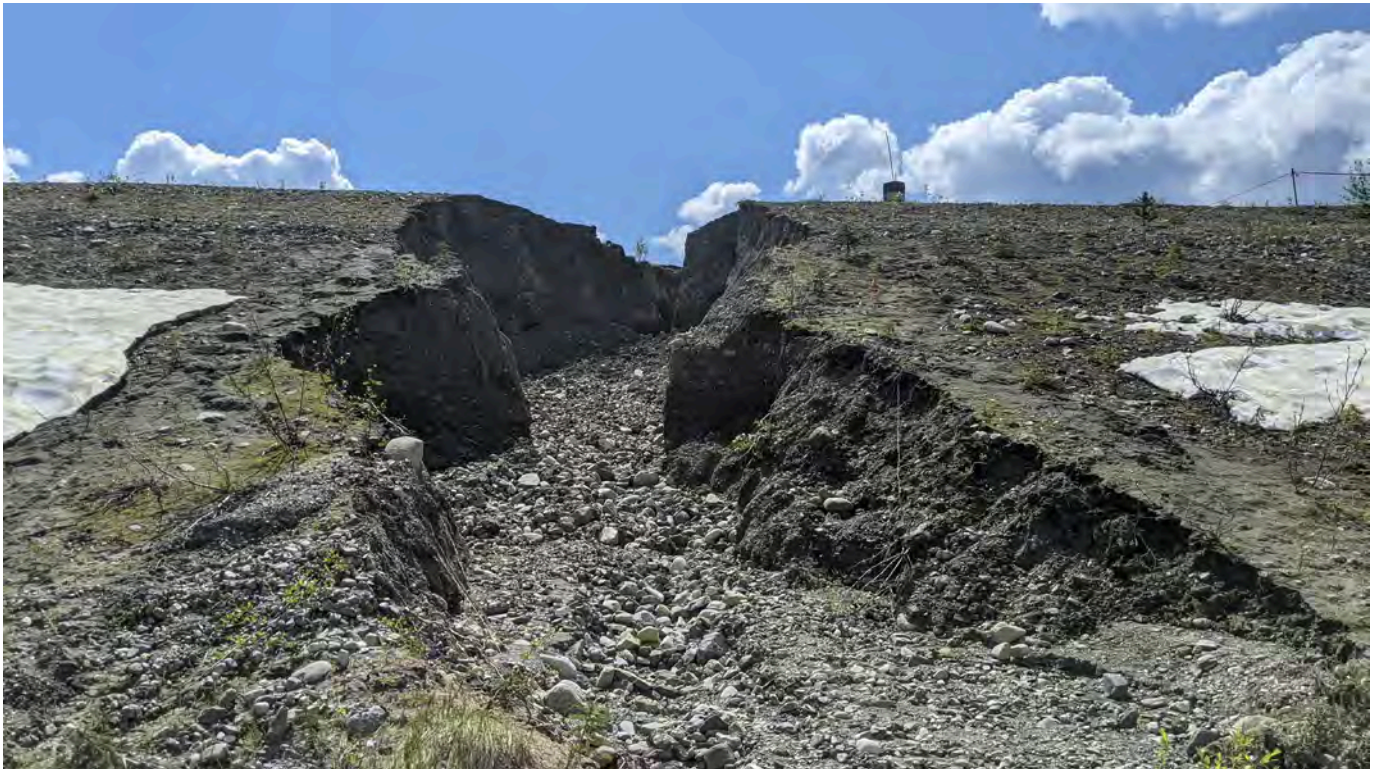
Photo 2: Erosion Gully looking upslope (June 21, 2022).

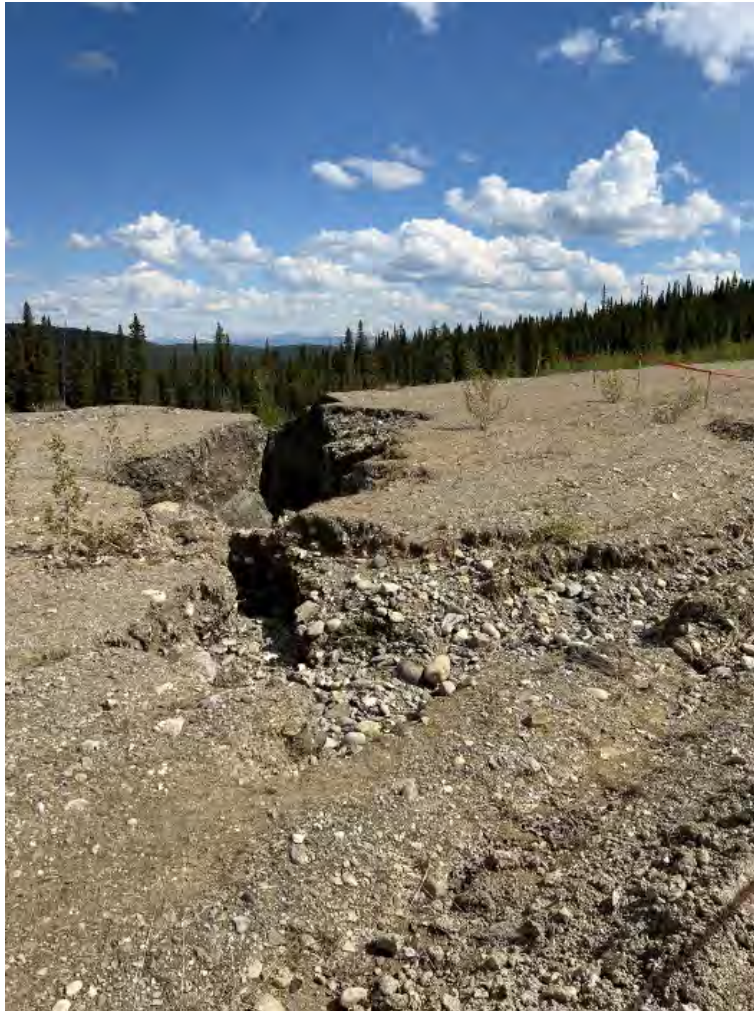
Photo 3: Erosion of the dam crest and tailings cover at the upstream end of the erosion gully (June 21, 2022).

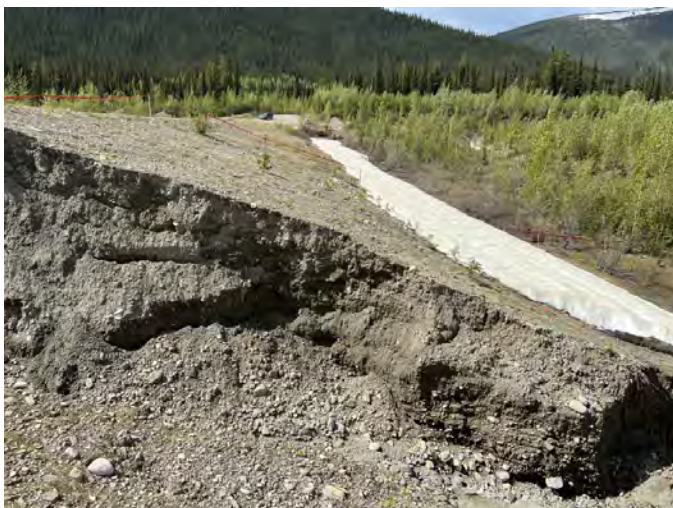
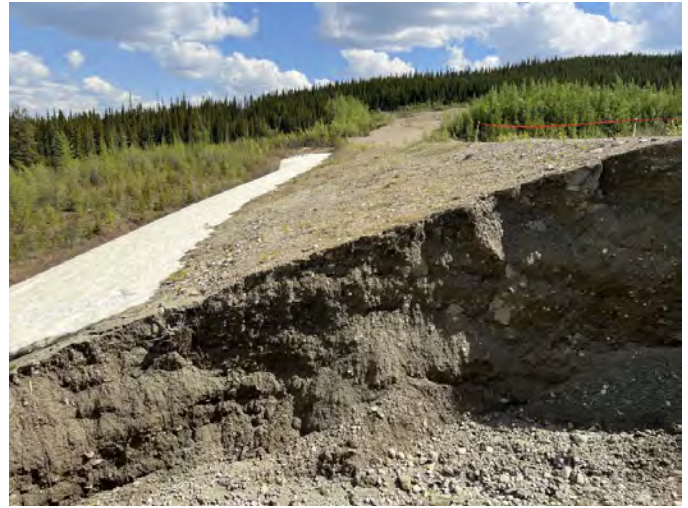
Photo 4a/b: West and east sides of the erosion gully (June 21, 2022).
