2022 Annual Facility Performance Review Summary Report

Tailings Management Facility, Quebrada Blanca 2

Compañía Minera Teck Quebrada Blanca S.A.

Golder Associates S.A.

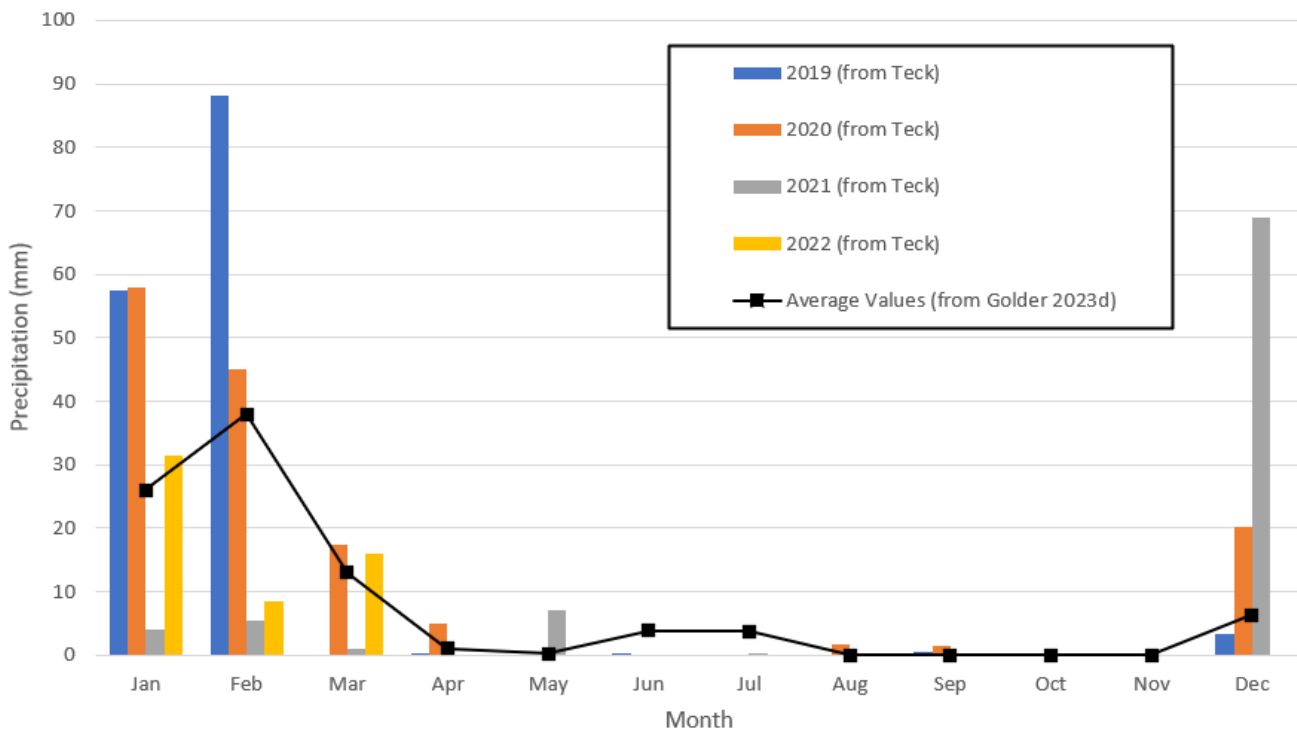
Figure 1: Precipitation for Period 2019 to 2022.

The monthly precipitation data collected by CMTQB on-site for the 2019 to 2022 period are shown in Figure 1 along with the average monthly values from Golder (2023d). No data for June to December 2022 was provided by CMTQB. The actual monthly precipitation values correspond to the average values.

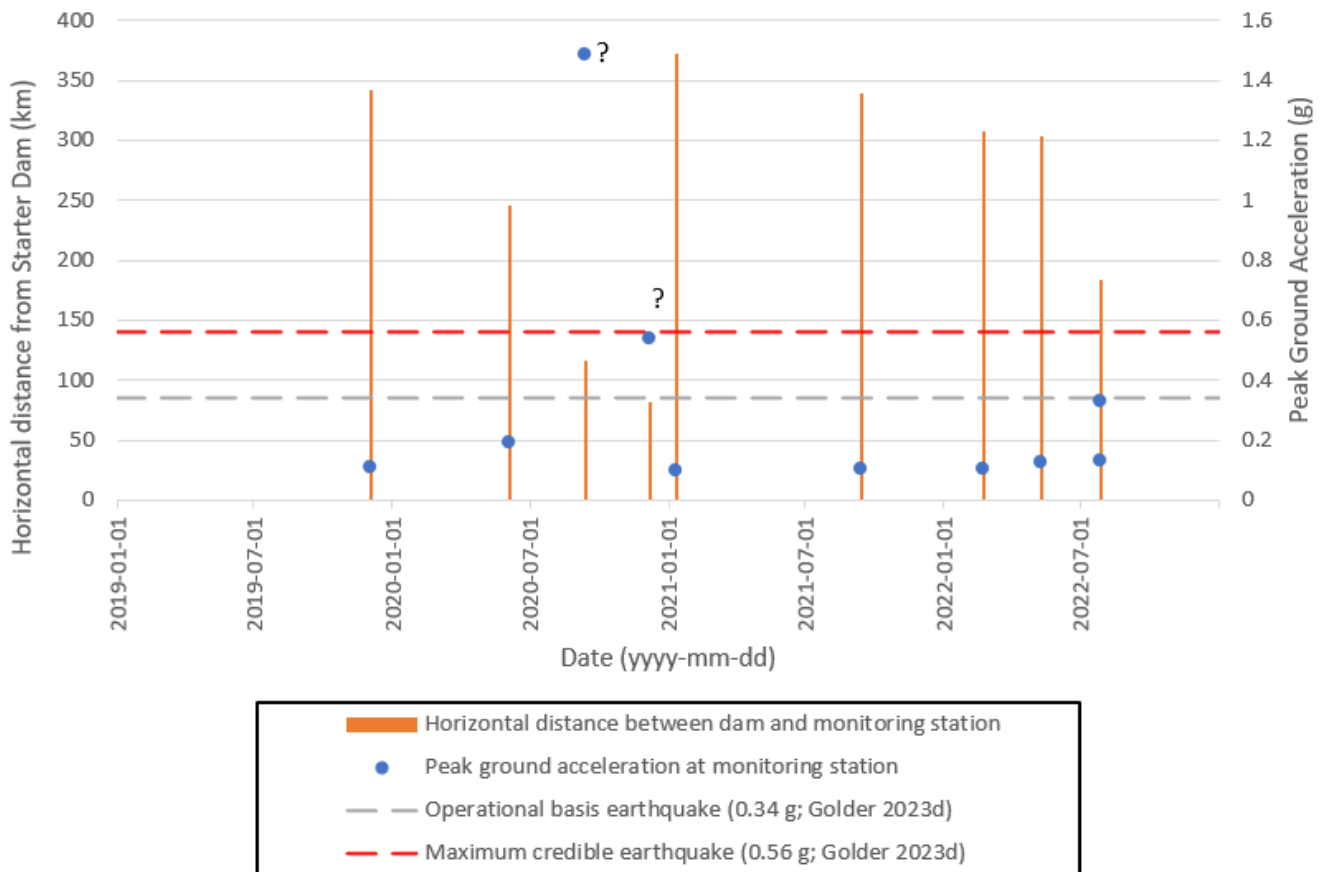
Figure 2: Ground Accelerations near Starter Dam for Period 2019 to 2022.

There was no seismograph on-site at QB2 during the period from 2019 to December 2022; therefore, seismic events in the area were sourced online at *evtdb.csn.uchile.cl*. Seismic events of Magnitude 6.0 ($M \leq 6.0$) were assessed to determine ground accelerations in consideration of the operational basis earthquake (OBE) ground acceleration of 0.34 g and the maximum credible earthquake (MCE) ground acceleration of 0.56 g used for the TMF design. Figure 2 shows the ground accelerations for these events, and their horizontal distances from the starter dam, along with the OBE and MCE ground accelerations. The two higher ground accelerations reported in late 2020 are questioned as no effects were reported at site; the depth to the epicentres likely impacted the effects experienced at site.

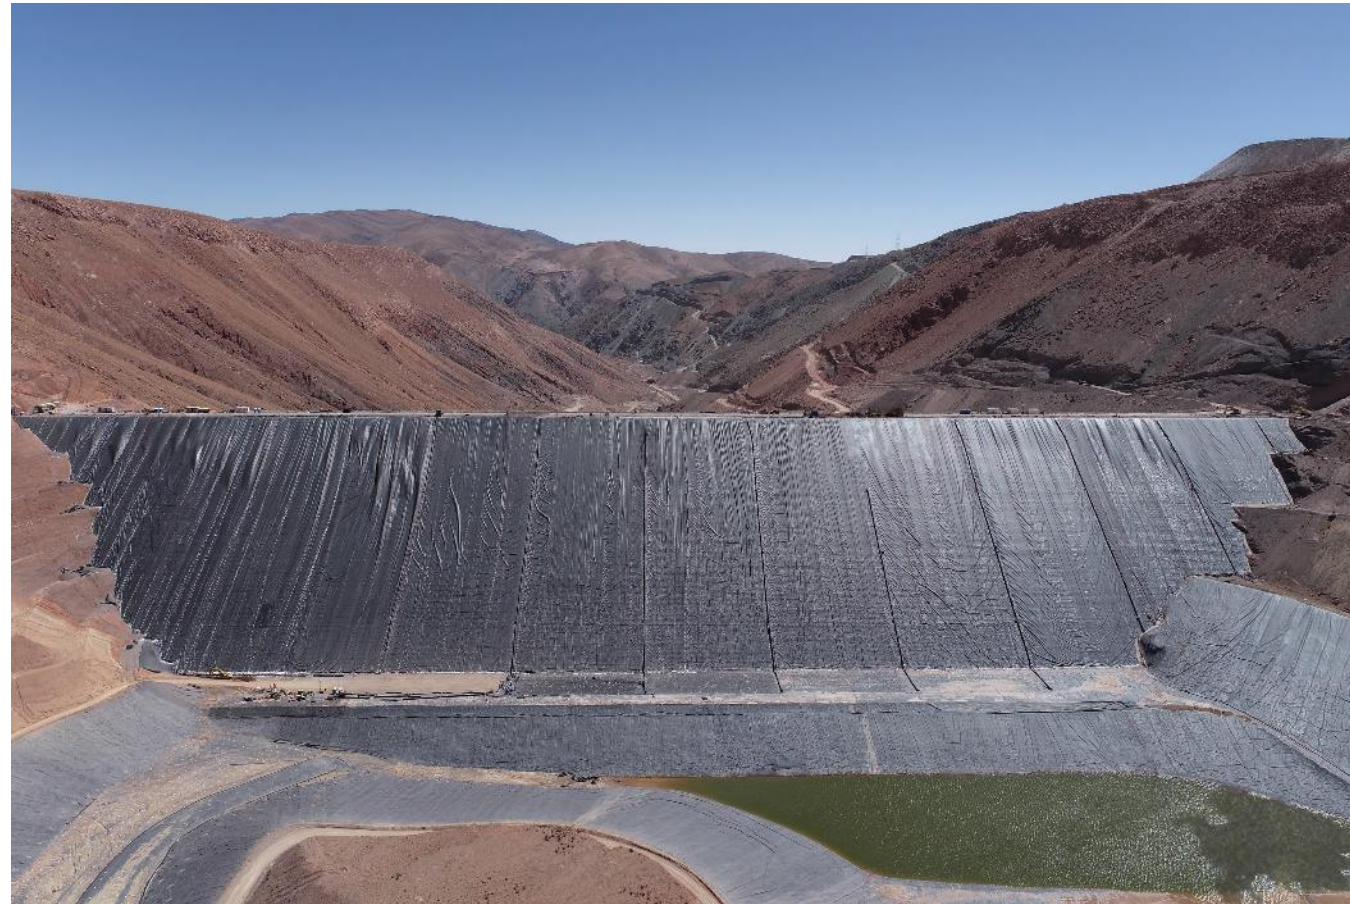
Plate 6: Starter Dam (1452)

Upstream face

1.3	Damage to lining system		x	6	Construction in-progress.
1.4	Unusual Accumulation of Debris		x		
1.5	Evidence of Sloughing/Sliding		x		
1.6	Evidence of Cracks		x

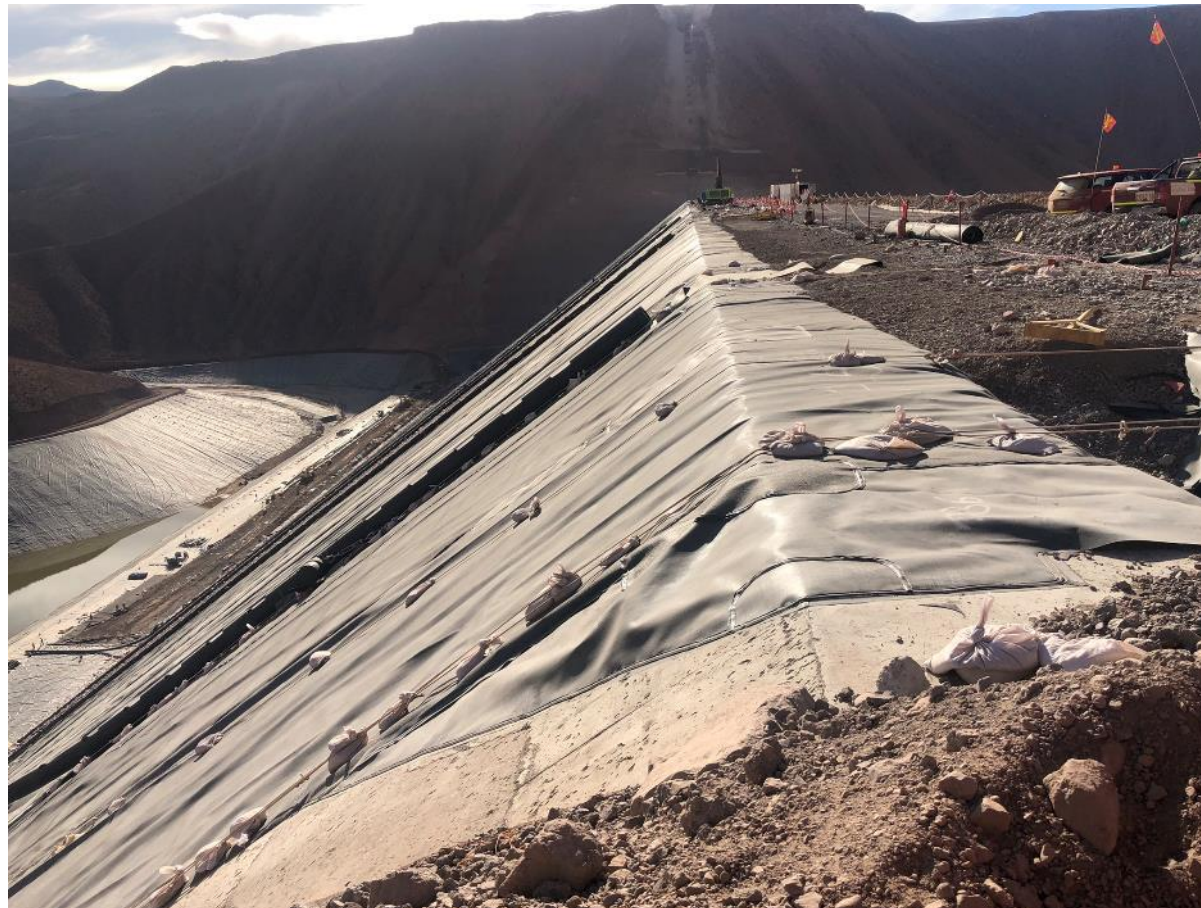
Plate 7: Starter Dam (1452)

Looking east along upstream crest limit

1.1	Concerns with deposition infrastructure		x	7	Construction in-progress.
1.1	Other Unusual Conditions		x		
2.0	<i>Dam Crest</i>				
2.1	Evidence of Shoulder Erosion		x

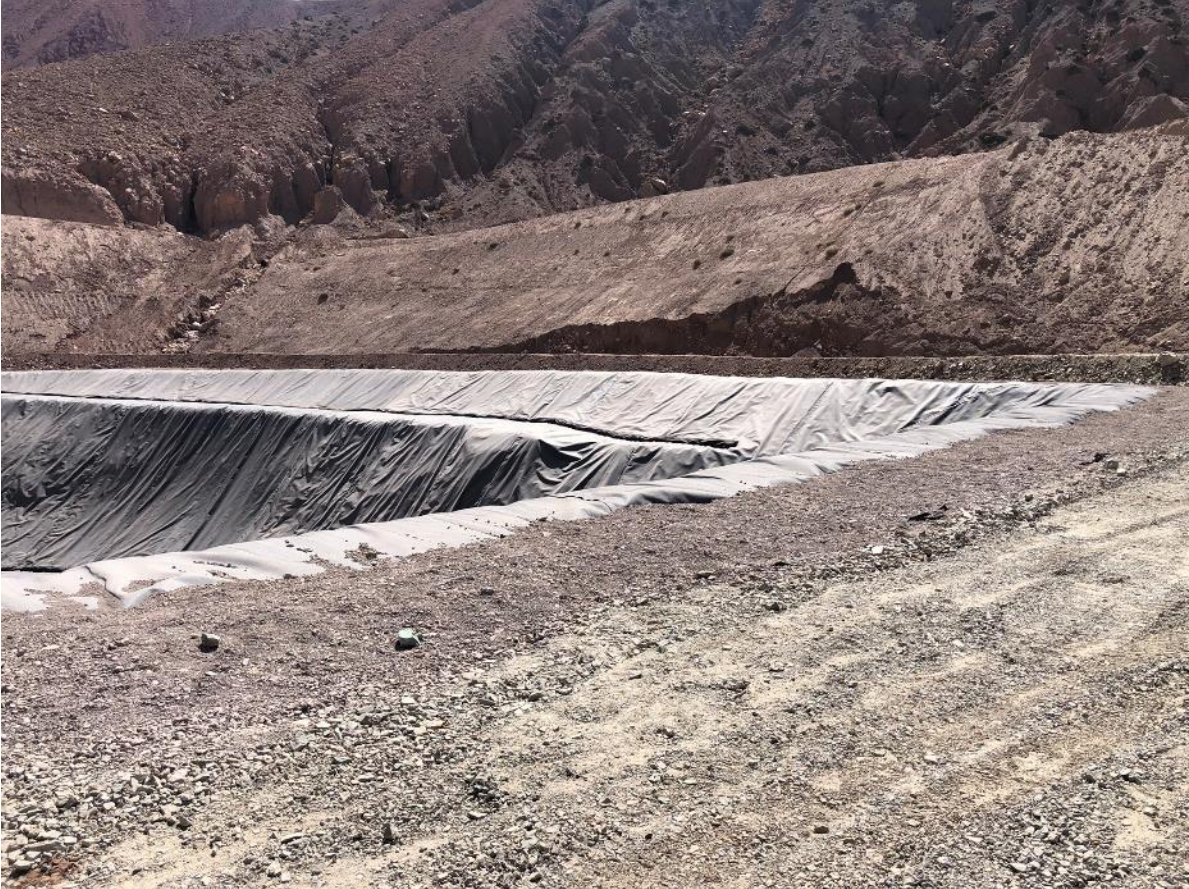
Plate 25: Year 2 Sump

- Entire system is complete.
- An opportunity was identified to improve the liner-to-bedrock connection at the Year 2 sump (see Plate 25) to reduce seepage losses. Any seepage bypassing the Year 2 sump will, per the design, report to the seepage collection ponds (1461). In discussions with CMTQB subsequent to the 2022 AFPR inspection, it was decided that any contemplated improvement will be carried out by CMTQB Operations. Golder would be pleased to assist CMTQB Operations should such an improvement be requested.
- Sloughing of soil above the eastern perimeter of the Year 2 sump was observed (see Plate 25). The sloughing is the result of concentrated runoff along the slope. This area is to be monitored and repaired, if warranted, to limit further sloughing.

Details

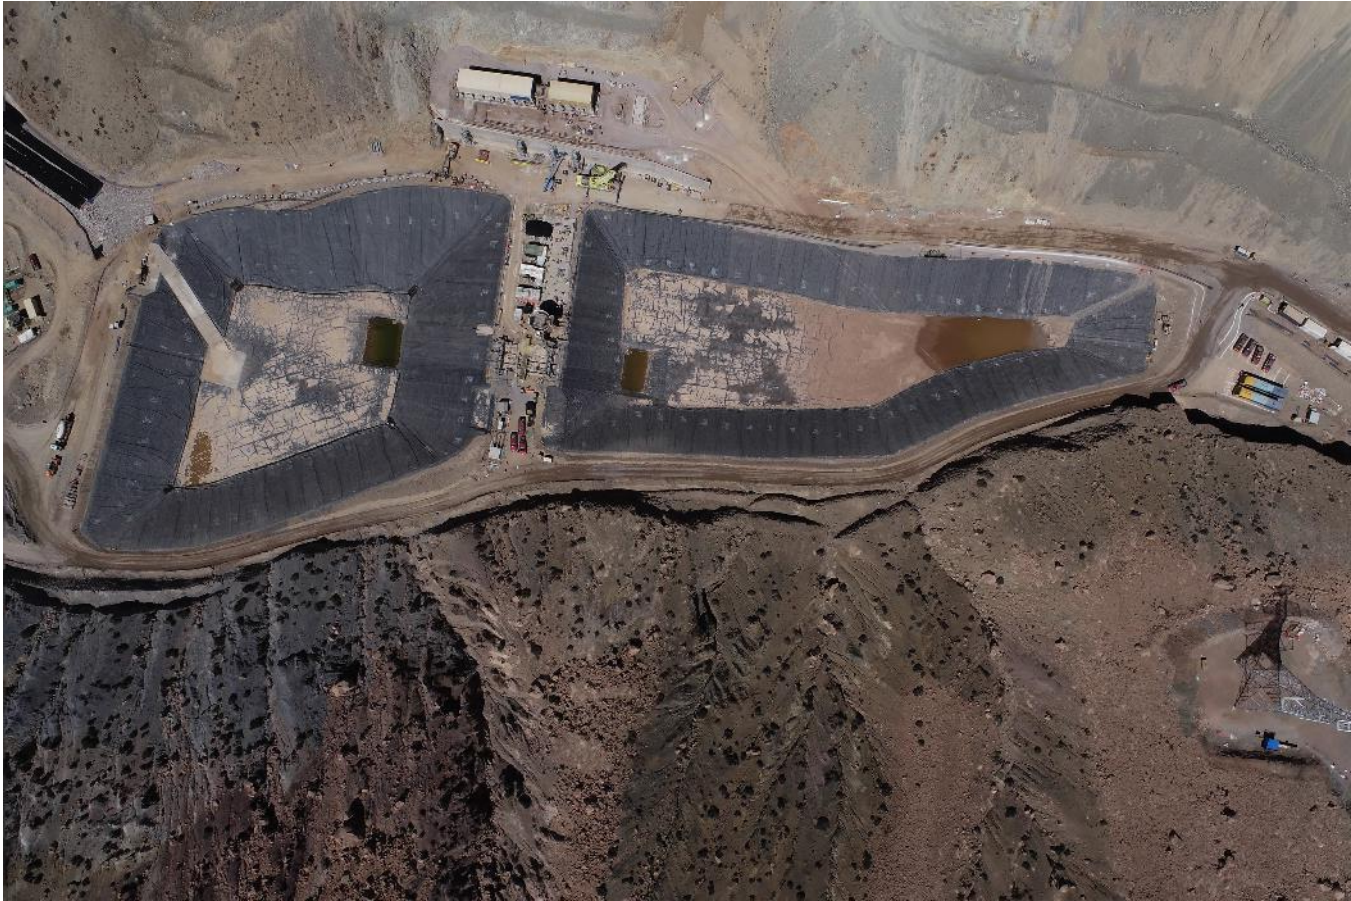
Plate 26: Seepage Collection Ponds (1461)

- Work continues on the non-contact water ditch on the east side of the seepage collection ponds.
- Material graded into Seepage Collection Pond 1 is to be removed and the lining system inspected for damage. This material was graded off of the access road by the contractor following rain events in December 2022 (see Plates 26, 27, and 28).

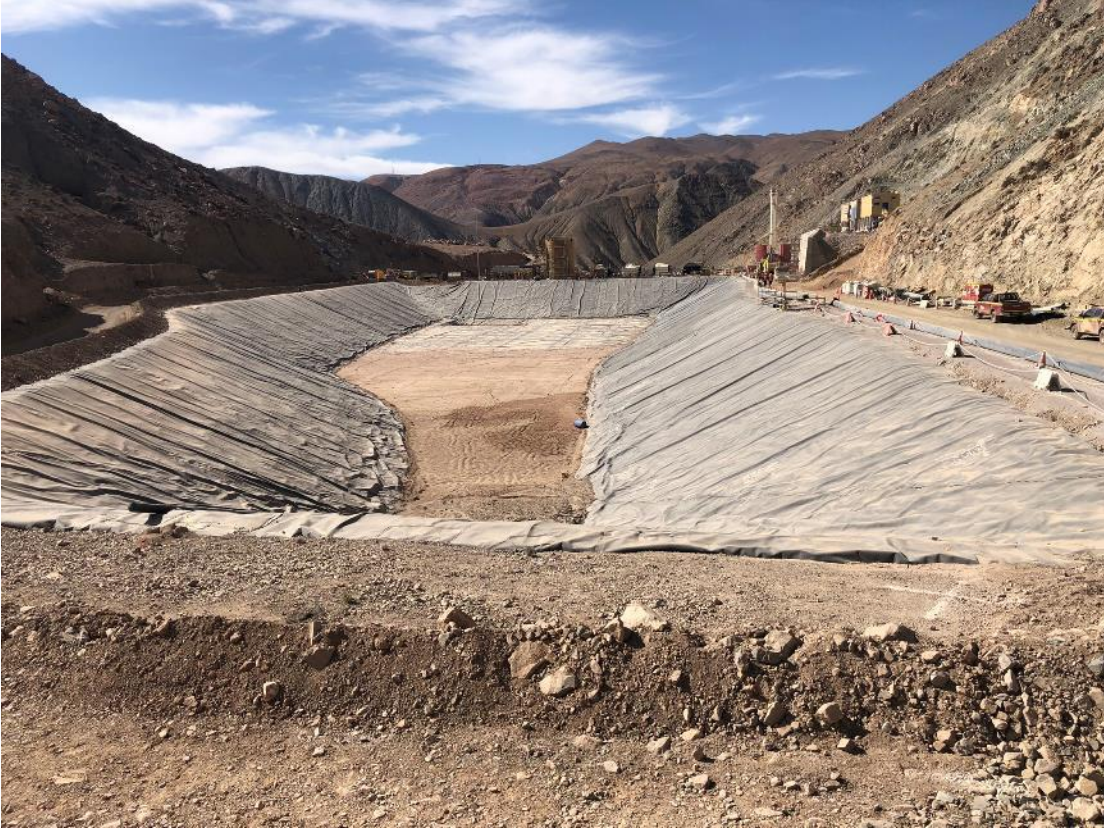
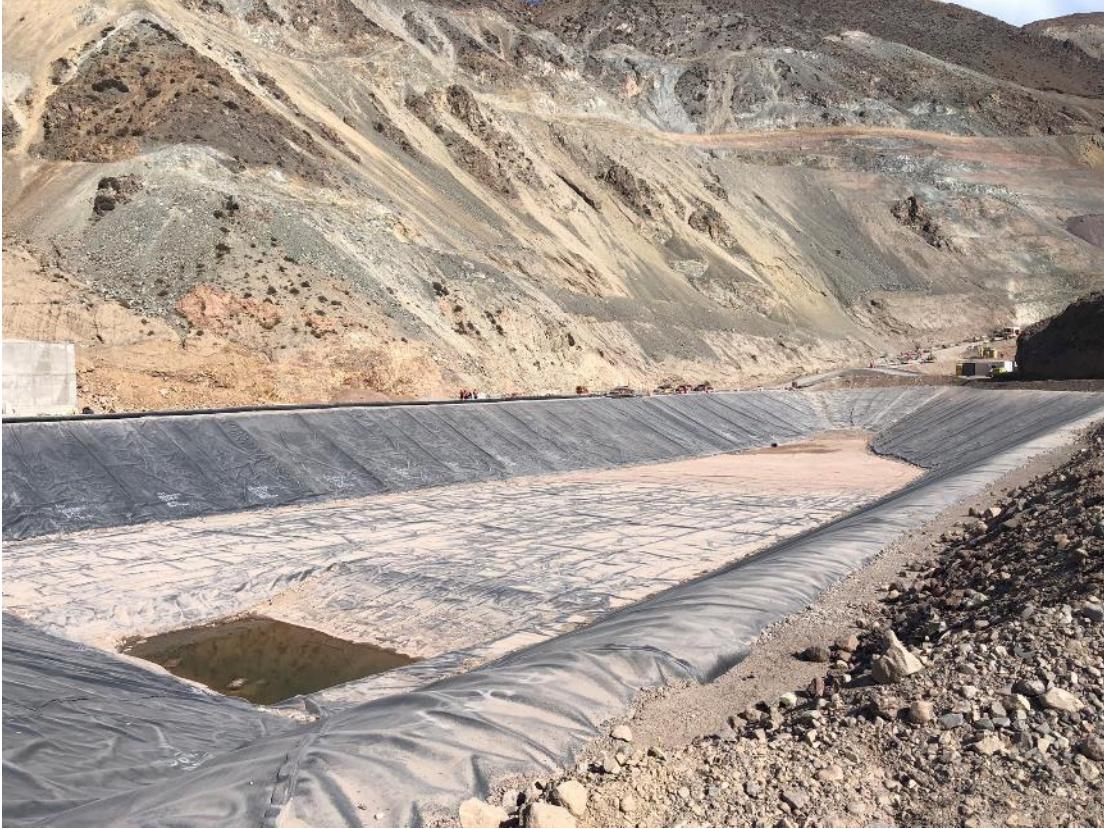
Plate 27: Seepage Collection Ponds (1461)

Seepage Collection Pond 1

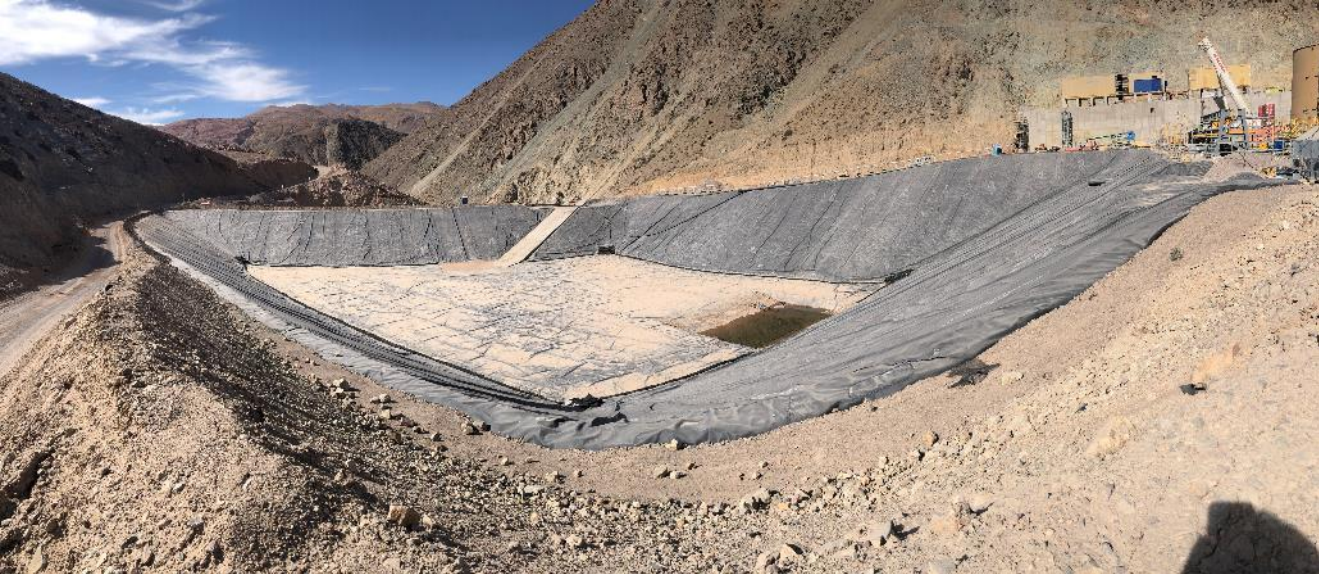
Plate 28: Seepage Collection Ponds (1461)

Seepage Collection Pond 2
