Louvicourt Mine Tailings Storage Facility and Polishing Pond

2019 Dam Safety Inspection

001-19118317-5000-RA-Rev0

25 March 2020

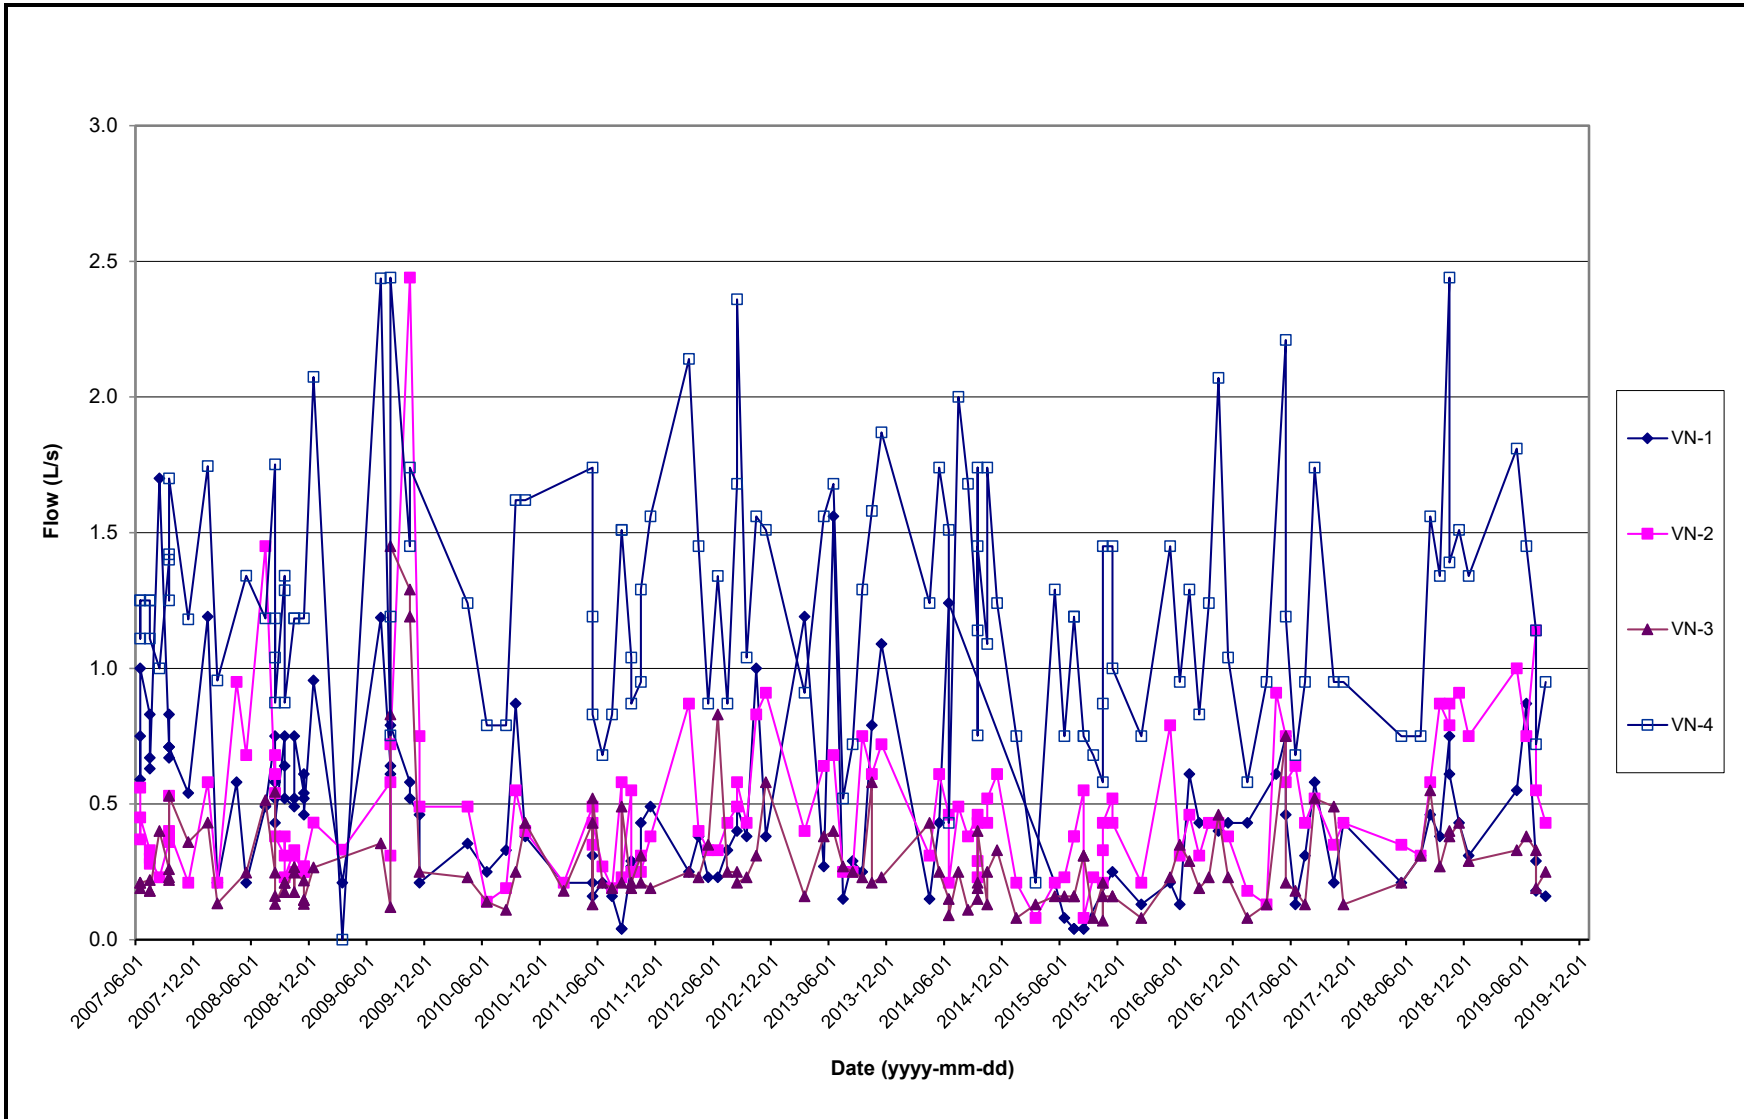
Figure 8: Louvicourt Mine Tailings Pond - Historical Trend of Seepage Flow Measured at the V-notch weirs
(provided by Teck)

Figure 8 shows the historical trend of seepage flow measurements at these V-notch weirs since their installation. The figure indicates that seepage flows measured during 2019 were consistent with previous historical trends. Seepage flows measured during 2019 were also slightly under (by 5% to 17%) those measured during 2018 except at V-notch 2. The increase of seepage flow (14%) measured at V-notch 2 was possibly caused by beaver activity adjacent to Dam 2A.

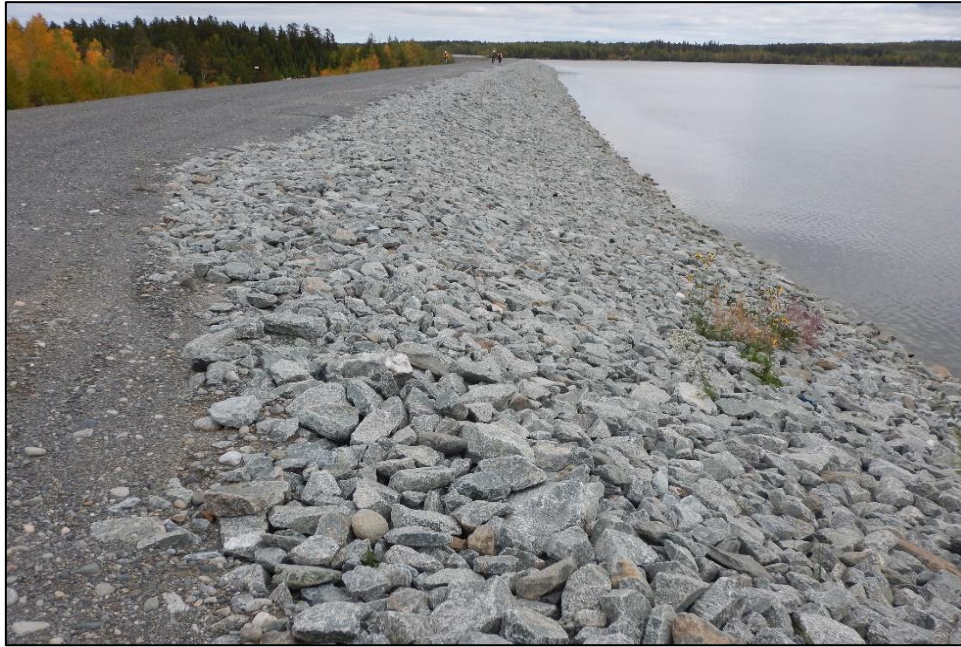
- The riprap on the upstream berms of Dams 1B and 1D was repaired with new riprap (photograph 1). The size of the riprap material was reviewed in 2018, and it was concluded that the material as placed provided appropriate protection to the dykes.

Photo 1 : Dam 1B - Photo of new rip rap placed on upstream slope.
View looking East.

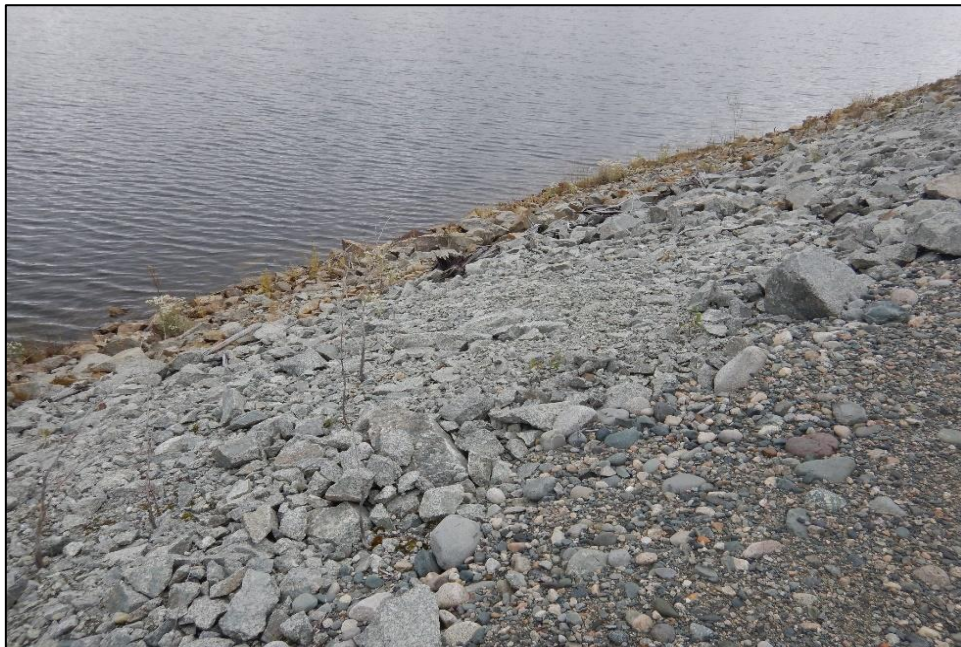
- The riprap on Dams 1A and 1C was unchanged from last year (Photograph 2). Replacement of the riprap will be undertaken within a reasonable timeframe. Operational procedures, including a provision in the OMS for an event-driven inspection after extreme wind events, are used to manage risk in the interim.

Photo 2 : Dam 1C – Photo of degraded rip rap area on the upstream slope.
View looking South.

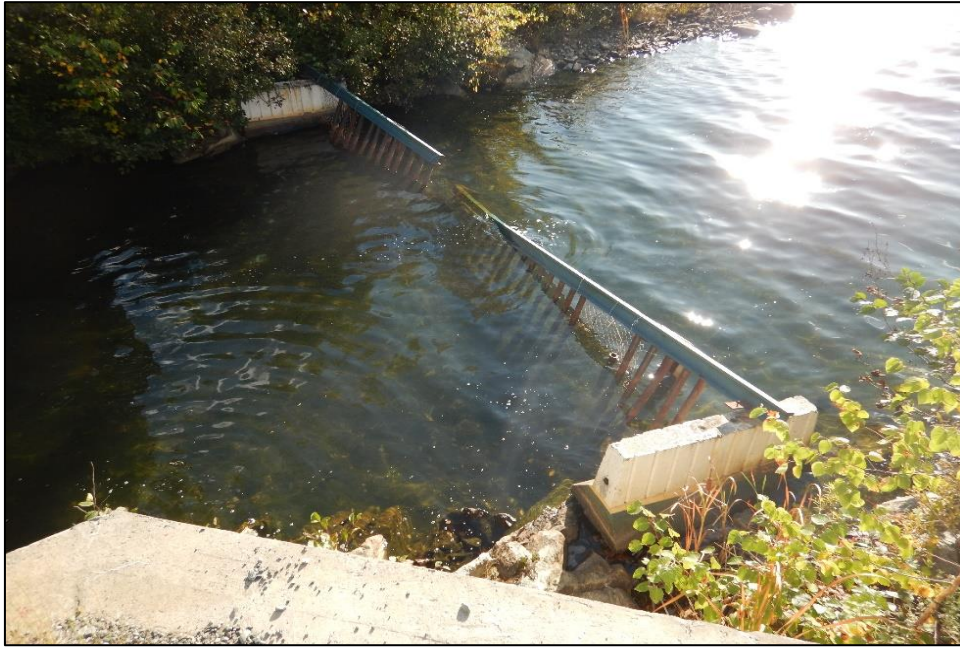
- The trash rack located upstream of the entry to the spillway is damaged (Photograph 3) and should be repaired. The design of a new trash rack is in progress.

Photo 3 : Dam 1E – Photo of damaged trash rack structure.

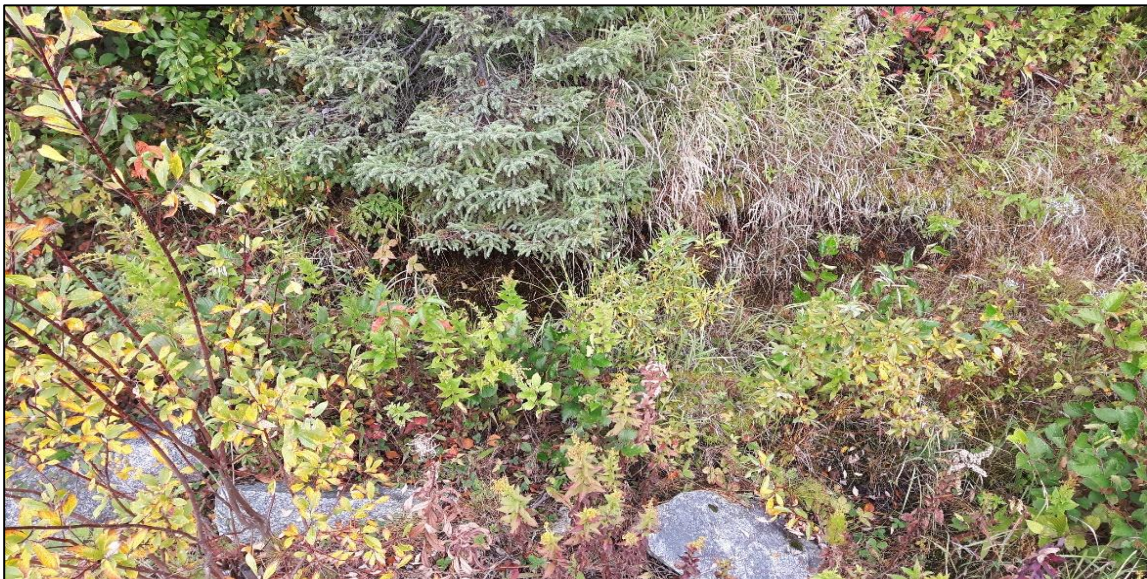
- Ponding water was observed at the toe of Dams 1A to 1E at almost the same locations as last year. The water seems to be stagnant or exhibits very low flow. A typical photo of one exfiltration location is shown as Photograph 4. The location of these points is presented on Figure 1.

Photo 4 : Dam 1B – Photo of seepage area at the toe of the embankment. No visible flow, area is slightly damp.

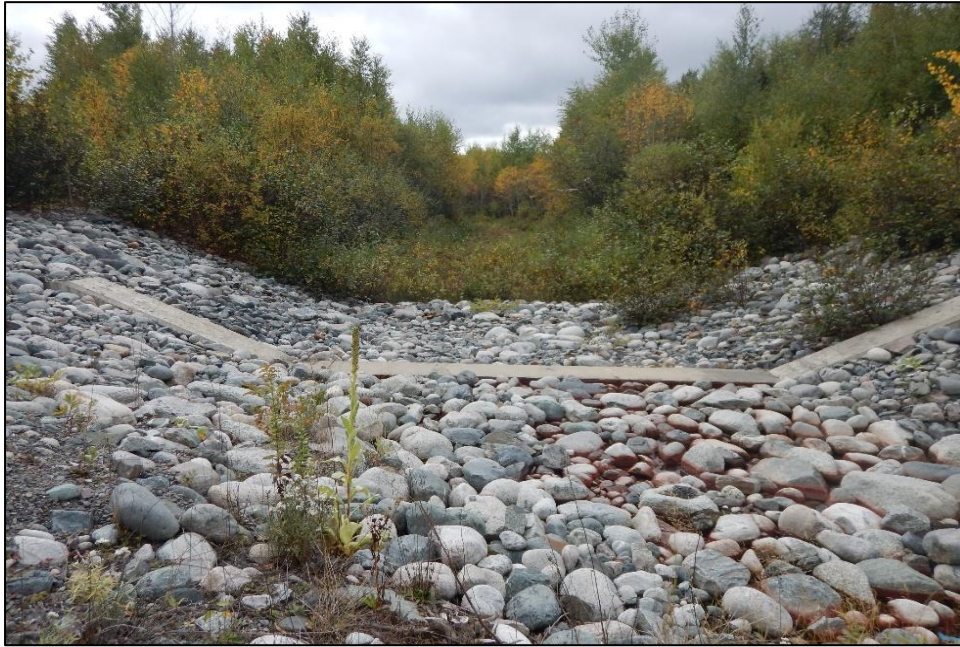
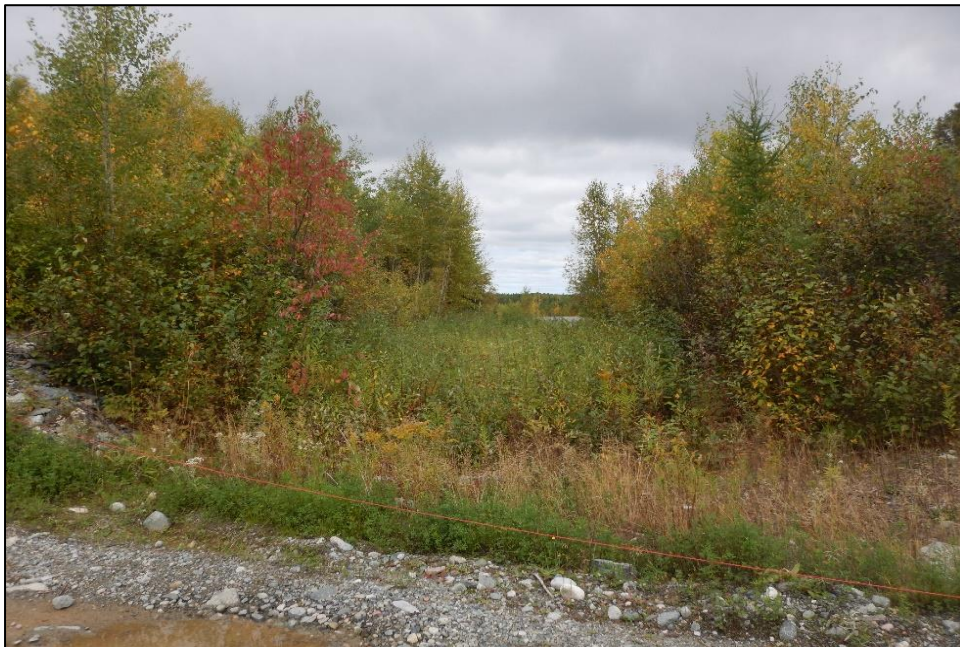
- The emergency spillway located between Dams 1D and 1E (denoted as the second emergency spillway) was in good condition. Vegetation in the downstream channel was cleared in 2018; there has been some regrowth in some areas (Photographs 5 and 6), which will require maintenance in the future.

Photo 5 : Dam 1D – Photo of concrete sill and upstream spillway channel at the TSF emergency spillway. Vegetation was cleared in 2018.

Photo 6 : Dam 1D - Photo of downstream spillway channel at the TSF emergency spillway. Vegetation was cleared in 2018.

Historically, the vegetation has been cleared every other year, and clearing in 2020 is appropriate. The riprap adjacent to the concrete spillway sill is in good condition. The access road at the outlet of the second emergency spillway is susceptible to erosion, which could affect the embankment of the Dam.

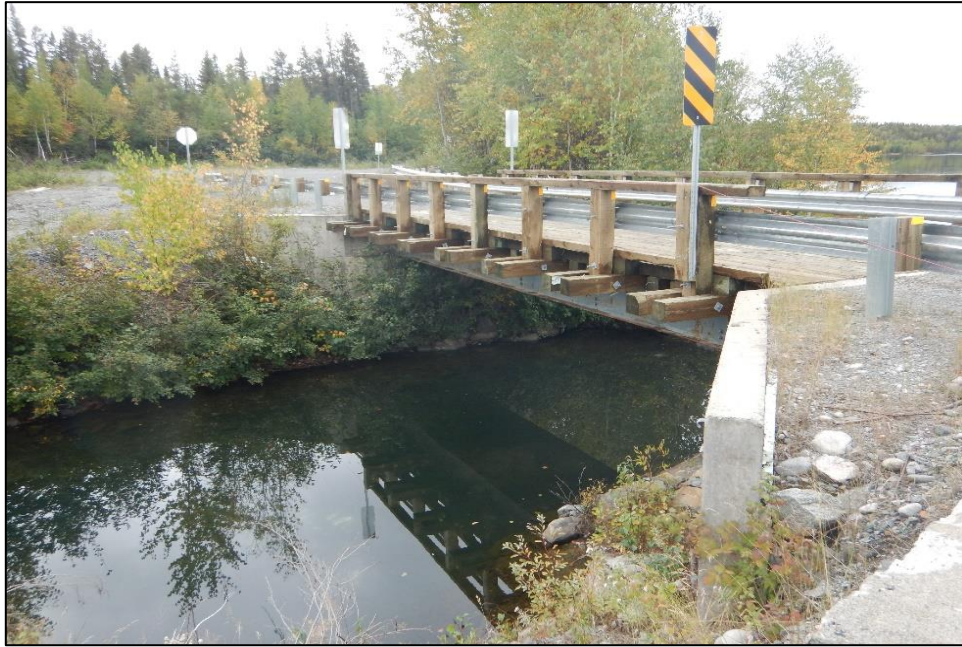
- The access bridge close to the spillway was rehabilitated in 2018 and appears in good condition (photograph 7).
- Several minor erosion points are visible at the crest of Dam 1E. These are not a concern but should continue to be observed.
- Vegetation is present at the downstream toe of Dams 1A, 1B and 1C (Photograph 8). This is not a stability concern.

Photo 7 : Dam 1E – Spillway bridge in good condition.

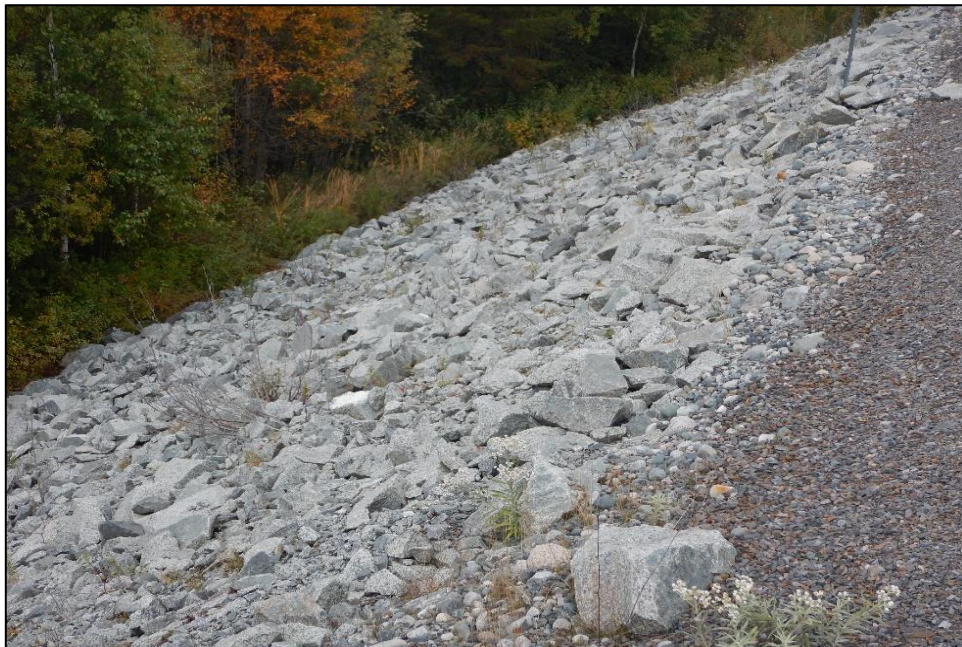
Photo 8 : Dam 1A – General view of vegetative growth at the toe of the embankment.

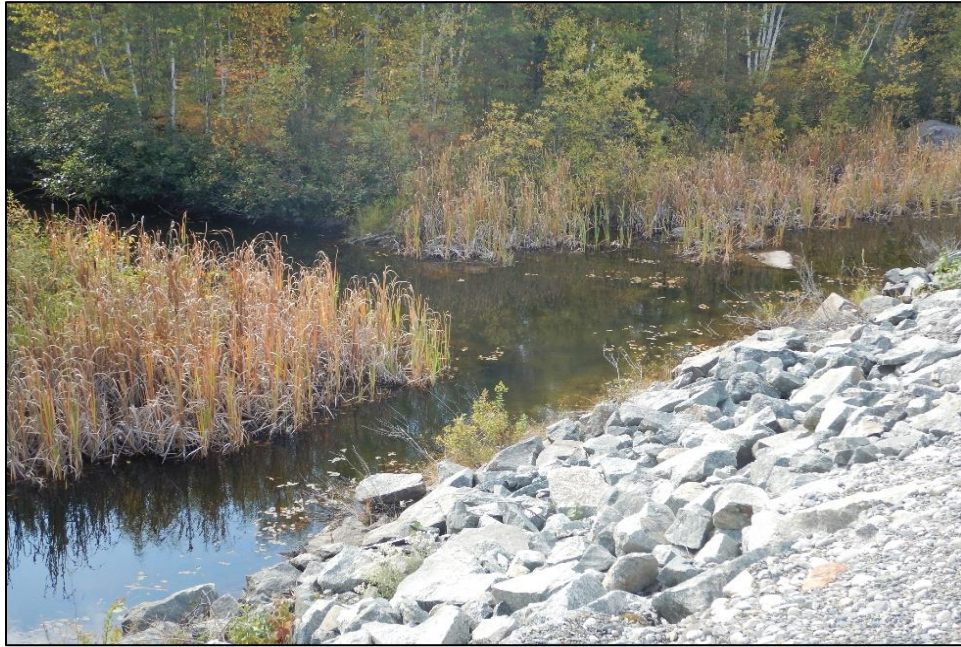
Photo 9 : Dam 2A – water ponding at the downstream toe of the dam, similar to previous years. This is a natural topographic low, however beaver activity nearby exacerbates the ponding.

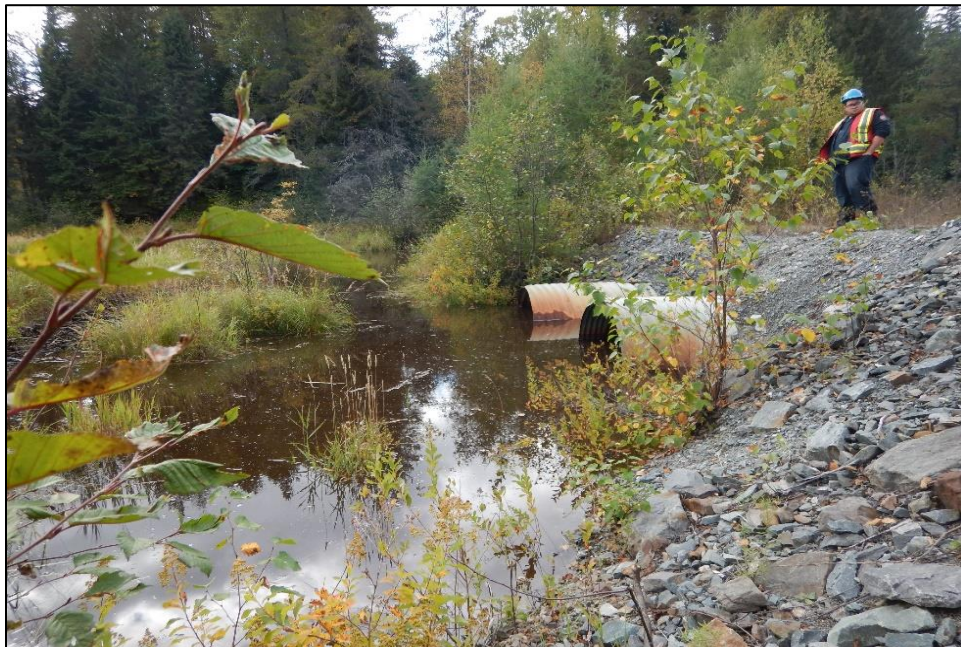
- Some stagnant water was observed at the toe of Dam 2B where previously seepage area 13 has been established, close to V-notch 2, exhibiting very low flow. Further south, seepage points 10, 11 and 12 are present in the vicinity of V-notch 1. V-notch 1 exhibits low but visible flow rates, and the water is clear.
- Stagnant water is observed at the toe of Dam 2A (Photograph 9). The extent of ponding is increased due to beaver activities; however it is noted that this area represents a zone where the natural topography drains towards the tailings pond, such that some accumulation at this location is expected.
- The culverts located across the unnamed creek, just north and west of the tailings pond are partially blocked by beaver activity, resulting in higher than normal water levels at this location (Photograph 10). The beaver blockage was removed in 2019.

Photo 10 : Dam 2B - Photo of culverts located northwest of the TSF. The culverts are partially blocked by beaver activity.

- Beaver activity in the culverts northwest of the tailings pond are resulting in increased ponding in the unnamed creek to the west of Dam 2B. It was recommended that the beaver blockage be removed; this was completed in October 2019.

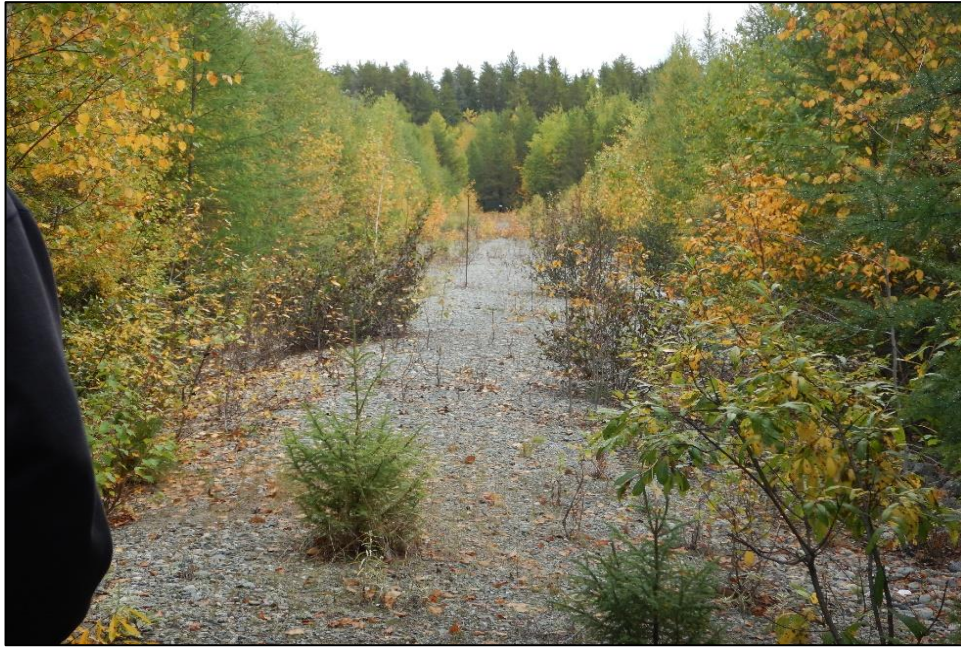
Photo 11 : Dam 4A - Crest of dam, looking East. Note significant vegetative growth on the sideslopes of the dam.

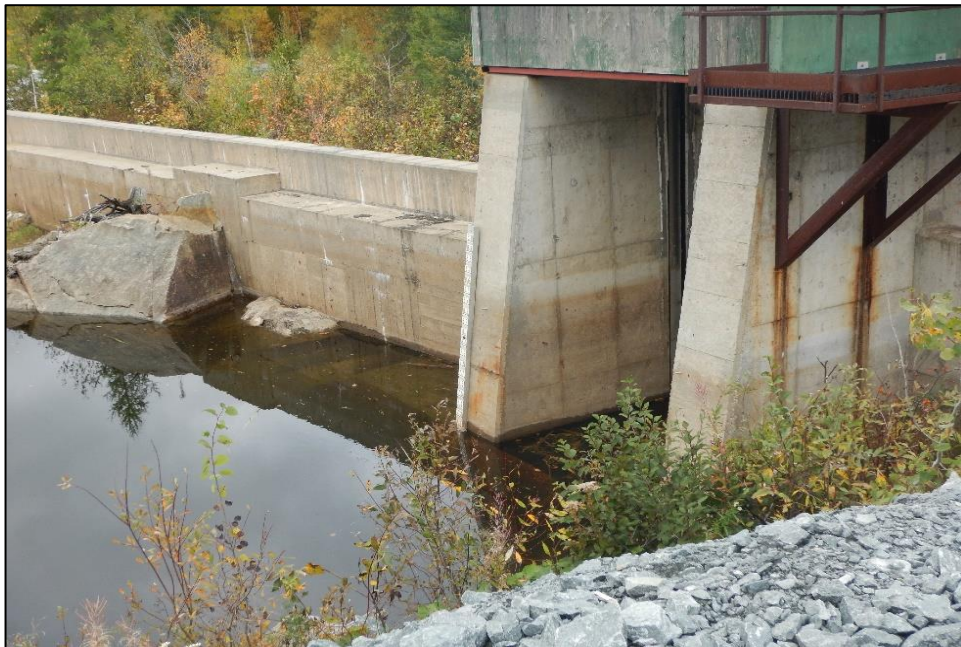
- The main spillway at Dam 4B was in good condition although no flow was passing over the structure (Photograph 12).
- The outflow channel from the spillway to the Parshall flume contains significant vegetation (Photograph 13). This does not represent a performance issue for the channel; however some vegetation removal may eventually be required in the future.

Photo 12 : Dam 4B – View of main spillway control structure and concrete overflow section adjacent to it. Concrete appears intact.

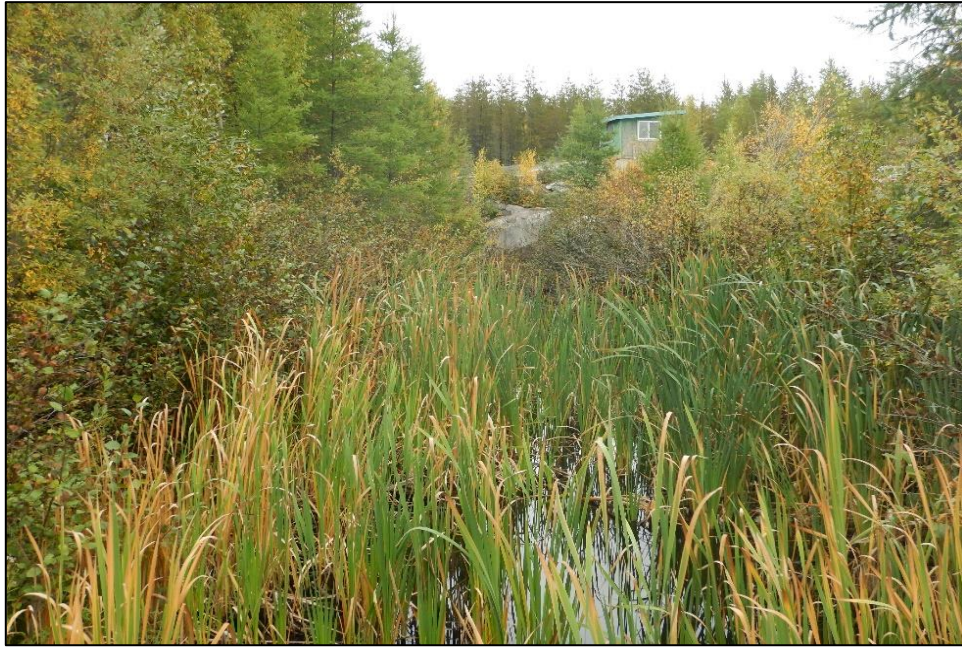
Photo 13 : Dam 4B – Vegetative growth in the final effluent channel to be monitored.

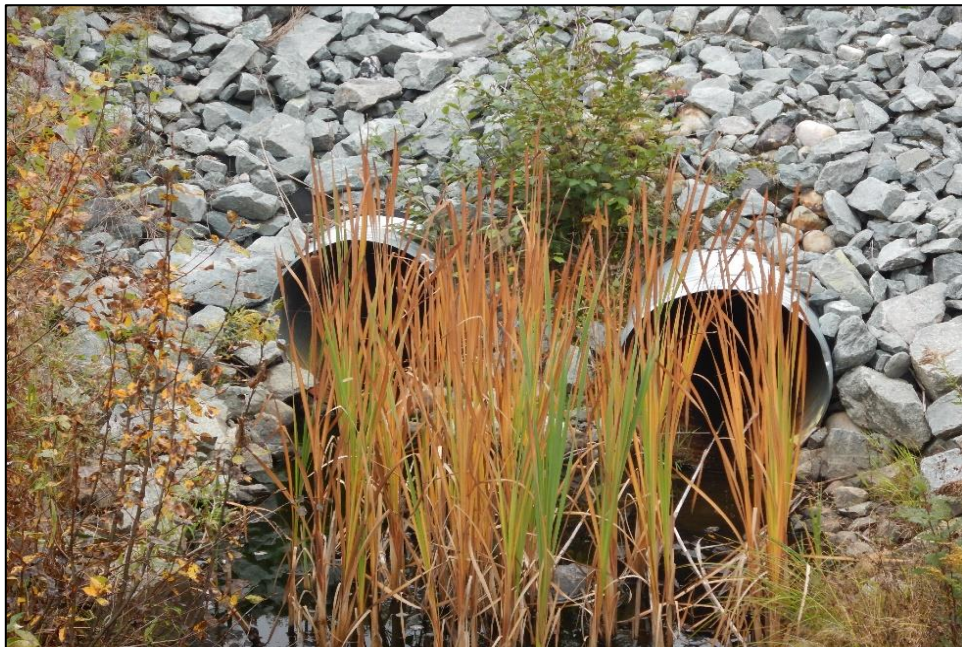
Photo 14 : Dam 4B – final outflow culverts are clear and unobstructed by sediment. Vegetative growth to be monitored.

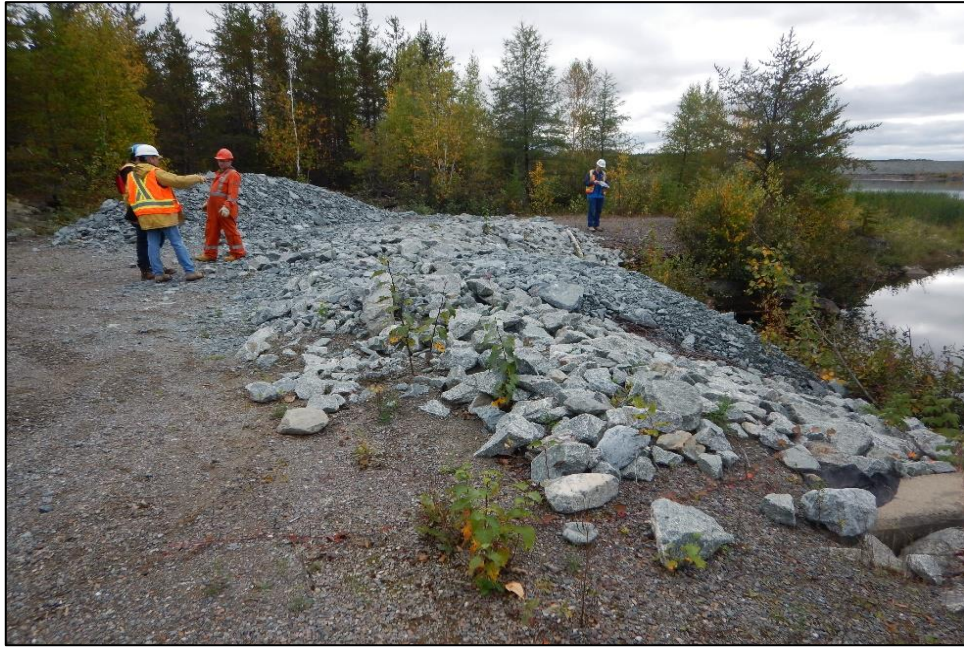
- The 15 m area immediately to the East of the main spillway was designed to serve as an emergency spillway at an elevation of 309.3. Rock fill has been placed to approximate elevation 309.8 m at this location (photograph 15) to enable maintenance work on the main spillway structure. Preliminary analyses suggest that the overflow section to the West of the main spillway is adequate to pass the design flood flow, and this analysis will be confirmed.
- The Dam 4B crest was generally in good condition and unchanged from 2018. Survey monuments are visible. No noticeable changes were visually apparent (i.e., damage) to the survey monuments.
- Ponding water was observed at the toe of Dam 4B at almost the same locations as last year (points 13 to 15 on Figure 1). The water appears to be stagnant.

Photo 15 : Dam 4B – granular fill placed across part of the emergency spillway.
