Beaverdell Mine
2016 Geotechnical Annual Report

March 31, 2017

BEAVERDELL MINE 2016 GEOTECHNICAL ANNUAL REPORT

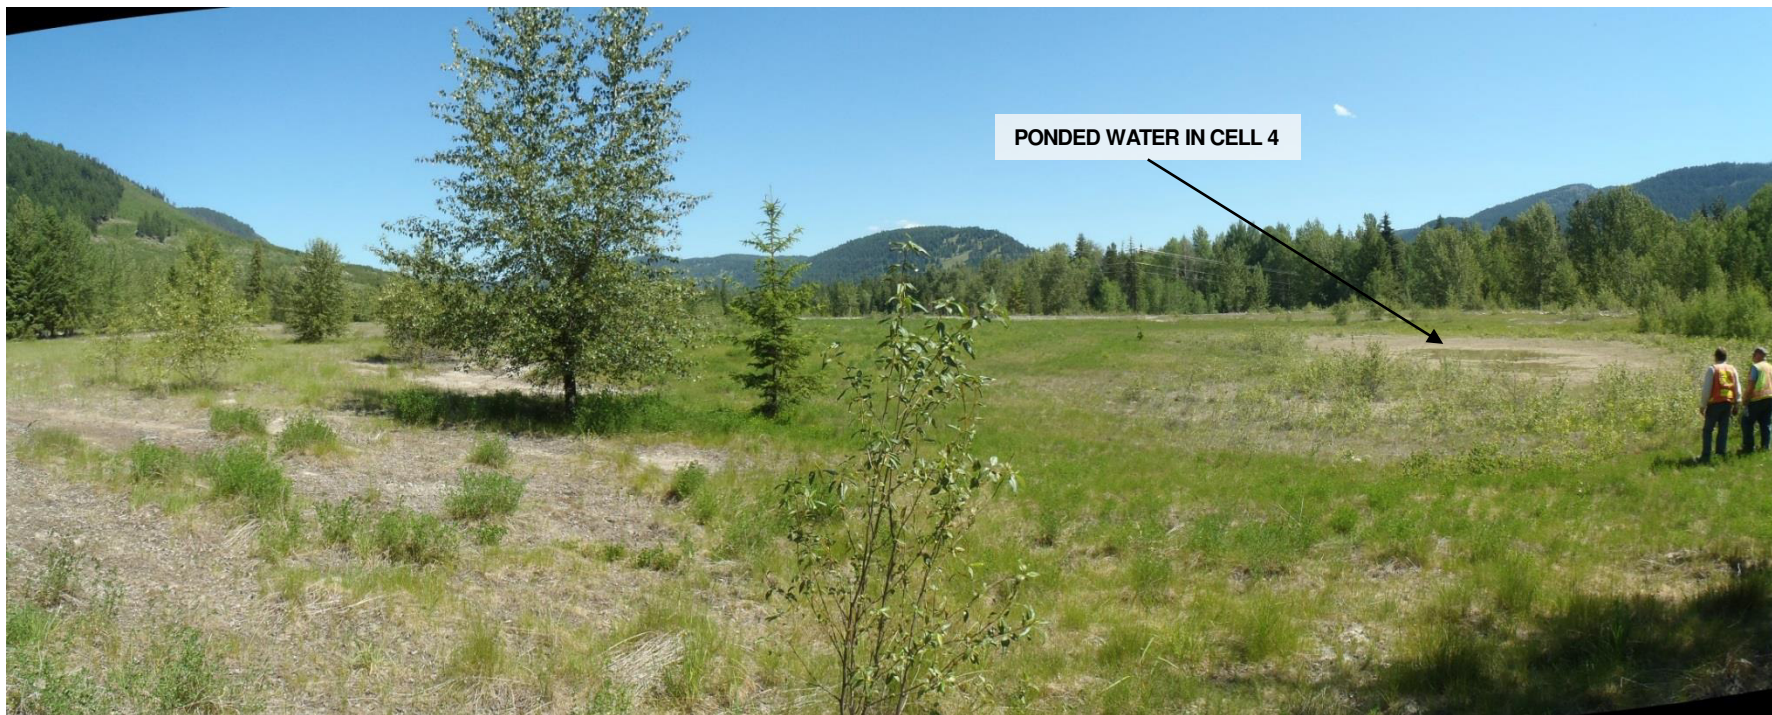
PHOTOGRAPH
A-4

PONDED WATER IN CELL 4

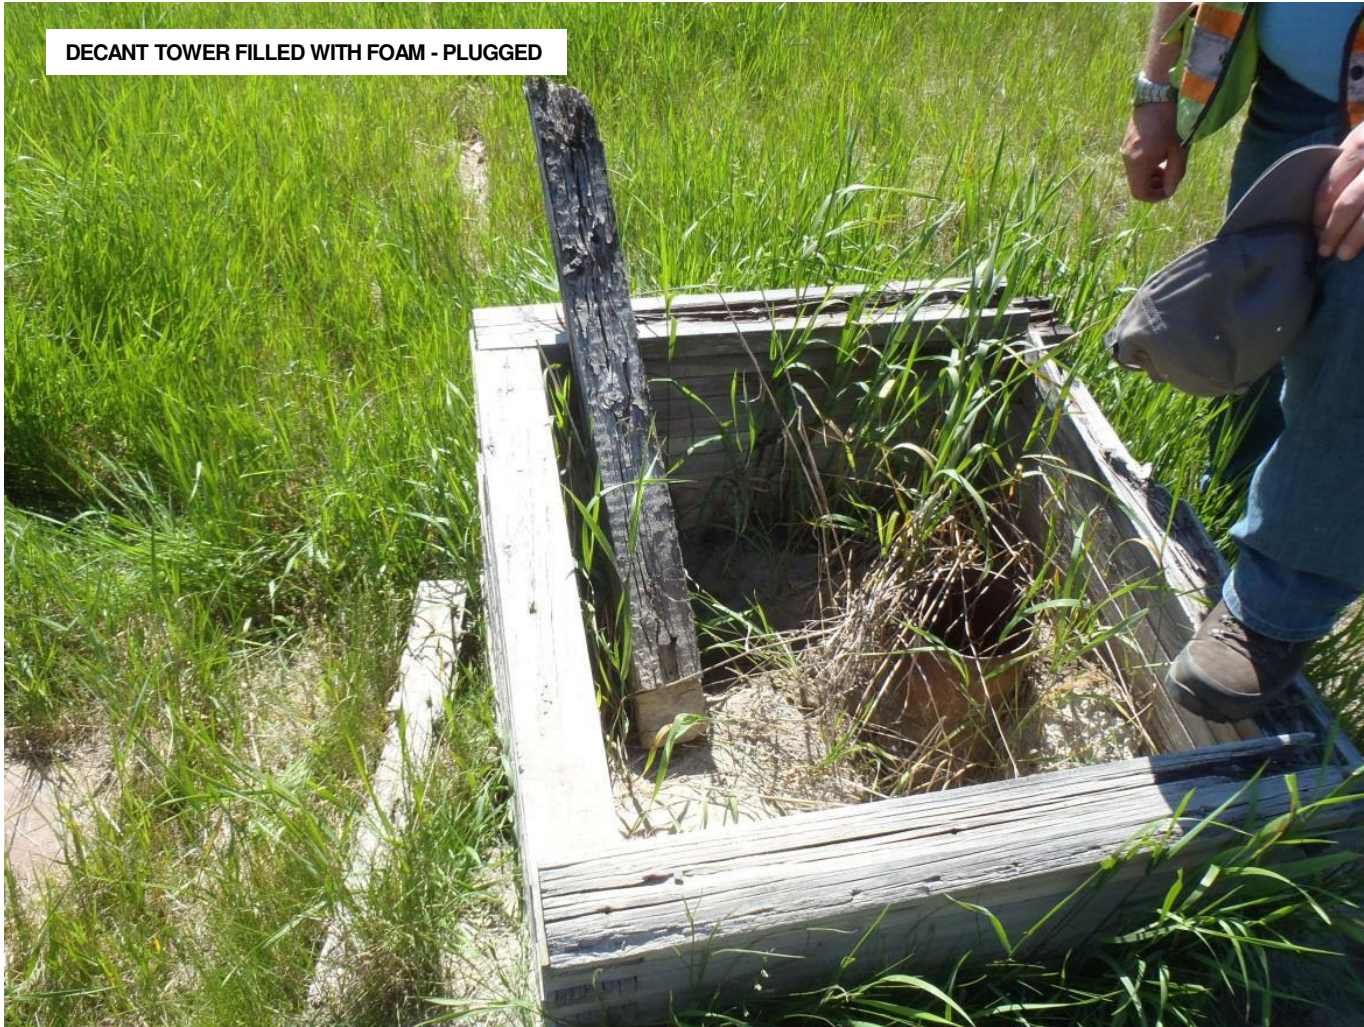
PHOTOGRAPH
A-10

DECANT TOWER FILLED WITH FOAM - PLUGGED
