# Beaverdell Tailings Storage Facilities 2018 Annual Dam Safety Inspection

*Teck Resources Limited - Beaverdell Mine*

Reference No. 18100805-122-R-Rev0-4000

29 March 2019

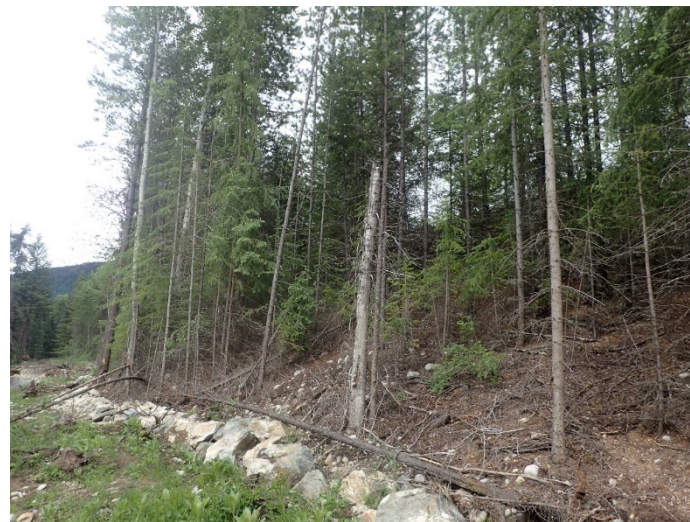
Photograph 10: South TSF, Cell 5, downstream dam face and buried riprap at toe of slope, looking southwest. 14 June 2018.

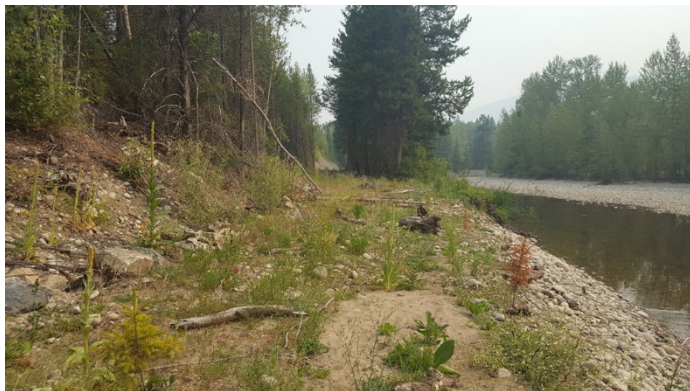
Photograph 11: South TSF, Cell 5, buried riprap at toe of TSF downstream slope, looking northeast. Low river flow. 8 August 2017.

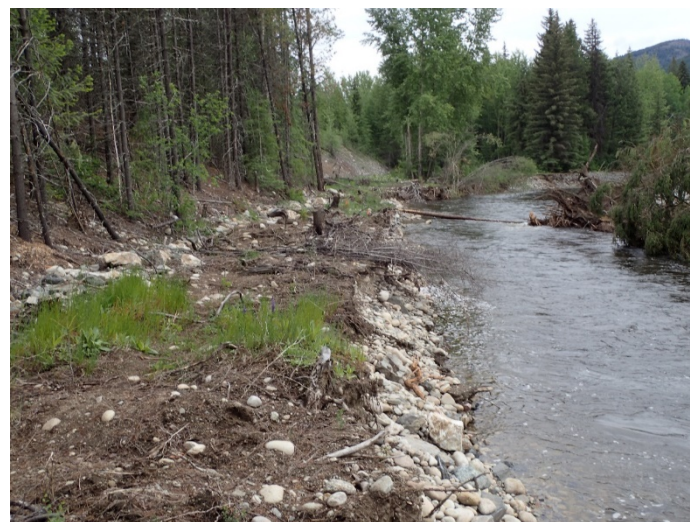
Photograph 12: South TSF, Cell 5, buried riprap at toe of TSF downstream slope, looking northeast. 14 June 2018.

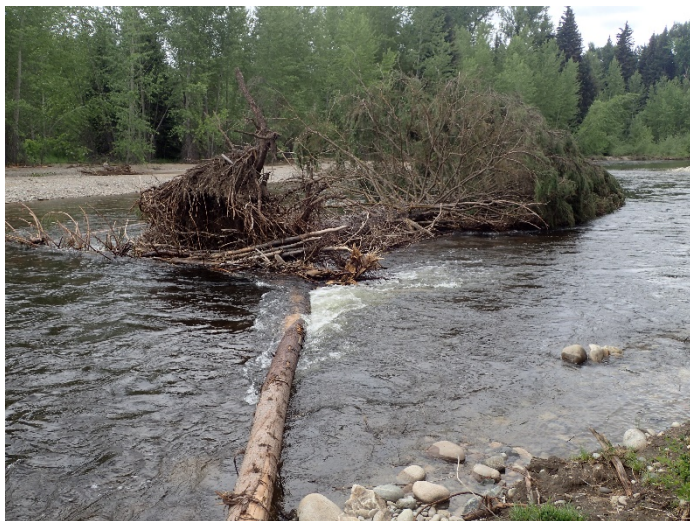
Photograph 13: South TSF, Cell 5, uprooted tree in the West Kettle River downstream of TSF toe, looking southeast. 14 June 2018.

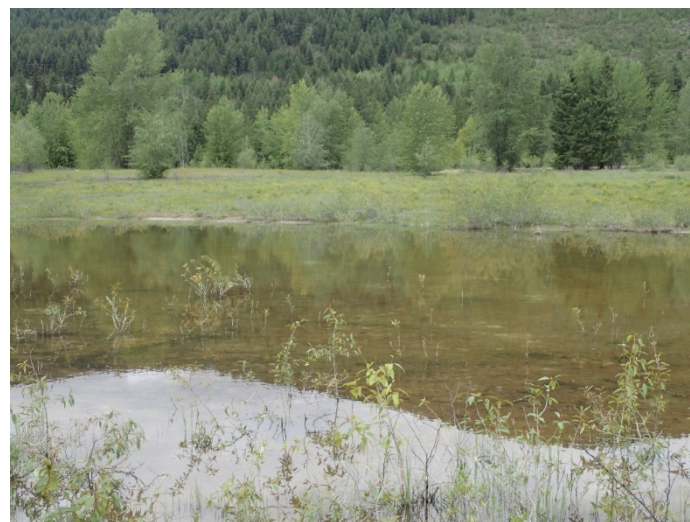
Photograph 16: South TSF, Cell 4, ponded water on tailings surface, looking northwest. 14 June 2018.

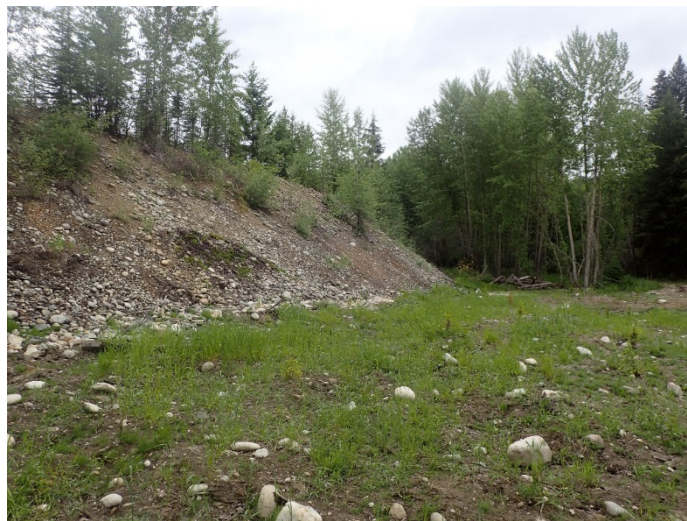
Photograph 18: South TSF, Cell 4, downstream slope and northern extent of buried riprap, looking northeast. 14 June 2018.

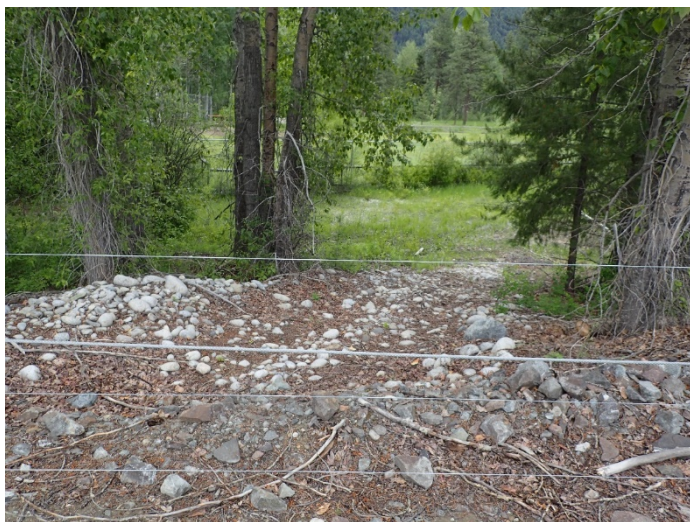
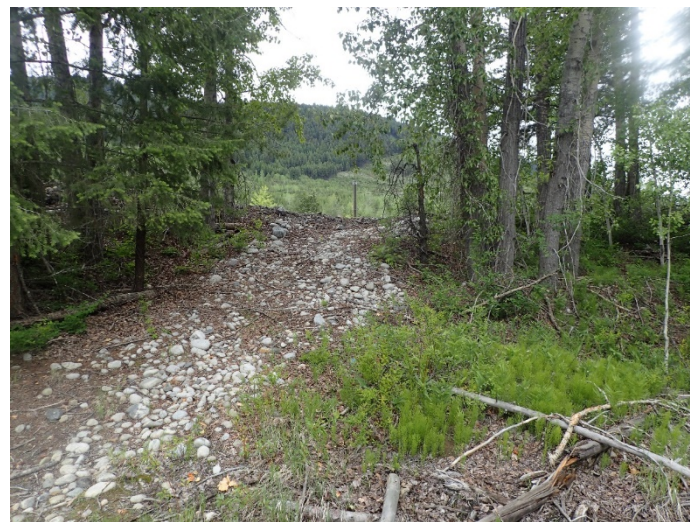
The condition of the Cell 3 spillway at the time of the DSI visit (before upgrade) is shown in Photographs 23 and 24 (Appendix A). The condition of the spillway in August 2018 is shown in Photographs 25 and 26 (Appendix A).

Photograph 23: South TSF, Cell 3, spillway from crest, looking east. 14 June 2018.

Photograph 24: South TSF, Cell 3, spillway from crest, looking west from downstream toe. 14 June 2018.

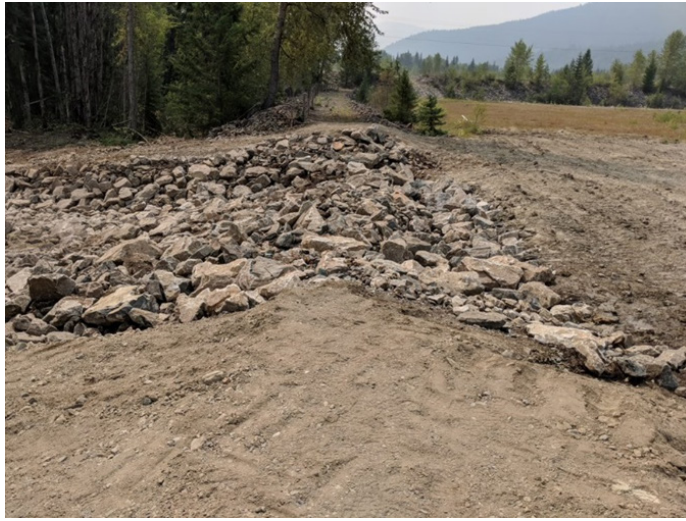
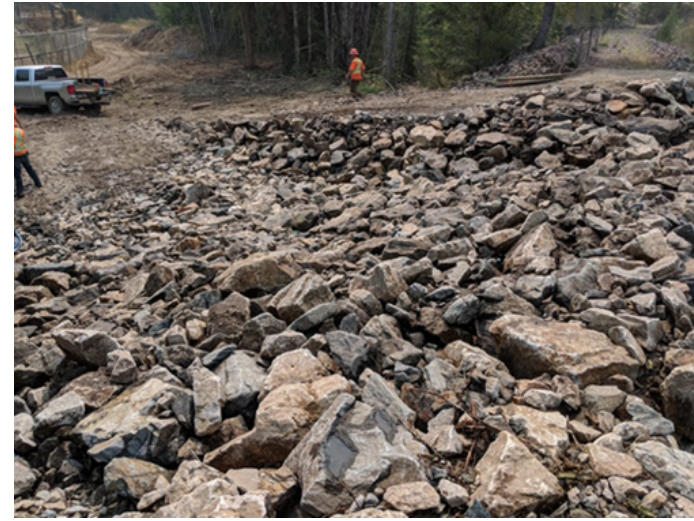
Photograph 25: South TSF, Cell 3, As-Built Spillway Crest., looking south 16 August 2018.

Photograph 26: South TSF, Cell 3, As-Built Spillway Downstream., looking southeast 16 August 2018.

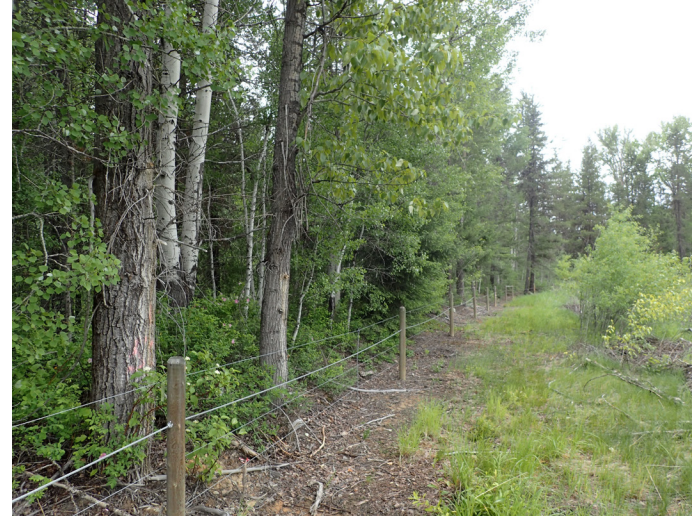
A number of trees within the Cell 3 dam crest were observed. These could present a potential risk to dam stability in that they could reduce the height of the Cell 3 dam should they fall (e.g., from high winds). Felling of these trees was completed by Teck in Q1 2019 as per Golder's preliminary recommendation following the DSI site visit in June 2018.

Photograph 30: South TSF, Cell 3, mature trees on dam crest, looking southeast. 14 June 2018.

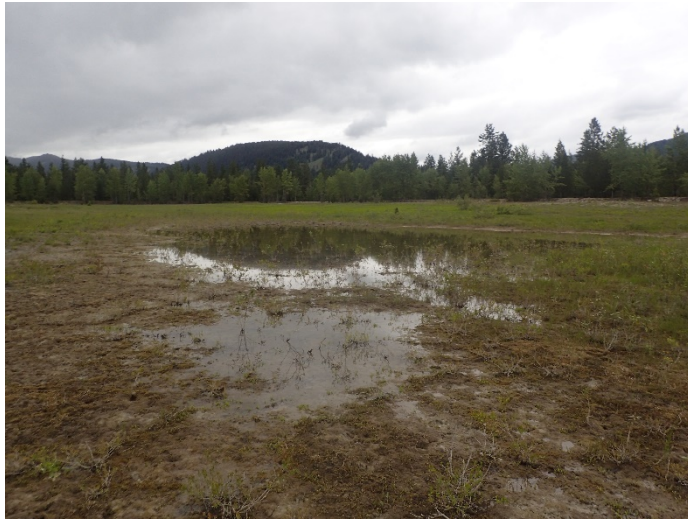
Photograph 33: North TSF, Cell 6, ponding water on tailings surface, looking north.  
14 June 2018.

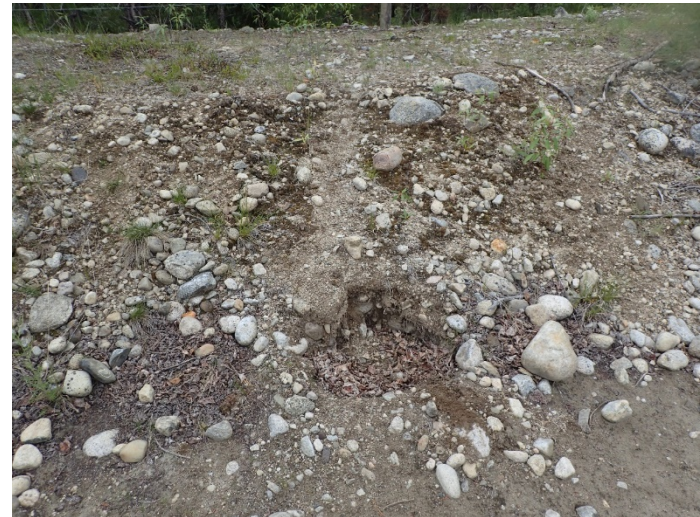
Photograph 36: North TSF, Cell 6, minor erosion in north embankment, looking northeast. 14 June 2018.

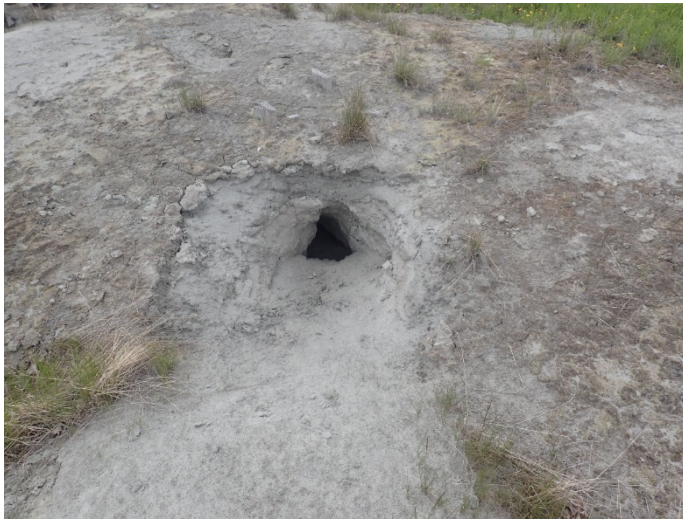
Photograph 47: North TSF, Cell 6, animal burrow in tailings surface, looking east.  
14 June 2018.
