Teck Highland Valley Copper Partnership

2018 Dam Safety Inspection Report

Bethlehem No. 1 Tailings Storage Facility

March 2019

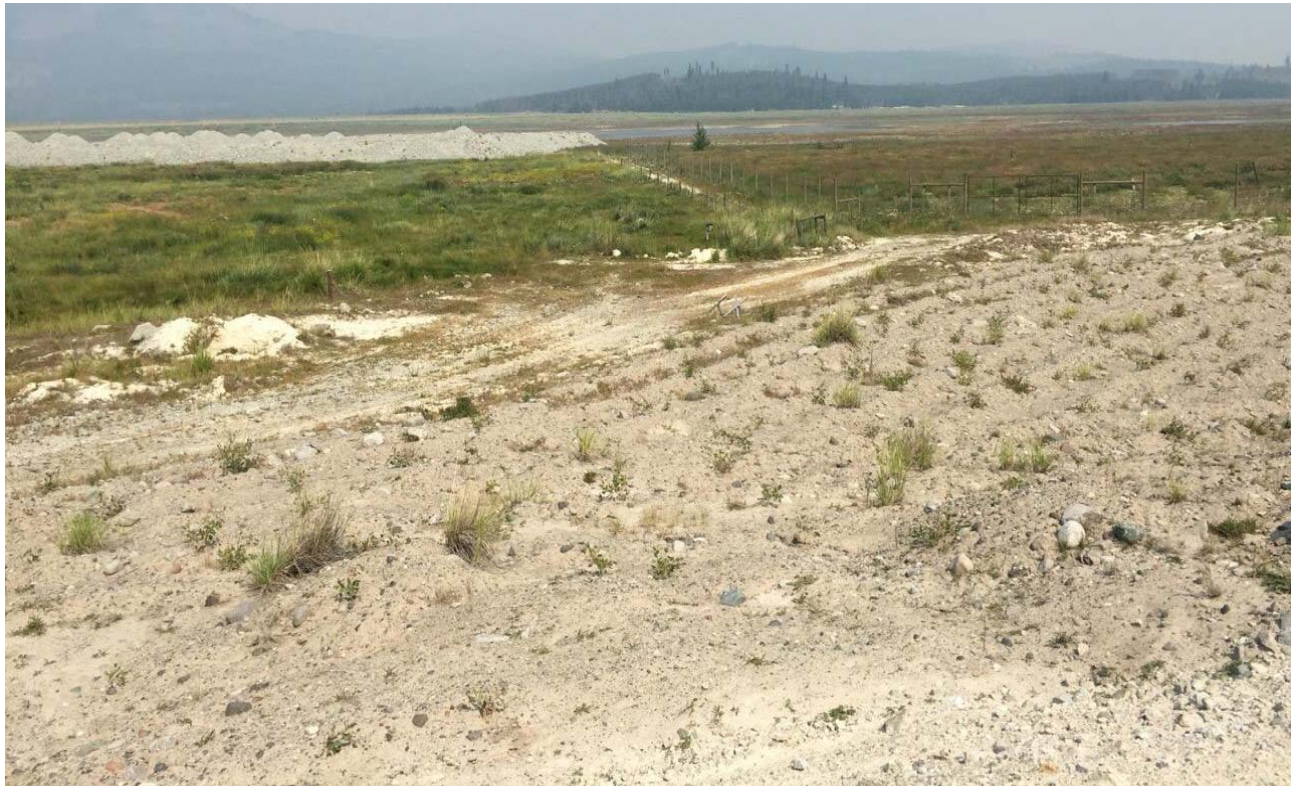
Photo II-A-1 Overview of tailings impoundment, looking north at Pond No. 1 and test fill pad. (BTH-2018-01)

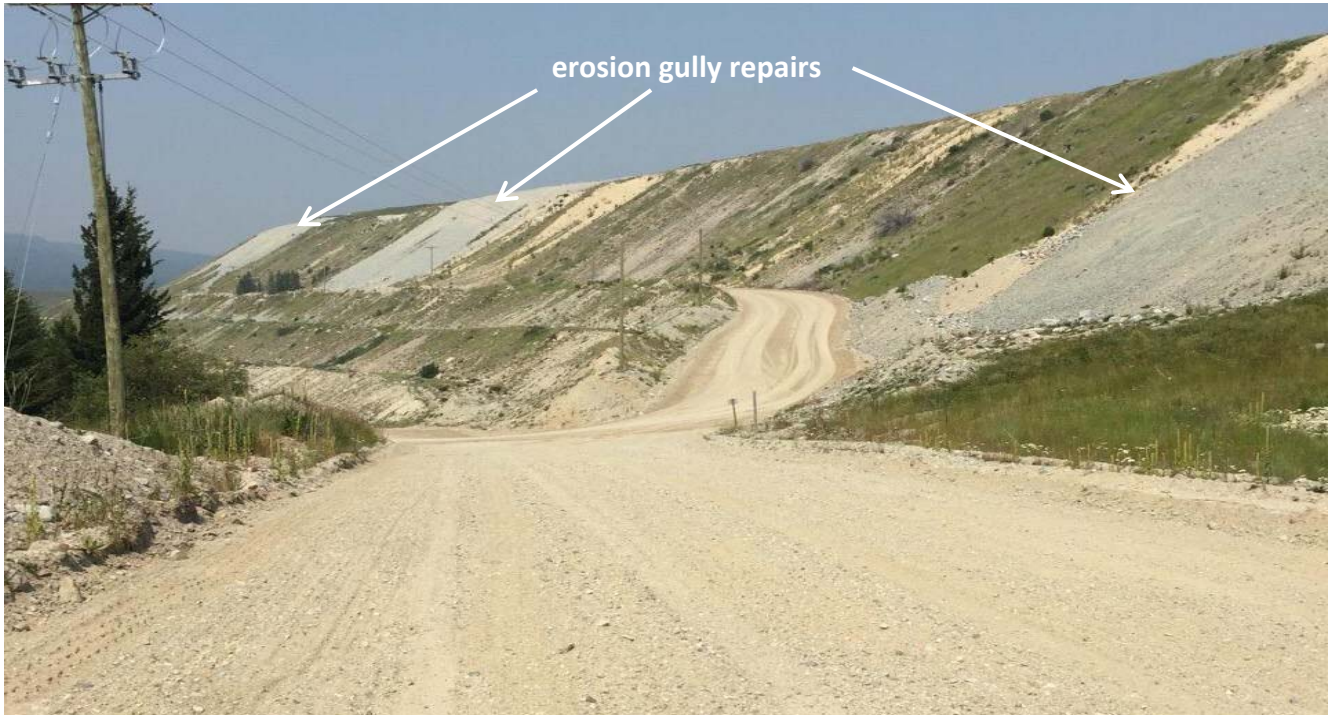
Photo II-A-4 Downstream slope of Dam No. 1, looking northeast. (BTH-2018-04)

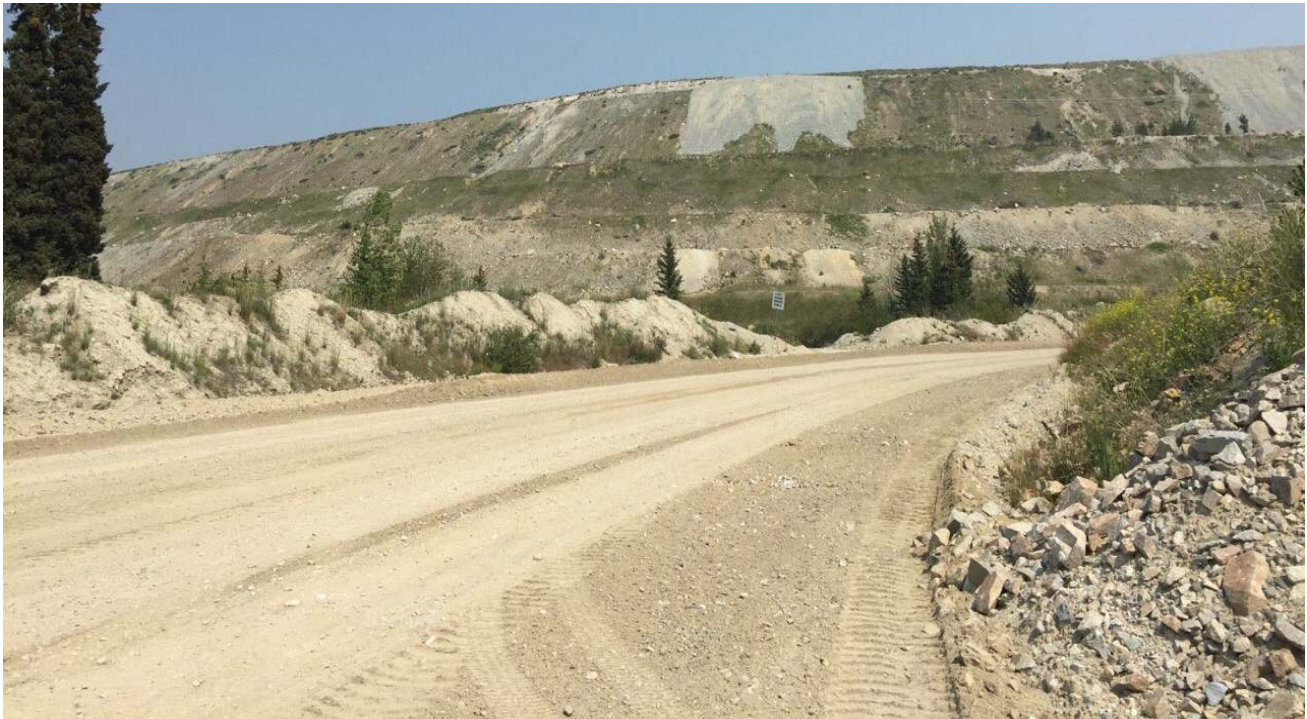
Photo II-A-5 Downstream slope of Dam No. 1, looking west from R3 Seepage Pond. (BTH-2018-05)

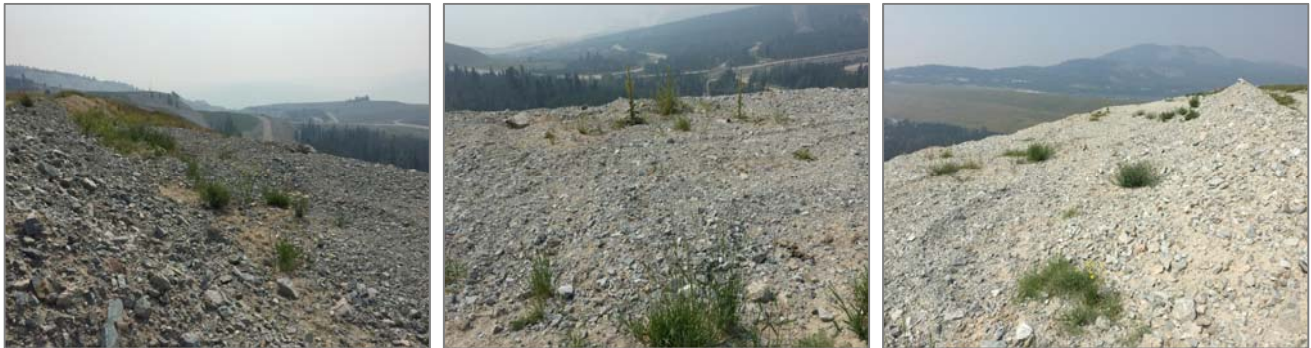
**Photo II-A-6 Downstream slope of Dam No. 1, looking (from left to right) south, west, north.
(BTH-2018-06)**

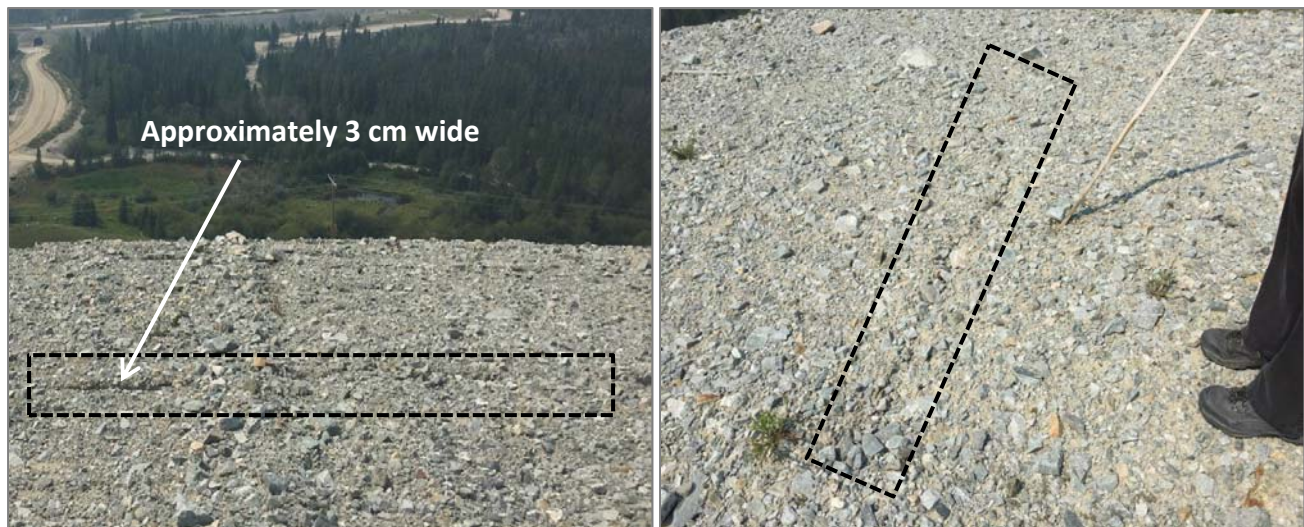
Photo II-A-7 Cracks (two separate instances shown in pictures below) on crest of rockfill placed in September 2015 as part of erosion gully repair. (BTH-2018-07)

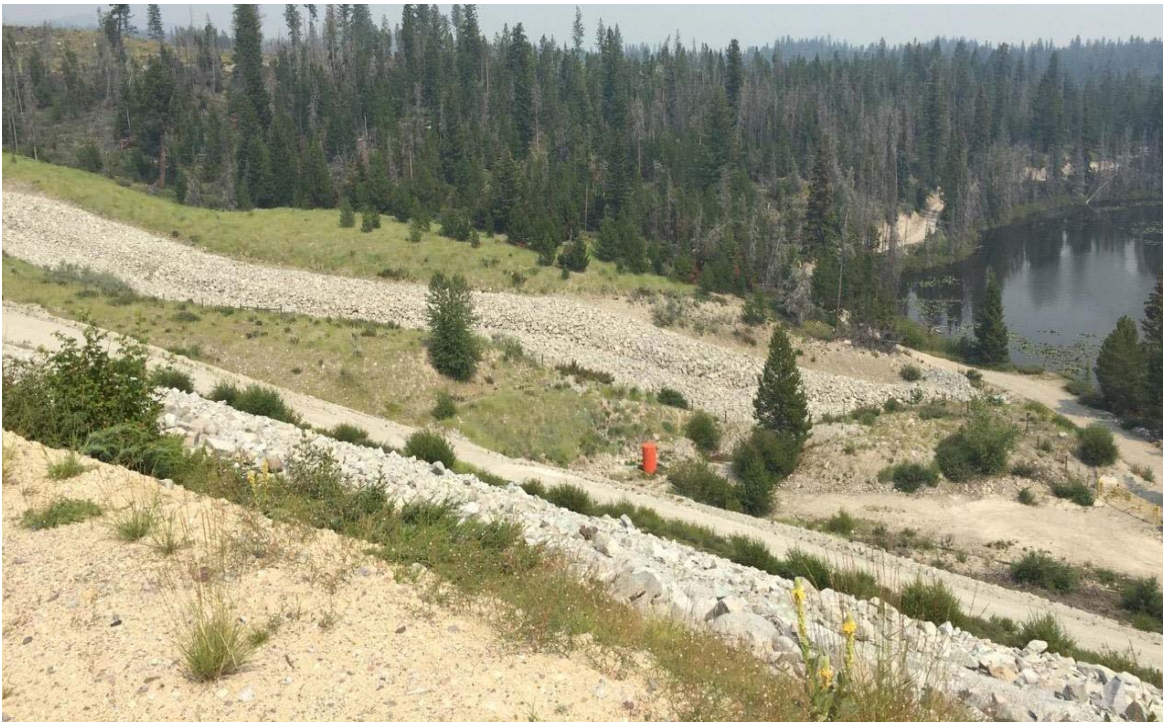
Photo II-B-12 Spillway overview (BTH-2018-15)

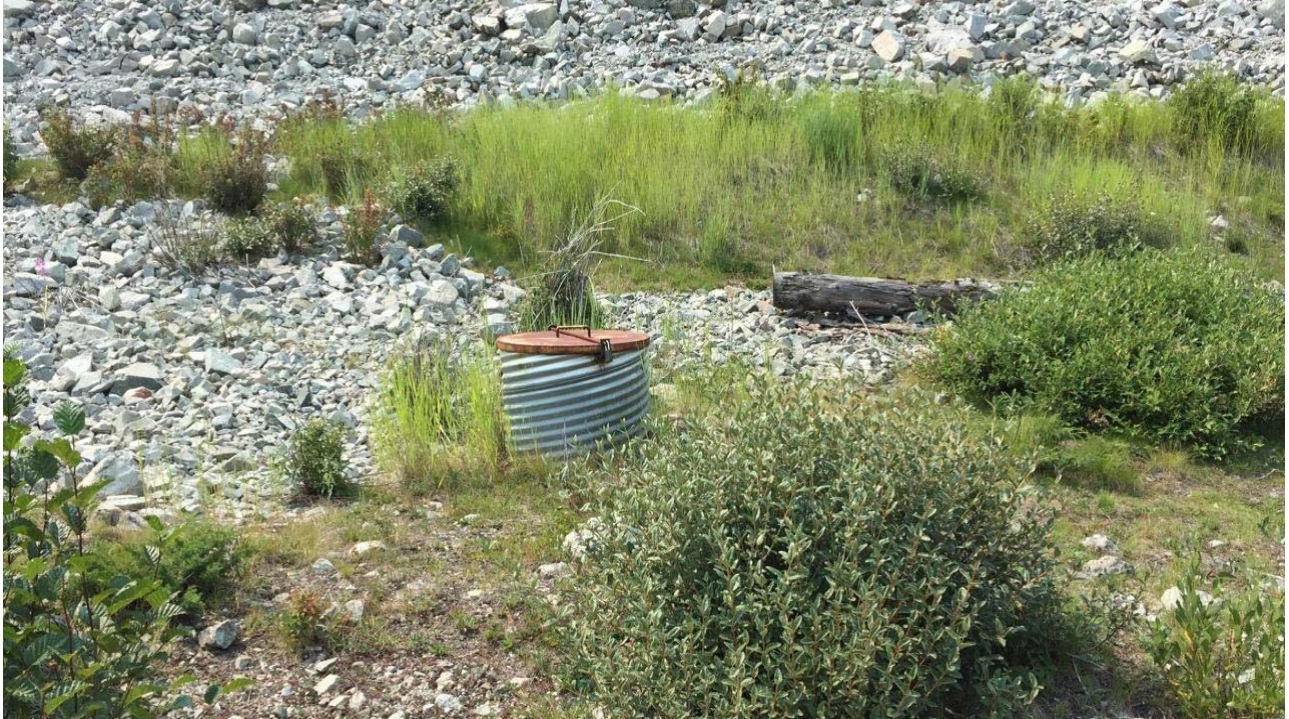
Photo II-B-13 Seepage relief well at downstream toe, looking west (upstream) (BTH-2018-16)

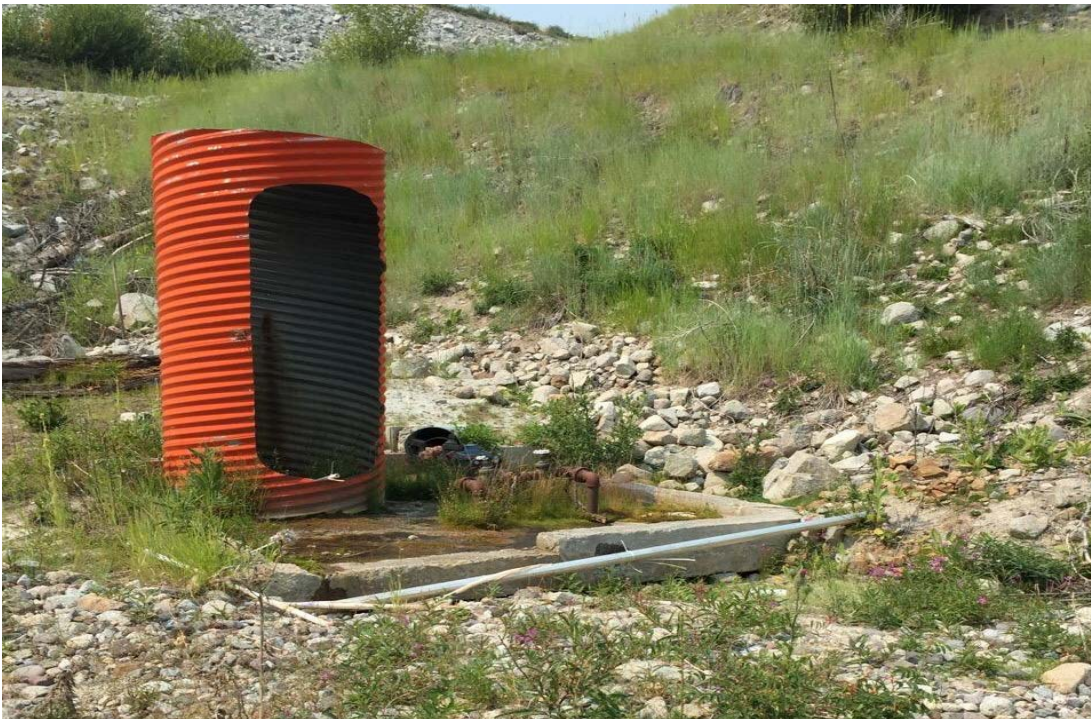
Photo II-B-14 Old gauge-house and decommissioned pump-well (BTH-2018-17)

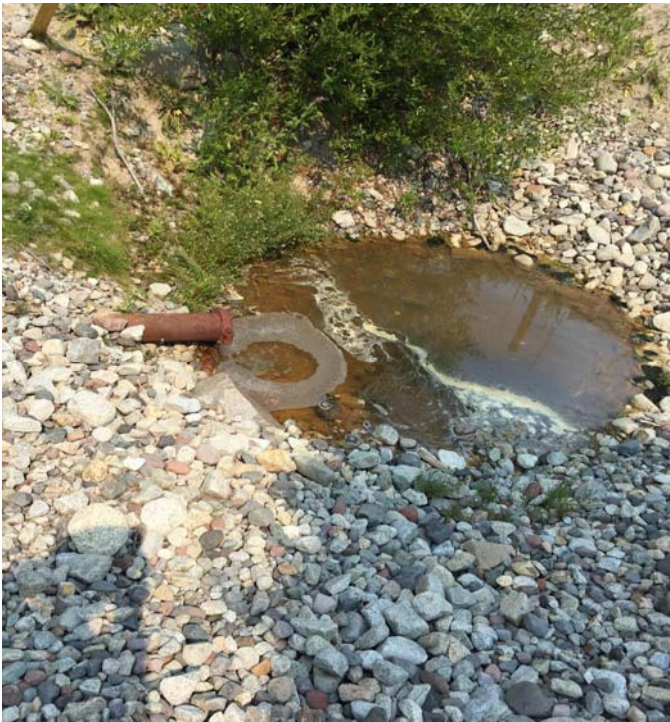
Photo II-B-15 Seepage outflow to riprap lined infiltration basin (BTH-2018-17)

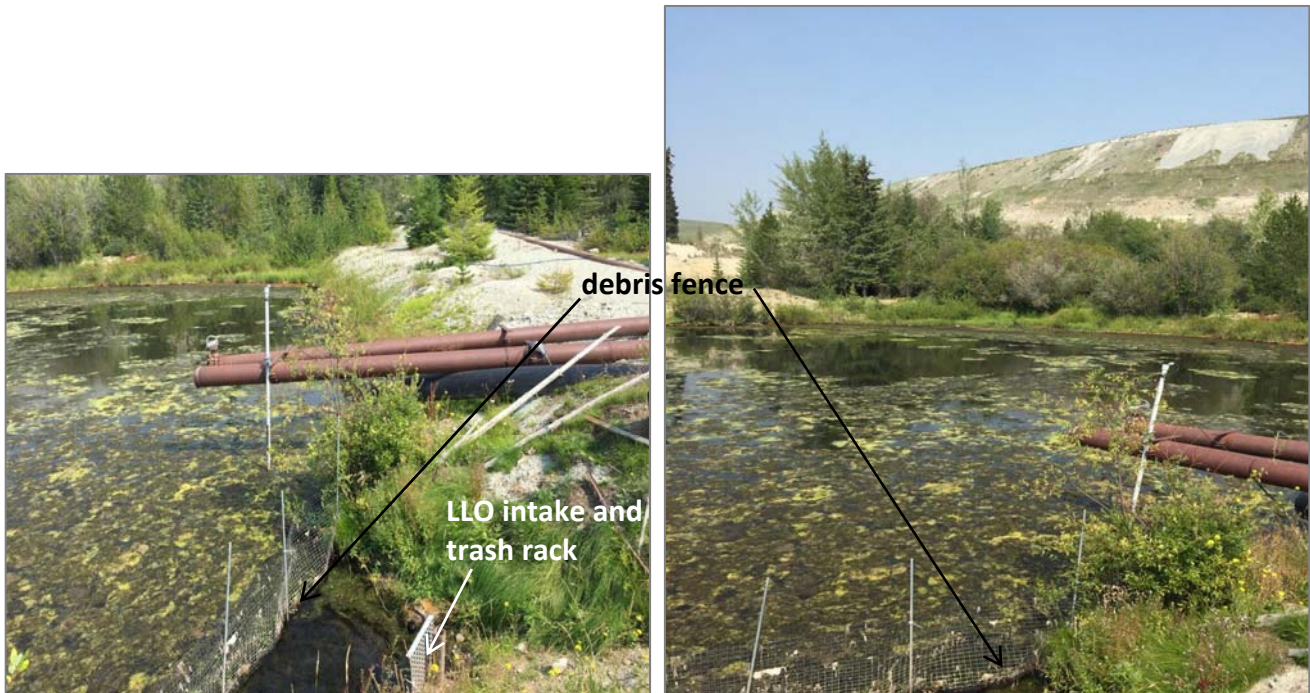
Photo II-C-4 Pond and debris fence for low-level outlet (BTH-2018-21)
