# Teck Resources Limited

## Bullmoose Mine

### *2018 Dam Safety Inspection*

### *Bullmoose Tailings Dam*

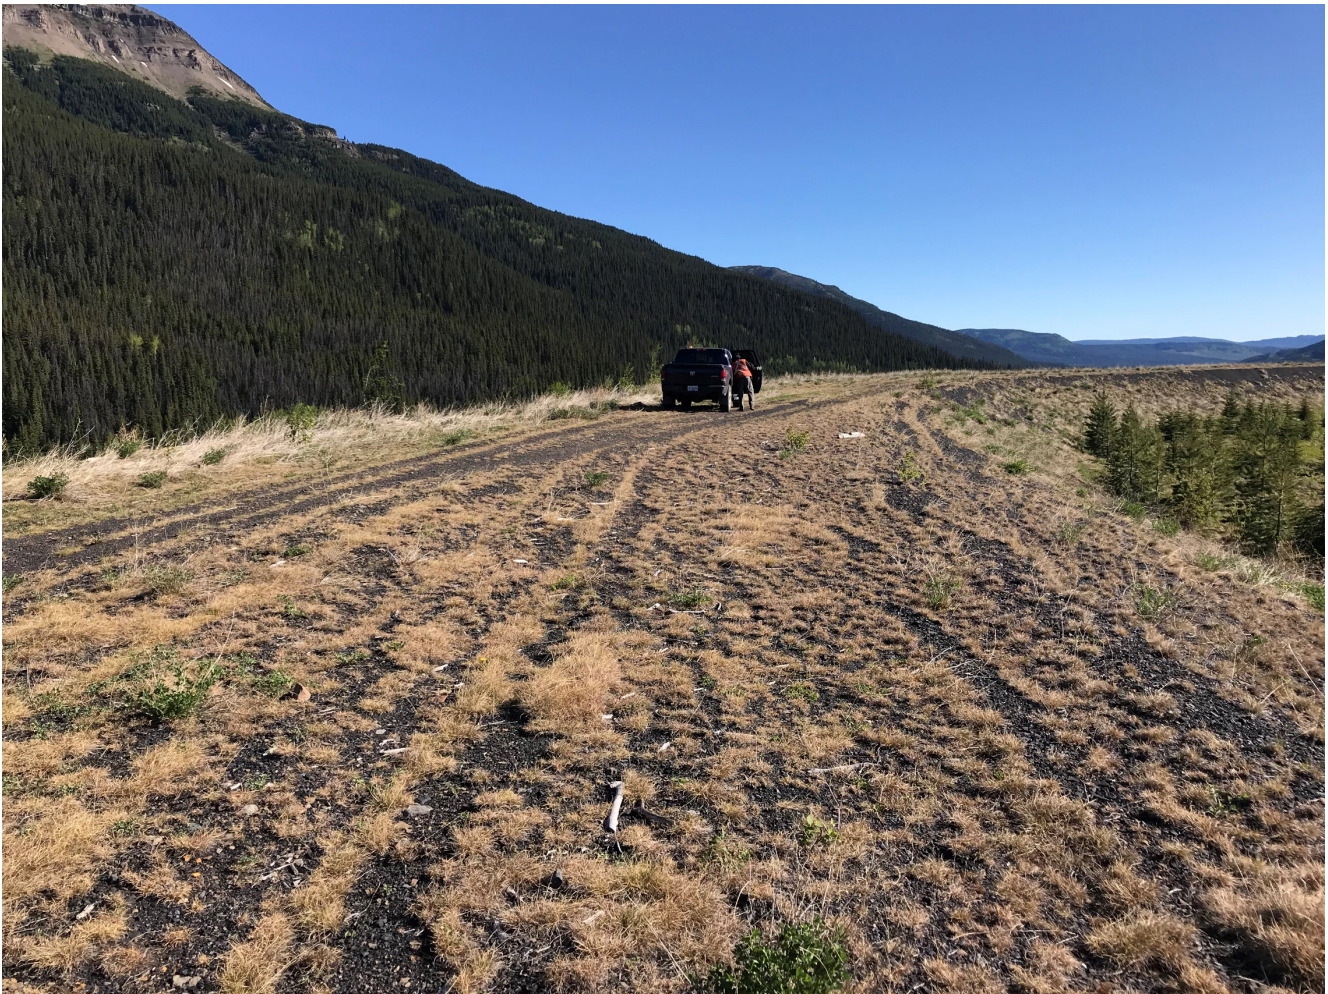
**Photo II-1 Overview of BTD crest – looking east. Slope is in good condition and no signs of erosion, settlement or cracking (BTD-2018-01)**

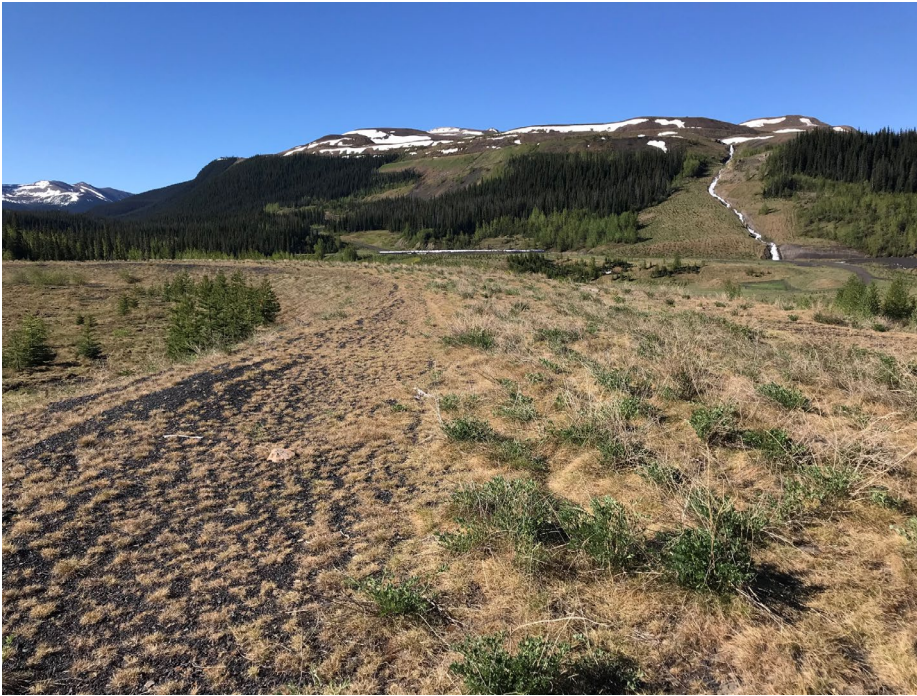
**Photo II-2 Overview of BTD crest - looking south. No signs of distress (BTD-2018-01)**

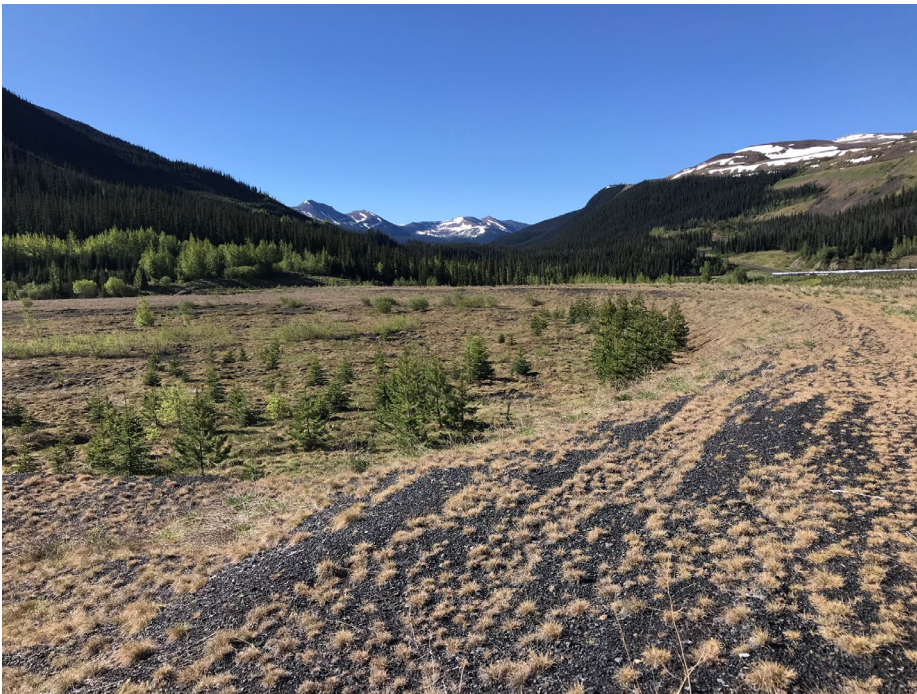
**Photo II-3 Overview of upstream slope - looking south. Slope is in good condition and no sign of distress (BTD-2018-01)**

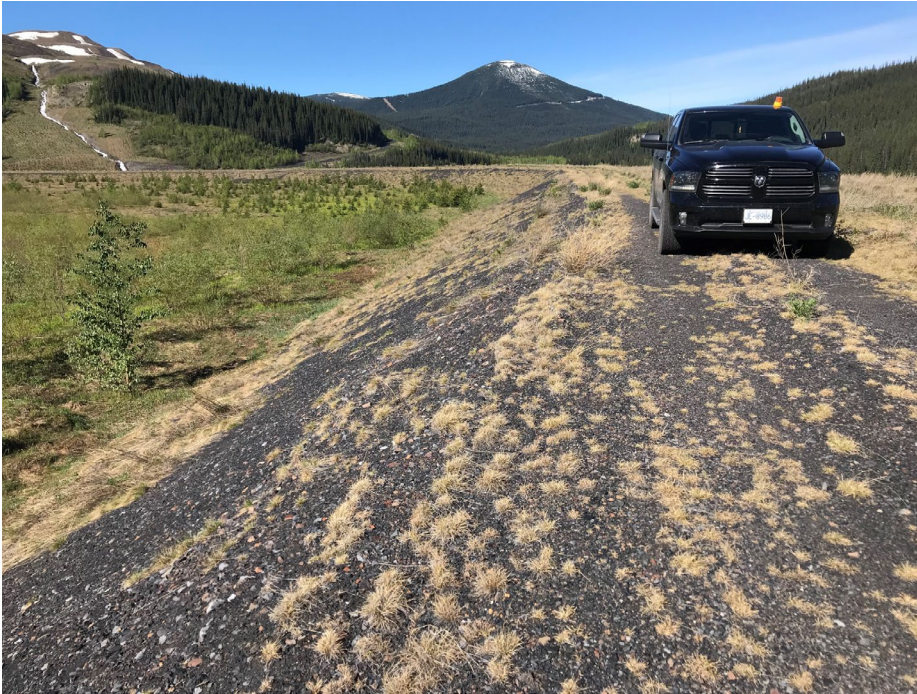
**Photo II-4 Overview of upstream slope - looking southwest. Slope is in good condition and no sign of distress (BTD-2018-02)**

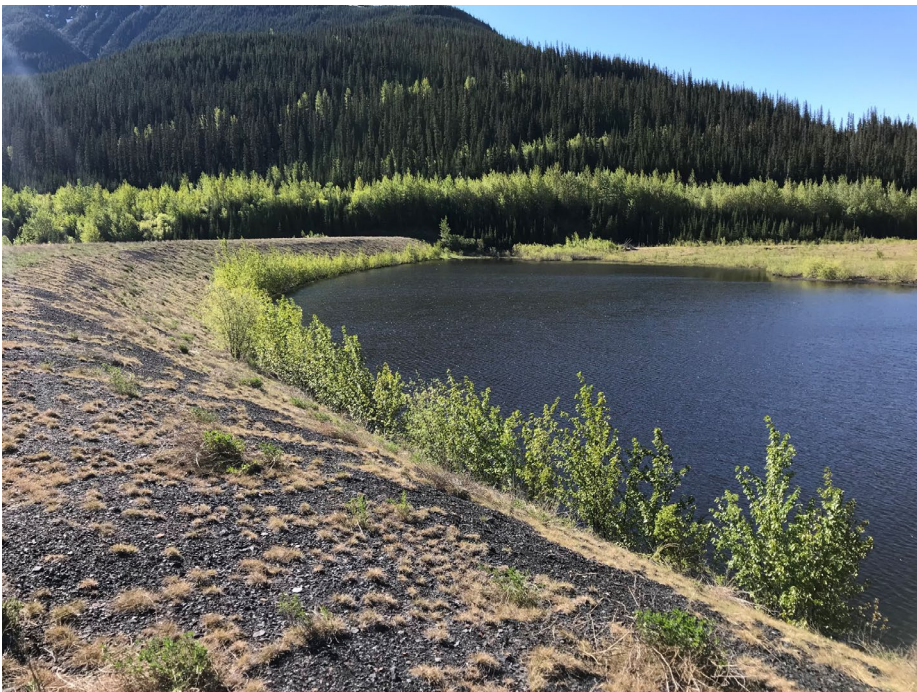
**Photo II-5 Overview of ponded area. Pond level appears to be elevated due to spring freshet - higher than previous year observation (not a dam safety concern) (BTD-2018-03)**

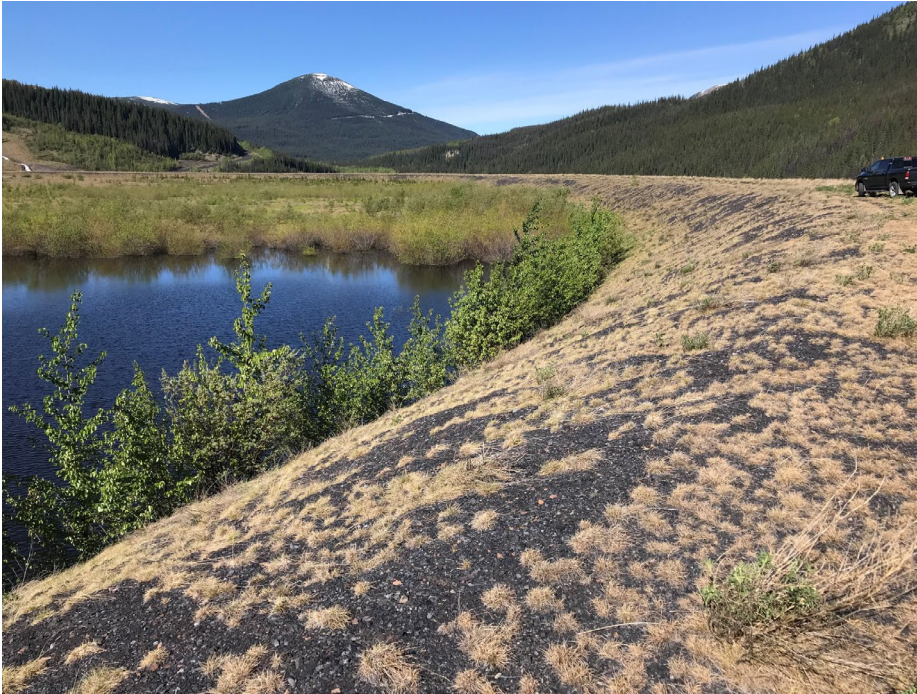
**Photo II-6 Overview of upstream slope - looking north. Slope is in good condition and no signs of distress (BTD-2018-03)**

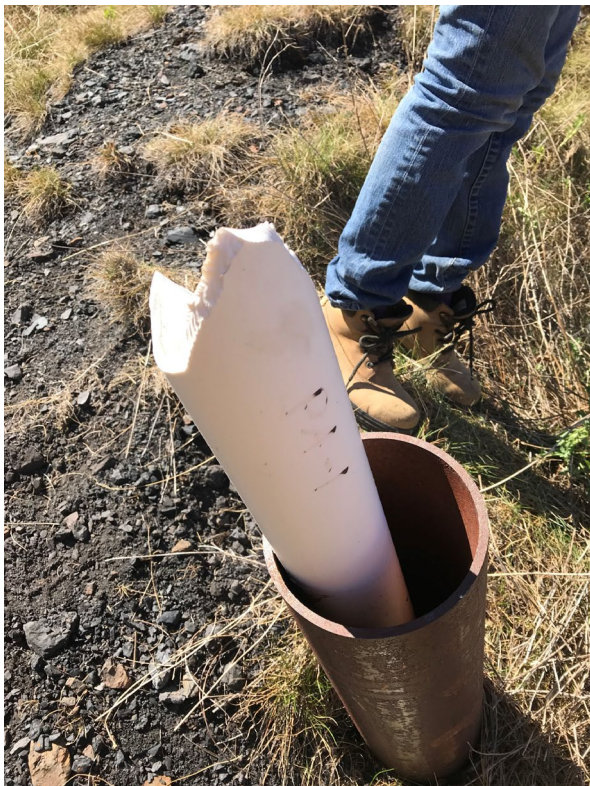
**Photo II-7 Standpipe piezometer PA-1 – top of casing requires trimming (BTD-2018-04)**

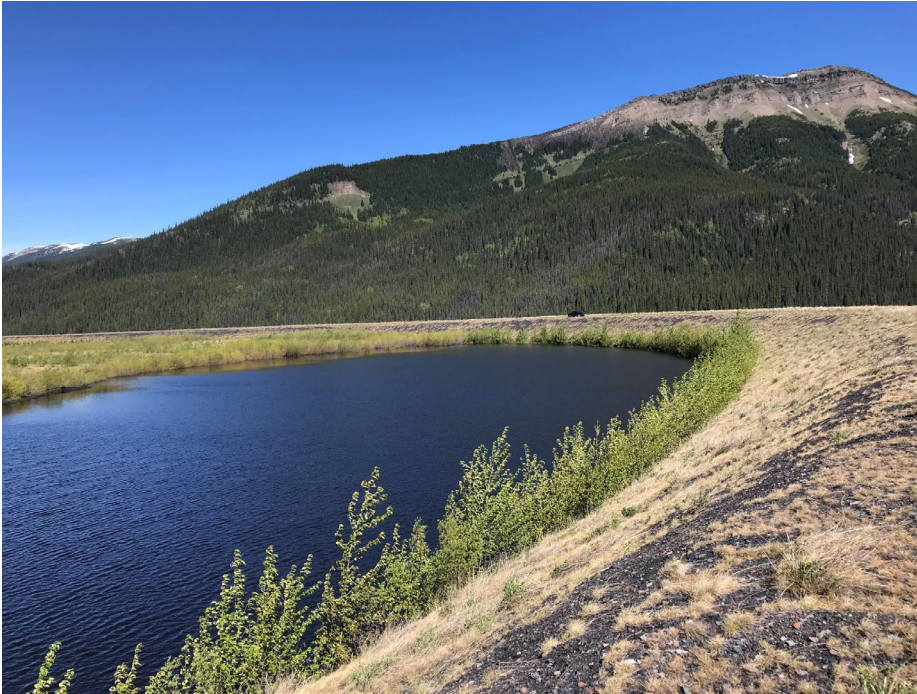
**Photo II-8 Overview of upstream slope adjacent to the ponded area - looking northwest. Slope is in good condition and no signs of distress (BTD-2018-05)**

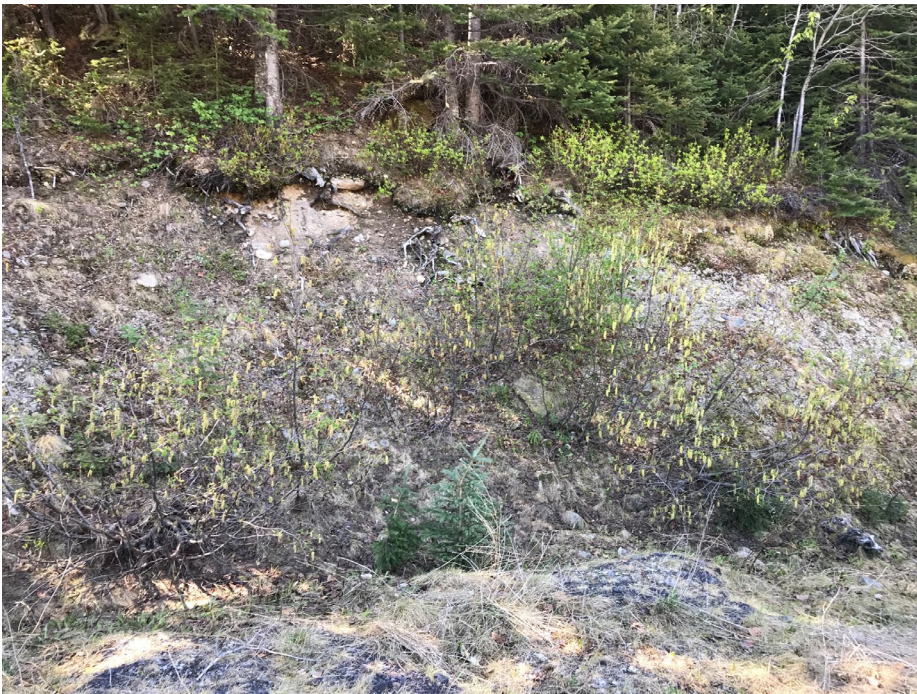
- **East Abutment:** Good condition. No signs of significant erosion or displacement of the natural slope. Vegetation is well established at the abutment and along the abutment/downstream slope contact (Photo II-9). A small channel running along BTD downstream slope contact with east abutment towards the toe had an estimated flow of 1 L/min and appeared to be unchanged from 2017 condition (Photos II-11 and II-12).

**Photo II-9 Over view of BTD east abutment – looking south. No changes were observed since 2016 (BTD-2018-06)**

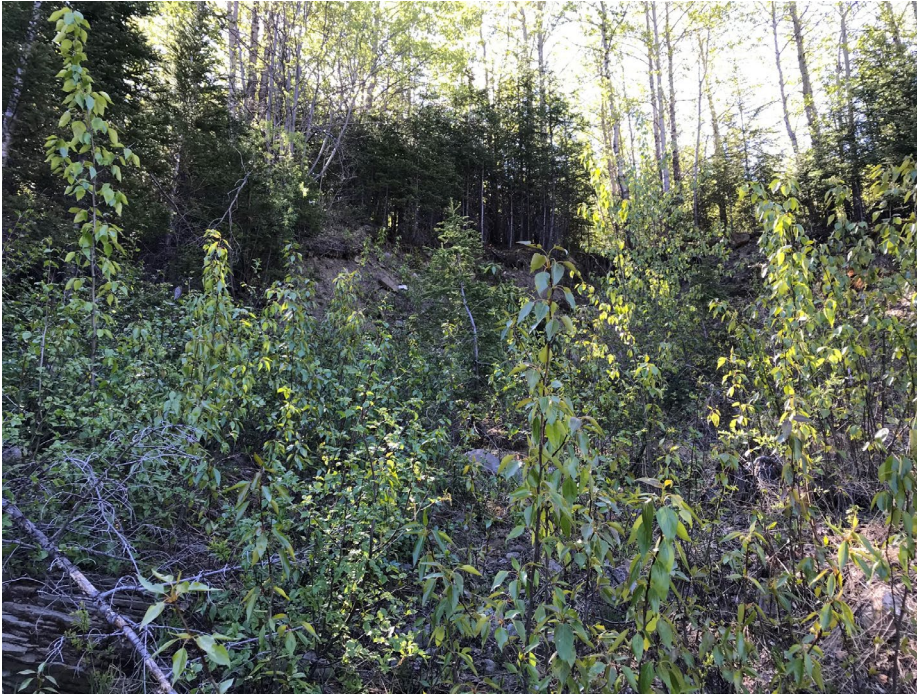
**Photo II-10**    Historical slide area on a natural slope south of the impoundment – looking south.  
No significant changes since 2015 observation (BTD-2018-07)

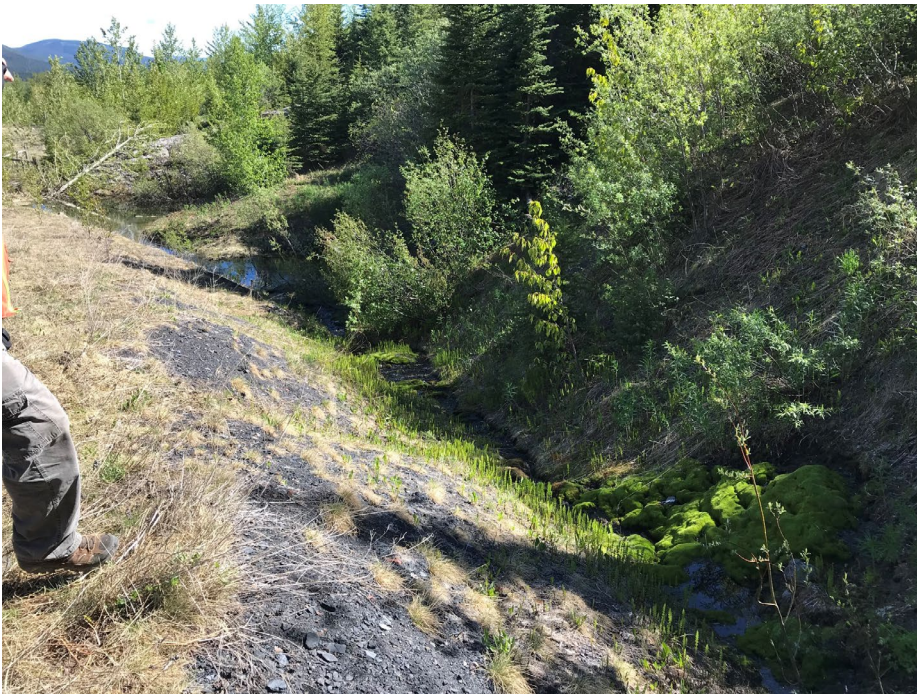
**Photo II-11**    Side channel which runs downslope from the east abutment – looking northeast.  
Flow was approximately 1 L/min (BTD-2018-08)

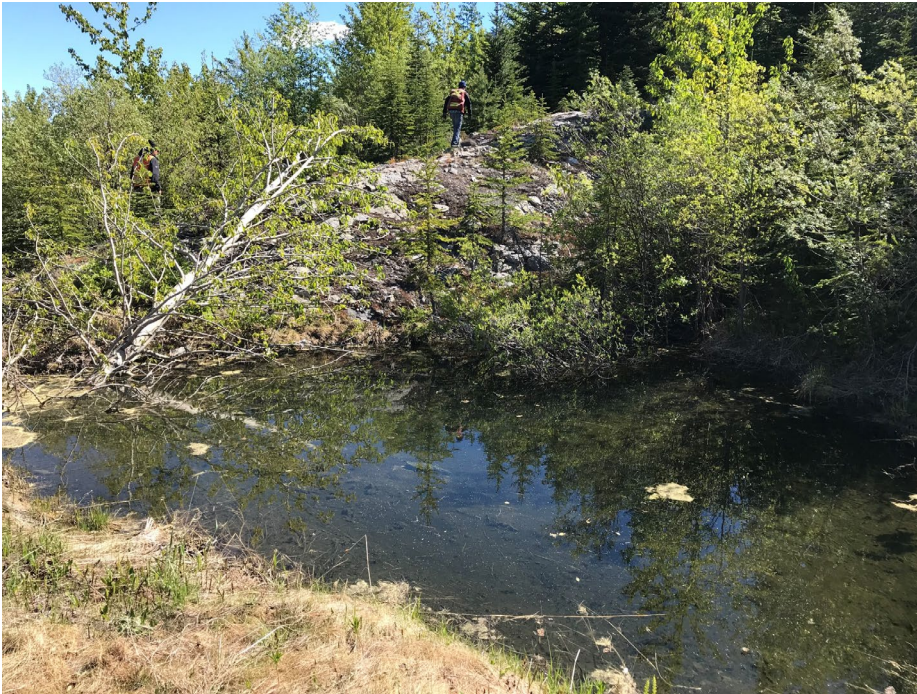
**Photo II-12** Ponded area downstream of the east abutment – looking north. Water level appears to be elevated due to freshet when compared to 2017 observation (BTD-2018-09)

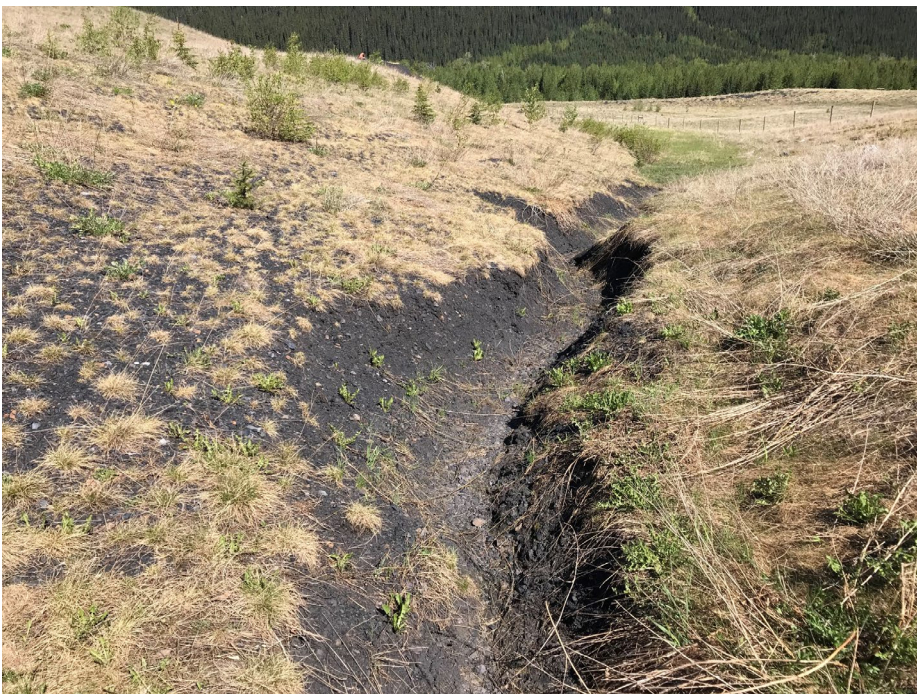
An erosion gully on the east downstream slope, likely caused by concentrated local flow during spring freshet, was inspected in 2018 (Photo II-13 at BTM-2018-10 on Figure 2). The gully is approximately 0.2 m to 0.3 m wide, 0.08 m to 0.11 m deep and 10 m to 15 m long and appeared to be unchanged from 2017 condition. This feature should be monitored and inspected for signs of changes during the routine visual inspections and annual DSI site visits.

**Photo II-13** Rain/snowmelt erosion feature – looking north. The gully is approximately 0.2 m to 0.3 m wide, and 0.8 m to 1.1 m deep, and approximately 10 m to 15 m long. No significant changes from 2017 observation (BTD-2018-10)

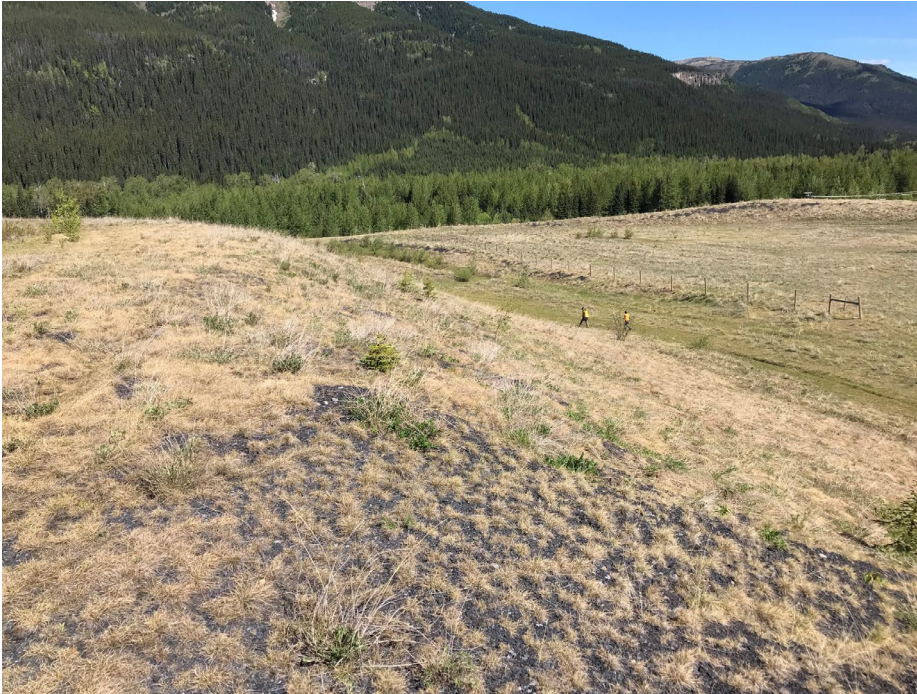
**Photo II-14** Overview of the lower downstream slope – looking north. Photo was taken standing on the mid-slope bench. No signs of distress (BTD-2018-11)

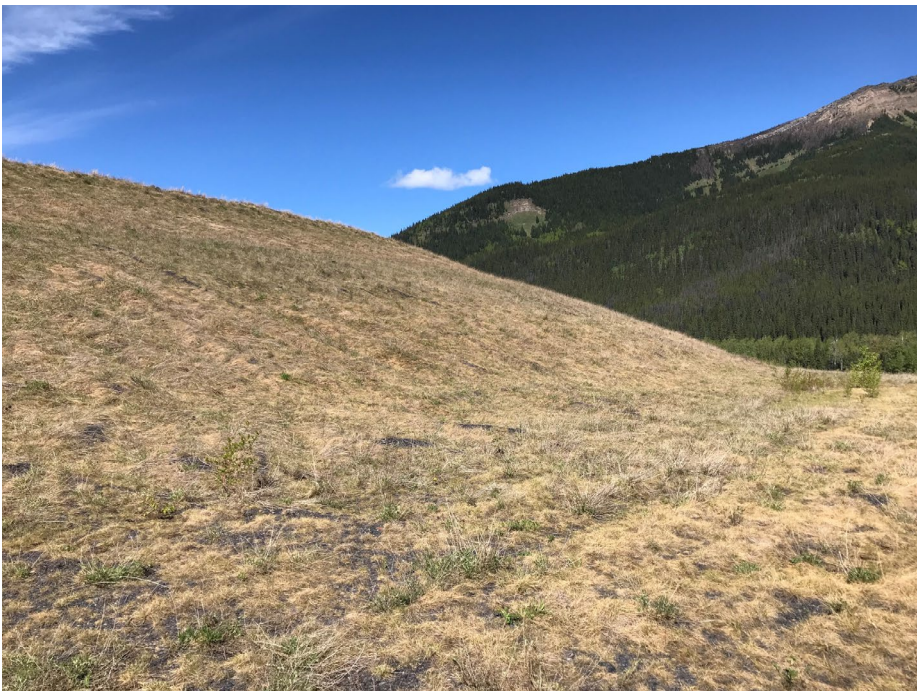
**Photo II-15** Overview of the upper downstream slope – looking northwest. Photo was taken standing on the mid-slope bench. No signs of distress (BTD-2018-12)

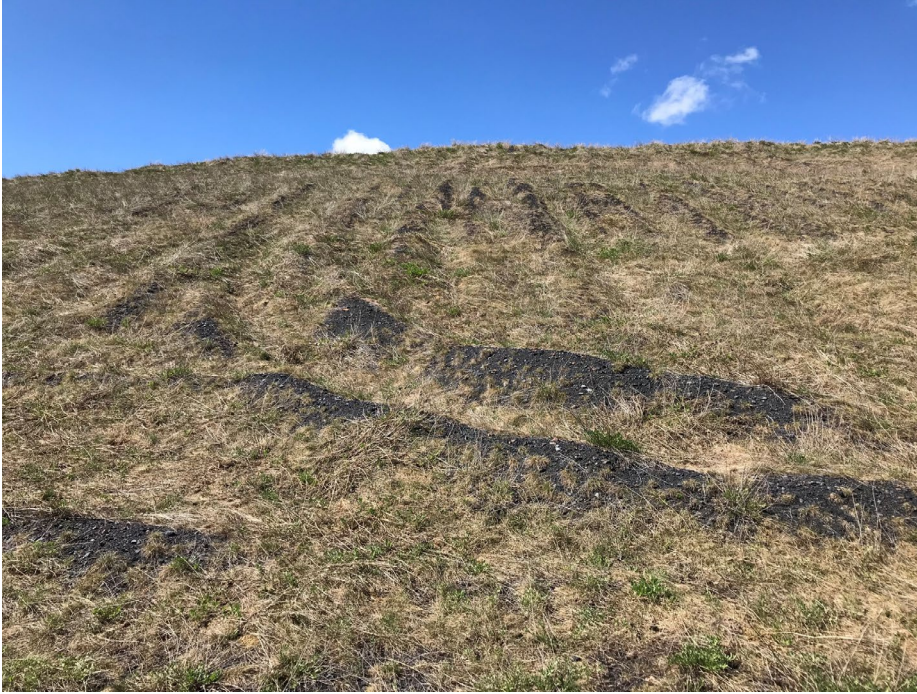
**Photo II-16** Overview of the upper portion of the downstream slope – looking southwest. Possible slope break observed likely due to normal soil erosion and rilling (BTD-2018-12)

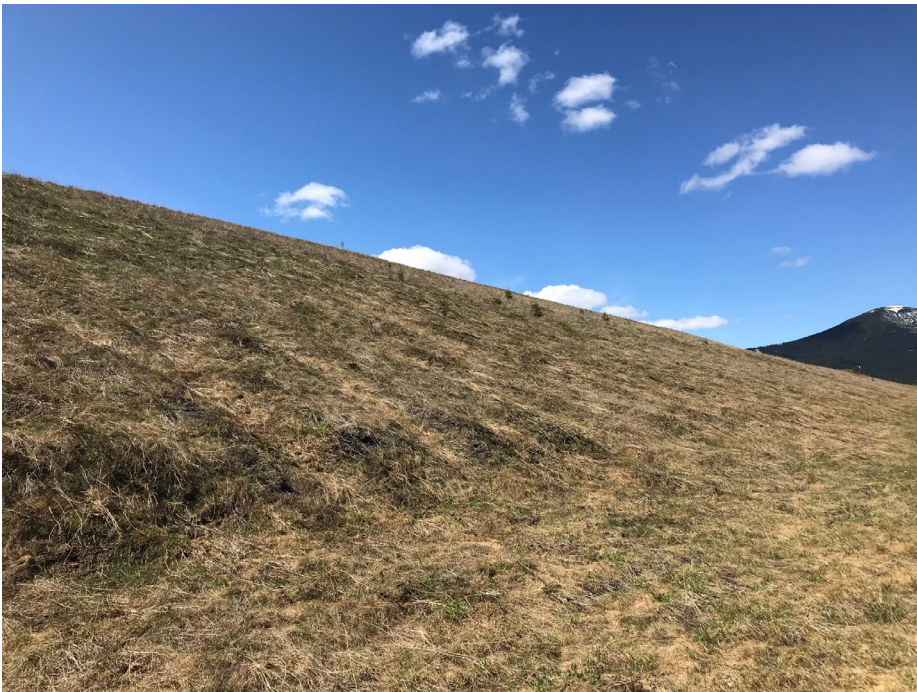
**Photo II-17** Upper portion of the downstream slope – looking north. Slope is in good condition with no signs of erosion or movement (BTD-2018-13)

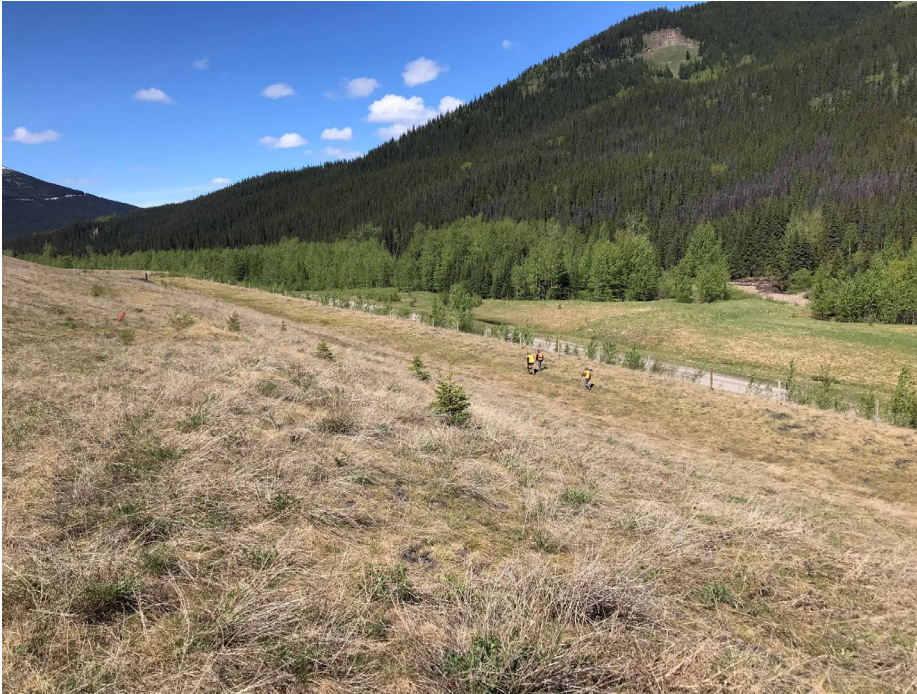
**Photo II-18** Lower portion of the downstream slope – looking west. Slope is in good condition with no signs of erosion or movement (BTD-2018-14)

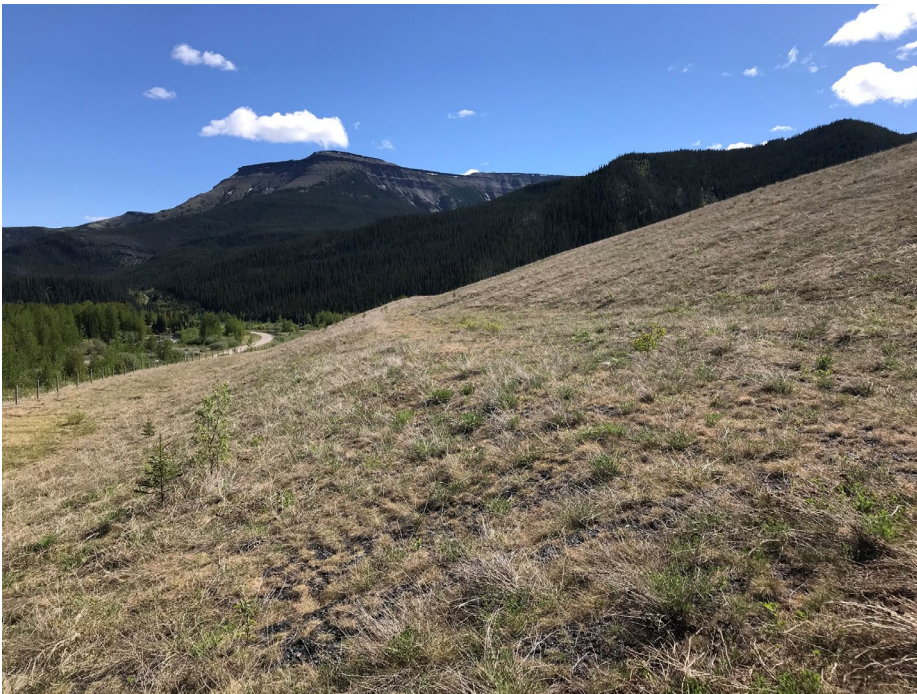
**Photo II-19** Overview of the downstream slope – looking east. Slope is in good condition with no signs of erosion or movement (BTD-2018-14)

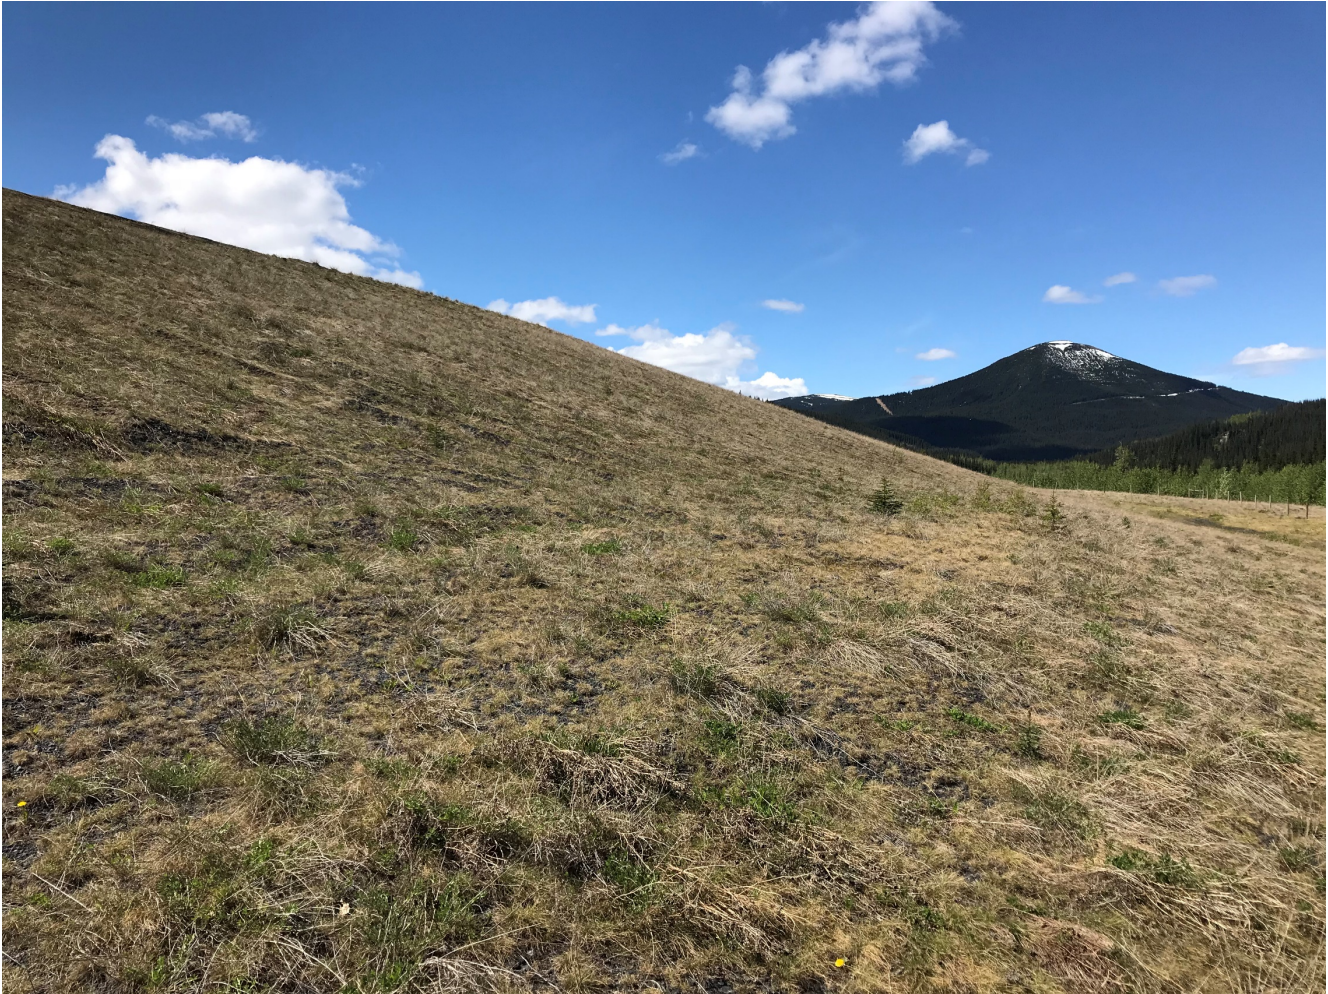
**Photo II-20**    **Overview of the downstream slope – looking west. Slope is in good condition with no signs of erosion or movement (BTD-2018-15)**

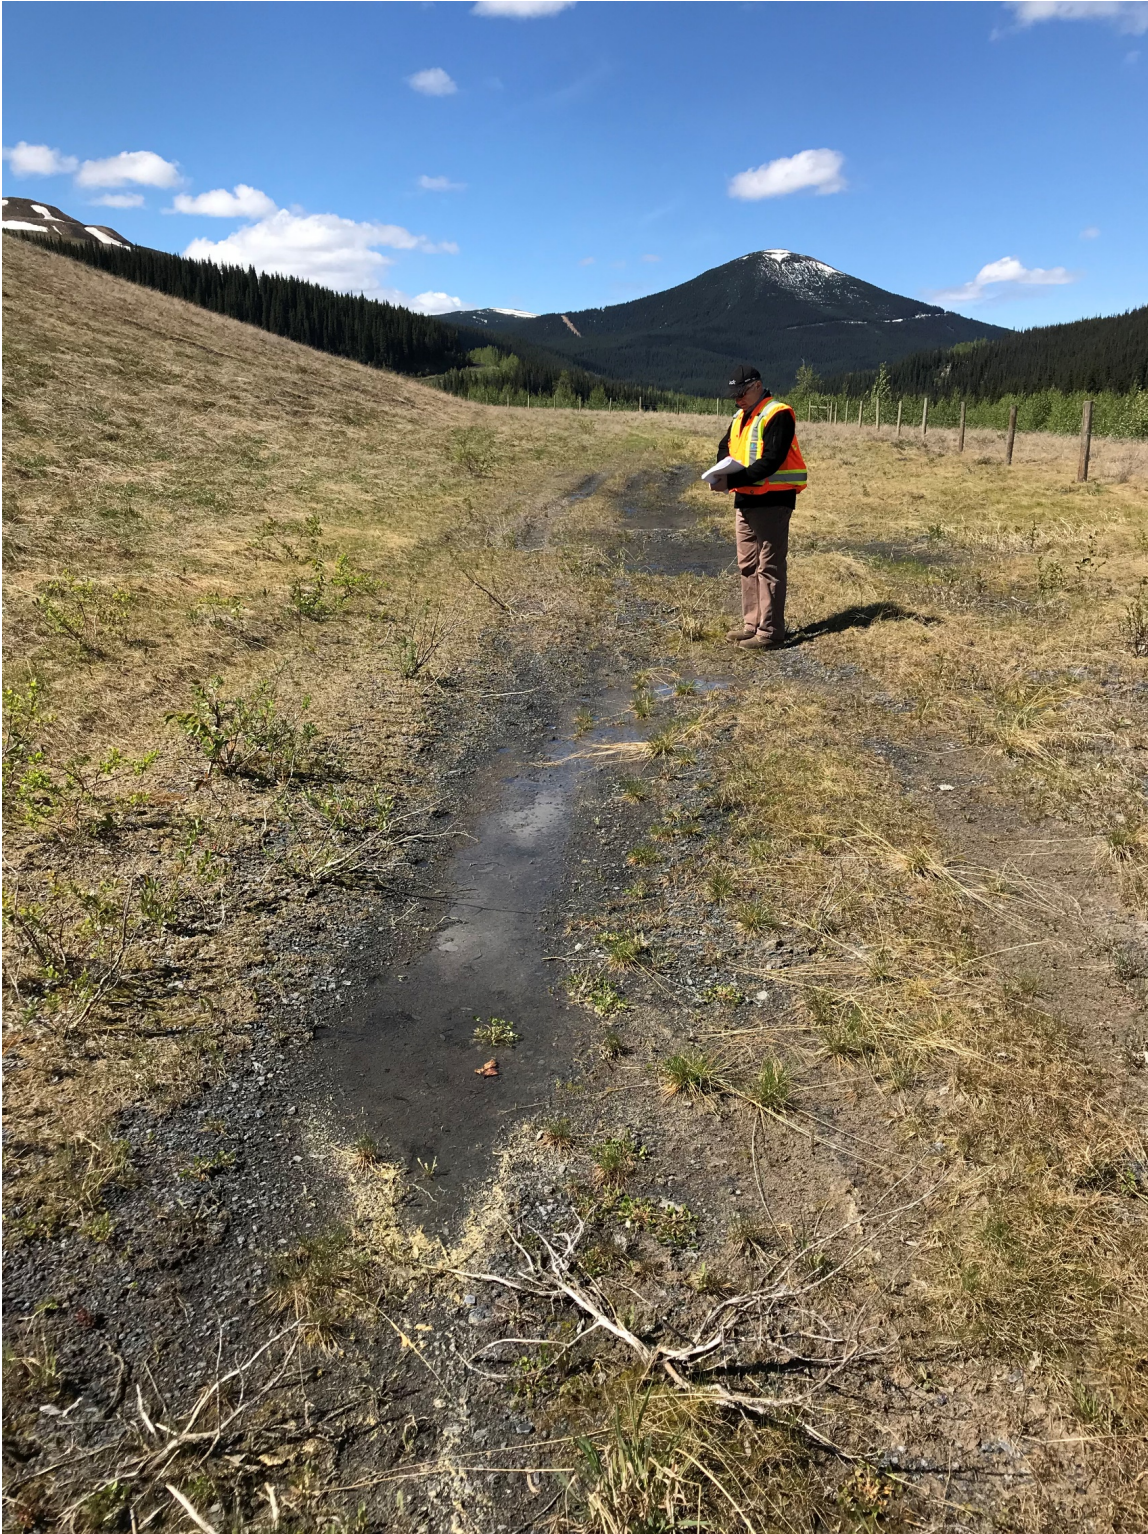
A small boggy area was noted at the toe of the north arm of the BTD during the DSI site visit (Photo II-21). Ponded water is likely due to snowmelt/freshet.

**Photo II-21** Boggy area observed at the toe – looking west. Ponded water likely due to recent freshet (BTD-2018-16)

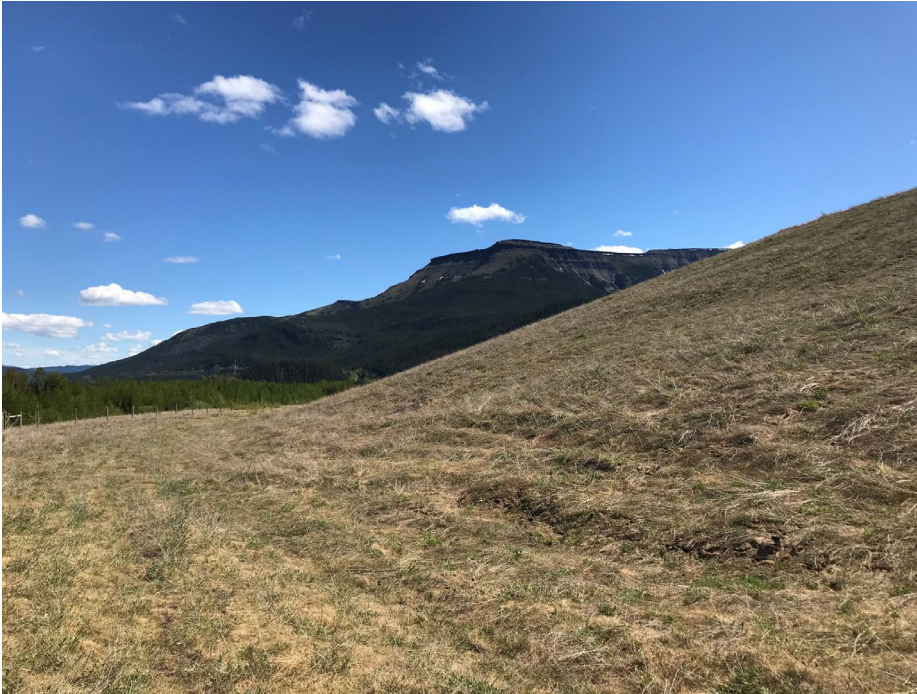
**Photo II-22** Downstream slope – looking east. Slope is in good condition with no signs of erosion or movement (BTD-2018-17)

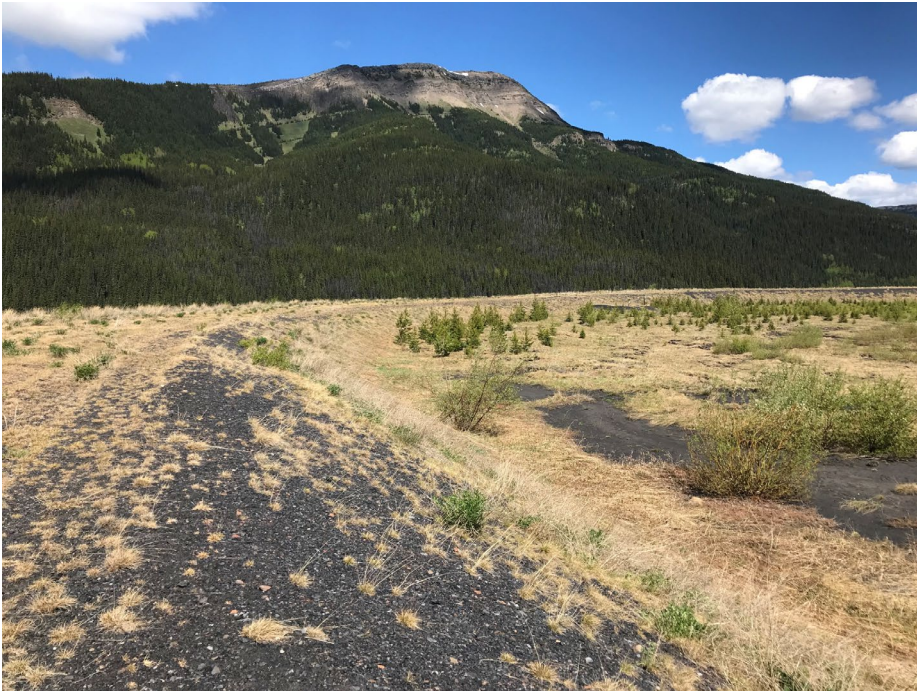
**Photo II-23** Upstream slope – looking north. Slope is in good condition with no signs of erosion or movement (BTD-2018-18)

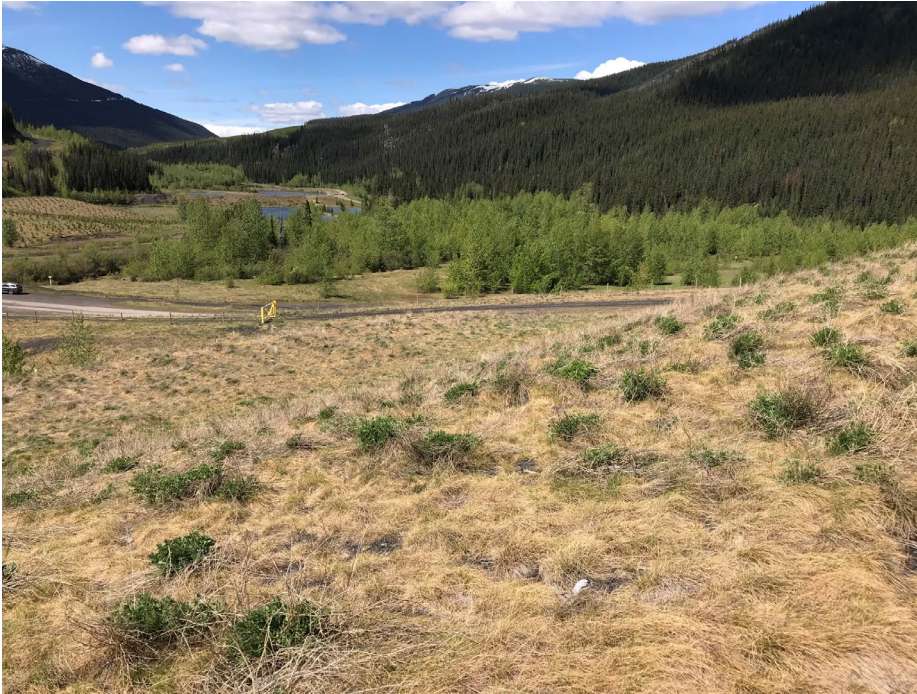
**Photo II-24** Downstream slope – looking west. Slope is in good condition with no signs of erosion or movement (BTD-2018-19)

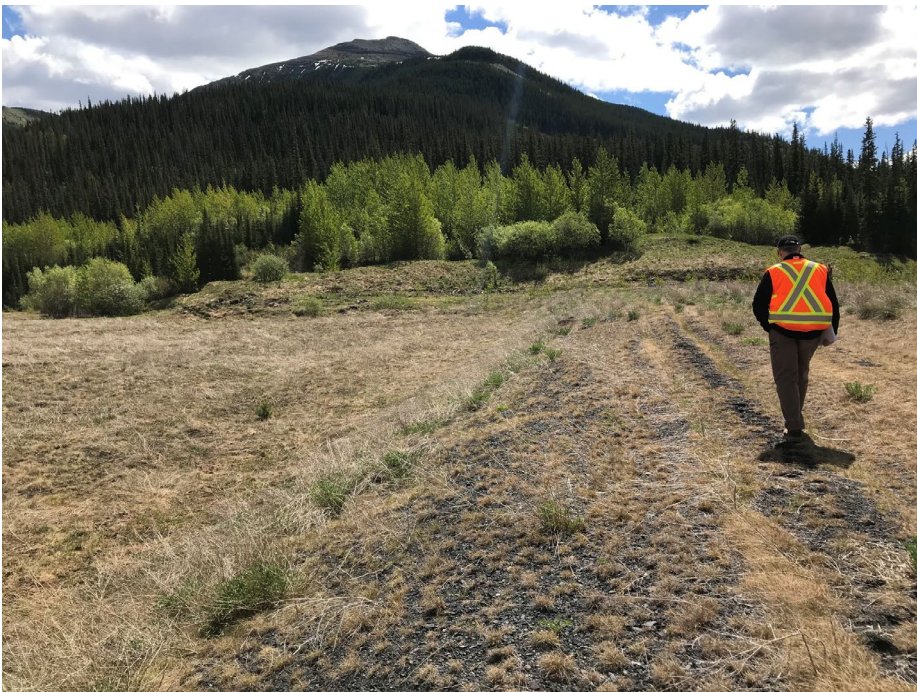
**Photo II-25** Upstream slope – looking southeast. Tailings surface elevation is approximately 1.5 m lower than the crest elevation (BTD-2018-20)

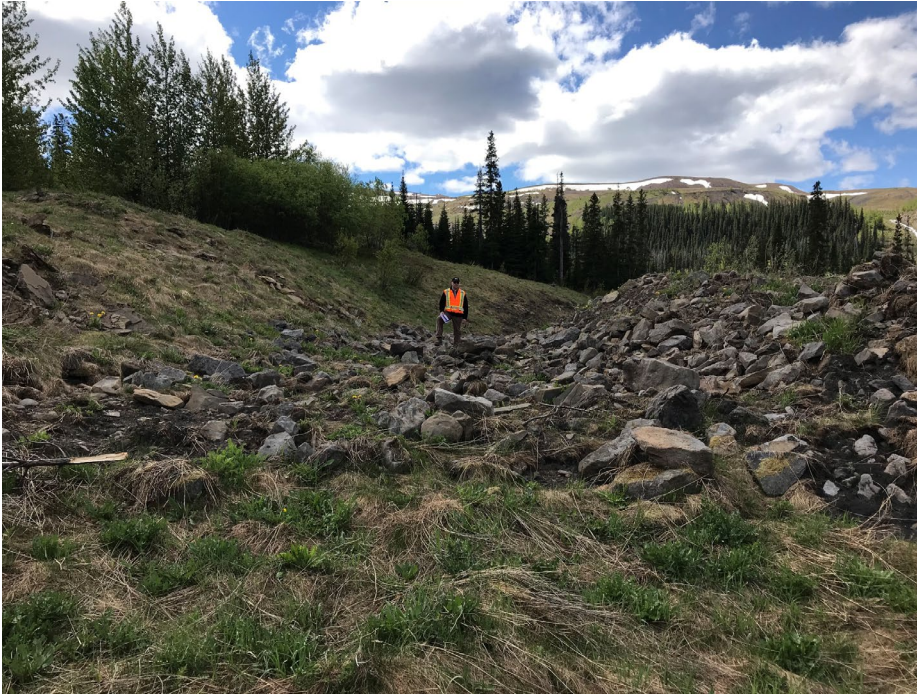
**Photo II-26** Spillway inlet – looking southwest. Vegetation was removed in 2017; no major obstruction (BTD-2018-21)

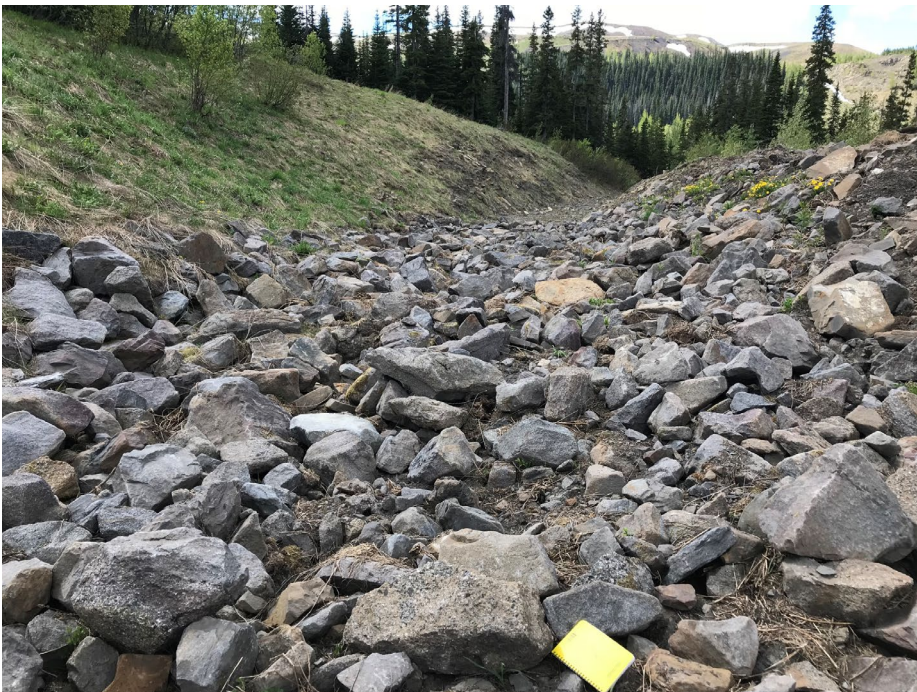
Minor degradation of the riprap within the channel was observed and should be monitored during future DSI site visits and event-driven inspections following flood events.

**Photo II-27** Spillway channel – looking southwest. Vegetation clearing activity disturbed riprap materials. Photo was taken before repair work was completed (BTD-2018-22)

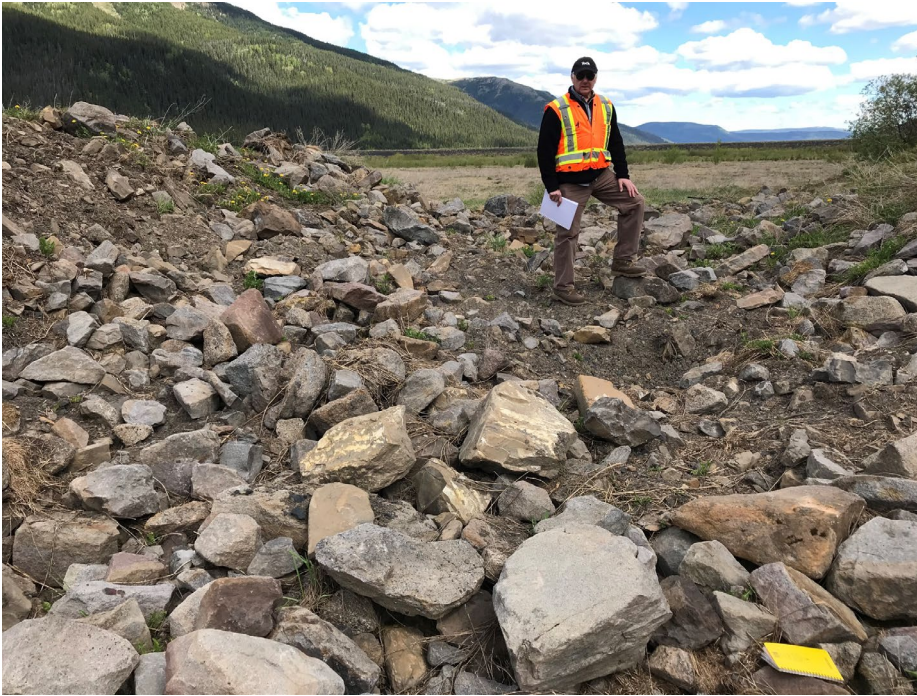
**Photo II-28** Disturbed riprap overview – photo was taken during the DSI site visit (BTD-2018-22)

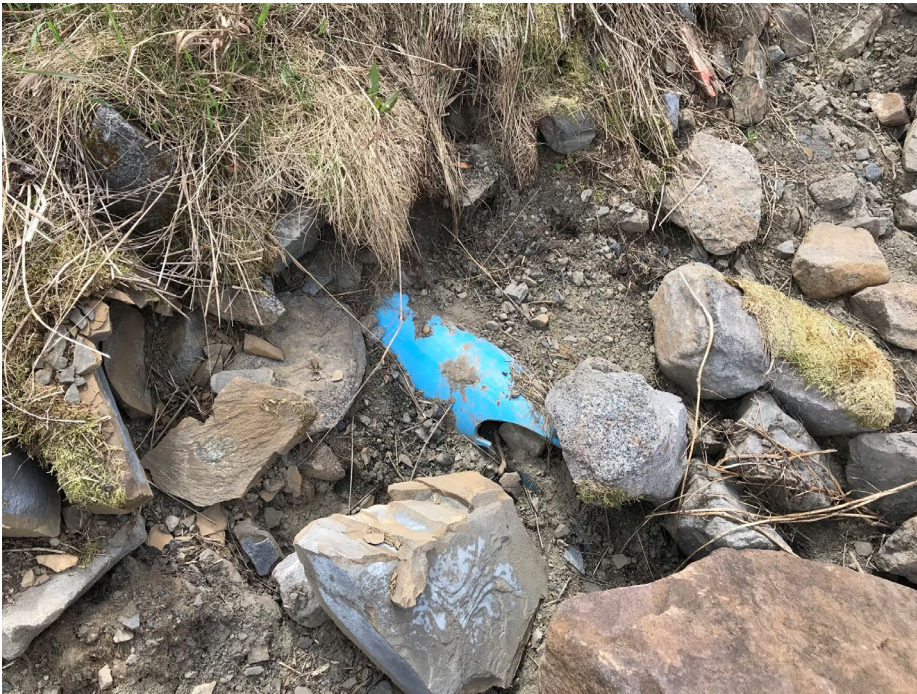
**Photo II-29** Blue PVC pipe fragment found in the BTD spillway channel – no information on the PVC pipe is available for review (BTD-2018-23)

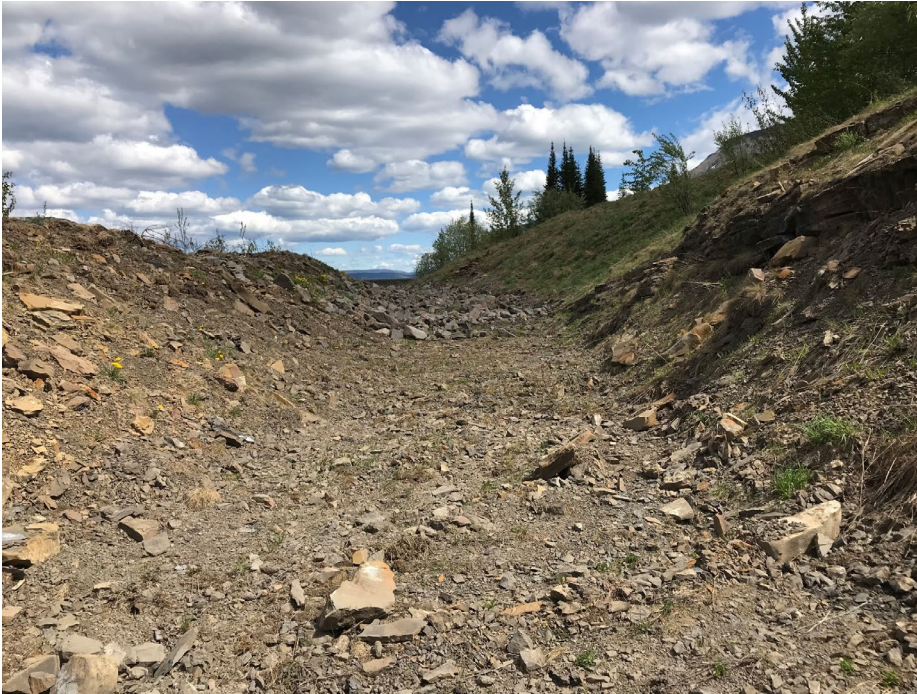
**Photo II-30** Spillway channel section founded on bedrock – looking upstream. No obstruction was observed (BTD-2018-24)
