# Teck Resources Limited

## Bullmoose Mine

### *2018 Dam Safety Inspection*

### *Bullmoose Tailings Dam*

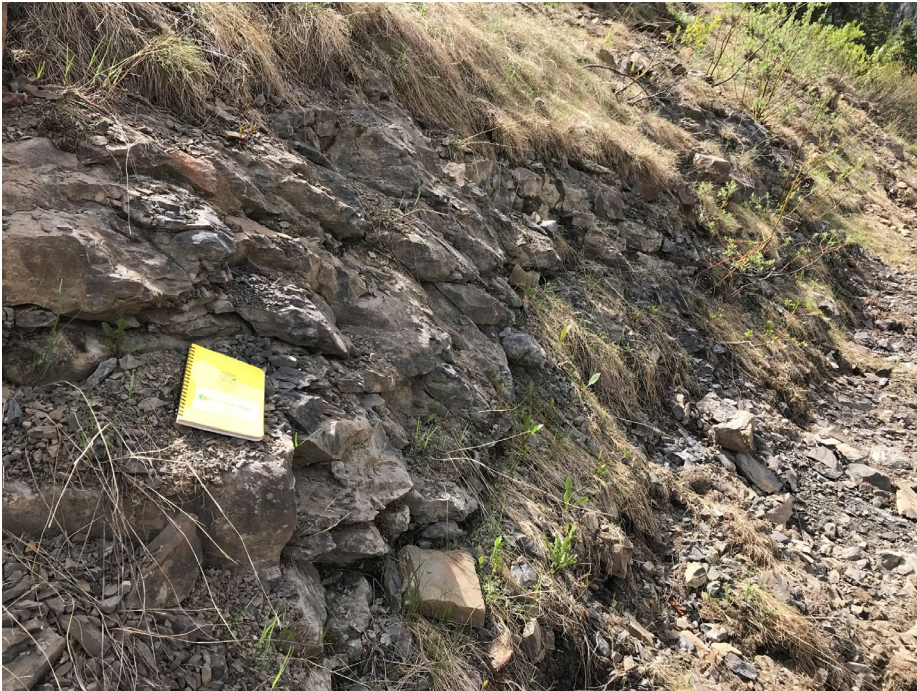
**Photo II-31** Typical cut in bedrock on left bank of spillway channel (BTD-2018-24)

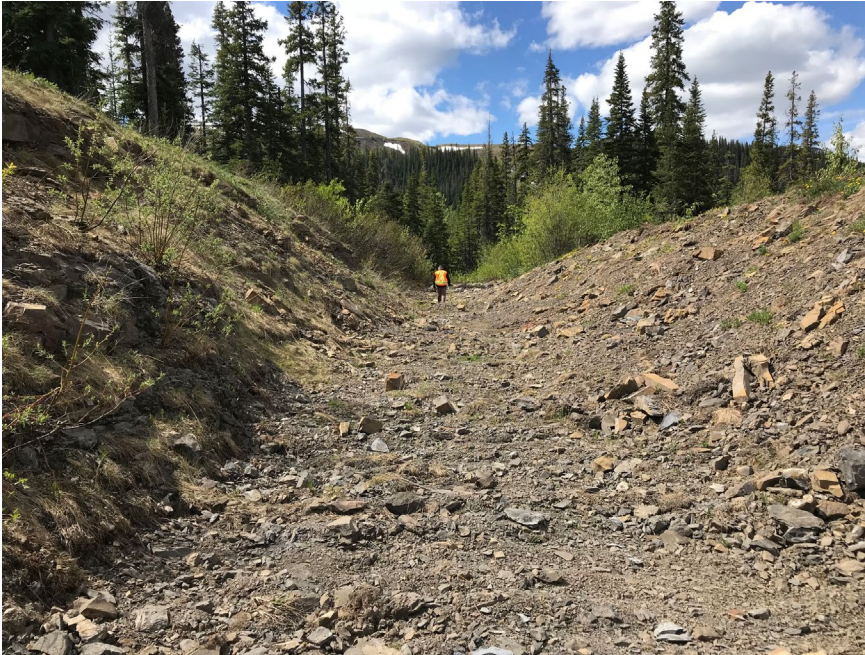
**Photo II-32** Spillway channel - looking downstream where channel transitions from riprap lined (invert and right bank) and bedrock (left bank) to channel being entirely in bedrock (BTD-2018-24)

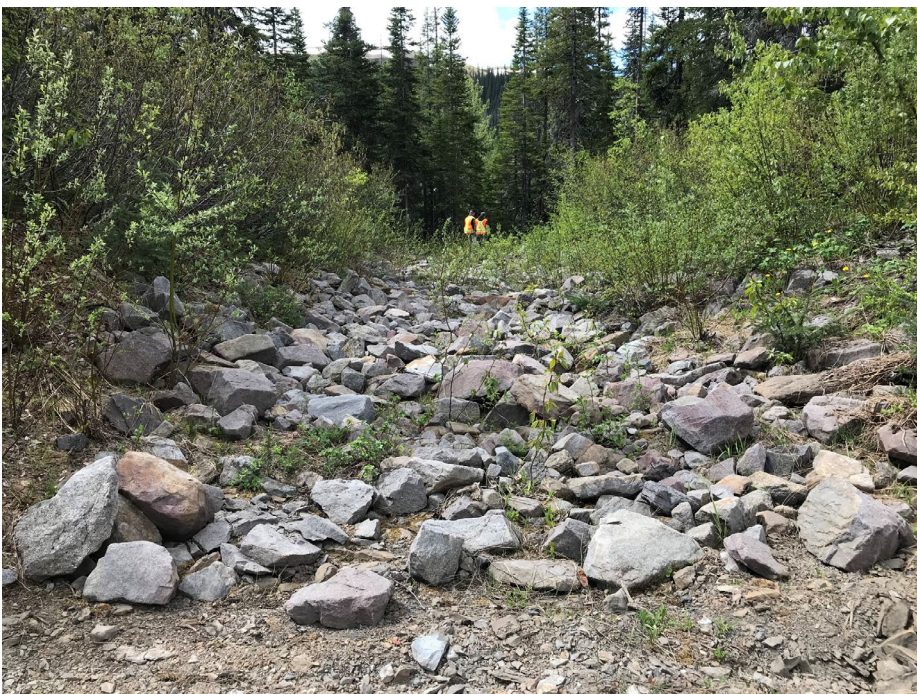
**Photo II-33** Spillway channel looking downstream after transition from bedrock to riprap. Channel is armoured with riprap on the invert and side slopes (BTD-2018-25)

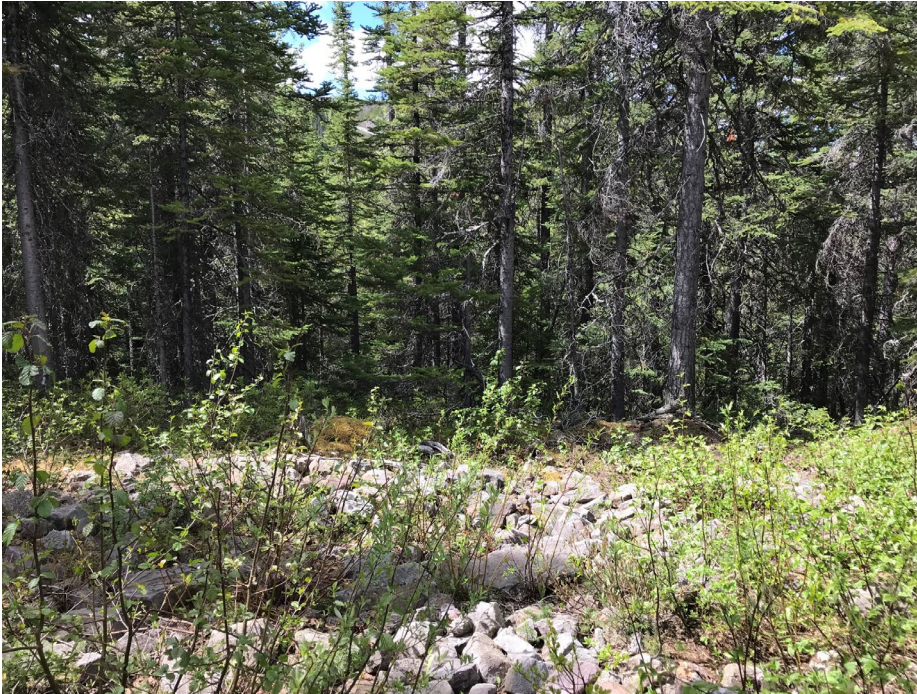
**Photo II-34** End of riprap along channel at spillway outfall – looking downstream. Spillway discharges over a natural steep slope (BTD-2018-26)

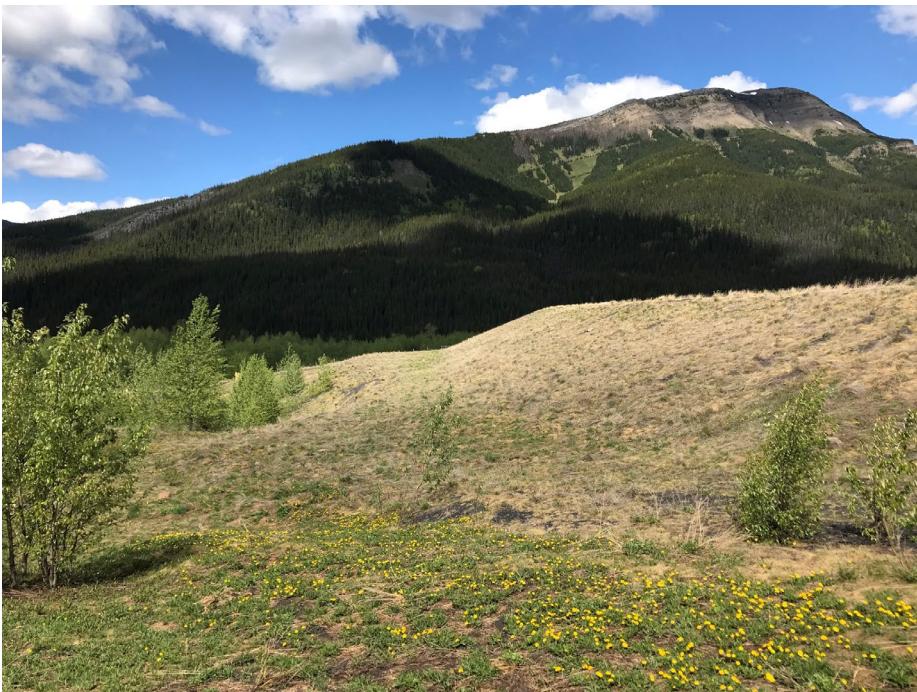
**Photo II-35** Downstream slope near the west abutment – looking north. No signs of distress (BTD-2018-27)

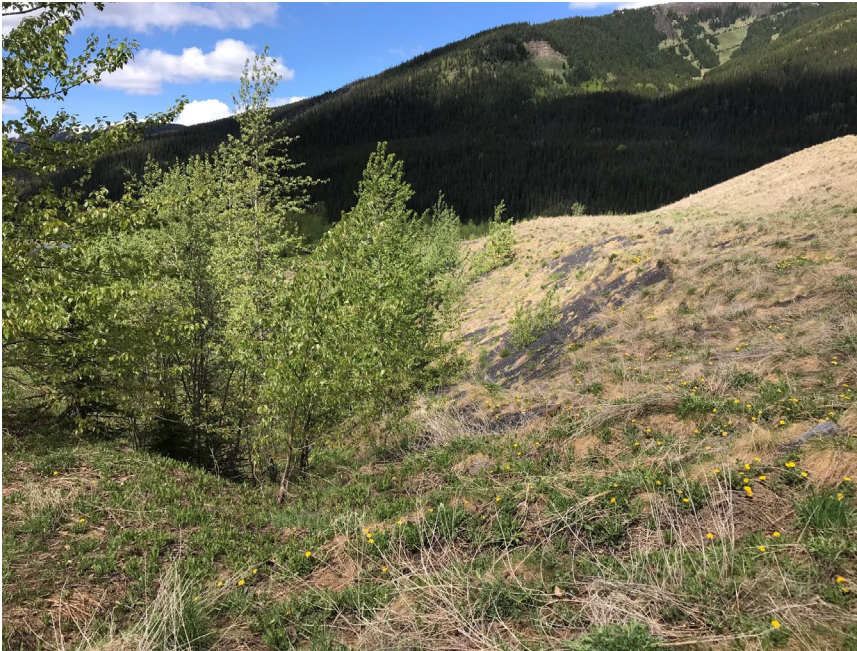
**Photo II-36** Toe of the dam along west slope is approximately 1.5H:1V – looking north. The slope appears to be stable with no significant sign of erosion or movement (BTD-2018-28)
