# Tailings Storage Facilities - West Fork Tailings Facility and Lagoons A, B, C and D 2018 Dam Safety Inspection

**FINAL REPORT**

Project # TE183022

25-Mar-19

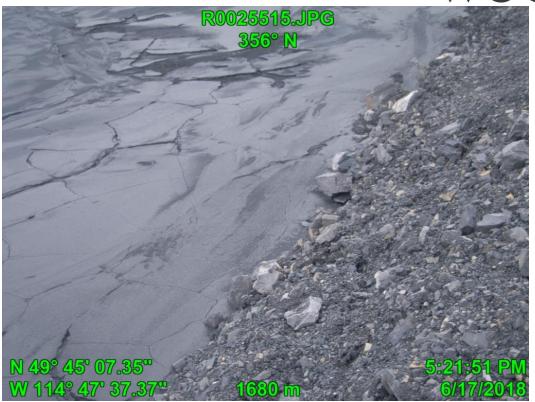
Photograph F - 9: Showing evidence of infiltration on the west side of the WFTF near the Adit dump, looking south.

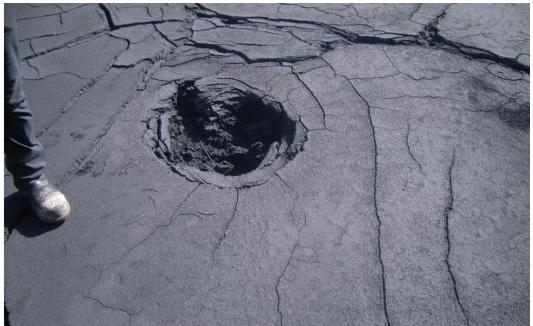
Photograph F - 10: Showing a sinkhole on the west side of the WFTF near the Adit dump. (Photo R0018420, 06/06/2017)

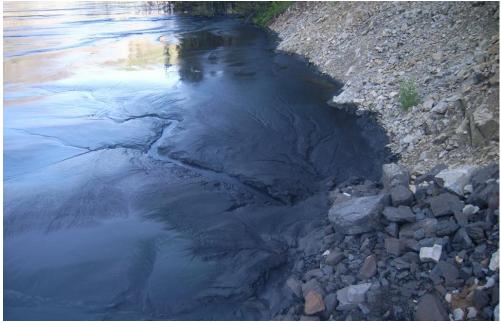
Photograph F - 16: Showing tailings beach at southeast corner of the basin, looking north. Noted seepage track on the tailings beach. (Photo R0018378, 06/06/2017)

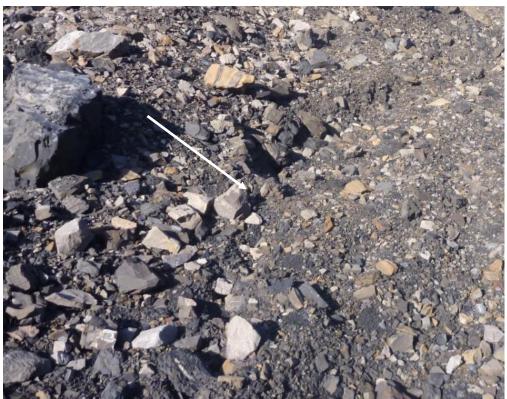
Photograph F - 19: Showing a longitudinal cracking around spigot 5 (Photo P1100577, 06/06/2017).

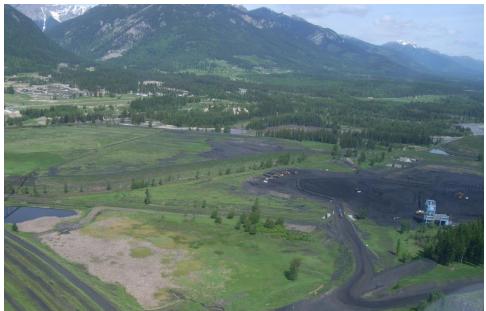
Photograph G - 2: Showing an overview of the Lagoon A. Noted the Cossarini Creek inflow to east side of Lagoon A through 2 culverts, looking northwest. (Photo R0018030, 06/06/2017)

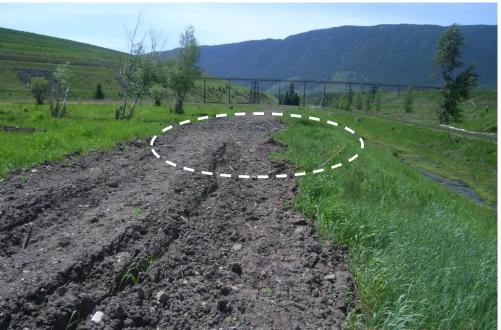
Photograph G - 14: Showing the road along the north side of Lagoon A, looking southwest. Noted an amoured outlet in the mid length of the north berm. (Photo R0018823, 06/07/2017)

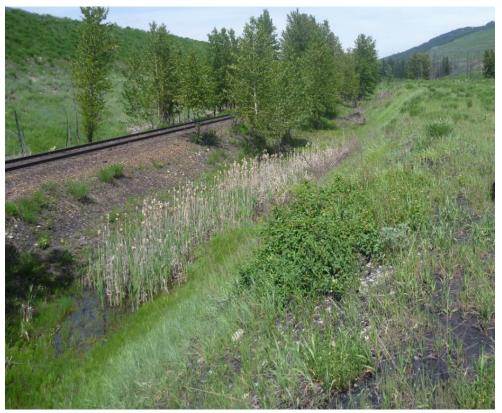
Photograph H - 5: Showing downstream slope of north end of the west embankment of Lagoon B, looking north. Noted ponded water at toe. (Photo No. P1100786, 2017/06/07)

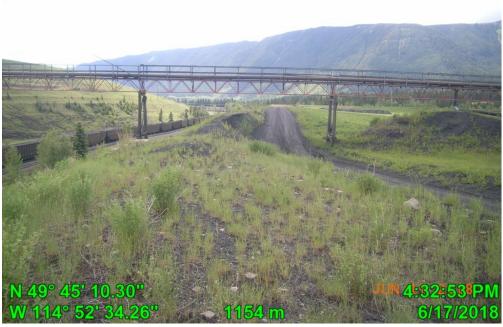
Photograph I - 12: Showing the crest and shoulder of Lagoon C south embankment, looking southwest. Noted the crest is narrow and the access road is depressed underneath the trestle.

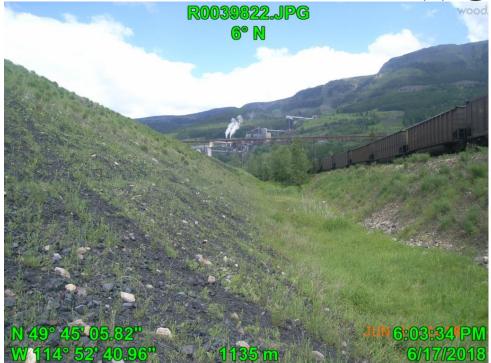
Photograph I - 13: Showing south slope and erosion on south slope of Lagoon C, looking northeast.

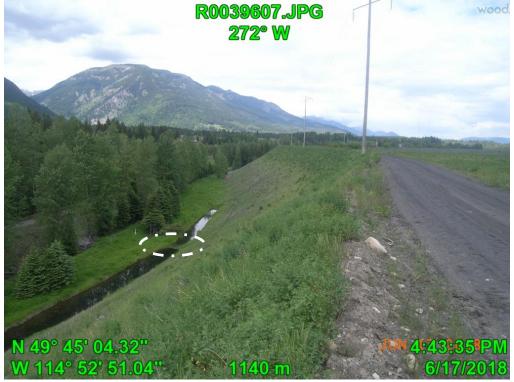
Photograph I - 15: Showing west crest and slope of Lagoon C at southwest corner, looking northwest. Noted beaver activities at the pond.

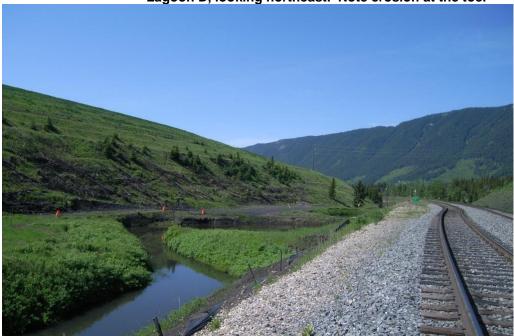
Photograph J - 16: Showing the lower north slope of Lagoon D, looking southwest. Noted Otto Pond at the toe and erosions on the slope. (Photo R0018499, 06/07/2017)

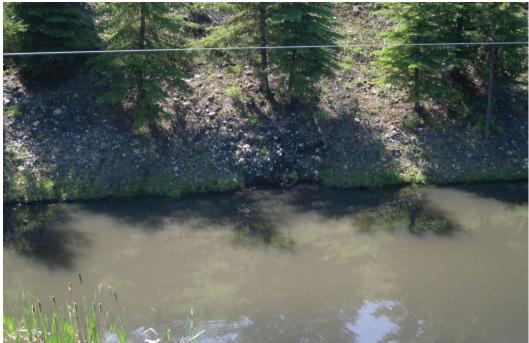
Photograph J - 17: Showing an erosion at the bank of the pond located at the toe of north slope of Lagoon D, looking south. (Photo R0018520, 06/07/2017)

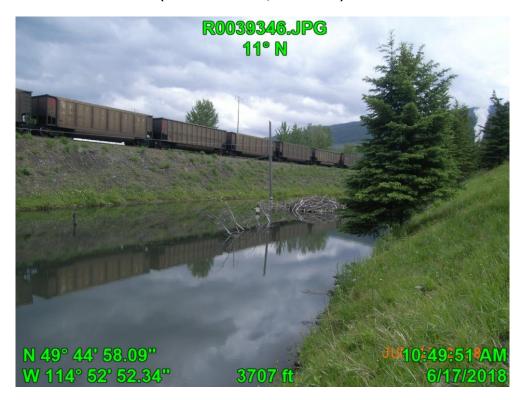
Photograph J - 18: Showing the toe at west end of the north slope of Lagoon D, looking northeast. Noted beaver activities within this area.

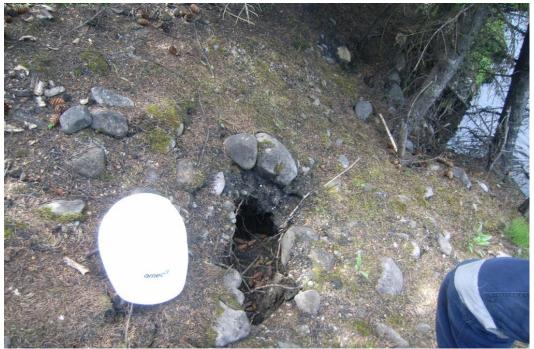
Photograph J - 19: Showing an animal borrow on the toe of north slope of Lagoon D, looking southwest. (Photo R0018721, 06/07/2017)

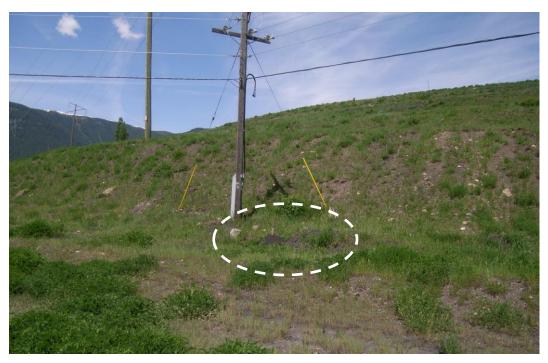
Photograph J - 33: Showing the toe and lower south slope at south corner of Lagoon D, looking northwest. Noted an animal borrow at the toe. (Photo R0018630, 06/07/2017
