2018 Dam Safety Inspection for North Tailings Pond and South Tailings Pond

Teck Coal Limited, Fording River Operations

Golder Associates Ltd.

29 March 2019

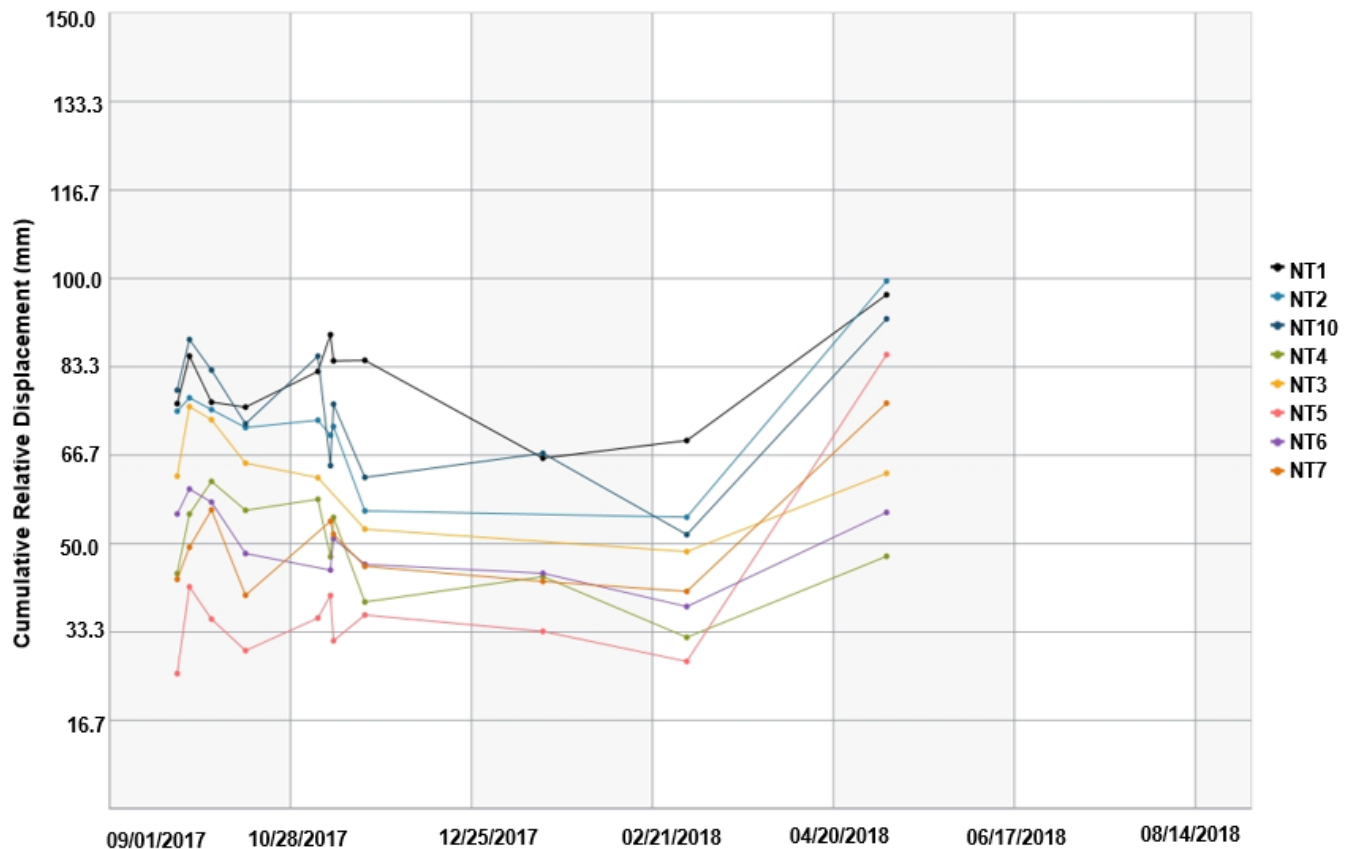
Chart 3: North Tailings Pond Prism Total Cumulative Relative Displacement from 1 September 2017 to May 2018

Generally, the prism data are surveyed once a month; however, in this reporting period, multiple readings were taken per month until November 2017, then every second month until the prisms were stopped in May 2018. The survey data indicate little crest displacement during the reporting period. Most of the prisms show a slight increase in movement during the spring freshet (March to April 2018). Movements are well below the GeoExplorer trigger for 3D movement (200 mm, GeoExplorer warning) and the updated QPOs provided by Golder (2018a) and listed in Section 2.5.

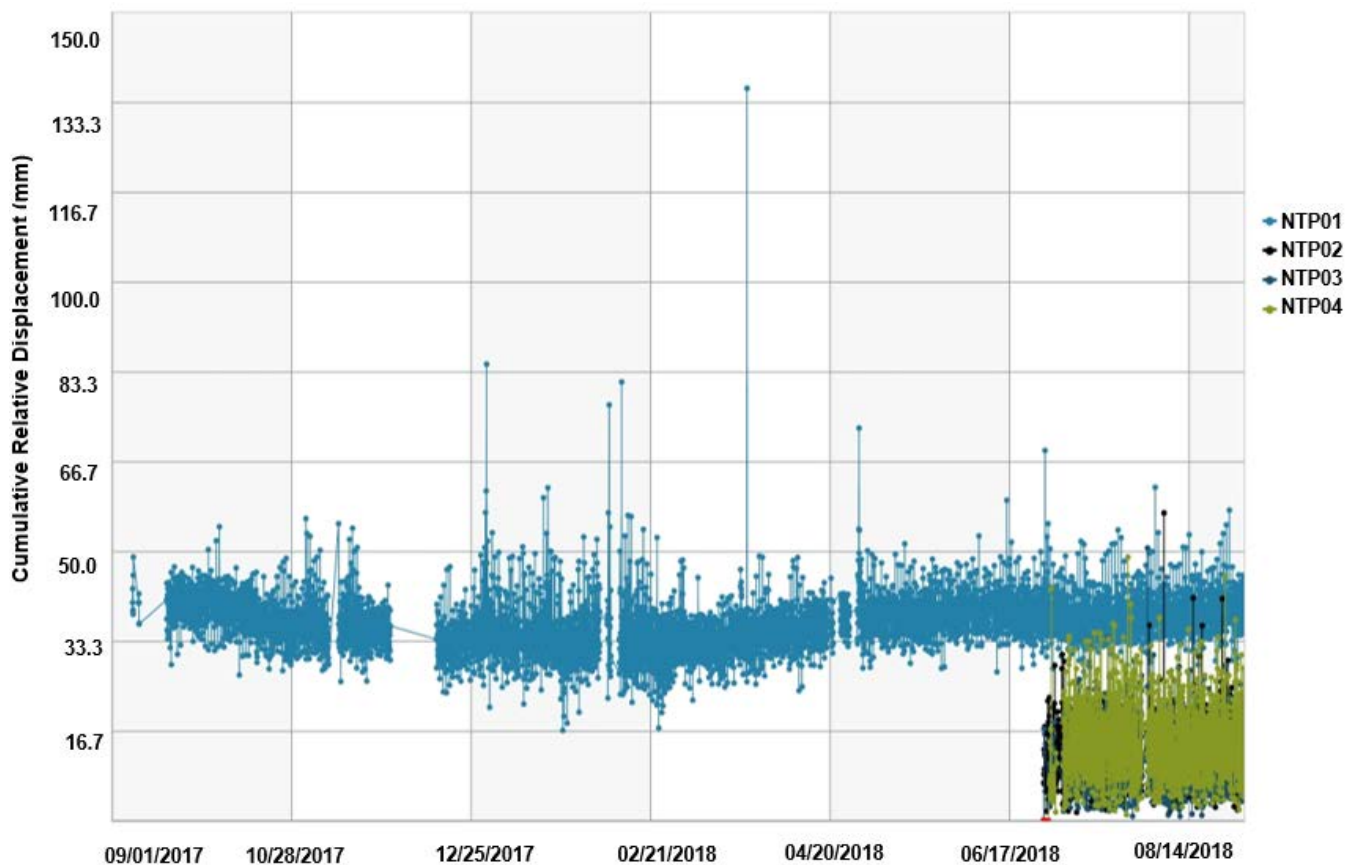
Chart 4: North Tailings Pond GPS Cumulative Relative Displacement from 1 September 2017 to 31 August 2018

Generally, the GPS devices recorded on an hourly frequency. The survey data indicate little crest displacement during the reporting period. Minor spikes in the data are most likely noise in the system and are not a concern. Movements are well below the GeoExplorer alarm trigger for 3D point velocity (300 mm/day, GeoExplorer alarm) and the updated QPOs provided by Golder (2018a) and listed in Section 2.5. No warnings were triggered in the reporting period.

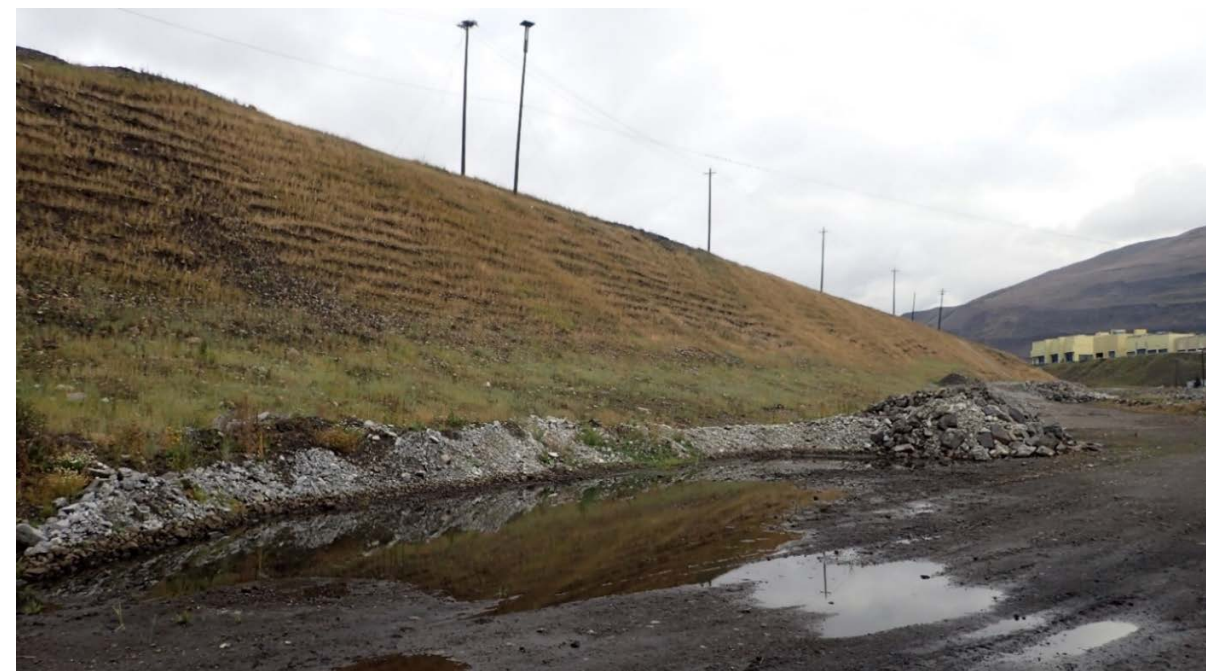
Photograph A-6: NTP dam downstream slope with stepped erosion and minor area of ponded water observed at the toe near Stn 0+970, looking northeast, 12 September 2018.

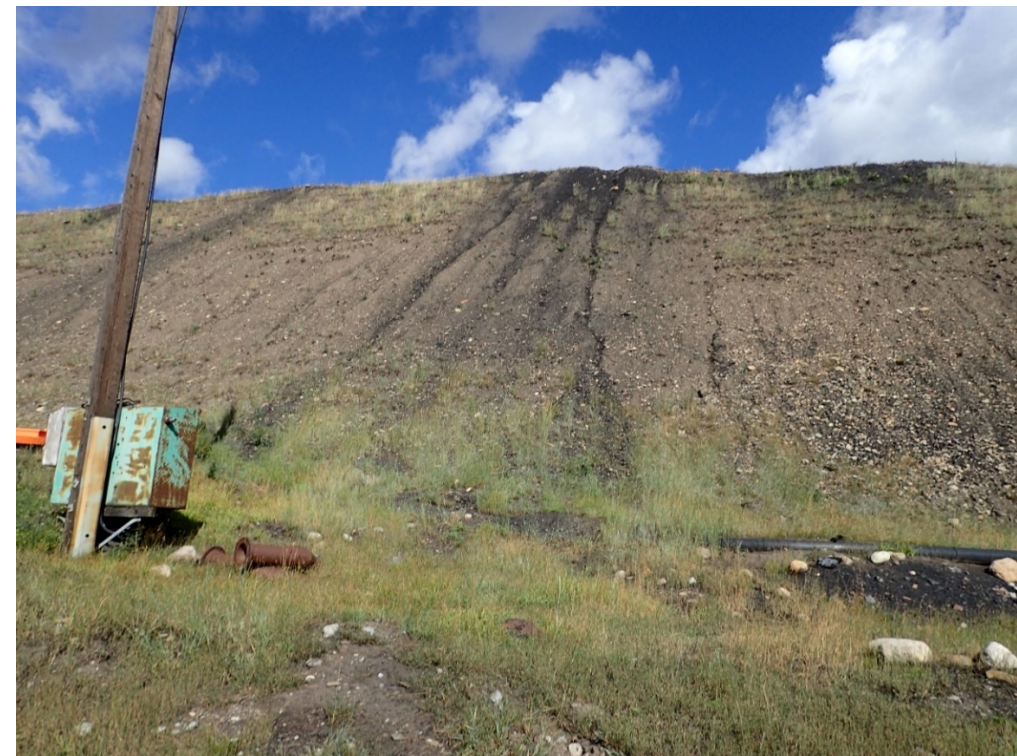
Photograph A-25: STP Main dam downstream slope from toe, showing area with on-going vertical erosion, 11 September 2018.

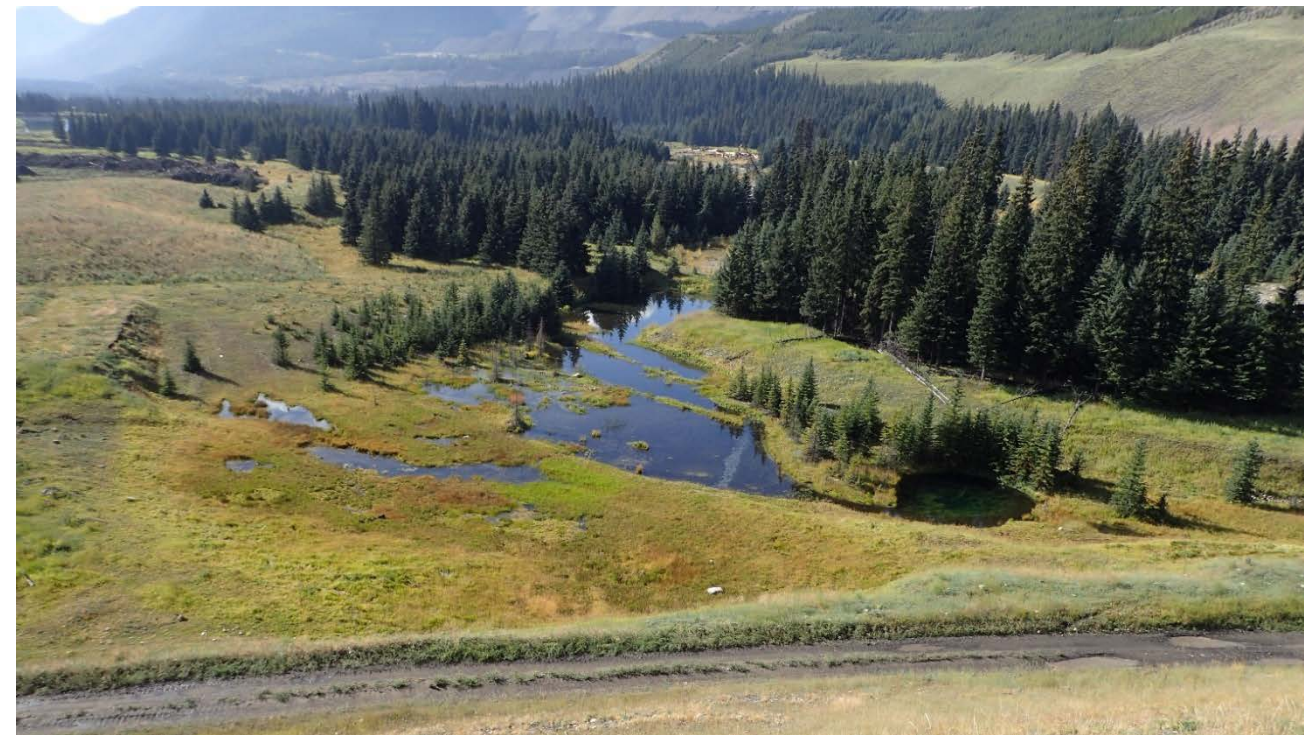
Photograph A-29: STP Main Dam, persistent ponding downstream of toe in old river channel, looking southwest, 11 September 2018.

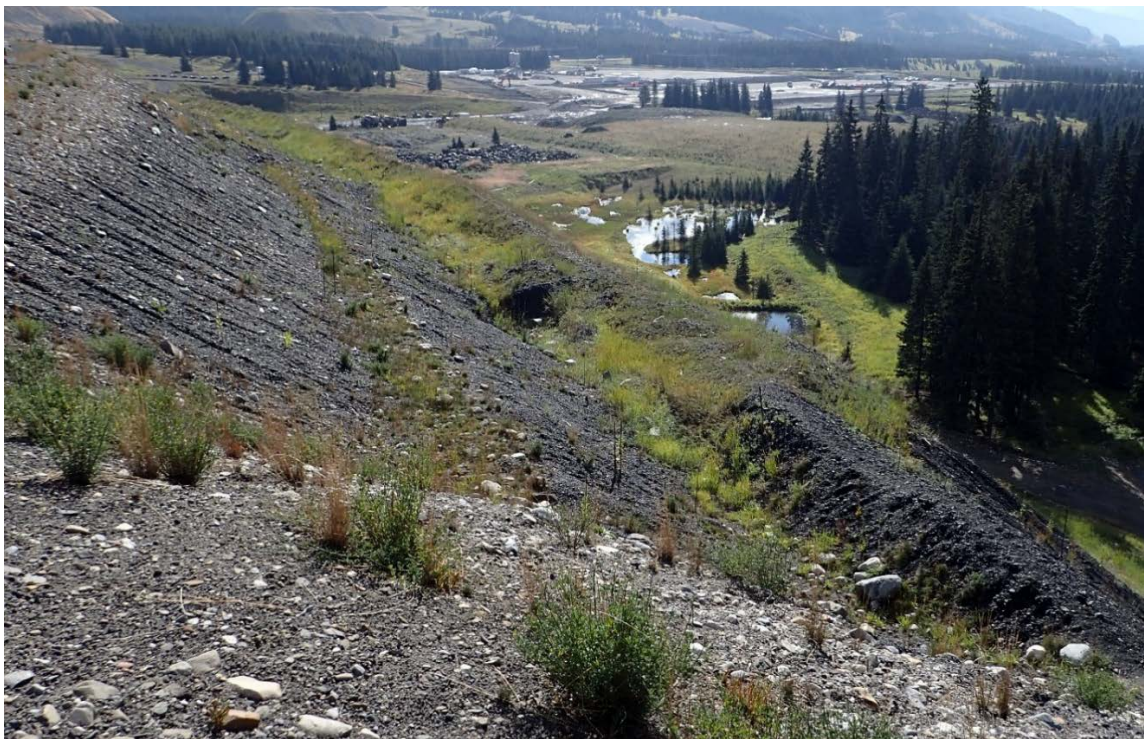
Photograph A-30: STP corner of West and Main dams, looking southeast. Vegetation not taking root in CCFR in this area, 11 September 2018.

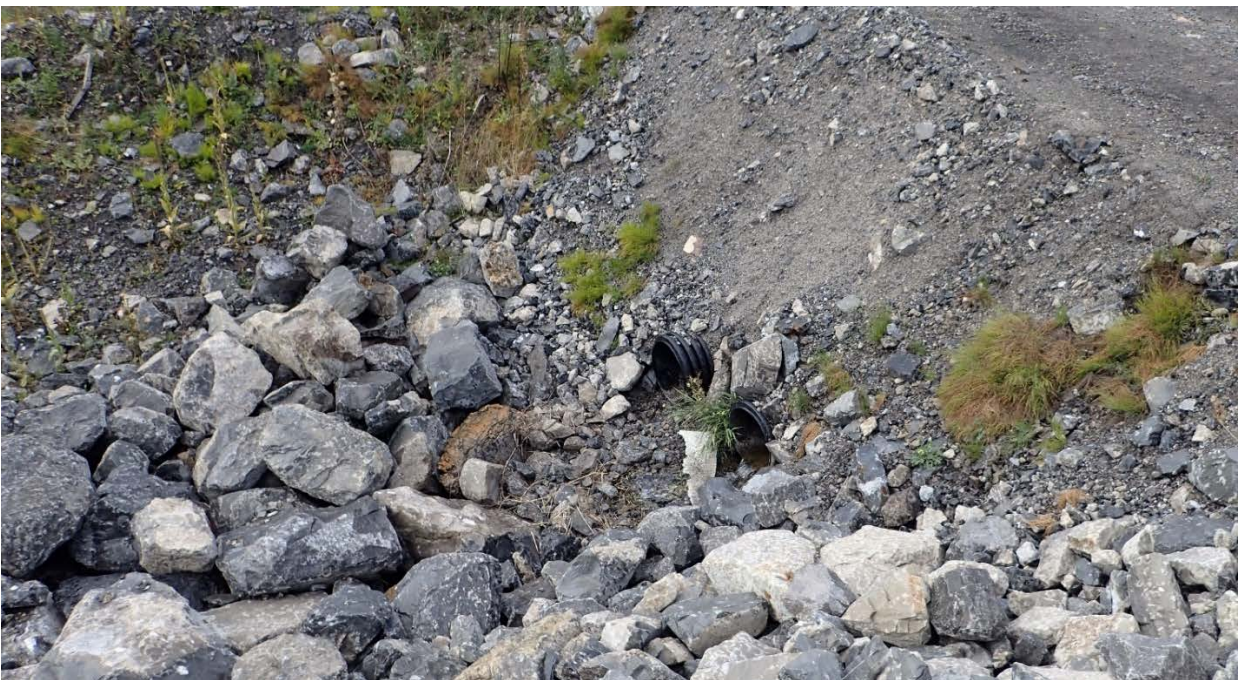
Photograph A-42: STP West Dam, twin culverts beneath access road at toe, looking east, 11 September 2018. The flow rate at the time of inspection was approximately 1.4 L/sec from the eastern pipe (closest to the page). The other pipe (further into the page) was dry.

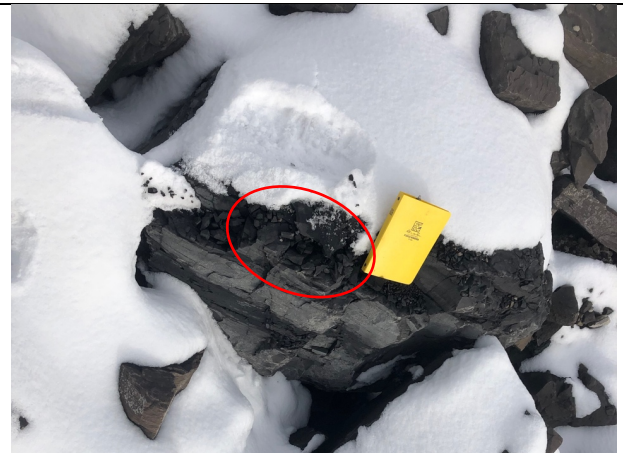
Photo 4: Riprap degradation due to weathering on a surface of a piece of riprap (red outline)

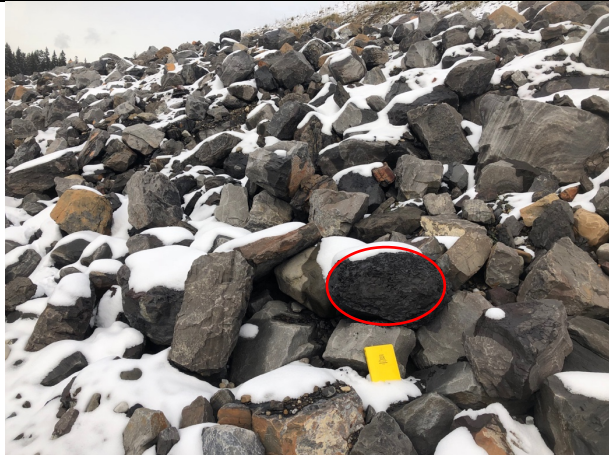
Photo 9: Riprap degradation due to weathering on a surface of a piece of riprap (red outline)
