REPORT

2018 Dam Safety Inspection for Greenhills Operations, Tailings Storage Facility

Teck Coal Limited, Greenhills Operations

Reference No. 1894290-2018-133-R-Rev0-2000

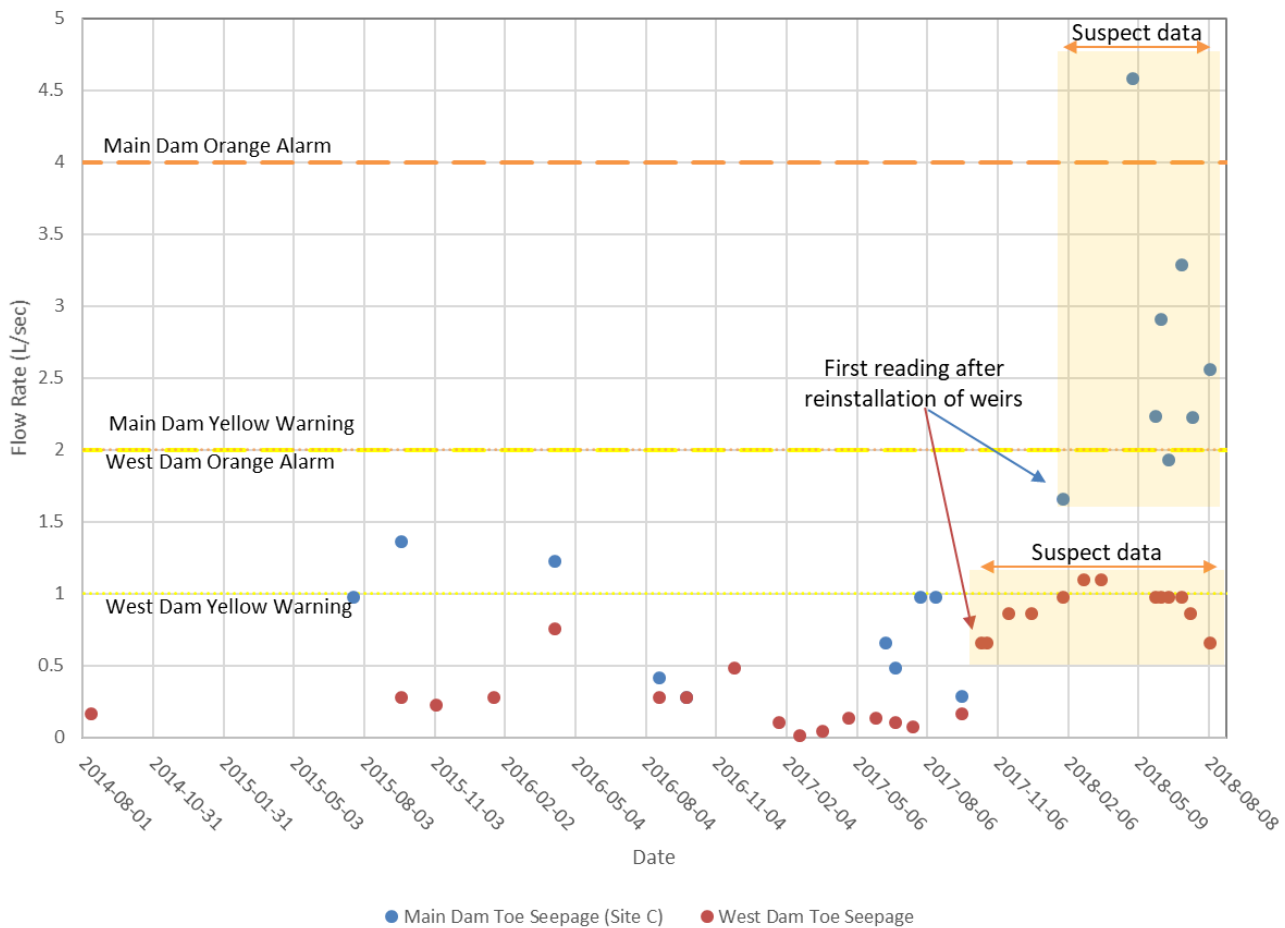
Chart 4: Flow Rates at Main Dam and West Dam Seepage Weirs

- (a) An Alarm (red) decision is to be made by the Engineer of Record and GHO's TSF Qualified Person.
- (b) Higher than typical flows were reported from 1 August 2017 to 31 August 2018 (refer to Chart 4). The flows reported were about four times higher than typical for the Main Dam and twice as high for the West Dam. Some of these flows exceeded QPO warning and alarm levels, however, these flow rates are suspected to be erroneous when observations from the 2018 DSI are compared to previous years (Photograph 1 and 2 in Section 5.3.1).

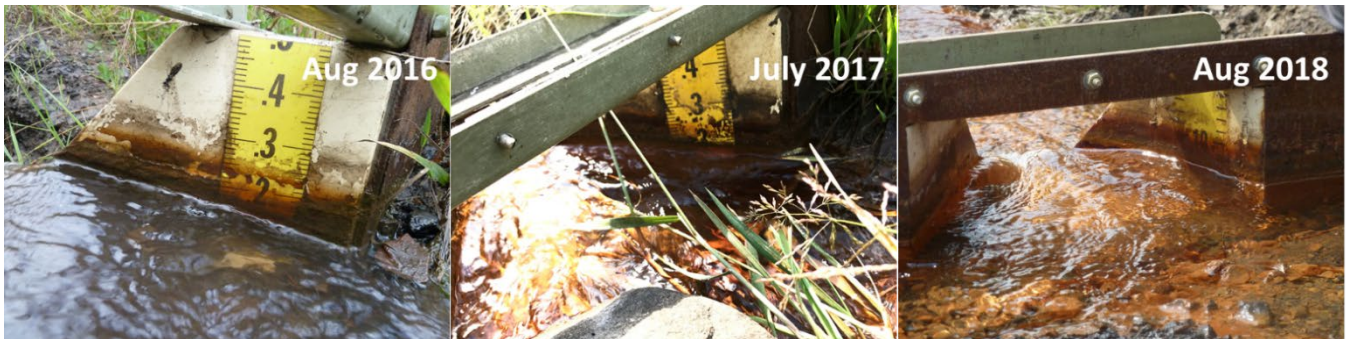
Photograph 1: Main Dam Seepage Comparison

Although these higher than expected flows are suspected to be erroneous and not of concern, it should be noted that the EoR was not informed of the QPO exceedances (as required by the TARP) when they occurred. Golder recommends that GHO review the TARP to ensure that the actions following an exceedance are fully understood and followed in the future.

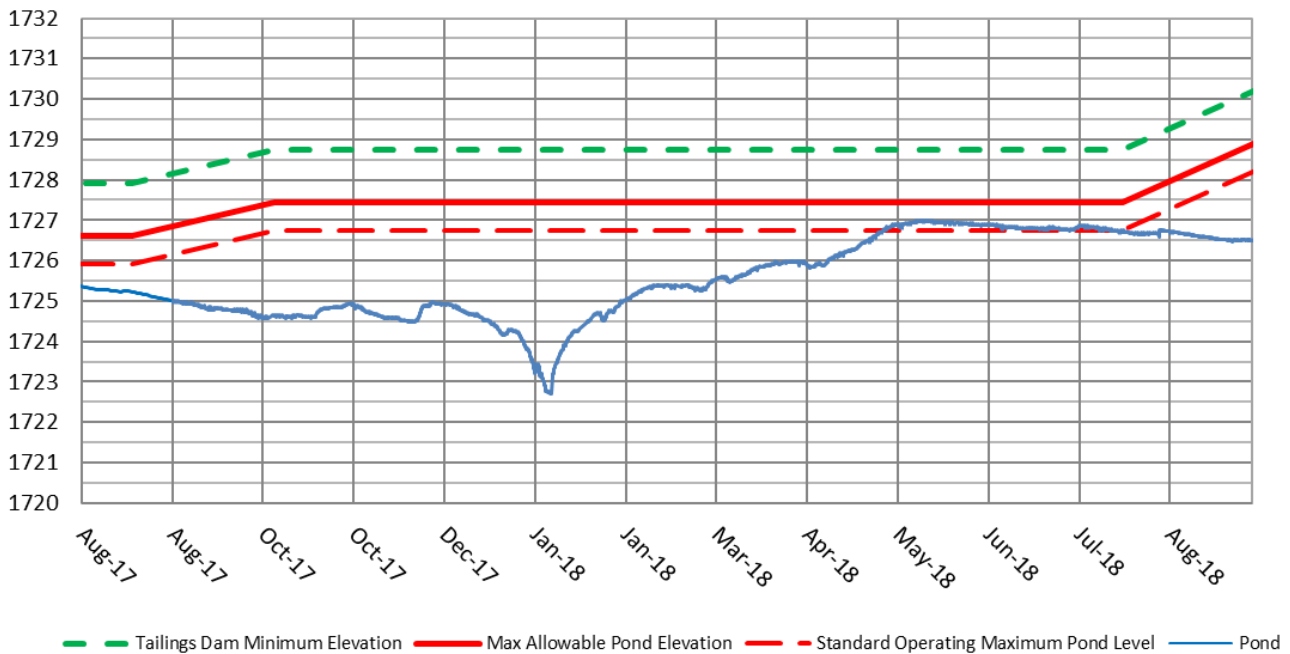
Chart 5: Tailings Pond Elevation Relative to Minimum Freeboard and Standard Pond Operating Level

(a) Yellow warning level was exceeded between the end of April and the middle of July 2018. The facility still had capacity to contain the Inflow Design Flood (IDF) and the Probable Maximum Flood (PMF) during this time.

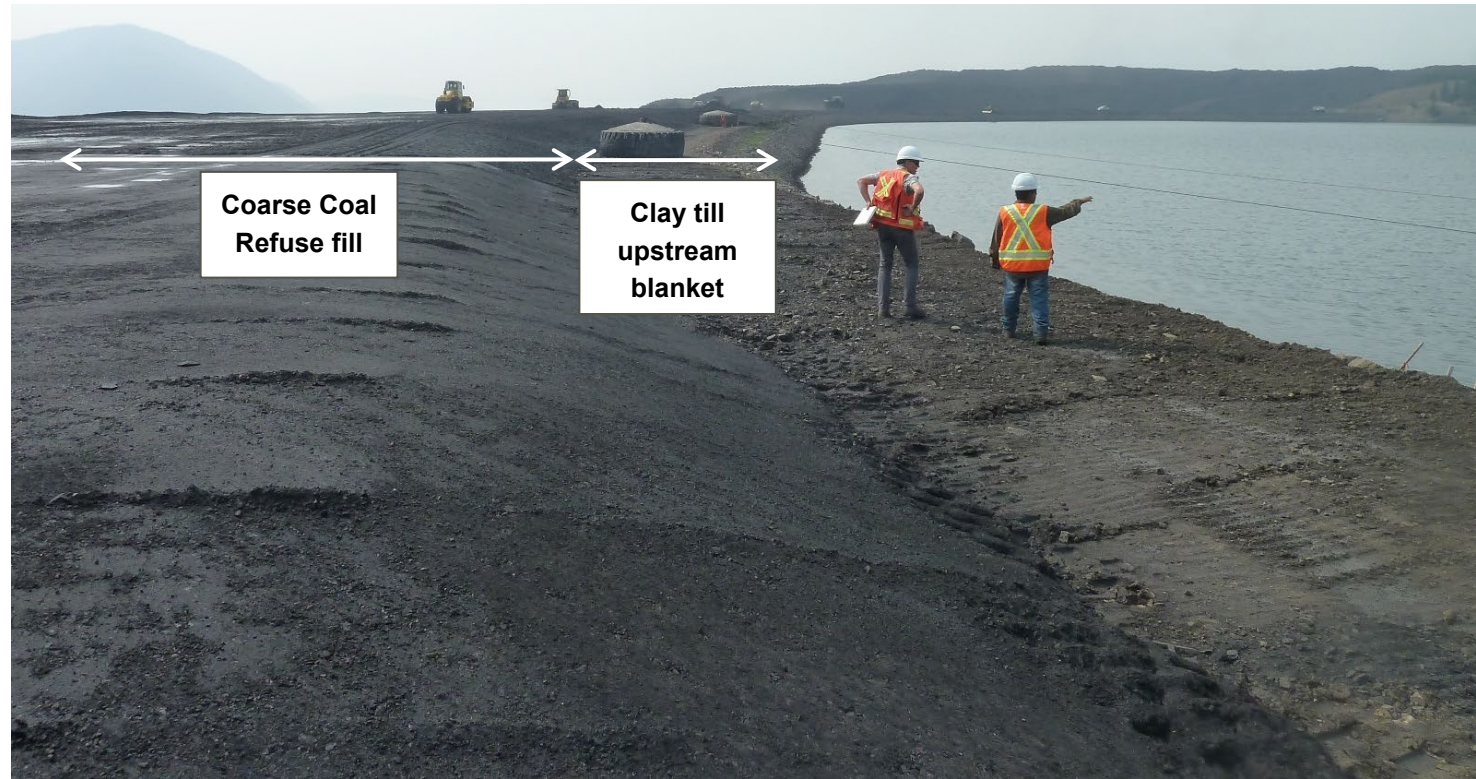
Photograph 3: Main Dam – crest, note clay till upstream blanket and coarse coal refuse fill, looking southwest. 15 August 2018.

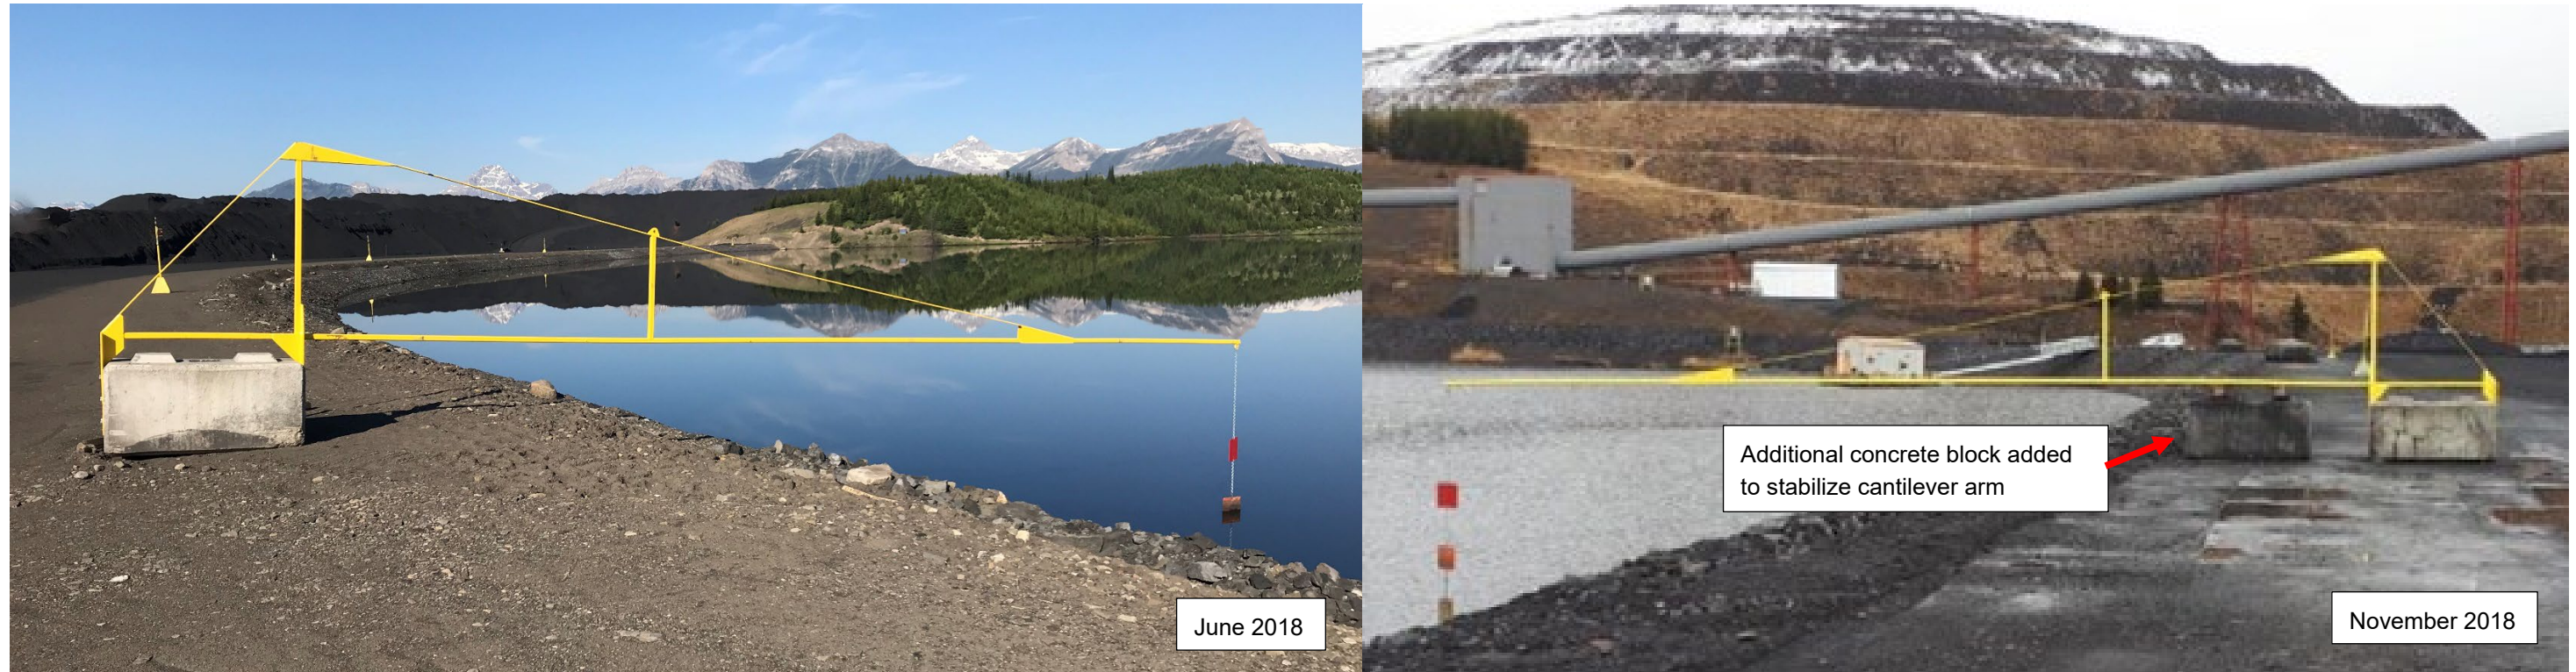
Photograph 7: Visual water level indicator showing rotation. June and November 2018.

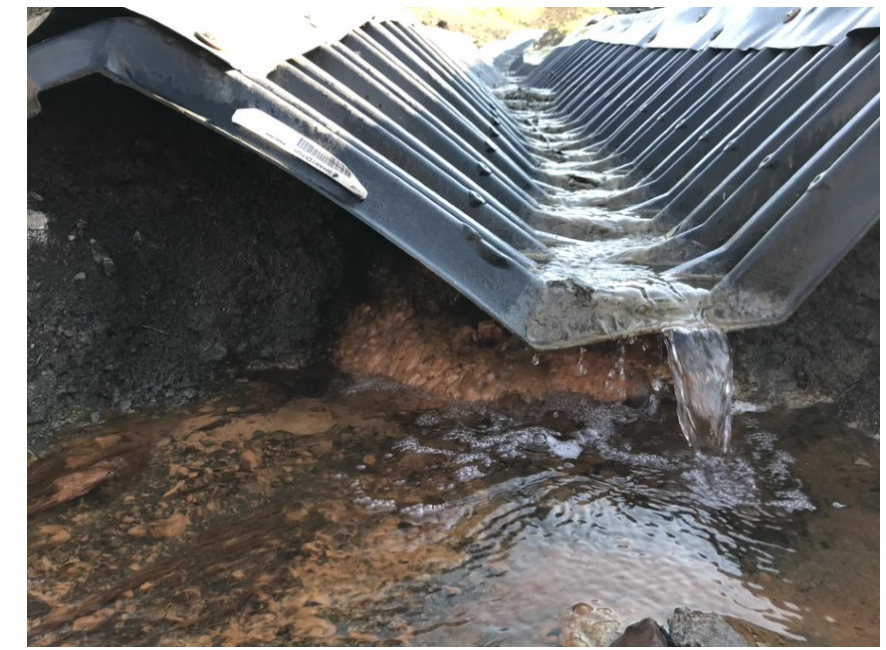
Photograph 12b: Site C –seepage under collection channel (red arrow), looking northeast. 15 August 2018.

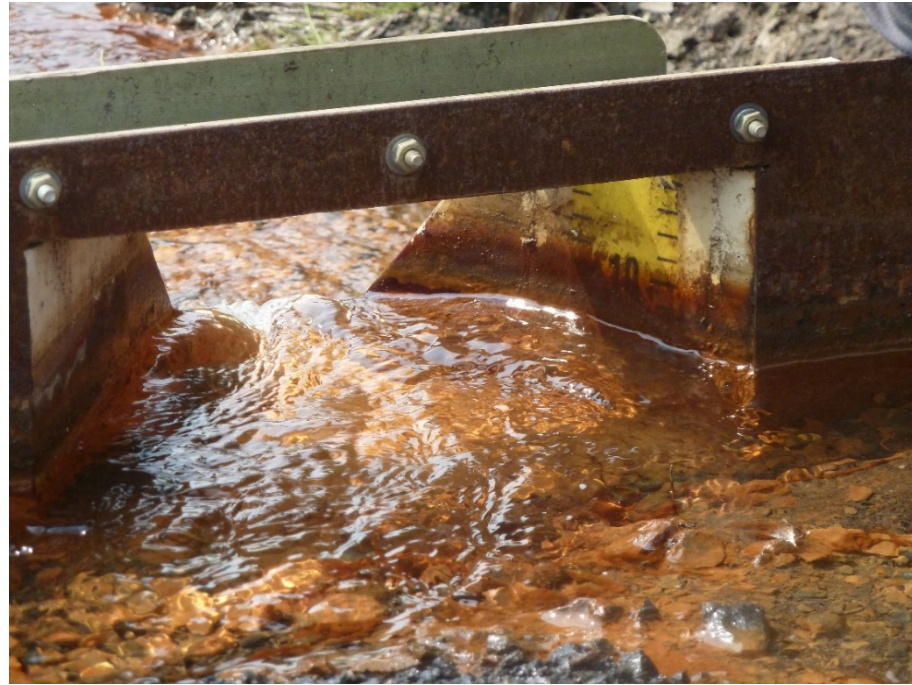
Photograph 13: Site C – weir at toe of Site C refuse spoil after trench upgrade, looking west. 15 August 2018.

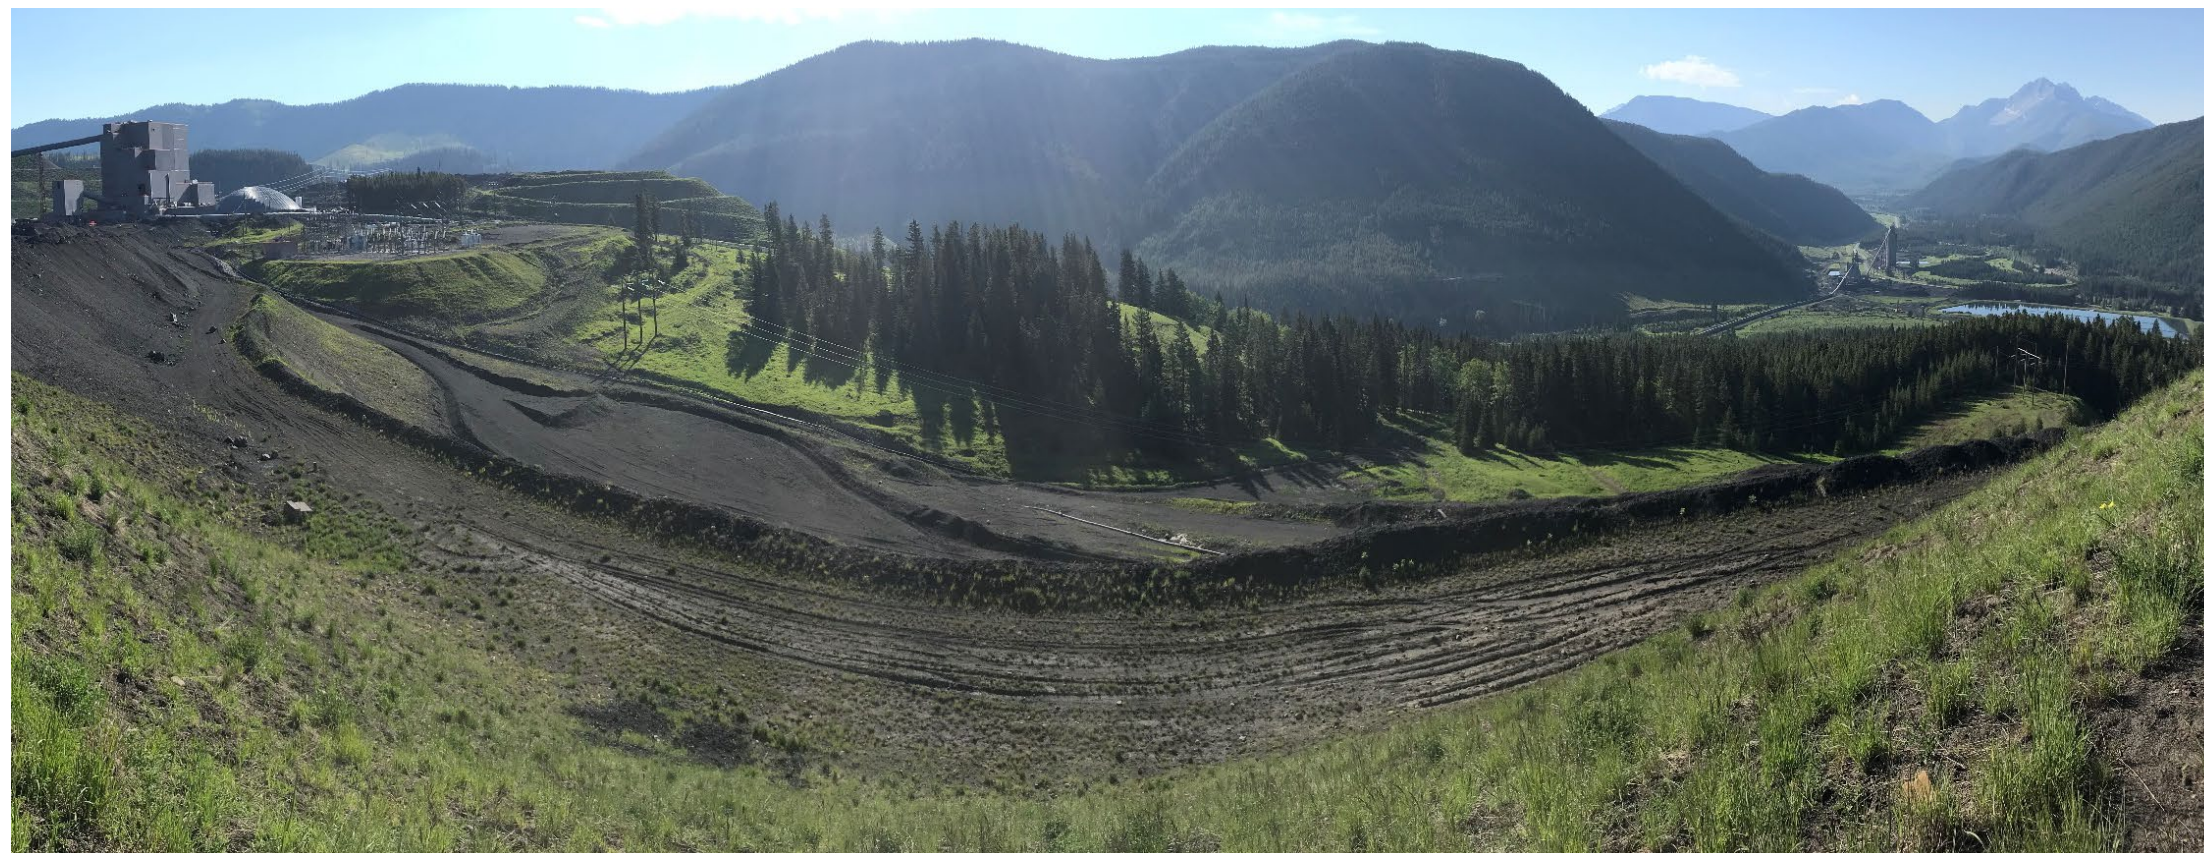
Photograph 15: Historic 2012 Site C failure scarp and toe bulge, looking east. No significant change since 2012. 18 June 2018.
