# **Teck Highland Valley Copper Partnership**

## **2018 Dam Safety Inspection Report**

### ***Highmont Tailings Storage Facility***

March 2019

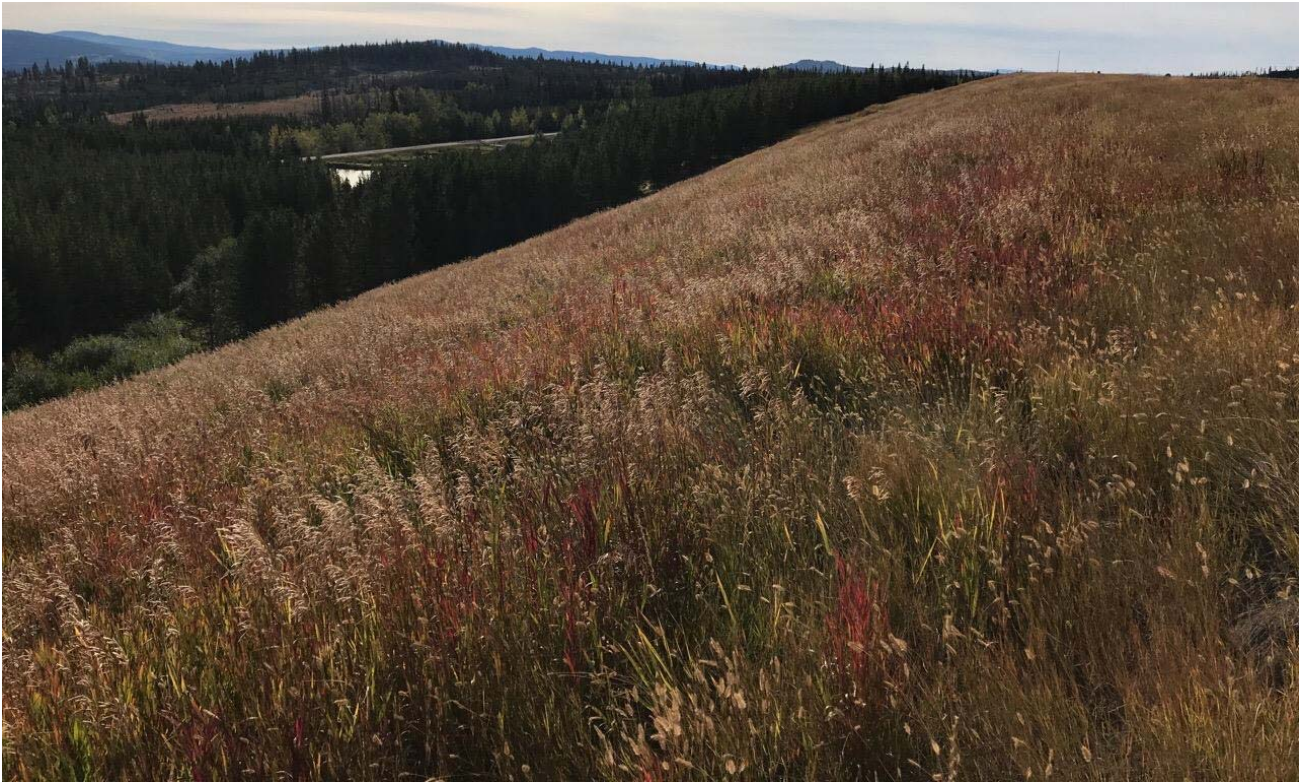
**Photo II-A-4 East Dam downstream overview looking South. Slope covered by vegetation. (HGH-2018-2)**

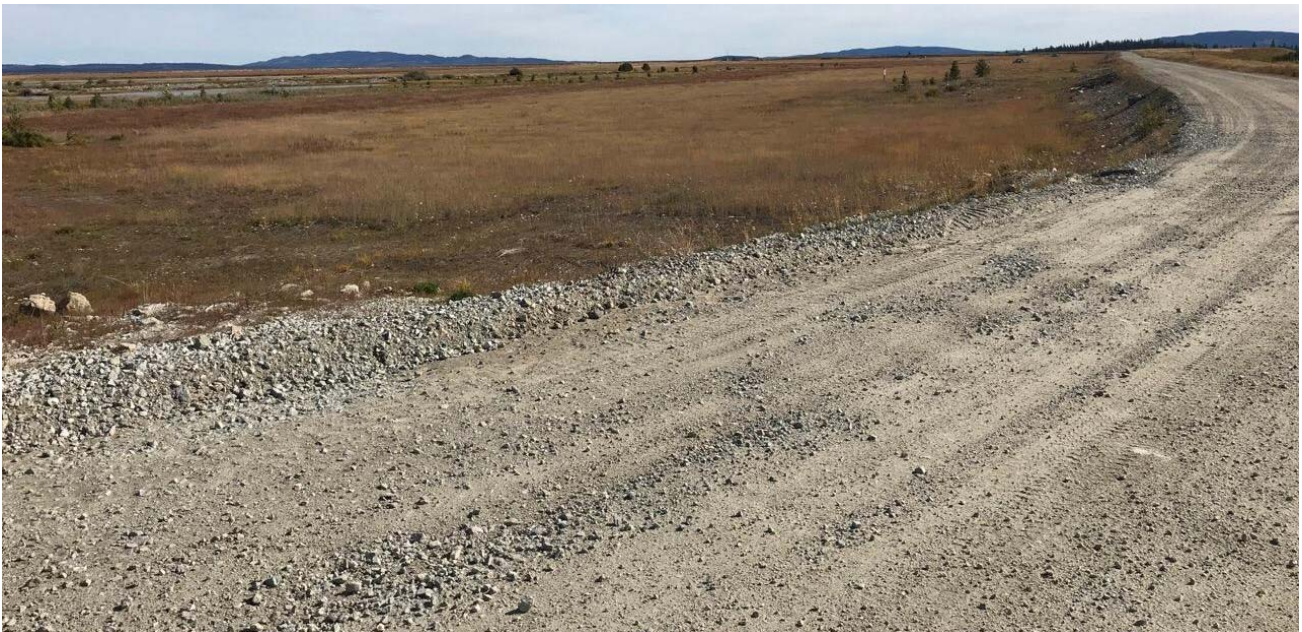
**Photo II-A-5 Downstream slope of the road at the toe of the South Dam looking West. Slope is in good condition. (HGH-2018-3)**

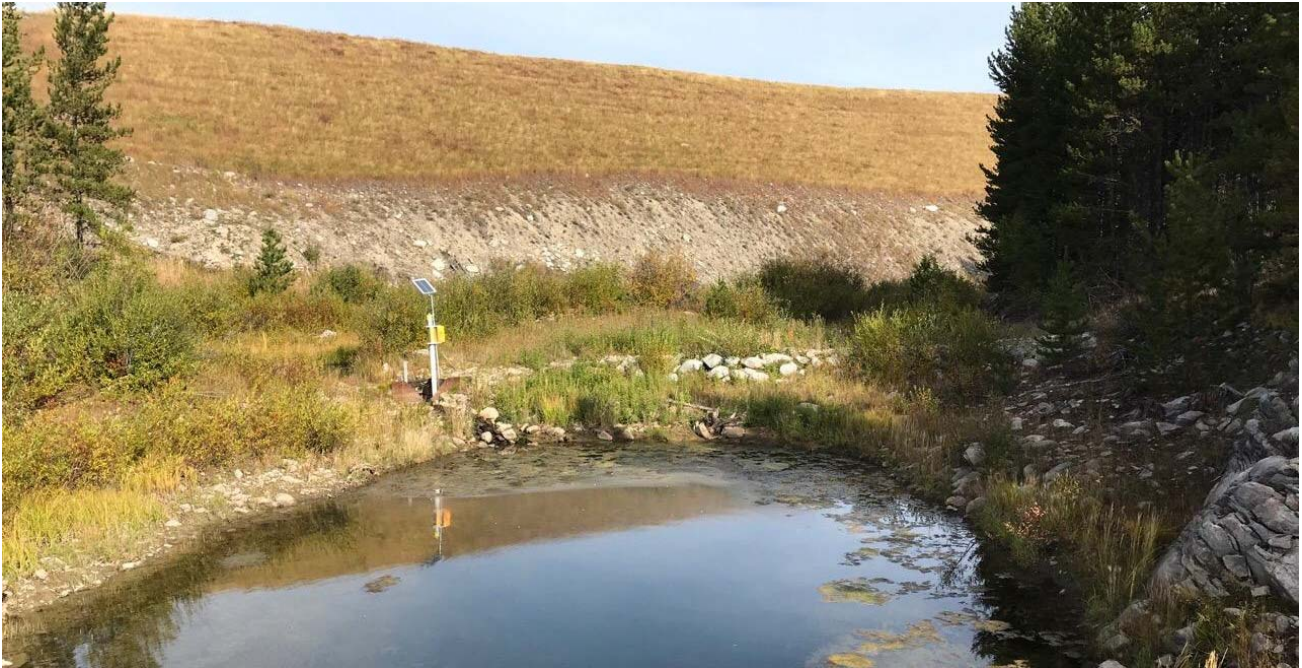
**Photo II-A-6 South Dam toe and HM-S3-FS-01 weir. S3 upstream slopes are in good condition (HGH-2018-4)**

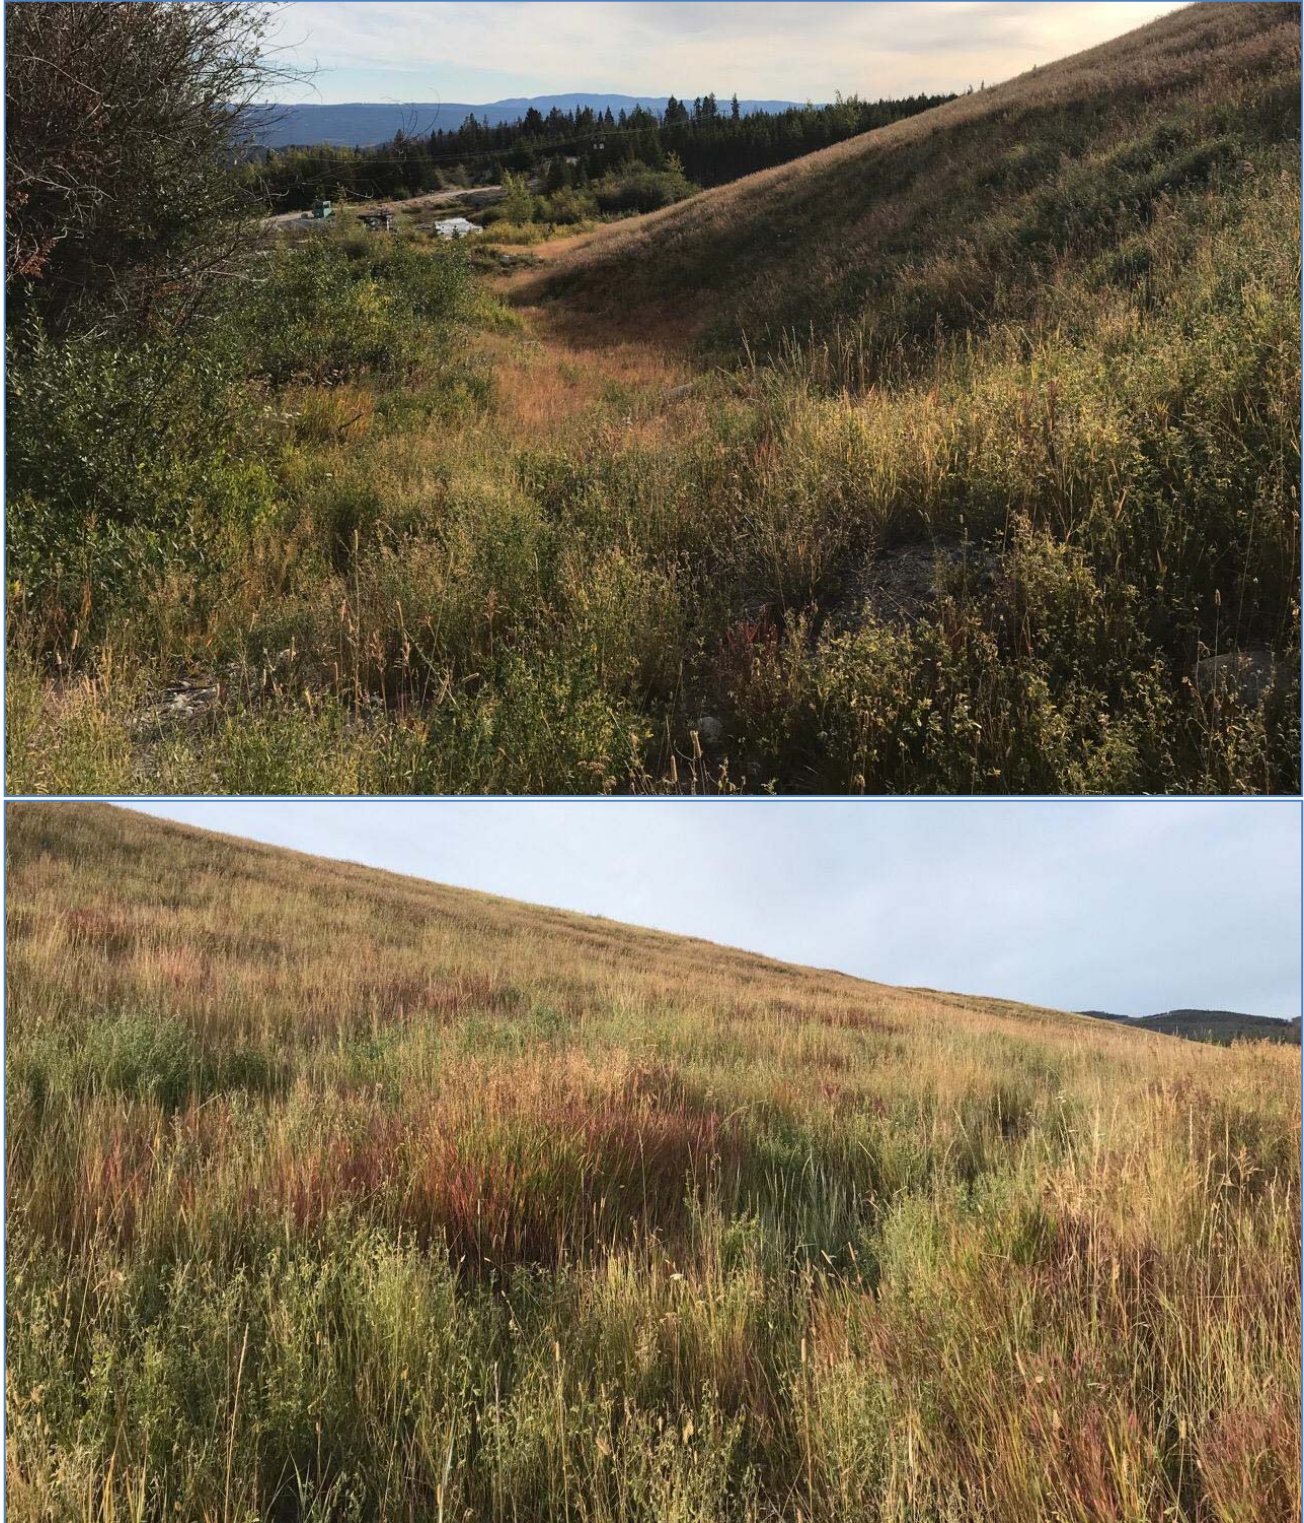
**Photo II-A-8 North Dam: local excavation. Appears to be an old pipeline bench excavated at the dam toe. (HGH-2018-6)**

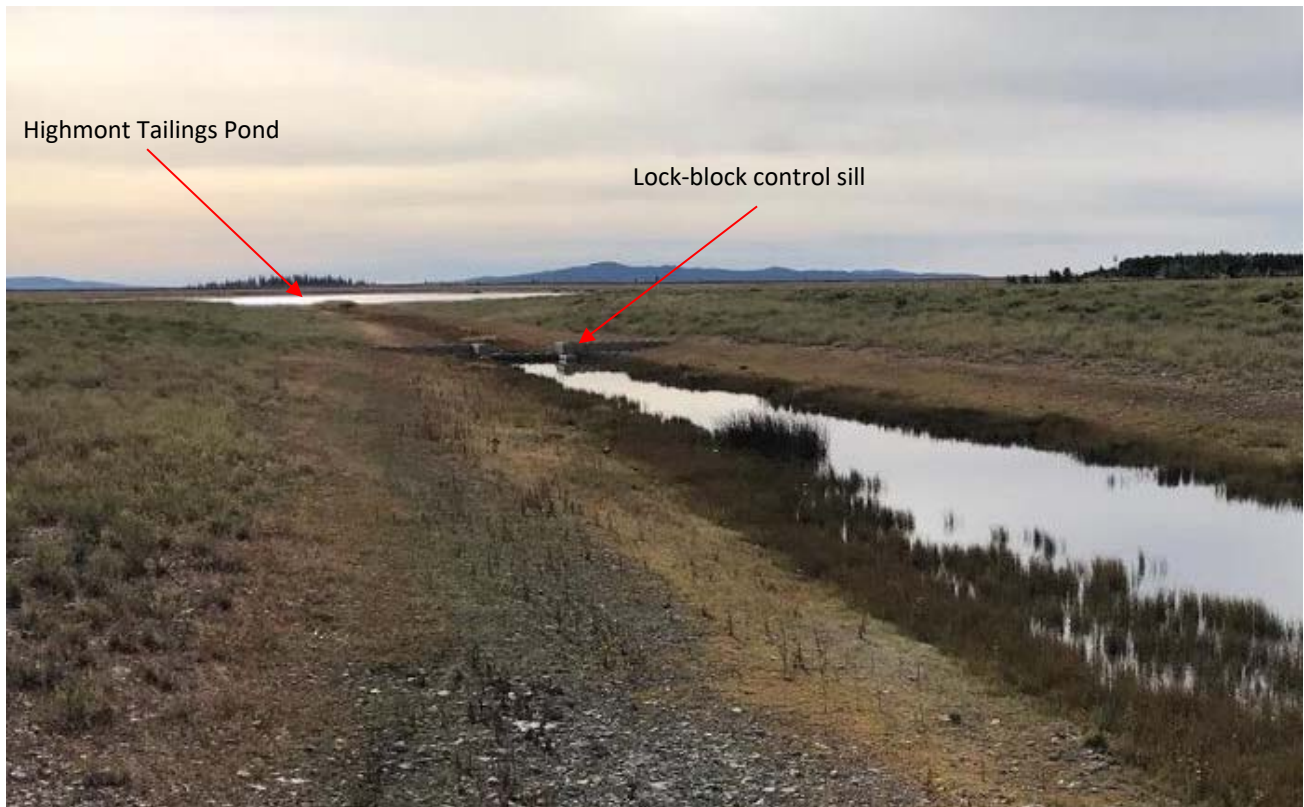
**Photo II-A-9 Spillway approach channel, concrete lock-block control sill (HGH-2018-7)**

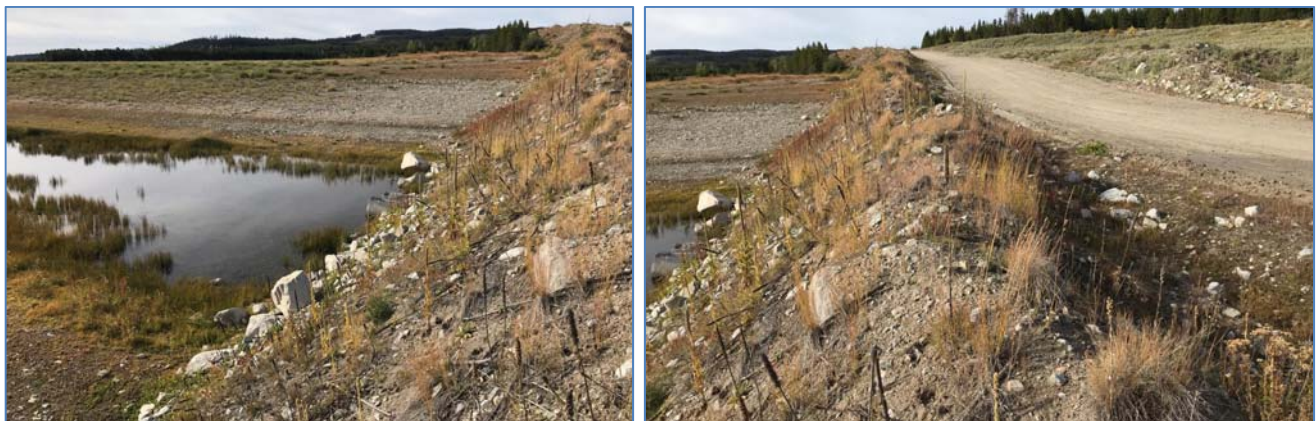
**Photo II-A-10 Spillway upstream of road crest. Road is in good condition. Spillway culverts are partially submerged (HGH-2018-7)**

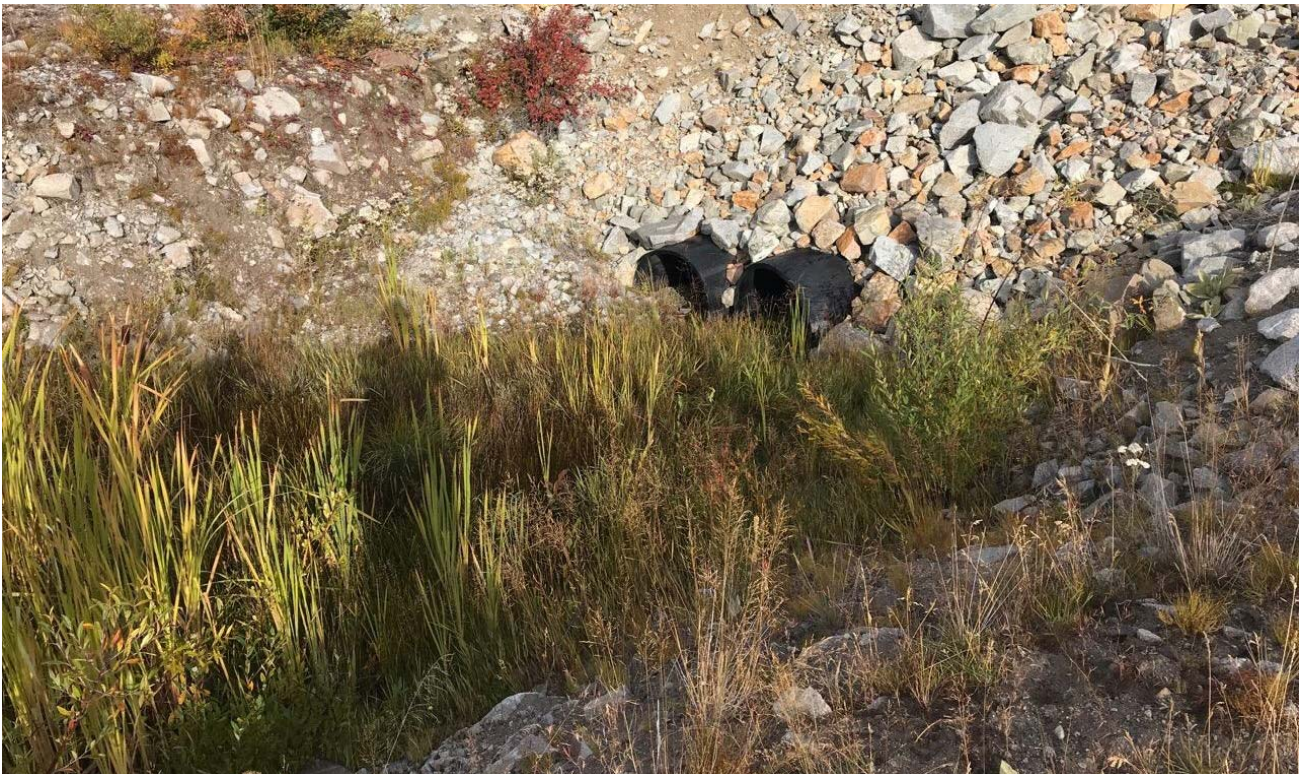
**Photo II-A-18 Inlet of 33" ID spillway road culverts, showing vegetation (HGH-2018-11)**

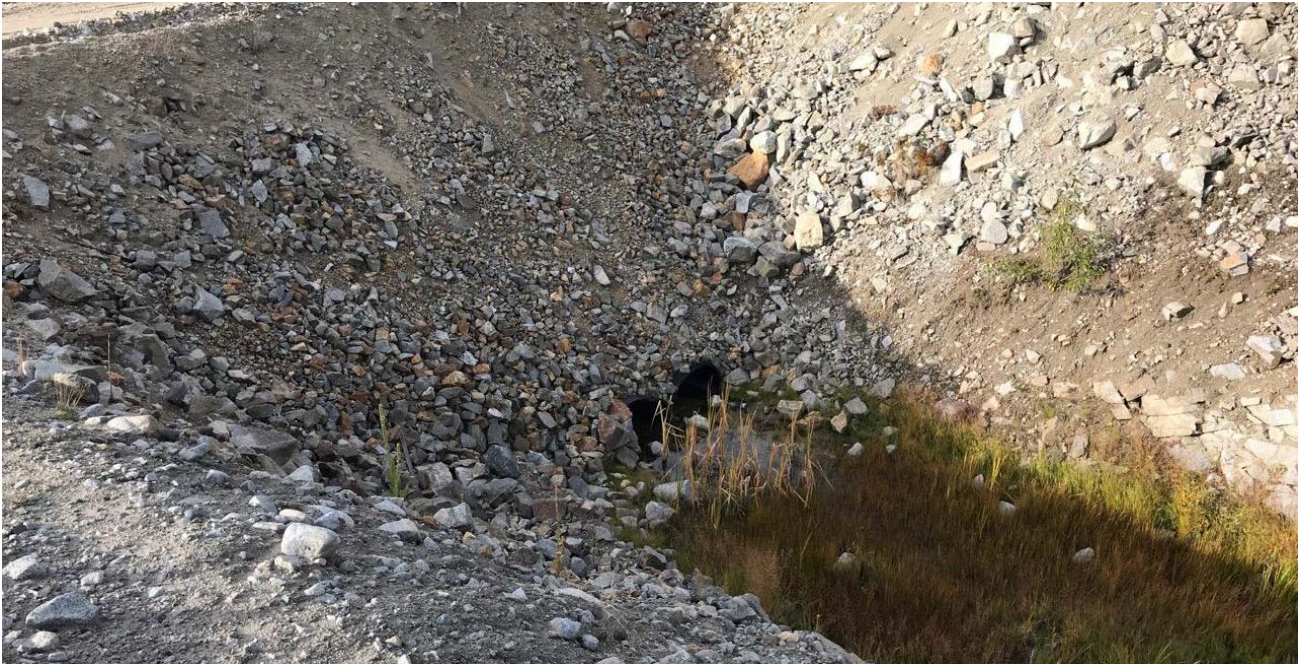
**Photo II-A-19 Highmont road-crossing spillway culverts, downstream side of the road, less vegetation observed compared to 2017DSI (HGH-2018-12)**

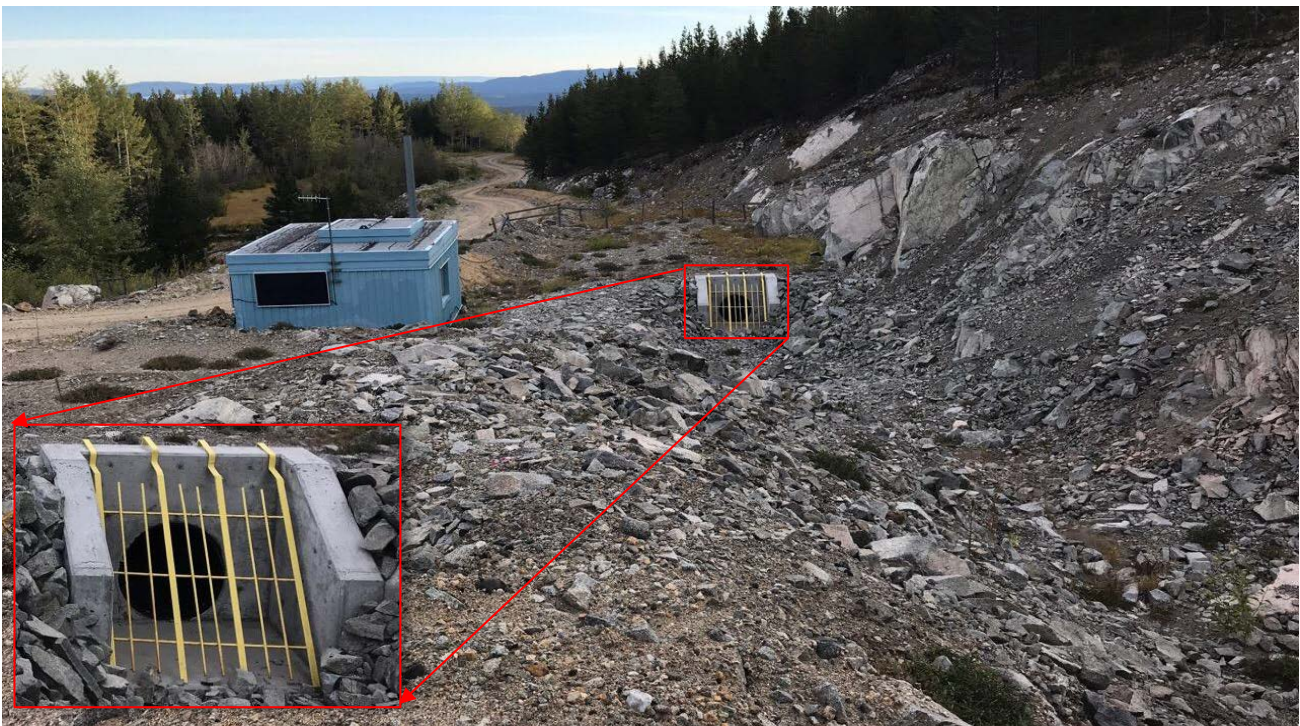
**Photo II-B-5 S1: Spillway channel and pipe intake looking downstream. Pipe intake is clear with no sign of vegetation or any other obstructions. (HGH-2018-14)**

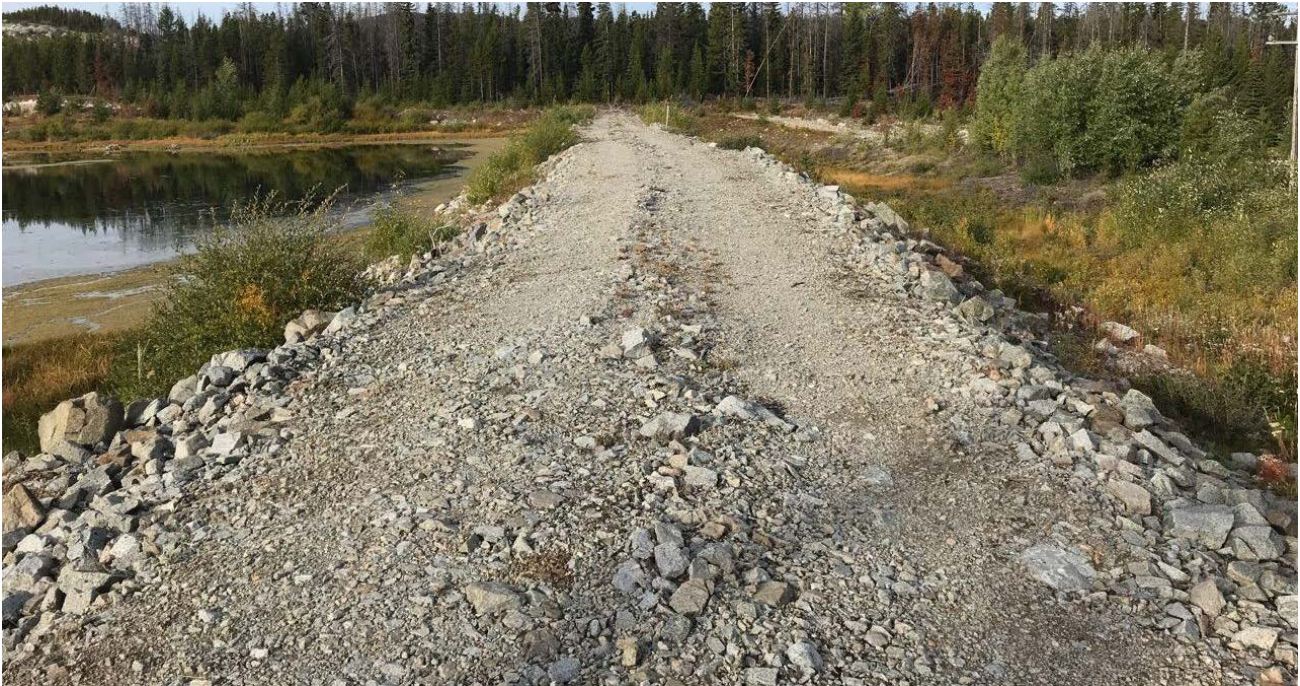
**Photo II-B-6 S2: Dam crest, view from right abutment. Crest in good condition; no sign of differential movement or distress was observed (HGH-2018-16)**

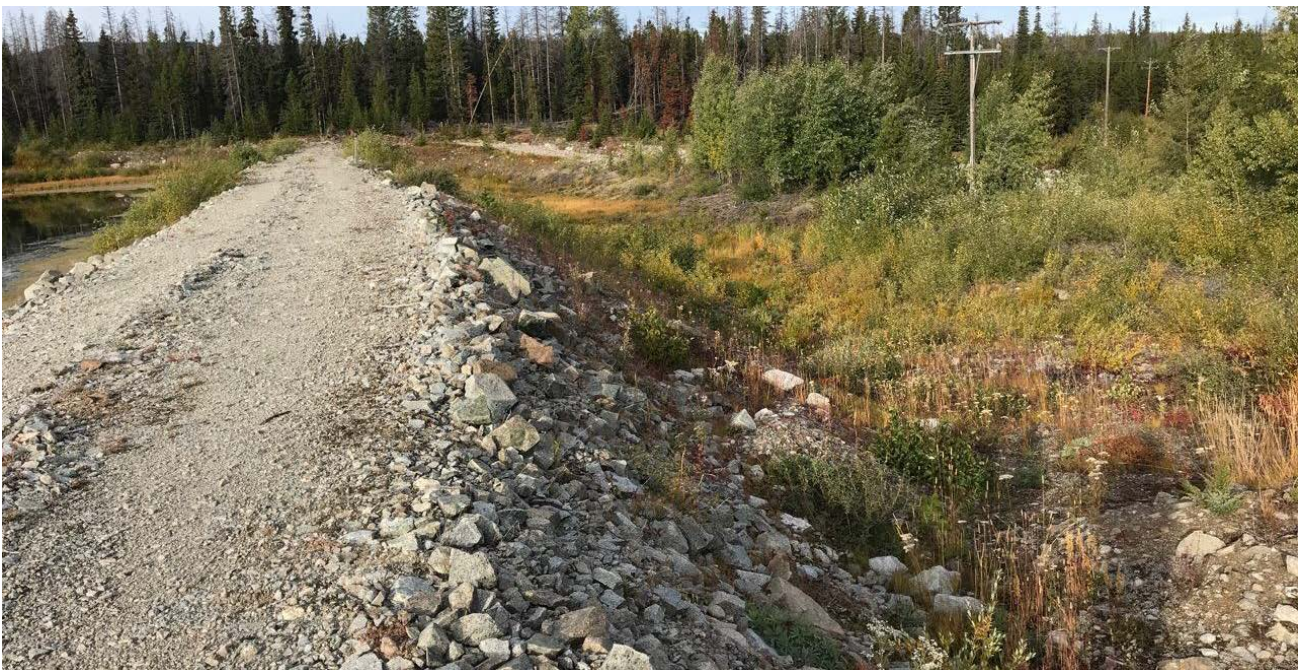
**Photo II-B-7 S2: Downstream slope looking from right abutment. The slope is in good condition; no erosion was observed (HGH-2018-16)**

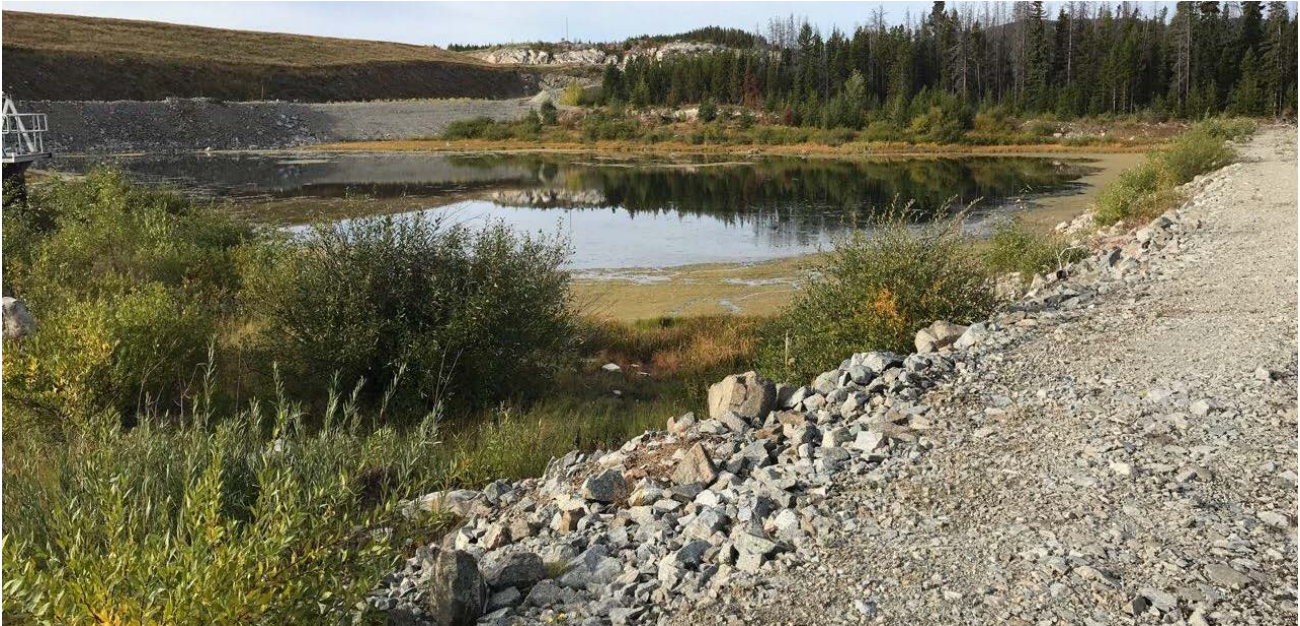
**Photo II-B-8 S2: Overview of the pond and upstream slope from right abutment. The slope is in good condition; no erosion was observed. Highmont North Dam downstream toe is visible in the background to the left. (HGH-2018-16)**

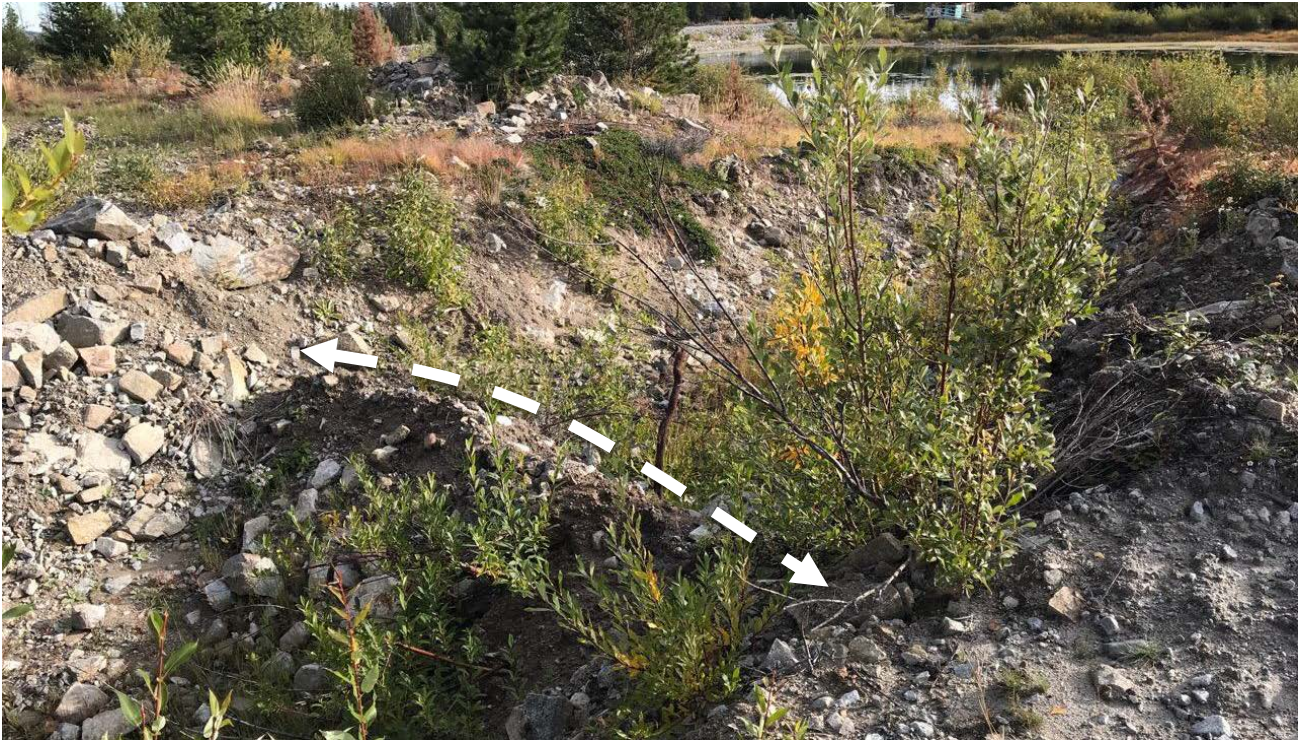
**Photo II-B-12 S2: Plug across inlet S2 channel to direct flow to spillway channel. View looking downstream (HGH-2018-13)**

- ◆ To improve dam safety of S2 Pond, by reducing overtopping risks, KCB recommend the till plug be permanently relocated to the S2 Pond inlet channel and built to sufficient height such that the plug would not be overtopped during the Highmont TSF IDF.

- ◆ Whenever in place, plug performance and S2 Pond freeboard should be monitored during high flow events such that intervening measures (e.g. pumping) can be implemented, if needed. KCB recommend this be included in the next OMS manual update.

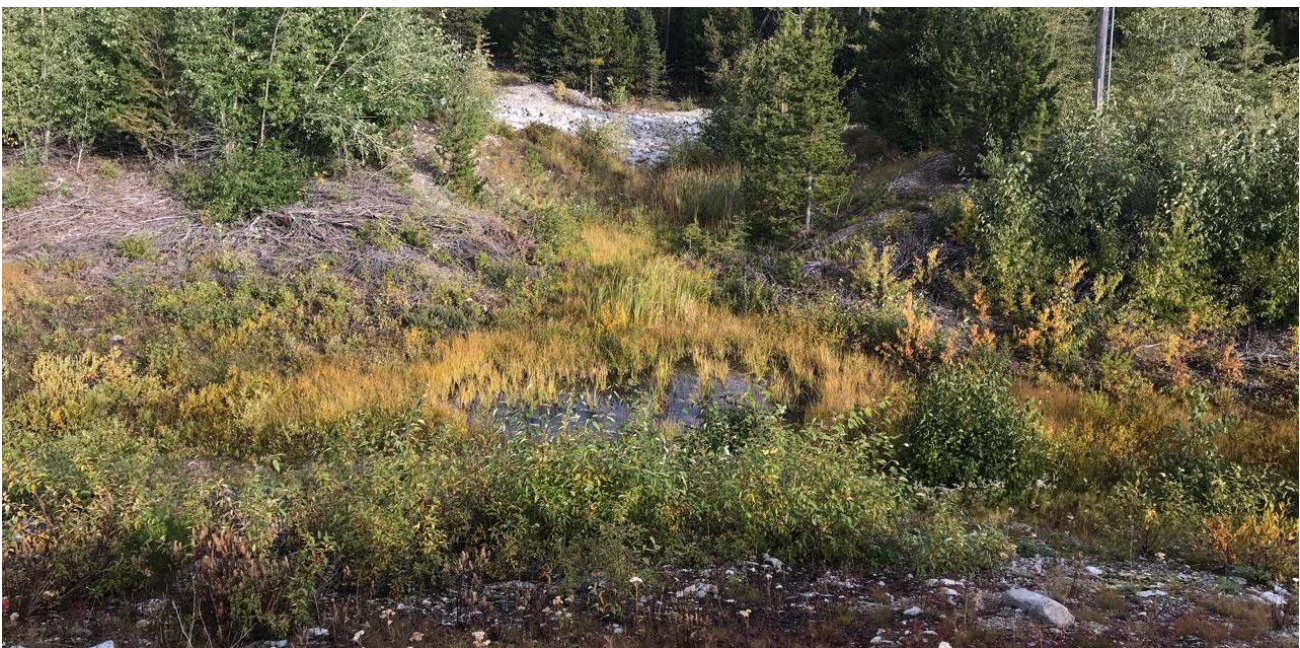
**Photo II-B-13 S2: Ponded water at downstream toe, similar in size to the pond noted during the 2015, 2016, and 2017 DSI. (HGH-2018-18)**

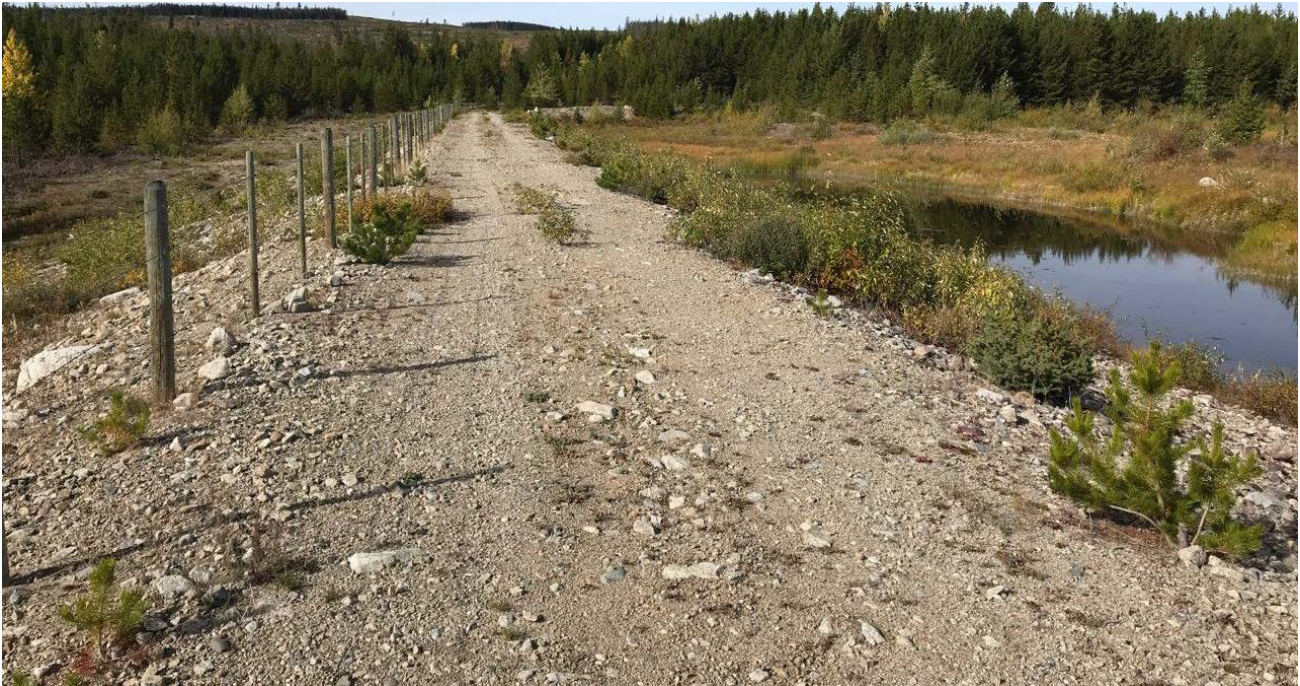
**Photo II-B-14 S3: Dam crest view from left abutment. Crest is in good condition; no sign of erosion or any differential movement is observed (HGH-2018-19)**

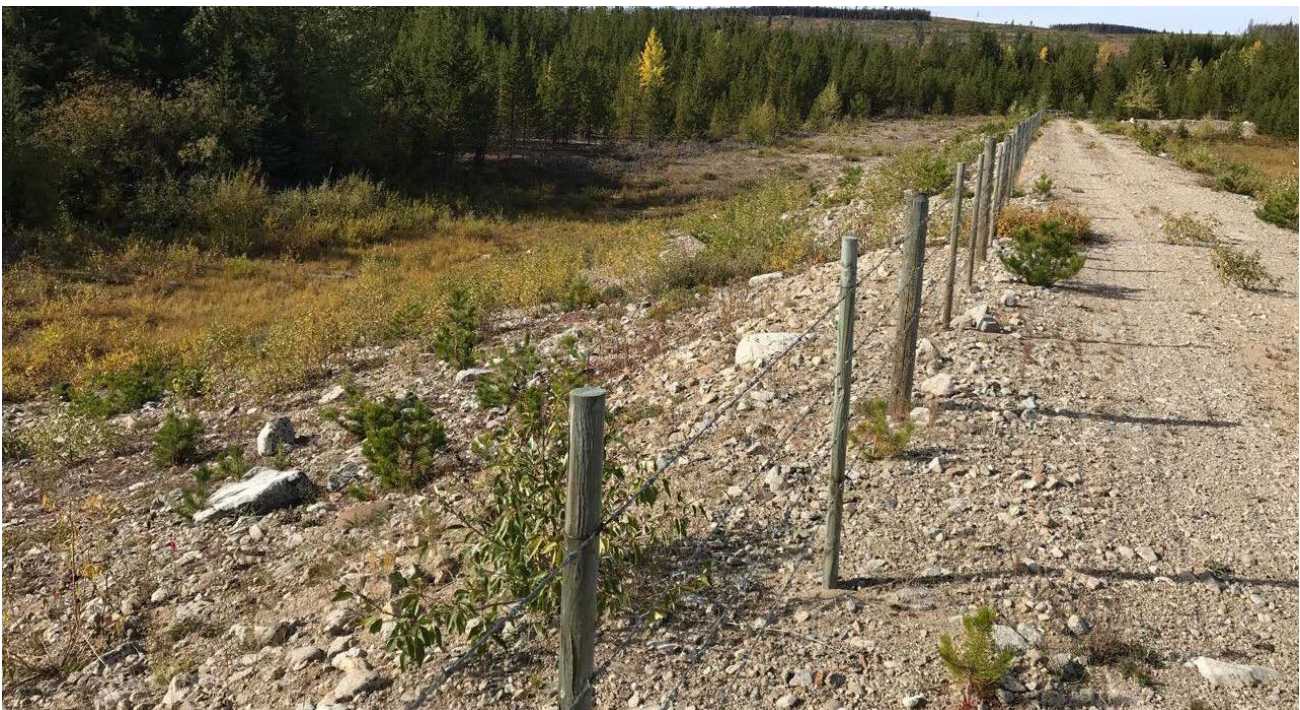
**Photo II-B-15 S3: Downstream slope; no sign of erosion is observed (HGH-2018-19)**

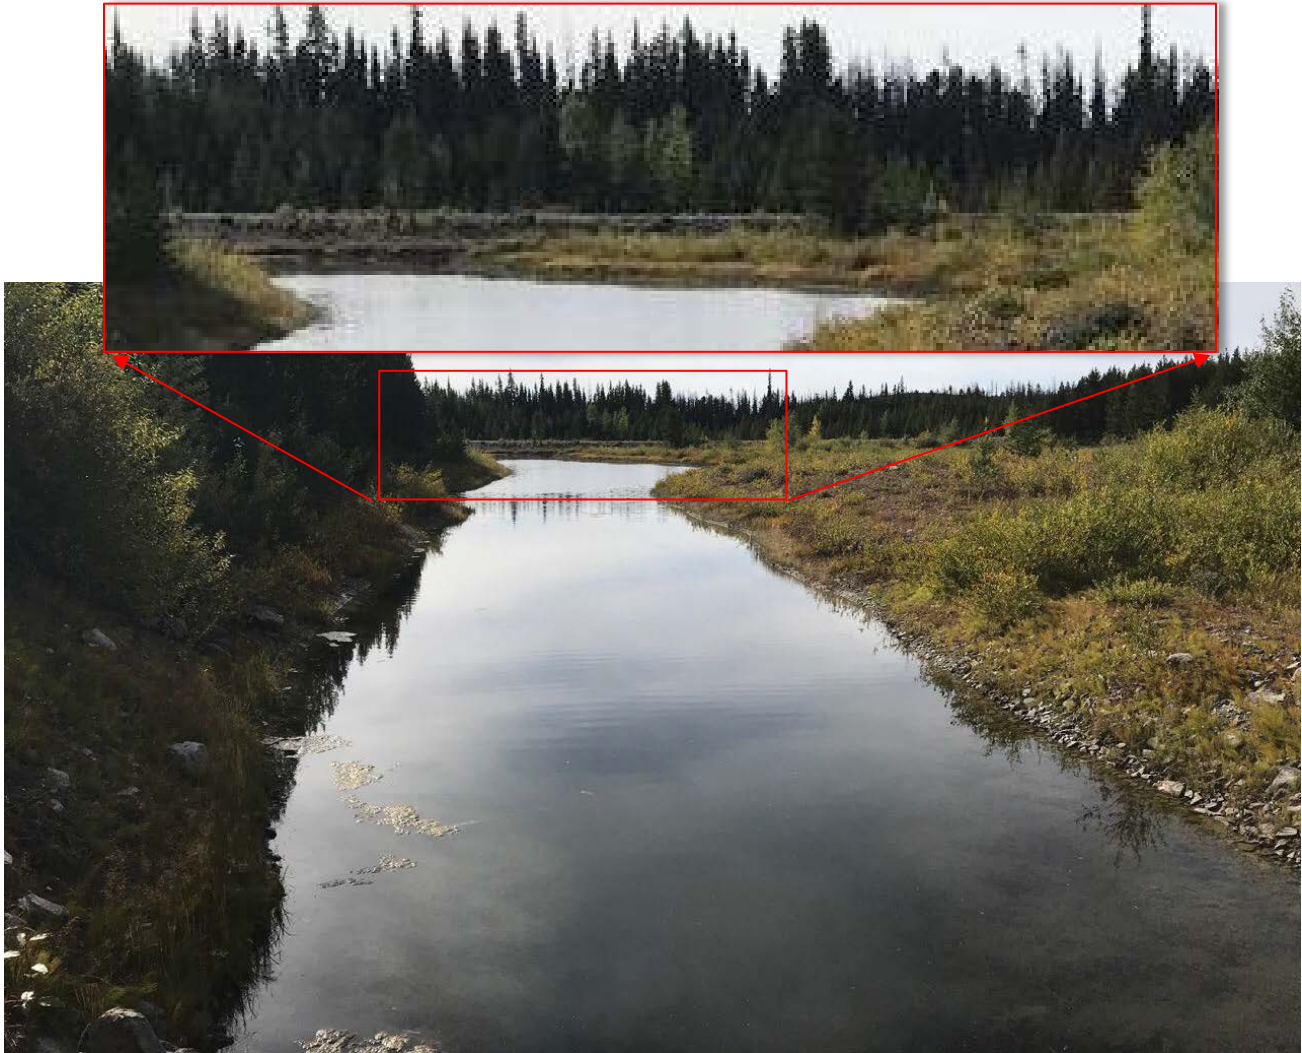
**Photo II-B-16 S3: Overview of the pond and upstream slopes, looking South. Slopes are in good condition. (HGH-2018-4)**

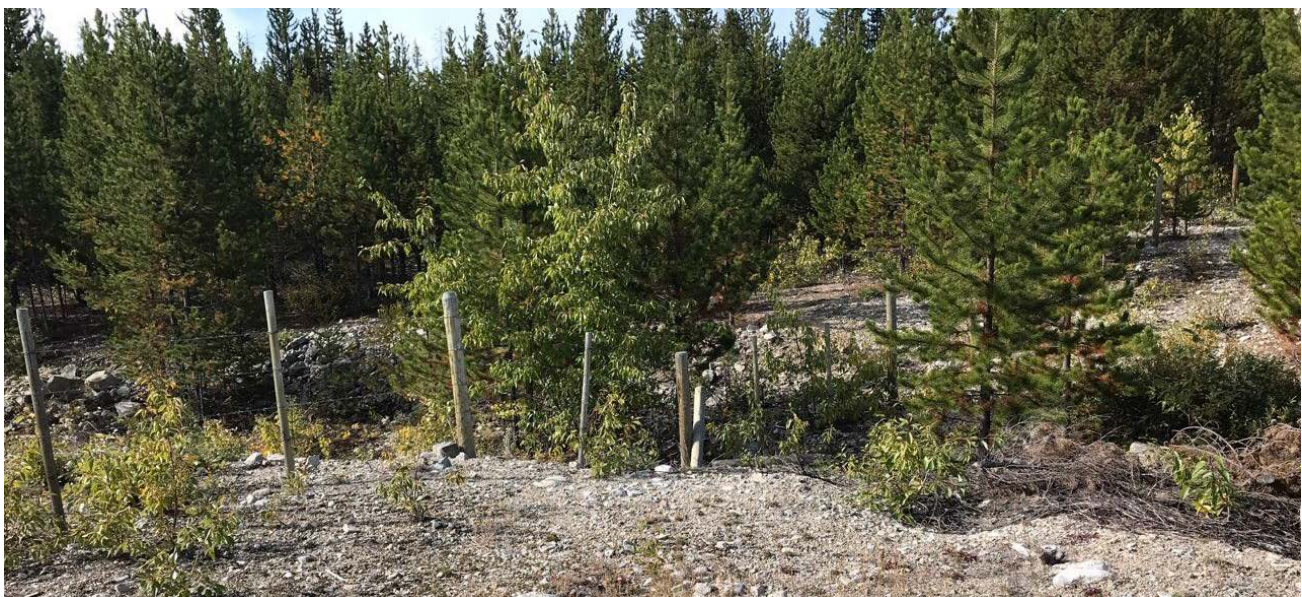
**Photo II-B-20 S3: spillway channel downstream of blockade. (HGH-2018-20)**

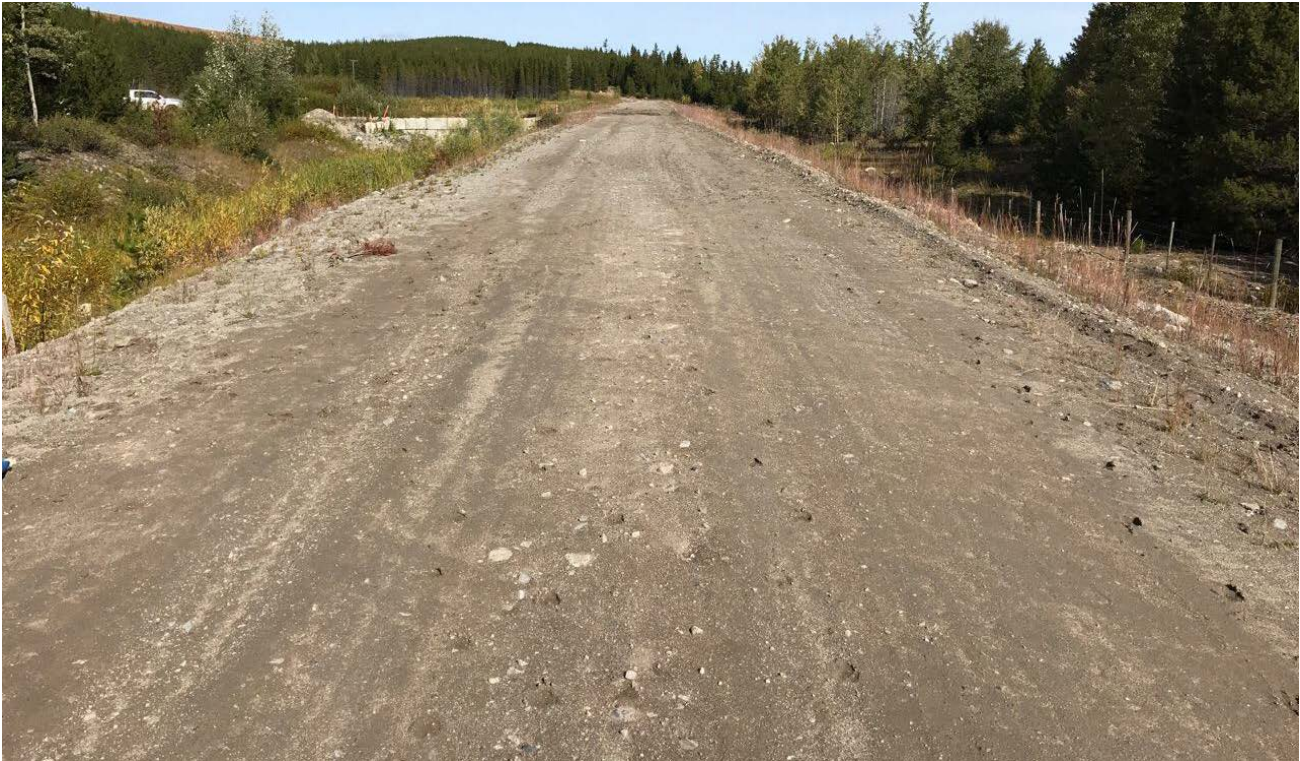
**Photo II-B-21 S5: dam crest is in good condition; no evidence of erosion or distress  
(HGH-2018-21)**

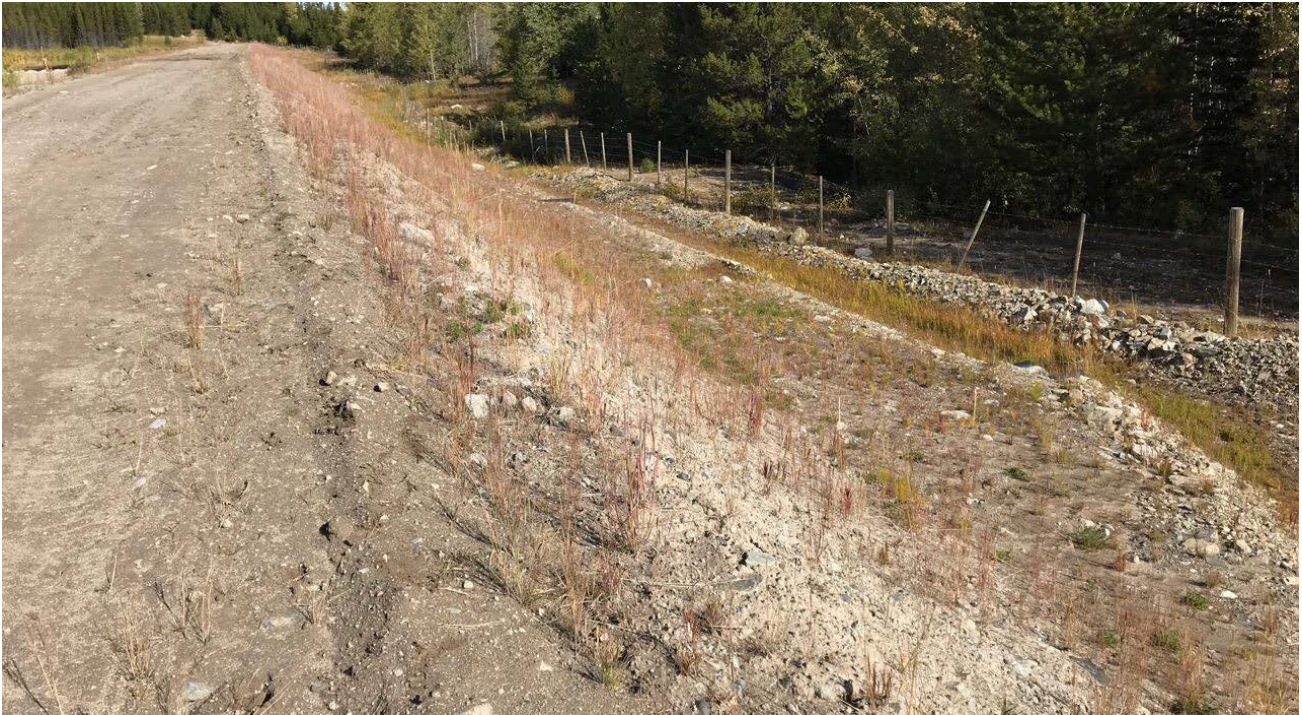
**Photo II-B-22 S5: Downstream slope looking North from right abutment. Slope is in good condition; no sign of erosion is observed (HGH-2018-21)**

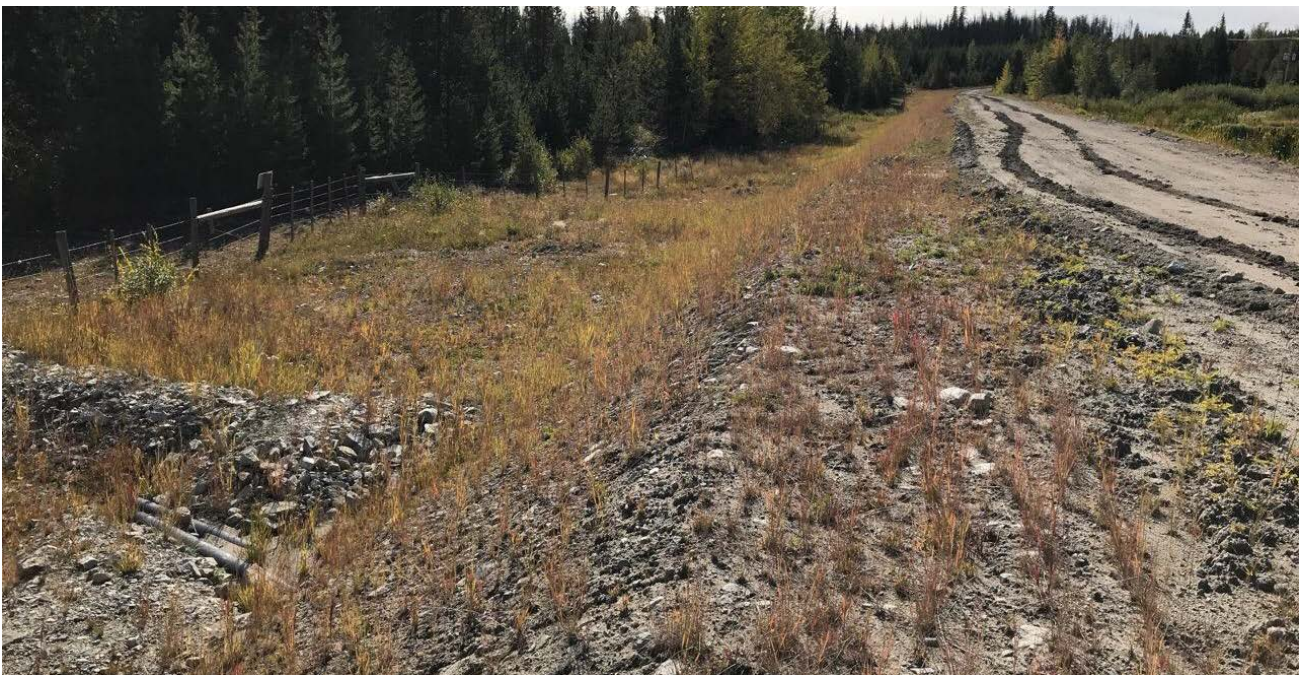
**Photo II-B-23 S5: Downstream slope of central pond looking south towards right abutment. Slope is in good condition (HGH-2018-22)**

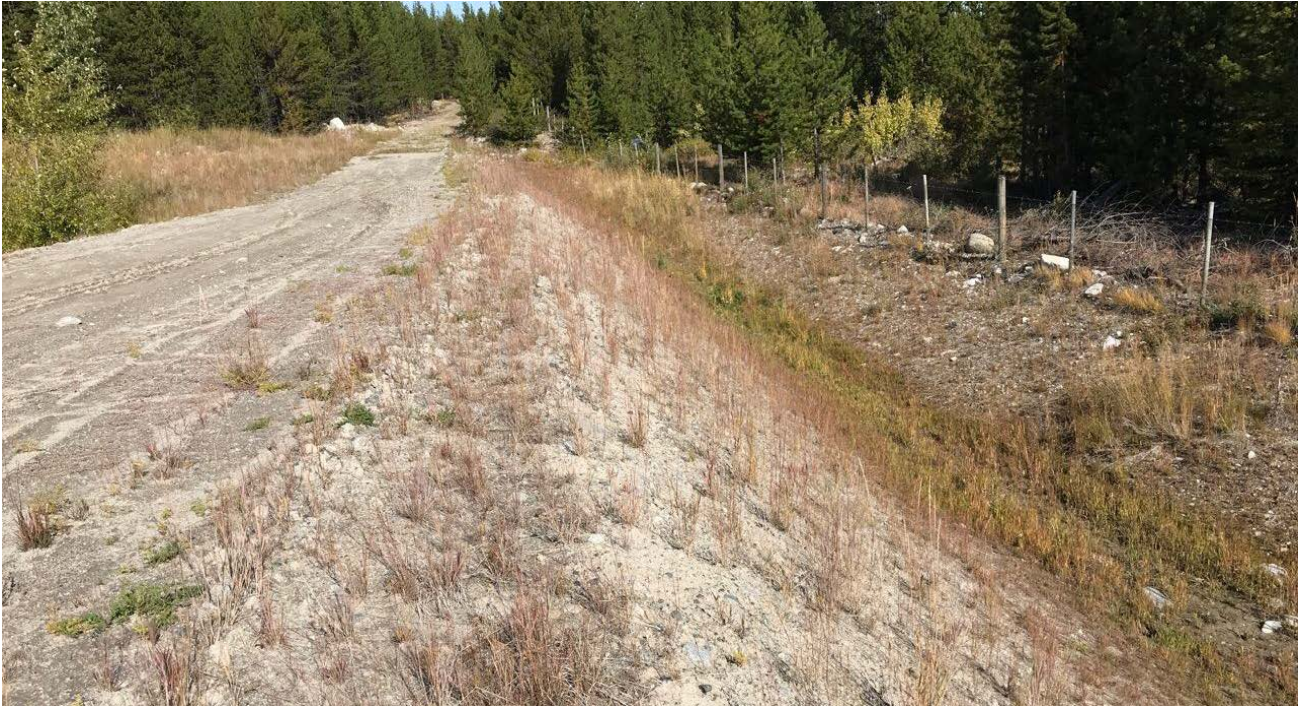
**Photo II-B-24 S5: Downstream slope of left abutment. Slope is in good condition (HGH-2018-22)**

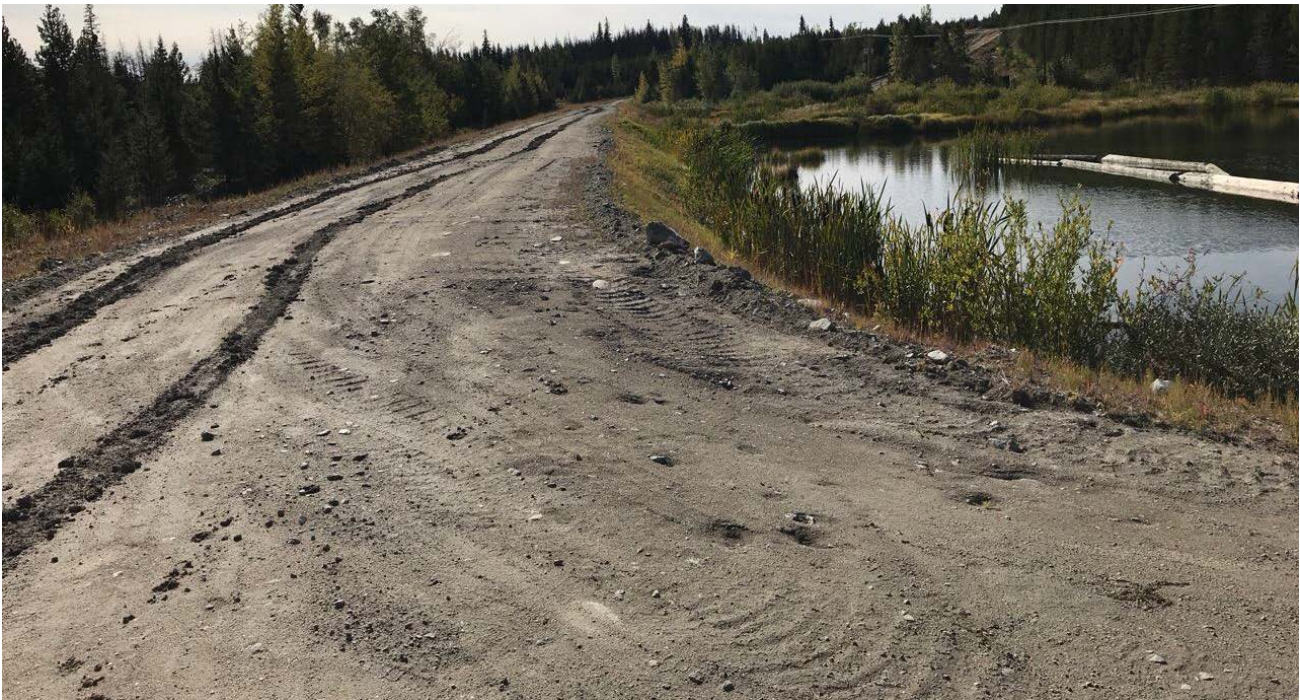
**Photo II-B-25 S5: Upstream slope of central pond looking south towards right abutment. Slope is in good condition (HGH-2018-22)**
