# **Teck Highland Valley Copper Partnership**

## **2018 Dam Safety Inspection Report**

### ***Highmont Tailings Storage Facility***

March 2019

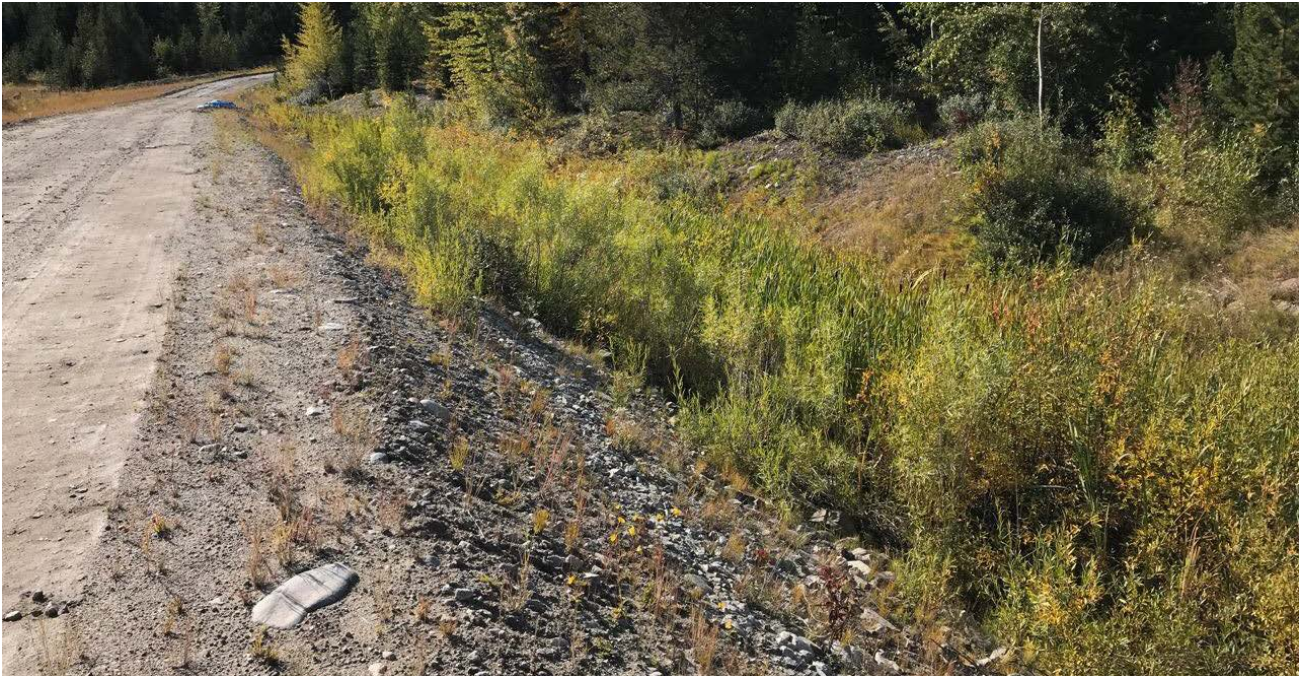
**Photo II-B-26 S5: Upstream slope looking South. Slope is in good condition; no sign of erosion is observed (HGH-2018-23)**

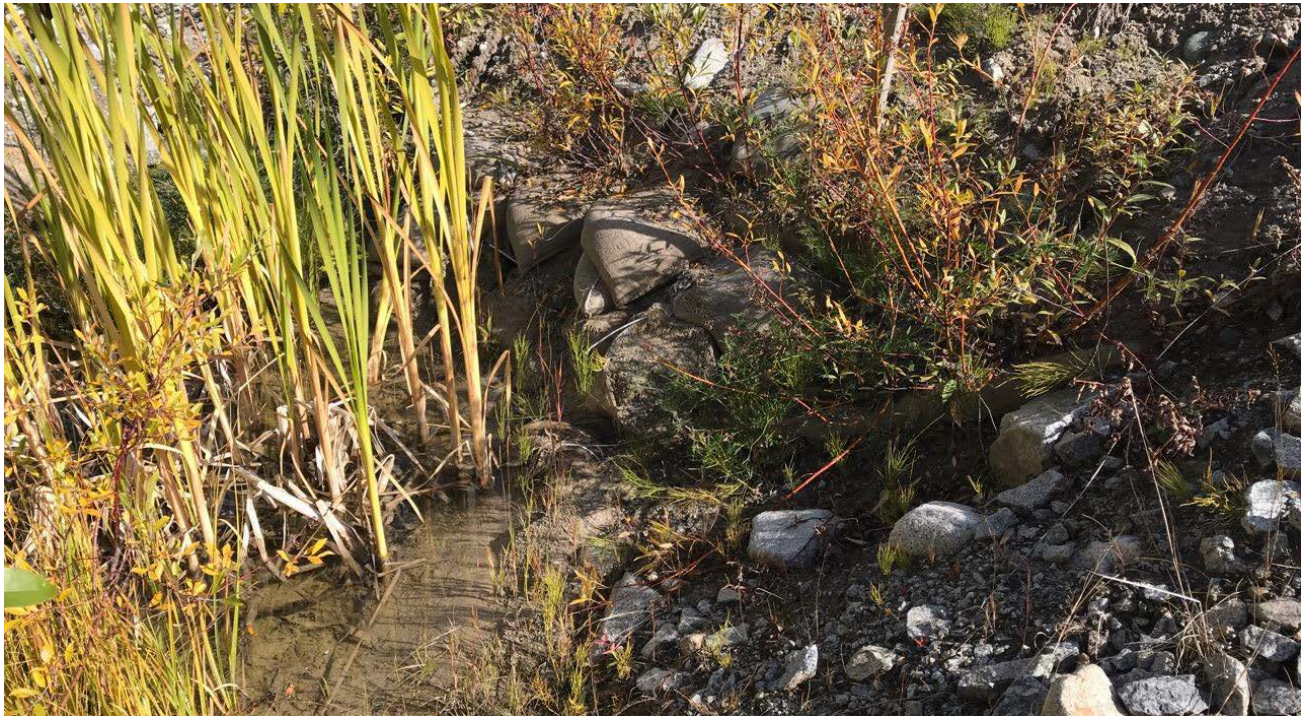
**Photo II-B-30 S5: Spillway pipes (2x), inlet blocked with sand bags. (HGH-2018-25)**

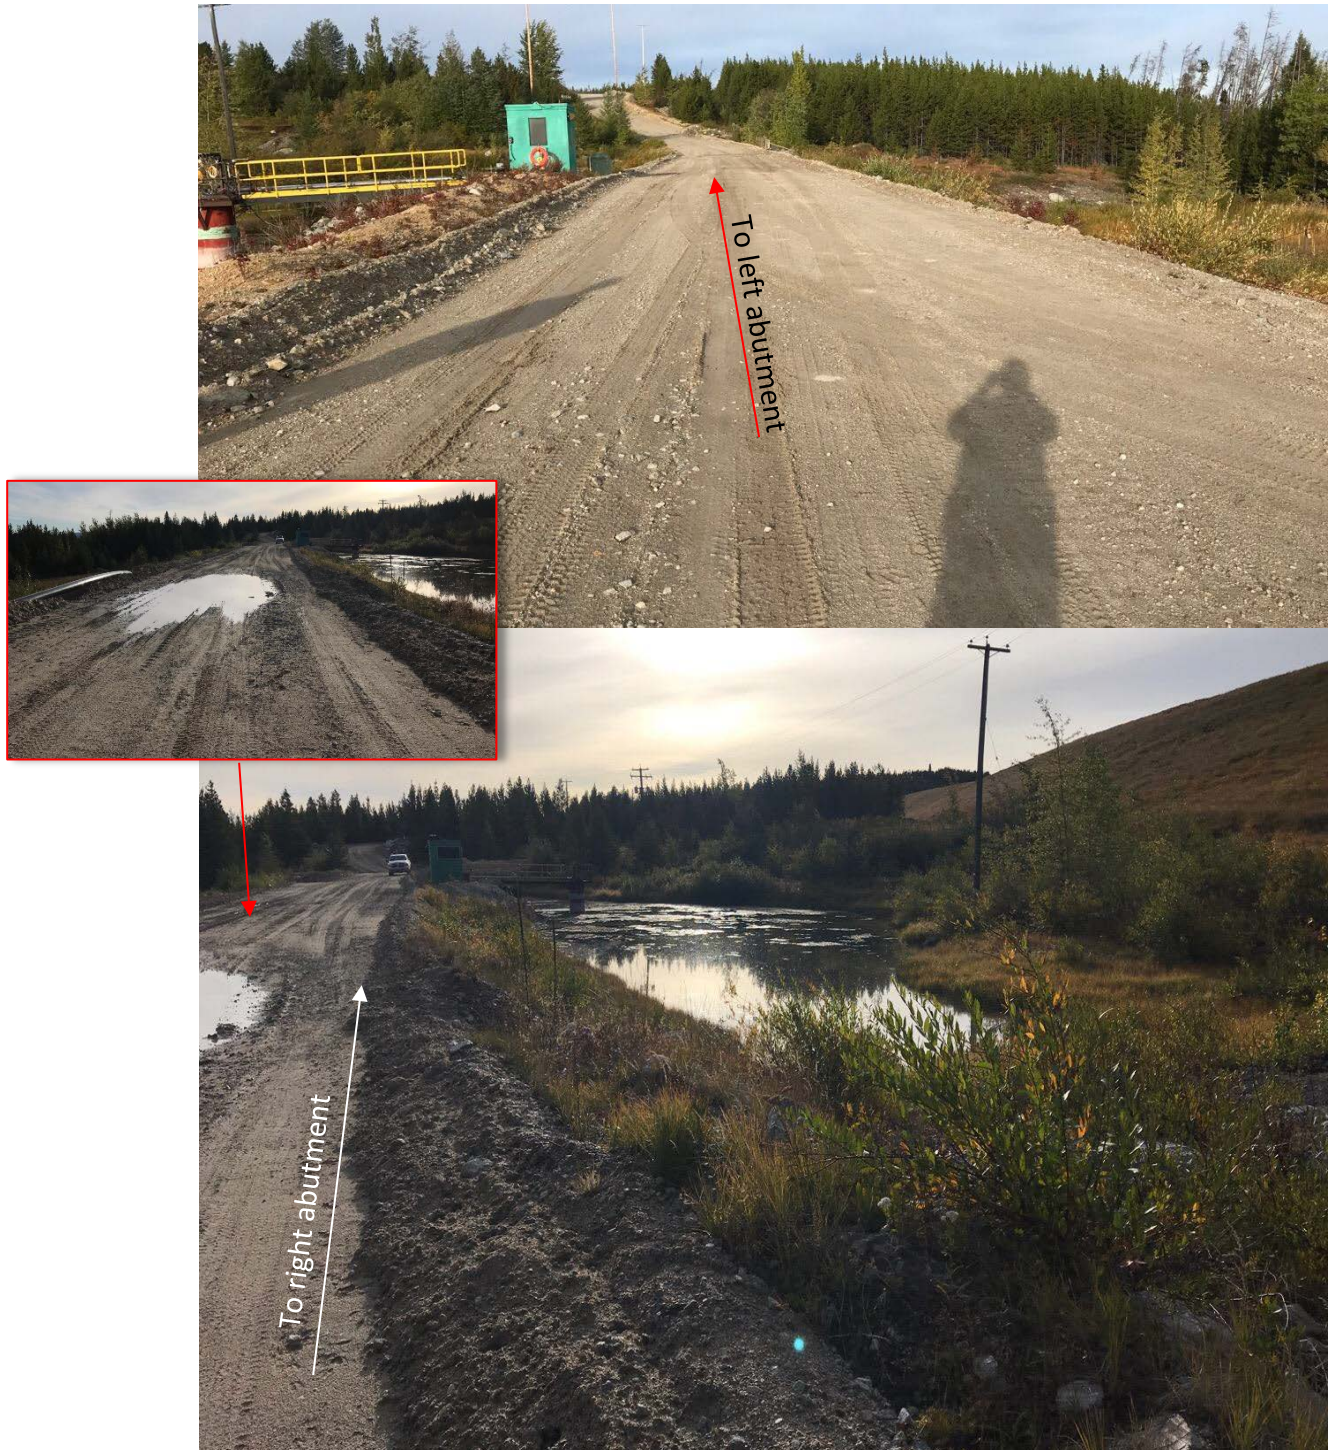
**Photo II-B-31 S8: Overview of crest and upstream slope. u/s slope is in good condition. Crest has low points but there is no major distress. (HGH-2018-26)**

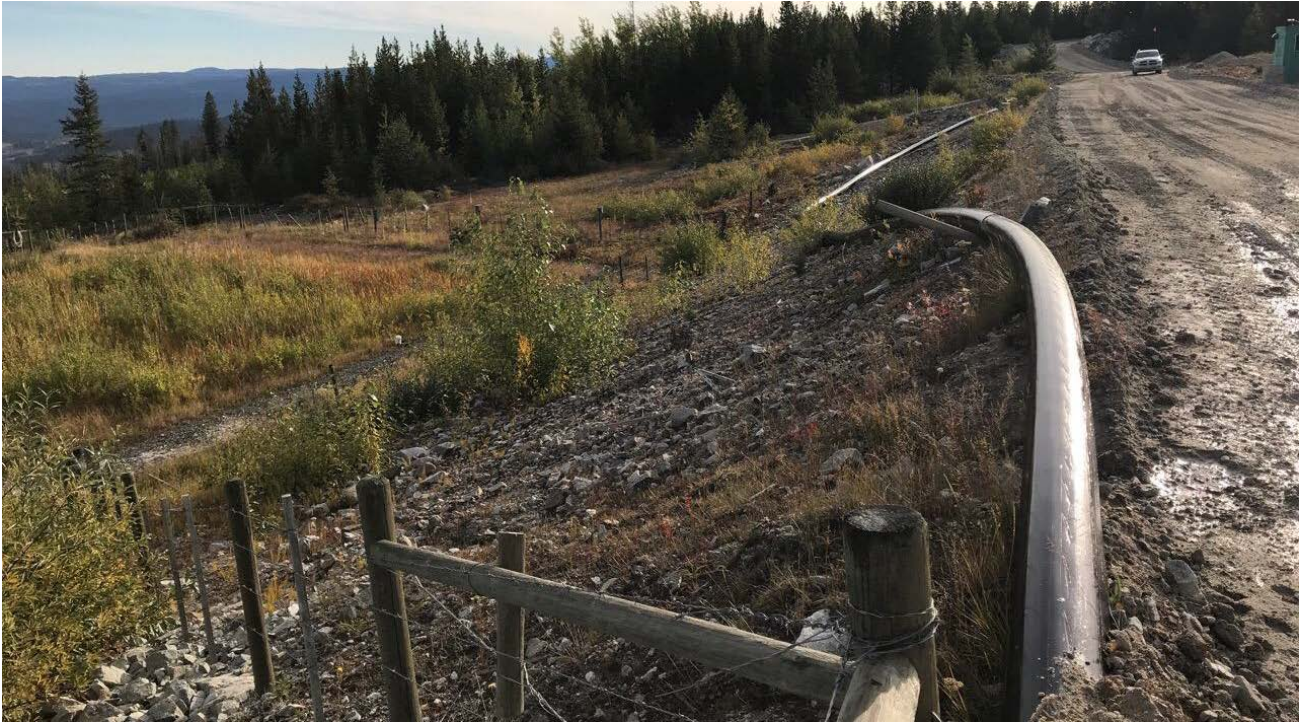
**Photo II-B-32 S8: Downstream slope looking East from left abutment. Slope is in good condition, pipe on slope is not connected to anything. (HGH-2018-26)**

S2-2018-02	Flood Routing	10.1.8	To improve dam safety of S2 Pond, by reducing overtopping risks, KCB recommend the Highmont TSF spillway till plug be permanently relocated to the S2 Pond inlet channel and built to sufficient height such that the plug would not be overtopped during the Highmont TSF IDF.	2	Q4, 2019
<b>S8 Pond</b>					
S8-2018-01	Maintenance	OMS	A pipe was observed on the slope of the S8 Pond dam that did not appear to be connected to anything. This pipe should be removed.	4	Q4, 2019
