TECK RESOURCES LTD.

Louvicourt Mine Tailings and Polishing Ponds 2018 Dam Safety Inspection

001-18102172-RA-Rev1

March 2019

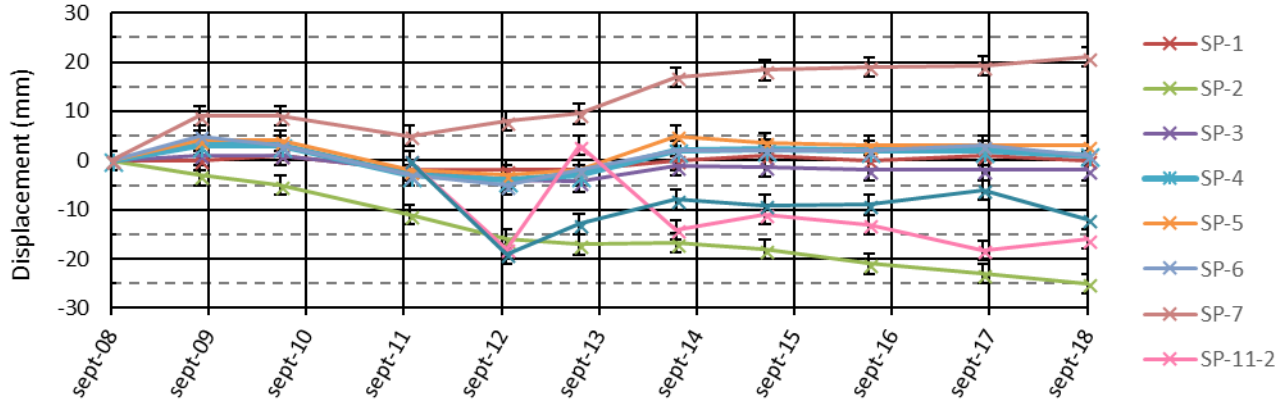
Figure 5: Vertical Displacement of the Survey Monuments at Dam 1

Vertical movements are noticeable on most monuments on a year to year basis, attributed to frost action and survey limitations. Monuments installed in 2011 seem to be more prone to these yearly movements than former monuments. Measured differences for monuments installed in 2011 are however small, the largest movement for this time interval (settlement of 24 mm) occurs at SP-11-3 located on Dam 4B. The magnitude of deformations indicated by the monitoring instrumentation do not present a dam safety concern but do warrant continued monitoring.

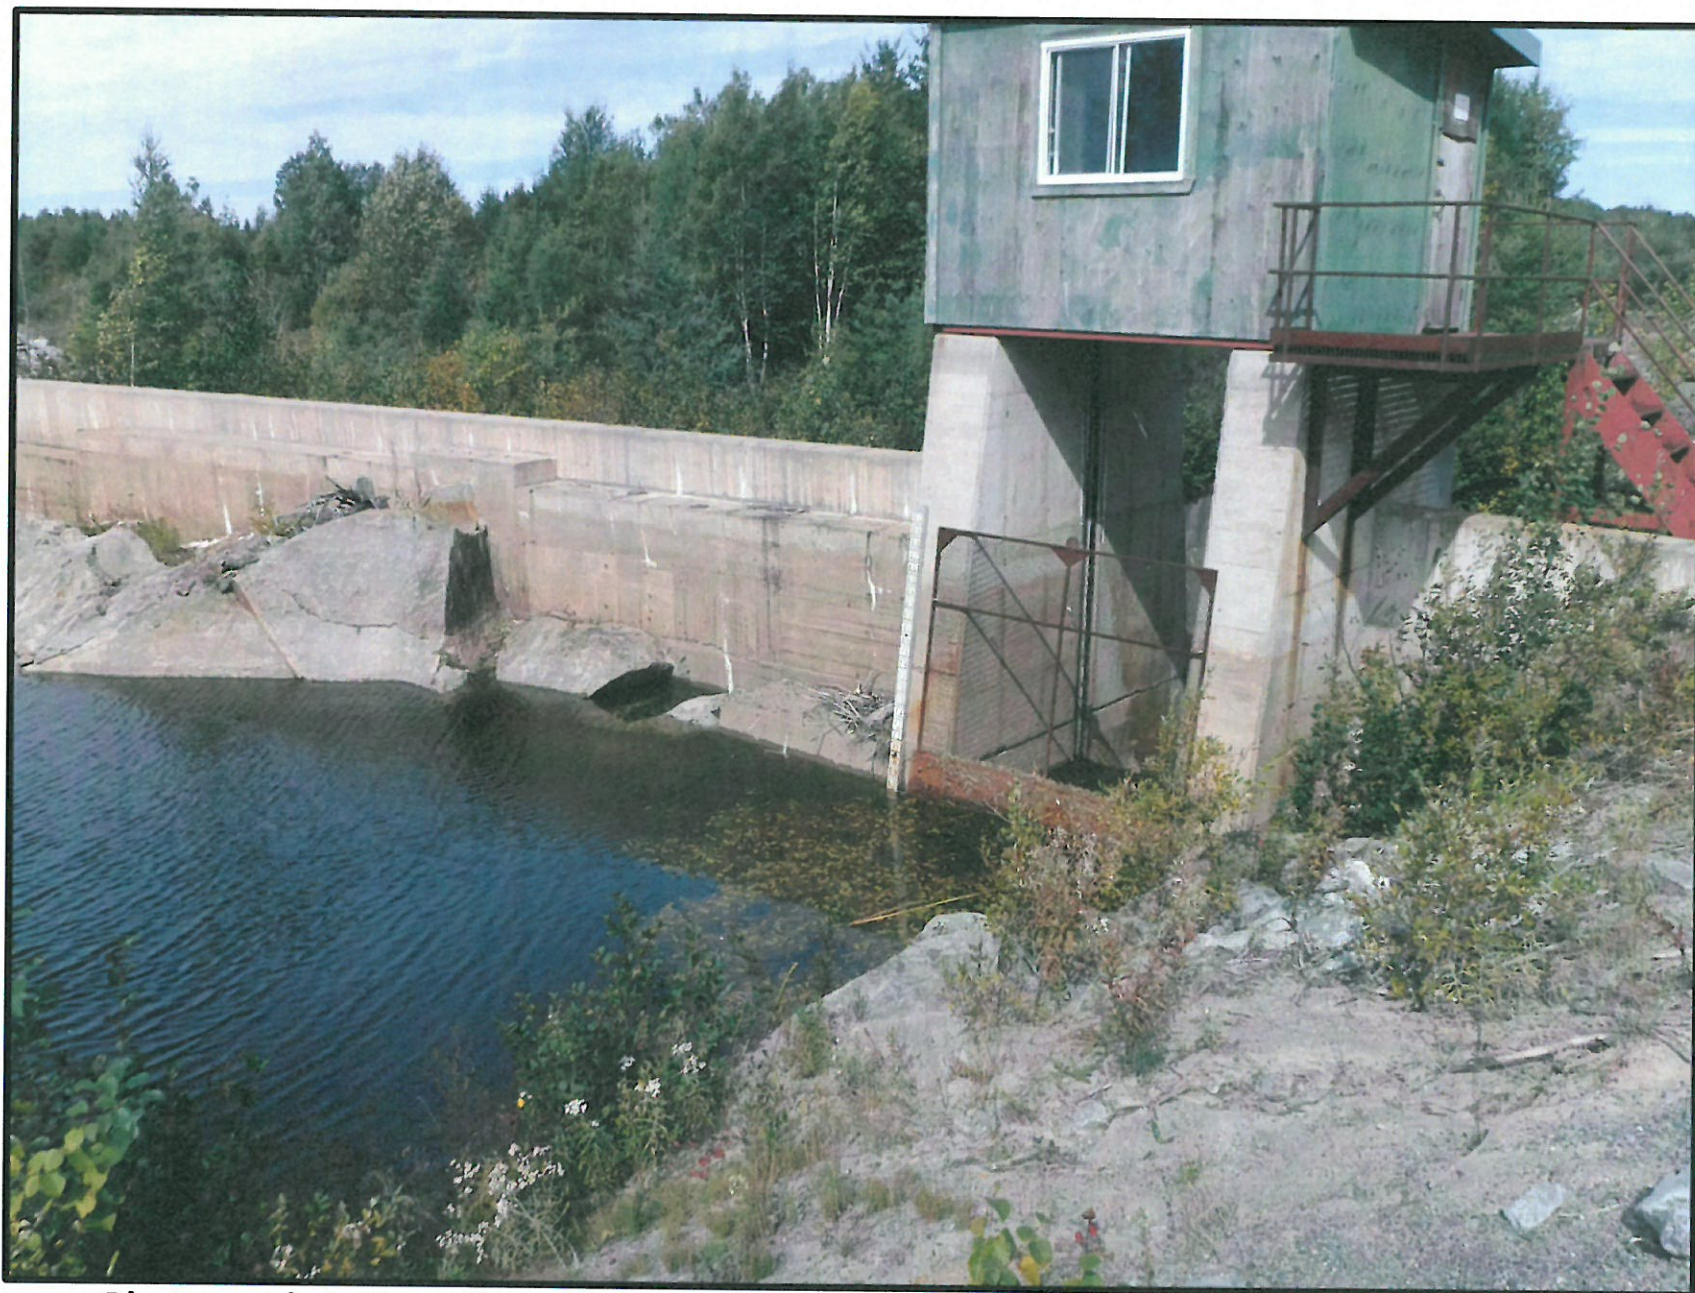
Photograph 1: Dam 4B, spillway

Overflow Weir at Dam 4B in good condition.

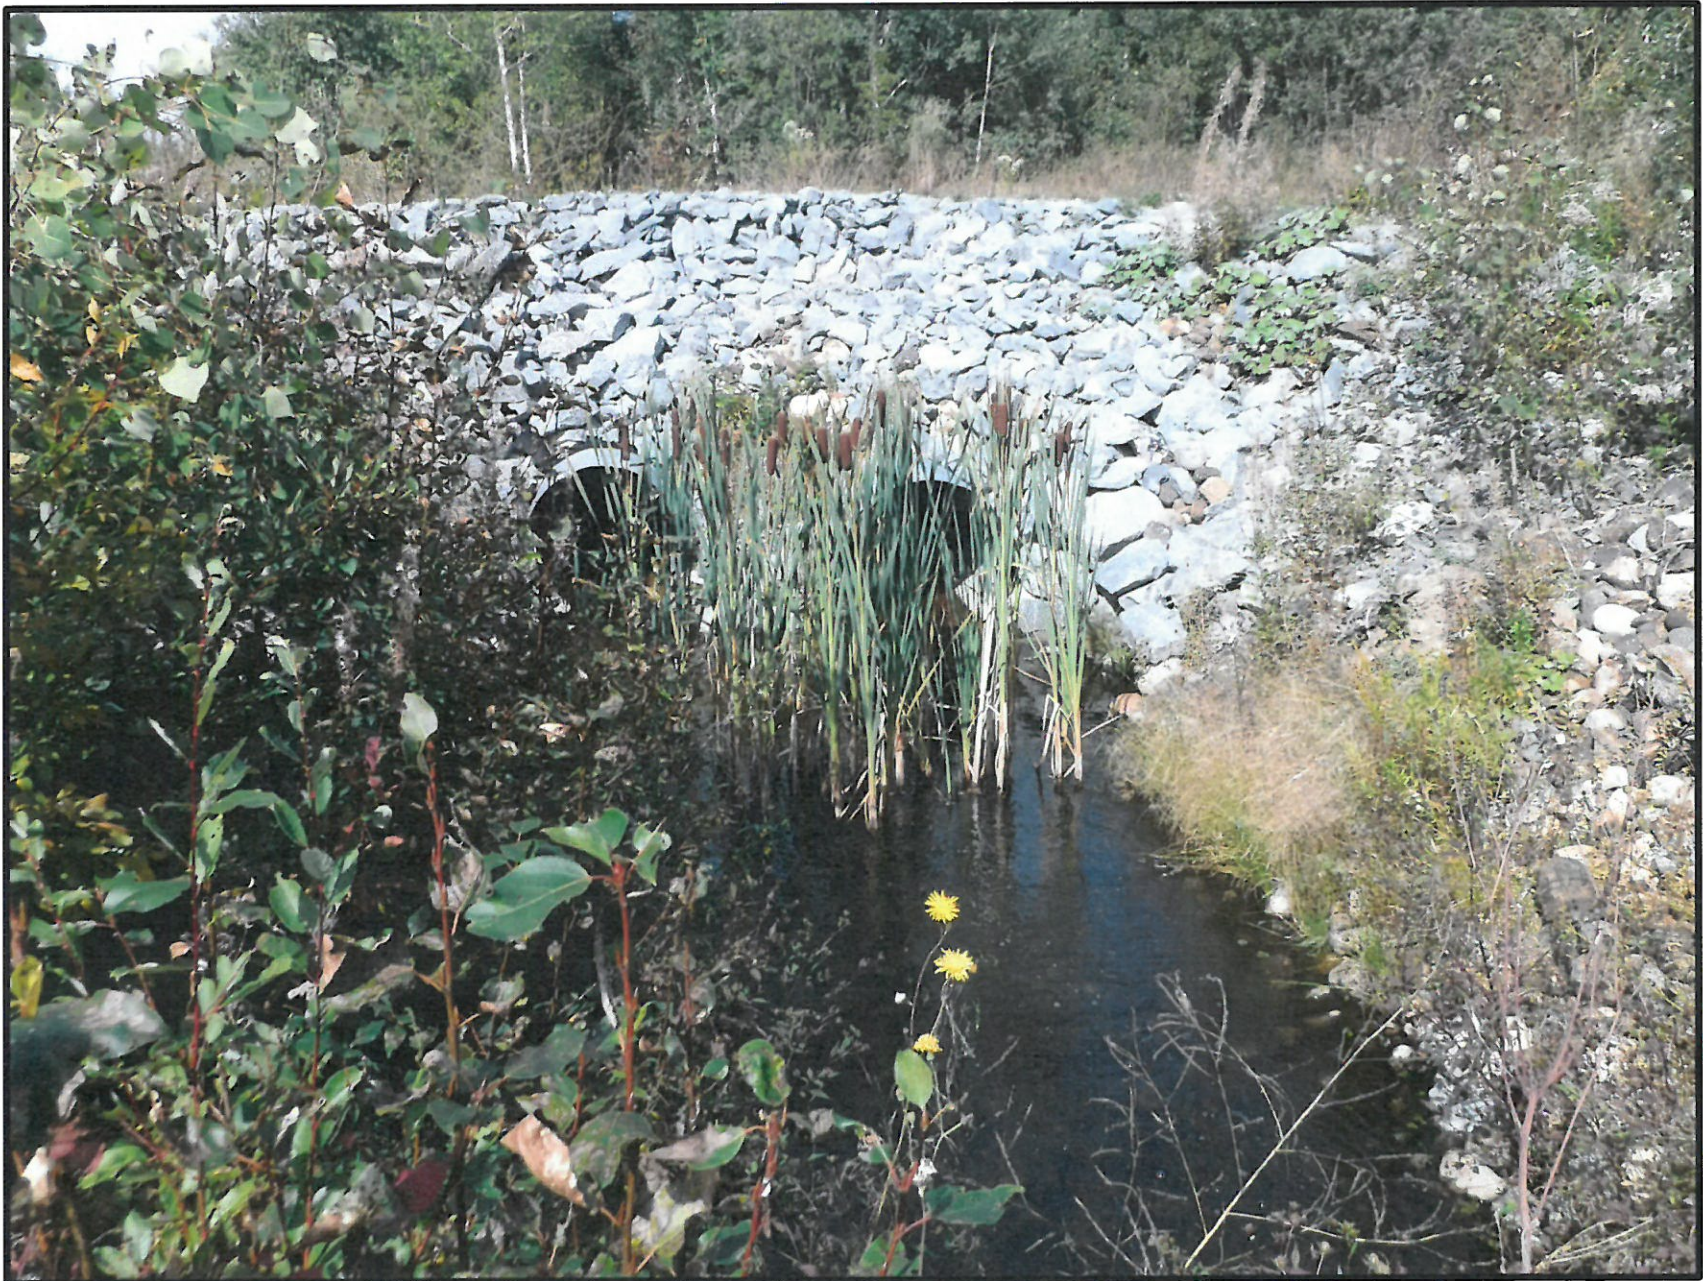
Photograph 2: Dam 4B, final effluent

Final effluent is clean, culverts in good conditions.

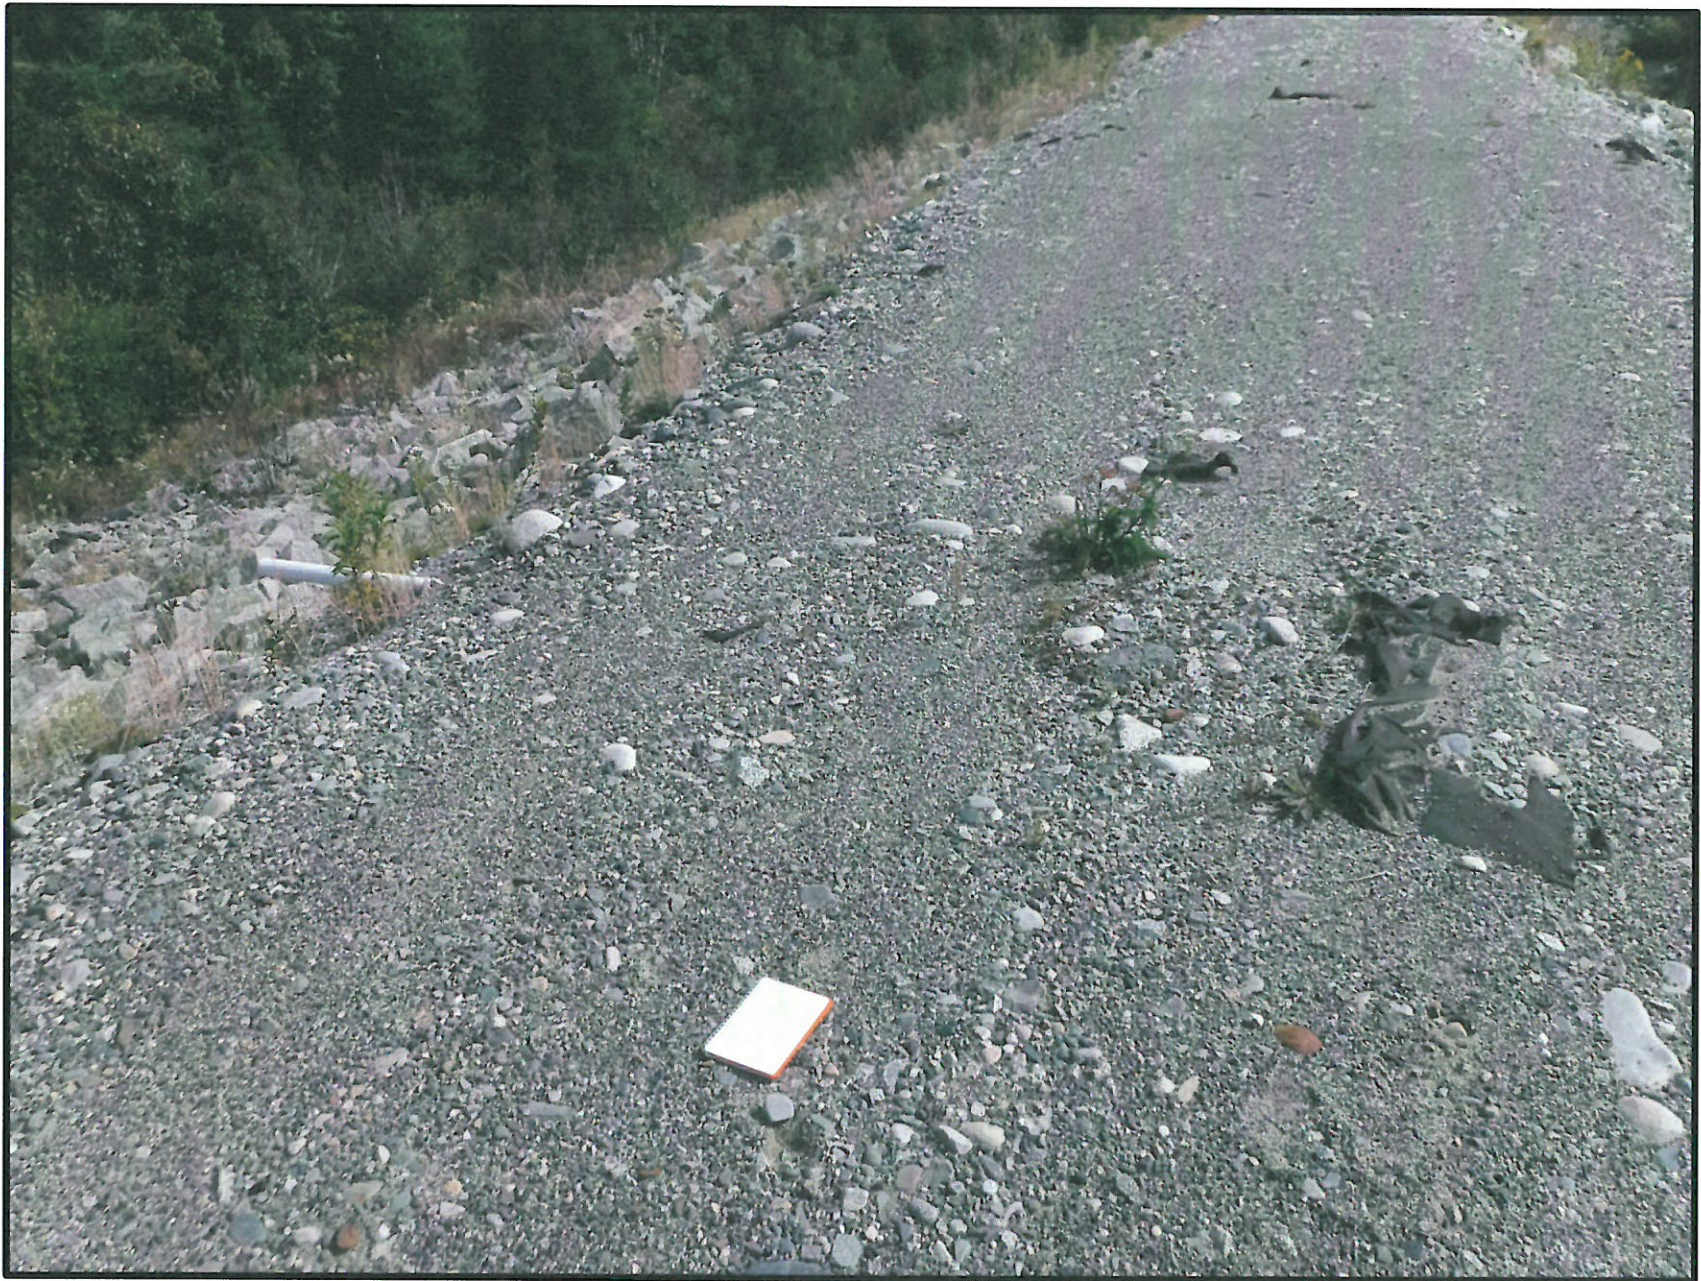
Photograph 3: Dam 4B, crest

Geotextile is exposed at some locations.

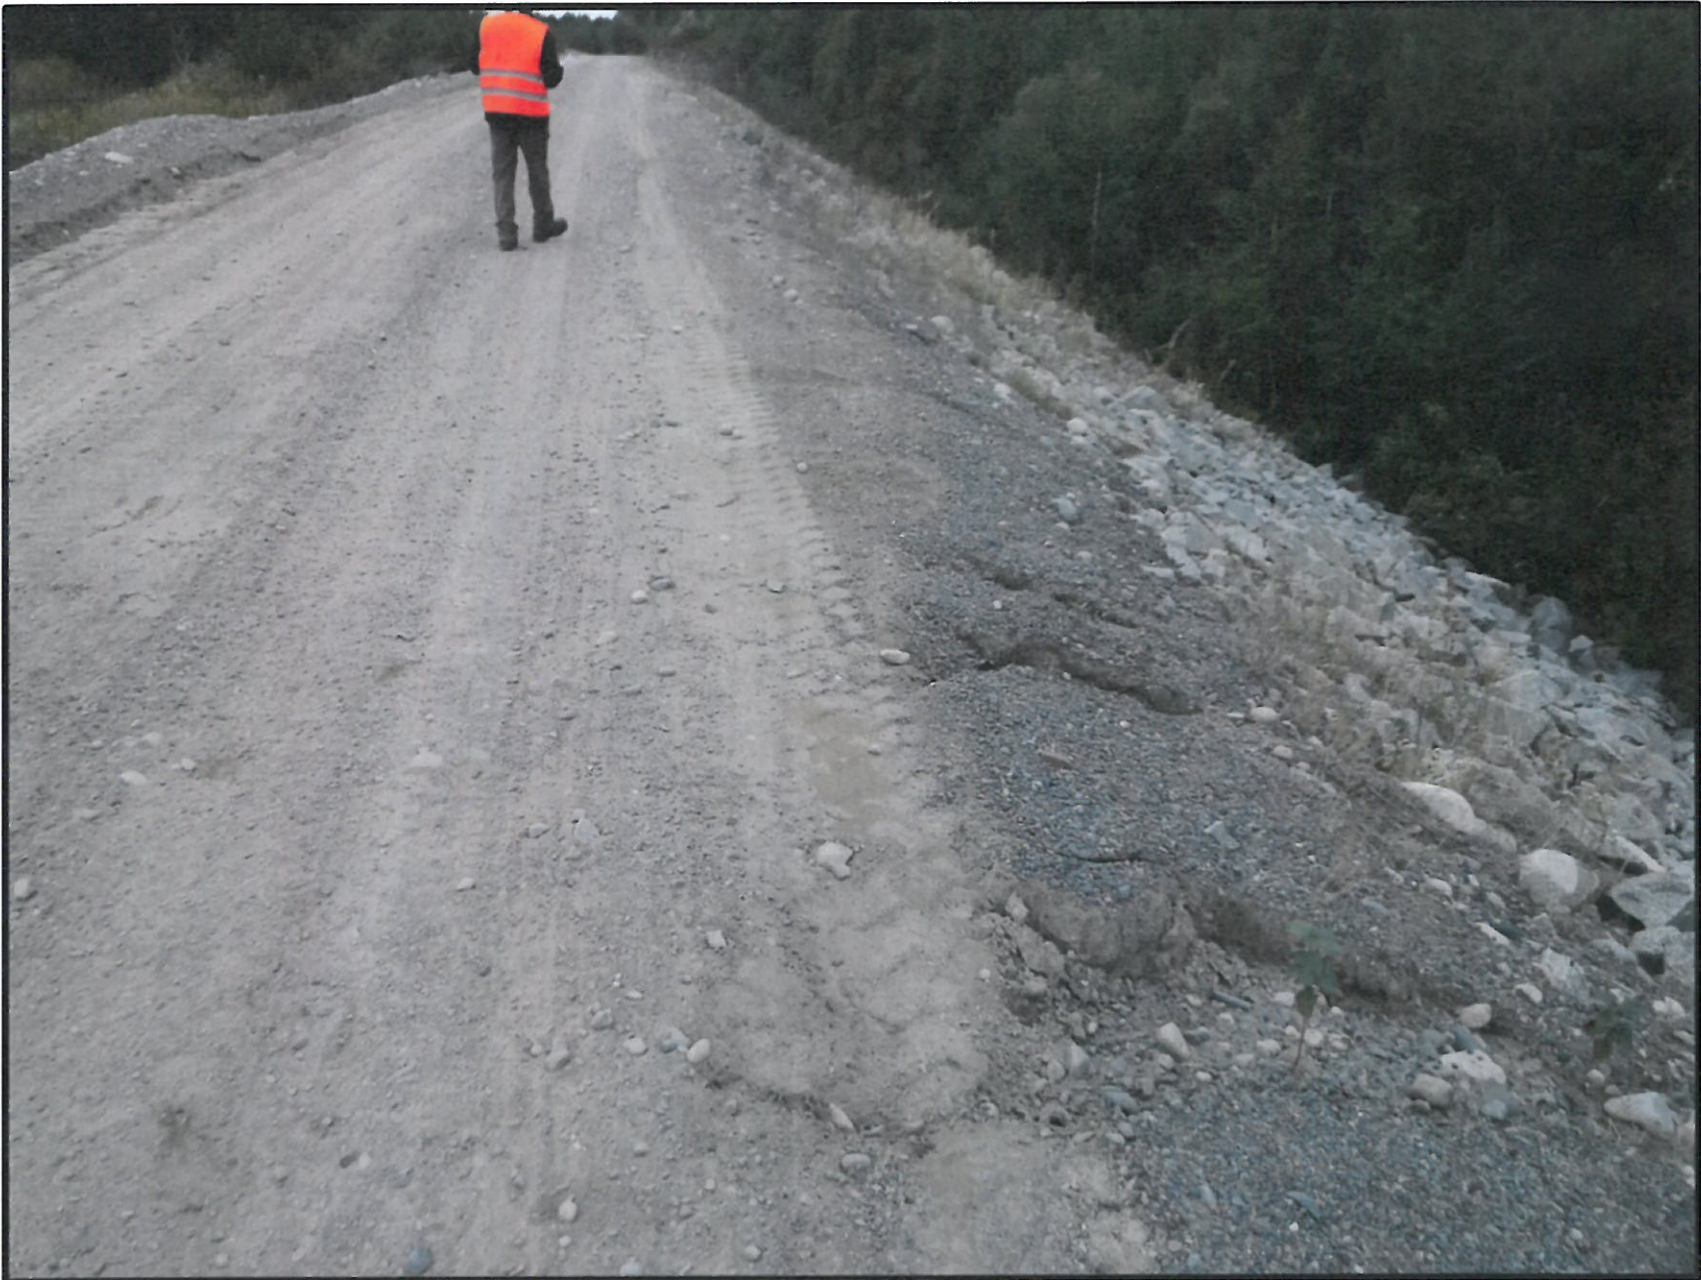
Photograph 4: Dam 4B, crest

Erosion is visible on downstream slope of the dam.

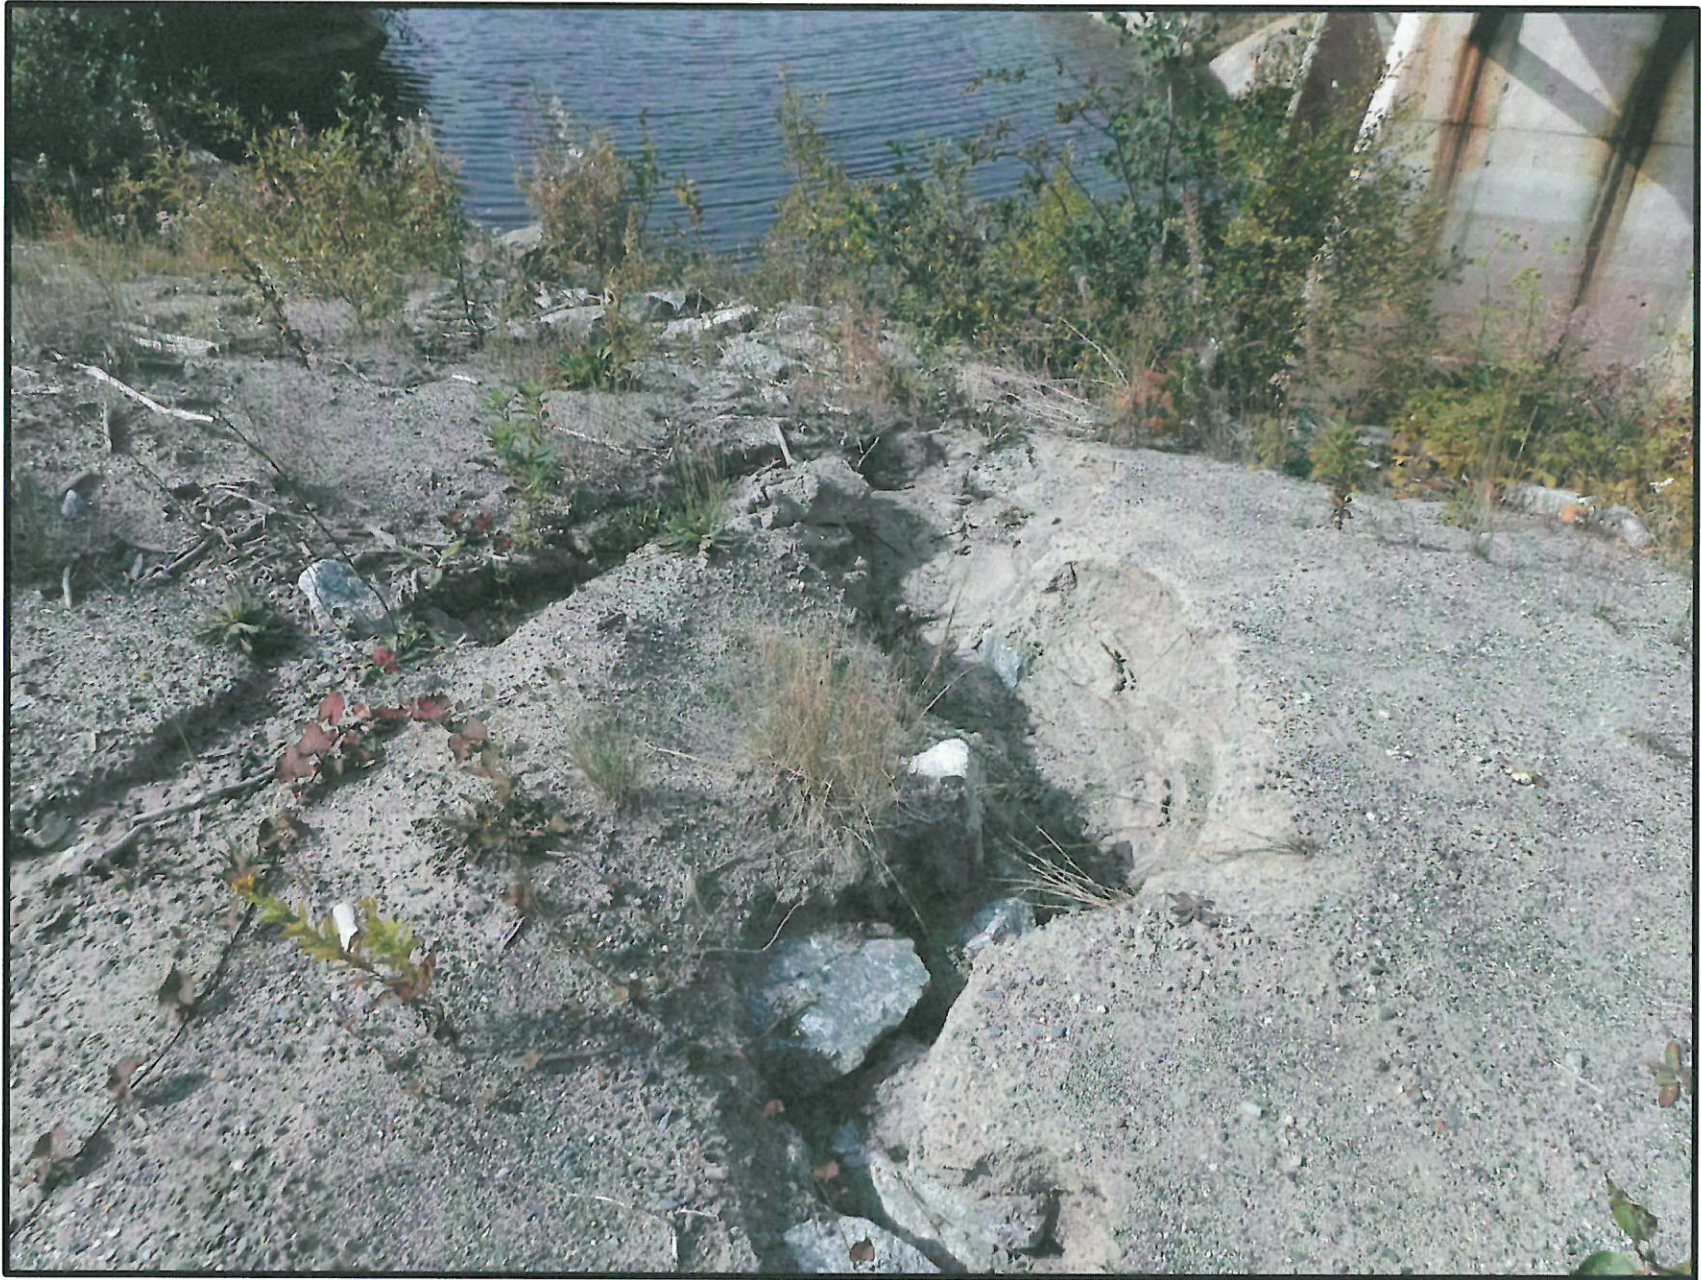
Photograph 5: Dam 4B, spillway

Erosion is visible on the access road leading to the spillway.

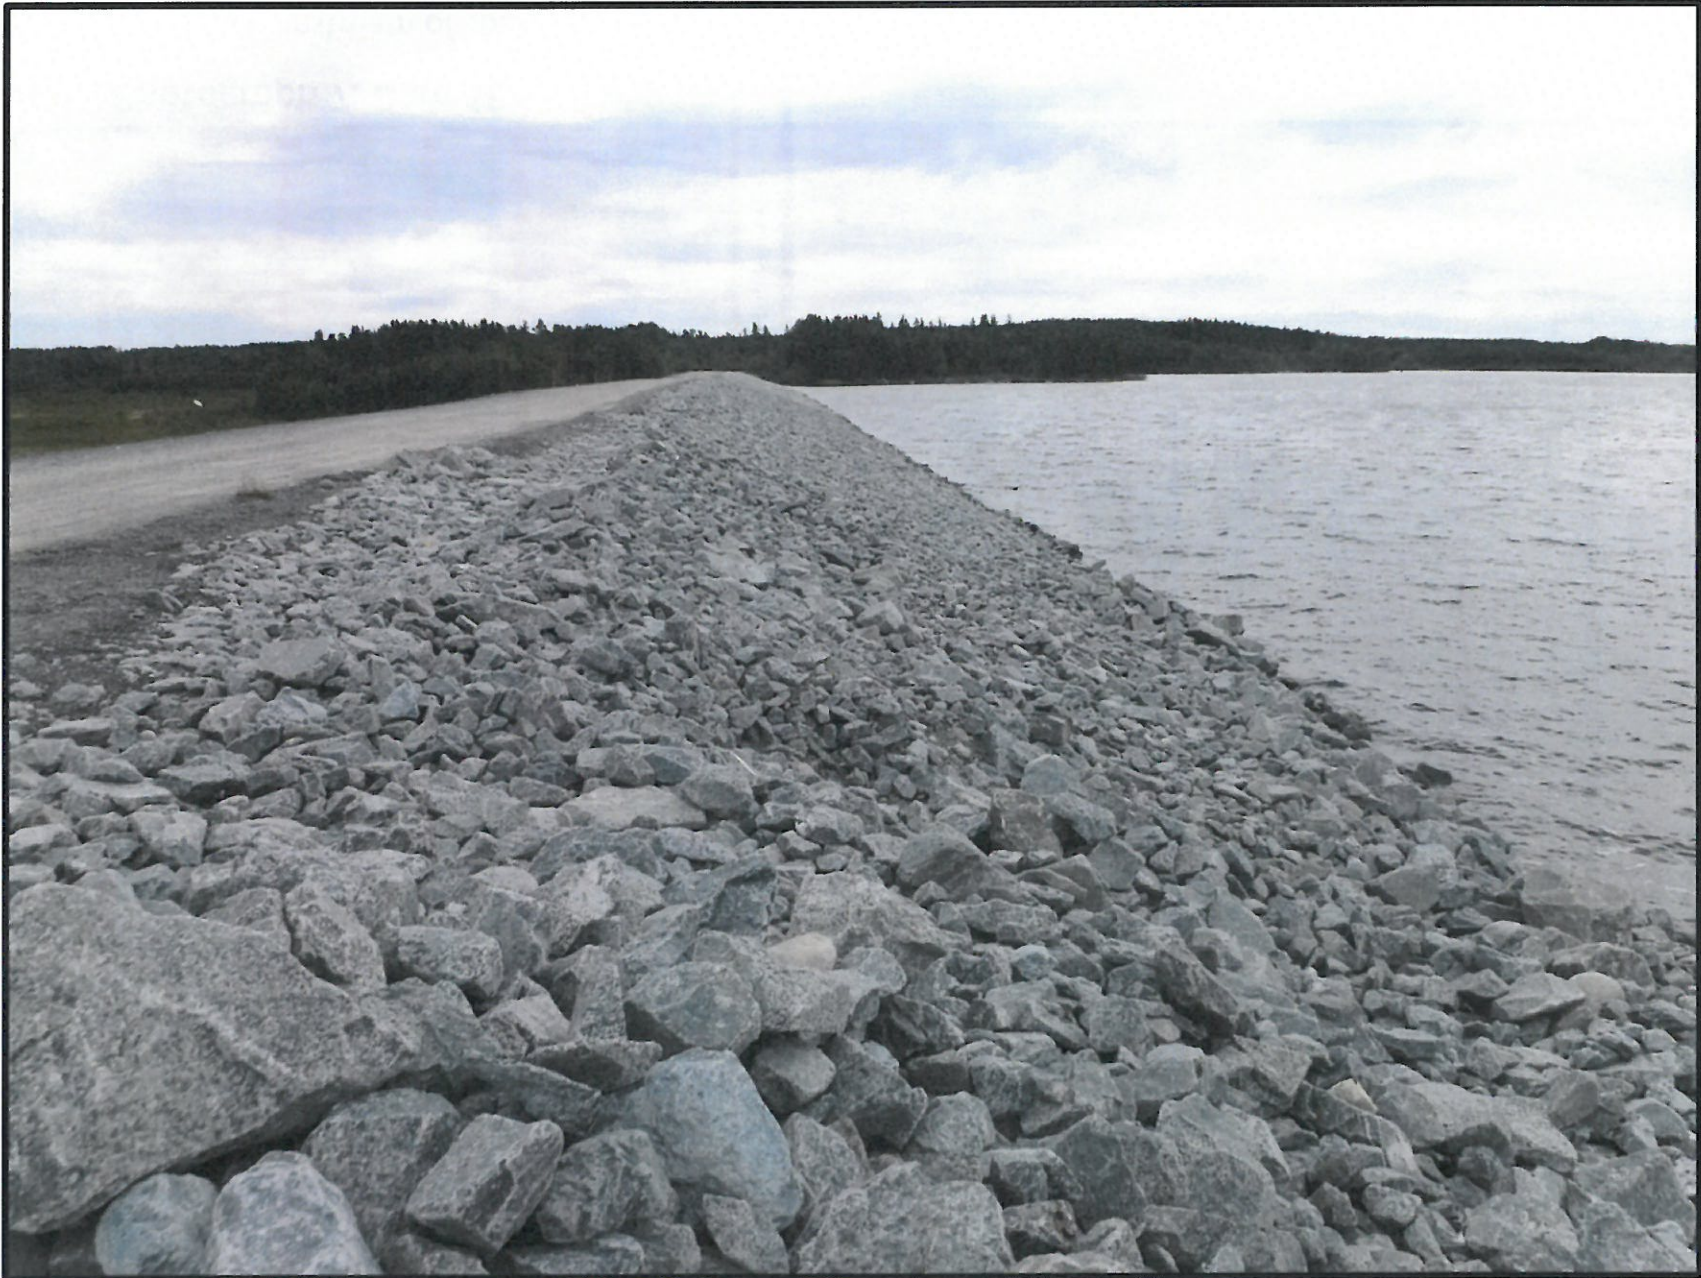
Photograph 6: Dam 1D, upstream slope

- The rip-rap on the upstream berm of Dam 1D was repaired with new rip-rap. During the site visit, the rip-rap on the upstream slope of Dam 1B was under reparation (photograph 6). The size of the rip-rap material installed is being assessed under separate cover to ensure it meets the required design criteria.

Rip-rap, upstream face where rehabilitation work was completed.

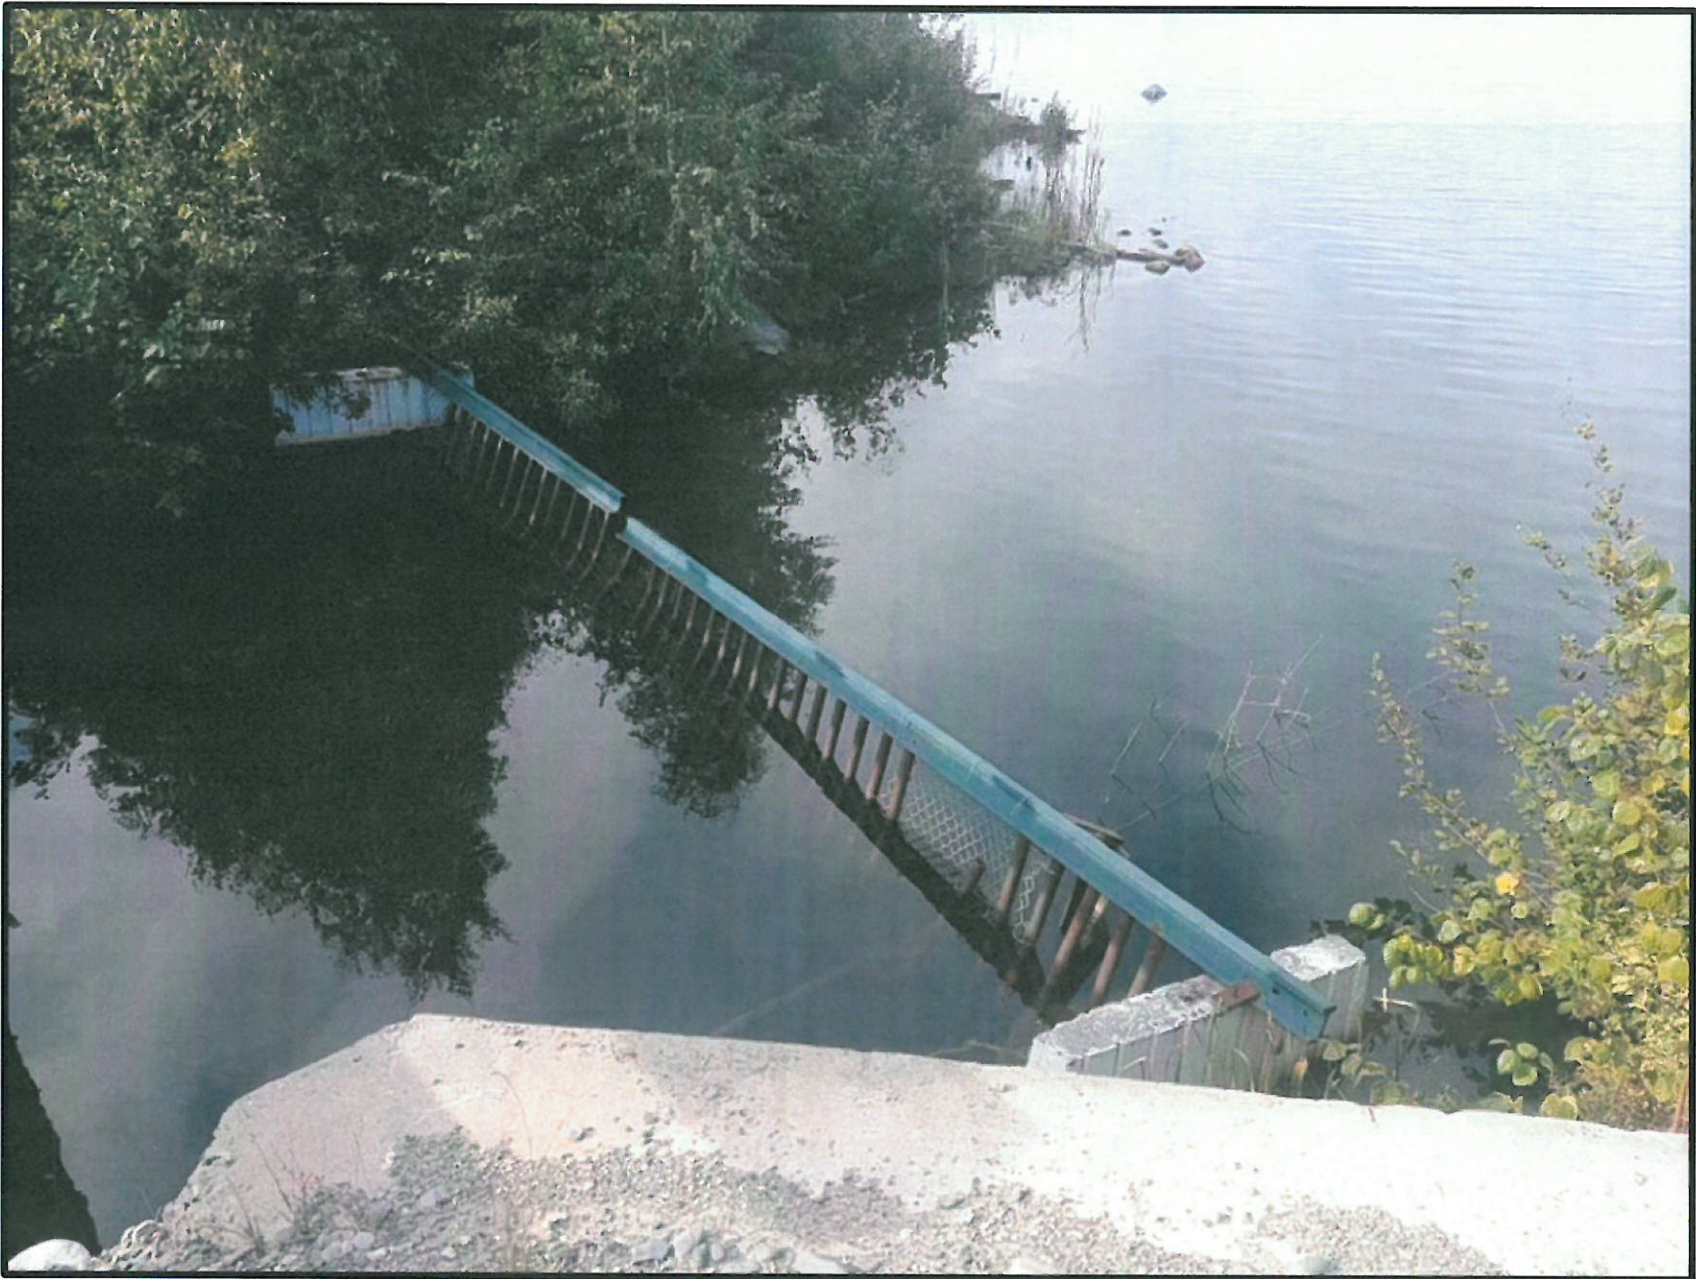
Photograph 7: Dam 1E Spillway

- The trash rack located upstream of the entry to the spillway is damaged (Photograph 7) and should be repaired.
- Ponding water was observed at the toe of Dams 1A, to 1E at the same locations as last year. The water seems to be stagnant or exhibits very low flow. Two new locations were observed with water ponding at the toe of the dams. Those locations are at point 1C and 3B at the toe of Dams 1A and 1B respectively. The location of these points is presented on Figure 1.

Trash rack upstream of spillway is damaged.

- The trash rack upstream of the tailings pond spillway is damaged and should be repaired as a best maintenance practice.
- Ponding water or seepage with low flows was observed at the toe of several dams, generally at the locations indicated in previous years. In general, the ponding and seepage were similar to previous years. The exception is the ponding area at the toe of Dam 1A, which is experiencing higher than anticipated ponding levels due to downstream beaver activity. The beaver blockage should be removed. Other seepage and ponding features do not represent any dam safety concerns.

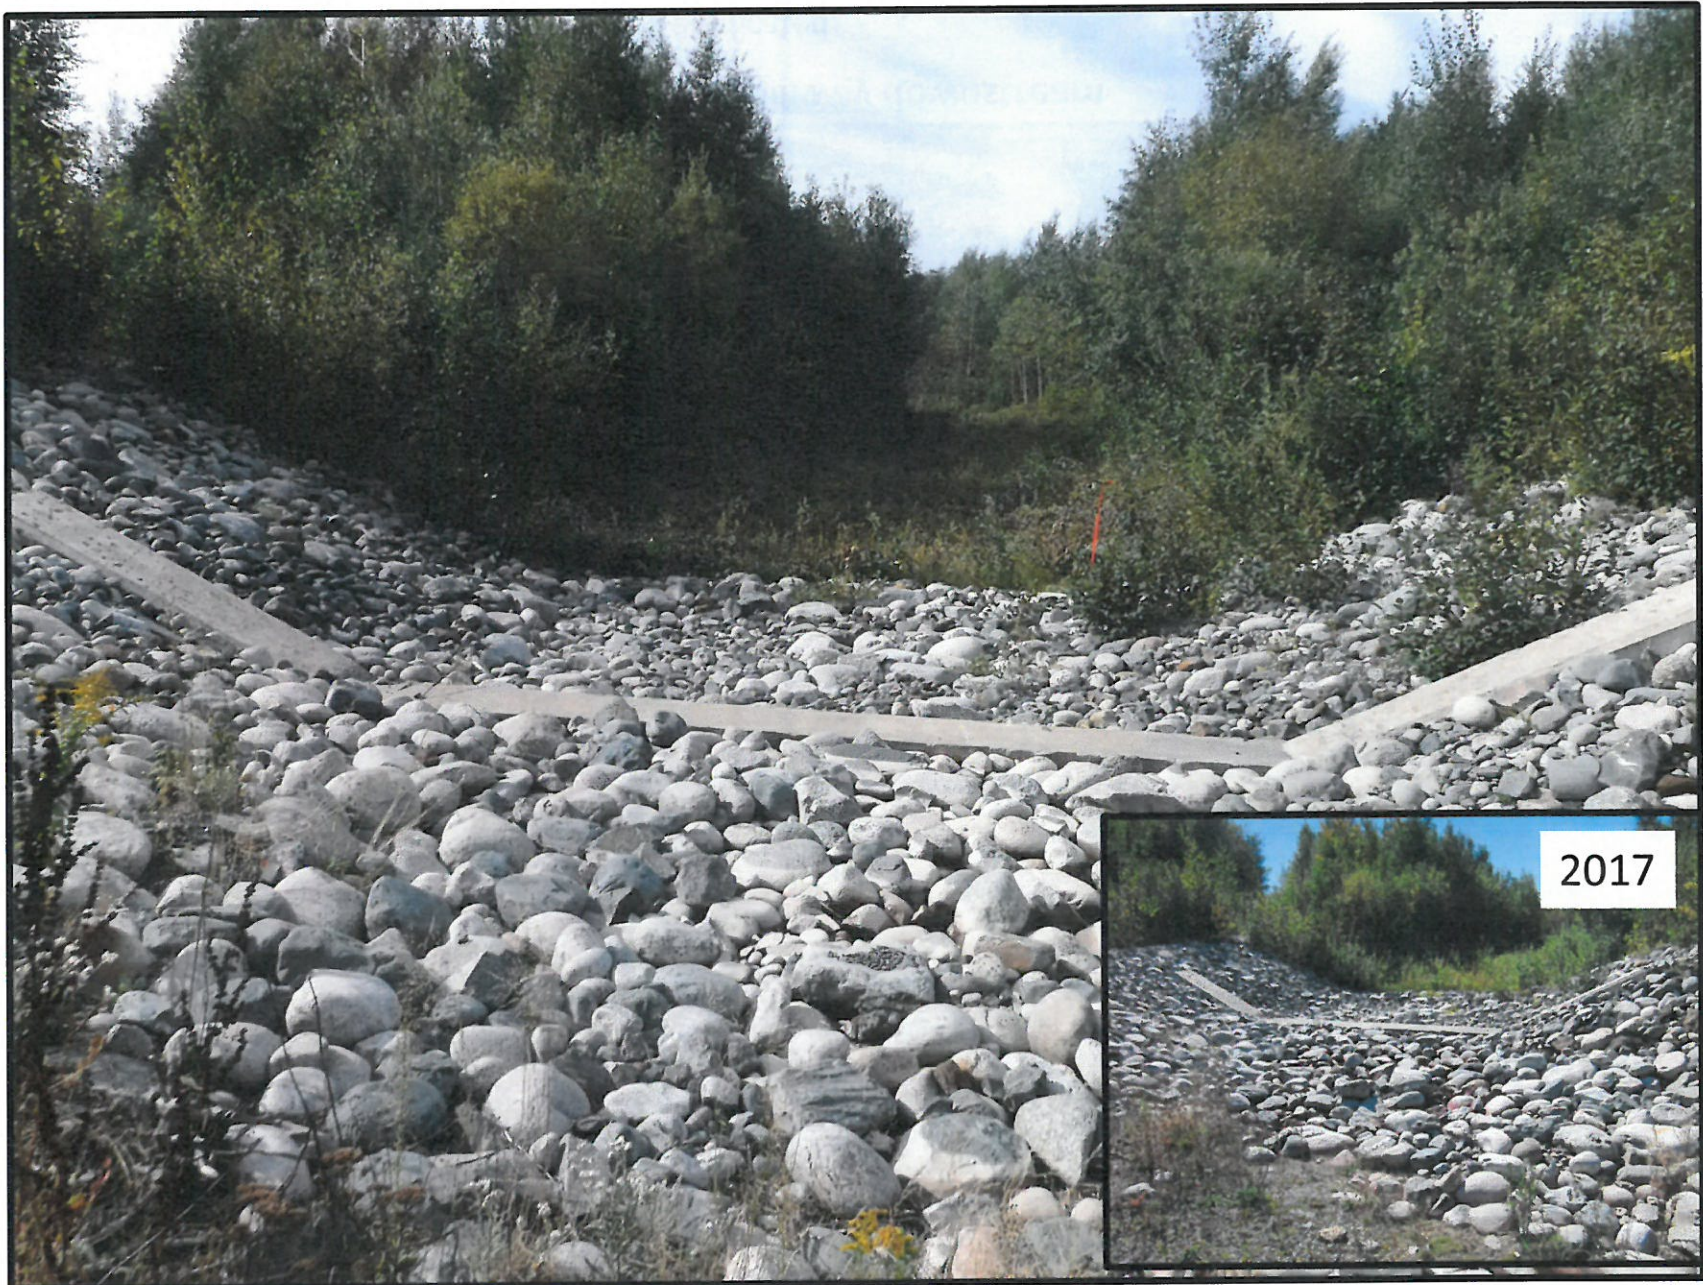
Photograph 8: Dam 1E, emergency spillway upstream

- The emergency spillway located between Dams 1D and 1E was in good condition. Vegetation in the downstream channel was cleared before the site visit (photographs 8 and 9). The access road at the outlet of second emergency spillway is susceptible to erosion, which could affect the embankment.

Emergency spillway – bed in excellent condition, vegetation was eradicated.

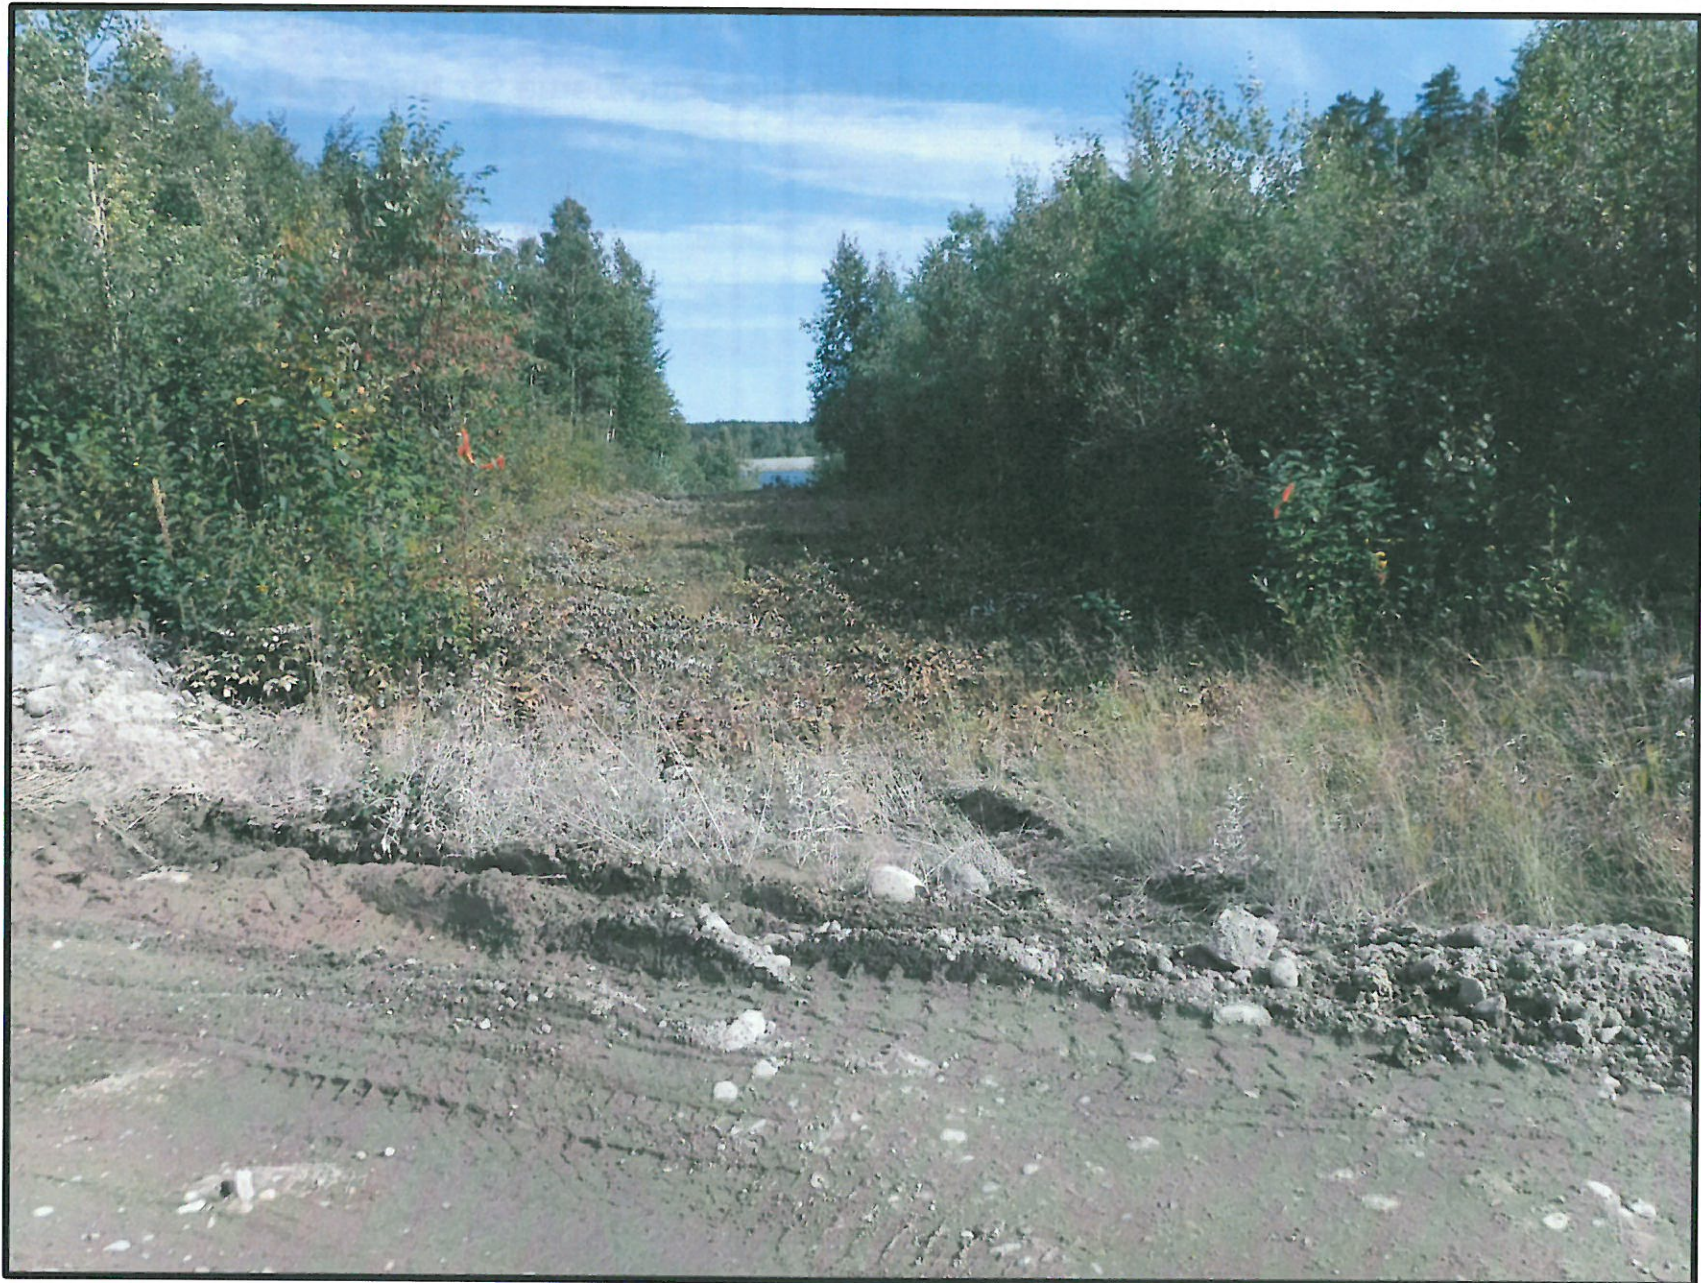
Photograph 9: Dam 1E, emergency spillway downstream

Emergency spillway –vegetation was eradicated.

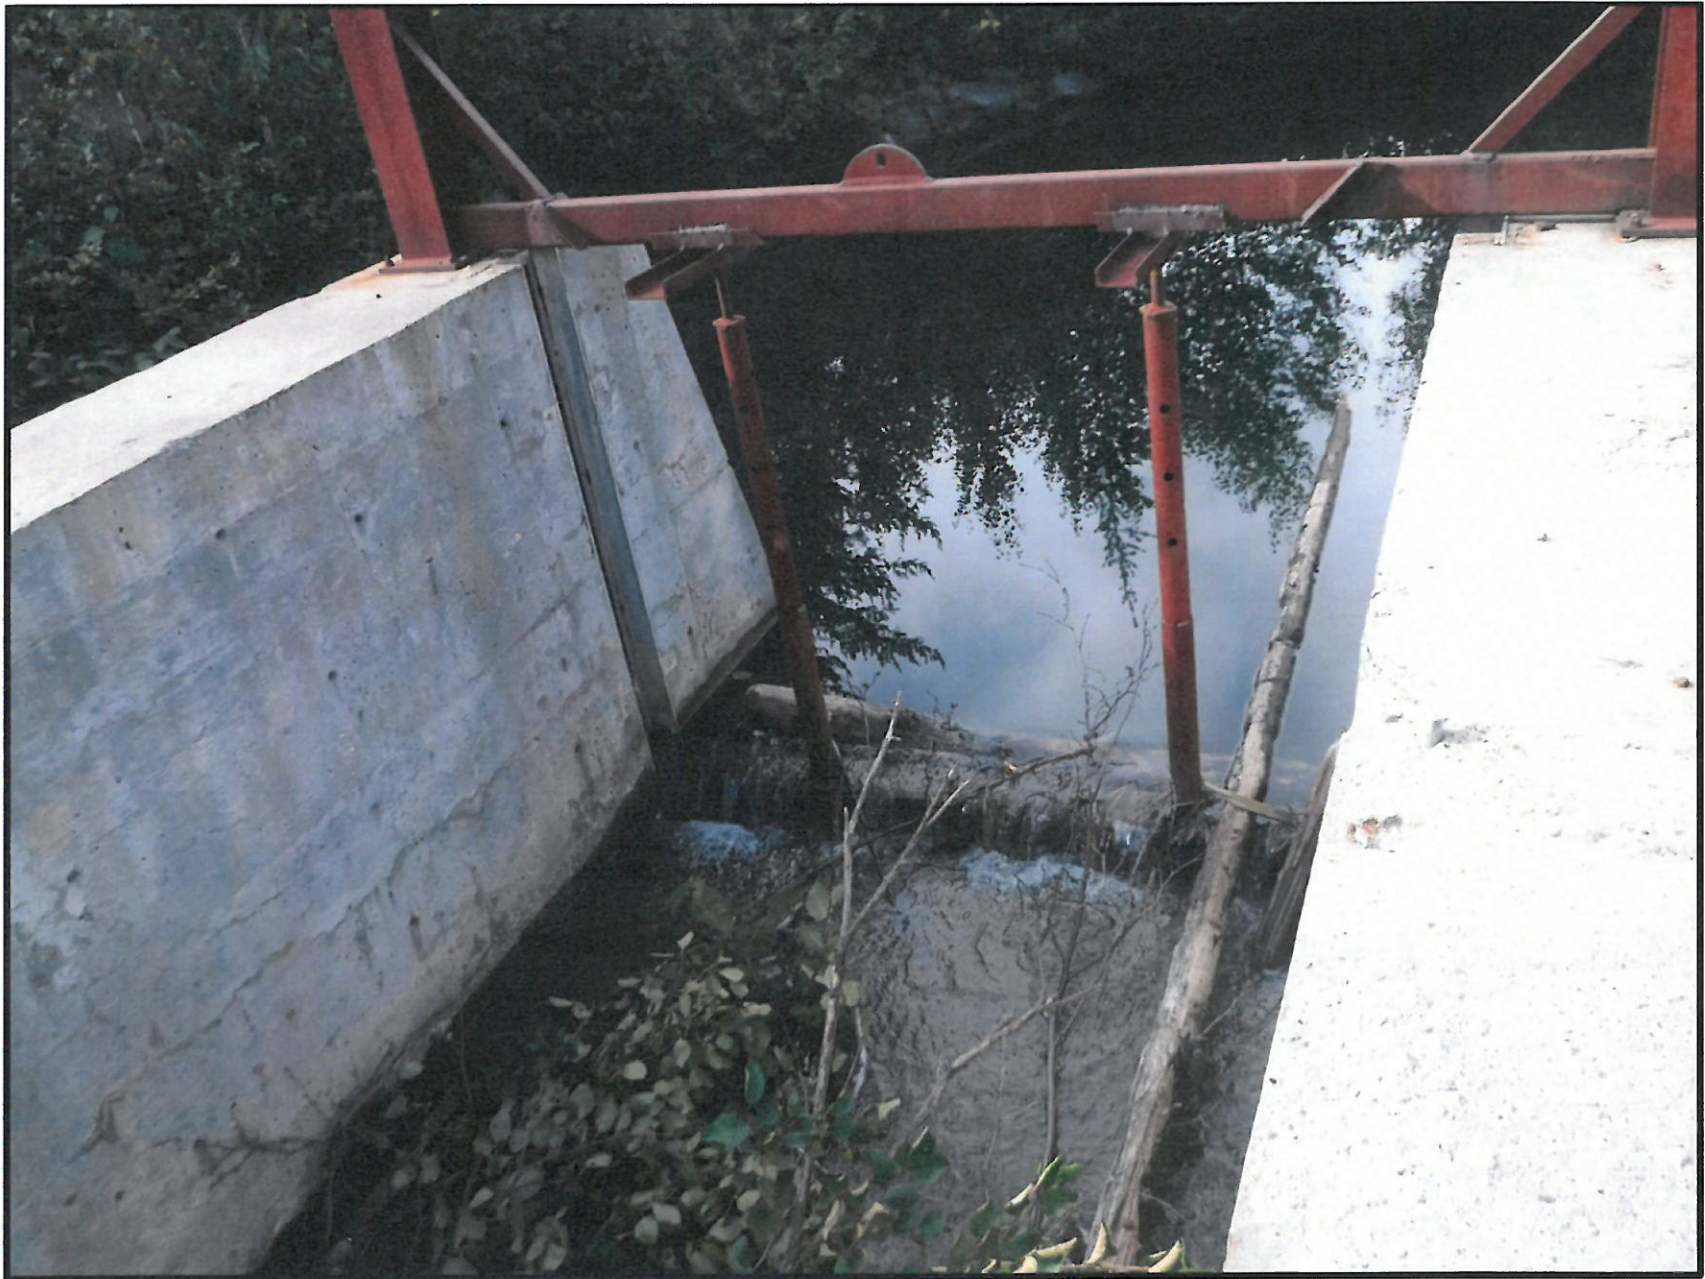
Photograph 10: Tailings pond effluent

- The trash rack at inlet to the tailings pond spillway is damaged. Debris were also accumulated in the spillway (photograph 10).
- The access bridge close to the spillway was rehabilitated in 2018 (photograph 11).

Good condition, accumulation of some debris.

- All embankments were in good condition without evidence of deteriorating geotechnical condition.
- The spillways at Dams 4B and 1D were in good condition and functional. Minor debris in the tailings pond spillway was present and should be removed as a best maintenance practice.
