TECK RESOURCES LTD.

Louvicourt Mine Tailings and Polishing Ponds 2018 Dam Safety Inspection

001-18102172-RA-Rev1

March 2019

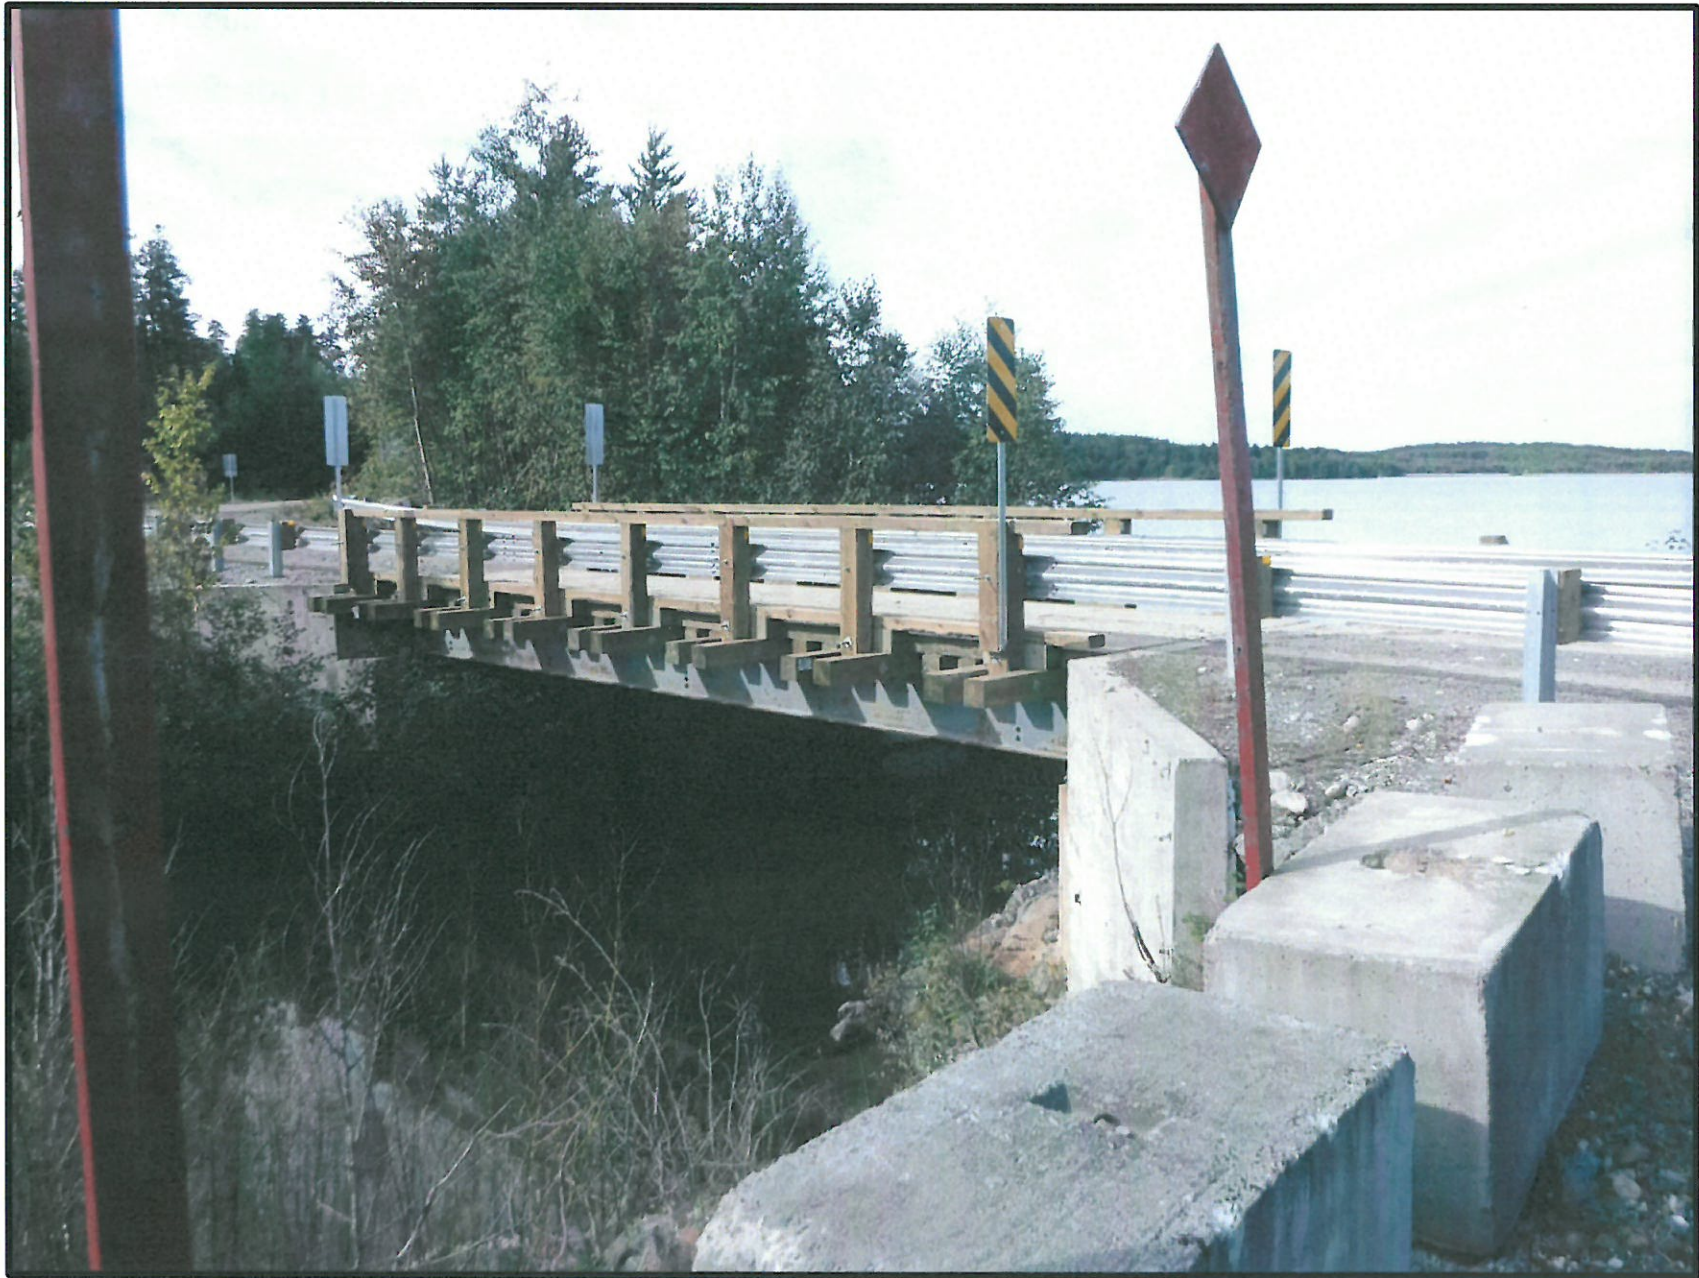
Photograph 11: Dam 1E

Access bridge was rehabilitated close to the spillway.

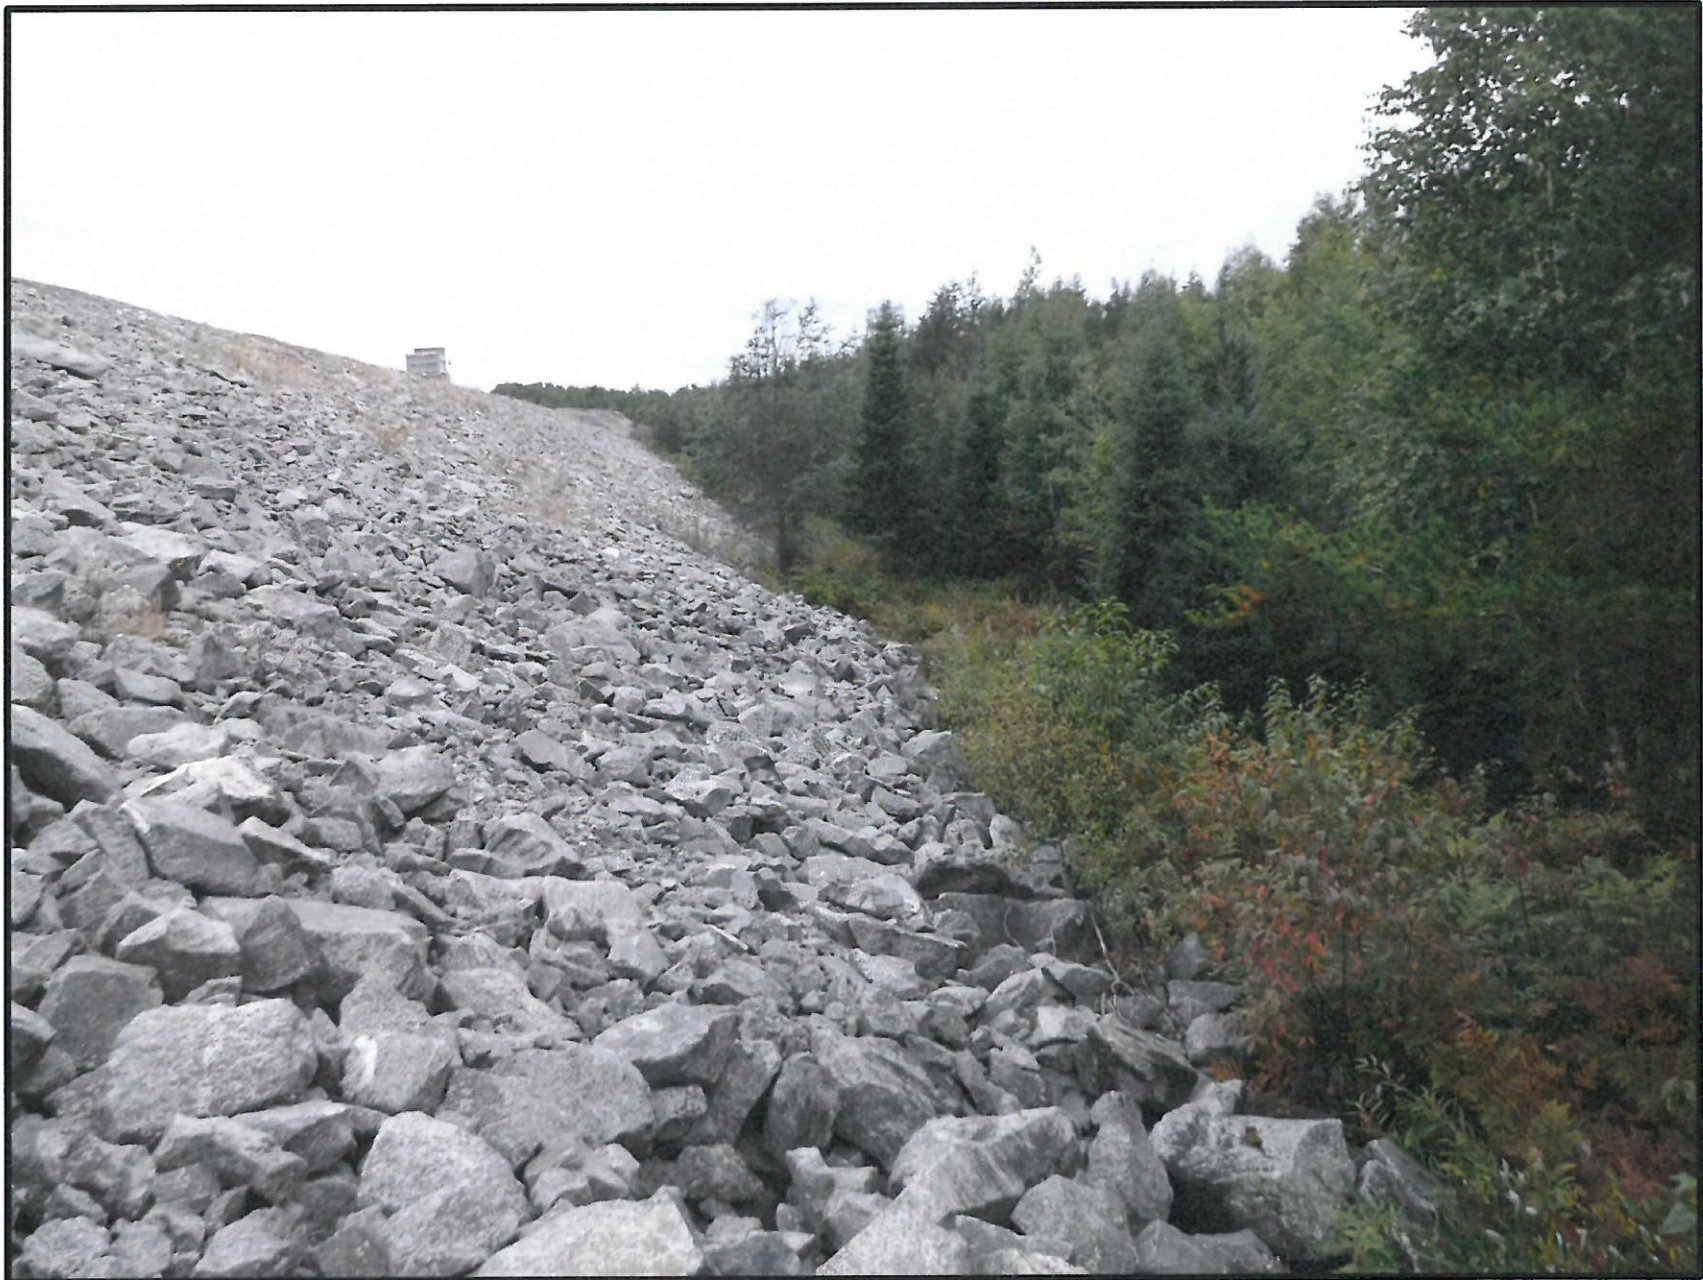
Photograph 12: Dam 1A

- Vegetation is present in the water collection ditch, downstream of Dams 1A, 1B and 1C (photograph 12).
- One closed longitudinal surface crack was observed on the crest of Dam 1C. It was reported that cracking occurs seasonally; this was assessed by Golder and attributed to freeze-thaw. The crack has been dormant since the onset of spring thaw.

Toe of downstream dam, difficult to access because of growing vegetation.

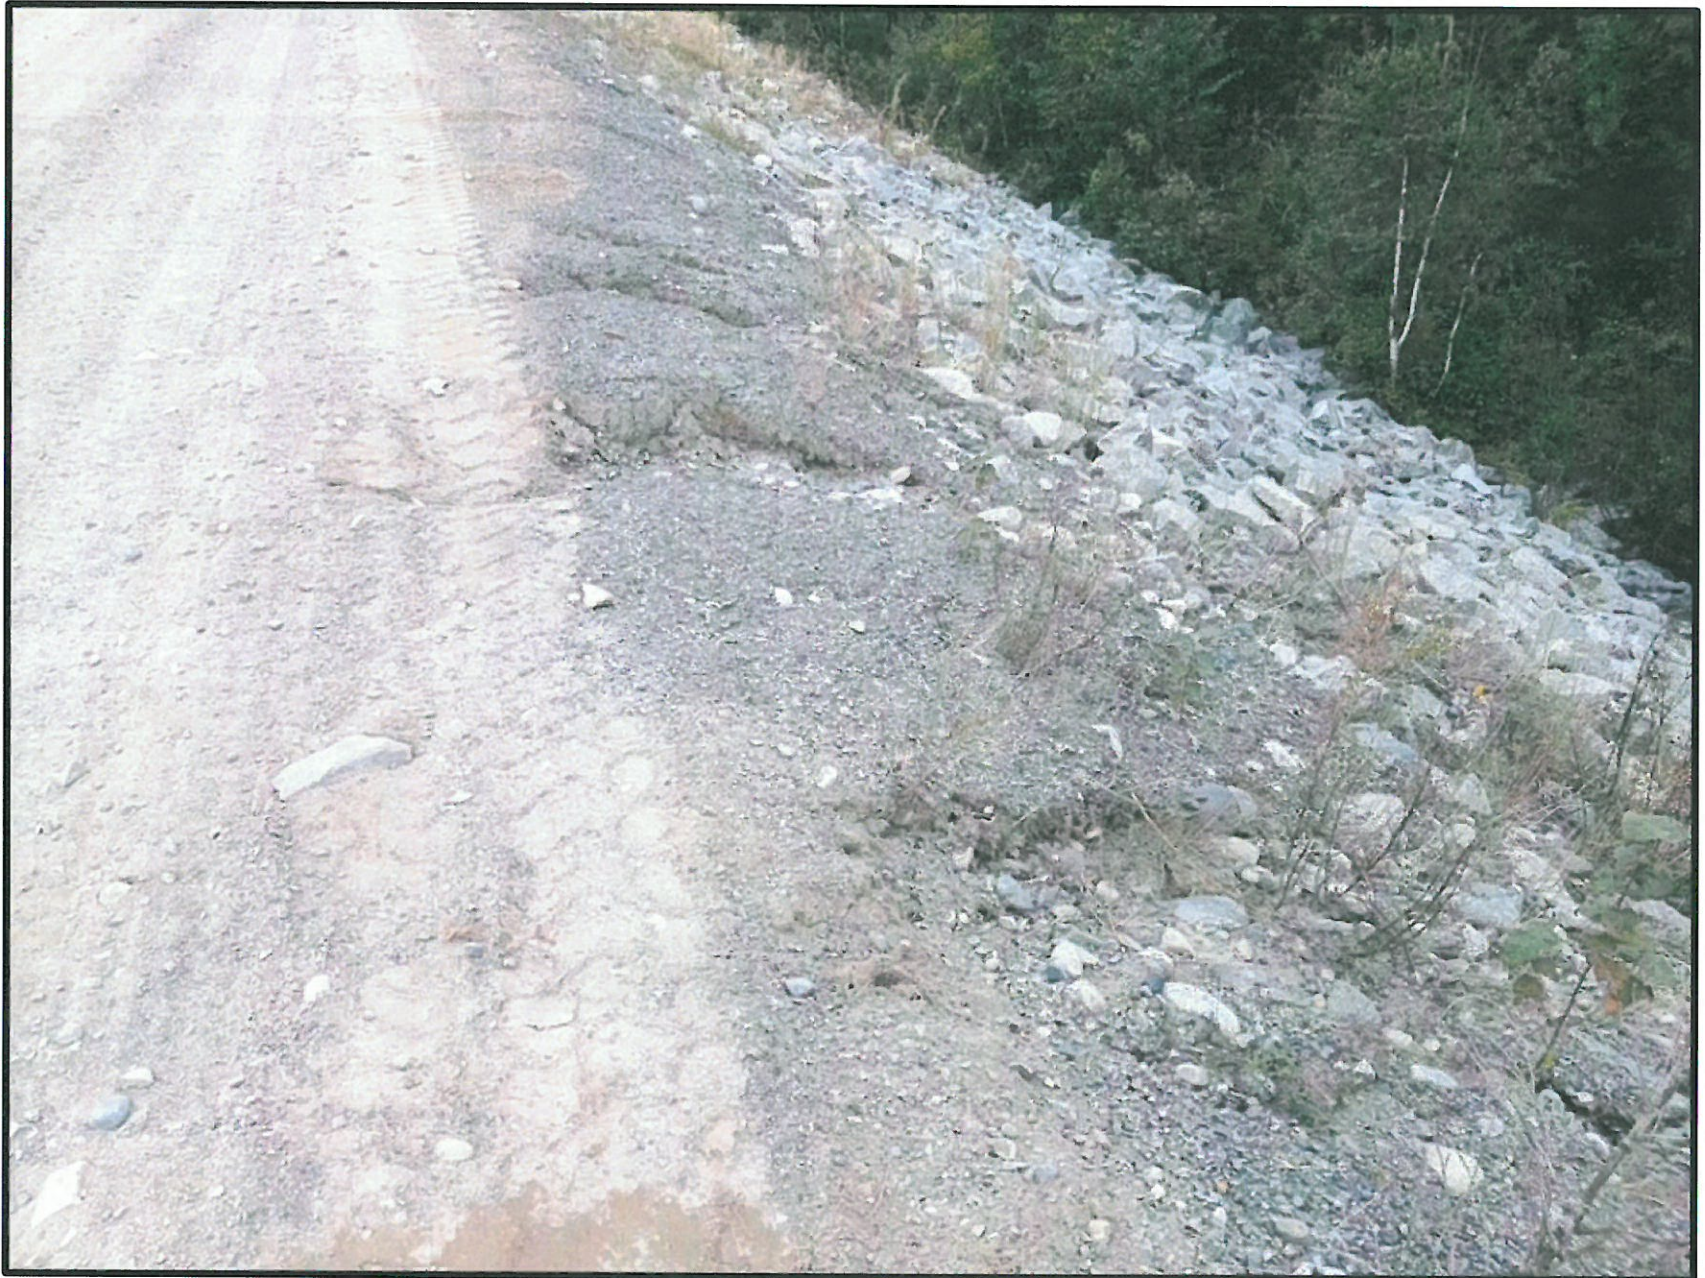
Photograph 13: Dam 2B

- A few minor erosion points are visible at the crest of Dam 2B (Photograph 13). These are to be observed.
- Some stagnant water was observed at the toe of Dam 2B where previously seepage area 13 has been established, close to V-notch 2, exhibiting very low flow. Further south, seepage points 10, 11 and 12 are present in the vicinity of V-notch 1. V-notch 1 exhibits low but visible flow rates, and the water is clear.
- Stagnant water is observed at the toe of Dam 2A (Photograph 14). The extent of ponding is increased due to beaver activities.

Erosion rills on the crest of embankment.

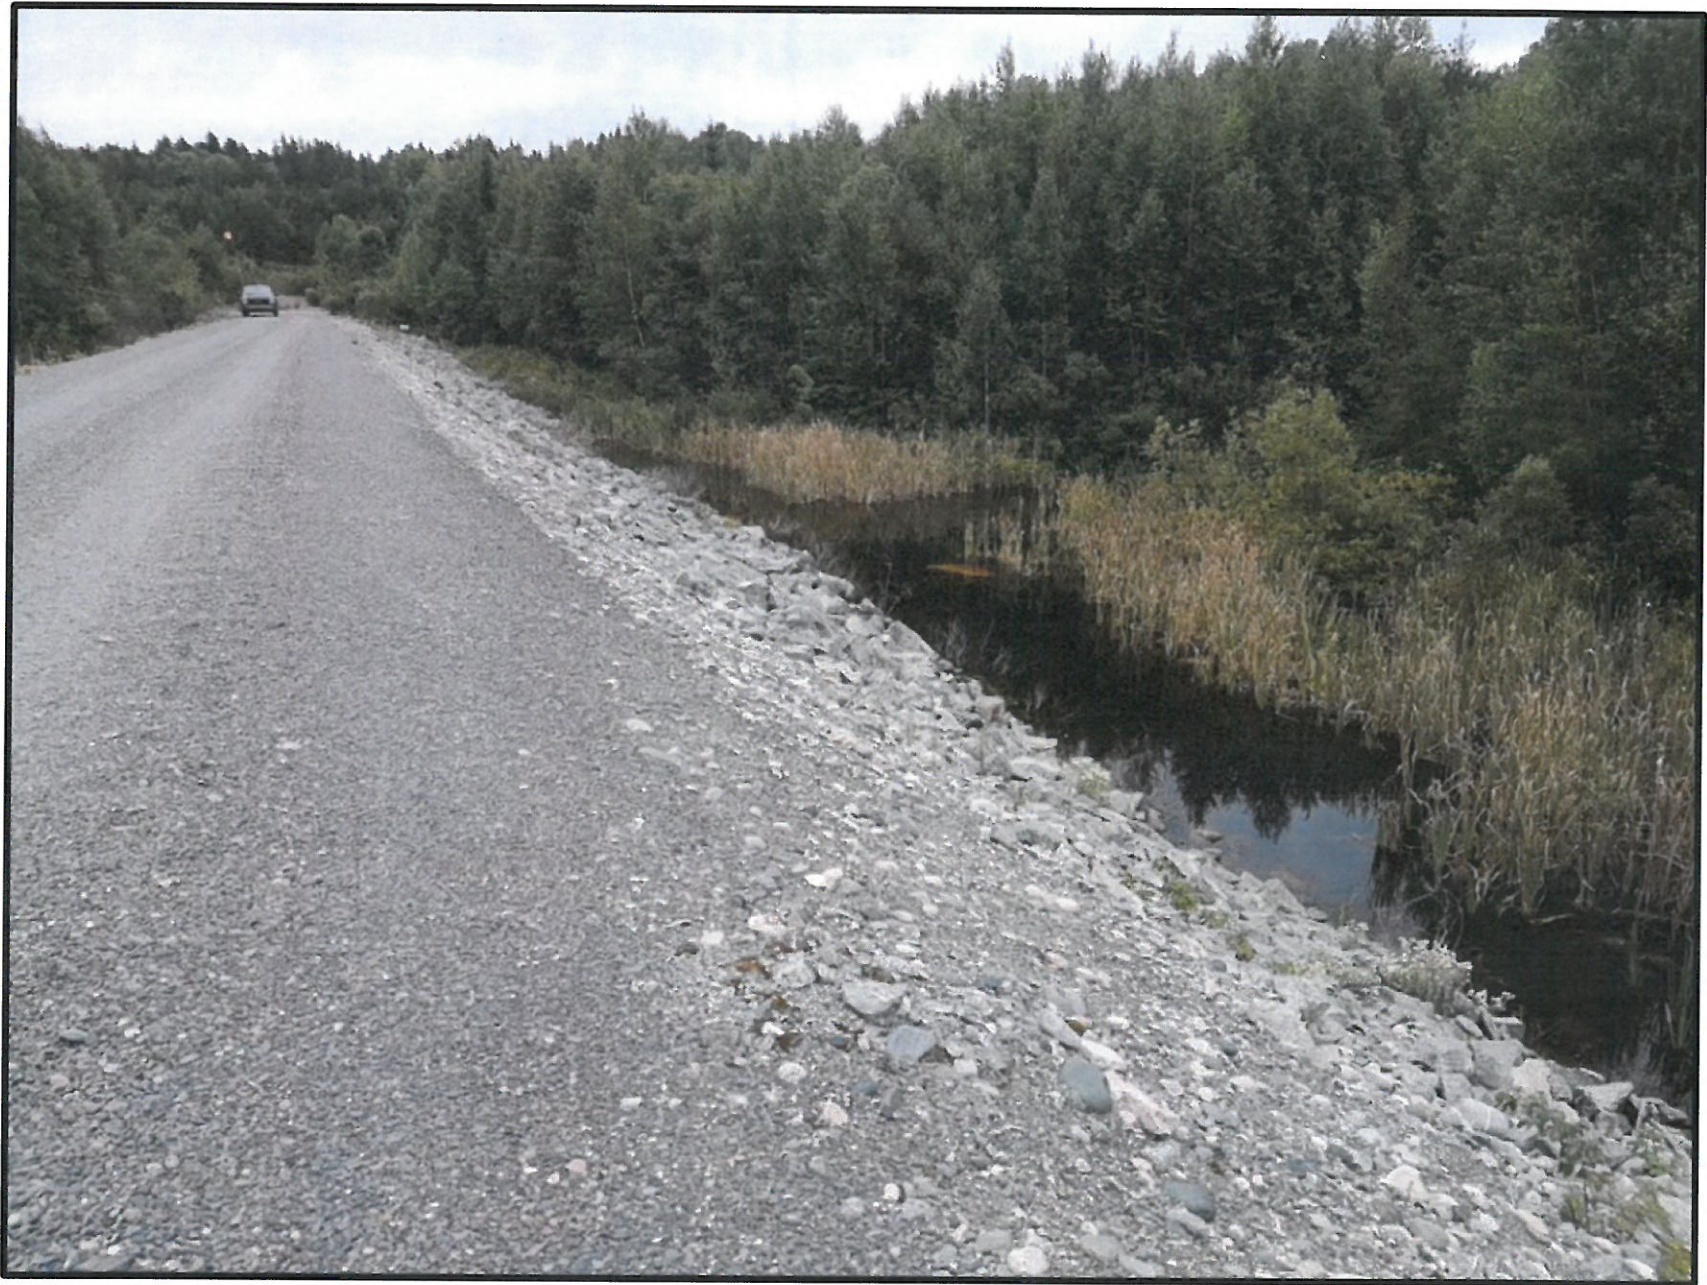
Photograph 14: Dam 2A

Ponding at the toe of Dam 2A is exacerbated by beaver activity.
