# **Teck Metals Ltd.**

## **Pinchi Lake Mine Tailings Storage Facility**

### ***2018 Dam Safety Inspection***

M07728A33.730

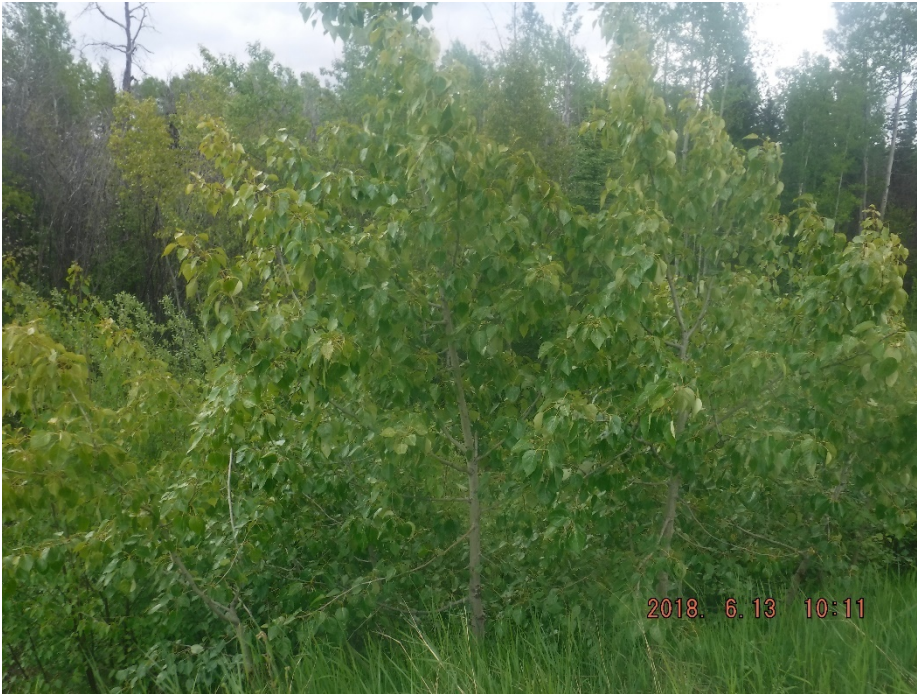
- There is vegetation on the slope of the east leg of the dam, especially on the north section, including trees up to about 3 m tall (Location 8 in Figure 4.1; Photos II-1 to II-4, II-6, and II-8). This vegetation is not currently considered to be a dam safety concern, although it may be prudent to clear it before the trees become more difficult to remove. The vegetation management plan recommends vegetation clearing prior to vegetation exceeding 1.5 m in height (Spectrum 2017).

**Photo II-4 Tailings Dam – east leg, looking upstream from toe. Note vegetation on dam slope.**

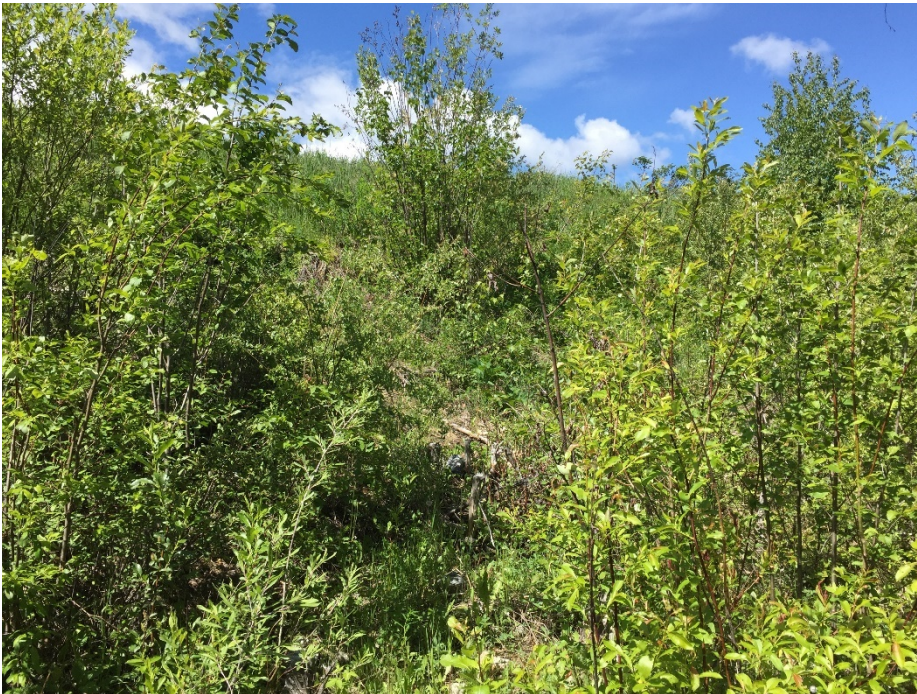
- A pond was observed in the trees near the toe of the east leg of the Tailings Dam (see Figure 1.2 for location; Photo II-5) as in previous inspections, except that the pond level was higher since this year's inspection was carried out in June rather than August or September. This pond is located near a drainage channel that was shown on historical drawings of the TSF (see Appendix V) and labelled "runoff channel." The channel ran parallel to the main Ed Creek channel, and apparently once joined up with Ed Creek just inside the TSF. The pond appears to collect local runoff, and it drains through a channel to the south and through a culvert into Ed Creek Diversion Channel.

**Photo II-5 Tailings Dam – pond near toe of east leg.**

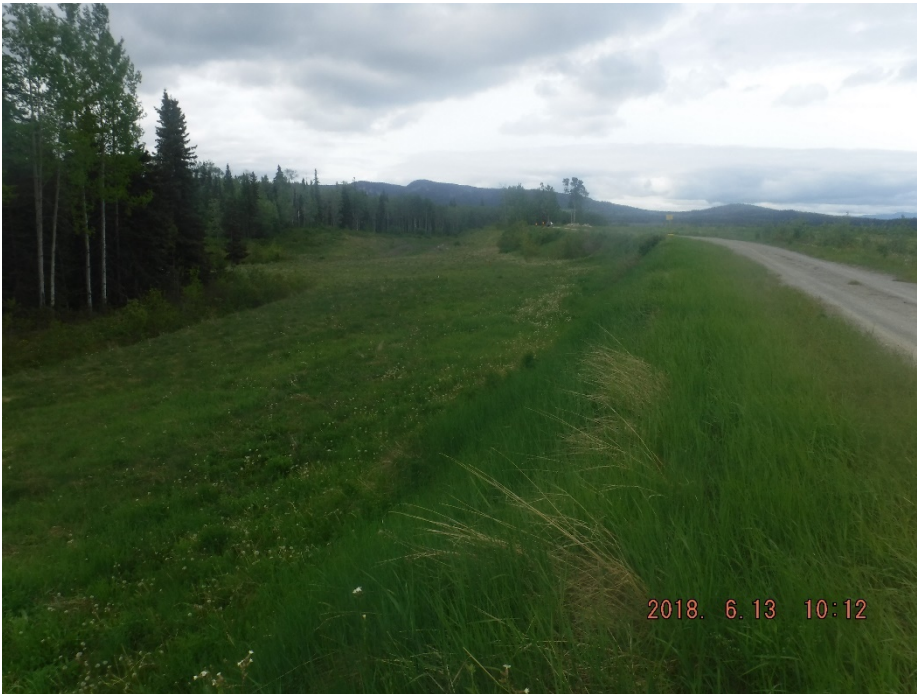
**Photo II-8 Tailings Dam – east leg, looking south. Note vegetation on dam slope.**

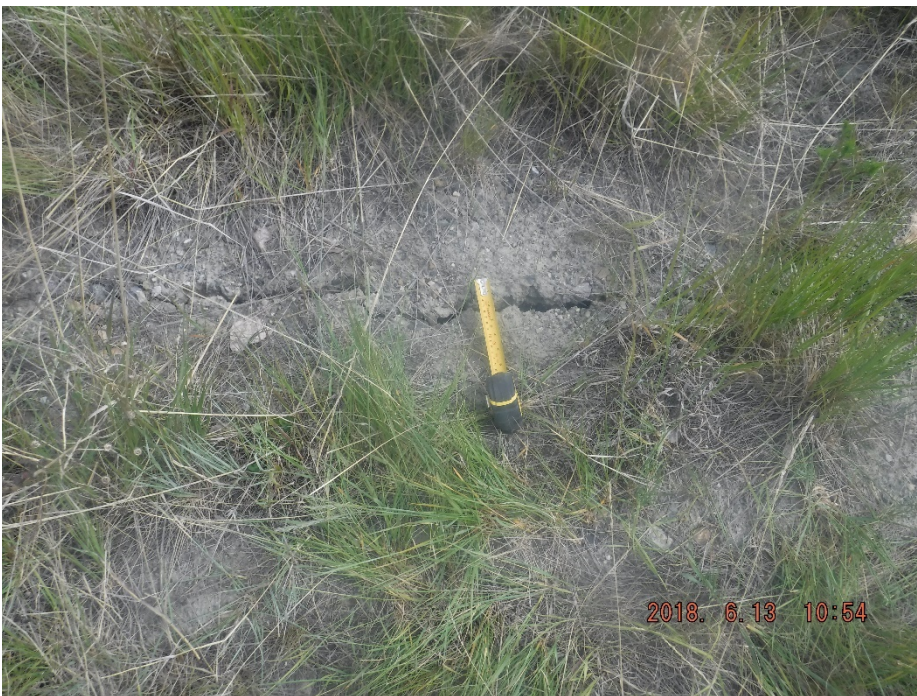
- The dam crest, and upstream and downstream slopes of the Tailings Dam appeared to be in good condition, except as noted below.
- Longitudinal cracks (up to 5 m long, 20 mm wide, and 250 mm deep) were observed on the dam crest along the southwest leg of the Tailings Dam (Location 4 in Figure 4.1; Photo II-18), similar to those observed in 2015 and 2017. There appeared to be fewer cracks than during the 2017 inspection. The cracks appear to be aligned with tire tracks. The cracks are believed to have been formed by loosening and drying of the soil as part of the reclamation and seeding. The cracks are not a dam safety issue.

**Photo II-18 Tailings Dam – southwest leg, crack on dam crest in tire track.**

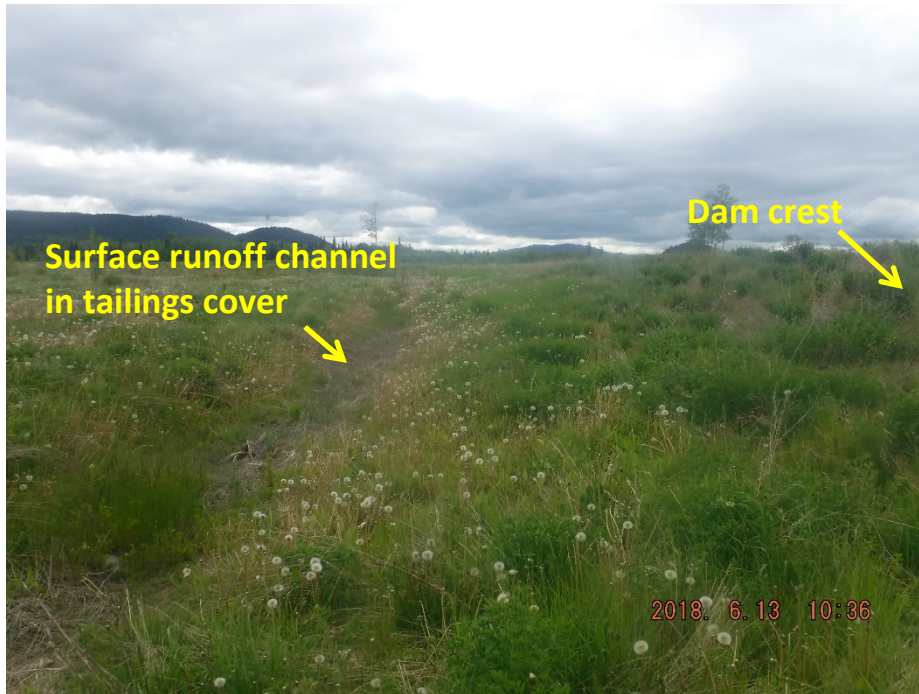
- As noted during previous inspections, a channel has formed in the soil cover parallel to the southwest leg of the Tailings Dam adjacent to the dam (Location 3 in Figure 4.1; Photos II-19 and II-20). There is good growth of grass and some cattails along most of the channel, with no signs of erosion.

**Photo II-19** Tailings Dam – southwest leg, surface runoff channel in tailings cover upstream of dam.

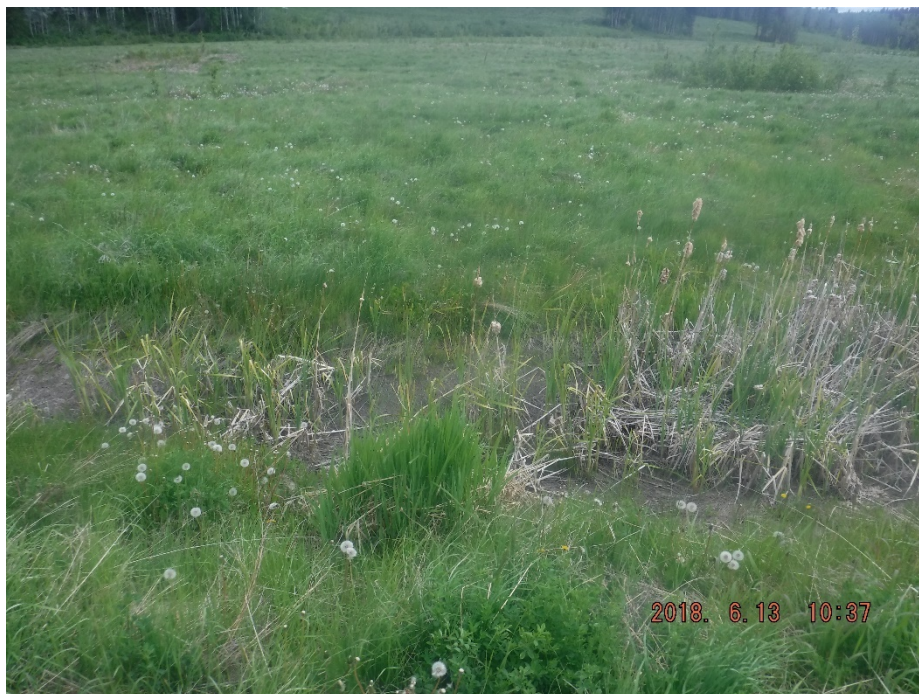
**Photo II-20** Tailings Dam – southwest leg, surface runoff channel in tailings cover upstream of dam.

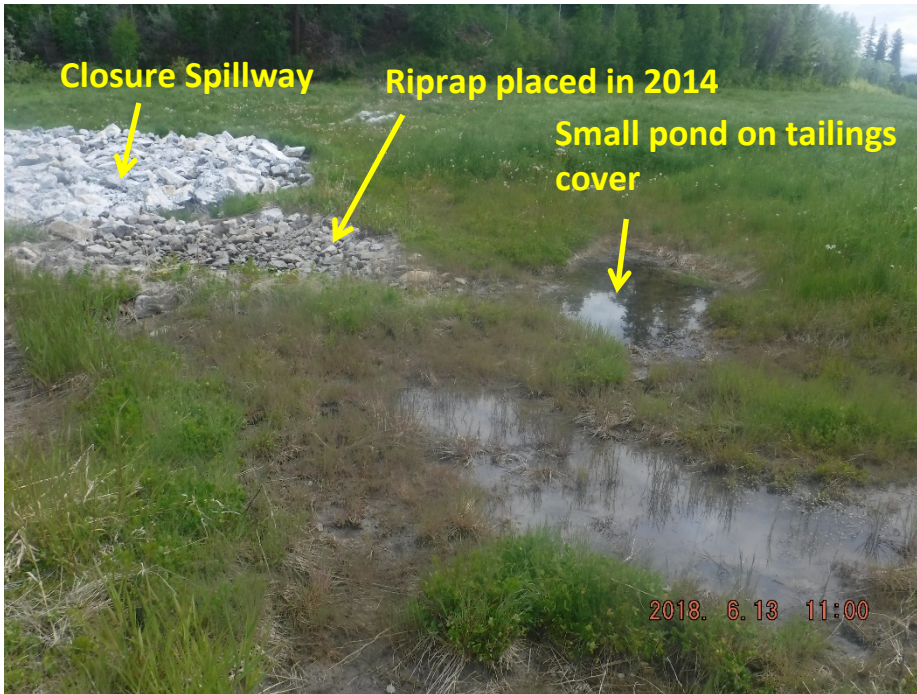
- In 2014, Teck placed riprap at the downstream end of the above-mentioned channel where it discharges into the Closure Spillway (Location 2 in Figure 4.1; Photos II-29 and II-30). The riprap appears to be performing well. A small pond (about 2 m wide) and a few associated wet areas were observed south of the riprap.

**Photo II-29** Downstream end of surface runoff channel where it discharges to the Closure Spillway, showing riprap which was placed in 2014.

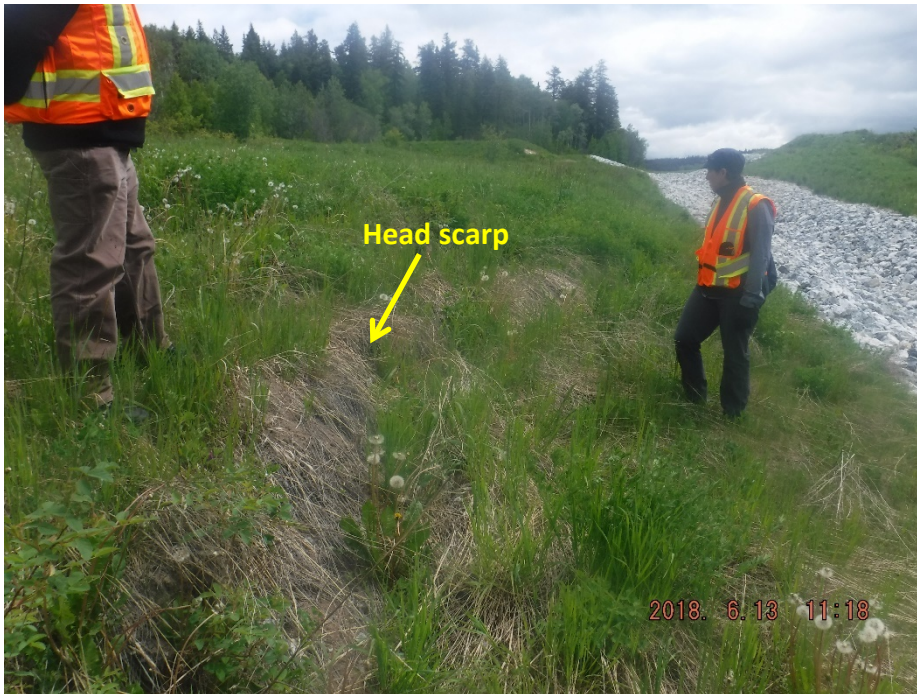
**Photo II-35** Closure Spillway – head scarp of slump above right bank, 90 m downstream of centreline

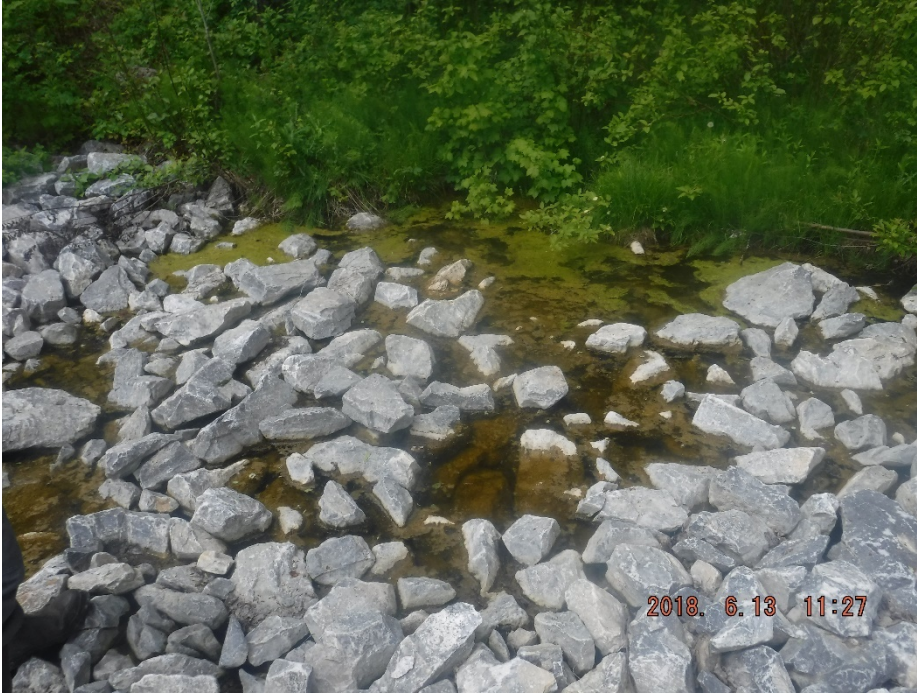
**Photo II-37** Closure Spillway – pond at downstream end of riprap.

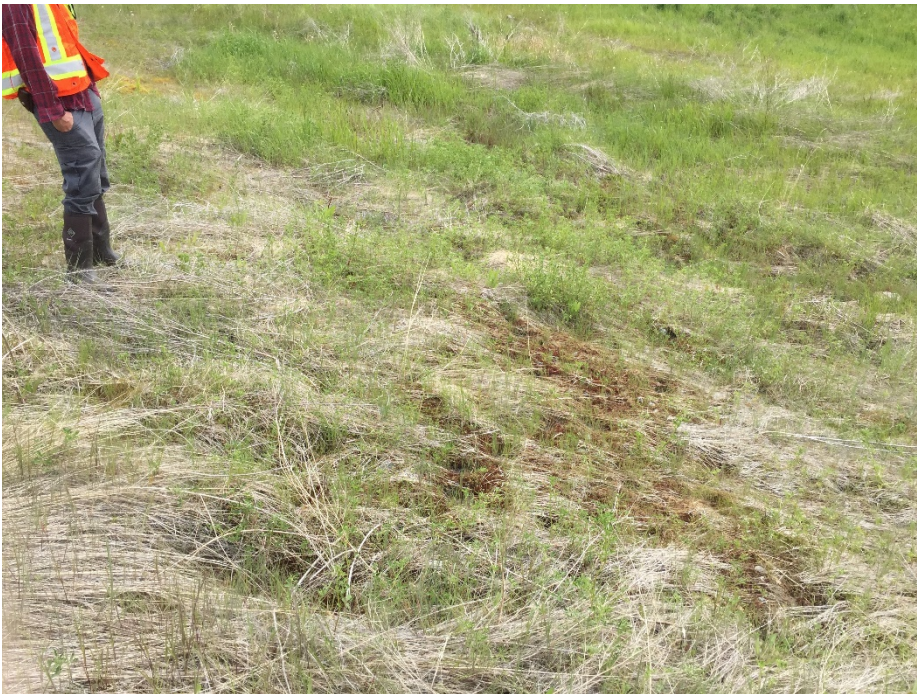
- A 60 m long wet area was observed at the toe of the slope in the northeast corner of Borrow Area A (Location 6 in Figure 4.1; Photos II-46 and II-47). No flow was observed at the time of the inspection, but the wet area is located approximately where four small seepage areas were identified in July 2011. The surveyed locations of the seeps are shown in Figure 1.2, and in the figures presented in Appendix IV. Ed Creek originally flowed through the Tailings Impoundment area north of the four seeps, and it is suspected that Ed Creek is the source of the water. Outside of this wet area, the ground on the slope and along the toe was dry.

**Photo II-46 Borrow Area A – wet ground in northeast corner,**

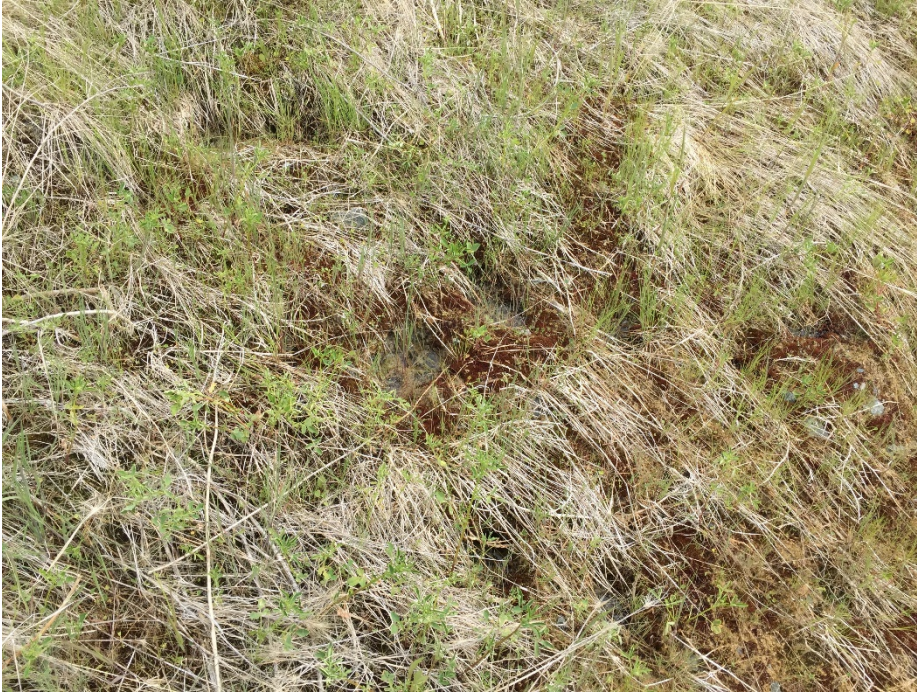
**Photo II-47 Borrow Area A – wet ground in northeast corner. No flowing water was observed.**

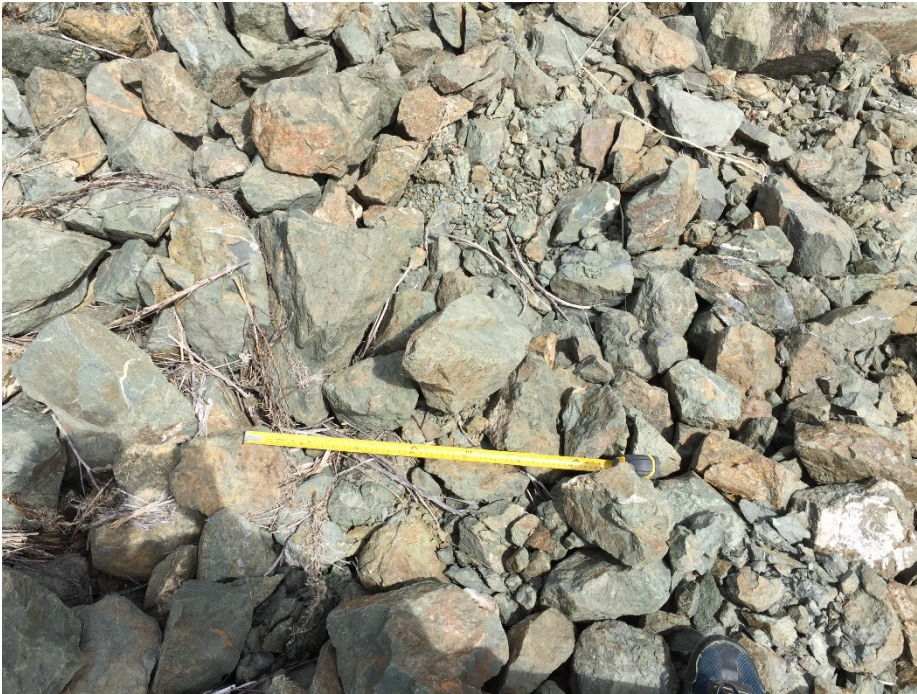
Previous annual inspection reports have noted that the riprap along some areas of the Ed Creek Diversion Channel is weathering and breaking up (Photo II-53). The condition of the riprap appeared similar to previous inspections.

A complete failure of the Ed Creek Diversion Channel could potentially affect the Tailings Dam by eroding the west bank of the channel towards the dam and undermining the dam foundation. That level of event could not occur within a one-year period given the current level of inspection occurring. However, a long-term solution remains the recommendation, first made in 2014, for Teck to re-establish erosion protection. Teck has committed to complete this work by the end of 2022 and are actively investigating erosion protection options for the channel given the lack of immediately available riprap material at site of appropriate size.

**Photo II-53 Ed Creek Diversion Channel – Riprap on right bank, showing weathering and breakage.**

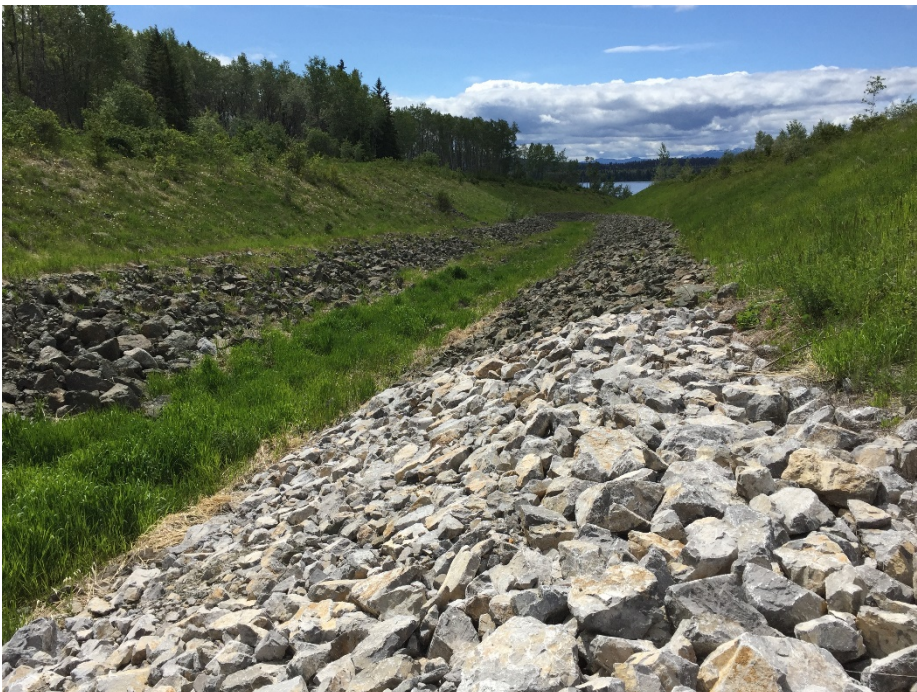
The riprap along a small section of the channel (Location 7 in Figure 4.1; Photo II-56), where a depression had formed in the riprap surface, was replaced in 2014. This riprap appeared to be in good condition.

**Photo II-56** Ed Creek Diversion Channel – looking downstream from near second bend. Light-coloured area of riprap was replaced in 2014, and is in good condition.

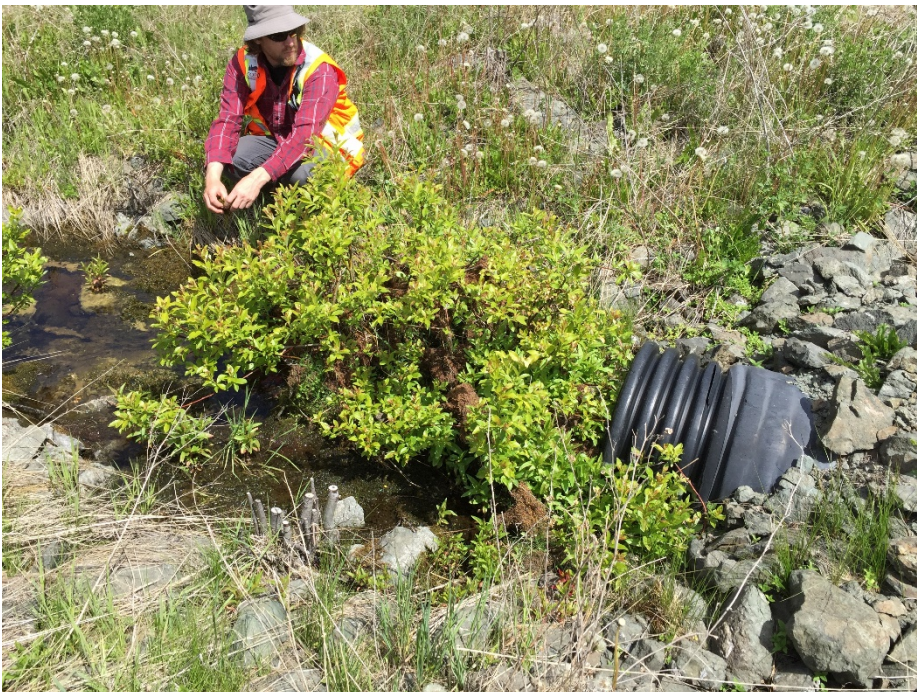
**Photo II-62 Inlet of 460 mm culvert on north bank of Ed Creek Diversion Channel. There is vegetation upstream of the inlet that could block the channel during flood conditions.**
