2018 Dam Safety Inspection

Pine Point Tailings Impoundment Area, Pine Point, NT

Reference No. 1788880-117-R-Rev2-5000

22 February 2019

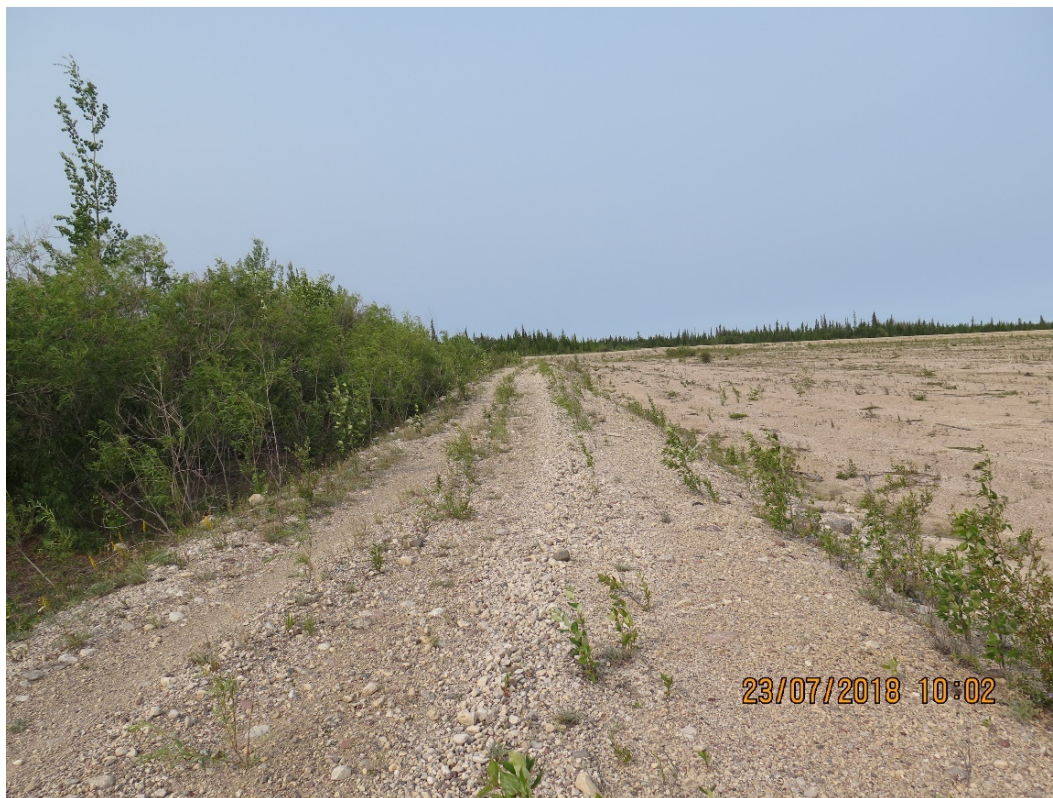
- Vegetation was observed on the downstream side of the west end of the south dyke.

Photograph 3: South Dyke – Crest at West End with Vegetation on Downstream Face, Looking West. 23 July 2018

Routine maintenance activities are recommended to address vegetation growth on the dykes.

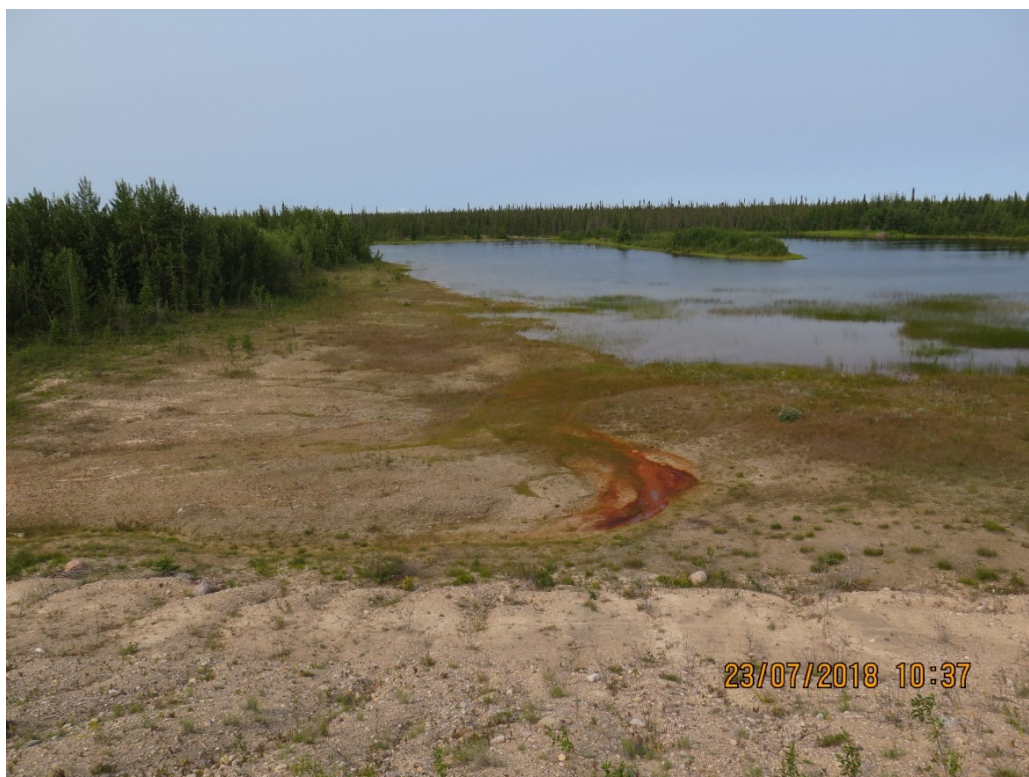
Photograph 6: West Dyke – Downstream Drainage Course near North End, Looking West, Staining Noted Near Seep. 23 July 2018

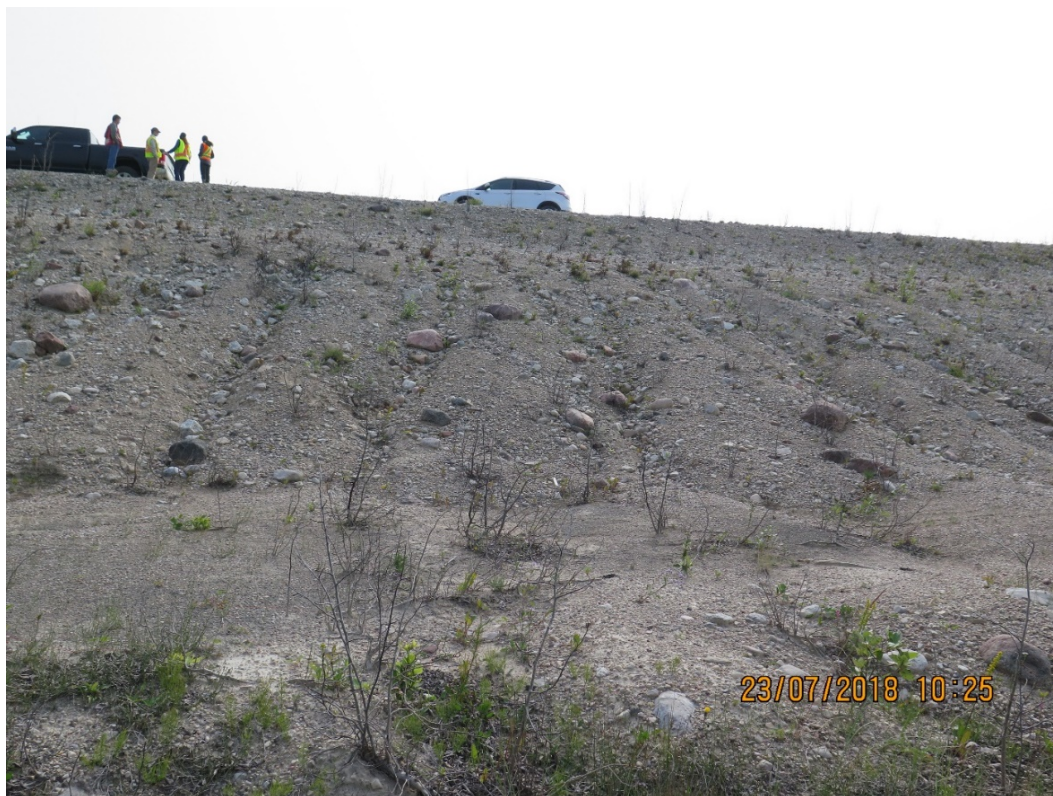
Photograph 7: West Dyke – Downstream Toe and Slope Near North End, Looking East, Minor Erosion Features. 23 July 2018

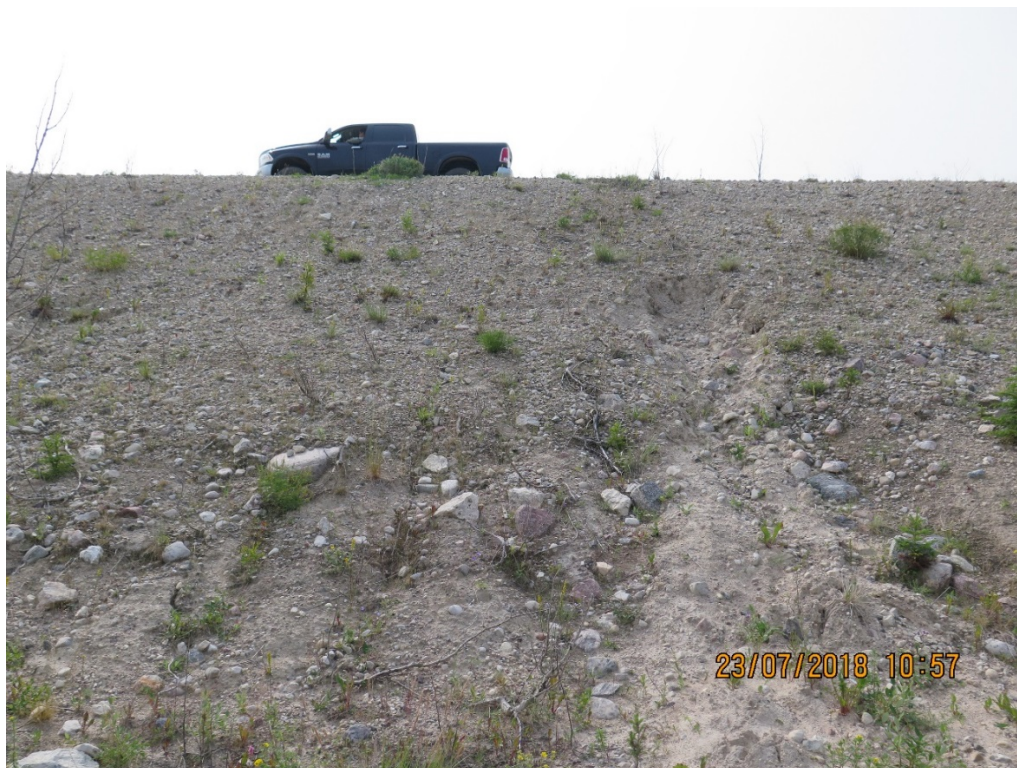
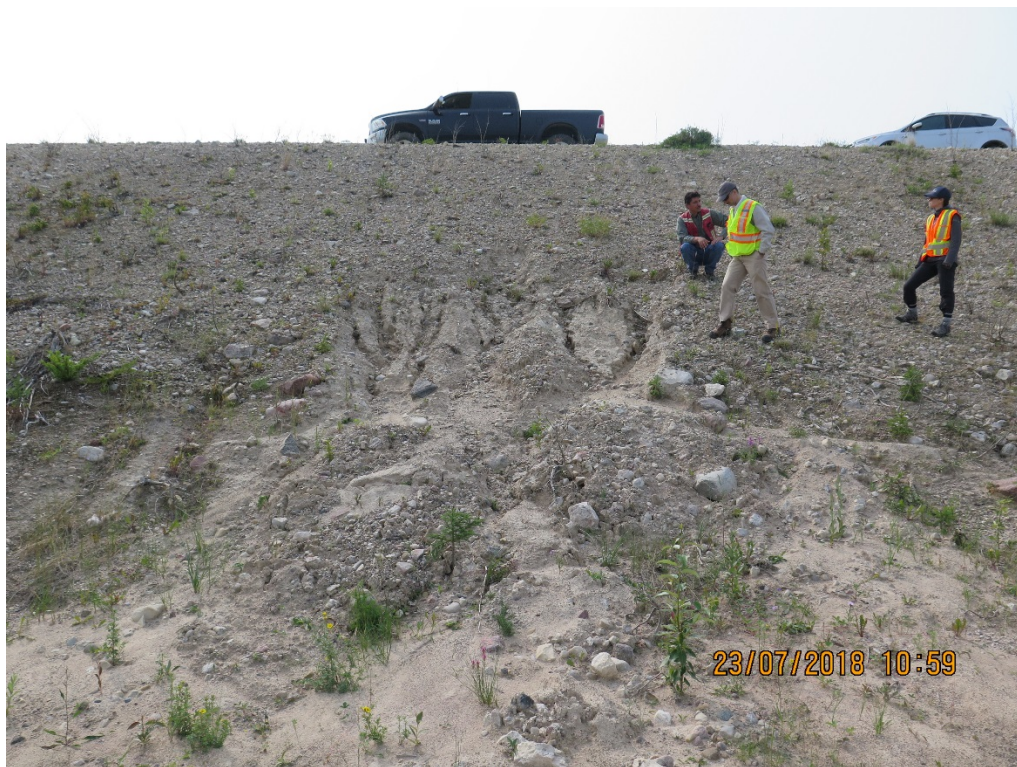
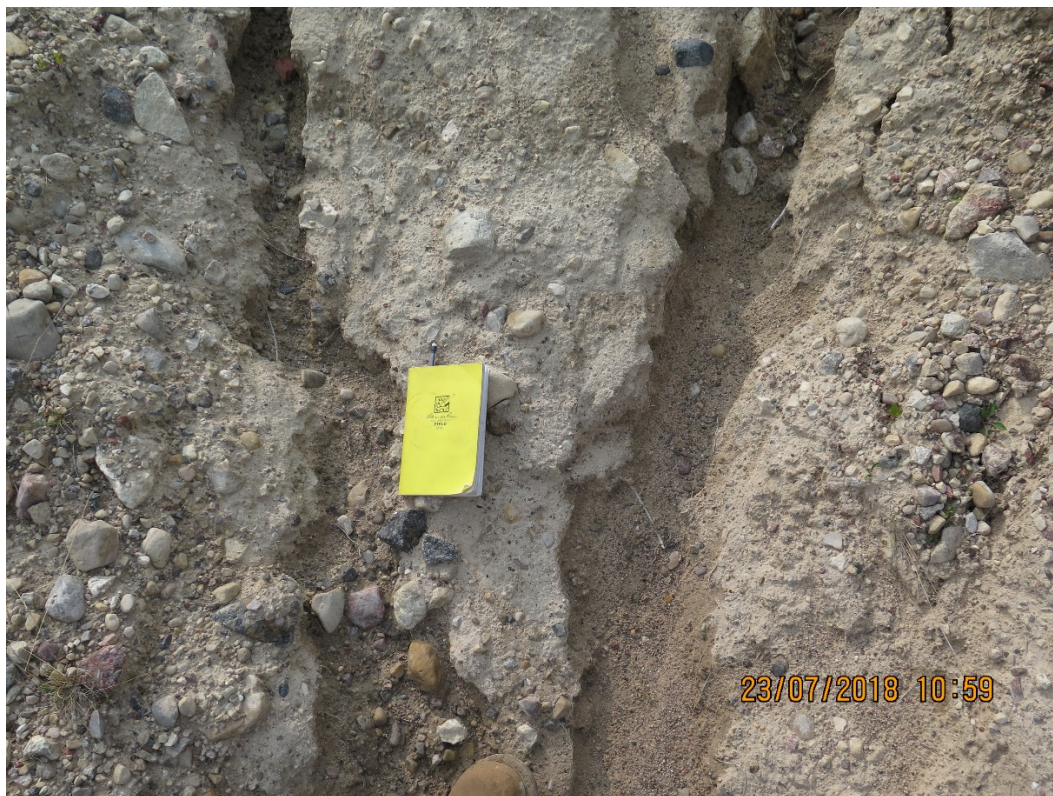
- Surface erosion rills (gullies)
 - Two rills, approximately 1 m deep, were observed on the downstream face of the north dyke and located approximately 70 m from the west dyke.

- Two surficial erosion rills, approximately 1 m deep, were observed on the lower portion of the downstream slope of the north dyke, approximately 70 m from the northwest corner. Repair of these features was recommended following the site visit.

Photograph 9: North Dyke – Erosion Feature on Downstream Slope Near West End, Looking South. 23 July 2018

Photograph 10: North Dyke – Erosion Feature on Downstream Slope Near West End, Looking South. 23 July 2018

Photograph 11: North Dyke - Close Up of Erosion Feature on Downstream Slope Near West End, Looking South. 23 July 2018

- These rills were repaired in October 2018.
 - Areas of rilling repaired prior to 2018 were observed to be in good condition.
- No impacts by erosion extended into the dyke crest.

- Maintenance repair by placement of granular fill in rills on downstream face of the north dyke between 10 and 15 October 2018.
- Site investigations of the TIA as per the Reclamation Research plan were completed between 6 September 2018 and 12 October 2018. Instrumentation was installed in the TIA as part of site investigations:

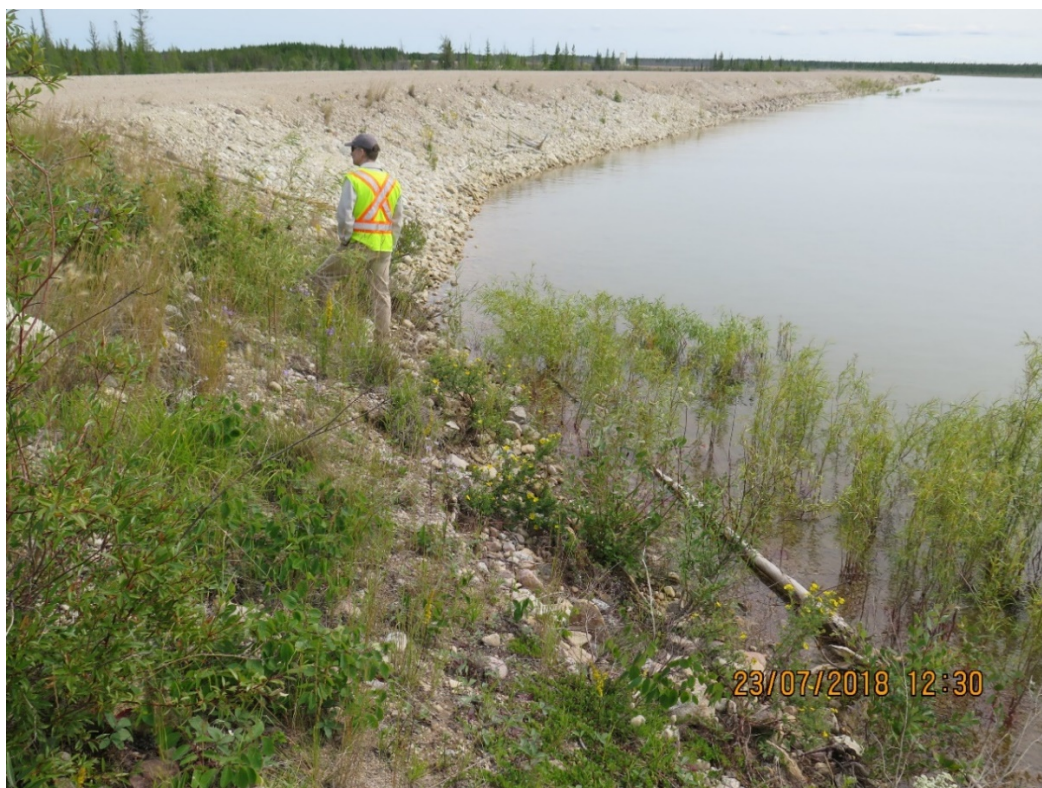
Photograph 12: North Dyke - Upstream Face, Gravel and Cobbles at Pond Waterline, at Dogleg Looking East. 23 July 2018

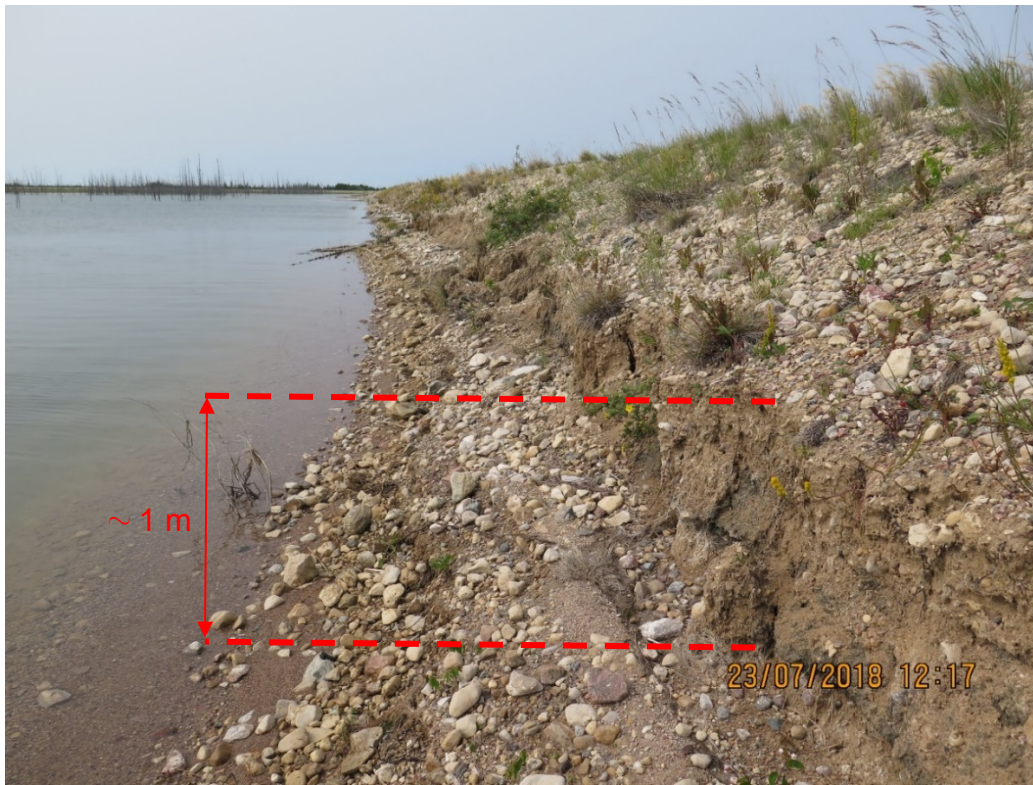
- Wave cut erosion
 - A 700 m long section of the upstream face of the north dyke was observed to be eroded. Erosion was attributed to high water levels in spring 2018.

- Restoration trial works along the upstream face of the north dyke appear to have been successful in preventing ongoing erosion in this area.
- An eroded bench up to 1 m high was observed on the upstream face of the north dyke along a 700 m section west of the dogleg during the July DSI. Erosion was above the water line and attributed to higher spring water levels and associated wave and/or ice action. The erosion had exposed silty clay core in some areas but had not reached the dyke crest nor reduced the dyke crest width. Repair was recommended following the site visit.

Photograph 13: North Dyke – Repair at Waterline on Upstream Face West of Dogleg, Erosion Approximately 1 m scarp, Looking West. 23 July 2018

- The erosion was repaired in October 2018.
 - In 2016 repairs were made to a test section of the upstream face of the north dyke using locally sourced fill with a particle size distribution that was smaller than conventional riprap armouring. The test section was intended to evaluate if the locally sourced fill was suitable for restorative maintenance of the remaining portion of north dyke upstream face that requires repairs due to erosion by the pond. The 2016 repairs were in good condition at the time of the 2018 DSI. Following further erosion of other parts of the dyke in 2018 the recommended material for the maintenance to repair included a sized riprap for erosion protection.

- The culvert connecting the main and polishing pond was closed during maintenance.
- Maintenance repair by placement of geotextile and riprap fill on upstream face of the north dyke between 10 and 15 October 2018.

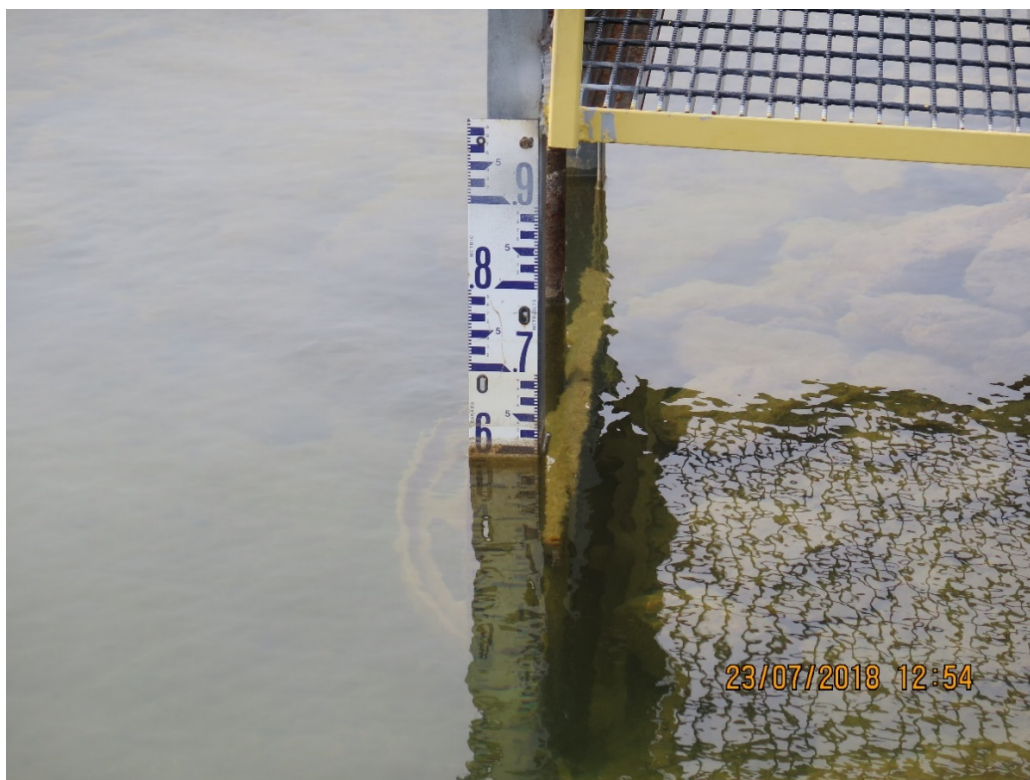
Photograph 17: Main Pond Water Level at Culvert Intake to Polishing Pond (201.62 m). 23 July 2018
