Teck Coal Limited

Quintette Coal Operations

2018 Dam Safety Inspection

Plantsite Tailings Dam

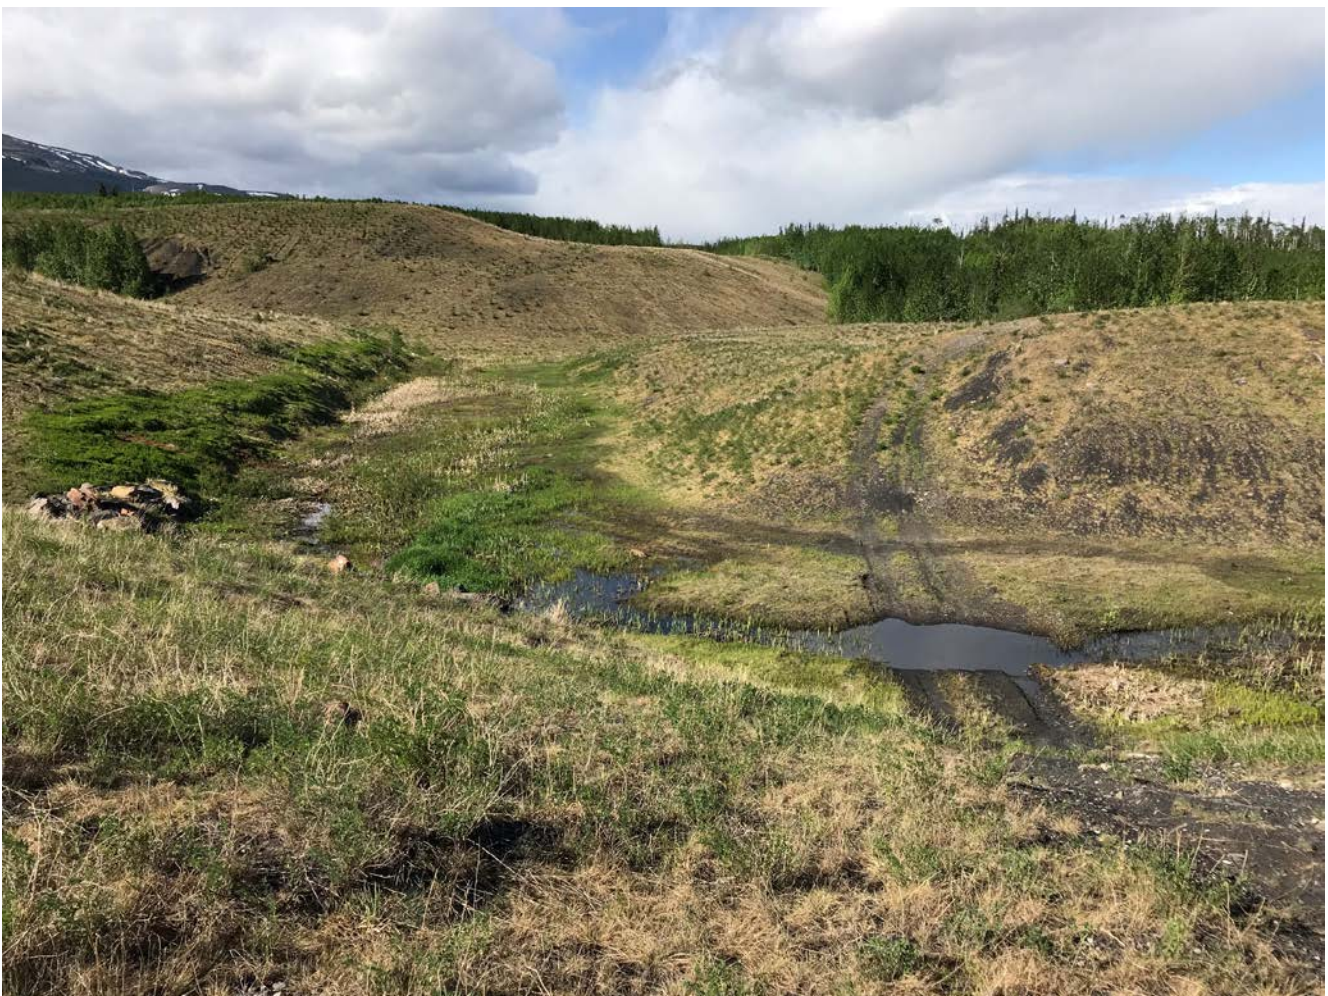
Photo I-1 Spillway outlet channel – viewed from spillway North Berm looking southwest toward discharge point into M17 Creek (PTD-2018-01)

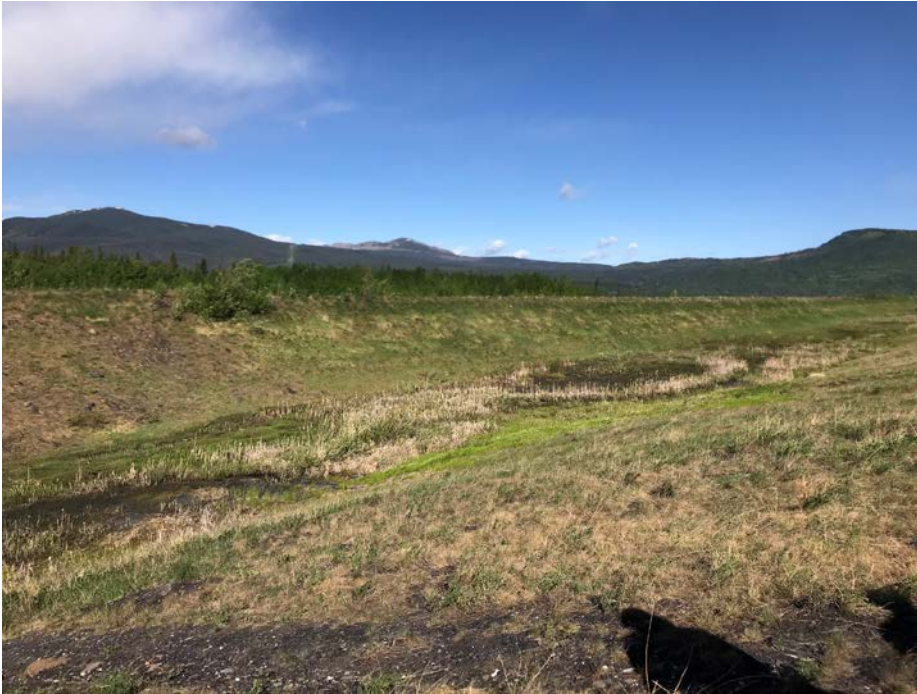
Photo I-2 **Spillway channel – viewed from spillway North Berm looking northwest along the channel. Channel is well vegetated but no obstruction observed (PTD-2018-01)**

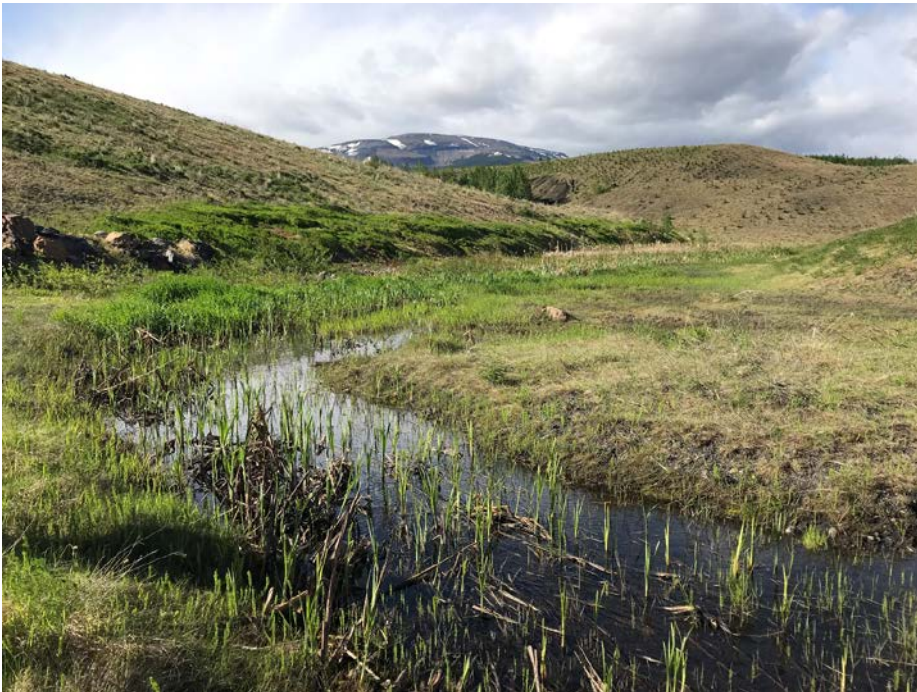
Photo I-3 **Closeup view of the outlet channel – looking southwest toward discharge point into M17 Creek. Flows in low flow channel was observed (PTD-2018-02)**

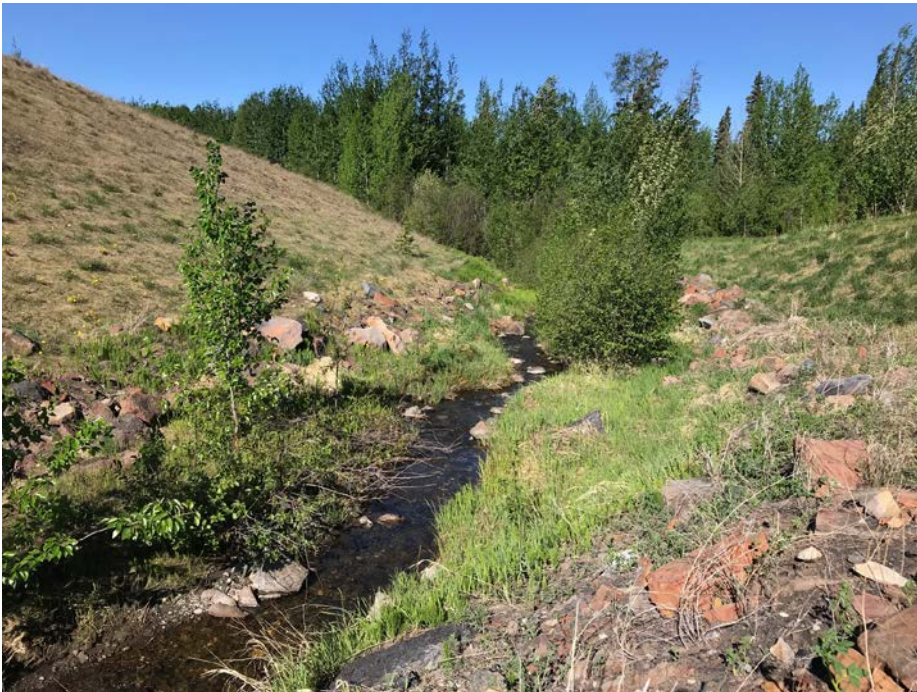
Photo I-5 **Looking south along the M17 Creek. Creek is well vegetated, but not a dam safety concern (PTD-2018-04)**

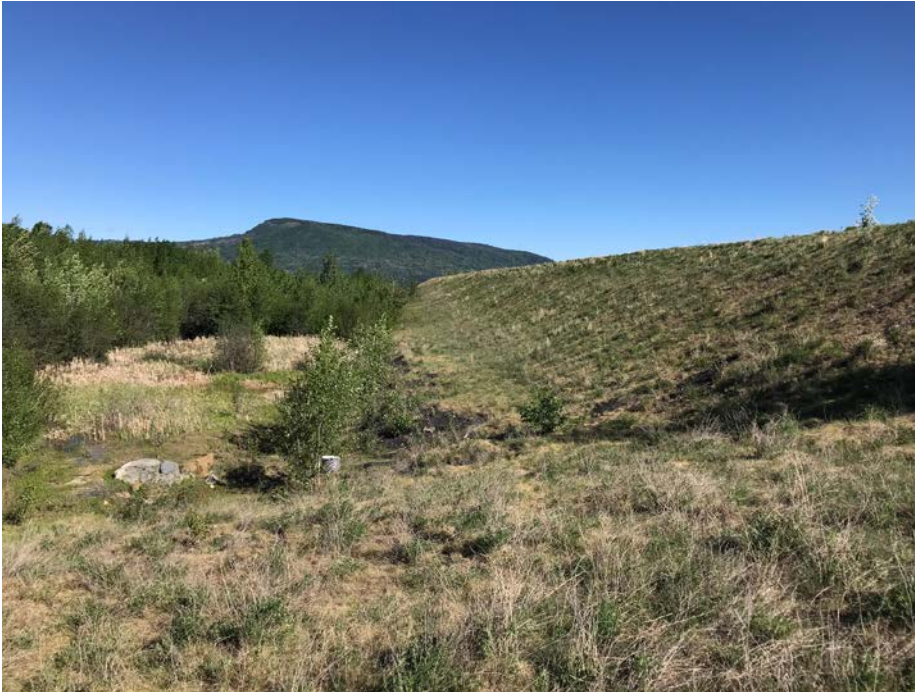
Photo I-6 **Overview of PTD downstream slope looking northwest – the slope is in good condition (PTD-2018-05)**

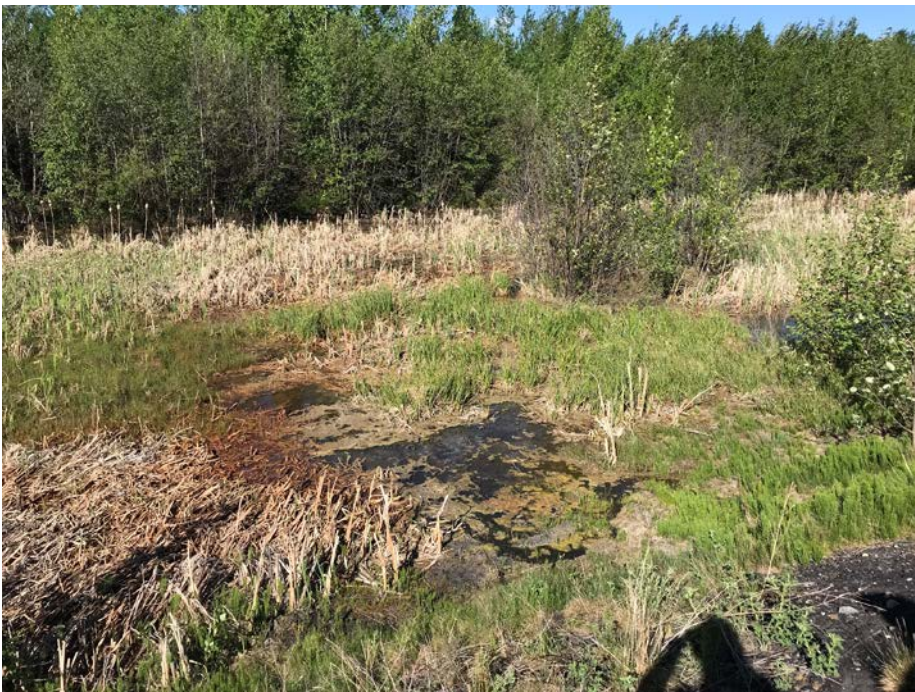
Photo I-7 **Looking southwest at a wet area downstream of PTD toe – no apparent change in condition from previous year (PTD-2018-06)**

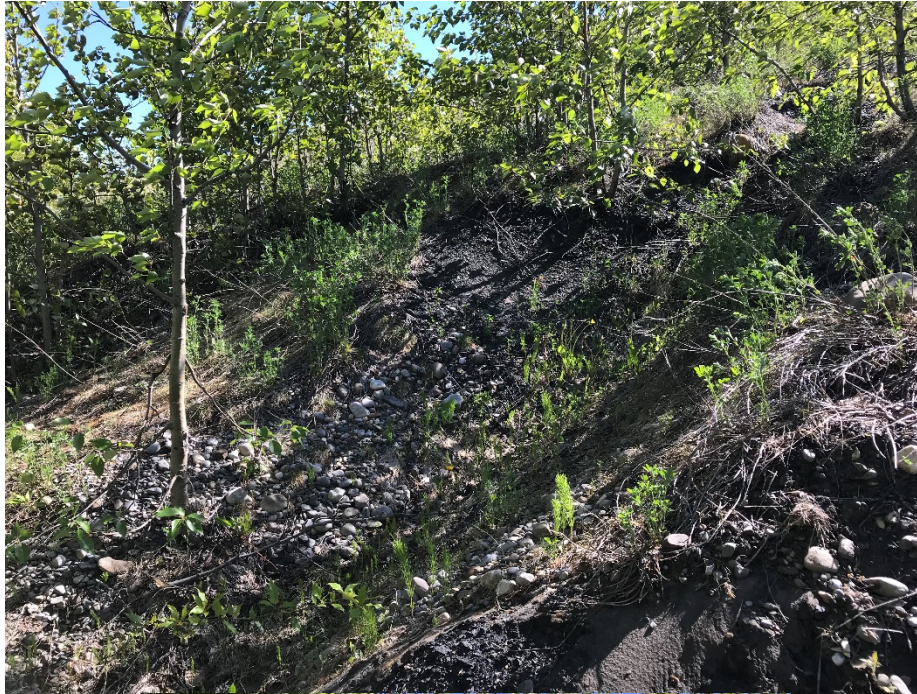
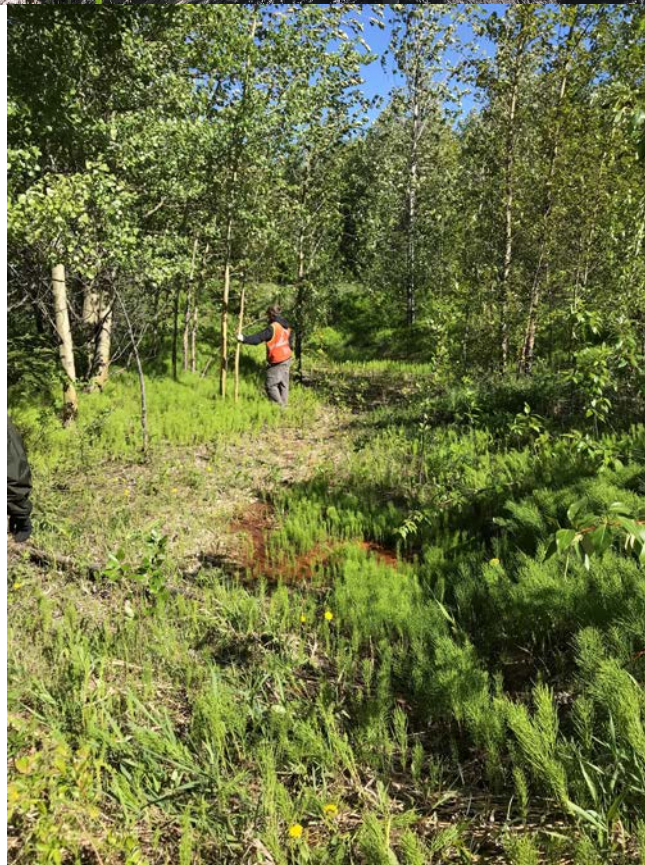
Photo I-10 **Finger drain at PTD toe; area downstream of the finger drain is boggy and well vegetated (PTD-DRAIN-08/09)**

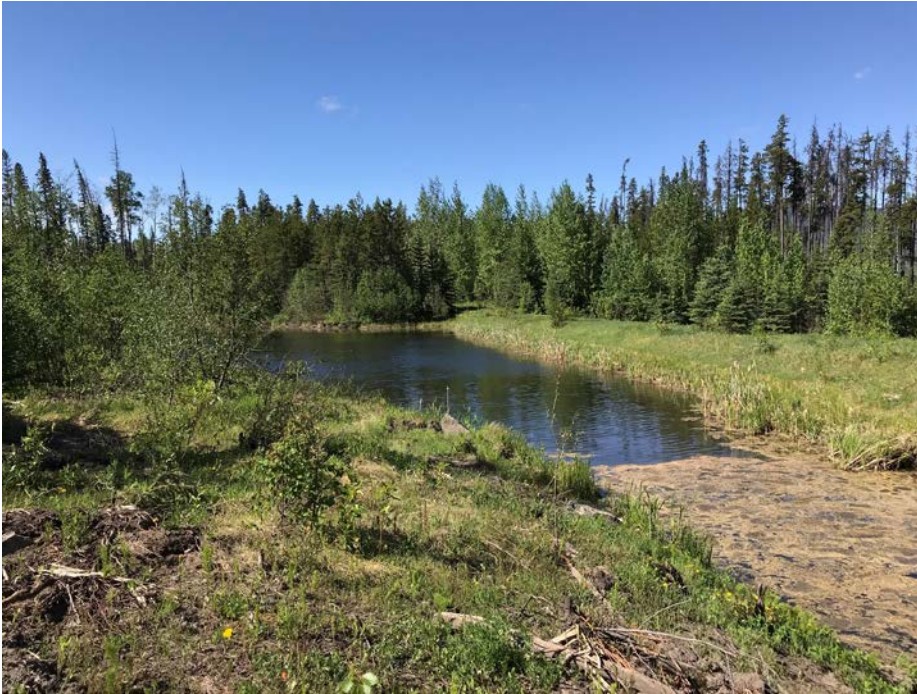
Photo I-11 **Seepage Collection Pond – located west of the PTD which discharges into M17B Creek. No signs of erosion, distress, or discernable discharge noted (PTD-2018-09)**

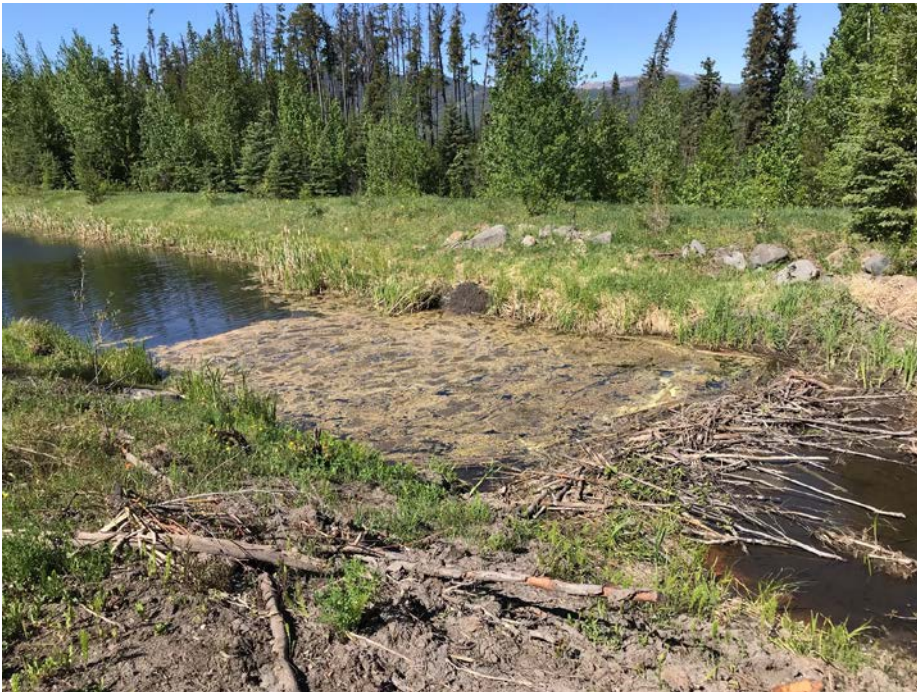
Photo I-12 **PTD Seepage Collection Pond – looking west. Beaver dam noted obstructing the outlet area of the pond (PTD-2018-09)**

ID Number	Deficiency or Non-Conformance	Applicable Regulation or OMS Manual Reference	Recommended Action	Priority	Recommended Deadline
PTD-2018-01	Beaver Activity at Seepage Collection Pond	OMS Manual	Monitoring of beaver activities which can impact dam performance (spillway blockages) should be included as a maintenance parameter in the OMS manual.	4	December 2018
PTD-2018-02	Evaluate piezometer reliability before the next DSR	OMS Manual	In the event that Quintette is not re-activated prior to the next Dam Safety Review, the reliability and performance of the piezometers should be evaluated.	4	December 2020
PTD-2018-03	n/a	n/a	Review whether the Seepage Collection Pond is still required, or if the structure can be decommissioned.	4	n/a
PTD-2018-04	Upper and Lower Met rain gauges unreliable in winter	n/a	Repair or improve the Upper and Lower Met climate station rain gauges to improve reliability of precipitation measurements during the winter months	4	December 2019

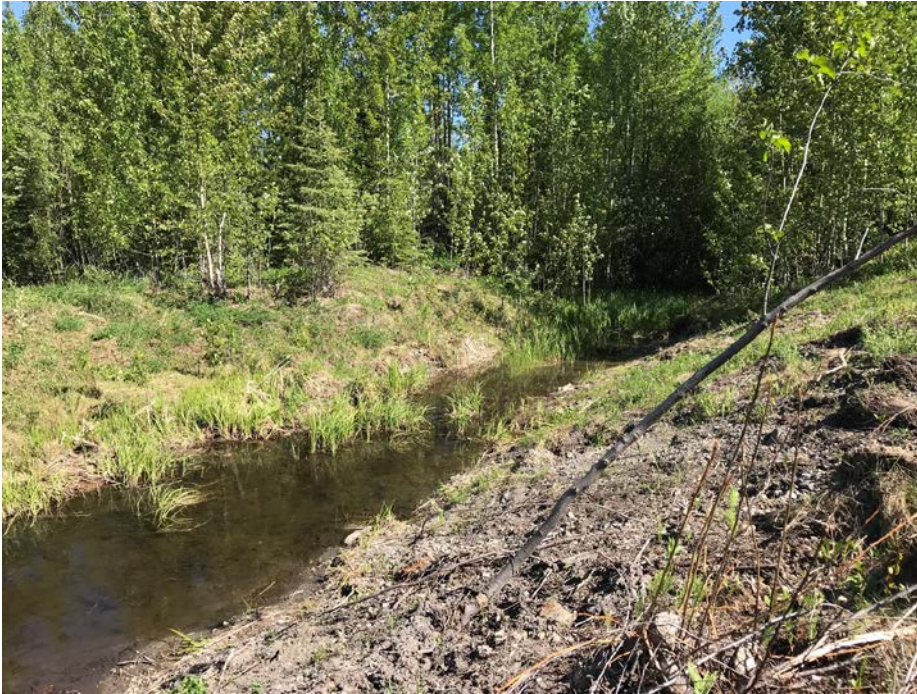
Photo I-13 **Seepage Collection Pond Outfall Channel – looking north. Small flow was noted. Majority of the channel appears to be in good condition (PTD-2018-09)**

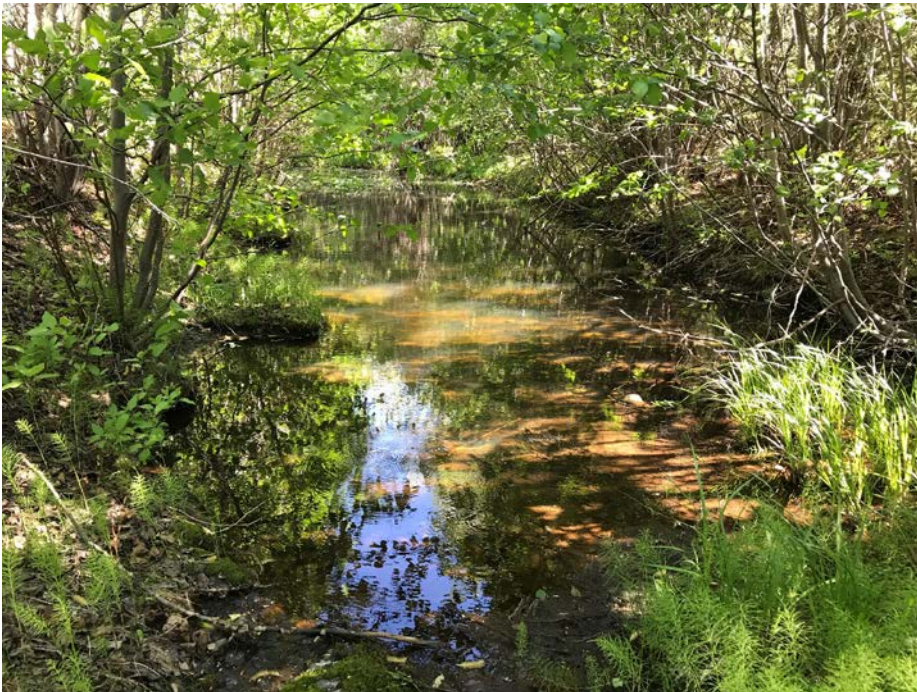
Photo I-14 **Outlet channel of the Seepage Collection Pond – looking northeast. Poned area appears to be larger than previous year – not a dam safety issue (PTD-2018-10)**

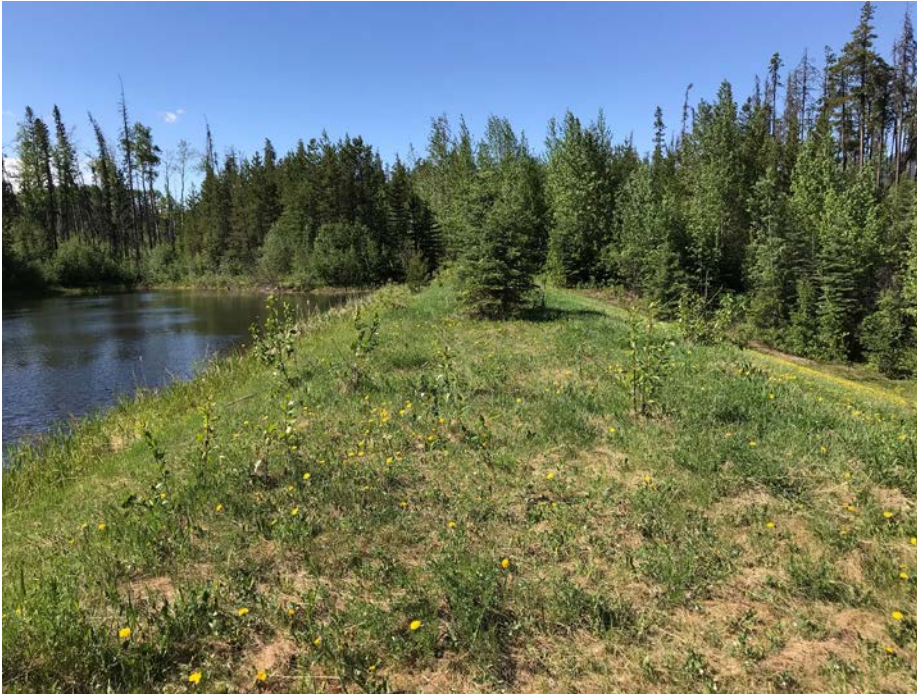
Photo I-15 Seepage Collection Pond crest – looking southwest. Medium trees noted, but no signs of distress (PTD-2018-11)

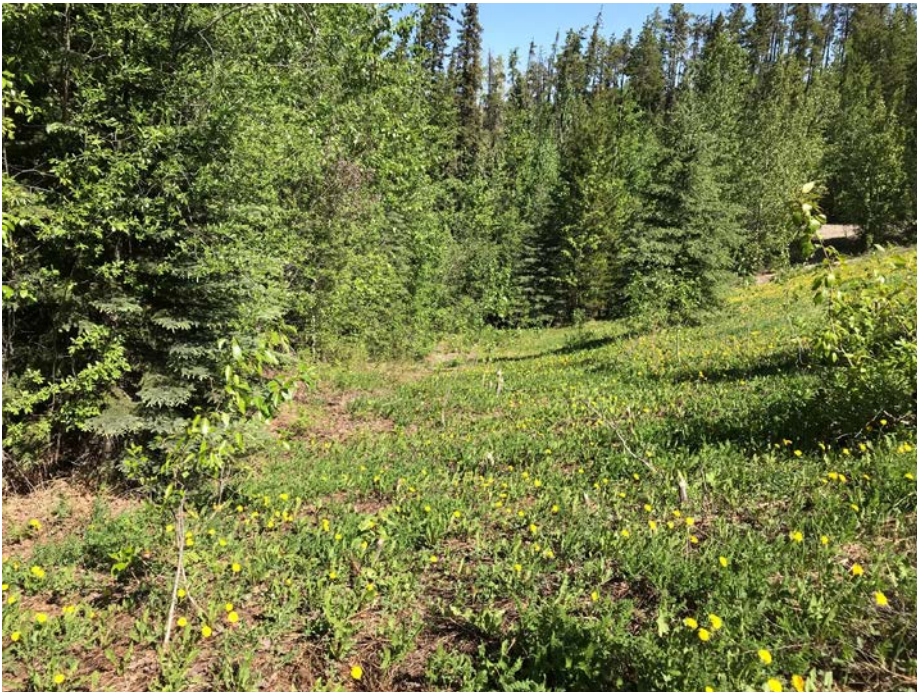
Photo I-16 Seepage Collection Pond downstream slope/south abutment contact – looking north. No signs of unusual conditions (PTD-2018-12)

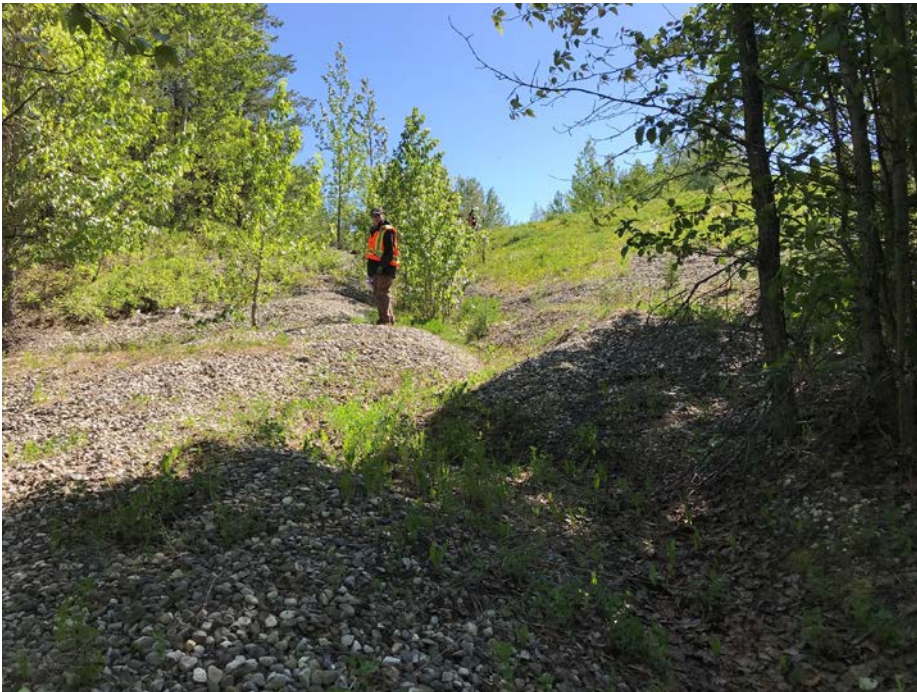
Photo I-18 Seepage Collection Pond – looking east. Spillway channel appears to be dry (PTD-2018-14)

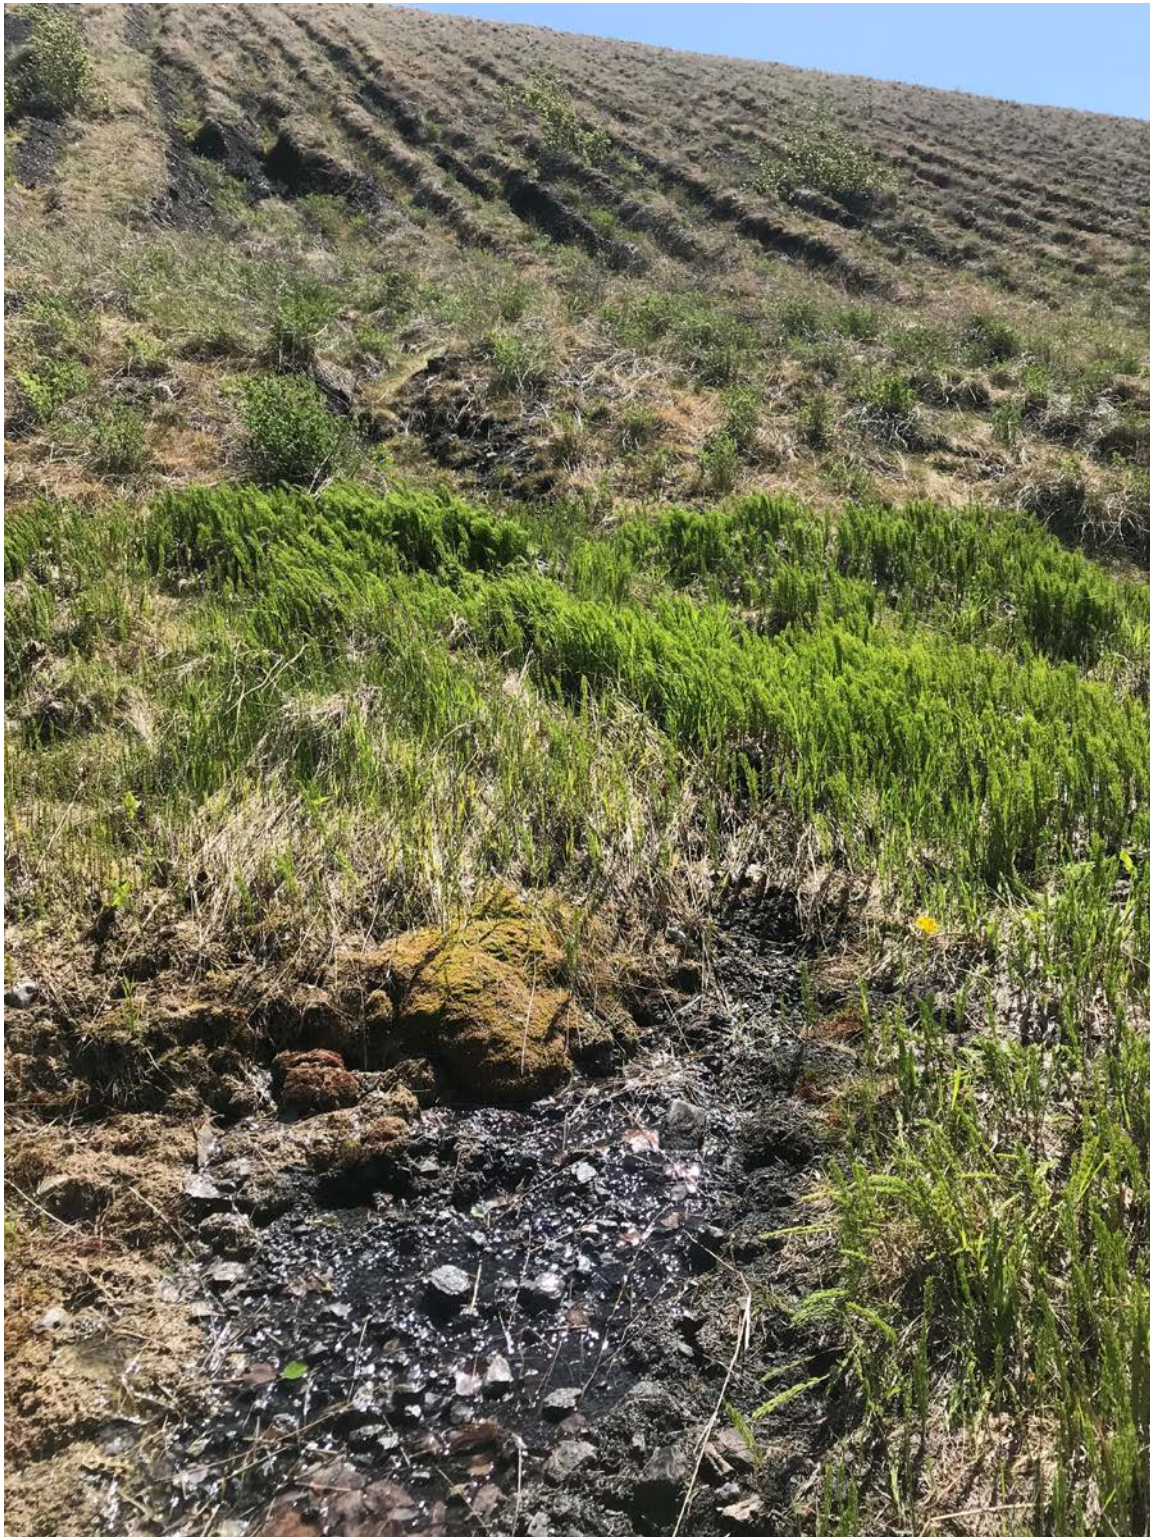
Photo I-19 **Flow noted coming from downstream toe adjacent to a finger drain (Chanel 1) - flow was estimated 1 L/min (PTD-DRAIN-19)**

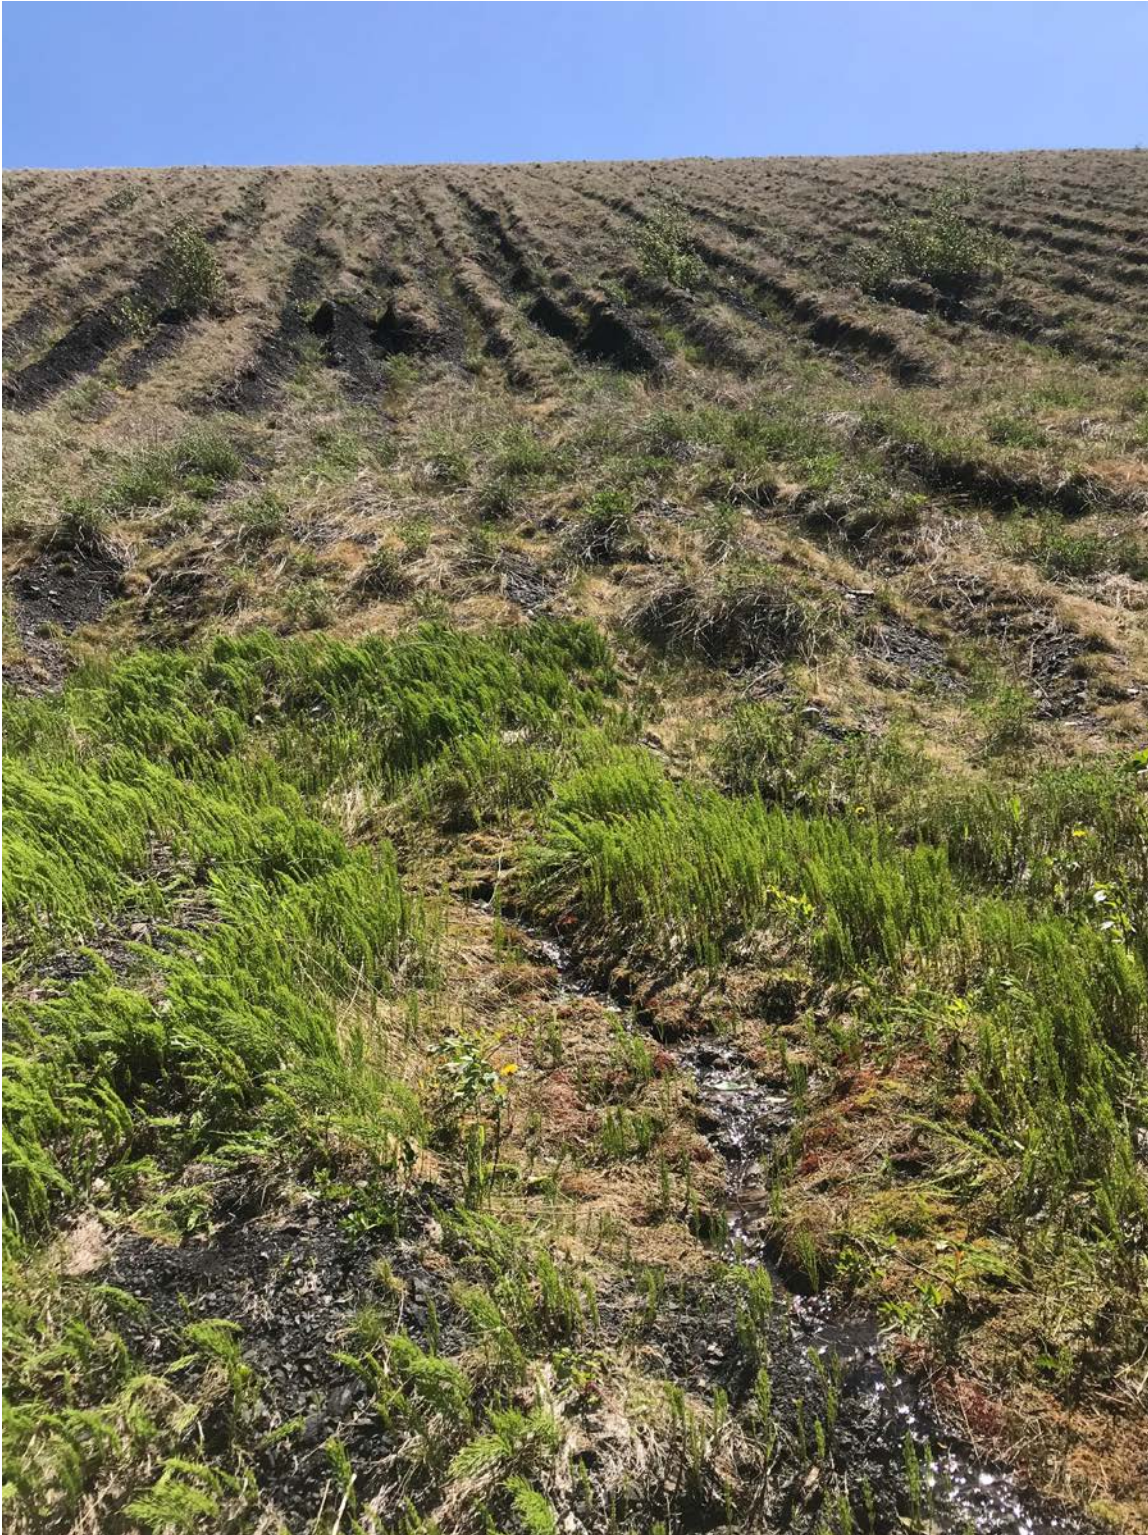
Photo I-20 **Flow noted coming from a finger drain (Chanel 2) – flow was estimated 1 L/min (PTD-DRAIN-19)**

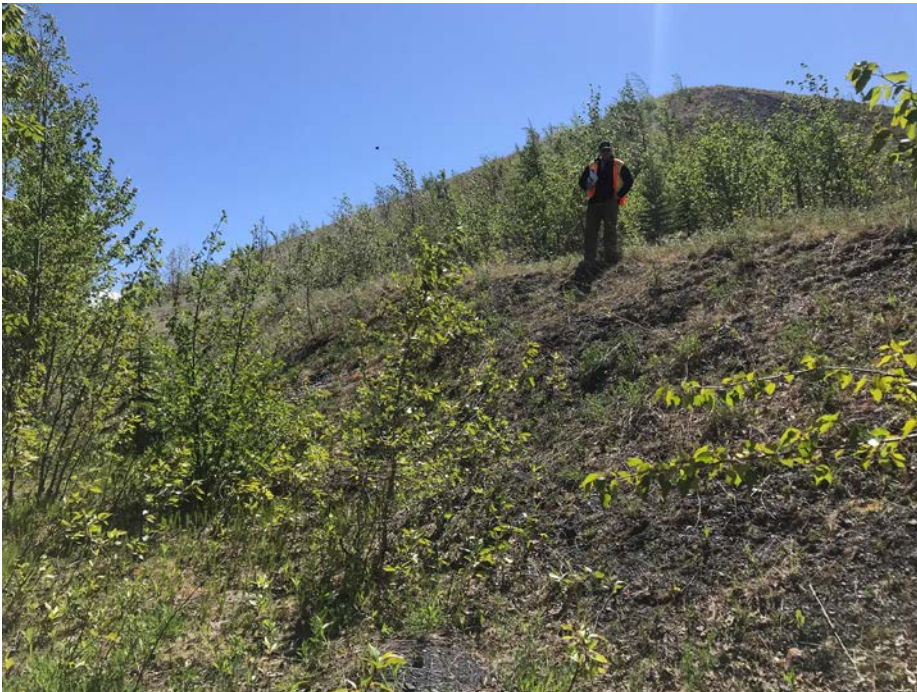
Photo I-22 **Overview of PTD northwest corner - steep scarp near downstream slope ramp – inactive due to the amount of vegetation growth on scarp (PTD-2018-16)**

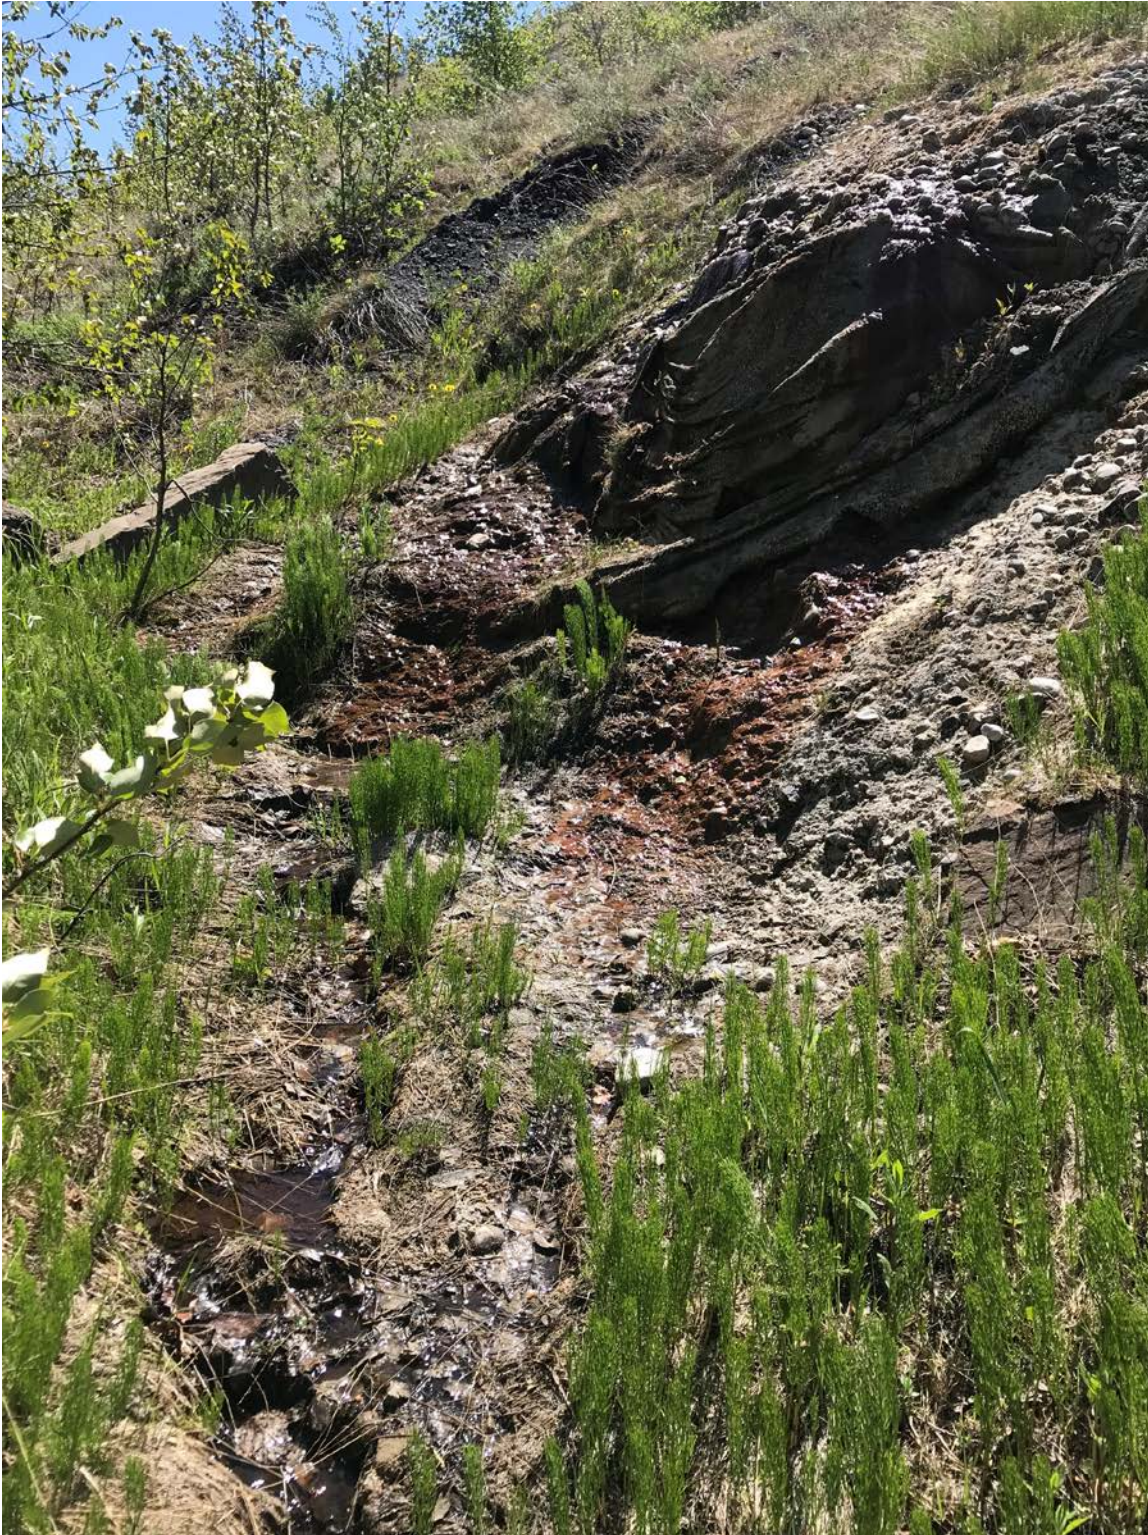
Photo I-23 Finger drain with geotextile – red (oxidized iron) precipitate observed (PTD-DRAIN-22)

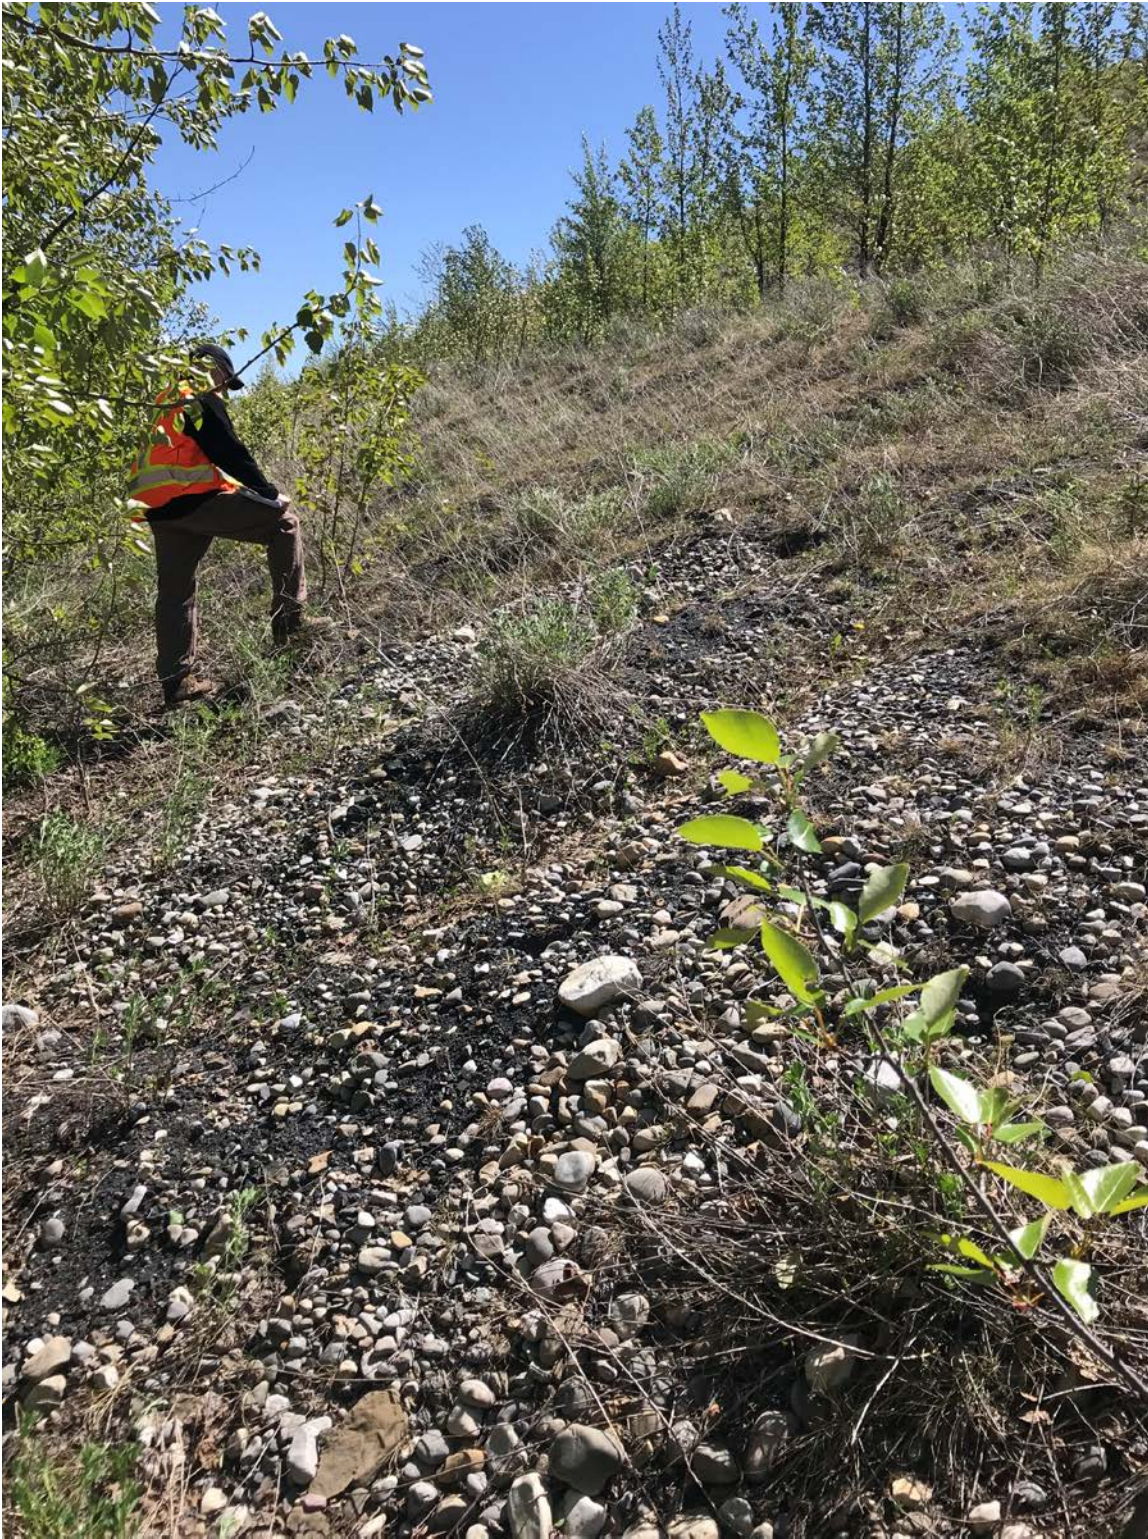
Photo I-24 Typical dry finger drain along the north embankment (PTD-DRAIN-23)

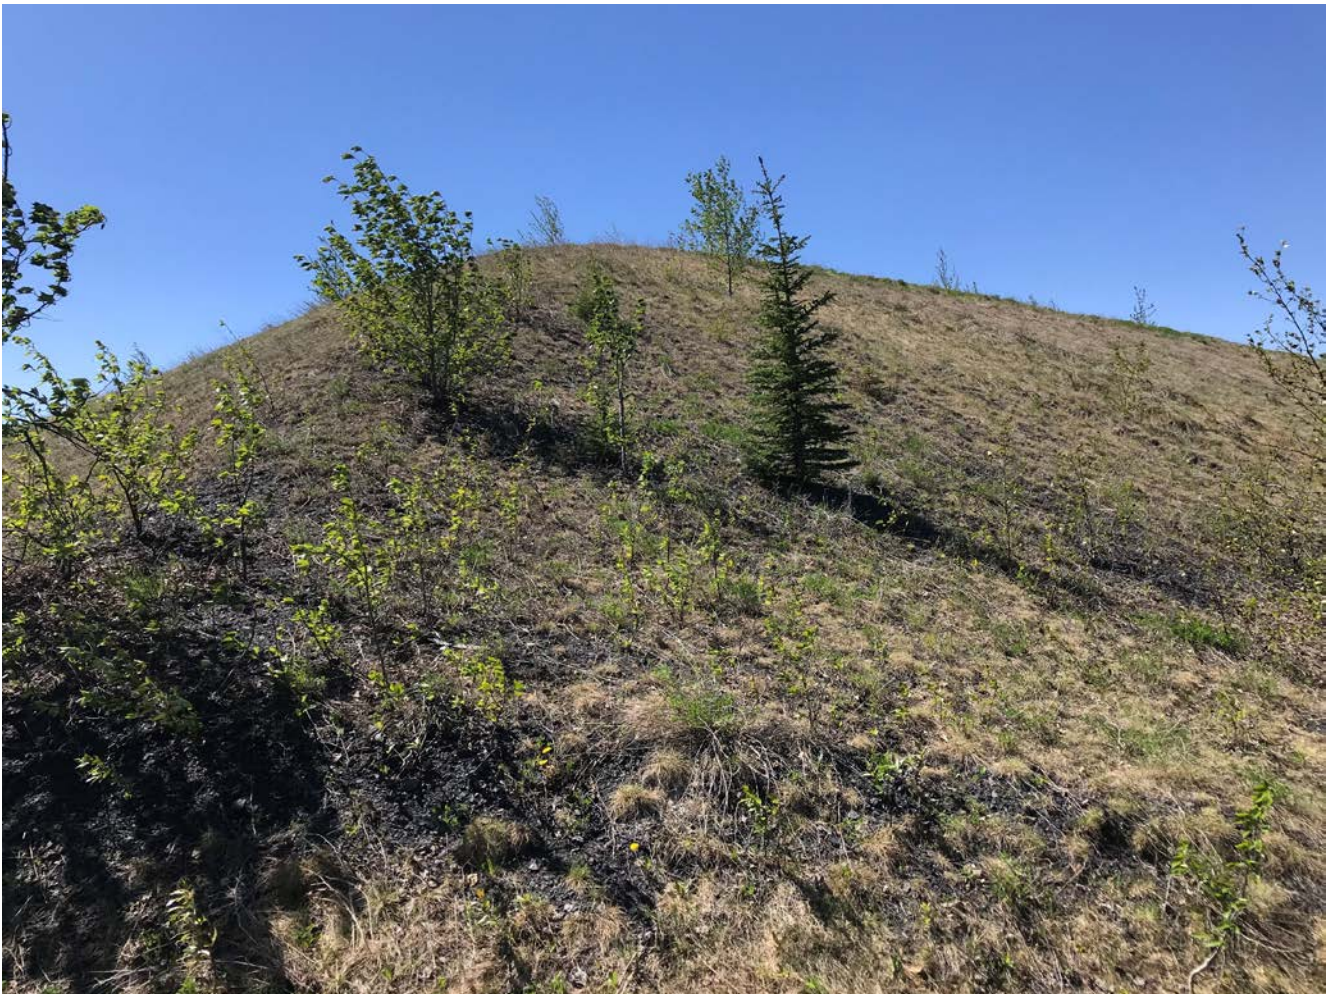
Photo I-25 PTD northeast corner's downstream slope – no signs of distress (PTD-2018-17)

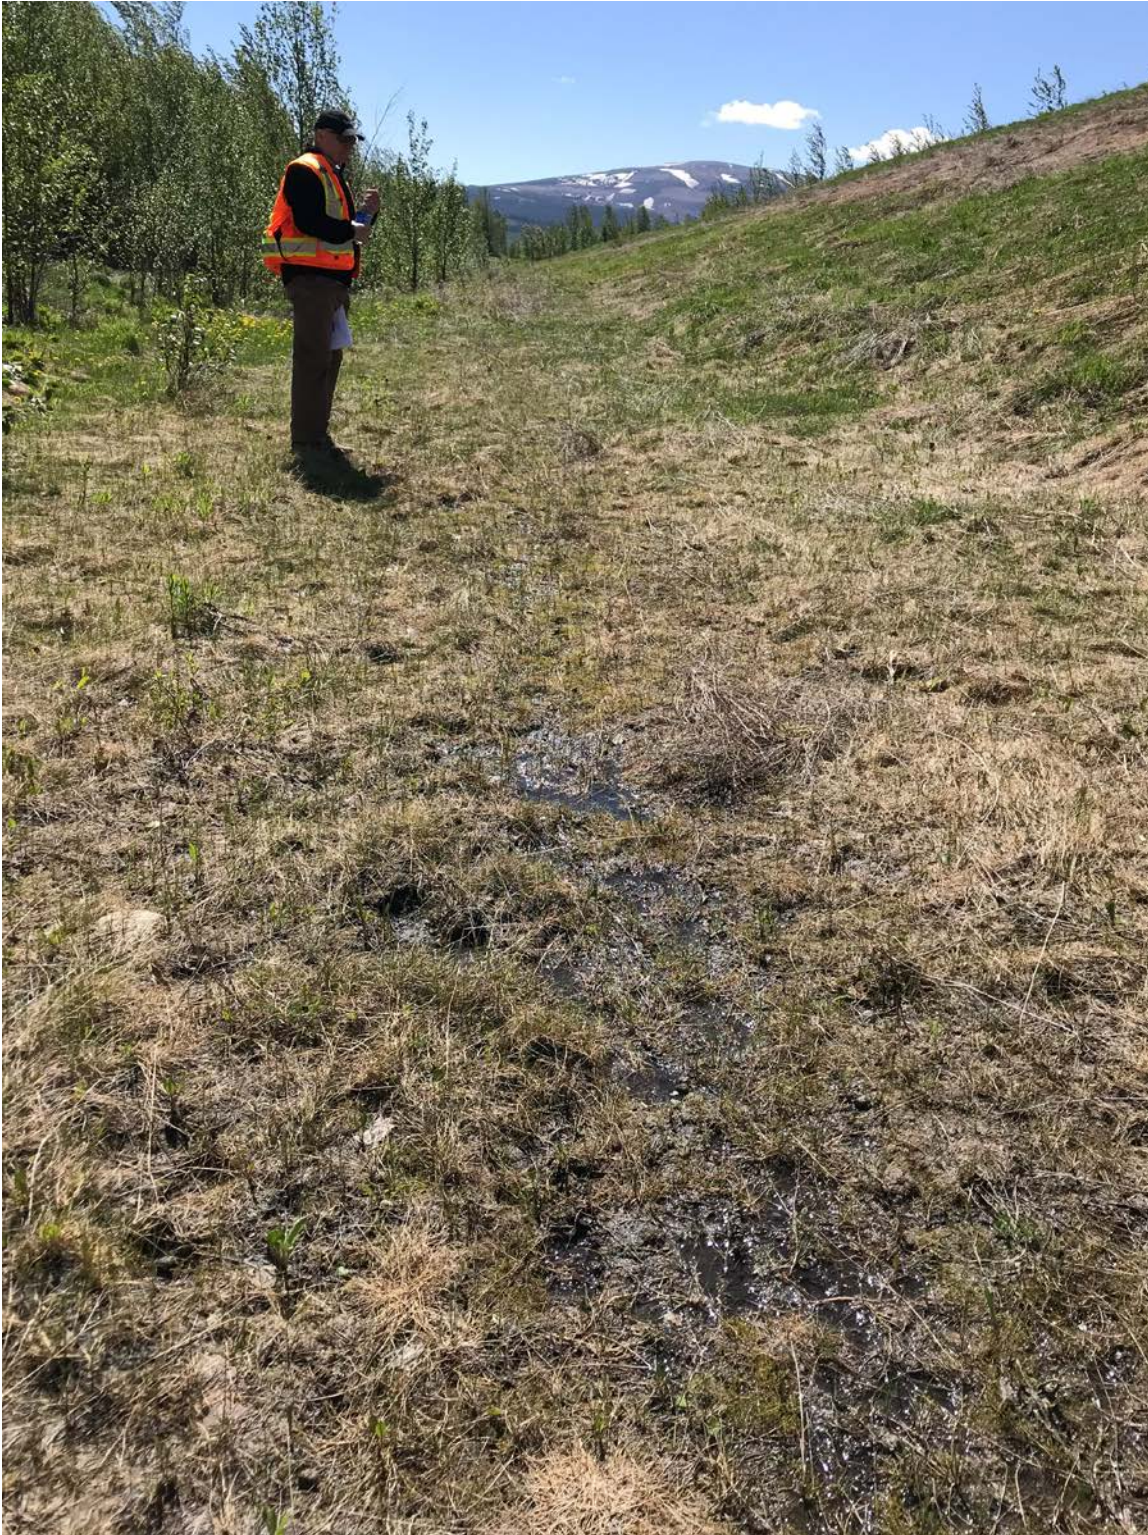
Photo I-26 PTD east embankment downstream toe area – looking south. Wet ground noted and likely due to seepage (PTD-2018-18)

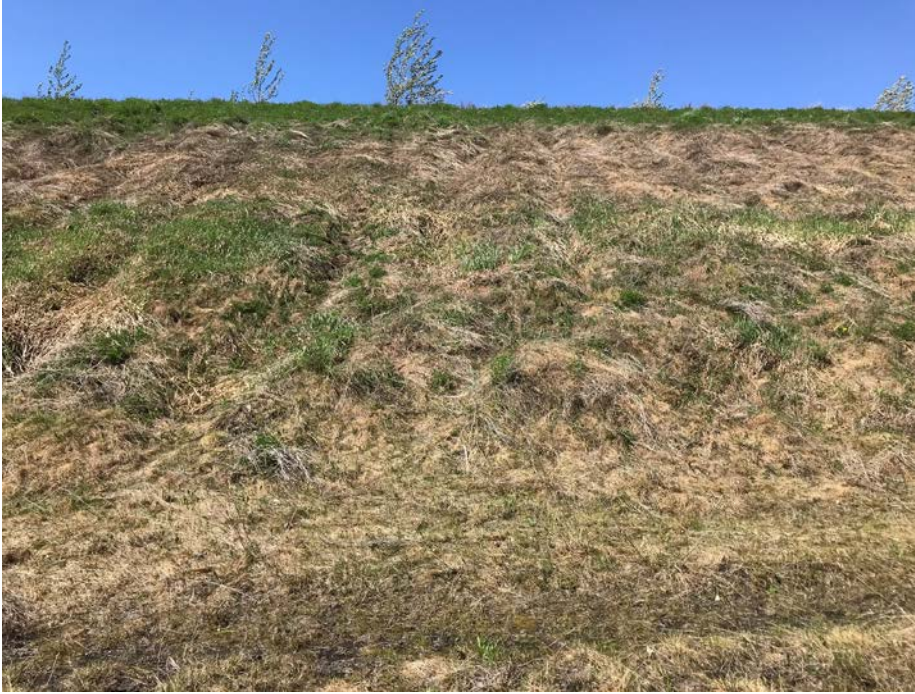
Photo I-27 **Change in vegetation type observed at approximately Sta. 2+200 – looking west. Vegetation is thick lush green, likely indication of increased moisture in this part of the dam (PTD-2018-18)**

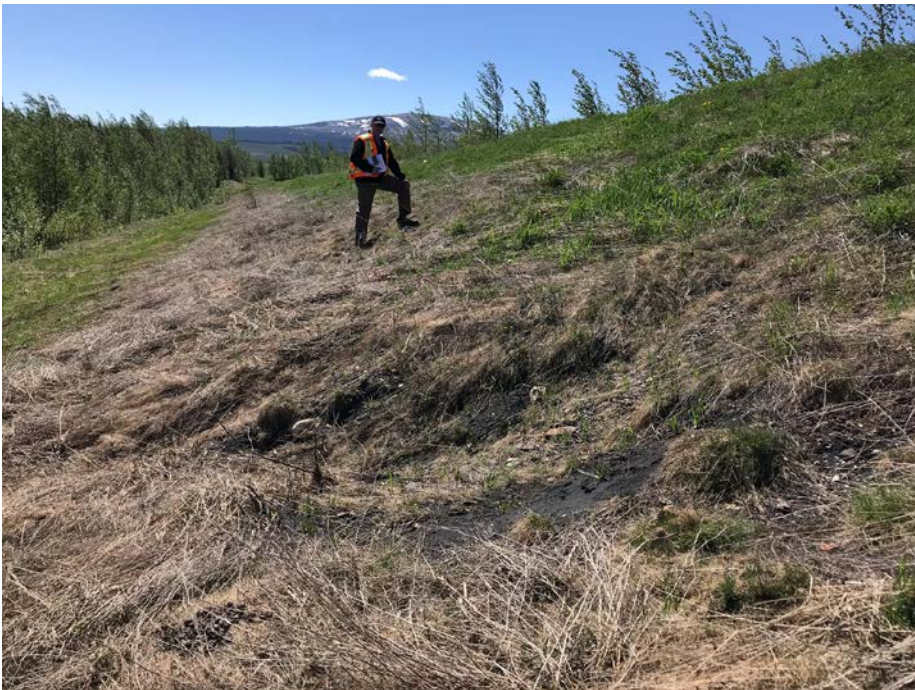
Photo I-28 **Small sloughed area on the dam's downstream slope – looking south. The feature is likely caused by animal activity (PTD-2018-19)**
