Teck Coal Limited

Quintette Coal Operations

2018 Dam Safety Inspection

Plantsite Tailings Dam

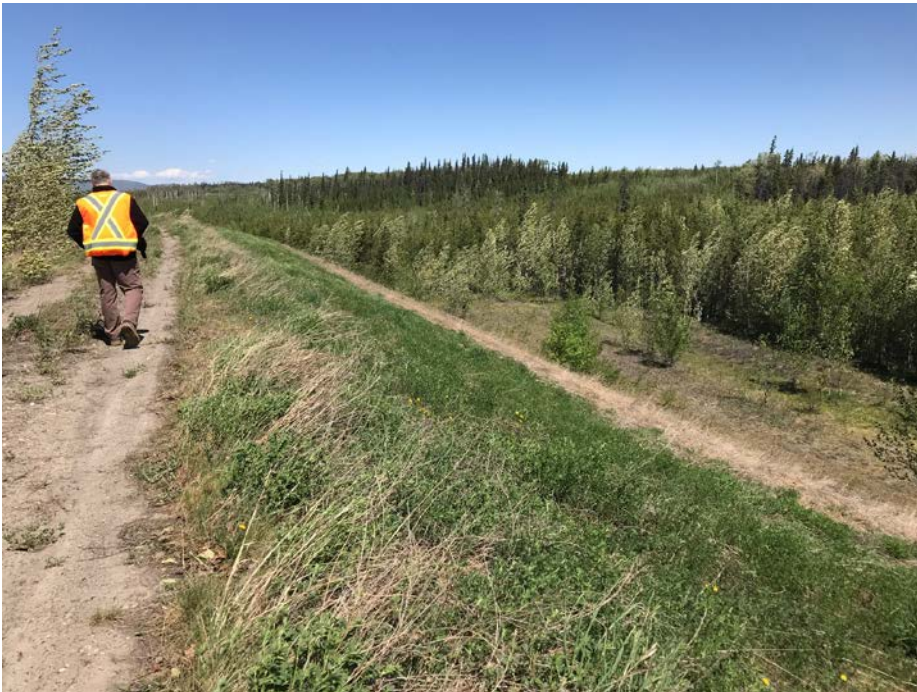
Photo I-30 **Downstream slope of the PTD - looking north at approximately Sta. 2+230 (PTD-2018-20)**

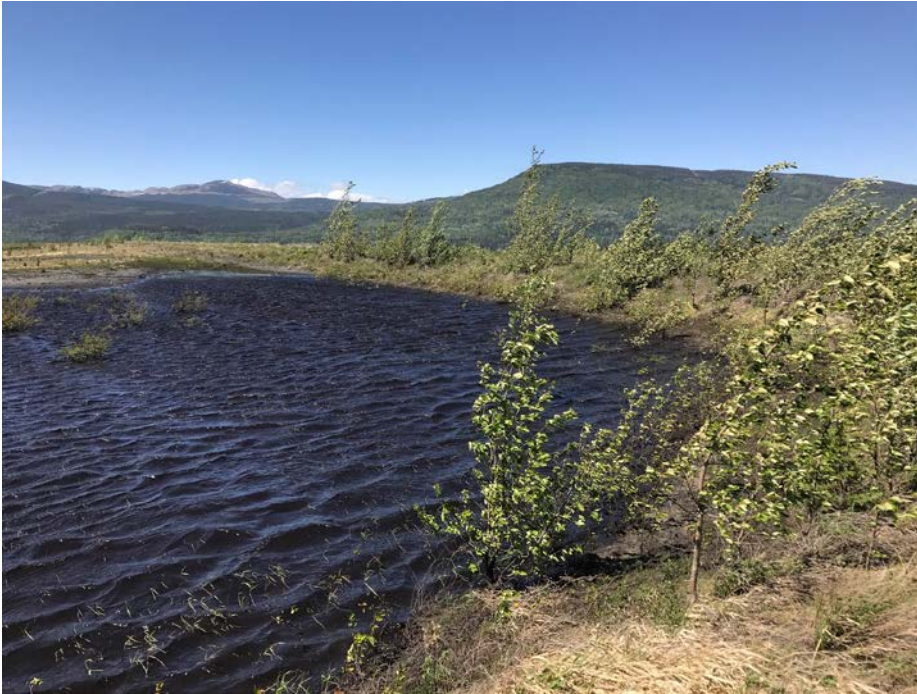
Photo I-31 PTD impoundment area - looking north at the northeast corner. Ponded water noted and was likely caused by snow melt (PTD-2018-21)

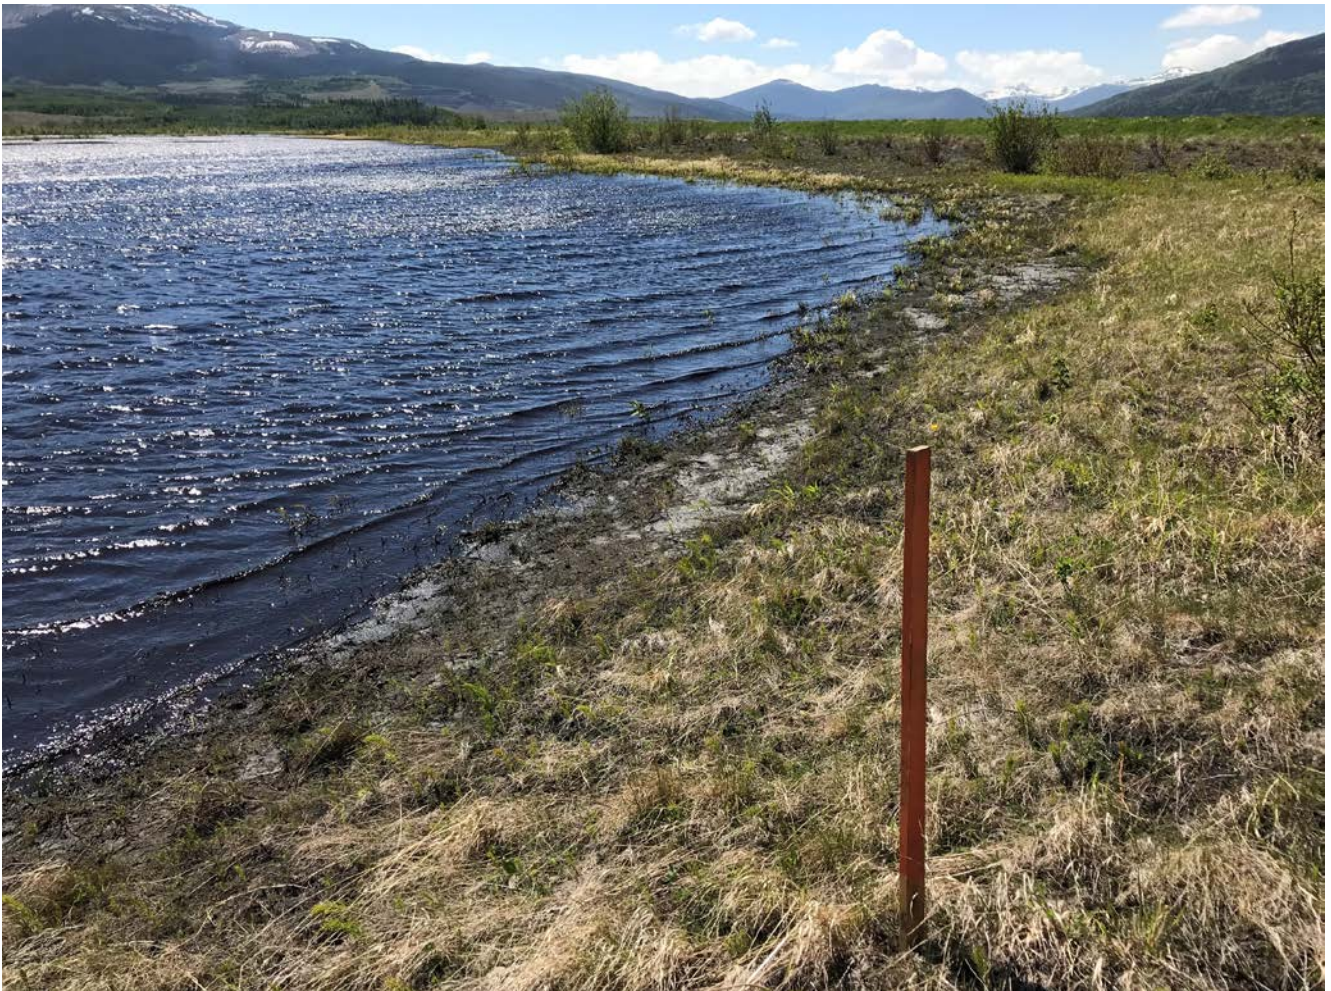
Photo I-36 Temporary stake installed at the ponded area at the northwest corner of the PTD for freeboard monitoring. A permanent staff gauge was installed in July 2018 (PTD-2018-25)

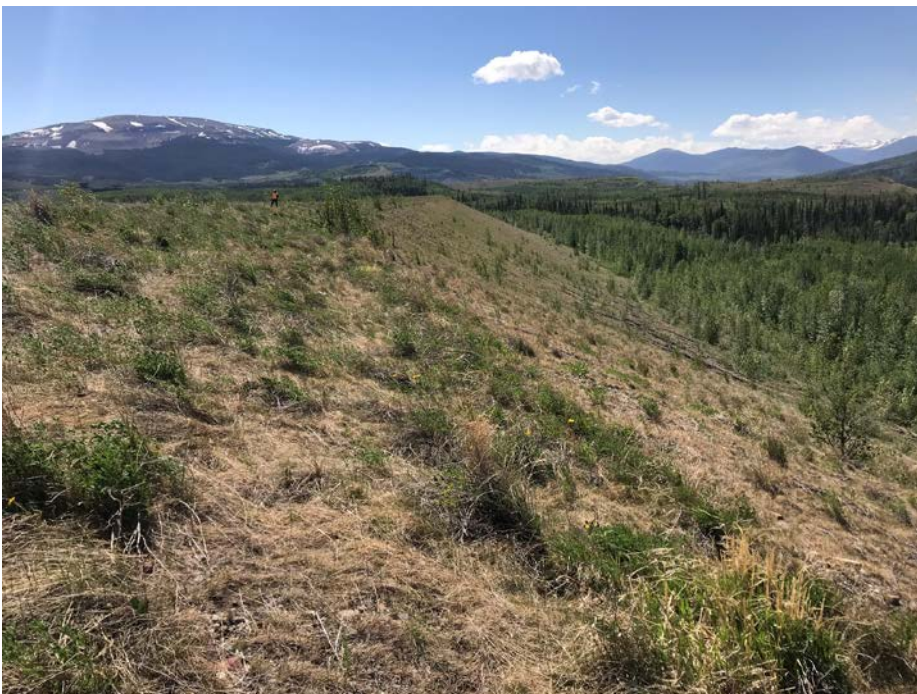
Photo I-40 **Overview of the downstream slope from the dam crest near Sta. 1+230 – looking south. No signs of distress, significant movement or erosion (PTD-2018-27)**

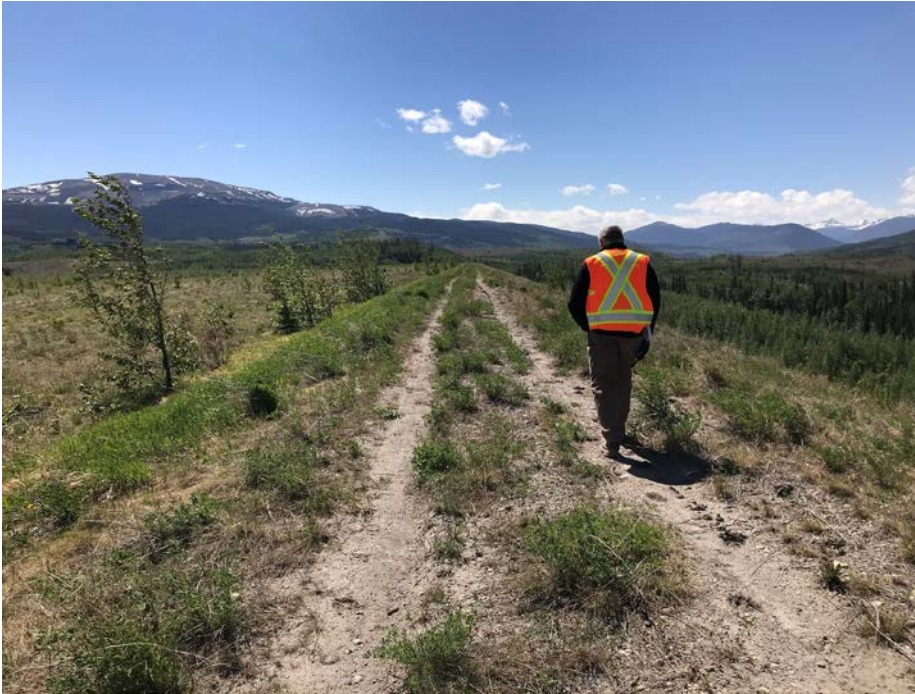
Photo I-41 **Overview of dam crest looking south. No signs of erosion or cracking observed (PTD-2018-28)**

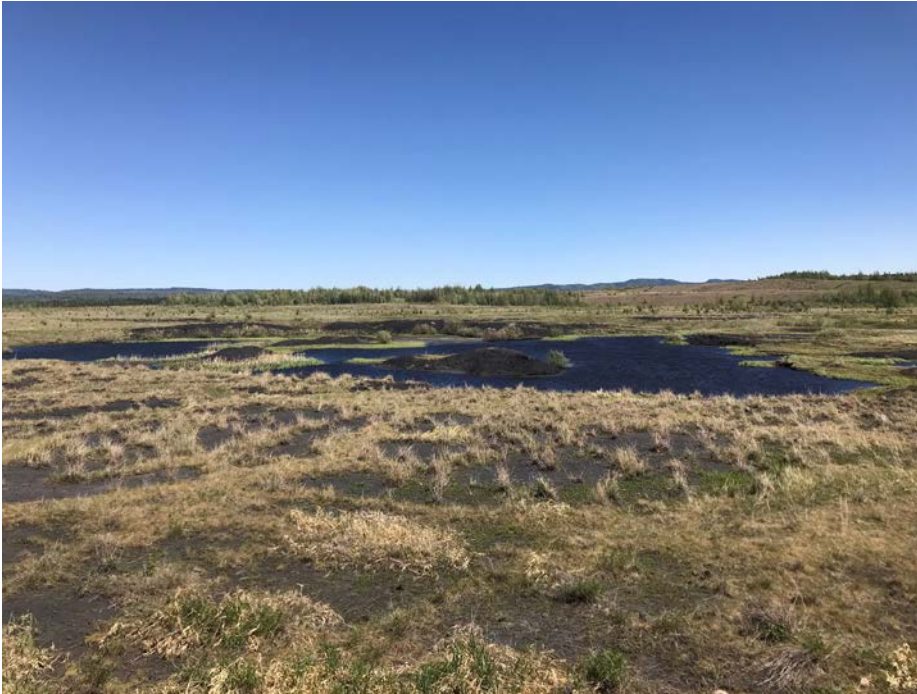
Photo I-45 Pond within depressions (Ponded Area 2) along the tailings beach near Sta. 0+440 – looking east. Pond appears to be the higher than 2017 observation (PTD-2018-32)

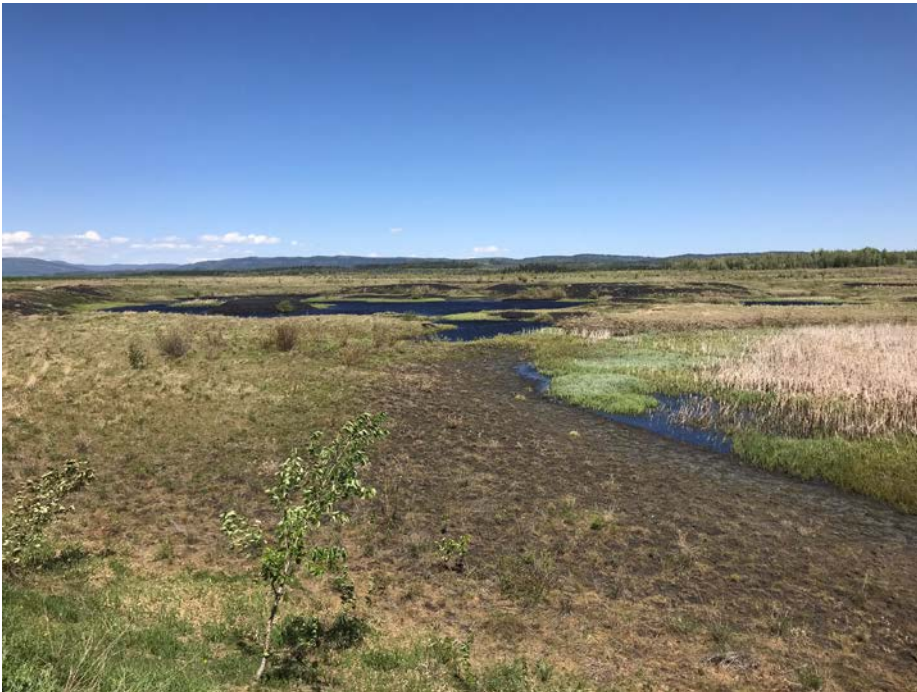
Photo I-46 Low Flow Channel inlet – looking north. Water was noted to be cresting over the depression (Ponded Area 2) into the Low Flow Channel (PTD-2018-33)

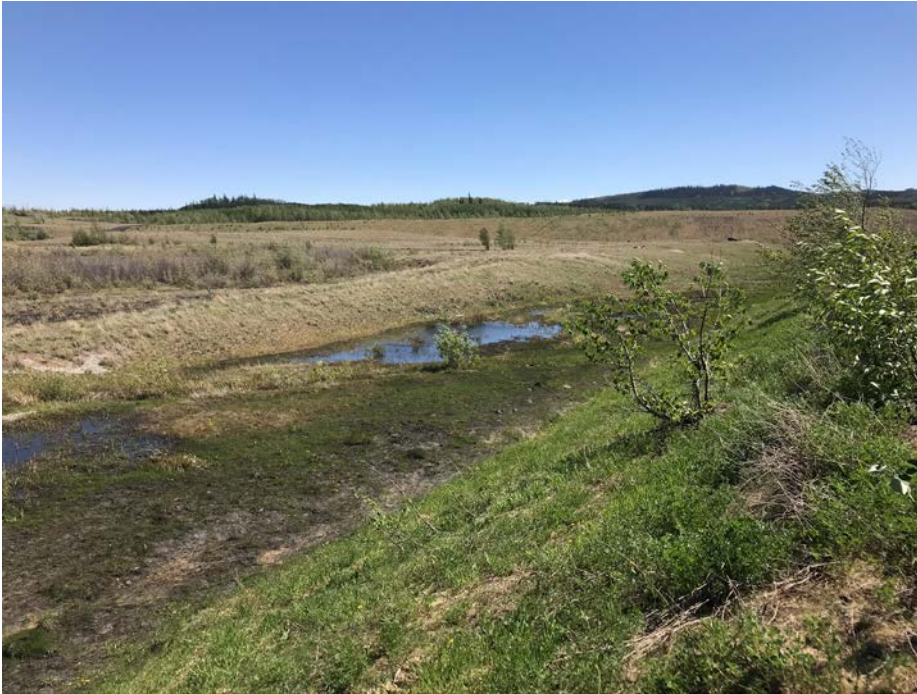
Photo I-47 From dam crest looking east at the Low Flow Channel and upstream slope – no obstruction in the channel and no signs of distress on the slope (PTD-2018-34)

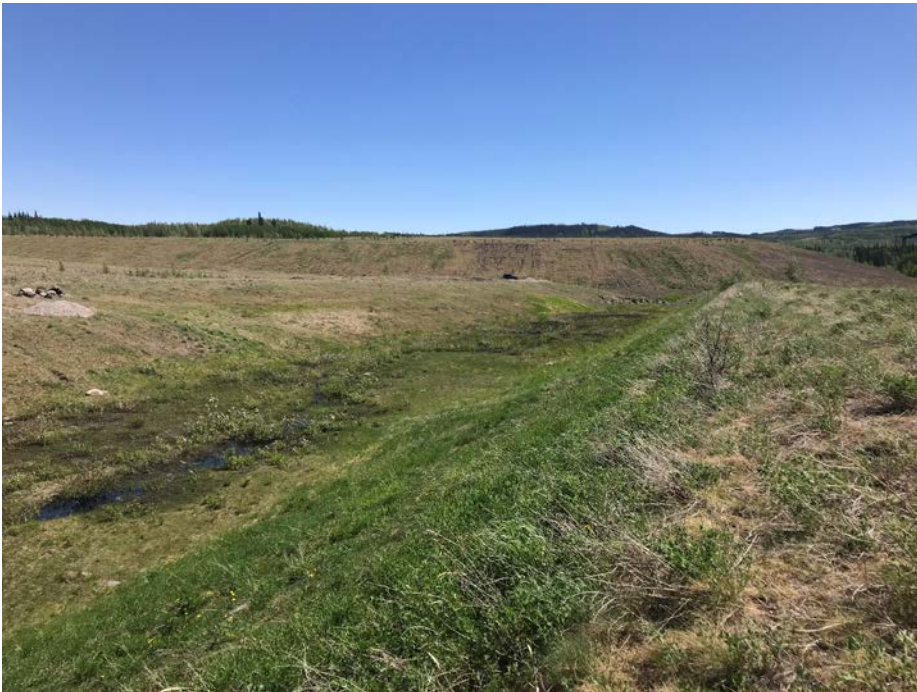
Photo I-48 Spillway channel - viewed from the embankment looking east along the channel – channel is well vegetated but no obstruction observed (PTD-2018-35)

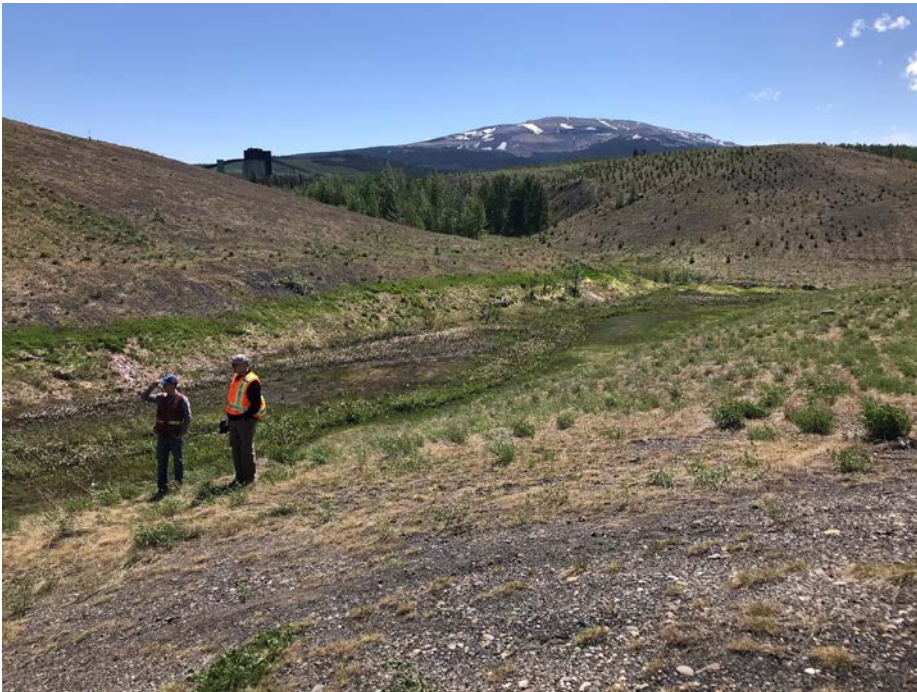
Photo I-50 **Overview of outlet channel – looking south toward discharge point into M17 Creek (PTD-2018-37)**

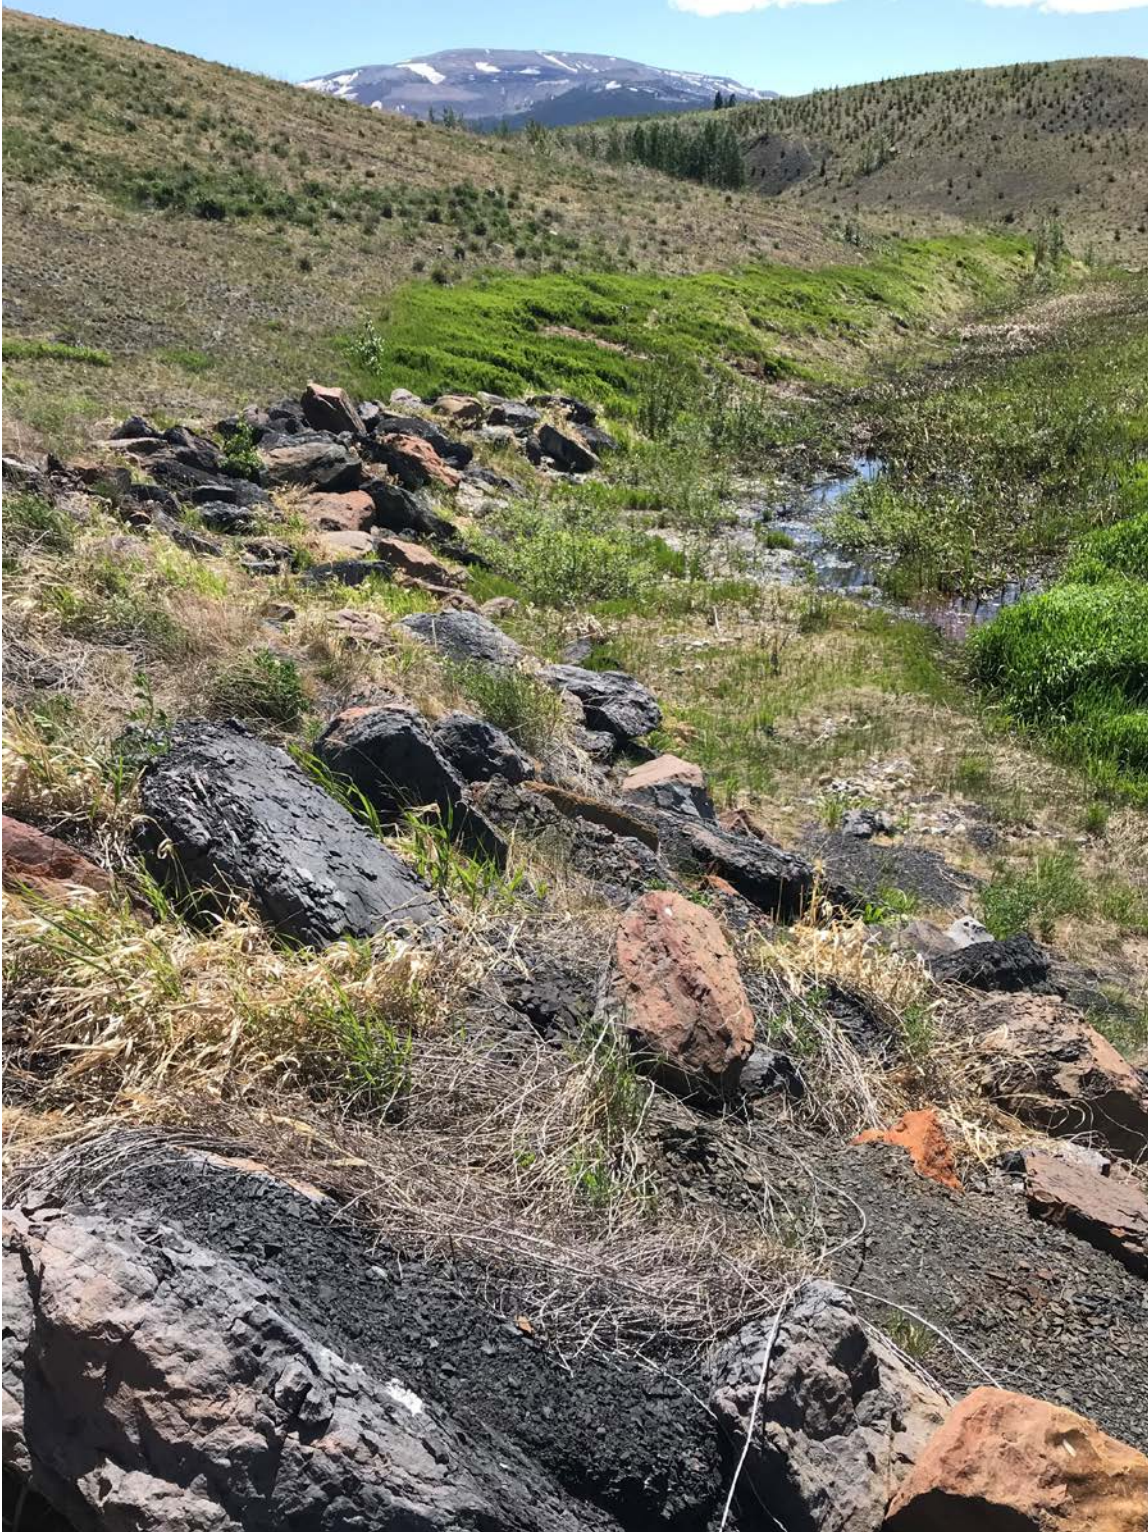
Photo I-51 Standing on the spillway channel slope looking south at deteriorating riprap and ponded area inside local depressions inside the channel (PTD-2018-38)

PTD-2018-05	Spillway channel erosion protection	OMS Manual	Add to the OMS that the spillway channel and level spreader should be inspected for erosion damage as part of event-driven inspections.	4	December, 2019

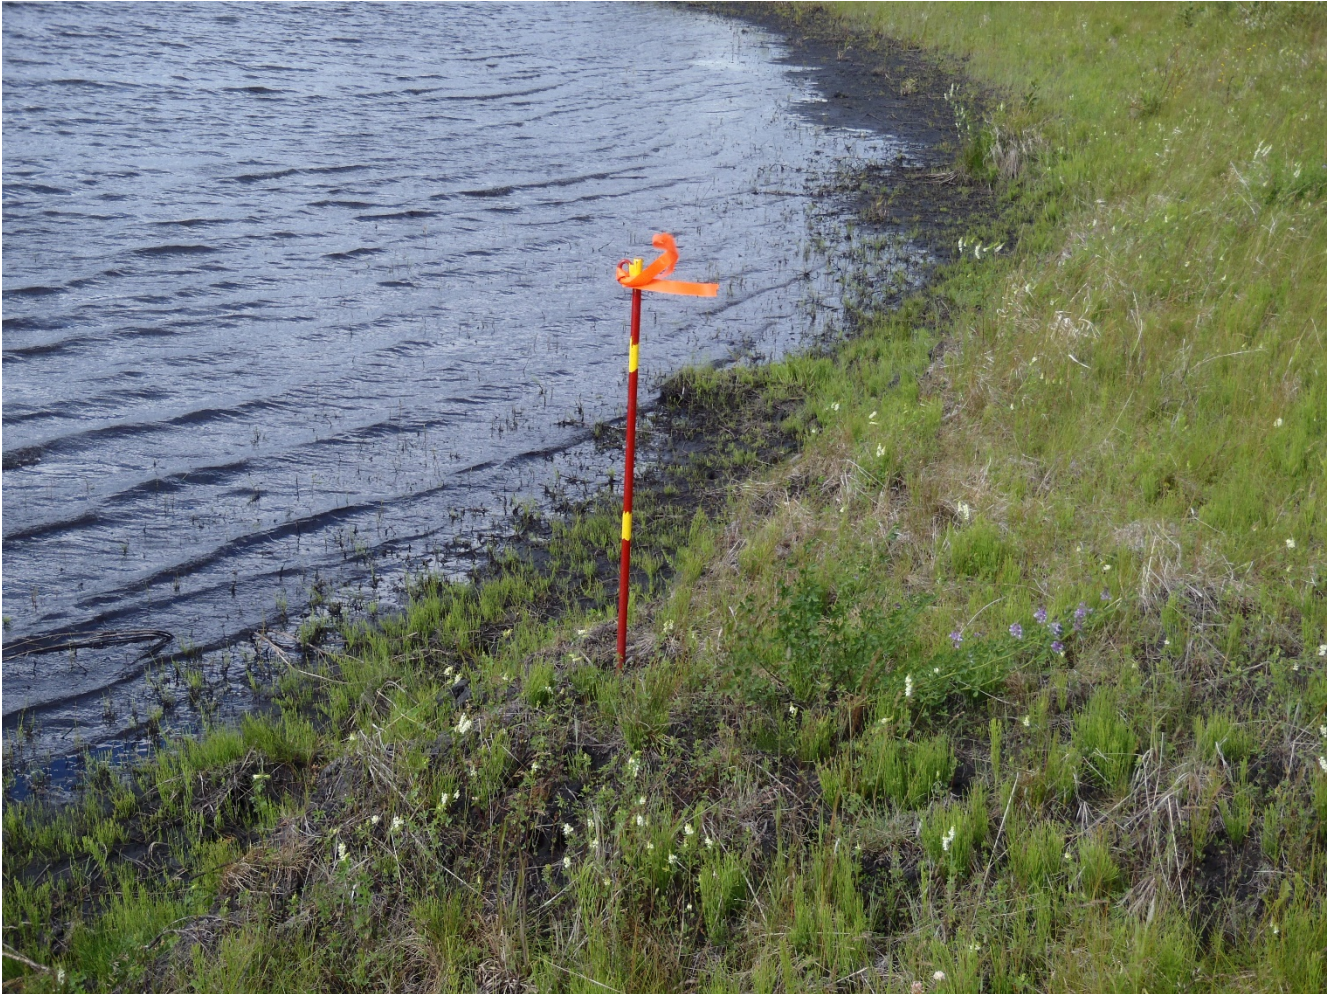
Photo I-52 **Permanent Poned Area 1 extent marker installed by Teck in July 2018 for pond level monitoring (near PTD-2018-25)**
