# **Teck Coal Limited**

## **Quintette Coal Operations**

### ***2018 Dam Safety Inspection***

### ***Shikano North Tailings Dam***

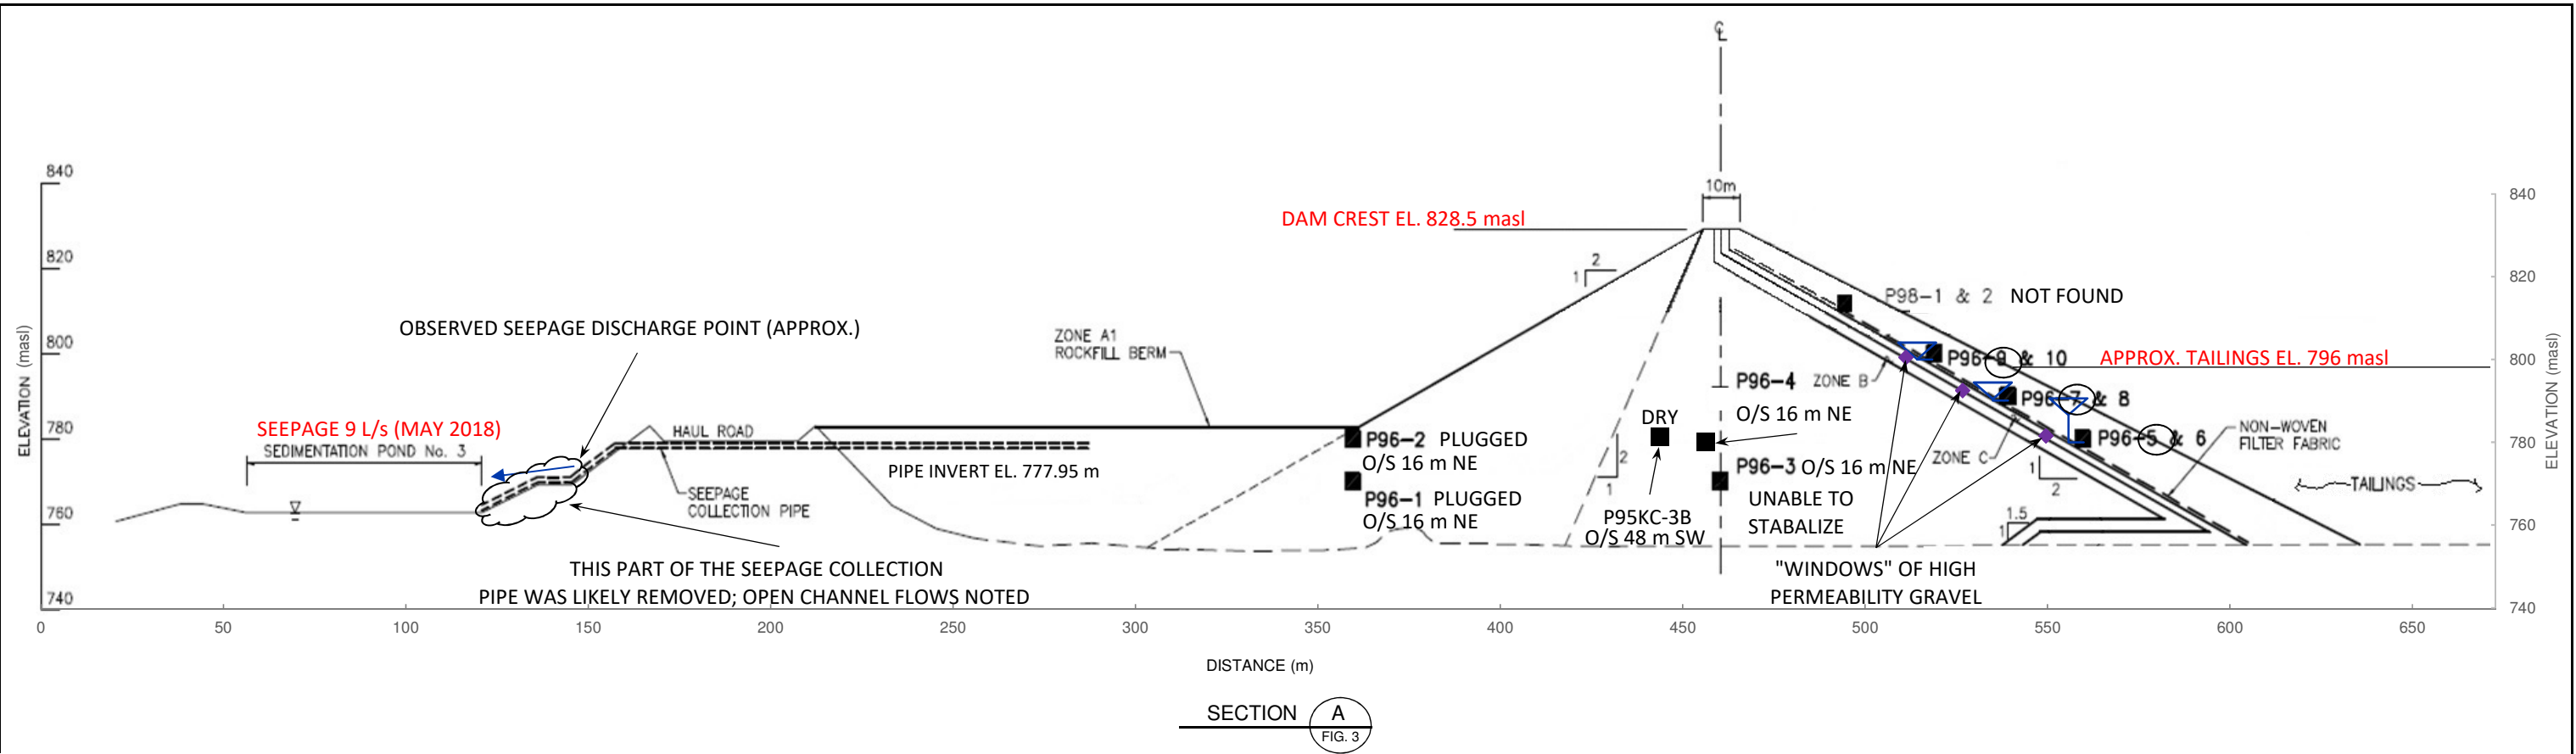
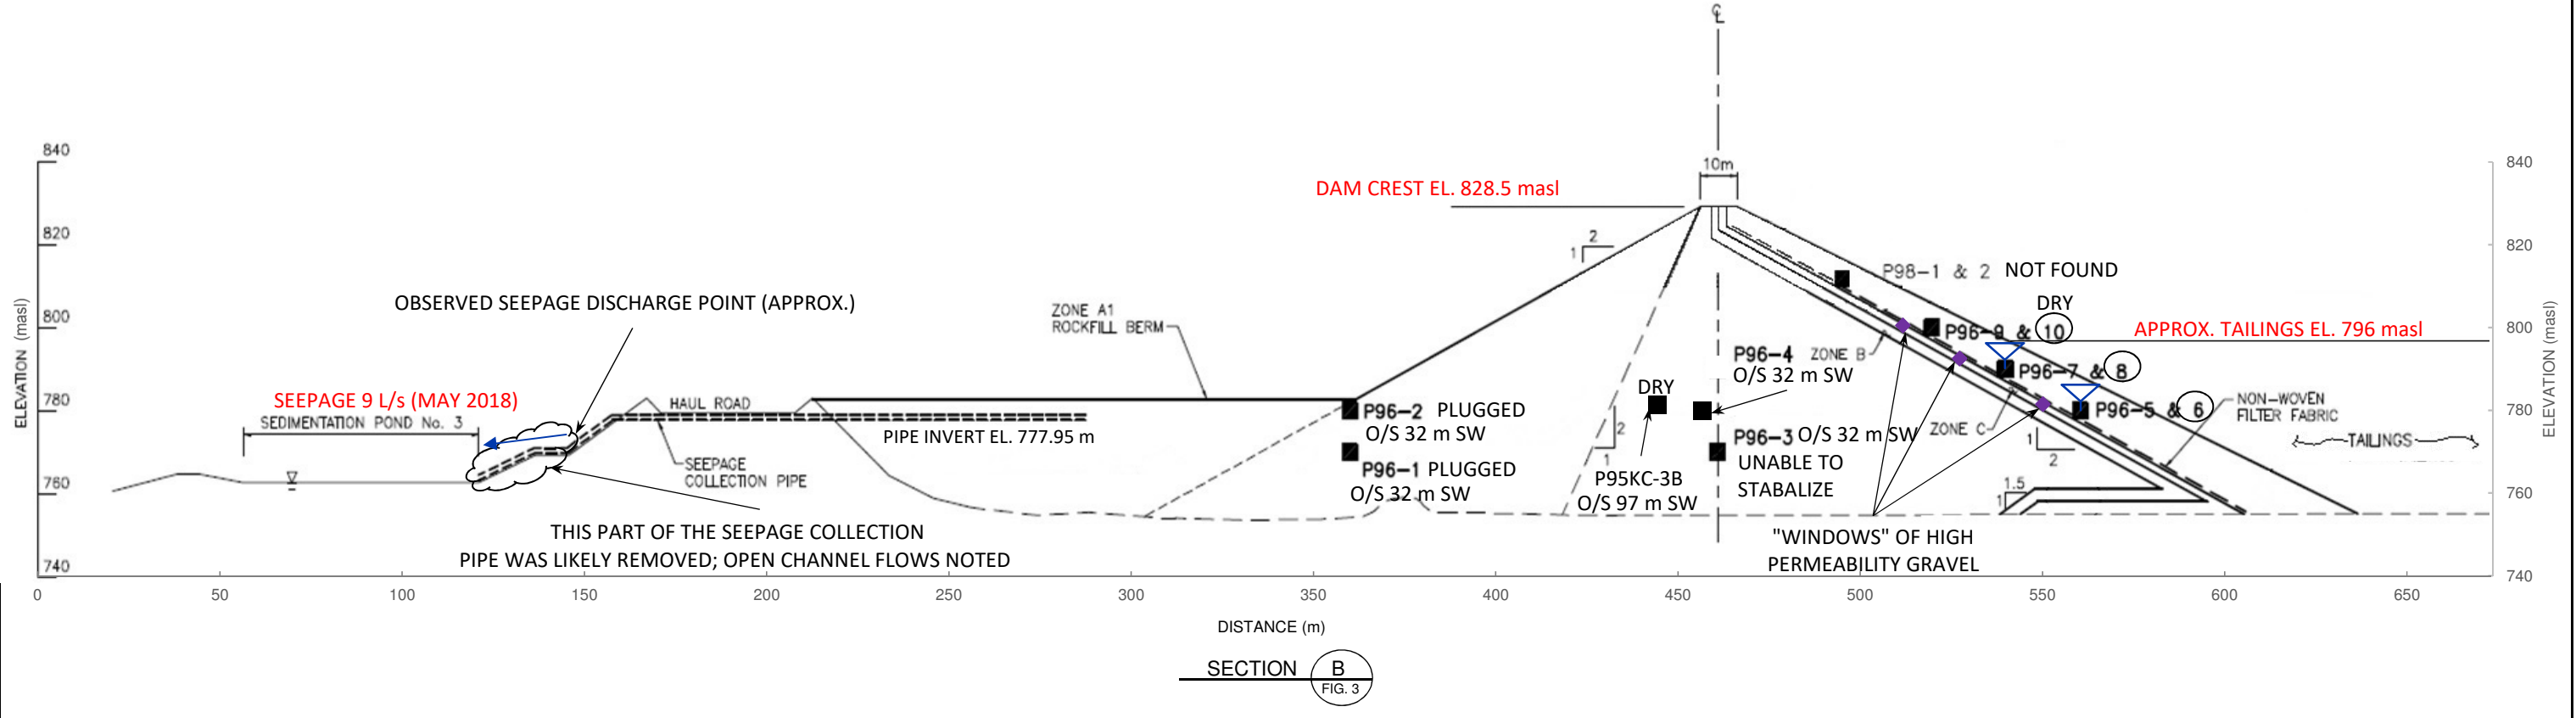
- All piezometer readings are below the established threshold levels. No significant changes in established trends were observed.
- Instruments are accessible and functioning with the exceptions of those noted in Table 4.1:

- ◆ Teck managed to find P95KC-3B after it has been reported as “not found” in previous DSI reports. The instrument location and its water levels are shown in Figures 5 and 6. P95KC-3B was dry during May 2018 inspection.

- P96-6 measured water level has been slightly lower than other upstream piezometers installed below the current tailings level, but it has been consistent since 2014. This may be due to blockage in the instrument cable, or leakage in the instrument fitting.

- The reason why the measured pressure for P96-9 is above the current pond and tailings level is not known but its readings have been consistent since 2013. There is no visible seepage from the upstream face of the dam and P96-4 historical readings indicate the water level in the dam fill is below tailings level. Instrument error or locally entrained water around the instrument tip is the most likely cause for the readings. This is not a dam safety concern and no follow up action is required.

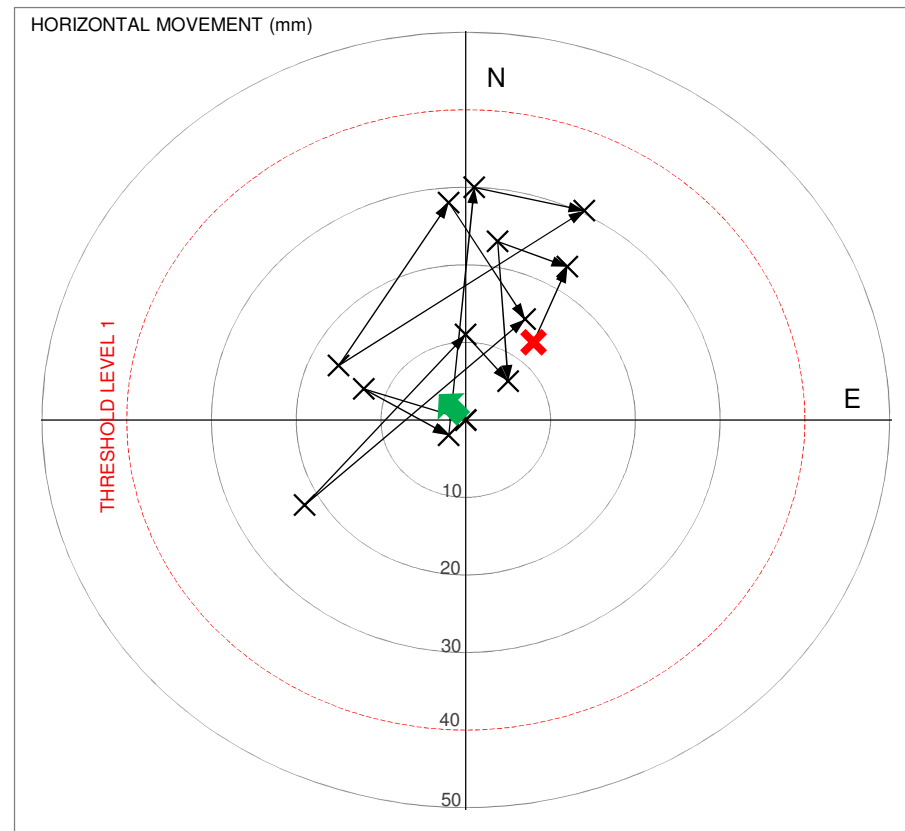
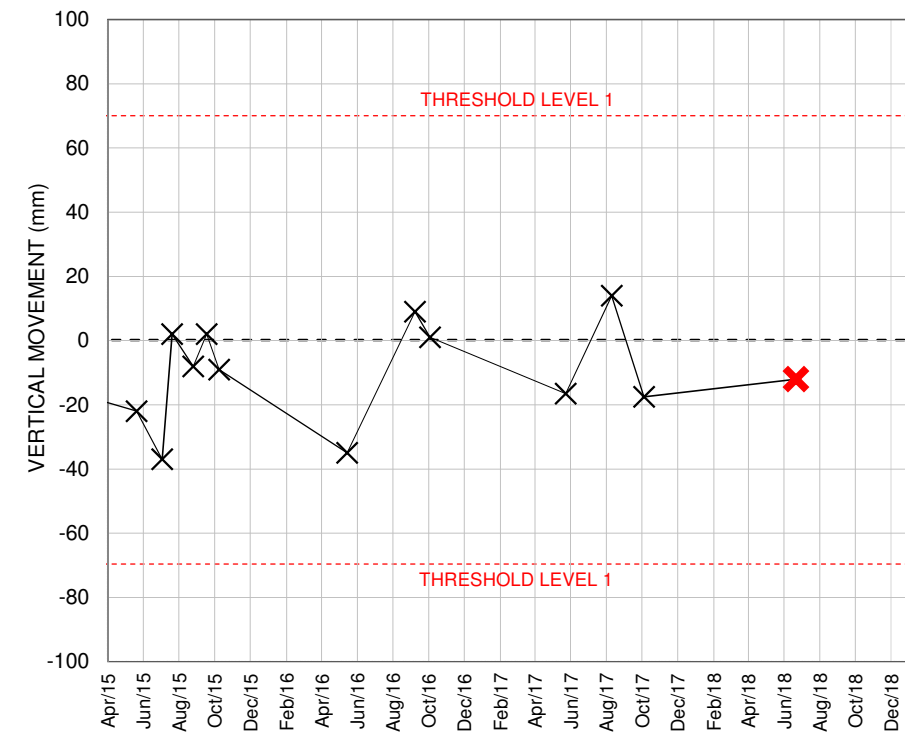
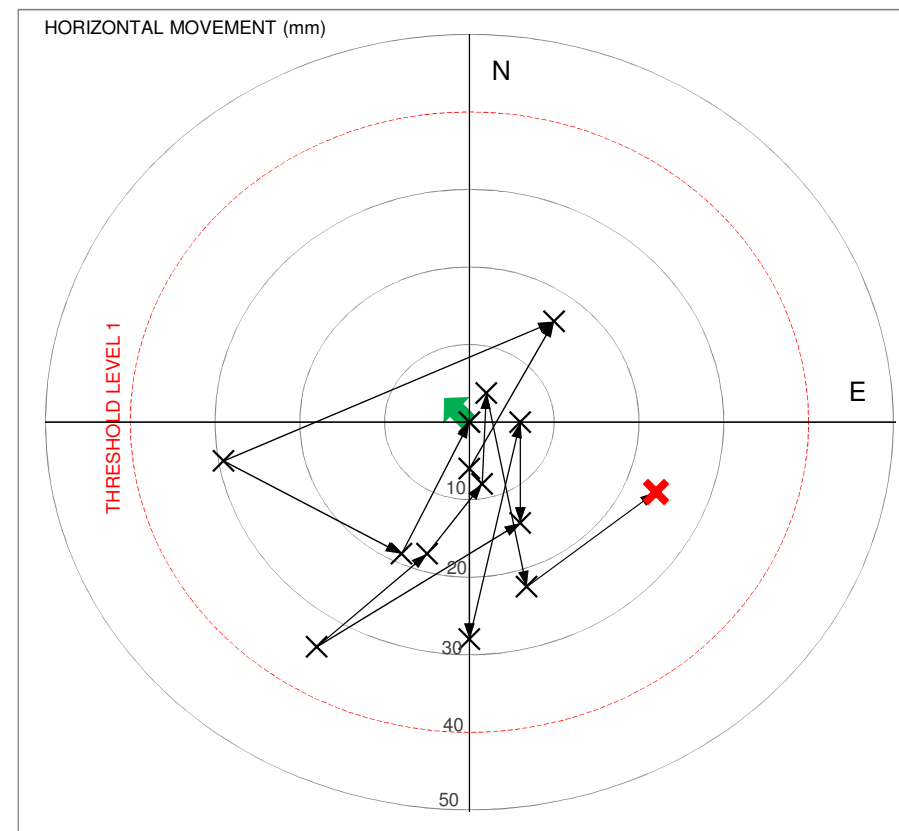
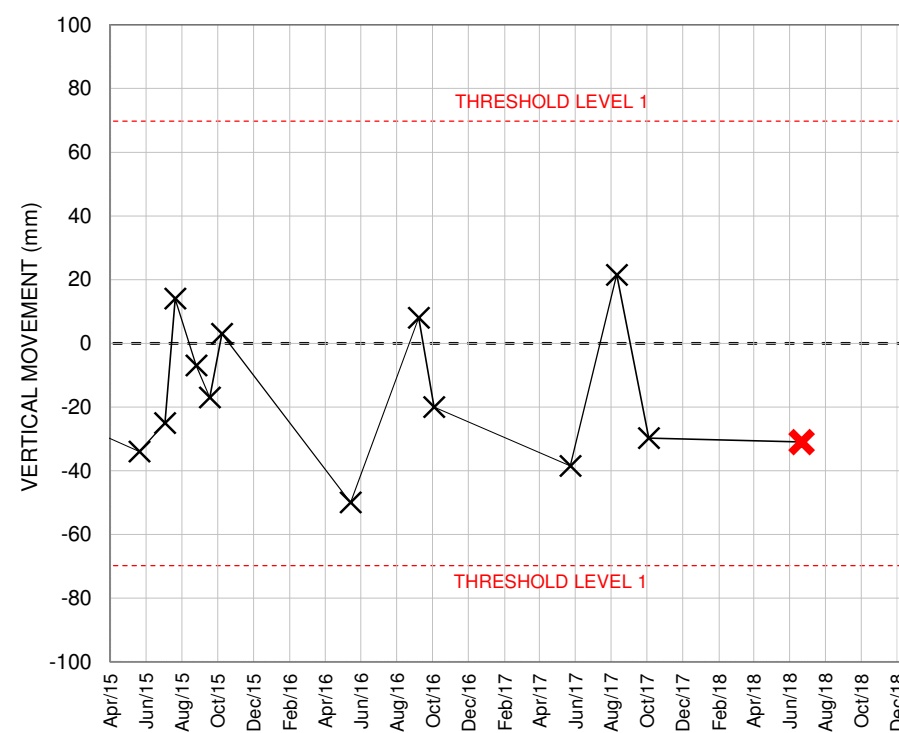
PROJECT	QUINTETTE COAL OPERATIONS 2018 DAM SAFETY INSPECTION	
TITLE	SHIKANO NORTH TAILINGS DAM 2018 SURVEY MONUMENT PLOTS CP9 AND CP10	
PROJECT No.	M09684A15	FIG. No. 8

Comparison of the October 2017 and June 2018 survey measurements is summarized in Figure 7. The observed movements are plotted on Figures 8 and 9.

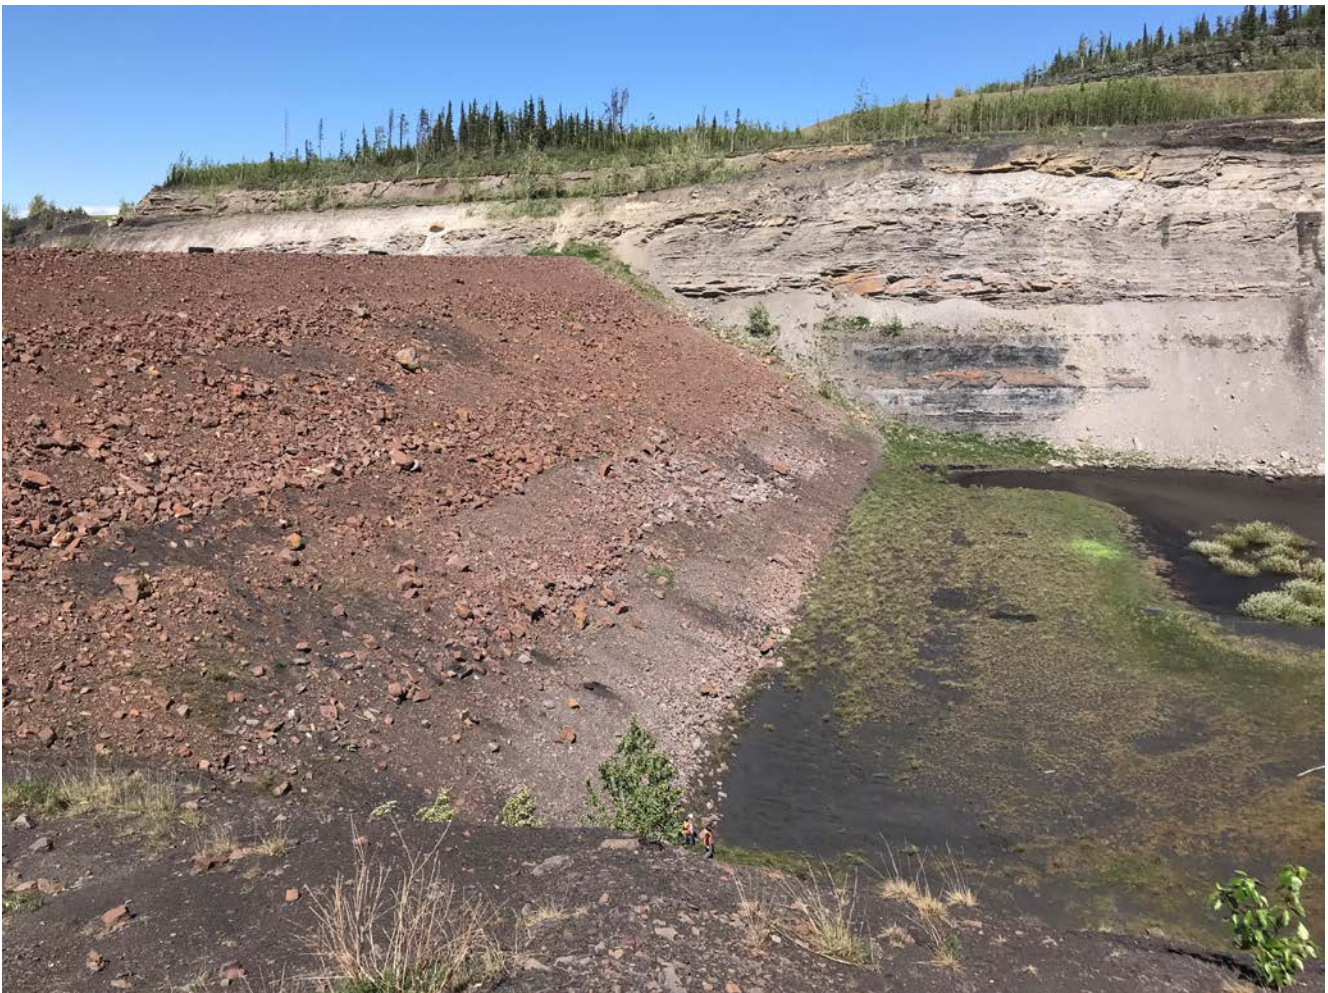
**Photo I-1 Upstream slope taken from the west abutment – looking northeast. Slope appears to be in good condition with no signs of erosion or movement (SNTD-2018-01)**

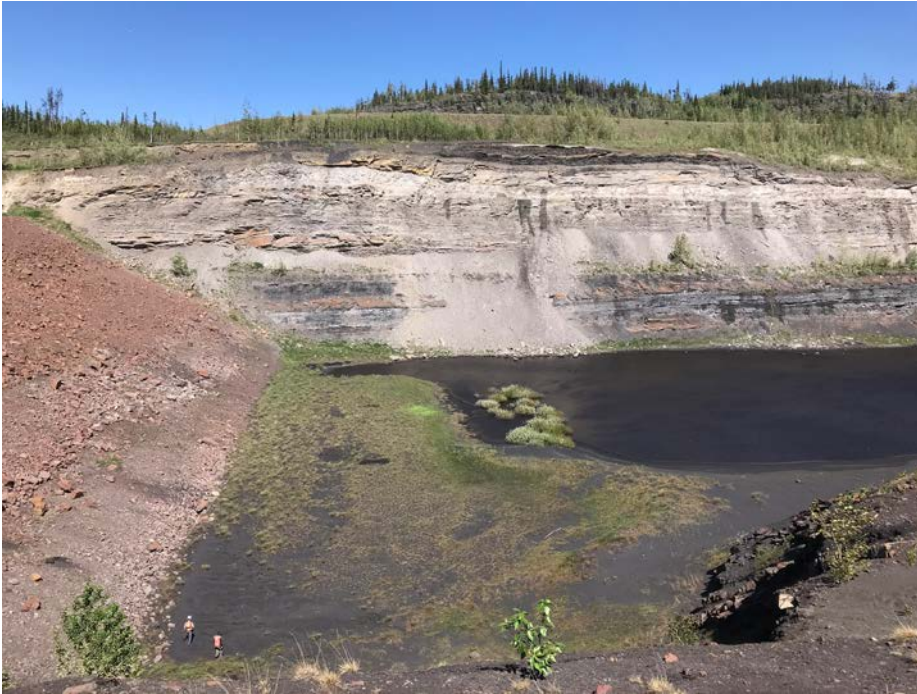
**Photo I-2 North abutment – looking northeast. Pit wall erosion appears unchanged from 2017 condition (SNTD-2018-01)**

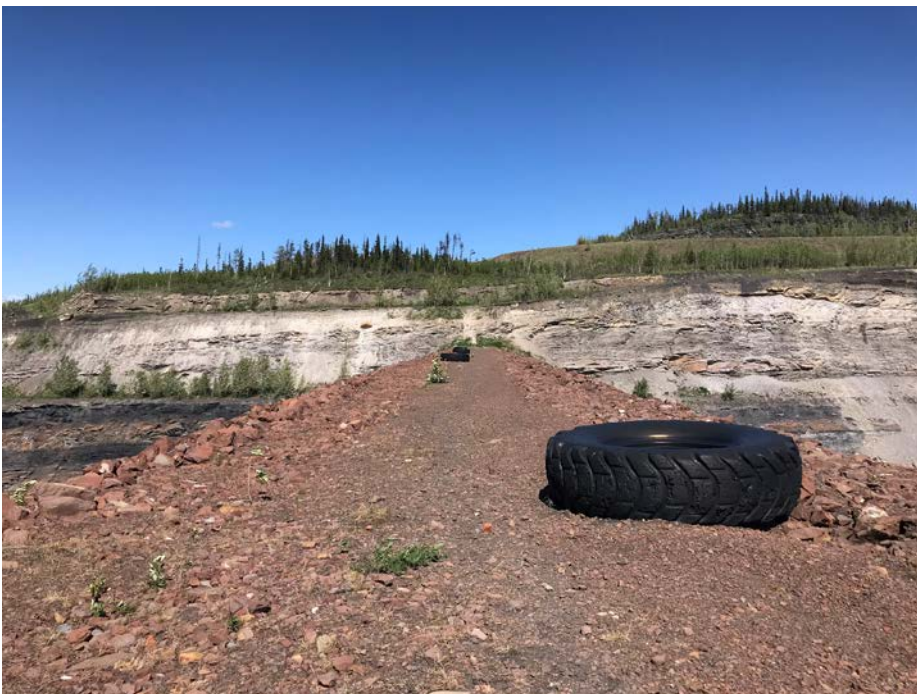
**Photo I-3 Dam crest from east abutment – looking northwest. No signs of dam safety issues (e.g., sinkholes, cracks, settlement, etc.) (SNTD-2018-02)**

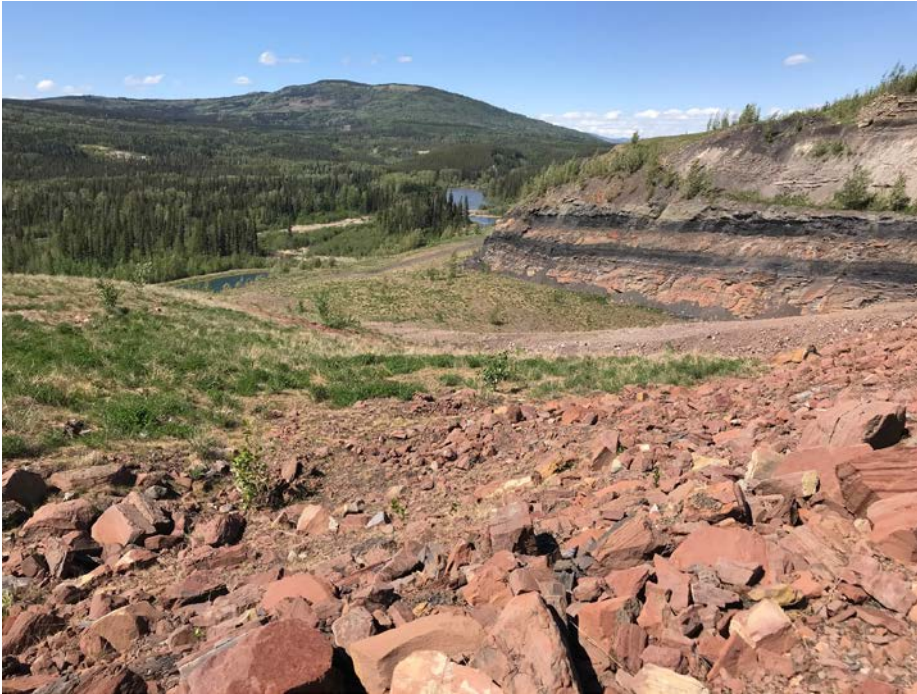
**Photo I-4** Downstream slope taken from west abutment – looking northwest. Slope appears to be in good condition (SNTD-2018-02)

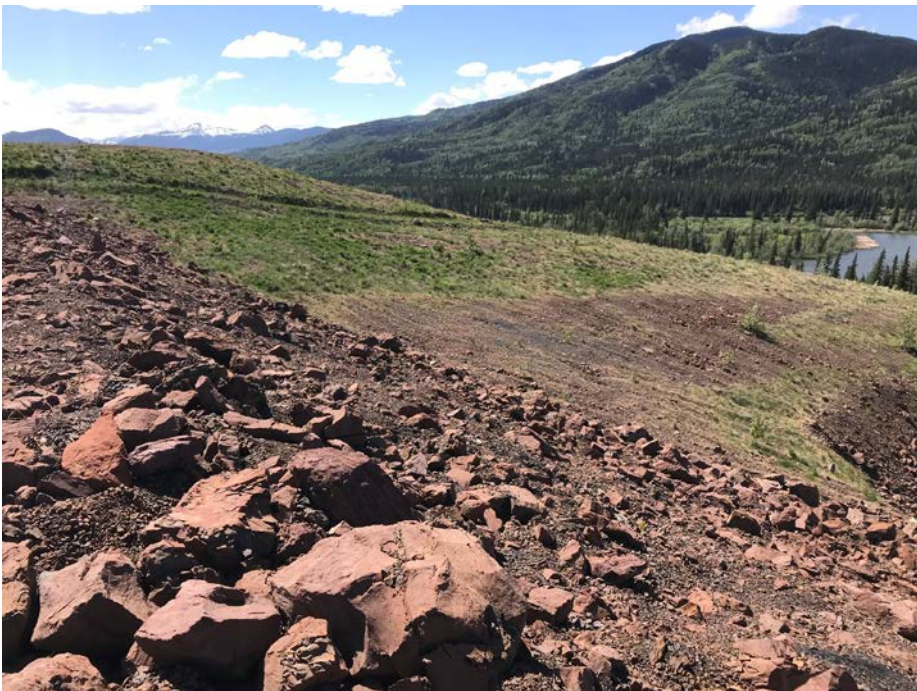
**Photo I-5** Downstream slope and west abutment contact – looking west. No signs of erosion or movement (SNTD-2018-03)

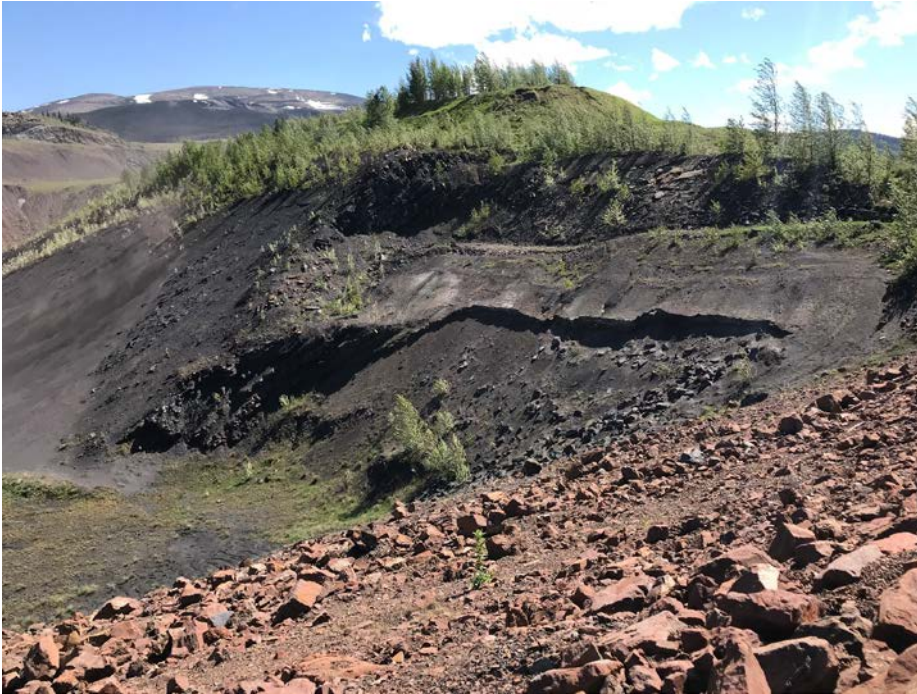
**Photo I-6 West abutment, continued ravelling of shale slope upstream of abutment. No significant changes from 2017 condition (SNTD-2018-03)**

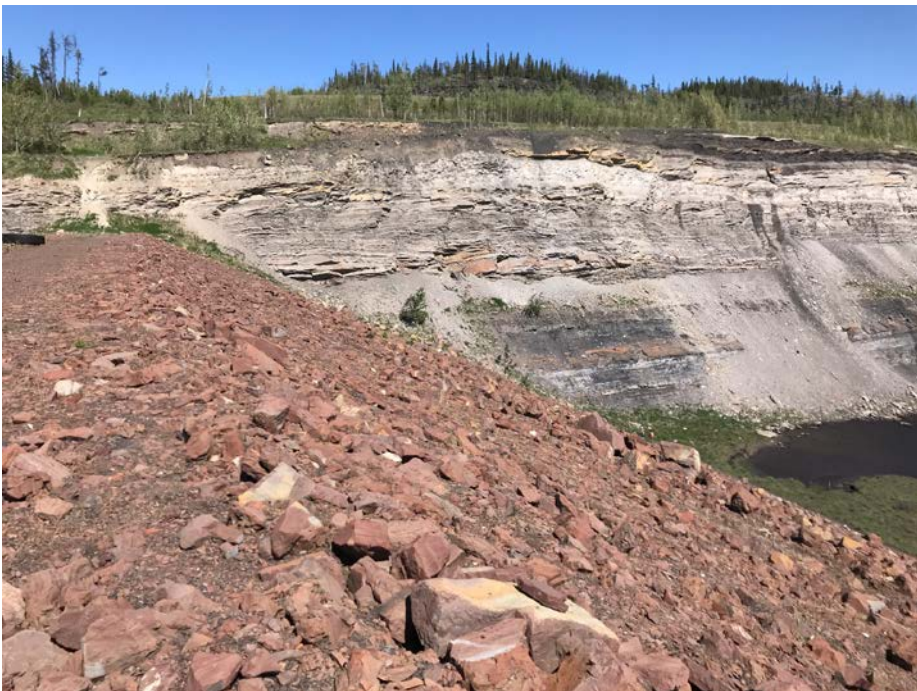
**Photo I-7 Upstream slope taken from mid-length of the crest – looking north. Slope appears to be in good condition (SNTD-2018-03)**

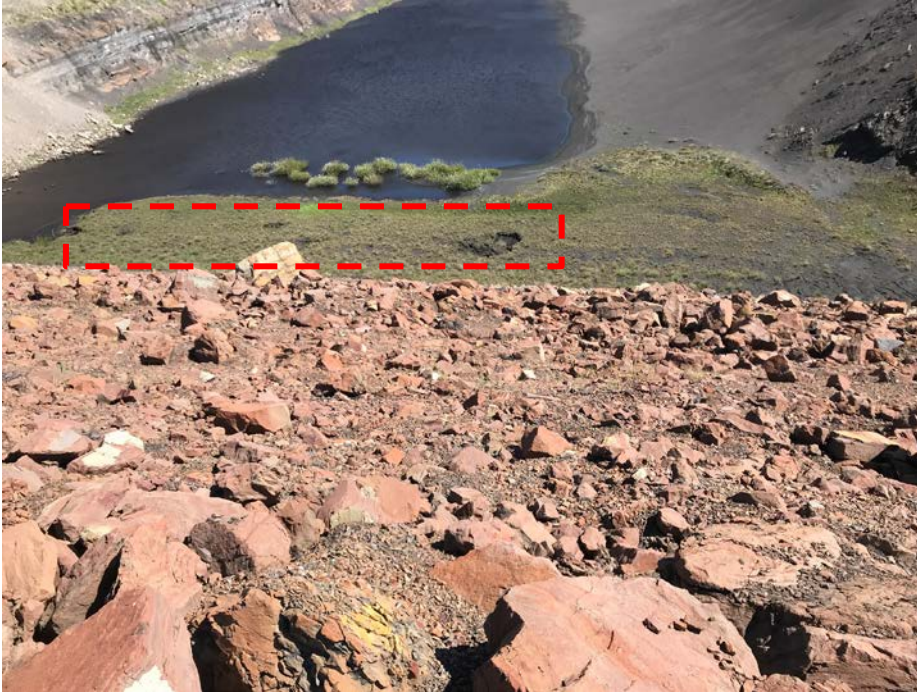
**Photo I-8** Upstream slope taken from mid-length of the crest – slope appears to be in good condition. General area where sinkholes are observed is shown in red box (SNTD-2018-03)

In 2017, KCB recommended a sinkhole monitoring program be established and conducted in conjunction with the routine visual inspections at the SNTD. The sinkholes should be shown on a drawing for future reference. The monitoring program should include the installation of stakes or wooden posts along the outside of the sinkholes to determine if there is growth and the rate of the growth (KCB to provide further guidance). Alternatively, an aerial survey or LiDAR may be utilized to capture the development of the sinkholes.

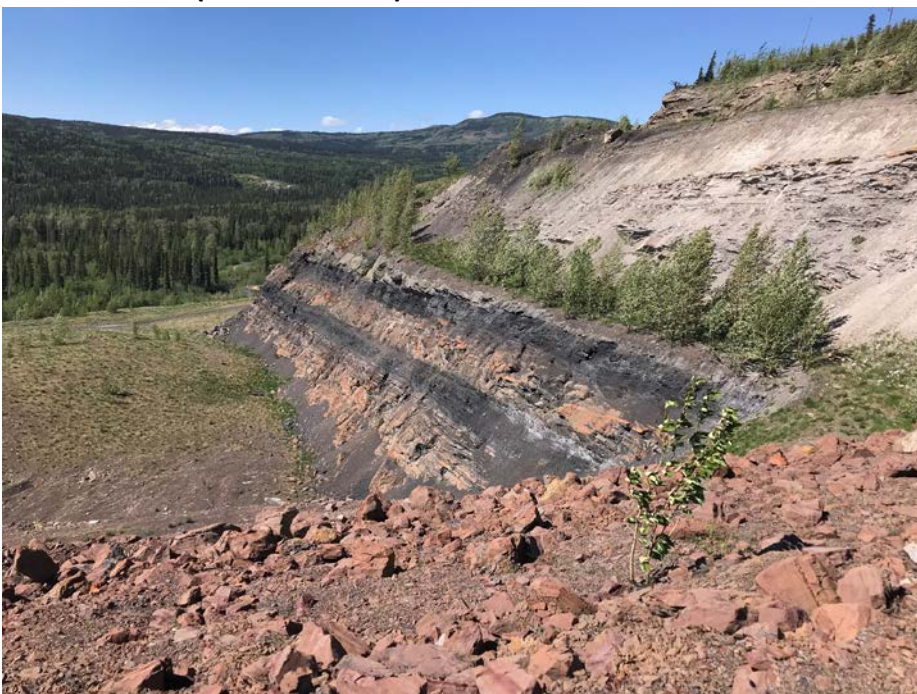
**Photo I-9** Downstream slope taken from the east abutment – looking northwest. Slope appears to be in good condition with no signs of erosion or movement (SNTD-2018-04)

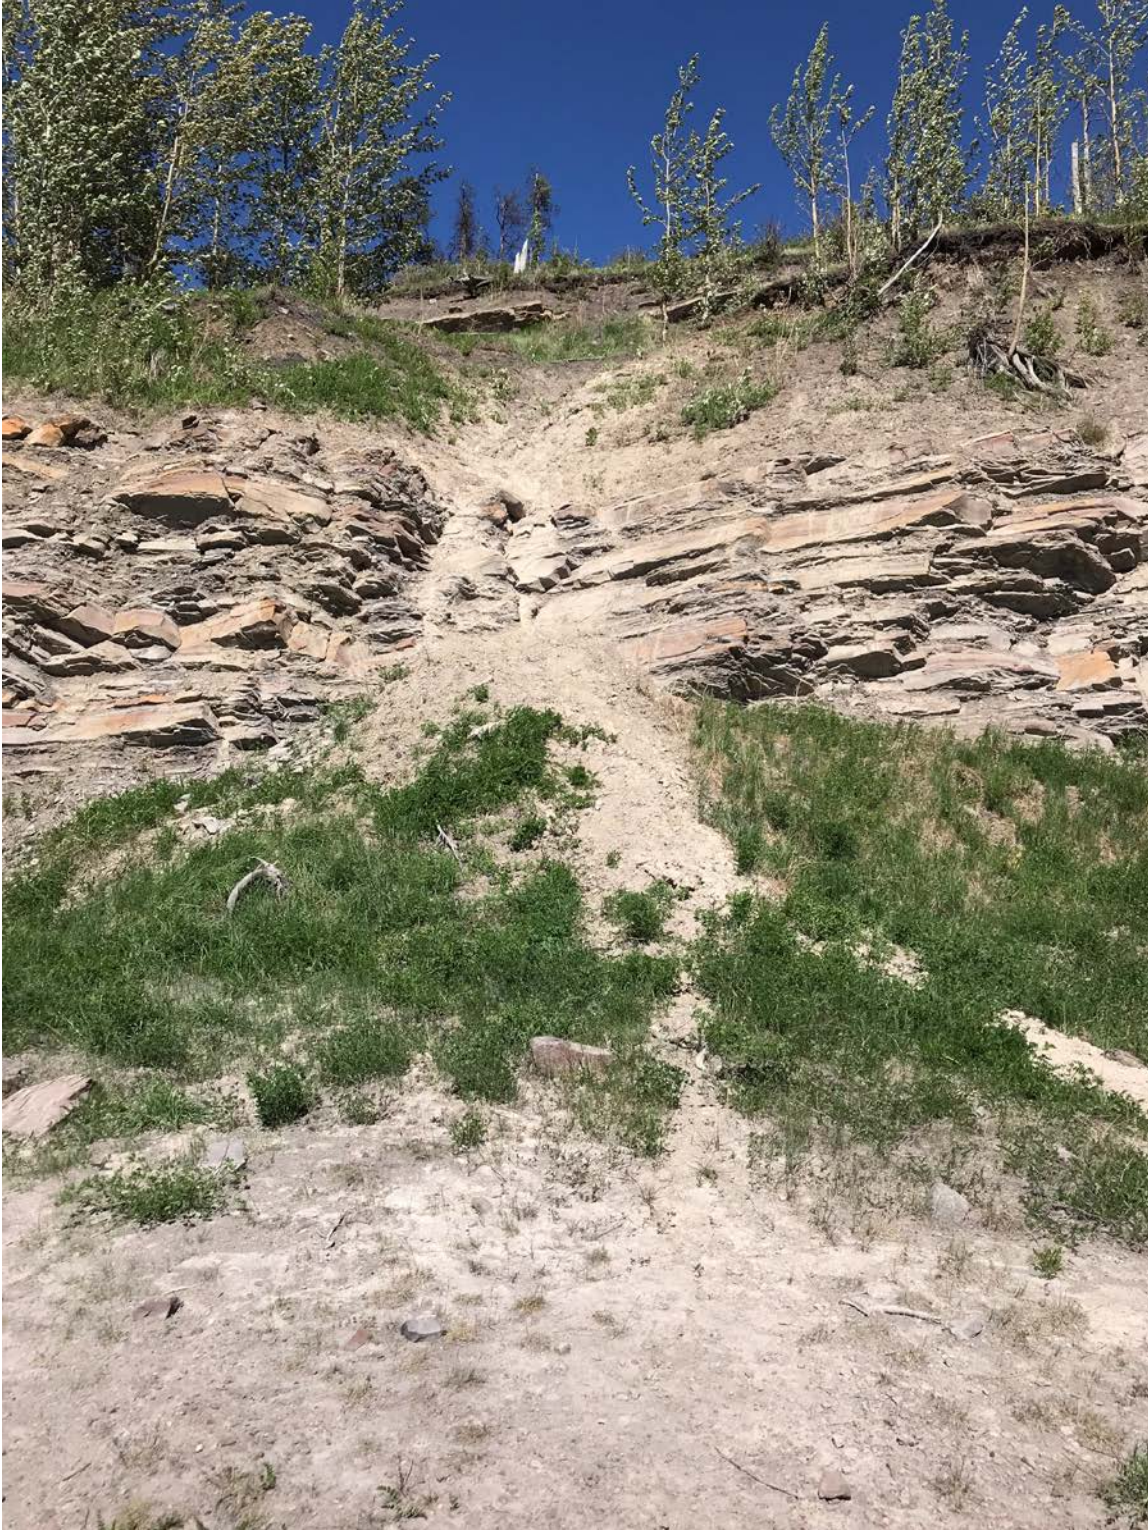
**Photo I-10 East abutment – minor ravelling of material from slope above onto the crest – appears to be in similar condition as previous year’s (SNTD-2018-05)**

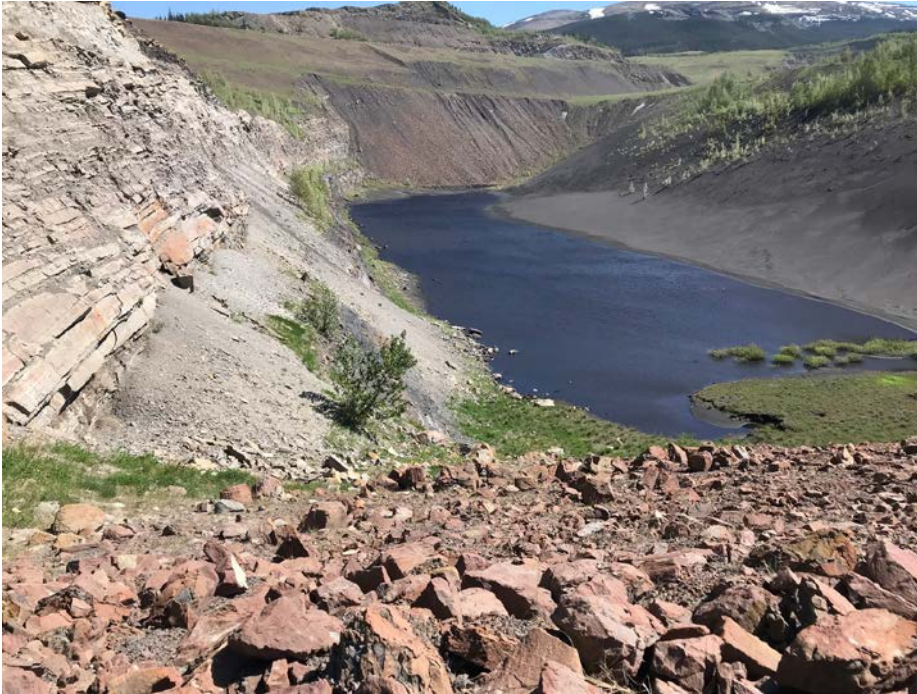
**Photo I-11 Upstream slope and impoundment overview from east abutment – looking southeast; no signs of erosion or movement (SNTD-2018-05)**

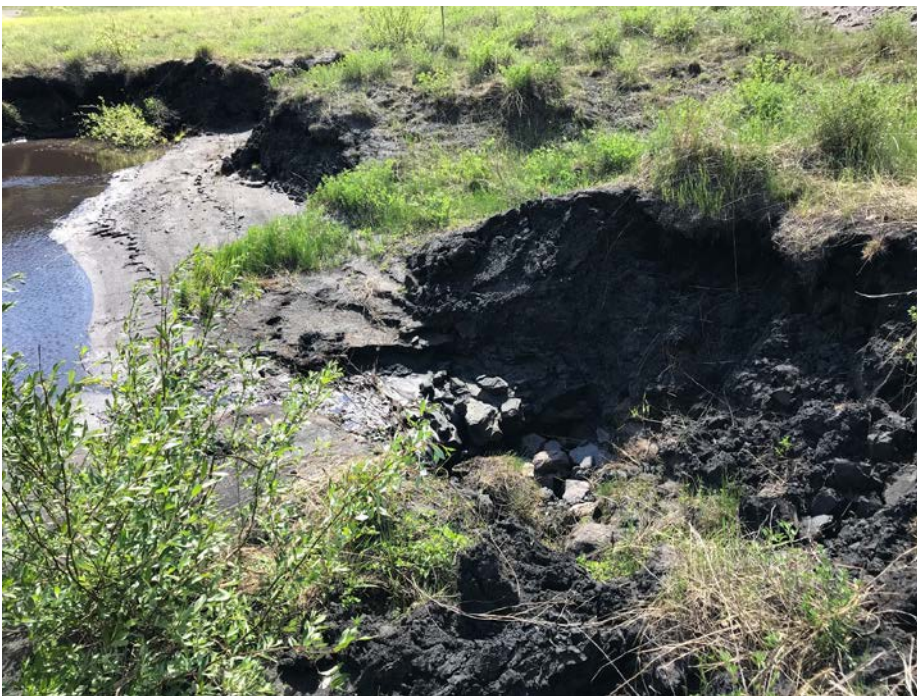
**Internal Erosion and Piping:** Several sinkholes have been observed on the tailings beach since the 2010 DSI inspection but may have been present or started to develop prior to this date. Overall, an increase in size was observed for all sinkholes during the 2018 inspection when compared to 2017 observations. However, this is not a dam safety concern. The sinkholes are most likely a local condition where tailings are migrating into the upstream coarse rockfill shell or into “windows” of high permeability fill, but not through the internal filters into the downstream shell. The “windows” of high permeability fill on the upstream slope were introduced during construction to encourage seepage flow through the dam as per the overall design concept because the material available for the fine filter zone of the embankment had a permeability lower than expected. If piping of tailings into the downstream shell were to occur, the probability of triggering a dam failure is very low.

**Photo I-12 Sinkhole 11 – first observed in 2018. Approximately 5.0 m x 3.0 m x 1.0 m deep. Flow of water into the underlying rockfill was observed – not a dam safety concern (SNTD-SINKHOLE-11)**

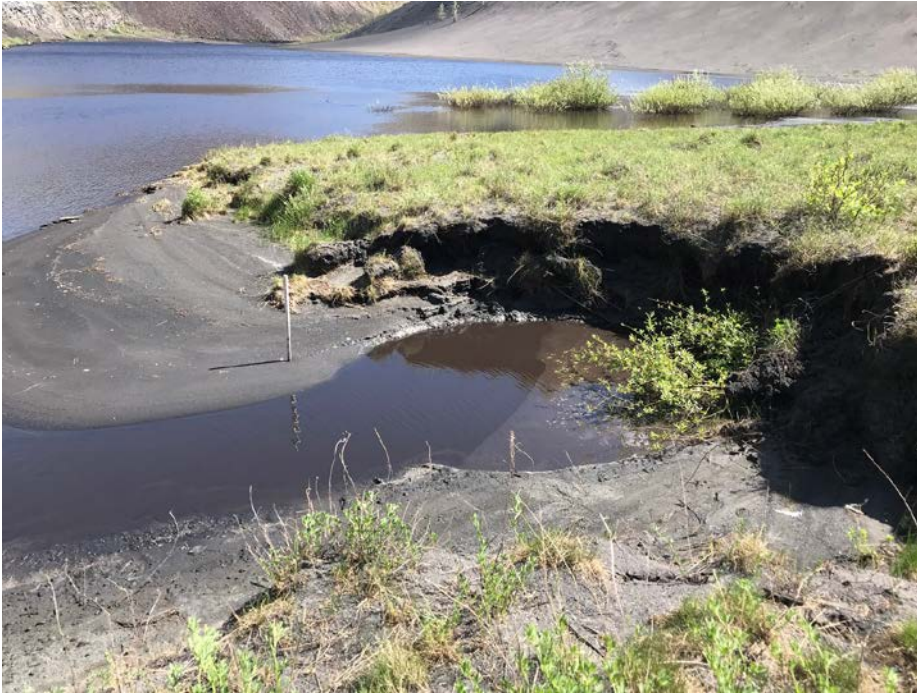
**Photo I-13 Drainage channel inside the impoundment (SNTD-2018-06)**

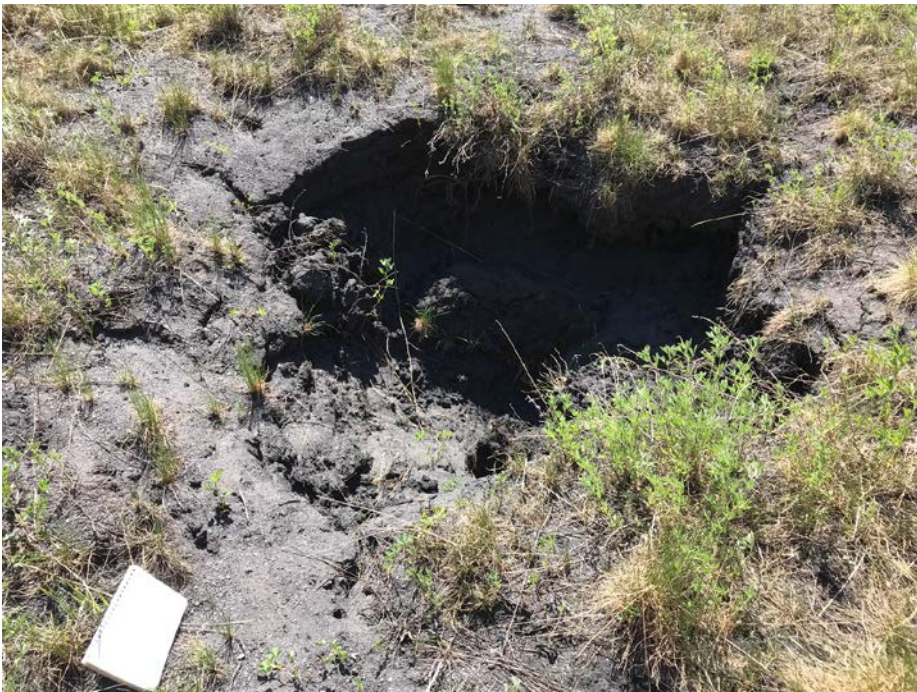
**Photo I-14 Sinkhole 1 – first observed in 2016. Approximately 1.9 m x 1.7 m x 1.0 m deep (SNTD-SINKHOLE-01)**

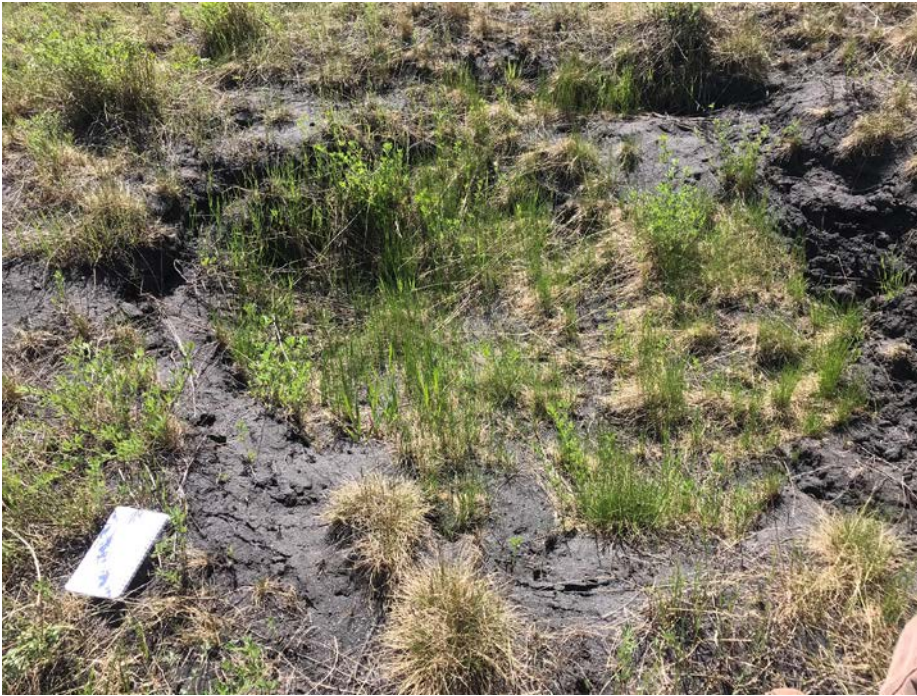
**Photo I-15 Sinkhole 2 – approximately 3.2 m x 3.0 m x 0.6 m deep (SNTD-SINKHOLE-02)**

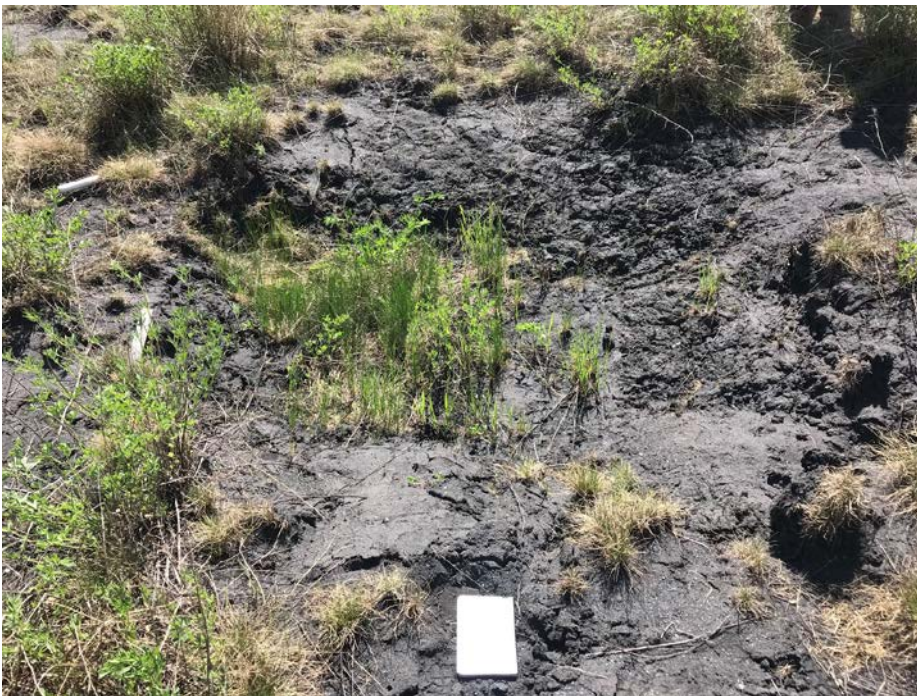
**Photo I-16 Sinkhole 3 – approximately 3.0 m x 2.5 m x 0.6 m deep (SNTD-SINKHOLE-03)**

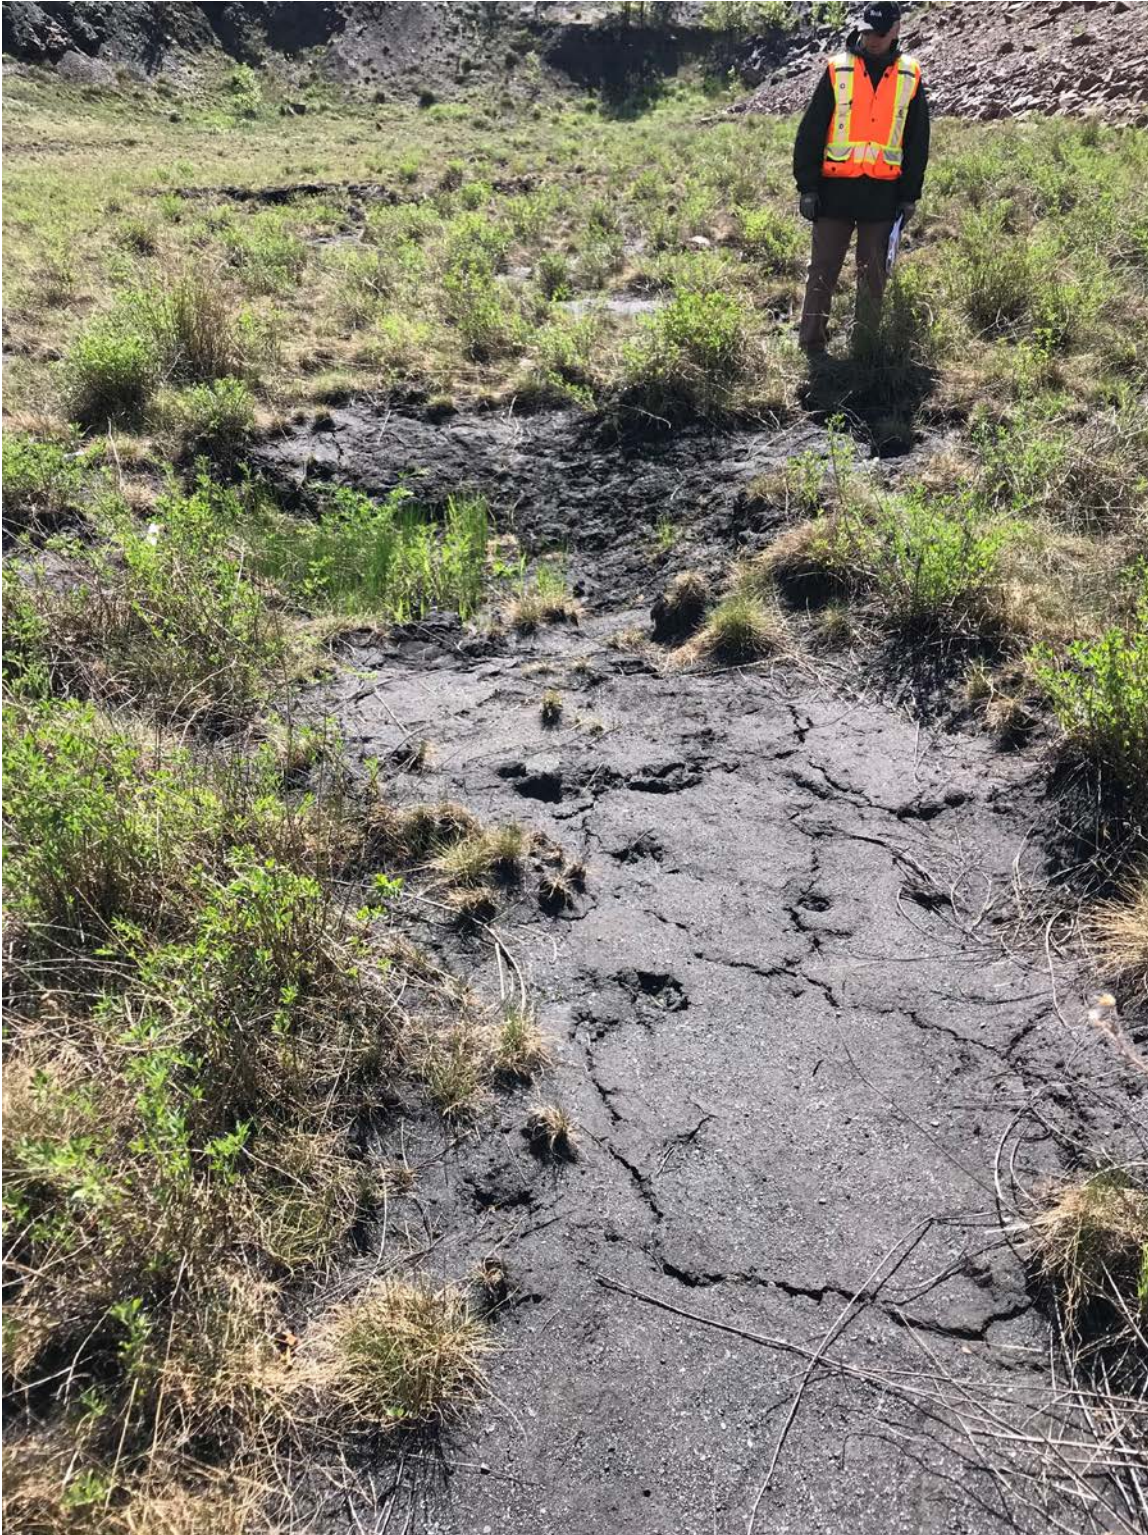
**Photo I-17 Sinkhole 3 – settled tailings surface immediately adjacent to Sinkhole 3, indicating Sinkhole 3 may be increasing in size (SNTD-SINKHOLE-03)**

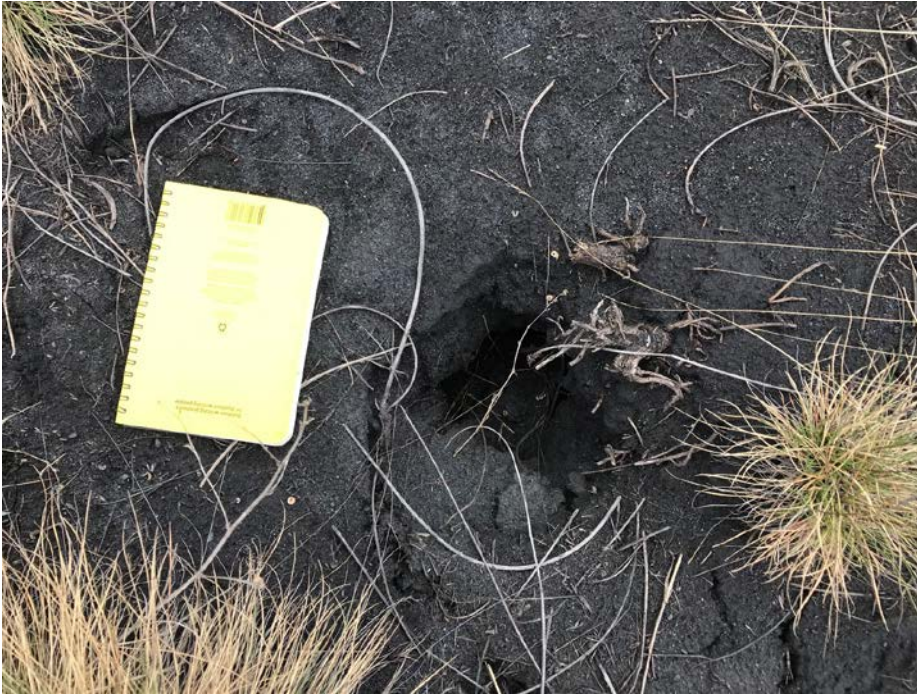
**Photo I-18 Sinkhole 4 – first observed in 2017. Approximately 0.2 m x 0.1 m x 0.3 m deep (SNTD-SINKHOLE-04)**

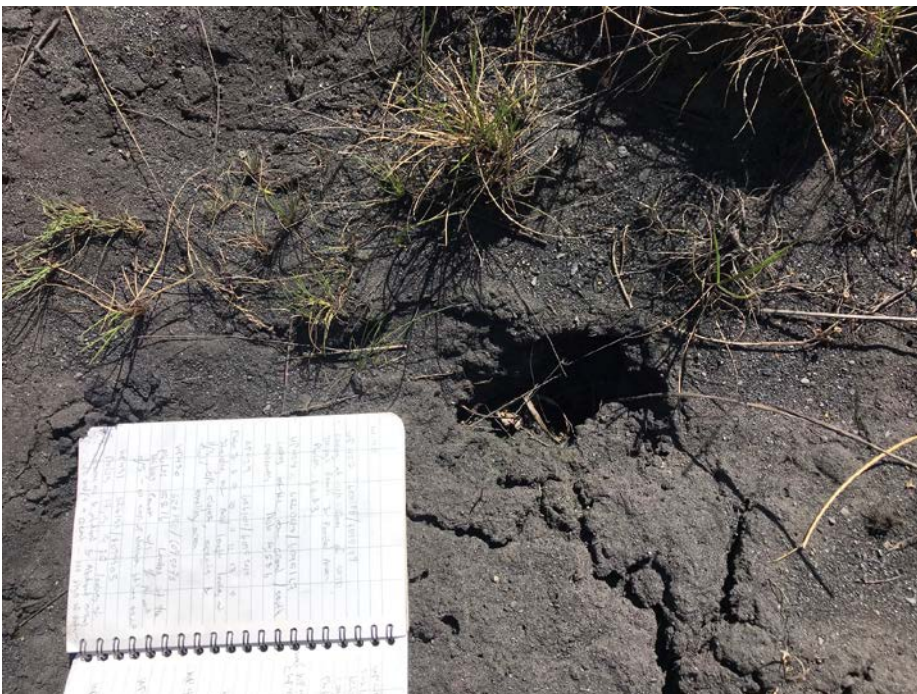
**Photo I-19 Sinkhole 5 – first observed in 2017. Approximately 0.2 m x 0.1 m x 0.2 m deep (SNTD-SINKHOLE-05)**
