# **Teck Coal Limited**

## **Quintette Coal Operations**

### ***2018 Dam Safety Inspection***

### ***Shikano North Tailings Dam***

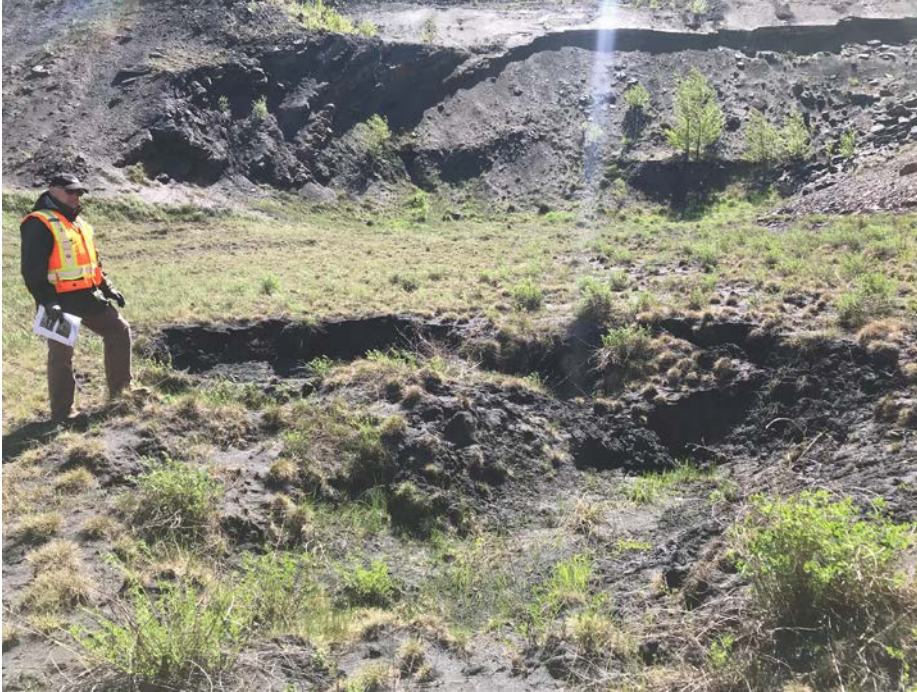
**Photo I-20 Sinkhole 6 used to be a cluster of three sinkholes up to 2017. In 2018, all three sinkholes have developed into one large sinkhole approximately 9.4 m x 7.4 m x 0.5 m deep (SNTD-SINKHOLE-06)**

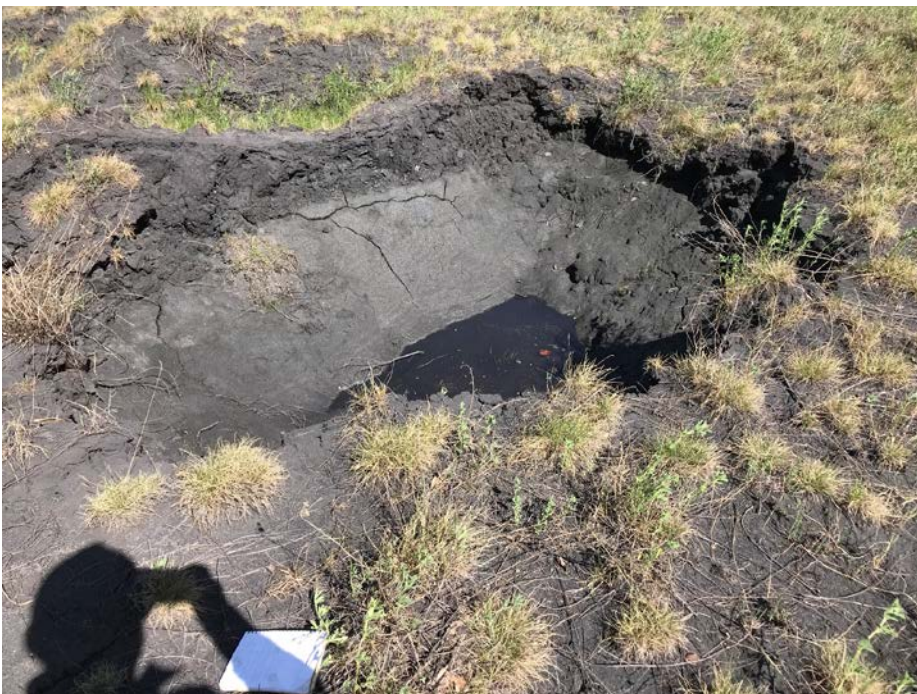
**Photo I-21 Sinkhole 6 – water noted at the bottom of one of the sinkholes (SNTD-SINKHOLE-06)**

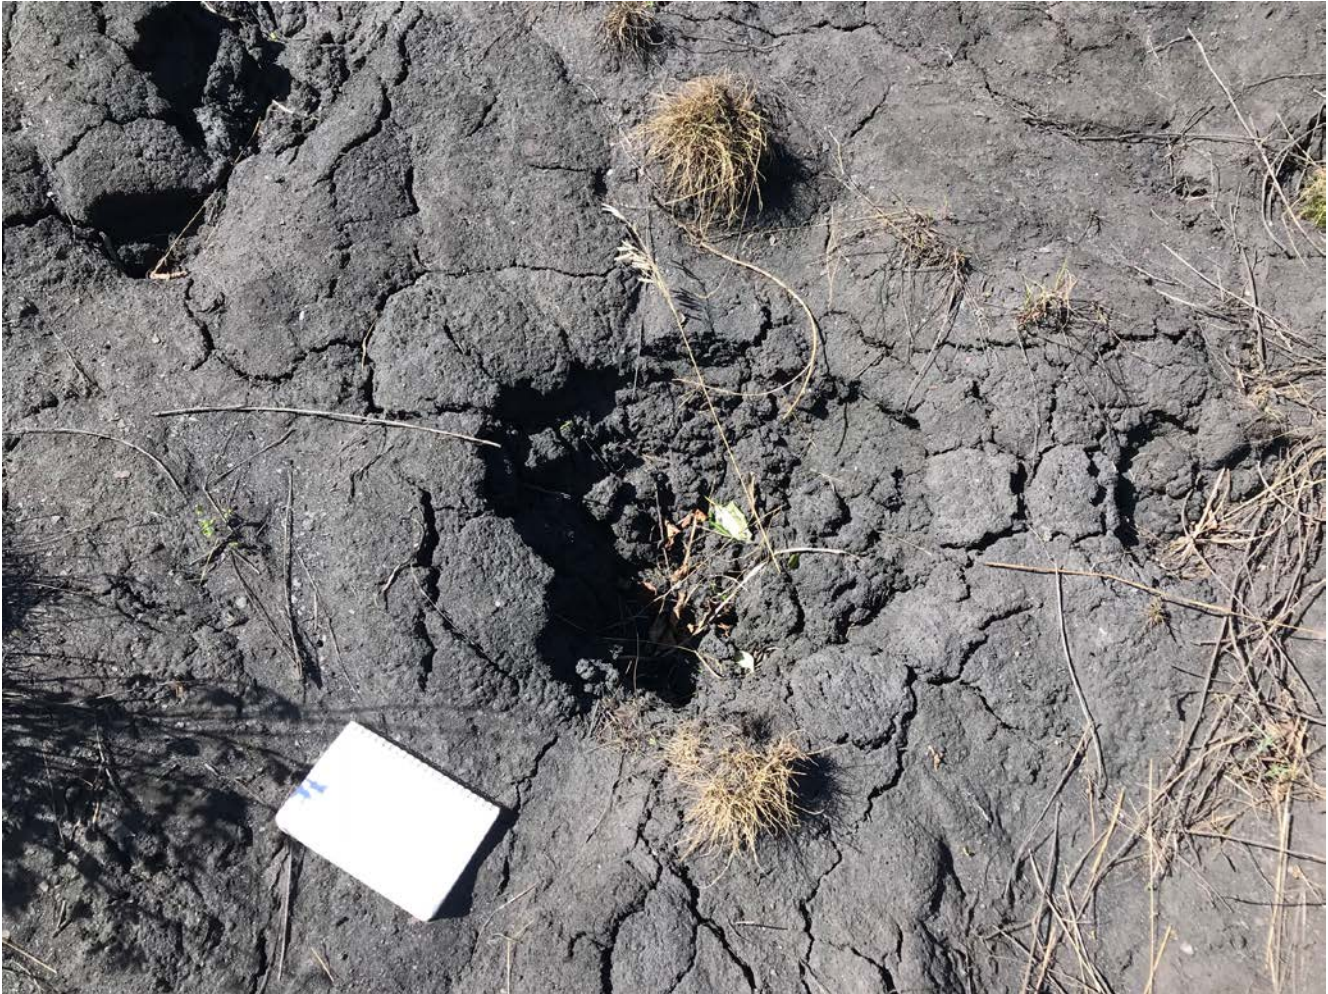
**Photo I-22 Sinkholes 7 to 10 - typical smaller sinkholes noted along the southern half of the tailings beach (between SNTD-2018-07 and SNTD-2018-08)**

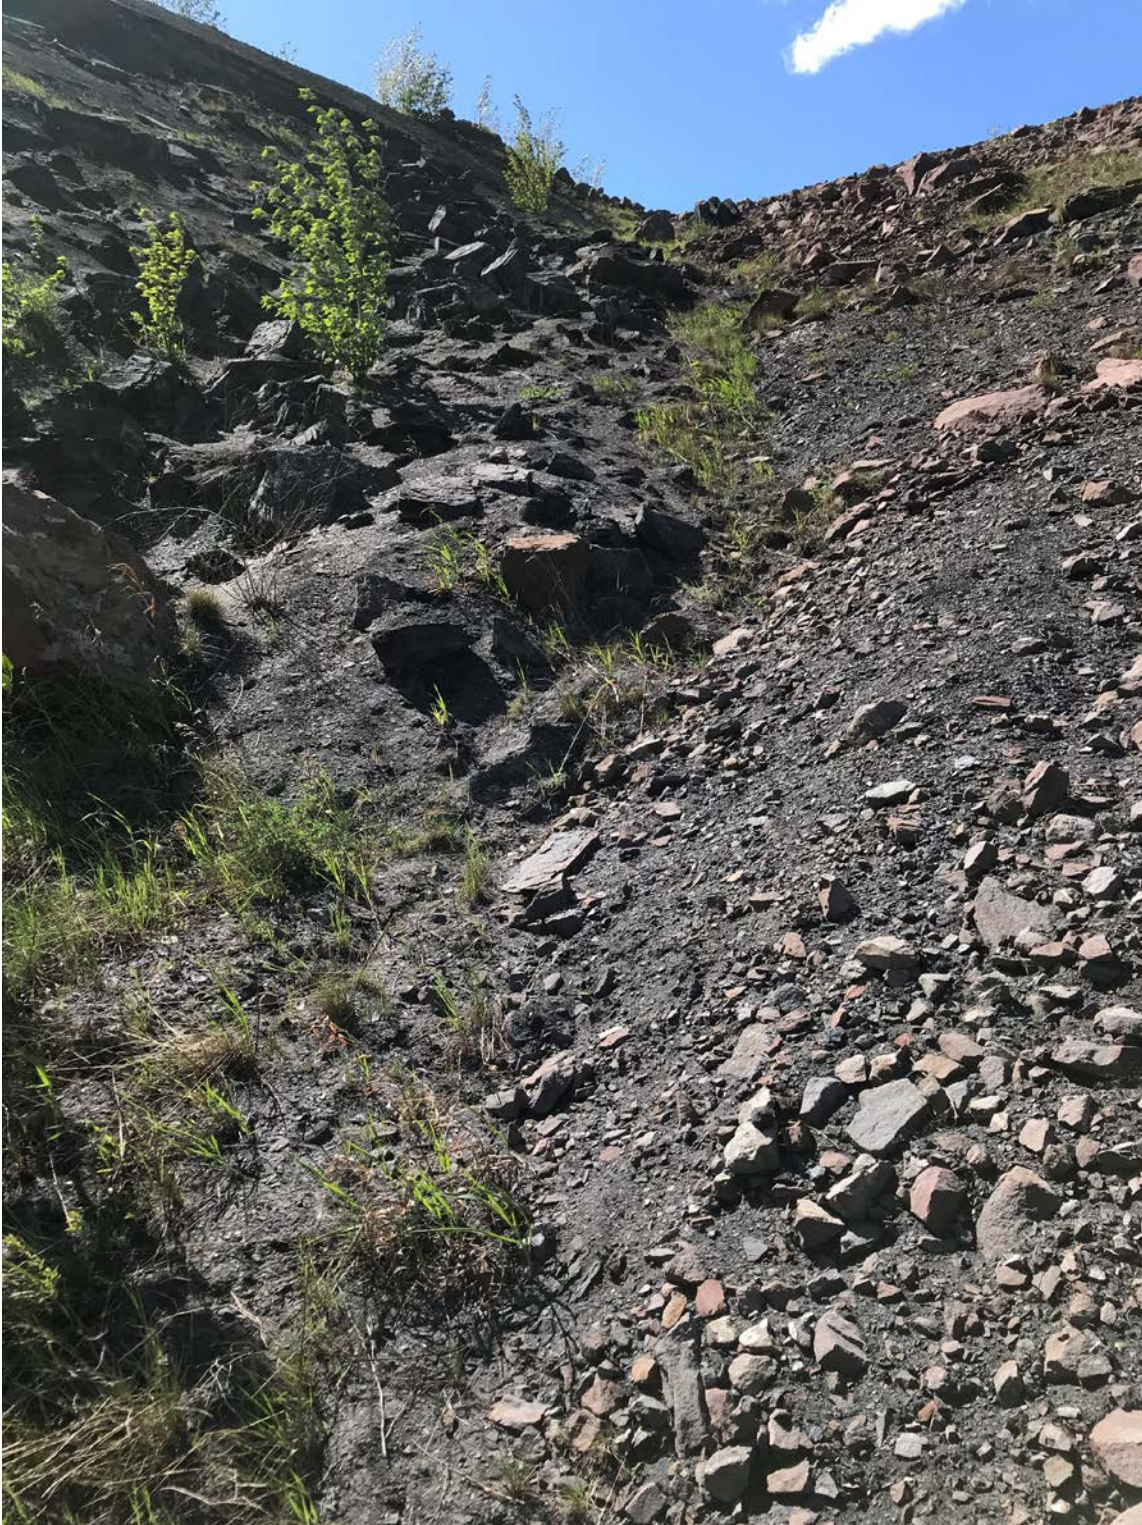
**Photo I-23** SNTD west abutment - upstream contact with the Shikano pit west wall – small erosion gully noted but appears to be unchanged from 2017 condition (SNTD-2018-09)

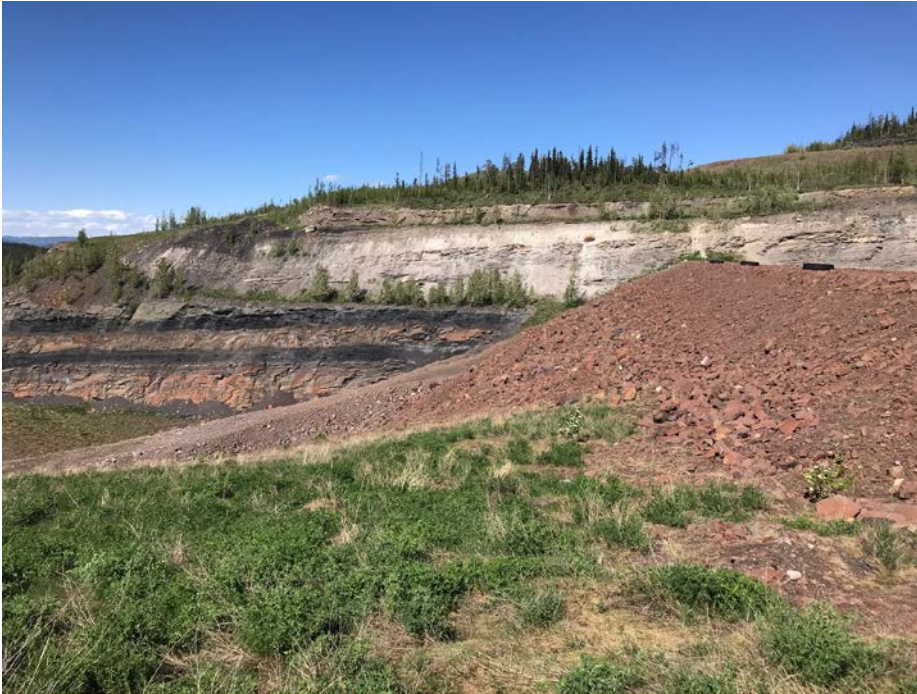
**Photo I-24** Downstream slope taken from west abutment – looking north; no signs of erosion or movement (SNTD-2018-10)

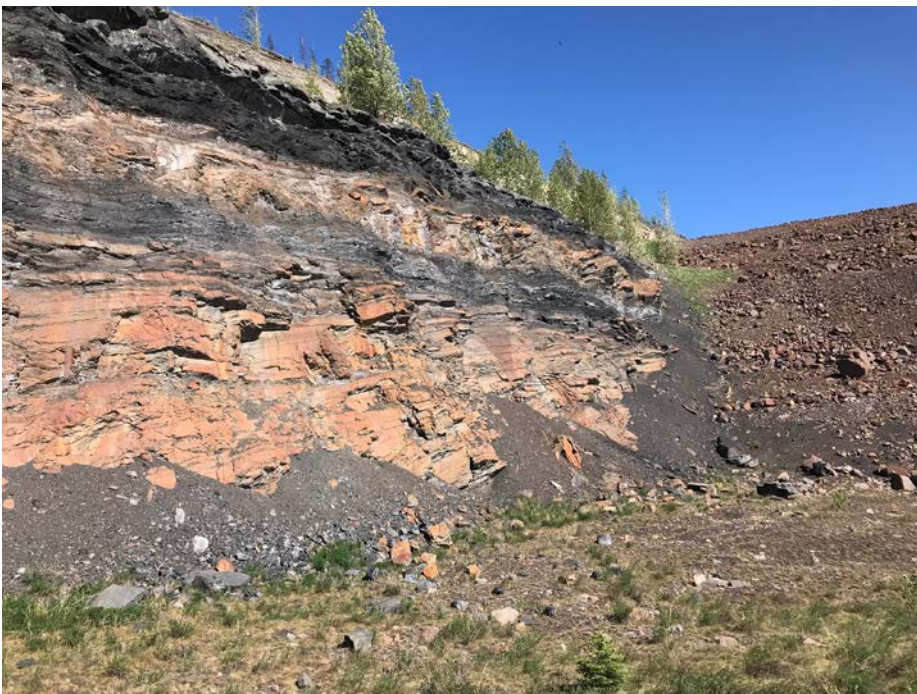
**Photo I-25** Downstream east abutment – looking east. No changes in condition when compared to 2017 observation (SNTD-2018-11)

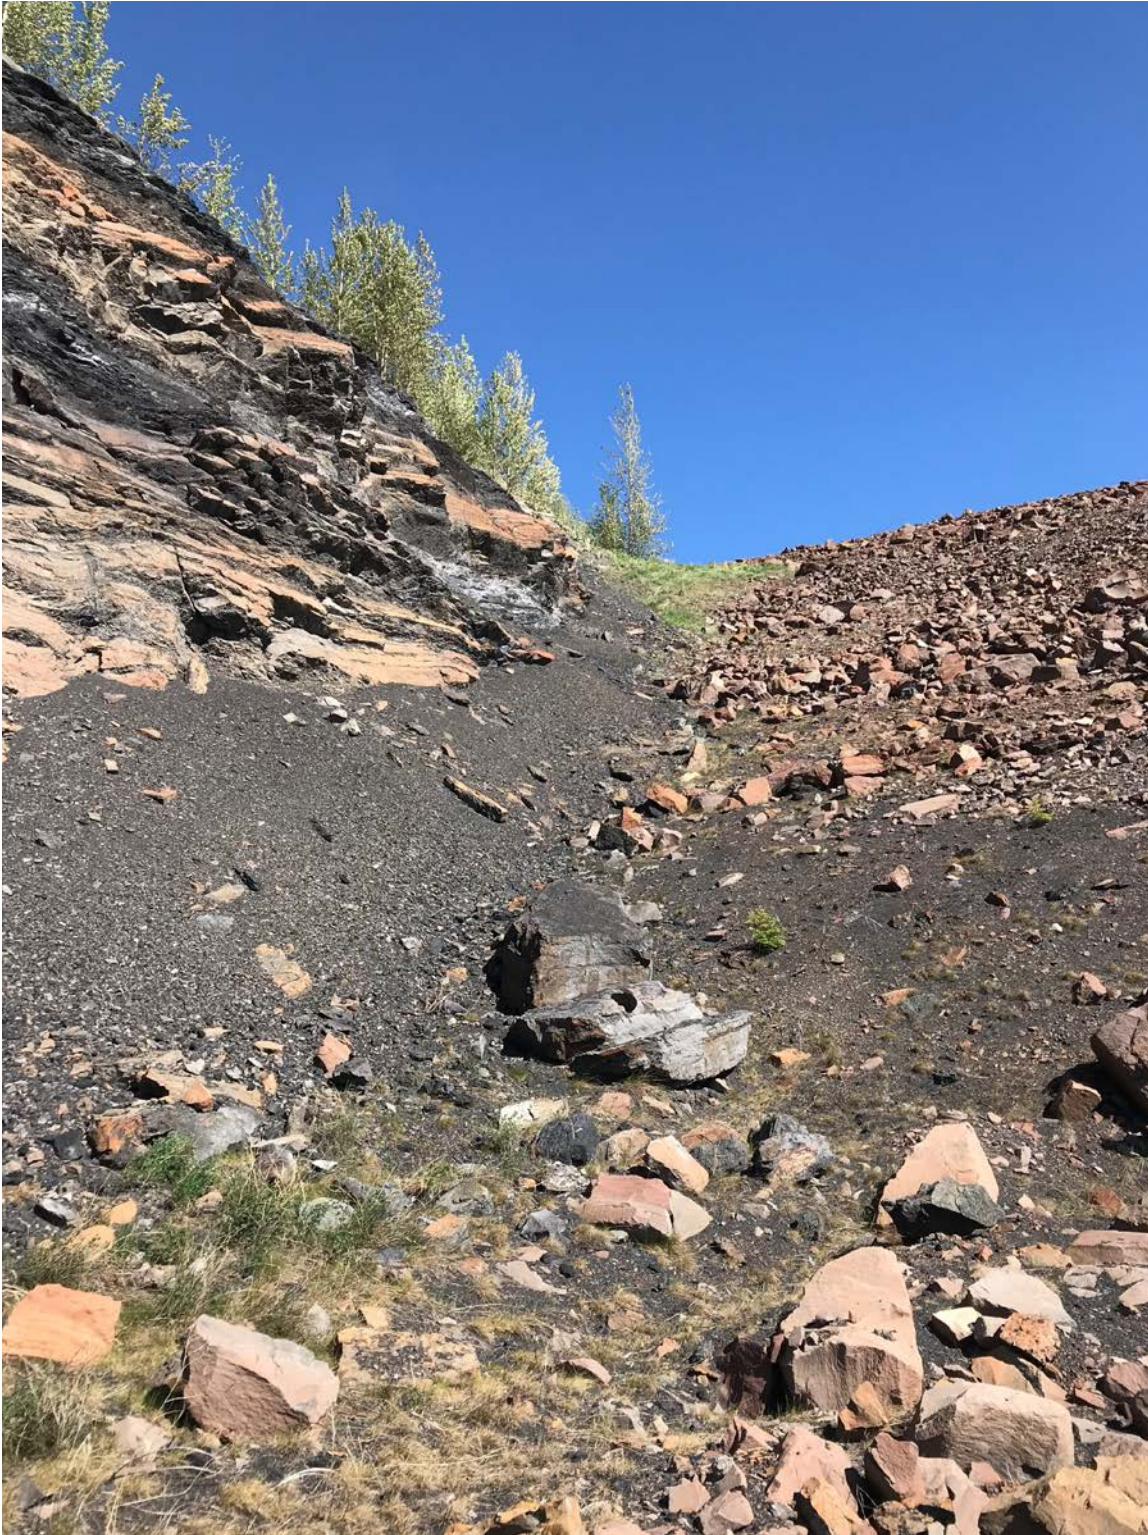
**Photo I-26** Downstream contact with east abutment – looking east. No changes in condition from previous year (SNTD-2018-12)

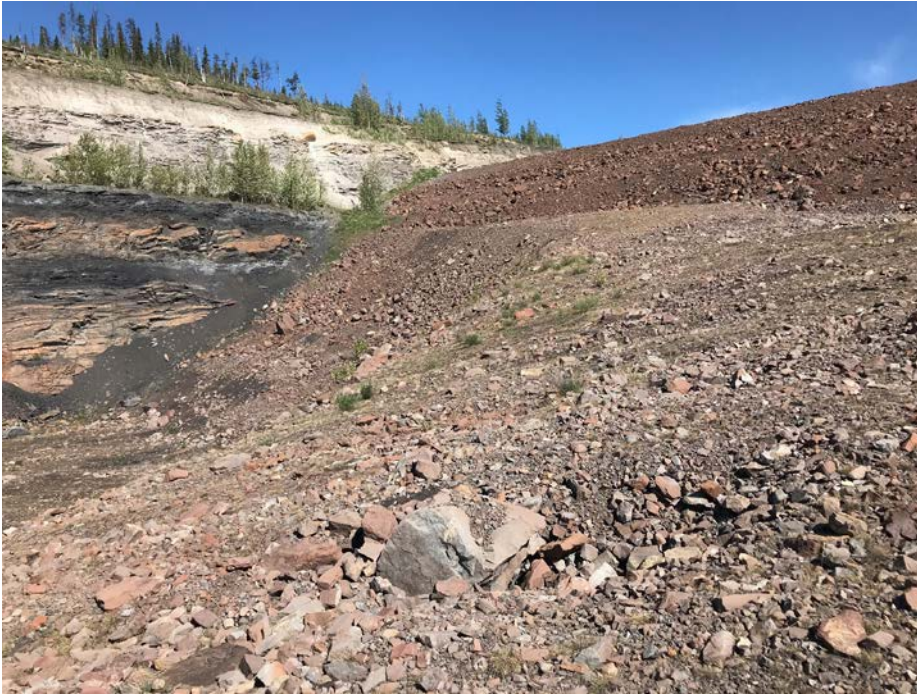
**Photo I-27** Downstream, access ramp and downstream slope – looking north. No significant signs of erosion or movement (SNTD-2018-13)

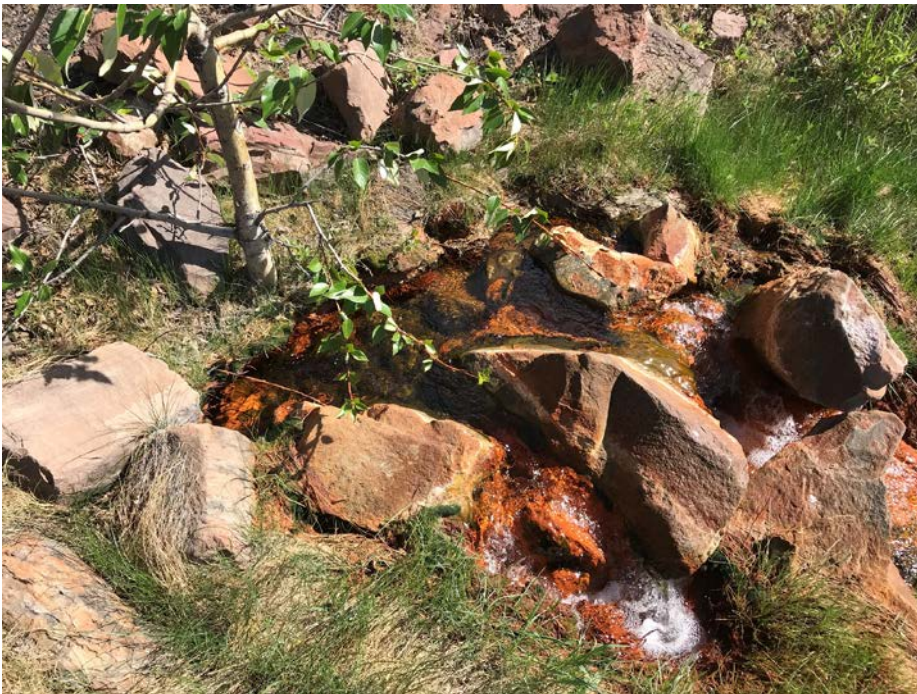
**Photo I-28** Seepage from low level outlet downstream of the dam (SNTD-2018-14)

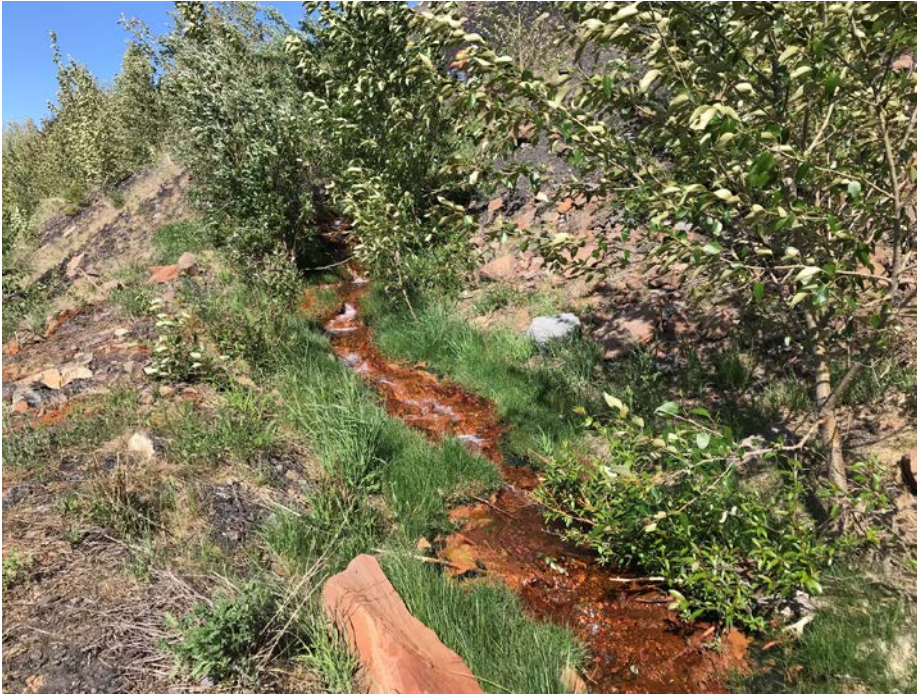
**Photo I-29 Seepage channel, which flows into Sediment Pond S3 – flow estimate: 9 L/s (SNTD-2018-15)**

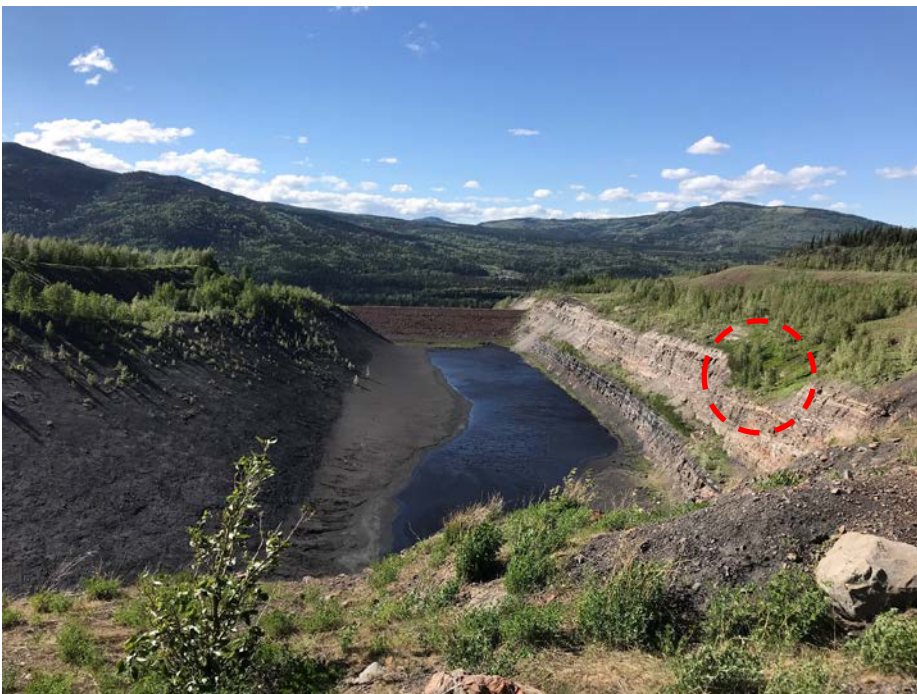
**Photo I-30 Shikano North Tailings Dam – looking northwest. Historic slumping failure circled with red dash line. No significant changes since 2012 (SNTD-2018-16)**
