October 01, 2018

Project No. 1895461

2018 ANNUAL PERFORMANCE REPORT FOR TAILINGS BACK DAM, RED DOG MINE, ALASKA

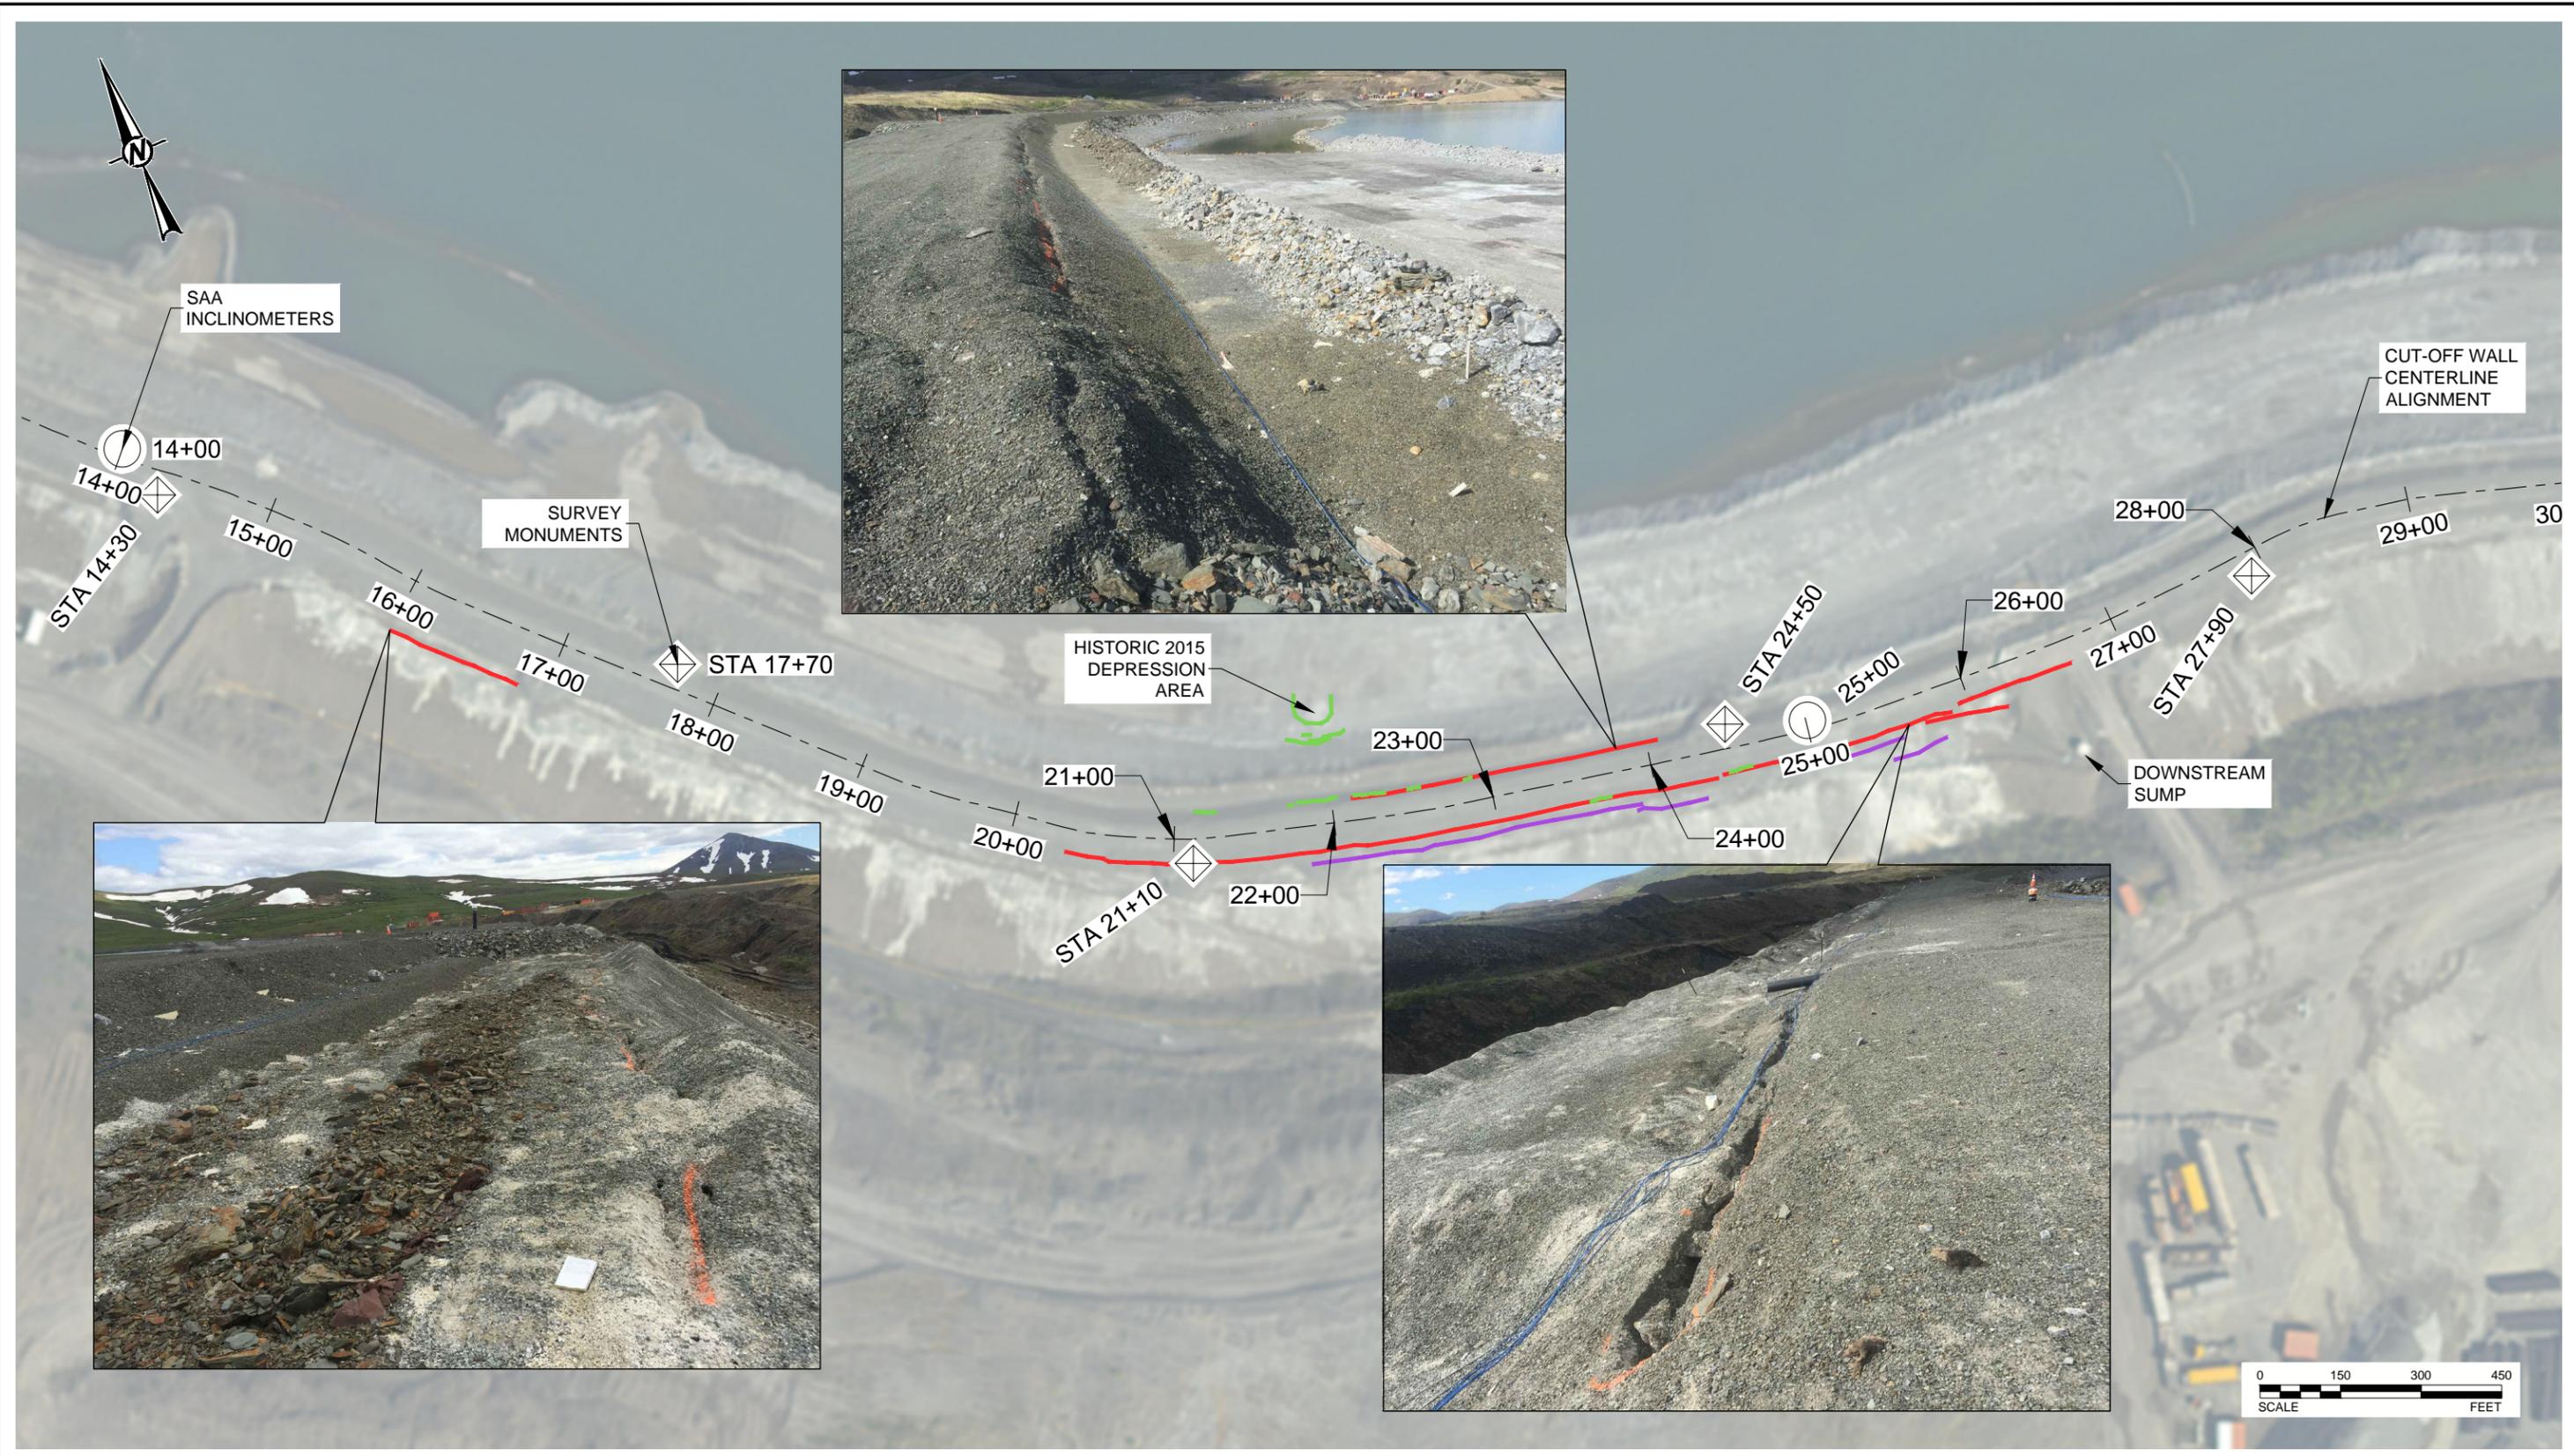
- Similar to past inspections, longitudinal surface cracking was observed on the downstream and upstream side of the dam. Figure 5 presents the surveyed locations of the cracking and some photos taken during the inspection. Golder probed along the length of the cracks, noting a maximum crack width of about 1.0 foot and maximum depth of 6.0 feet.

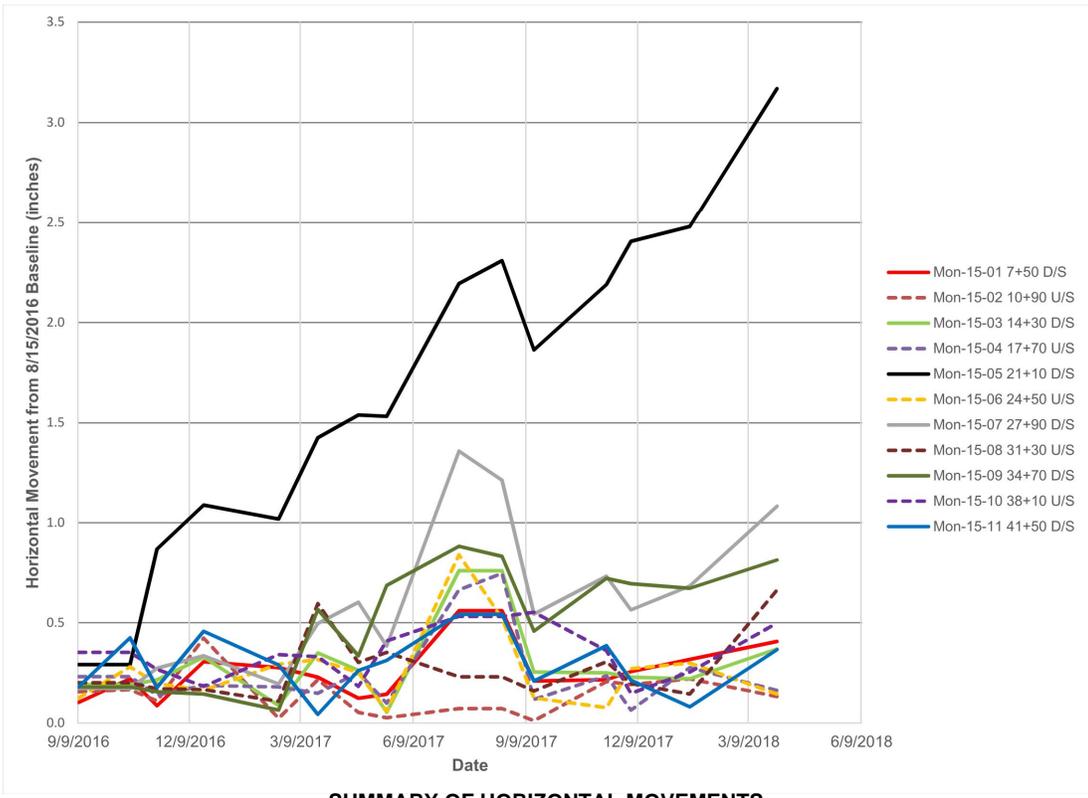
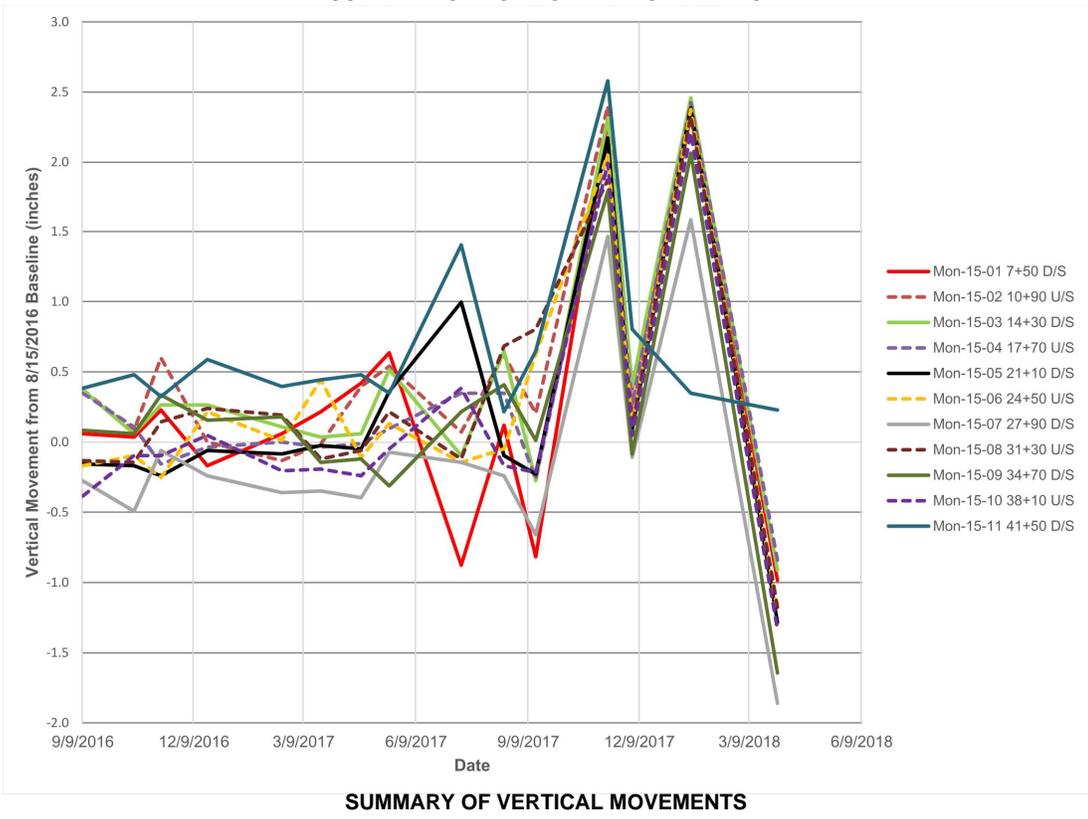
FIGURE
9

- With the exception of Mon-15-05, the cumulative horizontal movements of the survey monuments have remained below the trigger level of 3.0 inches, and generally less than 1.0 inch (Mon-15-07 is the exception and has fluctuated up to about 1.4 inches from the baseline). Mon-15-05 has recorded relatively continuous movement since the baseline reading, crossing the trigger threshold of 3.0 inches on April 1, 2018. The movement coincides with the nearby cracking observed at the select fill/rockfill interface and is understood to be an effect of consolidation of soft and thawed materials underneath the downstream rockfill sector of the embankment.

- The maximum cumulative vertical movements have ranged from about 1.8 inches downward to 2.6 inches upward. However, we infer that much of the variability observed since September 2017 is related to inconsistent equipment or survey vertical control, resulting in data which is impossible to relate back to the baseline reading. Teck has taken measures to improve the reliability of their surveys by controlling the equipment used for the surveys and correctly recording survey rod height.

- The survey monument at Station 21+10 downstream of the COW continues to record significantly more horizontal displacement than the other monuments, recently reaching a maximum of 3.2 inches. This is in excess of the trigger level threshold of 3.0 inches set in the O&M manual. Although this instrument is founded in the select fill prism, it was installed across the select fill/rockfill boundary so it registers movement that is occurring at this interface. No dominant direction of movement appears for any monument with respect to the vertical direction, with movement varying from -0.9 inches up to 1.4 inches before the November 13, 2017 survey. However, from the November 13, 2017 survey to April 1, 2018, vertical movement varied from 2.6 inches to -1.8 inches. It is suspected that the survey equipment or survey rod height varied for these surveys, resulting in inconsistent data.

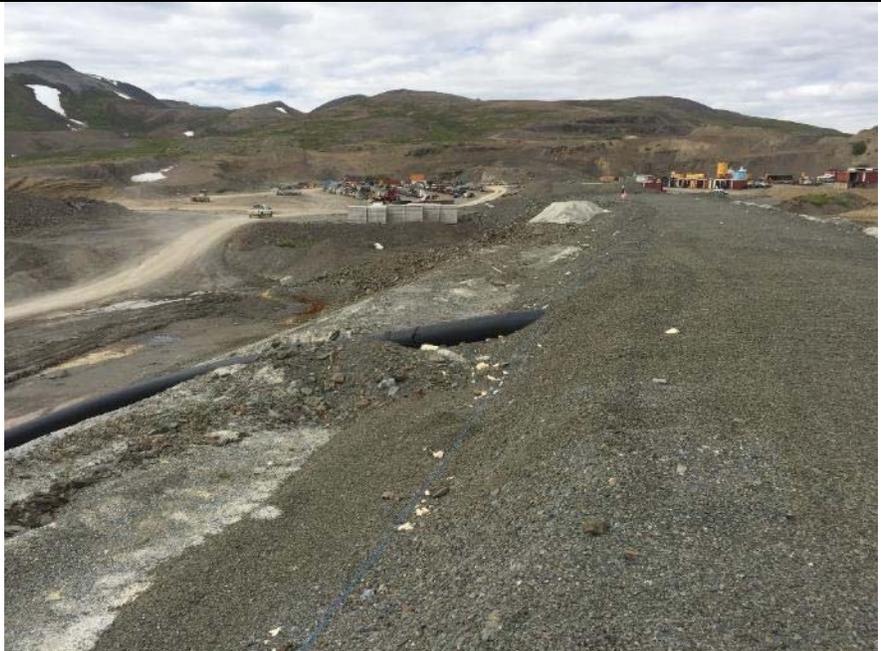
PHOTO 5

- The insulation layer appeared to be in good condition, with the exception of four penetrations of HDPE pipes through the insulation layer (above the foamboard). Two of these pipes are conduits to pass the instrumentation cables across the dam crest and over the top of the COW (See Photo 11, Appendix B). These pipes could increase the frost depth at the locations due to convective transfer of cold air. The two additional pipes are pipelines to pass water across the dam crest from the sump and Overburden Stockpile pumpback system (See Photo 5, Appendix B). These two pipelines are less likely to increase the frost depth,

PIPE CROSSING
THROUGH INSULATION
LAYER NEAR STATION
10+00

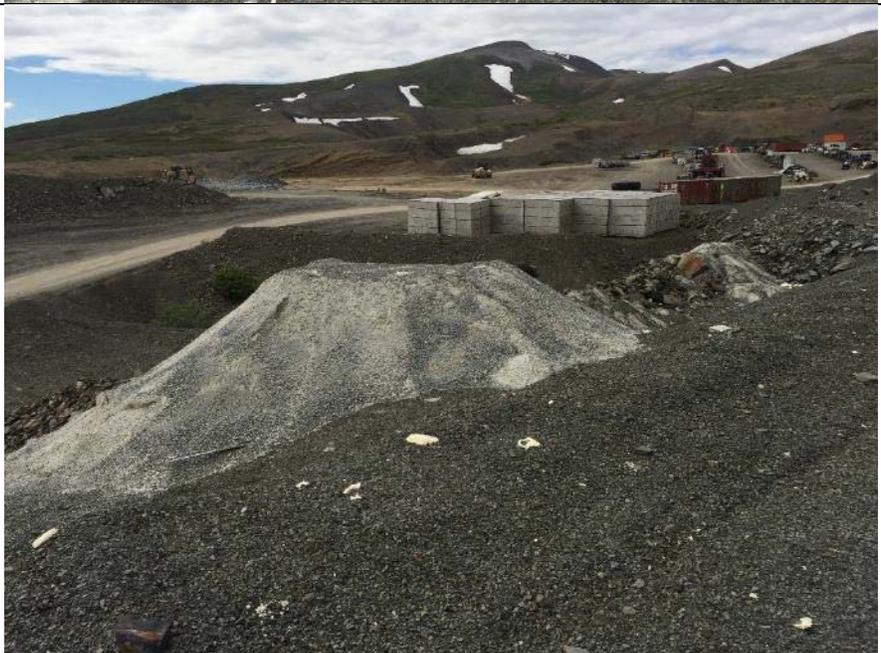
PHOTO 6

CUT-OFF WALL SPOILS
PILE ON DOWNSTREAM
EMBANKMENT NEAR
STATION 8+00

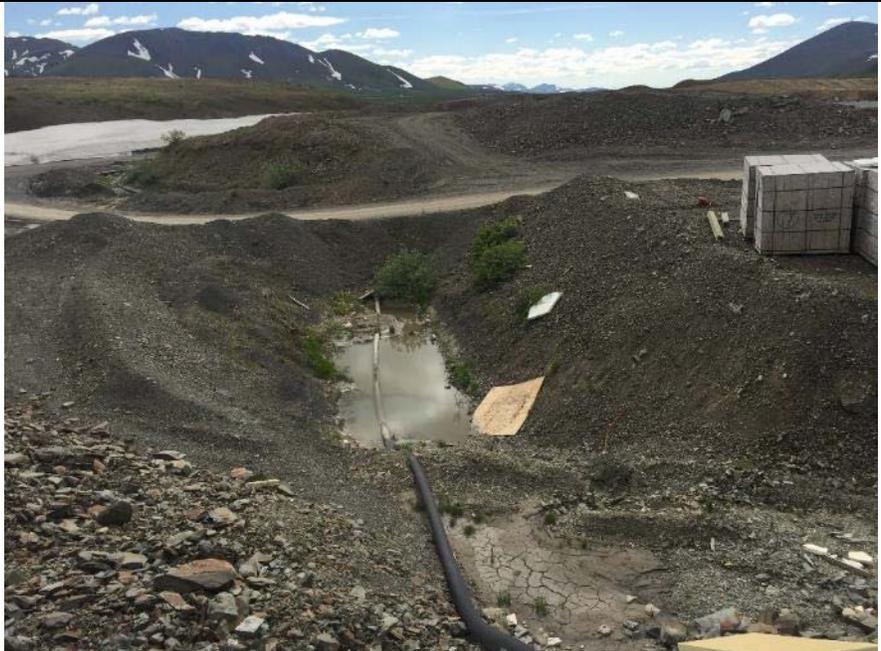
PHOTO 7

- The ponded water at a topographic low spot (now filled in) observed during this and previous field inspections near Station 7+00 (downstream of TBD) is inferred to be infilling in part from a seep originating near the Stage III TBD embankment. The estimated seep elevation of 966 feet is lower than the typical elevation of P-15-144 (located in the TBD embankment), which indicates a gradient from the TBD to the topographic low spot. Based on our understanding of the groundwater downstream of the TBD, this water reports to the sump pump and is eventually pumped to the tailings pond.

PONDED WATER IN LOW SPOT NEAR STATION 7+00

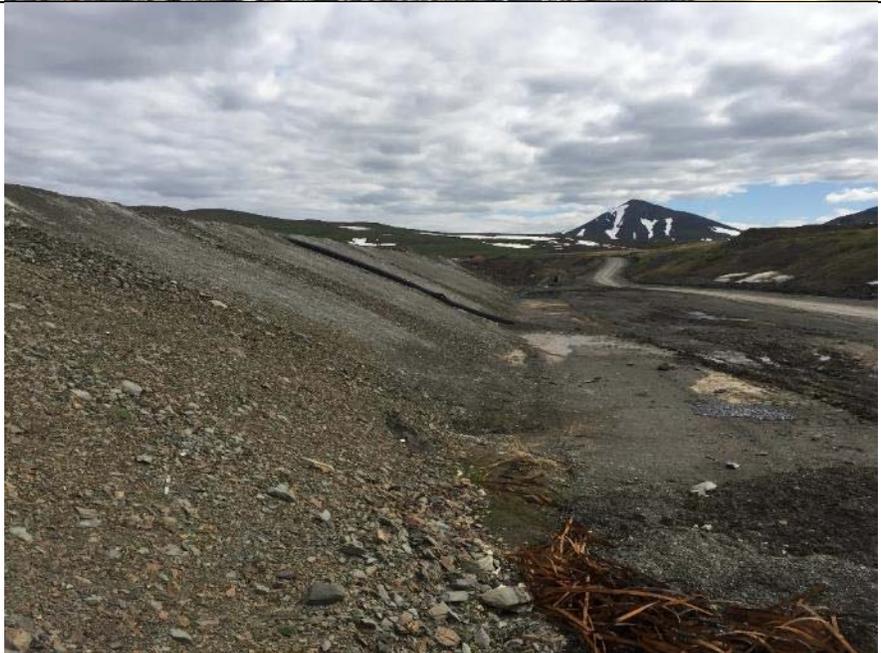
PHOTO 8

CUT-OFF WALL SPOILS ON DOWNSTREAM EMBANKMENT SLOPE NEAR STATION 8+00

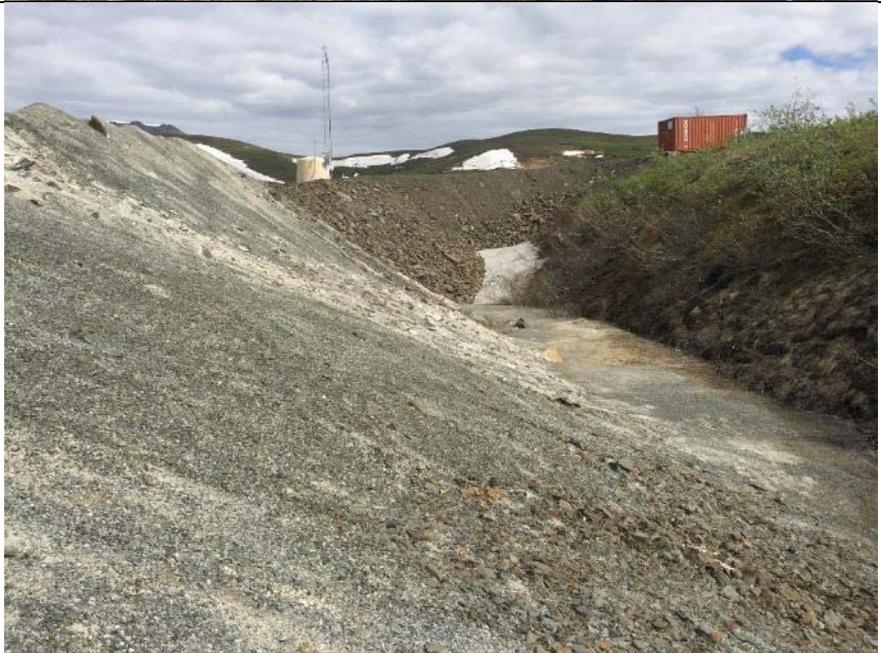
PHOTO 10

CUT-OFF WALL SPOILS
AND PLASTIC CONCRETE
TRUCK WASH DEPOSITS
ON DOWNSTREAM
EMBANKMENT SLOPE
NEAR STATION 25+00

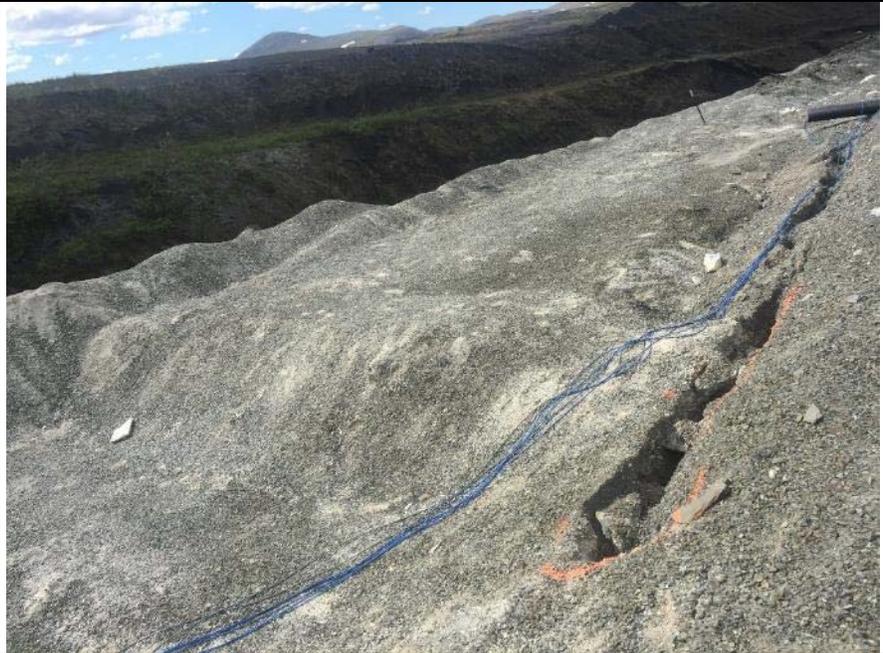
PHOTO 11

- Longitudinal cracking was observed from about Station 20+30 to 26+70 on the downstream side and from about Station 22+10 to 24+05 on the upstream side near the outside board insulation limits. The location of the cracking was about 15 to 17 feet from the alignment centerline, which corresponds approximately with the interface between rockfill and select fill. The deeper cracks and larger crack widths were measured on the downstream side between about Station 24+00 and Station 26+00. Per design, this cracking is understood to be related to deformations from thaw consolidation of the previously frozen foundation materials below the rockfill and is not a stability concern.

- The longitudinal cracking between Stations 20+00 and 27+00 is occurring near the interface of the select fill and rockfill materials. This behavior has been observed after each stage of construction and is not considered to be a concern for the performance of the COW or the stability of the embankment as the majority of related movements are occurring within the rockfill. As described in previous inspection reports, these cracks are believed to be related to thawing and consolidation of permafrost soils and were considered during the initial design. As might be anticipated considering the thicker zone of ice-rich materials, movement monitoring data in this area suggests that movement is occurring more rapidly than at other regions of the TBD.

CRACKING AT SELECT
FILL/ROCKFILL
INTERFACE,
DOWNSTREAM CREST
NEAR STATION 26+00

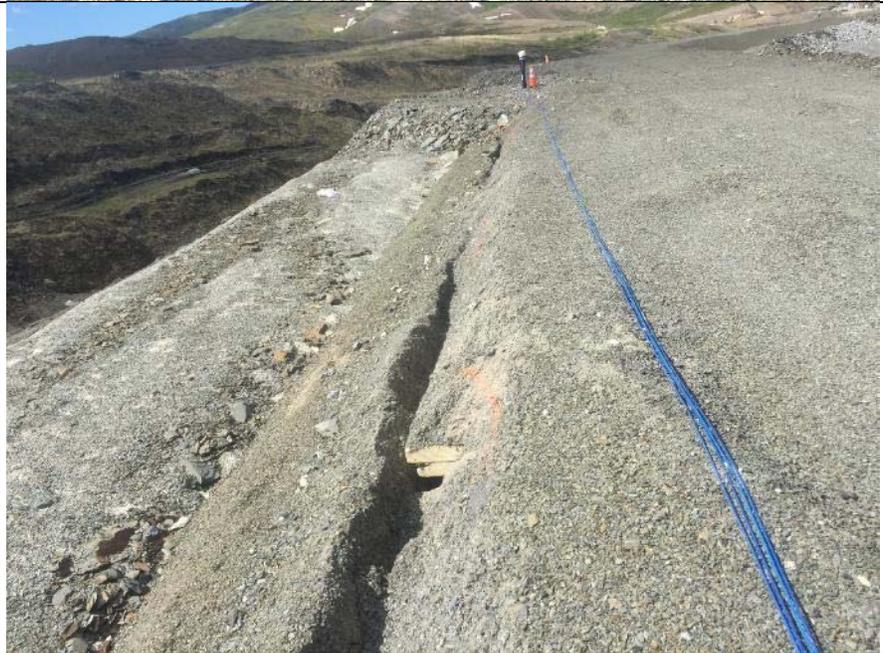
PHOTO 12

CRACKING AT SELECT
FILL/ROCKFILL
INTERFACE,
DOWNSTREAM CREST
NEAR STATION 24+00

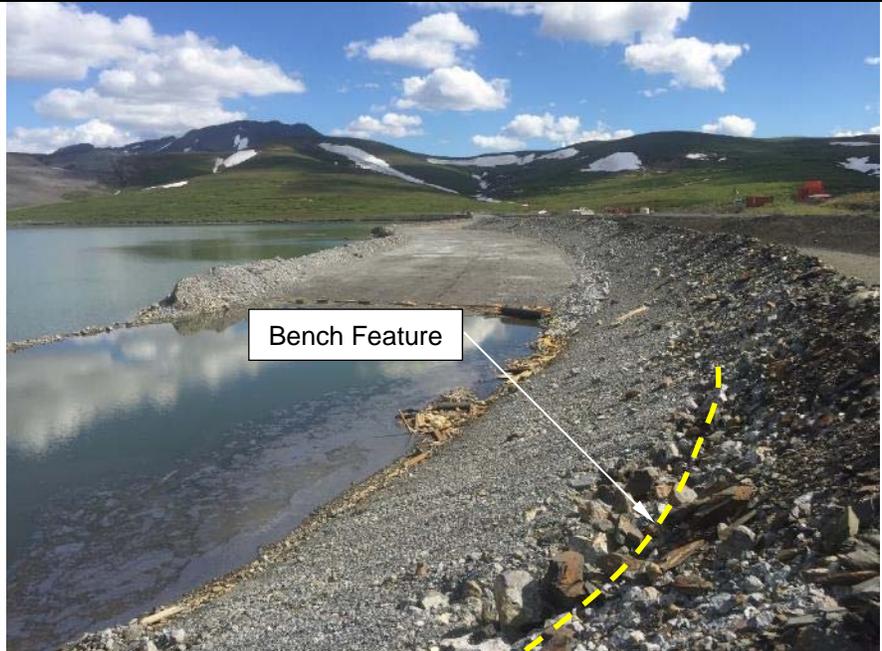
PHOTO 13

- A bench feature was observed on the upstream embankment slopes between about Station 20+00 and 24+00 (See Photos 13 and 14, Appendix B). Upon further review of historic construction and inspection photos, this feature is believed to be due to grading between constructed lifts where the upper lift was not filled out far enough. This feature will be remedied during the Stage IV construction during the key in of new fill lifts into the existing embankment.
- Similar to previous inspections, water was observed in a topographic low spot downstream of the TBD, near Station 7+00, and west of the Overburden Stockpile (see Photo 7, Appendix B). No other ponded water was observed at the ground surface near the downstream toe of the dam embankment during the inspection.

COFFERDAM ROAD AND
UPSTREAM
EMBANKMENT SLOPE
NEAR STATION 20+00

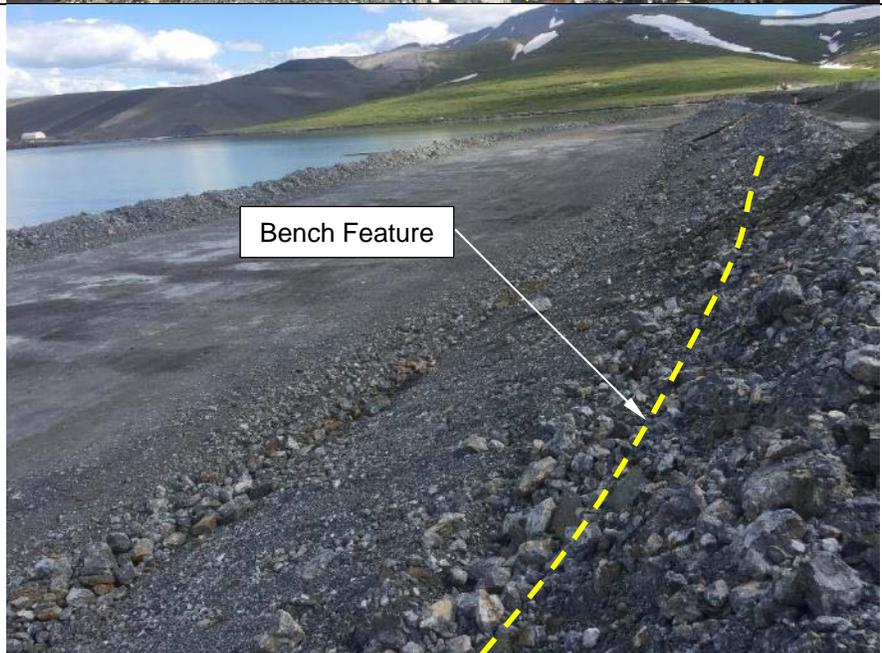
PHOTO 14

COFFERDAM ROAD AND
UPSTREAM
EMBANKMENT SLOPE
NEAR STATION 24+00

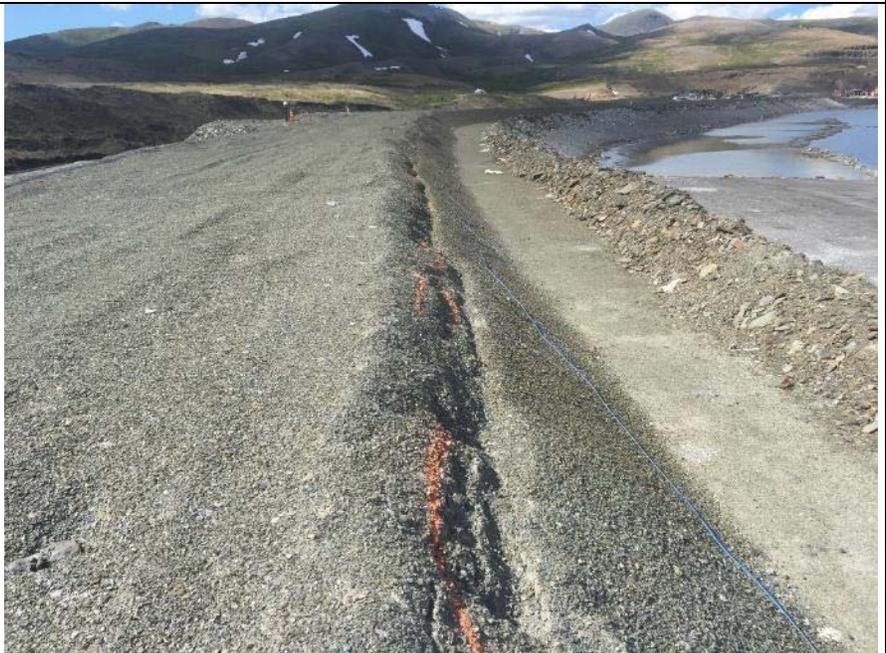
PHOTO 15

CRACKING AT SELECT
FILL/ROCKFILL
INTERFACE, UPSTREAM
CREST NEAR STATION
23+50

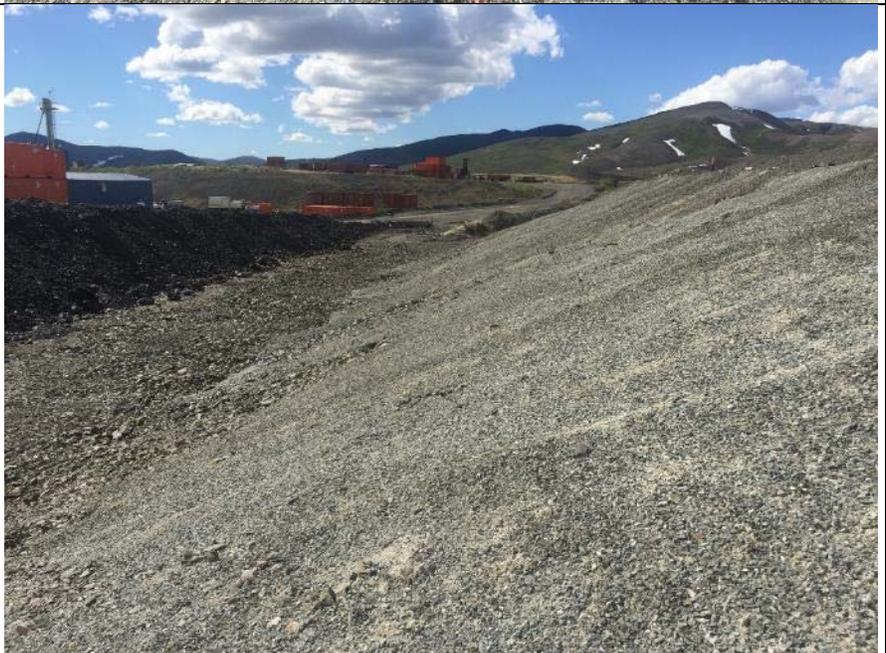
PHOTO 16

CUT-OFF WALL SPOILS
SPREAD OVER
DOWNSTREAM
EMBANKMENT SLOPE
NEAR STATION 39+50

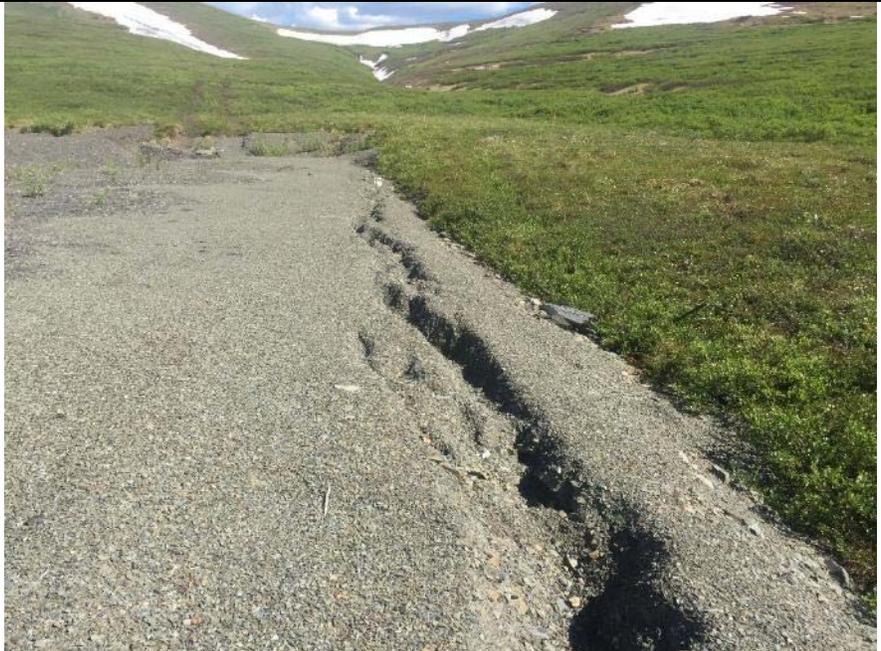
PHOTO 17

- Similar to previous inspections, longitudinal cracking was observed along the downstream slope crest east of the haul road (See Photos 17 and 18, Appendix B). This cracking was initially observed during the 2014 periodic safety inspection¹ (PSI). The length and width of the cracking appeared to be similar to what has been previously observed. As described in previous reports, this cracking is not a stability concern and poses no risk to the COW.

CRACKING AT
DOWNSTREAM
EMBANKMENT CREST
NEAR STATION 49+00

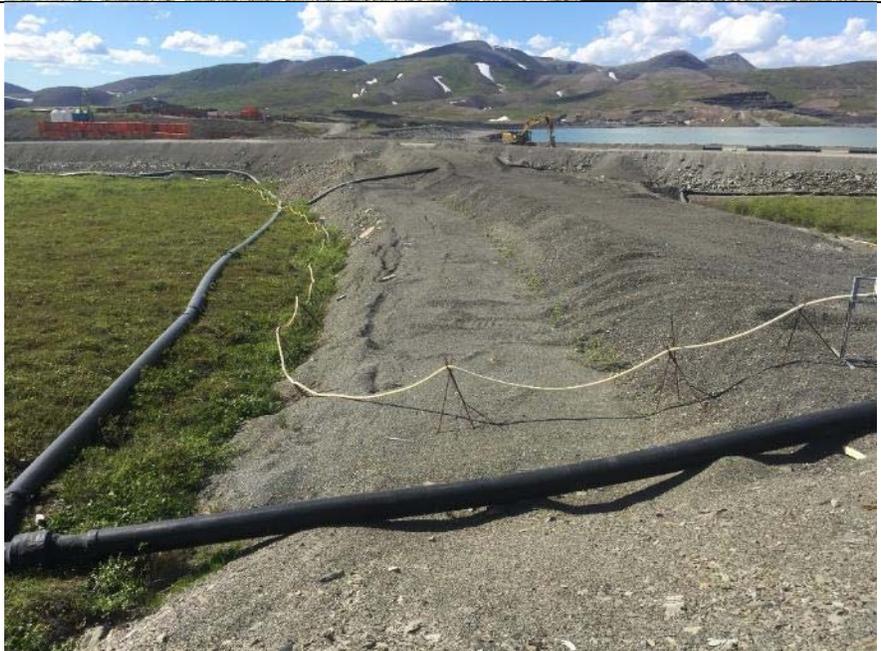
PHOTO 18

CRACKING AT
DOWNSTREAM
EMBANKMENT CREST
NEAR STATION 47+00
