November 5, 2018

Project No. 1895982

**Teck Tailings Main Dam Team**

**2018 ANNUAL PERFORMANCE REPORT FOR TAILINGS MAIN DAM, RED DOG MINE, ALASKA**

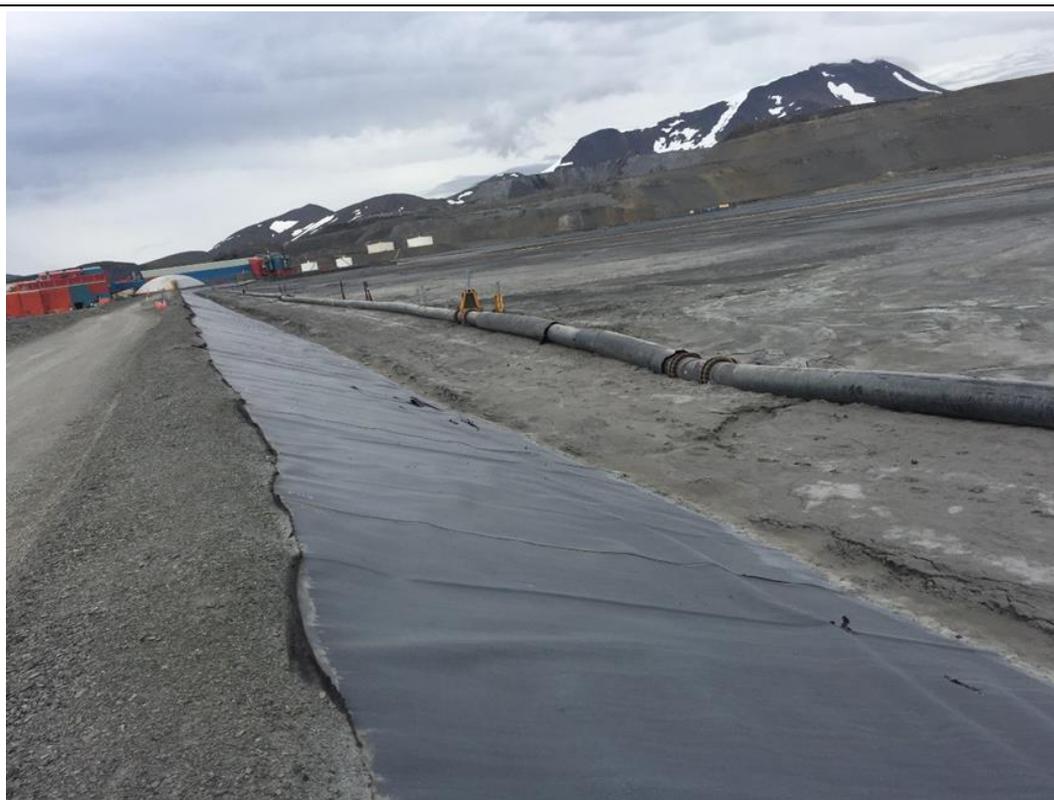
- The exposed upstream liner generally appeared to be in good condition, except for some liner damage observed near Station 11+80 (see Figure 6 and Photos 5 and 6). Teck was aware of this damage and informed us that it occurred last winter from an excavator during manipulation of the tailings discharge pipeline. Teck had already scheduled the repairs and we understand they have been completed before publication of this report. Teck is working to improve procedures during tailings pipeline manipulation to limit or prevent future damage to the upstream geomembrane liner.

**PHOTO 5**  
LINER DAMAGE  
AT TMD  
EMBANKMENT,  
LOOKING E

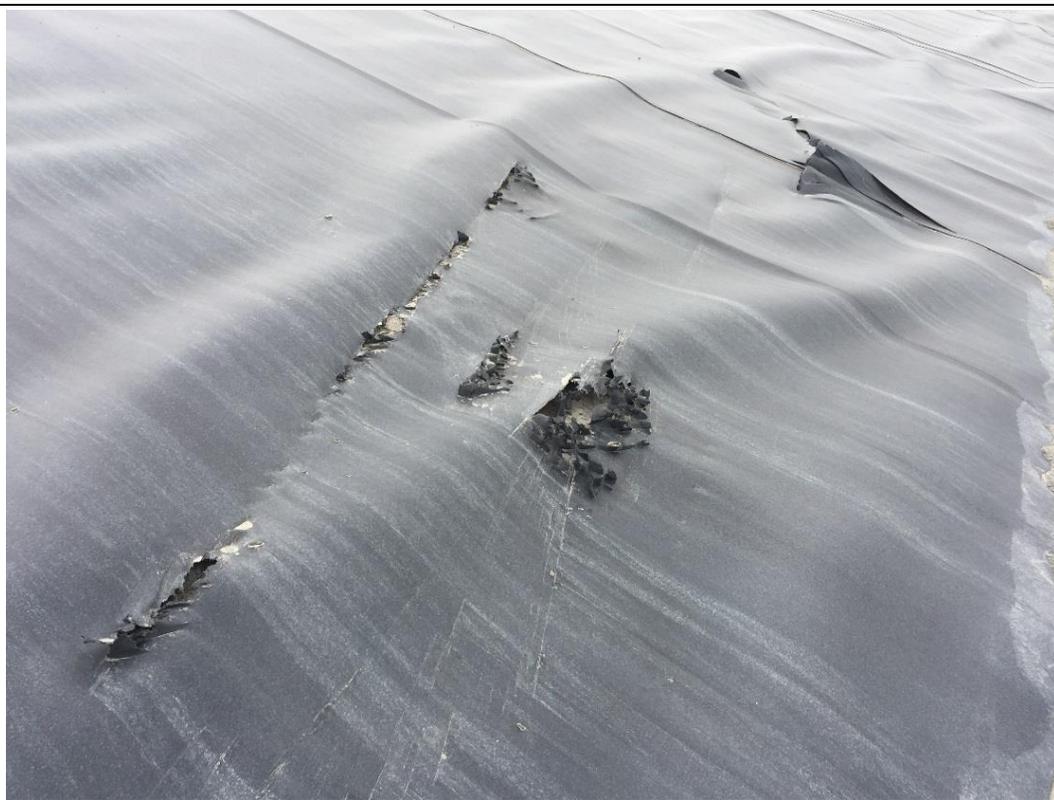
**PHOTO 6**  
CLOSEUP OF  
LINER DAMAGE

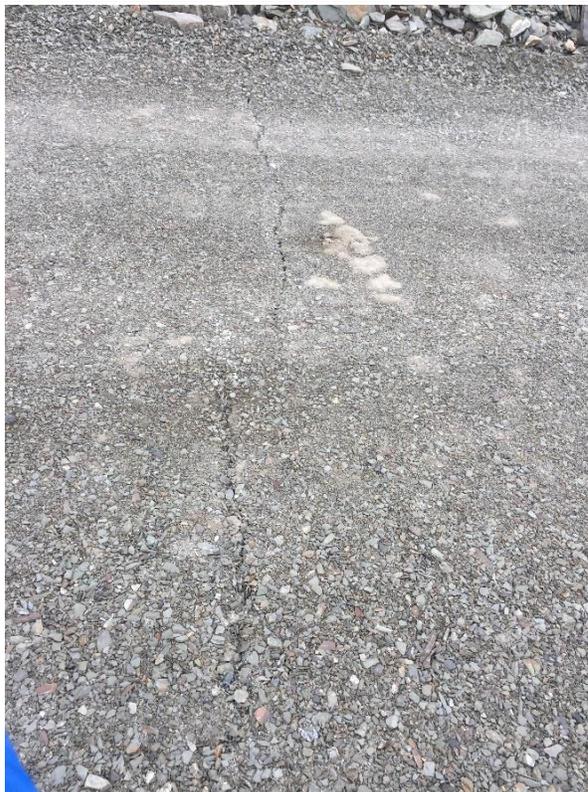
**PHOTO 10**

- The upstream and downstream slopes of the TMD Embankment and Wing Wall appeared to be stable with no signs of slumping, seeps, or lateral movements. Lateral cracking was observed along the Wing Wall crest near Station 35+30, as shown in Figure 6 and Photo 10, Appendix B. The crack was about a maximum of ¾ inches wide and less than 6 inches deep based on visual inspection. No signs of distress or instability were noted in the upstream liner or on the downstream slope near the crack. Similar lateral cracking has historically been observed in this area as shown in Figure 6, and they were typically marked with paint and had been surveyed. One such paint-marked lateral crack was observed near Station 51+30 (Figure 6 and Photo 15) that had not been surveyed. These historical lateral cracks were typically very small and seemed to have healed since initially observed based on discussion with Teck. A borehole was drilled at one of these crack locations near Station 35+70, where we observed some subsidence of the annulus backfill materials (Figure 6 and Photo 12). This lateral cracking is thought to be related to thaw consolidation of ice-rich native soils. The lateral nature of the cracks may be related to the orientation and variable ice content of ice-rich

NEW  
TRANSVERSE  
CRACK AT WING  
WALL CREST,  
LOOKING NE

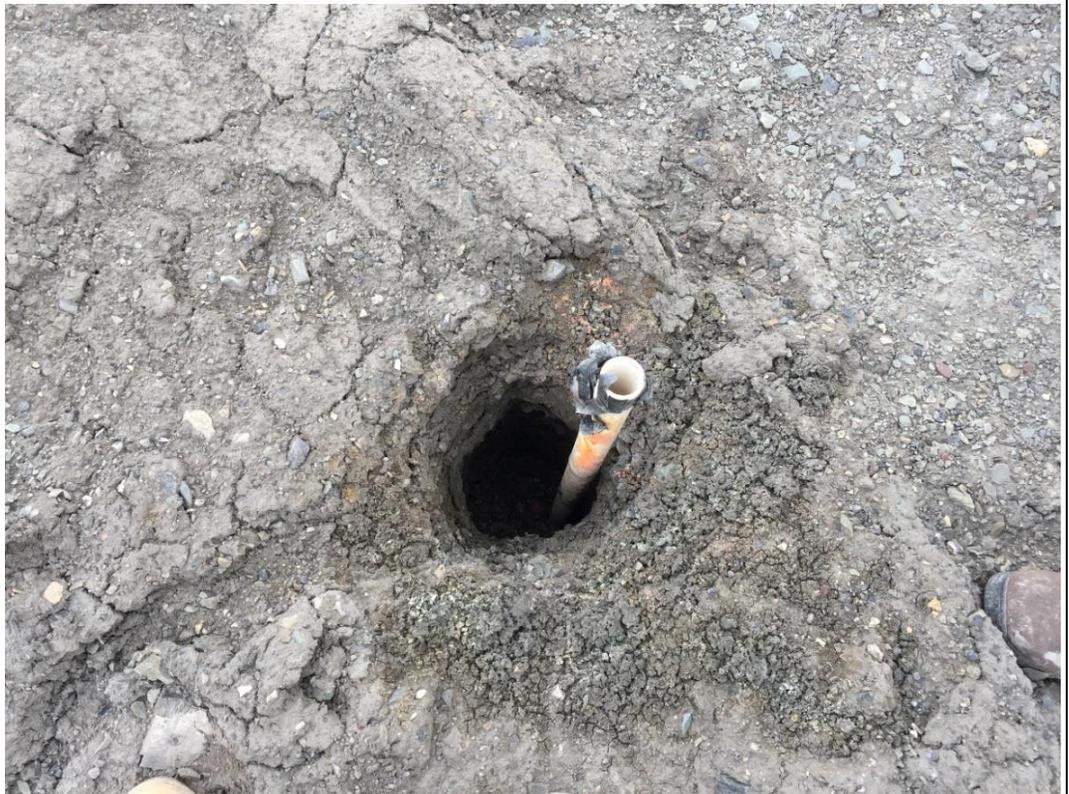
**PHOTO 12**

ANNULUS  
SUBSIDENCE AT  
2017 BOREHOLE IN  
WINGWALL CREST

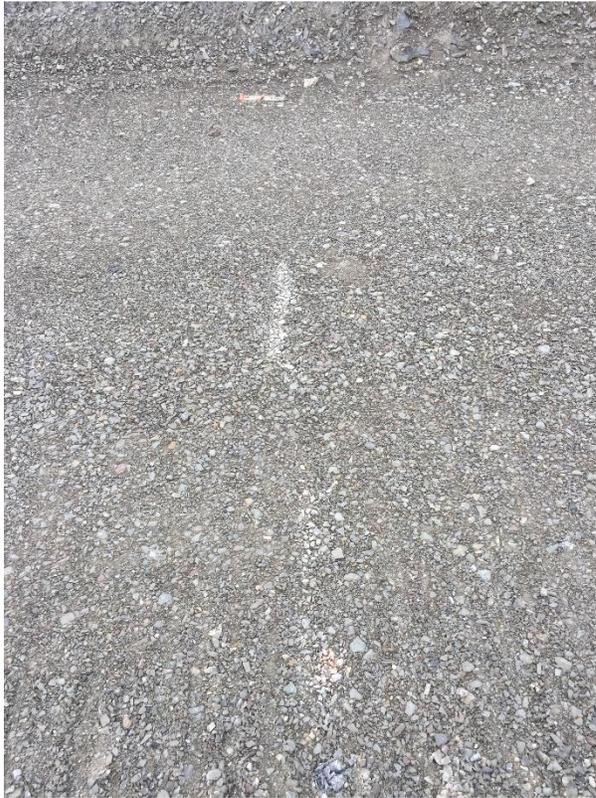
**Appendix B: Photographs****PHOTO 15**

HISTORIC  
TRANSVERSE  
CRACK AT WING  
WALL CREST,  
LOOKING E

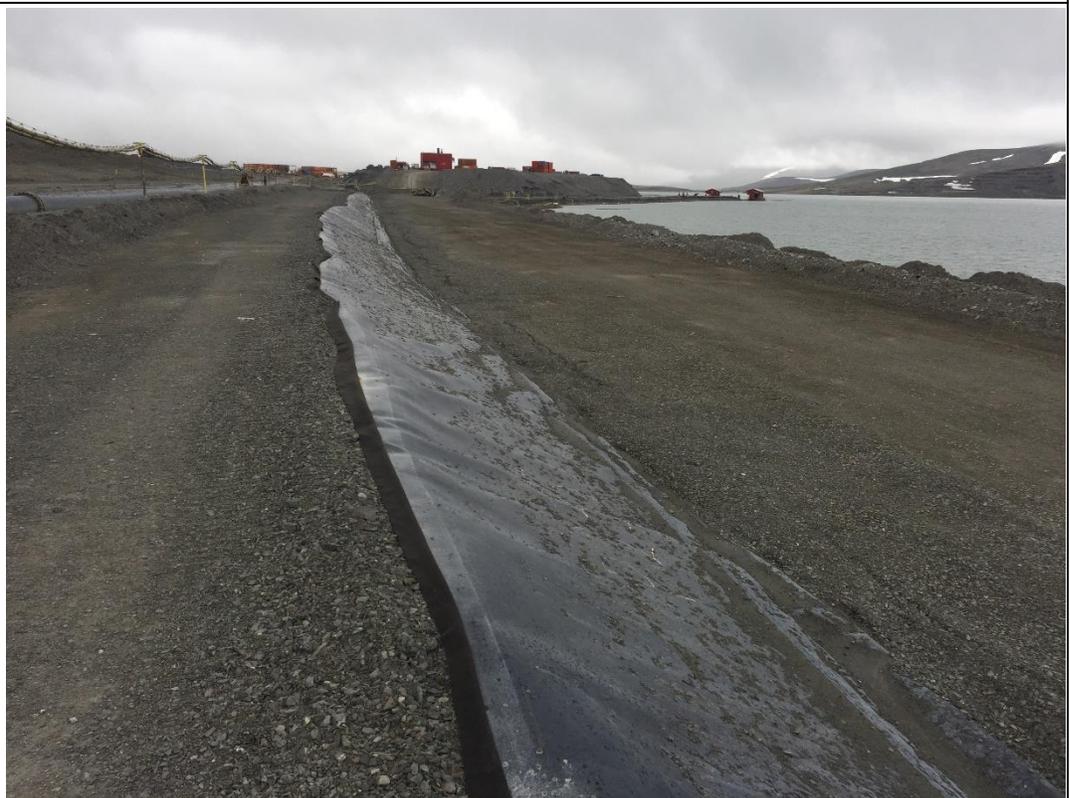
**PHOTO 16**

- Longitudinal cracking was observed along the upstream toe of the Stage X Wing Wall extension, from about Station 53+20 to 58+50, as shown in Figure 6 and Photos 16 and 17. The cracking appears to be where the geomembrane liner was connected into the slurry trench. Based on discussions with Teck, we understand that the soil-slag cement-clay (SSC) cap that was used at the top of the slurry trench did not meet the specified strength requirements. This cracking could be related to movement of the liner following backfill if the liner was not in intimate contact with the subgrade, or possibly consolidation of the SSC cap. We recommend carefully exposing the liner and examining the SSC cap in several locations before placing additional fill materials in this area.

CRACK ALONG  
STAGE X WING  
WALL UPSTREAM  
TOE, LOOKING S

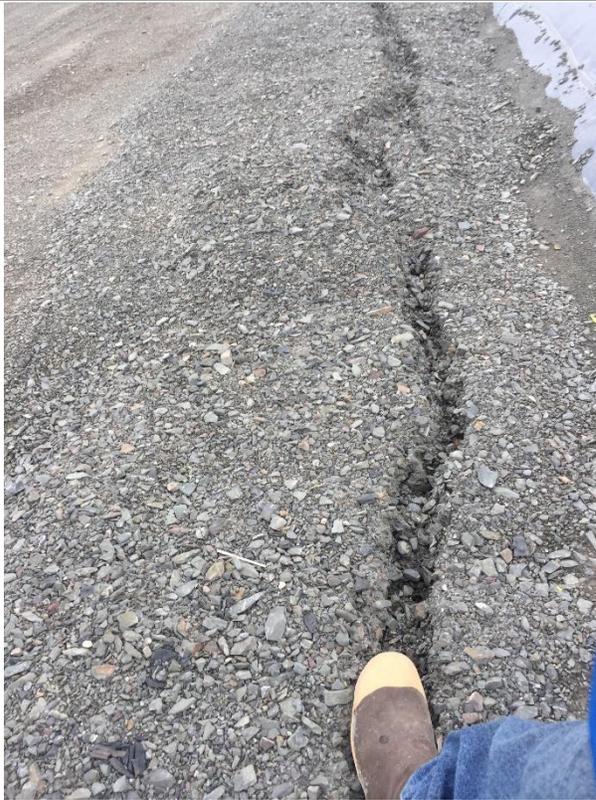
**Appendix B: Photographs****PHOTO 17**

CLOSEUP OF  
CRACK ALONG  
STAGE X WING  
WALL UPSTREAM  
TOE, LOOKING N

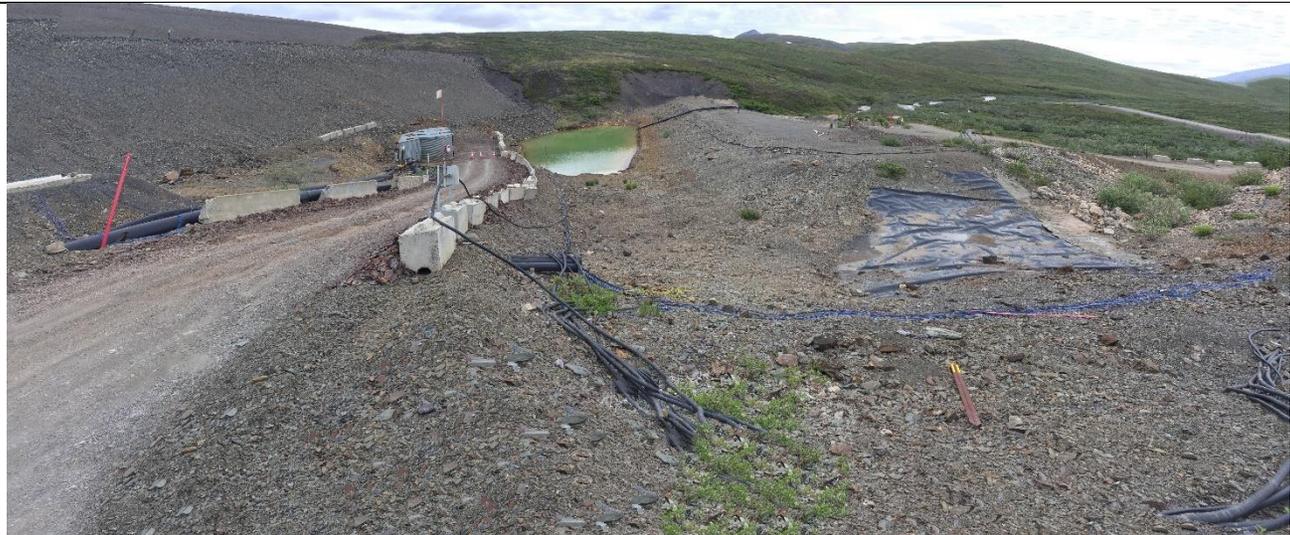
**PHOTO 26**

- The Seepage Collection Dam appeared to be in satisfactory condition with no indications of instability (see Photos 26 and 28). The Seepage Seepage Pumpback located downstream of the Seepage Collection Dam was also observed and did not appear to be actively pumping at that time.

TMD SEEPAGE  
COLLECTION POND AND  
DAM, LOOKING W

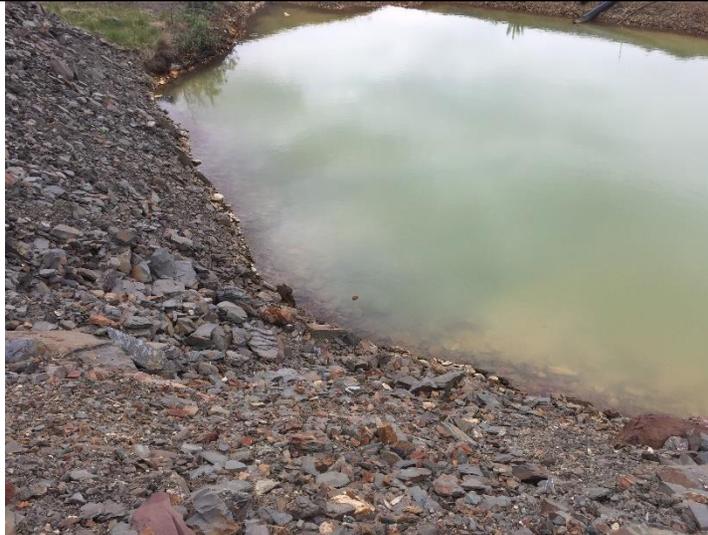
**Appendix B: Photographs****PHOTO 27**

- The SCP was at an elevation of about 789 feet and two of the three pumps were operating during our inspection. These pumps were operating at a combined pumping rate of about 600 gallons per minute (gpm). Some iron staining was observed near the toe of the buttress and around the SCP (see Photos 25 to 27). We understand this iron staining near the buttress toe is related to the rock drain repairs that occurred in 2013 to mitigate formation of ferricrete within the underdrain. We also noted a seep entering the SCP that appeared to be near where the underdrain connects into it (Photo 27).

SEEPAGE FLOW INTO  
SEEPAGE COLLECTION  
POND, LOOKING NW

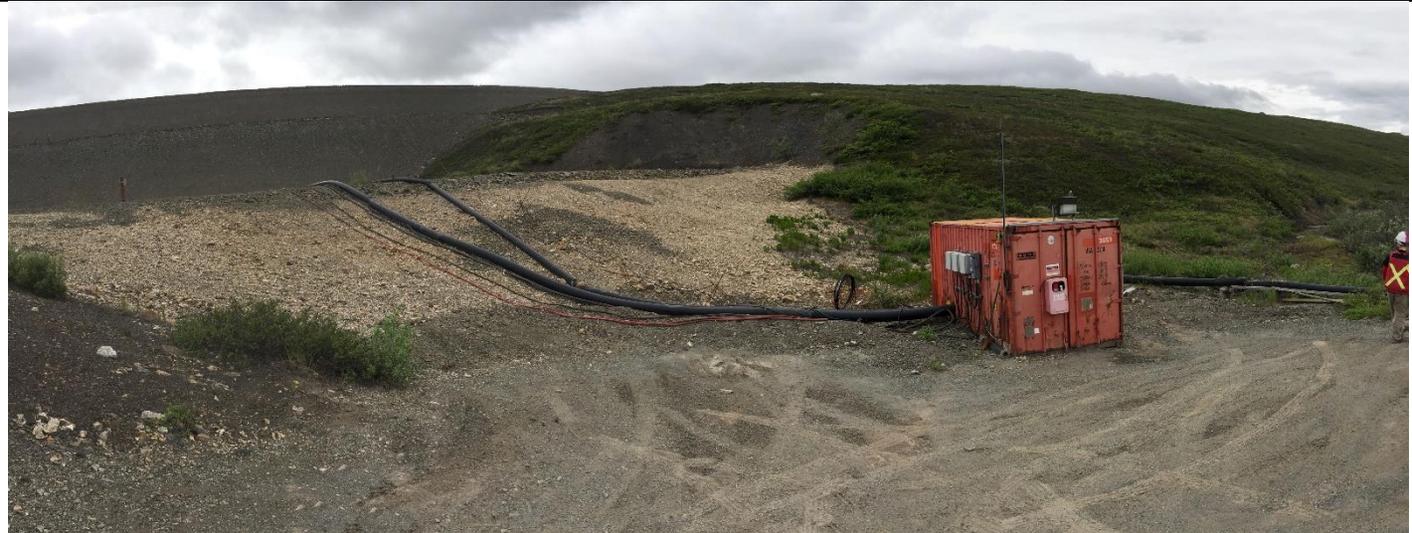
**PHOTO 28**

DOWNSTREAM SLOPE OF  
SEEPAGE COLLECTION  
DAM AND SEEPAGE  
SEEPAGE PUMPBACK,  
LOOKING W
