Sä Dena Hes Mine, Yukon Territory 2018 Dam Safety Inspection

SRK Consulting (Canada) Inc.
November 2018

Project No: 1CT008.068

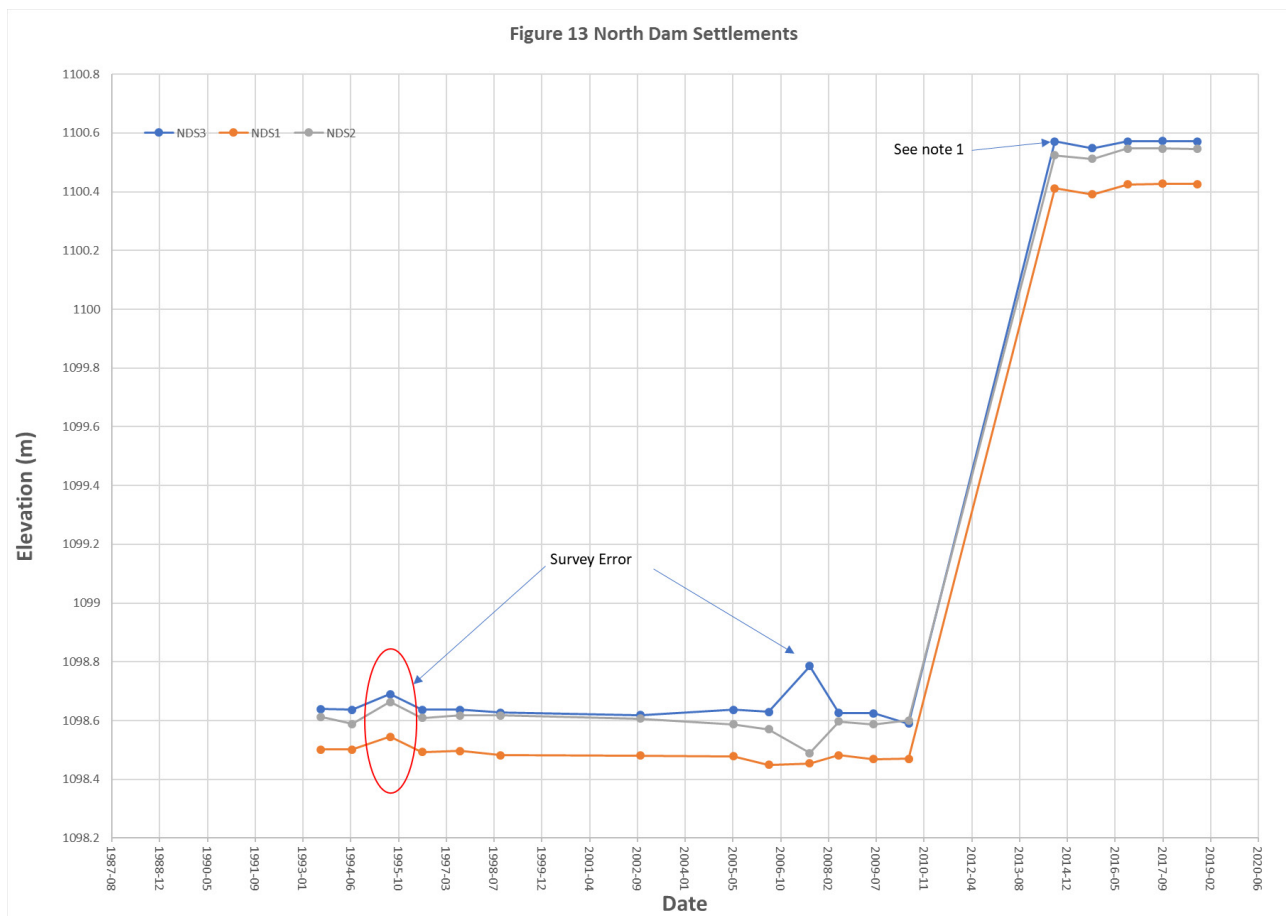
Figure 13: North Dam Settlements

Teck has been surveying the settlement gauges on the North Dam since 1993. Results are shown on Table 4-1. The results are elevations taken from the top of the steel pins that were set within the crest of the dam during construction. The last set of readings taken using the 1990 datum was completed in 2010. A recent set of readings was completed in 2017 based on the 2012 datum. The readings are consistent with those observed in previous years, with settlement

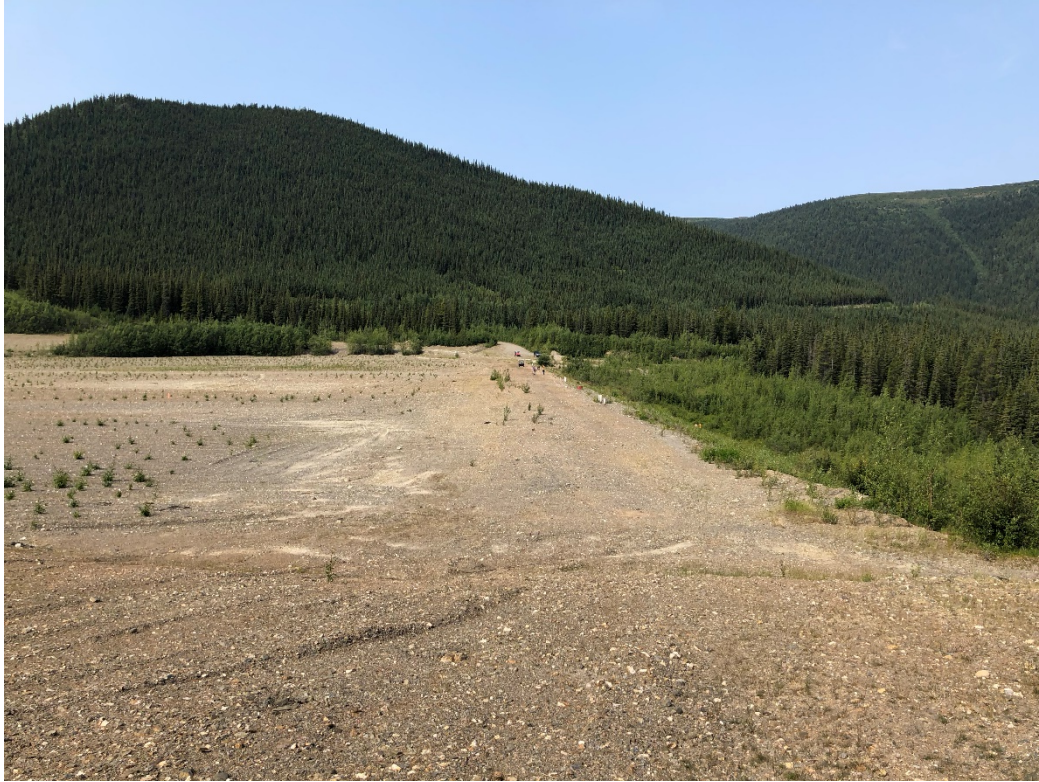
The crest of the North Dam looking west is shown in Photo 1, The dam is in good condition and shows no signs of deformation or abnormal settling. The downstream slope of the dam (Photo 2) shows no signs of surficial movement or erosion nor is there any sign of bulging at the downstream toe.

Photo 1: North Dam Crest looking west

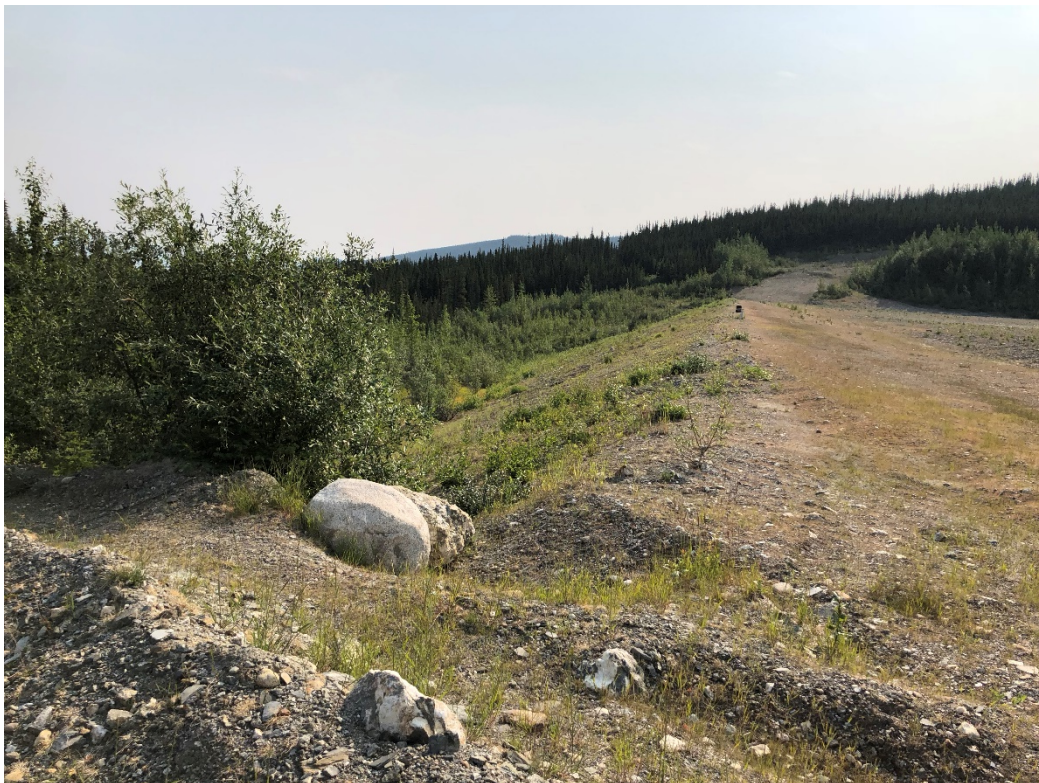
Photo 2: Downstream slope of the North Dam looking east

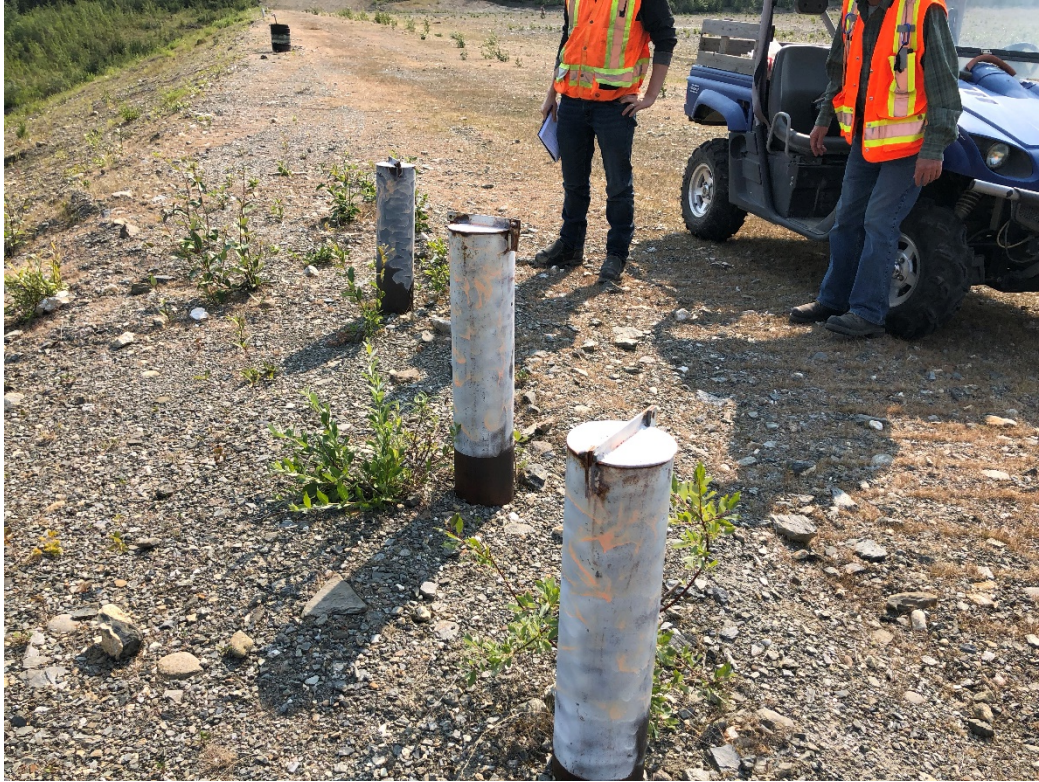
The piezometers and settlement gauges (Photos 3, 4, 5 and 6) on the North Dam are in good condition and continue to function as designed. Orange coloured piezometer caps provide visible identification for the monitoring team. However, it was noted that two of the piezometers (PVC pipes) namely NDW-2B and NDW-1A do not have plastic caps and are not labelled.

Photo 3: North Dam Piezometers NDW-3A and 3B, NDS-3

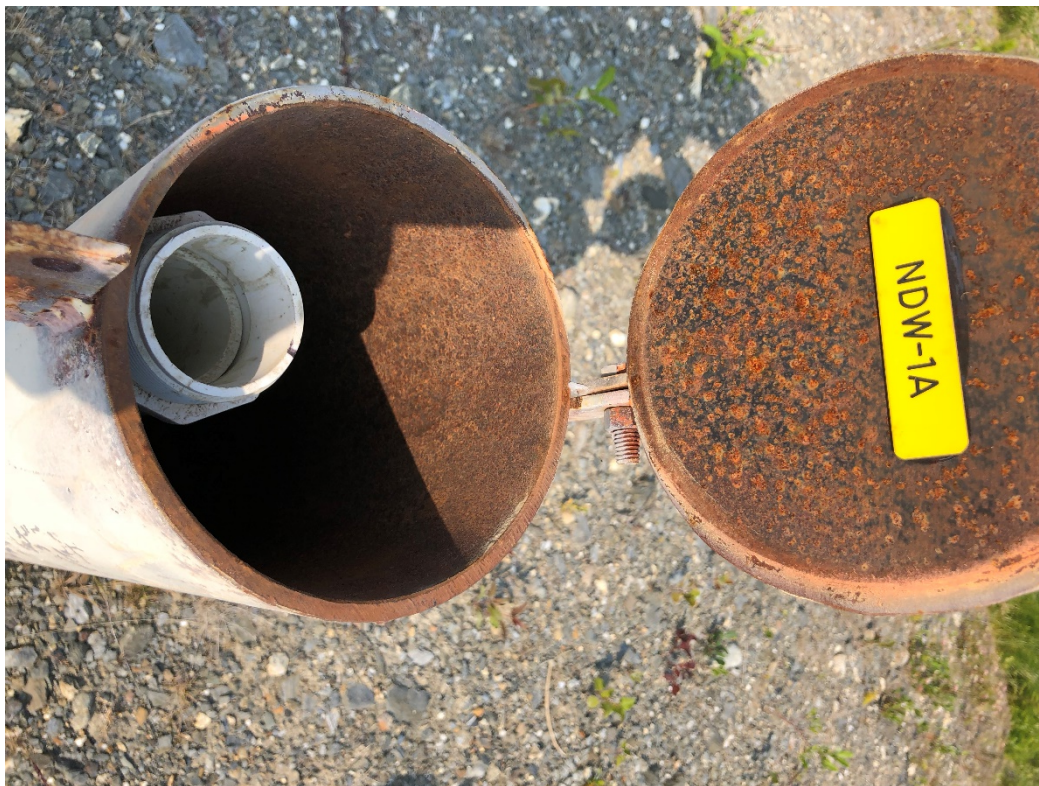
Photo 4: Missing cap on Piezo NDW 1A.

Structure	ID No.	Deficiency or Non Conformance	Applicable Regulatory or OMS Reference	Recommended Action	Priority ¹	Recommended Deadline/ Status
North Dam	2018-1	NDW-2B and 1A missing caps	OMS 5.3.2	Install plastic caps and label	3	Before end of 2018 Completed October 18, 2018 Closed

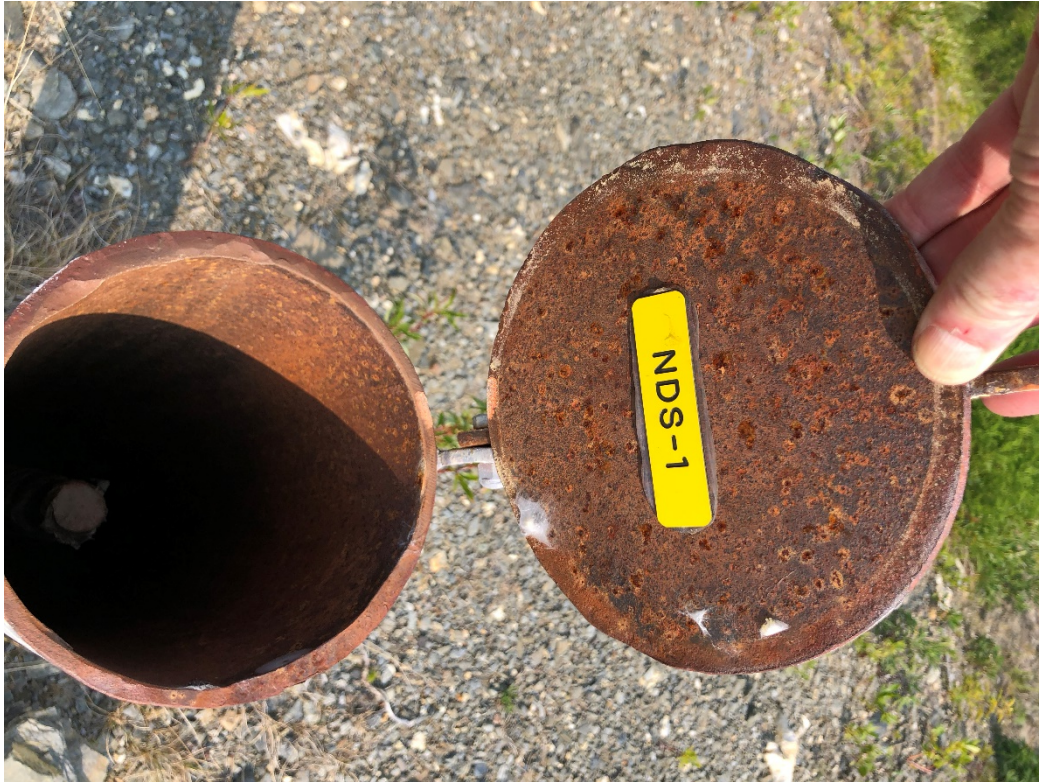
Photo 5: Settlement Gauge NDS-1

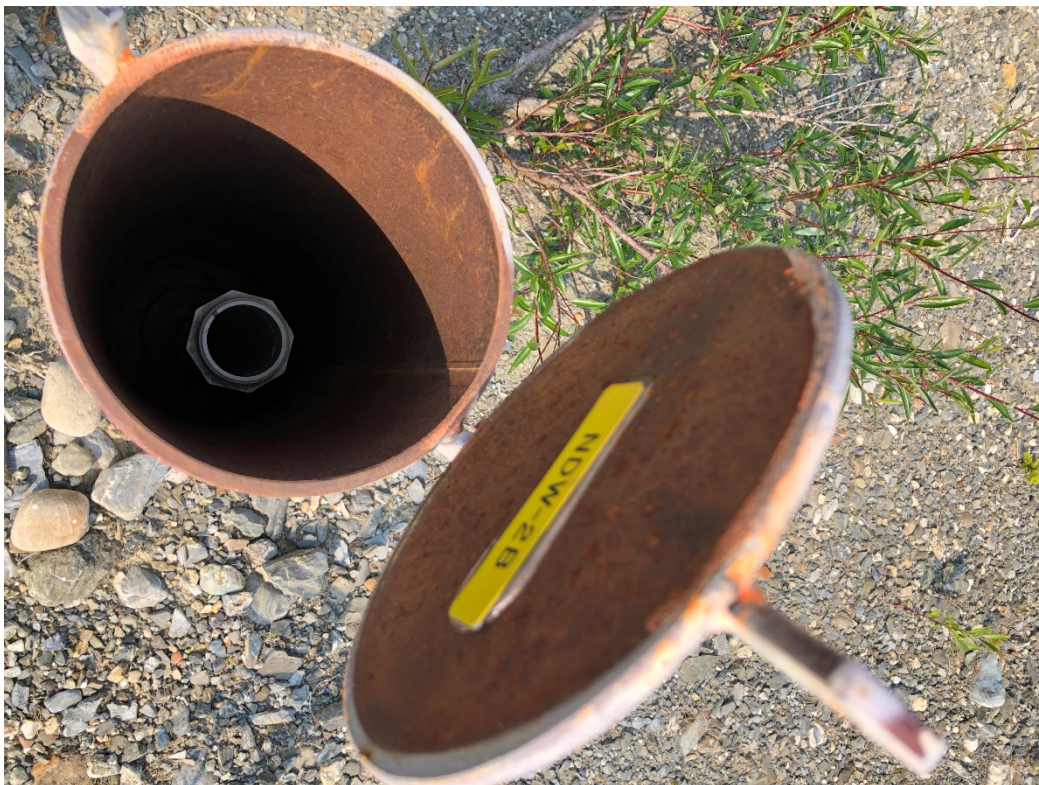
Photo 6: Missing cap on Piezometer NDW-2B

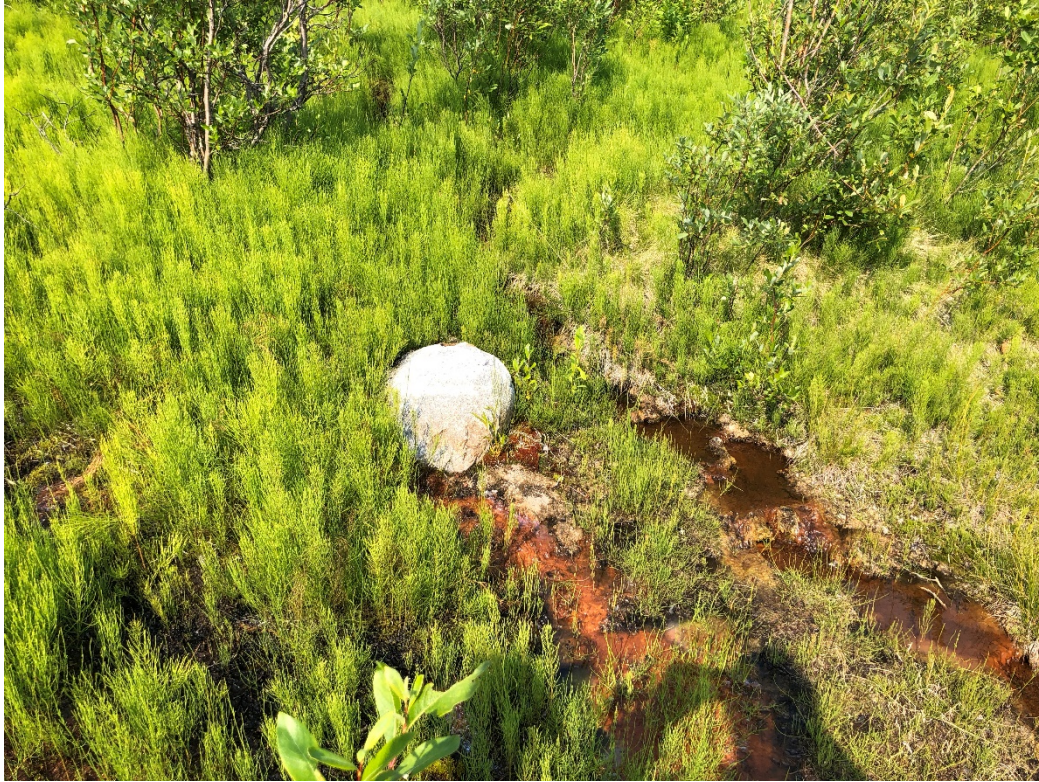
Photo 7: Seepage at toe of North Dam, mainly due to hillside seepage from the west

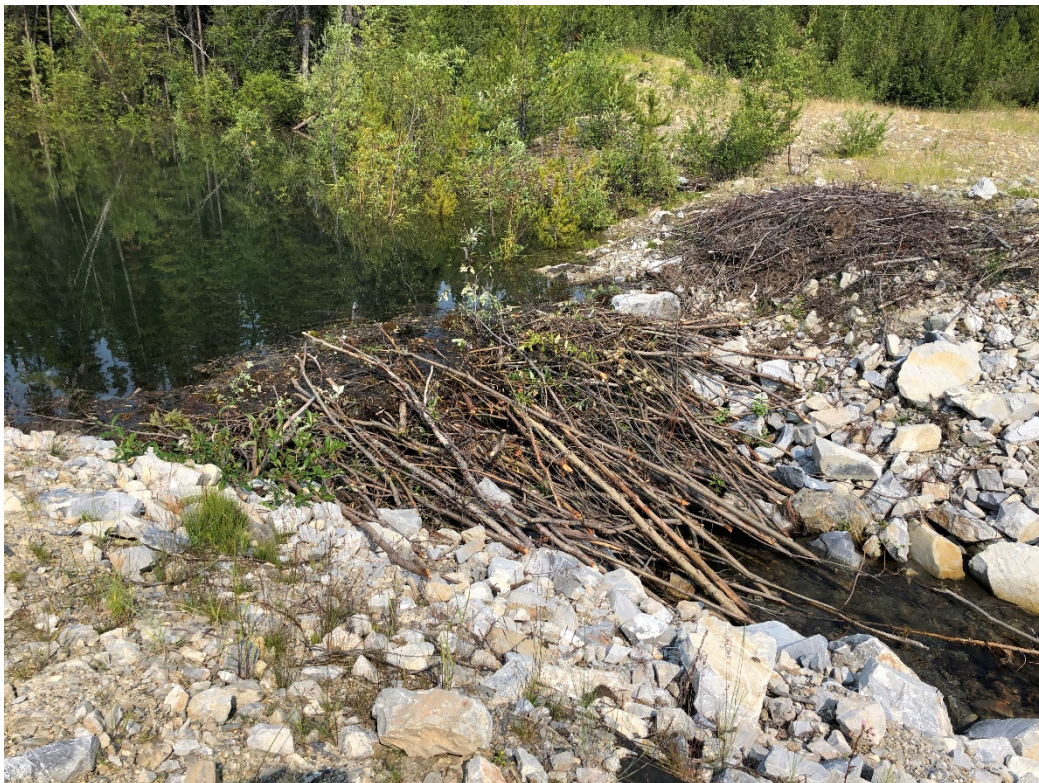
A riprapped channel conveys the North Creek over the original location of the decommissioned North Creek Dyke. It was noted at the inlet of the channel that beavers had again built a dam which was restricting flow (Photo 12). The dam raises the water level of the pond behind the structure and increases the risk of a rapid release of water that could result in erosion of the riprap protection in the channel. The dam was removed in 2018. Best Practice dictates that beaver dams be removed when identified during the routine inspections. Photo 13 shows a view looking upstream of the channel. At the outlet of the channel (Photo 14) some of the riprap had previously been dislodged by the flow, exposing a small area of the underlying filter fabric. There has been no noticeable change to this area since it was observed last year. The channel remains stable and no remediation is required.

Photo 12: Beaver dam at inlet to North Creek crossing

Structure	ID No.	Deficiency or Non Conformance	Applicable Regulatory or OMS Reference	Recommended Action	Priority ¹	Recommended Deadline/ Status
North Creek Channel	2018-2	Beaver Dam at inlet to channel	OMS 5.6.3	Remove beaver dam in channel	3	Before End of 2018 / Completed July 26 Closed
Jewelbox Waste Rock Dump	2018-3	Erosion Gully in North east corner	OMS 6.5.6 and 5.3.1	Install additional Monitoring pins	3	Before End of 2018 / Completed July 26 Closed

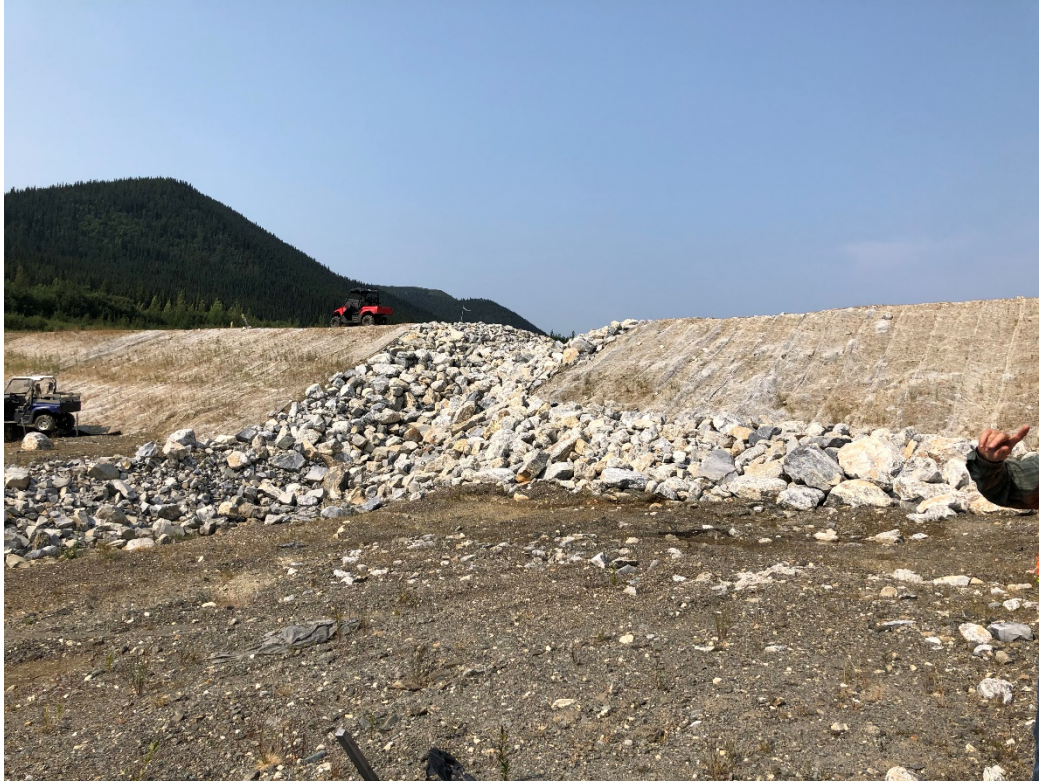
The spillway (Photo 17) remains in stable condition with no noticeable subsidence.

Photo 17: View looking north of the spillway at the SRS

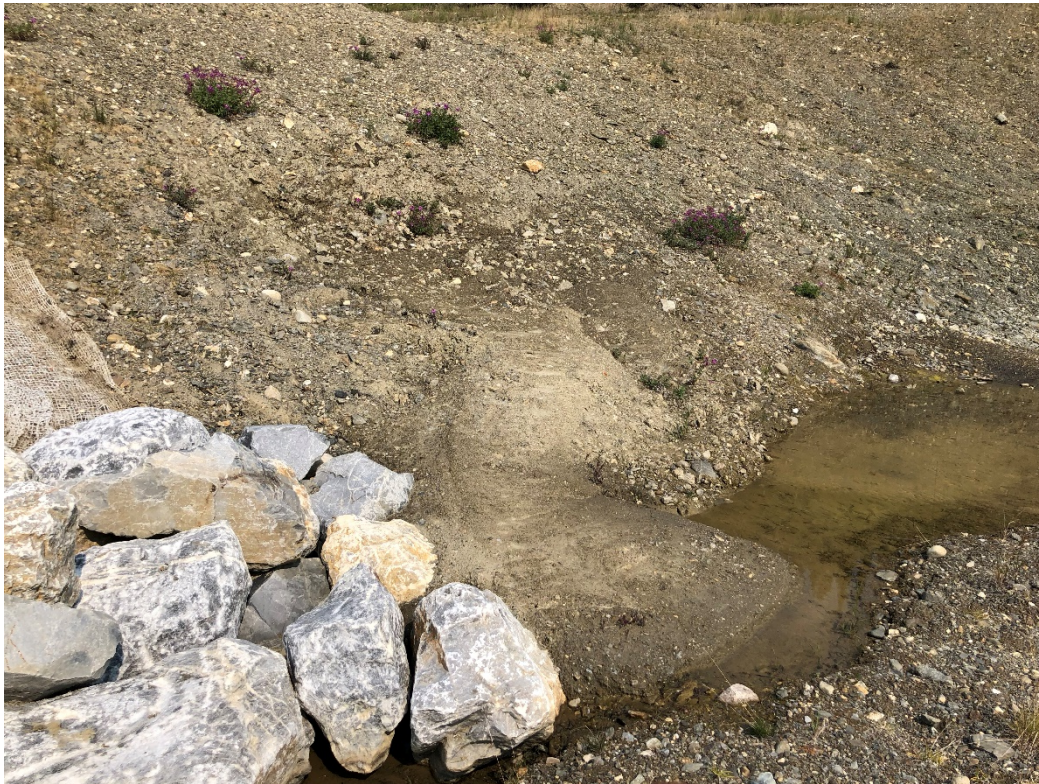
Seepage from the hillside area to the east of the structure is still evident along the downstream toe of the SRS (Photo 19). A small active boil that has been noted in previous inspections was still present. This boil is a remnant of pore pressures that were evident during and after the construction of the South Dam which prompted the construction of a toe buttress. The pore pressures were a result of the hydraulic gradient across the dam due to the stored water in behind the embankment. The pore pressures were accentuated by the sand and gravel zones in the foundation soils below the dam. Since the removal of the South Dam, the pore pressures have significantly reduced but the small head of water due to the retained pond behind the SRS dyke is the likely source of the boil.

Photo 19: View of the eastern end of the riprap buttress along the D/S toe of the SRS dyke

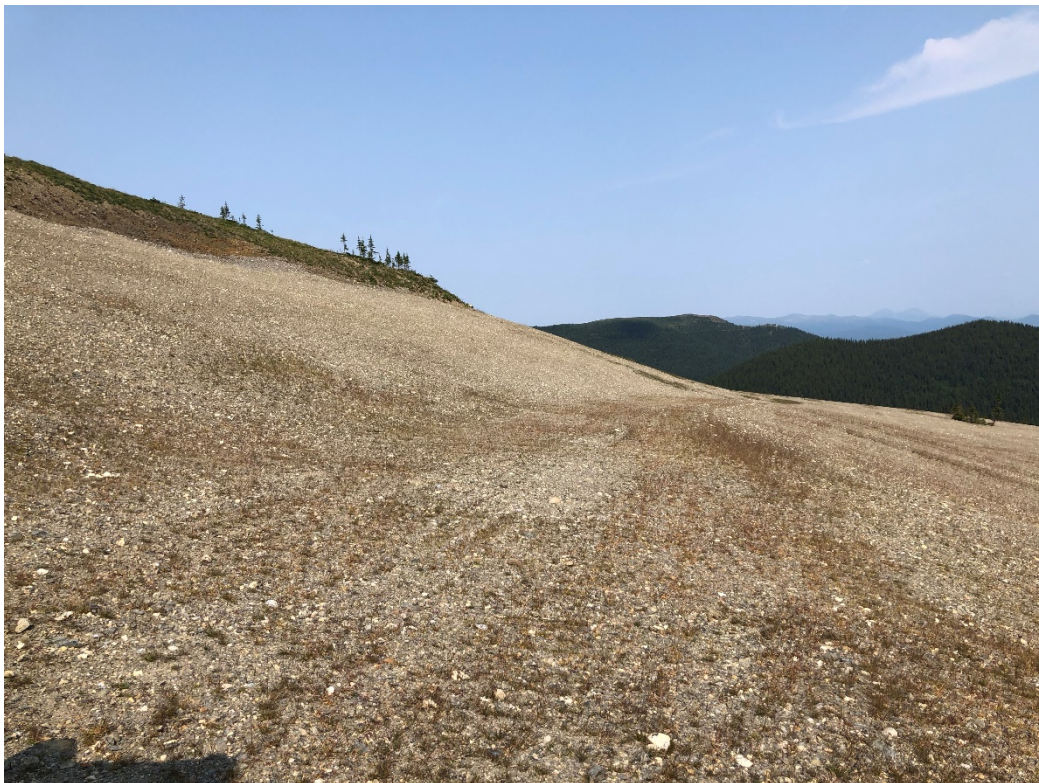
SRK inspected the resloped Main Zone and Jewelbox waste dumps (Photo 24 and Figure 12). It was noted that at the northeast end of the JewelBox dump, there was evidence of some erosion (Photos 25 and 26). Following the 2017 DSI, monitoring pins were installed at the base of the erosion gully to monitor any deepening of the gully over time. It was noted that the gully had not deepened but there was evidence of some minor sideways erosion. This erosion does not impact the stability of the dump.

Photo 24: Reggraded slopes of Jewelbox waste rock dump

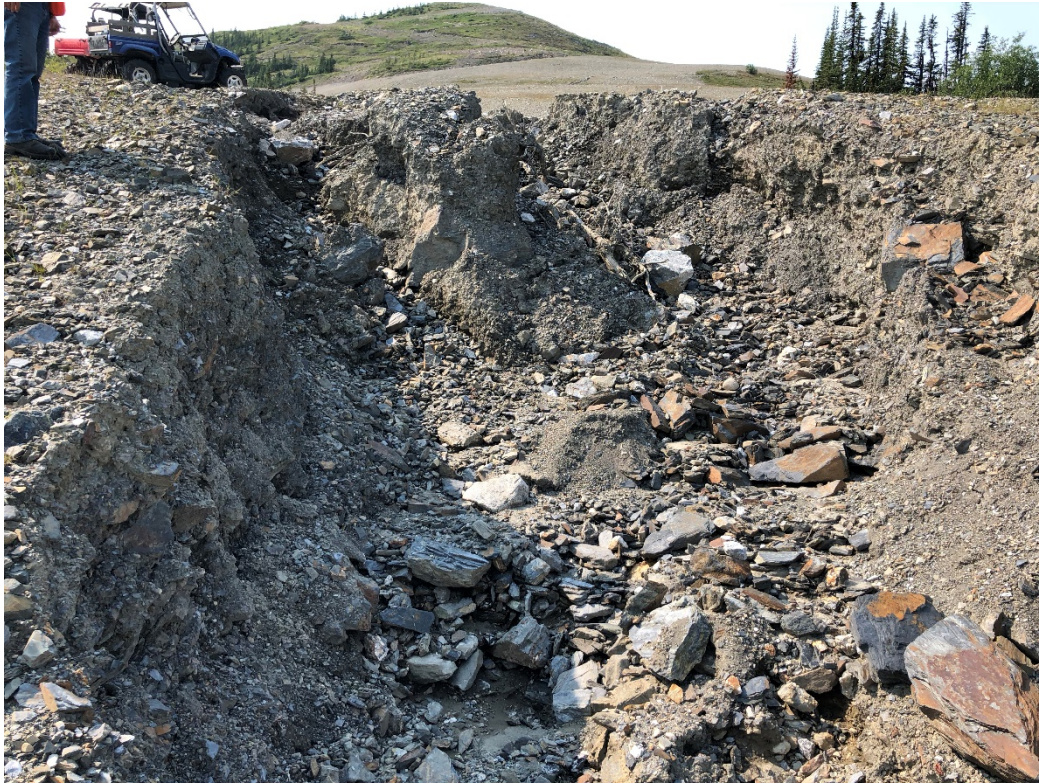
Photo 25: Erosion gully at toe of Jewelbox Waste rock dump

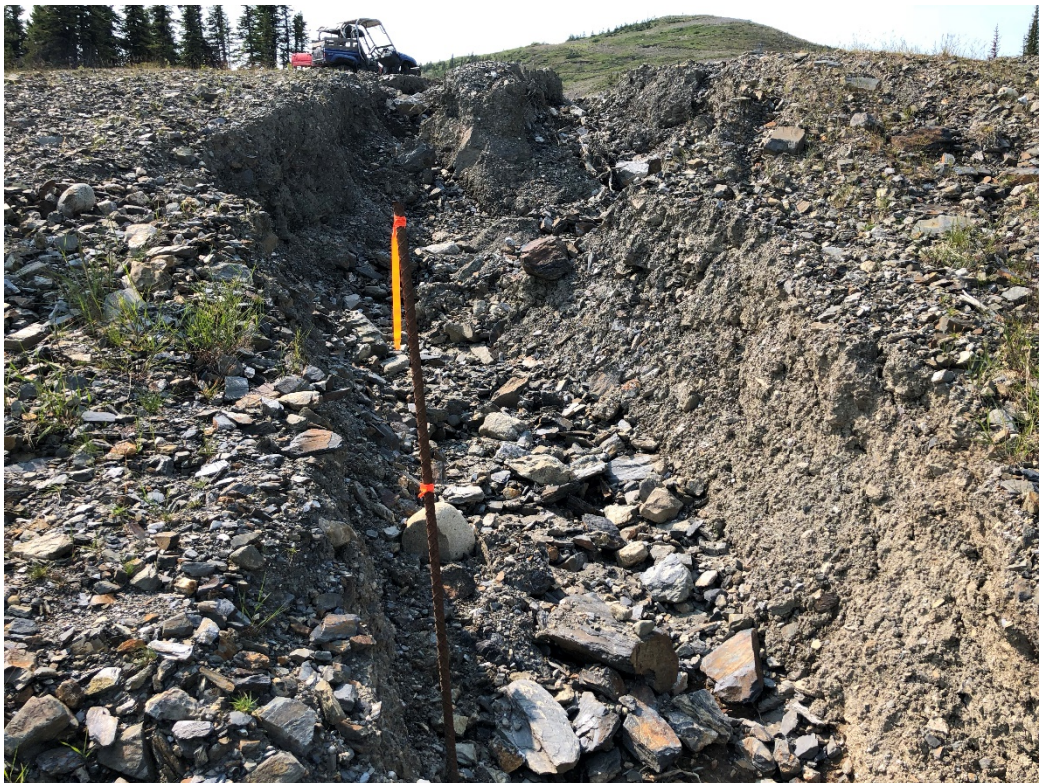
Photo 26: erosion gully at toe of Jewelbox waste rock dump with monitoring pin

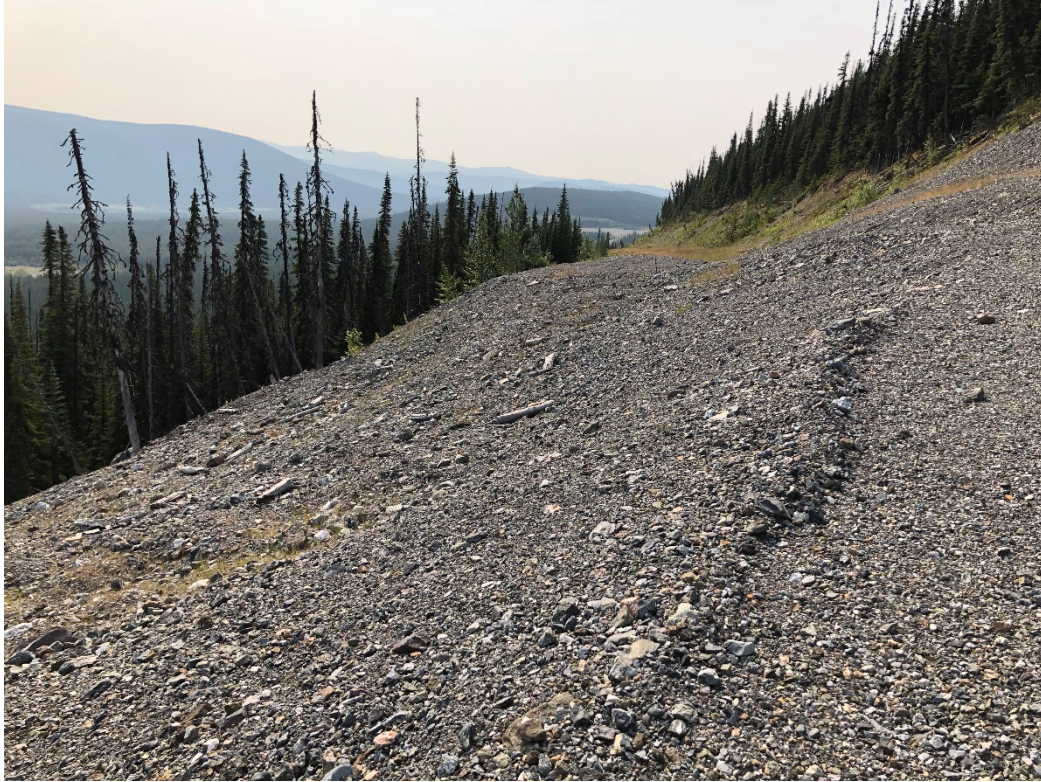
Minor settlement of the fill that was placed over the 1200 portal was noted during the 2017 inspection. The settled area was inspected this year (Photo 27) and no further settlement was noted.

Photo 27 minor subsidence on the slope of the backfill at Portal 1200 on Burnick
