**Teck Metals Ltd.**

**Sullivan Mine Tailings Facilities**

***2018 Dam Safety Inspection***

March 2019

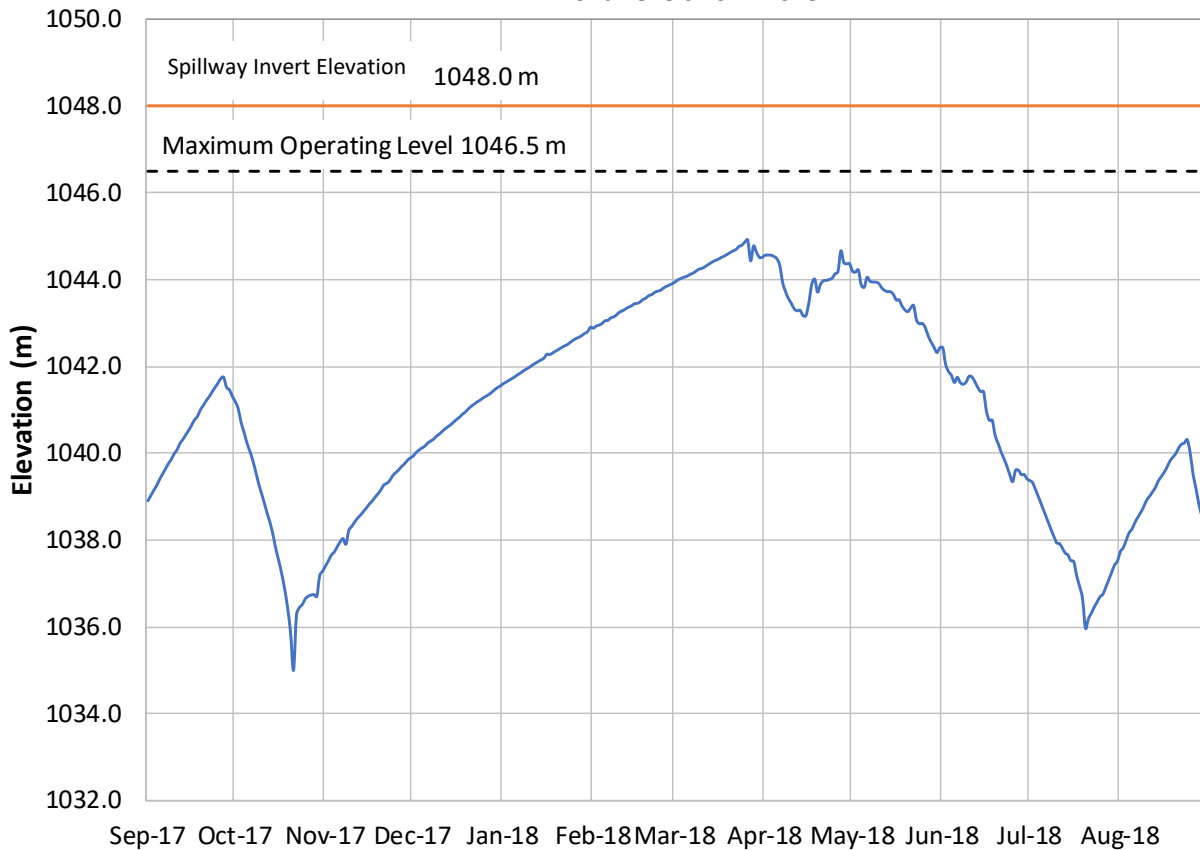
**Figure 3.2 ARD Pond Level 2017 – 2018**

Based on the pond water levels, the maximum level observed during the time period was 1044.9 m, which occurred on March 26, 2018. This is 1.6 m lower than the maximum operating level (MOL) and 2.5 m below the spillway crest elevation (spillway reports to the Iron Pond). There was no water discharged from the spillway to the Iron Pond during the water balance time period, and records show that water has never discharged from the ARD Pond spillway since it was commissioned in 2001.

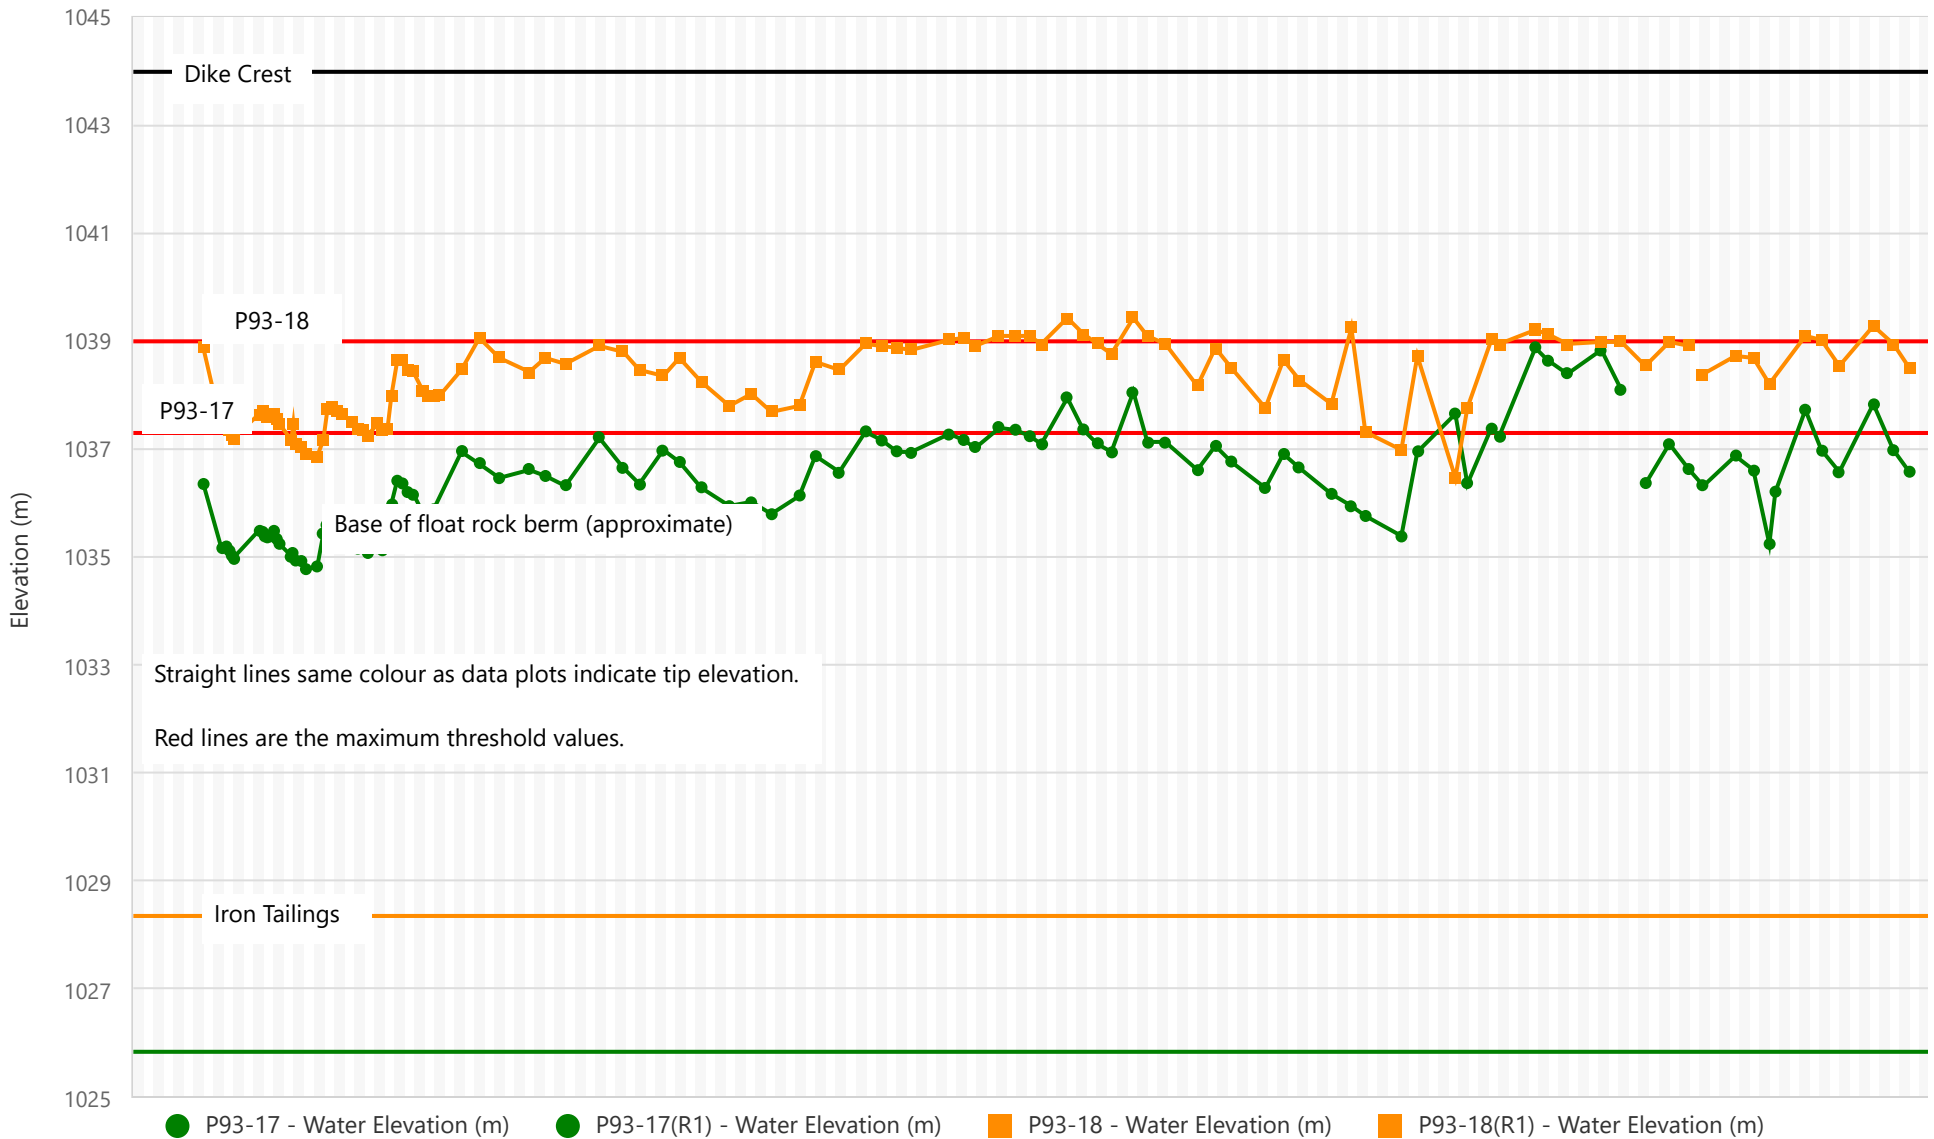
Figure V-2 Old Iron Dike

Standpipe piezometers were flushed in July/August 2014. Not all sediment was removed and some casings also cut or extended/repared at this time. Therefore a new top of casing and new depth to bottom of standpipe was recorded for many instruments. Older data will appear below tip elevation if previously read "dry" or if previous top of casing elevation was incorrect due to damage.

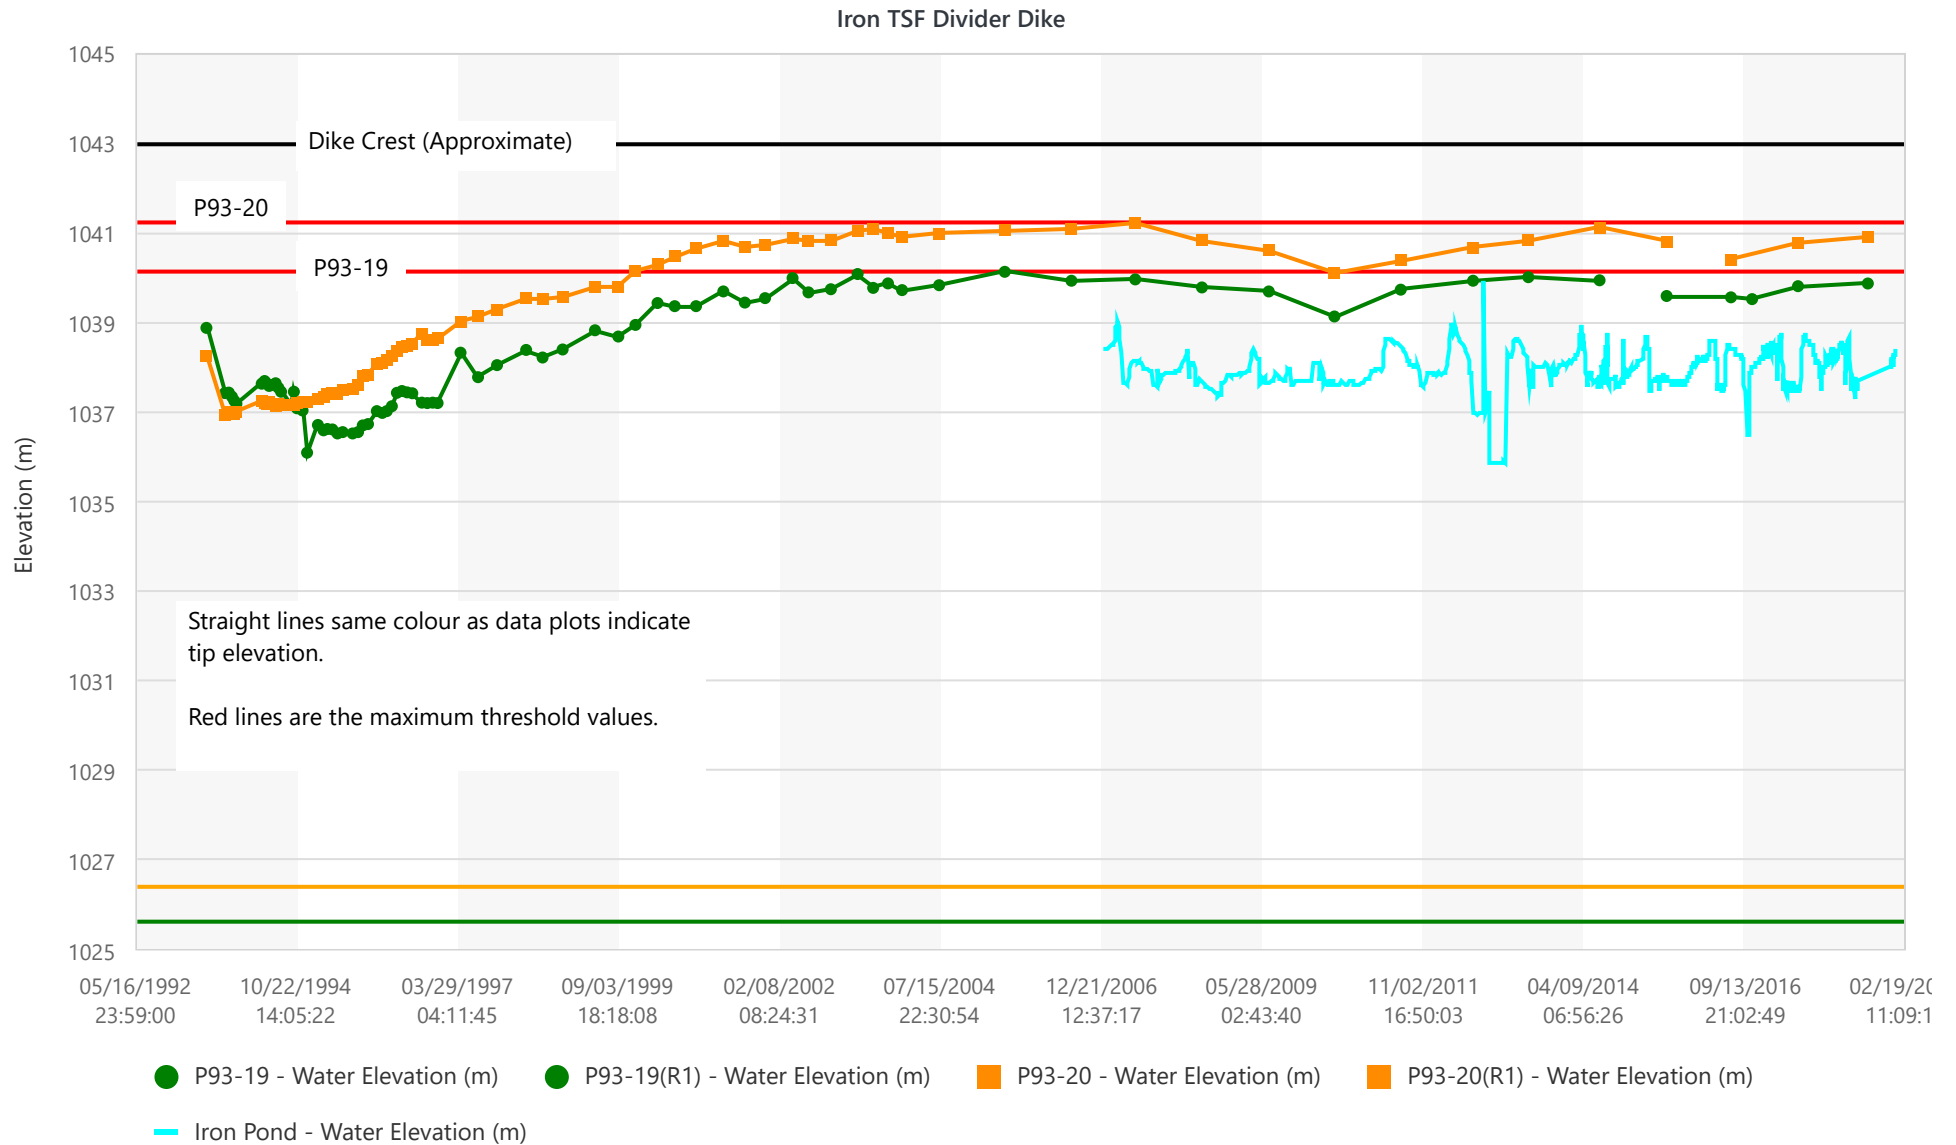
Standpipe piezometers were flushed in July/August 2014. Not all sediment was removed and some casings also cut or extended/repared at this time. Therefore a new top of casing and new depth to bottom of standpipe was recorded for many instruments. Older data will appear below tip elevation if previously read "dry" or if previous top of casing elevation was incorrect due to damage.

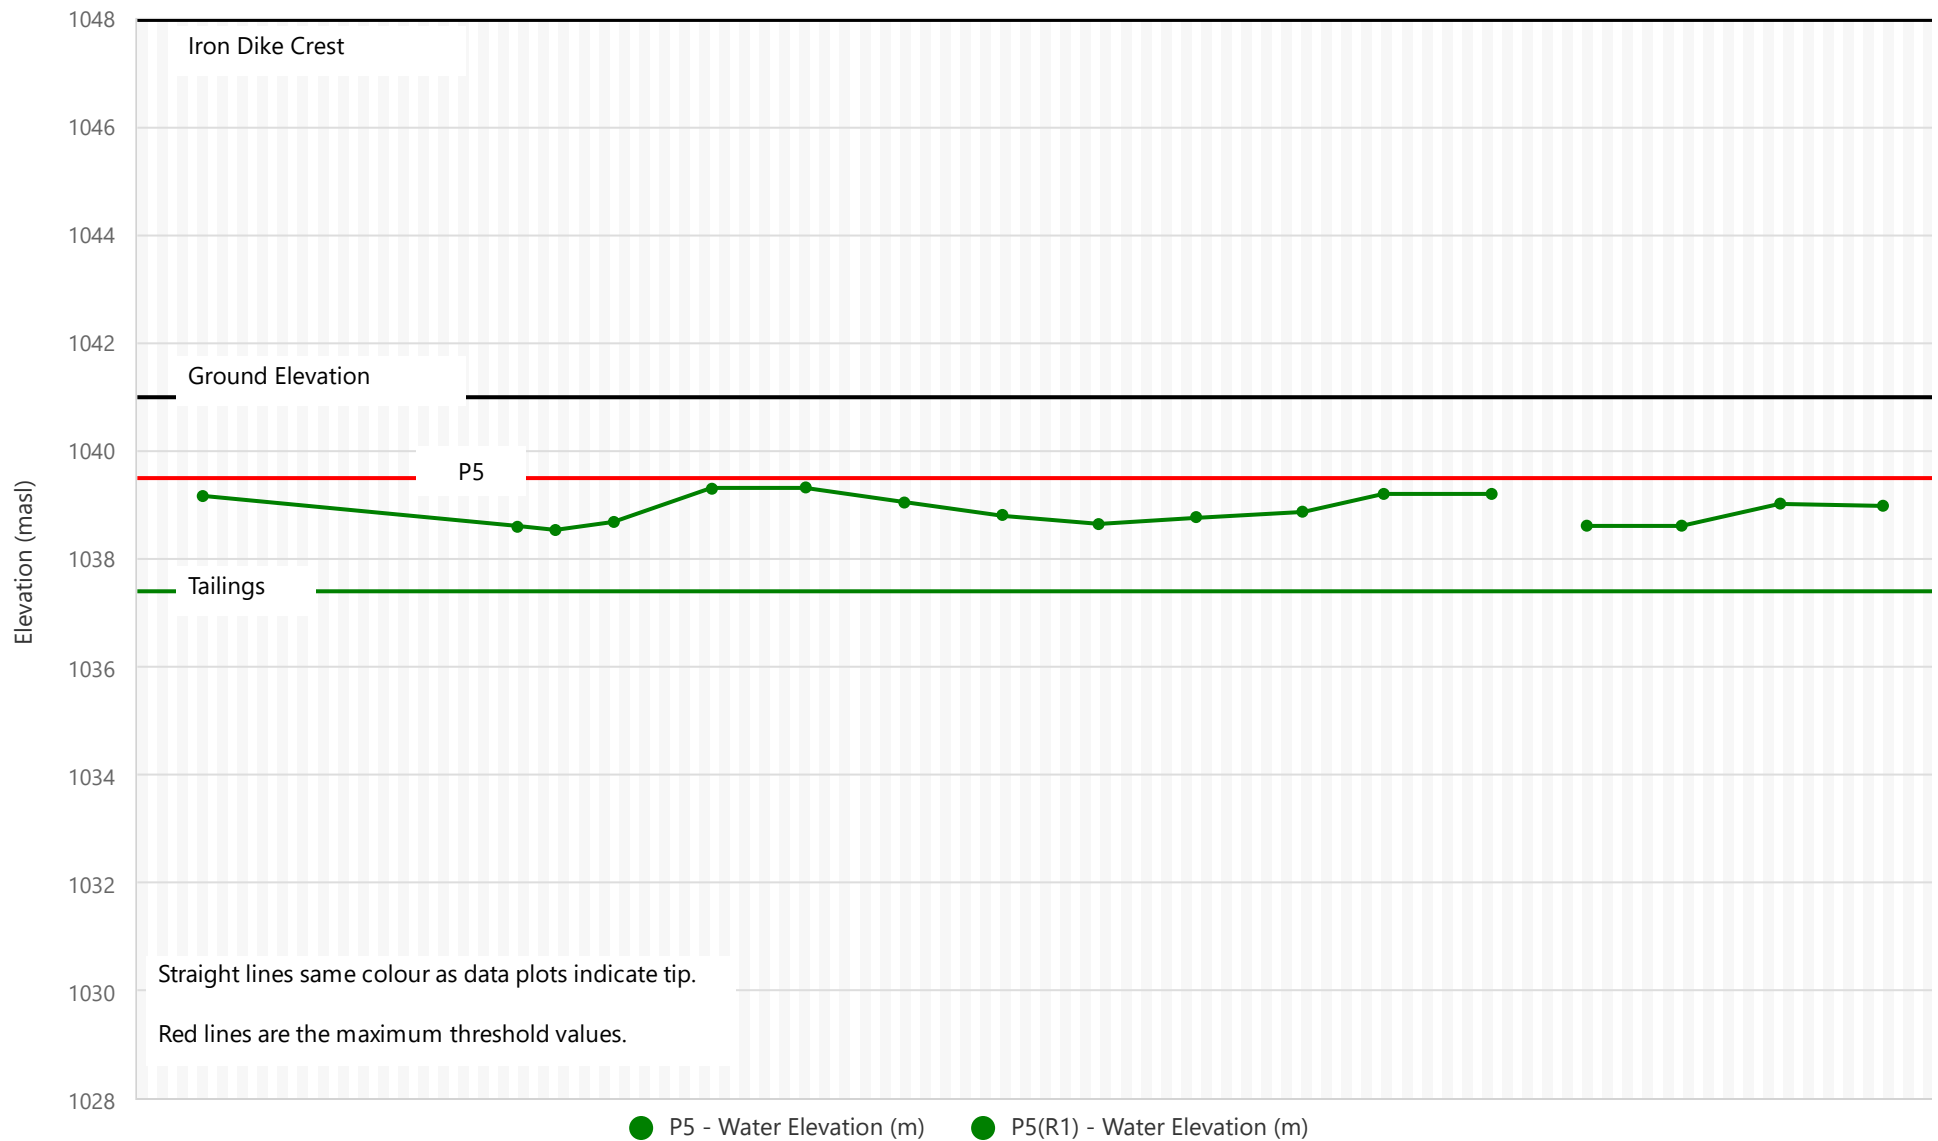
Standpipe piezometers were flushed in July/August 2014. Not all sediment was removed and some casings also cut or extended/repared at this time. Therefore a new top of casing and new depth to bottom of standpipe was recorded for many instruments. Older data will appear below tip elevation if previously read "dry" or if previous top of casing elevation was incorrect due to damage.

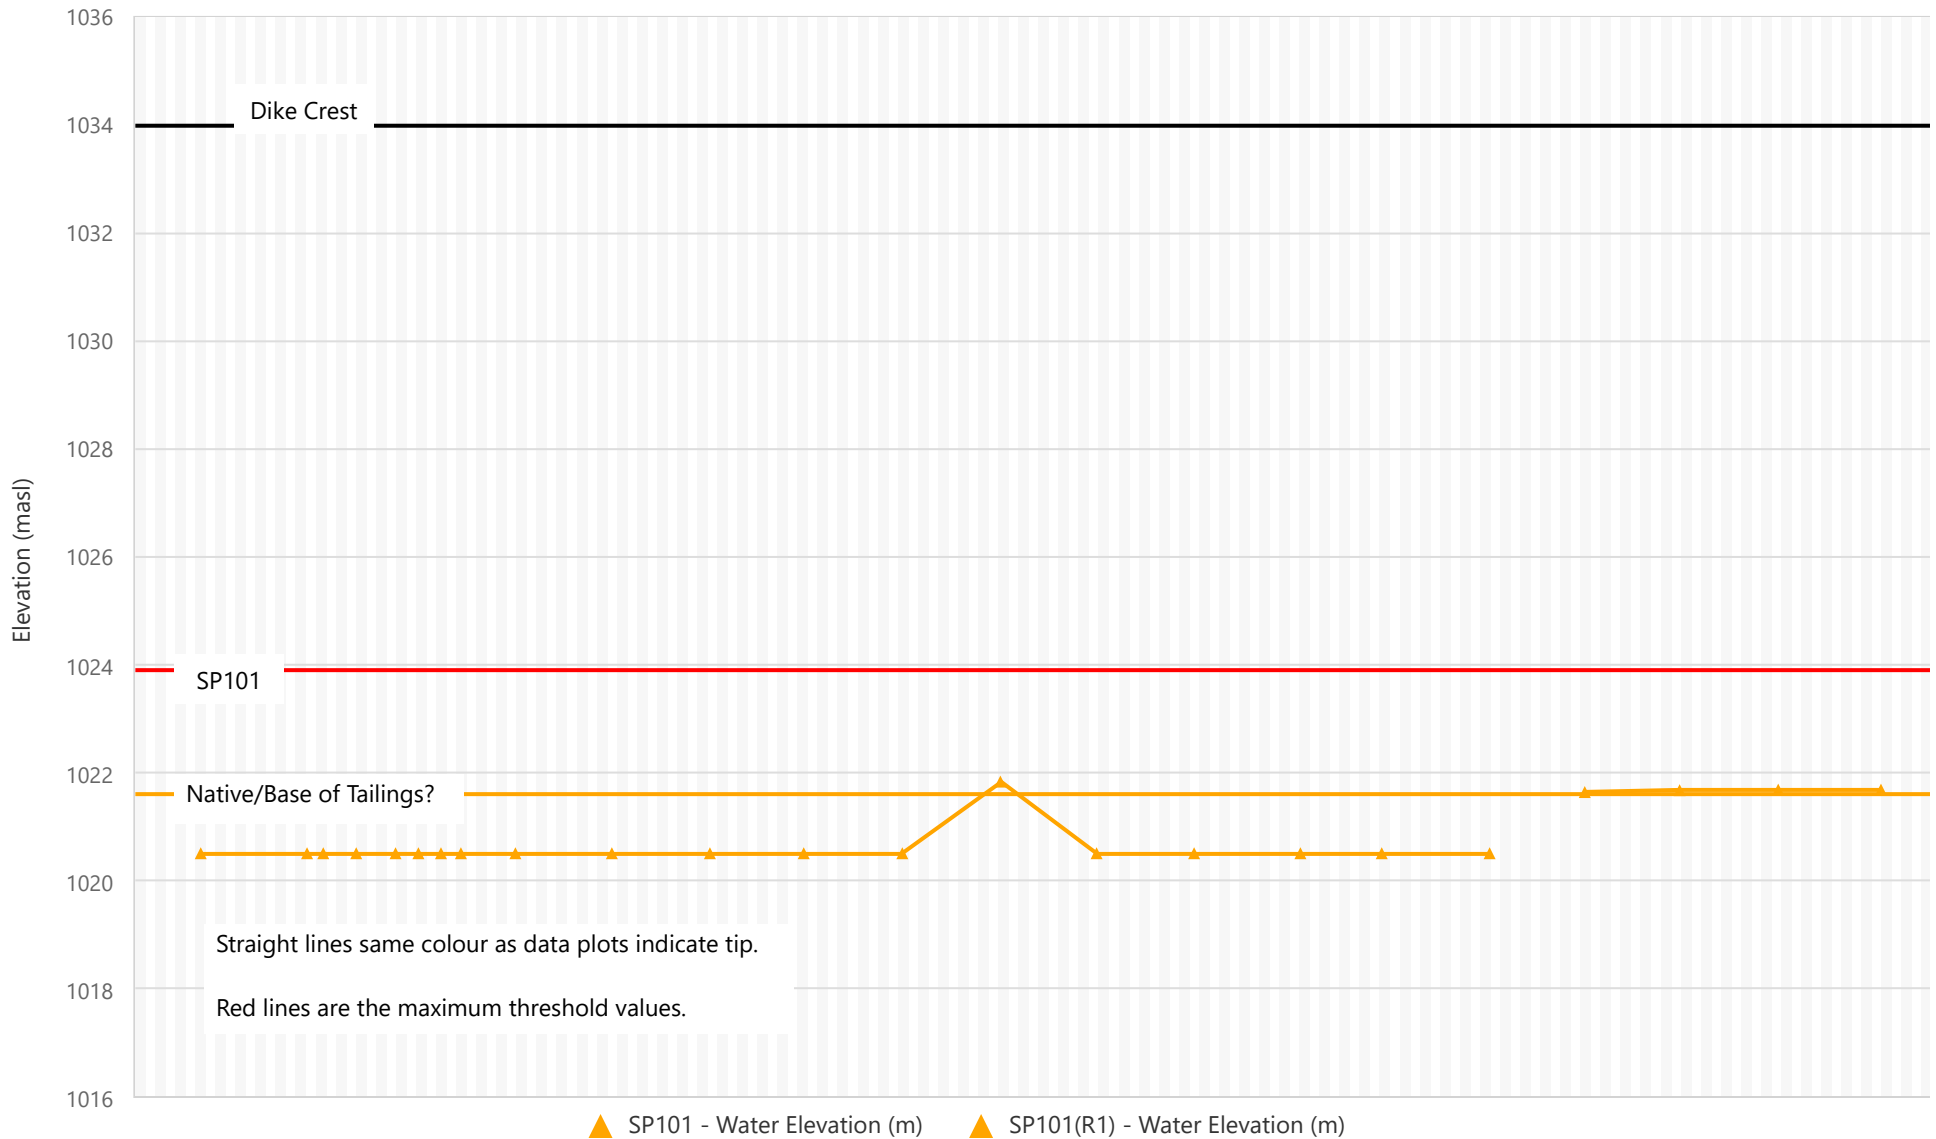
Standpipe piezometers were flushed in July/August 2014. Not all sediment was removed and some casings also cut or extended/repared at this time. Therefore a new top of casing and new depth to bottom of standpipe was recorded for many instruments. Older data will appear below tip elevation if previously read "dry" or if previous top of casing elevation was incorrect due to damage.

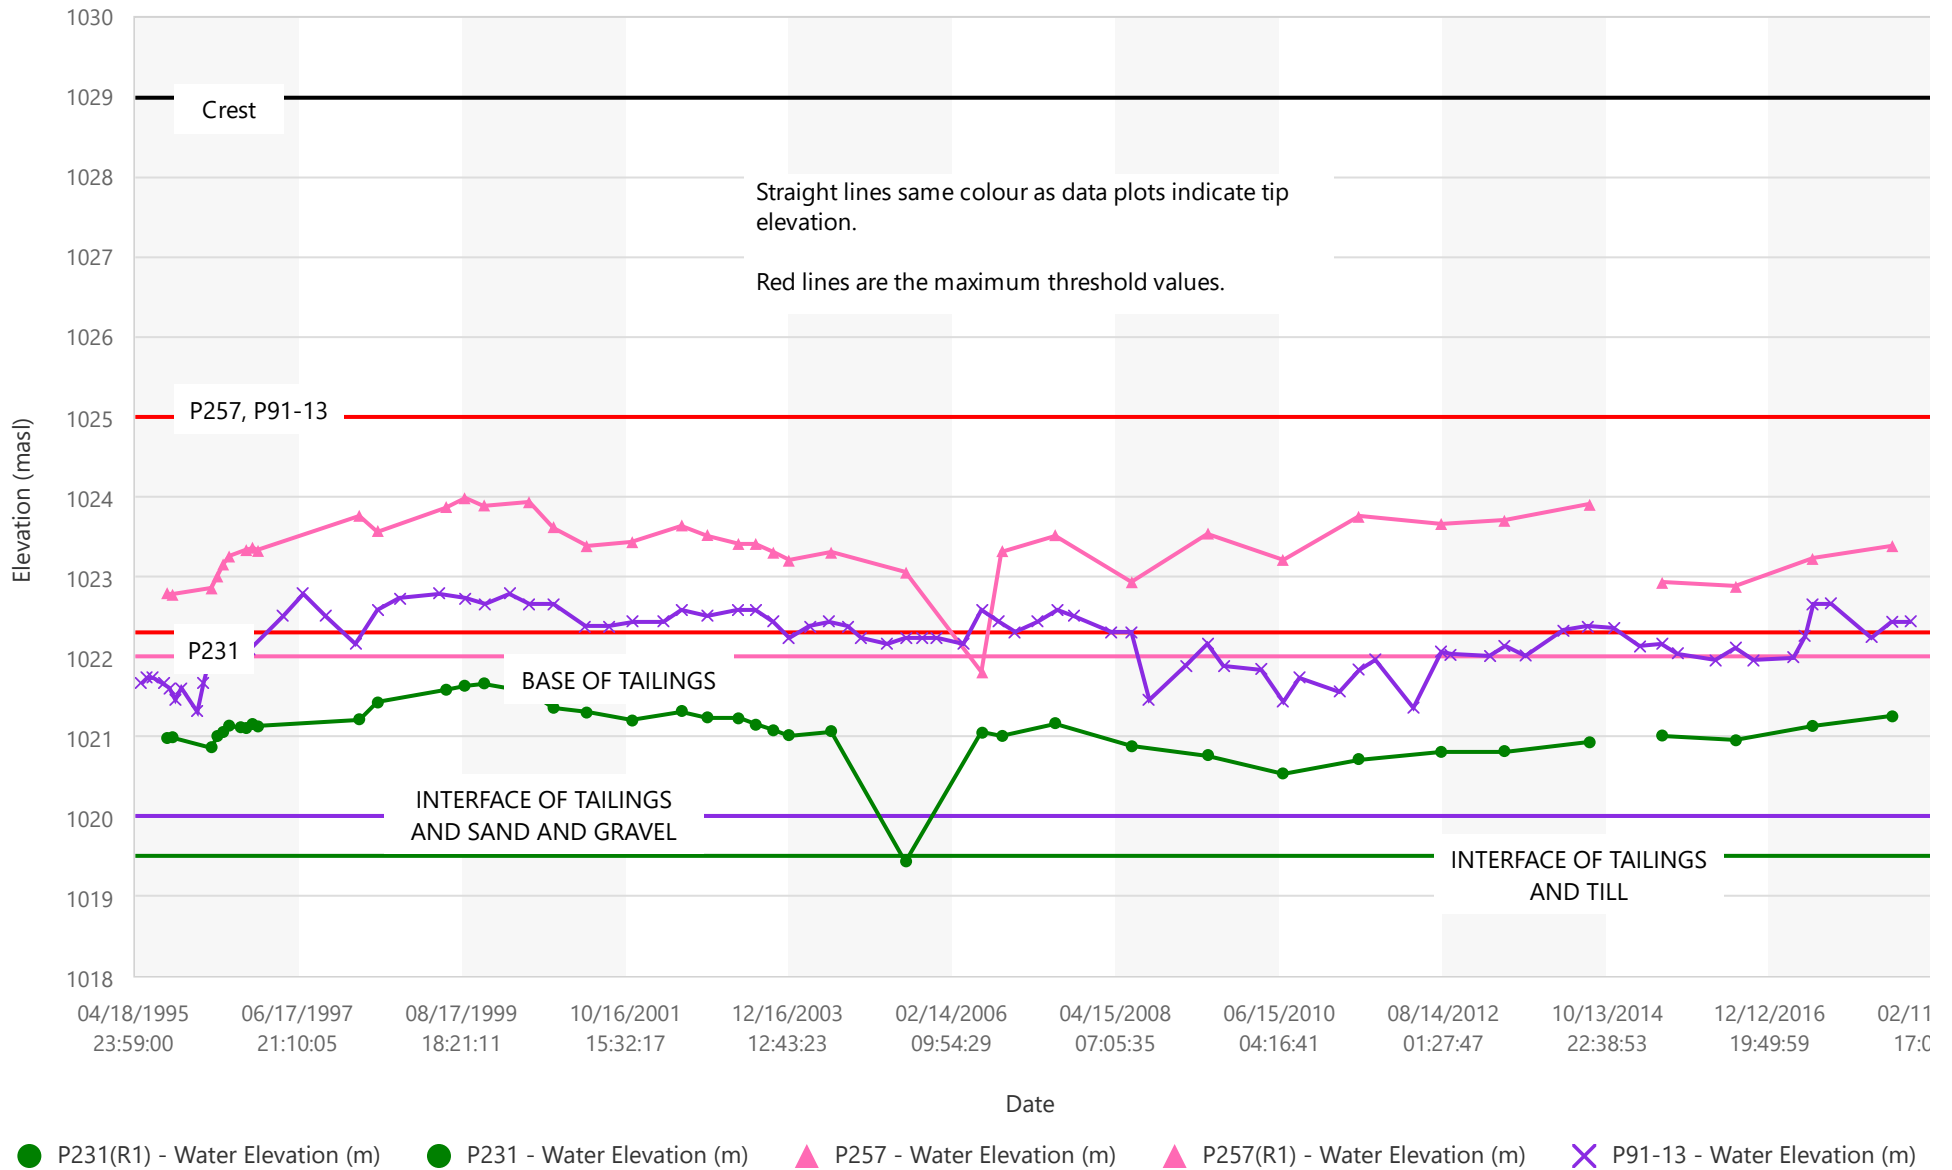
Standpipe piezometers were flushed in July/August 2014. Not all sediment was removed and some casings also cut or extended/repared at this time. Therefore a new top of casing and new depth to bottom of standpipe was recorded for many instruments. Older data will appear below tip elevation if previously read "dry" or if previous top of casing elevation was incorrect due to damage.

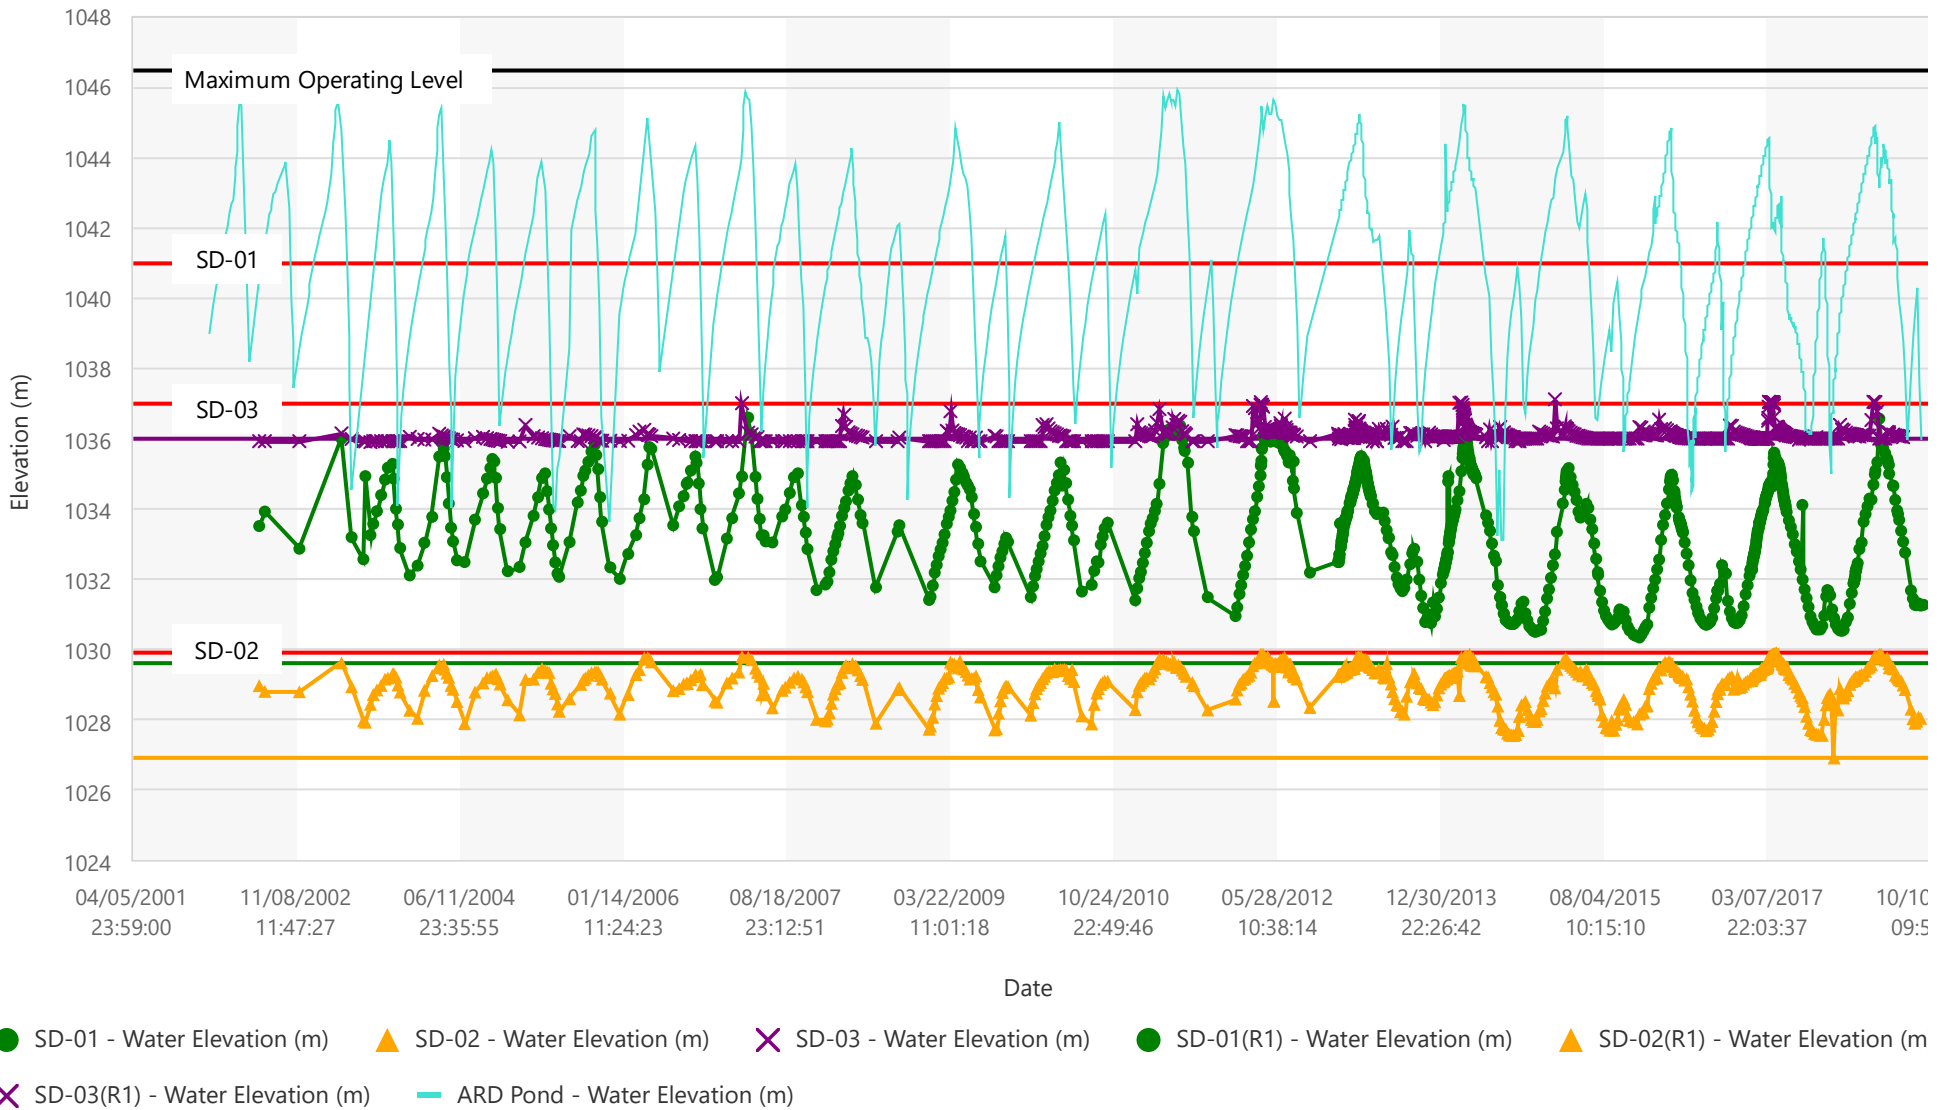
Standpipe piezometers were flushed in July/August 2014. Not all sediment was removed and some casings also cut or extended/repared at this time. Therefore a new top of casing and new depth to bottom of standpipe was recorded for many instruments. Only noticeable for those instruments which record "dry" or if previous top of casing elevation was incorrect due to damage.
