Teck Highland Valley Copper Partnership

2018 Dam Safety Inspection Report

Trojan Tailings Storage Facility

March 2019

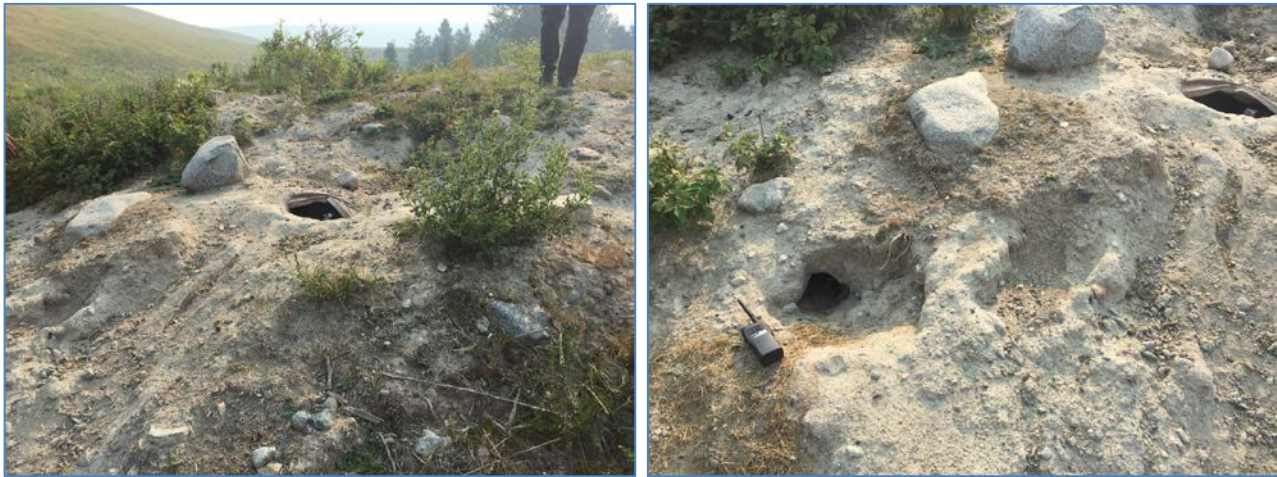
Photo II-A- 7 Animal burrows observed at downstream slope toe area near the R4 Seepage pond (TRJ-2018-08)

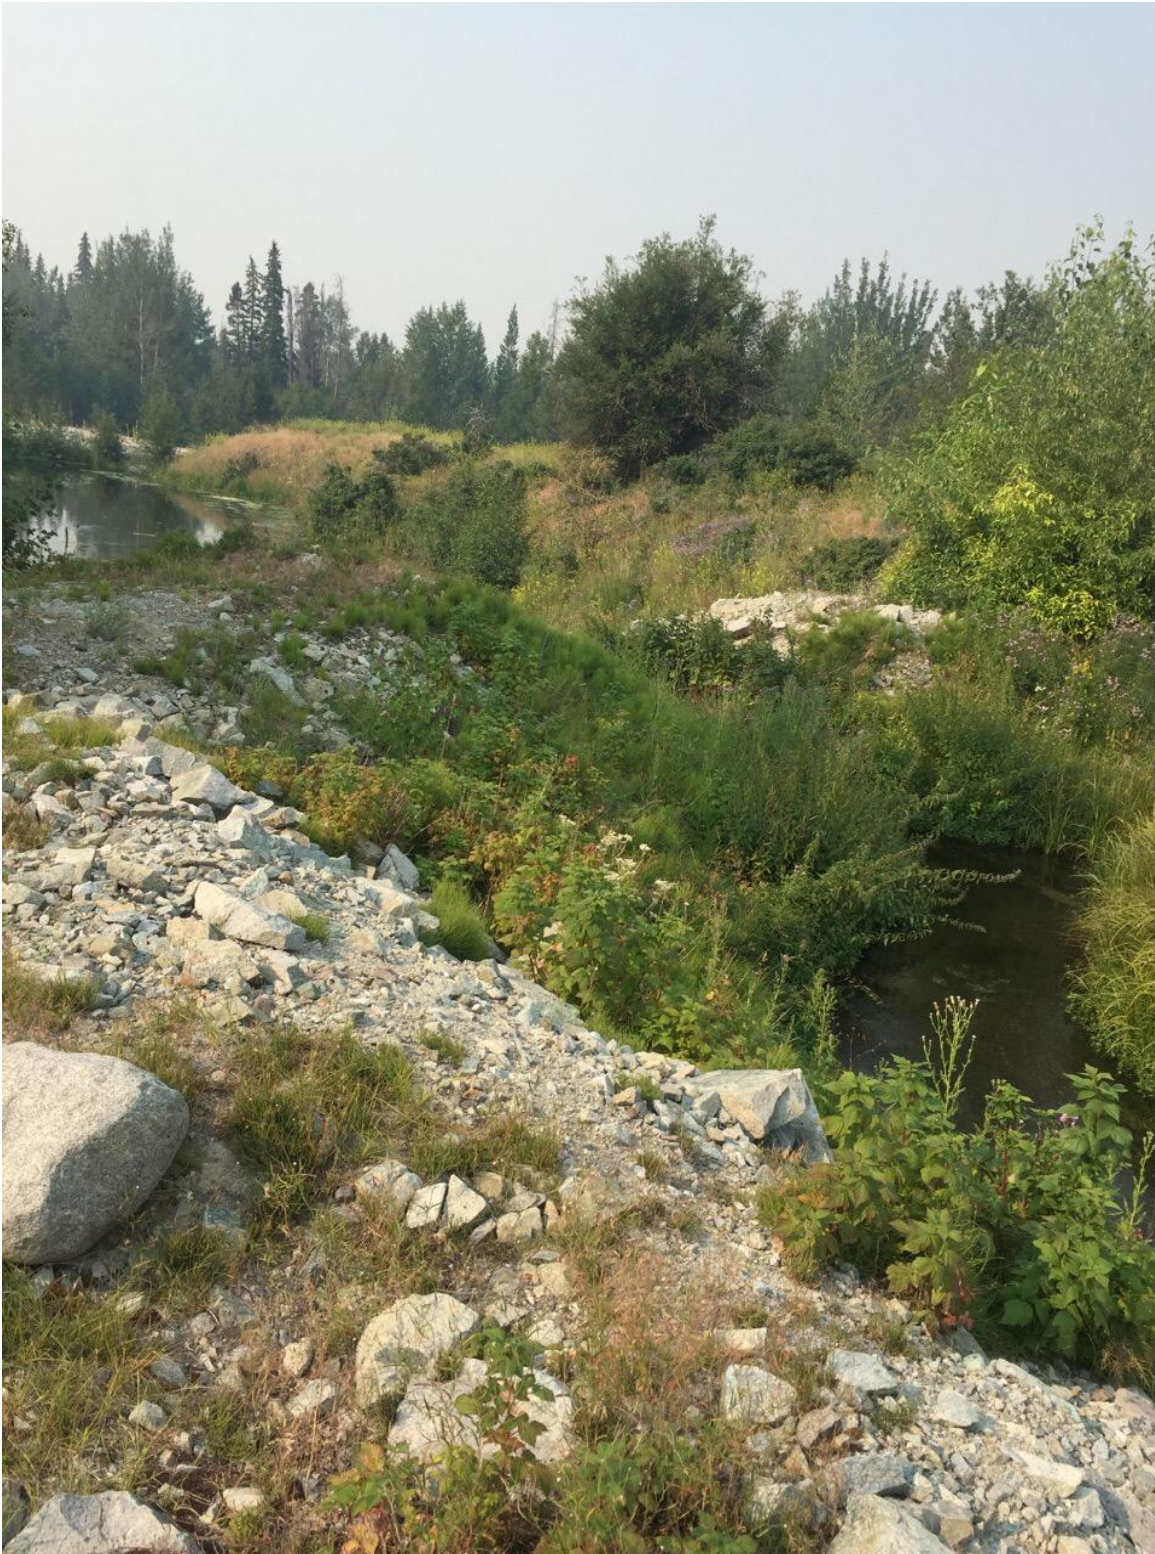
Photo II-A- 10 Immediately downstream of monitoring station TB-R4-FS-01, noted in Photo II-A-9 (TRJ-2018-11)

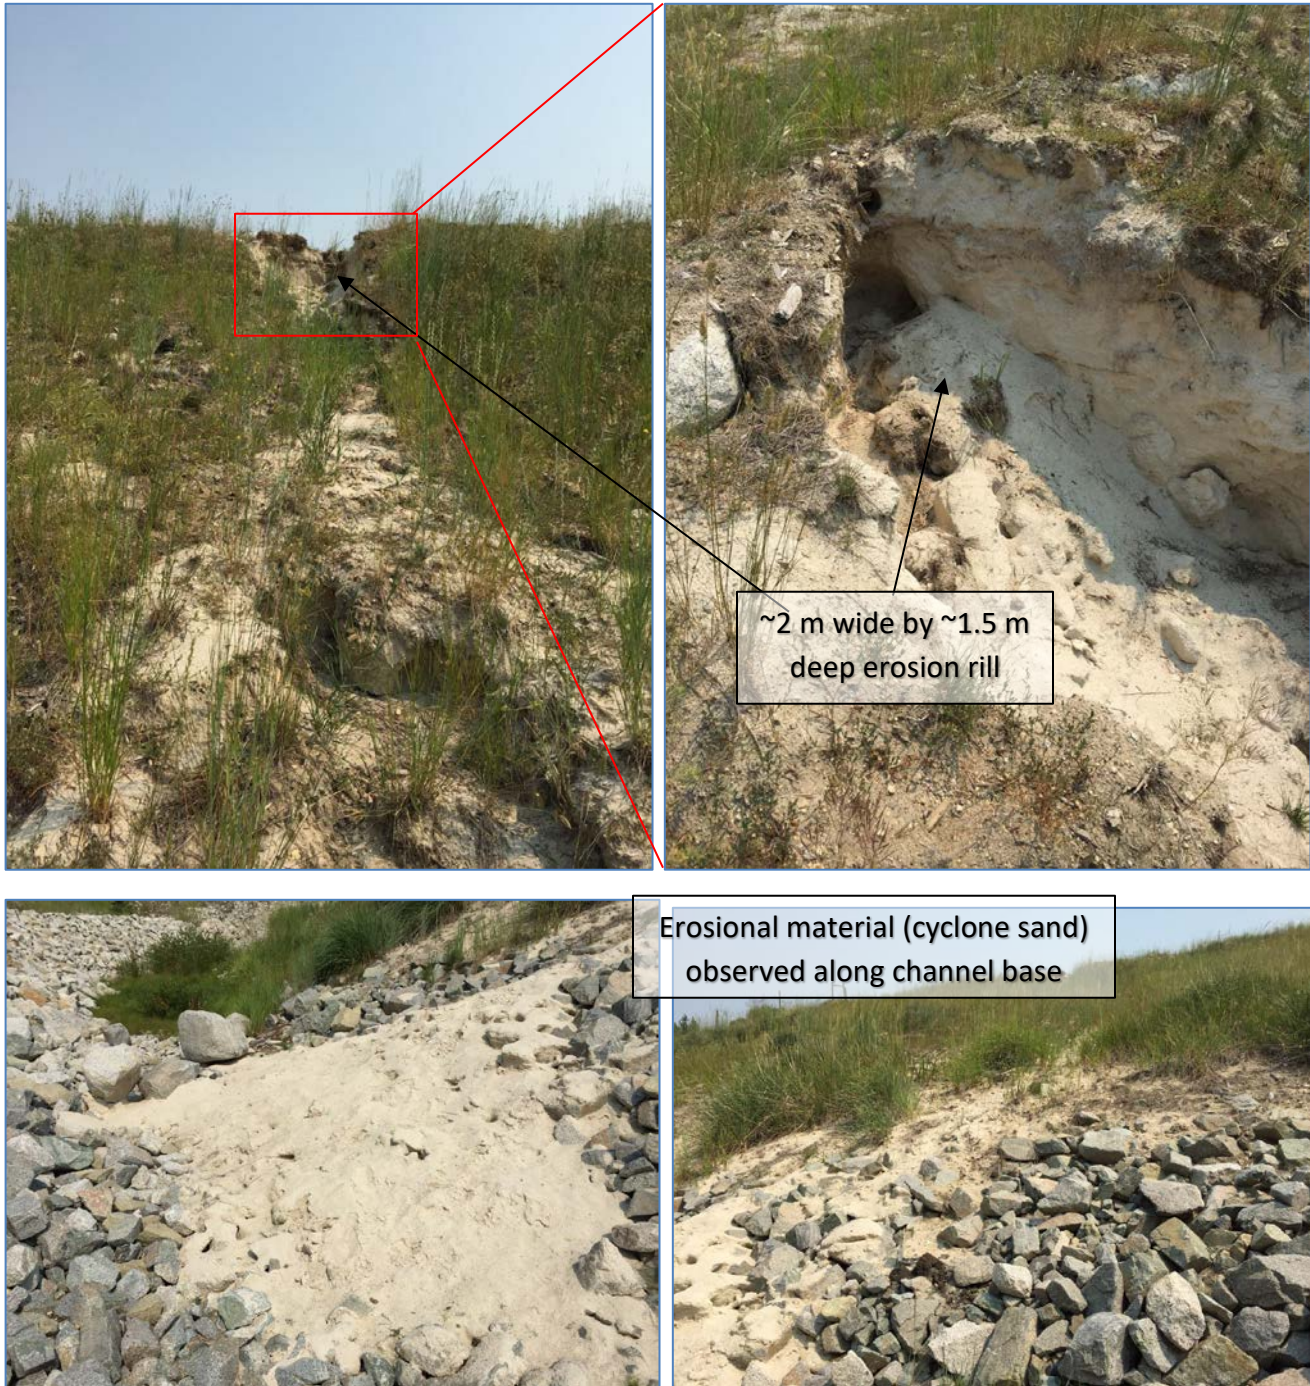
Photo II-A- 16 Spillway channel – left bank erosion feature erosion (TRJ-2018-18 & 19)

ID No.	Deficiency or Non-Conformance	Applicable Regulation or OMS Reference	Recommended Action	Priority ¹	Recommended Deadline (Status)
Trojan Dam					
TD-2018-01	Erosion	-	Repair two rill erosions on the left bank of spillway channel (along riprap section), founded in tailings. Re-grade to divert water away from these areas, as feasible.	3	Q4, 2019 (OPEN)
TD-2018-02	Flood Routing	10.1.8 (the Code)	Update flood routing assessment for Trojan impoundment, R3 Seepage Pond and LTD based on the most recent site wide hydrology information for consistency and to confirm compliance.	3	Q2, 2020
TD-2018-03	Surveillance	Inclinometer Monitoring	Complete spiral correction on IB16-2 to resolve any measurement issues which may be impacting cumulative plots.	3	Q3, 2019 (before 2019 reading)
R4 Seepage Pond					
			No new recommendations.		
Lower Trojan Dam					
			No new recommendations.

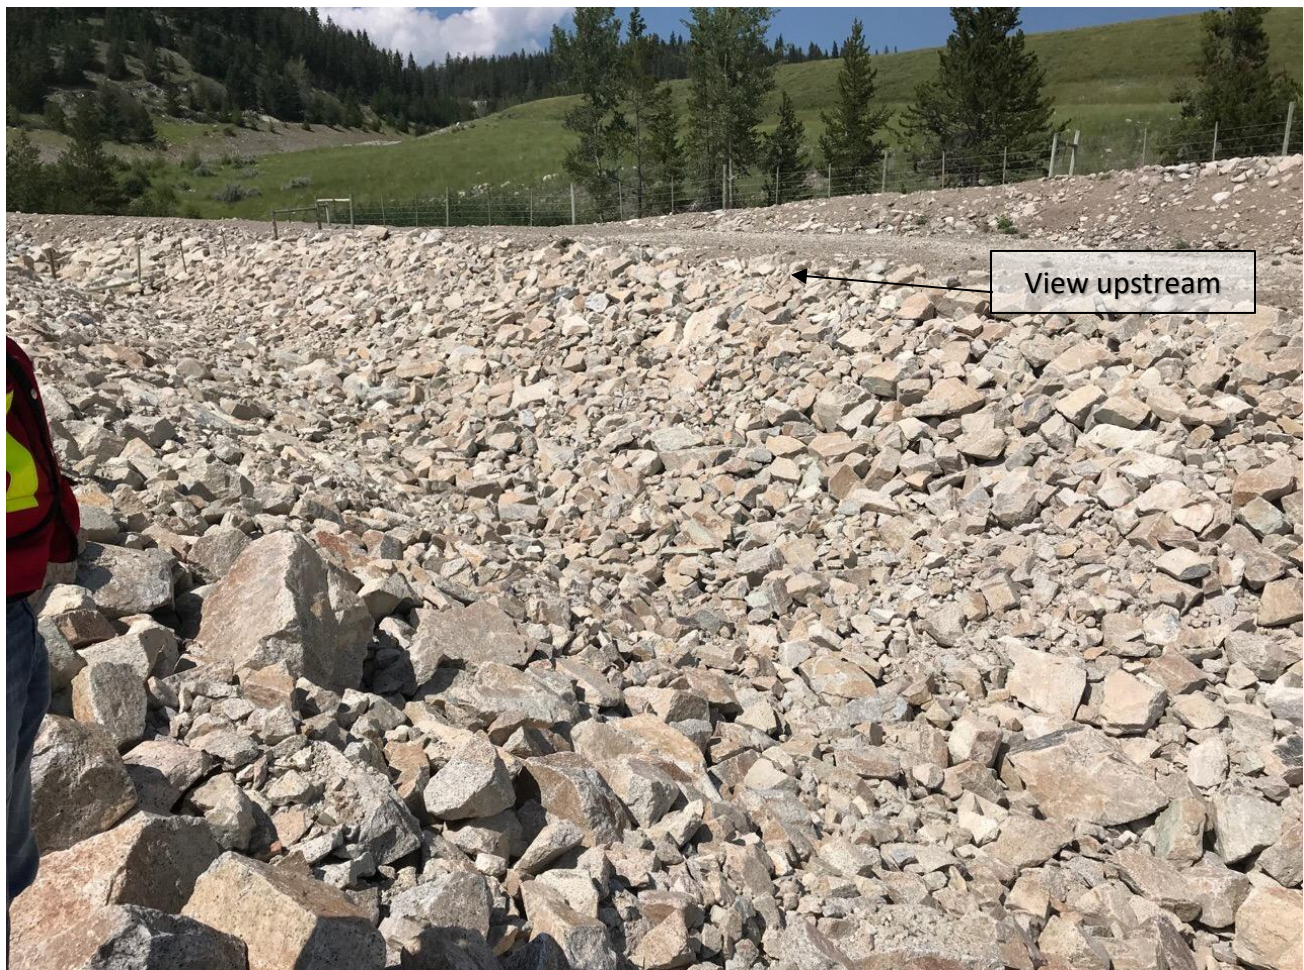
Photo II-A- 18 Spillway channel – extension of riprap section (TRJ-2018-21)

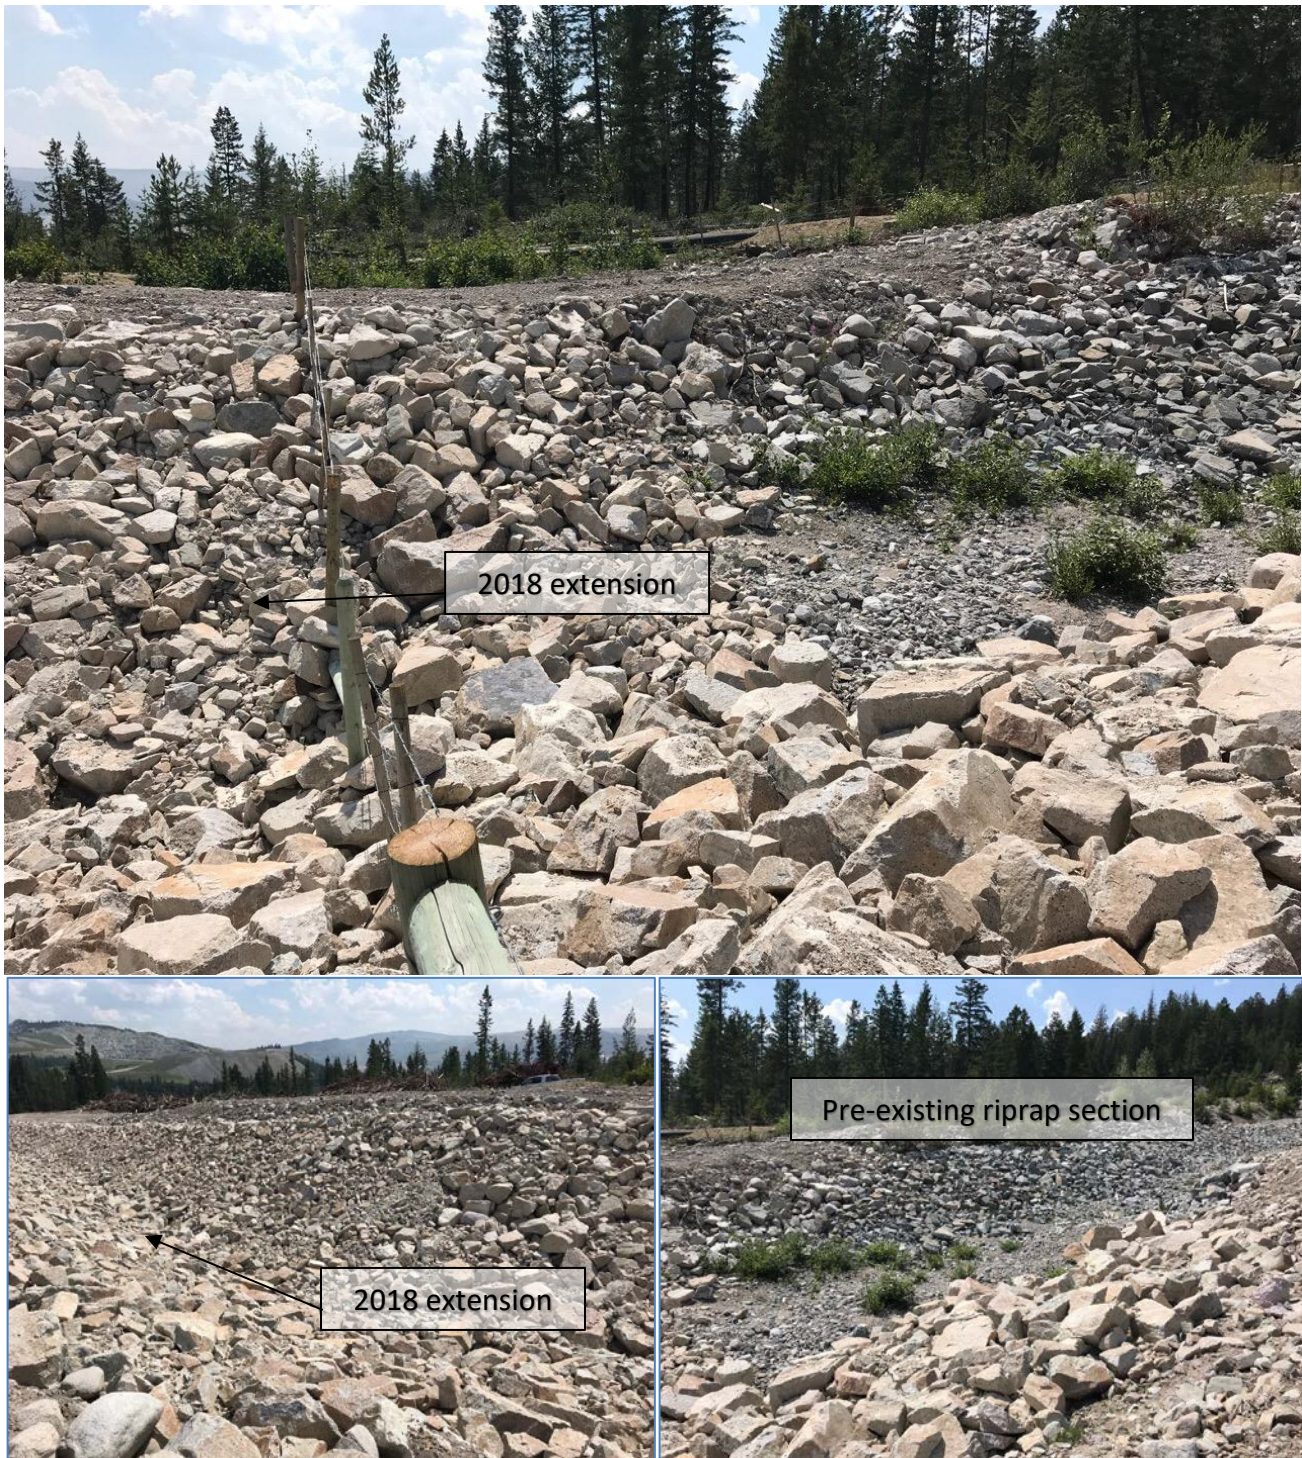
Photo II-A- 19 Spillway extension transition zone (TRJ-2018-22)
