Prepared for  
**Teck Washington Incorporated**  
1382 Pend Oreille Mine Road  
Metaline Falls, Washington  
USA, 99153

**VA101-18/26-1**

## **PEND OREILLE MINE - TAILINGS DISPOSAL FACILITY #3**

# **2019 DAM SAFETY INSPECTION REPORT**

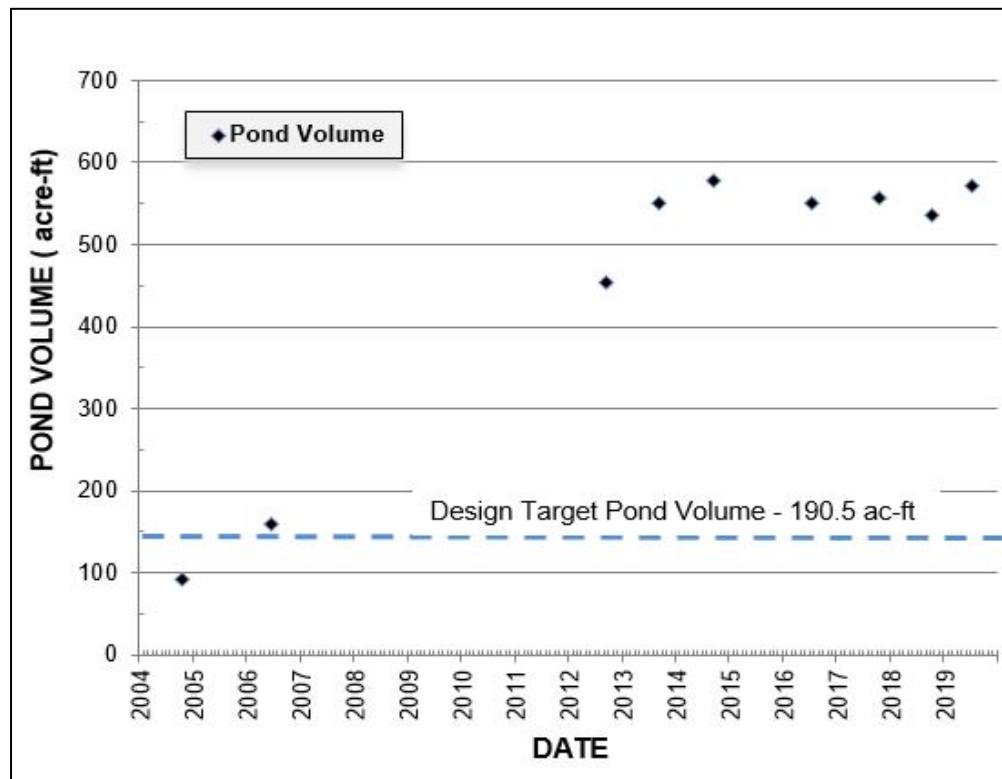
**Figure 2.3 TDF #3 Pond Volume versus Time**

A volumetric survey conducted in July 2019 provided an updated pond volume estimate. A pond volume of 24.9 million cubic feet (571.6 ac-ft) was estimated from the bathymetry survey in 2019 compared to 23.3 million cubic feet (534.9 ac-ft) in 2018, indicating an increase of 7% in the water storage inventory. The pond volume versus time is shown on Figure 2.3.

The targeted operational design pond volume of 190.5 acre-feet is included on the plot. The pond volume increased substantially during the 2009 to 2014 care and maintenance period as expected. The implementation of the evaporative program combined with tailings void losses during ongoing tailings deposition between 2014 and 2019 has halted the upward trend but has not made sufficient progress in decreasing the pond volume downwards towards the design target volume.

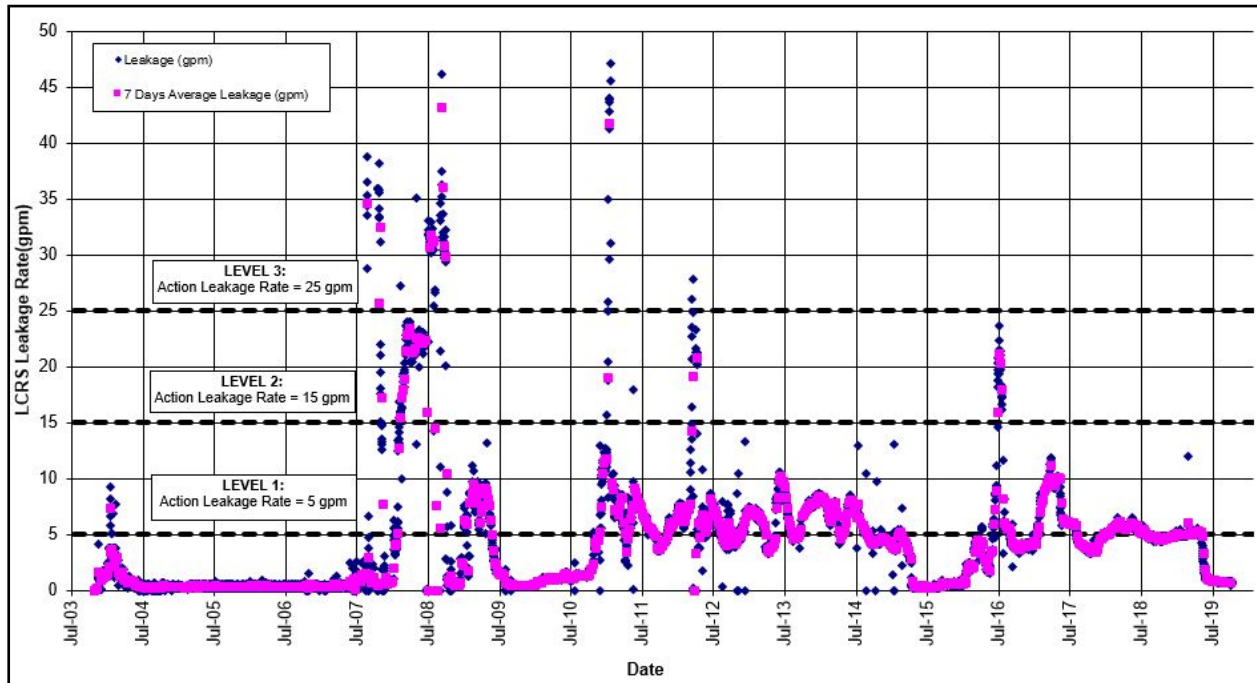
**Figure 2.5 LCRS Leakage Rate vs. Time**

Water reporting to the LCRS is pumped out via the LCRS riser pipes and the flow volume is measured. The daily and 7-day average leakage flow rates from the LCRS are provided on Figure 2.5. The LCRS flow rates fluctuated above and below the Level 1 Action Leakage Rate of 5 gpm from September 2014 to March 2015, then dropped below the Level 1 Action Leakage Rate in March 2015 and stabilized in the range of 0 to 2.5 gpm. The drop to historical LCRS leakage rates (July 2004 to July 2009) was expected once active tailings deposition resumed around the facility via the spigot points.

Leakage rates remained at historical levels from March 2015 to February 2016. The LCRS flow rates fluctuated above and below the Level 1 Action Leakage Rate from February 2016 to June 2016. Leakage rates peaked at 23 gpm in July 2016, just below the Level 3 Action Leakage Rate and two liner leaks were suspected: one near the barge area and one near the LCRS area. Tailings discharge and sand bag placement were focused at suspected leak areas and leakage rates decreased to the range of 2 to 4 gpm, which are below the Level 1 Action Leakage Rate of 5 gpm.

In January 2017, the leakage rate again exceeded the Level 1 Action Leakage Rate peaking in May 2017 at approximately 10 gpm. Suspected liner leaks were sealed, and the leakage rate was reduced to below the Level 1 Action Leakage Rate in August 2017. The leakage rate hovered around the Level 1 Action Leakage Rate in 2018. Selective spigotting on the north end of the impoundment resulted in a slight lowering of the leakage rate from summer to fall 2018.

Leakage rates held steady at slightly higher than Level 1 Action Leakage rates levels, from 2018 to summer 2019. Leakage rates dropped back to historical levels and below the Level 1 Action Leakage Rate in the last few months before the September 2019 annual inspection.

TWI continues to monitor leakage rates and uses acoustic sounding methods to detect leaks as necessary.

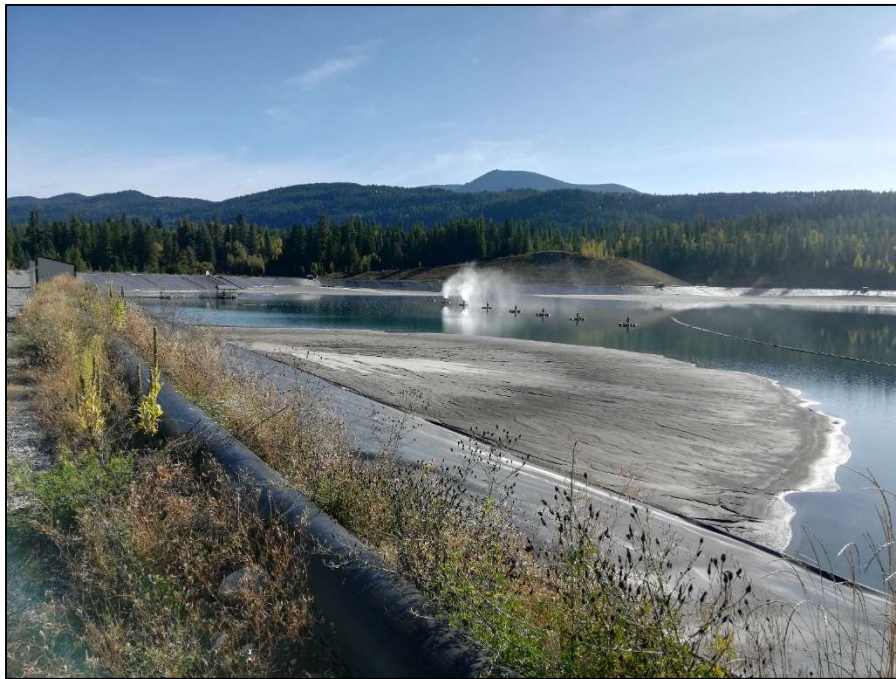
Evaporators generally functioned properly throughout the year, although at the time of inspection, six of eight evaporators were not functioning and required minor maintenance to become operational. Evaporator recommendations are provided in Section 4.

**PHOTO 5** – Evaporators from the northwest. Two operational at time of inspection.

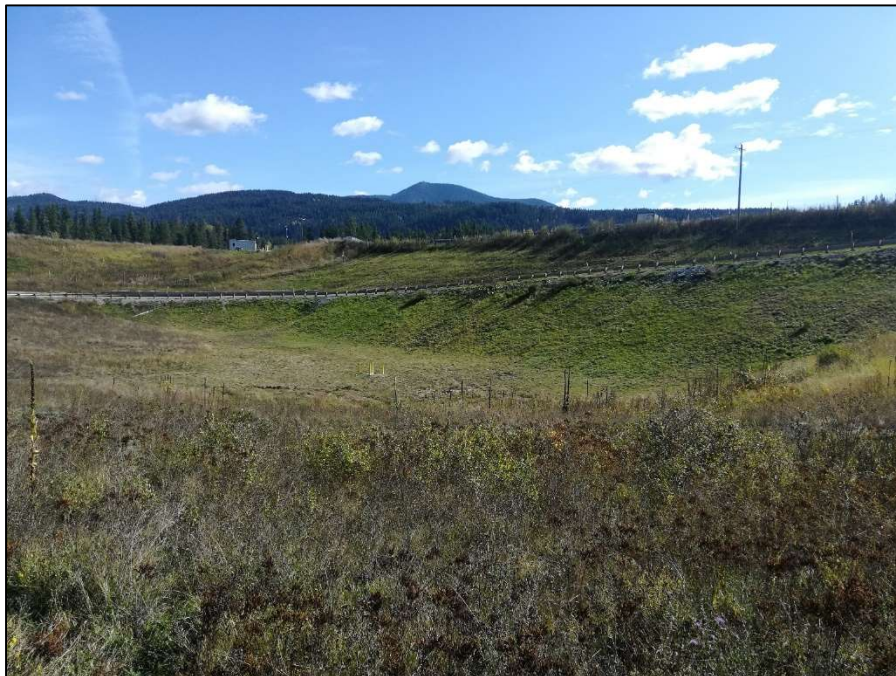
No signs of distress were noted during the inspection of the NE and NW Embankments. No seepage, wet or soft spots were observed on the downstream slopes. The embankment slopes were approximately planar and there was no evidence of cracking, bulging, or slumping in the embankment fill. The embankment crest appeared to be level with no signs of differential settlement or distress. The abutments appear sound with no evidence of erosion, seepage, settlement or cracking. There was some evidence of animal burrowing at the toe of the NE embankment. TWI implements an ongoing pest control program during the summer months, which has proven effective in decreasing the number of animal burrowing incidents. The reclaimed downstream embankment slopes were mowed during the summer as part of the ongoing maintenance of the embankments. Tree growth on the abutments and a removal program are in place for the abutments where past tree growth has occurred. No significant construction activities took place over the course of the year.

**PHOTO 8** – Downstream face of northwest dam from toe.

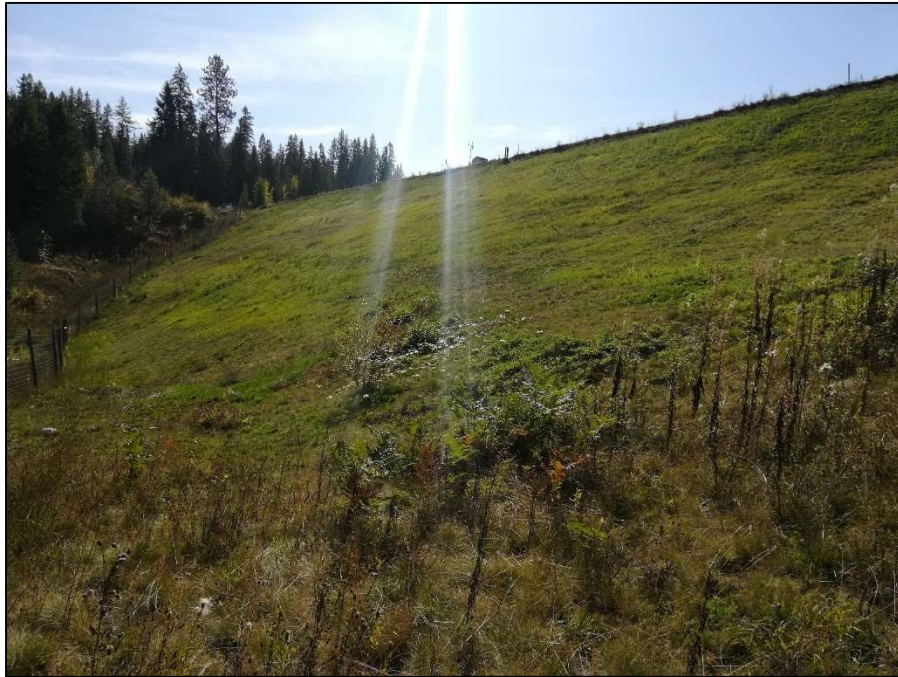
**PHOTO 11** – Downstream face of northeast dam from toe.

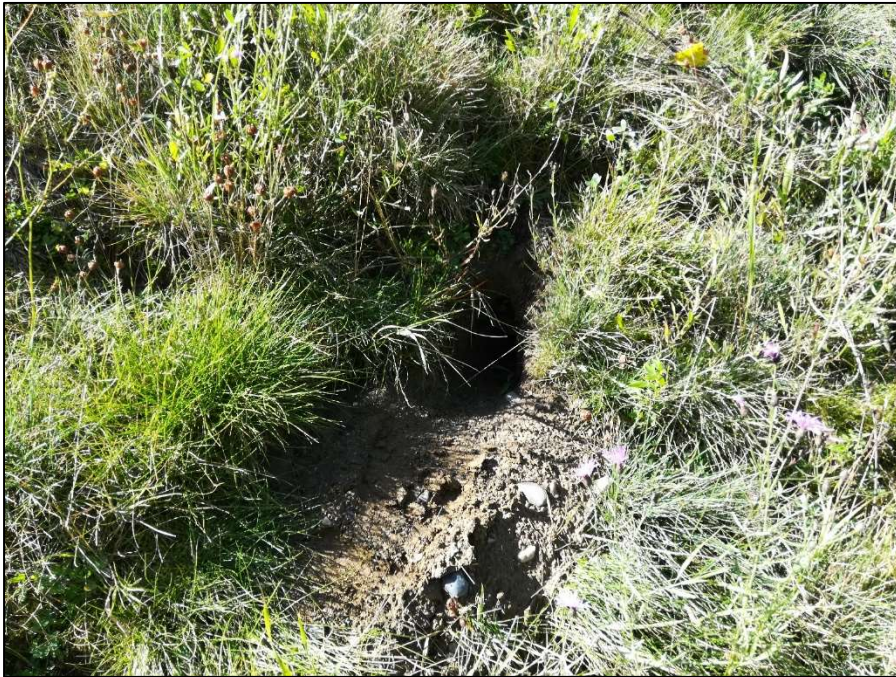
**PHOTO 13** – Animal burrow at downstream toe of northeast dam.

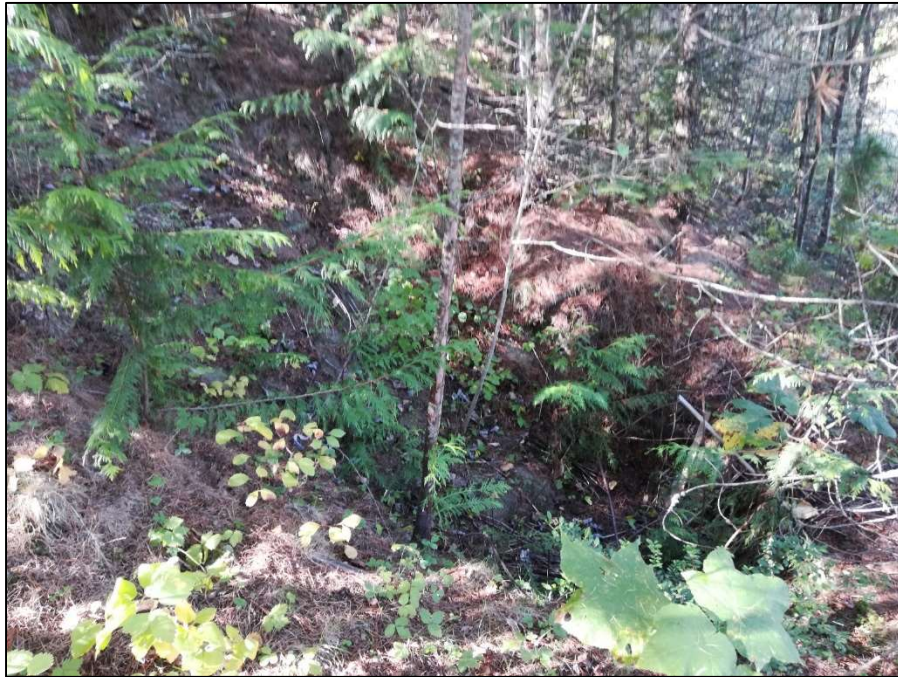
Rockfill was placed along the perimeter road of the TDF in low areas with poor drainage to improve water management and surface water runoff. The minor depression previously referred to as a “sink hole” on the upper slope of the basin, was inspected and no issues were noted. The wildlife fence was inspected, and repairs completed as needed.

**PHOTO 23** – “Sink hole” location upstream of TDF#3 basin.

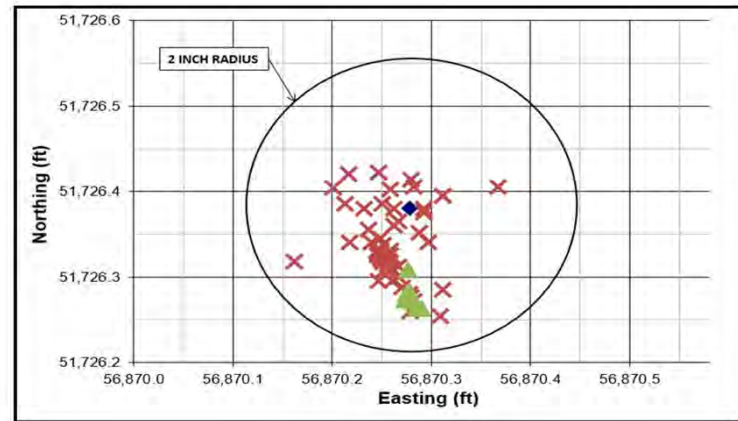
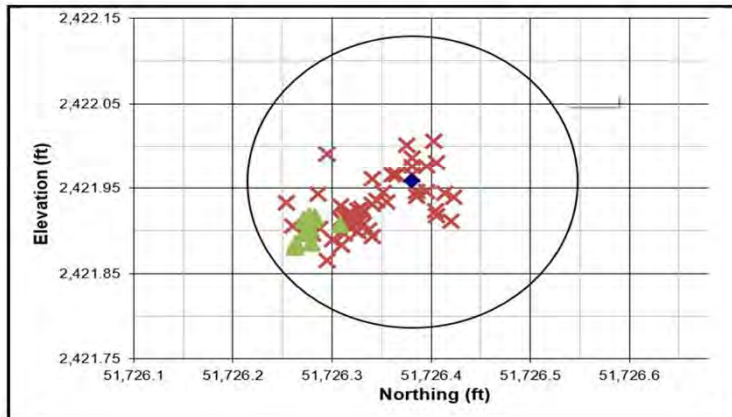
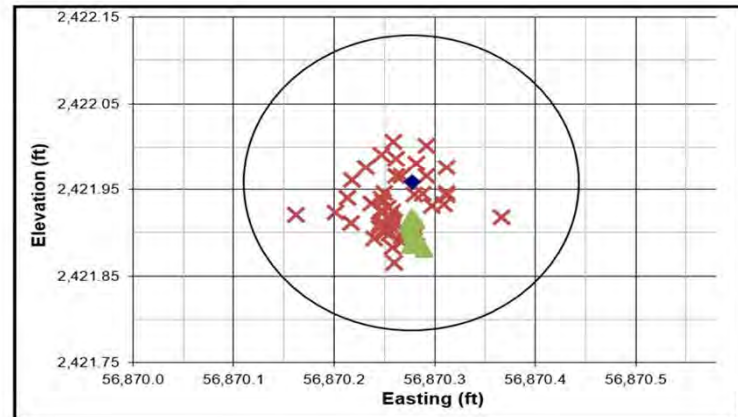
TECK WASHINGTON INCORPORATED		
PEND OREILLE MINE		
NORTHWEST EMBANKMENT M5 SURVEY MONUMENT

At M5, the survey movement monitoring in 2019 was within the tolerances specified in the OMS Manual. Measured movement at M6 was consistent and continued to be slightly outside the 2 inch tolerance during most of 2019 but did not extend any further from the datum. As noted in previous inspections, the survey movement monitoring at M6 implies the dam crest is moving laterally inwards towards the impoundment side which is not realistic. It is likely that M6 has been impacted by surface equipment, possibly snow moving equipment. KP recommends further monitoring and incremental review during 2020 to determine if the monument datum should be adjusted.
