Teck Highland Valley Copper Partnership

2019 Dam Safety Inspection Report

7 Day Pond Tailings Storage Facility

April 2020

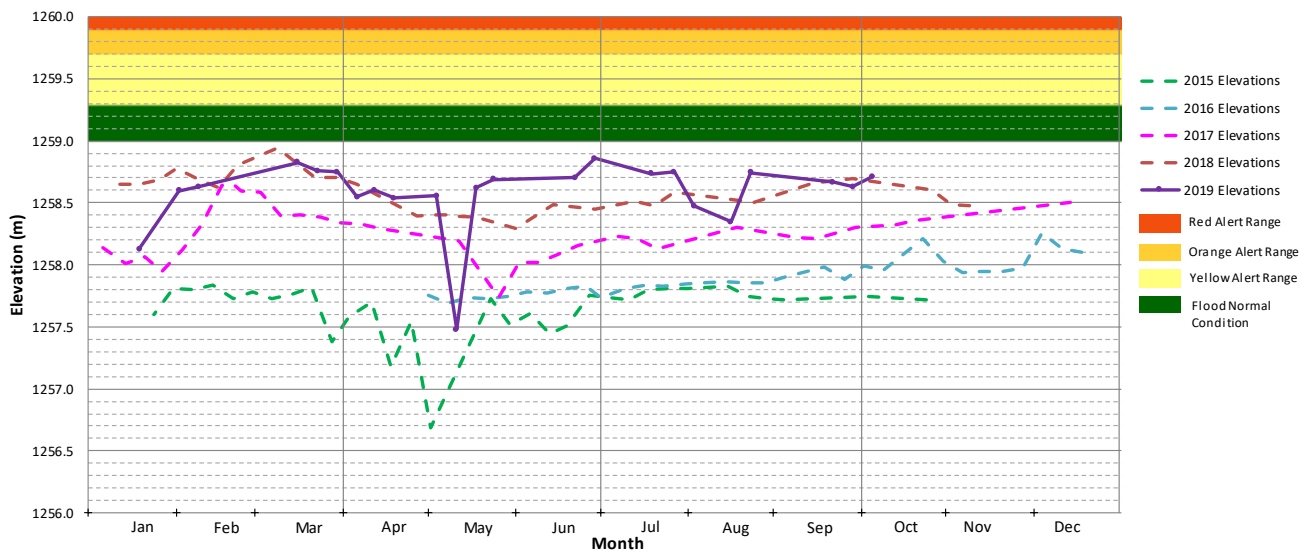
Figure 5.1 7-Day Pond Reservoir Levels with Threshold Ranges

THVCP has adopted 0.5 m as the minimum freeboard for 7 Day Pond, which exceeds the Code and CDA design requirements. Minimum observed freeboard in 2019 was 1.1 m and remained below "Flood Normal" range as shown on Figure 5.1.

- The peak pond level in 2019 was ~0.1 m less than the peak level recorded in 2018. During 2019, pond levels were within normal operating conditions.
- The available freeboard during 2019 was greater than 1.1 m (measured using the crest elevation of 1260 m, corresponding to the east perimeter road berm elevation).

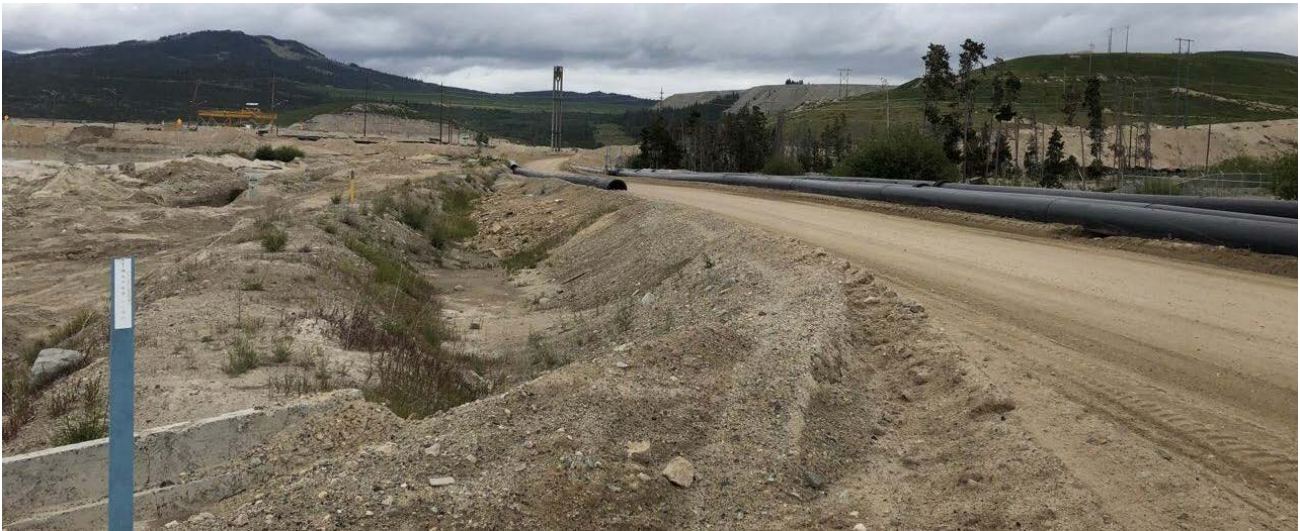
- **Crest:** The haul road which forms the crest of the dam around 7-Day Pond was in good physical condition. No indicators of significant concern were observed (e.g. cracking, slumping) (Photo II-1).

Photo II-1 Overview of east perimeter access road crest looking north (SDP-2019-01)

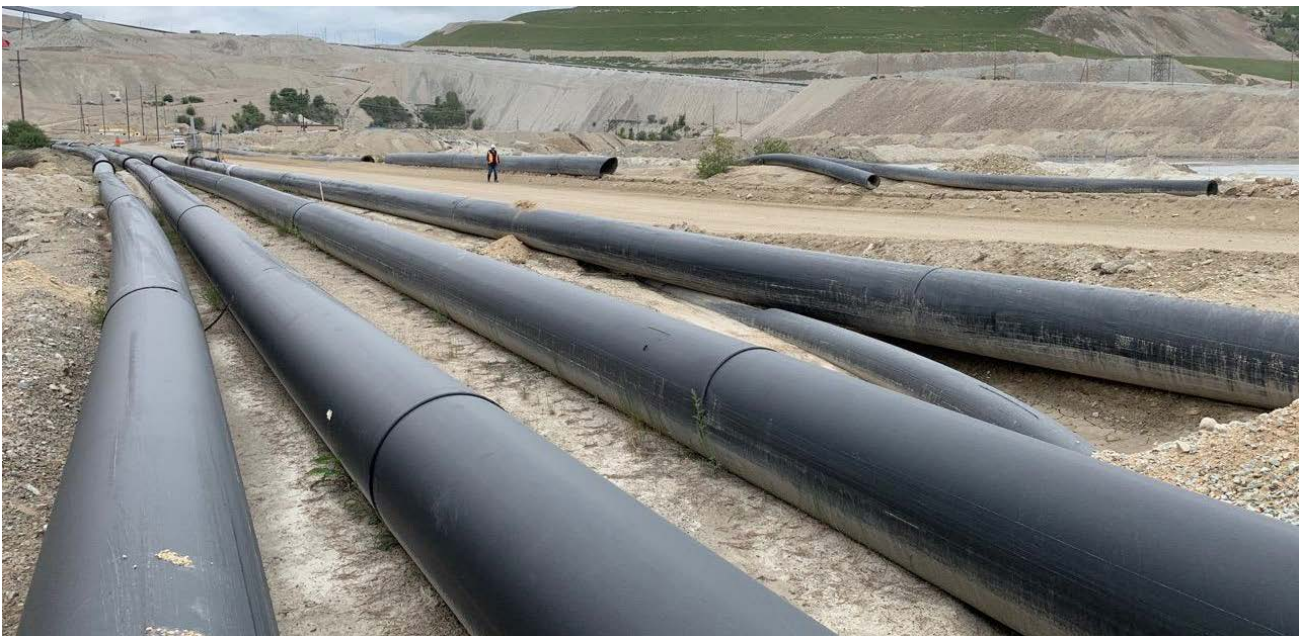
Photo II-2 Tailings and water pipelines along downstream side of east perimeter access road crest (SDP-2019-02)

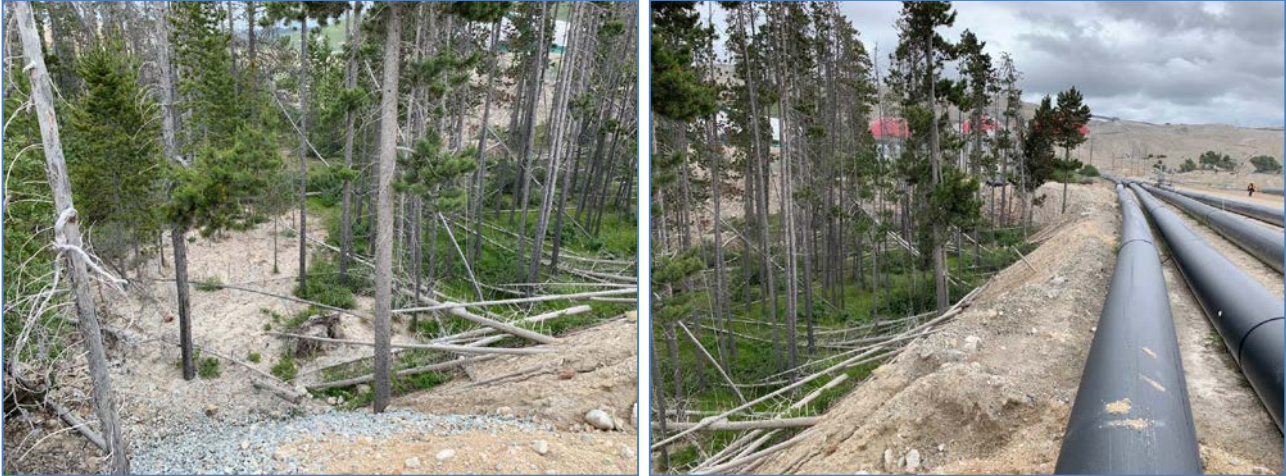
- **Upstream and Downstream Slopes:** Upstream slopes were in good physical. The upstream slopes were not vegetated, but no indicators of significant concern were observed (e.g. animal activity, cracking, slumping, surface erosion features). The visible parts of the downstream slope of the haul road forming the east containment of the impoundment was in good physical condition. Ponding was observed in the two adjacent treed areas, i.e. at the downstream toe of the east perimeter access road (Photo II-3 to Photo II-5).

Photo II-3 Treed area downstream (d/s) of 7-Day Pond retaining berm formed by east perimeter access road. Tailings and water pipelines along d/s side of crest (SDP-2019-02)

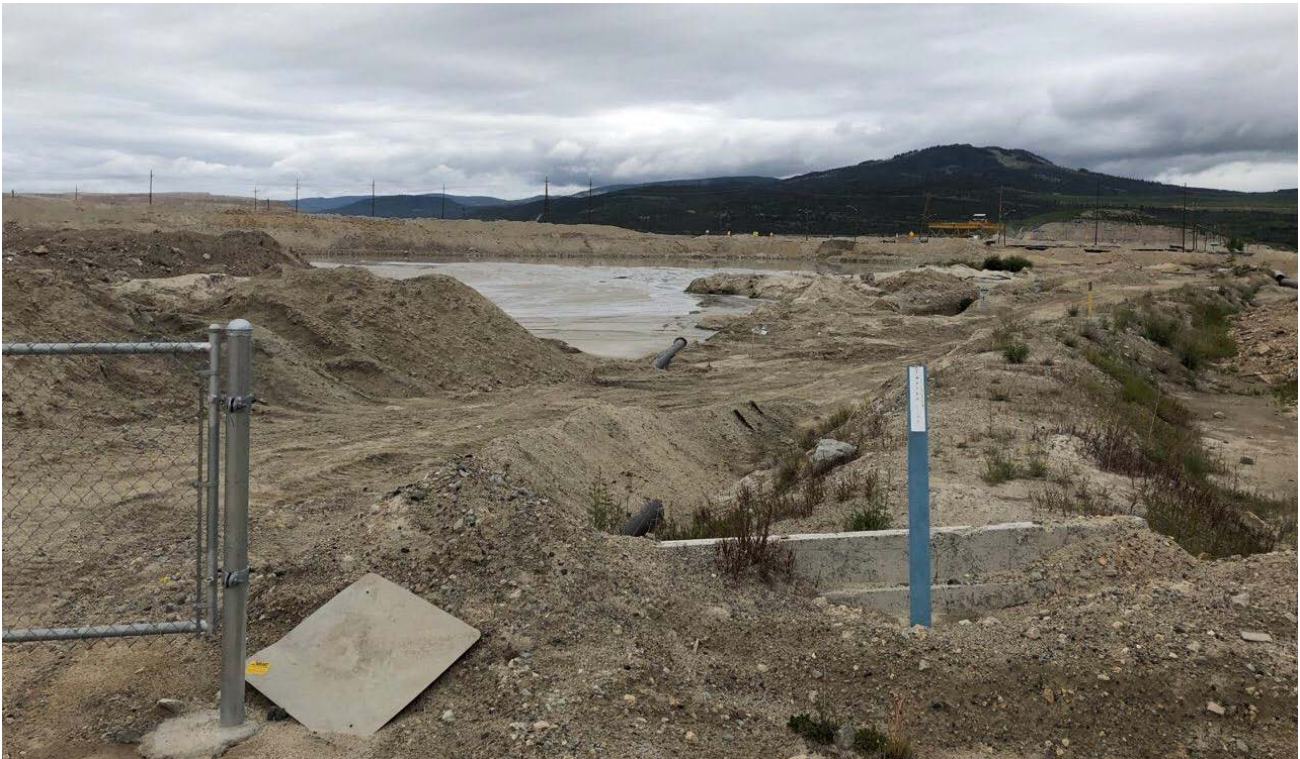
Photo II-4 Overview of pond and upstream slope of west and north perimeter access roads – good freeboard is maintained (SDP-2019-15)

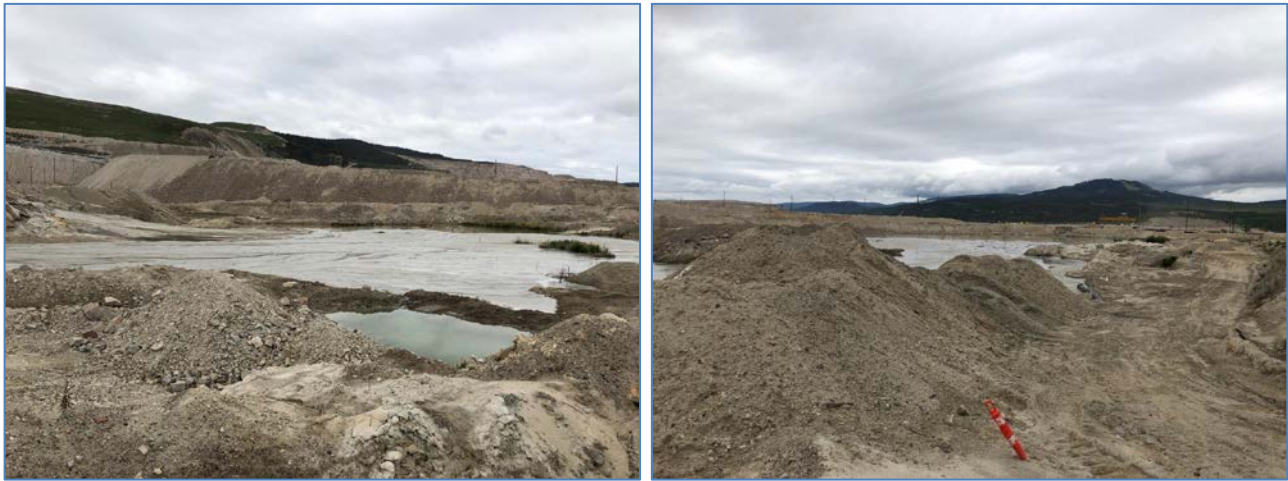
Photo II-5 Overview of the upstream slope of western and northern perimeter access roads looking north (SDP-2019-01)

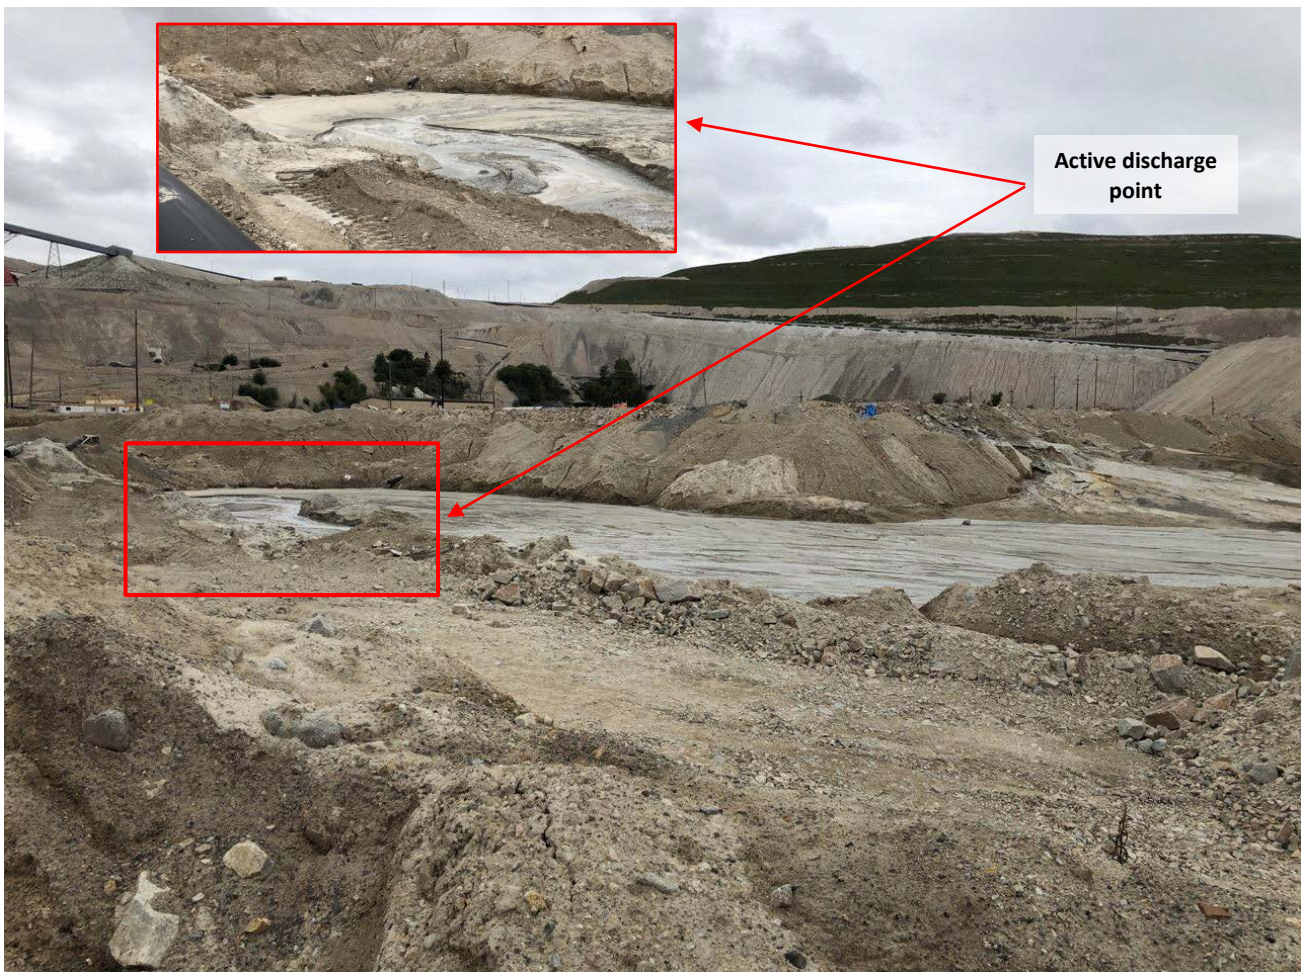
Photo II-6 Overview of the upstream slope and active discharge point looking south (SDP-2019-01)

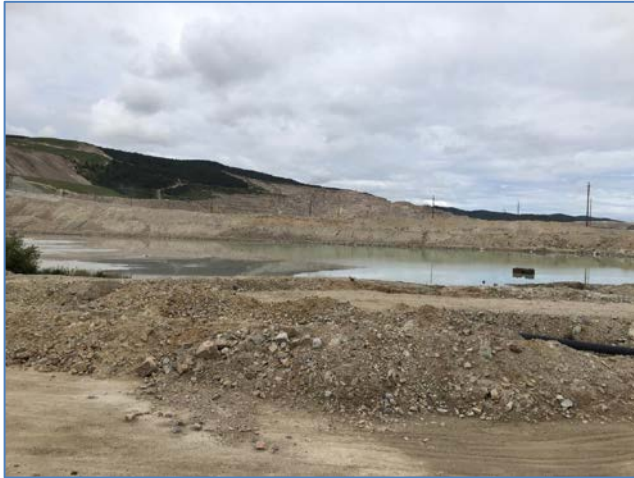
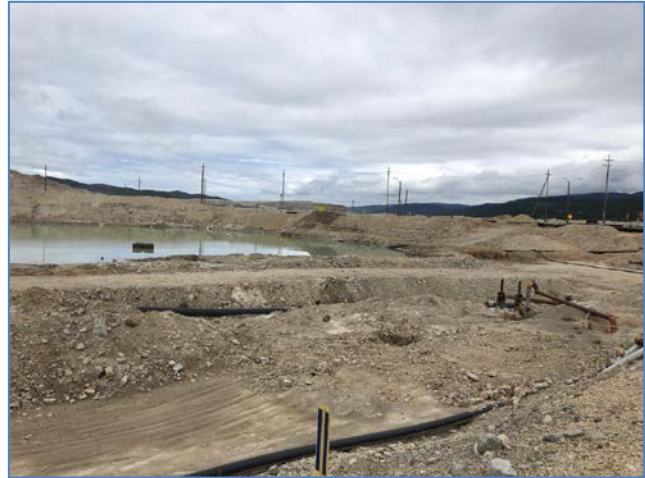
Photo II-7 Overview of west and north perimeter access roads (SDP-2019-03)

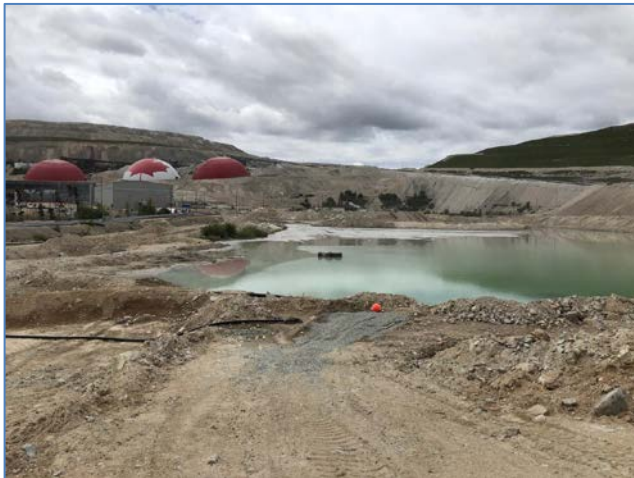
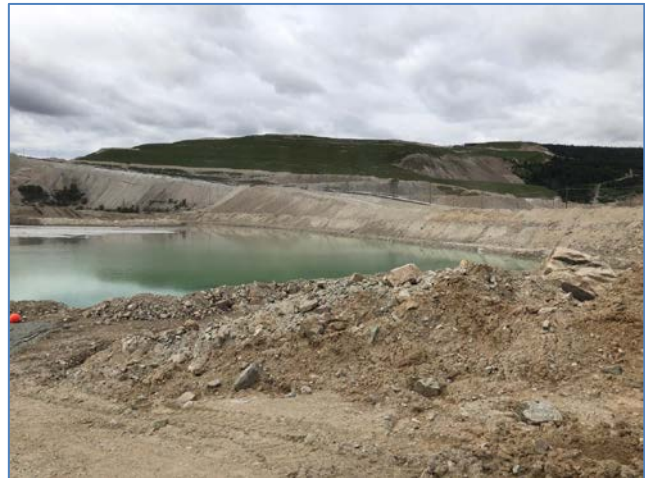
- **Pond:** At the time of inspection, freeboard was more than 1 m (Photo II-8).
- **Outflow Pump:** Had not been installed at the time of inspection.
- **Seepage:** None observed.

Photo II-8 Overview of the pond looking south from north perimeter access road (SDP-2019-04)

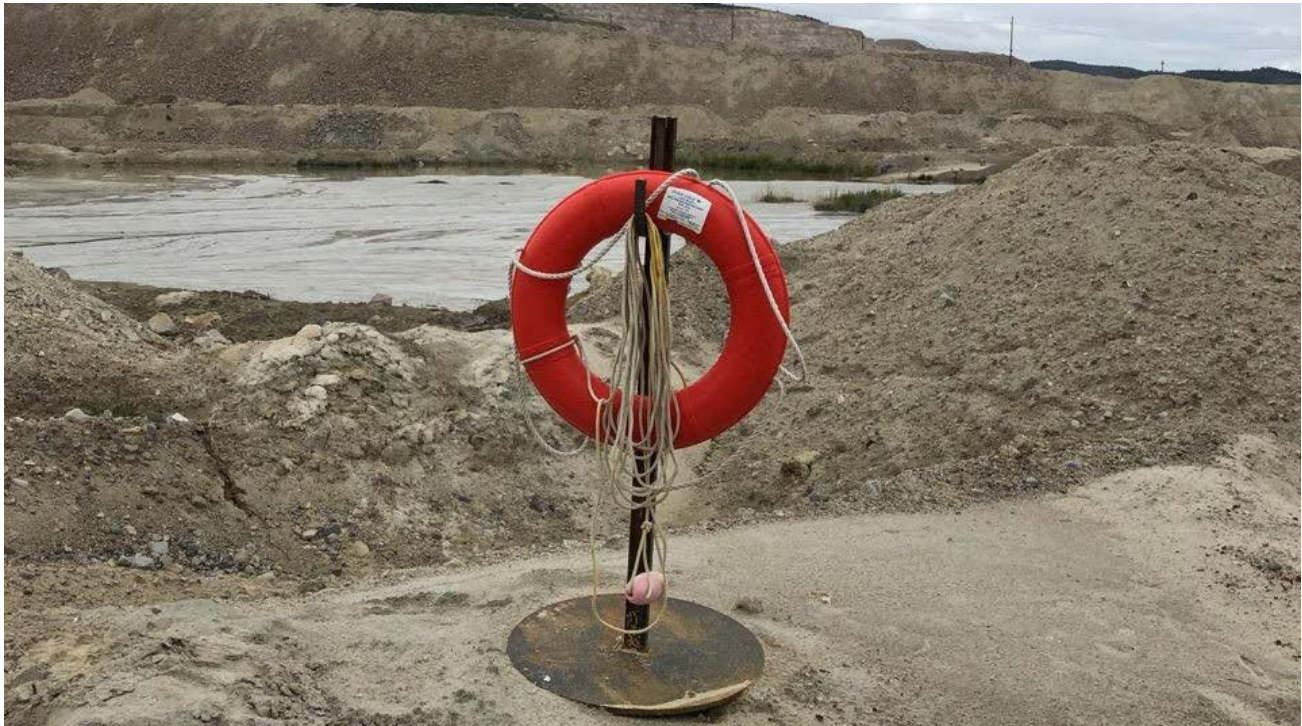
Photo II-9 Lifebuoy is in place along east perimeter access road (SDP-2019-01)

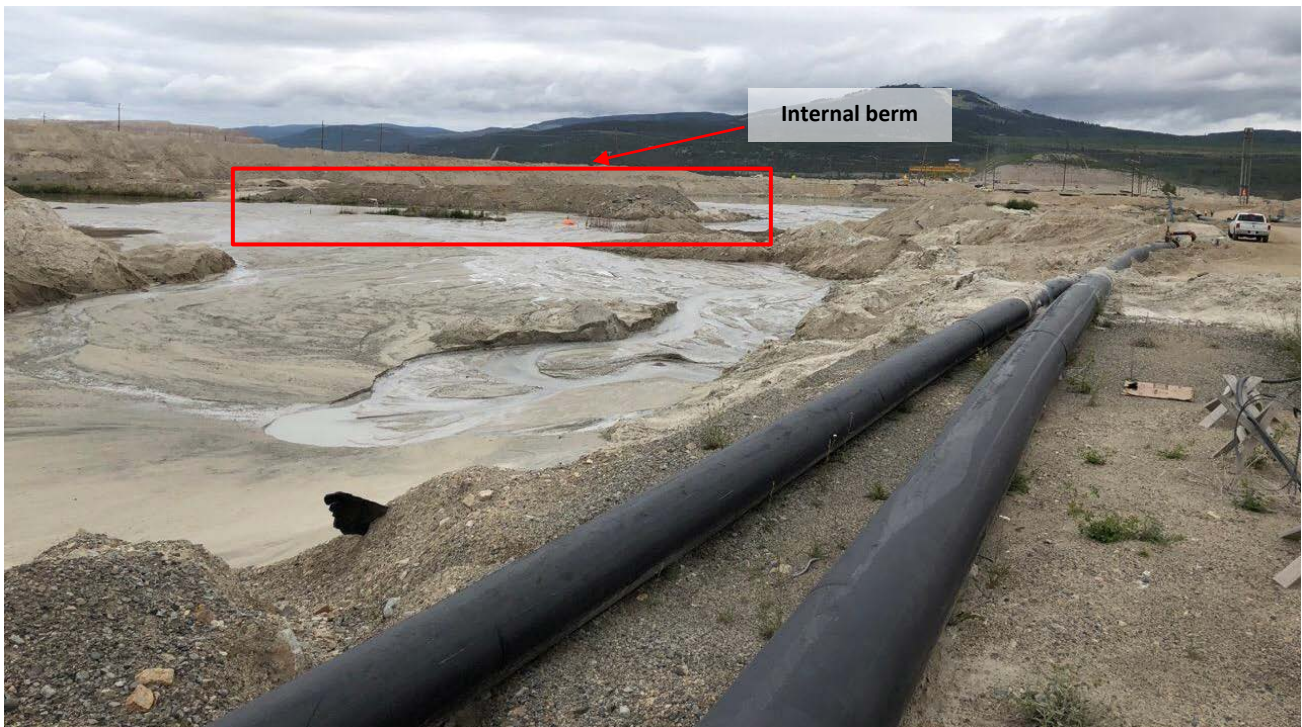
Photo II-10 Overview of the internal berm within the impoundment (SDP-2019-05)
