Beaverdell Tailings Storage Facilities

2019 Annual Dam Safety Inspection

Golder Associates Ltd.

16 April 2020

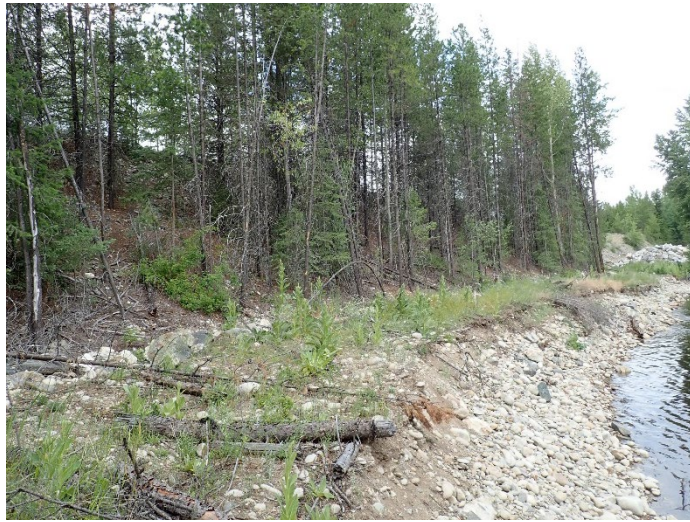
A number of dead trees were identified at the toe of the Cell 5 dam at the South TSF during the July DSI site inspection. Uncontrolled felling of these trees could lead to damage of the dam and should be removed (Recommendation 2019-02).

Photograph 9: South TSF, Cell 5, toe and downstream slope, looking northeast. 10 July 2019.

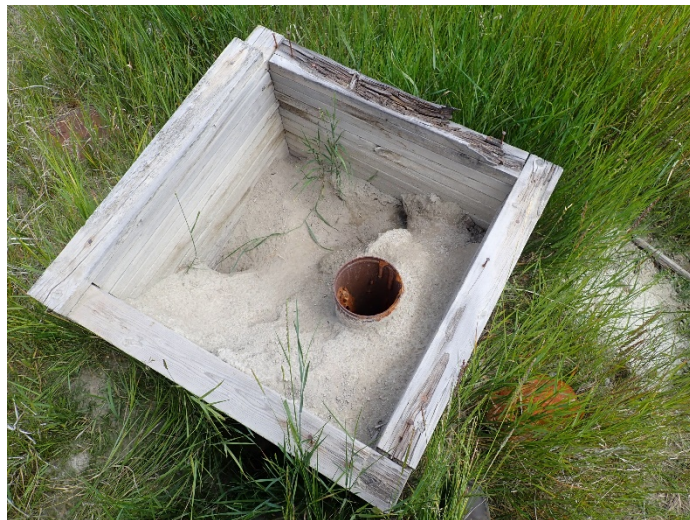
A supernatant pond historically existed downstream of the southwest corner of Cell 5, where it is understood the decant tower outlet exited the cell during operations (Binnie 1980c). The decant pipe outlet is not currently visible in the downstream area of Cell 5. During previous inspections, tailings were observed in the area downstream of Cell 5 which could be related to the decant outlet. The vertical portion of the Cell 5 decant pipe has been plugged. The location and alignment of the horizontal portion of the Cell 5 decant pipe should be determined (Recommendation 2019-01).

Photograph 11: South TSF, Cell 5, backfilled decant tower, 10 July 2019.

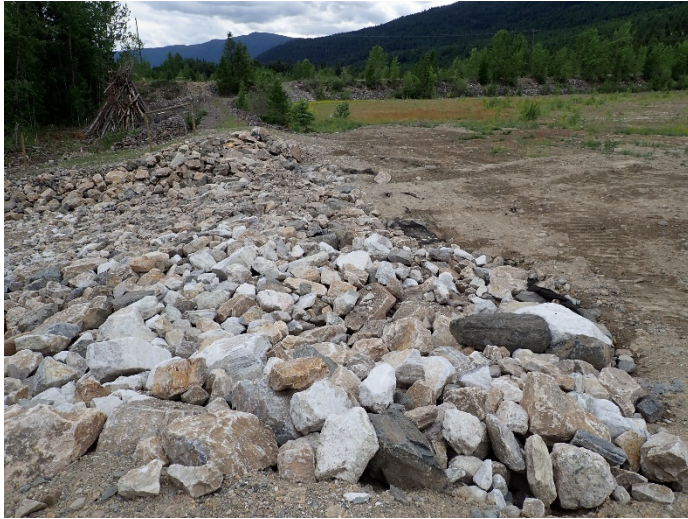
Photograph 17: South TSF, Cell 3, remediated spillway crest, looking southwest. 10 July 2019.

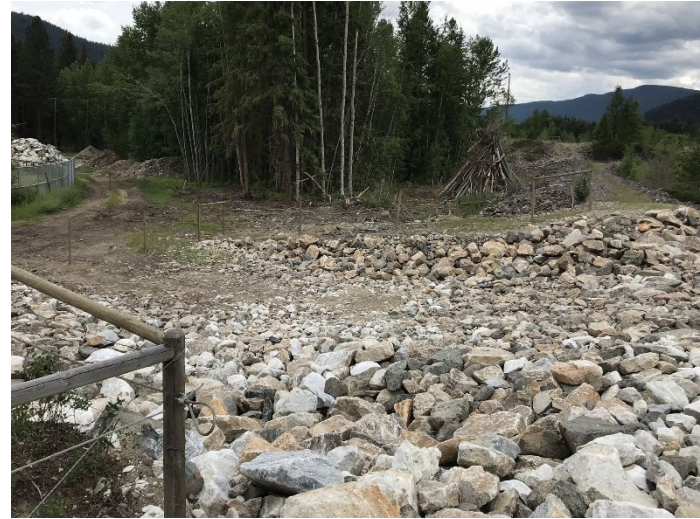
Photograph 18: South TSF, Cell 3, remediated spillway downstream, looking southeast. 10 July 2019.

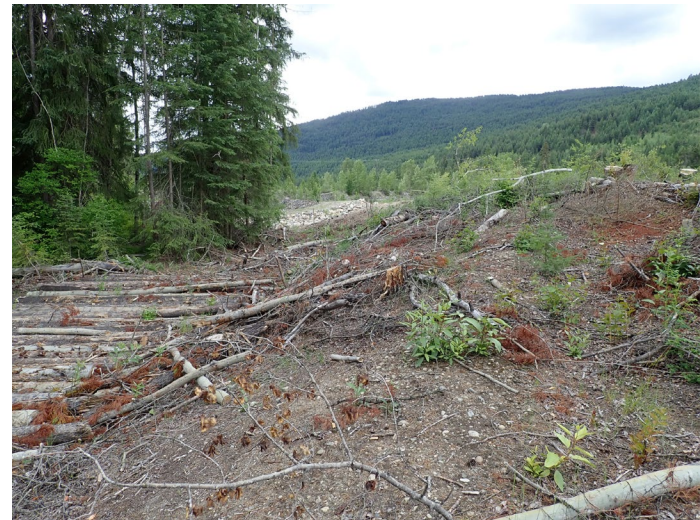
During the July 2019 site visit, soft ground was observed at the downstream toe of the Cell 3 dam, north of the Cell 3 spillway, with felled trees, from the 25 and 26 January 2019 work, placed in this area. Discussions with Teck staff indicated that these trees were placed to provide platforms for equipment during the tree felling work, as a result of soft ground. In addition, a review of the draft borehole log for monitoring well MW18-03 (Wood 2019), indicated an approximately 0.8 m thick layer of dark brown, low plasticity, damp silt approximately 0.15 m below ground surface. Topographic contours also indicate that the tailings surface slopes towards the dam with deposition from the west, i.e., prior to the use of spigot deposition of tailings from the dam. These conditions may be indicative of tailings deposition in Cell 3 prior to the construction of the Cell 3 embankment (i.e., tailings and water were not contained), similar to conditions observed for Cells 1 and 2. Tailings may therefore be present in the foundation of the Cell 3 embankment which could pose a risk to the stability of the dam in this section of the South TSF, and should be investigated (Recommendation 2019-03). Similar conditions were not observed at the remainder of the South TSF and at the North TSF. The likelihood of instability for the North TSF and South TSF is considered to be close to non-credible (drained condition) to unlikely⁴ (seismic loading condition).

Photograph 20: South TSF, Cell 3, downstream slope and toe with felled trees, looking south. 10 July 2019.

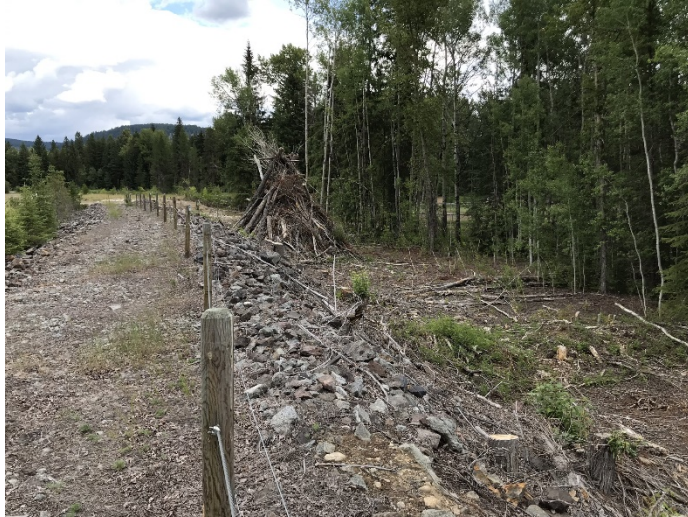
Photograph 21: South TSF, Cell 3, crest and downstream slope with felled trees, looking northeast. 10 July 2019.

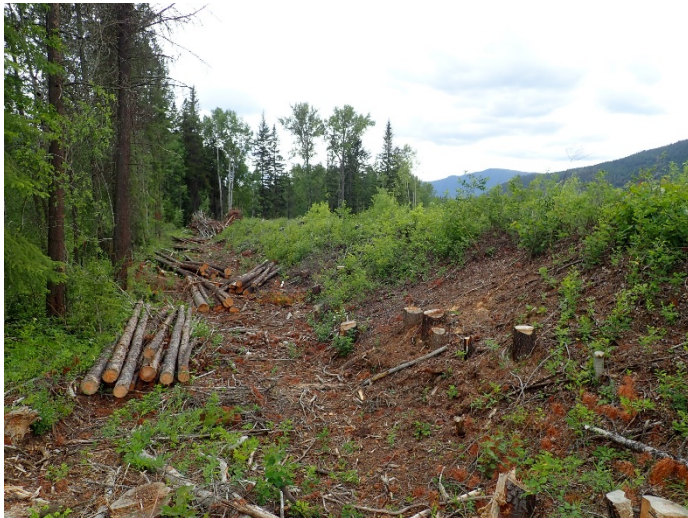
Photograph 23: South TSF, Cell 3, felled trees on crest and downstream slope, looking south. 10 July 2019.

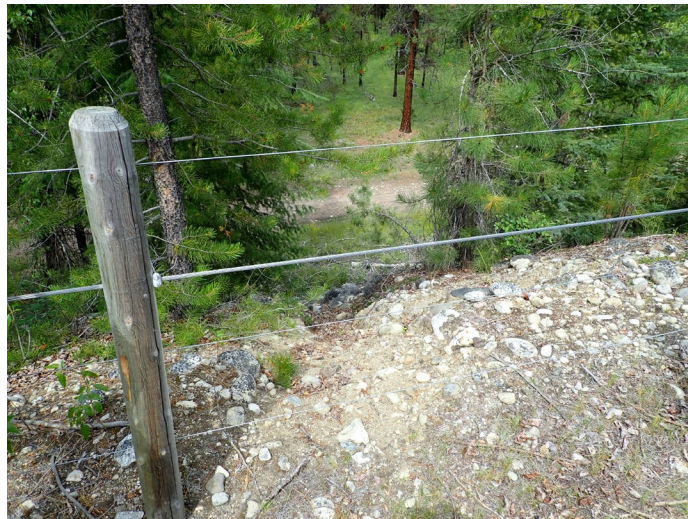
Photograph 27: North TSF, Cell 6, erosion on north embankment downstream slope, looking northeast. 10 July 2019.

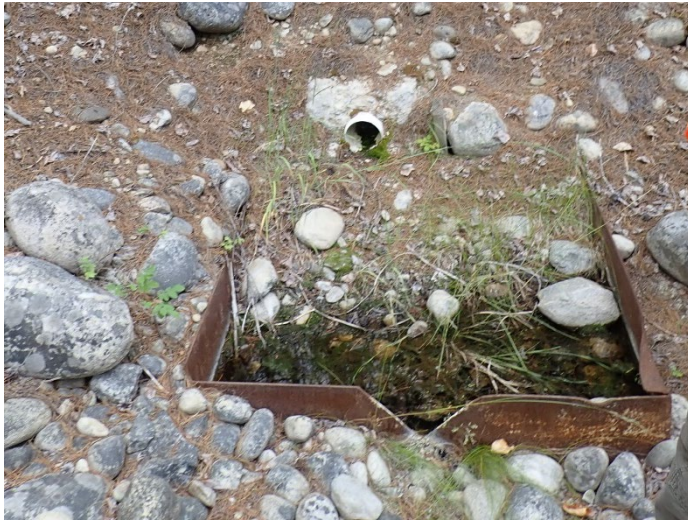
No seepage at the Cell 6 or Cell 7 decant pipe outlets was noted during the July 2019 inspection, although a small accumulation of water was observed at the outlet structure of the Cell 6 decant. Concentration of water in this structure may lead to water chemistry readings exceeding permit requirements. It is recommended that this outlet structure be decommissioned (Recommendation 2019-04).

Photograph 29: North TSF, Cell 6, decant outlet at toe of south embankment, looking north. 10 July 2019.

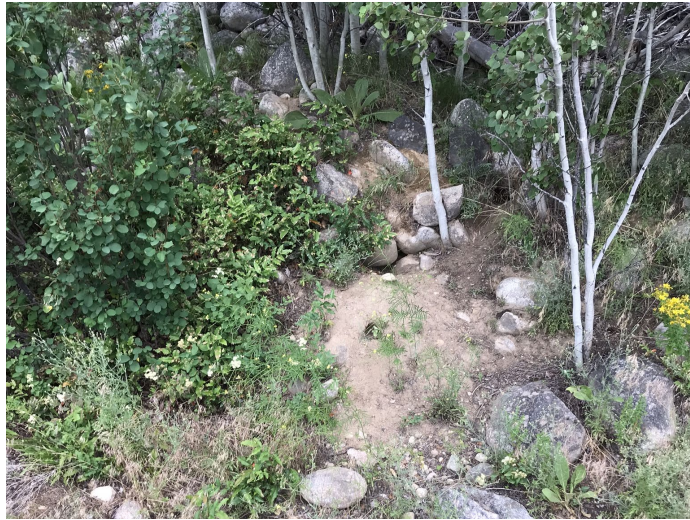
Photograph 33: North TSF, Cell 7, animal burrow in downstream slope of south embankment, looking north. 10 July 2019.

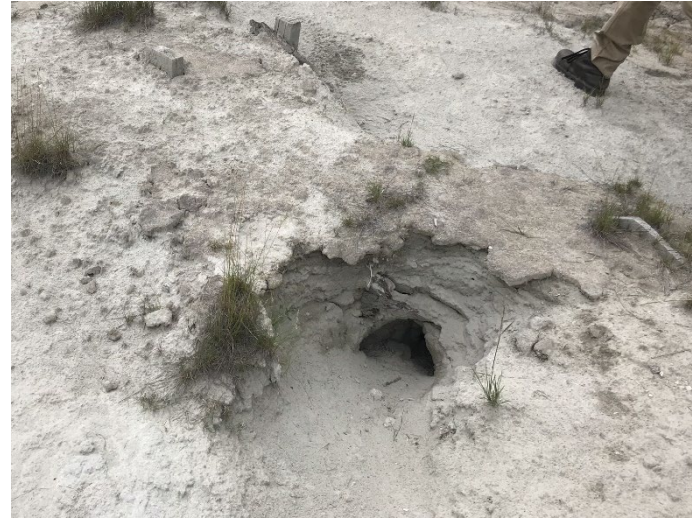
Photograph 38: North TSF, Cell 7, animal burrow in tailings surface, looking east. 10 July 2019.

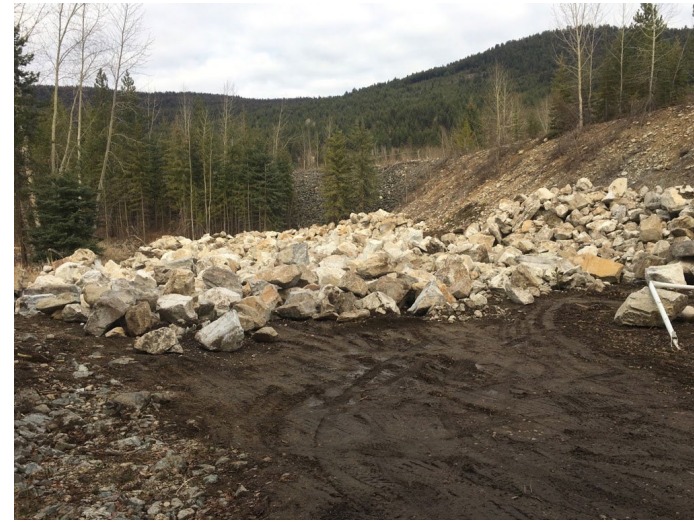
Photograph 42: Riprap stockpile at the toe of Cells 4 and 5, looking southwest. 12 April 2019.

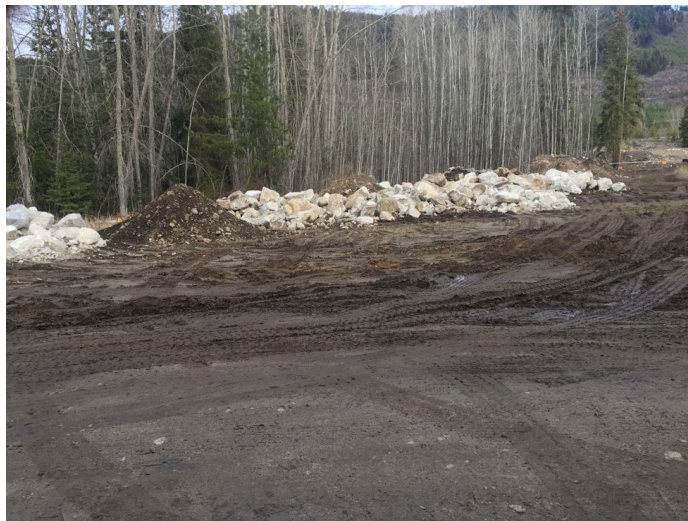
Photograph 43: Riprap stockpile adjacent to the baseball field east of Cell 3, looking west. 12 April 2019.
