# **Teck Highland Valley Copper Partnership**

**2019 Dam Safety Inspection Report**

***Bethlehem No.1 Tailings Storage Facility***

April 2020

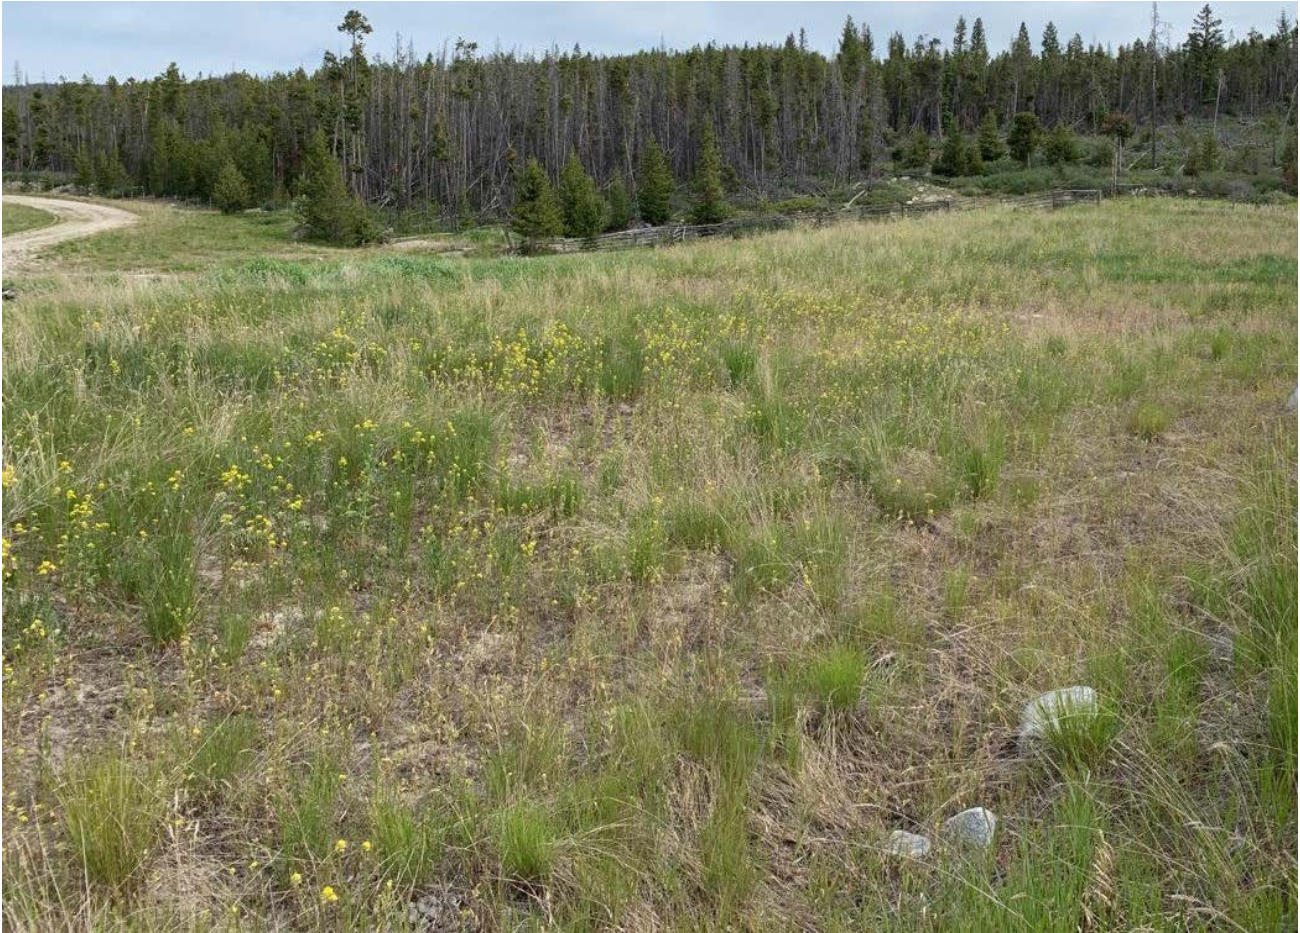
**Photo II-A-4 Overview of downstream slope of Dam No.1 from Trojan Dam (BTH-2019-03)**

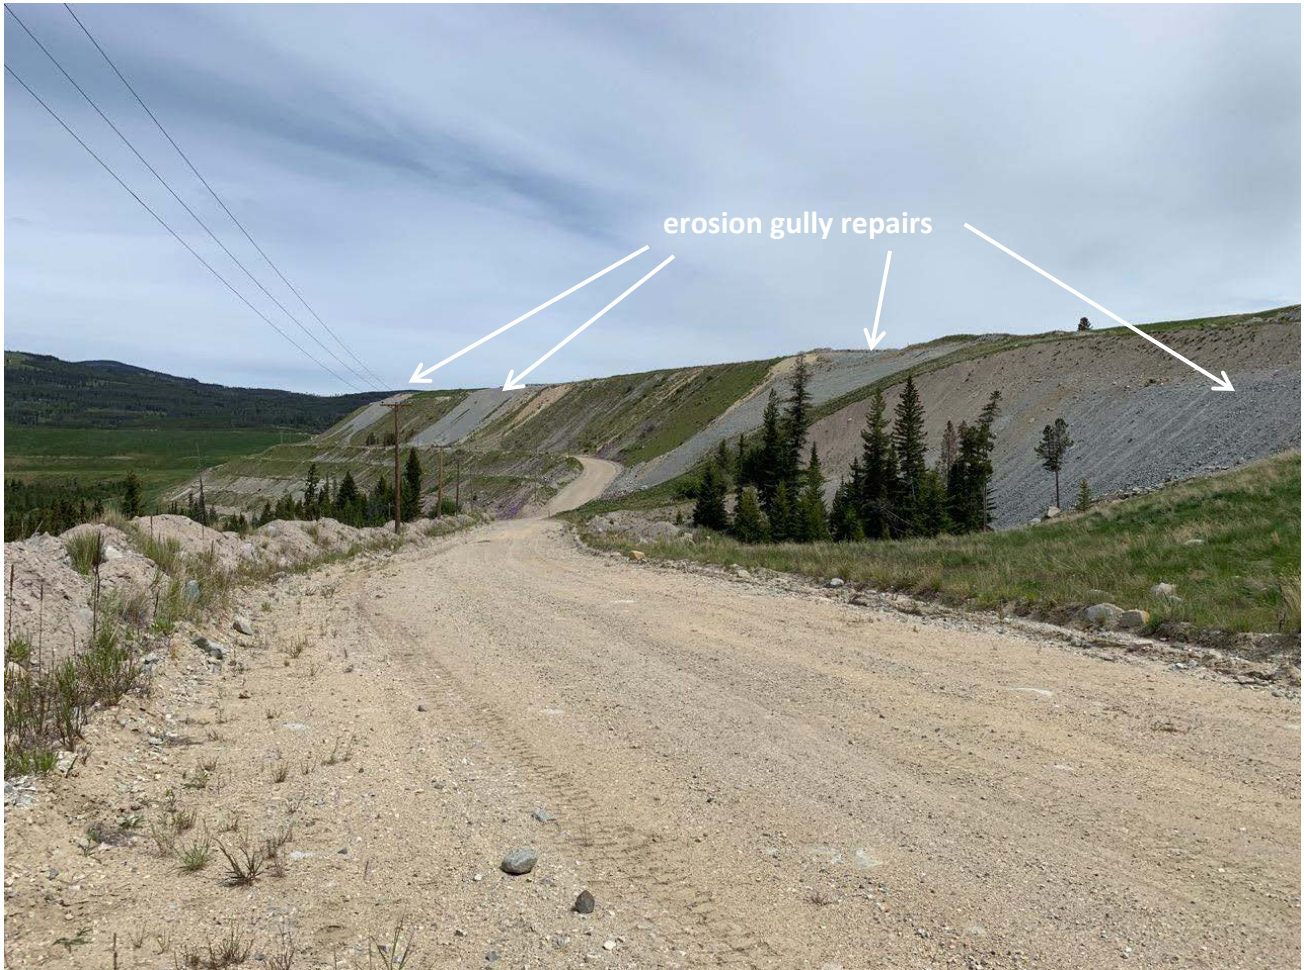
**Photo II-A-5 Overview of downstream slope and toe from left abutment (BTH-2019-04)**

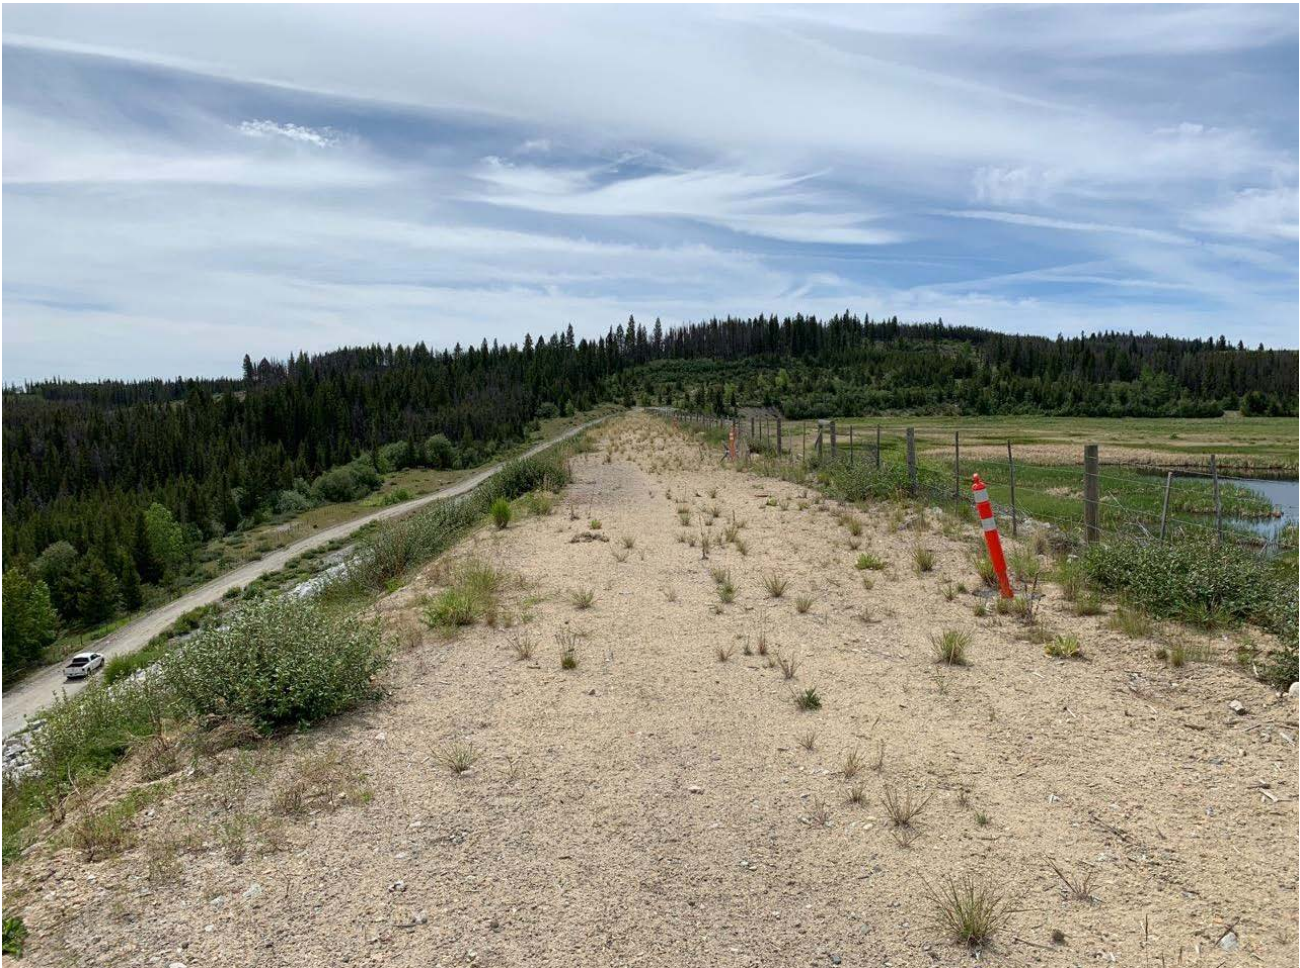
### Photo II-B-1 Overview of dam crest looking towards right abutment (BTH-2019-05)

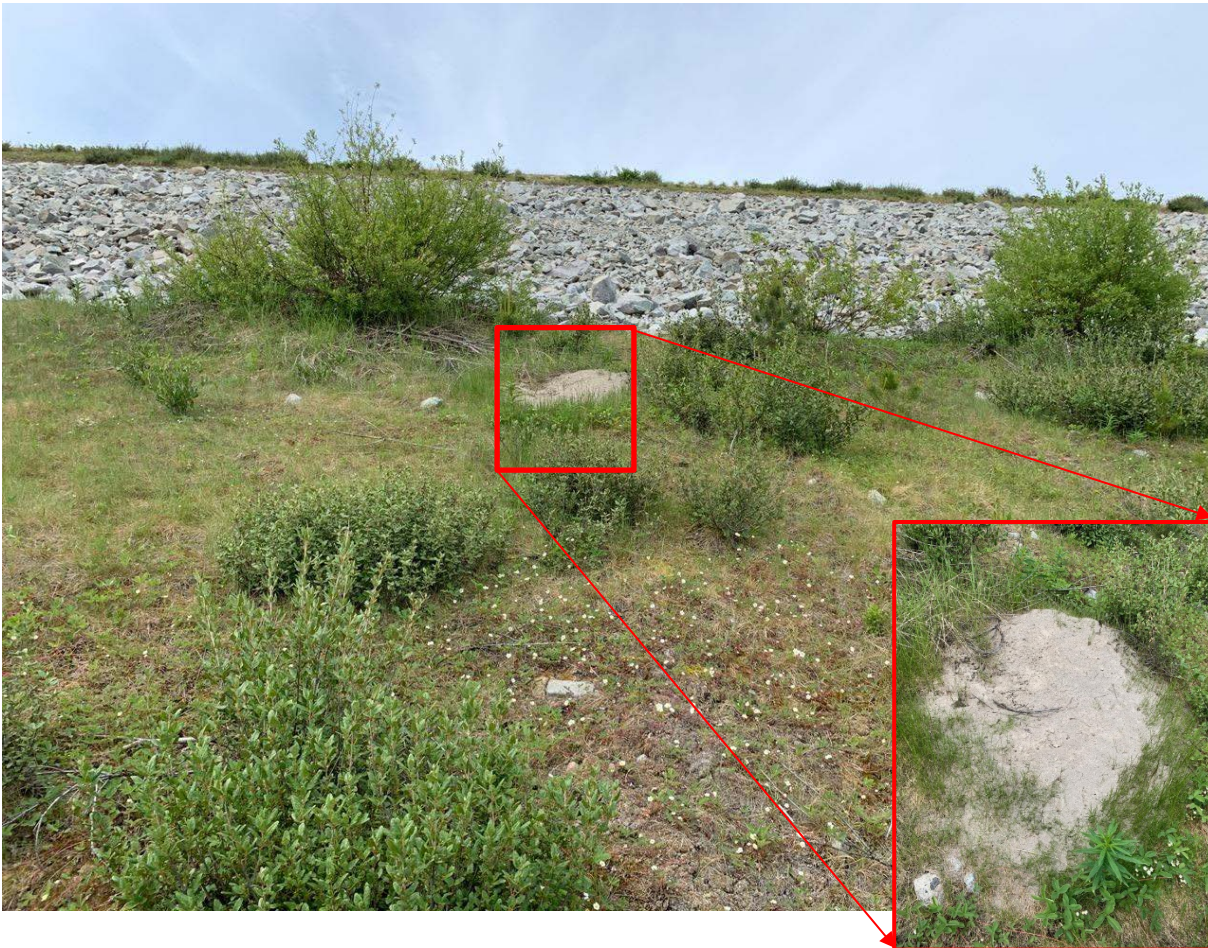
**Photo II-B-6 Pile of sand (not tailings) on upper part of starter dam slope. Appears to have been dumped there rather than resulting from seepage. Well above water level and no sign of flow in the area (BTH-2019-09)**

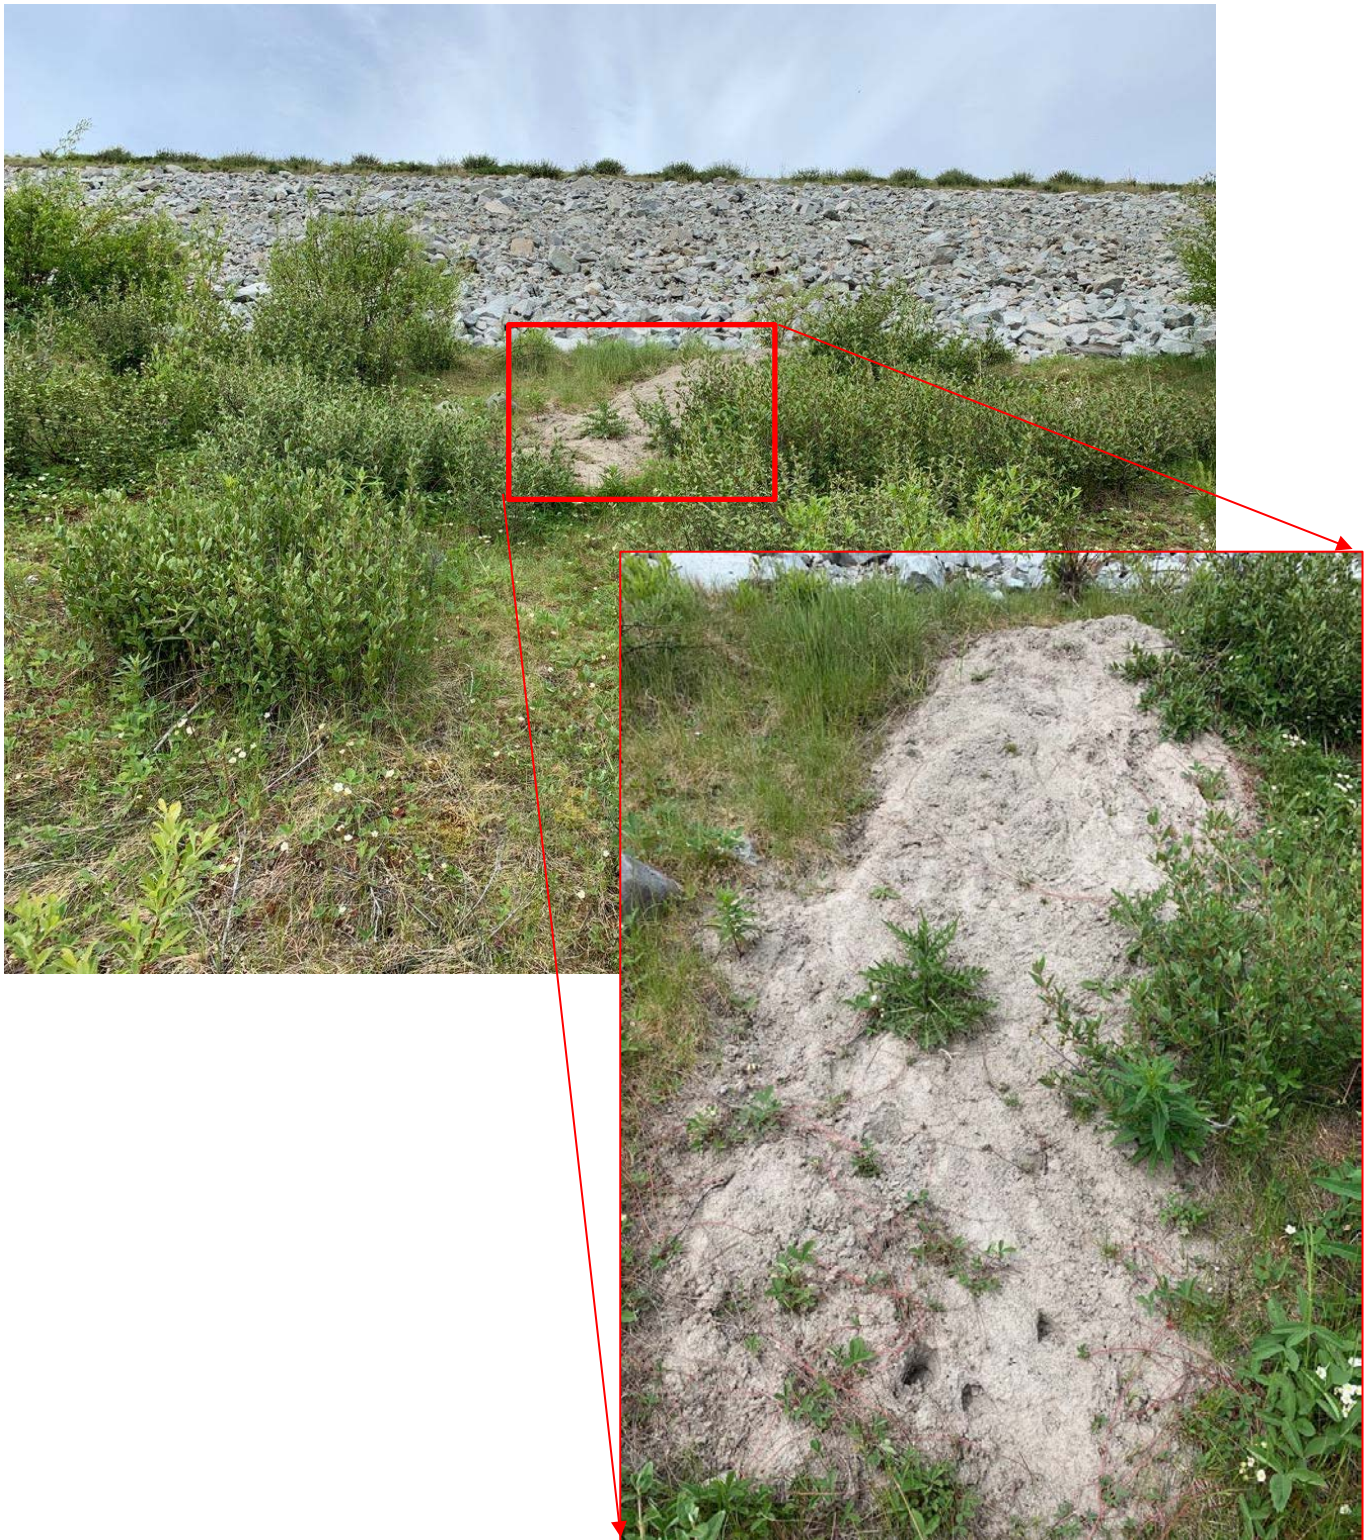
**Photo II-B-7 Sand pile similar to the one observed in Photo II-B-6 and at a similar elevation (BTH-2019-10)**

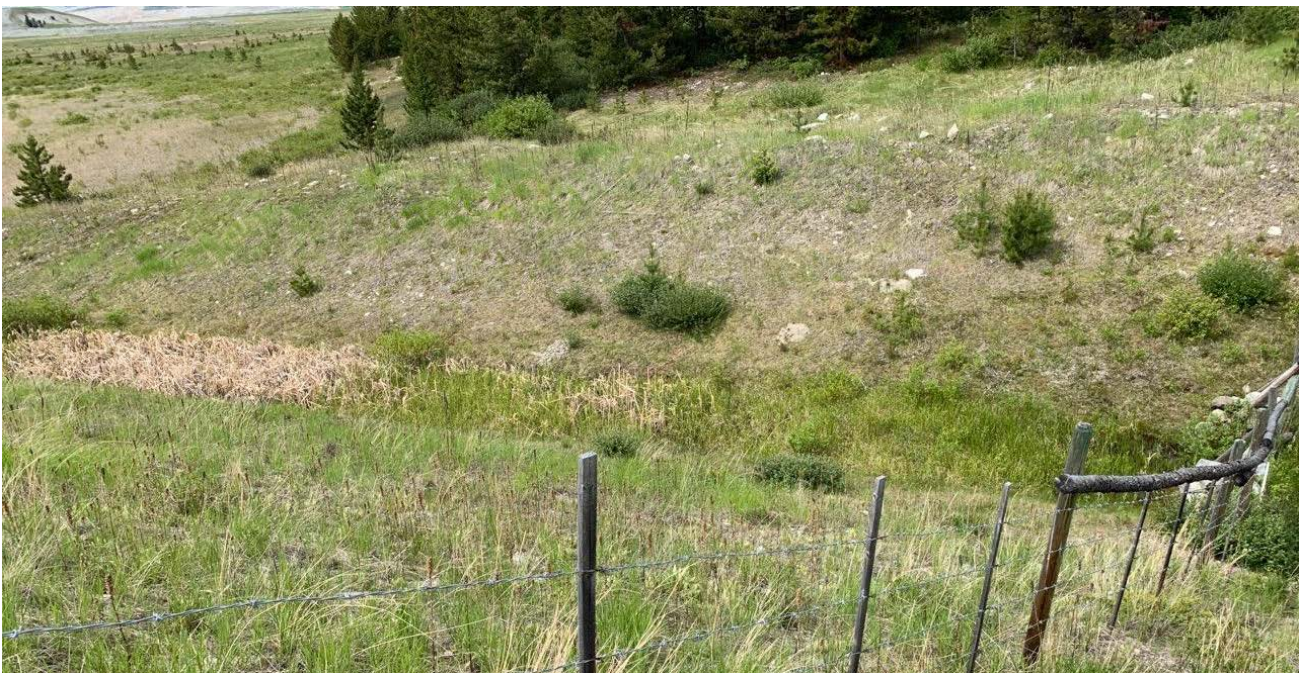
**Photo II-B-13 Spillway inlet and approach channel, looking southwest towards impoundment (BTH-2019-11)**

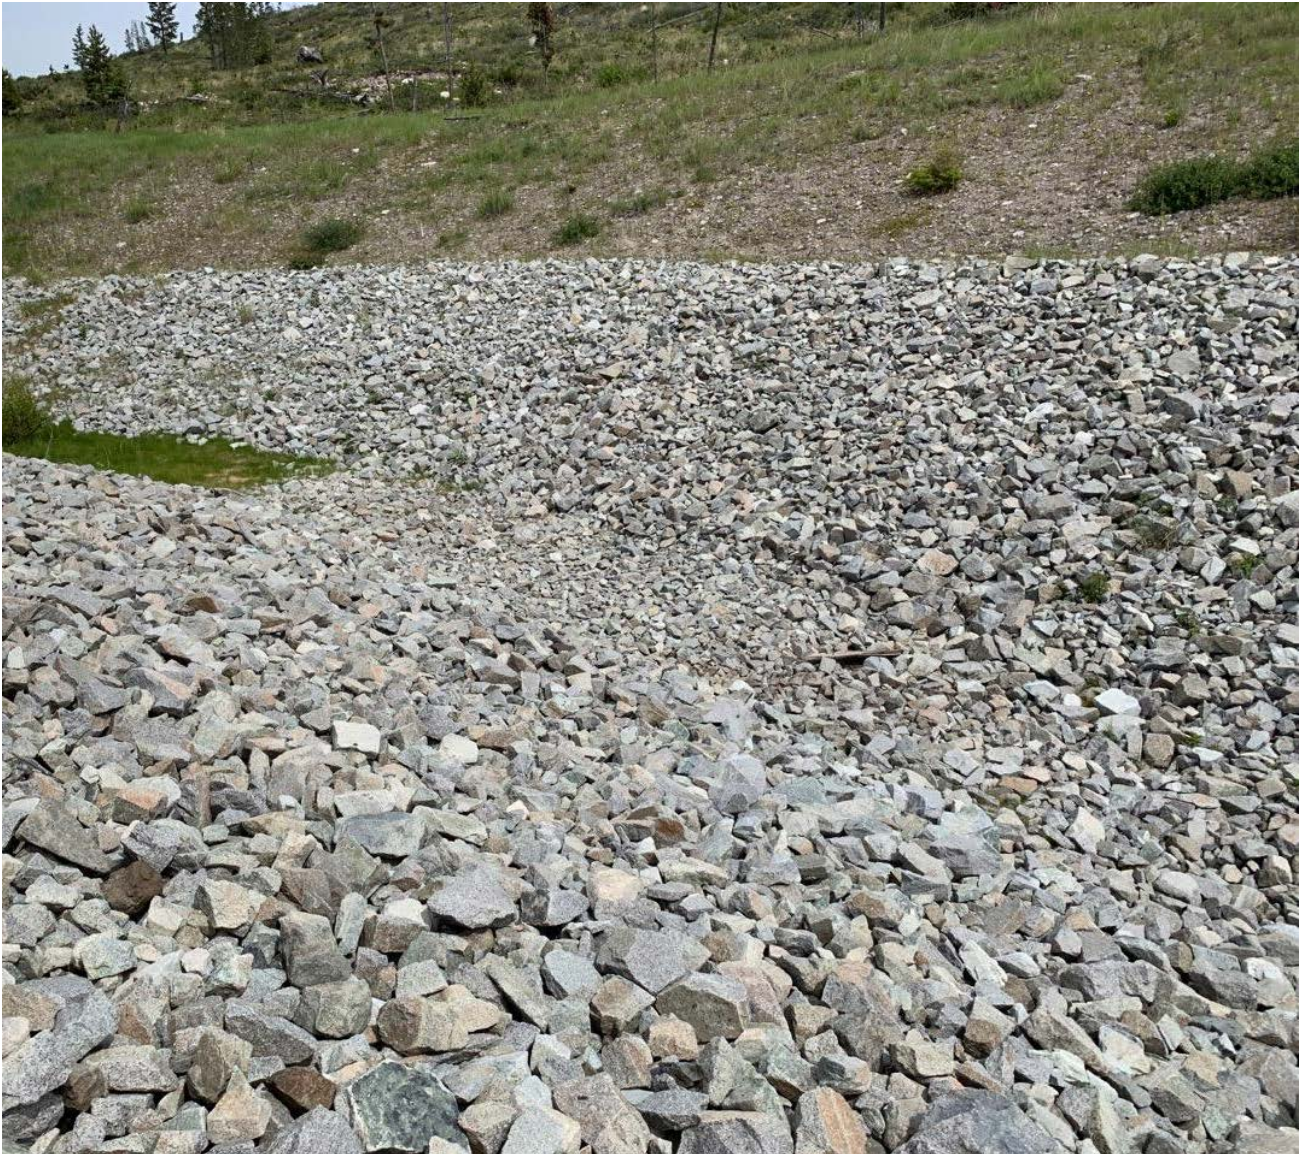
**Photo II-B-14 Overview of spillway channel – No vegetation around spillway bend. Riprap not degrading (BTH-2019-12)**

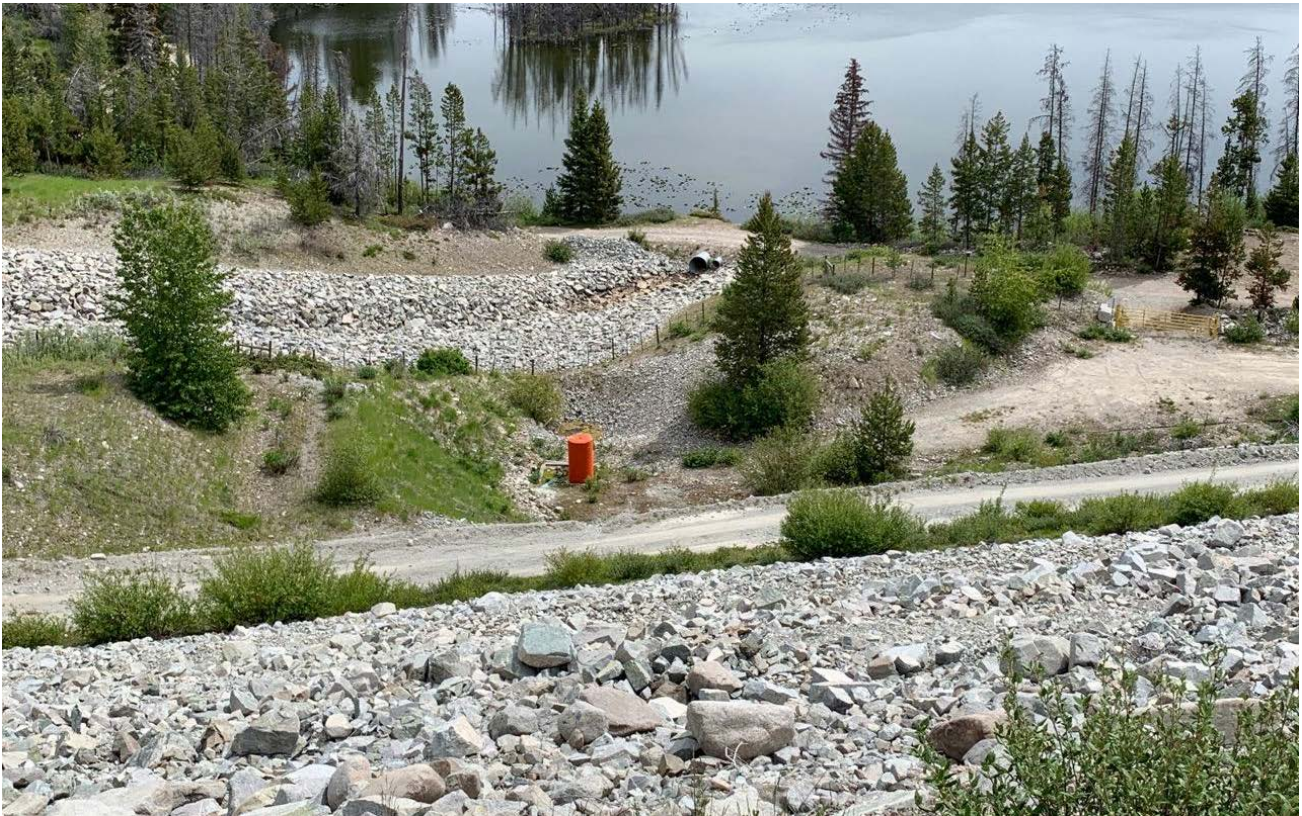
**Photo II-B-17 Spillway channel and outlet to Bose Lake (BTH-2019-13)**

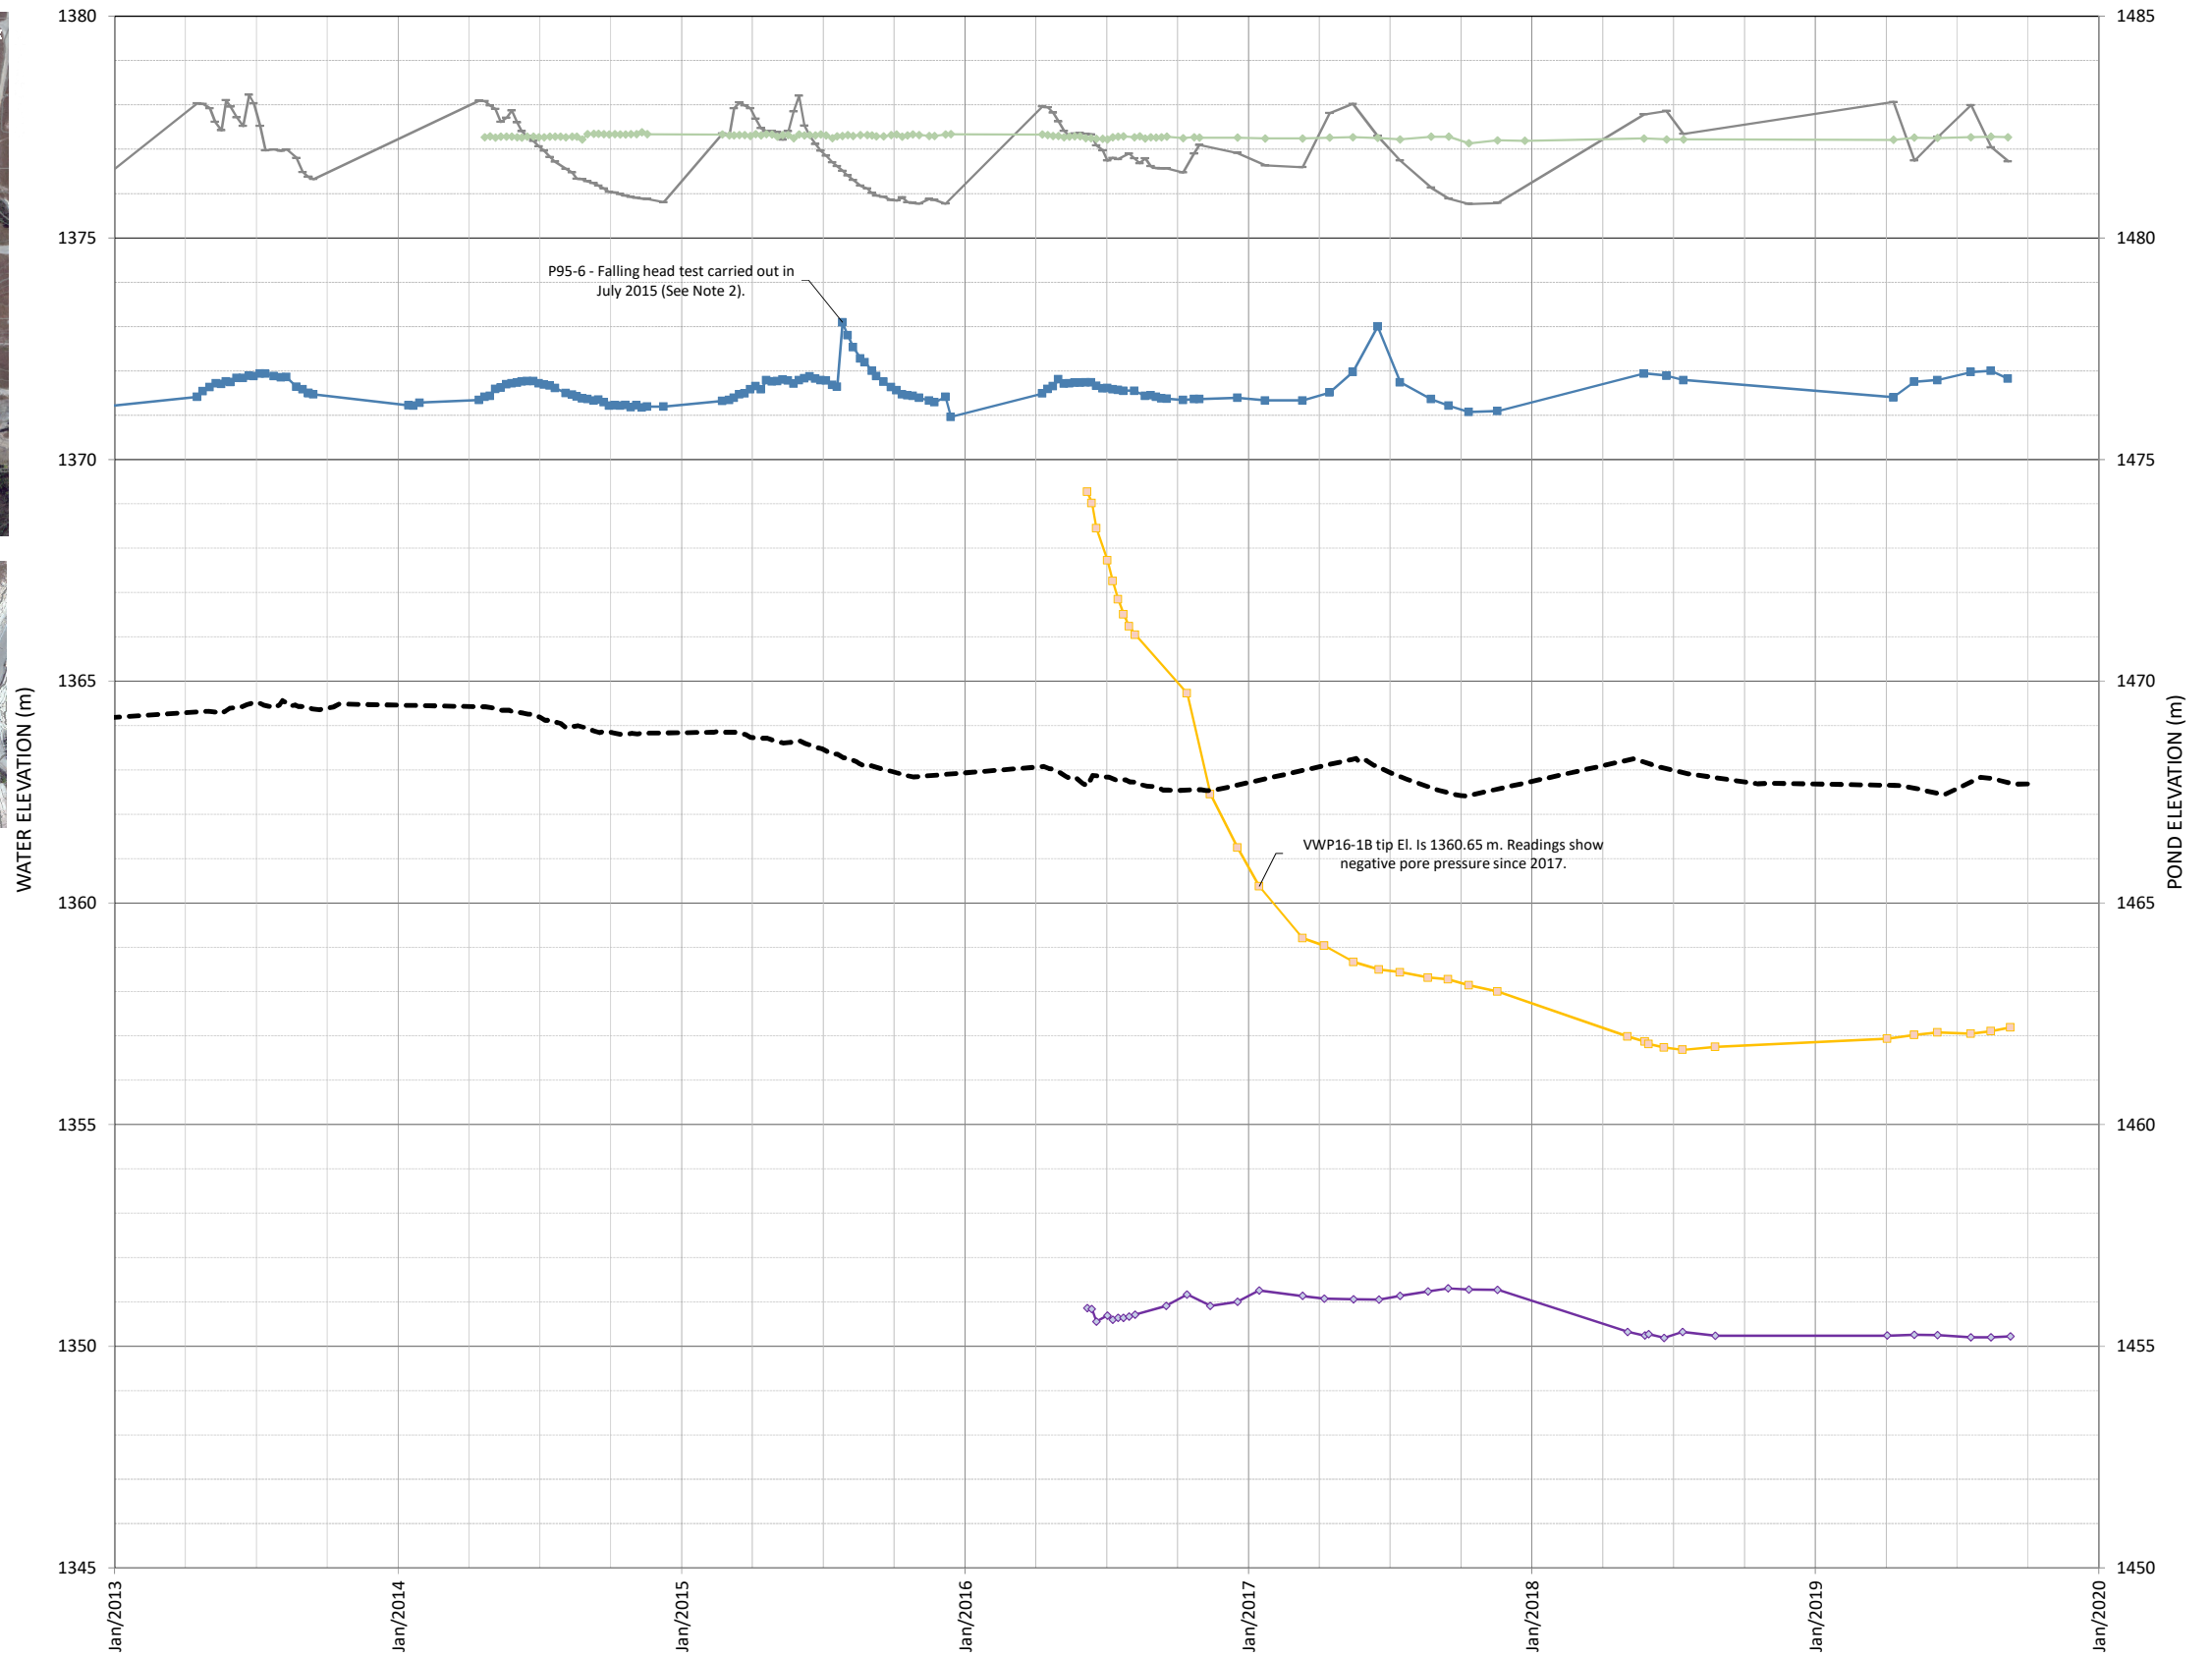
1. PIEZOMETER WATER ELEVATIONS PLOTTED ON PRIMARY (LEFT) AXIS, POND ELEVATION PLOTTED ON SECONDARY (RIGHT) AXIS.
2. FALLING HEAD TEST CARRIED OUT ON P95-6 DURING JULY 2015 - CAUSE OF SPIKE IN PIEZOMETRIC LEVELS
