Teck Resources Limited

Bullmoose Mine

Bullmoose Tailings Dam

2019 Dam Safety Inspection

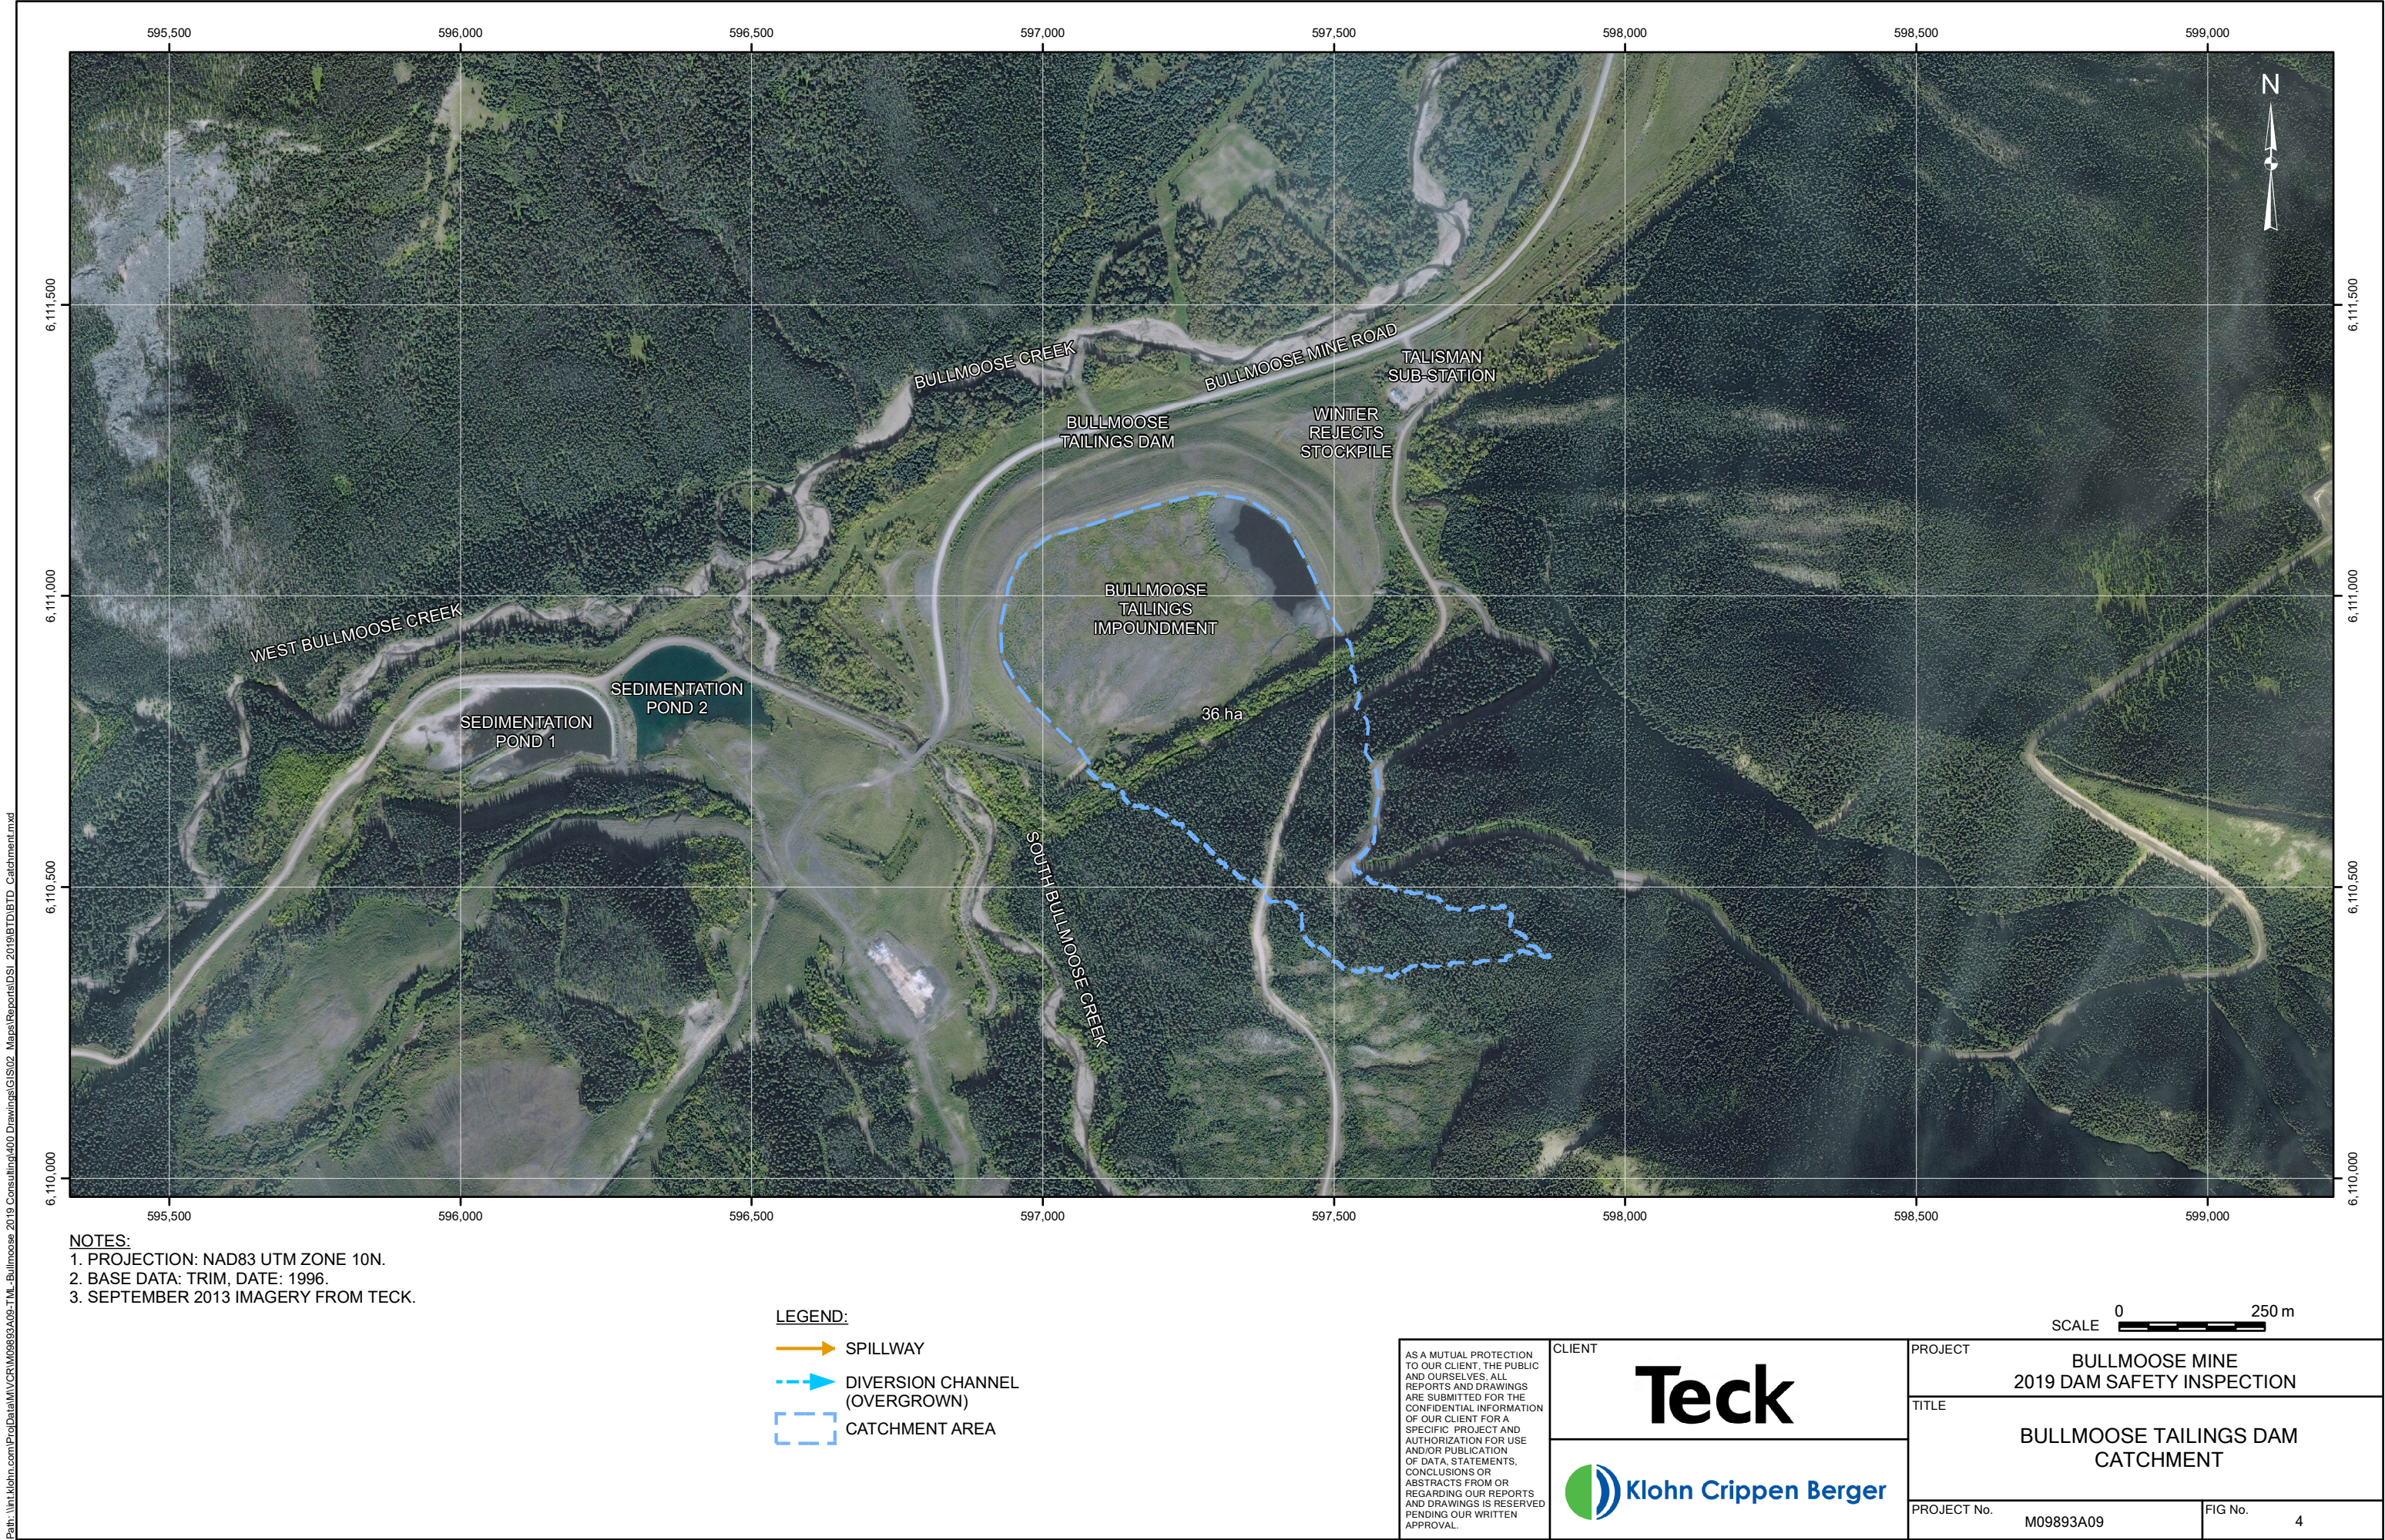
- None of the measured piezometers exceed Threshold Level 1.
- All measured piezometers have similar water levels to those measured in 2018 (see Figures 5 and 6):
 - ◆ PA-1, PA-4, PA-5, PB-4, PB-5 and PC-1 appeared to be stable with no general decreasing or increasing trend.
 - ◆ PA-2 water level dropped about 4 m between 2014 and 2015; the instrument has been relatively stable since 2015.
 - ◆ PB-3 and PC-3, installed in the dam, have been registered as “dry” since 2017 indicating relatively low phreatic level across the BTM embankment.
 - ◆ PB-1 and PC-2, installed in the foundation, continue to show a piezometric level below the instrument tips (i.e., they are dry). Other foundation piezometers PB-4, PB-5 and PC-1 indicate water levels are slightly below PB-1 and PC-2 tips.

The piezometer measurements show that pore pressures have been stable, and the dam shell is drained with low gradient of approximately 0.04 to 0.05 (KCB 2018c). Operation and construction induced pore pressure responses are no longer observed. Therefore, piezometers monitoring frequency of once per year is sufficient for ongoing monitoring of the structure under “Closure-Passive Care” conditions.

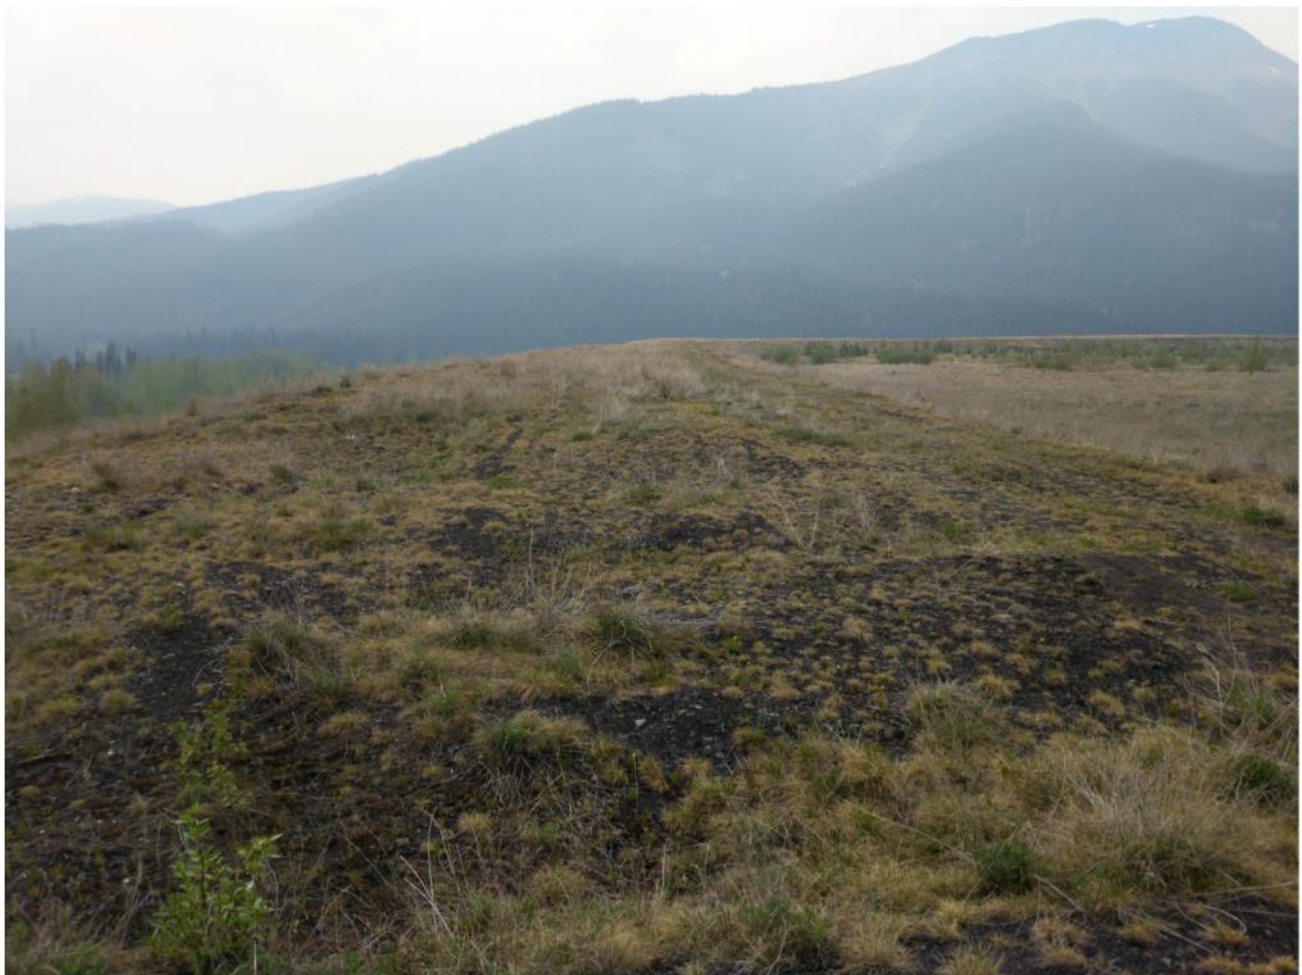
Photo II-1 BTD Crest – looking north (BTD-2019-01)

- **Dam Crest:** Good condition. No signs of lateral movement, differential settlement or cracking of the dam crest (Photos II-1, II-3 to II-5, II-7, and II-10).
- **Downstream Slope and Toe:** Good condition. No visible signs of significant erosion, displacement, or bulging (Photos II-14 to II-20). Vegetation (grasses and moss) are well established.
 - ◆ An erosion gully was observed at the toe near the East Abutment (Photo II-15). The gully was first observed in 2017 and dimensions appeared similar to observations to previous DSIs (approximately 0.2 m to 0.3 m wide, 0.1 m deep and 10 m to 15 m long). The likely cause was concentrated local flow during spring freshet. This feature continues to be monitored and inspected for signs of change during routine visual inspections and annual DSI site visits.

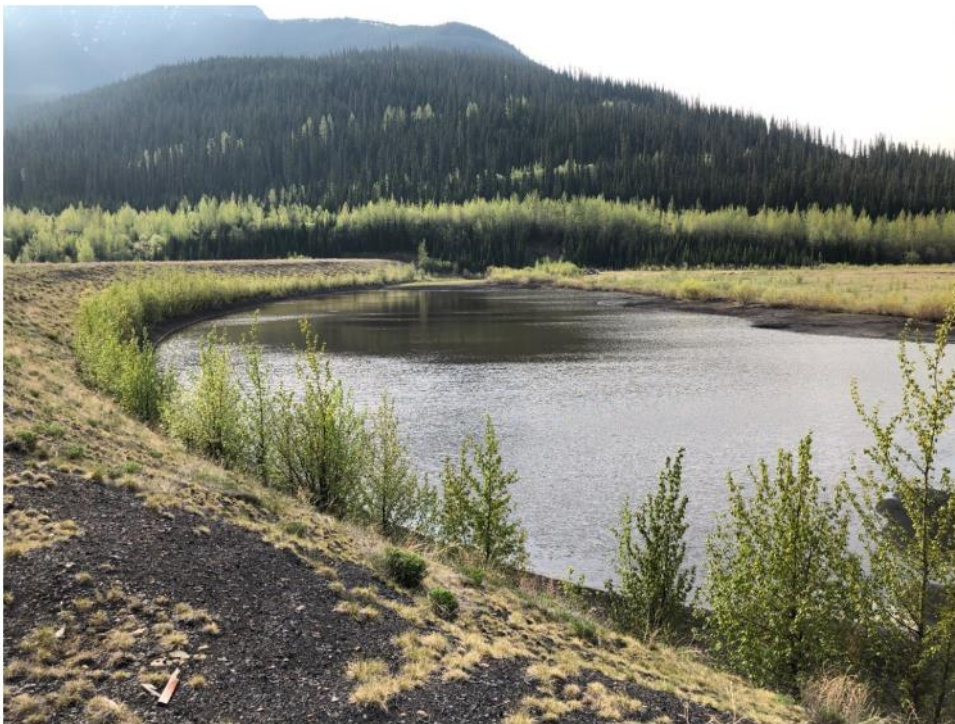
Photo II-9 BTD Pond – looking south (BTD-2019-06)

- **Upstream Slope:** Good condition. No signs of significant erosion or displacement (Photos II-9 and II-10).
- **West Abutment:** Good condition. The spillway is excavated through the west abutment, no signs of erosion at the abutment (Photo II-20).

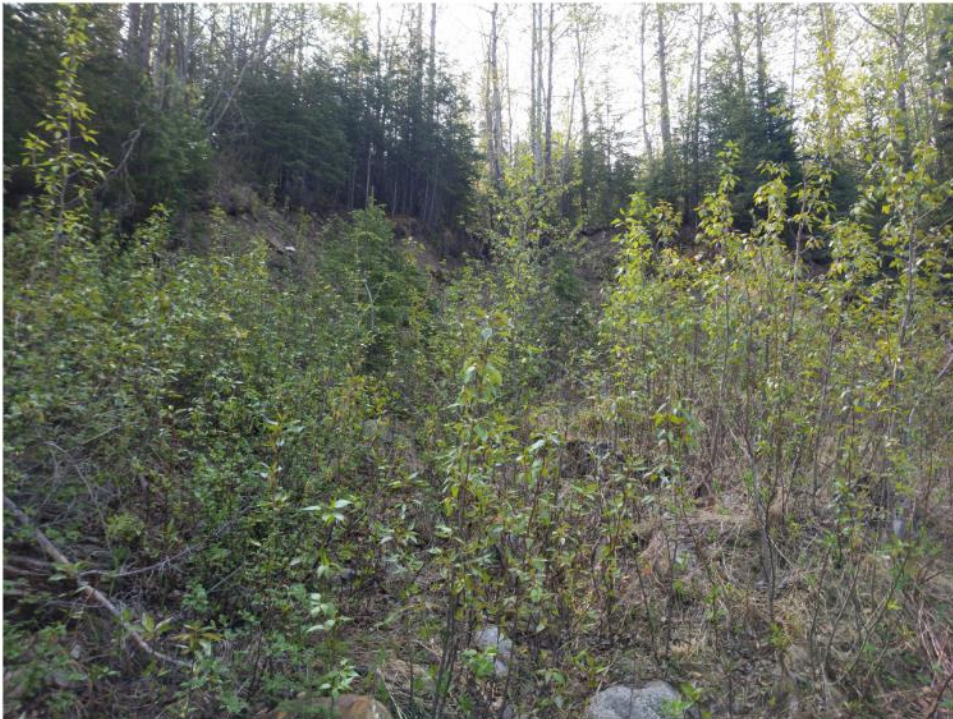
- **Historical Slope Failure On Natural Slope South Of Impoundment:** A historical slope failure is present in the natural slope on the south side of the impoundment (Photo II-11). The failure is also visible in photographs from previous inspection reports (Teck 2013a, KCB 2011, and KCB 2014a) indicating this has been present since at least 2010. The slide mass is overgrown with vegetation including small trees. Comparison of photographs between 2010 and 2019 does not indicate any visually identifiable changes. This feature is not a risk to the dam safety.

Photo II-11 Historic slide from the natural slope. Mostly overgrown with small trees. No signs of change from previous inspections – looking south (BTD-2019-09)

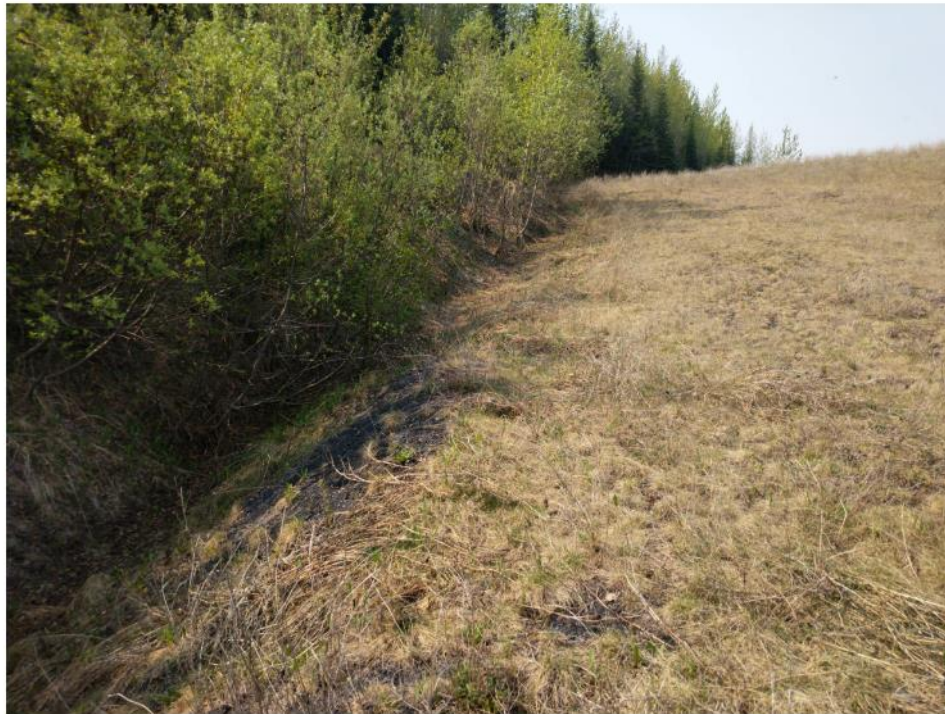
Photo II-12 BTD East Abutment – looking west (BTD-2019-10)

- **East Abutment:** Good condition. No signs of significant erosion or displacement of the natural slope. Vegetation is well established at the abutment and along the abutment/downstream slope contact (Photo II-12 and II-13). There is a small channel running along the east abutment towards the toe which is unchanged from the 2018 condition.

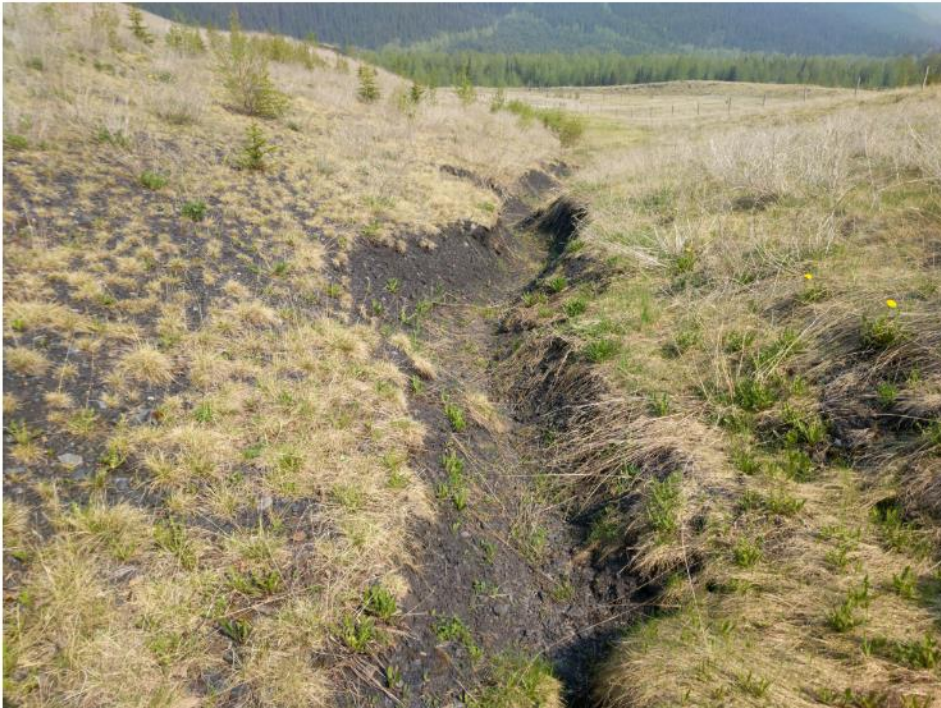
Photo II-15 BTD Toe. Erosion gulley observed during previous inspections. No obvious signs of change – looking north (BTD-2019-11)

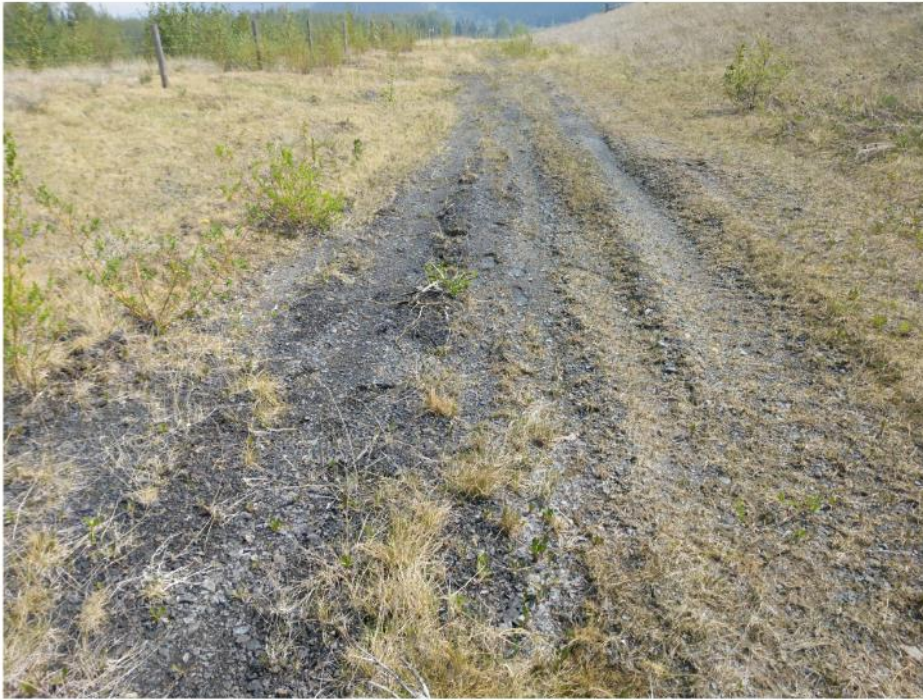
- ♦ A small wet area was noted near the toe of the north arm of the BTD during the DSI site visit (Photo II-18). There were no signs of seepage emerging from the downstream slope, and the wet area is believed to be due to ponding from snowmelt from the slopes.

Photo II-18 **BTD Downstream Toe. Wet area along the toe. Noted in previous DSI reports as being an area where snowmelt water collects. No signs of seepage emerging from the slope – looking east (BTD-2019-14)**

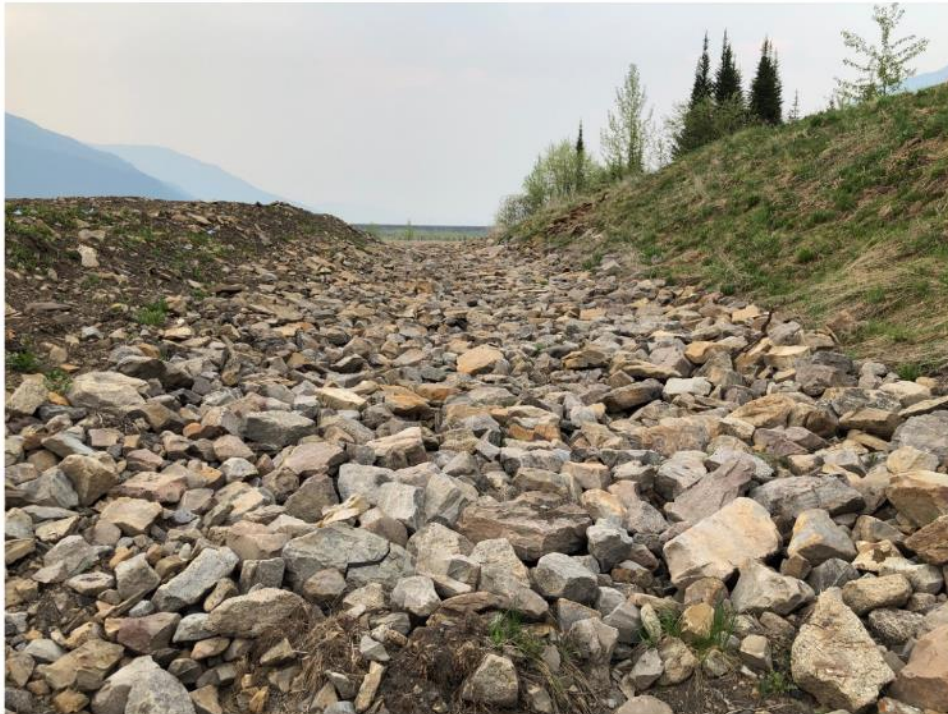
- **Spillway:** Good condition (Photos II-21 to II-24). There was some minor vegetation growth in the spillway where the riprap entered the forested area. KCB have included a recommendation to clear this vegetation in this DSI report. Riprap at the BTD spillway was noted to have a “disturbed” appearance (i.e., not interlocked) in 2018. The riprap was repaired and the post-repair riprap conditions observed during the 2019 DSI site visit appeared to be adequate (Photo II-21 and II-22).

Photo II-21 BTD Spillway. Riprap armoured portion of the spillway – looking upstream (BTD-2019-16)

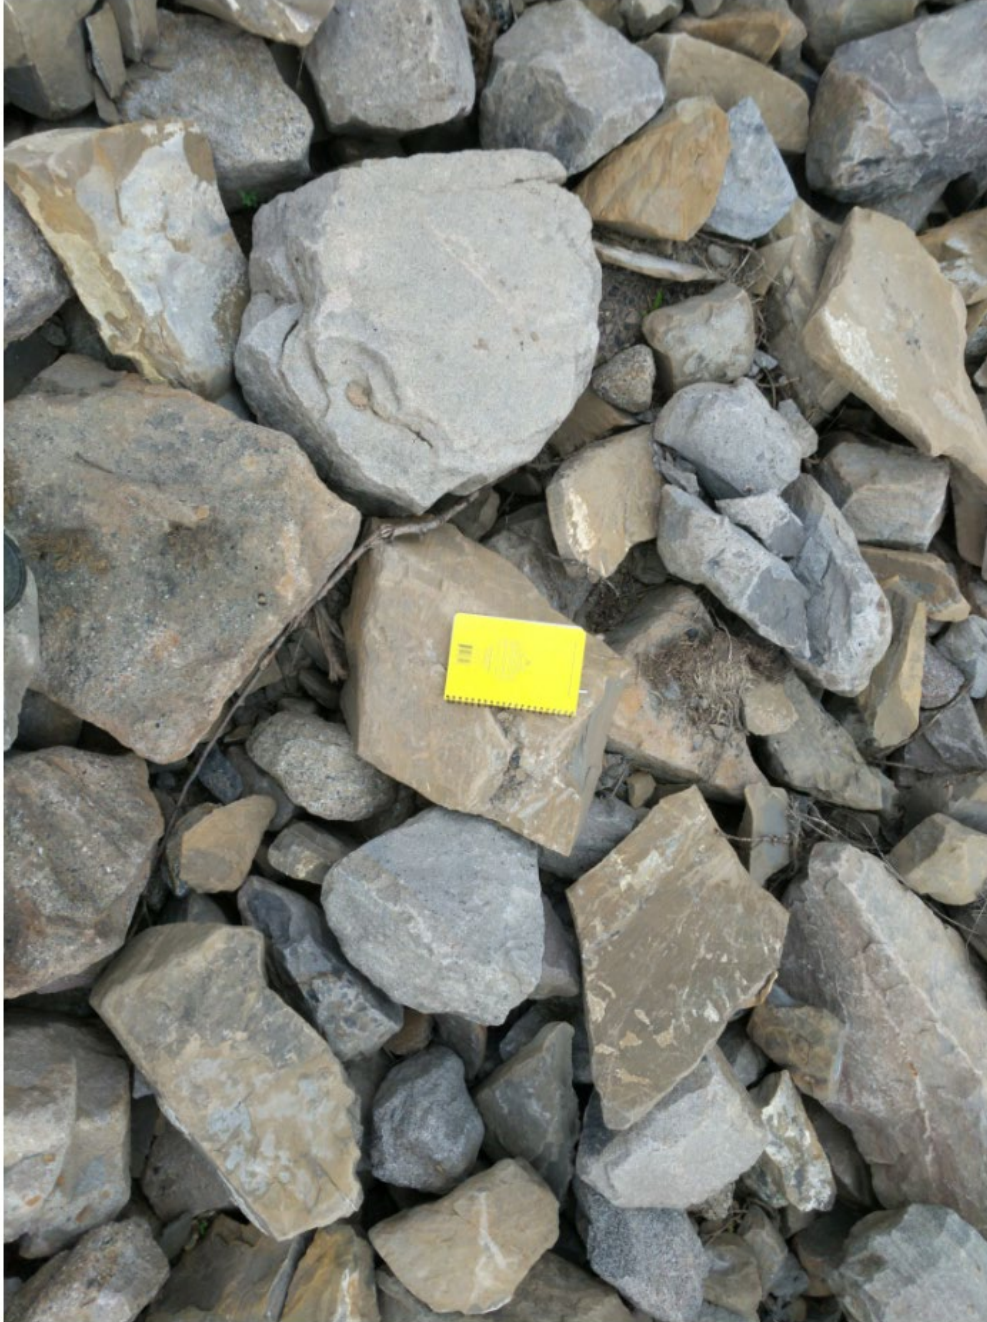
Photo II-22 **BTD Spillway Riprap. D₅₀ of approximately 300 mm – looking upstream (BTD-2019-16)**

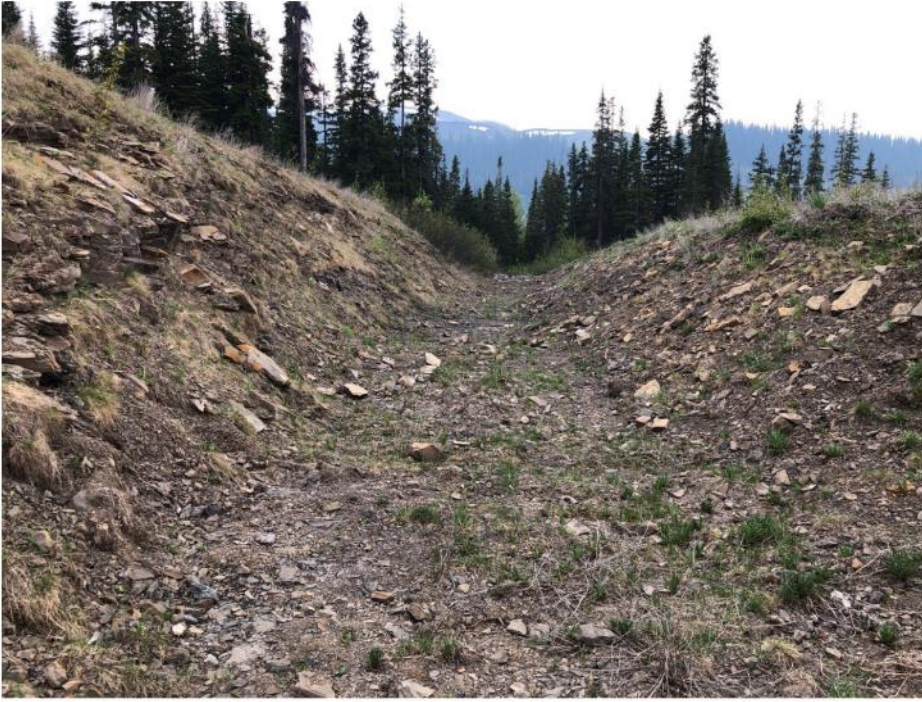
Photo II-23 **BTD Spillway. Unarmoured portion of the spillway (left bank comprised of bedrock) – looking downstream (BTD-2019-16)**

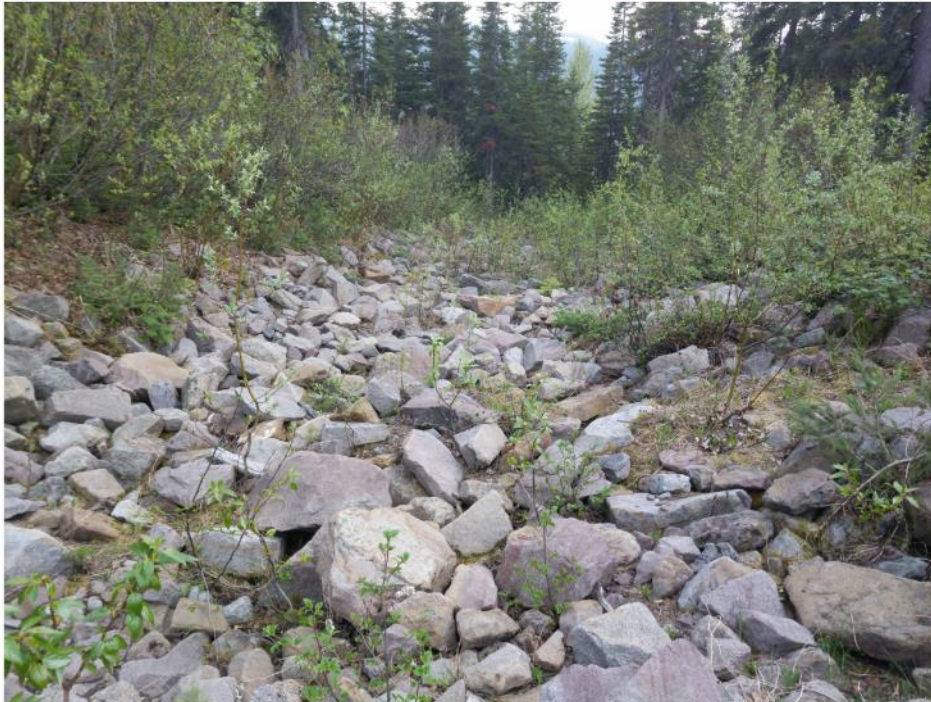
Photo II-24 **BTD Spillway Outlet. Riprap D_{50} of approximately 300 mm – looking downstream (BTD-2019-17)**
