Klohn Crippen Berger

Teck Coal Limited Elkview Operations

West Fork Tailings Facility and Lagoons A, B, C, and D

2019 Dam Safety Inspection

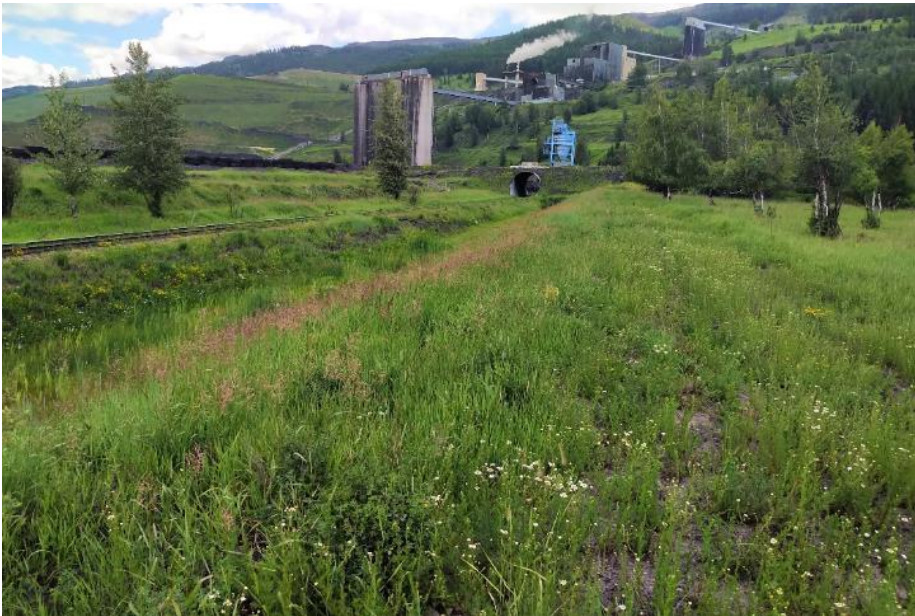
Photo IA-3 Typical surface conditions. (looking south)

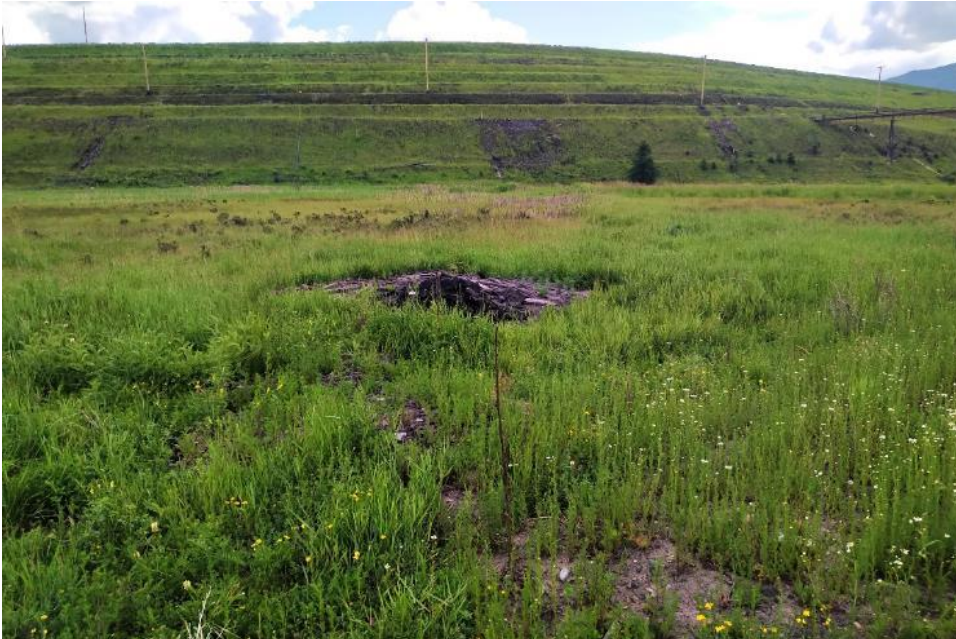
Photo IA-4 Rockfill armoured spillway. (looking north)

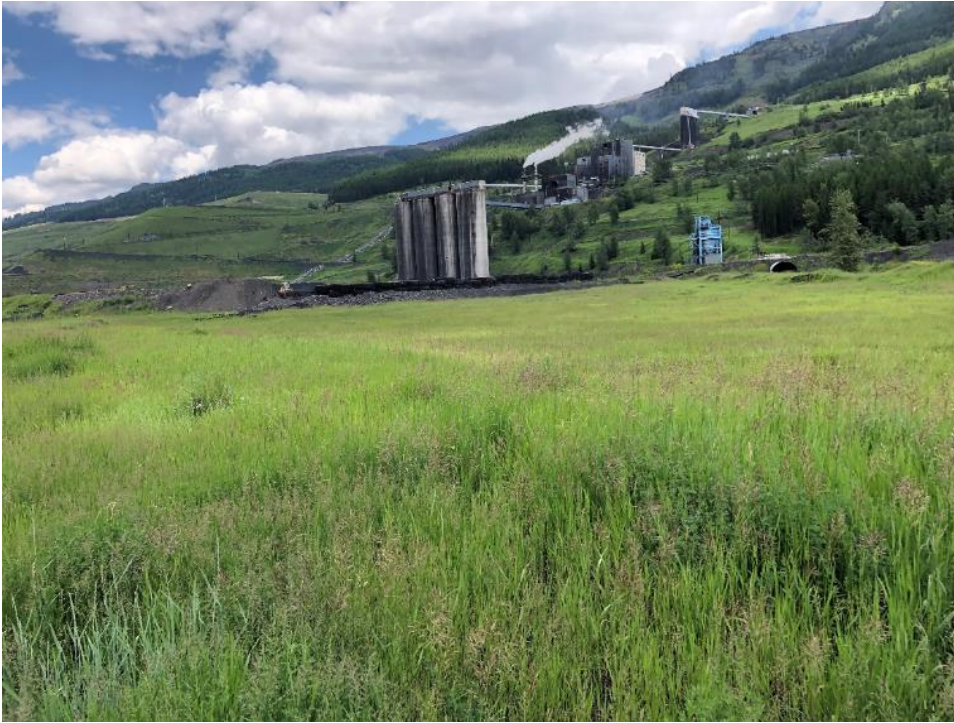
Photo IB-4 Minor slumping of Lagoon B. (looking northeast)

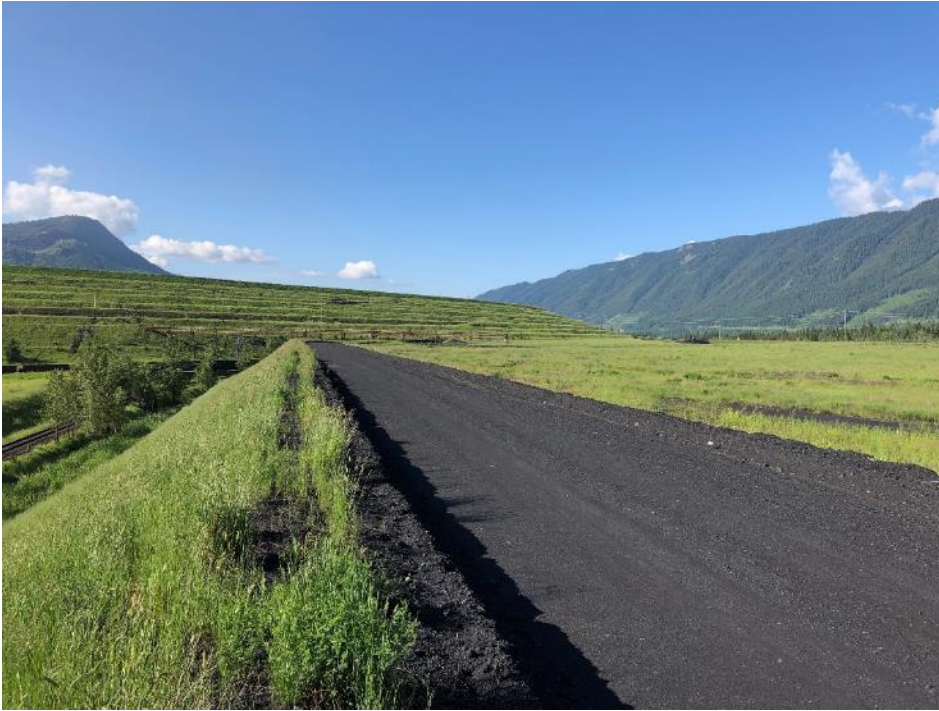
Photo IC-4 Typical downstream slope condition. (looking north)

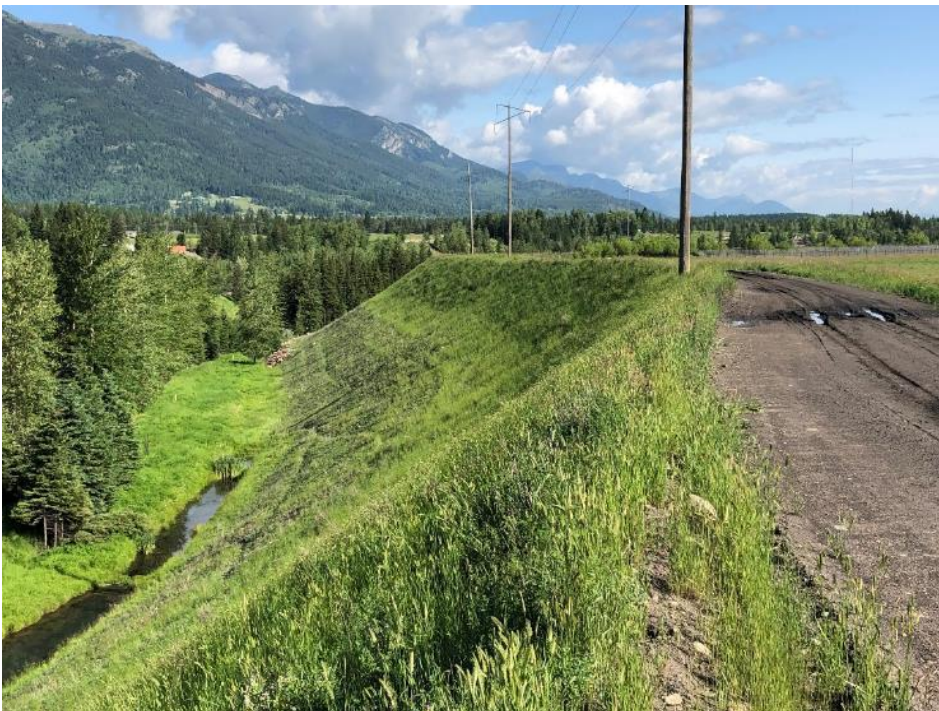
Photo IC-5 Local erosion and sparse vegetation. (looking southwest)

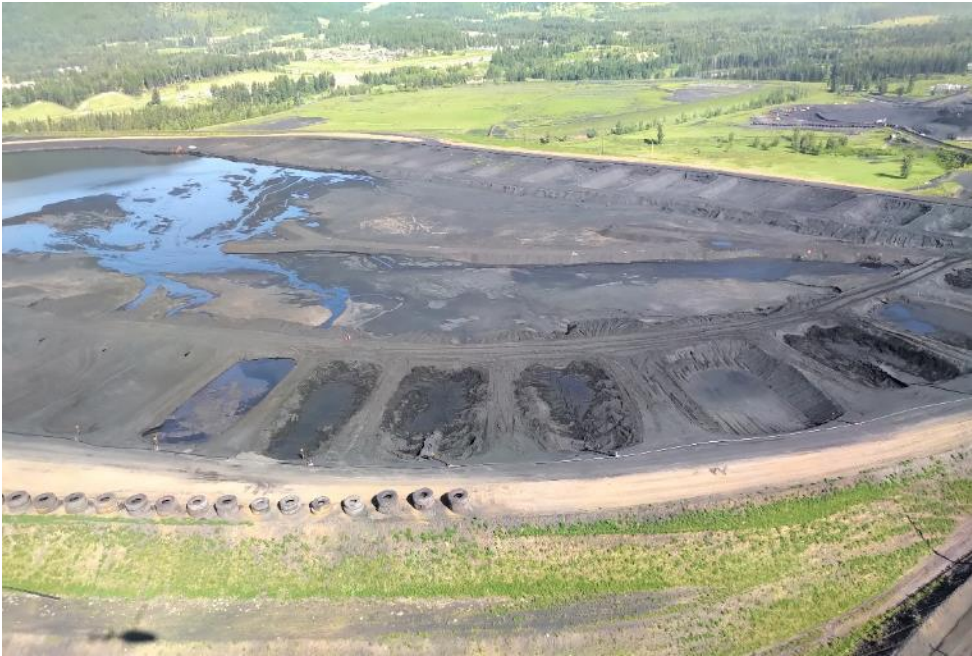
Photo ID-4 Typical crest conditions. (looking east)

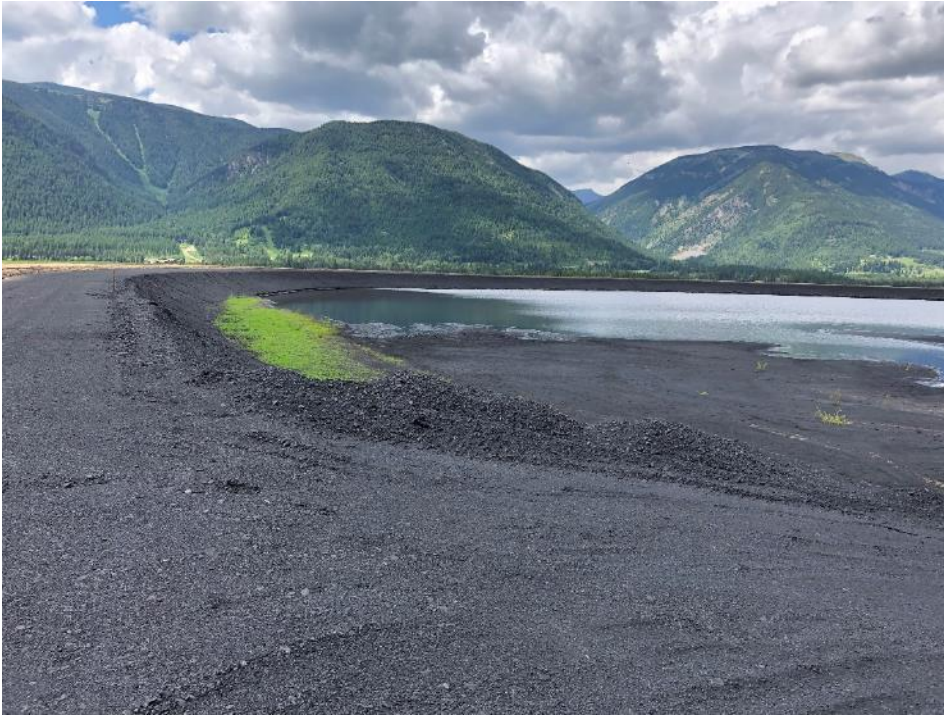
Photo ID-18 Downstream erosion and sparse vegetation. (looking west)

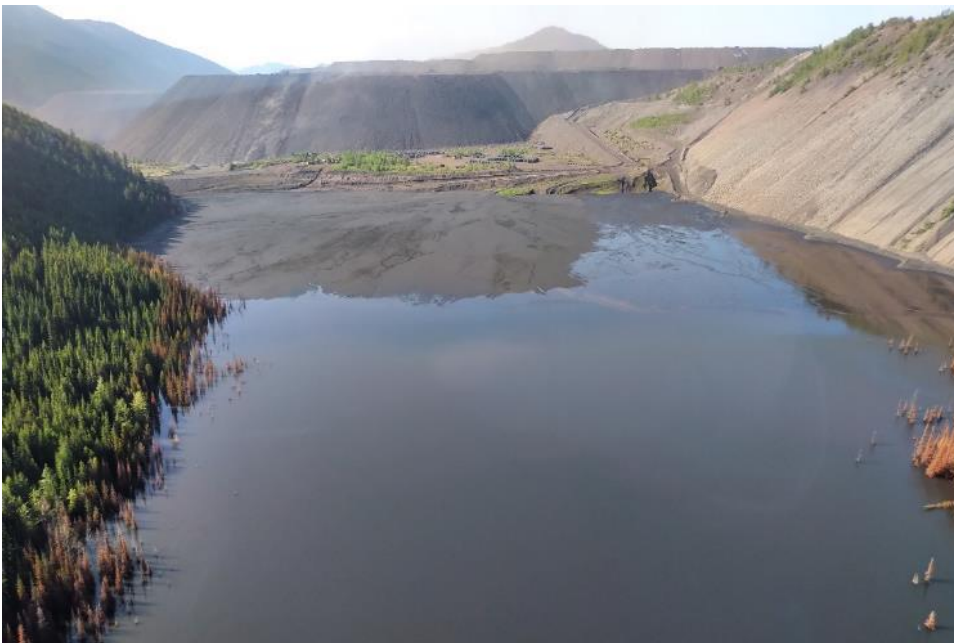
Photo IW-3 Adit Toe Berm and tailings infiltration into west abutment. (looking north)

2019-04	WFTF	Possible signs of tailings migration into the abutment was observed during the 2019 inspection. The next stage of the design to El. 1,710 m should include measures to minimize the risk of tailings migration through WFTF embankment.	3	Potential Deficiency	New Action / Not Complete	End of 2020	N/A
2019-05	WFTF	The freeboard requirements for the WFTF should be stated in the OMS manual.	3	Potential Non-Conformance	New Action / Not Complete	End of 2020	N/A

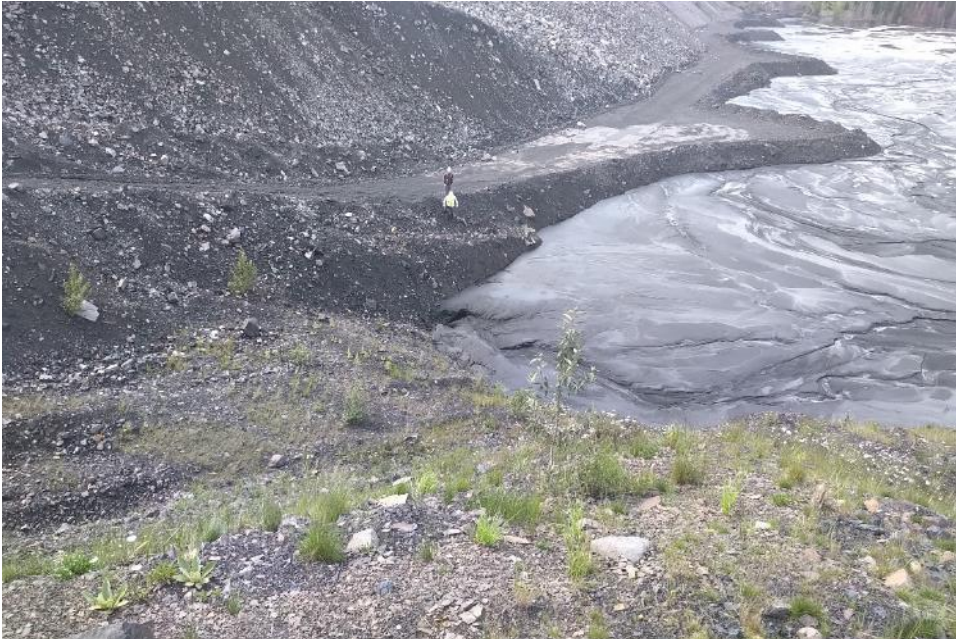
Photo IW-4 Tailings infiltration into east abutment. (looking north)
