2019 Dam Safety Inspection for South Tailings Pond and North Tailings Pond

Teck Coal Limited, Fording River Operations

Reference No. 18110785-2019-159-R-Rev0-1000

4 March 2020

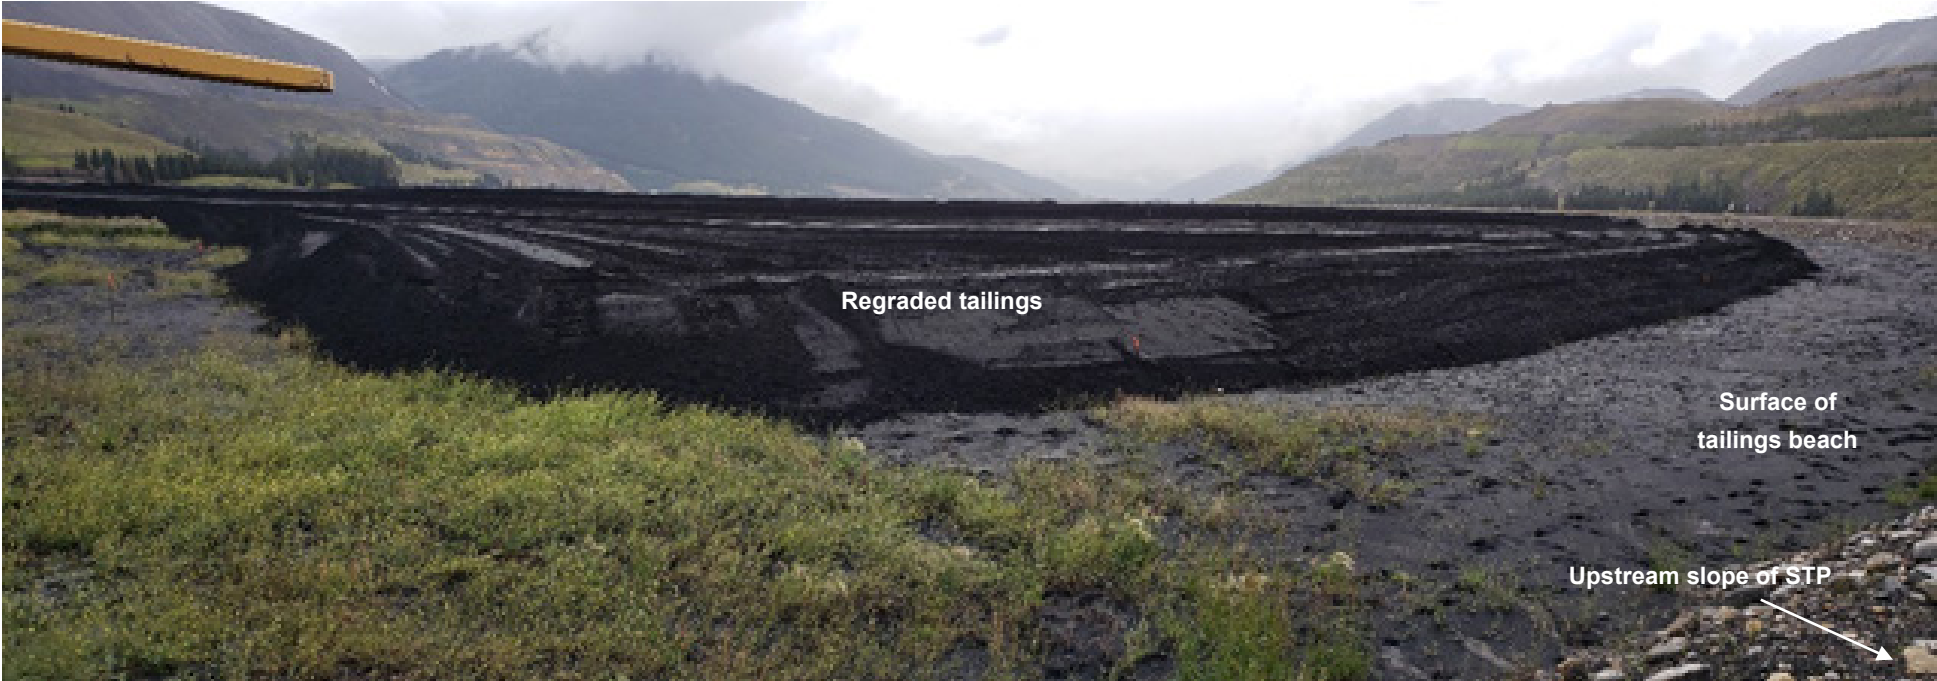
Photograph A-6: STP West Dam near Station 0+000, Regraded tailings to 0.2 m below STP dam crest and minimum 10 m Wide Channel was Maintained between Regarded Tailings and Upstream Slope of Dam during Tailings Regrading Work, looking South, 10 September 2019

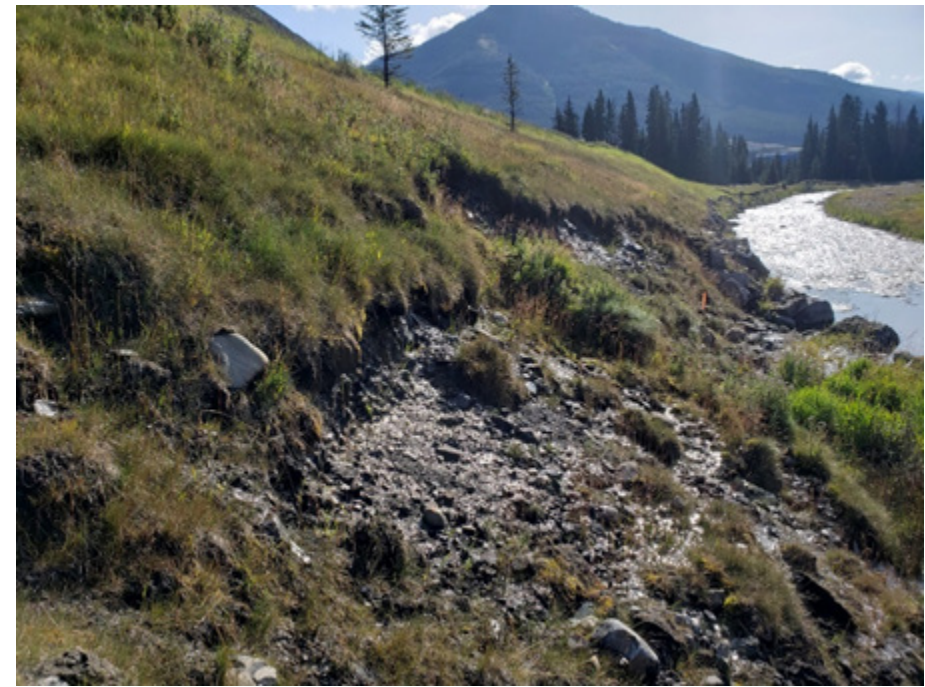
Photograph A-9: STP West Dam, looking South at the Toe of the Cut Slope Above Fording River Diversion, Seepage was Observed to be Coming out of the Slope Adjacent to the West Seepage Pipes, 10 September 2019

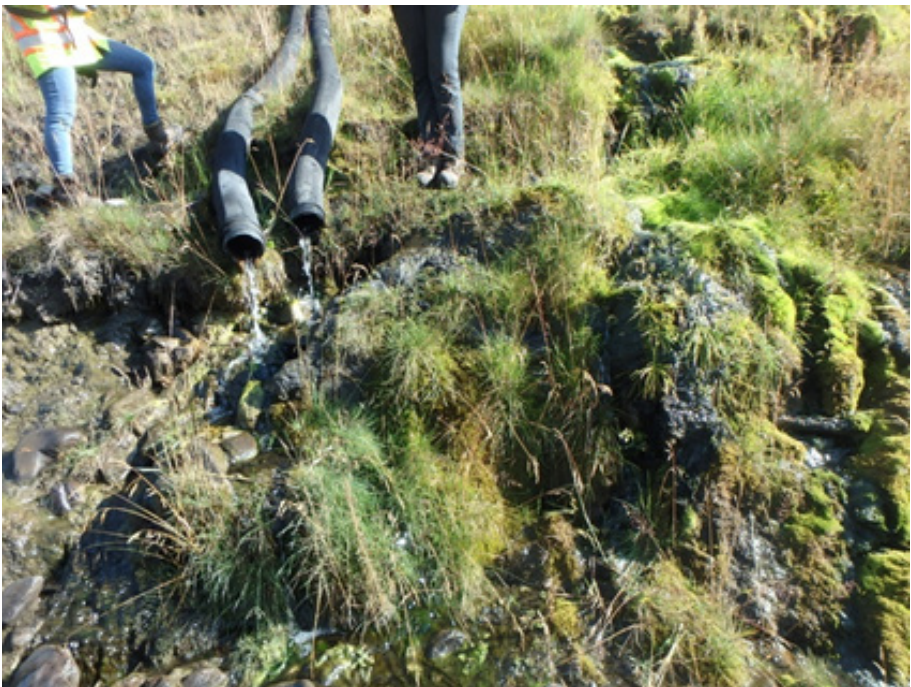
Photograph A-10: STP West Dam, looking at the West Seepage Pipes Discharging Cut Slope above Fording River Diversion near Station 1+000, 10 September 2019, Seepage Rate was 0.27 L/sec for the North Pipe (left) and 0.2 L/sec for the South Pipe (right)

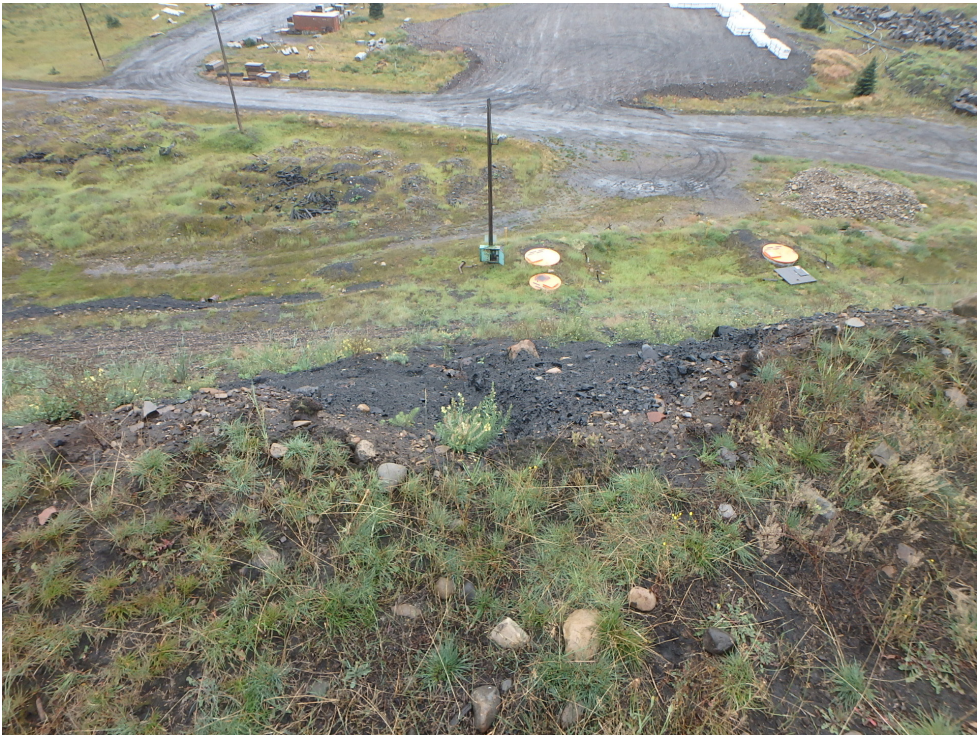
Photograph A-13: STP Main Dam, Looking Southeast At Erosion Channel Along Downstream Slope At Station 1+450, 10 September 2019

2019-01	Portions of the Main Dam were eroded as a result of discharge of effluent on undesignated areas of the dam	CDA 2013 §3.5.3	Repair by placing breaker rock over geotextile on the eroded areas.	2	2020
	2019-02	The existing water level sensor is located near the upstream slope of the dam, where the sensor would detect dam/ground surface if the water level is lower	HSRC §4.4.1 CDA 2013 §3.6.3	Dredge the tailings under the relocated existing water level sensor to re-establish free water or add a new sensor.	3	Q2 2020

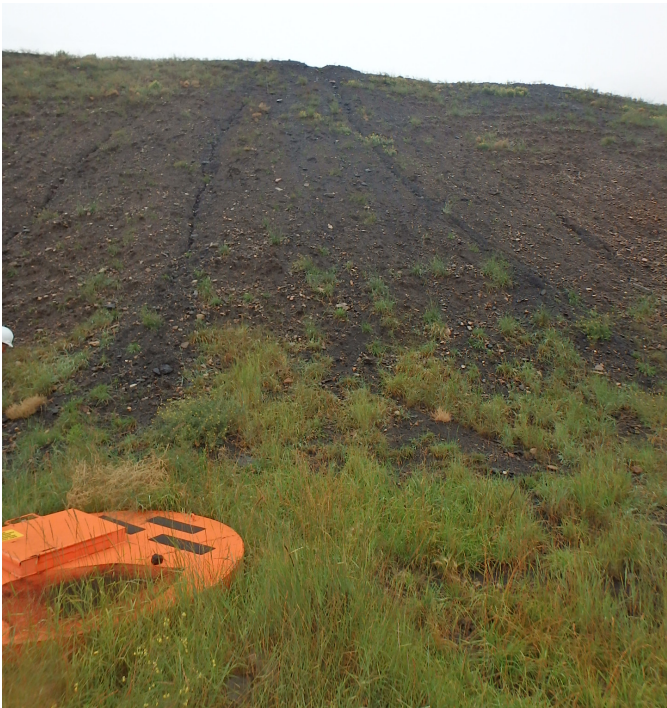
Photograph A-14: STP Main Dam, Looking Up At Downstream Slope From Dam Toe At Erosion Gullies From Photo A-13, 10 September 2019

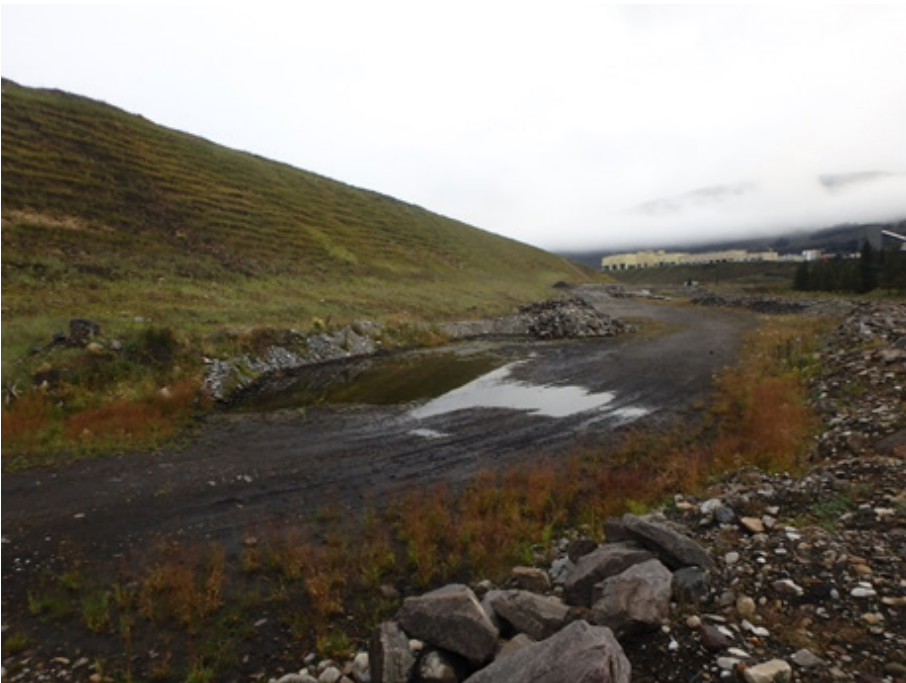
Photograph A-32: NTP Dam Downstream Slope and Toe and Stepped Erosion and Area of Ponding Water, at Station 1+200, 11 September 2019

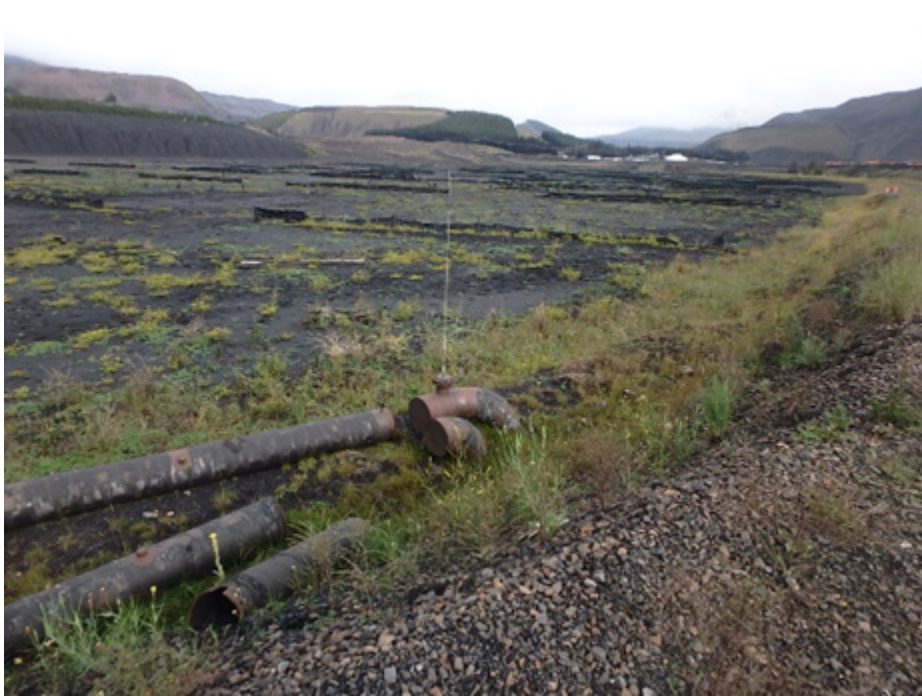
Photograph A-35: On NTP Upstream Slope, Unused Reclaim Pipelines (capped pipeline that go into dam section and cross under dam crest), looking North, 11 September 2019

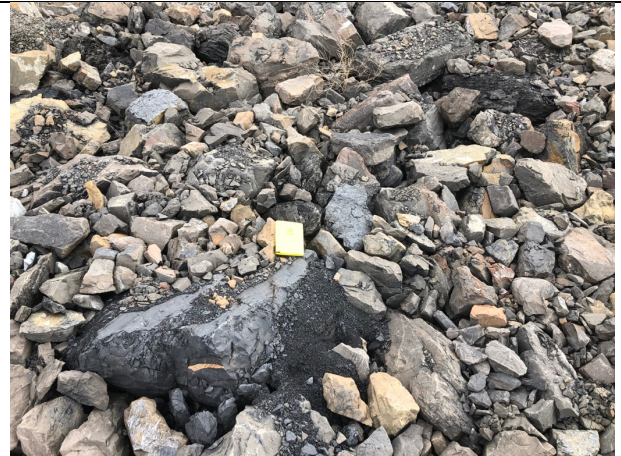
Photo 6: Riprap degradation due to weathering on
a surface of a piece of riprap (approx. Sta. 0+900)

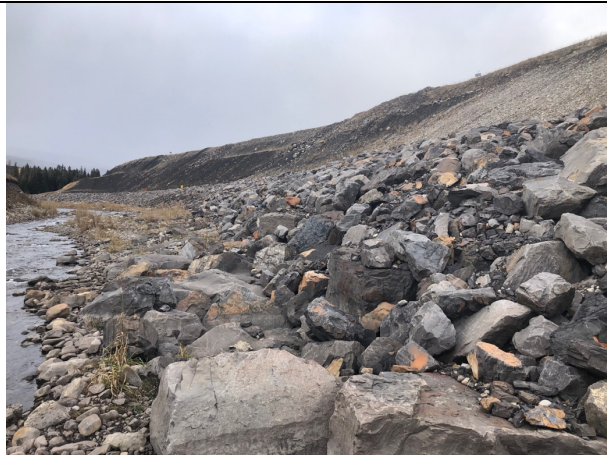
Photo 10: Riprap degradation due to weathering on several pieces of riprap
