2019 Dam Safety Inspection

Greenhills Operations Tailings Storage Facility

Teck Coal Limited

Reference No. 18110798-2019-148-R-Rev0-3000

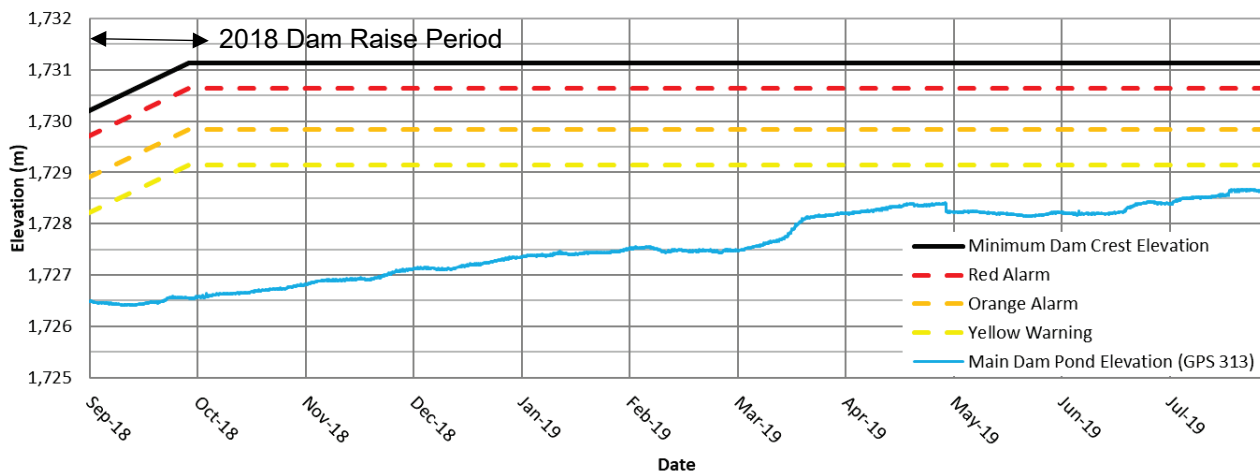
Illustration 4: Tailings Pond Elevation Relative to Minimum Freeboard and Standard Pond Operating Level

The pond elevation recorded from 1 September 2018 to 31 July 2019 is presented in Illustration 4.

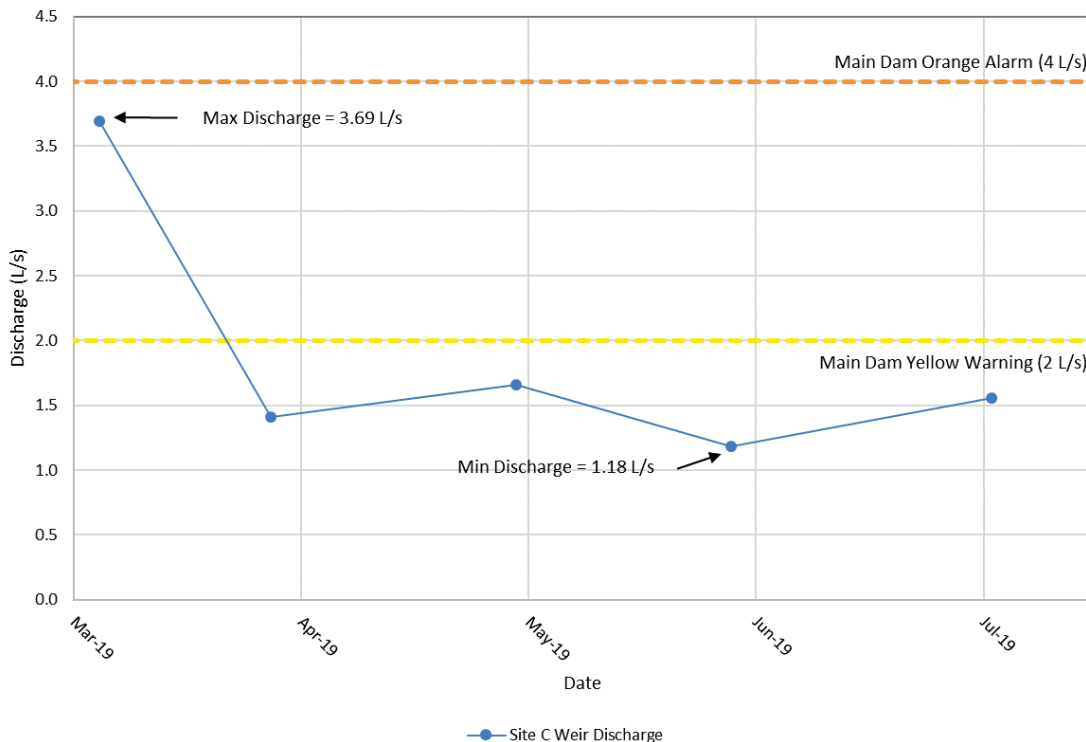
Illustration 7: Site C Weir Discharge

The flows in both weirs were low and within the expected range for normal operation. There were some exceedances of the Yellow Warning QPO, but this reflects a need to update the warning QPO to reflect the small increase in seepage that occurs with the normal increases in pond level as the TSF is raised.

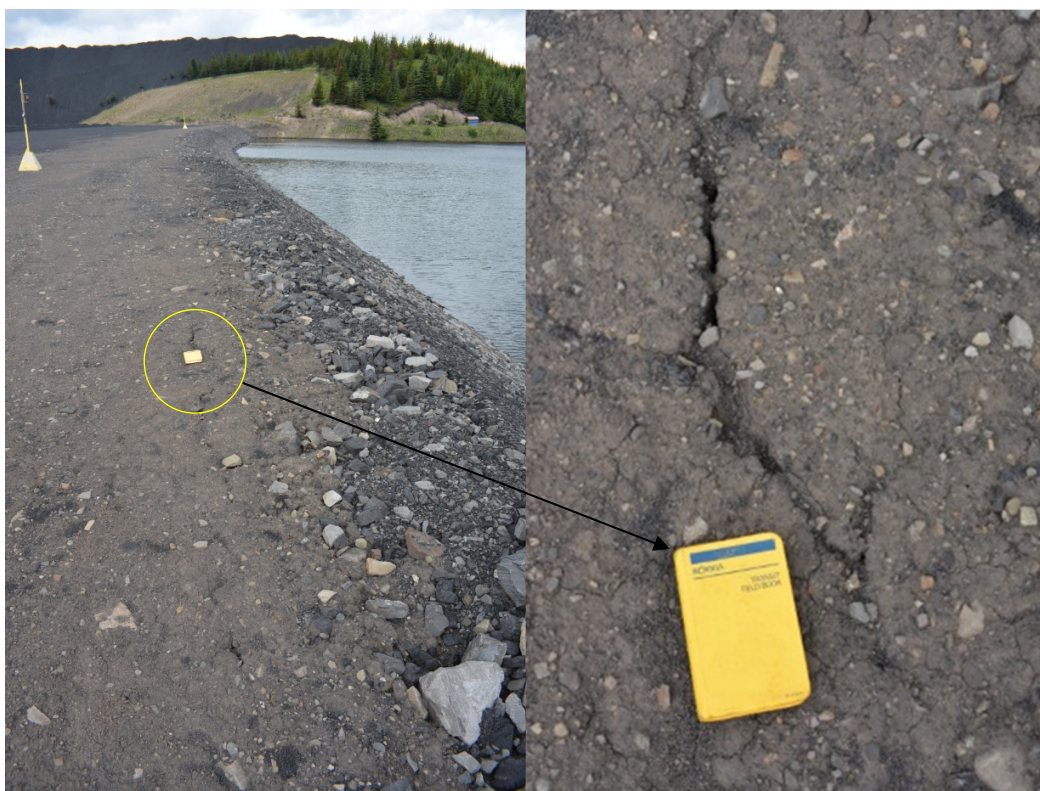
Photograph 6a (left) and 6b (right): Main Tailings Dam – Minor Longitudinal Cracks on Crest Adjacent to Riprap on Upstream Slope; looking Southwest, 17 July 2019

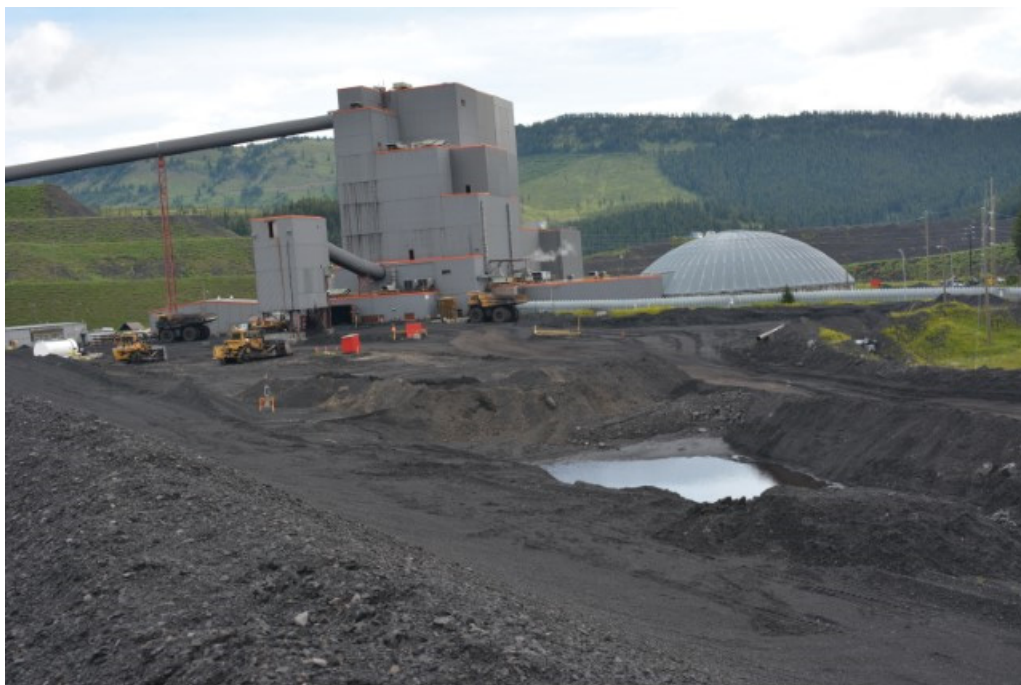
2019-04	Ponded water on downstream crest of Site C spoils at east abutment of Main Tailings Dam (See Photograph 9, Appendix A)	Erosion of downstream shell of CCR spoils leading to instability	3	Revise drainage to prevent long term ponding of surface water.	End Q3 2020
2019-05 (2018-05)	Closure plan does not meet HSRC requirements.	Operational procedures do not align with closure design; long-term environmental hazards become difficult and costly to mitigate.	3	Develop the current concept level closure plan to align with the current life of mine strategy and HSRC requirements.	In progress End Q1 2020
2019-06 (2018-06)	Inundation study modelling of the downstream area does not reflect recent changes in topography	Potential for sub-optimal emergency response	3	Update inundation study	In progress End Q1 2020
2019-07	■ OMS manual does not reflect: ■ Current geotechnical instrumentation details including revised QPOs. ■ Revised MAC and Teck guidance documents. ■ Multiple coordinate grid systems appear to be used in the OMS manual.	Potential to ineffectively respond to alerts and warnings from geotechnical instrumentation.	3	Update OMS manual to: ■ Remove non-functioning geotechnical instrumentation and update QPOs. ■ Update based on MAC (2019) and Teck (2019). ■ Use a single coordinate grid system.	End April 2020

Photograph 9: Main Tailings Dam – East Abutment, Poned Surface Water; looking Northeast, 17 July 2019

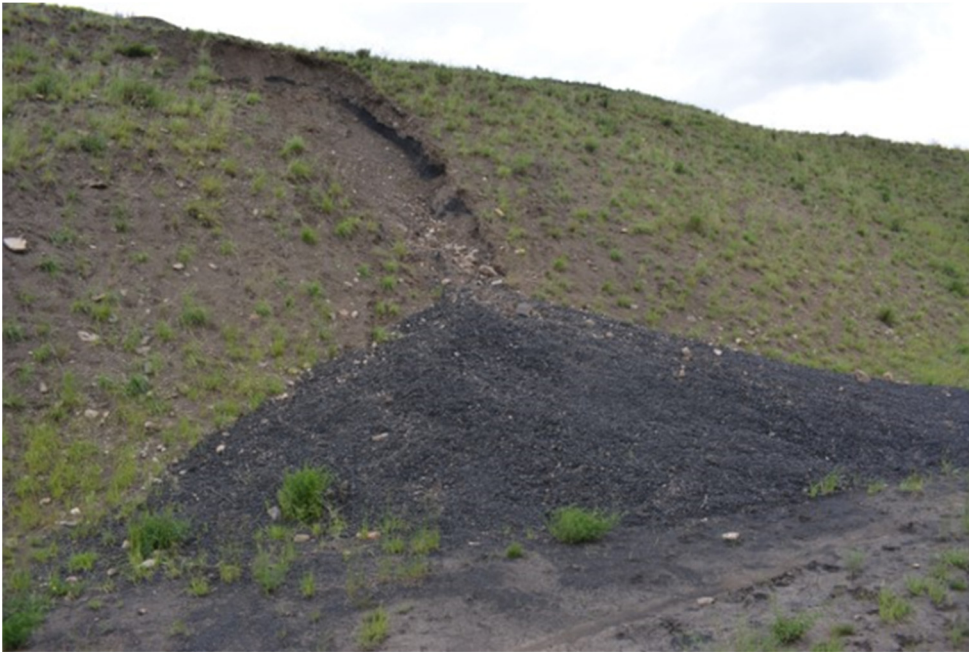
Photograph 17: Site C Coarse Coal Refuse Spoil – Slump First Observed 18 April 2019; 17 July 2019

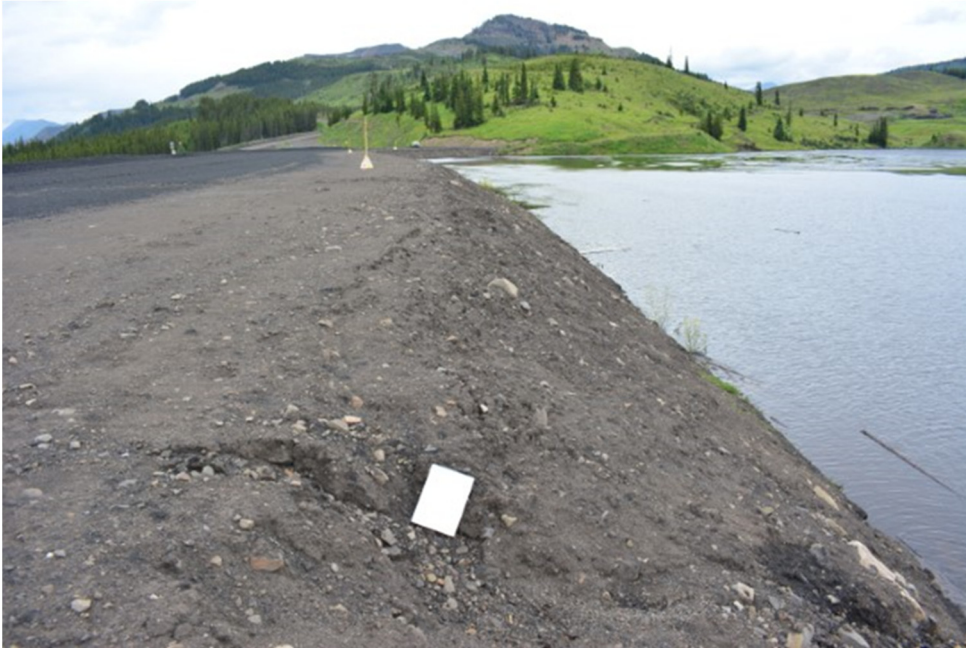
No significant changes were noted during the 2019 site inspection or monthly visual inspections. Some minor erosion of the upstream slope and crest of the Main and West Tailings Dams were observed which require routine maintenance. This minor erosion does not present a dam safety concern.

Photograph 21: West Tailings Dam – crest and Upstream Slope, Minor Erosion Rill on Upstream Slope; looking North, 17 July 2019
