# **Teck Highland Valley Copper Partnership**

**2019 Dam Safety Inspection Report**

*Highmont Tailings Storage Facility*

April 2020

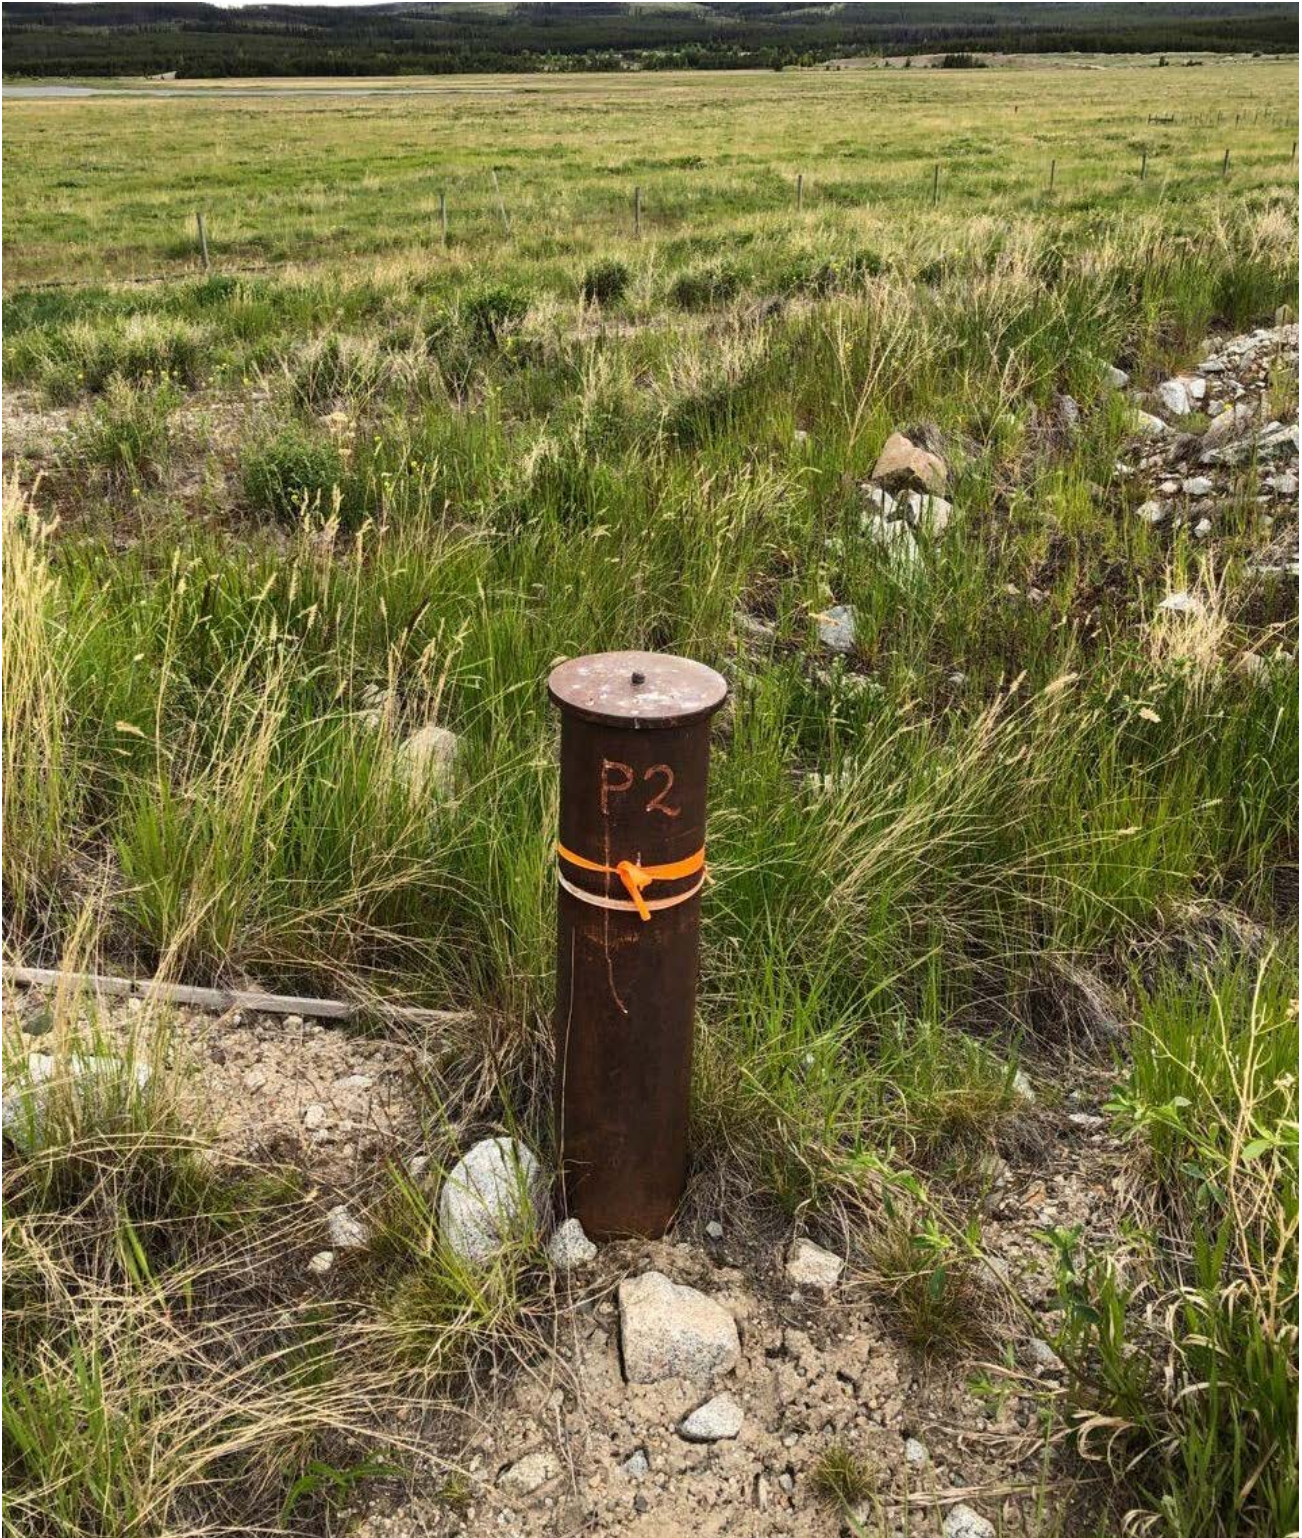
**Photo II-A-3 Low spot on crest visible around P2 also demonstrated by contours on the plan view. No signs of distress, settlement or depressions. (HGH-2019-01)**

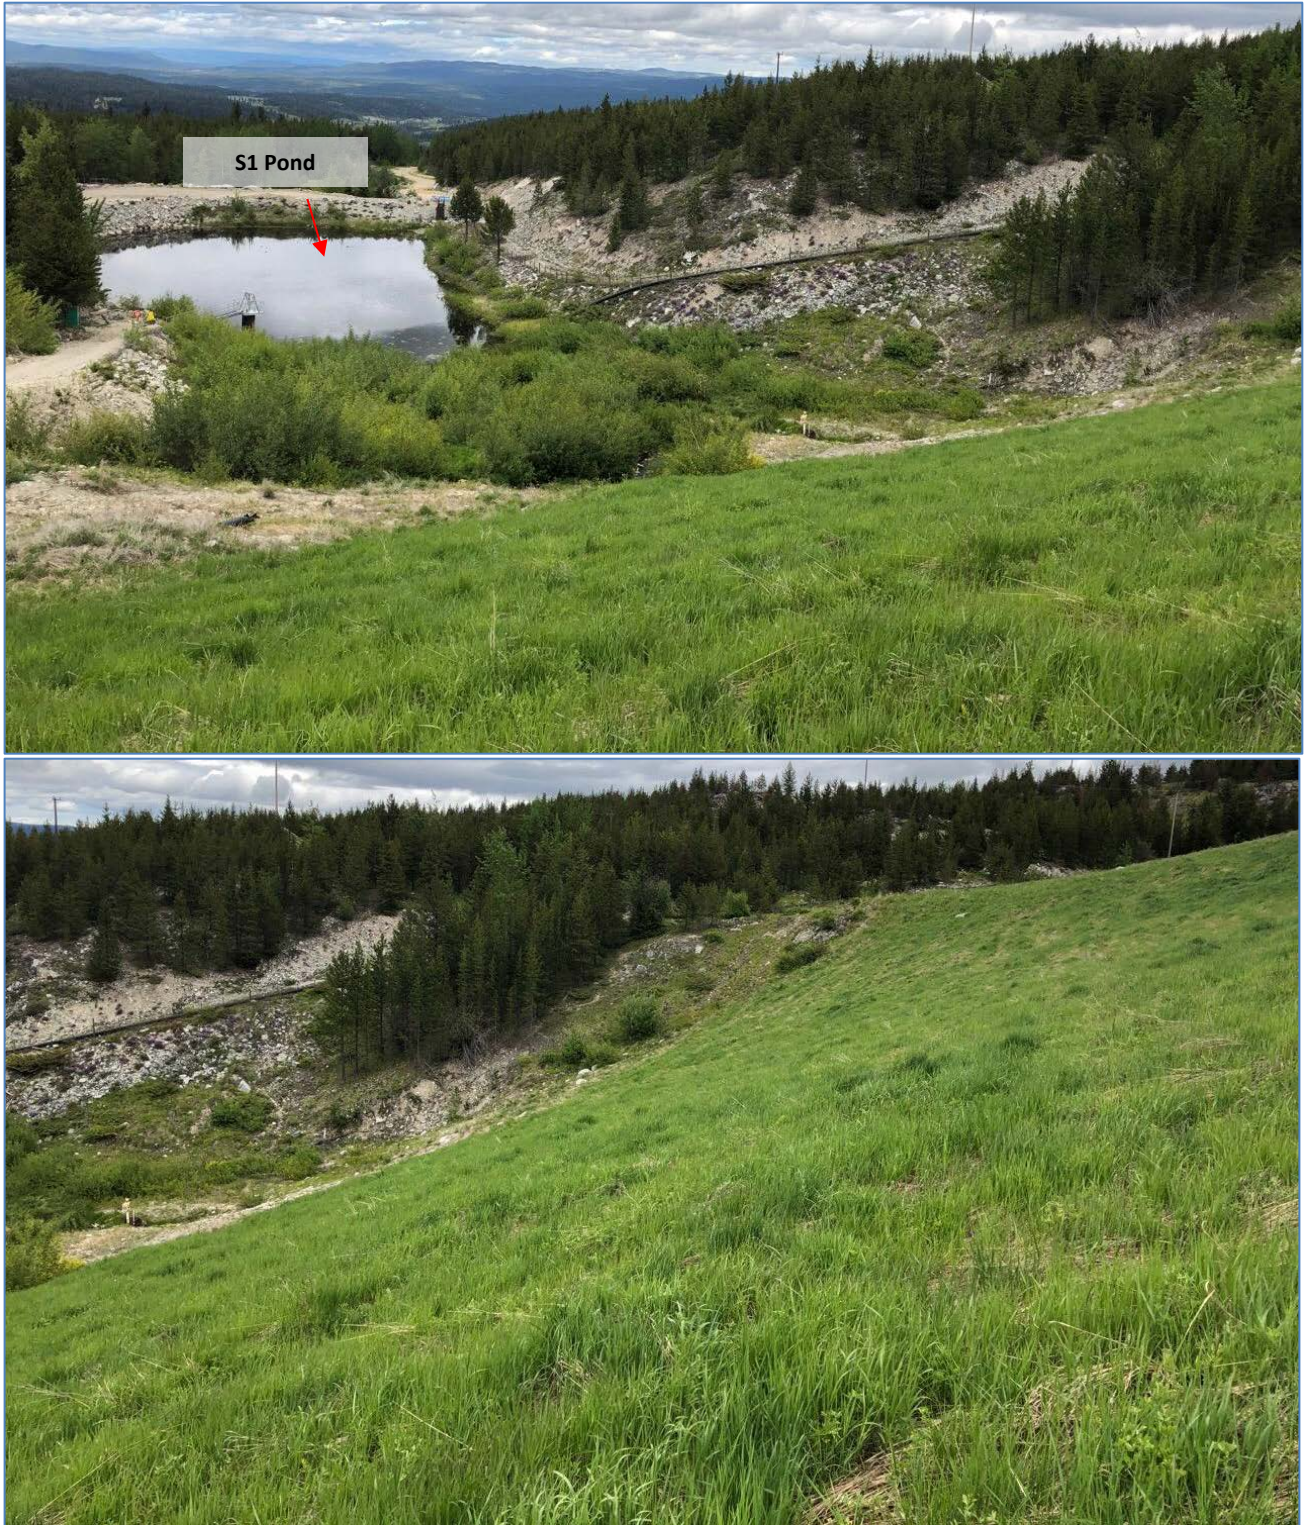
**Photo II-A-4 Overview of North Dam downstream toe and S1 Pond. No signs of distress or deformations (HGH-2019-02)**

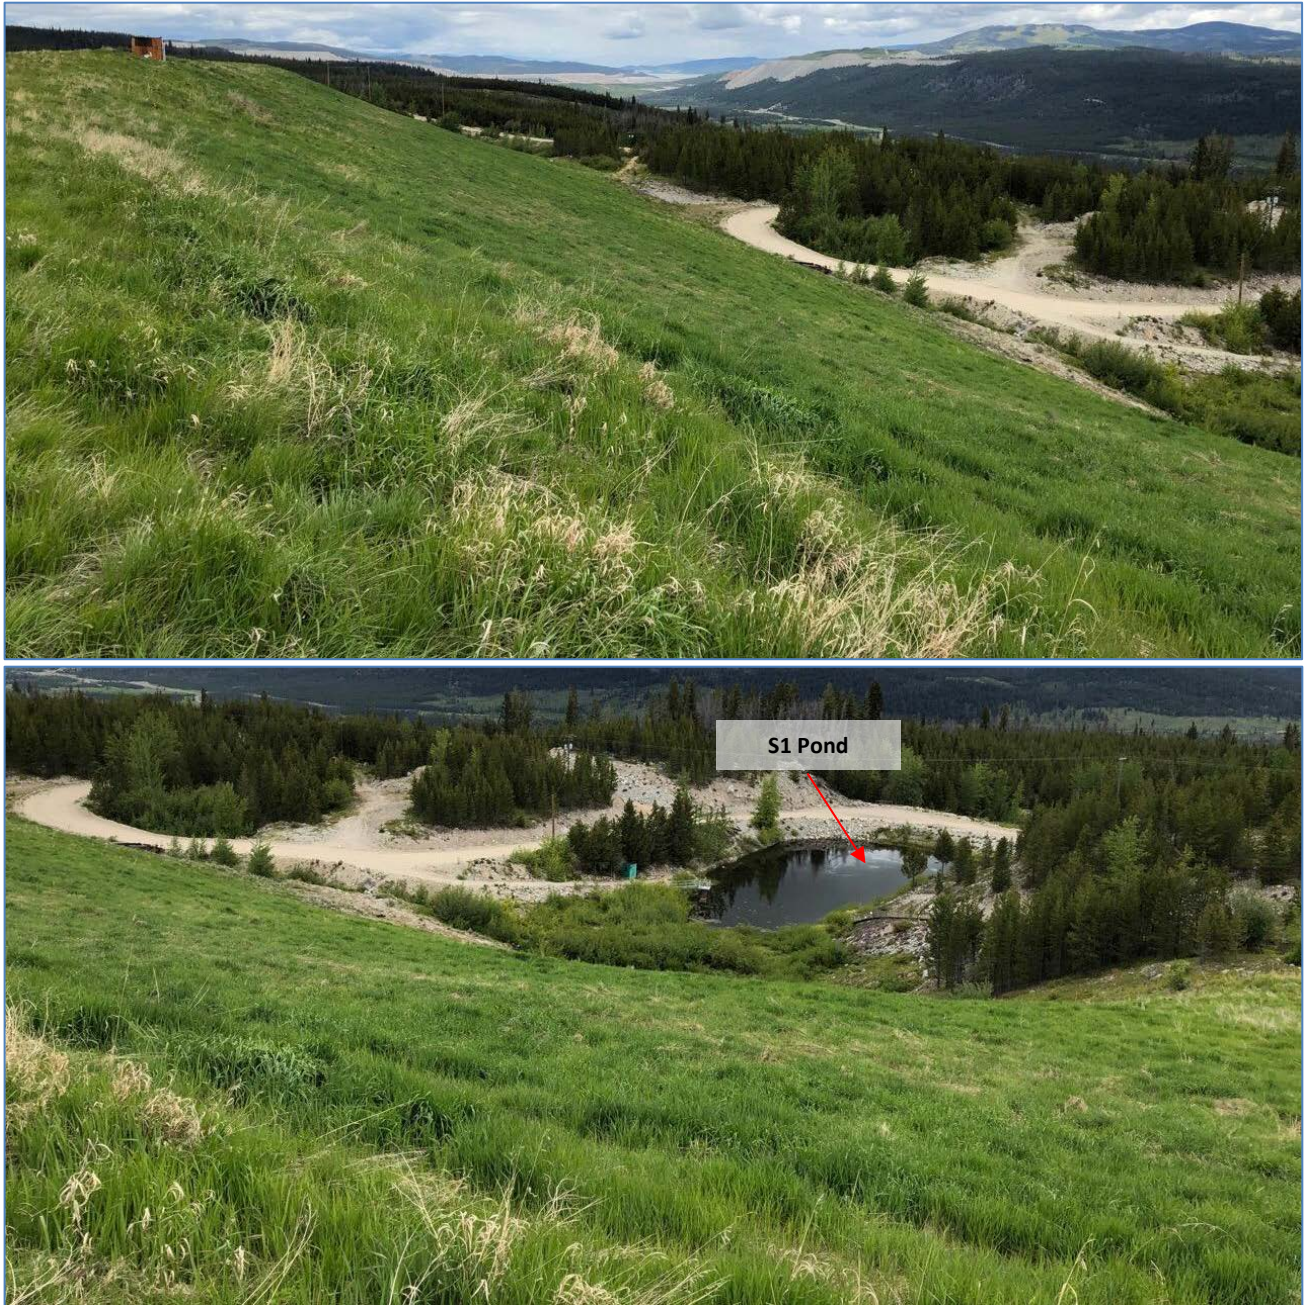
**Photo II-A-5 Overview of North Dam downstream slope downstream of P2. No signs of distress or deformations. (HGH-2019-03)**

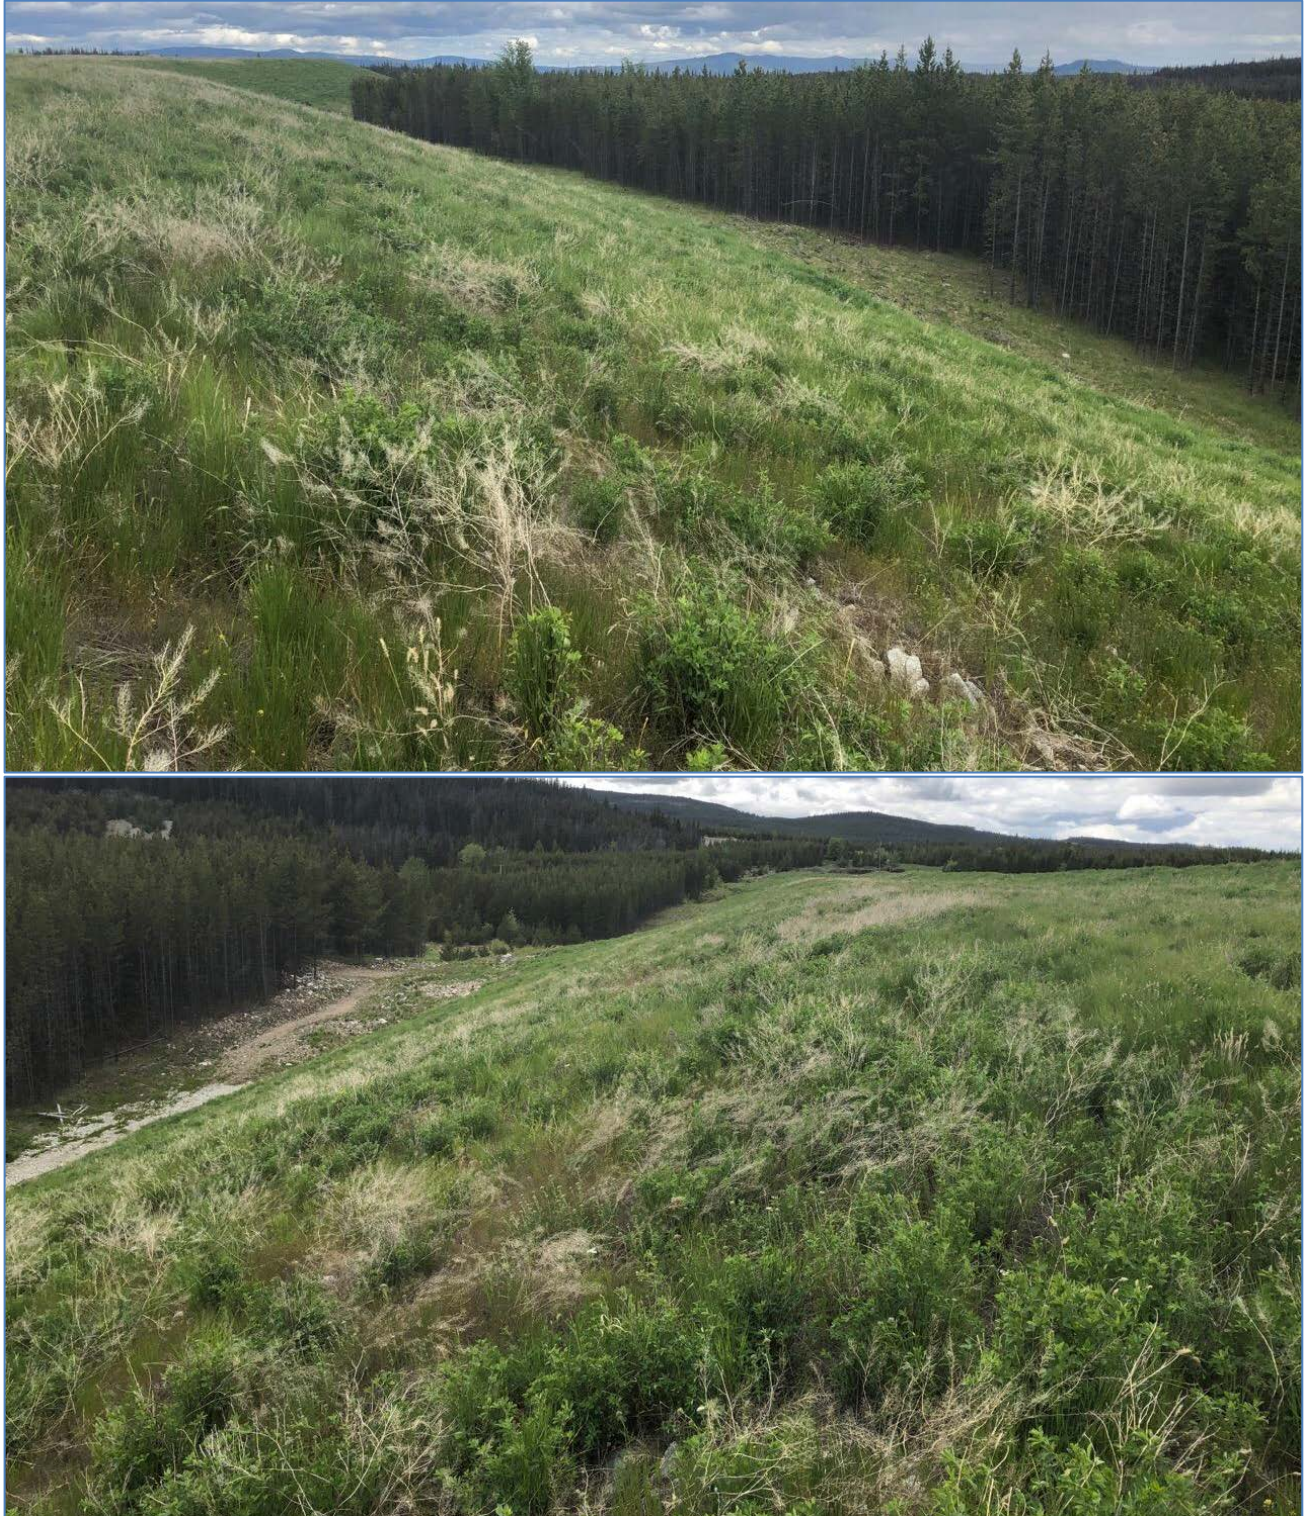
**Photo II-A-7 Overview of South Dam downstream slope. Slope covered by vegetation (HGH-2019-05)**

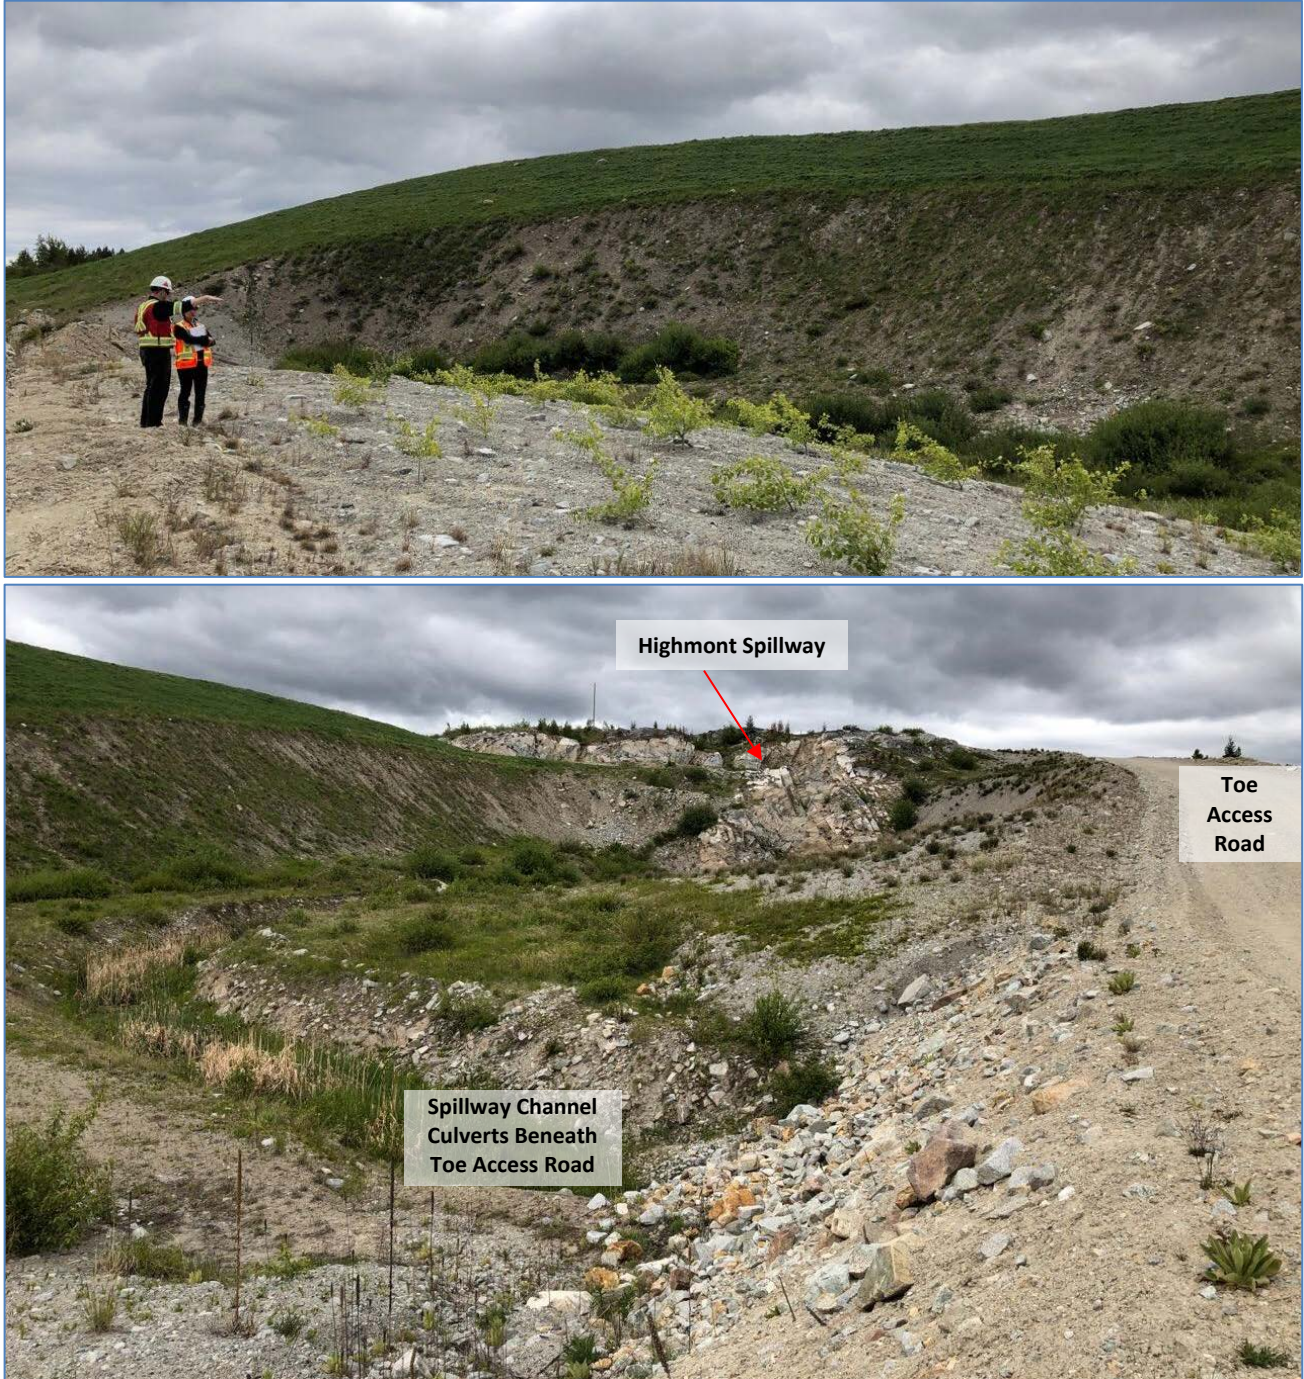
**Photo II-A-8 Overview of North Dam downstream slope and toe, downstream of Highmont Spillway (HGH-2019-06 )**

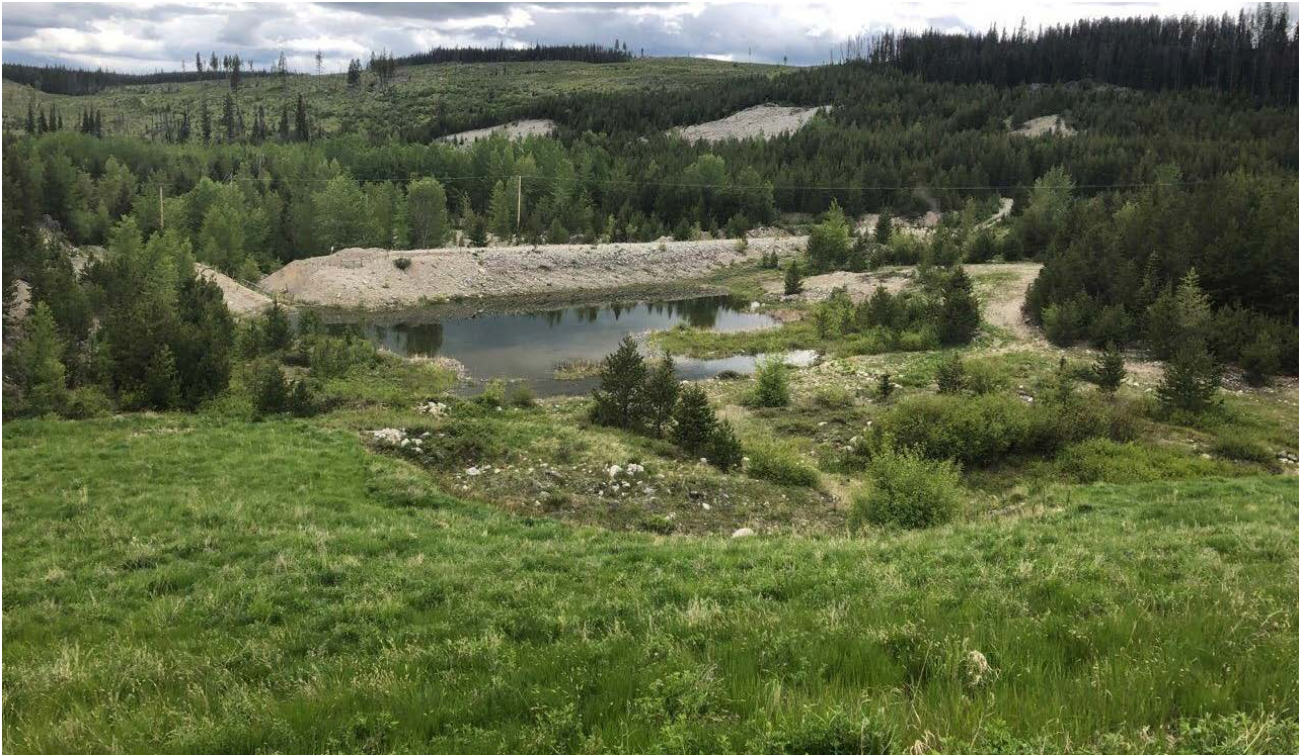
**Photo II-A-9 Overview of South Dam downstream toe and S4 Pond breached embankment (HGH-2019-08)**

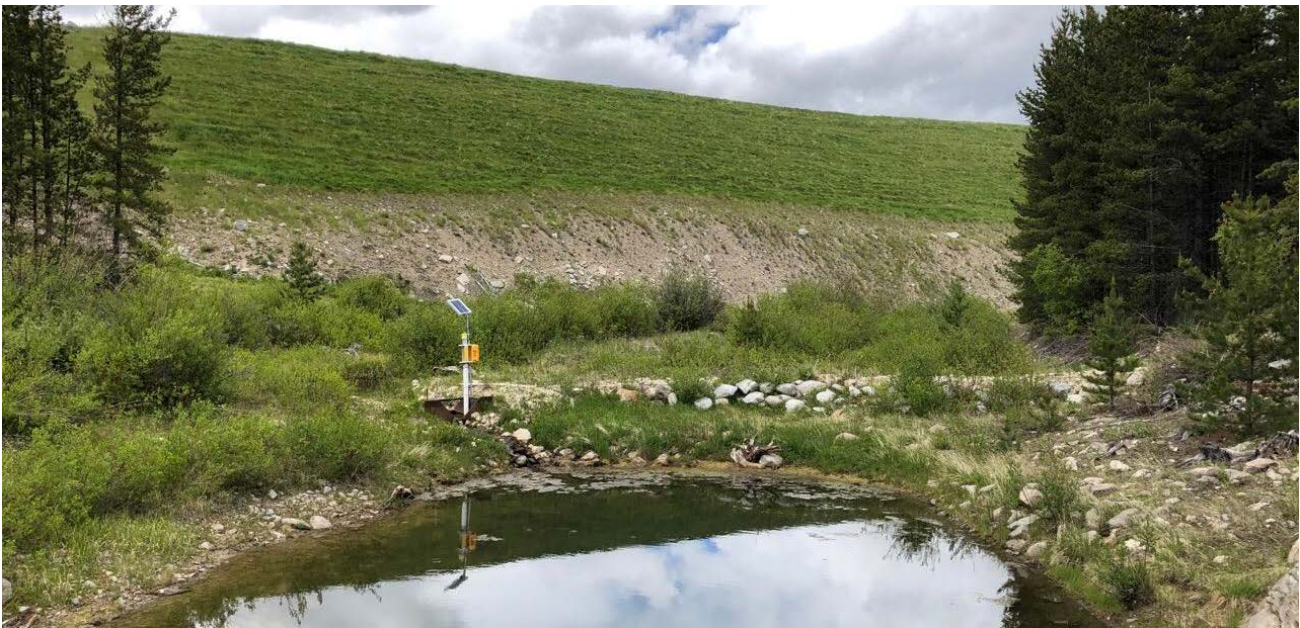
**Photo II-A-10 Overview of the South Dam downstream slope and seepage weir upstream of S3 Pond. Flow is clear. No seepage face observed on dam slope (HGH-2019-09)**

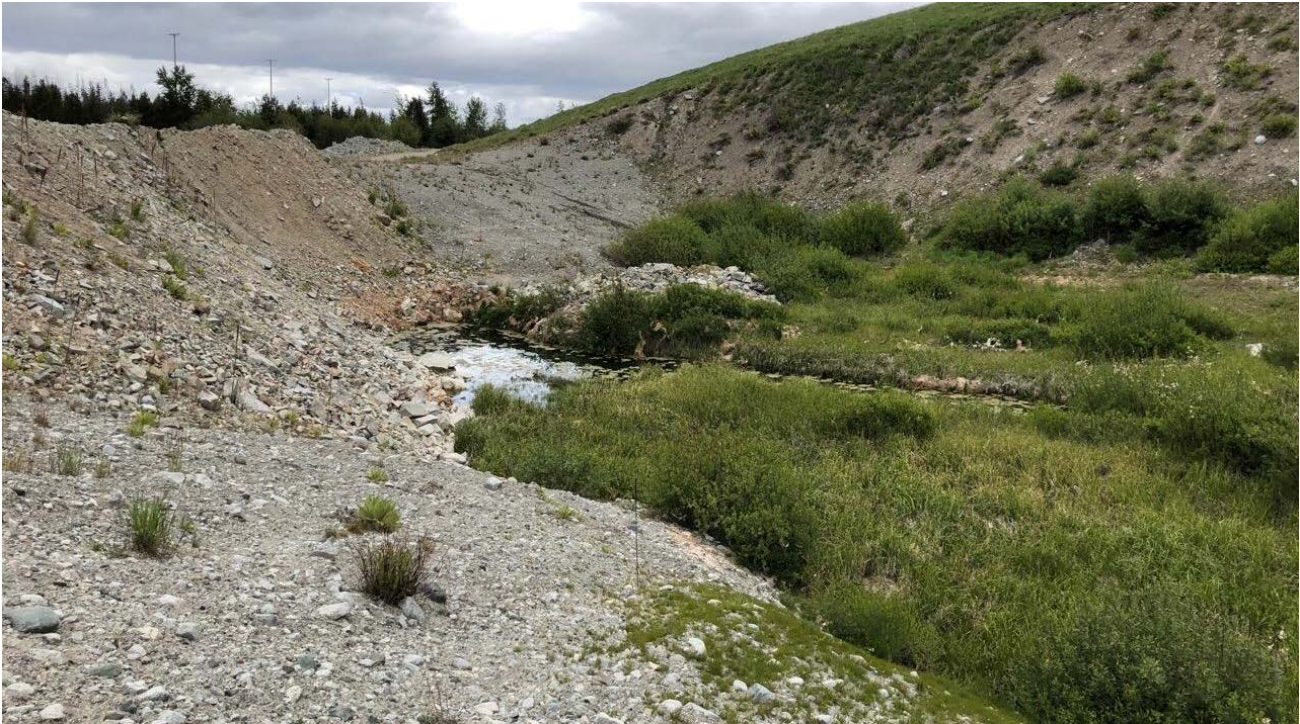
**Photo II-A-22 No visible seepage through road downstream of North Dam and no evidence of excessive ponding or high-water level on dam toe (HGH-2019-18)**

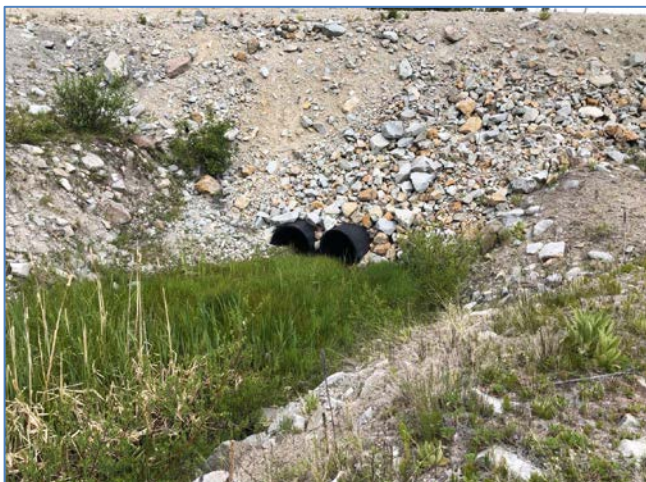
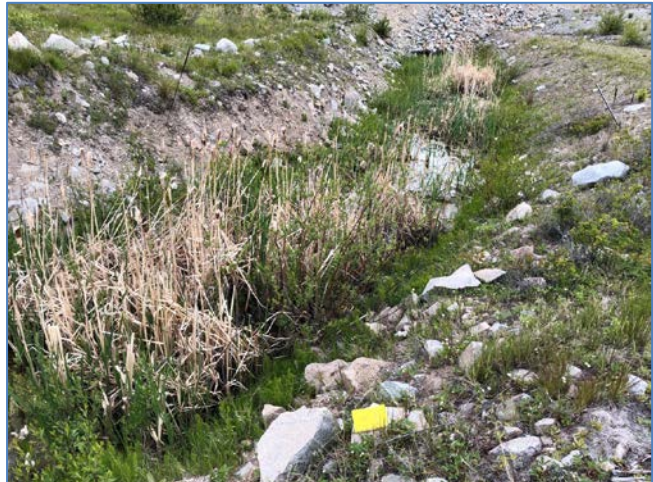
**Photo II-A-23 Inlet of 33" ID Highmont Spillway culverts crossing toe access road. Channel is vegetated in this area. No flow was observed through the culverts. (HGH-2019-07)**

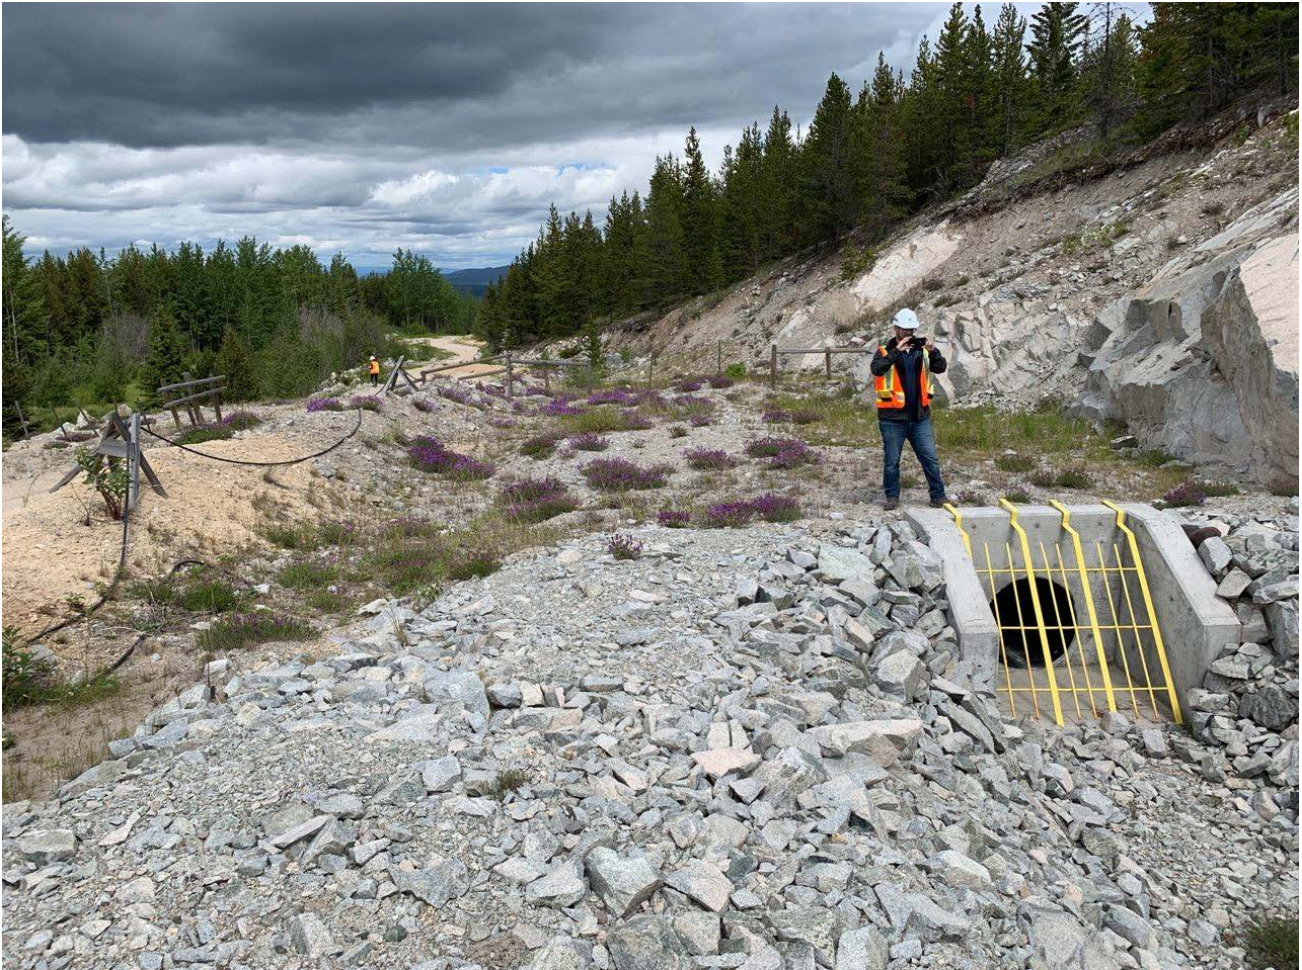
**Photo II-B-6 S1 Pond: Spillway channel and pipe intake looking downstream. Pipe intake is clear with no sign of vegetation or any other obstructions. (HGH-2019-24)**

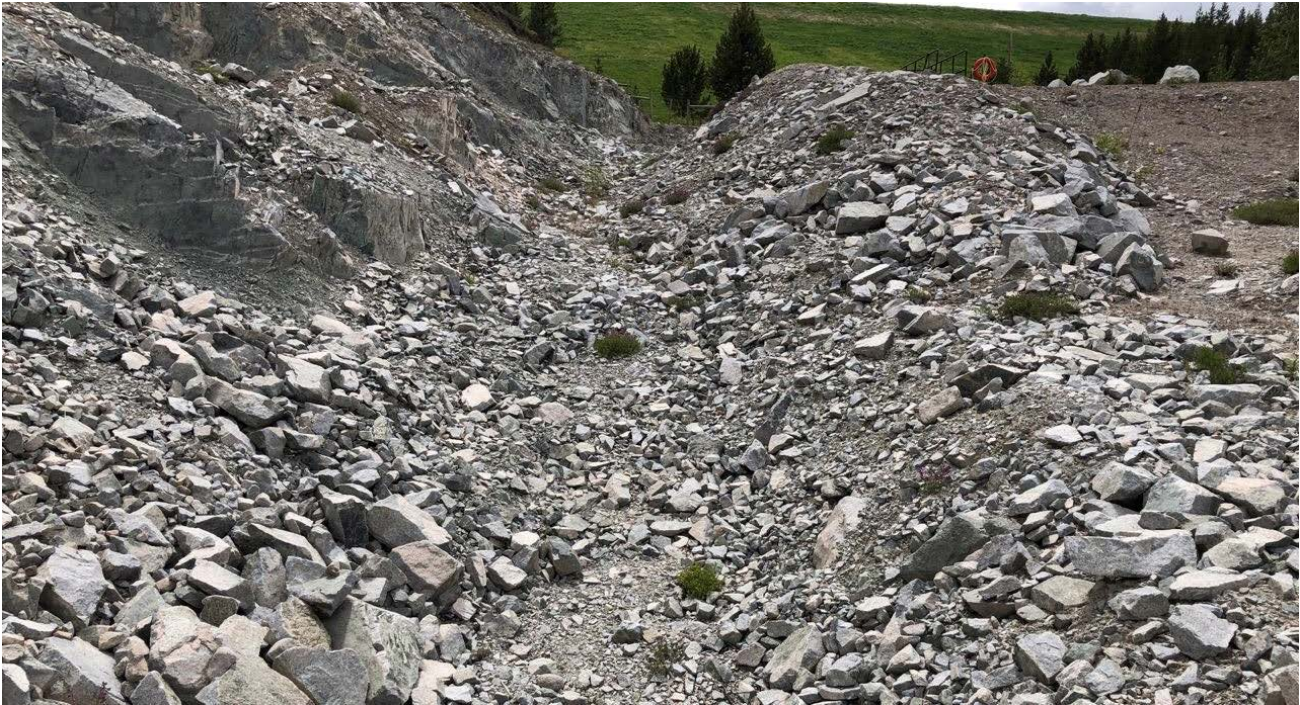
**Photo II-B-7 S1 Pond: Spillway channel looking towards pond. No significant obstructions observed in channel (HGH-2019-25)**

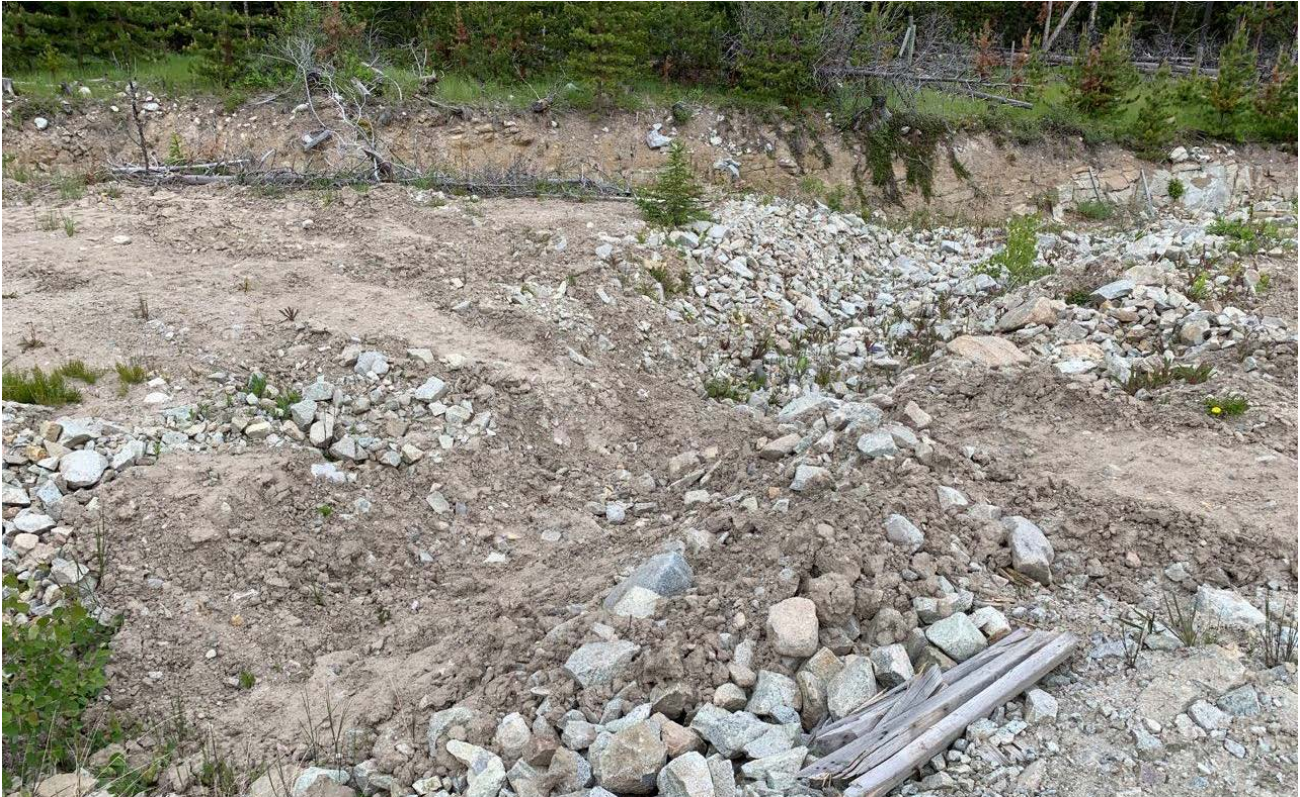
**Photo II-B-13 S2 Pond: S2 Pond Spillway invert and channel; remnant of a temporary access built over the channel remains in place has reduced the spillway flow channel and should be removed as part of routine maintenance before freshet (HGH-2019-29)**

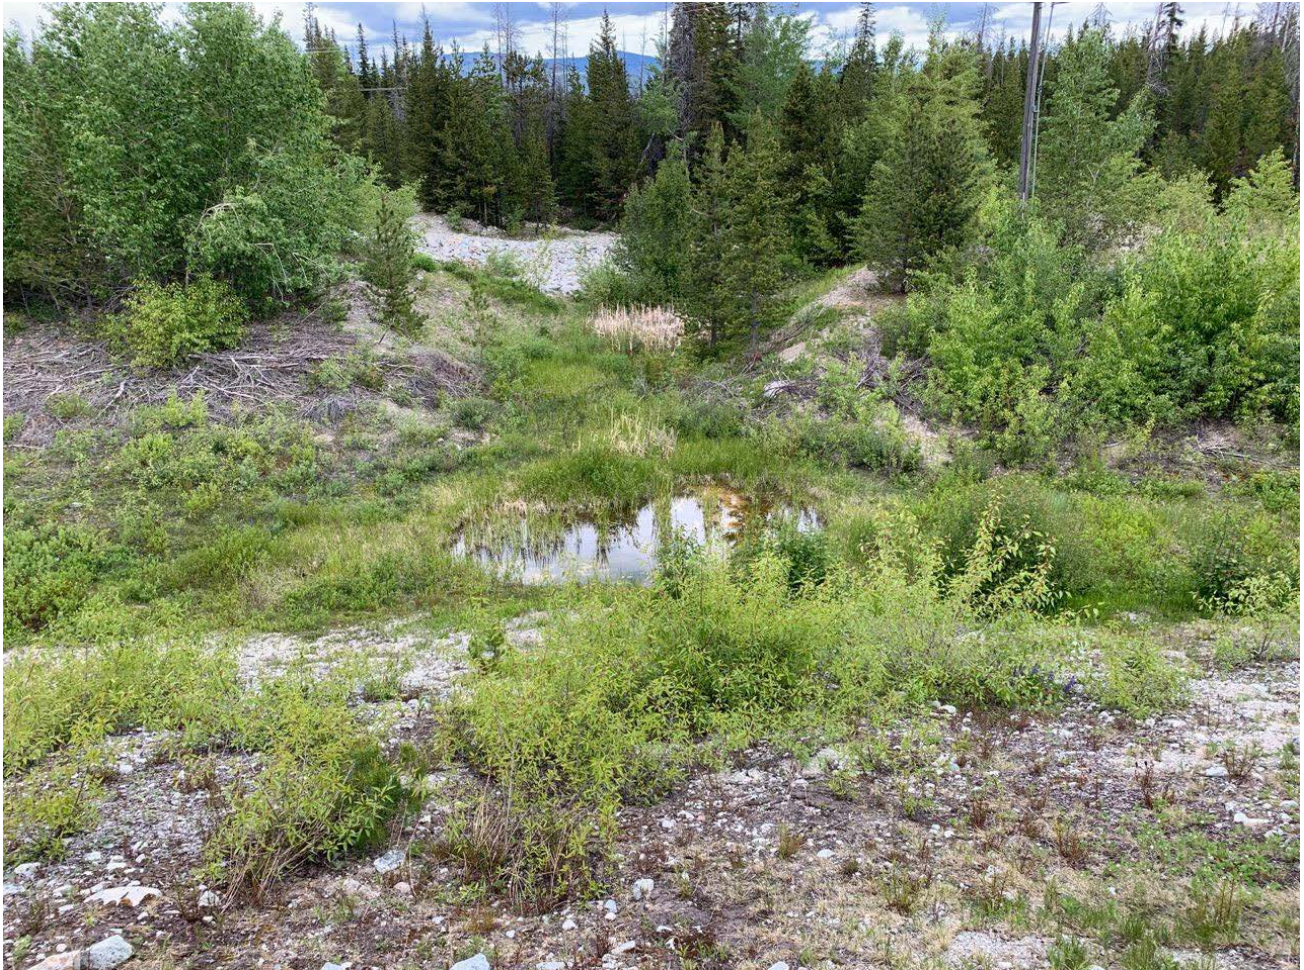
**Photo II-B-14 S2 Pond: Ponded water at downstream toe, similar in size to the pond noted during previous year DSIs (HGH-2019-28)**

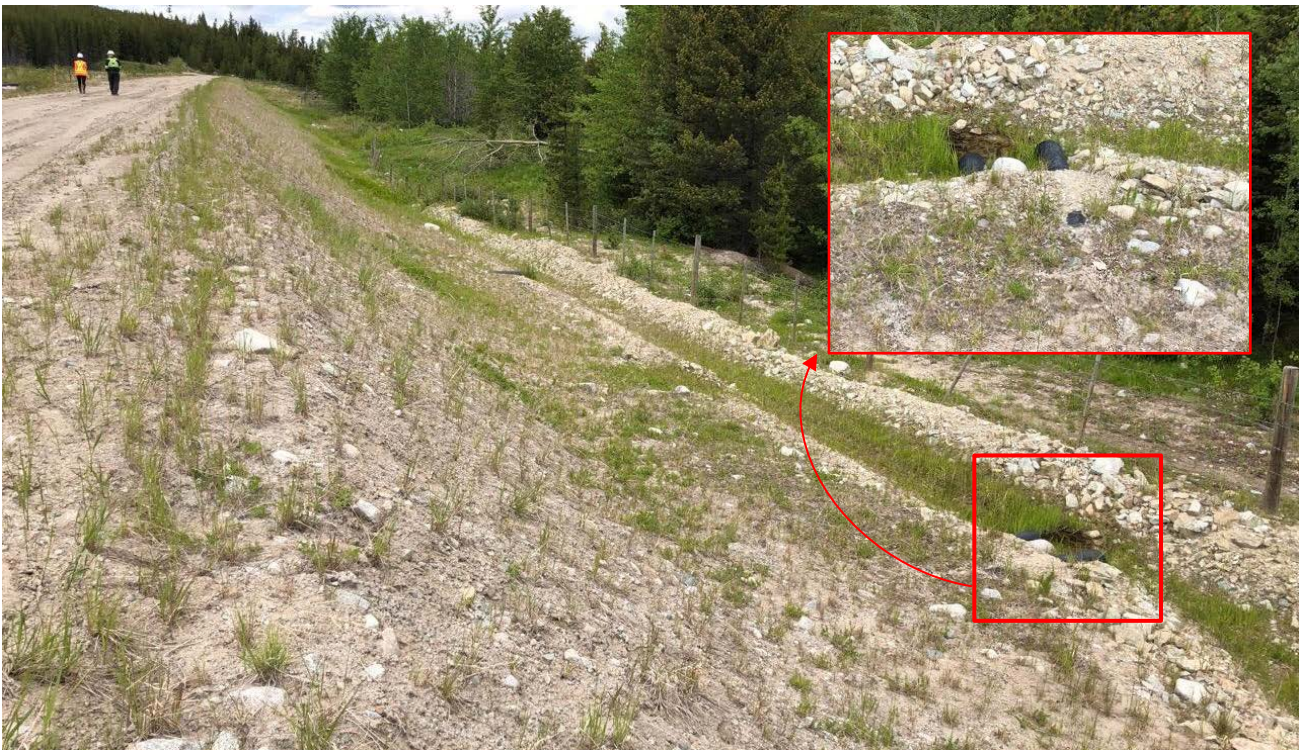
**Photo II-B-30 S5 Pond: Overview of downstream slope and blocked outlet pipe daylighting at toe, looking north (HGH-2019-35)**

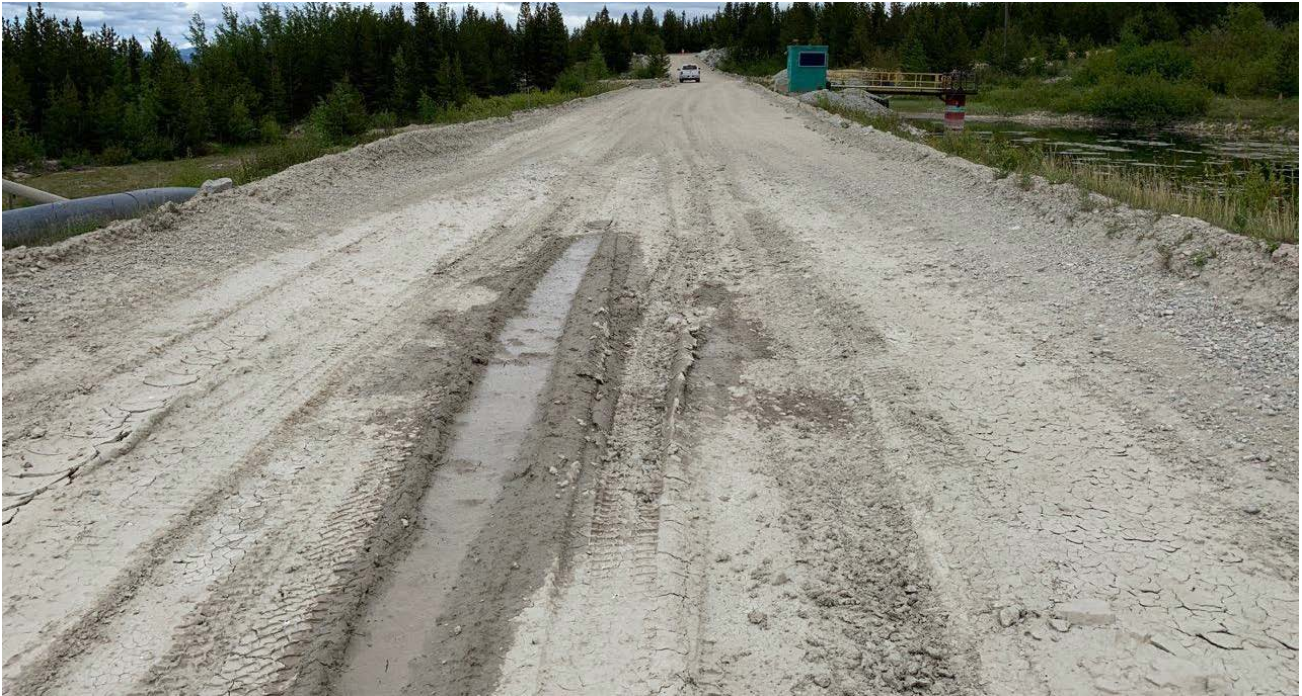
**Photo II-B-31 S8 Pond: Overview of crest from left abutment. Muddy road surface and rutting to be repaired as part of routine maintenance activities (HGH-2019-40)**

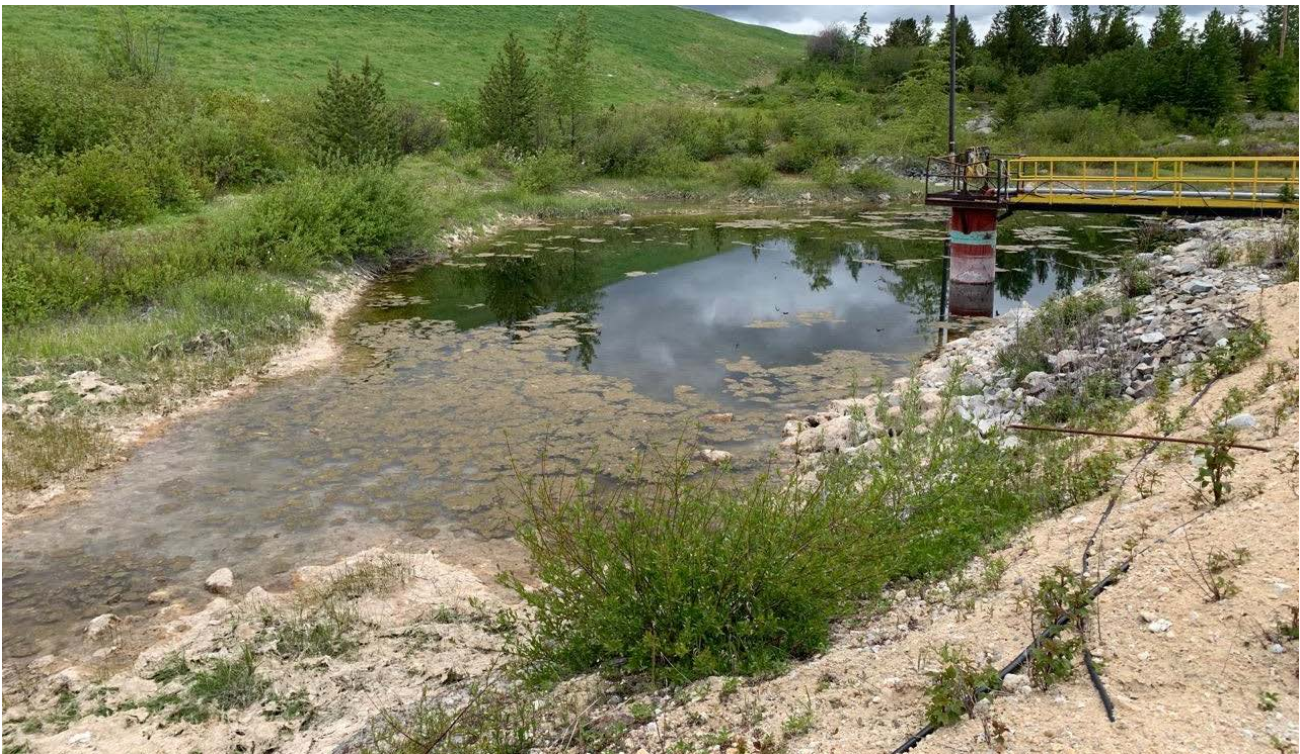
**Photo II-B-34 S8 Pond: Overview of impoundment, catwalk and outlet pump to S1 Pond (HGH-2019-41)**

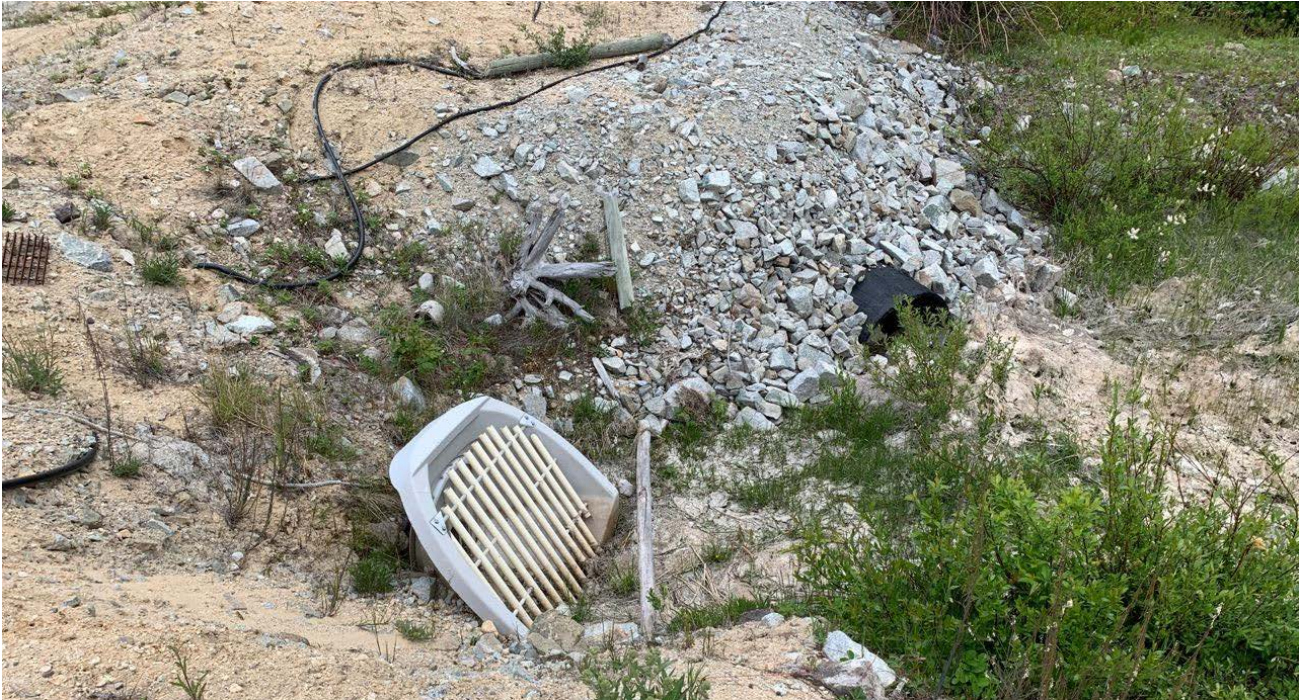
**Photo II-B-35 S8 Pond: Overview of overflow pipe. Trash rack is clear of debris; and water level observed below invert. Second pipe discharges into pond from east ditch.**  
**(HGH-2019-39)**
