# **Teck Metals Ltd.**

## **Pinchi Lake Mine Tailings Storage Facility**

### ***2019 Dam Safety Inspection***

M07728A34.730

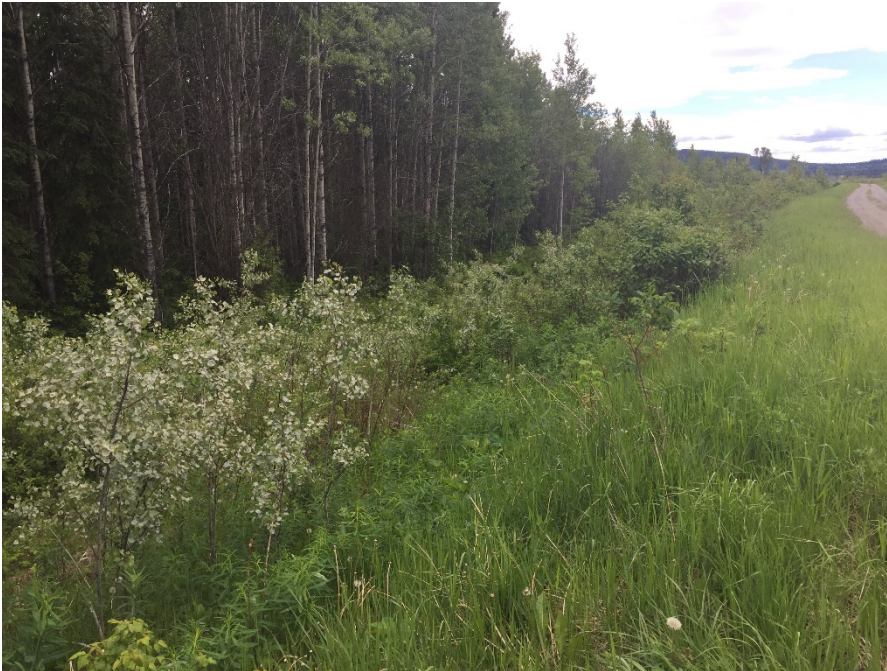
- There is vegetation on the slope of the east leg of the dam, especially on the north section, including trees up to about 3 m tall (Location 9 in Figure 4.1; Photos II-1, II-2, II-4, and II-5). This vegetation is not currently considered to be a dam safety concern, although it may be prudent to clear it before the trees become more difficult to remove. The vegetation management plan recommends vegetation clearing prior to vegetation exceeding 1.5 m in height (Spectrum 2017).

**Photo II-1 Tailings Dam – east leg, looking south. Note vegetation on dam slope.**

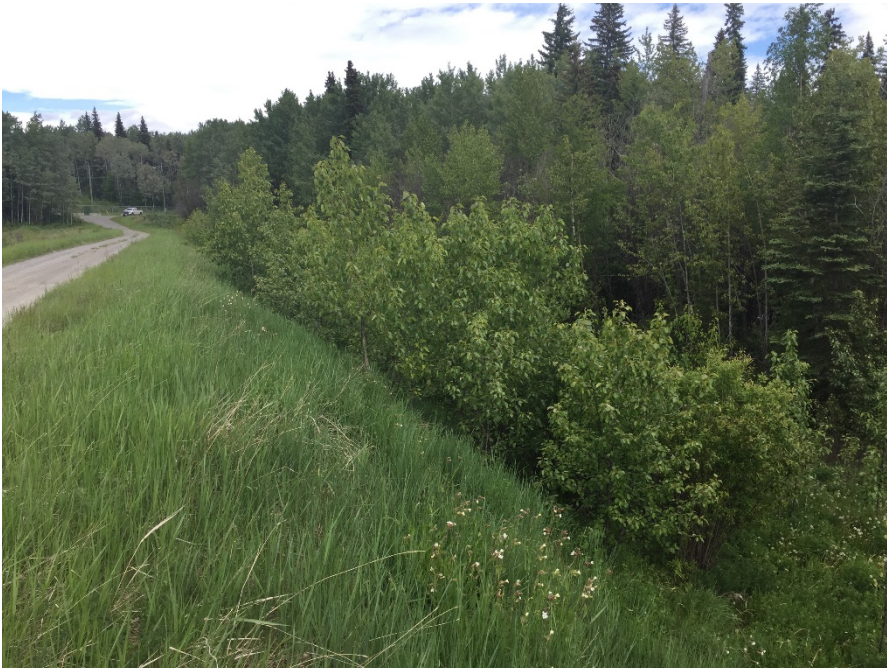
**Photo II-2 Tailings Dam – east leg, looking north. Note vegetation on dam slope.**

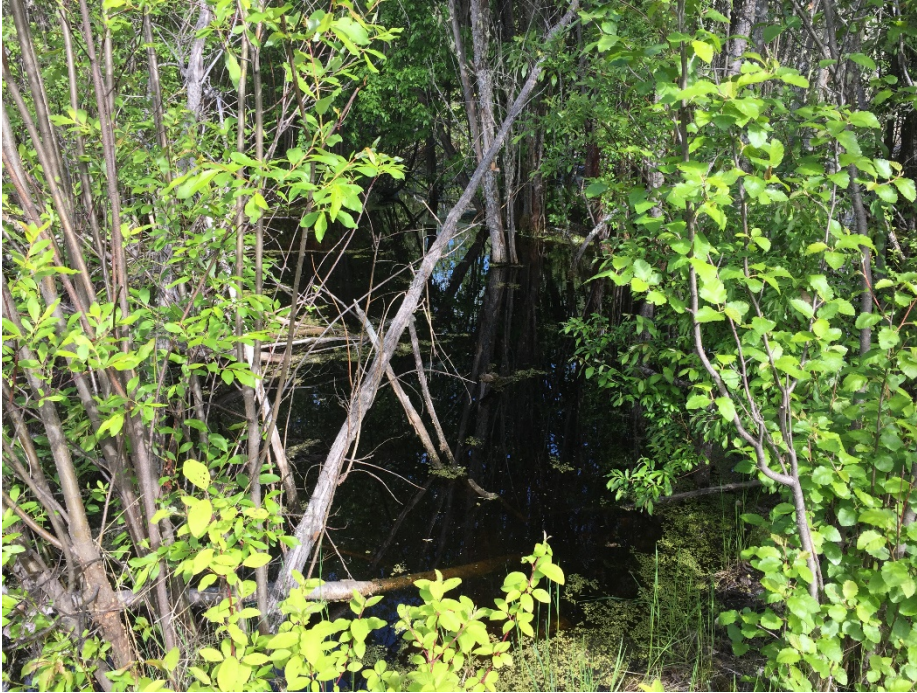
- A pond was observed in the trees near the toe of the east leg of the Tailings Dam (see Figure 1.2 for location; Photo II-3) as in previous inspections. This pond is located near a drainage channel that was shown on historical drawings of the TSF (see Appendix IV) and labelled “runoff channel.” The channel ran parallel to the main Ed Creek channel, and apparently once joined up with Ed Creek just inside the TSF. The pond appears to collect local runoff, and it drains through a channel to the south and through a culvert into Ed Creek Diversion Channel.

**Photo II-3 Tailings Dam – pond near toe of east leg.**

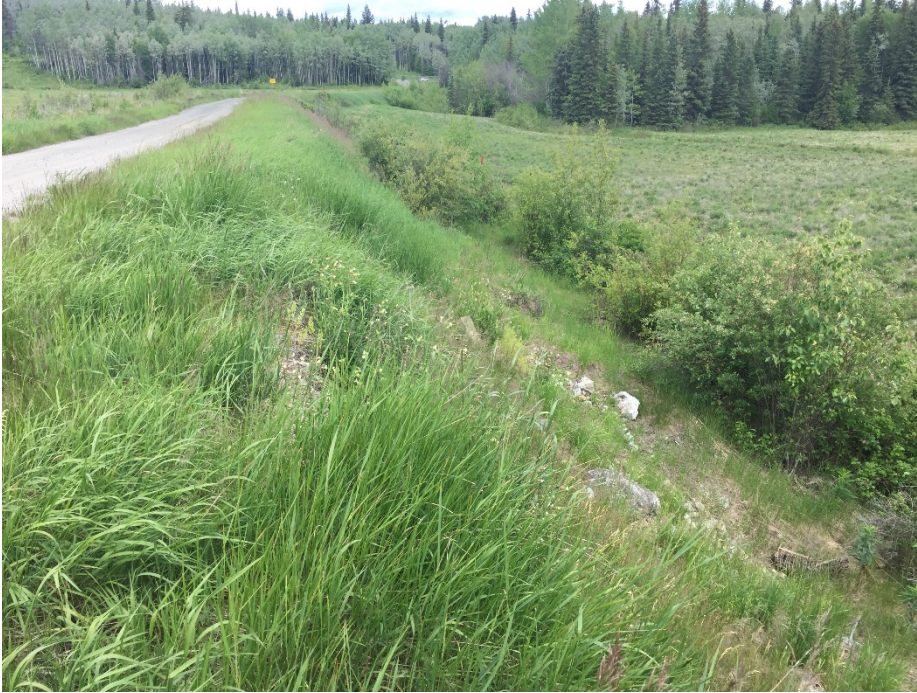
**Photo II-5 Tailings Dam – east leg, looking north. Note vegetation on dam slope.**

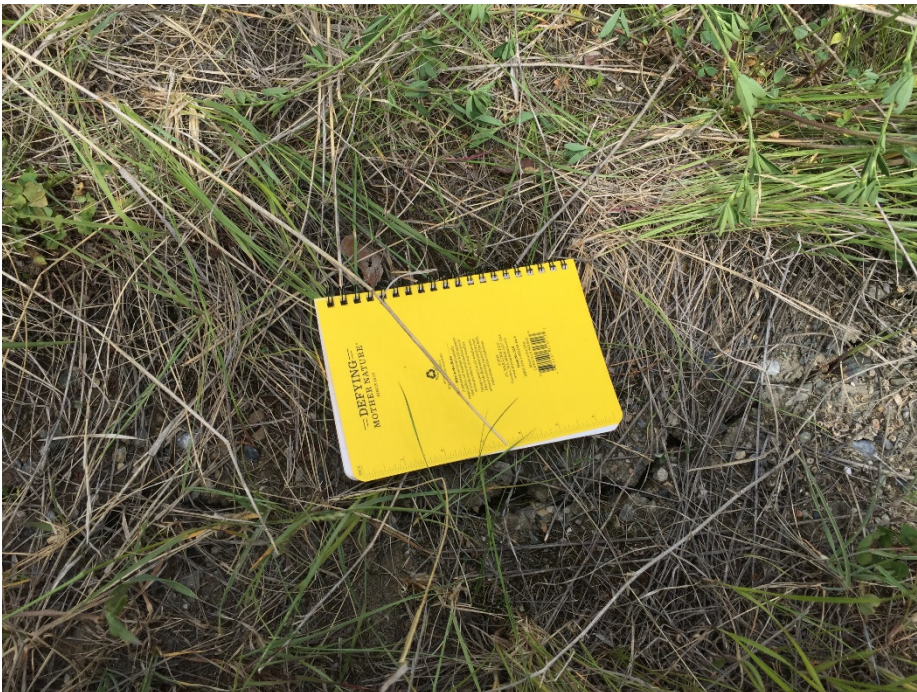
- One longitudinal crack (3 m long, 10 mm wide, and 70 mm deep) was observed on the dam crest along the southwest leg of the Tailings Dam (Location 4 in Figure 4.1; Photo II-14), similar to those observed in 2015, 2017 and 2018. The cracks appear to be aligned with tire tracks. These cracks are believed to have been formed by loosening and drying of the soil as part of the reclamation and seeding. The cracks are not a dam safety issue.

**Photo II-14 Tailings Dam – southwest leg, crack on dam crest in tire track.**

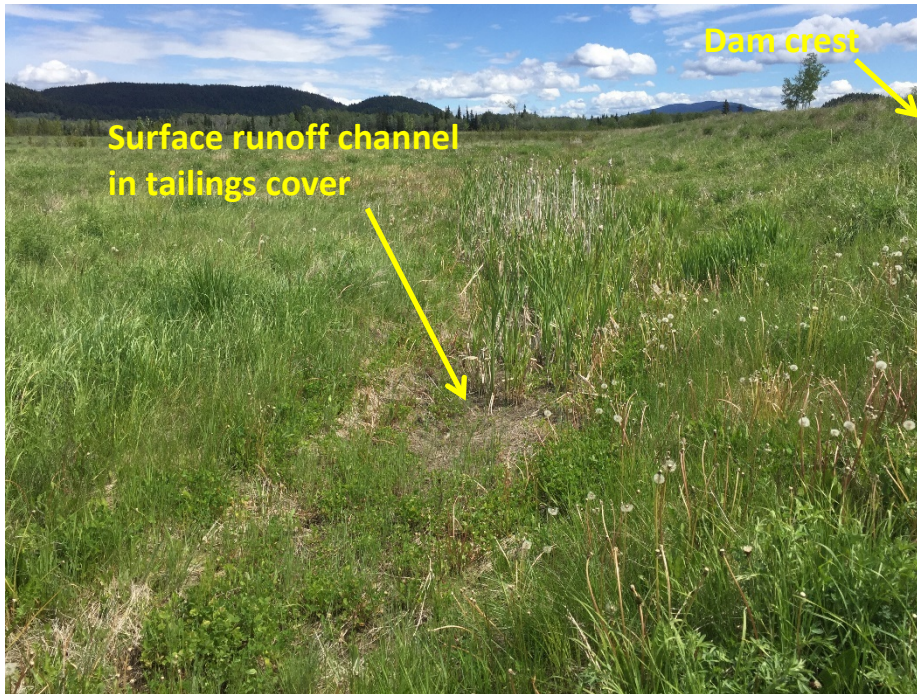
- As noted during previous inspections, a channel has formed in the soil cover parallel to the southwest leg of the Tailings Dam adjacent to the dam (Location 3 in Figure 4.1; Photos II-15). There is good growth of grass and some cattails along most of the channel, with no signs of erosion.

**Photo II-15** Tailings Dam – southwest leg, surface runoff channel in tailings cover upstream of dam (no water observed in channel).

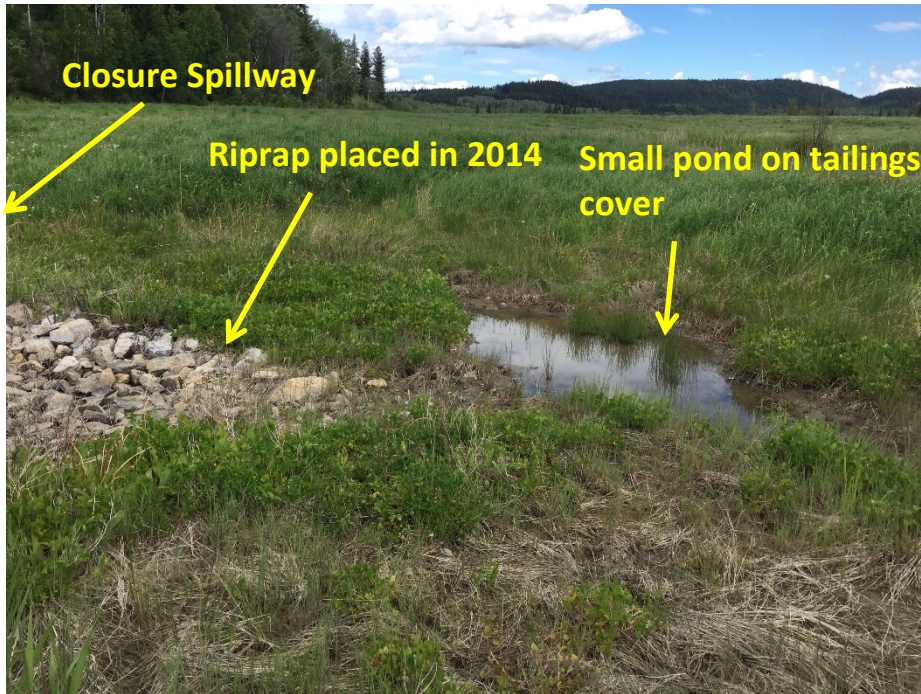
- In 2014, Teck placed riprap at the downstream end of the above-mentioned channel where it discharges into the Closure Spillway (Location 2 in Figure 4.1; Photos II-20 and II-21). The riprap appears to be performing well. A small pond (about 1 m wide) was observed south of the riprap (Photo II-21).

**Photo II-21** Downstream end of surface runoff channel where it discharges to the Closure Spillway, showing riprap which was placed in 2014.

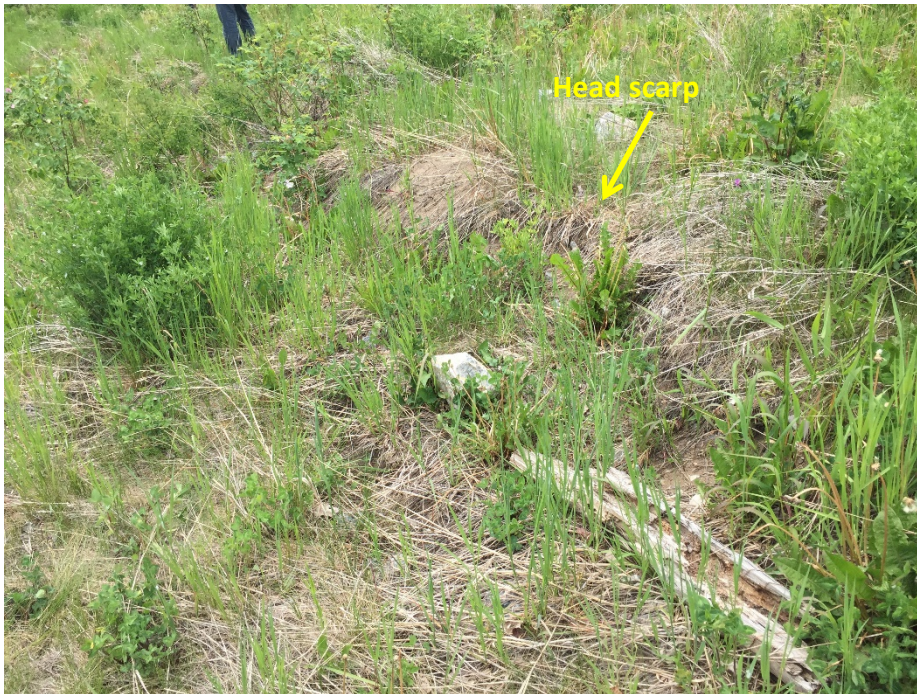
- A small slump in the slope above the riprap on the right (north) side of the spillway channel has been noted in inspections since 2014 (Location 1 in Figure 4.1). The slump area was covered in grass and the head scarp was only visible at close range (Photo II-27). The upstream side of the slump is located about 90 m downstream of the dam centreline. The condition of the slump has not noticeably changed in the last five years, and it is not expected to impact the Tailings Dam or the performance of the spillway.

**Photo II-27** Closure Spillway – head scarp of slump above right bank, 90 m downstream of centreline

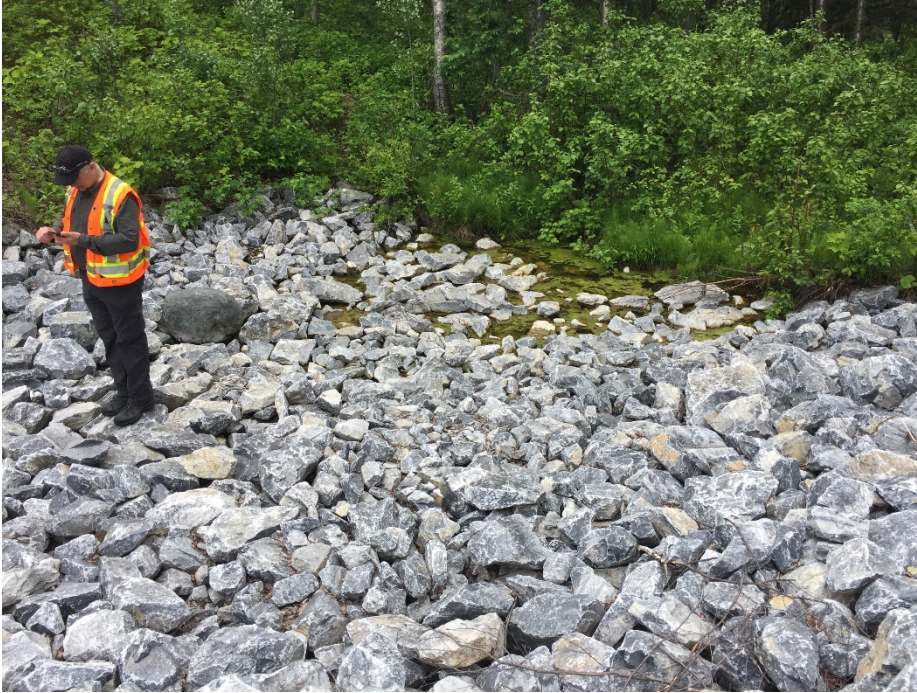
**Photo II-29 Closure Spillway – pond at downstream end of riprap.**

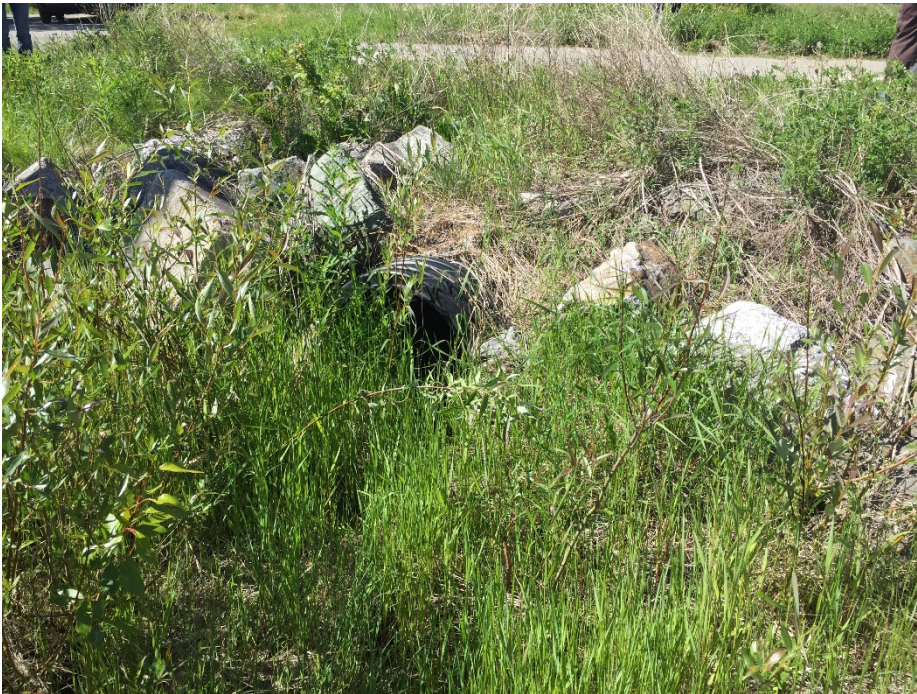
- The spillway downstream channel was observed at the culvert crossing on the road to the on-site residence (Photos II-30 to II-34). The middle reach immediately upstream of the culvert appeared to be in good condition with minor vegetation growth (Photo II-32). There was grass growing in front of the culvert inlet, partially blocking it (Photos II-30 and II-31). There was no flow into the culvert at the time of the inspection. The outlet of the culvert was clear of vegetation, but there was water ponding locally at the outlet to 11 cm above the invert

**Photo II-30 Spillway Downstream Channel – inlet to culvert beneath road to on-site residence. Note vegetation growth.**

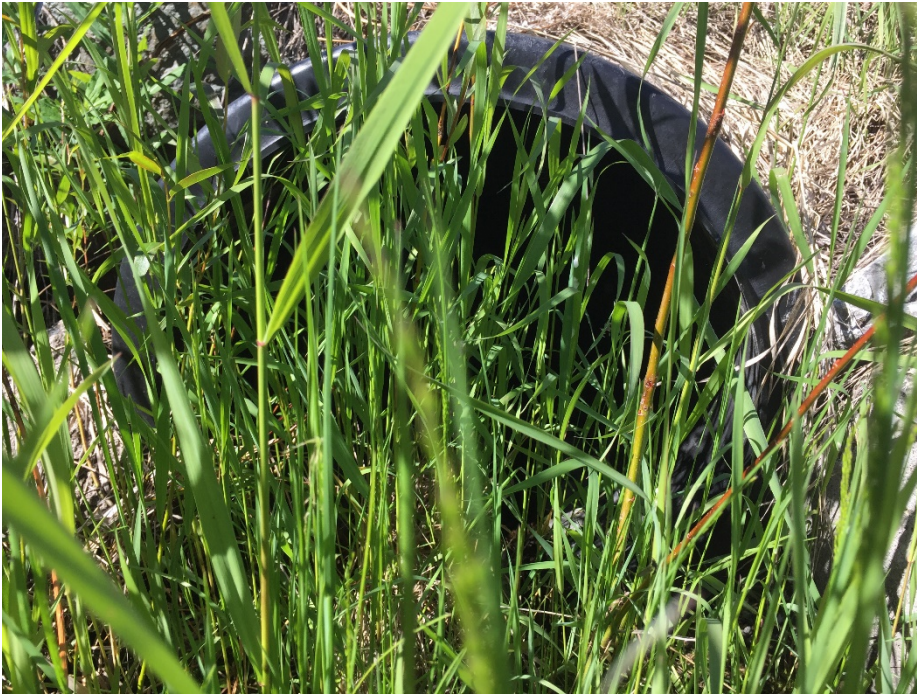
**Photo II-31 Spillway Downstream Channel – close up of inlet to culvert beneath road to on-site residence. Note vegetation growth.**

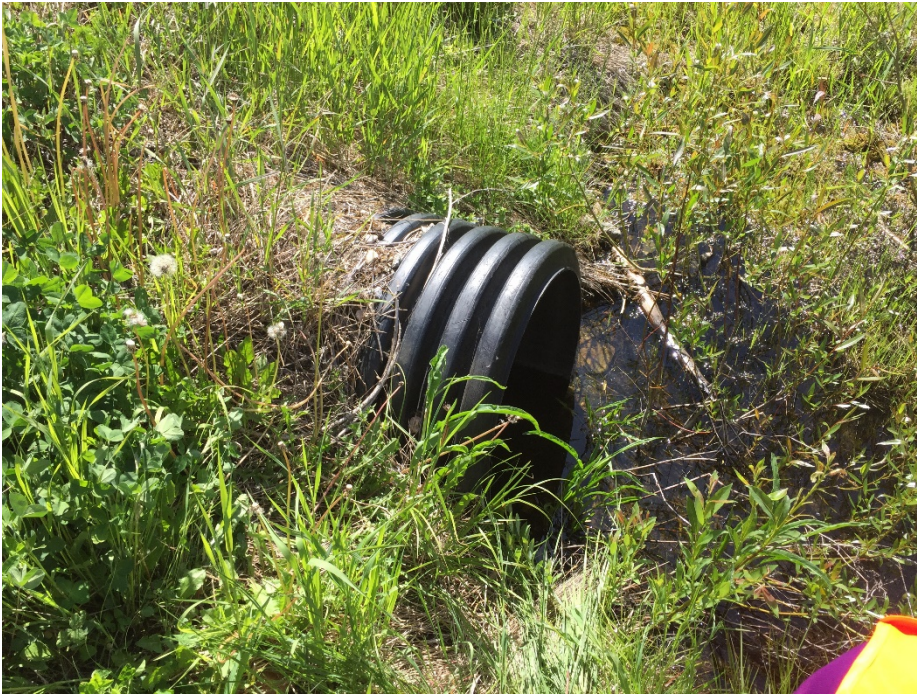
(Photo II-33). The culvert is not related to dam safety but clearing of the inlet may be prudent to restore its normal flow capacity. The lower reach of the spillway downstream channel appeared to be in good condition with minor vegetation growth (Photo II-34).

**Photo II-33 Spillway Downstream Channel – outlet of culvert beneath road to former caretaker’s house.**

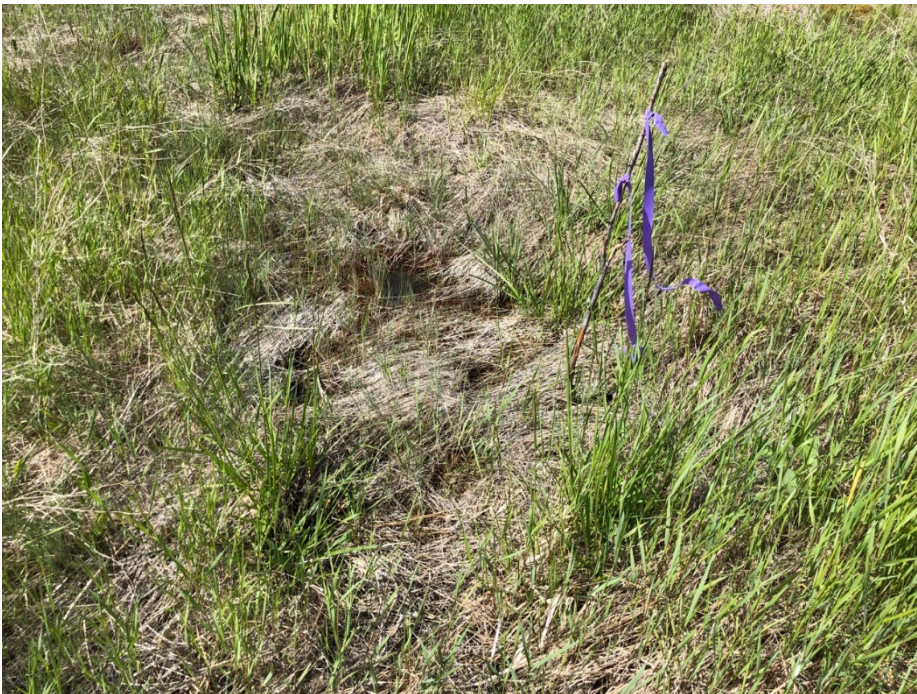
- A few small areas of wet ground were observed starting in the northeast corner of the borrow area and moving slightly downhill to the west along the toe of the slope for 60 m (Location 7 in Figure 4.1; Photo II-38), where a small pond was observed (Location 6 in Figure 4.1). There was no flowing water observed. Similar wet areas have been observed since 2011, and they are believed to be associated with groundwater unrelated to the TSF. Outside of these wet areas, the ground on the slope and along the toe was dry.

**Photo II-38 Borrow Area A – wet ground in northeast corner.**

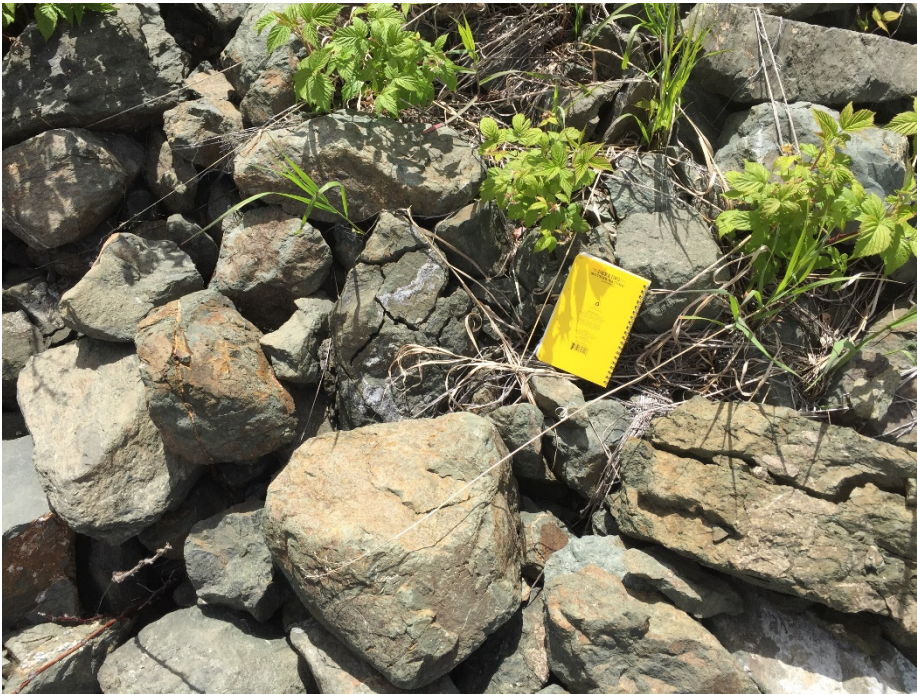
| Structure | ID No. | Deficiency or Non-Conformance | Applicable Regulation or OMS Reference | Recommended Action | Priority | Recommended Deadline/Status |
|---|---|--|--|---|---|--|
| Ed Creek Diversion Channel | 2019-02 | The riprap along the Ed Creek Diversion Channel is undersized and is deteriorating due to weathering (2014-02). | OMS Manual | An options assessment and conceptual design should be completed for upgrading the channel to meet erosion protection requirements. Since failure of the riprap would not immediately affect the dam, the risk to the dam in the interim is effectively managed through inspections and maintenance as per the OMS Manual, and there is no immediate concern for dam safety. | 3 | End of 2020 |

A complete failure of the Ed Creek Diversion Channel could potentially affect the Tailings Dam by eroding the west bank of the channel towards the dam and undermining the dam foundation. That level of event could not occur within a one-year period given the current

**Photo II-44** Ed Creek Diversion Channel – Riprap on right bank, showing weathering and breakage.

*An options assessment and conceptual design should be completed for upgrading the channel to meet erosion protection requirements. Since failure of the riprap would not immediately affect the dam, the risk to the dam in the interim is effectively managed through inspections and maintenance as per the OMS Manual, and there is no immediate concern for dam safety.*

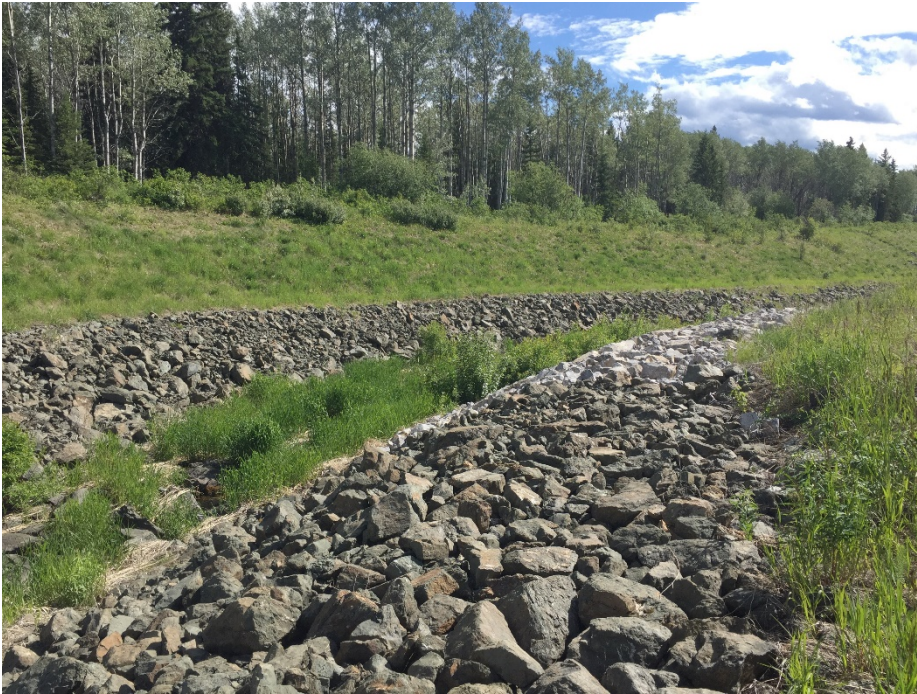
The riprap along a small section of the channel (Location 8 in Figure 4.1; Photo II-47), where a depression had formed in the riprap surface, was replaced in 2014. This riprap appeared to be in good condition.

**Photo II-47** Ed Creek Diversion Channel – looking downstream from near second bend. Light-coloured area of riprap was replaced in 2014, and is in good condition.

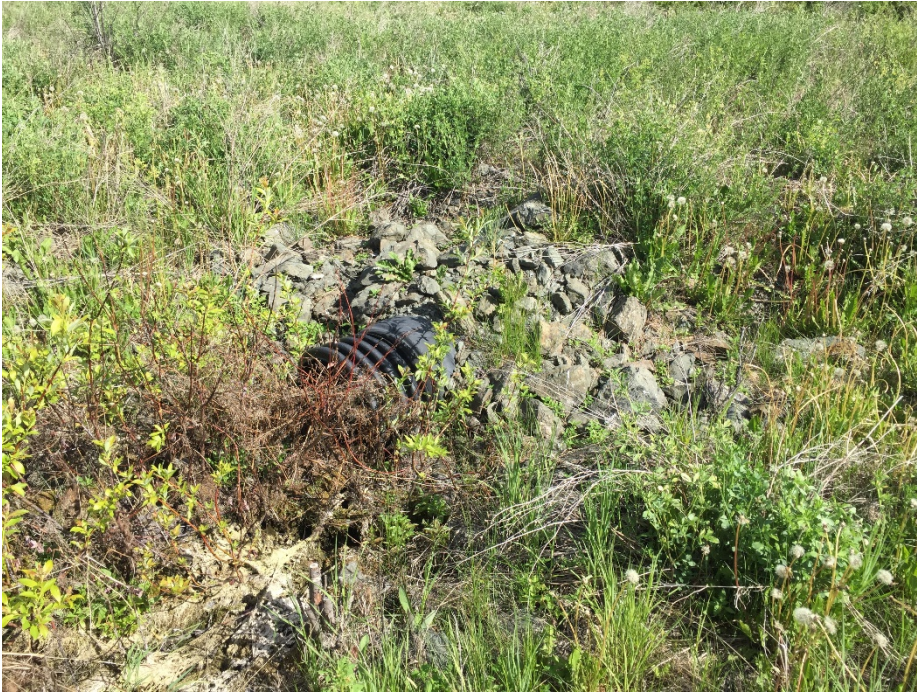
- The 460 mm diameter HDPE culvert on the north bank of the Ed Creek Diversion Channel had some vegetation growing in front of the inlet (see Figure 1.2 for culvert location, and Photos II-52 and II-53). This is not a dam safety concern.
- Vegetation growth at the base of Ed Creek Diversion Channel has reached up to 2 m height (Photos II-42, II-43 and II-45 to II-51). This is not currently considered to be a dam safety concern. However, the vegetation management plan recommends vegetation clearing prior to vegetation exceeding 1.5 m in height (Spectrum 2017).
- Previous annual inspection reports have noted that the riprap along some areas of the Ed Creek Diversion Channel is weathering and breaking up (Photo II-44). The condition of the riprap appeared similar to previous inspections.

**Photo II-53** Inlet of 460 mm culvert on north bank of Ed Creek Diversion Channel. There is vegetation upstream of the inlet that could block the channel during flood conditions.

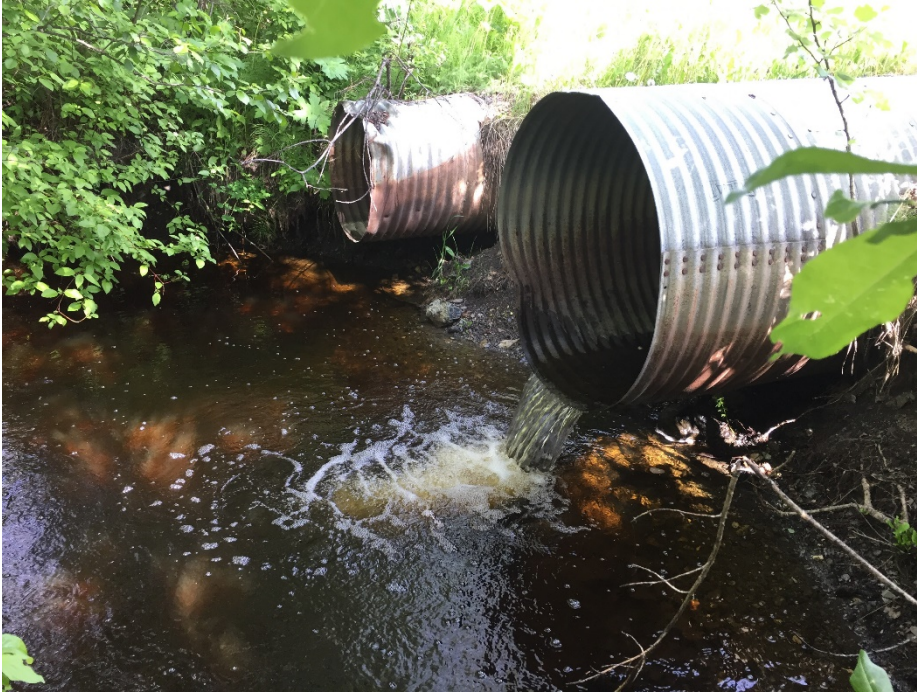
- There are two culverts on Ed Creek under Pinchi Lake Road east of the mine gate (see Figure 1.2 for location). Flow was observed in the east culvert only, with a depth of 80 mm at the inlet.
- There was overhanging vegetation in front of the culvert inlets (Photos II-55 and I-56). A blockage of the culverts could potentially cause a washout of the road, and a sudden failure of the road embankment may subject the Ed Creek Diversion Channel to large flood flows. Monitoring of these culverts is included in the inspection checklists in the OMS Manual, and they will continue to be monitored in future inspections.

**Photo II-57** Outlets of Ed Creek culverts under Pinchi Lake Road. Note only one culvert is flowing.
