# 2019 Dam Safety Inspection

*Pine Point Tailings Impoundment Area, Pine Point, NT*

**Golder Associates Ltd.**

8 November 2019

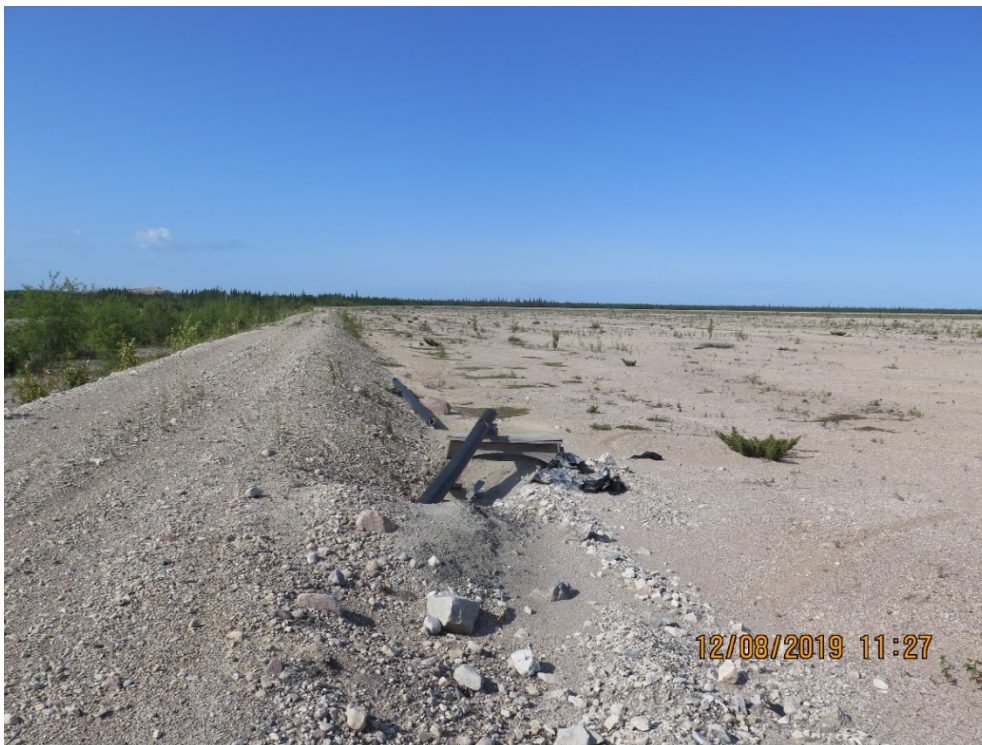
**Photograph 2: South Dyke – Upstream Slope of Central Portion, and Debris in Impoundment Area, Looking West, 12 August 2019**

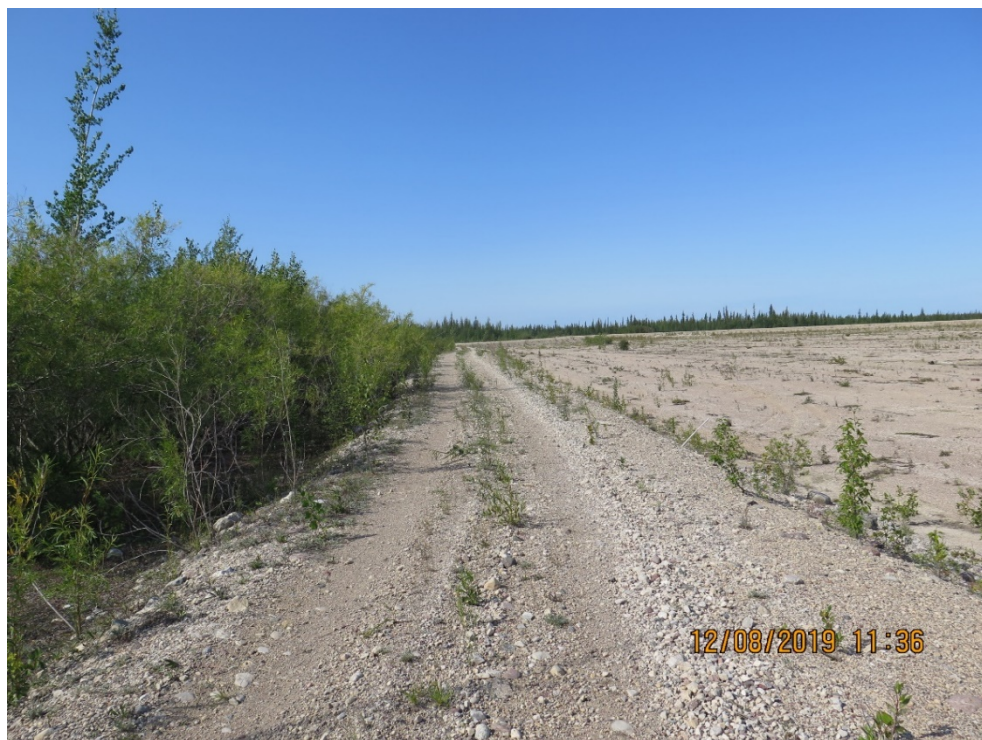
- Vegetation was observed on the downstream slope of the south dyke, at the west end.
- Minor vegetation was observed on upstream and downstream slopes of the north dyke.

**Photograph 3: South Dyke – Crest at West End with Vegetation on Downstream Slope, Looking West, 12 August 2019**

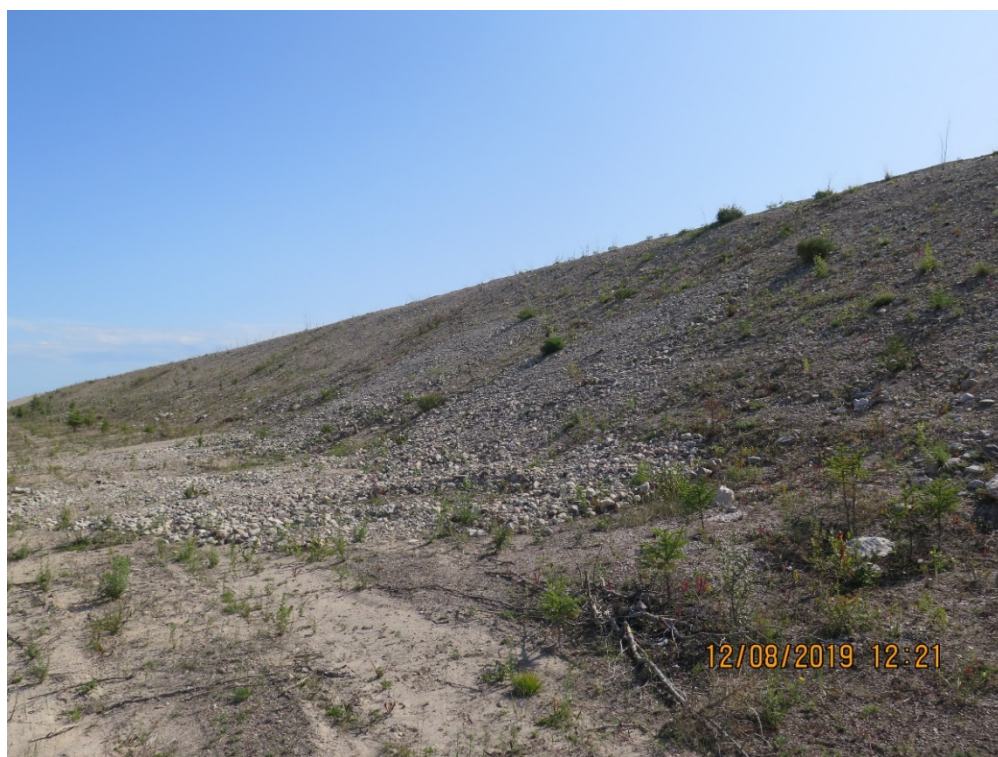
- No rills were observed to extend into the dyke crest, crest width was intact
- Large rills on the downstream slope of the north dyke observed during 2018 had been repaired using coarse gravels and cobbles. Repairs were in good condition.

**Photograph 9: North Dyke – Repaired Erosion Rills on Downstream Slope Near West End, Looking Southeast, 12 August 2019**

- maintenance repair by placement of granular fill in rills on the downstream face of the north dyke between 10 and 15 October 2018, reported in Golder (2019a) and inspected in 2019

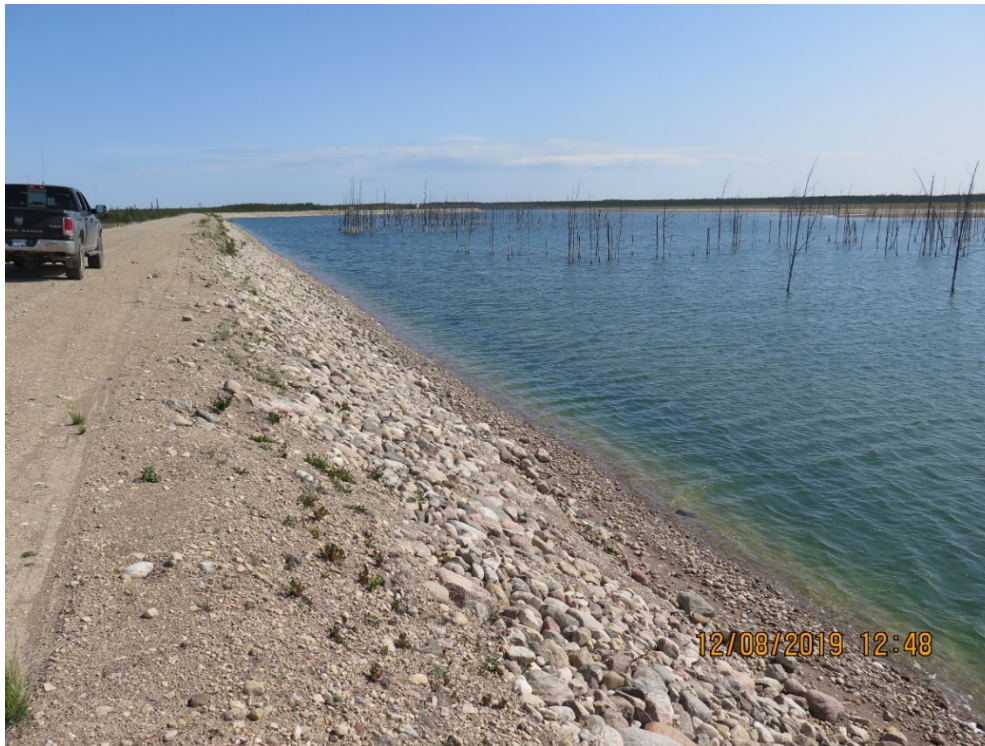
**Photograph 11: North Dyke – Upstream Slope, Repaired with Riprap, Looking Northeast, 12 August 2019**

- maintenance repair by placement of geotextile and riprap fill on upstream face of the north dyke between 10 and 15 October 2018, reported in Golder (2019a) and inspected in 2019

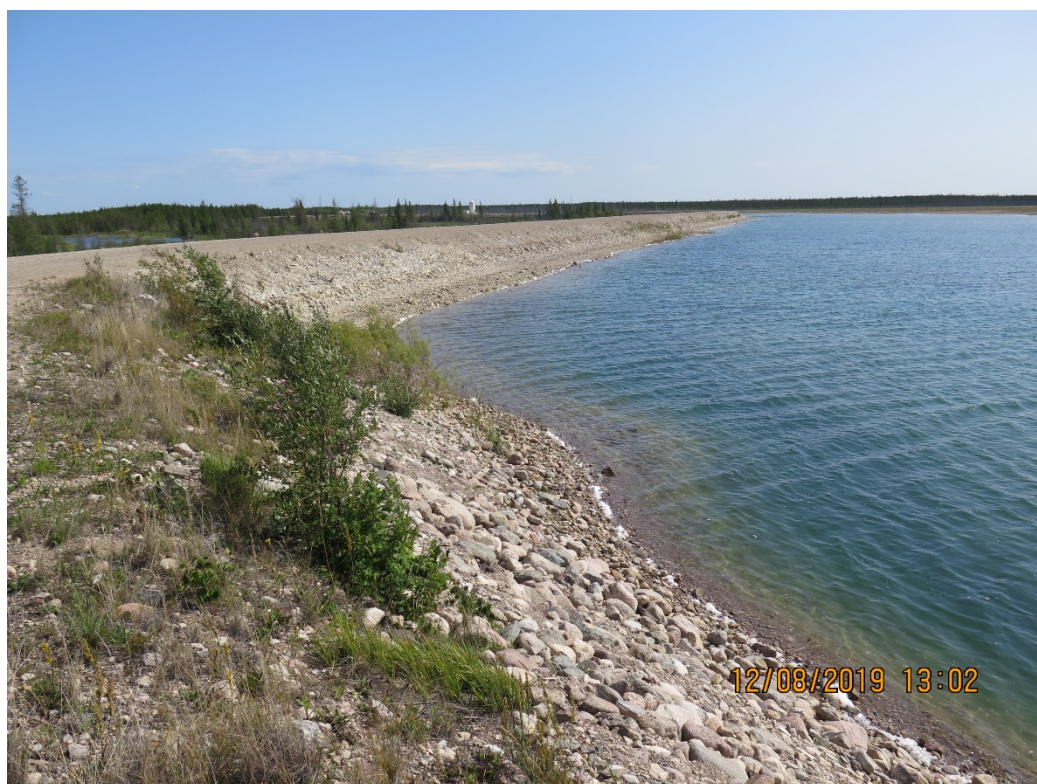
**Photograph 13: North Dyke – Upstream Slope West of Dogleg, Looking East, 12 August 2019**

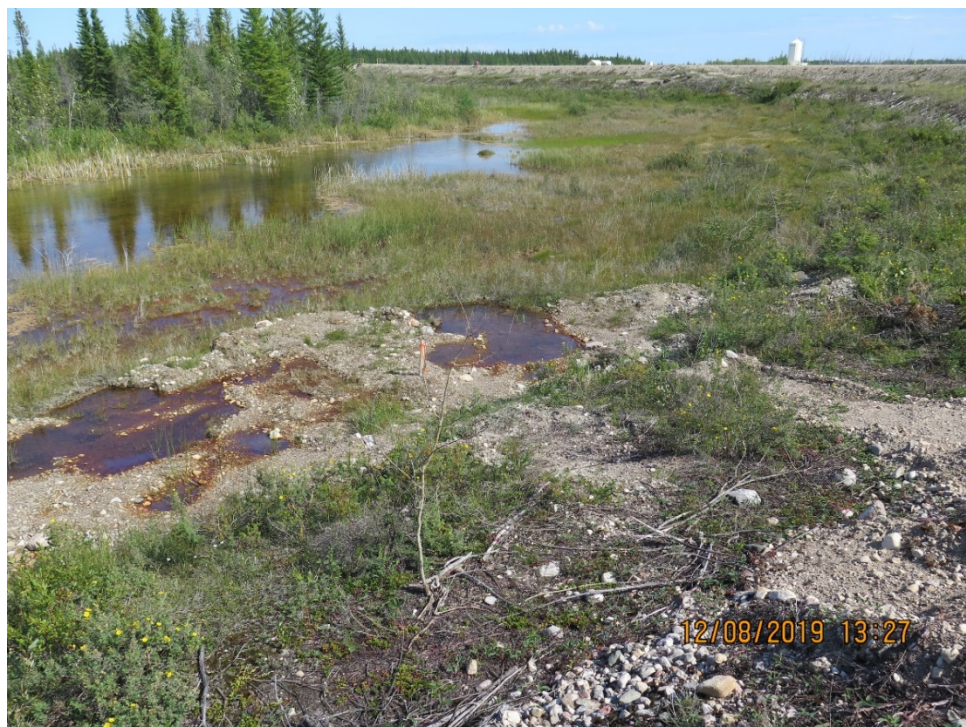
**Photograph 14: North Dyke – Downstream Toe Area at Dogleg, Red Staining, Looking East, 12 August 2019**

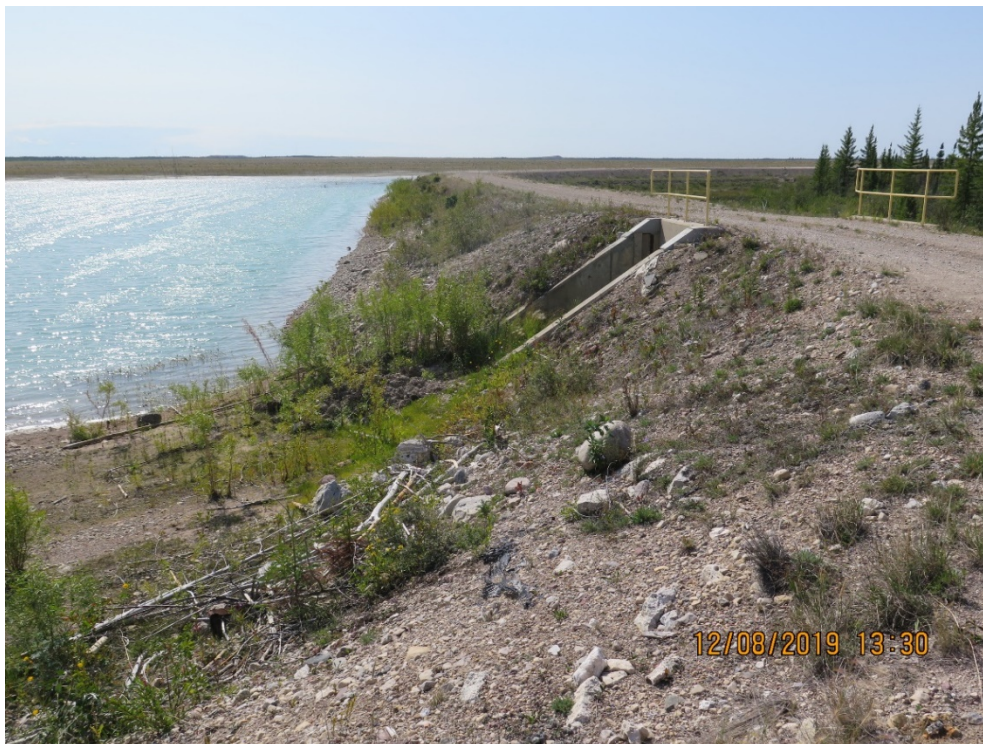
**Photograph 15: Main Pond Spillway (Spillway No. 1) – Upstream Side, Looking South, 12 August 2019**

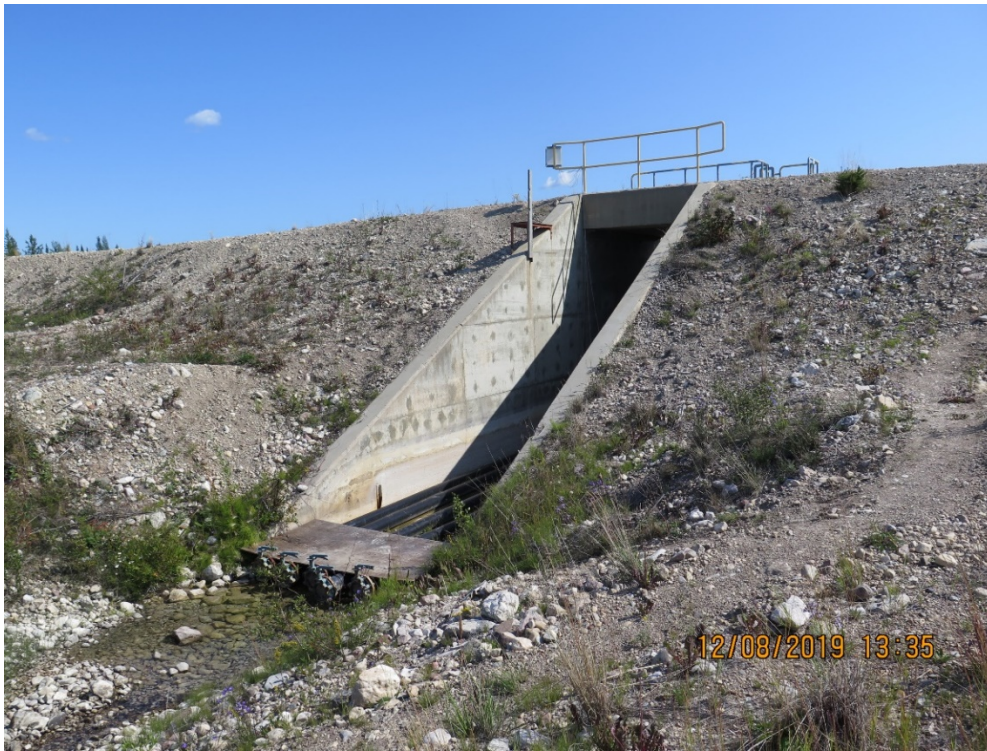
**Photograph 17: Polishing Pond Spillway (Spillway No.2) – Outlet, Syphons in Place, Looking East, 12 August 2019**
