Teck Coal Ltd.

Quintette Coal Operations

Shikano North Tailings Dam

2019 Dam Safety Inspection

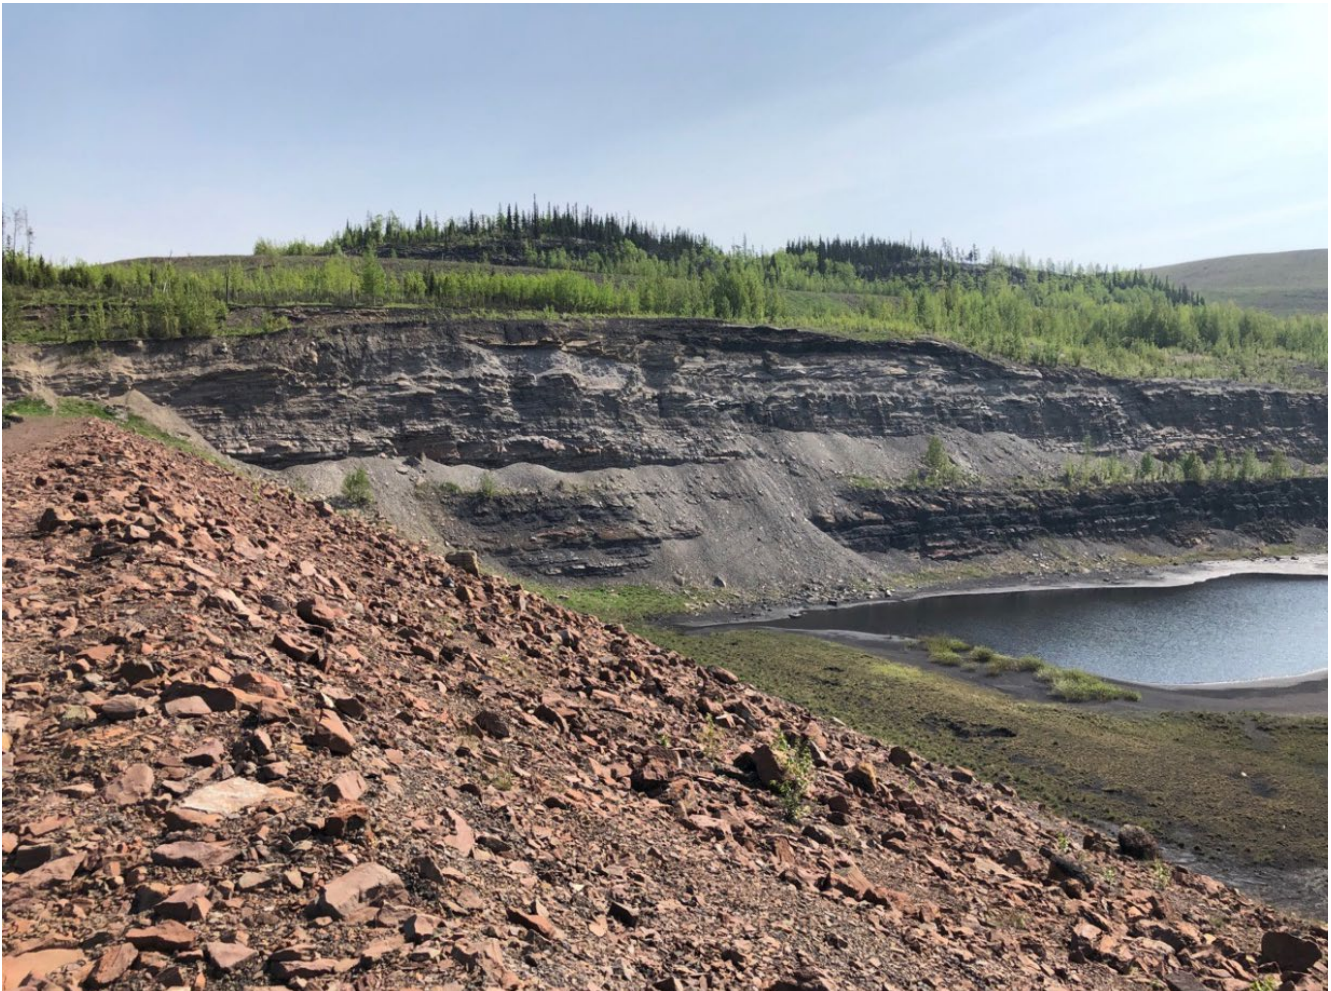
Photo I-1 Upstream slope from the left abutment with pit wall in the background – looking northeast (SNTD-2019-01)

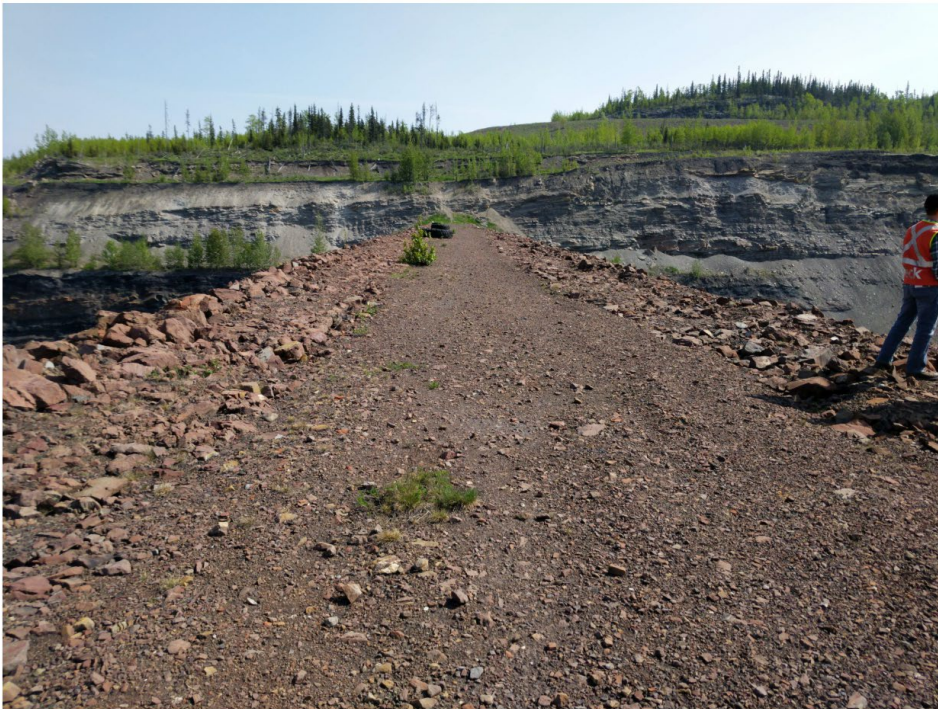
Photo I-2 Dam crest from left abutment – looking northeast (SNTD-2019-01)

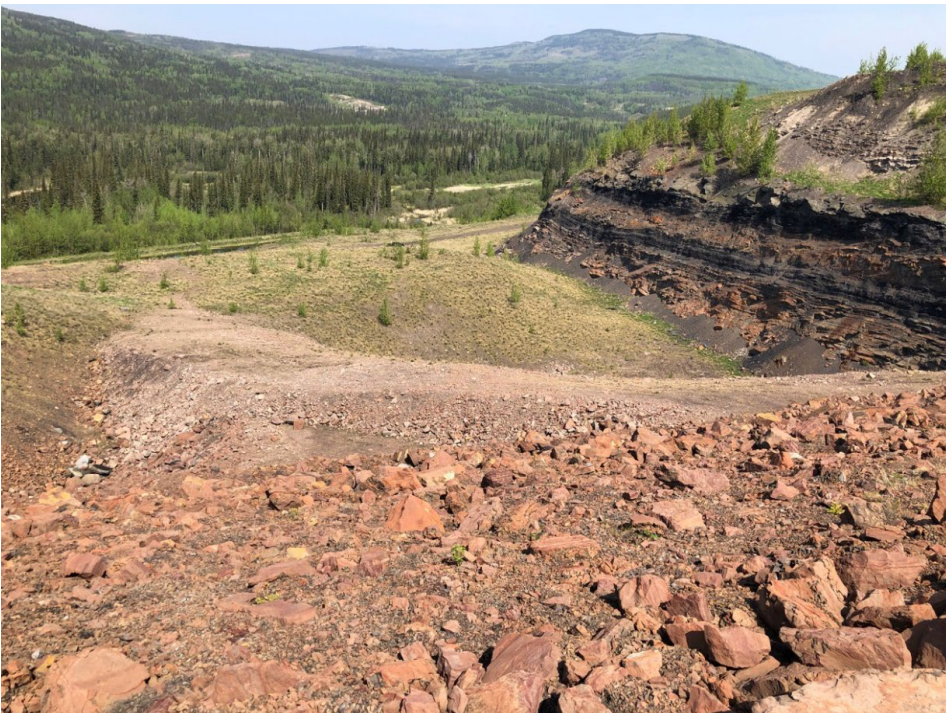
Photo I-3 Downstream slope – looking northwest (SNTD-2019-02)

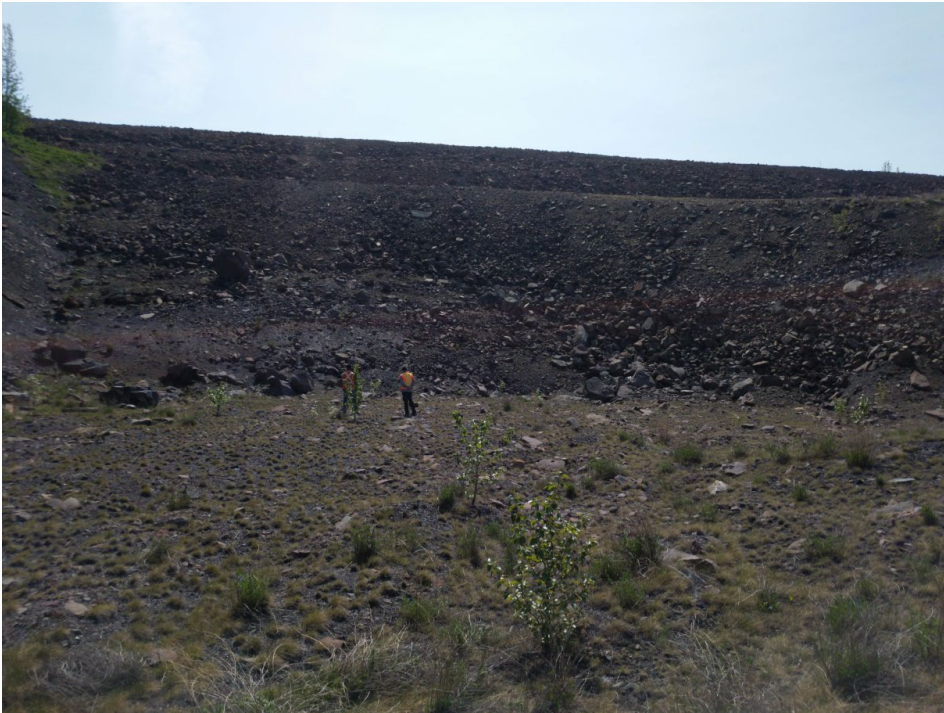
Photo I-4 Downstream slope – looking east (SNTD-2019-03)

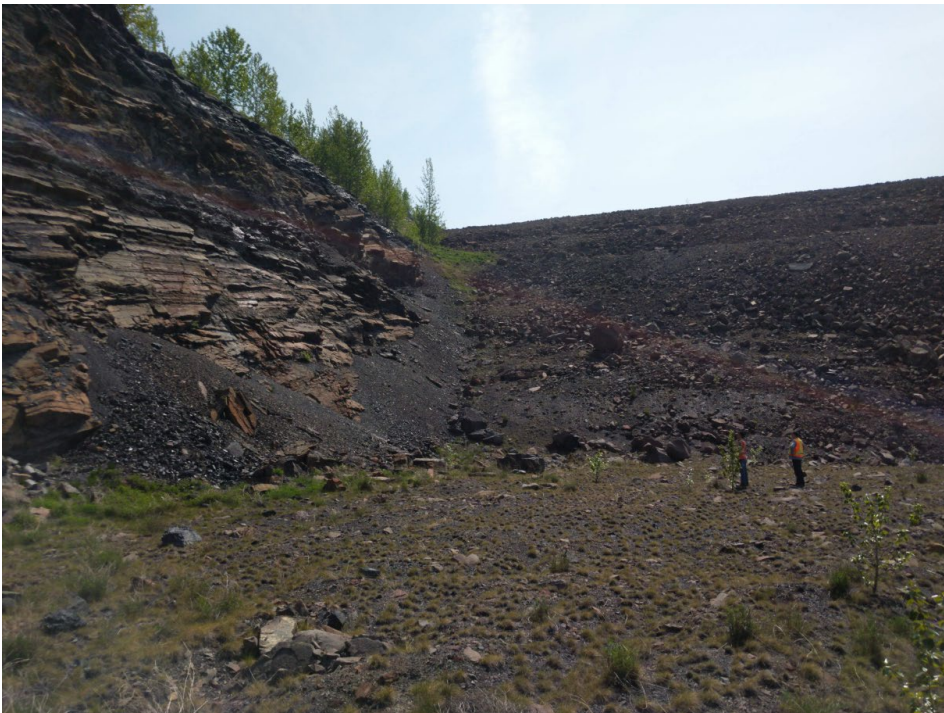
Photo I-5 Downstream right abutment – looking east (SNTD-2019-03)

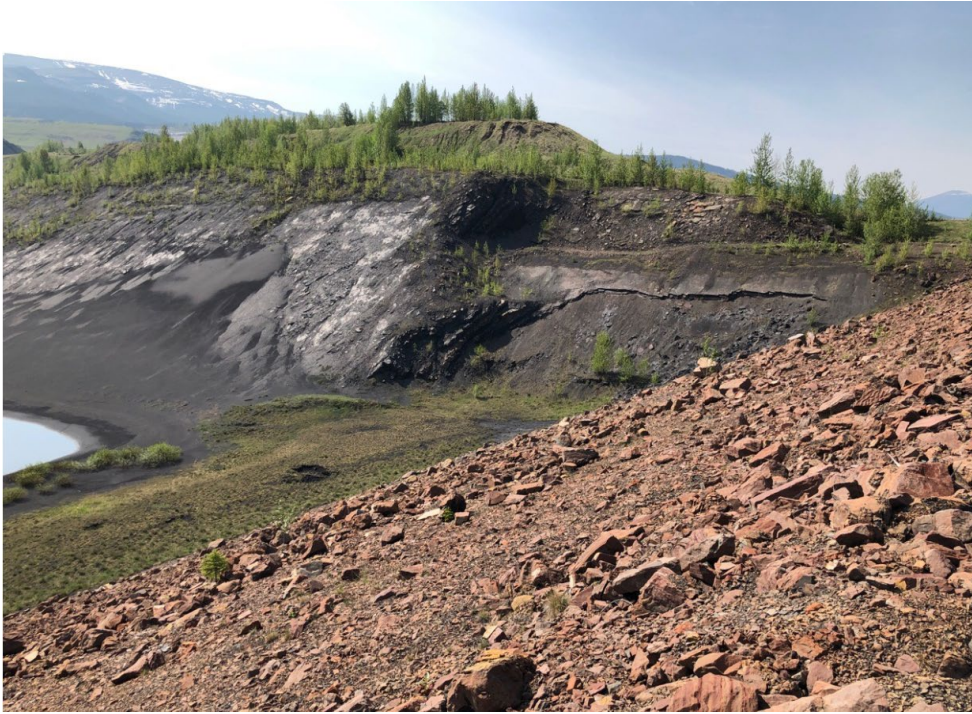
Photo I-6 Ravelling of shale slope upstream of the left abutment – looking southwest (SNTD-2019-04)

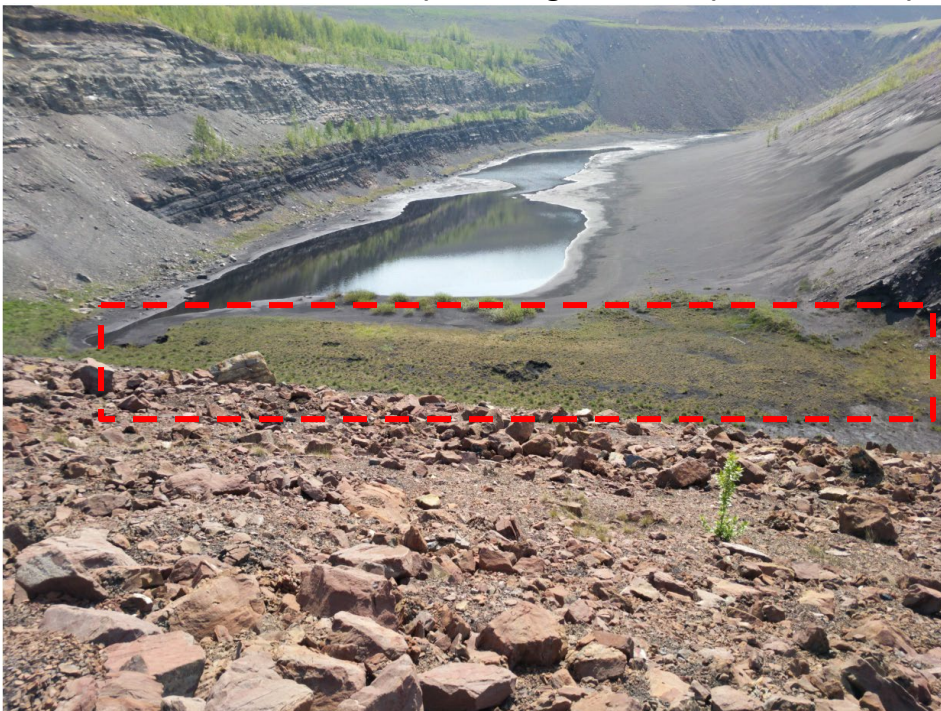
Photo I-7 Upstream slope and impoundment (general area where sinkholes are observed is shown in red box) – looking southeast (SNTD-2019-02)

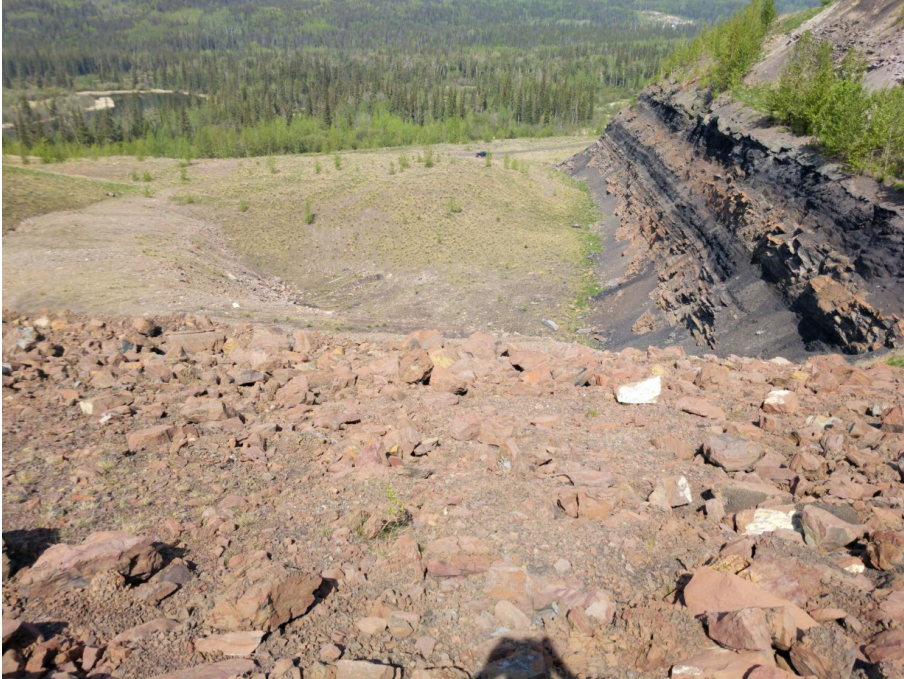
Photo I-8 Downstream slope – looking northwest (SNTD-2019-04)

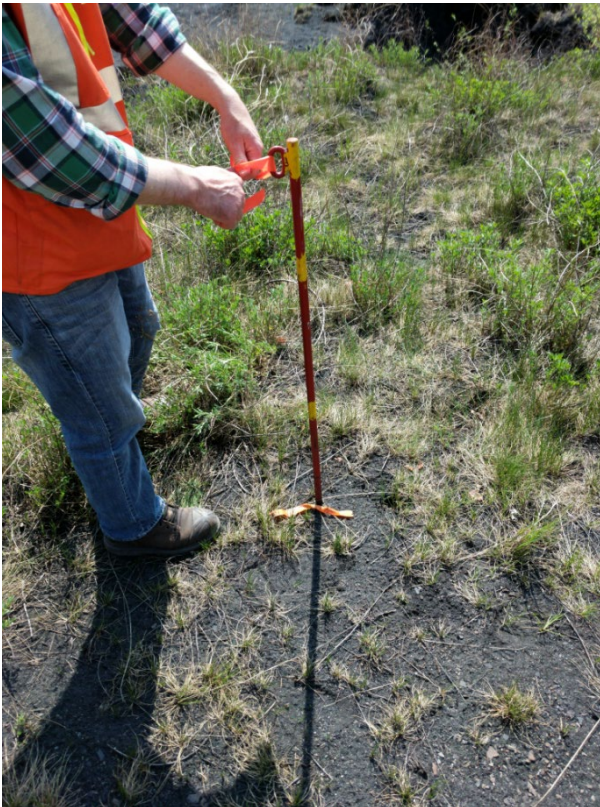
Photo I-9 Freeboard water level stake (SNTD-2019-05)

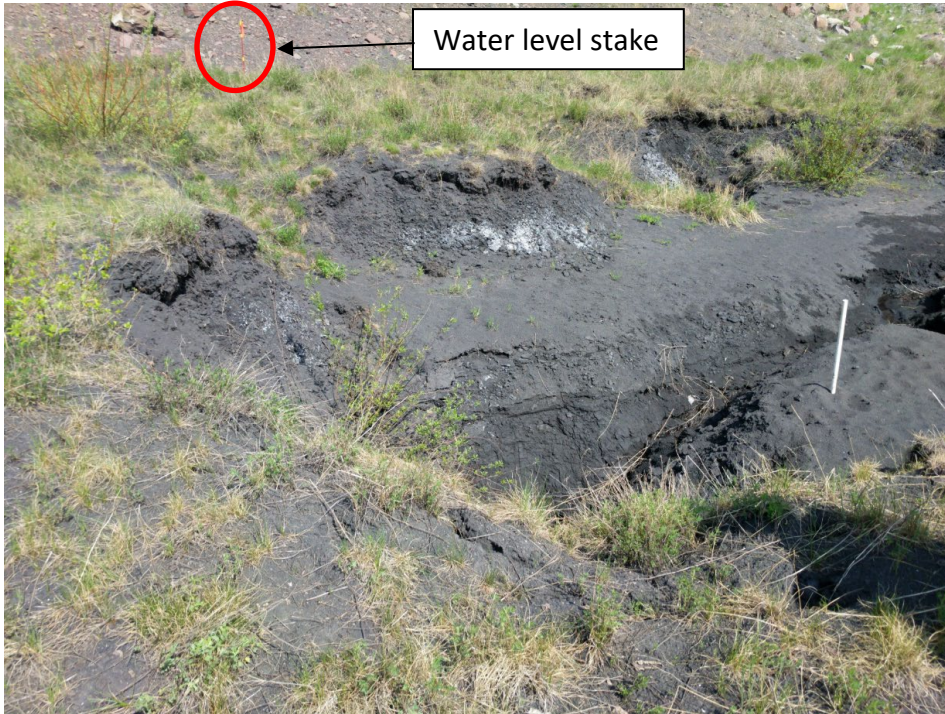
- Sinkhole 11 was first documented during the 2018 inspection (KCB 2019) and is the first sinkhole where apparent flowing of water into the coarse rockfill overlying filters and geotextile was observed. Inspection of the downstream seepage indicated flow was clear (Photo I-14) (i.e., no indication of internal erosion). No photos were taken for Sinkhole 11.

Photo I-10 Sinkhole 11, water level indicator visible in the background (SNTD-SINKHOLE-2019-11)

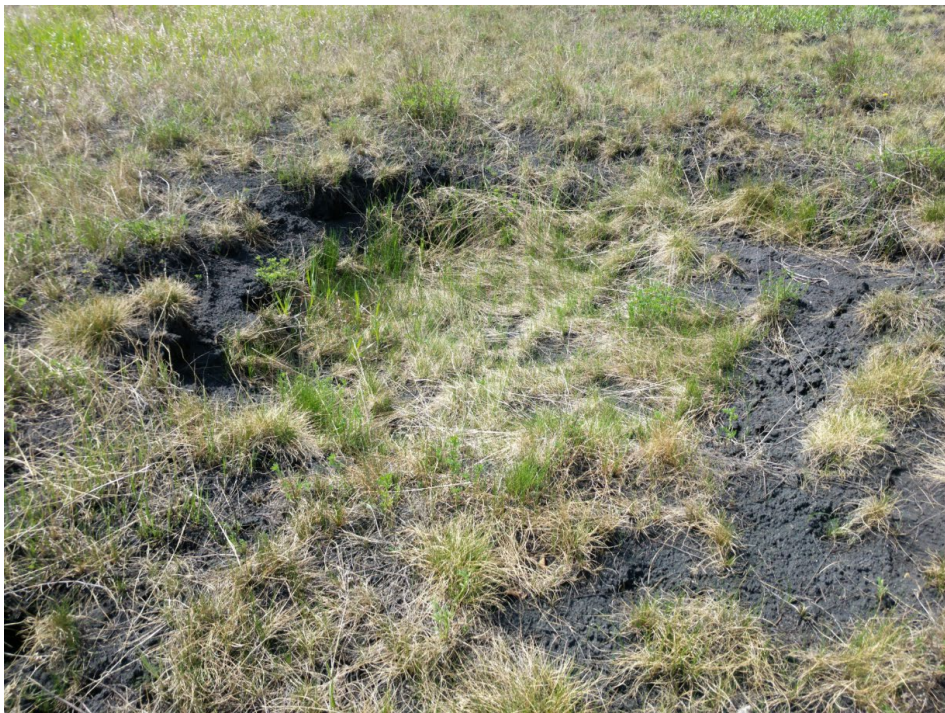
- Sinkholes 2 and 3 were first documented in 2015 (KCB 2016a). There was no visually obvious change observed between the 2018 and 2019 inspections.
- Sinkhole 1 was first documented in 2016. There was no visually obvious change observed between the 2018 and 2019 inspections.

Photo I-11 Sinkhole 2 (SNTD-SINKHOLE-2019-02)

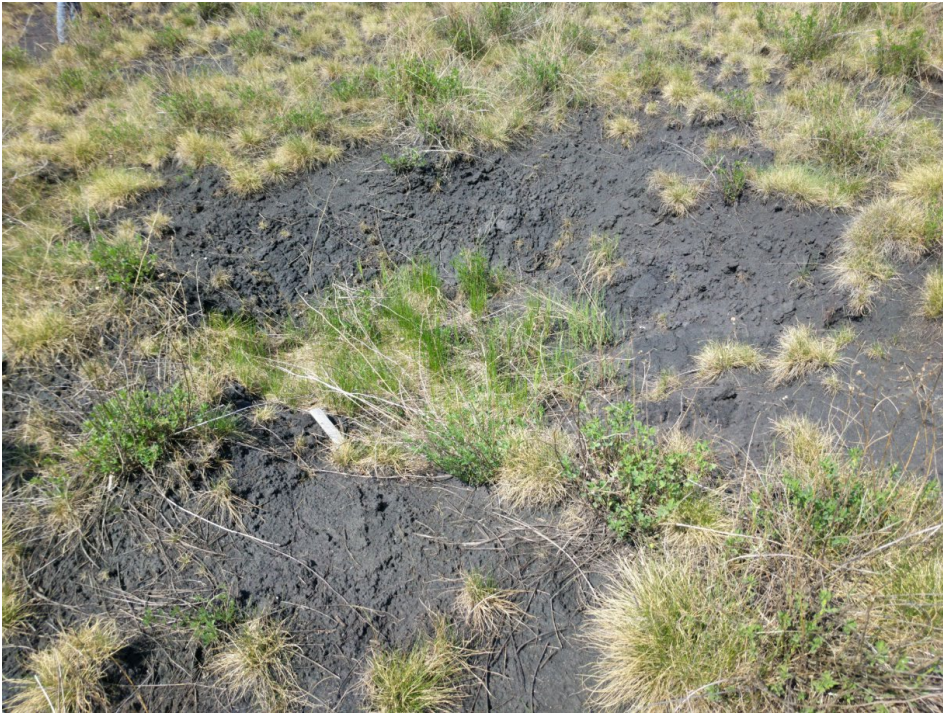
Photo I-12 Sinkhole 3 (SNTD-SINKHOLE-2019-03)

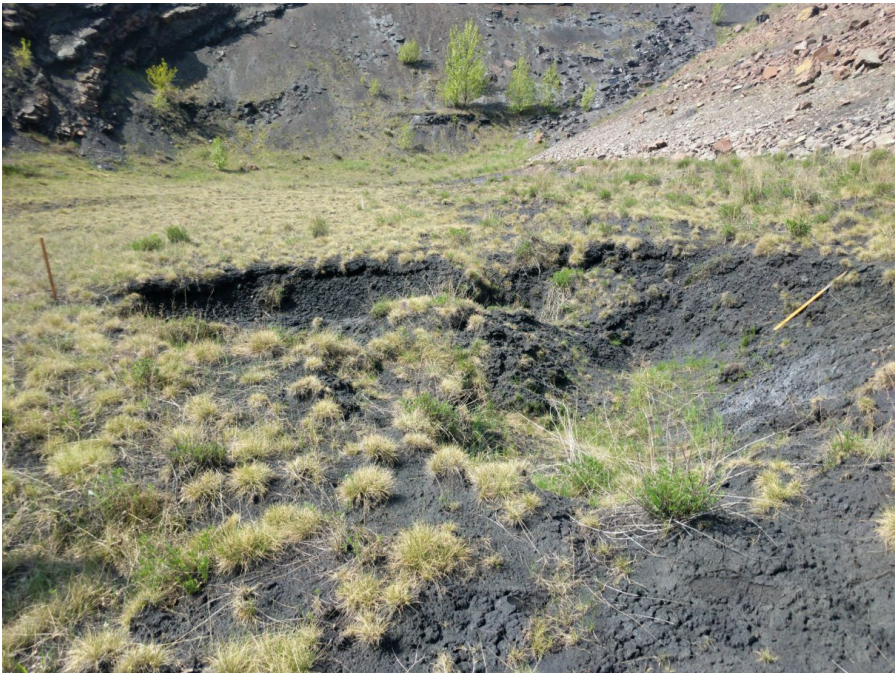
- A cluster of 3 sinkholes (Sinkhole 6) were noted to have merged into a single large sinkhole in 2018 (KCB 2019) (Photo I-13). The sinkhole is approximately 9.4 m by 7.4 m and 0.5 m deep and there was no visually obvious change observed in 2019. The bottom of the sinkhole was dry in 2019.

Photo I-13 Sinkhole 6, formerly a cluster of three sinkholes that were observed to have merged in 2018 (SNTD-SINKHOLE-2019-06)

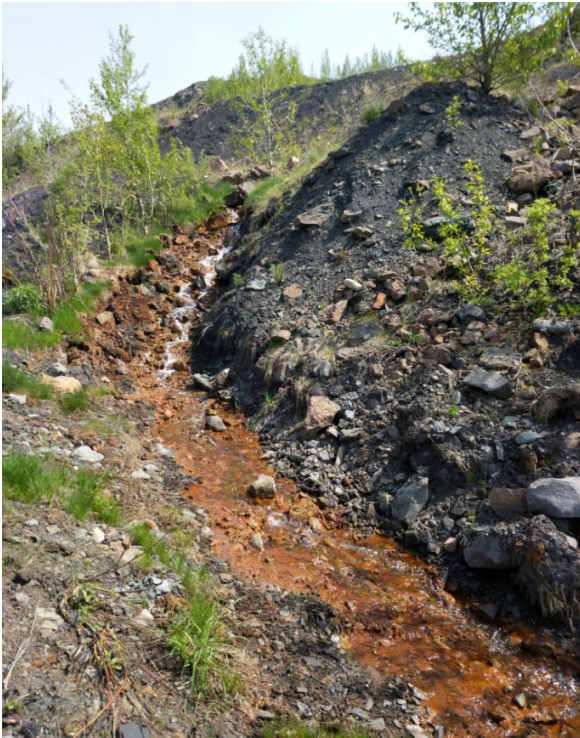
Photo I-14 Seepage channel, which flows into Sediment Pond S3 – looking east (SNTD-2019-07)

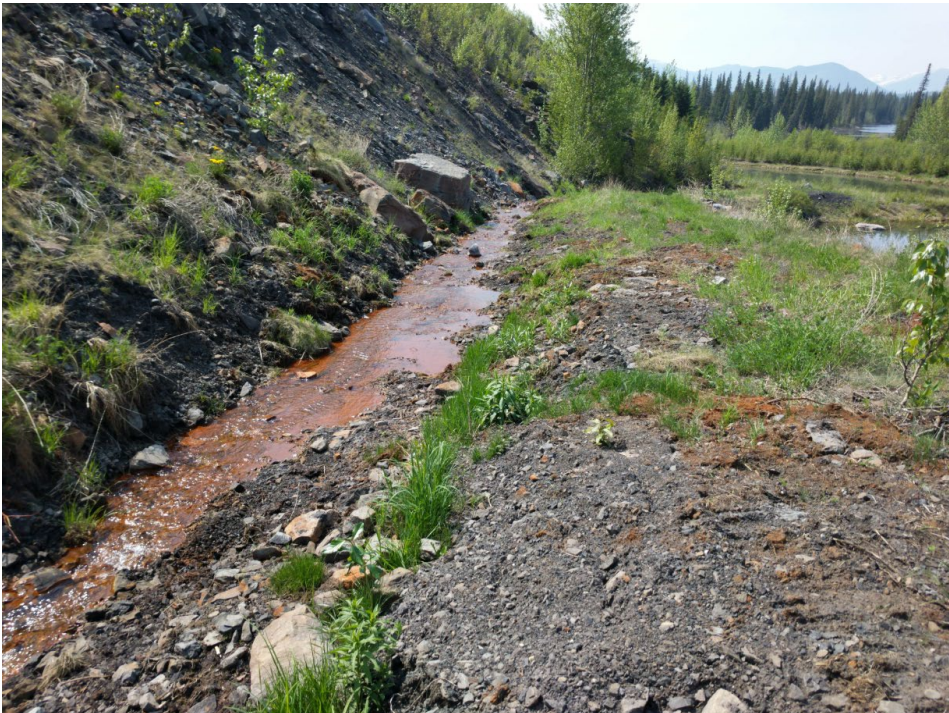
Photo I-15 Seepage channel to S3 Pond – looking southwest (SNTD-2019-07)

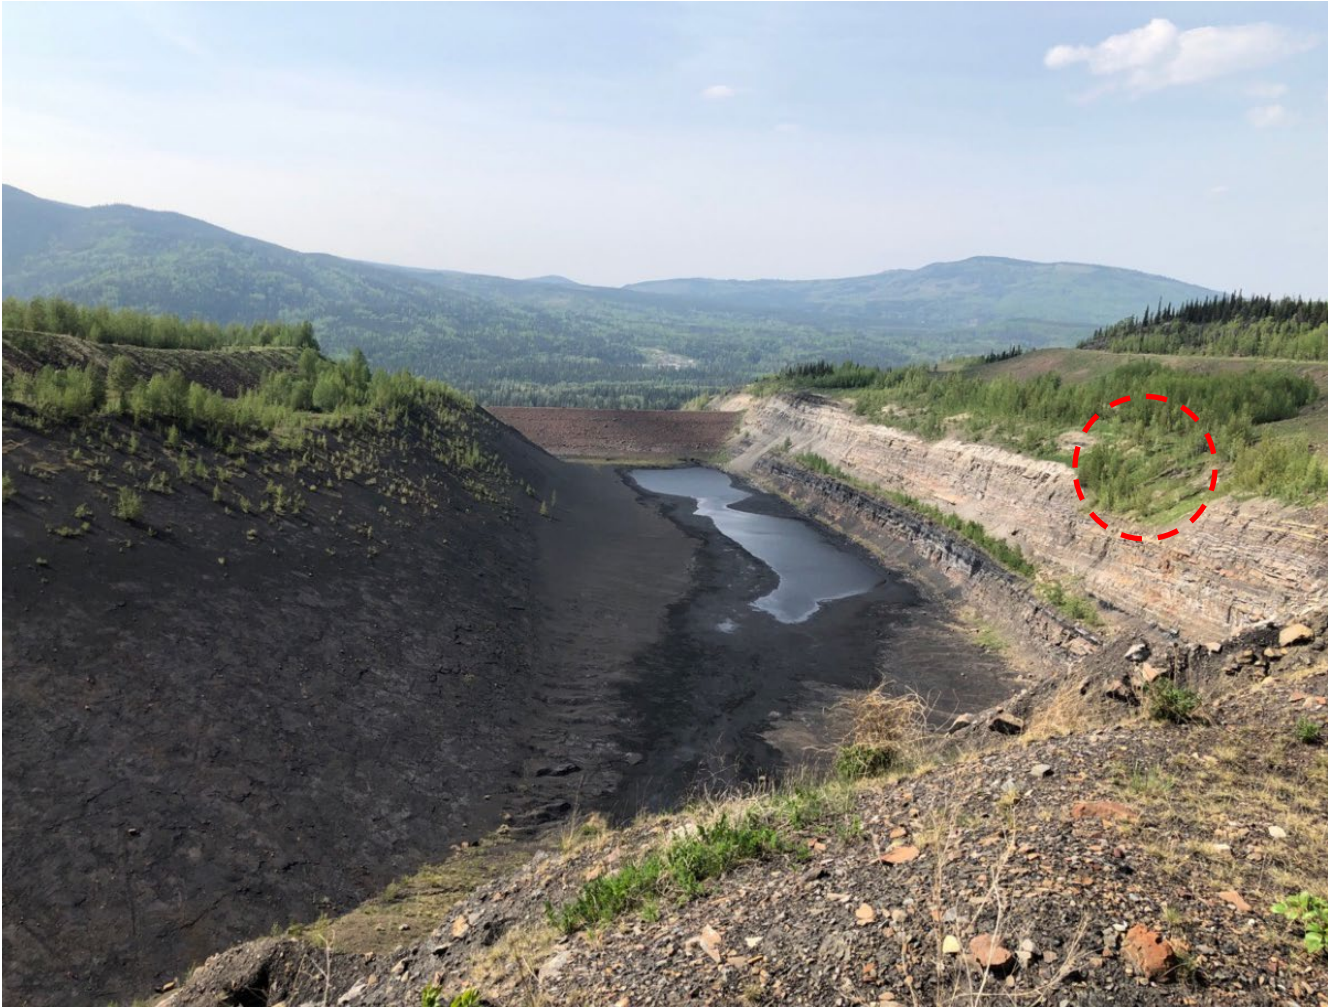
Photo I-16 Shikano North Tailings Dam – looking northwest. Historic slumping failure circled with red dash line (SNTD-2019-06)
