October 24, 2019

Reference No. 18113464-004-L-Rev1-3000-TBD

## **Red Dog Tailings and Water Department**

## **2019 ANNUAL PERFORMANCE REPORT FOR TAILINGS BACK DAM, RED DOG MINE, ALASKA**

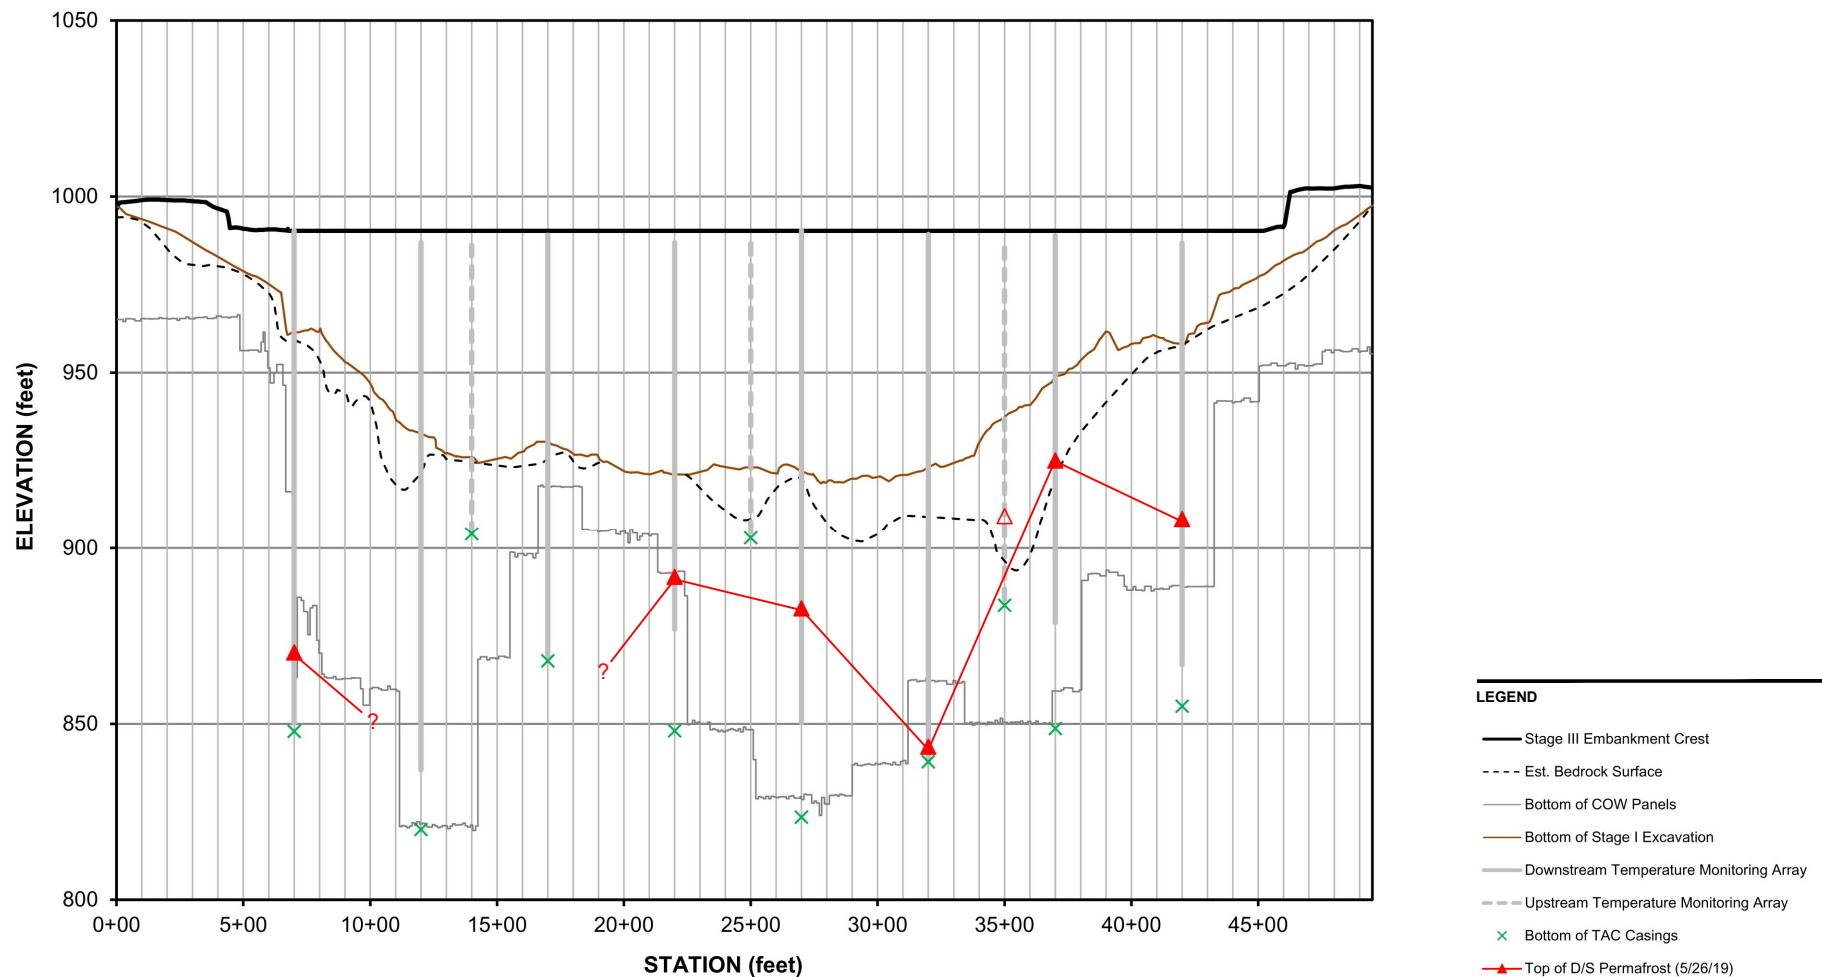
PROFILE VIEW - PERMAFROST SURFACE (HISTORICAL AND RECENT DATA)

Figure 12 shows the interpolated permafrost table at each of the ground temperature monitoring arrays within the TBD along the COW profile. This profile view shows that the highest permafrost table elevation occurs downstream near Station 37+00 and is within the native overburden materials. The permafrost surface is below the ground temperature array at Station 17+00 and appears to be near the bottom of the ground temperature array at Station 12+00 where the bottom two nodes are slightly above 32 degrees Fahrenheit. Considering the accuracy of the Beaded Stream digital temperature cables are about plus or minus 0.2 degrees Fahrenheit, the permafrost elevation at Station 12+00 may be about 845 feet. The recent ground temperature monitoring data at Station 17+00 shown in Figure C-4, Appendix C indicates warming near the bottom of the COW, which may be indicative of higher seepage at that location.

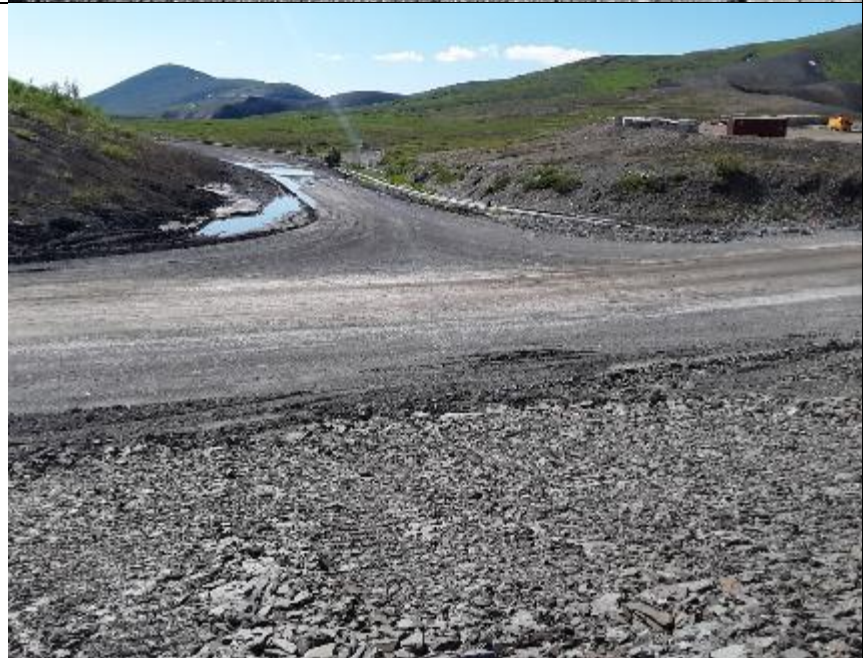
**PHOTO 6**

- Water was observed in a topographic low spot downstream of the TBD, near Station 10+00, and closer to the southwest corner of the Overburden Stockpile (Photo 6). This ponded water is likely associated with watering for dust control. No other ponded water was observed at the ground surface near the downstream toe of the dam embankment during the inspection.

PONDED WATER IN LOW  
SPOT ON DOWNSTREAM  
SIDE NEAR STATION 10+00,  
LOOKING SOUTHWEST

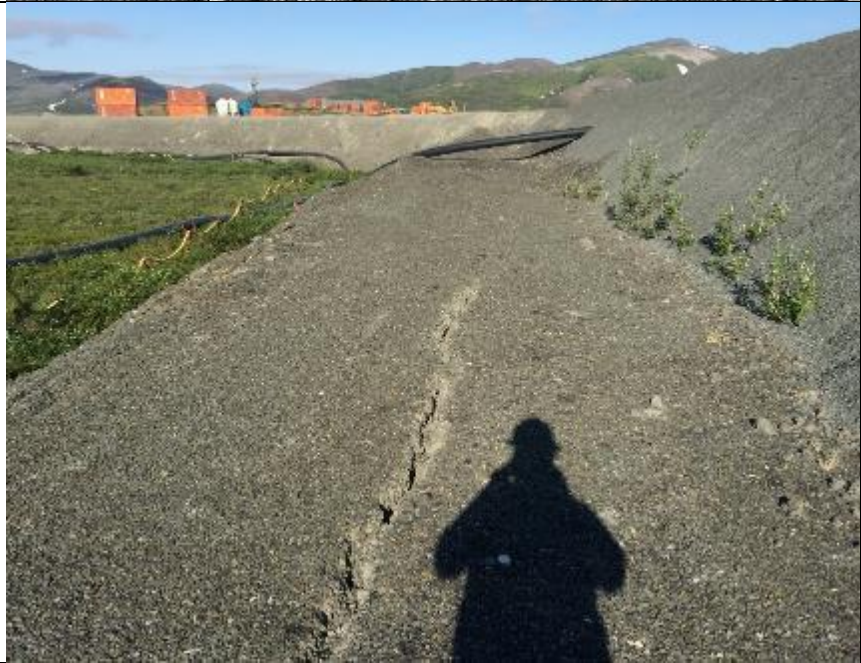
**PHOTO 22**

- Similar to previous inspections, longitudinal cracking was observed along the downstream crest of the east abutment near Station 49+00 (Photo 24) and within the downstream rockfill about 8 feet from the crest near Station 45+00 (Photo 22). This cracking was observed during previous inspections and initially observed during the 2014 periodic safety inspection (PSI). The length and width of the cracking appeared to be similar to what has been previously observed. As described in previous reports, this cracking is not a stability concern and poses no risk to the COW.

HISTORIC CRACKING AT  
DOWNSTREAM CREST  
NEAR STATION 45+00,  
LOOKING WEST

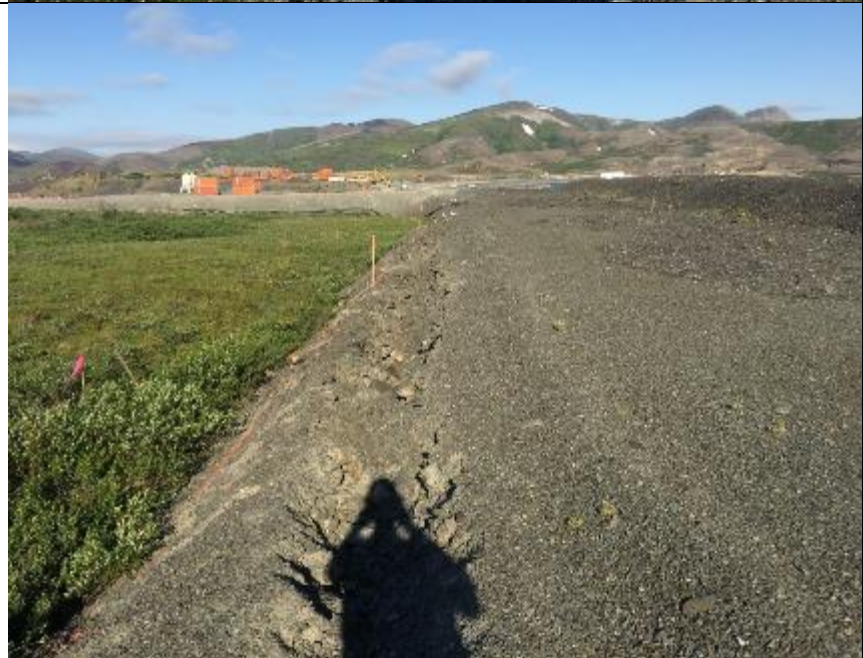
**PHOTO 24**

HISTORIC CRACKING AT  
DOWNSTREAM  
EMBANKMENT CREST  
NEAR STATION 49+00,  
LOOKING WEST

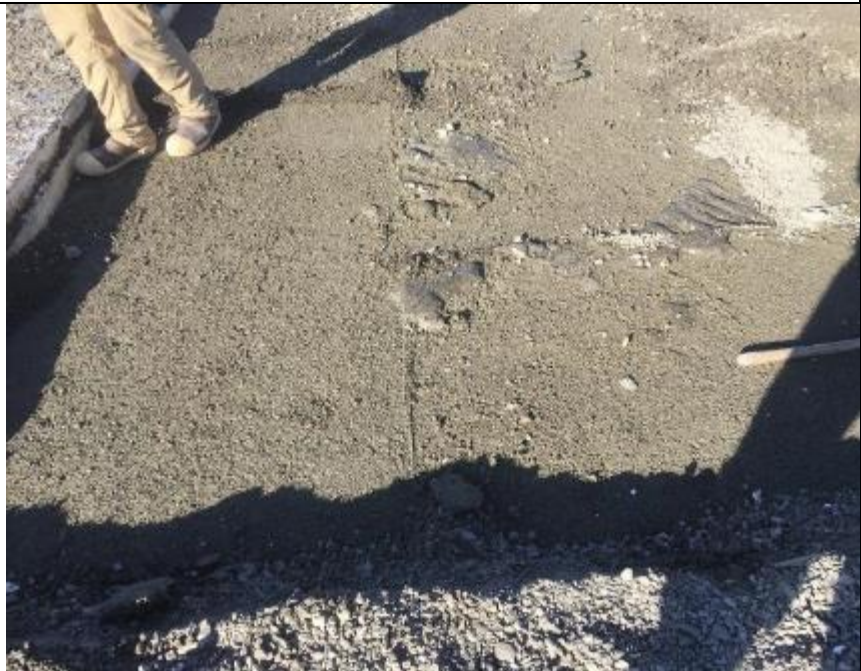
- Sporadic ice and ice veining (Photo 31) was found at a few locations (Station 6+50, 10+50, and 12+00) on the select fill surface after removal of the insulation boards. The ice did not penetrate the fill material and appeared to follow the bottom surface irregularities of the insulation board or underneath the interface between two boards that may have had a gap between them.

SURFICIAL ICE BENEATH  
BOARD INSULATION

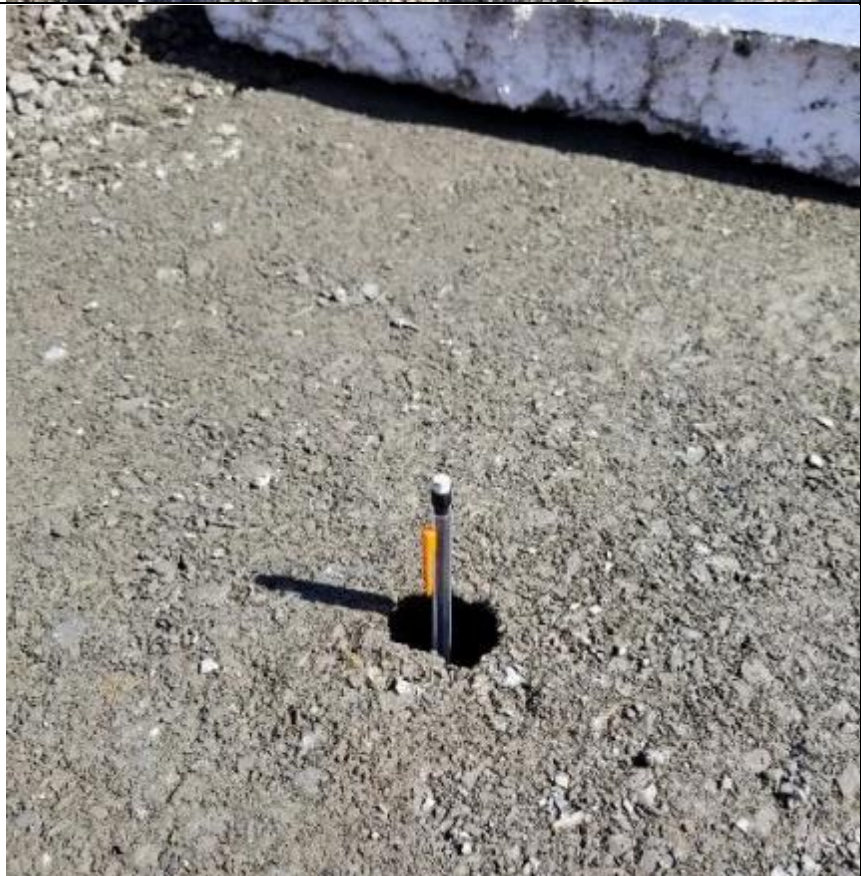
**PHOTO 32**

- A small surficial void of approximately 1.5 inch diameter (Photo 32) was observed on the select fill near Station 28+75 following removal of the board insulation. After further investigation, Golder personnel measured an approximately 7-inch by 5-inch void to a depth of 3.5 inches (Photo 33) underneath the smaller surface opening. Snow and freezing temperatures were occurring onsite in 2015 when the insulation fill placement took place; therefore, the void was likely caused by snow or ice trapped between the select fill and insulation board and does not pose a concern to the performance of the TBD.

VOID IN SELECT FILL  
SURFACE AFTER  
INSULATION REMOVAL  
NEAR STATION 28+75

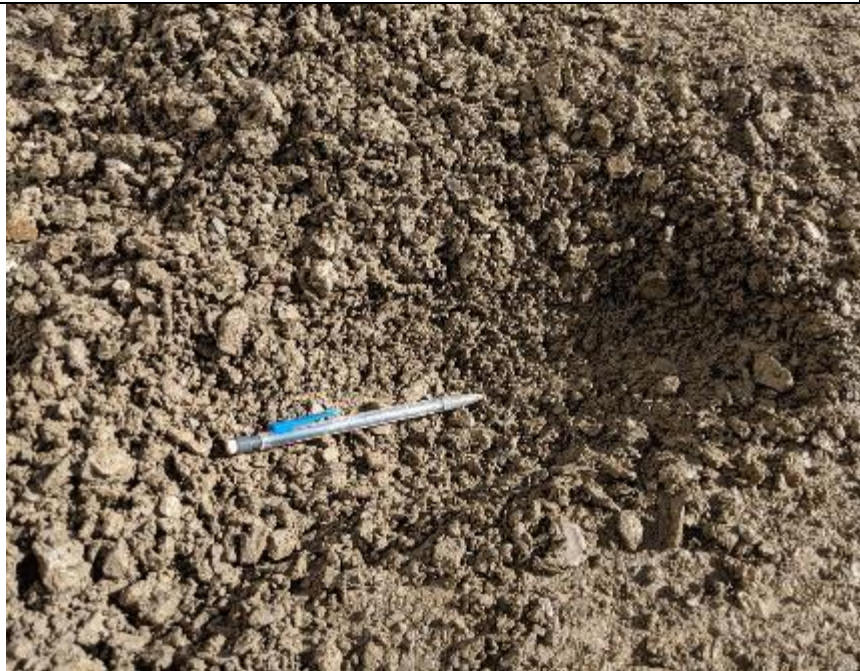
**Appendix A: Photographs****PHOTO 33**

DUG UP VOID IN SELECT  
FILL NEAR STATION 28+75

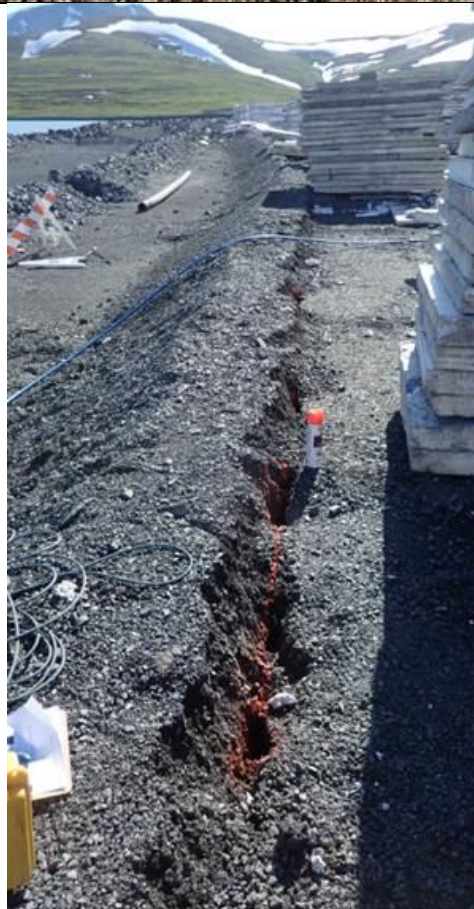
**PHOTO 34**

CRACKING NEAR THE  
UPSTREAM SELECT  
FILL/ROCKFILL INTERFACE  
FROM APPROX. STATION  
24+00 TO 28+00, LOOKING  
EAST

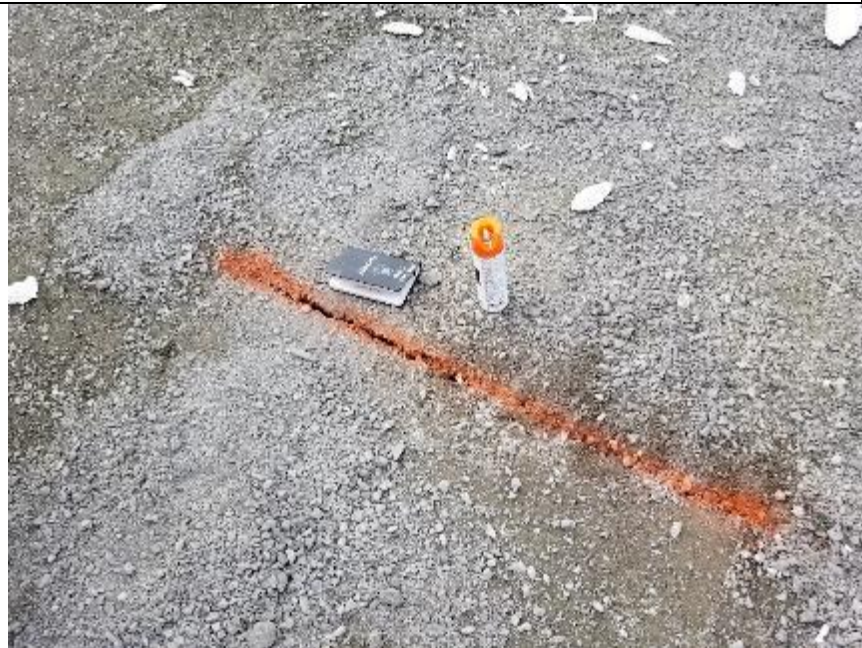
**Appendix A: Photographs****PHOTO 35**

- Minor cracking near the select fill centerline (Photo 35) was observed at multiple locations under the insulation board layer at approximately 1/8-inches wide and up to 4.5-inches deep, although typically to a shallower depth. This cracking occurred underneath and at the interface between two insulation boards. These cracks are likely attributable to surficial thermal contractions of the select fill and do not impact the performance of the TBD.

CRACKING OBSERVED AT  
CENTERLINE OF SELECT  
FILL AFTER INSULATION  
REMOVAL NEAR STATION  
35+75

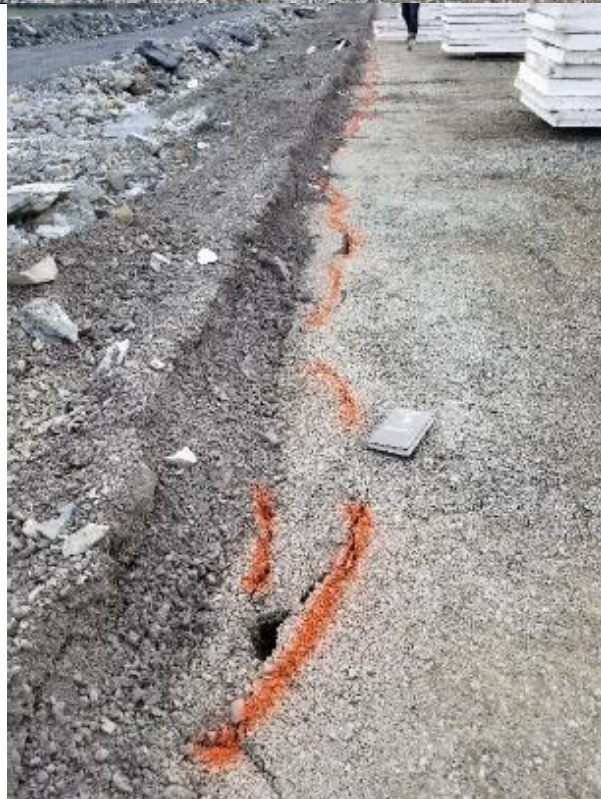
**PHOTO 36**

- Golder observed longitudinal cracking of both the upstream and downstream select fill/rockfill interface (Photos 36 and 37) of up to 1-foot deep. The upstream cracks occurred intermittently from approximately Station 23+75 to 37+00. Per design, this cracking is understood to be related to deformations from thaw consolidation of the previously frozen foundation materials below the rockfill and is not a stability concern.

CRACKING NEAR THE  
UPSTREAM SELECT  
FILL/ROCKFILL INTERFACE  
NEAR STATION 32+00,  
LOOKING EAST

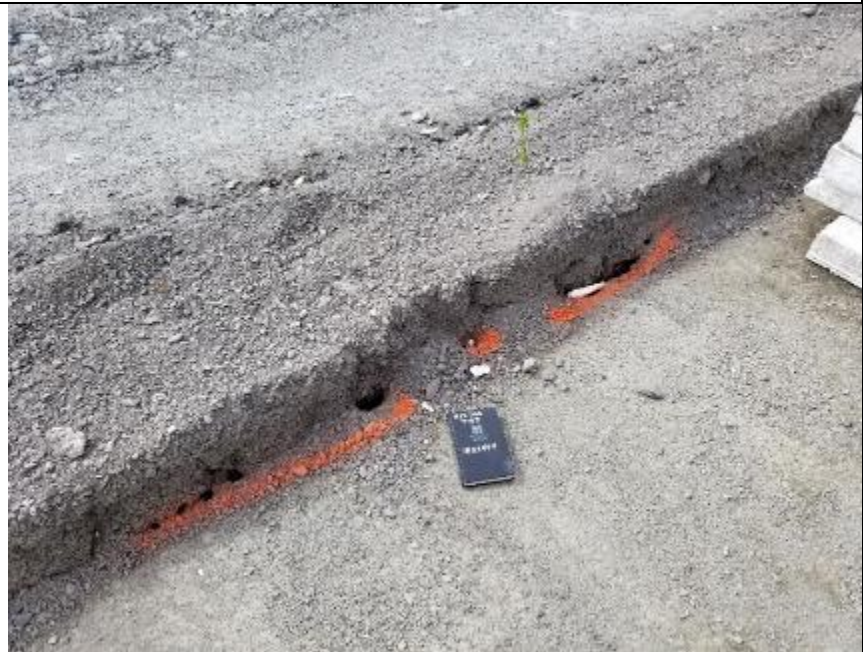
**Appendix A: Photographs****PHOTO 37**

CRACKING OF THE  
DOWNSTREAM SELECT  
FILL-ROCKFILL INTERFACE  
NEAR STATION 31+00
