October 24, 2019

Reference No. 18113464-005-L-Rev0

2019 ANNUAL PERFORMANCE REPORT FOR TAILINGS MAIN DAM, RED DOG MINE, ALASKA**Tailings and Water Team:**

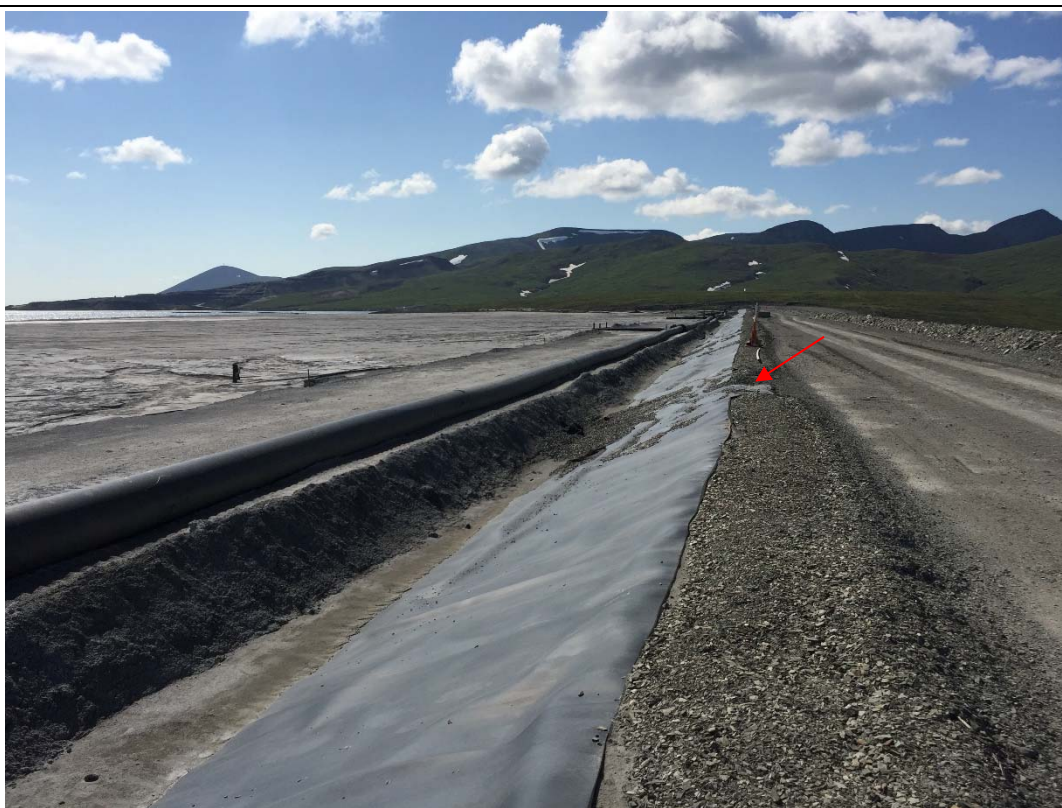
Appendix A: Photographs**PHOTO 5**

- The exposed upstream liner generally appeared to be in good condition, except for some liner damage observed near Stations 3+00, 19+00, and 51+ 00 (Photos 5 and 6). Teck was aware of this damage and

LINER DAMAGE
AT TMD
EMBANKMENT,
LOOKING W

Golder produced a technical memorandum (Golder 2019d) that summarized the defects and recommended repair methods. The defects were repaired according to the recommendations in the Golder technical memorandum (Golder 2019e).

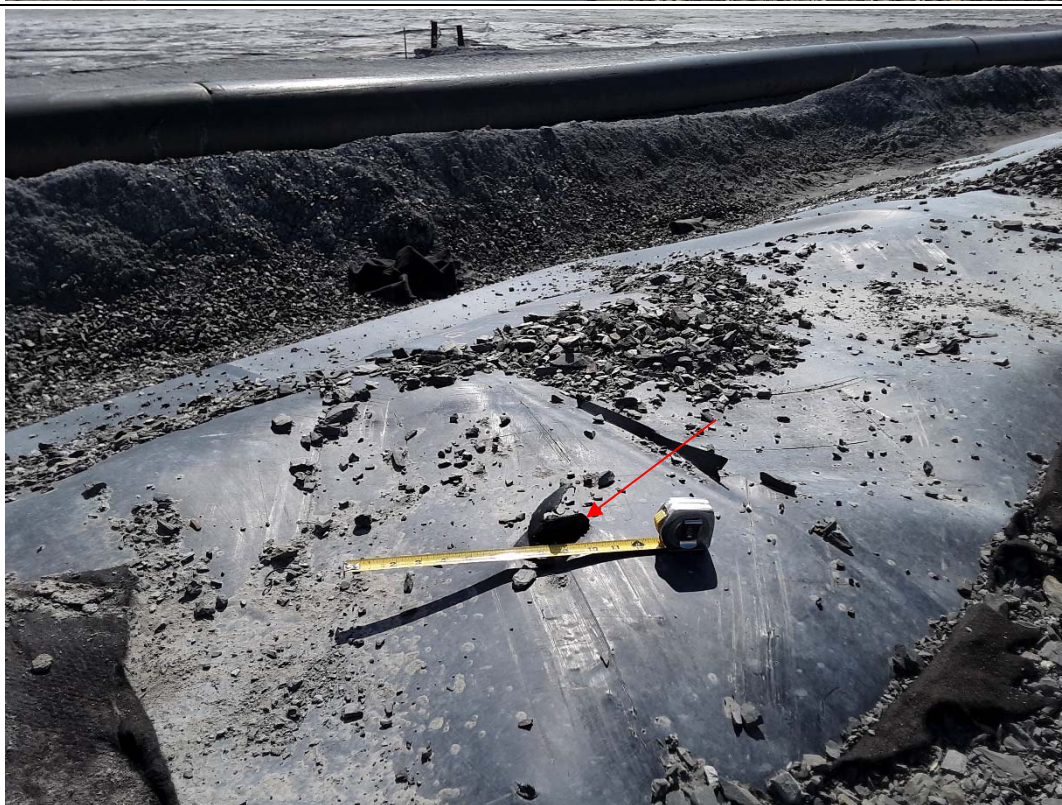
**PHOTO 6**

CLOSEUP OF
LINER DAMAGE

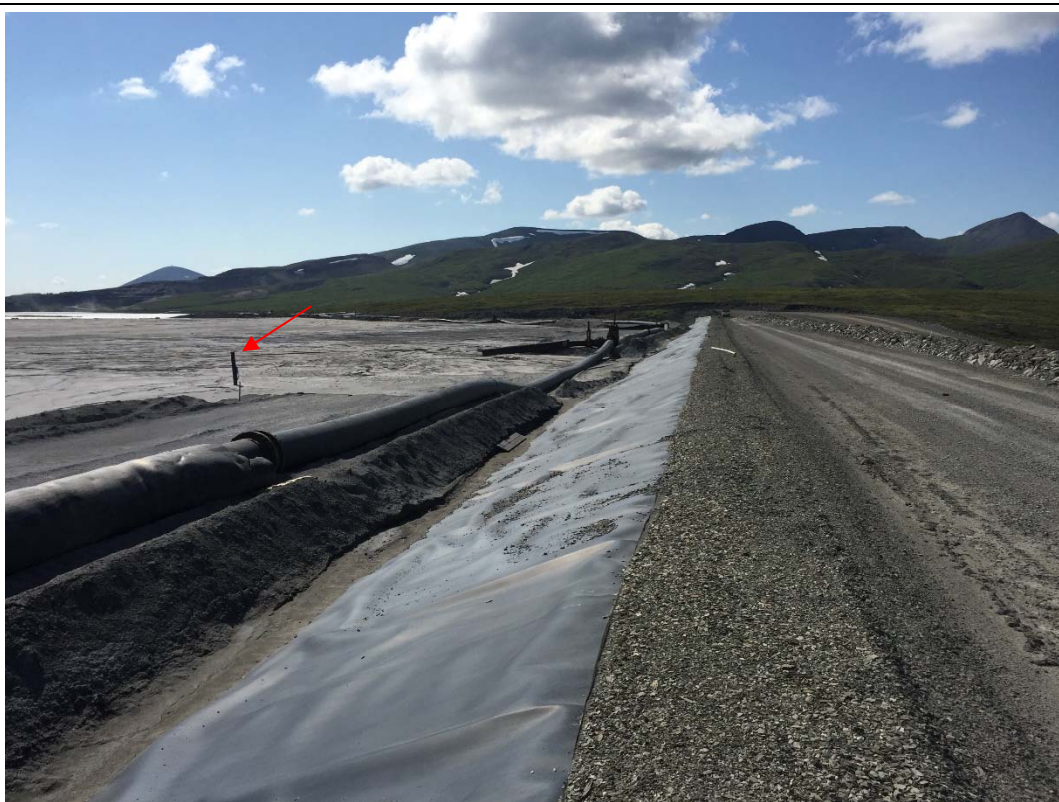
**PHOTO 8**

- The tailings beach appeared to be flatter and smoother as compared to observations during previous inspections (Photos 2, 5, and 7 to 9). An area where the tailings pipe bench had been washed out was observed near Piezometer P-11 (Photo 8).

PIPE BENCH
WASHOUT NEAR
PIEZOMETER
P-11, LOOKING
SW

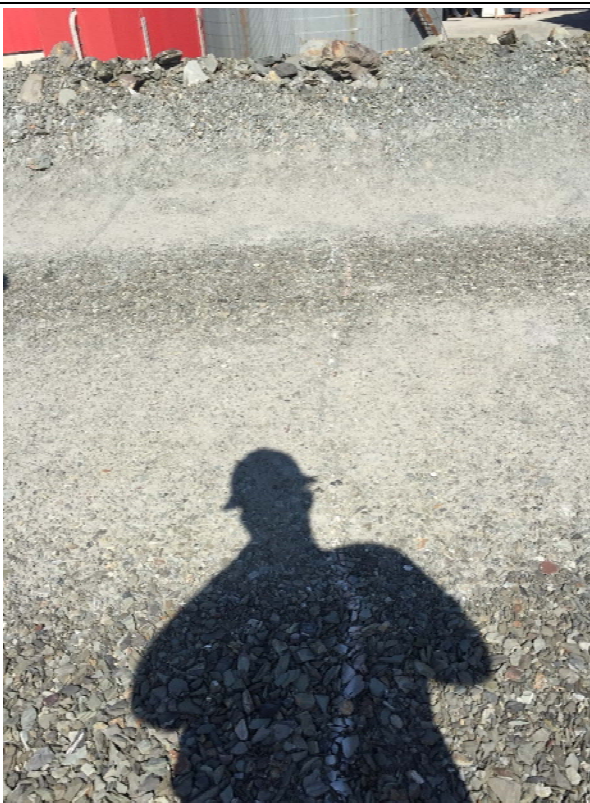
**PHOTO 11**

HISTORIC
TRANSVERSE
CRACK AT WING
WALL CREST,
LOOKING NE

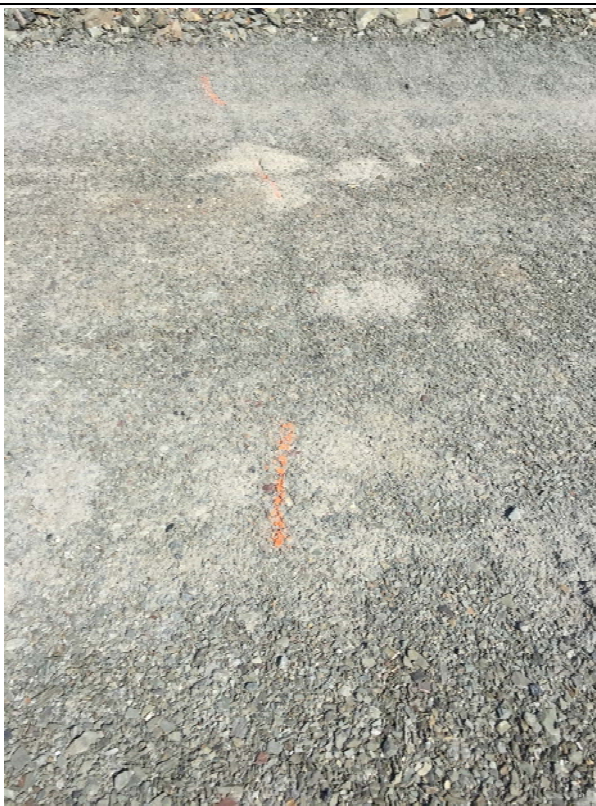
Appendix A: Photographs**PHOTO 14**

HISTORIC
TRANSVERSE
CRACK AT WING
WALL CREST,
LOOKING E

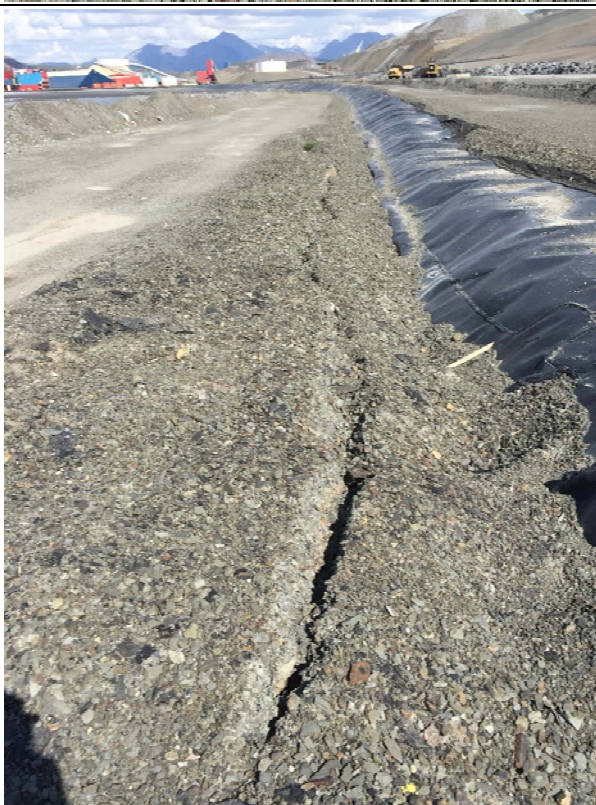
**PHOTO 15**

- Longitudinal cracking (Photos 15 and 16) was observed at the Wing Wall near Station 55+50 along the geomembrane anchor trench and attributed to the settlement of the anchor trench fill; therefore, it was not believed to be related to instability or movements of the embankment fill.

HISTORIC CRACK
ALONG STAGE X
WING WALL
UPSTREAM TOE,
LOOKING N

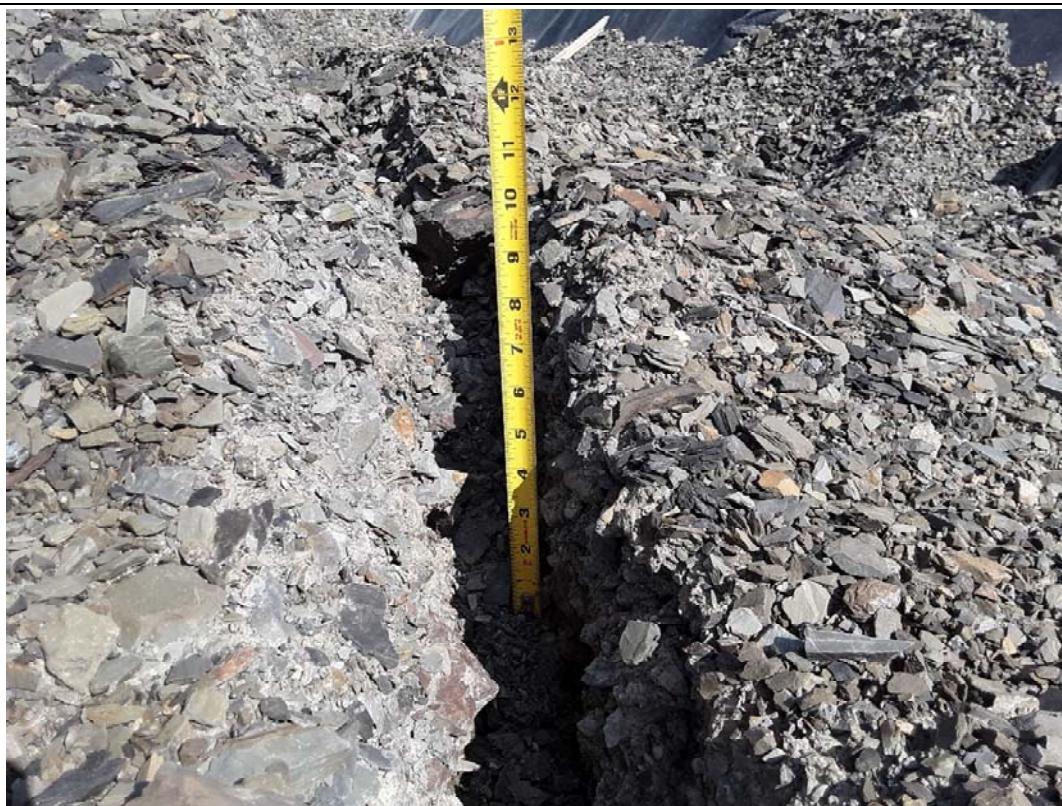
Appendix A: Photographs**PHOTO 16**

CLOSEUP OF
CRACK ALONG
STAGE X WING
WALL UPSTREAM
TOE, LOOKING N

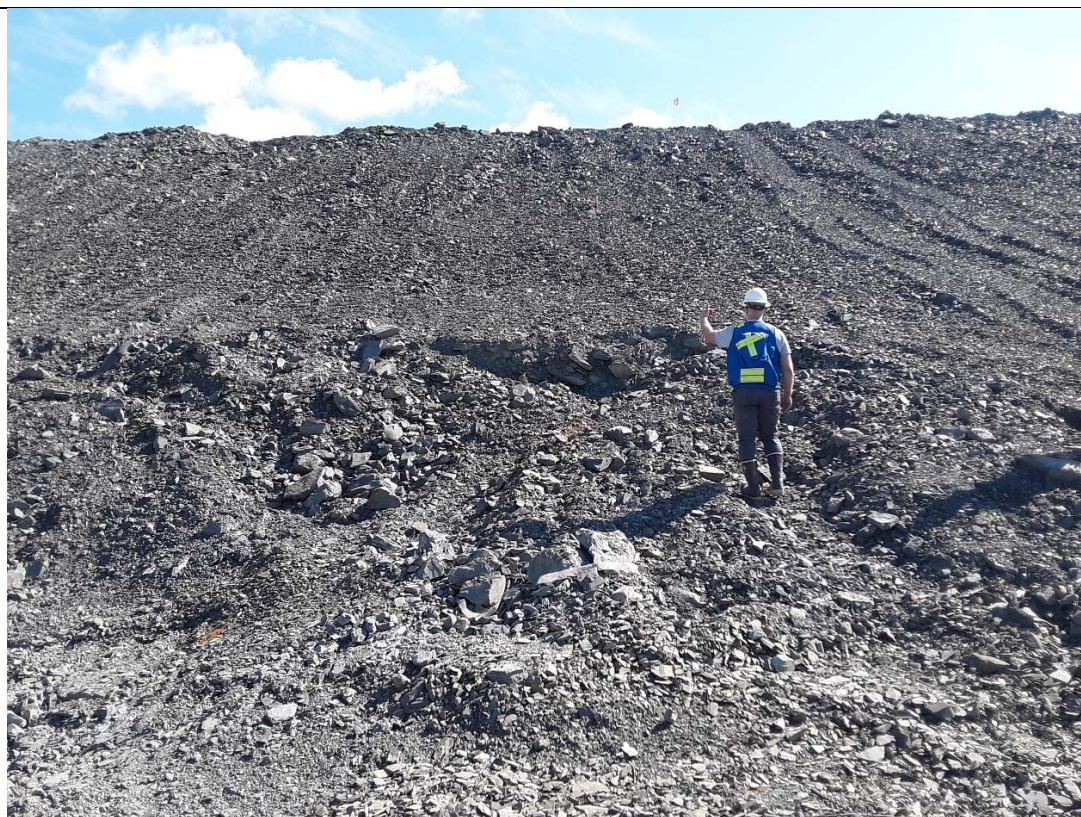
Appendix A: Photographs**PHOTO 24**

- Near the center of the downstream embankment buttress slope, an irregularity in the fill on the slope was noted (Photo 24). This was identified as a remnant from the 2018 construction and should be repaired as part of the 2019 construction.

TMD EMBANKMENT
DOWNSTREAM
BUTTRESS SLOPE,
LOOKING S

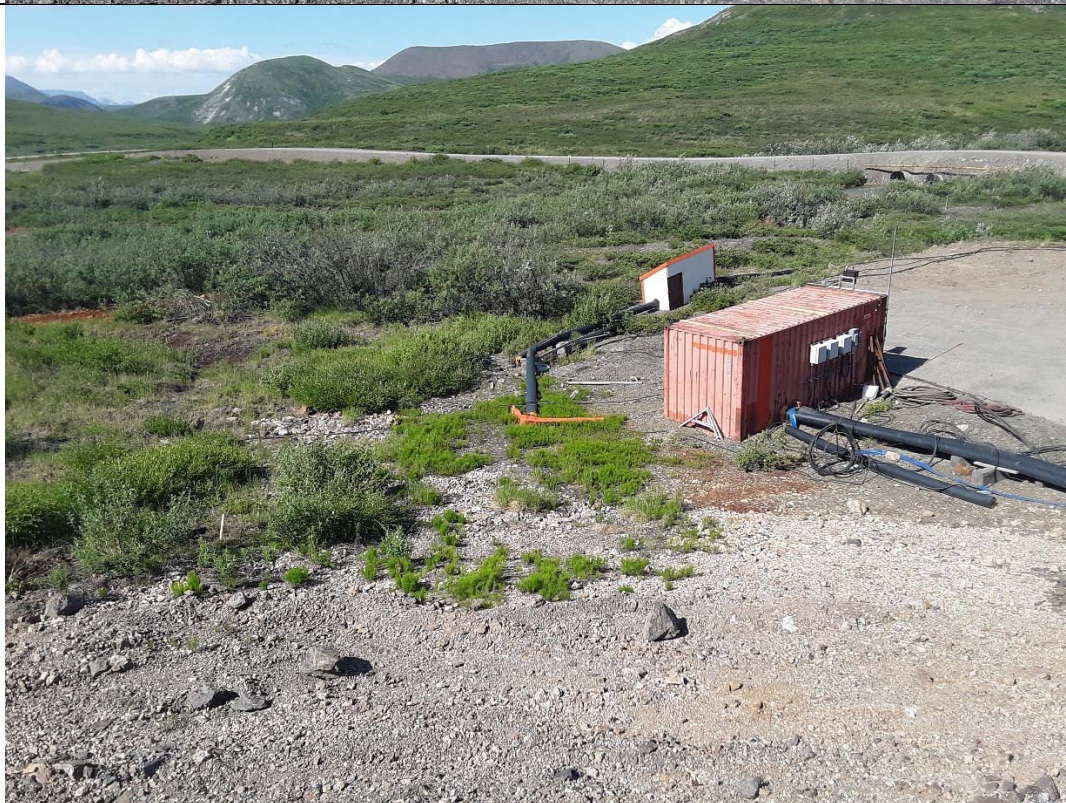
**PHOTO 27**

- The Seepage Collection Dam appeared to be in satisfactory condition with no indications of instability (Photos 25 and 26). The Seepage Seepage Pumpback located downstream of the Seepage Collection Dam was also observed (Photo 27) and did not appear to be actively pumping at that time.

SEEPAGE-SEEPAGE
PUMPBACK,
LOOKING N

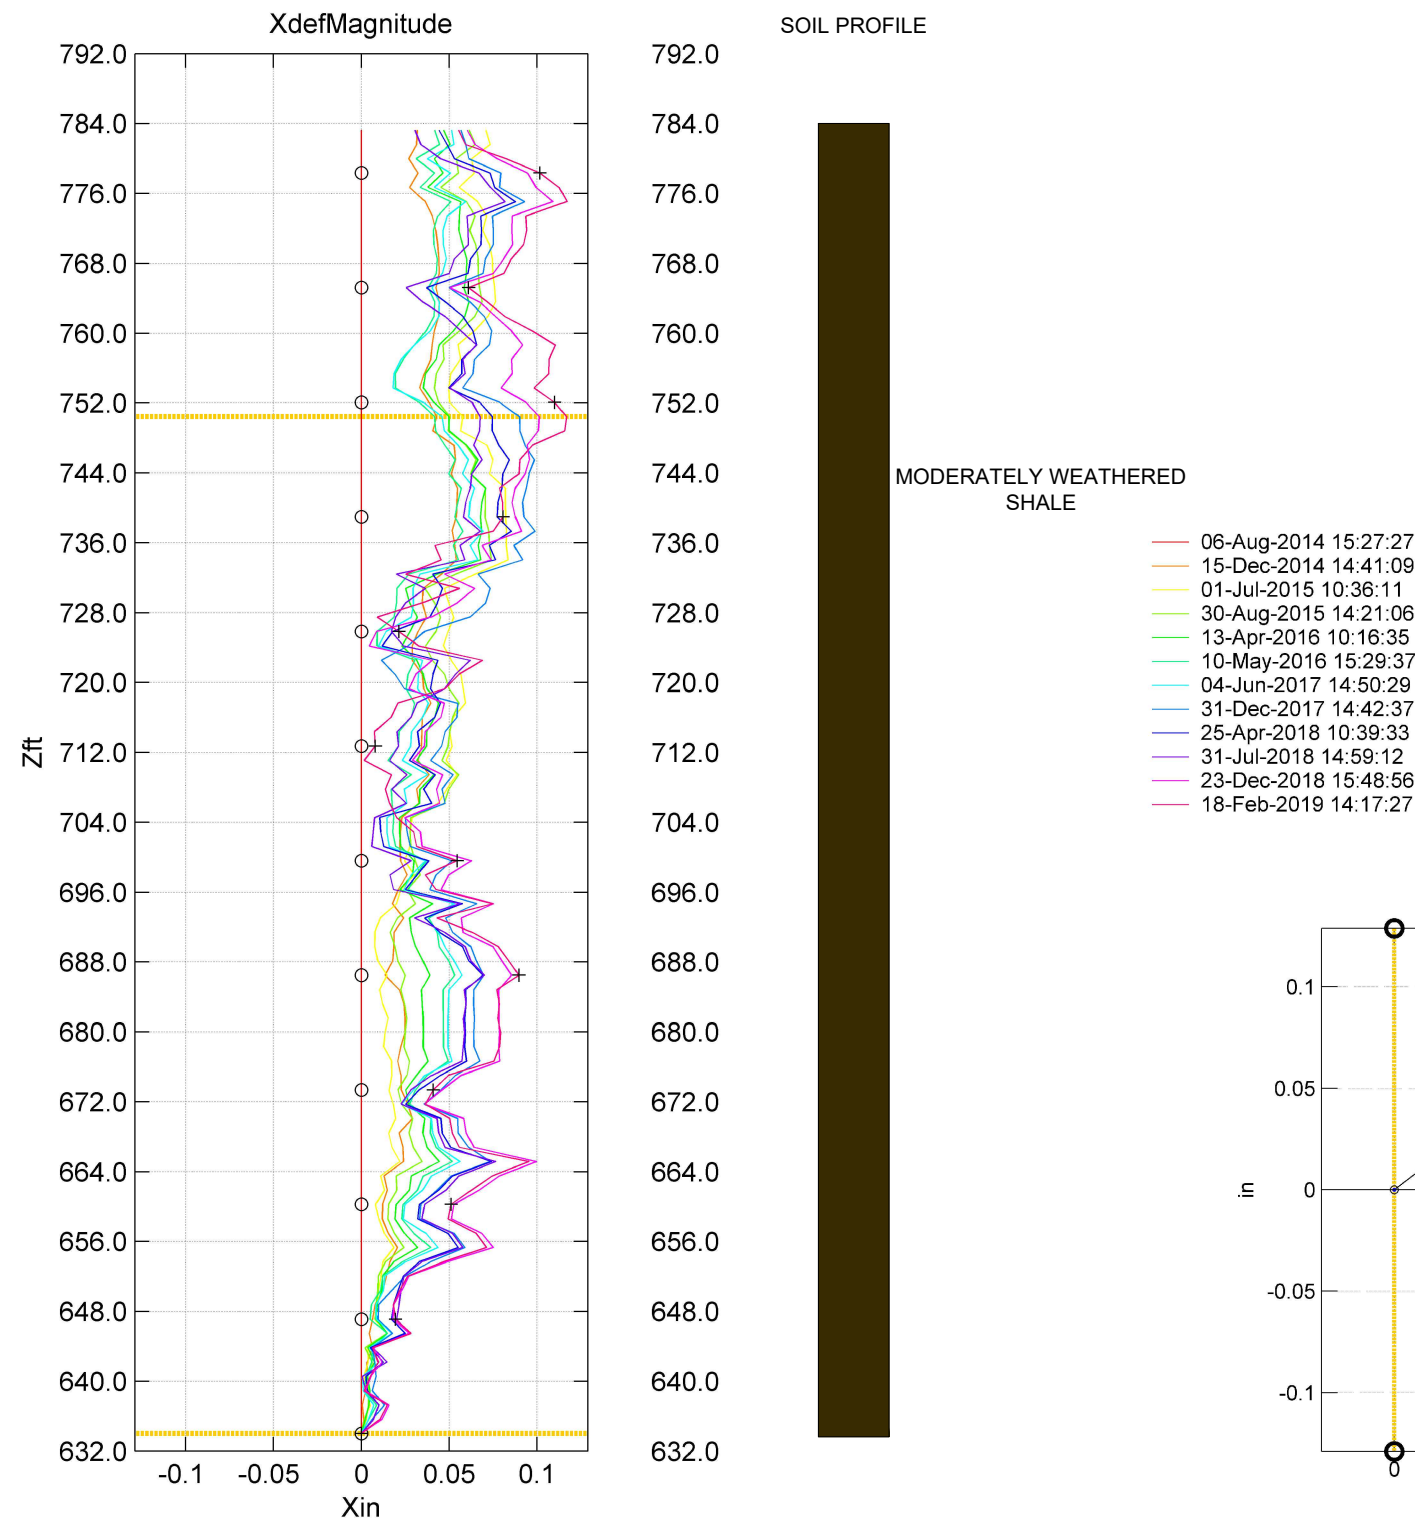
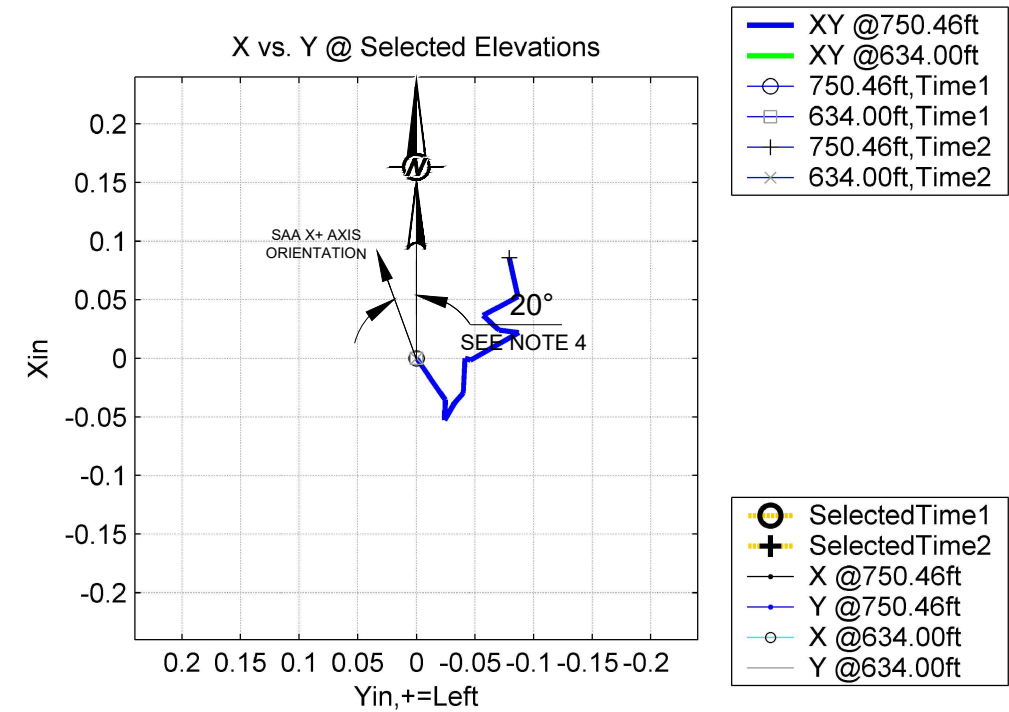
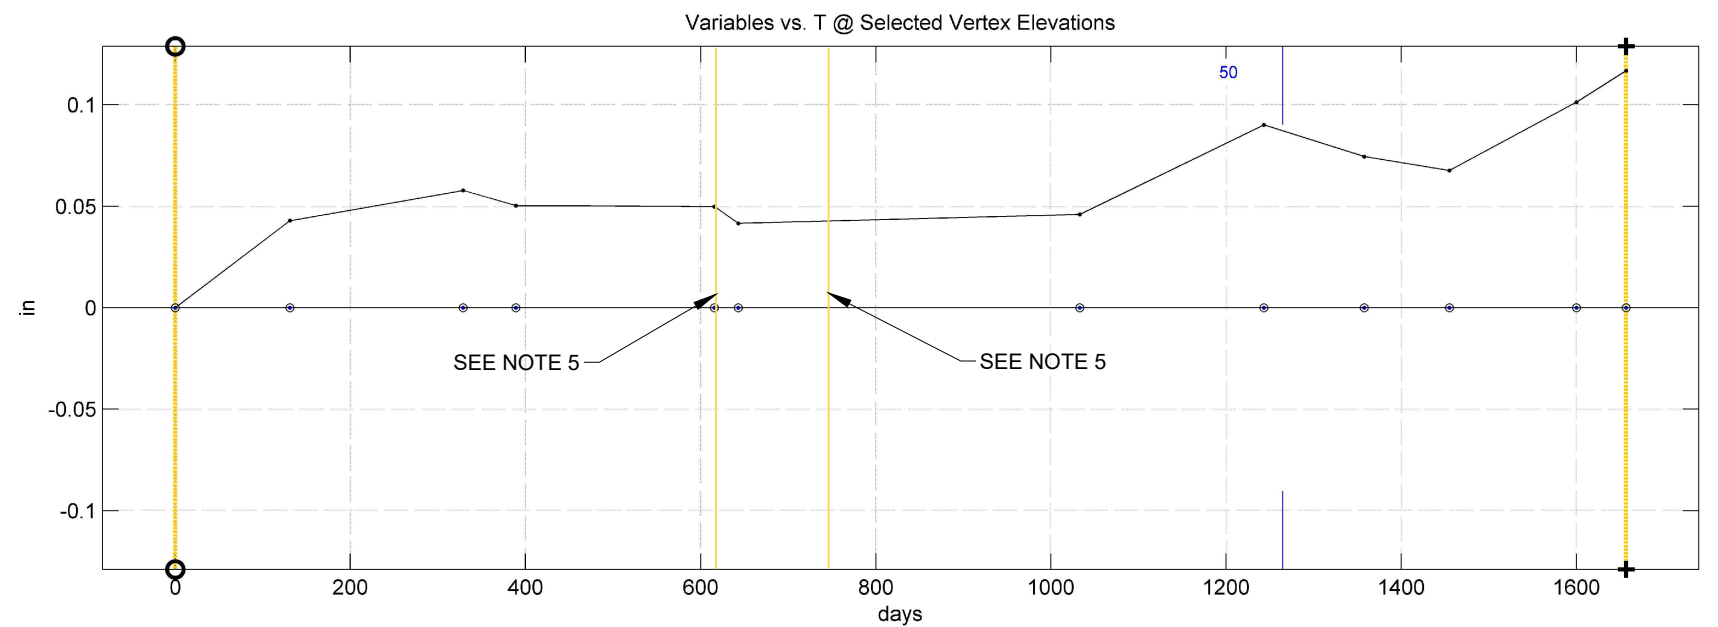
- **INC-03-14:** As shown in Figure C-3, INC-03-14 has recorded a cumulative maximum horizontal displacement of approximately 0.12 inches at an elevation of about 750 feet (since the August 2014 baseline). The cumulative direction of movement is approximate to the northeast, in the downstream direction. This displacement direction appears opposite to what was observed during the last APR (Golder 2019c) and is possibly related to the 2018 construction activities. Movements in the east-west direction appear to have occurred during the 2016 buttress construction and again during the 2018 construction season. Since the size of the movement is similar to the accuracy of the instrument, this unusual movement direction is not a concern. The average annual rate of cumulative displacement is about 0.03 inches per year. The SAA inclinometer monitoring data indicates the cumulative displacements and movement rates and are within the acceptable limits prescribed in the O&M Manual.
